**Flood Control Project Maintenance
Levee Inspections**

Maintenance Issue Types Only, Levee Inspection Report By Mile - Spring 2022

Lower San Joaquin Levee District

Waterway	Bank	Unit Miles	Inspection Start/End	Inspector
Unit No. 01 San Joaquin River	Right	22.52	04/05/2022 04/05/2022	Corey Fujitani

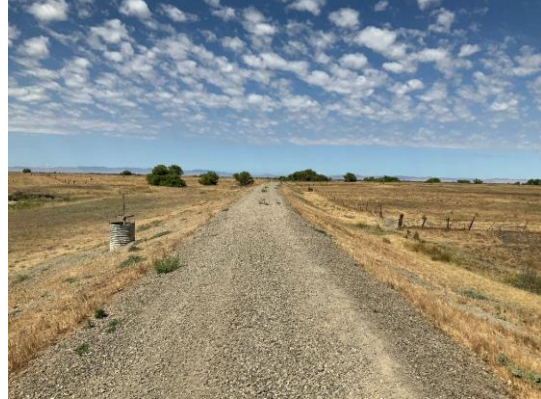
Photo 1 of 3 : UCIP_SP_2022_69554_103170.jpg

Comment Code						
Inspector Comment						
FS_ID:69554 DS_ID:19841 EP_NO: N/A Repair Type: Non-Urgent Crossing Status: Found UCIP Comments: 06/09/2021 The record remains Non-Urgent. Limited inspection of landside (LS) and WS due to water and mud. LS CMP riser has missing lid. WS outlet pipe edges are warped. No permit was found authorizing this encroachment. CVFPB will need to review crossing to determine owner. The UCIP inspection was completed with GEI staff, H.Dunn. (P.Espinoza ? GEI) 04/22/2014 Concrete headwalls on landward and waterward under water. Need photo to confirm condition of concrete headwalls, pipe, and gate on both toes. (W. Wylie - DWR UCIP) FIELD_STRUCT_DESC: 24-inch corrugated metal gravity drainage pipe through the levee, 18.7 feet below the crown. Slide gate in a 36-inch corrugated metal pipe (CMP) riser on the waterside (WS) slope. Concrete U-shaped headwall on each end. [Additional Reference(s): DWR Levee Log, 2002 (HLM 0.48), listed as a 24-inch corrugated metal pipe (CMP). USACE San Joaquin O&M Manual, Unit 601 Part 1 (SJR601.1), 1967, (HLM 0.47), listed as a 24-inch CMP]. FS Date: 6/9/2021 2:41:00 PM

Overview of levee from crown facing upstream. CMP riser visible on WS slope.

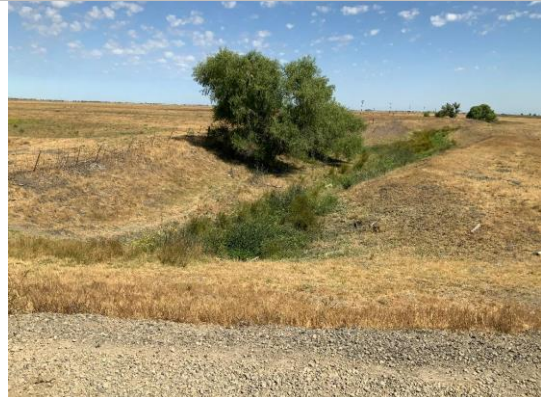
Photo 2 of 3 : UCIP_SP_2022_69554_103177.jpg

LS view: Toe from crown.

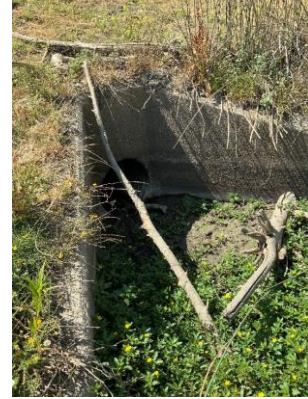
Photo 3 of 3 : UCIP_SP_2022_69554_103178.jpg

LS view: Concrete headwall and inlet pipe visible at toe.

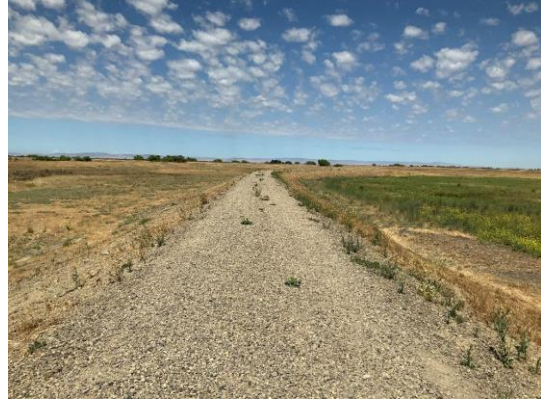
Photo 1 of 3 : UCIP_SP_2022_68984_103232.jpg

Comment Code						
Inspector Comment						
FS_ID:68984 DS_ID:19842 EP_NO: N/A Repair Type: Non-Urgent Crossing Status: Found UCIP Comments: 06/09/2021 The record remains Non-Urgent. DWR DMP internal inspection has not found pipe integrity issues. LOF of crossing is less or equal to 4.0. Recommend next video inspection in 5 years. No permit was found authorizing this encroachment. CVFPB will need to review crossing to determine owner. The UCIP inspection was completed with GEI staff, H.Dunn. (P.Espinoza ? GEI) 04/22/2014 Animal burrows in area on LS slope. Minor sediment buildup in pipe visible on landward side--recommend clearing. (W. Wylie - DWR UCIP) FIELD_STRUCT_DESC: 24-inch corrugated metal gravity drainage pipe through the levee, 8.7 feet below the crown. Flap gate on the waterside (WS) end. Concrete headwall on the landside (LS) end. Concrete U-shaped headwall on the WS end. [Additional Reference(s): DWR Levee Log, 2002 (HLM 0.70), listed as a 24-inch corrugated metal pipe (CMP). USACE San Joaquin O&M Manual, Unit 601 Part 1 (SJR601.1), 1967, (HLM 0.70), listed as a 24-inch CMP]. FS Date: 6/9/2021

View of levee crown.

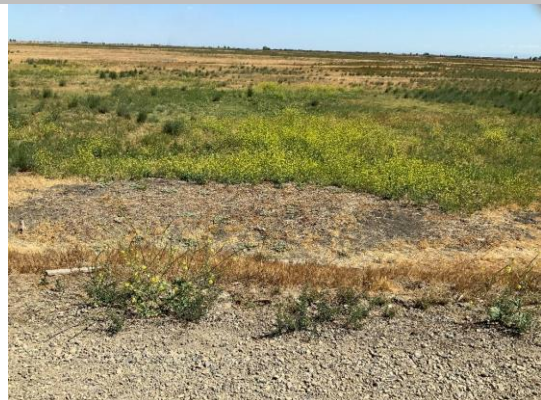
Photo 2 of 3 : UCIP_SP_2022_68984_103233.jpg

LS view: Slope from crown.

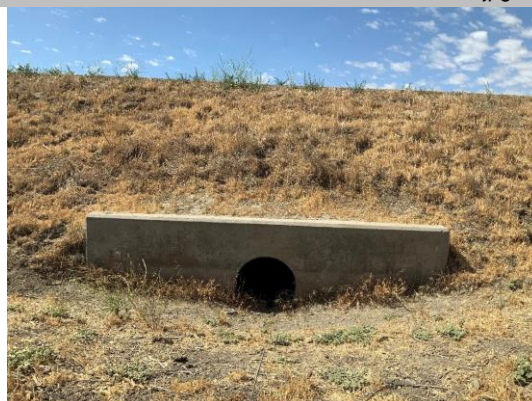
Photo 3 of 3 : UCIP_SP_2022_68984_103235.jpg

LS view: Concrete headwall and inlet pipe at toe.

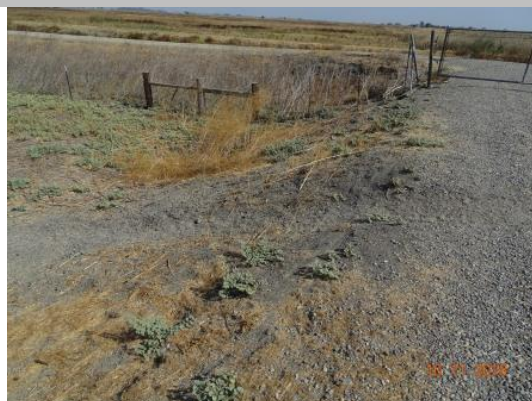
Photo 1 of 1 : SP_2022_NA0010_127_4_20220308_00001.jpg

LM Start	0.86	Rating **	A/W	Issue No.	4
LM End	0.86	Issue Type +	Ma	Location *	LS
Category	Earthen Levee			GPS Latitude/Longitude	
				Start	End
Item	Erosion / Livestock			37.220041 °	37.220041 °
				-120.698425 °	-120.698425 °
DWR ID	DWR_NA0010_09_f_2017_4				
Comment Code					
E4 : Repair the levee slope damaged by livestock and prevent large animal access.					
Inspector Comment					
Material has been placed over the animal erosion site. Monitor for settlement.

View of slope erosion due to foot traffic. (Fall 2018)

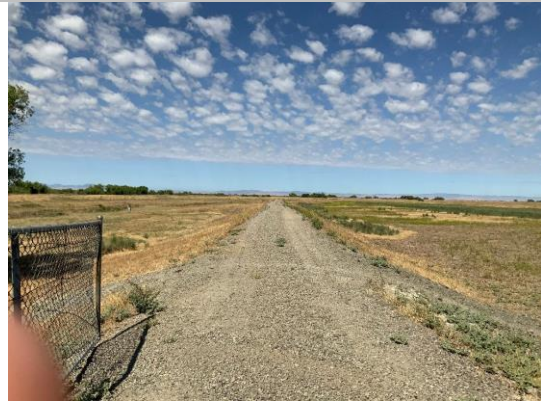
Photo 1 of 3 : UCIP_SP_2022_68989_103181.jpg

Comment Code						
Inspector Comment						
FS_ID:68989 DS_ID:19843 EP_NO: N/A Repair Type: Non-Urgent Crossing Status: Found UCIP Comments: 06/09/2021 The record has been upgraded from No Action Needed to Non-Urgent. No cover or handle on CMP riser on WS slope. Water in riser shows evidence that flapgate is open. Outlet pipe on WS toe not found. Dense vegetation and sediment limits inspectors ability to identify signs of inlet pipe condition on LS toe recommend removal of vegetation and sediment. LS inlet pipe appears to have slight warping around edges. No permit was found authorizing this encroachment. CVFPB will need to review crossing to determine owner. The UCIP inspection was completed with GEI staff, H.Dunn. (P.Espinoza ? GEI) FIELD_STRUCT_DESC: [Crane Irrigation Structure] 24-inch corrugated metal gravity drainage pipe through the levee, 9.7 feet below the crown. Two slide gates in a 48-inch corrugated metal pipe (CMP) riser on the waterside (WS) slope. Concrete U-shaped headwall on the landside (LS) end. WS end cobble revetted on the bank and in the outlet drain. [Additional Reference(s): DWR Levee Log, 2002 (HLM 0.87), listed as a 24-inch corrugated metal pipe (CMP). USACE San Joaquin O&M Manual, Unit 601 Part 1 (SJR601.1), 1967, (HLM 0.87), listed as a 24-inch CMP]. FS Date: 6/9/2021 4:30:00 PM

View of levee crown.

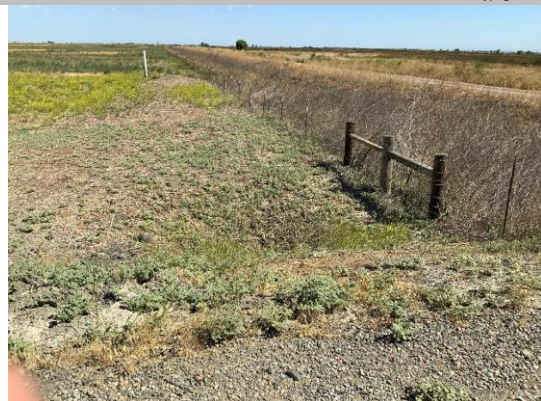
Photo 2 of 3 : UCIP_SP_2022_68989_103183.jpg

LS view: Toe from crown.

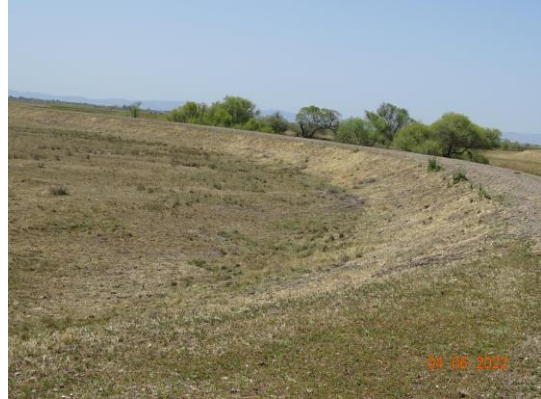
Photo 1 of 1 : SP_2022_NA0010_128_3_20220414_00005.jpg

LM Start	0.19	Rating **	A	Issue No.	3
LM End	0.19	Issue Type +	Ma	Location *	LS
Category	Earthen Levee			GPS Latitude/Longitude	
				Start	End
Item	Vegetation			37.219127 °	37.219127 °
				-120.708578 °	-120.708578 °
DWR ID	DWR_NA0010_10_s_2022_3				
Comment Code					
V1 : Control annual grass and weeds on the levee slopes and easements.					
Inspector Comment

View of vegetation management on the landside slope. (Spring 2022)

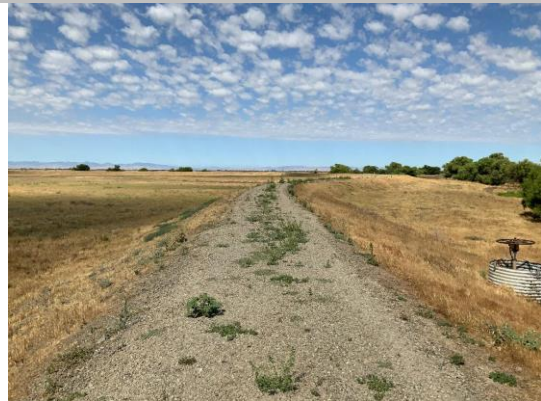
Photo 1 of 3 : UCIP_SP_2022_69817_103399.jpg

Comment Code					
Inspector Comment					
FS_ID:69817 DS_ID:19845 EP_NO: N/A Repair Type: Non-Urgent Crossing Status: Found UCIP Comments: 06/09/2021 The record remains Non-Urgent. No cover on CMP riser on WS slope, creating a safety hazard. Limited inspection of inlet pipe on LS and outlet pipe on WS due to elevated water levels around the headwalls and inlet/outlets, limiting the ability to inspect pipes at a close proximity. No permit was found authorizing this encroachment. CVFPB will need to review crossing to determine owner. The UCIP inspection was completed with GEI staff, H.Dunn. (P.Espinoza ? GEI) 04/22/2014 Inlet blocked at LS toe by wooden gate. Need to contact owner to determine status. (W. Wylie - DWR UCIP) FIELD_STRUCT_DESC: 36-inch corrugated metal gravity drainage pipe through the levee, 19.6 feet below the crown. Slide gate in a 48-inch corrugated metal pipe (CMP) riser on the waterside (WS) slope. Concrete U-shaped headwall on each end. [Additional Reference(s): DWR Levee Log, 2002 (HLM 0.31), listed as a 24-inch corrugated metal pipe (CMP). USACE San Joaquin O&M Manual, Unit 601 Part 1 (SJR601.1), 1967, (HLM 0.31), listed as a 24-inch CMP]. FS Date: 6/9/2021 11:34:00 AM

View of levee crown.

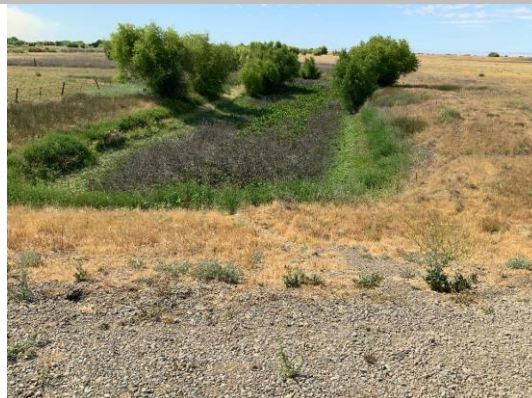
Photo 2 of 3 : UCIP_SP_2022_69817_103400.jpg

LS view: Toe from crown.

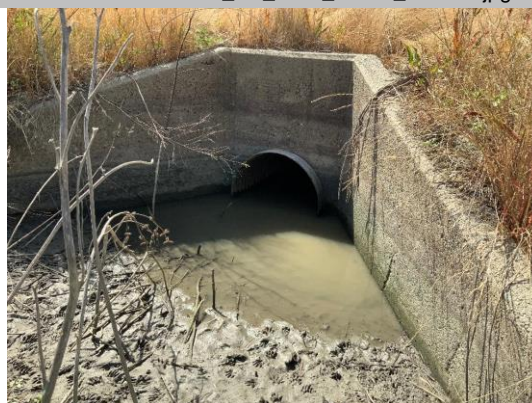
Photo 3 of 3 : UCIP_SP_2022_69817_103403.jpg

WS view: Concrete headwall and inlet pipe at toe.

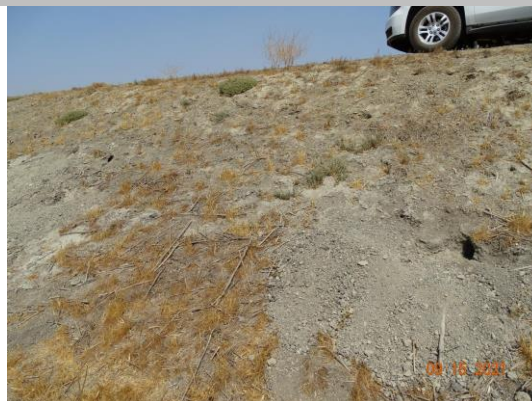
Photo 1 of 1 : SP_2022_NA0010_128_2_20220308_00001.jpg

LM Start	0.51	Rating **	M	Issue No.	2
LM End	0.51	Issue Type +	Ma	Location *	LS
Category	Earthen Levee			GPS Latitude/Longitude	
				Start	End
Item	Animal Control			37.219268 °	37.219268 °
				-120.703046 °	-120.703046 °
DWR ID	DWR_NA0010_10_f_2021_2				
Comment Code					
A3 : No rodents visible, but rodent burrows visible; need to backfill and compact or grout burrows.					
Inspector Comment

View squirrel holes on the landside slope. (Fall 2021)

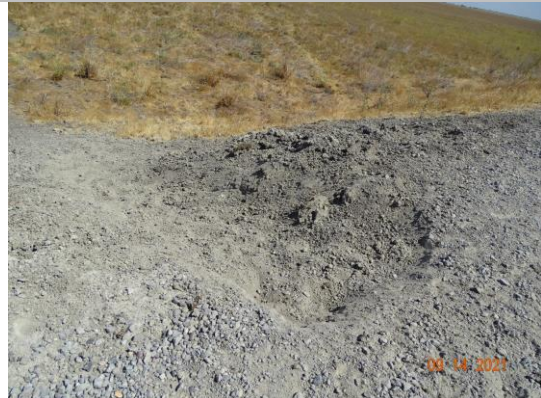
Photo 1 of 1 : SP_2022_NA0010_129_10_20220308_00002.jpg

LM Start	0.16	Rating **	M	Issue No.	10
LM End	0.16	Issue Type +	Ma	Location *	LS
Category	Earthen Levee			GPS Latitude/Longitude	
				Start	End
Item	Erosion / Livestock			37.202730 °	37.202730 °
				-120.752270 °	-120.752270 °
DWR ID	DWR_NA0010_11_f_2018_10				
Comment Code					
E4 : Repair the levee slope damaged by livestock and prevent large animal access.					
Inspector Comment					
Damage to the landside slope and shoulder.

View of livestock damage to the landside slope. (Fall 2021)

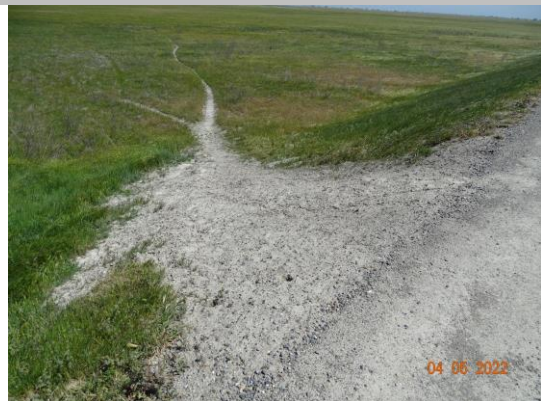
Photo 1 of 1 : SP_2022_NA0010_129_11_20220414_00035.jpg

LM Start	0.21	Rating **	A/W	Issue No.	11
LM End	0.21	Issue Type +	Ma	Location *	LS
Category	Earthen Levee			GPS Latitude/Longitude	
				Start	End
Item	Erosion / Livestock			37.202731 °	37.202731 °
				-120.751389 °	-120.751389 °
DWR ID	DWR_NA0010_11_f_2018_11				
Comment Code					
E4 : Repair the levee slope damaged by livestock and prevent large animal access.					
Inspector Comment					
Material has been placed on the levee damage. Monitor for settlement.

View of slope damage on landside. (Spring 2022)

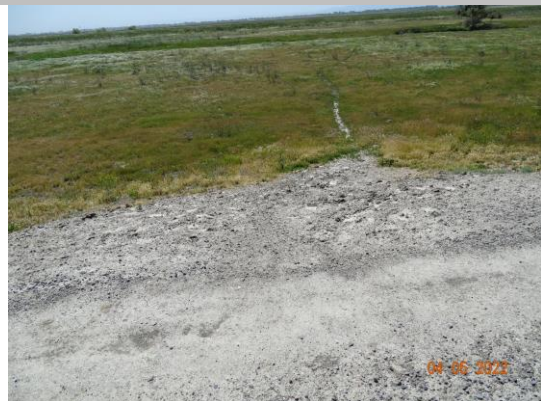
Photo 1 of 1 : SP_2022_NA0010_129_13_20220414_00036.jpg

LM Start	0.21	Rating **	A/W	Issue No.	13
LM End	0.21	Issue Type +	Ma	Location *	WS
Category	Earthen Levee			GPS Latitude/Longitude	
				Start	End
Item	Erosion / Livestock			37.202731 °	37.202731 °
				-120.751389 °	-120.751389 °
DWR ID	DWR_NA0010_11_s_2020_13				
Comment Code					
E4 : Repair the levee slope damaged by livestock and prevent large animal access.					
Inspector Comment					
Material has been placed on the levee damage. Monitor for settlement.

View of damage on waterside shoulder and slope. (Spring 2022)

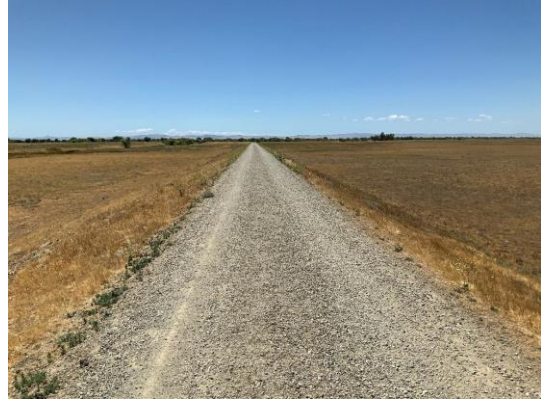
Photo 1 of 3 : UCIP_SP_2022_67619_100411.jpg

Comment Code						
Inspector Comment						
FS_ID:67619 DS_ID:19846 EP_NO: N/A Repair Type: Non-Urgent Crossing Status: Found UCIP Comments: 06/8/2021 The record remains Non-Urgent. WS pipe end either completely buried under dirt or has been removed. Only riser visible on WS slope, pipe end not visible at all. Recommend contacting owner to determine status of pipe. No permit was found authorizing this encroachment. CVFPB will need to review crossing to determine owner. The UCIP inspection was completed with GEI staff, P. Espinoza. (H. Dunn- GEI) 04/18/201 Need to contact owner. Recommend clearing sediment deposit inside pipe. (O. Magana - DWR UCIP) FIELD_STRUCT_DESC: 24-inch corrugated metal gravity drainage pipe through the levee, 11 feet below the crown. Slide gate in a corrugated metal pipe (CMP) riser on the waterside (WS) end. [Additional Reference(s): DWR Levee Log, 2002 (HLM 0.43), listed as a 24-inch corrugated metal pipe (CMP). USACE San Joaquin O&M Manual, Unit 601 Part 1 (SJR601.1), 1967, (HLM 0.42), listed as a 24-inch CMP]. FS Date: 6/8/2021

Levee crown looking downstream.

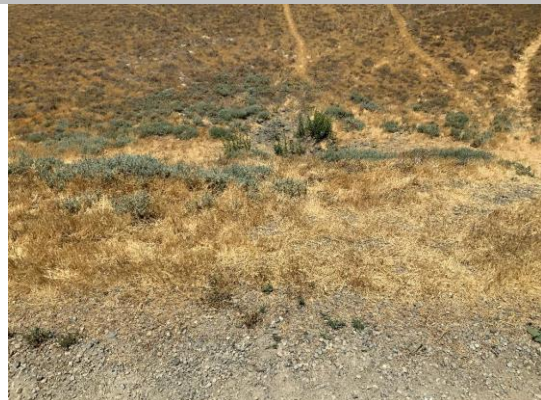
Photo 2 of 3 : UCIP_SP_2022_67619_100408.jpg

LS view: Toe from crown.

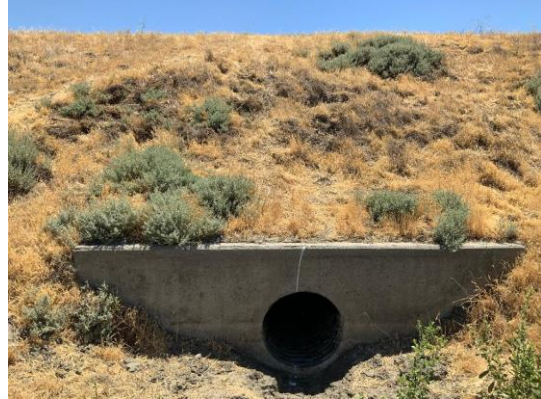
Photo 3 of 3 : UCIP_SP_2022_67619_100409.jpg

LS view: Slope and headwall at toe.

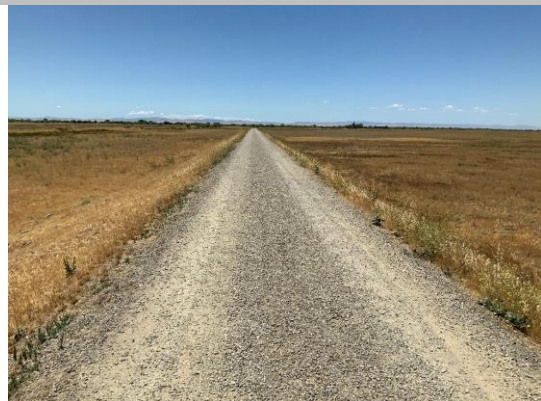
Photo 1 of 3 : UCIP_SP_2022_67927_100419.jpg

FS_ID:67927
 DS_ID:19847
 EP_NO: N/A
 Repair Type: Non-Urgent
 Crossing Status: Found
 UCIP Comments: 06/8/2021 The record remains Non-Urgent. DWR DMP internal inspection has not found pipe integrity issues. LOF of crossing is less or equal to 4.0. Recommend next video inspection in 5 years. No permit was found authorizing this encroachment. CVFPB will need to review crossing to determine owner. The UCIP inspection was completed with GEI staff, P. Espinoza. (H. Dunn - GEI) 04/18/201
 Need to contact owner. Recommend clearing sediment deposit inside pipe. (O. Magana - DWR UCIP)
 FIELD_STRUCT_DESC: 24-inch corrugated metal gravity drainage pipe through the levee, 10 feet below the crown. Flap gate on the waterside (WS) end. [Additional Reference(s): DWR Levee Log, 2002 (HLM 0.65), listed as a 24-inch corrugated metal pipe (CMP). USACE San Joaquin O&M Manual, Unit 601 Part 1 (SJR601.1), 1967, (HLM 0.65), listed as a 24-inch CMP].

Levee crown looking downstream.

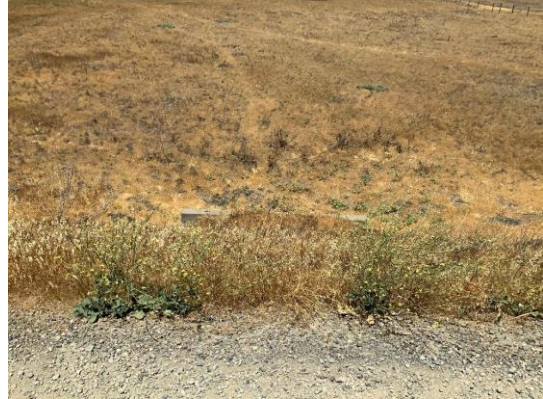
Photo 2 of 3 : UCIP_SP_2022_67927_100416.jpg

LS view: Headwall visible at toe from crown.

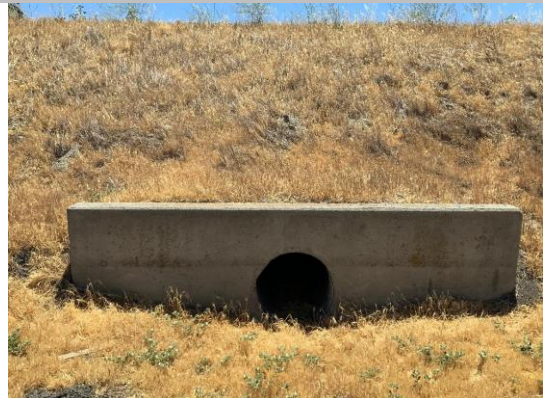
Photo 3 of 3 : UCIP_SP_2022_67927_100417.jpg

LS view: Slope and headwall at toe.

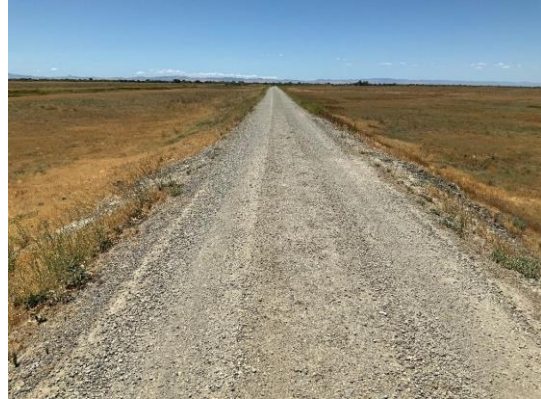
Photo 1 of 3 : UCIP_SP_2022_67621_100425.jpg

Comment Code					
Inspector Comment					
FS_ID:67621 DS_ID:19848 EP_NO: N/A Repair Type: Non-Urgent Crossing Status: Found UCIP Comments: 06/8/2021 The record remains Non-Urgent. DWR DMP internal inspection has not found pipe integrity issues. LOF of crossing is less or equal to 4.0. Recommend next video inspection in 5 years. No permit was found authorizing this encroachment. CVFPB will need to review crossing to determine owner. The UCIP inspection was completed with GEI staff, P. Espinoza. (H. Dunn - GEI) 04/18/201 Need to contact owner. Recommend clearing sediment deposit inside pipe. (O. Magana - DWR UCIP) FIELD_STRUCT_DESC: 24-inch corrugated metal gravity drainage pipe through the levee, 10.3 feet below the crown. Flap gate on the waterside (WS) end. [Additional Reference(s): DWR Levee Log, 2002 (HLM 0.85), listed as a 24-inch corrugated metal pipe (CMP). USACE San Joaquin O&M Manual, Unit 601 Part 1 (SJR601.1), 1967, (HLM 0.84), listed as a 24-inch CMP]. FS Date: 6/8/2021

Levee crown looking downstream.

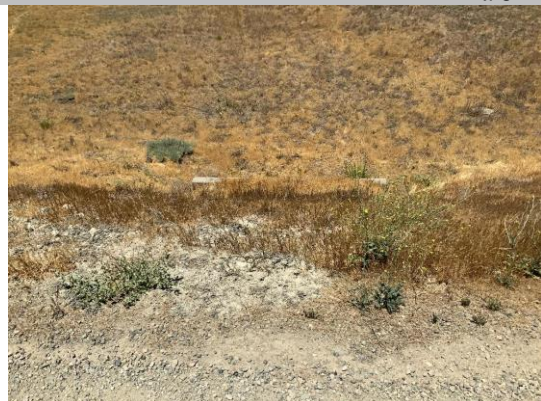
Photo 2 of 3 : UCIP_SP_2022_67621_100429.jpg

LS view: Toe from crown.

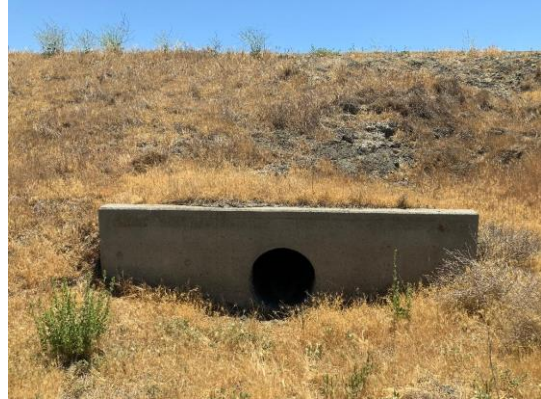
Photo 3 of 3 : UCIP_SP_2022_67621_100423.jpg

LS view: Headwall and slope from toe.

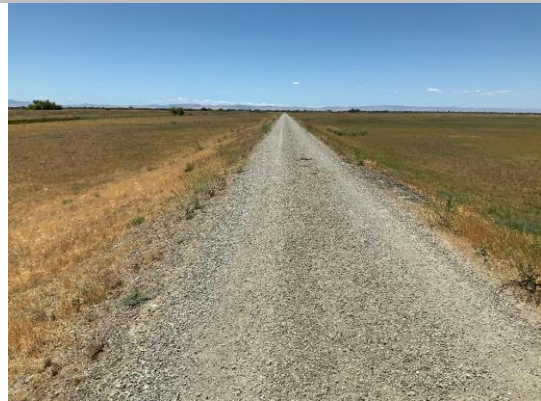
Photo 1 of 3 : UCIP_SP_2022_67622_100431.jpg

Levee crown looking downstream.

Comment Code					
Inspector Comment					
FS_ID:67622 DS_ID:19849 EP_NO: N/A Repair Type: Non-Urgent Crossing Status: Found UCIP Comments: 06/8/2021 The record remains Non-Urgent. DWR DMP internal inspection has not found pipe integrity issues. LOF of crossing is less or equal to 4.0. Recommend next video inspection in 5 years. Dense tumbleweeds blocking both LS and WS ends, recommend removal. No permit was found authorizing this encroachment. CVFPB will need to review crossing to determine owner. The UCIP inspection was completed with GEI staff, P. Espinoza. (H. Dunn - GEI) 04/18/2014 Need to contact owner. Recommend clearing sediment deposit inside pipe. (O. Magana - DWR UCIP) FIELD_STRUCT_DESC: 24-inch corrugated metal gravity drainage pipe through the levee, 9 feet below the crown. Flap gate on the waterside (WS) end. [Additional Reference(s): DWR Levee Log, 2002 (HLM 1.13), listed as a 24-inch corrugated metal pipe (CMP). USACE San Joaquin O&M Manual, Unit 601 Part 1 (SJR601.1), 1967, (HLM 1.13), listed as a 24-inch CMP]. FS Date: 6/8/2021

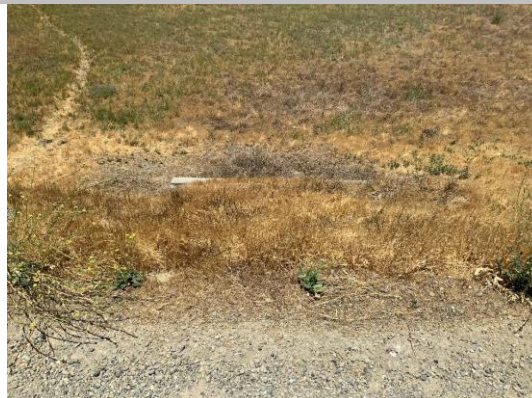
Photo 2 of 3 : UCIP_SP_2022_67622_100435.jpg

LS view: Headwall visible at toe from crown.

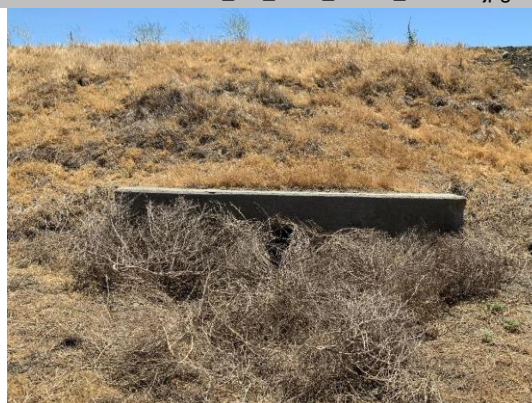
Photo 3 of 3 : UCIP_SP_2022_67622_100436.jpg

LS view: Headwall and slope at toe.

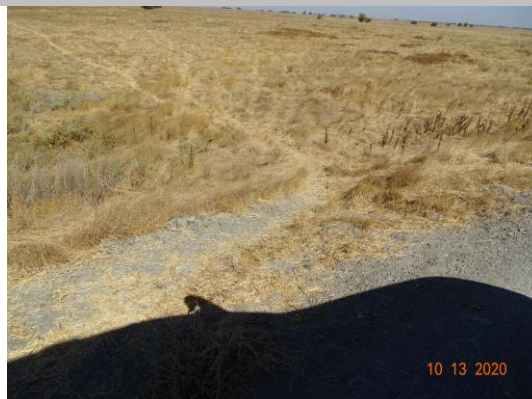
Photo 1 of 1 : SP_2022_NA0010_129_9_20220308_00001.jpg

LM Start	1.49	Rating **	A/W	Issue No.	9
LM End	1.49	Issue Type +	Ma	Location *	LS
Category	Earthen Levee			GPS Latitude/Longitude	
				Start	End
Item	Erosion / Livestock			37.202748 °	37.202748 °
				-120.728182 °	-120.728182 °
DWR ID	DWR_NA0010_11_f_2017_9				
Comment Code					
E4 : Repair the levee slope damaged by livestock and prevent large animal access.					
Inspector Comment

View of livestock trail on the landside slope. (Fall 2020)

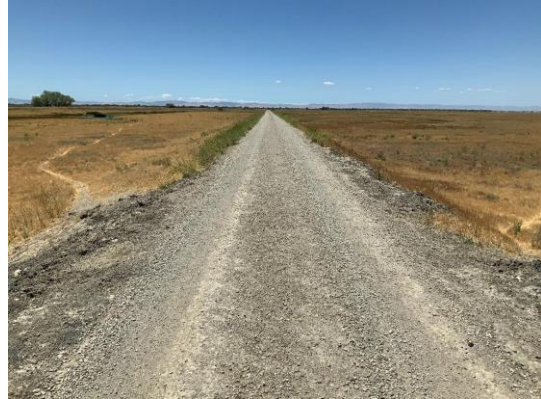
Photo 1 of 3 : UCIP_SP_2022_67623_100441.jpg

Comment Code					
Inspector Comment					
FS_ID:67623 DS_ID:19850 EP_NO: N/A Repair Type: Non-Urgent Crossing Status: Found UCIP Comments: 06/8/2021 The record remains Non-Urgent. Sediment buildup in both WS and LS pipe inlet and outlet, recommend clearing out. WS pipe edges are slightly warped. No permit was found authorizing this encroachment. CVFPB will need to review crossing to determine owner. The UCIP inspection was completed with GEI staff, P. Espinoza. (H. Dunn - GEI) 04/18/2014 Need to contact owner. Recommend clearing sediment deposit inside pipe. (O. Magana - DWR UCIP) FIELD_STRUCT_DESC: 48-inch corrugated metal gravity drainage pipe through the levee, 16.3 feet below the crown. Slide gate in a pipe riser on the waterside (WS) slope. [Additional Reference(s): DWR Levee Log, 2002 (HLM 1.50), listed as a 48-inch corrugated metal pipe (CMP). USACE San Joaquin O&M Manual, Unit 601 Part 1 (SJR601.1), 1967, (HLM 1.50), listed as a 48-inch CMP]. FS Date: 6/8/2021

Levee crown looking downstream.

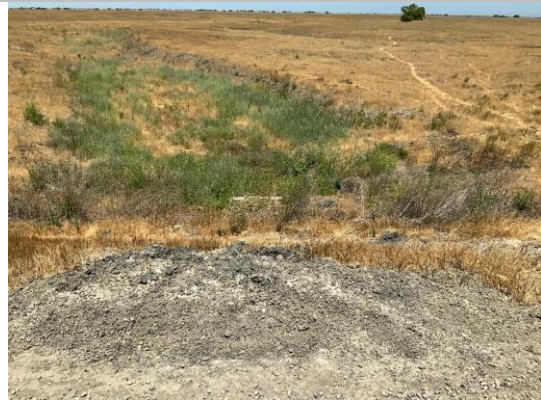
Photo 2 of 3 : UCIP_SP_2022_67623_100438.jpg

LS view: Headwall visible at toe from crown.

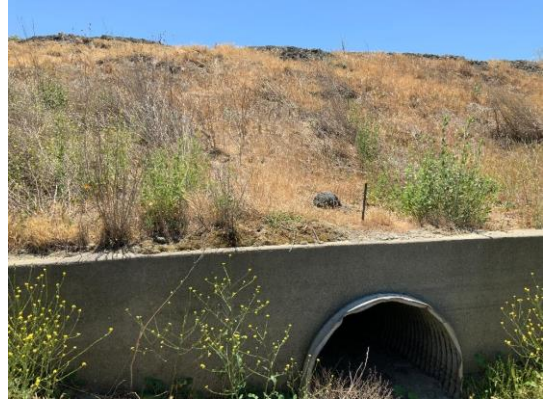
Photo 3 of 3 : UCIP_SP_2022_67623_100439.jpg

LS view: Slope and headwall from toe.

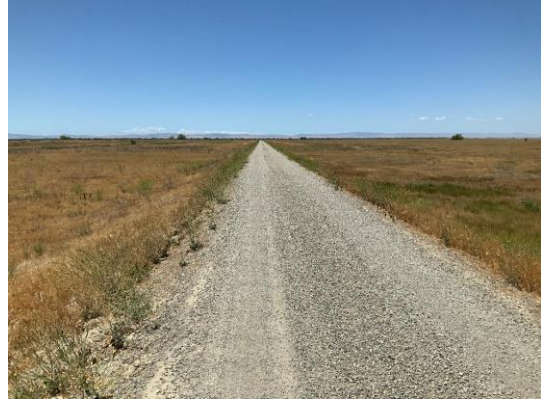
Photo 1 of 3 : UCIP_SP_2022_67624_100447.jpg

Comment Code					
Inspector Comment					
FS_ID:67624					
DS_ID:19851					
EP_NO: N/A					
Repair Type: Non-Urgent					
Crossing Status: Found					
UCIP Comments: 06/8/2021 The record remains Non-Urgent. DWR					
DMP internal inspection has found pipe integrity issues. LOF of					
crossing is between 4.1 and 5. Crossing will be monitored until funding					
becomes available for rehabilitation. Vegetation on both WS and LS					
ends, recommend removal. No permit was found authorizing this					
encroachment. CVFPB will need to review crossing to determine owner.					
The UCIP inspection was completed with GEI staff, P. Espinoza. (H.					
Dunn - GEI) 04/18/201 Need to contact owner. Recommend clearing					
sediment deposit inside pipe. (O. Magana - DWR UCIP)					
FIELD_STRUCT_DESC: 24-inch corrugated metal gravity drainage					
pipe through the levee, 12.8 feet below the crown. Flap gate on the					
waterside (WS) end. [Additional Reference(s): DWR Levee Log, 2002

Levee crown looking downstream.

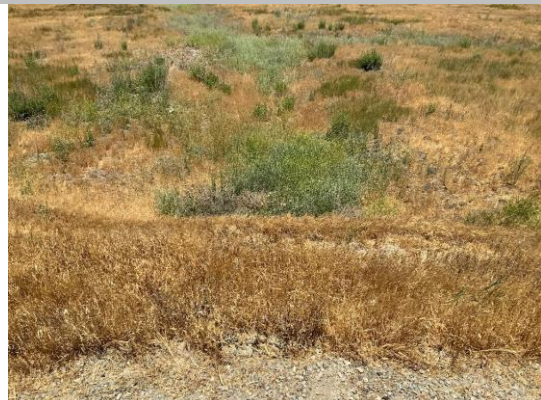
Photo 2 of 3 : UCIP_SP_2022_67624_100444.jpg

LS view: Toe from crown.

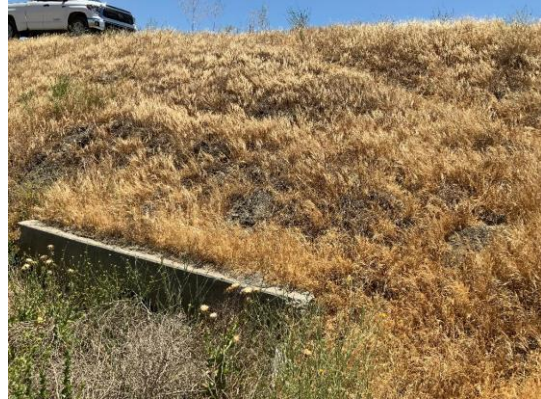
Photo 3 of 3 : UCIP_SP_2022_67624_100445.jpg

LS view: Headwall and slope from toe.

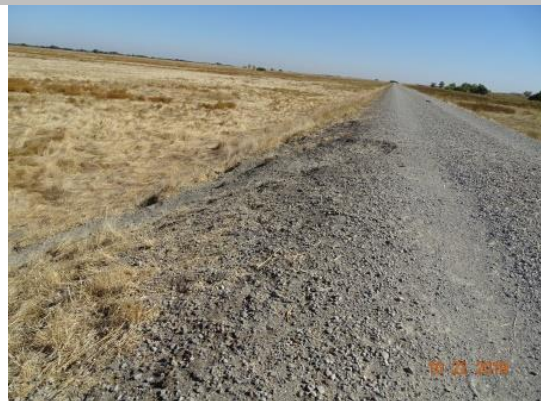
Photo 1 of 1 : SP_2022_NA0010_129_17_20220308_00007.jpg

LM Start	2.31	Rating **	M	Issue No.	17
LM End	2.31	Issue Type +	Ma	Location *	LS
Category	Earthen Levee			GPS Latitude/Longitude	
				Start	End
Item	Erosion / Livestock			37.202730 °	37.202730 °
				-120.713368 °	-120.713368 °
DWR ID	DWR_NA0010_11_f_2019_17				
Comment Code					
E4 : Repair the levee slope damaged by livestock and prevent large animal access.					
Inspector Comment

Damage to the landside slope from livestock traffic. (Fall 2019)

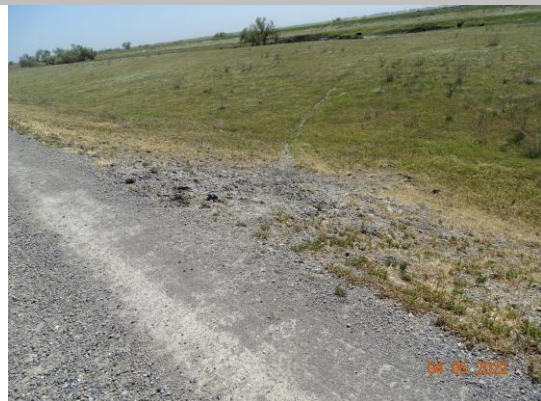
Photo 1 of 2 : SP_2022_NA0010_129_12_20220414_00037.jpg

LM Start	2.46	Rating **	A/W	Issue No.	12
LM End	2.46	Issue Type +	Ma	Location *	LS
Category	Earthen Levee			GPS Latitude/Longitude	
				Start	End
Item	Erosion / Livestock			37.202712 °	37.202712 °
				-120.710633 °	-120.710633 °
DWR ID	DWR_NA0010_11_f_2018_12				
Comment Code					
E4 : Repair the levee slope damaged by livestock and prevent large animal access.					
Inspector Comment					
Damage is from livestock to both landside and waterside slopes.

View of the landside slope. (Spring 2022)

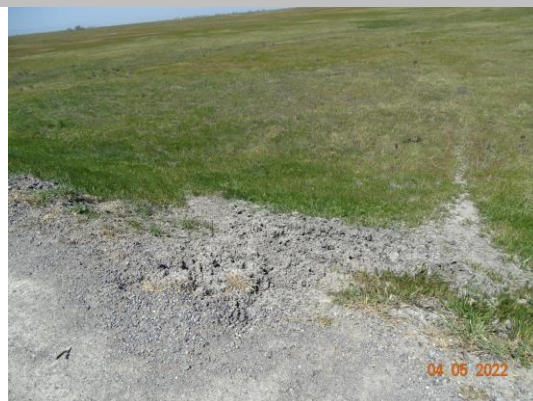
Photo 2 of 2 : SP_2022_NA0010_129_12_20220414_00038.jpg

View of the waterside slope. (Spring 2022)

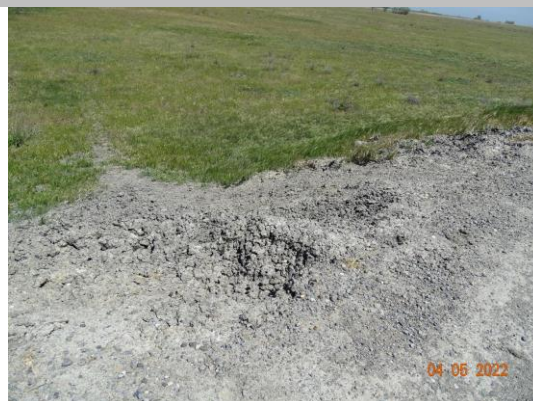
Photo 1 of 1 : SP_2022_NA0010_129_16_20220414_00039.jpg

LM Start	2.52	Rating **	A/W	Issue No.	16
LM End	2.52	Issue Type +	Ma	Location *	LS
Category	Earthen Levee			GPS Latitude/Longitude	
				Start	End
Item	Erosion / Livestock			37.202738 °	37.202738 °
				-120.709455 °	-120.709455 °
DWR ID	DWR_NA0010_11_s_2022_16				
Comment Code					
E4 : Repair the levee slope damaged by livestock and prevent large animal access.					
Inspector Comment

Looking downhill and damage to the landside slope. (Spring 2022)

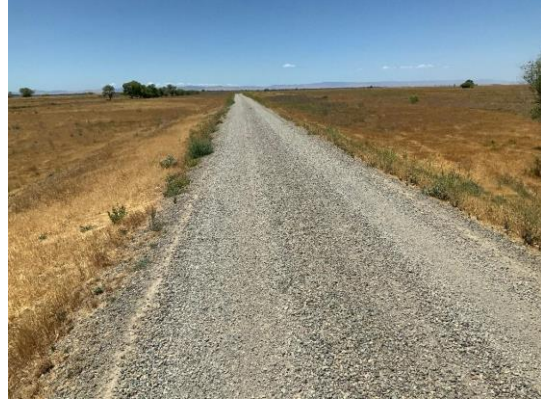
Photo 1 of 3 : UCIP_SP_2022_67928_100453.jpg

Comment Code					
Inspector Comment					
FS_ID:67928 DS_ID:19852 EP_NO: N/A Repair Type: Urgent Crossing Status: Found UCIP Comments: 06/8/2021 The record has been upgraded from Non-Urgent to Urgent. DWR DMP internal inspection has found pipe integrity issues. LOF of crossing is between 5 and 6. Crossing will be monitored until funding becomes available to address the issues. No permit was found authorizing this encroachment. CVFPB will need to review crossing to determine owner. Pipe has since been cleared out of sediment since previous inspection. The UCIP inspection was completed with GEI staff, P. Espinoza. (H. Dunn- GE)04/18/201 Need to contact owner. Recommend clearing sediment deposit inside pipe. (O. Magana - DWR UCIP) FIELD_STRUCT_DESC: 24-inch corrugated metal gravity drainage pipe through the levee, 15 feet below the crown. Flap gate on the waterside (WS) end. [Additional Reference(s): DWR Levee Log, 2002 (HLM 3.04), listed as a 24-inch corrugated metal pipe (CMP). USACE San Joaquin O&M Manual, Unit 601 Part 1 (SJR601.1), 1967, (HLM 3.04), listed as a 24-inch CMP]. FS Date: 6/8/2021

Levee crown looking downstream.

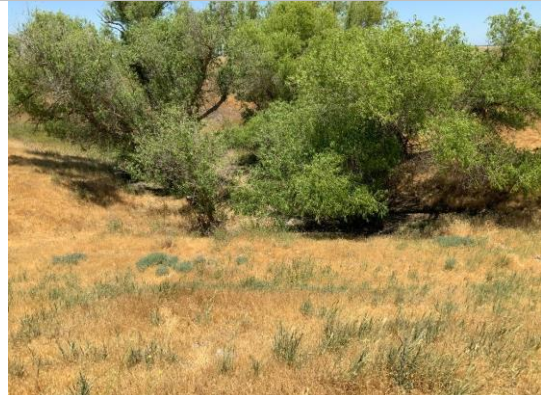
Photo 2 of 3 : UCIP_SP_2022_67928_100457.jpg

LS view: Toe from crown.

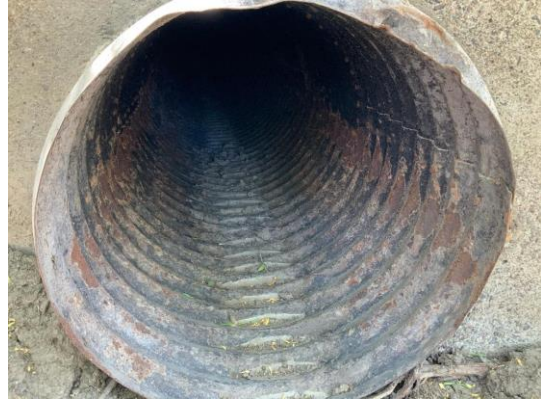
Photo 3 of 3 : UCIP_SP_2022_67928_100451.jpg

LS view: Close up of pipe inlet at toe.

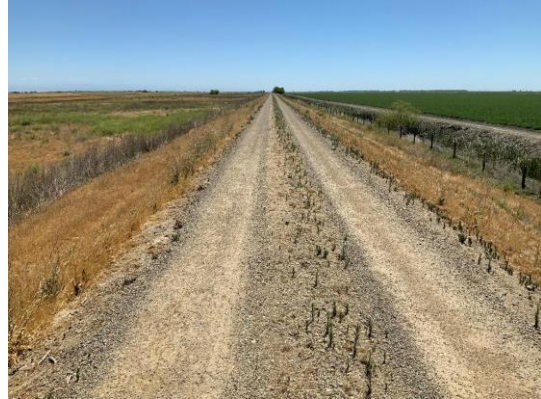
Photo 1 of 3 : UCIP_SP_2022_67726_100627.jpg

Comment Code						
Inspector Comment						
FS_ID:67726 DS_ID:19855 EP_NO: N/A Repair Type: Non-Urgent Crossing Status: Found UCIP Comments: 06/8/2021 The record remains Non-Urgent. DWR DMP internal inspection has not found pipe integrity issues. LOF of crossing is less or equal to 4.0. Recommend next video inspection in 5 years. No permit was found authorizing this encroachment. CVFPB will need to review crossing to determine owner. The UCIP inspection was completed with GEI staff, P. Espinoza. (H. Dunn ? GEI) 04/18/2014 Need to contact owner. Dense vegetation limits the inspector's visibility to identify signs of pipe failure (leaks) along the waterward slope. Recommend removing vegetation along pipe alignment to conduct proper inspection of structure. (O. Magana - DWR UCIP) FIELD_STRUCT_DESC: 24-inch corrugated metal gravity drainage pipe through the levee, 10.5 feet below the crown. Flap gate on the waterside (WS) end. [Additional Reference(s): DWR Levee Log, 2002 (HLM 0.41), listed as a 24-inch corrugated metal pipe (CMP). USACE San Joaquin O&M Manual, Unit 601 Part 1 (SJR601.1), 1967, (HLM 0.39), listed as a 24-inch CMP]. FS Date: 6/8/2021

Levee crown looking downstream.

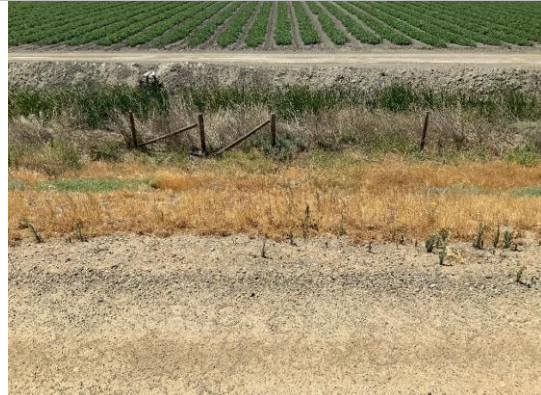
Photo 2 of 3 : UCIP_SP_2022_67726_100630.jpg

LS view: Toe from crown.

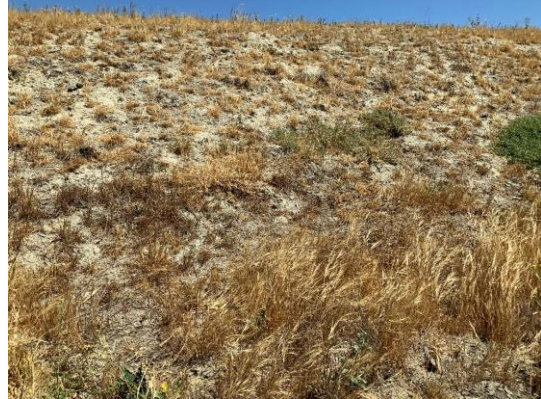
Photo 3 of 3 : UCIP_SP_2022_67726_100625.jpg

LS view: Slope from toe.

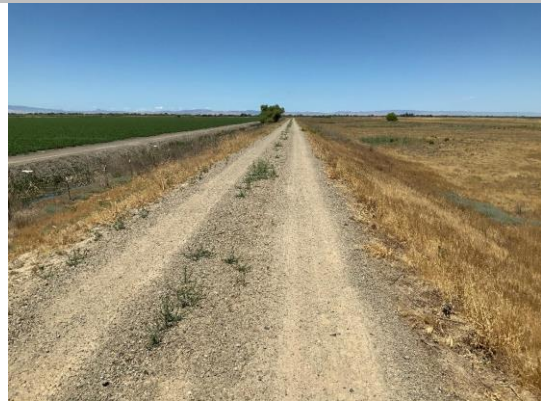
Photo 1 of 3 : UCIP_SP_2022_68233_100633.jpg

FS_ID:68233
DS_ID:19856
EP_NO: N/A
Repair Type: Non-Urgent
Crossing Status: Found
UCIP Comments: 06/8/2021 The record remains Non-Urgent. DWR DMP internal inspection has not found pipe integrity issues. LOF of crossing is less or equal to 4.0. Recommend next video inspection in 5 years. Some vegetation growth starting over WS flapgate and LS pipe inlet, recommend removal. No permit was found authorizing this encroachment. CVFPB will need to review crossing to determine owner. The UCIP inspection was completed with GEI staff, P. Espinoza. (H. Dunn ? GEI) 04/18/2014 Need to contact owner. Recommend clearing sediment deposit inside pipe. (O. Magana - DWR UCIP)
FIELD_STRUCT_DESC: 24-inch corrugated metal gravity drainage pipe through the levee, 10.5 feet below the crown. Flap gate on the waterside (WS) end. [Additional Reference(s): DWR Levee Log, 2002 (HLM 1.06), listed as a 24-inch corrugated metal pipe (CMP). USACE San Joaquin O&M Manual, Unit 601 Part 1 (SJR601.1), 1967, (HLM 1.06), listed as a 24-inch CMP].

Levee crown looking upstream.

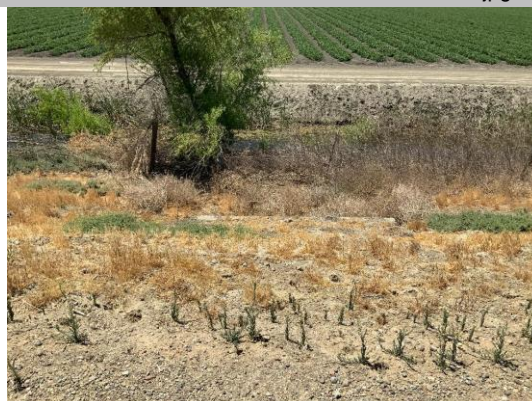
Photo 2 of 3 : UCIP_SP_2022_68233_100637.jpg

LS view: Headwall visible at toe from crown.

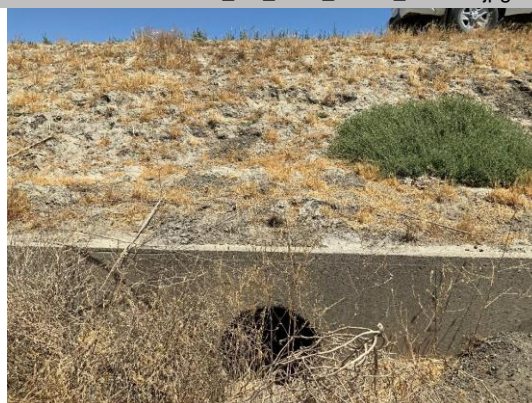
Photo 3 of 3 : UCIP_SP_2022_68233_100631.jpg

LS view: Slope and headwall at toe.

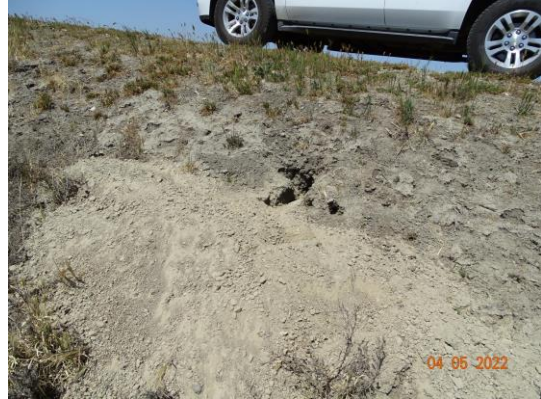
Photo 1 of 1 : SP_2022_NA0010_130_10_20220414_00025.jpg

LM Start	1.15	Rating **	M	Issue No.	10
LM End	1.15	Issue Type +	Ma	Location *	LS
Category	Earthen Levee			GPS Latitude/Longitude	
				Start	End
Item	Animal Control			37.200935 °	37.200935 °
				-120.734471 °	-120.734471 °
DWR ID	DWR_NA0010_12_s_2022_10				
Comment Code					
A3 : No rodents visible, but rodent burrows visible; need to backfill and compact or grout burrows.					
Inspector Comment

View of rodent hole with a large quantity of material removed. (Spring 2022)

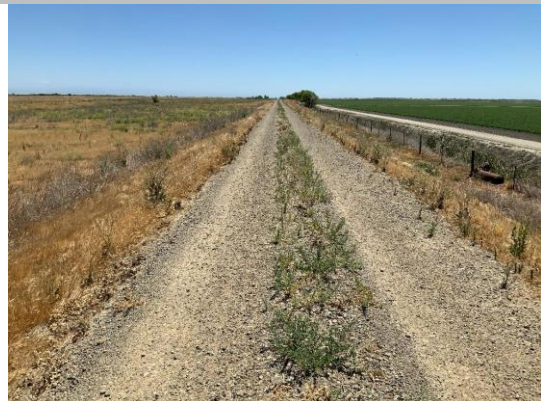
Photo 1 of 3 : UCIP_SP_2022_67729_100646.jpg

Comment Code						
Inspector Comment						
FS_ID:67729 DS_ID:19858 EP_NO: N/A Repair Type: Non-Urgent Crossing Status: Found UCIP Comments: 06/8/2021 The record remains Non-Urgent. DWR DMP internal inspection has not found pipe integrity issues. LOF of crossing is less or equal to 4.0. Recommend next video inspection in 5 years. Dense vegetation over LS pipe inlet, headwall barely visible. Recommend removal of vegetation. No permit was found authorizing this encroachment. CVFPB will need to review crossing to determine owner. The UCIP inspection was completed with GEI staff, P. Espinoza. (H. Dunn ? GEI) 04/18/2014 Limited access on landward side due to fence and dense vegetation. Recommend obtaining access to landward side and clear vegetation on landward side. (O. Magana - DWR UCIP) FIELD_STRUCT_DESC: 24-inch corrugated metal gravity drainage pipe through the levee, 10.7 feet below the crown. Flap gate on the waterside (WS) end. [Additional Reference(s): DWR Levee Log, 2002 (HLM 1.53), listed as a 24-inch corrugated metal pipe (CMP). USACE San Joaquin O&M Manual, Unit 601 Part 1 (SJR601.1), 1967, (HLM 1.53), listed as a 24-inch CMP]. FS Date: 6/8/2021

Levee crown looking upstream.

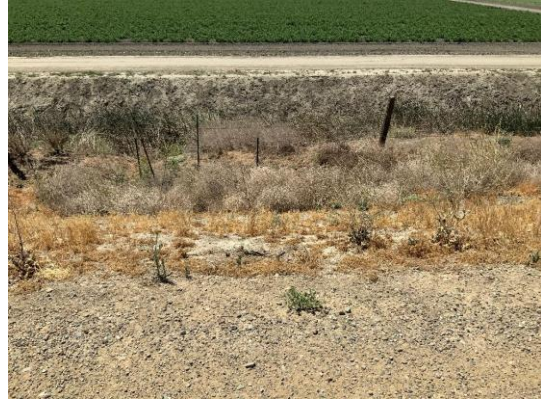
Photo 2 of 3 : UCIP_SP_2022_67729_100650.jpg

LS view: Toe from crown.

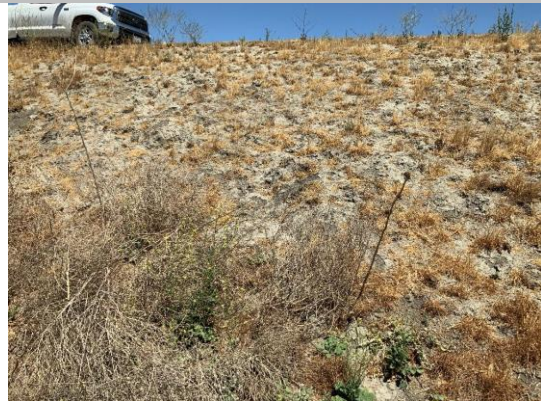
Photo 3 of 3 : UCIP_SP_2022_67729_100651.jpg

LS view: Slope from toe.

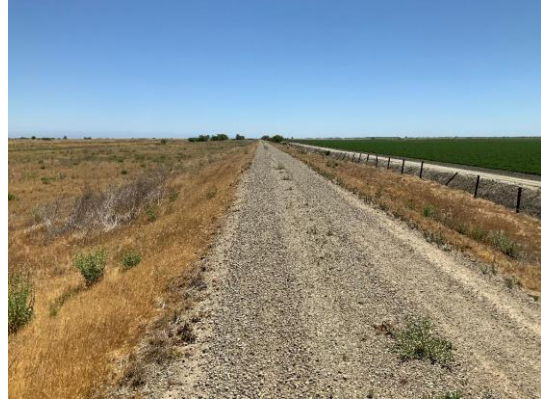
Photo 1 of 3 : UCIP_SP_2022_68234_100655.jpg

Comment Code						
Inspector Comment						
FS_ID:68234 DS_ID:19859 EP_NO: N/A Repair Type: Non-Urgent Crossing Status: Found UCIP Comments: 06/8/2021 The record remains Non-Urgent. DWR DMP internal inspection has not found pipe integrity issues. LOF of crossing is less or equal to 4.0. Recommend next video inspection in 5 years. LS pipe inlet inaccessible due to barbed wire, just the top of the headwall visible. No permit was found authorizing this encroachment. CVFPB will need to review crossing to determine owner. The UCIP inspection was completed with GEI staff, P. Espinoza. (H. Dunn ? GEI) 04/18/2014 Need to contact owner. Recommend clearing vegetation from landward side--headwall blocked. (O. Magana - DWR UCIP) FIELD_STRUCT_DESC: 24-inch corrugated metal gravity drainage pipe through the levee, 14.4 feet below the crown. Flap gate on the waterside (WS) end. [Additional Reference(s): DWR Levee Log, 2002 (HLM 2.16), listed as a 24-inch corrugated metal pipe (CMP). USACE San Joaquin O&M Manual, Unit 601 Part 1 (SJR601.1), 1967, (HLM 2.16), listed as a 24-inch CMP]. FS Date: 6/8/2021

Levee crown looking upstream.

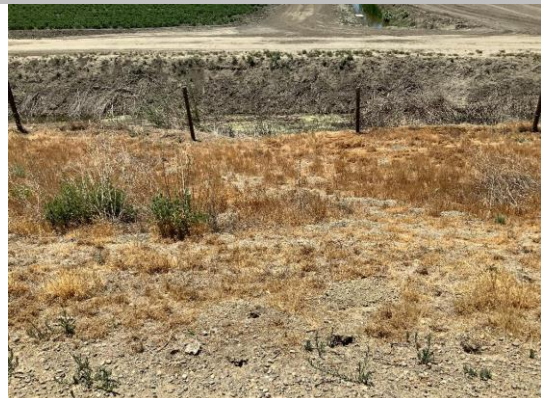
Photo 2 of 3 : UCIP_SP_2022_68234_100659.jpg

LS view: Toe from crown.

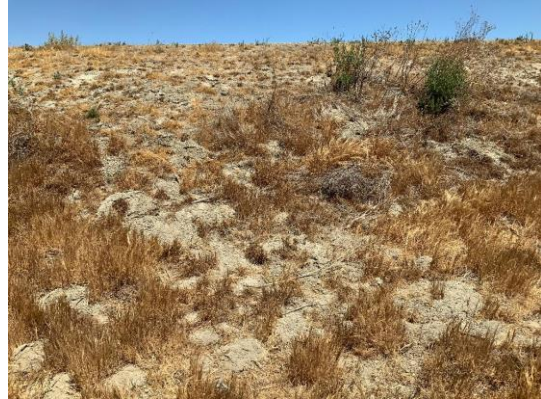
Photo 3 of 3 : UCIP_SP_2022_68234_100653.jpg

LS view: Slope from toe.

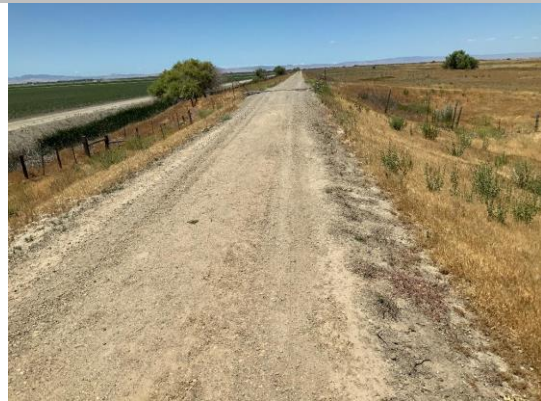
Photo 1 of 3 : UCIP_SP_2022_67731_100663.jpg

FS_ID:67731
 DS_ID:19860
 EP_NO: N/A
 Repair Type: Non-Urgent
 Crossing Status: Found
 UCIP Comments: 06/8/2021 The record remains Non-Urgent. DWR DMP internal inspection has not found pipe integrity issues. LOF of crossing is less or equal to 4.0. Recommend next video inspection in 5 years. LS pipe inlet covered with vegetation, recommend removal. No permit was found authorizing this encroachment. CVFPB will need to review crossing to determine owner. The UCIP inspection was completed with GEI staff, P. Espinoza. (H. Dunn ? GEI) 04/18/2014 Need to contact owner. Recommend clearing sediment deposit inside pipe. (O. Magana - DWR UCIP)
 FIELD_STRUCT_DESC: 24-inch corrugated metal gravity drainage pipe through the levee, 10.7 feet below the crown. Flap gate on the waterside (WS) end. [Additional Reference(s): DWR Levee Log, 2002 (HLM 2.70), listed as a 24-inch corrugated metal pipe (CMP). USACE San Joaquin O&M Manual, Unit 601 Part 1 (SJR601.1), 1967, (HLM 2.70), listed as a 24-inch CMP].

Levee crown looking upstream.

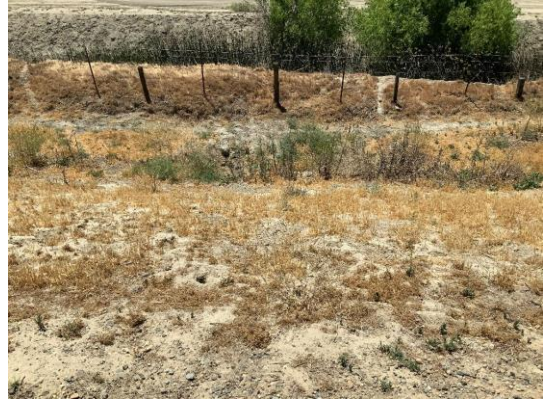
Photo 2 of 3 : UCIP_SP_2022_67731_100666.jpg

LS view: Toe from crown.

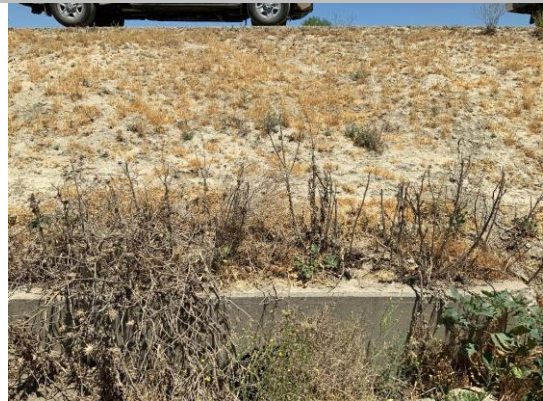
Photo 3 of 3 : UCIP_SP_2022_67731_100660.jpg

LS view: Headwall and slope from toe.

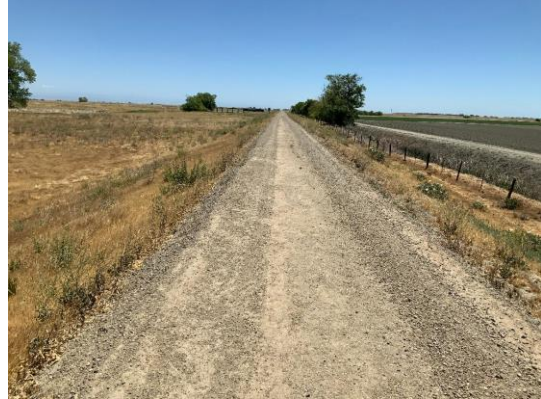
Photo 1 of 3 : UCIP_SP_2022_68235_100670.jpg

Comment Code					
Inspector Comment					
FS_ID:68235 DS_ID:19861 EP_NO: N/A Repair Type: Non-Urgent Crossing Status: Found UCIP Comments: 06/8/2021 The record remains Non-Urgent. DWR DMP internal inspection has not found pipe integrity issues. LOF of crossing is less or equal to 4.0. Recommend next video inspection in 5 years. LS pipe inlet inaccessible due to barbed wire and WS flapgate surrounded by water, limited inspection for both. LS pipe inlet also has dense vegetation covering it, recommend removal. No permit was found authorizing this encroachment. CVFPB will need to review crossing to determine owner. The UCIP inspection was completed with GEI staff, P. Espinoza. (H. Dunn ? GEI) 11/09/2015 DWR Inspection section confirmed issue has been addressed. Need to coordinate with LMA to determine additional details for extent of repair. (O. Magana - DWR UCIP)04/18/2014 Soil missing behind concrete headwall on waterward side. Unable to determine if missing soil is due to sink holes, rodent activity, or due to erosion. Headwall appears to be leaning slightly forward. Reason why this crossing was labelled urgent was due to the uncertainty of damage to concrete headwall and reason for soil missing behind concrete. Need to coordinate with LMA to determine more information about repair at this location. (O. Magana -DWR UCIP) FIELD_STRUCT_DESC: 24-inch corrugated metal gravity drainage pipe through the levee, 2 feet below the crown. Flap gate on the waterside (WS) end. [Additional Reference(s): DWR Levee Log, 2002 (HLM 3.00), listed as a 24-inch corrugated metal pipe (CMP). USACE San Joaquin O&M Manual, Unit 601 Part 1 (SJR601.1), 1967, (HLM 3.00), listed as a 24-inch CMP]. FS Date: 6/8/2021

Levee crown looking upstream.

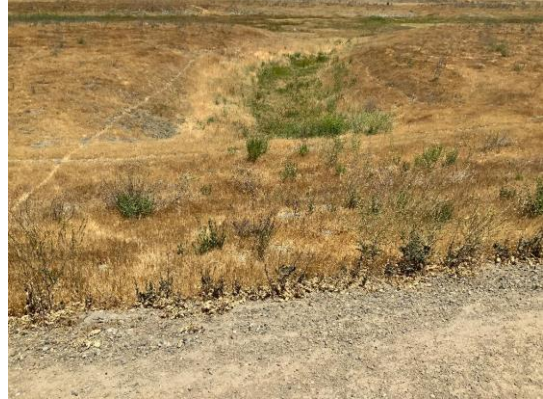
Photo 2 of 3 : UCIP_SP_2022_68235_100671.jpg

LS view: Toe from crown.

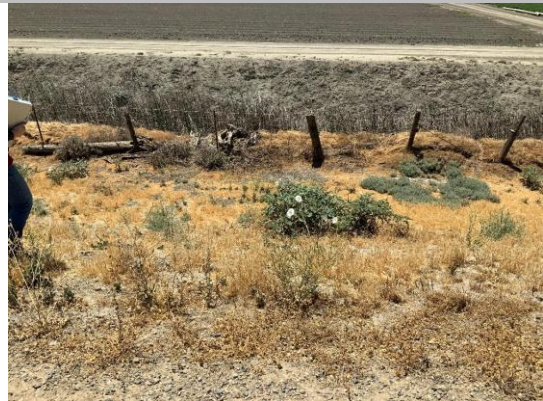
Photo 3 of 3 : UCIP_SP_2022_68235_100667.jpg

LS view: Toe from crown.

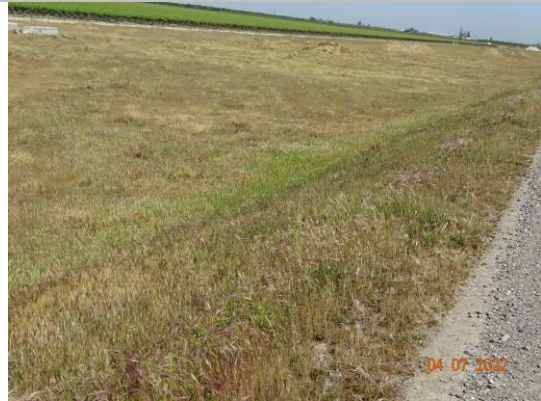
Photo 1 of 1 : SP_2022_NA0010_131_7_20220414_00013.jpg

LM Start	0.30	Rating **	M	Issue No.	7
LM End	1.25	Issue Type +	Ma	Location *	LS
Category	Earthen Levee			GPS Latitude/Longitude	
				Start	End
Item	Vegetation			37.037779 °	37.046300 °
				-120.440413 °	-120.428143 °
DWR ID	DWR_NA0010_13_s_2022_7				
Comment Code					
V1 : Control annual grass and weeds on the levee slopes and easements.					
Inspector Comment

View of vegetation on the landside slope. (Spring 2022)

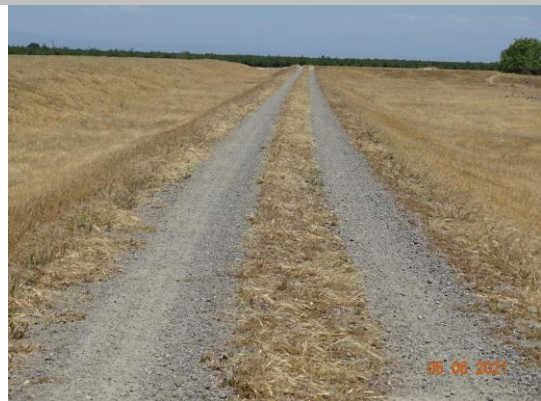
Photo 1 of 1 : SP_2022_NA0010_131_3_20220308_00001.jpg

LM Start	0.56	Rating **	M	Issue No.	3
LM End	0.70	Issue Type +	Ma	Location *	CR
Category	Earthen Levee			GPS Latitude/Longitude	
				Start	End
Item	Vegetation			37.041294 °	37.042745 °
				-120.438570 °	-120.436775 °
DWR ID	DWR_NA0010_13_s_2021_3				
Comment Code					
V9 : Keep the crown roadway free of vegetation.					
Inspector Comment

Looking upstream along the levee crown. (Spring 2021)
