**Flood Control Project Maintenance
Levee Inspections**

Maintenance Issue Types Only, Levee Inspection Report By Mile - Spring 2022

Lower San Joaquin Levee District

Waterway	Bank	Unit Miles	Inspection Start/End	Inspector
Unit No. 01 San Joaquin River	Right	22.52	04/05/2022 04/05/2022	Corey Fujitani

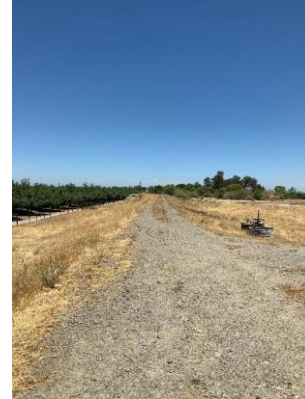
Photo 1 of 3 : UCIP_SP_2022_69821_103411.jpg

Comment Code						
Inspector Comment						
FS_ID:69821 DS_ID:19727 EP_NO: N/A Repair Type: Non-Urgent Crossing Status: Found UCIP Comments: 06/23/2021 The record remains Non-Urgent. Appears abandoned due to actuator missing on slidegate on the WS shoulder and if abandoned, should be done properly. Limited inspection of inlet and outlet due to standing water over concrete platforms surrounding pipe inlet/outlet, creating inability to inspect closely. No permit was found authorizing this encroachment. CVFPB will need to review crossing to determine owner. The UCIP inspection was completed with GEI staff, H.Dunn. (P.Espinoza ? GEI)03/27/2014 Appears abandoned and if so should be done so properly. Pipe filled with soil on WS at outlet. Actuator missing from slide gate on WS shoulder. (W. Wylie - DWR UCIP) FIELD_STRUCT_DESC: [Rounder Irrigation Structure] 1 of 2: 36-inch corrugated metal gravity drainage pipe through the levee, 12.3 feet below the crown. Slide gate in a 48-inch corrugated metal pipe (CMP) riser on the waterside (WS) slope. 6-foot by 12-foot concrete distribution box on the landside (LS). 7-foot by 14-foot concrete outlet structure on the WS toe. [Additional Reference(s): DWR Levee Log, 2002 (HLM 1.14), listed as a 36-inch corrugated metal pipe (CMP). USACE San Joaquin O&M Manual, Unit 601 Part 1 (SJR601.1), 1967, (HLM 1.14), listed as a 36-inch CMP]. FS Date: 6/23/2021 1:08:00 PM

View of levee crown.

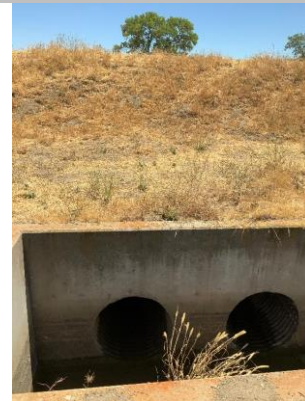
Photo 2 of 3 : UCIP_SP_2022_69821_103418.jpg

LS view: concrete inlet pipe on LS toe.

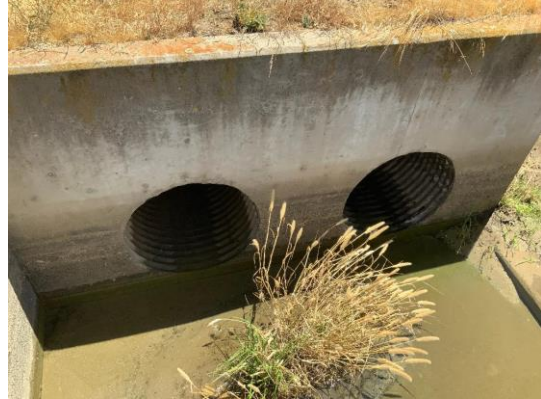
Photo 3 of 3 : UCIP_SP_2022_69821_103419.jpg

LS view: close up of concrete inlet pipe on LS toe.

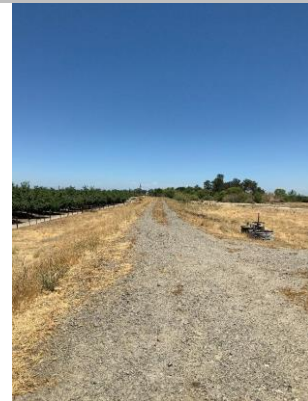
Photo 1 of 3 : UCIP_SP_2022_69820_103422.jpg

FS_ID:69820
DS_ID:19908
EP_NO: N/A
Repair Type: Non-Urgent
Crossing Status: Found
UCIP Comments: 06/23/2021 The record remains Non-Urgent. DWR DMP internal inspection has found pipe integrity issues. LOF of crossing is between 4.1 and 5. Crossing will be monitored until funding becomes available for rehabilitation. No lid on riser at WS shoulder, causing safety hazard. Limited inspection of both inlet and outlet due to standing water over concrete pads around the pipe inlet/out. Outlet also has metal grate over it, limiting ability to inspect pipe closely. No permit was found authorizing this encroachment. CVFPB will need to review crossing to determine owner. The UCIP inspection was completed with GEI staff, H.Dunn. (P.Espinoza ? GEI)03/27/2014 No lid on riser at WS shoulder could be safety issue. (W. Wylie - DWR UCIP)
FIELD_STRUCT_DESC: [Rounder Irrigation Structure] 2 of 2: 36-inch corrugated metal gravity drainage pipe through the levee, 12.3 feet below the crown. Slide gate in a 48-inch corrugated metal pipe (CMP) riser on the waterside (WS) slope. 6-foot by 12-foot concrete distribution box on the landside (LS). 7-foot by 14-foot concrete outlet structure on the WS toe. [Additional Reference(s): DWR Levee Log, 2002 (HLM 1.14), listed as a 36-inch corrugated metal pipe (CMP). USACE San Joaquin O&M Manual, Unit 601 Part 1 (SJR601.1), 1967, (HLM 1.14), listed as a 36-inch CMP].

View of levee crown.

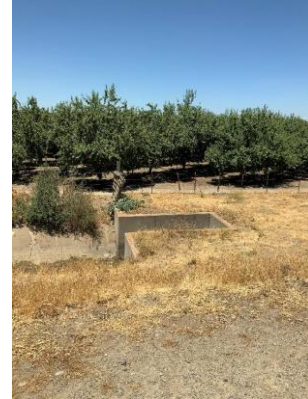
Photo 2 of 3 : UCIP_SP_2022_69820_103423.jpg

LS view from levee crown.

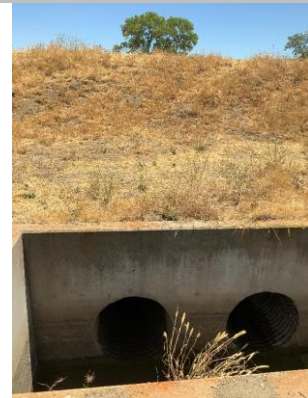
Photo 3 of 3 : UCIP_SP_2022_69820_103430.jpg

LS view: Slope and headwall from toe.

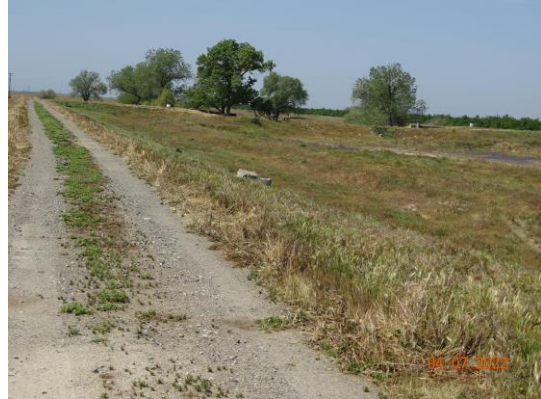
Photo 1 of 1 : SP_2022_NA0010_132_8_20220414_00011.jpg

LM Start	0.01	Rating **	M	Issue No.	8
LM End	1.26	Issue Type +	Ma	Location *	WS
Category	Earthen Levee			GPS Latitude/Longitude	
				Start	End
Item	Vegetation			37.032449 °	37.045399 °
				-120.441252 °	-120.427793 °
DWR ID	DWR_NA0010_14_s_2022_8				
Comment Code					
V1 : Control annual grass and weeds on the levee slopes and easements.					
Inspector Comment

View of vegetation on the waterside slope looking downstream. (Spring 2022)

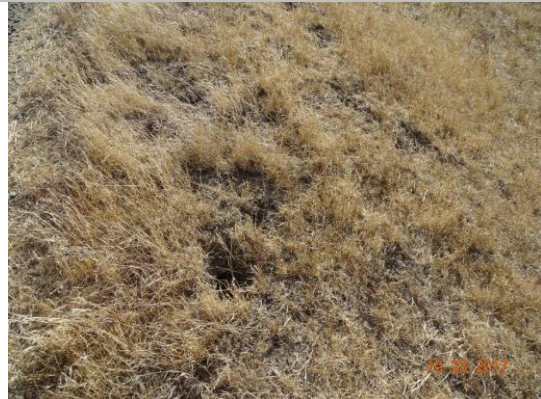
Photo 1 of 1 : SP_2022_NA0010_132_5_20220308_00002.jpg

LM Start	0.25	Rating **	A/W	Issue No.	5
LM End	0.25	Issue Type +	Ma	Location *	LS
Category	Earthen Levee			GPS Latitude/Longitude	
				Start	End
Item	Animal Control			37.035841 °	37.035841 °
				-120.439795 °	-120.439795 °
DWR ID	DWR_NA0010_14_f_2017_5				
Comment Code					
A3 : No rodents visible, but rodent burrows visible; need to backfill and compact or grout burrows.					
Inspector Comment

Looking at the landside slope.

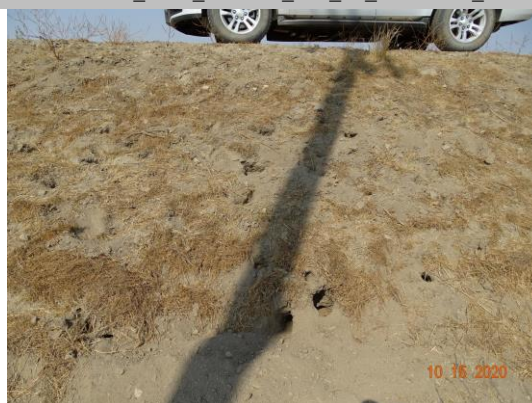
Photo 1 of 1 : SP_2022_NA0010_132_79_20220308_00004.jpg

LM Start	1.24	Rating **	M	Issue No.	79
LM End	1.24	Issue Type +	Ma	Location *	LS
Category	Earthen Levee			GPS Latitude/Longitude	
				Start	End
Item	Animal Control			37.045343 °	37.045343 °
				-120.428007 °	-120.428007 °
DWR ID	DWR_NA0010_14_s_2021_79				
Comment Code					
A3 : No rodents visible, but rodent burrows visible; need to backfill and compact or grout burrows.					
Inspector Comment					
Several rodent holes are noted on the landside at this location.

View of rodent burrows on the landside slope. (Fall 2020)

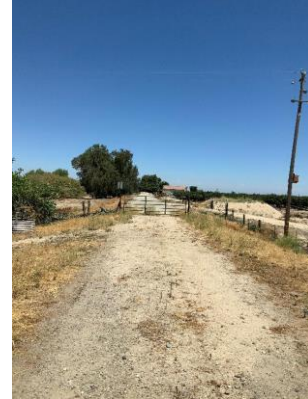
Photo 1 of 3 : UCIP_SP_2022_69824_103809.jpg

Comment Code					
Inspector Comment					
FS_ID:69824 DS_ID:19910 EP_NO: N/A Repair Type: Urgent Crossing Status: Found UCIP Comments: 06/23/2021 Record has been upgraded from No Action Needed to Urgent. DWR DMP internal inspection has found pipe integrity issues. LOF of crossing is between 5 and 6. Crossing will be monitored until funding becomes available to address the issues. Lid missing from CMP riser on WS slope, causing safety concern. LS not accessible; limited inspection due to barbed wire. No permit was found authorizing this encroachment. CVFPB will need to review crossing to determine owner. The UCIP inspection was completed with GEI staff, H.Dunn. (P.Espinoza ? GEI) FIELD_STRUCT_DESC: 36-inch corrugated metal gravity drainage pipe through the levee, 9 feet below the crown. Slide gate in a 42-inch corrugated metal pipe (CMP) riser on the waterside (WS) slope. Concrete U-shaped headwall on the WS end. Pipe terminates into a concrete ditch on the landside (LS). [Additional Reference(s): DWR Levee Log, 2002 (HLM 1.26), listed as a 36-inch corrugated metal pipe (CMP). USACE San Joaquin O&M Manual, Unit 601 Part 1 (SJR601.1), 1967, (HLM 1.26), listed as a 36-inch CMP]. FS Date: 6/23/2021 2:07:00 PM

View from levee crown.

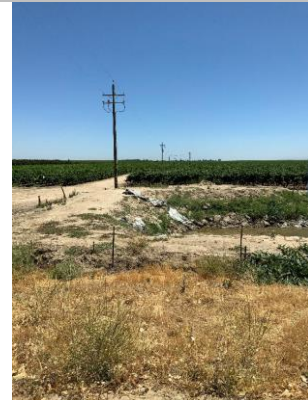
Photo 2 of 3 : UCIP_SP_2022_69824_103811.jpg

LS view: inlet assumed to be within irrigation structure off of toe.

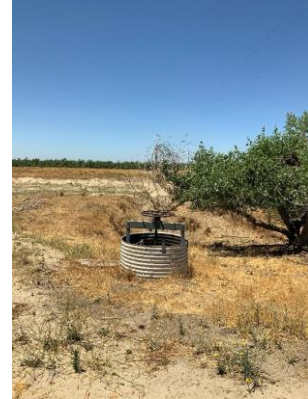
Photo 3 of 3 : UCIP_SP_2022_69824_103810.jpg

WS view: slidegate in CMP riser.

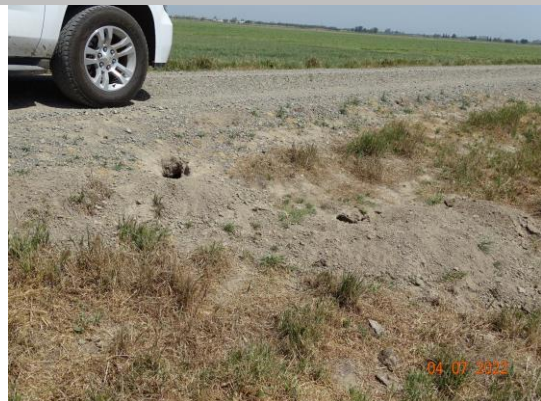
Photo 1 of 1 : SP_2022_NA0010_133_6_20220414_00013.jpg

LM Start	0.95	Rating **	M	Issue No.	6
LM End	0.95	Issue Type +	Ma	Location *	WS
Category	Earthen Levee			GPS Latitude/Longitude	
				Start	End
Item	Animal Control			36.996555 °	36.996555 °
				-120.393195 °	-120.393195 °
DWR ID	DWR_NA0010_15_s_2022_6				
Comment Code					
A1 : Exterminate rodents and backfill and compact or grout burrows.					
Inspector Comment					
Burrows on both landside and waterside slopes.

View of rodent holes in the waterside slope. (Spring 2022)

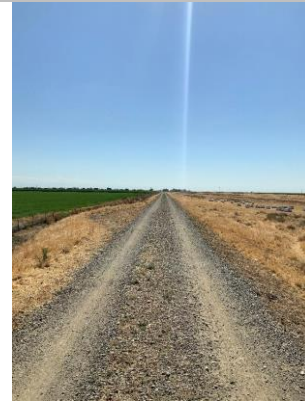
Photo 1 of 3 : UCIP_SP_2022_69727_103822.jpg

Comment Code						
Inspector Comment						
FS_ID:69727 DS_ID:19912 EP_NO: N/A Repair Type: Non-Urgent Crossing Status: Found UCIP Comments: 06/24/2021 The record remains Non-Urgent. Limited inspection of LS pipe due to vegetation overgrowth; recommend removal. No permit was found authorizing this encroachment. CVFPB will need to review crossing to determine owner. The UCIP inspection was completed with GEI staff, H.Dunn. (P.Espinoza ? GEI) 03/27/2014 Dense vegetation limits the inspector's visibility to identify signs of pipe failure (leaks) along the landward slope. Recommend removing vegetation along pipe alignment to conduct proper inspection of structure. (W. Wylie - DWR UCIP) FIELD_STRUCT_DESC: 30-inch by 30-inch square reinforced concrete box gravity drainage culvert through the levee, 8.5 feet below the crown. Flap gate on the waterside (WS) end. Concrete headwall on the landside (LS) end. Concrete U-shaped headwall on the WS end. [Additional Reference(s): DWR Levee Log, 2002 (HLM 1.01), listed as a 30-inch square reinforced concrete box culvert (RCBC). USACE San Joaquin O&M Manual, Unit 601 Part 1 (SJR601.1), 1967, (HLM 1.01), listed as a 2.5-feet by 2.5-feet RCBC]. FS Date: 6/24/2021 3:18:00 PM

view of levee crown

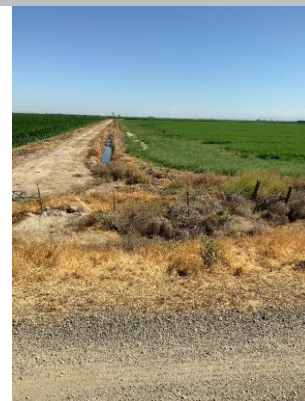
Photo 2 of 3 : UCIP_SP_2022_69727_103823.jpg

LS view: toe from levee crown

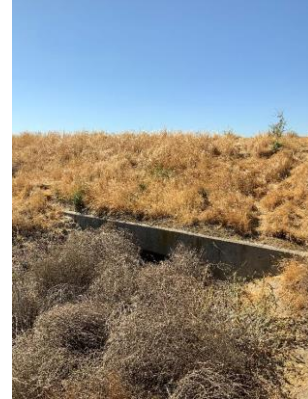
Photo 3 of 3 : UCIP_SP_2022_69727_103825.jpg

LS view: concrete headwall on toe.

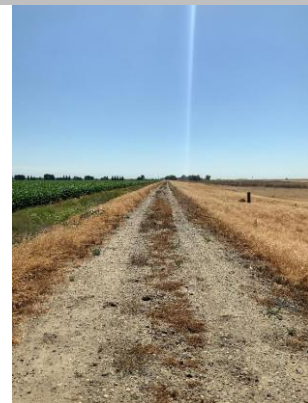
Photo 1 of 3 : UCIP_SP_2022_69728_103828.jpg

FS_ID:69728
DS_ID:19913
EP_NO: N/A
Repair Type: Non-Urgent
Crossing Status: Found
UCIP Comments: 06/24/2021 The record remains Non-Urgent. Limited inspection of LS pipe due to vegetation overgrowth; recommend removal. Note that wooden board is holding flapgate closed on WS; recommend removing before flood season to allow for flow. No permit was found authorizing this encroachment. CVFPB will need to review crossing to determine owner. The UCIP inspection was completed with GEI staff, H.Dunn. (P.Espinoza ? GEI) 03/27/2014 Excessive vegetation at inlet on LS toe. (W. Wylie - DWR UCIP)
FIELD_STRUCT_DESC: 30-inch by 30-inch square reinforced concrete box gravity drainage culvert through the levee, 8.9 feet below the crown. Flap gate on the waterside (WS) end. Concrete headwall on the landside (LS) end. Concrete U-shaped headwall on the WS end.
[Additional Reference(s): DWR Levee Log, 2002 (HLM 1.54), listed as a 30-inch square reinforced concrete box culvert (RCBC). USACE San Joaquin O&M Manual, Unit 601 Part 1 (SJR601.1), 1967, (HLM 1.53), listed as a 2.5-feet by 2.5-feet RCBC].

view of levee crown.

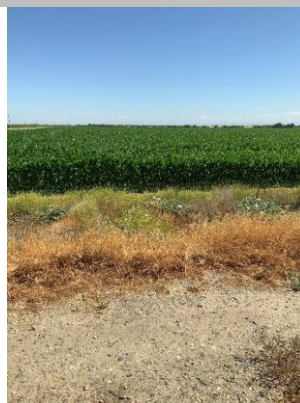
Photo 2 of 3 : UCIP_SP_2022_69728_103829.jpg

LS view of toe from levee crown.

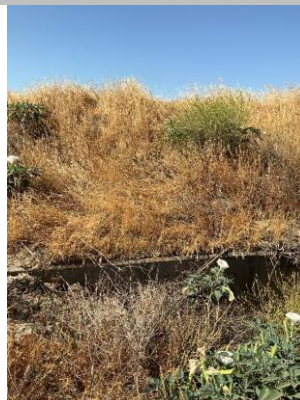
Photo 3 of 3 : UCIP_SP_2022_69728_103831.jpg

LS view: concrete headwall from toe.

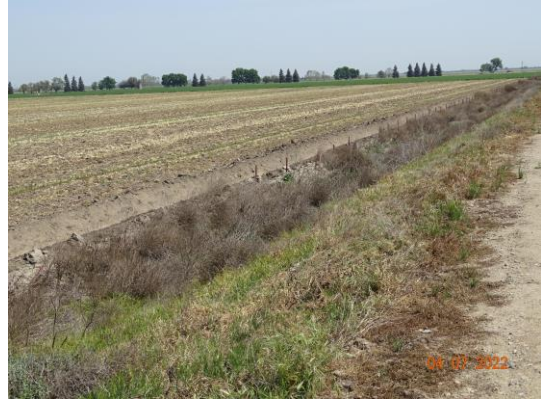
Photo 1 of 1 : SP_2022_NA0010_133_7_20220414_00014.jpg

LM Start	1.60	Rating **	M	Issue No.	7
LM End	2.01	Issue Type +	Ma	Location *	LS
Category	Earthen Levee			GPS Latitude/Longitude	
				Start	End
Item	Vegetation			36.996587 °	36.996613 °
				-120.381540 °	-120.374046 °
DWR ID	DWR_NA0010_15_s_2022_7				
Comment Code					
V1 : Control annual grass and weeds on the levee slopes and easements.					
Inspector Comment

Looking downstream along the landside slope. (Spring 2022)

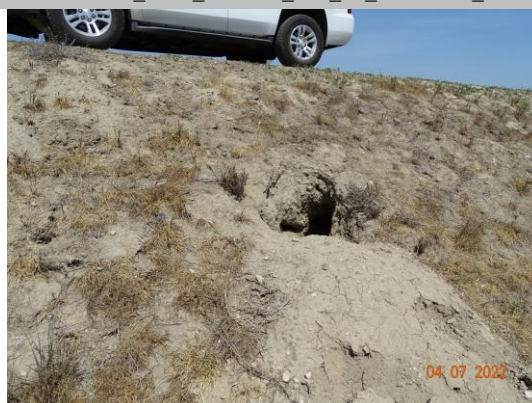
Photo 1 of 1 : SP_2022_NA0010_134_10_20220414_00010.jpg

LM Start	0.30	Rating **	U	Issue No.	10
LM End	0.30	Issue Type +	Ma	Location *	LS
Category	Earthen Levee			GPS Latitude/Longitude	
				Start	End
Item	Animal Control			36.995433 °	36.995433 °
				-120.403543 °	-120.403543 °
DWR ID	DWR_NA0010_16_s_2022_10				
Comment Code					
A3 : No rodents visible, but rodent burrows visible; need to backfill and compact or grout burrows.					
Inspector Comment					
Burrow is approximately 18-inches across.

Large animal burrow on the landside slope. (Spring 2022)

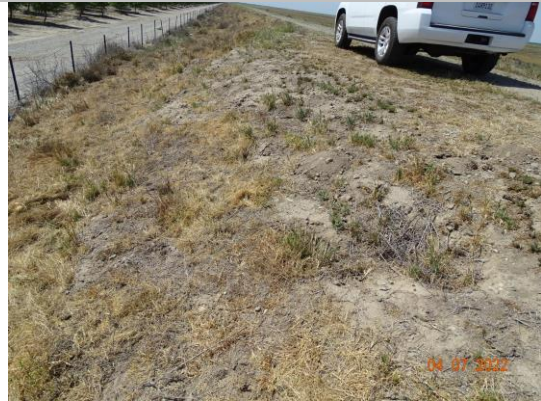
Photo 1 of 1 : SP_2022_NA0010_134_92_20220414_00011.jpg

LM Start	0.93	Rating **	M	Issue No.	92
LM End	0.93	Issue Type +	Ma	Location *	LS
Category	Earthen Levee			GPS Latitude/Longitude	
				Start	End
Item	Animal Control			36.995439 °	36.995439 °
				-120.392146 °	-120.392146 °
DWR ID	DWR_NA0010_16_s_2015_92				
Comment Code					
A3 : No rodents visible, but rodent burrows visible; need to backfill and compact or grout burrows.					
Inspector Comment					
Several rodent holes are identified within this section.

Looking at several rodent holes on landward slope. (Spring 2022)

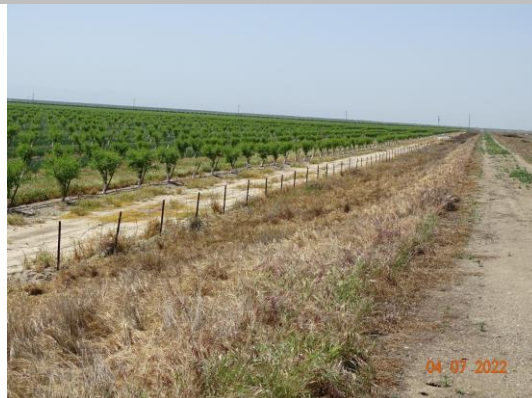
Photo 1 of 1 : SP_2022_NA0010_134_5_20220414_00012.jpg

LM Start	1.40	Rating **	M	Issue No.	5
LM End	1.95	Issue Type +	Ma	Location *	LS
Category	Earthen Levee			GPS Latitude/Longitude	
				Start	End
Item	Vegetation			36.995487 °	36.995500 °
				-120.383748 °	-120.373700 °
DWR ID	DWR_NA0010_16_s_2022_5				
Comment Code					
V1 : Control annual grass and weeds on the levee slopes and easements.					
Inspector Comment

Looking vegetation on the landside slope. (Spring 2022)

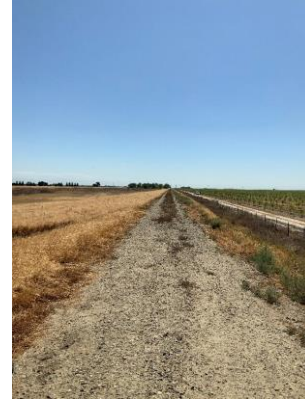
Photo 1 of 3 : UCIP_SP_2022_69769_103847.jpg

Comment Code					
Inspector Comment					
FS_ID:69769 DS_ID:19915 EP_NO: N/A Repair Type: Non-Urgent Crossing Status: Found UCIP Comments: 06/24/2021 The record remains Non-Urgent. Limited inspection on LS and WS due to vegetation overgrowth, recommend removal. No permit was found authorizing this encroachment. CVFPB will need to review crossing to determine owner. The UCIP inspection was completed with GEI staff, H.Dunn. (P.Espinoza ? GEI) 04/01/2014 Dense vegetation buildup at landside toe--recommend clearing. (W. Wylie - DWR UCIP) FIELD_STRUCT_DESC: 30-inch by 30-inch square reinforced concrete box gravity drainage culvert through the levee, 8.5 feet below the crown. Two concrete cutoff walls. Flap gate on the waterside (WS) end. Concrete headwall on the landside (LS) end. Concrete U-shaped headwall on the WS end. [Additional Reference(s): DWR Levee Log, 2002 (HLM 1.46), listed as a 30-inch square reinforced concrete box culvert (RCBC). USACE San Joaquin O&M Manual, Unit 601 Part 1 (SJR601.1), 1967, (HLM 1.46), listed as a 2.5-feet by 2.5-feet RCBC]. FS Date: 6/24/2021 11:09:00 AM

View of levee crown.

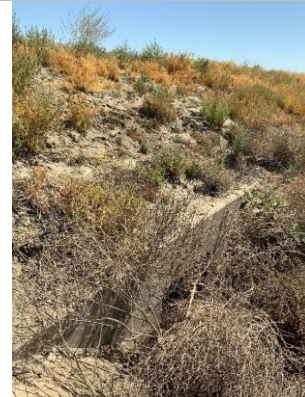
Photo 2 of 3 : UCIP_SP_2022_69769_103851.jpg

LS view: Slope and concrete headwall at inlet, covered by heavy vegetation.

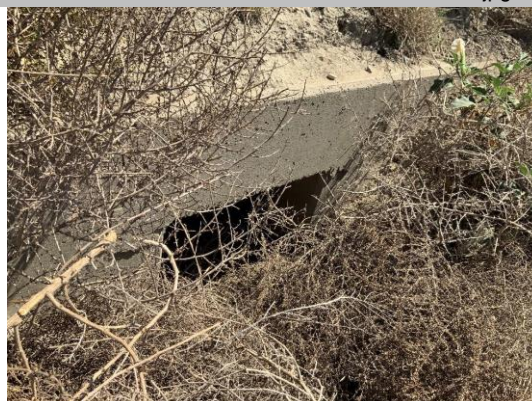
Photo 3 of 3 : UCIP_SP_2022_69769_103852.jpg

LS view: close up of concrete headwall at inlet.

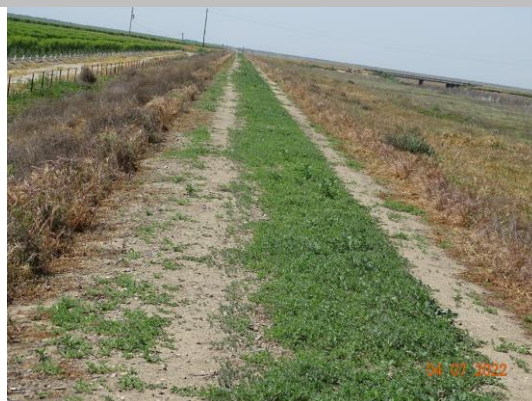
Photo 1 of 1 : SP_2022_NA0010_134_8_20220414_00013.jpg

LM Start	1.65	Rating **	M	Issue No.	8
LM End	1.84	Issue Type +	Ma	Location *	CR
Category	Earthen Levee			GPS Latitude/Longitude	
				Start	End
Item	Vegetation			36.995498 °	36.995502 °
				-120.379192 °	-120.375747 °
DWR ID	DWR_NA0010_16_s_2022_8				
Comment Code					
V9 : Keep the crown roadway free of vegetation.					
Inspector Comment

Looking downstream along the levee crown. (Spring 2022)

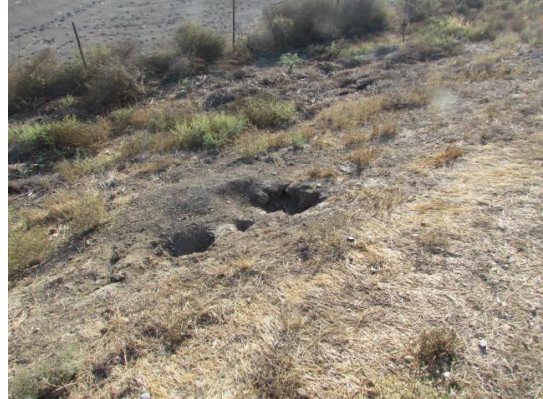
Photo 1 of 1 : SP_2022_NA0010_134_2_20220308_00001.jpg

LM Start	1.77	Rating **	U	Issue No.	2
LM End	1.77	Issue Type +	Ma	Location *	LS
Category	Earthen Levee			GPS Latitude/Longitude	
				Start	End
Item	Animal Control			36.995487 °	36.995487 °
				-120.377054 °	-120.377054 °
DWR ID	DWR_NA0010_16_f_2014_2				
Comment Code					
A3 : No rodents visible, but rodent burrows visible; need to backfill and compact or grout burrows.					
Inspector Comment					
Large rodent holes are on the landside slope.

Looking southwest at several rodent holes on landward slope.

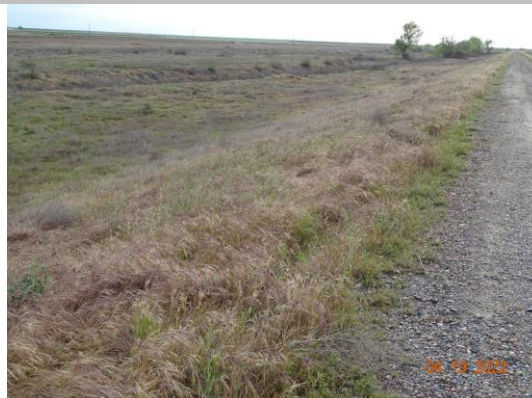
Photo 1 of 1 : SP_2022_NA0010_135_14_20220502_00040.jpg

LM Start	0.00	Rating **	M	Issue No.	14
LM End	2.56	Issue Type +	Ma	Location *	LS
Category	Earthen Levee			GPS Latitude/Longitude	
				Start	End
Item	Vegetation			36.976437 °	36.952462 °
				-120.374767 °	-120.348948 °
DWR ID	DWR_NA0010_17_s_2022_14				
Comment Code					
V1 : Control annual grass and weeds on the levee slopes and easements.					
Inspector Comment

View of vegetation growing along the landside slope. (Spring 2022)

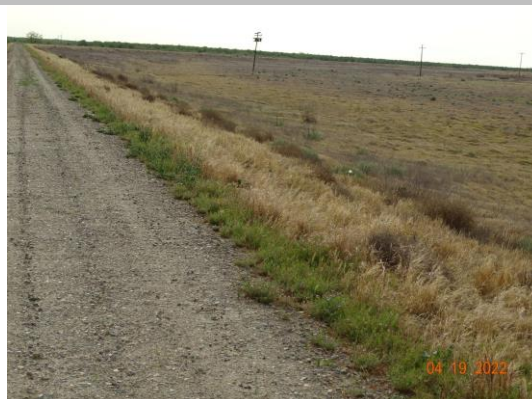
Photo 1 of 1 : SP_2022_NA0010_135_15_20220502_00041.jpg

LM Start	0.03	Rating **	M	Issue No.	15
LM End	2.56	Issue Type +	Ma	Location *	WS
Category	Earthen Levee			GPS Latitude/Longitude	
				Start	End
Item	Vegetation			36.976441 °	36.952462 °
				-120.374245 °	-120.348948 °
DWR ID	DWR_NA0010_17_s_2022_15				
Comment Code					
V1 : Control annual grass and weeds on the levee slopes and easements.					
Inspector Comment

Looking upstream along the waterside slope. (Spring 2022)

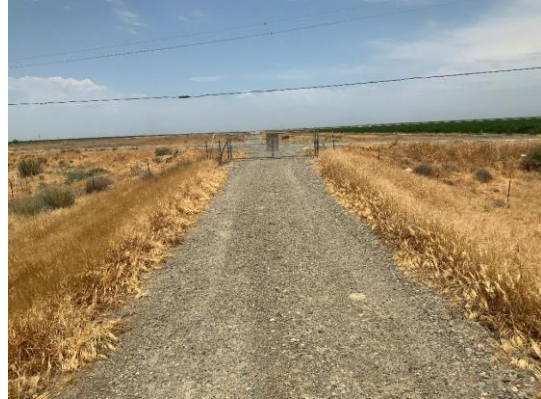
Photo 1 of 3 : UCIP_SP_2022_68828_102399.jpg

Comment Code						
Inspector Comment						
FS_ID:68828 DS_ID:19916 EP_NO: N/A Repair Type: Non-Urgent Crossing Status: Found UCIP Comments: 07/13/2021 The record remains Non-Urgent. Limited inspection due to tumbleweeds blocking LS pipe inlet, recommend removal. No permit was found authorizing this encroachment. CVFPB will need to review crossing to determine owner. The UCIP inspection was completed with GEI staff, P. Espinoza. (H. Dunn ? GEI) 04/01/2014 Dense vegetation limits the inspector's visibility to identify signs of pipe failure (leaks) along the landward slope. Recommend removing vegetation along pipe alignment to conduct proper inspection of structure. (W. Wylie - DWR UCIP) FIELD_STRUCT_DESC: 48-inch by 60-inch reinforced concrete box gravity drainage culvert through the levee, 14.6 feet below the crown. Flap gate on the waterside (WS) end. Concrete headwall on the landside (LS) end. Concrete U-shaped headwall on the WS end. [Additional Reference(s): DWR Levee Log, 2002 (HLM 2.58), listed as a 48-inch by 60-inch reinforced concrete box culvert (RCBC). USACE San Joaquin O&M Manual, Unit 601 Part 1 (SJR601.1), 1967, (HLM 2.58), listed as a 5-feet by 4-feet RCBC]. FS Date: 7/19/2021

Levee crown.

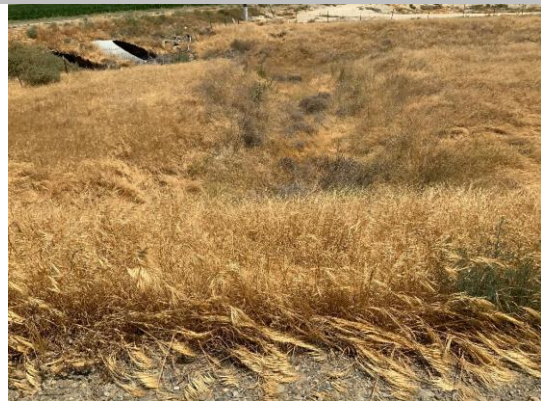
Photo 2 of 3 : UCIP_SP_2022_68828_102403.jpg

LS view: Toe from crown.

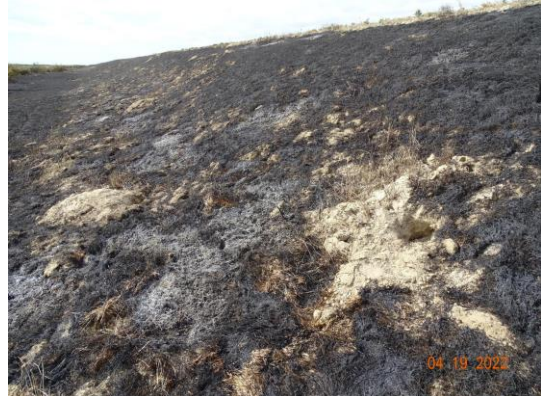
Photo 1 of 1 : SP_2022_NA0010_135_4_20220502_00044.jpg

LM Start	6.51	Rating **	M	Issue No.	4
LM End	6.80	Issue Type +	Ma	Location *	LS
Category	Earthen Levee			GPS Latitude/Longitude	
				Start	End
Item	Animal Control			36.898093 °	36.894147 °
				-120.326689 °	-120.324763 °
DWR ID	DWR_NA0010_17_s_2012_4				
Comment Code					
A1 : Exterminate rodents and backfill and compact or grout burrows.					
Inspector Comment					
Several rodent holes are identified within this reach.

View of rodent holes on the landside slope. (Spring 2022)

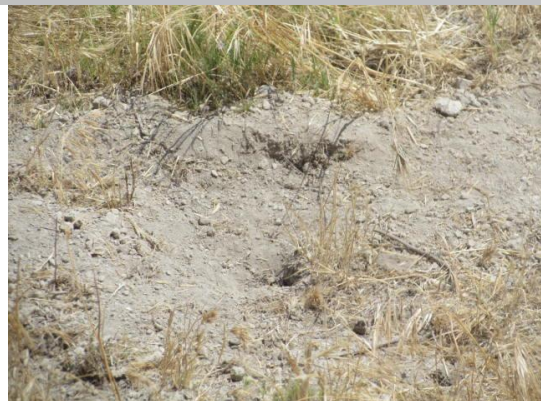
Photo 1 of 1 : SP_2022_NA0010_135_5_20220308_00003.jpg

LM Start	7.27	Rating **	M	Issue No.	5
LM End	7.38	Issue Type +	Ma	Location *	LS
Category	Earthen Levee			GPS Latitude/Longitude	
				Start	End
Item	Animal Control			36.887852 °	36.886388 °
				-120.321668 °	-120.320950 °
DWR ID	DWR_NA0010_17_s_2012_5				
Comment Code					
A3 : No rodents visible, but rodent burrows visible; need to backfill and compact or grout burrows.					
Inspector Comment					
Several rodent holes are identified within this reach.

Looking at typical view of rodent holes on landward slope.

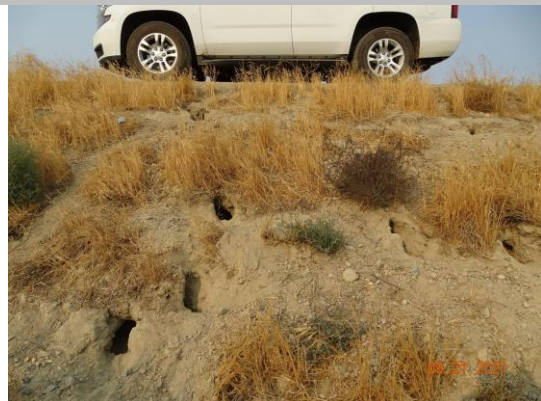
Photo 1 of 1 : SP_2022_NA0010_135_18_20220308_00008.jpg

LM Start	7.74	Rating **	U	Issue No.	18
LM End	7.74	Issue Type +	Ma	Location *	LS
Category	Earthen Levee			GPS Latitude/Longitude	
				Start	End
Item	Animal Control			36.881470 °	36.881470 °
				-120.318961 °	-120.318961 °
DWR ID	DWR_NA0010_17_f_2021_18				
Comment Code					
A3 : No rodents visible, but rodent burrows visible; need to backfill and compact or grout burrows.					
Inspector Comment

Looking up the landside slope at several rodent holes. (Fall 2021)

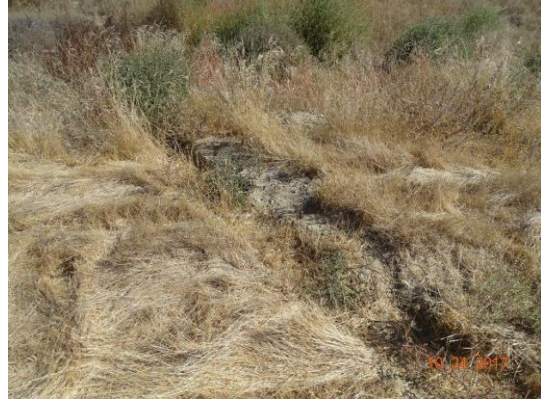
Photo 1 of 1 : SP_2022_NA0010_135_24_20220308_00010.jpg

LM Start	8.15	Rating **	M	Issue No.	24
LM End	8.15	Issue Type +	Ma	Location *	LS
Category	Earthen Levee			GPS Latitude/Longitude	
				Start	End
Item	Animal Control			36.875525 °	36.875525 °
				-120.317788 °	-120.317788 °
DWR ID	DWR_NA0010_17_f_2017_24				
Comment Code					
A3 : No rodents visible, but rodent burrows visible; need to backfill and compact or grout burrows.					
Inspector Comment					
Rodent holes are on the landside and crown of levee. Rodent holes have caused some erosion on the landside slope.

Looking east at the landside slope.

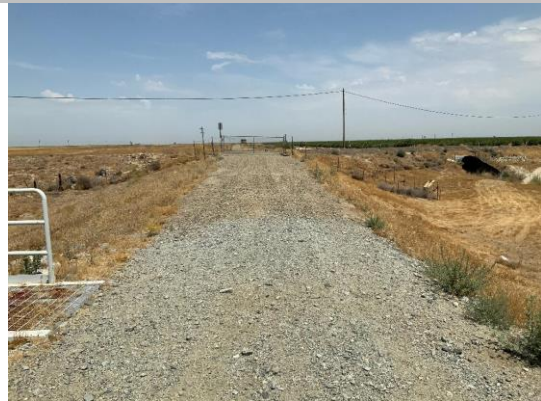
Photo 1 of 3 : UCIP_SP_2022_68829_102421.jpg

Comment Code						
Inspector Comment						
FS_ID:68829						
DS_ID:19922						
EP_NO: N/A						
Repair Type: Non-Urgent						
Crossing Status: Found						
UCIP Comments: 07/13/2021 The record has been upgraded from No Action Needed to Non-Urgent. Limited inspection due to dense tumbleweeds over LS pipe inlet, recommend removal. No permit was found authorizing this encroachment. CVFPB will need to review crossing to determine owner. The UCIP inspection was completed with GEI staff, P. Espinoza. (H. Dunn ? GEI)						
FIELD_STRUCT_DESC: 48-inch by 60-inch reinforced concrete box gravity drainage culvert through the levee, 16.5 feet below the crown. Flap gate on the waterside (WS) end. Concrete headwall on the landside (LS) end. Concrete U-shaped headwall on the WS end. [Additional Reference(s): DWR Levee Log, 2002 (HLM 8.38), listed as a 48-inch by 60-inch reinforced concrete box culvert (RCBC). USACE San Joaquin O&M Manual, Unit 601 Part 1 (SJR601.1), 1967, (HLM 8.38), listed as a 5-feet by 4-feet RCBC].

Levee crown.

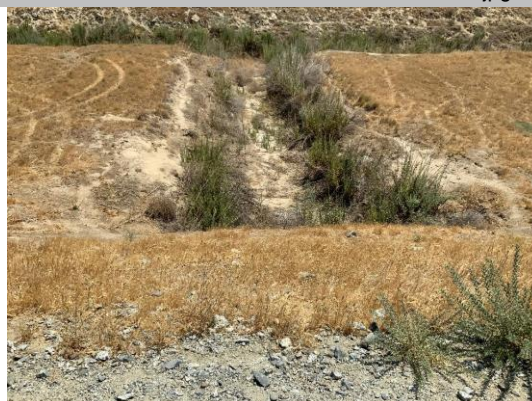
Photo 2 of 3 : UCIP_SP_2022_68829_102425.jpg

LS view: Toe from crown.

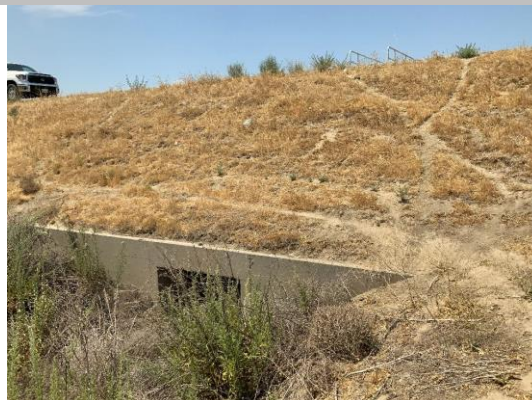
Photo 3 of 3 : UCIP_SP_2022_68829_102426.jpg

LS view: Headwall and slope from toe.

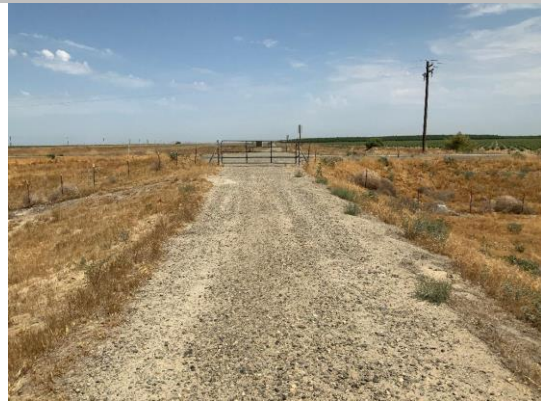
Photo 1 of 3 : UCIP_SP_2022_68830_102428.jpg

Comment Code						
Inspector Comment						
FS_ID:68830 DS_ID:19917 EP_NO: N/A Repair Type: Non-Urgent Crossing Status: Found UCIP Comments: 07/13/2021 The record remains Non-Urgent. Limited inspection due to dense tumbleweeds over LS pipe inlet, recommend removal. No permit was found authorizing this encroachment. CVFPB will need to review crossing to determine owner. The UCIP inspection was completed with GEI staff, P. Espinoza. (H. Dunn ? GEI) 04/01/2014 Dense vegetation limits the inspector's visibility to identify signs of pipe failure (leaks) along the landward slope. Recommend removing vegetation along pipe alignment to conduct proper inspection of structure. (W. Wylie - DWR UCIP) FIELD_STRUCT_DESC: 48-inch by 60-inch reinforced concrete box gravity drainage culvert through the levee, 15 feet below the crown. Concrete headwall on the landside (LS) end. Concrete U-shaped headwall on the waterside (WS) end. [Additional Reference(s): DWR Levee Log, 2002 (HLM 9.89), listed as a 48-inch by 60-inch reinforced concrete box culvert (RCBC). USACE San Joaquin O&M Manual, Unit 601 Part 1 (SJR601.1), 1967, (HLM 9.89), listed as a 5-feet by 4-feet RCBC]. FS Date: 7/19/2021

Levee crown.

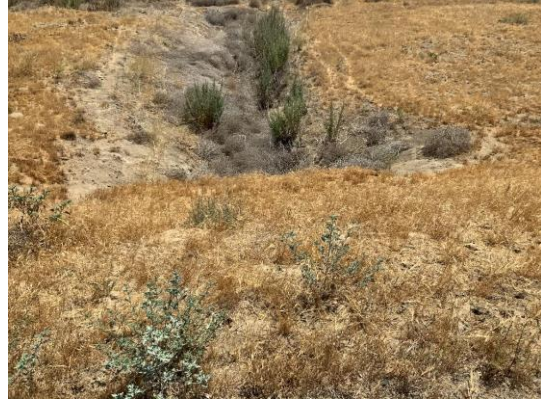
Photo 2 of 3 : UCIP_SP_2022_68830_102432.jpg

LS view: Toe from crown.

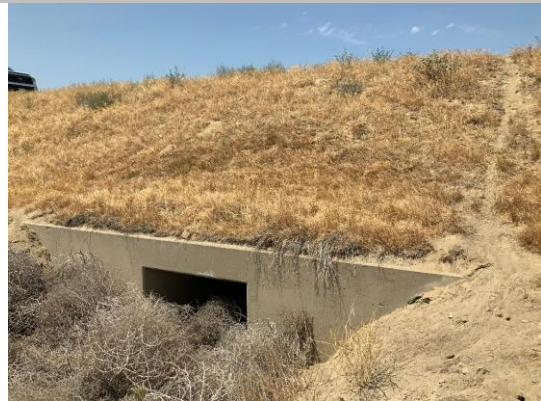
Photo 3 of 3 : UCIP_SP_2022_68830_102433.jpg

LS view: Headwall and slope from toe.

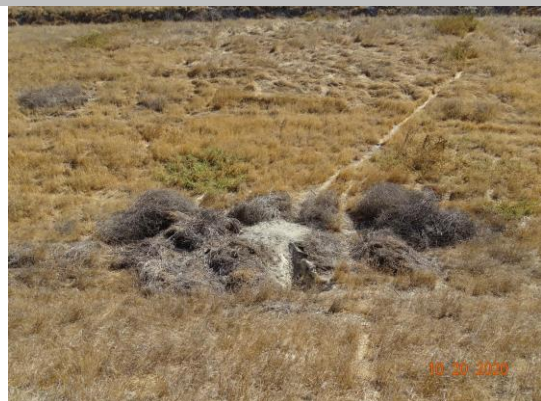
Photo 1 of 1 : SP_2022_NA0010_135_39_20220308_00012.jpg

LM Start	12.17	Rating **	A/W	Issue No.	39
LM End	12.17	Issue Type +	Ma	Location *	LS
Category	Earthen Levee			GPS Latitude/Longitude	
				Start	End
Item	Animal Control			36.822818 °	36.822818 °
				-120.299680 °	-120.299680 °
DWR ID	DWR_NA0010_17_f_2018_39				
Comment Code					
A3 : No rodents visible, but rodent burrows visible; need to backfill and compact or grout burrows.					
Inspector Comment					
A large hole is on the landside toe.

Large rodent hole at toe of levee. (Fall 2020)

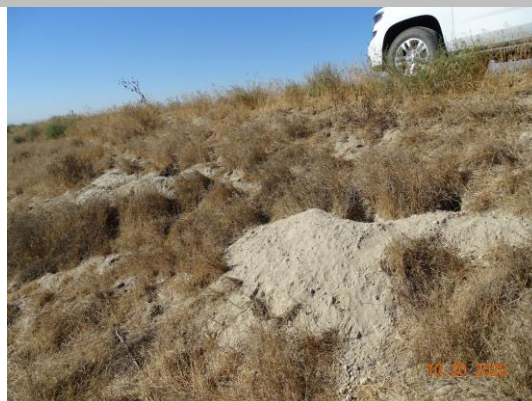
Photo 1 of 1 : SP_2022_NA0010_135_19_20220308_00009.jpg

LM Start	12.25	Rating **	U	Issue No.	19
LM End	12.25	Issue Type +	Ma	Location *	LS
Category	Earthen Levee			GPS Latitude/Longitude	
				Start	End
Item	Animal Control			36.821776 °	36.821776 °
				-120.300137 °	-120.300137 °
DWR ID	DWR_NA0010_17_f_2020_19				
Comment Code					
A3 : No rodents visible, but rodent burrows visible; need to backfill and compact or grout burrows.					
Inspector Comment

View of rodent burrows on the landside slope. (Fall 2020)

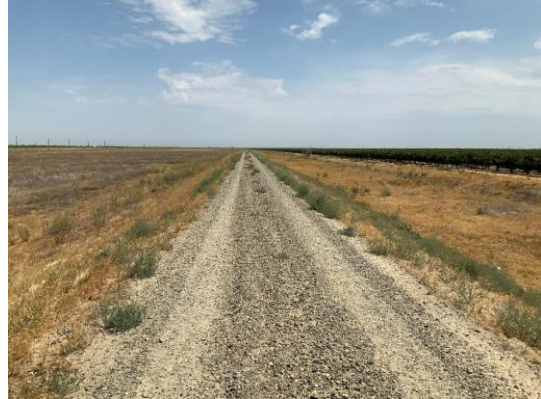
Photo 1 of 3 : UCIP_SP_2022_68831_102435.jpg

Comment Code						
Inspector Comment						
FS_ID:68831 DS_ID:19918 EP_NO: N/A Repair Type: Non-Urgent Crossing Status: Found UCIP Comments: 07/13/2021 The record remains Non-Urgent. WS flapgate has plank holding it shut, remove before flood season. Limited inspection due to dense tumbleweeds covering LS pipe inlet, recommend removal. No permit was found authorizing this encroachment. CVFPB will need to review crossing to determine owner. The UCIP inspection was completed with GEI staff, P. Espinoza. (H. Dunn ? GEI) 04/01/2014 Some vegetation buildup at inlet--recommend clearing. (W. Wylie - DWR UCIP) FIELD_STRUCT_DESC: 48-inch by 60-inch reinforced concrete box gravity drainage culvert through the levee, 15.3 feet below the crown. Flap gate on the waterside (WS) end. Concrete headwall on the landside (LS) end. Concrete U-shaped headwall on the WS end. [Additional Reference(s): DWR Levee Log, 2002 (HLM 13.29), listed as a 48-inch by 60-inch reinforced concrete box culvert (RCBC). USACE San Joaquin O&M Manual, Unit 601 Part 1 (SJR601.1), 1967, (HLM 13.30), listed as a 5-feet by 4-feet RCBC]. FS Date: 7/19/2021

Levee crown.

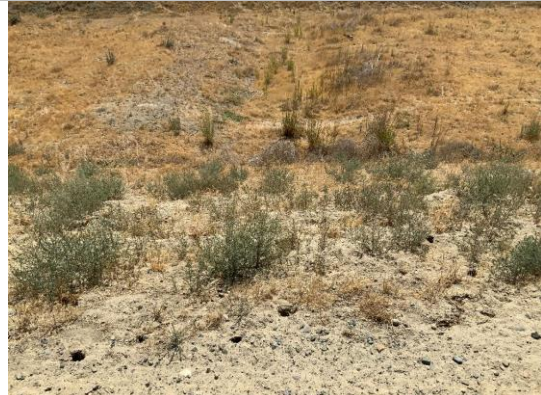
Photo 2 of 3 : UCIP_SP_2022_68831_102439.jpg

LS view: Headwall visible at toe from crown.

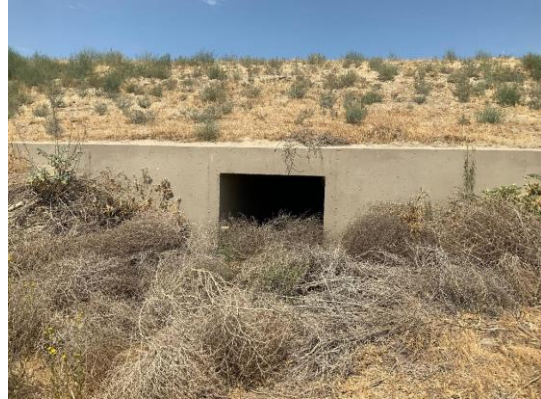
Photo 3 of 3 : UCIP_SP_2022_68831_102440.jpg

LS view: Headwall and slope from toe.

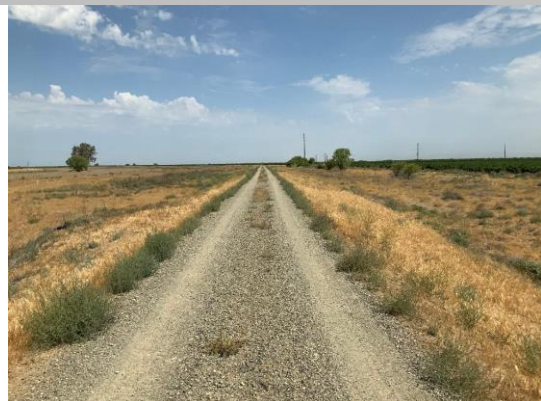
Photo 1 of 3 : UCIP_SP_2022_68525_102470.jpg

FS_ID:68525
DS_ID:19920
EP_NO: N/A
Repair Type: Non-Urgent
Crossing Status: Found
UCIP Comments: 07/19/2021 The record remains Non-Urgent. Dense tumbleweeds over WS flapgate and LS inlet, recommend removal of both sides. Limited inspection on both WS and LS ends. No permit was found authorizing this encroachment. CVFPB will need to review crossing to determine owner. The UCIP inspection was completed with GEI staff, P. Espinoza. (H. Dunn ? GEI) 04/01/2014 Heavy vegetation buildup at LS toe--recommend clearing. (W. Wylie - DWR UCIP)
FIELD_STRUCT_DESC: 30-inch by 30-inch square reinforced concrete box gravity drainage culvert through the levee, 14 feet below the crown. Flap gate on the waterside (WS) end. Concrete headwall on the landside (LS) end. Concrete U-shaped headwall on the WS end.
[Additional Reference(s): DWR Levee Log, 2002 (HLM 14.70), listed as a 30-inch square reinforced concrete box culvert (RCBC). USACE San Joaquin O&M Manual, Unit 601 Part 1 (SJR601.1), 1967, (HLM 14.69), listed as a 2.5-feet by 2.5-feet RCBC].

Levee crown.

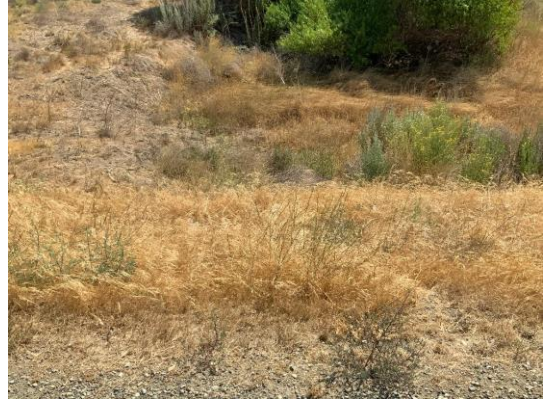
Photo 2 of 3 : UCIP_SP_2022_68525_102474.jpg

LS view: Toe from crown.

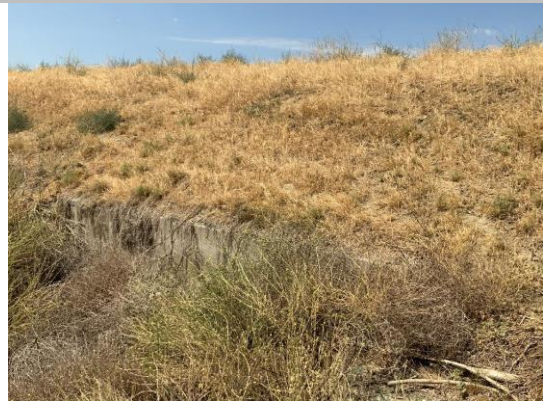
Photo 3 of 3 : UCIP_SP_2022_68525_102475.jpg

LS view: Slope from toe.

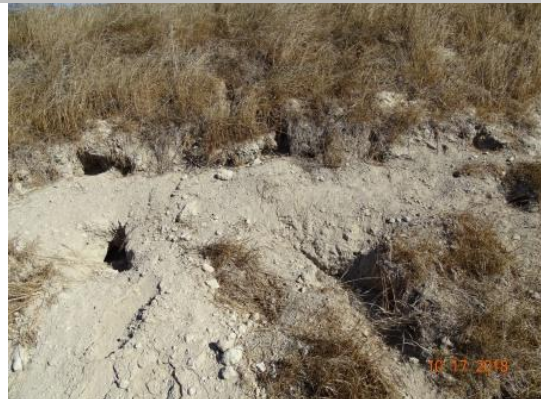
Photo 1 of 1 : SP_2022_NA0010_137_55_20220308_00016.jpg

LM Start	0.78	Rating **	M	Issue No.	55
LM End	0.78	Issue Type +	Ma	Location *	LS
Category	Earthen Levee		GPS Latitude/Longitude		
			Start	End	
Item	Animal Control		36.964824 °	36.964824 °	
			-120.358065 °	-120.358065 °	
DWR ID	DWR_NA0010_18_f_2018_55				
Comment Code					
A3 : No rodents visible, but rodent burrows visible; need to backfill and compact or grout burrows.					
Inspector Comment

View of rodent holes from levee toe looking towards centerline. (Fall 2018)

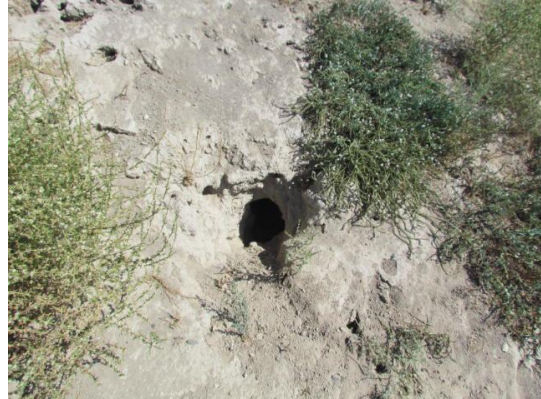
Photo 1 of 1 : SP_2022_NA0010_137_8_20220308_00002.jpg

LM Start	2.25	Rating **	U	Issue No.	8
LM End	2.25	Issue Type +	Ma	Location *	LS
Category	Earthen Levee			GPS Latitude/Longitude	
				Start	End
Item	Animal Control			36.945563 °	36.945563 °
				-120.347121 °	-120.347121 °
DWR ID	DWR_NA0010_18_f_2015_8				
Comment Code					
A3 : No rodents visible, but rodent burrows visible; need to backfill and compact or grout burrows.					
Inspector Comment					
There is one large rodent hole and other smaller rodent holes within this area.

Looking at large rodent hole on landward slope.

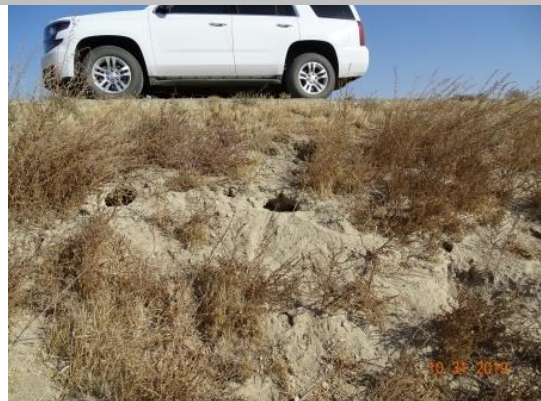
Photo 1 of 1 : SP_2022_NA0010_137_31_20220308_00009.jpg

LM Start	3.41	Rating **	U	Issue No.	31
LM End	3.44	Issue Type +	Ma	Location *	LS
Category	Earthen Levee			GPS Latitude/Longitude	
				Start	End
Item	Animal Control			36.929498 °	36.929093 °
				-120.341091 °	-120.340920 °
DWR ID	DWR_NA0010_18_f_2019_31				
Comment Code					
A3 : No rodents visible, but rodent burrows visible; need to backfill and compact or grout burrows.					
Inspector Comment

View of rodent burrows in the landside slope. (Fall 2019)

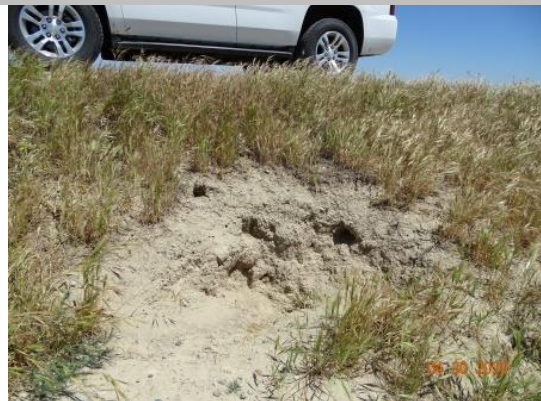
Photo 1 of 1 : SP_2022_NA0010_137_47_20220308_00015.jpg

LM Start	3.73	Rating **	U	Issue No.	47
LM End	3.73	Issue Type +	Ma	Location *	LS
Category	Earthen Levee			GPS Latitude/Longitude	
				Start	End
Item	Animal Control			36.924969 °	36.924969 °
				-120.339407 °	-120.339407 °
DWR ID	DWR_NA0010_18_s_2020_47				
Comment Code					
A3 : No rodents visible, but rodent burrows visible; need to backfill and compact or grout burrows.					
Inspector Comment

Large rodent burrow in the landside slope. (Spring 2020)

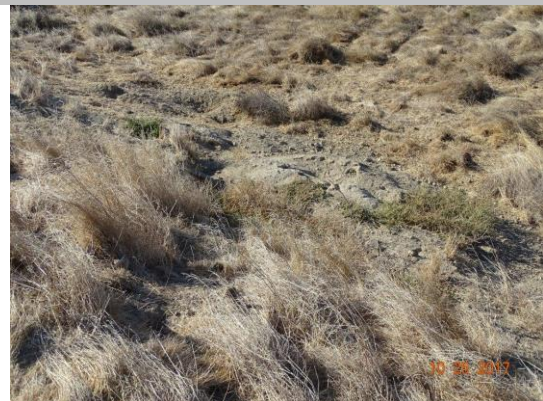
Photo 1 of 1 : SP_2022_NA0010_137_15_20220308_00005.jpg

LM Start	5.74	Rating **	U	Issue No.	15
LM End	5.99	Issue Type +	Ma	Location *	LS
Category	Earthen Levee			GPS Latitude/Longitude	
				Start	End
Item	Animal Control			36.897237 °	36.893924 °
				-120.328633 °	-120.327020 °
DWR ID	DWR_NA0010_18_f_2017_15				
Comment Code					
A3 : No rodents visible, but rodent burrows visible; need to backfill and compact or grout burrows.					
Inspector Comment					
There are multiple large rodent holes at the landside toe.

Looking west at the landside slope. (Fall 2017)

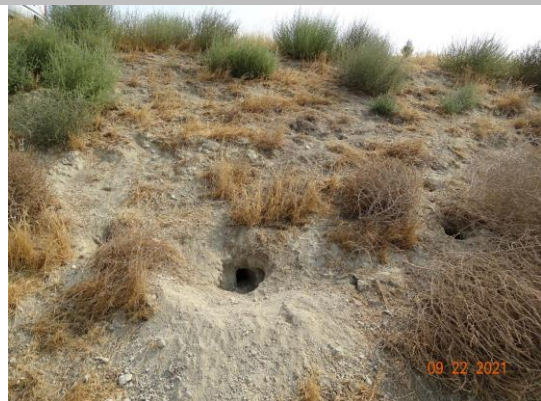
Photo 1 of 1 : SP_2022_NA0010_137_35_20220308_00012.jpg

LM Start	6.62	Rating **	M	Issue No.	35
LM End	6.62	Issue Type +	Ma	Location *	LS
Category	Earthen Levee			GPS Latitude/Longitude	
				Start	End
Item	Animal Control			36.885376 °	36.885376 °
				-120.322820 °	-120.322820 °
DWR ID	DWR_NA0010_18_f_2021_35				
Comment Code					
A3 : No rodents visible, but rodent burrows visible; need to backfill and compact or grout burrows.					
Inspector Comment

Looking at rodent holes on the landside slope. (Fall 2021)

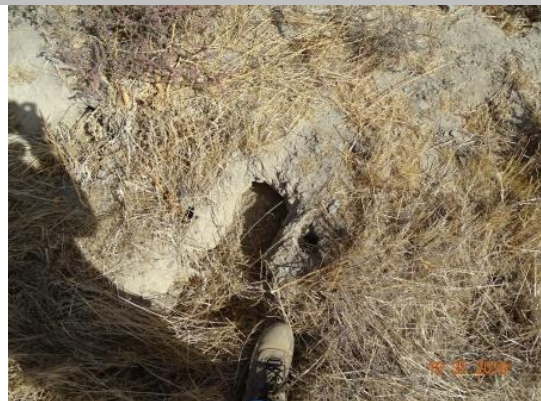
Photo 1 of 1 : SP_2022_NA0010_137_23_20220308_00008.jpg

LM Start	6.84	Rating **	U	Issue No.	23
LM End	6.84	Issue Type +	Ma	Location *	LS
Category	Earthen Levee			GPS Latitude/Longitude	
				Start	End
Item	Animal Control			36.882384 °	36.882384 °
				-120.321417 °	-120.321417 °
DWR ID	DWR_NA0010_18_f_2019_23				
Comment Code					
A1 : Exterminate rodents and backfill and compact or grout burrows.					
Inspector Comment

Representative view of rodent burrows observed at this location. (Fall 2019)

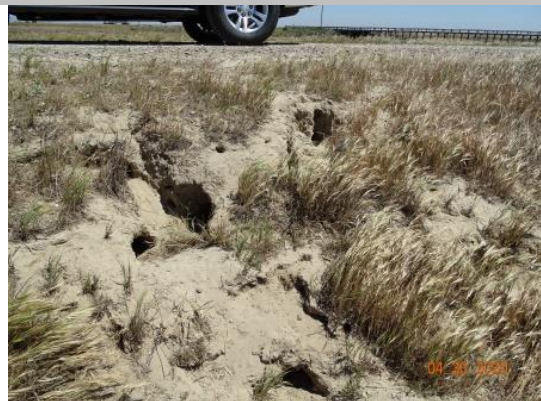
Photo 1 of 1 : SP_2022_NA0010_137_14_20220308_00004.jpg

LM Start	7.39	Rating **	U	Issue No.	14
LM End	7.53	Issue Type +	Ma	Location *	LS
Category	Earthen Levee			GPS Latitude/Longitude	
				Start	End
Item	Animal Control			36.874479 °	36.872503 °
				-120.319831 °	-120.319438 °
DWR ID	DWR_NA0010_18_f_2017_14				
Comment Code					
A3 : No rodents visible, but rodent burrows visible; need to backfill and compact or grout burrows.					
Inspector Comment					
There are several rodent holes noted along the landside slope in this area.

View of rodent burrows in the landside slope. (Spring 2020)

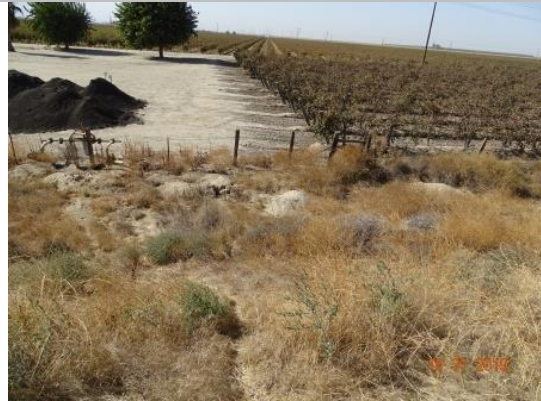
Photo 1 of 1 : SP_2022_NA0010_137_21_20220308_00007.jpg

LM Start	7.91	Rating **	U	Issue No.	21
LM End	7.91	Issue Type +	Ma	Location *	LS
Category	Earthen Levee			GPS Latitude/Longitude	
				Start	End
Item	Animal Control			36.867030 °	36.867030 °
				-120.318361 °	-120.318361 °
DWR ID	DWR_NA0010_18_f _ 2019_21				
Comment Code					
A3 : No rodents visible, but rodent burrows visible; need to backfill and compact or grout burrows.					
Inspector Comment					
Several large rodent burrows in the landside toe.

Several rodent burrows observed at the landside toe. (Fall 2019)

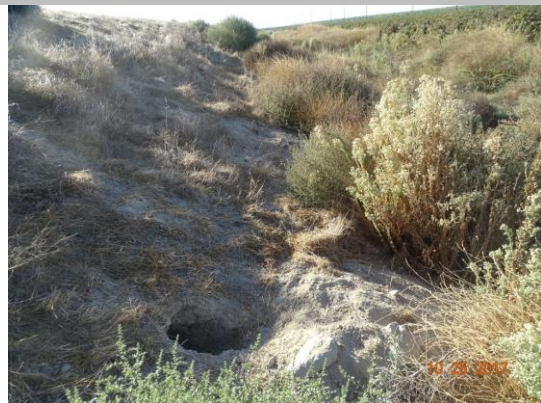
Photo 1 of 1 : SP_2022_NA0010_137_13_20220308_00003.jpg

LM Start	8.67	Rating **	U	Issue No.	13
LM End	8.67	Issue Type +	Ma	Location *	LS
Category	Earthen Levee			GPS Latitude/Longitude	
				Start	End
Item	Animal Control			36.856115 °	36.856115 °
				-120.316595 °	-120.316595 °
DWR ID	DWR_NA0010_18_f_2017_13				
Comment Code					
A3 : No rodents visible, but rodent burrows visible; need to backfill and compact or grout burrows.					
Inspector Comment

Looking south at the landside slope.

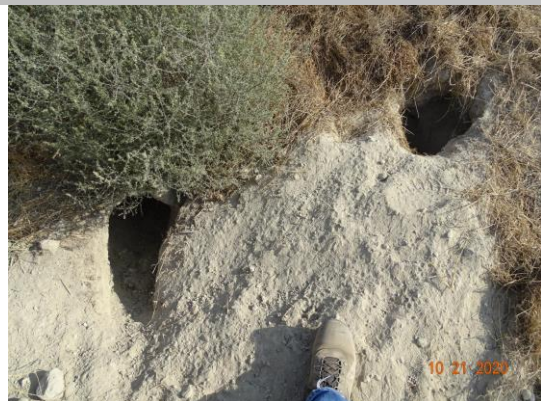
Photo 1 of 1 : SP_2022_NA0010_137_18_20220308_00006.jpg

LM Start	8.89	Rating **	U	Issue No.	18
LM End	8.89	Issue Type +	Ma	Location *	LS
Category	Earthen Levee			GPS Latitude/Longitude	
				Start	End
Item	Animal Control			36.852936 °	36.852936 °
				-120.316451 °	-120.316451 °
DWR ID	DWR_NA0010_18_f_2020_18				
Comment Code					
A3 : No rodents visible, but rodent burrows visible; need to backfill and compact or grout burrows.					
Inspector Comment

Large rodent holes in the landside slope. (Fall 2020)

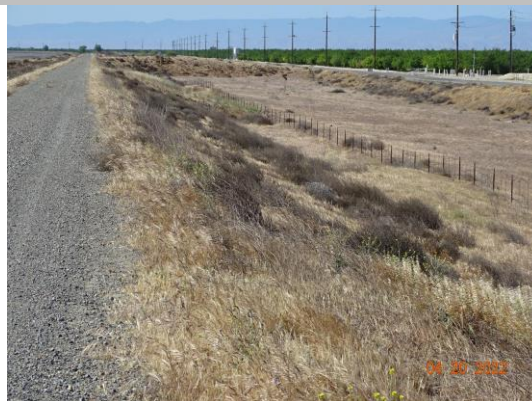
Photo 1 of 1 : SP_2022_NA0010_137_33_20220502_00061.jpg

LM Start	10.97	Rating **	M	Issue No.	33
LM End	12.21	Issue Type +	Ma	Location *	LS
Category	Earthen Levee			GPS Latitude/Longitude	
				Start	End
Item	Vegetation			36.827901 °	36.810895 °
				-120.300125 °	-120.307029 °
DWR ID	DWR_NA0010_18_s_2022_33				
Comment Code					
V1 : Control annual grass and weeds on the levee slopes and easements.					
Inspector Comment

Looking upstream along the landside slope. (Spring 2022)

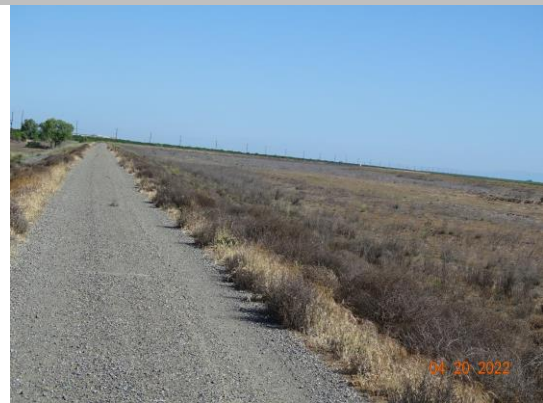
Photo 1 of 1 : SP_2022_NA0010_137_32_20220502_00062.jpg

LM Start	13.03	Rating **	M	Issue No.	32
LM End	13.24	Issue Type +	Ma	Location *	WS
Category	Earthen Levee			GPS Latitude/Longitude	
				Start	End
Item	Vegetation			36.799306 °	36.796389 °
				-120.308828 °	-120.308388 °
DWR ID	DWR_NA0010_18_s_2022_32				
Comment Code					
V1 : Control annual grass and weeds on the levee slopes and easements.					
Inspector Comment

View of vegetation on the waterside slope looking downstream. (Spring 2022)

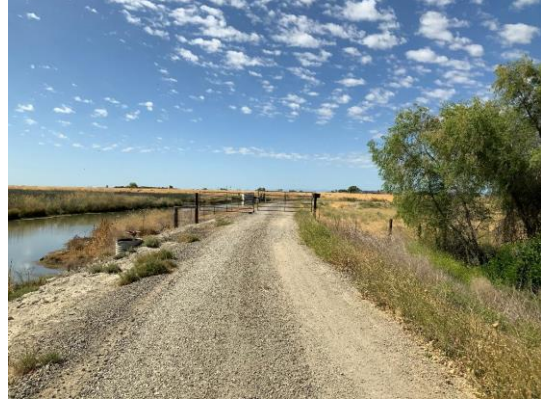
Photo 1 of 3 : UCIP_SP_2022_69879_103853.jpg

Comment Code						
Inspector Comment						
FS_ID:69879 DS_ID:19933 EP_NO: N/A Repair Type: Non-Urgent Crossing Status: Found UCIP Comments: 06/09/2021 The record remains Non-Urgent. Limited inspection of LS due to dense vegetation; recommend removal. Limited inspection on WS due to elevated water level. No pipe inlet or outlet was visible on LS or WS. Riser on WS missing lid, causing a safety hazard. No permit was found authorizing this encroachment. CVFPB will need to review crossing to determine owner. The UCIP inspection was completed with GEI staff, H.Dunn. (P.Espinoza ? GEI)						
07/19/2016 Gate inside riser appears operable--riser lid damage. Crossing is not visible on LS due to dense vegetation. Recommend clearing dense vegetation along WS and LS slope and repairing riser cover. (O. Magana - DWR UCIP)04/15/2014 No actuator wheel on slide gate at WS shoulder. (W. Wylie - DWR UCIP) FIELD_STRUCT_DESC: 24-inch corrugated metal gravity drainage pipe through the levee, 14.8 feet below the crown. Slide gate in a 36-inch corrugated metal pipe (CMP) riser on the waterside (WS) slope. Concrete U-shaped headwall on each end. [Additional Reference(s): DWR Levee Log, 2002 (HLM 0.10), listed as a 24-inch corrugated metal pipe (CMP). USACE San Joaquin O&M Manual, Unit 601 Part 1 (SJR601.1), 1967, Revised 25 May 2011, (HLM 0.10), listed as a 24-inch CMP]. FS Date: 6/9/2021 12:38:00 PM

View from levee crown. CMP riser visible on WS.

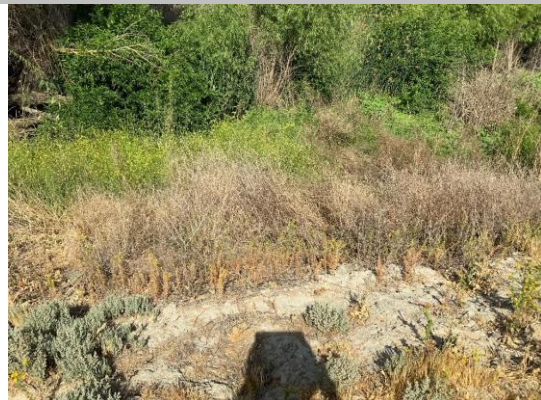
Photo 2 of 3 : UCIP_SP_2022_69879_103856.jpg

LS view: Toe from crown, dense vegetation.

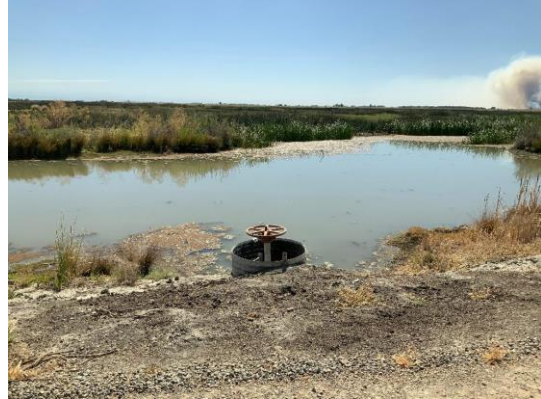
Photo 3 of 3 : UCIP_SP_2022_69879_103854.jpg

WS view: Slope from crown, CMP riser visible at toe.
