**Flood Control Project Maintenance
Levee Inspections**

Maintenance Issue Types Only, Levee Inspection Report By Mile - Spring 2022

Lower San Joaquin Levee District

Waterway	Bank	Unit Miles	Inspection Start/End	Inspector
Unit No. 01 San Joaquin River	Right	22.52	04/05/2022 04/05/2022	Corey Fujitani

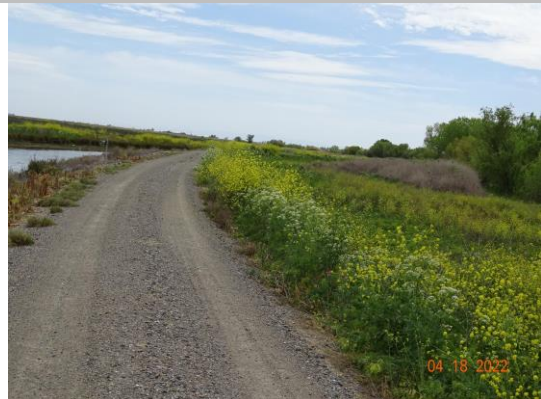
Photo 1 of 1 : SP_2022_NA0010_138_38_20220502_00060.jpg

LM Start	0.50	Rating **	U	Issue No.	38
LM End	0.89	Issue Type +	Ma	Location *	LS
Category	Earthen Levee			GPS Latitude/Longitude	
				Start	End
Item	Vegetation			37.212601 °	37.218166 °
				-120.697992 °	-120.697531 °
DWR ID	DWR_NA0010_22A_s _ 2022_38				
Comment Code					
V1 : Control annual grass and weeds on the levee slopes and easements.					
Inspector Comment

View of the vegetation growing on the landside slope. (Spring 2022)

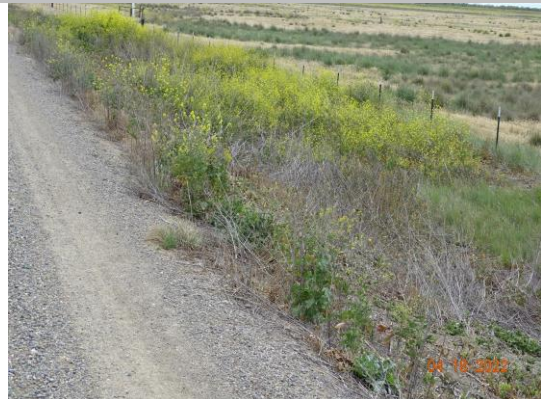
Photo 1 of 1 : SP_2022_NA0010_138_36_20220502_00061.jpg

LM Start	0.89	Rating **	M	Issue No.	36
LM End	1.58	Issue Type +	Ma	Location *	LS
Category	Earthen Levee			GPS Latitude/Longitude	
				Start	End
Item	Vegetation			37.218166 °	37.227678 °
				-120.697531 °	-120.700998 °
DWR ID	DWR_NA0010_22A_s_2022_36				
Comment Code					
V1 : Control annual grass and weeds on the levee slopes and easements.					
Inspector Comment

Looking upstream along the landside slope. (Spring 2022)

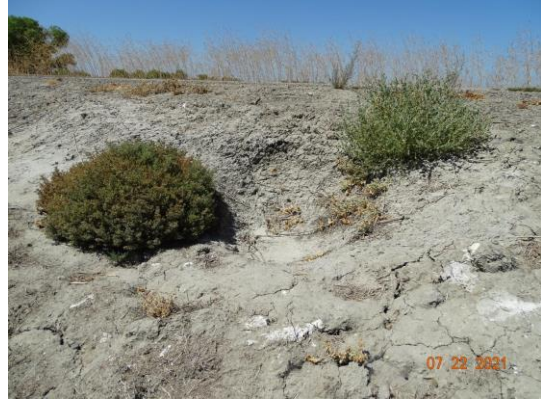
Photo 1 of 1 : SP_2022_NA0010_138_22_20220308_00020.jpg

LM Start	1.04	Rating **	M	Issue No.	22
LM End	1.04	Issue Type +	Ma	Location *	WS
Category	Earthen Levee			GPS Latitude/Longitude	
				Start	End
Item	Slope Stability			37.220281 °	37.220281 °
				-120.698287 °	-120.698287 °
DWR ID	DWR_NA0010_22A_f_2021_22				
Comment Code					
S1 : Repair slope instability.					
Inspector Comment

View of the erosion pocket on the levee slope (Fall 2021).

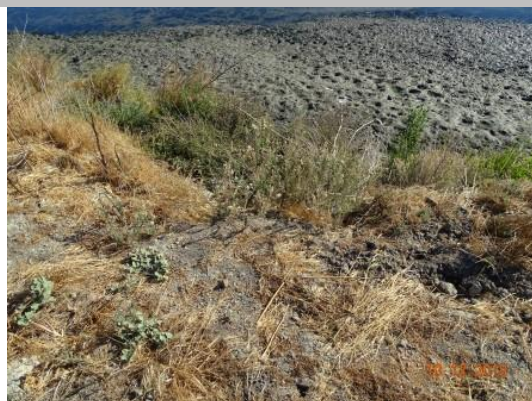
Photo 1 of 1 : SP_2022_NA0010_138_29_20220308_00023.jpg

LM Start	2.25	Rating **	M	Issue No.	29	
LM End	2.37	Issue Type +	Ma	Location *	WS	
Category	Earthen Levee			GPS Latitude/Longitude		
				Start		End
Item	Erosion / Livestock			37.237050 °	37.238776 °	
				-120.704393 °	-120.705028 °	
DWR ID	DWR_NA0010_22A_f_2018_29					
Comment Code						
E4 : Repair the levee slope damaged by livestock and prevent large animal access.						
Inspector Comment						
There is slope erosion from livestock, the slope is no longer 3:1.

View of waterside slope from levee crown. (Fall 2018)

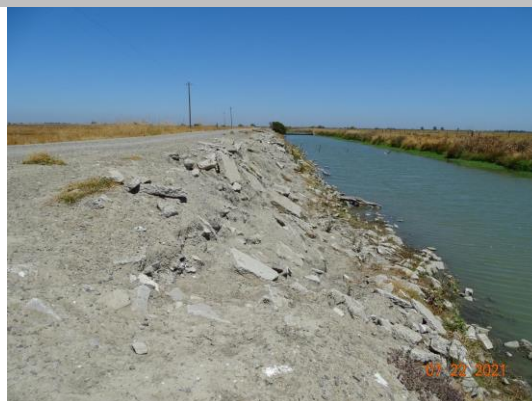
Photo 1 of 2 : SP_2022_NA0010_138_1_20220308_00001.jpg

LM Start	2.65	Rating **	U	Issue No.	1
LM End	2.66	Issue Type +	Ma	Location *	WS
Category	Supplemental			GPS Latitude/Longitude	
				Start	End
Item	DWR Erosion Survey			37.242595 °	37.242595 °
				-120.706470 °	-120.706470 °
DWR ID	NA0010U22RM3.87				
Comment Code					
Inspector Comment					
Site ID: NA0010U22RM3.87 07/22/2021: The erosion length was updated to 50 ft based on more accurate field measurements. Otherwise, no significant changes were observed since the previous inspection. 08/18/2020: The site has been covered with loose fill and crushed concrete pieces. The erosion will likely worsen again during the next high water. 09/12/2019: The erosion has cut into the levee prism and damaged almost half of the levee. The livestock traffic has likely caused the erosion.

7/22/2021: View of the erosion with fill and concrete looking downstream.

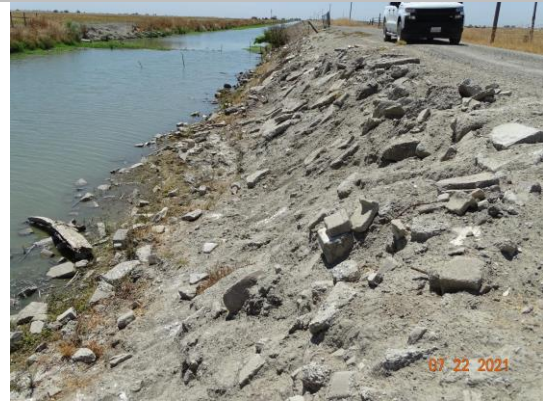
Photo 2 of 2 : SP_2022_NA0010_138_1_20220308_00002.jpg

8/18/2020: Close-up view of the erosion.

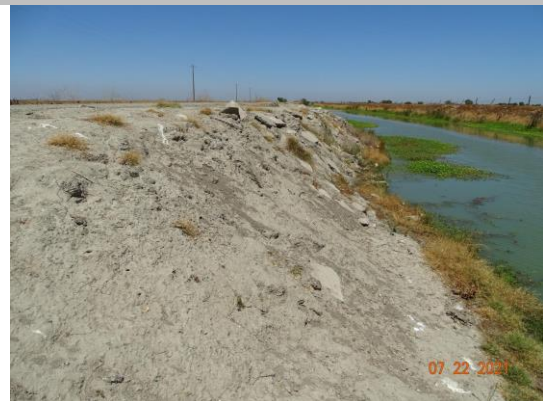
Photo 1 of 2 : SP_2022_NA0010_138_3_20220308_00005.jpg

07/22/2021: From 2020 to present, no significant changes were observed during the annual survey. In some areas, the levee shoulder width is up to 8 ft. There is some crushed concrete on the levee slope. 09/12/2019: The erosion has damaged entire levee slope. The livestock traffic likely has caused the erosion.

7/22/2021: View of the erosion looking downstream.

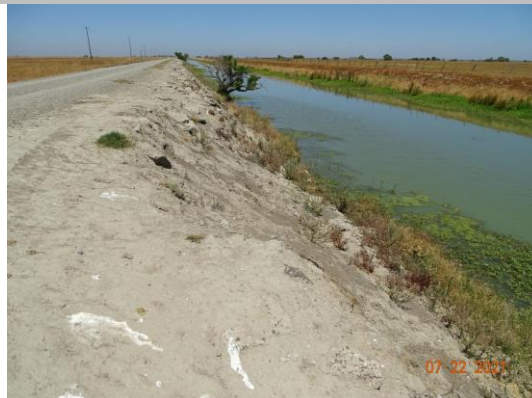
Photo 1 of 2 : SP_2022_NA0010_138_4_20220308_00007.jpg

07/22/2021: No significant changes were observed since the previous inspection.

08/18/2020: No vegetation visible in the area of the erosion. Noticed some crushed concrete pieces on the levee slope and a small amount of loose fill.

09/12/2019: The erosion has damaged entire levee slope. The livestock traffic likely has caused the erosion.

7/22/2021: View of the erosion looking downstream.

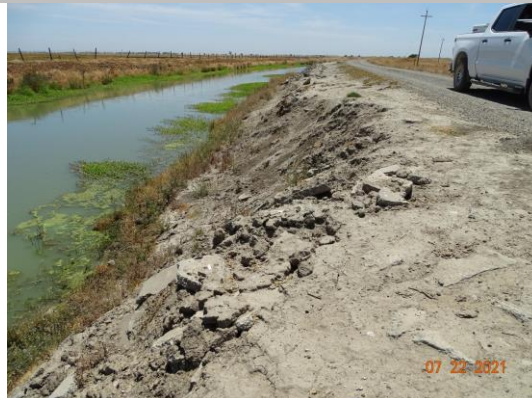
Photo 2 of 2 : SP_2022_NA0010_138_4_20220308_00008.jpg

7/22/2021: View of the erosion looking upstream.

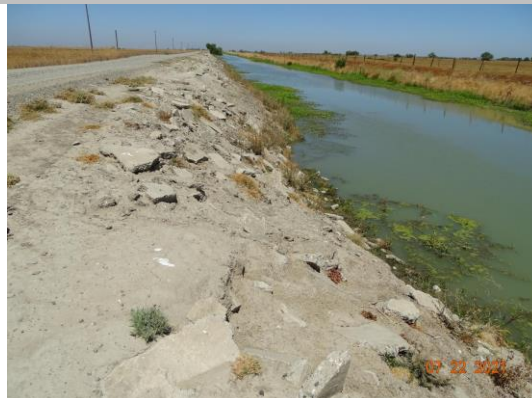
Photo 1 of 2 : SP_2022_NA0010_138_7_20220308_00010.jpg

07/22/2021: No significant changes were observed since the previous inspection.

08/18/2020: The erosion has been covered with loose fill and crushed concrete pieces. A nearly vertical slope remains at the levee toe in some sections. The site will likely worsen again during the next high water.

09/12/2019: The erosion has damaged entire levee slope. The livestock activity likely has caused the erosion.

7/22/2021: View of the erosion and crushed concrete on the slope.

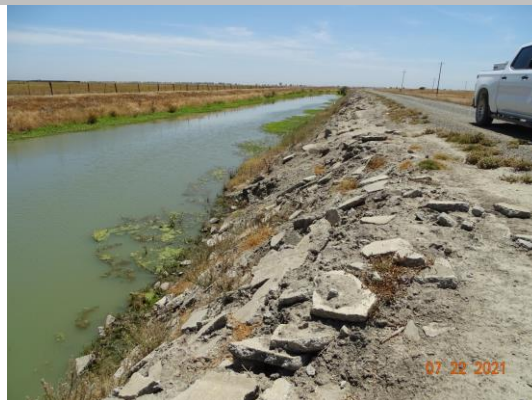
Photo 2 of 2 : SP_2022_NA0010_138_7_20220308_00011.jpg

7/22/2021: View of the erosion looking upstream.

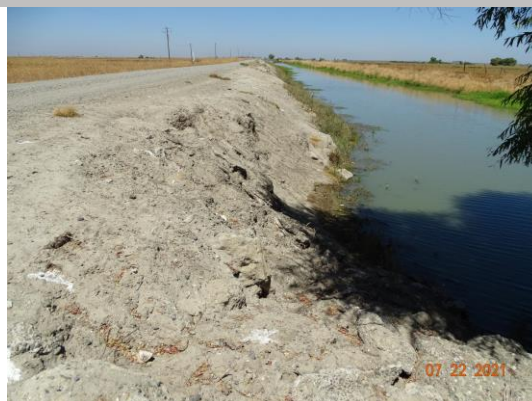
Photo 1 of 2 : SP_2022_NA0010_138_2_20220308_00003.jpg

LM Start	3.14	Rating **	U	Issue No.	2
LM End	3.15	Issue Type +	Ma	Location *	WS
Category	Supplemental			GPS Latitude/Longitude	
				Start	End
Item	DWR Erosion Survey			37.248257 °	37.248257 °
				-120.711547 °	-120.711547 °
DWR ID	NA0010U22RM3.38				
Comment Code					
Inspector Comment					
Site ID: NA0010U22RM3.38					
07/22/2021: No significant changes were observed since the previous inspection.					
08/18/2020: The erosion has slightly worsened and cut into the levee prism. The site is immediately downstream of a tree on the levee toe.					
09/12/2019: The erosion has damaged the entire levee slope. Livestock activity likely has caused the erosion.

7/22/2021: View of the erosion looking downstream.

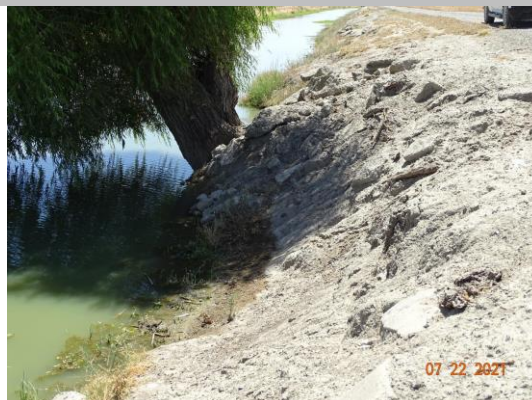
Photo 2 of 2 : SP_2022_NA0010_138_2_20220308_00004.jpg

7/22/2021: View of the erosion by the tree.

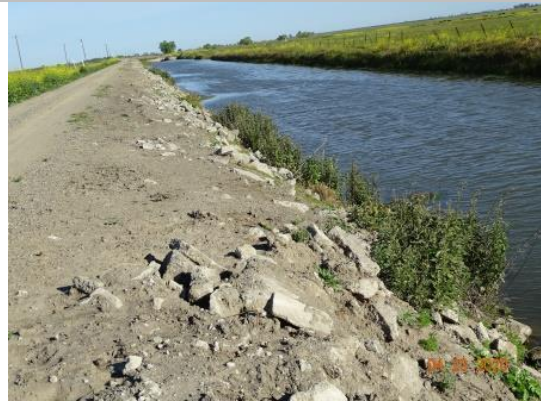
Photo 1 of 1 : SP_2022_NA0010_138_34_20220308_00024.jpg

LM Start	3.44	Rating **	U	Issue No.	34
LM End	3.44	Issue Type +	Ma	Location *	WS
Category	Earthen Levee			GPS Latitude/Longitude	
				Start	End
Item	Erosion / Livestock			37.251370 °	37.251370 °
				-120.715344 °	-120.715344 °
DWR ID	DWR_NA0010_22A_f_2018_34				
Comment Code					
E4 : Repair the levee slope damaged by livestock and prevent large animal access.					
Inspector Comment					
Broken concrete was placed on the waterside slope to prevent erosion from livestock. Concrete with rebar should be removed.

Fill and concrete were placed to repair erosion on the waterside slope.
Concrete with rebar should be removed. (Spring 2020)

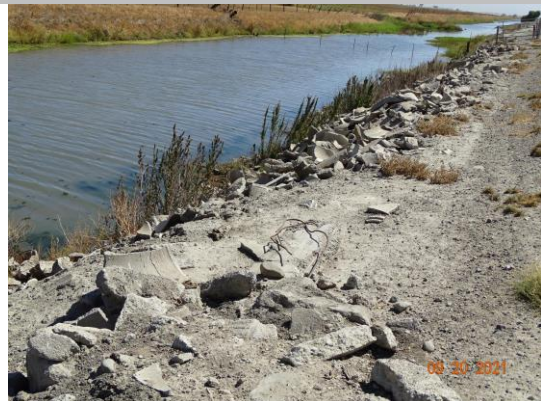
Photo 1 of 1 : SP_2022_NA0010_138_35_20220308_00025.jpg

LM Start	3.47	Rating **	U	Issue No.	35
LM End	3.47	Issue Type +	Ma	Location *	WS
Category	Earthen Levee			GPS Latitude/Longitude	
				Start	End
Item	Erosion / Livestock			37.251621 °	37.251621 °
				-120.715649 °	-120.715649 °
DWR ID	DWR_NA0010_22A_f_2018_35				
Comment Code					
E4 : Repair the levee slope damaged by livestock and prevent large animal access.					
Inspector Comment					
Waterside slope erosion is from livestock activity. Slope stabilized with broken concrete. Concrete with rebar in it should be removed.

Fill and concrete placed on the waterside slope. Rebar should be removed for safety. (Fall 2021)

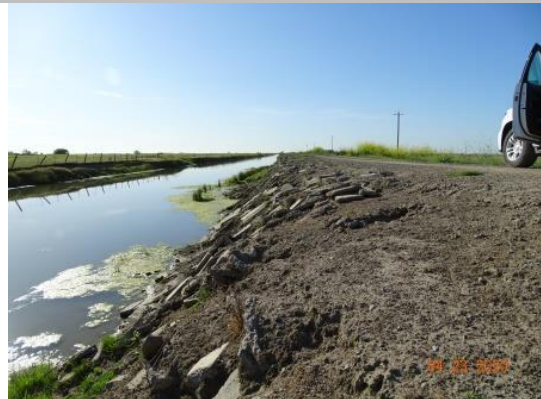
Photo 1 of 1 : SP_2022_NA0010_138_9_20220308_00013.jpg

LM Start	3.64	Rating **	A/W	Issue No.	9
LM End	3.69	Issue Type +	Ma	Location *	WS
Category	Earthen Levee			GPS Latitude/Longitude	
				Start	End
Item	Erosion / Livestock			37.253362 °	37.253862 °
				-120.717873 °	-120.718507 °
DWR ID	DWR_NA0010_22A_f_2016_9				
Comment Code					
E4 : Repair the levee slope damaged by livestock and prevent large animal access.					
Inspector Comment					
Broken concrete has been placed to limit further erosion caused by livestock. Monitor.

View of waterside slope looking upstream. (Spring 2020)

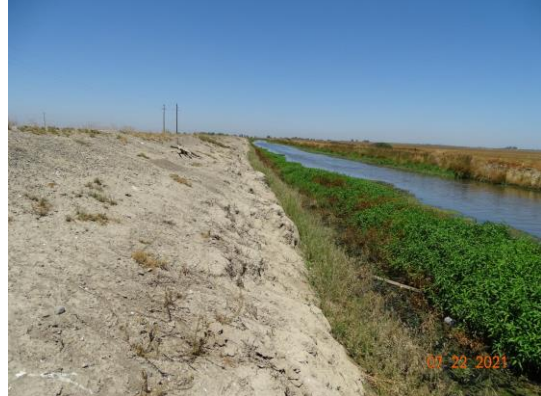
Photo 1 of 2 : SP_2022_NA0010_138_10_20220308_00014.jpg

LM Start	4.26	Rating **	U	Issue No.	10
LM End	4.30	Issue Type +	Ma	Location *	WS
Category	Supplemental			GPS Latitude/Longitude	
				Start	End
Item	DWR Erosion Survey			37.260111 °	37.260111 °
				-120.725900 °	-120.725900 °
DWR ID	NA0010U22RM2.25				
Comment Code					
Inspector Comment					
Site ID: NA0010U22RM2.25					
07/22/2021: From 2020 to present, no significant changes were observed during the annual survey.					
09/12/2019: Erosion has developed into the lower levee slope. Loose material was observed at the site.

7/22/2021: View of the erosion looking downstream.

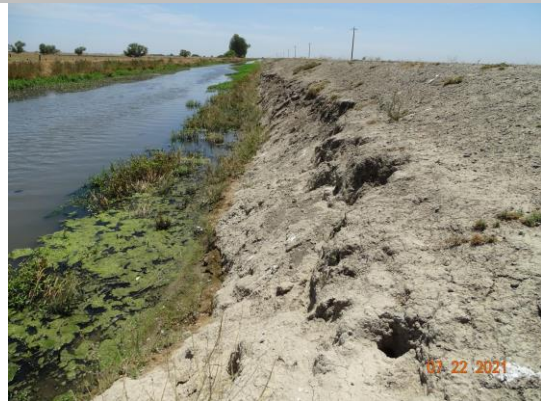
Photo 2 of 2 : SP_2022_NA0010_138_10_20220308_00015.jpg

7/22/2021: Close-up view of the erosion looking upstream.

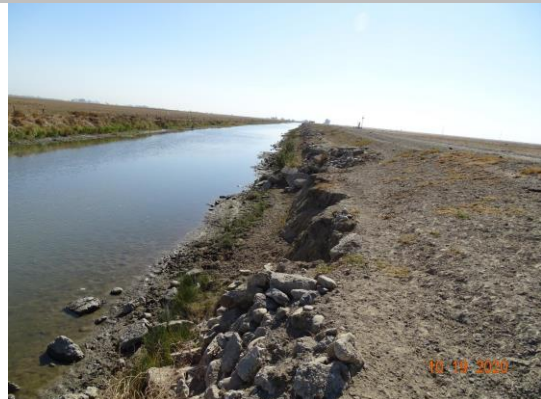
Photo 1 of 1 : SP_2022_NA0010_138_37_20220308_00026.jpg

LM Start	4.30	Rating **	U	Issue No.	37
LM End	5.11	Issue Type +	Ma	Location *	WS
Category	Earthen Levee			GPS Latitude/Longitude	
				Start	End
Item	Erosion / Livestock			37.260111 °	37.268135 °
				-120.725900 °	-120.737130 °
DWR ID	DWR_NA0010_22A_f_2018_37				
Comment Code					
E4 : Repair the levee slope damaged by livestock and prevent large animal access.					
Inspector Comment					
Erosion is cutting into the waterside slope. Some sections have been stabilized with cobble stone and broken concrete.

View of waterside slope damage looking upstream. (Fall 2020)

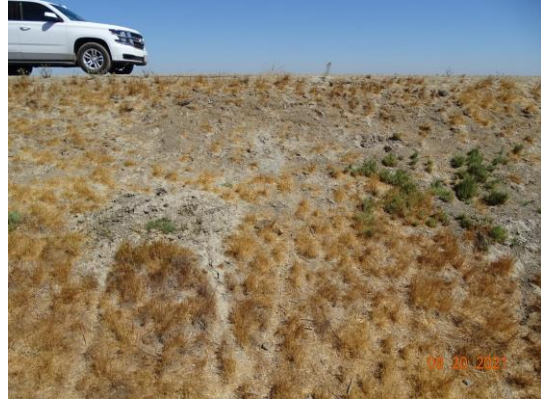
Photo 1 of 1 : SP_2022_NA0010_138_21_20220308_00019.jpg

LM Start	4.42	Rating **	M	Issue No.	21
LM End	4.42	Issue Type +	Ma	Location *	LS
Category	Earthen Levee			GPS Latitude/Longitude	
				Start	End
Item	Animal Control			37.261573 °	37.261573 °
				-120.727622 °	-120.727622 °
DWR ID	DWR_NA0010_22A_f_2021_21				
Comment Code					
A3 : No rodents visible, but rodent burrows visible; need to backfill and compact or grout burrows.					
Inspector Comment					
District has placed a bait station at the location.

View of displaced earth and rodent holes in the landside slope. (Fall 2021)

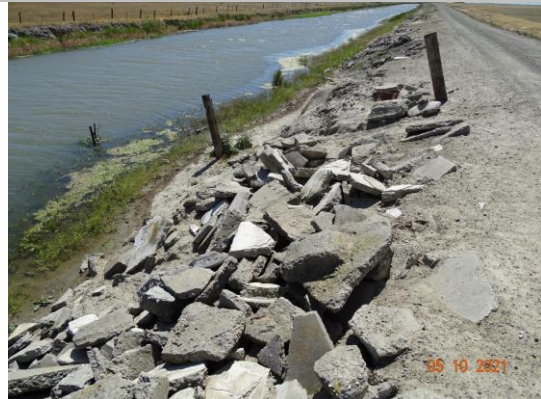
Photo 1 of 1 : SP_2022_NA0010_138_8_20220308_00012.jpg

LM Start	4.87	Rating **	A/W	Issue No.	8
LM End	4.87	Issue Type +	Ma	Location *	WS
Category	Earthen Levee			GPS Latitude/Longitude	
				Start	End
Item	Erosion / Livestock			37.265813 °	37.265813 °
				-120.733748 °	-120.733748 °
DWR ID	DWR_NA0010_22A_f_2016_8				
Comment Code					
E4 : Repair the levee slope damaged by livestock and prevent large animal access.					
Inspector Comment					
Levee damage caused by animal traffic. Several sites repaired with broken concrete.

Slope damage repaired with concrete rubble on the waterside slope and shoulder. (Spring 2021)

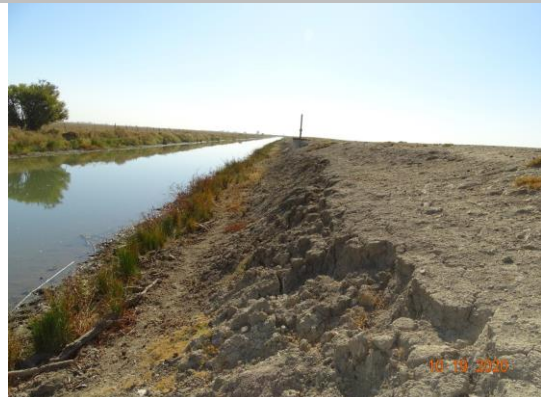
Photo 1 of 1 : SP_2022_NA0010_138_6_20220308_00009.jpg

LM Start	5.12	Rating **	M	Issue No.	6
LM End	5.49	Issue Type +	Ma	Location *	WS
Category	Earthen Levee			GPS Latitude/Longitude	
				Start	End
Item	Erosion / Livestock			37.268236 °	37.272262 °
				-120.737210 °	-120.741778 °
DWR ID	DWR_NA0010_22A_s_2022_6				
Comment Code					
E4 : Repair the levee slope damaged by livestock and prevent large animal access.					
Inspector Comment					
Slope damage is caused by livestock on waterside toe.

Looking southeast at livestock erosion on waterward toe. (Fall 2020)

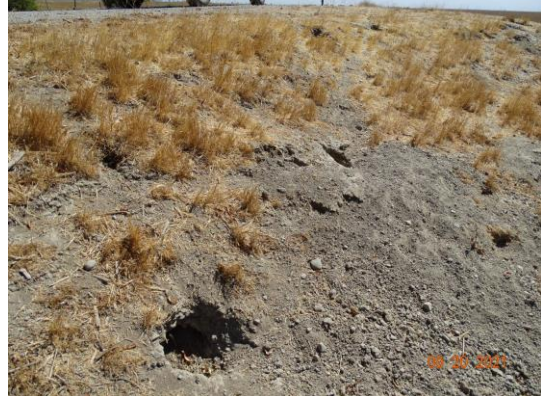
Photo 1 of 1 : SP_2022_NA0010_138_20_20220308_00018.jpg

LM Start	5.50	Rating **	M	Issue No.	20
LM End	5.50	Issue Type +	Ma	Location *	LS
Category	Earthen Levee			GPS Latitude/Longitude	
				Start	End
Item	Animal Control			37.272345 °	37.272345 °
				-120.741883 °	-120.741883 °
DWR ID	DWR_NA0010_22A_f_2021_20				
Comment Code					
A3 : No rodents visible, but rodent burrows visible; need to backfill and compact or grout burrows.					
Inspector Comment

View of rodent holes in the landside slope looking upstream. (Fall 2021)

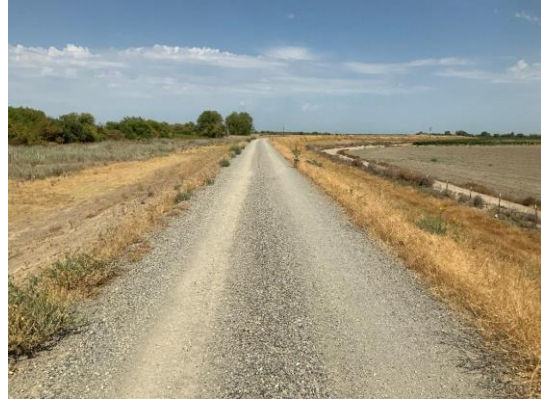
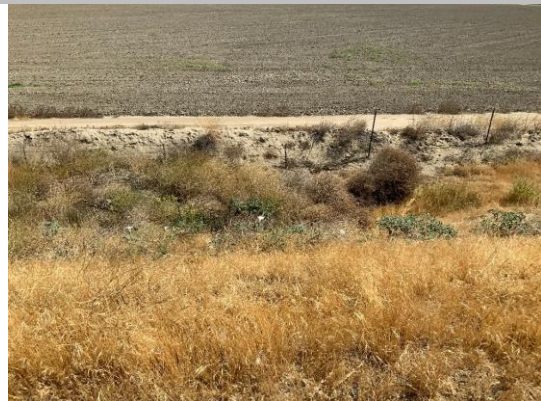
Comment Code						
Inspector Comment						
FS_ID:68586						
DS_ID:19945						
EP_NO: N/A						
Repair Type: Non-Urgent						
Crossing Status: Found						
UCIP Comments: 07/19/2021 The record remains Non-Urgent. Dense LS vegetation over pipe inlet, recommend removal. No permit was found authorizing this encroachment. CVFPB will need to review crossing to determine owner. The UCIP inspection was completed with GEI staff, P. Espinoza. (H. Dunn ? GEI) 04/03/2014 Excessive vegetation at inlet--recommend clearing. (W. Wylie - DWR UCIP)						
FIELD_STRUCT_DESC: 30-inch by 30-inch square reinforced concrete box gravity drainage culvert through the levee, 13 feet below the crown. Flap gate on the waterside (WS) end. Concrete headwall on the landside (LS) end. Concrete U-shaped headwall on the WS end. (Plans to construct a new discharge structure and to rehabilitate one existing diversion structure to return intercepted seepage to the San Joaquin River authorized under Permit No. 13085, 1981 - Diener, Dry River Farms). [Additional Reference(s): DWR Levee Log, 2002 (HLM 0.21), listed as a 30-inch square reinforced concrete box culvert (RCBC). USACE San Joaquin O&M Manual, Unit 601 Part 1 (SJR601.1), 1967, Revised 25 May 2011, (HLM 0.21), listed as a 2.5-foot by 2.5-foot RCBC]

Levee crown.

LS view: Toe from crown.

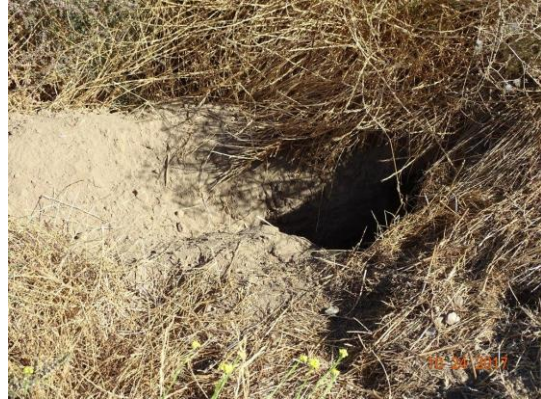
Photo 1 of 1 : SP_2022_NA0010_139_26_20220308_00006.jpg

LM Start	1.09	Rating **	A/W	Issue No.	26
LM End	1.09	Issue Type +	Ma	Location *	LS
Category	Earthen Levee			GPS Latitude/Longitude	
				Start	End
Item	Animal Control			36.772743 °	36.772743 °
				-120.266800 °	-120.266800 °
DWR ID	DWR_NA0010_23_f _ 2017_26				
Comment Code					
A3 : No rodents visible, but rodent burrows visible; need to backfill and compact or grout burrows.					
Inspector Comment

Looking at the landside slope.

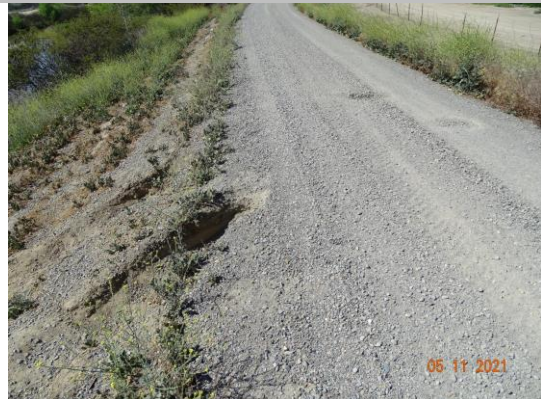
Photo 1 of 1 : SP_2022_NA0010_139_28_20220308_00007.jpg

LM Start	1.90	Rating **	U	Issue No.	28
LM End	1.90	Issue Type +	Ma	Location *	WS
Category	Earthen Levee			GPS Latitude/Longitude	
				Start	End
Item	Erosion / Vehicle Traffic			36.772731 °	36.772731 °
				-120.253590 °	-120.253590 °
DWR ID	DWR_NA0010_23_s_2021_28				
Comment Code					
E6 : Repair the levee slope damaged by vehicle traffic and prevent access where possible.					
Inspector Comment

View of damage to the waterside slope and shoulder. (Spring 2021)

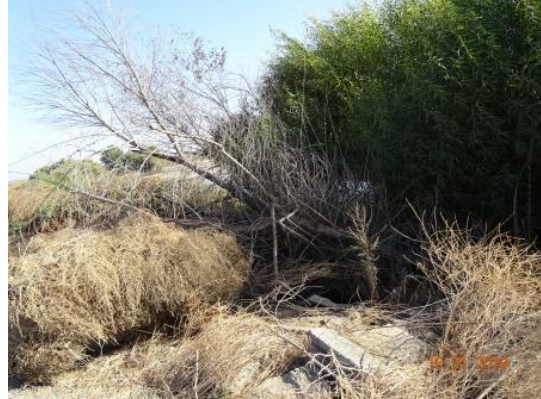
Photo 1 of 1 : SP_2022_NA0010_139_1_20220308_00001.jpg

LM Start	1.91	Rating **	M	Issue No.	1
LM End	1.91	Issue Type +	Ma	Location *	WS
Category	Earthen Levee			GPS Latitude/Longitude	
				Start	End
Item	Encroachments			36.772943 °	36.772943 °
				-120.253511 °	-120.253511 °
DWR ID	DWR_NA0010_23_s_2015_1				
Comment Code					
TR : Tree or limb					
Inspector Comment					
There is a downed tree on the waterside slope.

View of fallen tree on the waterside slope. (Fall 2019)

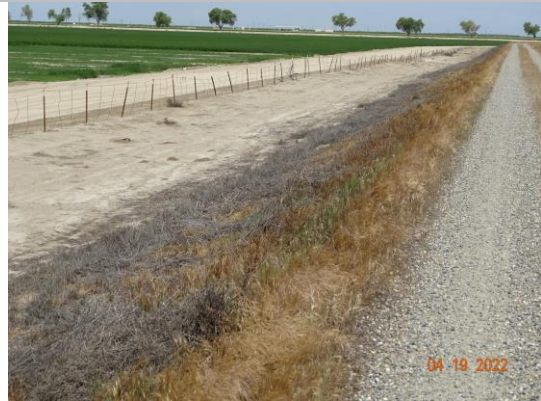
Photo 1 of 1 : SP_2022_NA0010_139_42_20220502_00069.jpg

LM Start	3.41	Rating **	M	Issue No.	42
LM End	4.33	Issue Type +	Ma	Location *	LS
Category	Earthen Levee			GPS Latitude/Longitude	
				Start	End
Item	Vegetation			36.776070 °	36.783869 °
				-120.234633 °	-120.225213 °
DWR ID	DWR_NA0010_23_s_2022_42				
Comment Code					
V1 : Control annual grass and weeds on the levee slopes and easements.					
Inspector Comment

View of vegetation on the landside slope. (Spring 2022)

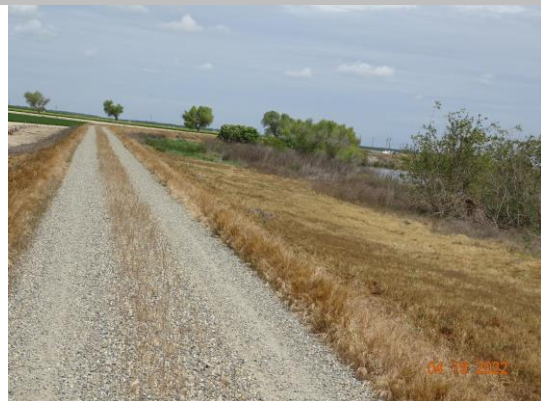
Photo 1 of 1 : SP_2022_NA0010_139_43_20220502_00070.jpg

LM Start	3.42	Rating **	M	Issue No.	43
LM End	9.74	Issue Type +	Ma	Location *	WS
Category	Earthen Levee			GPS Latitude/Longitude	
				Start	End
Item	Vegetation			36.776123 °	36.807597 °
				-120.234629 °	-120.168835 °
DWR ID	DWR_NA0010_23_s_2022_43				
Comment Code					
V1 : Control annual grass and weeds on the levee slopes and easements.					
Inspector Comment

Looking upstream along the waterside slope. (Spring 2022)

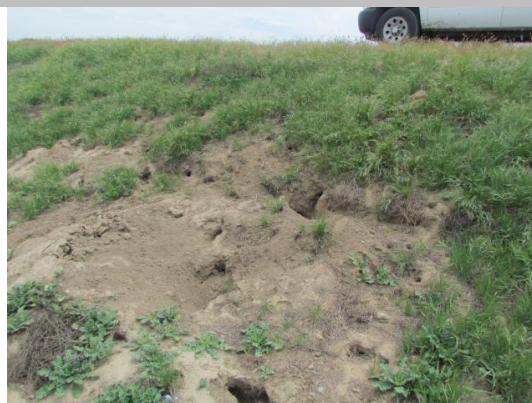
Photo 1 of 1 : SP_2022_NA0010_139_5_20220308_00002.jpg

LM Start	5.68	Rating **	M	Issue No.	5
LM End	5.68	Issue Type +	Ma	Location *	LS
Category	Earthen Levee		GPS Latitude/Longitude		
			Start	End	
Item	Animal Control		36.791981 °	36.791981 °	
			-120.206274 °	-120.206274 °	
DWR ID	DWR_NA0010_23_s_2012_5				
Comment Code					
A1 : Exterminate rodents and backfill and compact or grout burrows.					
Inspector Comment					
There are several large rodent holes in this area.

Looking at several rodent holes on landside slope.

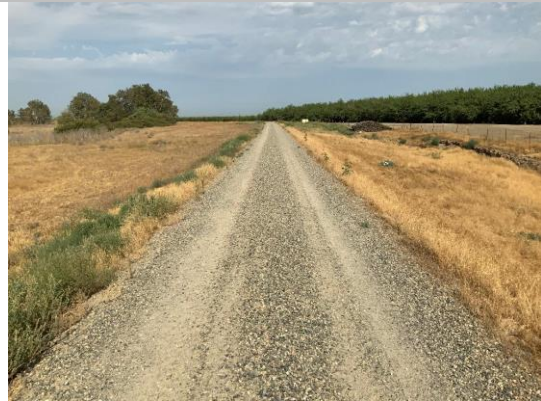
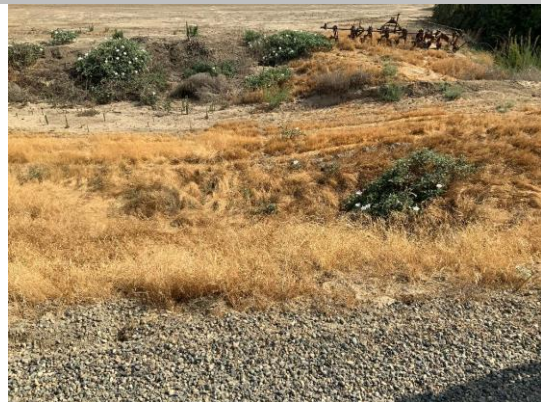
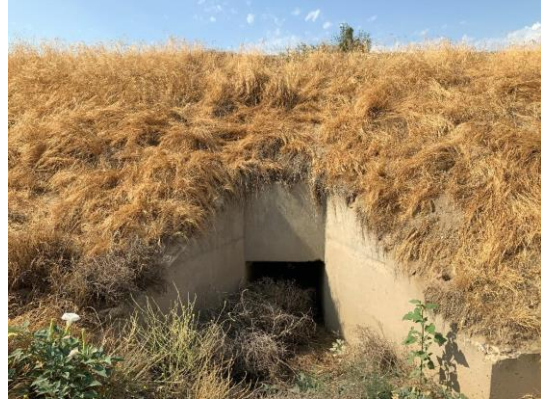
Comment Code						
Inspector Comment						
FS_ID:68602 DS_ID:19954 EP_NO: N/A Repair Type: Non-Urgent Crossing Status: Found UCIP Comments: 07/19/2021 The record remains Non-Urgent. LS has sediment buildup in pipe inlet and buildup of tumbleweeds around pipe inlet, recommend clearing out. No permit was found authorizing this encroachment. CVFPB will need to review crossing to determine owner. The UCIP inspection was completed with GEI staff, P. Espinoza. (H. Dunn ? GEI) 04/03/2014 Dense vegetation limits the inspector's visibility to identify signs of pipe failure (leaks) along the landward slope. Recommend removing vegetation along pipe alignment to conduct proper inspection of structure. (W. Wylie - DWR UCIP) FIELD_STRUCT_DESC: 36-inch by 36-inch square reinforced concrete box gravity drainage culvert through the levee, 9 feet below the crown. Flap gate on the waterside (WS) end. Concrete U-shaped headwall on each end. 5-foot-long cobble revetted outlet channel. [Additional Reference(s): DWR Levee Log, 2002 (HLM 5.71), listed as a 36-inch square reinforced concrete box culvert (RCBC). USACE San Joaquin O&M Manual, Unit 601 Part 1 (SJR601.1), 1967, Revised 25 May 2011, (HLM 5.71), listed as a 3-foot by 3-foot RCBC]]. FS Date: 7/19/2021

Levee crown.

LS view: Toe from crown.

LS view: Headwall and slope from toe.

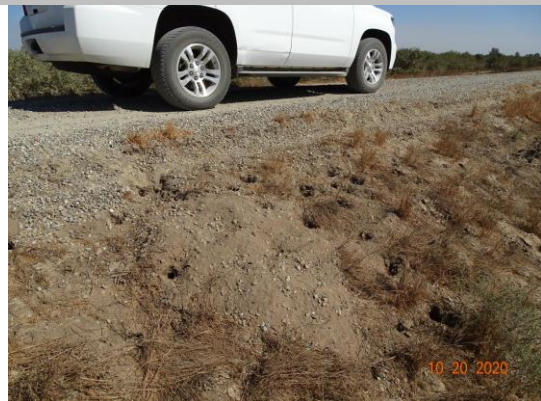
Photo 1 of 1 : SP_2022_NA0010_139_24_20220308_00004.jpg

LM Start	6.85	Rating **	M	Issue No.	24
LM End	6.85	Issue Type +	Ma	Location *	WS
Category	Earthen Levee			GPS Latitude/Longitude	
				Start	End
Item	Animal Control			36.780282 °	36.780282 °
				-120.195583 °	-120.195583 °
DWR ID	DWR_NA0010_23_f_2020_24				
Comment Code					
A3 : No rodents visible, but rodent burrows visible; need to backfill and compact or grout burrows.					
Inspector Comment

Several rodent holes noted at this location. (Fall 2020)

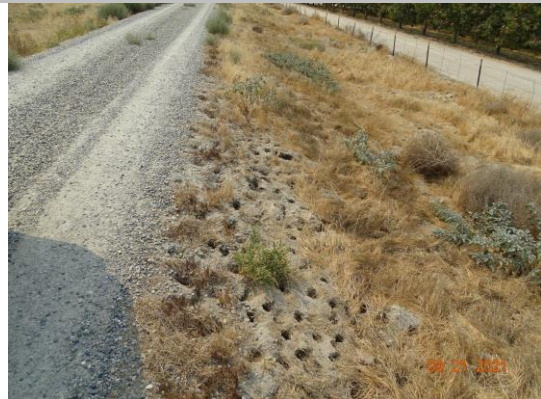
Photo 1 of 1 : SP_2022_NA0010_139_46_20220308_00012.jpg

LM Start	7.52	Rating **	M	Issue No.	46
LM End	7.72	Issue Type +	Ma	Location *	LS
Category	Earthen Levee			GPS Latitude/Longitude	
				Start	End
Item	Animal Control			36.781983 °	36.784231 °
				-120.186095 °	-120.184096 °
DWR ID	DWR_NA0010_23_f_2021_46				
Comment Code					
A3 : No rodents visible, but rodent burrows visible; need to backfill and compact or grout burrows.					
Inspector Comment					
Several burrows in the landside slope.

View of several rodent burrows in the landside slope. (Fall 2021)

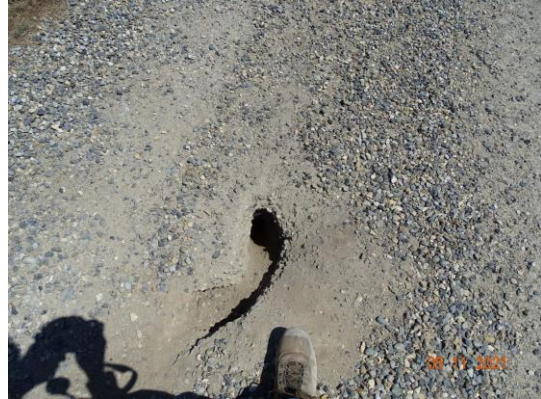
Photo 1 of 1 : SP_2022_NA0010_139_31_20220308_00009.jpg

LM Start	8.32	Rating **	M	Issue No.	31
LM End	8.32	Issue Type +	Ma	Location *	CR
Category	Earthen Levee			GPS Latitude/Longitude	
				Start	End
Item	Animal Control			36.792436 °	36.792436 °
				-120.181289 °	-120.181289 °
DWR ID	DWR_NA0010_23_s_2021_31				
Comment Code					
A3 : No rodents visible, but rodent burrows visible; need to backfill and compact or grout burrows.					
Inspector Comment

View of rodent burrow in the levee crown. (Spring 2021)

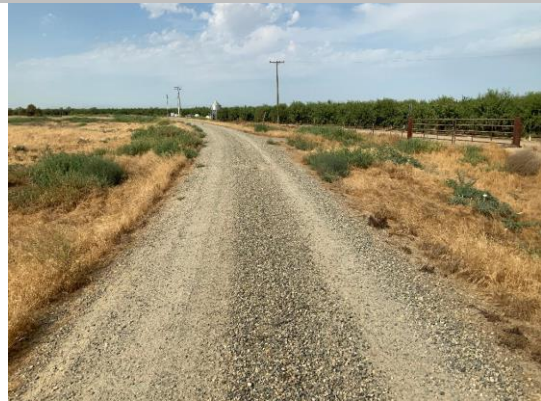
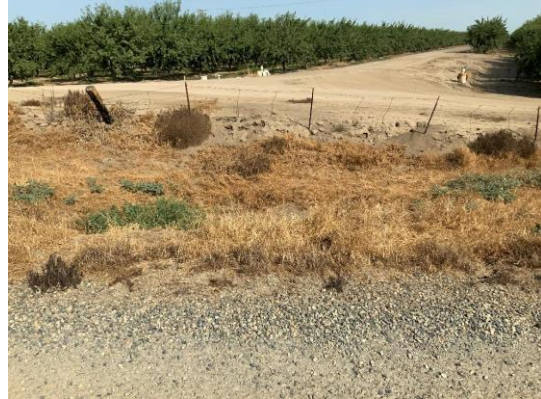
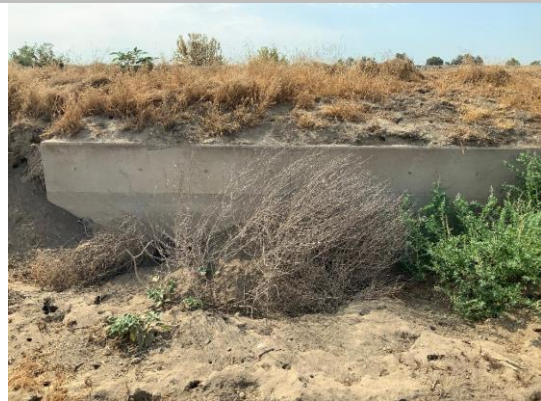
Comment Code					
Inspector Comment					
FS_ID:68605 DS_ID:19940 EP_NO: N/A Repair Type: Non-Urgent Crossing Status: Found UCIP Comments: 07/19/2021 The record remains Non-Urgent. LS pipe inlet almost completely covered by sediment, recommend clearing out. Some minor erosion along one side of the WS headwall as well as some burrow complexes on the slope adjacent to same headwall side. No permit was found authorizing this encroachment. CVFPB will need to review crossing to determine owner. The UCIP inspection was completed with GEI staff, P. Espinoza. (H. Dunn ? GEI) 04/03/2014 Some sediment buildup at inlet at LS toe. Also dense vegetation limits the inspector's visibility to identify signs of pipe failure (leaks) along the landward slope. Recommend removing vegetation along pipe alignment to conduct proper inspection of structure. (W. Wylie - DWR UCIP) FIELD_STRUCT_DESC: 30-inch by 30-inch square reinforced concrete box gravity drainage culvert through the levee, 5.2 feet below the crown. Flap gate on the waterside (WS) end. Concrete headwall on the landside (LS) end. Concrete U-shaped headwall on the WS end. [Additional Reference(s): DWR Levee Log, 2002 (HLM 8.33), listed as a 30-inch square reinforced concrete box culvert (RCBC). USACE San Joaquin O&M Manual, Unit 601 Part 1 (SJR601.1), 1967, Revised 25 May 2011, (HLM 8.33), listed as a 2.5-foot by 2.5-foot RCBC] FS Date: 7/19/2021

Levee crown.

LS view: Toe from crown.

LS view: Headwall and slope from toe.

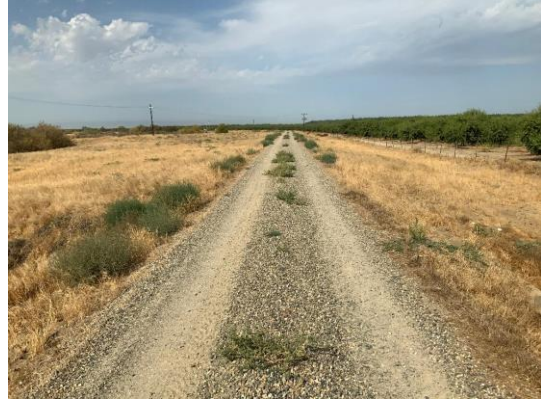
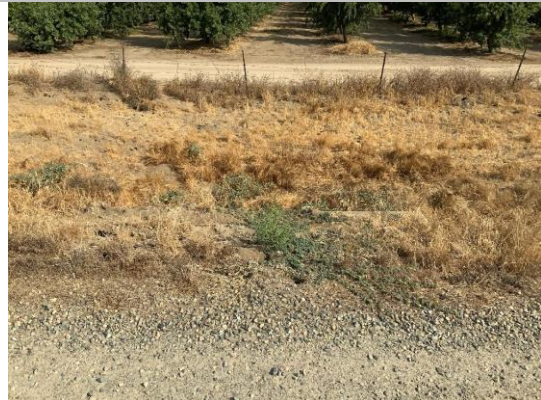
Comment Code					
Inspector Comment					
FS_ID:68606 DS_ID:19941 EP_NO: N/A Repair Type: Non-Urgent Crossing Status: Found UCIP Comments: 07/19/2021 The record remains Non-Urgent. LS pipe inlet has sediment buildup inside, recommend removal. Extensive burrows above the LS headwall slope. No permit was found authorizing this encroachment. CVFPB will need to review crossing to determine owner. The UCIP inspection was completed with GEI staff, P. Espinoza. (H. Dunn ? GEI) 04/03/2014 Dense vegetation limits the inspector's visibility to identify signs of pipe failure (leaks) along the landward slope. Recommend removing vegetation along pipe alignment to conduct proper inspection of structure. (W. Wylie - DWR UCIP) FIELD_STRUCT_DESC: 30-inch by 30-inch square reinforced concrete box gravity drainage culvert through the levee, 5.6 feet below the crown. Flap gate on the waterside (WS) end. Concrete headwall on the landside (LS) end. Concrete U-shaped headwall on the WS end. [Additional Reference(s): DWR Levee Log, 2002 (HLM 8.53), listed as a 30-inch square reinforced concrete box culvert (RCBC). USACE San Joaquin O&M Manual, Unit 601 Part 1 (SJR601.1), 1967, Revised 25 May 2011, (HLM 8.54), listed as a 2.5-foot by 2.5-foot RCBC] FS Date: 7/19/2021

Levee crown.

LS view: Toe from crown.

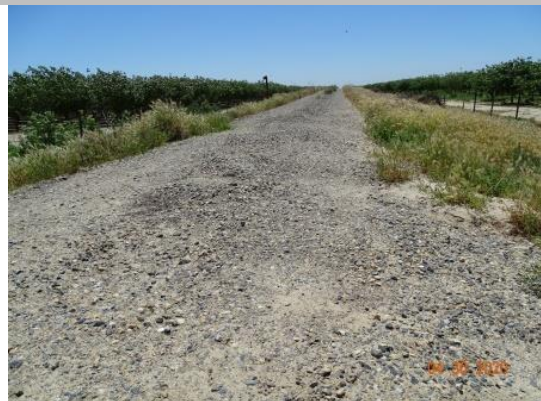
Photo 1 of 1 : SP_2022_NA0010_139_65_20220308_00015.jpg

LM Start	9.74	Rating **	M	Issue No.	65
LM End	9.74	Issue Type +	Ma	Location *	CR
Category	Earthen Levee			GPS Latitude/Longitude	
				Start	End
Item	Crown Surface / Depressions / Rutting			36.807603 °	36.807603 °
				-120.168825 °	-120.168825 °
DWR ID	DWR_NA0010_23_s_2019_65				
Comment Code					
C2 : Repair depressions or ruts in the crown or slope.					
Inspector Comment

Depressions forming in the levee crown. (Spring 2020)

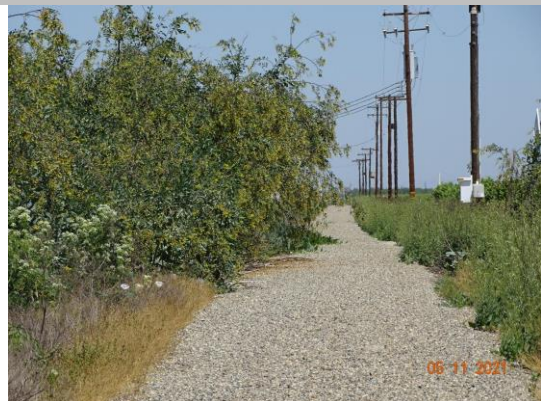
Photo 1 of 1 : SP_2022_NA0010_139_58_20220308_00014.jpg

LM Start	9.76	Rating **	M	Issue No.	58
LM End	9.81	Issue Type +	Ma	Location *	LS
Category	Earthen Levee			GPS Latitude/Longitude	
				Start	End
Item	Trim / Thin Trees			36.807810 °	36.808553 °
				-120.168829 °	-120.168827 °
DWR ID	DWR_NA0010_23_f_2018_58				
Comment Code					
T4 : Trim trees over roadway to at least 12 feet above ground level.					
Inspector Comment					
Woody vegetation is partially blocking crown and landside slope.

Woody vegetation on landside toe obstructing landside of crown. (Spring 2021)

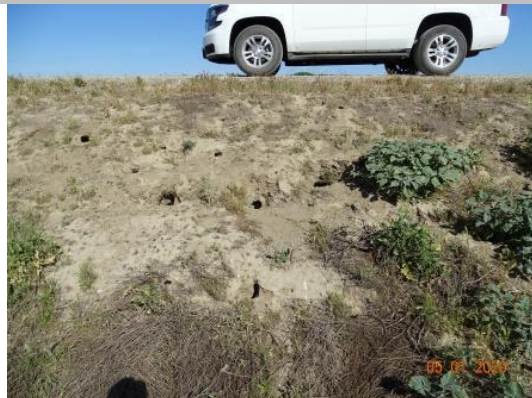
Photo 1 of 1 : SP_2022_NA0010_140_6_20220308_00001.jpg

LM Start	0.80	Rating **	M	Issue No.	6
LM End	0.84	Issue Type +	Ma	Location *	LS
Category	Earthen Levee			GPS Latitude/Longitude	
				Start	End
Item	Animal Control			36.766553 °	36.766962 °
				-120.278947 °	-120.278602 °
DWR ID	DWR_NA0010_24_s_2013_6				
Comment Code					
A1 : Exterminate rodents and backfill and compact or grout burrows.					
Inspector Comment					
There are several rodent holes identified within this section.

Rodent burrows in the landside slope. (Spring 2020)

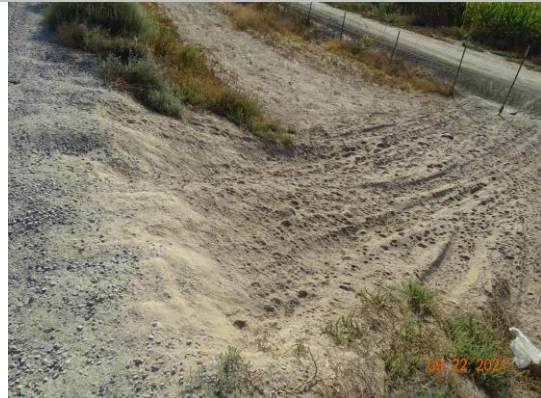
Photo 1 of 1 : SP_2022_NA0010_140_39_20220308_00015.jpg

LM Start	2.77	Rating **	M	Issue No.	39
LM End	2.77	Issue Type +	Ma	Location *	LS
Category	Earthen Levee			GPS Latitude/Longitude	
				Start	End
Item	Erosion / Vehicle Traffic			36.772289 °	36.772289 °
				-120.249693 °	-120.249693 °
DWR ID	DWR_NA0010_24_f _ 2021_39				
Comment Code					
E6 : Repair the levee slope damaged by vehicle traffic and prevent access where possible.					
Inspector Comment

Damage to the landside slope from vehicle traffic. (Fall 2021)

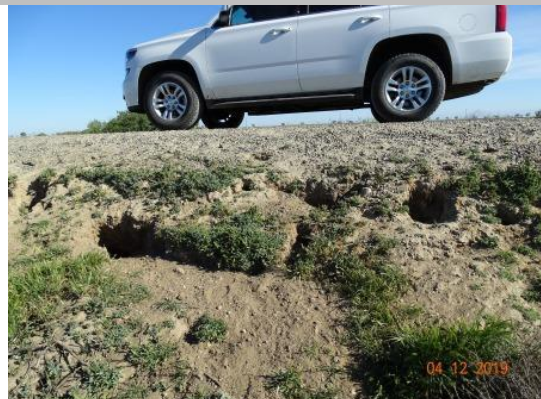
Photo 1 of 1 : SP_2022_NA0010_140_51_20220308_00017.jpg

LM Start	3.05	Rating **	U	Issue No.	51
LM End	3.20	Issue Type +	Ma	Location *	LS
Category	Earthen Levee			GPS Latitude/Longitude	
				Start	End
Item	Animal Control			36.770146 °	36.769796 °
				-120.245703 °	-120.243035 °
DWR ID	DWR_NA0010_24_s_2019_51				
Comment Code					
A3 : No rodents visible, but rodent burrows visible; need to backfill and compact or grout burrows.					
Inspector Comment

View of rodent holes in landside slope. (Spring 2019)

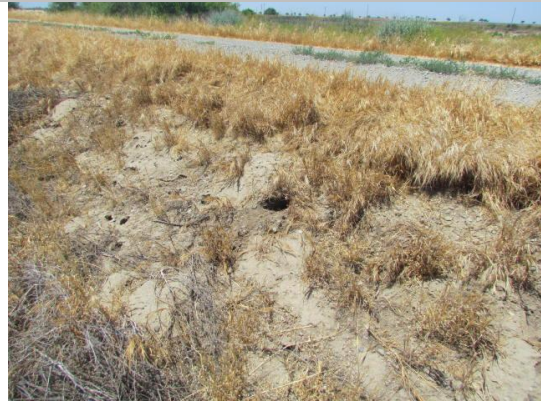
Photo 1 of 1 : SP_2022_NA0010_140_7_20220308_00002.jpg

LM Start	3.46	Rating **	M	Issue No.	7
LM End	3.46	Issue Type +	Ma	Location *	LS
Category	Earthen Levee			GPS Latitude/Longitude	
				Start	End
Item	Animal Control			36.769345 °	36.769345 °
				-120.238370 °	-120.238370 °
DWR ID	DWR_NA0010_24_s_2012_7				
Comment Code					
A3 : No rodents visible, but rodent burrows visible; need to backfill and compact or grout burrows.					
Inspector Comment					
There are several rodent holes on the landside slope.

Looking east at one of several rodent holes on landward slope.

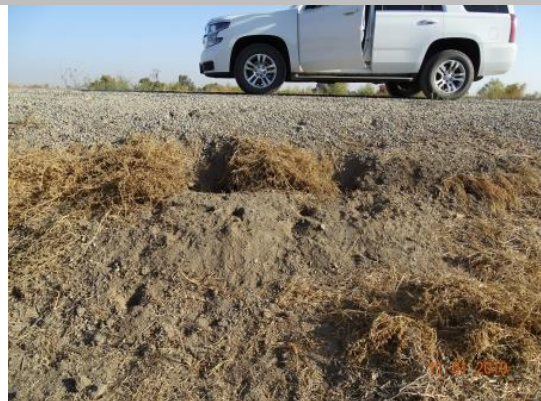
Photo 1 of 1 : SP_2022_NA0010_140_28_20220308_00011.jpg

LM Start	3.53	Rating **	M	Issue No.	28
LM End	3.59	Issue Type +	Ma	Location *	LS
Category	Earthen Levee			GPS Latitude/Longitude	
				Start	End
Item	Animal Control			36.768886 °	36.768531 °
				-120.237154 °	-120.236226 °
DWR ID	DWR_NA0010_24_f_2019_28				
Comment Code					
A3 : No rodents visible, but rodent burrows visible; need to backfill and compact or grout burrows.					
Inspector Comment

View of rodent burrows in the landside slope. (Fall 2019)

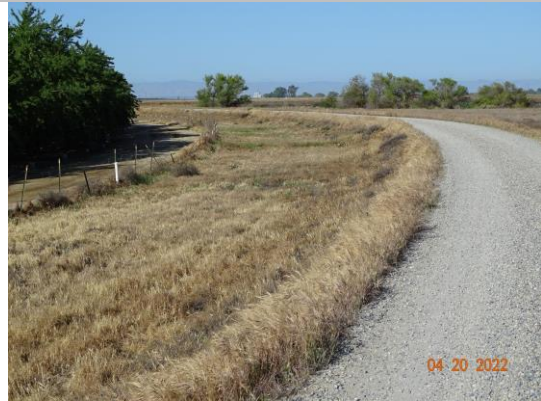
Photo 1 of 1 : SP_2022_NA0010_140_34_20220503_00055.jpg

LM Start	3.67	Rating **	M	Issue No.	34
LM End	5.21	Issue Type +	Ma	Location *	LS
Category	Earthen Levee			GPS Latitude/Longitude	
				Start	End
Item	Vegetation			36.768043 °	36.781651 °
				-120.234902 °	-120.226168 °
DWR ID	DWR_NA0010_24_s_2022_34				
Comment Code					
V1 : Control annual grass and weeds on the levee slopes and easements.					
Inspector Comment

View of vegetation on the landside slope. (Spring 2022)

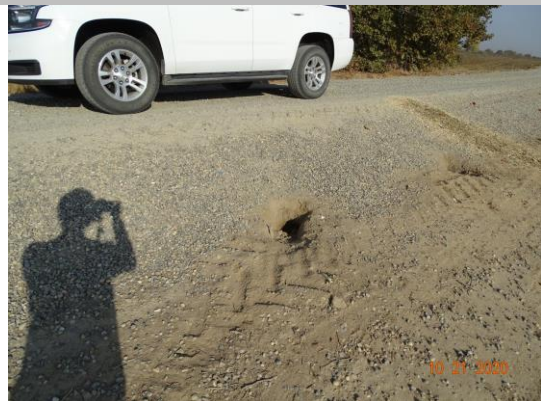
Photo 1 of 1 : SP_2022_NA0010_140_20_20220308_00008.jpg

LM Start	5.66	Rating **	M	Issue No.	20
LM End	5.66	Issue Type +	Ma	Location *	LS
Category	Earthen Levee			GPS Latitude/Longitude	
				Start	End
Item	Animal Control			36.784215 °	36.784215 °
				-120.218882 °	-120.218882 °
DWR ID	DWR_NA0010_24_f_2020_20				
Comment Code					
A3 : No rodents visible, but rodent burrows visible; need to backfill and compact or grout burrows.					
Inspector Comment

Rodent holes at the landside toe. (Fall 2020)

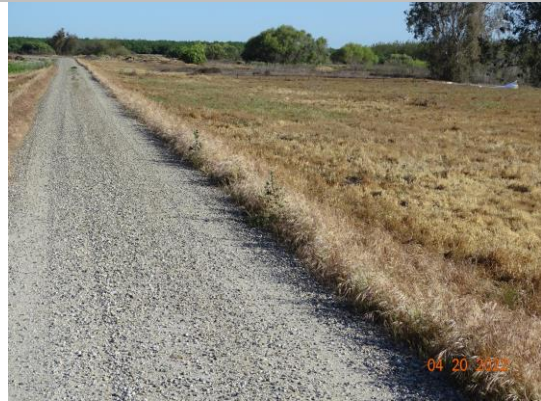
Photo 1 of 1 : SP_2022_NA0010_140_32_20220503_00056.jpg

LM Start	6.25	Rating **	M	Issue No.	32
LM End	6.81	Issue Type +	Ma	Location *	WS
Category	Earthen Levee			GPS Latitude/Longitude	
				Start	End
Item	Vegetation			36.788099 °	36.785472 °
				-120.211070 °	-120.204301 °
DWR ID	DWR_NA0010_24_s_2022_32				
Comment Code					
V1 : Control annual grass and weeds on the levee slopes and easements.					
Inspector Comment

Looking downstream along the waterside slope. (Spring 2022)

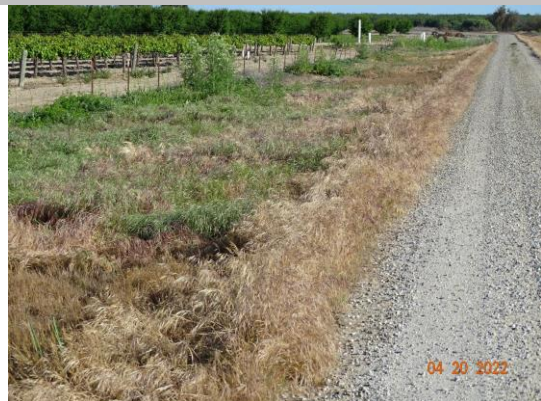
Photo 1 of 1 : SP_2022_NA0010_140_30_20220503_00057.jpg

LM Start	6.73	Rating **	M	Issue No.	30
LM End	6.81	Issue Type +	Ma	Location *	LS
Category	Earthen Levee			GPS Latitude/Longitude	
				Start	End
Item	Vegetation			36.786597 °	36.785411 °
				-120.204705 °	-120.204278 °
DWR ID	DWR_NA0010_24_s_2022_30				
Comment Code					
V1 : Control annual grass and weeds on the levee slopes and easements.					
Inspector Comment

Looking downstream along the landside slope at annual vegetation. (Spring 2022)

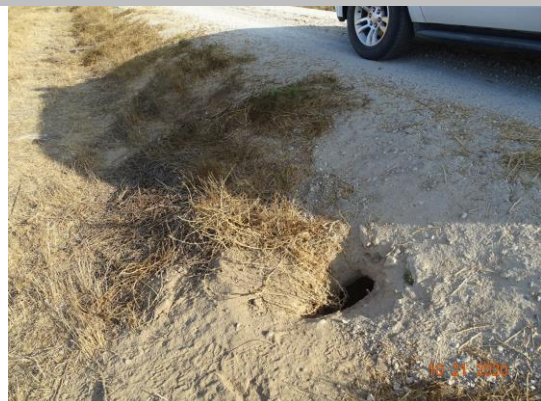
Photo 1 of 1 : SP_2022_NA0010_140_14_20220308_00005.jpg

LM Start	6.86	Rating **	M	Issue No.	14
LM End	6.86	Issue Type +	Ma	Location *	LS
Category	Earthen Levee			GPS Latitude/Longitude	
				Start	End
Item	Animal Control			36.784716 °	36.784716 °
				-120.204043 °	-120.204043 °
DWR ID	DWR_NA0010_24_f_2020_14				
Comment Code					
A3 : No rodents visible, but rodent burrows visible; need to backfill and compact or grout burrows.					
Inspector Comment

Rodent burrow on the landside slope. (Fall 2020)

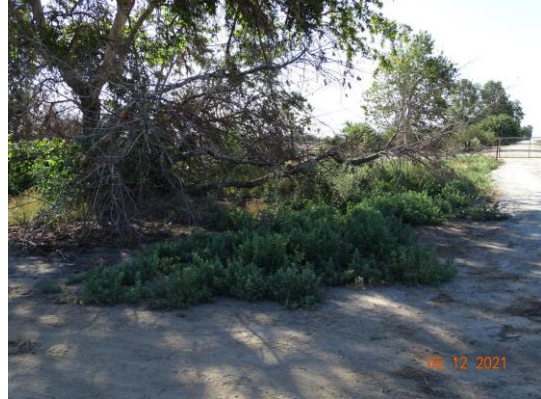
Photo 1 of 1 : SP_2022_NA0010_140_21_20220308_00009.jpg

LM Start	7.33	Rating **	M	Issue No.	21
LM End	7.33	Issue Type +	Ma	Location *	WS
Category	Earthen Levee			GPS Latitude/Longitude	
				Start	End
Item	Encroachments			36.779416 °	36.779416 °
				-120.199091 °	-120.199091 °
DWR ID	DWR_NA0010_24_s_2021_21				
Comment Code					
TR : Tree or limb					
Inspector Comment

Tree limb fallen on the waterside slope. (Spring 2021)

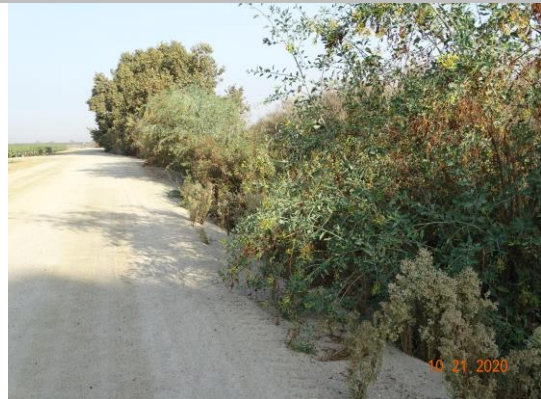
Photo 1 of 1 : SP_2022_NA0010_140_10_20220308_00003.jpg

LM Start	7.35	Rating **	U	Issue No.	10
LM End	7.86	Issue Type +	Ma	Location *	WS
Category	Earthen Levee			GPS Latitude/Longitude	
				Start	End
Item	Vegetation			36.779209 °	36.775239 °
				-120.198886 °	-120.191872 °
DWR ID	DWR_NA0010_24_f_2020_10				
Comment Code					
V2 : Remove the wild growth and woody vegetation other than native grasses from the levee slopes.					
Inspector Comment

View of the waterside slope looking downstream. (Fall 2020)

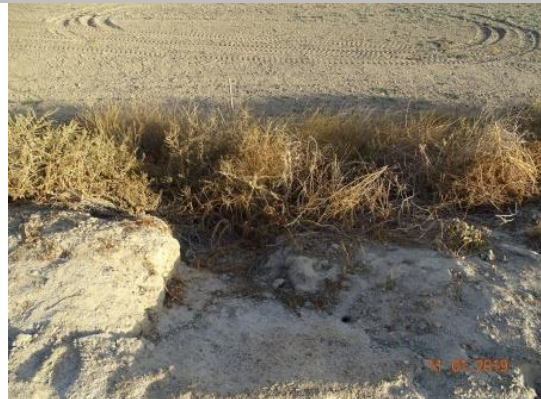
Photo 1 of 1 : SP_2022_NA0010_140_11_20220308_00004.jpg

LM Start	7.83	Rating **	A/W	Issue No.	11
LM End	7.83	Issue Type +	Ma	Location *	WS
Category	Earthen Levee			GPS Latitude/Longitude	
				Start	End
Item	Erosion / Bank Caving			36.775271 °	36.775271 °
				-120.192400 °	-120.192400 °
DWR ID	DWR_NA0010_24_f_2019_11				
Comment Code					
E1 : Note and monitor erosion site.					
Inspector Comment

Looking East down the waterside slope. (Fall 2019)

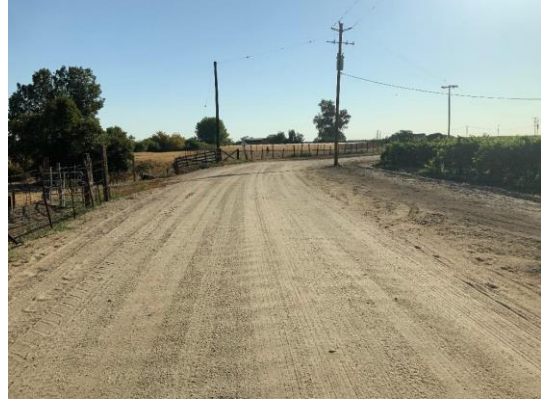
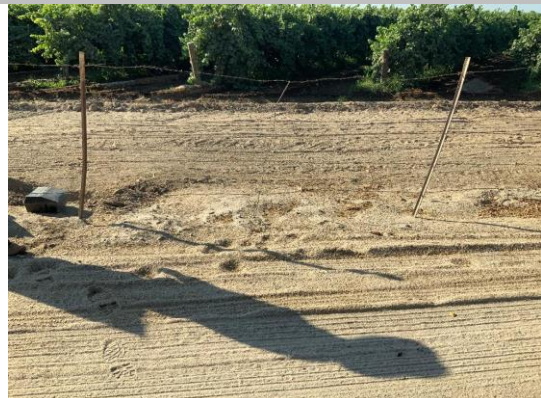
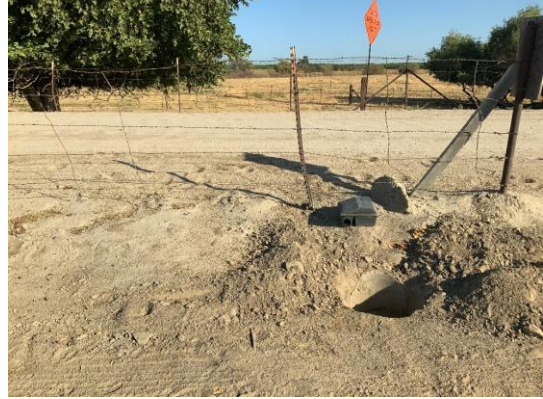
Comment Code						
Inspector Comment						
FS_ID:68925 DS_ID:19960 EP_NO: N/A Repair Type: Non-Urgent Crossing Status: Found UCIP Comments: 07/20/2021 The record remains Non-Urgent. WS outlet filled with sediment, recommend cleaning out. LS pipe inlet not found, likely buried under dirt, recommend removal. No permit was found authorizing this encroachment. CVFPB will need to review crossing to determine owner. Levee prism appears to be less than 3 feet in height. The UCIP inspection was completed with GEI staff, P. Espinoza. (H. Dunn ? GEI) 04/08/2014 Barbed wire along levee shoulder--no access. Need to confirm crossing size and condition of crossing. (O. Magana - DWR UCIP) FIELD_STRUCT_DESC: 12-inch reinforced concrete gravity drainage pipe through the levee, 3 feet below the crown. Flap gate on the waterside (WS) end. Concrete headwall on the WS end. [Additional Reference(s): DWR Levee Log, 2002 (HLM 8.33), listed as a 12-inch concrete pipe. USACE San Joaquin O&M Manual, Unit 601 Part 1 (SJR601.1), 1967, Revised 25 May 2011, (HLM 8.32), listed as a 12-inch concrete pipe] FS Date: 7/20/2021

LS view: Toe from crown, no pipe visible.

LS view: Slope from toe, no pipe visible.

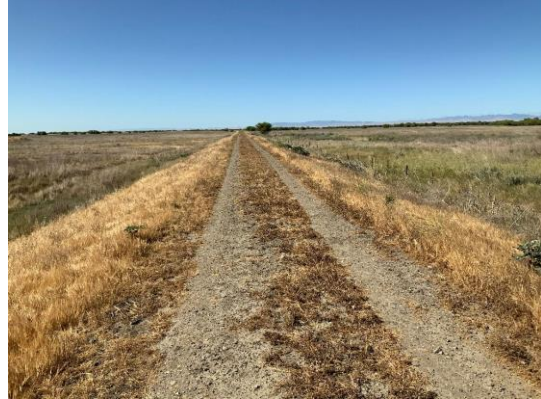
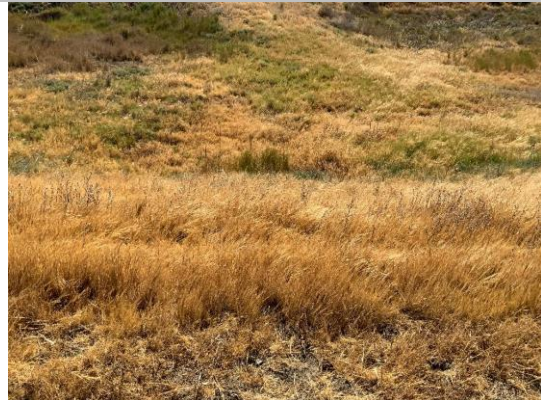
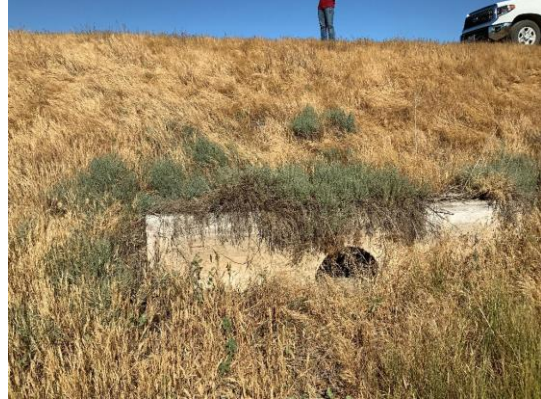
Comment Code						
Inspector Comment						
FS_ID:68238 DS_ID:19965 EP_NO: N/A Repair Type: Non-Urgent Crossing Status: Found UCIP Comments: 06/8/2021 The record remains Non-Urgent. Landside (LS) pipe inlet has some vegetation and sediment buildup, recommend cleaning out. No permit was found authorizing this encroachment. CVFPB will need to review crossing to determine owner. The UCIP inspection was completed with GEI staff, P. Espinoza. (H. Dunn ? GEI) 05/01/2014 Dense vegetation limits the inspectors visibility to identify signs of pipe failure (leaks) along the slope. Recommend removing vegetation along pipe alignment to conduct proper inspection of structure. Sediment buildup in pipe visible from landward side-- recommend clearing. (O. Magana - DWR UCIP) FIELD_STRUCT_DESC: 24-inch corrugated metal gravity drainage pipe through the levee, 10 feet below the crown. Flap gate on the waterside (WS) end. [Additional Reference(s): DWR Levee Log, 2002 (HLM 0.01), listed as a 24-inch corrugated metal pipe (CMP). USACE San Joaquin O&M Manual, Unit 601 Part 1 (SJR601.1), 1967, Revised 25 May 2011, (HLM 0.02), listed as a 24-inch CMP] FS Date: 6/8/2021

LS view: Slope and headwall from toe.
