**Flood Control Project Maintenance
Levee Inspections**

Maintenance Issue Types Only, Levee Inspection Report By Mile - Spring 2022

Lower San Joaquin Levee District

Waterway	Bank	Unit Miles	Inspection Start/End	Inspector
Unit No. 01 San Joaquin River	Right	22.52	04/05/2022 04/05/2022	Corey Fujitani

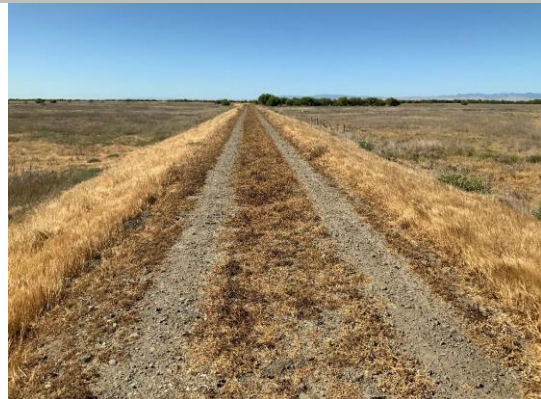
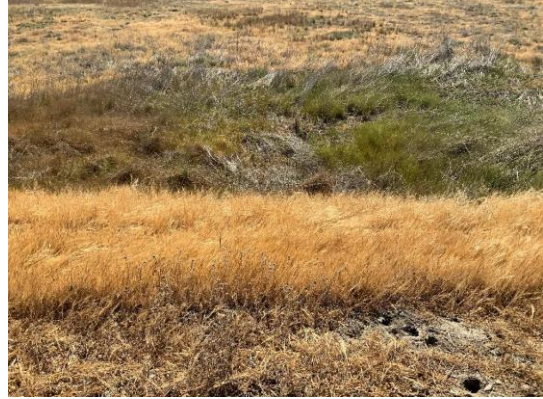
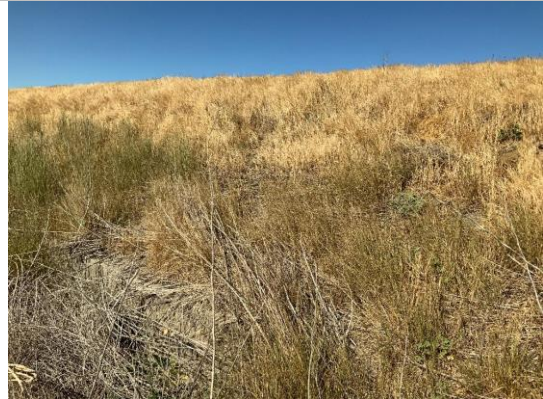
FS_ID:68240
DS_ID:19966
EP_NO: N/A
Repair Type: Non-Urgent
Crossing Status: Found
UCIP Comments: 06/8/2021 The record remains Non-Urgent. Dense LS vegetation over pipe inlet and headwall, recommend removal. No permit was found authorizing this encroachment. CVFPB will need to review crossing to determine owner. The UCIP inspection was completed with GEI staff, P. Espinoza. (H. Dunn ? GEI) 05/01/2014 Dense vegetation limits the inspectors visibility to identify signs of pipe failure (leaks) along the slope. Recommend removing vegetation along pipe alignment to conduct proper inspection of structure. (O. Magana - DWR UCIP)
FIELD_STRUCT_DESC: 24-inch corrugated metal gravity drainage pipe through the levee, 11.6 feet below the crown. Flap gate on the waterside (WS) end. [Additional Reference(s): DWR Levee Log, 2002 (HLM 0.36), listed as a 24-inch corrugated metal pipe (CMP). USACE San Joaquin O&M Manual, Unit 601 Part 1 (SJR601.1), 1967, Revised 25 May 2011, (HLM 0.35), listed as a 24-inch CMP].

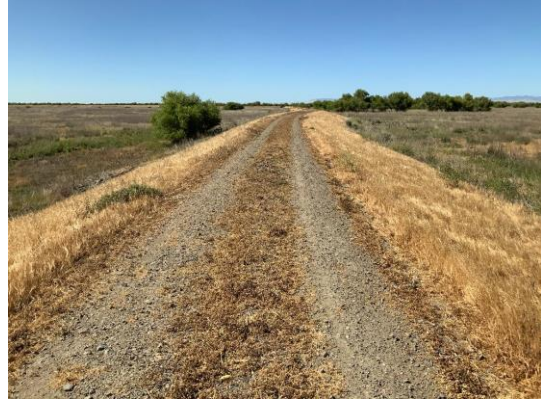
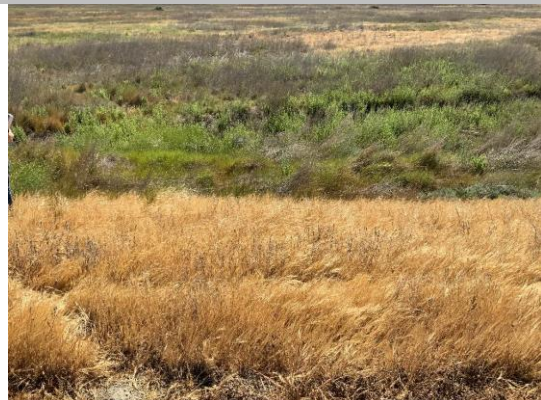
Comment Code					
Inspector Comment					
FS_ID:67743 DS_ID:19967 EP_NO: N/A Repair Type: Non-Urgent Crossing Status: Found UCIP Comments: 06/8/2021 The record remains Non-Urgent. Dense LS vegetation, recommend removal around pipe inlet. No permit was found authorizing this encroachment. CVFPB will need to review crossing to determine owner. The UCIP inspection was completed with GEI staff, P. Espinoza. (H. Dunn ? GEI) 05/01/2014 Dense vegetation limits the inspectors visibility to identify signs of pipe failure (leaks) along the slope. Recommend removing vegetation along pipe alignment to conduct proper inspection of structure. (O. Magana - DWR UCIP) FIELD_STRUCT_DESC: 24-inch corrugated metal gravity drainage pipe through the levee, 14.7 feet below the crown. Flap gate on the waterside (WS) end. [Additional Reference(s): DWR Levee Log, 2002 (HLM 0.58), listed as a 24-inch corrugated metal pipe (CMP). USACE San Joaquin O&M Manual, Unit 601 Part 1, (SJR601.1), 1967, Revised 25 May 2011, (HLM 0.59), listed as a 24-inch CMP]. FS Date: 6/8/2021

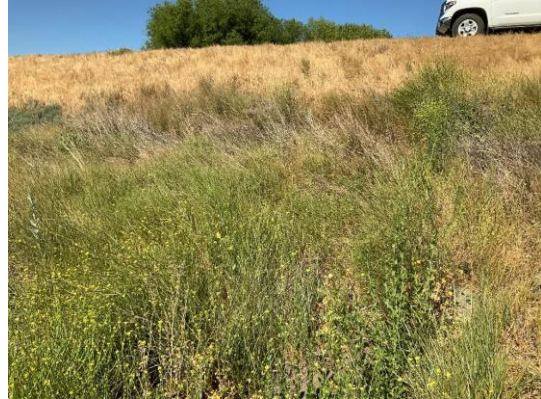
Photo 3 of 3 : UCIP_SP_2022_67743_100703.jpg

LS view: Slope from toe.

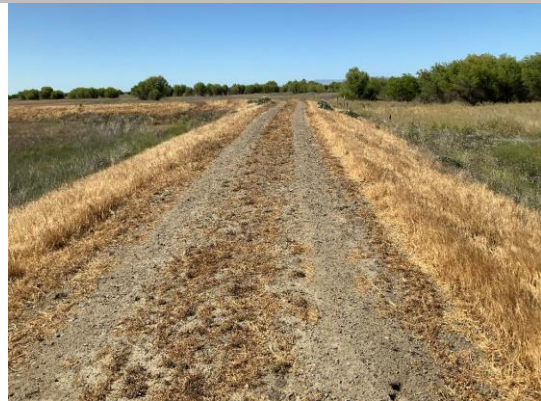
Photo 1 of 3 : UCIP_SP_2022_67745_100717.jpg

FS_ID:67745
DS_ID:19968
EP_NO: N/A
Repair Type: Non-Urgent
Crossing Status: Found
UCIP Comments: 06/8/2021 The record remains Non-Urgent. Dense LS vegetation over pipe inlet, recommend removal. Lots of small burrow holes all along the crown and along the sides, recommend filling in. No permit was found authorizing this encroachment. CVFPB will need to review crossing to determine owner. The UCIP inspection was completed with GEI staff, P. Espinoza. (H. Dunn ? GEI) 05/01/2014
Dense vegetation limits the inspectors visibility to identify signs of pipe failure (leaks) along the slope. Recommend removing vegetation along pipe alignment to conduct proper inspection of structure. (O. Magana - DWR UCIP)
FIELD_STRUCT_DESC: 24-inch corrugated metal gravity drainage pipe through the levee, 11.4 feet below the crown. Flap gate on the waterside (WS) end. [Additional Reference(s): DWR Levee Log, 2002 (HLM 0.97), listed as a 24-inch corrugated metal pipe (CMP). USACE San Joaquin O&M Manual, Unit 601 Part 1 (SJR601.1), 1967, Revised 25 May 2011, (HLM 0.97), listed as a 24-inch CMP]

Levee crown looking downstream.

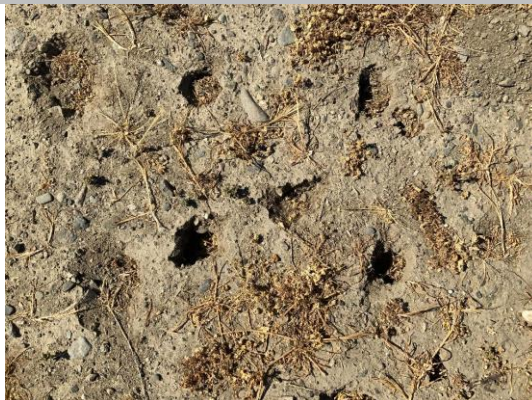
Photo 2 of 3 : UCIP_SP_2022_67745_100718.jpg

Crown: Small burrow holes along the crown, 1 of 2 photos.

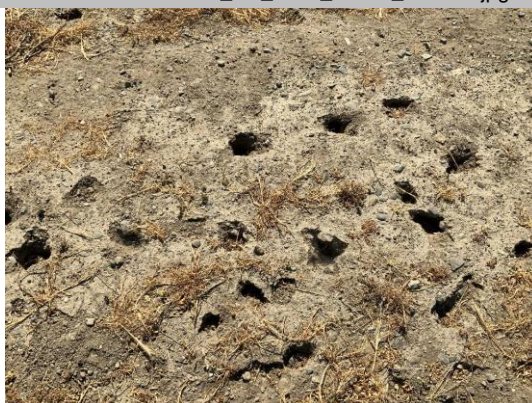
Photo 3 of 3 : UCIP_SP_2022_67745_100716.jpg

Crown: Small burrow holes on the top of the levee, 2 of 2 photos.

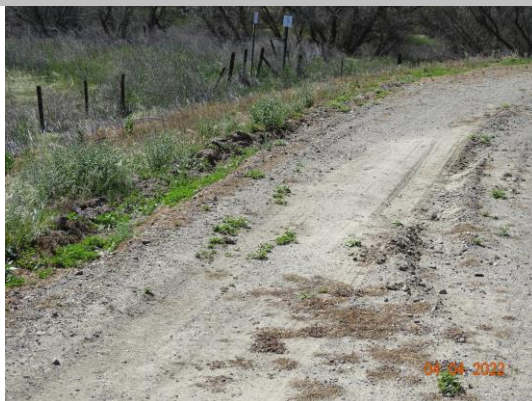
Photo 1 of 1 : SP_2022_NA0010_141_8_20220411_00019.jpg

View of rutting from vehicle traffic on the levee crown. (Spring 2022)

LM Start	1.02	Rating **	M	Issue No.	8
LM End	1.02	Issue Type +	Ma	Location *	WS
Category	Earthen Levee			GPS Latitude/Longitude	
				Start	End
Item	Erosion / Vehicle Traffic			37.281710 °	37.281710 °
				-120.880523 °	-120.880523 °
DWR ID	DWR_NA0010_25_s_2022_8				
Comment Code					
E6 : Repair the levee slope damaged by vehicle traffic and prevent access where possible.					
Inspector Comment

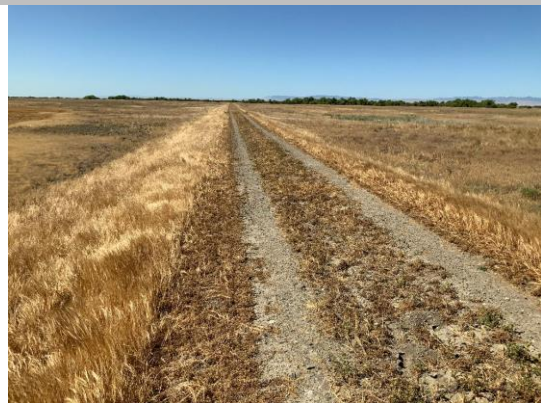
Photo 1 of 3 : UCIP_SP_2022_67747_100729.jpg

Comment Code						
Inspector Comment						
FS_ID:67747 DS_ID:19969 EP_NO: N/A Repair Type: Non-Urgent Crossing Status: Found UCIP Comments: 06/8/2021 The record remains Non-Urgent. Levee prism appears to be around or slightly less than 3 feet. Dense vegetation on LS pipe inlet, recommend removal. No permit was found authorizing this encroachment. CVFPB will need to review crossing to determine owner. The UCIP inspection was completed with GEI staff, P. Espinoza. (H. Dunn ? GEI) 05/01/2014 Dense vegetation limits the inspectors visibility to identify signs of pipe failure (leaks) along the slope. Recommend removing vegetation along pipe alignment to conduct proper inspection of structure. (O. Magana - DWR UCIP) FIELD_STRUCT_DESC: 24-inch corrugated metal gravity drainage pipe through the levee, 4 feet below the crown. Flap gate on the waterside (WS) end. [Additional Reference(s): DWR Levee Log, 2002 (HLM 2.05), listed as a 24-inch corrugated metal pipe (CMP). USACE San Joaquin O&M Manual, Unit 601 Part 1 (SJR601.1), 1967, Revised 25 May 2011, (HLM 2.05), listed as a 24-inch CMP] FS Date: 6/8/2021

Levee crown looking upstream.

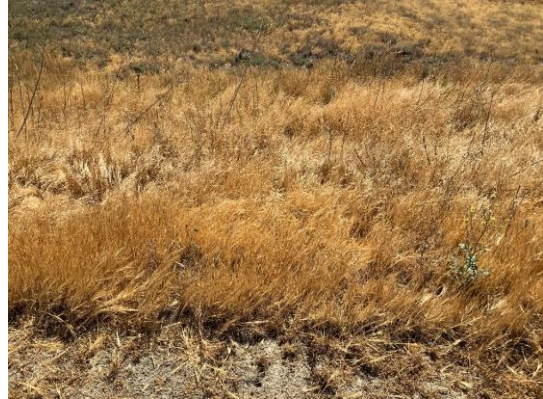
Photo 2 of 3 : UCIP_SP_2022_67747_100730.jpg

LS view: Toe from crown.

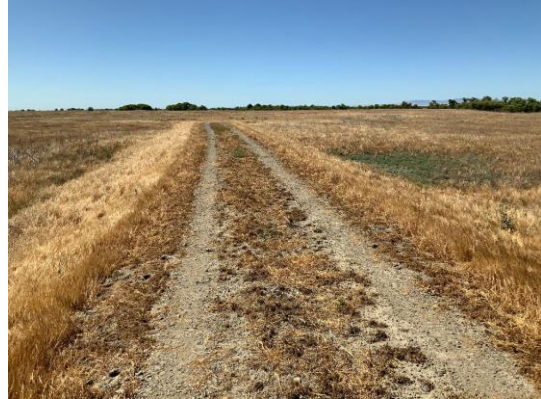
Photo 1 of 3 : UCIP_SP_2022_68241_100735.jpg

Comment Code						
Inspector Comment						
FS_ID:68241 DS_ID:19970 EP_NO: N/A Repair Type: Urgent Crossing Status: Found UCIP Comments: 06/8/2021 Record has been upgraded from Non-Urgent to Urgent. External inspection in the field has found pipe integrity issues. WS pipe end is rusted with multiple large deteriorated holes under and around the flapgate. Rusting and peeling of metal and liner inside the LS pipe inlet. Also sediment buildup inside LS inlet, recommend cleaning out and recommend monitoring crossing until funding becomes available to address the issues. No permit was found authorizing this encroachment. CVFPB will need to review crossing to determine owner. The UCIP inspection was completed with GEI staff, P. Espinoza. (H. Dunn ? GEI)05/01/2014 Dense vegetation limits the inspectors visibility to identify signs of pipe failure (leaks) along the slope. Recommend removing vegetation along pipe alignment to conduct proper inspection of structure. Sediment buildup in pipe visible on landward side--recommend clearing. (O. Magana - DWR UCIP) FIELD_STRUCT_DESC: 24-inch corrugated metal gravity drainage pipe through the levee, 11.2 feet below the crown. Flap gate on the waterside (WS) end. [Additional Reference(s): DWR Levee Log, 2002 (HLM 2.45), listed as a 24-inch corrugated metal pipe (CMP). USACE San Joaquin O&M Manual, Unit 601 Part 1 (SJR601.1), 1967, Revised 25 May 2011, (HLM 2.45), listed as a 24-inch CMP] FS Date: 6/8/2021

Levee crown looking upstream.

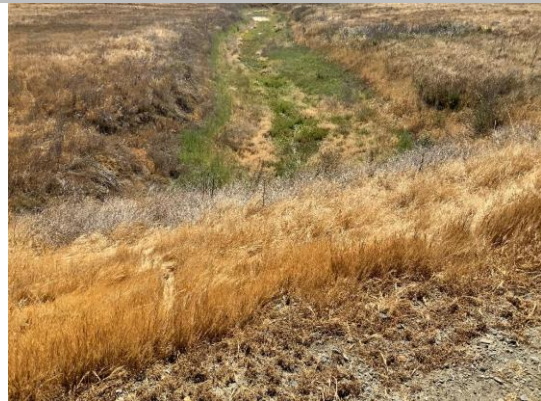
Photo 2 of 3 : UCIP_SP_2022_68241_100736.jpg

LS view: Toe from crown.

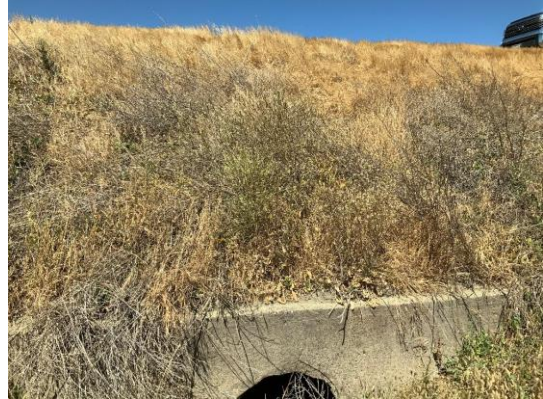
Photo 3 of 3 : UCIP_SP_2022_68241_100737.jpg

LS view: Headwall and slope from toe.
