**Flood Control Project Maintenance
Levee Inspections**

Maintenance Issue Types Only, Levee Inspection Report By Mile - Spring 2024

Lower San Joaquin Levee District

Waterway	Bank	Unit Miles	Inspection Start/End	Inspector
Unit No. 01 San Joaquin River	Right	22.52	03/12/2024 03/12/2024	Corey Fujitani

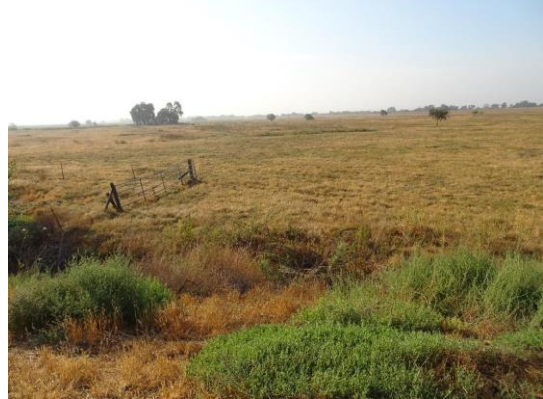
Photo 2 of 3 : UCIP_SP_2024_70636_92088.jpg

LS view: overview of LS, dense vegetation on slope and levee toe.

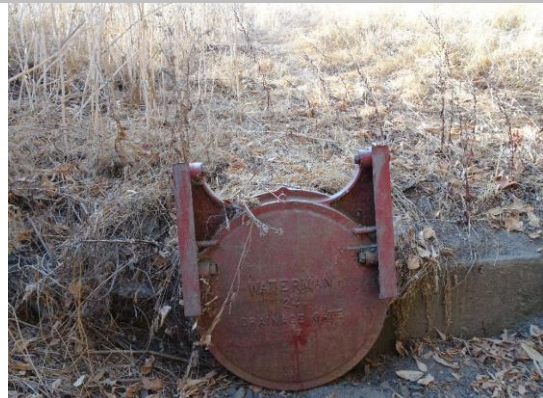
Photo 3 of 3 : UCIP_SP_2024_70636_92089.jpg

WS view: gate visible on the WS toe with concrete wall supporting pipe.

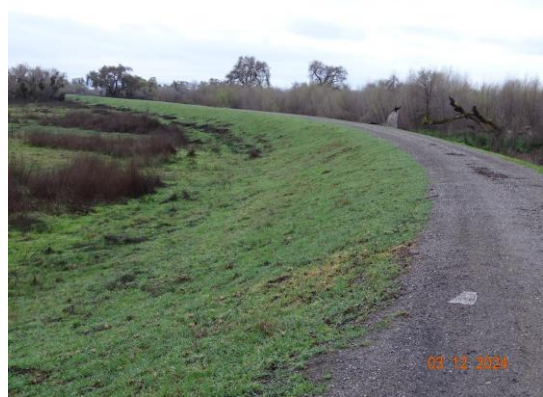
Photo 1 of 1 : SP_2024_NA0010_118_88_20240326_00256.jpg

LM Start	0.01	Rating **	A	Issue No.	88	
LM End	0.01	Issue Type +	Ma	Location *	LS	
Category	Earthen Levee			GPS Latitude/Longitude		
				Start		End
Item	Vegetation			37.348608°		37.348608°
				-120.959015°		-120.959015°
DWR ID	DWR_NA0010_01_s_2024_88					
Comment Code						
V1 : Control annual grass and weeds on the levee slopes and easements.						
Inspector Comment

View of the landside slope looking upstream. (Spring 2024)

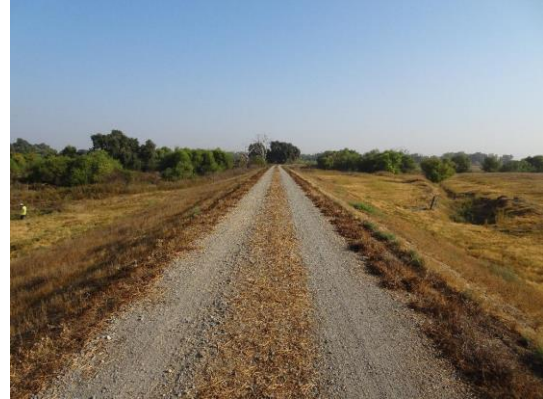
Photo 1 of 3 : UCIP_SP_2024_70637_90529.jpg

Comment Code					
Inspector Comment					
DS_ID:19651 FS_ID:70637 EP_NO: N/A Repair Type: Non-Urgent EVAL Issue: 11, Maintenance Compliance Issue Crossing Status: Found UCIP Comments: 10/06/2020 Record remains Non-Urgent. No permit was found authorizing this encroachment. Sediment buildup found on the LS. Recommend maintenance to clear up sediment buildup along pipe invert. CVFPB will need to review crossing to determine owner. DWR DMP internal inspection is pending and scheduled for 2021. (O. Magana - DWR UCIP, B. Singh - GEI)04/08/2014 Pipe has significant sediment buildup and shows some signs of corrosion at landward toe. Recommend cleaning sediment from inside pipe and check wall integrity. (W. Wylie - DWR UCIP) FIELD_STRUCT_DESC: 36-inch corrugated metal (CM) gravity drainage pipe through the levee, 18.5 feet below the crown. Flap gate on the waterside (WS) end. Brass cap No. 108 bench mark (BM) on the headwall on the landside (LS). [Additional Reference(s): DWR Levee Log, 2002, (HLM 0.35). USACE San Joaquin O&M Manual, Unit No. 601, Part No. 1, (SJR601.1), 1967, Revised 25 May 2011, (HLM 0.35)]. FS Date: 10/6/2020

Overview of levee looking US

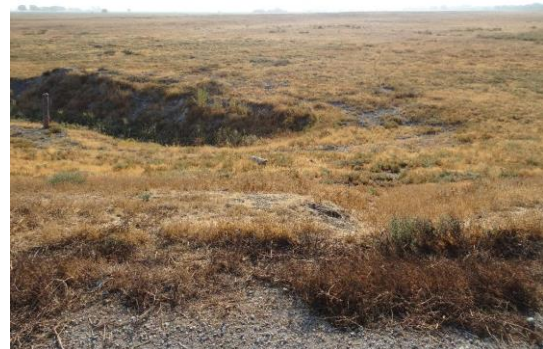
Photo 2 of 3 : UCIP_SP_2024_70637_90530.jpg

LS view: Overview of LS from levee crest, looking US

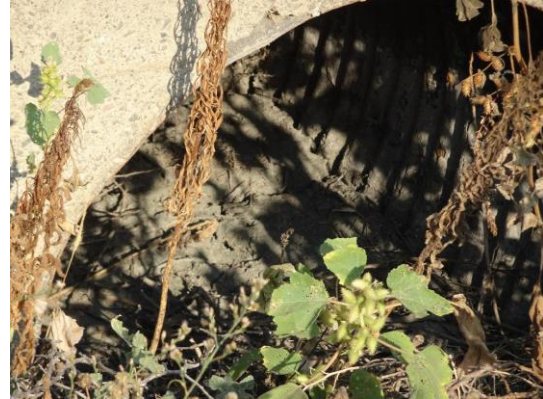
Photo 3 of 3 : UCIP_SP_2024_70637_92300.jpg

LS view: sediment build up along the pipe invert.

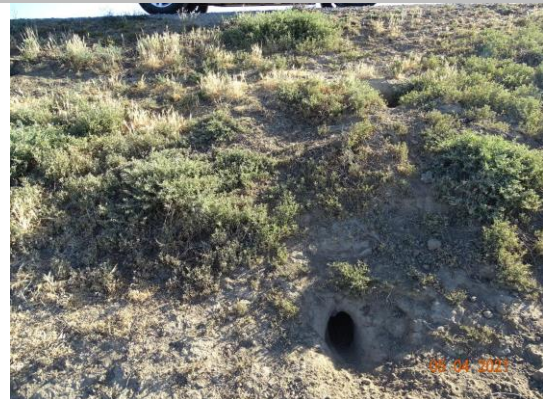
Photo 1 of 1 : SP_2024_NA0010_118_97_20240212_00006.jpg

LM Start	0.45	Rating **	M	Issue No.	97
LM End	0.45	Issue Type +	Ma	Location *	WS
Category	Earthen Levee			GPS Latitude/Longitude	
				Start	End
Item	Animal Control			37.343243°	37.343243°
				-120.962159°	-120.962159°
DWR ID	DWR_NA0010_01_s_2021_97				
Comment Code					
A1 : Exterminate rodents and backfill and compact or grout burrows.					
Inspector Comment

View of rodent burrows in the waterside slope. (Spring 2021)

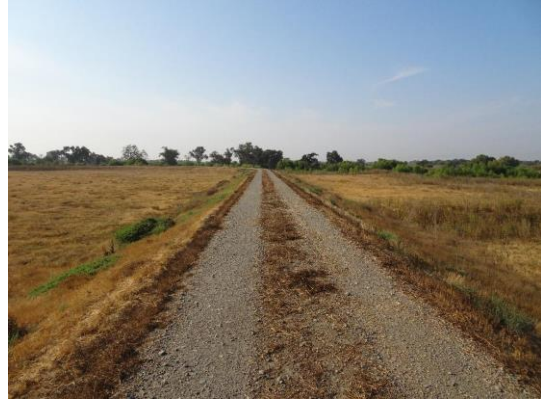
Photo 1 of 3 : UCIP_SP_2024_83224_90537.jpg

Comment Code						
Inspector Comment						
DS_ID:19583 FS_ID:83224 EP_NO: N/A Repair Type: Non-Urgent EVAL Issue: Crossing Status: Found UCIP Comments: 04/23/2024 Record updated from Non-Urgent to No Action Needed. DMP internal video inspection has found none or minor pipe defects. (M. Thao - DWR UCIP) 10/06/2020 Record remains Non-Urgent. No permit was found authorizing this encroachment. Rodent activity found near pipe location. CVFPB will need to review crossing to determine owner. DWR DMP has not found internal issues, LOF between 1 and 2. Recommend inspection in 5 years. (B. Singh - GEI, O. Magana - DWR UCIP) 04/08/2014 Recommend removing vegetation pile from waterward toe. (W. Wylie - DWR UCIP) FIELD_STRUCT_DESC: 24-inch corrugated metal (CM) gravity drainage pipe through the levee, 8.5 feet below the crown. Flap gate on the waterside (WS) end. Brass cap No. 108 bench mark (BM) on the headwall on the landside (LS). [Additional Reference(s): DWR Levee Log, 2002, (HLM 0.62). USACE San Joaquin O&M Manual, Unit No. 601, Part No. 1, (SJR601.1), 1967, Revised 25 May 2011, (HLM 0.62)]. FS Date: 10/6/2020

Overview of levee crown, looking US

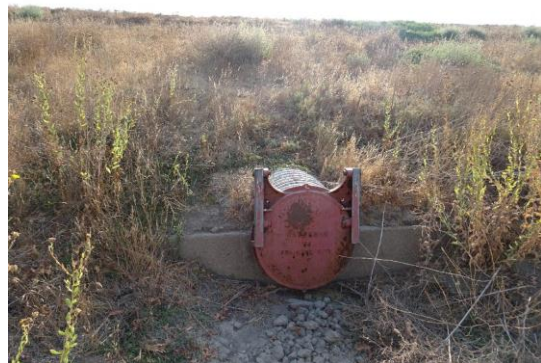
Photo 2 of 3 : UCIP_SP_2024_83224_90535.jpg

WS view: Flapgate and headwall at WS toe

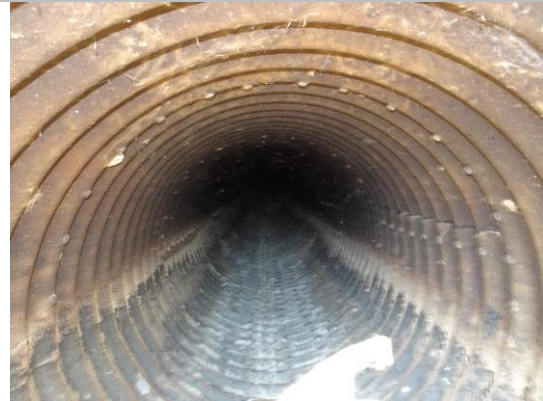
Photo 3 of 3 : UCIP_SP_2024_83224_90540.jpg

LS view: Inside pipe from LS toe

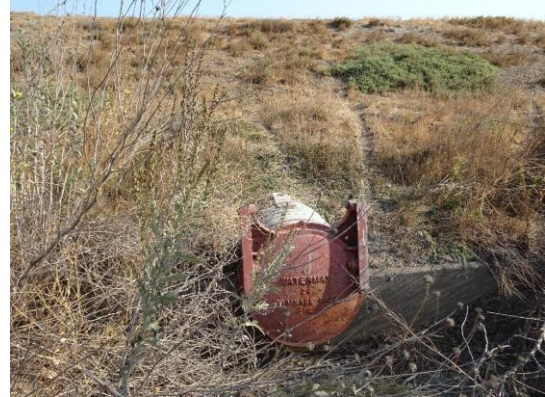
Photo 2 of 3 : UCIP_SP_2024_70639_90546.jpg

DS_ID:19584
 FS_ID:70639
 EP_NO: N/A
 Repair Type: Non-Urgent
 EVAL Issue:
 Crossing Status: Found
 UCIP Comments: 10/06/2020 Record has been updated from No Action Needed to Non-Urgent. No permit was found authorizing this encroachment. CVFPB will need to review crossing to determine owner. Rodent activity found near this stretch of levee. DWR DMP has not found internal issues, LOF between 1 and 2. Recommend inspection in 5 years. (B. Singh - GEI, O. Magana - DWR UCIP)
 FIELD_STRUCT_DESC: 24-inch corrugated metal (CM) gravity drainage pipe through the levee, 7.0 feet below the crown. Flap gate on the waterside (WS) end. Brass cap No. 108 bench mark (BM) on the headwall on the landside (LS). [Additional Reference(s): DWR Levee Log, 2002, (HLM 0.88). USACE San Joaquin O&M Manual, Unit No. 601, Part No. 1, (SJR601.1), 1967, Revised 25 May 2011, (HLM 0.87)].
 FS Date: 10/6/2020

WS view: Pipe, flapgate, and headwall at WS toe

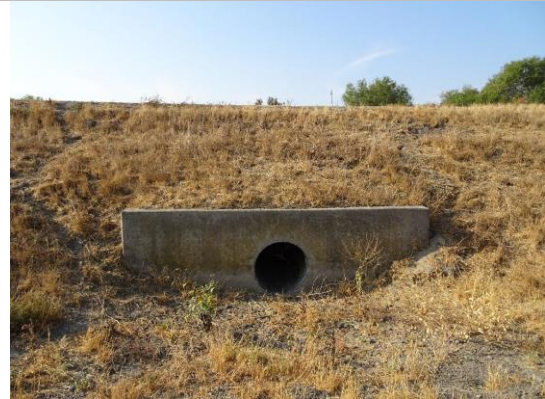
Photo 3 of 3 : UCIP_SP_2024_70639_90544.jpg

LS view: Pipe and headwall at LS toe

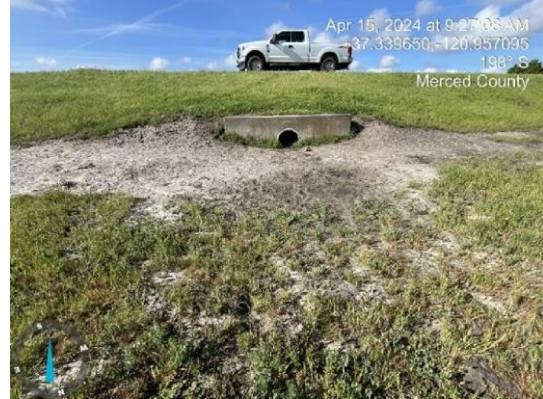
Photo 1 of 3 : UCIP_SP_2024_83233_121598.jpg

Comment Code					
Inspector Comment					
DS_ID:19585 FS_ID:83233 EP_NO: N/A Repair Type: No Action Needed EVAL Issue: Crossing Status: Found UCIP Comments: 04/23/2024 Record updated from Urgent to No Action Needed. The scour noted from previous inspection behind the concrete headwall on the LS toe has been corrected by the LMA. DMP internal video inspection has found none or minor pipe defects. (M. Thao - DWR UCIP) 12/19/2022 Record remains Urgent. Pipe has been CIPP-lined. LOF of crossing is less or equal to 4. Recommend next video inspection in 5 years. Scour behind the concrete headwall on the LS toe needs repair. (O. Yakimov - DWR UCIP) 10/06/2020 Record has been updated from Non-Urgent to Urgent. DWR DMP has found integrity issues, LOF between 5 and 6. Scour visible behind the concrete headwall on the LS toe. Recommend monitoring crossing until funding becomes available to addressed. No permit was found authorizing this encroachment. CVFPB will need to review crossing to determine owner. (B. Singh - GEI, O. Magana - DWR UCIP) 04/08/2014 Moderate erosion around headwall on landward toe. May or may not be an issue. Need to contact owner to determine status of crossing and to address erosion issue on landward side. (W. Wylie - DWR UCIP) FIELD_STRUCT_DESC: 24-inch CIPP-lined corrugated metal (CM) gravity drainage pipe through the levee, 9.0 feet below the crown. Flap gate on the waterside (WS) end. Brass cap No. 108 bench mark (BM) on the headwall on the landside (LS). [Additional Reference(s): DWR Levee Log, 2002, (HLM 0.96). USACE San Joaquin O&M Manual, Unit No. 601, Part No. 1, (SJR601.1), 1967, Revised 25 May 2011, (HLM 0.95)]. FS Date: 10/6/2020 4:21:36 PM

LS view: Headwall and pipe on LS toe. Scour surrounding headwall has been addressed (photo sent by LMA).

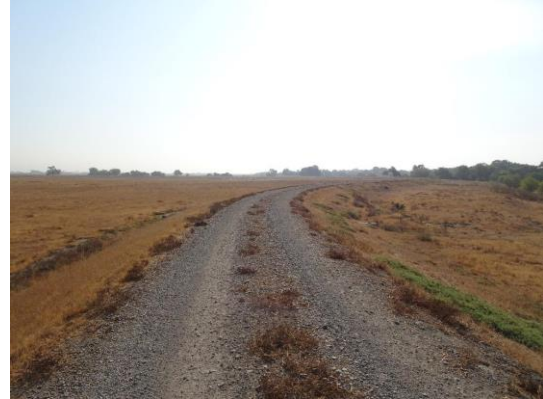
Photo 2 of 3 : UCIP_SP_2024_83233_90550.jpg

Overview of levee crown, looking US

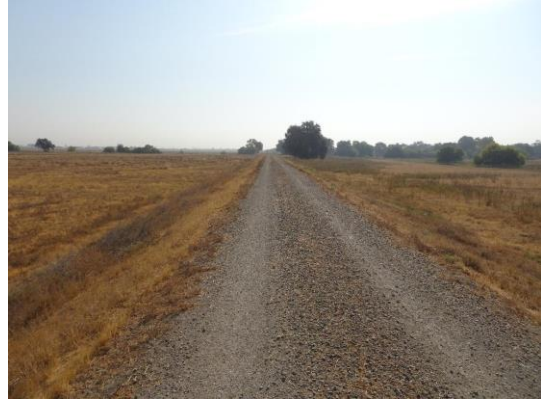
Photo 1 of 3 : UCIP_SP_2024_83235_90554.jpg

Comment Code						
Inspector Comment						
DS_ID:19586 FS_ID:83235 EP_NO: N/A Repair Type: No Action Needed EVAL Issue: Crossing Status: Found UCIP Comments: 04/23/2024 Record updated from Non-Urgent to No Action Needed. DMP internal video inspection has found none or minor pipe defects. (M. Thao - DWR UCIP) 10/06/2020 Record has been updated from No Action Needed to Non-Urgent. No permit was found authorizing this encroachment. CVFPB will need to review crossing to determine owner. DWR DMP has not found internal issues, LOF between 1 and 2. Recommend inspection in 5 years. (B. Singh - GEI, O. Magana - DWR UCIP) FIELD_STRUCT_DESC: 24-inch corrugated metal (CM) gravity drainage pipe through the levee, 7.5 feet below the crown. Flap gate on the waterside (WS) end. Brass cap No. 108 bench mark (BM) on the headwall on the landside (LS). [Additional Reference(s): DWR Levee Log, 2002, (HLM 1.18). USACE San Joaquin O&M Manual, Unit No. 601, Part No. 1, (SJR601.1), 1967, Revised 25 May 2011, (HLM 1.17)]. FS Date: 10/6/2020

Overview of levee crown, looking US

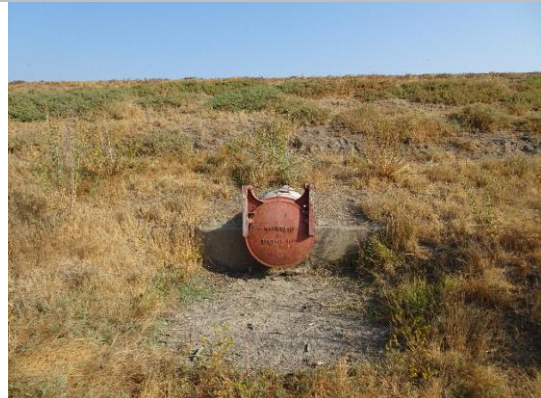
Photo 2 of 3 : UCIP_SP_2024_83235_90553.jpg

Pipe, flapgate and headwall on WS toe

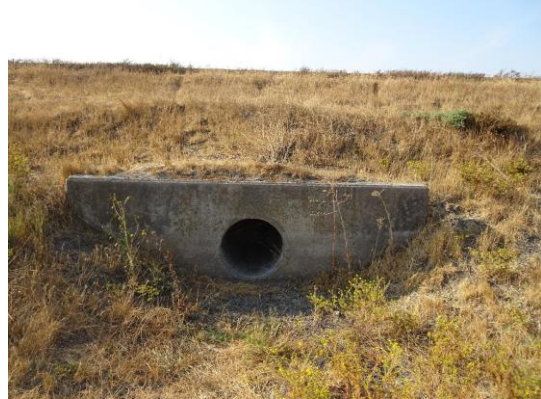
Photo 3 of 3 : UCIP_SP_2024_83235_90557.jpg

Headwall and pipe at LS toe

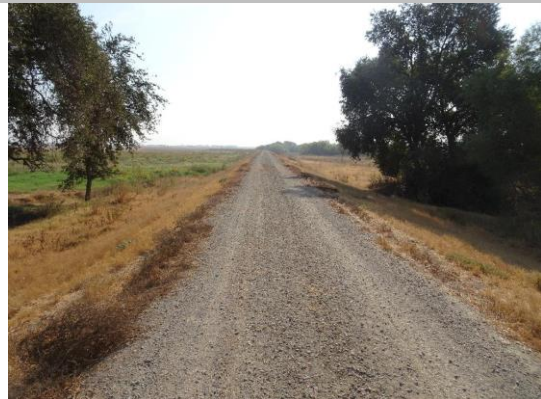
Photo 1 of 3 : UCIP_SP_2024_83236_90560.jpg

Overview of levee crown, looking US

DS_ID:19587
 FS_ID:83236
 EP_NO: N/A
 Repair Type: No Action Needed
 EVAL Issue:
 Crossing Status: Found
 UCIP Comments: 04/23/2024 Record updated from Non-Urgent to No Action Needed. DMP internal video inspection has found none or minor pipe defects. (M. Thao - DWR UCIP)
 10/06/2020 Record has been updated from No Action Needed to Non-Urgent. No permit was found authorizing this encroachment. CVFPB will need to review crossing to determine owner. DWR DMP internal inspection is still pending and scheduled for 2021. (B. Singh - GEI, O. Magana - DWR UCIP)
 FIELD_STRUCT_DESC: 36-inch corrugated metal (CM) gravity drainage pipe through the levee, 12.8 feet below the crown. Flap gate on the waterside (WS) end. Brass cap No. 108 bench mark (BM) on the headwall on the landside (LS). Pipe crosses through the levee at about a 45-degree angle. [Additional Reference(s): DWR Levee Log, 2002, (HLM 1.35). USACE San Joaquin O&M Manual, Unit No. 601, Part No. 1, (SJR601.1), 1967, Revised 25 May 2011, (HLM 1.34)].

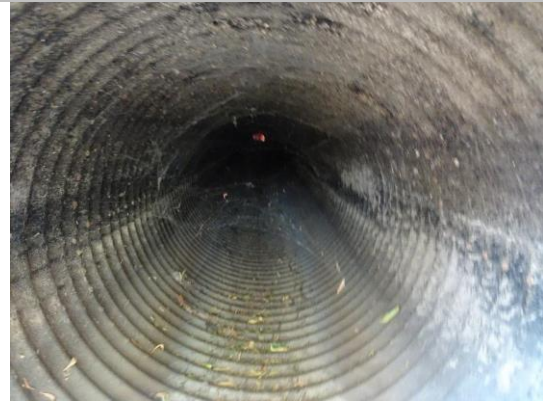
Photo 2 of 3 : UCIP_SP_2024_83236_90562.jpg

LS view: Inside pipe at LS toe

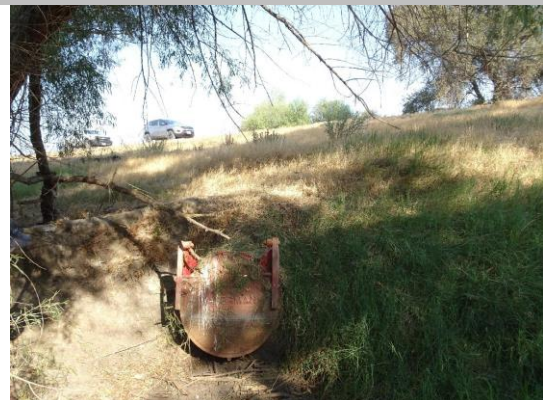
Photo 3 of 3 : UCIP_SP_2024_83236_90559.jpg

WS view: Concrete headwall and flapgate visible at WS toe

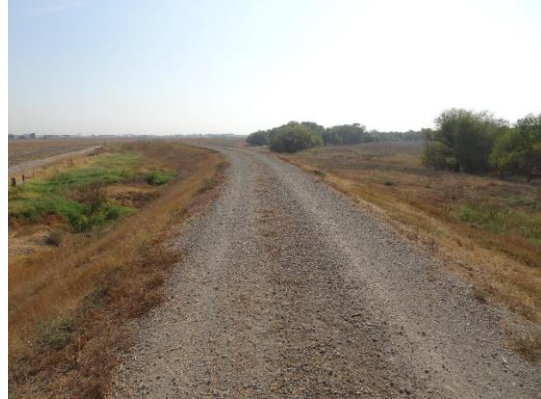
Photo 1 of 3 : UCIP_SP_2024_83238_90567.jpg

Comment Code						
Inspector Comment						
DS_ID:19588 FS_ID:83238 EP_NO: N/A Repair Type: No Action Needed EVAL Issue: Crossing Status: Found UCIP Comments: 04/23/2024 Record updated from Non-Urgent to No Action Needed. DMP internal video inspection has found none or minor pipe defects. (M. Thao - DWR UCIP) 10/06/2020 Record remains Non-Urgent. No permit was found authorizing this encroachment. CVFPB will need to review crossing to determine owner. DWR DMP has not found internal issues, LOF between 1 and 2. Recommend inspection in 5 years. (B. Singh - GEI, O. Magana - DWR UCIP) 04/08/2014 Some sediment buildup inside pipe at LS toe. Recommend contacting owner to clear sediment buildup and check wall integrity through pipe section. (W. Wylie - DWR UCIP) FIELD_STRUCT_DESC: 24-inch corrugated metal (CM) gravity drainage pipe through the levee, 11.0 feet below the crown. Flap gate on the waterside (WS) end. Brass cap No. 108 bench mark (BM) on the headwall on the landside (LS). [Additional Reference(s): DWR Levee Log, 2002, (HLM 1.48). USACE San Joaquin O&M Manual, Unit No. 601, Part No. 1, (SJR601.1), 1967, Revised 25 May 2011, (HLM 1.48)]. FS Date: 10/6/2020

Overview of levee crown, looking US

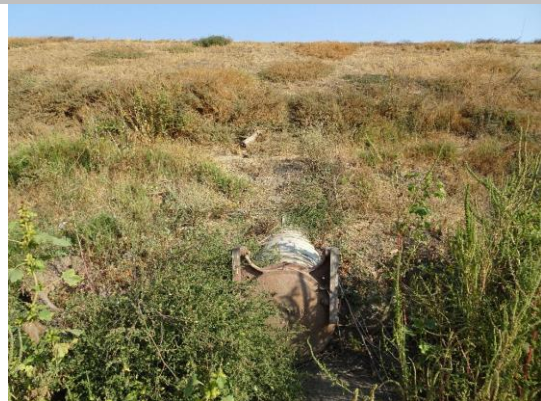
Photo 2 of 3 : UCIP_SP_2024_83238_90570.jpg

Pipe and flapgate visible on WS toe

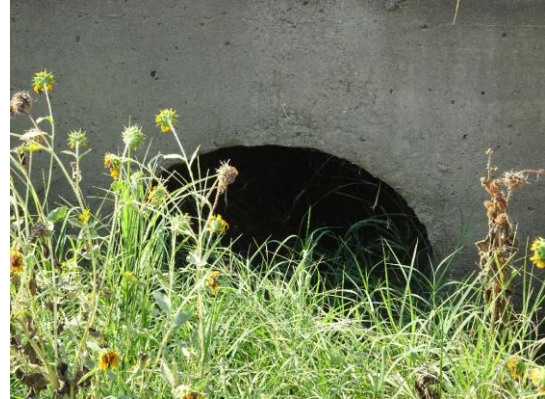
Photo 3 of 3 : UCIP_SP_2024_83238_90566.jpg

Pipe partially visible on LS toe

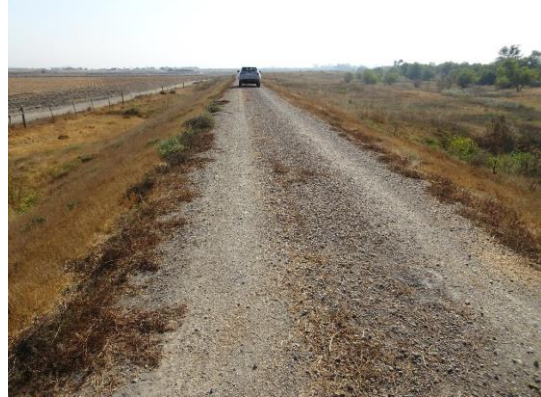
Photo 1 of 3 : UCIP_SP_2024_70644_90572.jpg

Comment Code					
Inspector Comment					
DS_ID:19589 FS_ID:70644 EP_NO: N/A Repair Type: No Action Needed EVAL Issue: Crossing Status: Found UCIP Comments: 09/15/2023 Record updated from Non-Urgent to No Action Needed. Pipe was CIPP lined. DMP internal video inspection has found none or minor pipe defects. Recommend next video inspection in 5 years. (O. Yakimov - DWR UCIP) 10/06/2020 Record remains Non-Urgent. DWR DMP has found integrity issues, LOF between 4 and 5. Crossing will be monitored until funding becomes available for rehabilitation. No permit was found authorizing this encroachment. CVFPB will need to review crossing to determine owner. Dense vegetation was found along the WS and LS toe. Recommend removing vegetation along the pipe alignment. Based on the 2014 photos, the LS toe appears to be heavily silted up. Recommend removing silt to increase flow capacity and meet pipe design capacity. (B. Singh - GEI, O. Magana - DWR UCIP)04/08/2014 Heavy sediment buildup in pipe at LS toe. (DWR UCIP - W. Wylie) FIELD_STRUCT_DESC: 24-inch CIPP-lined corrugated metal (CM) gravity drainage pipe through the levee, 13.6 feet below the crown. Flap gate on the waterside (WS) end. Brass cap No. 108 bench mark (BM) on the headwall on the landside (LS). [Additional Reference(s): DWR Levee Log, 2002, (HLM 1.70). USACE San Joaquin O&M Manual, Unit No. 601, Part No. 1, (SJR601.1), 1967, Revised 25 May 2011, (HLM 1.69)]. FS Date: 10/6/2020

Overview of levee crown, looking US

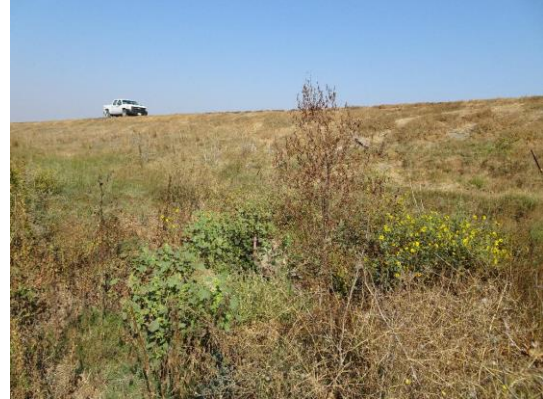
Photo 2 of 3 : UCIP_SP_2024_70644_90575.jpg

WS view: Flapgate and headwall visible at WS toe; dense vegetation

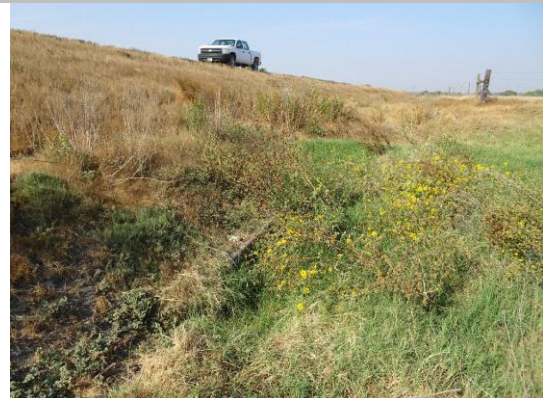
Photo 3 of 3 : UCIP_SP_2024_70644_90576.jpg

LS view: Headwall and pipe partially visible at LS toe; dense vegetation

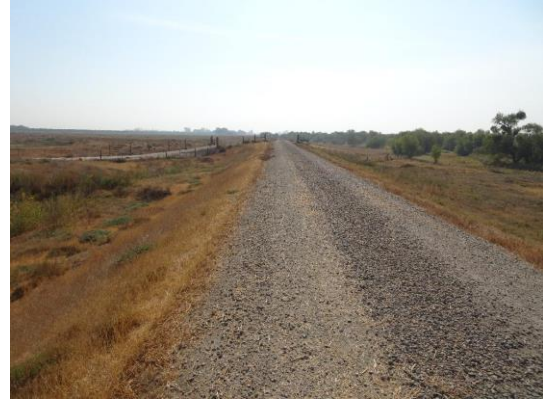
Photo 1 of 3 : UCIP_SP_2024_77847_90581.jpg

Comment Code						
Inspector Comment						
DS_ID:19590 FS_ID:77847 EP_NO: N/A Repair Type: Urgent EVAL Issue: 1, Pipe Integrity Crossing Status: Found UCIP Comments: 12/14/2022 Record updated from Non-Urgent to Urgent. DMP internal video inspection has found pipe integrity issues. LOF of crossing is between 5 and 6. Crossing will be monitored until funding becomes available to address the issues. (O.Yakimov - DWR UCIP) 10/06/2020 Record has been updated from No Action Needed to Non-Urgent. No permit was found authorizing this encroachment. CVFPB will need to review crossing to determine owner. DWR DMP internal inspection is pending and scheduled for 2021. Dense vegetation was observed along the pipe alignment and both WS and LS toe. Recommend clearing vegetation along pipe alignment. (B. Singh - GEI, O. Magana - DWR UCIP) FIELD_STRUCT_DESC: 36-inch corrugated metal (CM) gravity drainage pipe through the levee, 14.2 feet below the crown. Flap gate on the waterside (WS) end. Brass cap No. 100 bench mark (BM) on the headwall on the landside (LS). [Additional Reference(s): DWR Levee Log, 2002, (HLM 1.84). USACE San Joaquin O&M Manual, Unit No. 601, Part No. 1, (SJR601.1), 1967, Revised 25 May 2011, (HLM 1.83)]. FS Date: 10/6/2020 1:27:14 PM

Overview of levee crown, looking upstream

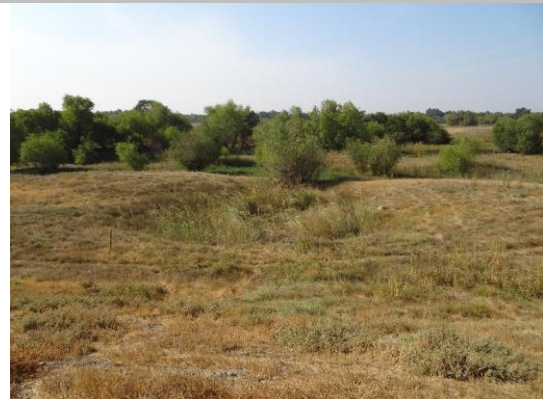
Photo 2 of 3 : UCIP_SP_2024_77847_90582.jpg

WS view: Pipe, flapgate, and headwall are not visible at WS toe from levee crown

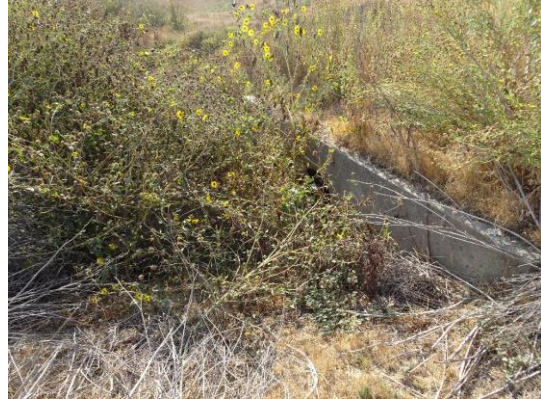
Photo 3 of 3 : UCIP_SP_2024_77847_90578.jpg

LS view: Pipe and concrete headwall partially visible at LS toe

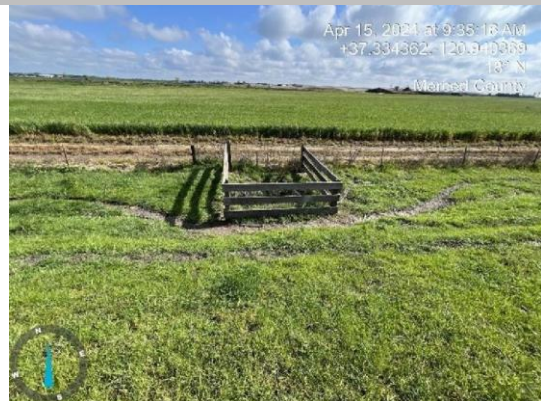
Photo 1 of 3 : UCIP_SP_2024_83239_121609.jpg

DS_ID:19591
FS_ID:83239
EP_NO: N/A
Repair Type: No Action Needed
EVAL Issue:
Crossing Status: Found
UCIP Comments: 04/23/2024 Record updated from Non-Urgent to No Action Needed. LMA has corrected the rodent activity noted in the previous inspection. DMP internal video inspection has found none or minor pipe defects. (M. Thao - DWR UCIP)
10/06/2020 Record remains Non-Urgent. Rodent activity found in the general area. No permit was found authorizing this encroachment. CVFPB will need to review crossing to determine owner. DWR DMP has not found internal issues, LOF between 1 and 2. Recommend inspection in 5 years. (B. Singh - GEI, O. Magana - DWR UCIP)
04/08/2014 Need to contact owner to determine crossing status. Inlet drop box silted in and needs to be cleaned out. (W. Wylie - DWR UCIP)
FIELD_STRUCT_DESC: 24-inch corrugated metal (CM) gravity drainage pipe through the levee, 9.7 feet below the crown. Flap gate on the waterside (WS) end. Brass cap No. 100 bench mark (BM) on the headwall on the landside (LS). Wooden barrier around drop inlet on the LS toe. [Additional Reference(s): DWR Levee Log, 2002, (HLM 1.98). USACE San Joaquin O&M Manual, Unit No. 601, Part No. 1, (SJR601.1), 1967, Revised 25 May 2011, (HLM 1.98)].

LS view: Rodent activity near crossing noted in 10/06/2020 inspection has been corrected (photo sent by LMA).

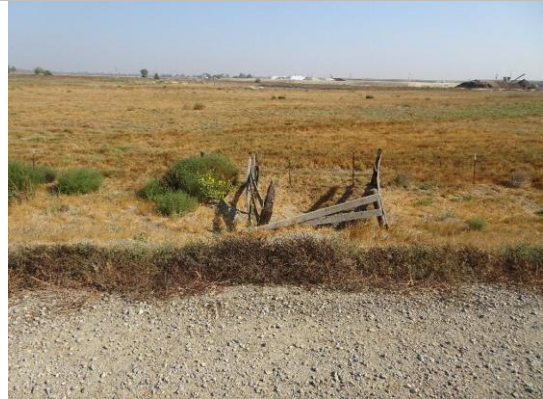
Photo 3 of 3 : UCIP_SP_2024_83239_90613.jpg

LS view: View toward LS pipe and headwall from levee crown

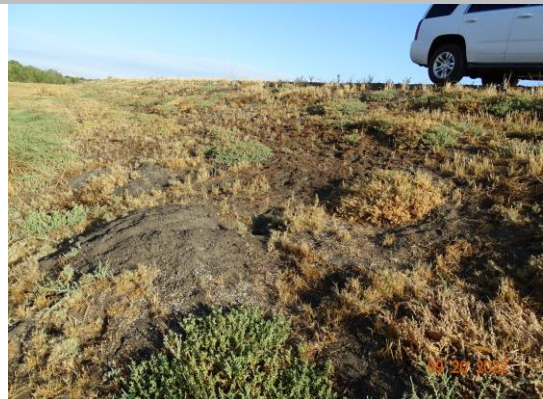
Photo 1 of 1 : SP_2024_NA0010_118_122_20240212_00021.jpg

LM Start	1.97	Rating **	M	Issue No.	122
LM End	1.97	Issue Type +	Ma	Location *	WS
Category	Earthen Levee			GPS Latitude/Longitude	
				Start	End
Item	Animal Control			37.334259°	37.334259°
				-120.940113°	-120.940113°
DWR ID	DWR_NA0010_01_f_2022_122				
Comment Code					
A3 : No rodents visible, but rodent burrows visible; need to backfill and compact or grout burrows.					
Inspector Comment

View of large rodent burrow on the waterside slope. (Fall 2022)

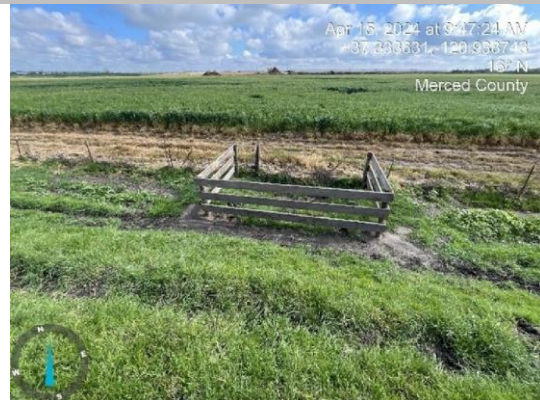
Photo 1 of 3 : UCIP_SP_2024_83241_121610.jpg

Comment Code						
Inspector Comment						
DS_ID:19570 FS_ID:83241 EP_NO: N/A Repair Type: No Action Needed EVAL Issue: Crossing Status: Found UCIP Comments: 04/23/2024 Record updated from Non-Urgent to No Action Needed. DMP internal video inspection has found none or minor pipe defects. Wooden barrier noted in the 10/06/2020 inspection surrounding drop-inlet has been corrected. (M. Thao - DWR UCIP) 12/19/2022 Record updated from Urgent to Non-Urgent. Pipe has been CIPP-lined. LOF of crossing is less or equal to 4. Recommend next video inspection in 5 years. (O. Yakimov - DWR UCIP). 10/06/2020 Record updated from Non-Urgent to Urgent. DMP internal video inspection has found pipe integrity issues. LOF of crossing is between 5 and 6. Crossing will be monitored until funding becomes available to address the issues. Wooden barrier surrounding drop-inlet is dilapidated. No permit was found authorizing this encroachment. CVFPB will need to review crossing to determine owner. (B. Singh - GEI, O. Magana - DWR UCIP) 04/08/2014 Unable to find inlet on landward toe. Recommend clearing vegetation on landward side to properly inspect inlet. (W. Wylie - DWR UCIP) FIELD_STRUCT_DESC: 24-inch CIPP-lined corrugated metal (CM) gravity drainage pipe through the levee, 9.8 feet below the crown. Flap gate on the waterside (WS) end. Brass cap No. 100 bench mark (BM) on the headwall on the landside (LS). [Additional Reference(s): DWR Levee Log, 2002, (HLM 2.08). USACE San Joaquin O&M Manual, Unit No. 601, Part No. 1, (SJR601.1), 1967, Revised 25 May 2011, (HLM 2.08)]. FS Date: 10/6/2020 4:15:32 PM

LS view: Corrected wood barrier around drop-inlet on LS toe (photo sent by LMA).

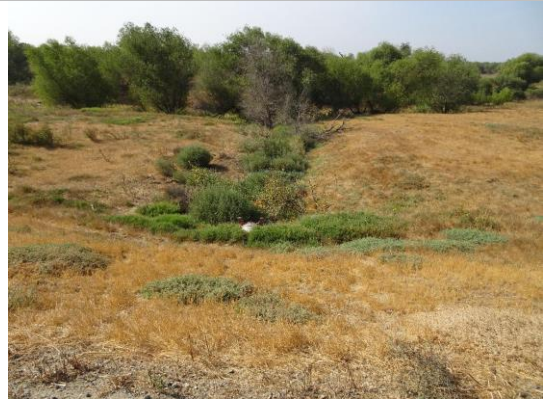
Photo 3 of 3 : UCIP_SP_2024_83241_90618.jpg

WS view: Pipe and flapgate visible on WS toe

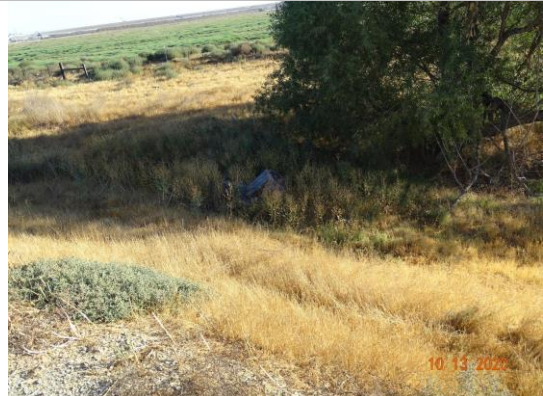
Photo 1 of 1 : SP_2024_NA0010_118_110_20240212_00012.jpg

LM Start	2.20	Rating **	N	Issue No.	110
LM End	2.20	Issue Type +	Ma	Location *	LS
Category	Earthen Levee			GPS Latitude/Longitude	
				Start	End
Item	Trim / Thin Trees			37.331820°	37.331820°
				-120.937605°	-120.937605°
DWR ID	DWR_NA0010_01_f_2018_110				
Comment Code					
T5 : Tree stumps.					
Inspector Comment					
Tree stump on landside slope should be removed.

View of tree stump on the landside slope. (Fall 2020)

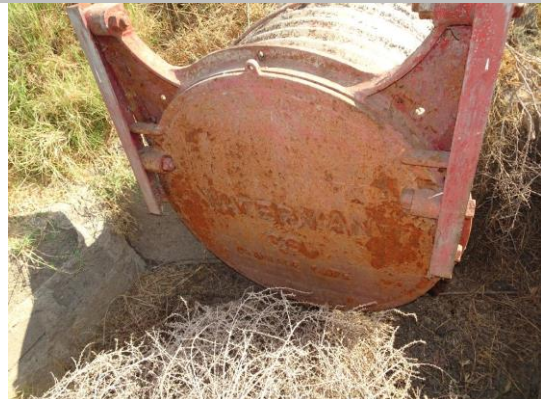
Photo 2 of 3 : UCIP_SP_2024_77843_90628.jpg

WS view: Pipe, flapgate, and headwall on WS toe

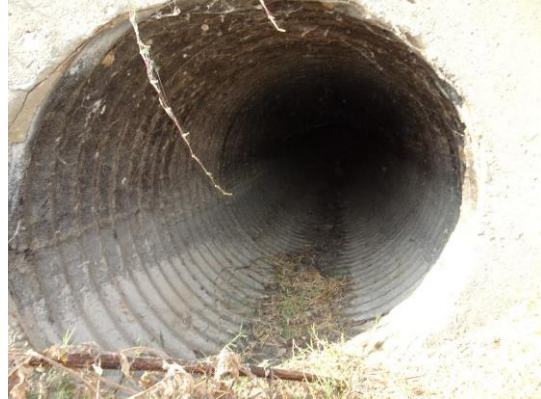
Photo 3 of 3 : UCIP_SP_2024_77843_90623.jpg

LS view: inside view of pipe

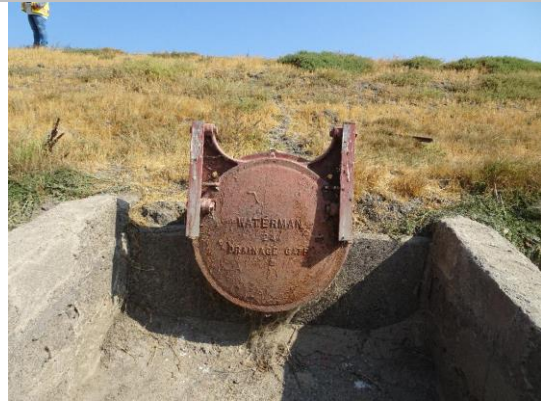
Photo 2 of 3 : UCIP_SP_2024_70649_90635.jpg

DS_ID:19572
 FS_ID:70649
 EP_NO: N/A
 Repair Type: Non-Urgent
 EVAL Issue:
 Crossing Status: Found
 UCIP Comments: 10/06/2020 Record has been updated from No Action Needed to Non-Urgent. No permit was found authorizing this encroachment. CVFPB will need to review crossing to determine owner. DWR DMP has not found internal issues, LOF between 1 and 2. Recommend inspection in 5 years. (B. Singh - GEI, O. Magana - DWR UCIP)
 FIELD_STRUCT_DESC: 24-inch corrugated metal (CM) gravity drainage pipe through the levee, 8.0 feet below the crown. Flap gate on the waterside (WS) end. Brass cap No. 100 bench mark (BM) on the headwall on the landside (LS). [Additional Reference(s): DWR Levee Log, 2002, (HLM 2.53). USACE San Joaquin O&M Manual, Unit No. 601, Part No. 1, (SJR601.1), 1967, Revised 25 May 2011, (HLM 2.52)].
 FS Date: 10/6/2020

WS view: Pipe, flapgate, and headwall on WS toe

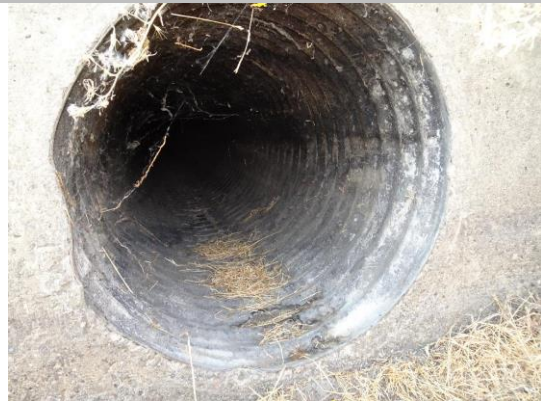
Photo 3 of 3 : UCIP_SP_2024_70649_90636.jpg

LS view: close up view inside pipe inlet

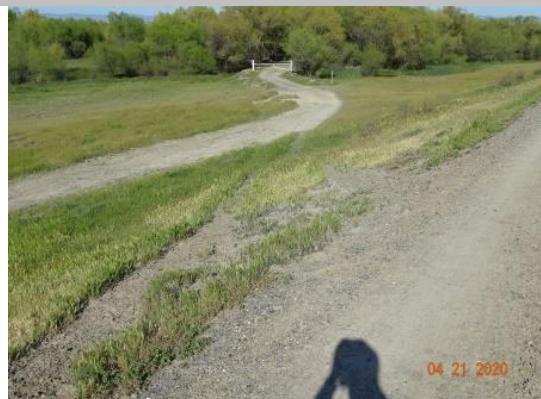
Photo 1 of 1 : SP_2024_NA0010_118_113_20240212_00014.jpg

LM Start	2.58	Rating **	A/W	Issue No.	113
LM End	2.58	Issue Type +	Ma	Location *	WS
Category	Earthen Levee			GPS Latitude/Longitude	
				Start	End
Item	Erosion / Vehicle Traffic			37.327936°	37.327936°
				-120.933013°	-120.933013°
DWR ID	DWR_NA0010_01_f_2018_113				
Comment Code					
E6 : Repair the levee slope damaged by vehicle traffic and prevent access where possible.					
Inspector Comment					
There is damage caused by vehicle traffic over the levee but the integrity of the levee is not compromised. Continue to monitor.

Slope damage by vehicle traffic. (Spring 2020)

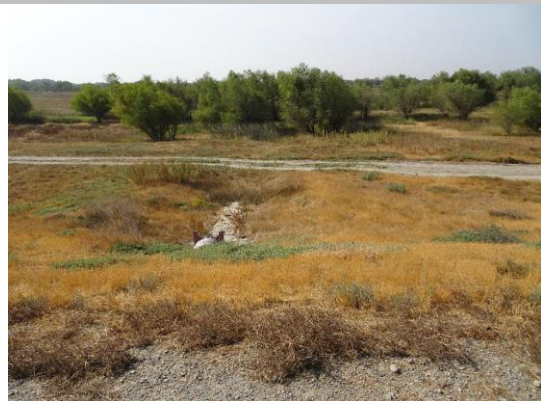
Photo 2 of 3 : UCIP_SP_2024_70650_90638.jpg

Comment Code						
Inspector Comment						
DS_ID:19573 FS_ID:70650 EP_NO: N/A Repair Type: Non-Urgent EVAL Issue: Crossing Status: Found UCIP Comments: 10/06/2020 Record remains Non-Urgent. No permit was found authorizing this encroachment. CVFPB will need to review crossing to determine owner. DWR DMP has not found internal issues, LOF between 1 and 2. Recommend inspection in 5 years. (B. Singh - GEI, O. Magana - DWR UCIP)04/08/2014 Sedimentation in pipe at landward toe. (W. Wylie - DWR UCIP) FIELD_STRUCT_DESC: 24-inch corrugated metal (CM) gravity drainage pipe through the levee, 7.3 feet below the crown. Flap gate on the waterside (WS) end. Brass cap No. 100 bench mark (BM) on the headwall on the landside (LS). [Additional Reference(s): DWR Levee Log, 2002, (HLM 2.71). USACE San Joaquin O&M Manual, Unit No. 601, Part No. 1, (SJR601.1), 1967, Revised 25 May 2011, (HLM 2.70)]. FS Date: 10/6/2020

WS view: Pipe and flapgate visible on WS toe

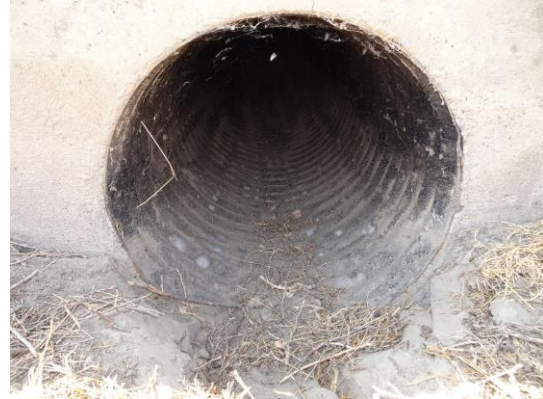
Photo 3 of 3 : UCIP_SP_2024_70650_90642.jpg

WS view: Pipe and headwall at WS toe

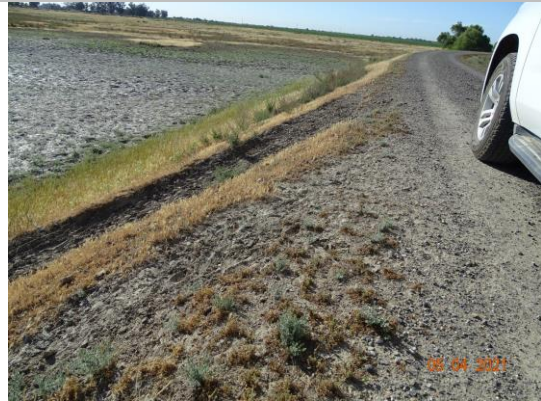
Photo 1 of 1 : SP_2024_NA0010_118_104_20240212_00008.jpg

LM Start	3.06	Rating **	M	Issue No.	104
LM End	3.06	Issue Type +	Ma	Location *	LS
Category	Earthen Levee			GPS Latitude/Longitude	
				Start	End
Item	Erosion / Livestock			37.322499°	37.322499°
				-120.928986°	-120.928986°
DWR ID	DWR_NA0010_01_f_2017_104				
Comment Code					
E4 : Repair the levee slope damaged by livestock and prevent large animal access.					
Inspector Comment					
Slope damage caused by animal foot traffic.

Slope damage on the landside slope from livestock traffic. (Spring 2021)

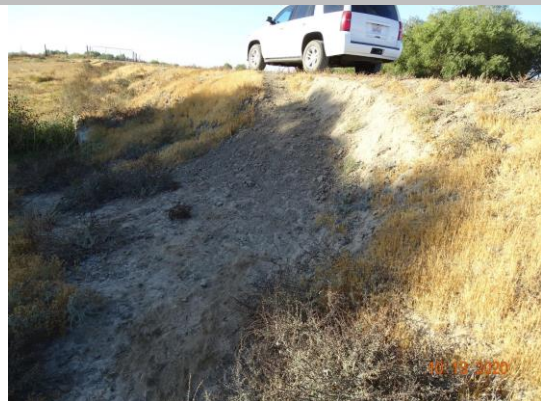
Photo 1 of 1 : SP_2024_NA0010_118_108_20240212_00011.jpg

LM Start	3.13	Rating **	M	Issue No.	108
LM End	3.13	Issue Type +	Ma	Location *	LS
Category	Earthen Levee			GPS Latitude/Longitude	
				Start	End
Item	Erosion / Livestock			37.321488°	37.321488°
				-120.928758°	-120.928758°
DWR ID	DWR_NA0010_01_s_2017_108				
Comment Code					
E4 : Repair the levee slope damaged by livestock and prevent large animal access.					
Inspector Comment					
Slope damage caused by animal traffic on landside toe.

View of landside slope damage by animal traffic. (Fall 2020)

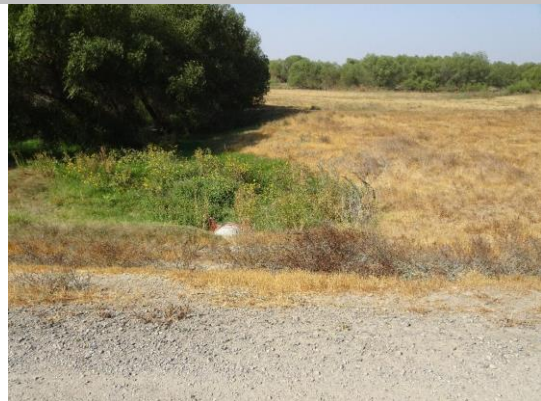
Photo 2 of 3 : UCIP_SP_2024_77846_90645.jpg

Comment Code						
Inspector Comment						
DS_ID:19574 FS_ID:77846 EP_NO: N/A Repair Type: Urgent EVAL Issue: 1, Pipe Integrity Crossing Status: Found UCIP Comments: 12/14/2022 Record updated from Non-Urgent to Urgent. DMP internal video inspection has found pipe integrity issues. LOF of crossing is between 5 and 6. Crossing will be monitored until funding becomes available to address the issues. (O.Yakimov - DWR UCIP) 10/06/2020 Record remains Non-Urgent. No permit was found authorizing this encroachment. CVFPB will need to review crossing to determine owner. DWR DMP internal inspection is pending and scheduled for 2021. (B. Singh - GEI, O. Magana - DWR UCIP)04/08/2014 Some minor erosion around headwall on LS toe. (W. Wylie - DWR UCIP) FIELD_STRUCT_DESC: 36-inch corrugated metal (CM) gravity drainage pipe through the levee, 8.0 feet below the crown. Flap gate on the waterside (WS) end. Brass cap No. 100 bench mark (BM) on the headwall on the landside (LS). [Additional Reference(s): DWR Levee Log, 2002, (HLM 3.17). USACE San Joaquin O&M Manual, Unit No. 601, Part No. 1, (SJR601.1), 1967, Revised 25 May 2011, (HLM 3.16)]. FS Date: 10/6/2020

WS view: Pipe and flapgate visible at WS toe

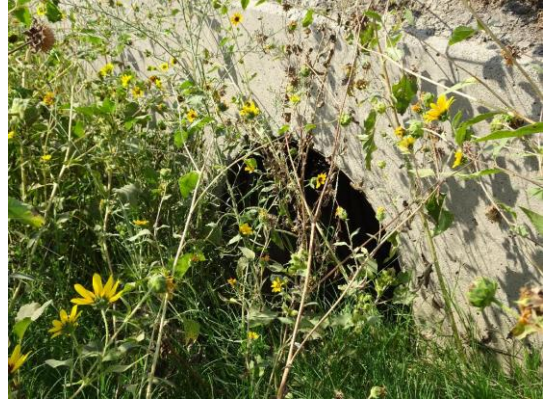
Photo 3 of 3 : UCIP_SP_2024_77846_90648.jpg

LS view: Pipe and headwall at LS toe. Heavy vegetation.

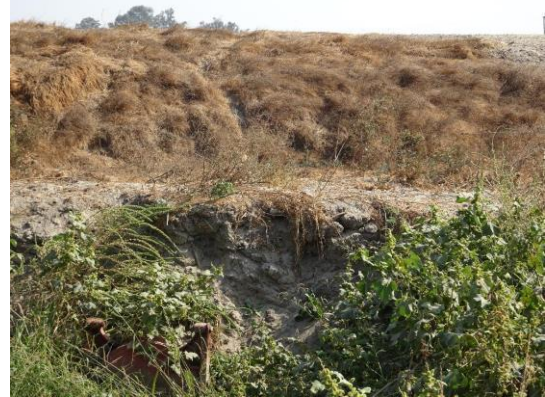
Photo 2 of 3 : UCIP_SP_2024_70652_90586.jpg

Comment Code					
Inspector Comment					
DS_ID:19575 FS_ID:70652 EP_NO: N/A Repair Type: Urgent EVAL Issue: 1, Pipe Integrity Crossing Status: Found UCIP Comments: 10/06/2020 Record remains Urgent. Sinkhole present directly above the LS headwall and along pipe alignment. Pipe collapse visible from from the LS toe. Erosion present on the WS just behind the flap gate. No permit was found authorizing this encroachment. CVFPB will need to review crossing to determine owner. DWR DMP internal inspection is pending and scheduled in 2021. (B. Singh - GEI, O. Magana - DWR UCIP)11/01/2018 Pipe continues to rust through, causing the pipe to collapse on the LS. Sediment buildup visible from the LS inlet. Loss of soil just above the LS concrete headwall and along the LS slope. Crossing remains Urgent due to the levee slope issues and pipe failure through the levee. (O. Magana - DWR UCIP)07/19/2016 Same as previous inspection. Erosion present on LS slope. (O. Magana - DWR UCIP)04/08/2014 Pipe rusted through at Springline on LS toe. Flapgate blocked by sediment on WS toe. Heavy sediment on both ends of pipe. Need to contact owner to address issues. (W. Wylie - DWR UCIP) FIELD_STRUCT_DESC: 36-inch corrugated metal (CM) gravity drainage pipe through the levee, 9.7 feet below the crown. Flap gate on the waterside (WS) end. Brass cap No. 100 bench mark (BM) on the headwall on the landside (LS). [Additional Reference(s): DWR Levee Log, 2002, (HLM 3.50). USACE San Joaquin O&M Manual, Unit No. 601, Part No. 1, (SJR601.1), 1967, Revised 25 May 2011, (HLM 3.50)]. FS Date: 10/6/2020

WS view: Slope from WS toe

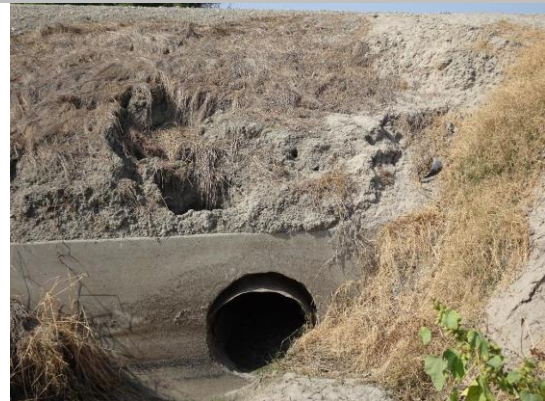
Photo 3 of 3 : UCIP_SP_2024_70652_90591.jpg

LS view: Pipe, headwall, and sinkhole at LS toe

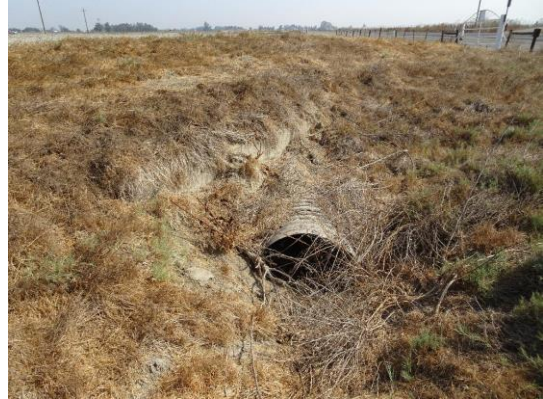
Photo 2 of 3 : UCIP_SP_2024_70653_90652.jpg

Comment Code					
Inspector Comment					
DS_ID:19576 FS_ID:70653 EP_NO: N/A Repair Type: Urgent EVAL Issue: 3a, Flood Risk Crossing Status: Found UCIP Comments: 10/06/2020 Record updated from Non-Urgent to Urgent. Heavy siltation through the length of the pipe was observed and recommend removal. Flap gate is missing on the WS toe. Recommend adding flap gate to prevent flooding from the WS to the LS. No permit was found authorizing this encroachment. CVFPB will need to review crossing to determine owner. DWR DMP internal inspection is pending and scheduled for 2021. Pipe goes through the levee at an angle. System description has been updated to include angled pipe information.(B. Singh - GEI, O. Magana - DWR UCIP)04/08/2014 Slide gate missing from WS. No closure device, but degrading of levee at Highway 140 is lower than pipe, so this does not appear to be a critical issue. Also dense vegetation limits the inspector's visibility to identify signs of pipe failure (leaks) along the slope. Recommend removing vegetation along pipe alignment to conduct proper inspection of structure and appurtenances. (W. Wylie - DWR UCIP) FIELD_STRUCT_DESC: 30-inch corrugated metal (CM) gravity drainage pipe through the levee at an angle, 3.5 feet below the crown. Flap gate on the waterside (WS) end. Brass cap No. 100 bench mark (BM) on the headwall on the landside (LS). [Additional Reference(s): DWR Levee Log, 2002, (HLM 3.95). USACE San Joaquin O&M Manual, Unit No. 601, Part No. 1, (SJR601.1), 1967, Revised 25 May 2011, (HLM 3.95)]. FS Date: 10/6/2020

WS view: Heavy siltation at WS invert. Pipe flapgate missing at WS toe.

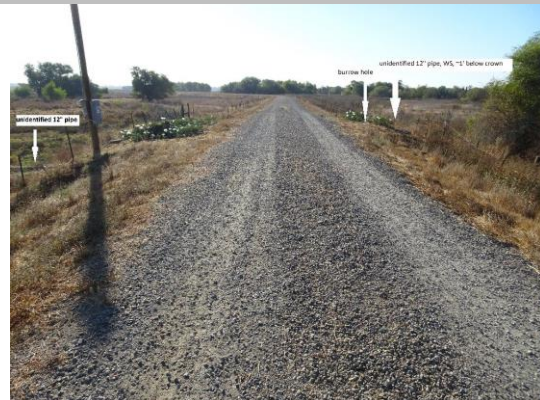
Photo 1 of 3 : UCIP_SP_2024_70655_90661.jpg

Comment Code						
Inspector Comment						
DS_ID:19607 FS_ID:70655 EP_NO: N/A Repair Type: Non-Urgent EVAL Issue: 10, Unauthorized Modification or Non-Compliant Permit Crossing Status: Found UCIP Comments: 10/20/2020 Record remains Non-Urgent. Barbed wire prevented access to the pipe located on the LS toe. Unpermitted modifications were made to the structure. There appears to be multiple crossings at this location, two 12-inch pipes and 48-inch refurbished pipe. Recommend adding new DSID for the second 12-inch pipe found during field inspection. Portion of concrete headwall visible on the WS toe that corresponds to 48-inch pipe. Recommend contacting owner to determine status of structure and obtain as-builts. No permit was found authorizing these encroachments. CVFPB will need to review crossing to determine owner(s). (B. Singh - GEI, O. Magana - DWR UCIP)04/08/2014 Pipe appears sleeved with a 12-inch steel pipe with a slide gate at the LS toe. No identified authorization for changes to this crossing. Need to contact owner to obtain additional information about the modifications to crossing. (W. Wylie - DWR UCIP) FIELD_STRUCT_DESC: 48-inch corrugated metal (CM) gravity drainage pipe through the levee, 14.0 feet below the crown. Flap gate on the waterside (WS) end. Brass cap No. 90 bench mark (BM) on the headwall on the landside (LS). [Additional Reference(s): DWR Levee Log, 2002, (HLM 4.16). USACE San Joaquin O&M Manual, Unit No. 601, Part No. 1, (SJR601.1), 1967, Revised 25 May 2011, (HLM 4.16)]. FS Date: 10/20/2020

Overview of levee crown showing location of burrow hole and alignment of unauthorized 12" pipe

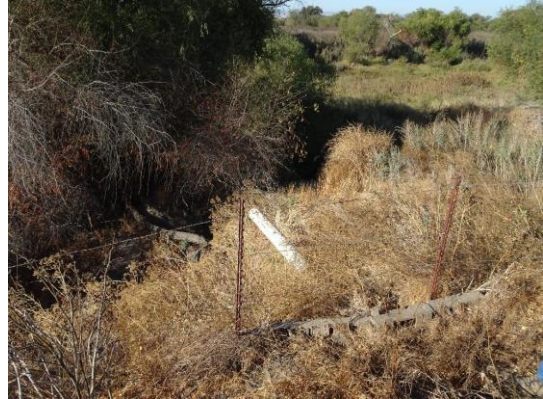
Photo 2 of 3 : UCIP_SP_2024_70655_90662.jpg

WS view: Unauthorized 12-inch PVC pipe on WS, approximately 1 foot below levee crown.

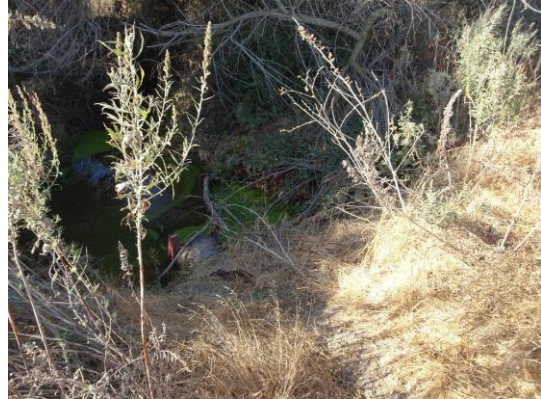
Photo 2 of 3 : UCIP_SP_2024_77849_90672.jpg

WS view: Pipe and flapgate visible at WS toe. Further inspection inhibited by barbed wire fencing

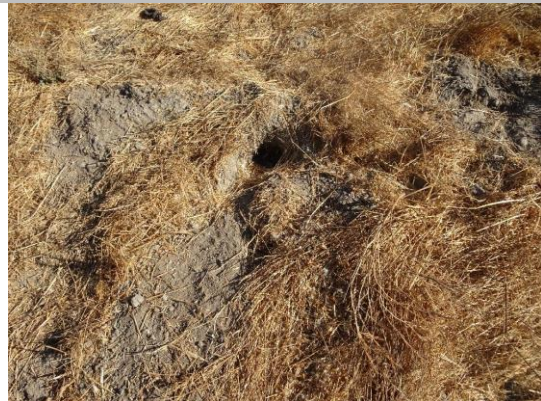
Photo 3 of 3 : UCIP_SP_2024_77849_90673.jpg

Observed burrowing on limited view of LS and WS slopes

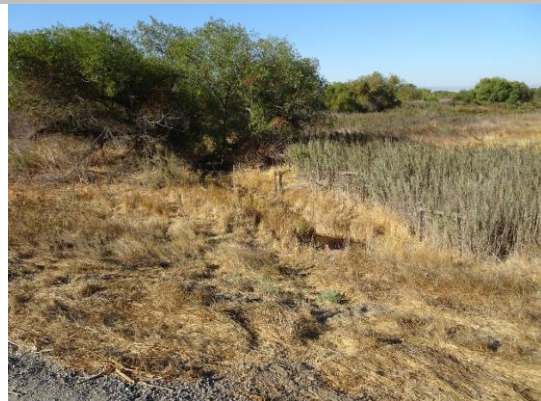
Photo 2 of 3 : UCIP_SP_2024_70658_90678.jpg

WS view: Pipe and flapgate visible at WS toe

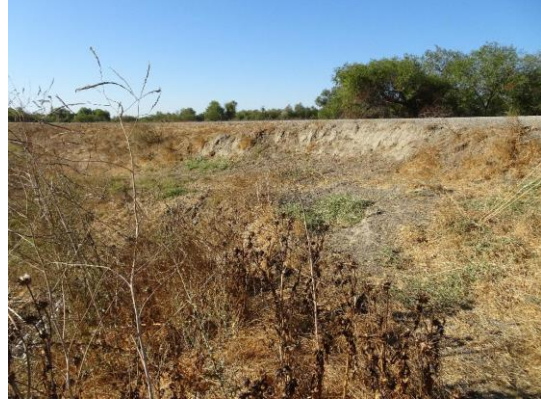
Photo 3 of 3 : UCIP_SP_2024_70658_90681.jpg

LS view: land movement/scarp of LS slope at levee crown

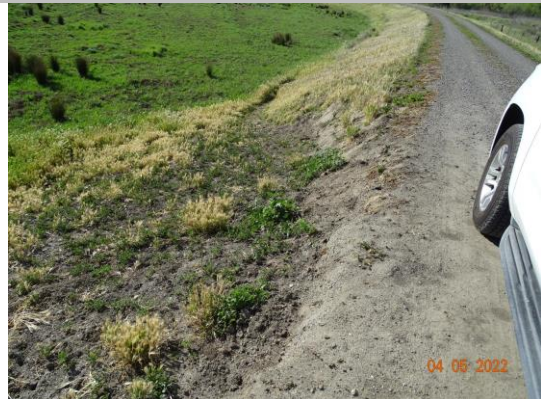
Photo 1 of 1 : SP_2024_NA0010_118_9_20240212_00003.jpg

LM Start	4.69	Rating **	M	Issue No.	9
LM End	4.69	Issue Type +	Ma	Location *	LS
Category	Earthen Levee			GPS Latitude/Longitude	
				Start	End
Item	Erosion / Livestock			37.302398°	37.302398°
				-120.920920°	-120.920920°
DWR ID	DWR_NA0010_01_s_2013_9				
Comment Code					
E4 : Repair the levee slope damaged by livestock and prevent large animal access.					
Inspector Comment					
Material used to repair the livestock damage in 2021 has eroded away.

View of damage to the landside slope from livestock. (Spring 2022)

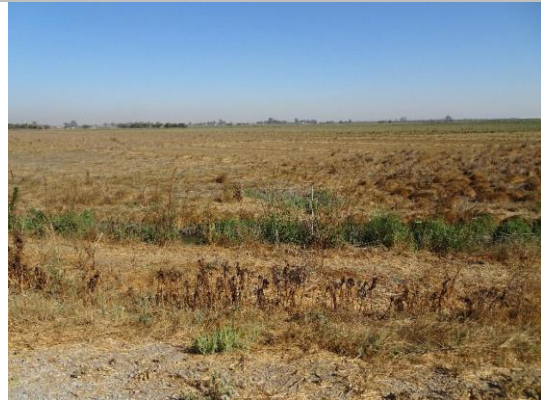
Photo 2 of 3 : UCIP_SP_2024_70659_90683.jpg

LS view: Pipe and headwall not visible at LS toe from levee crown

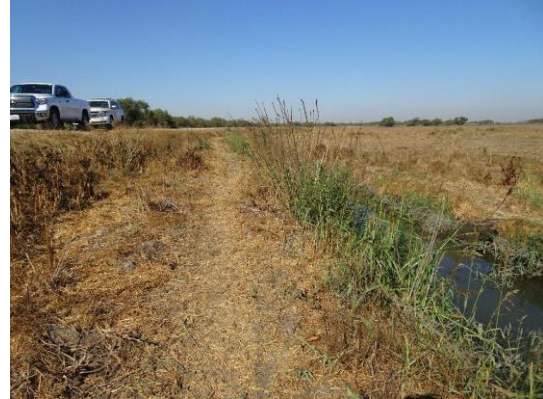
Photo 3 of 3 : UCIP_SP_2024_70659_90685.jpg

LS view: LS pipe and headwall not accessible/visible due to high vegetation

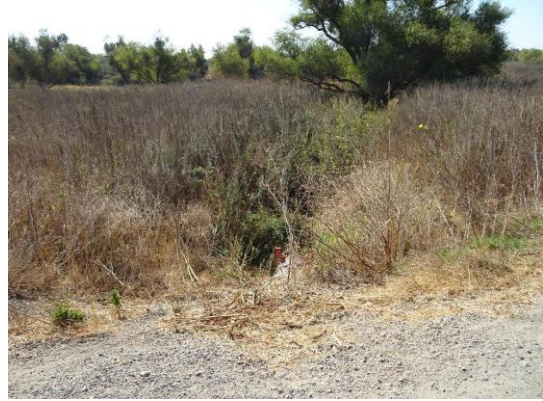
Photo 2 of 3 : UCIP_SP_2024_77850_90691.jpg

Comment Code					
Inspector Comment					
DS_ID:19611 FS_ID:77850 EP_NO: N/A Repair Type: Urgent EVAL Issue: 1, Pipe Integrity Crossing Status: Found UCIP Comments: 12/14/2022 Record updated from Non-Urgent to Urgent. DMP internal video inspection has found pipe integrity issues. LOF of crossing is between 5 and 6. Crossing will be monitored until funding becomes available to address the issues. (O.Yakimov - DWR UCIP) 10/20/2020 Record remains Non-Urgent. Depression observed across levee crown, less than 6 inches in depth. Pipe inlet located at the LS toe is completely blocked by soil. This crossing is non-functional. Recommend evaluating the purpose of this drainage structure. No permit was found authorizing this encroachment. CVFPB will need to review crossing to determine owner. DWR DMP internal inspection is pending and scheduled for 2021. Recommend reviewing DMP's internal inspection when completed to investigate reason for depression across the levee crown. (B. Singh - GEI, O. Magana - DWR UCIP)04/08/2014 Dense vegetation limits the inspector's visibility to identify signs of pipe failure (leaks) along waterward and landward slopes. Recommend removing vegetation along pipe alignment to conduct proper inspection of structure and appurtenances. Landward side filled in with soil. Need to contact owner. If crossing is no longer used need to coordinate with CVFPB for proper abandonment. (W. Wylie - DWR UCIP) FIELD_STRUCT_DESC: 24-inch corrugated metal (CM) gravity drainage pipe through the levee, 8.6 feet below the crown. Flap gate on the waterside (WS) end. Brass cap No. 90 bench mark (BM) on the headwall on the landside (LS). [Additional Reference(s): DWR Levee Log, 2002, (HLM 5.96). USACE San Joaquin O&M Manual, Unit No. 601, Part No. 1, (SJR601.1), 1967, Revised 25 May 2011, (HLM 5.95)]. FS Date: 10/20/2020 1:32:14 PM

WS view: Pipe and flapgate visible at WS toe

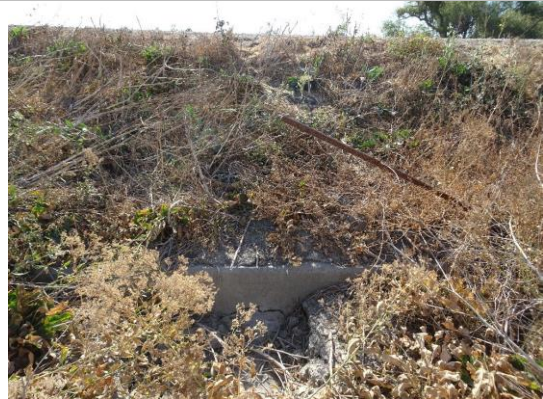
Photo 3 of 3 : UCIP_SP_2024_77850_90692.jpg

LS view: Headwall at LS toe. Pipe is completely blocked by heavy siltation at LS invert.
