**Flood Control Project Maintenance
Levee Inspections**

Maintenance Issue Types Only, Levee Inspection Report By Mile - Spring 2024

Lower San Joaquin Levee District

Waterway	Bank	Unit Miles	Inspection Start/End	Inspector
Unit No. 01 San Joaquin River	Right	22.52	03/12/2024 03/12/2024	Corey Fujitani

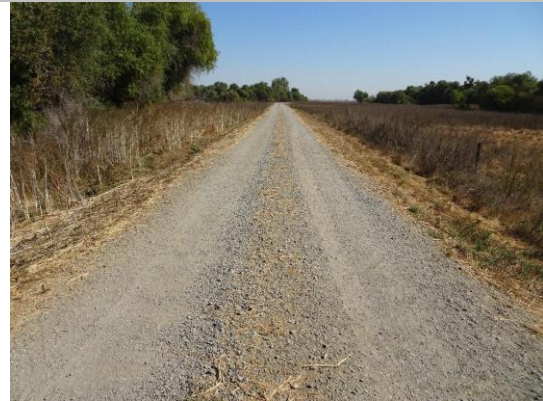
Photo 1 of 3 : UCIP_SP_2024_77851_90696.jpg

Comment Code					
Inspector Comment					
DS_ID:19612 FS_ID:77851 EP_NO: N/A Repair Type: Urgent EVAL Issue: 1, Pipe Integrity Crossing Status: Found UCIP Comments: 12/14/2022 Record updated from Non-Urgent to Urgent. DMP internal video inspection has found pipe integrity issues. LOF of crossing is between 5 and 6. Crossing will be monitored until funding becomes available to address the issues. (O.Yakimov - DWR UCIP) 10/20/2020 Record remains Non-Urgent. Scour is still present on both sides of the concrete LS headwall. Dense vegetation prevented updates on the scour progression along the LS slope. Recommend re-inspecting pipe when vegetation is removed. Unable to access to WS outlet due to wired fence. No permit was found authorizing this encroachment. CVFPB will need to review crossing to determine owner. DWR DMP internal inspection is pending and scheduled for 2021. (B. Singh - GEI, O. Magana - DWR UCIP)04/08/2014 Dense vegetation limits the inspector's visibility to identify signs of pipe failure (leaks) along waterward and landward slopes. Recommend removing vegetation along pipe alignment to conduct proper inspection of structure and appurtenances. Pipe completely blocked by soil on LS toe due to animal activity. Slide gate blocked open. (W. Wylie - DWR UCIP) FIELD_STRUCT_DESC: 48-inch corrugated metal (CM) gravity drainage pipe through the levee at an angle, 13.1 feet below the crown. Walkway to slide gate at the concrete headwall on the landside (LS) toe. Flap gate at the concrete headwall on the waterside (WS) toe. Brass cap No. 90 bench mark (BM) on the headwall on the LS. [Additional Reference(s): DWR Levee Log, 2002, (HLM 6.13). USACE San Joaquin O&M Manual, Unit No. 601, Part No. 1, (SJR601.1), 1967, Revised 25 May 2011, (HLM 6.13)]. FS Date: 10/20/2020 1:32:39 PM

Overview of levee crown, looking US

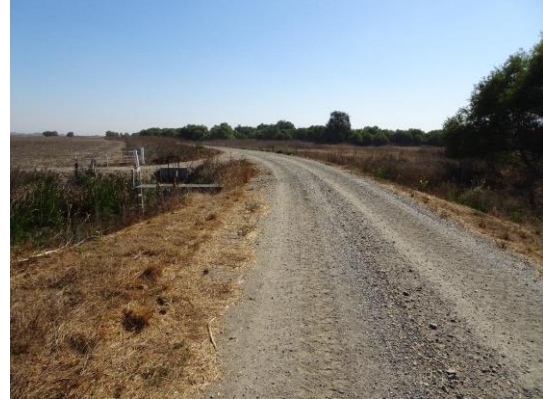
Photo 1 of 3 : UCIP_SP_2024_77852_90702.jpg

Comment Code					
Inspector Comment					
DS_ID:19613 FS_ID:77852 EP_NO: N/A Repair Type: Urgent EVAL Issue: 1, Pipe Integrity Crossing Status: Found UCIP Comments: 12/14/2022 Record updated from Non-Urgent to Urgent. DMP internal video inspection has found pipe integrity issues. LOF of crossing is between 5 and 6. Crossing will be monitored until funding becomes available to address the issues. (O.Yakimov - DWR UCIP) 10/20/2020 Record remains Non-Urgent. Dense vegetation on WS toe, recommend removal for proper inspection. Minor surface erosion visible on the LS toe near the standpipe. No permit was found authorizing this encroachment. CVFPB will need to review crossing to determine owner. DWR DMP internal inspection is pending and scheduled for 2021. (B. Singh - GEI, O. Magana - DWR UCIP)04/08/2014 Dense vegetation limits the inspector's visibility to identify signs of pipe failure (leaks) along the slope. Recommend removing vegetation along pipe alignment to conduct proper inspection of structure and appurtenances. (W. Wylie - DWR UCIP) FIELD_STRUCT_DESC: 24-inch corrugated metal (CM) gravity drainage pipe through the levee, 9.5 feet below the crown. Flap gate on the waterside (WS) end. Slide gate on the landside (LS) end next to a 48-inch concrete riser unit with walkway over the top. Brass cap No. 90 bench mark (BM) on the headwall on the LS. [Additional Reference(s): DWR Levee Log, 2002, (HLM 6.44). USACE San Joaquin O&M Manual, Unit No. 601, Part No. 1, (SJR601.1), 1967, Revised 25 May 2011, (HLM 6.40)]. FS Date: 10/20/2020 1:35:41 PM

Overview of levee crown, looking upstream

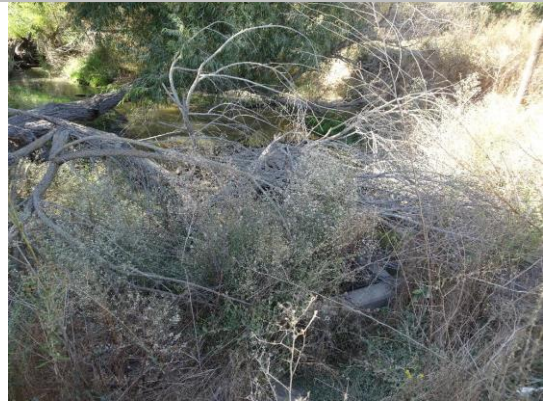
Photo 2 of 3 : UCIP_SP_2024_77852_90706.jpg

WS view: Inspection of WS headwall, pipe, and flapgate inhibited by dense vegetation

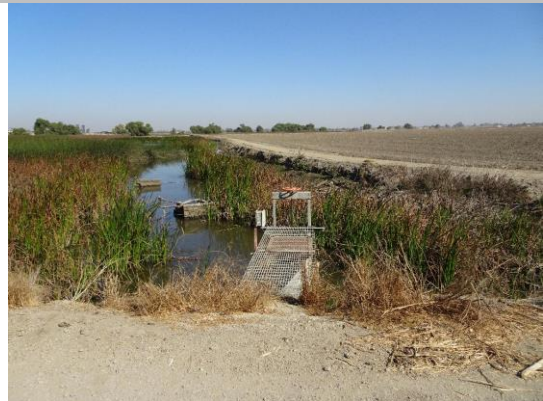
Photo 3 of 3 : UCIP_SP_2024_77852_90703.jpg

LS view: Metal walkway and slidegate visible on LS toe.

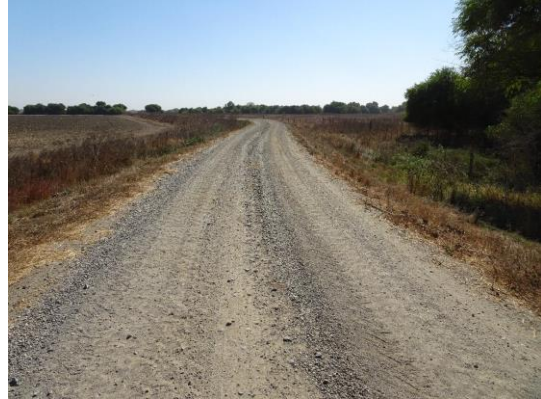
Photo 1 of 3 : UCIP_SP_2024_70663_90712.jpg

Comment Code					
Inspector Comment					
DS_ID:19614 FS_ID:70663 EP_NO: N/A Repair Type: Non-Urgent EVAL Issue: Crossing Status: Found UCIP Comments: 10/20/2020 Record remains Non-Urgent. Dense vegetation inhibits inspection of the pipe on the LS toe, and both slopes. No permit was found authorizing this encroachment. CVFPB will need to review crossing to determine owner. DWR DMP internal inspection is pending and scheduled for 2021. (B. Singh - GEI, O. Magana - DWR UCIP)7/19/2016 Same as previous inspection. Outlet and inlet are under water. (O. Magana - DWR UCIP)4/08/2014 Flapgate blocked by sedimentation at WS toe. Dense vegetation limits the inspector's visibility to identify signs of pipe failure (leaks) along the slope. Recommend removing vegetation along pipe alignment to conduct proper inspection of structure and appurtenances. Also recommend clearing vegetation from both waterward and landward toe. (W. Wylie - DWR UCIP) FIELD_STRUCT_DESC: 24-inch corrugated metal (CM) gravity drainage pipe through the levee, 9.8 feet below the crown. Wooden fence around a 4-foot by 4-foot drop inlet on the landside (LS) toe. Flap gate on the waterside (WS) end. Brass cap No. 90 bench mark (BM) on the headwall on the LS. [Additional Reference(s): DWR Levee Log, 2002, (HLM 6.65). USACE San Joaquin O&M Manual, Unit No. 601, Part No. 1, (SJR601.1), 1967, Revised 25 May 2011, (HLM 6.64)]. FS Date: 10/20/2020

Overview of levee crown, looking US

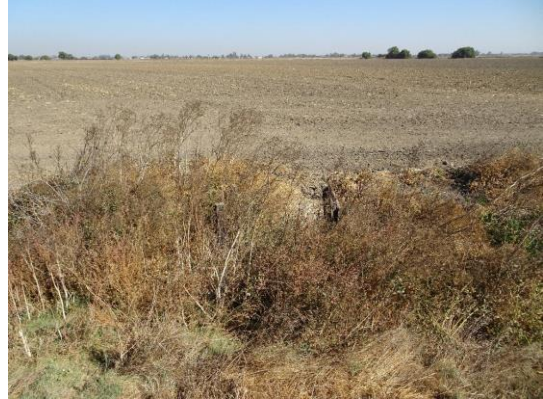
Photo 2 of 3 : UCIP_SP_2024_70663_90713.jpg

LS view: Dense vegetation on LS limiting view of wooden barrier around drop-inlet.

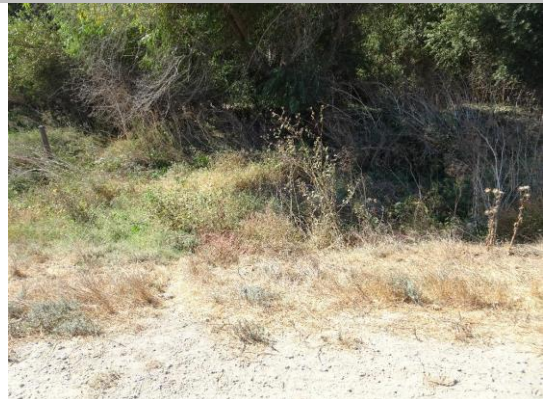
Photo 3 of 3 : UCIP_SP_2024_70663_90708.jpg

WS view: Pipe and flapgate at WS toe not visible from levee crown due to dense vegetation

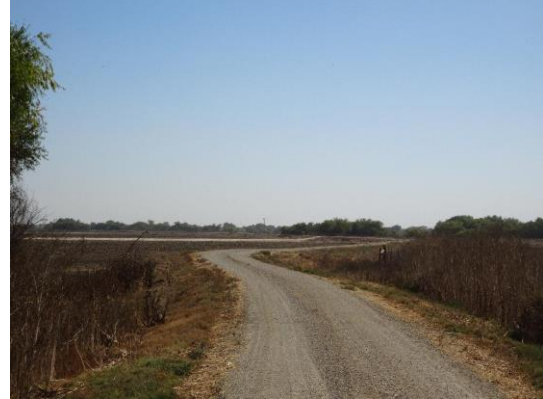
Photo 1 of 3 : UCIP_SP_2024_70664_90726.jpg

DS_ID:19615
 FS_ID:70664
 EP_NO: N/A
 Repair Type: Urgent
 EVAL Issue: 1, Pipe Integrity
 Crossing Status: Found
 UCIP Comments: 10/20/2020 Record has been updated from Non-Urgent to Urgent. Heavy corrosion present with visible holes found at the WS outlet near flap gate. Surface erosion present on the LS slope just upstream of slide gate. Evidence of surface erosion on the WS slope (vertical slope) was present approximately 15 feet downstream of the pipe. Plastic sheeting has been placed to prevent further erosion by LMA (assumed). Recommend notifying DWR Levee Inspector to monitor progress of surface erosion on the WS. No permit was found authorizing this encroachment. CVFPB will need to review crossing to determine owner. DWR DMP internal inspection is pending and scheduled for 2021. (B. Singh - GEI, O. Magana - DWR UCIP)07/19/2016 Potential LS slope damage--difficult to determine due to dense vegetation. Limited access on WS toe due to wire fence. (O. Magana - DWR UCIP)04/08/2014 Slide gate blocked by debris at LS toe. Flapgate won't close because of debris. Dense vegetation limits the inspector's visibility to identify signs of pipe failure (leaks) along the slope. Recommend removing vegetation along pipe alignment to conduct proper inspection of structure and appurtenances. (W. Wylie - DWR UCIP)

Overview of levee crown, looking US

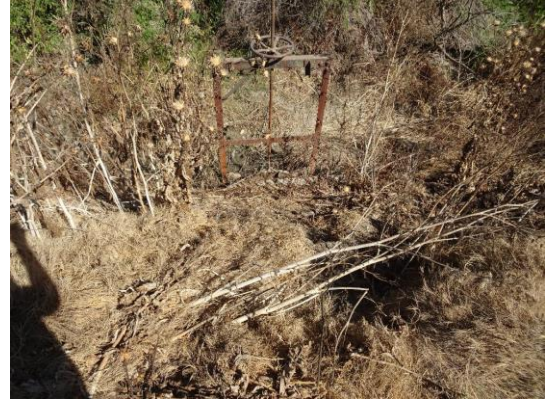
Photo 2 of 3 : UCIP_SP_2024_70664_90728.jpg

LS view: Surface erosion above LS headwall

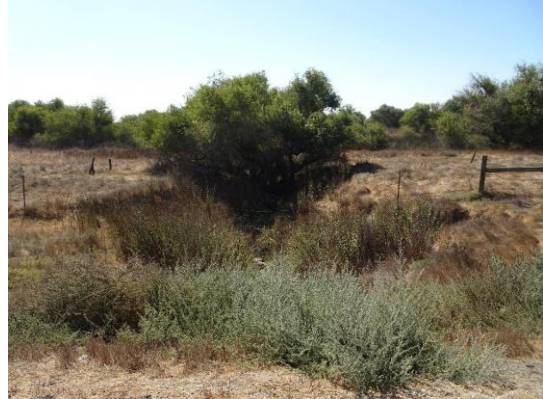
Photo 2 of 3 : UCIP_SP_2024_70665_90717.jpg

WS view: Pipe and flapgate at WS toe not visible from levee crown due to vegetation.

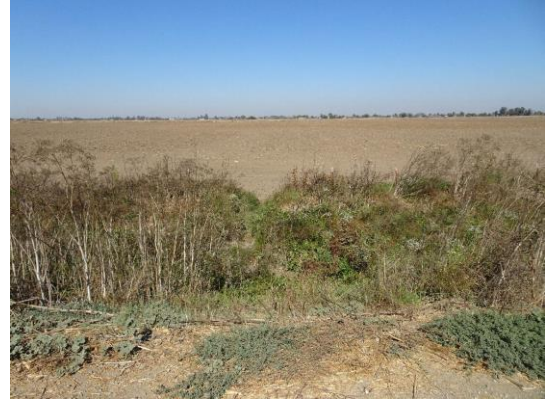
Photo 2 of 3 : UCIP_SP_2024_83244_90739.jpg

LS view: Headwall not visible at LS toe from levee crown due to vegetation

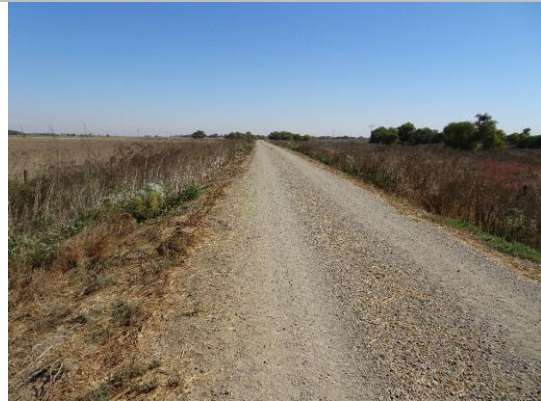
Photo 1 of 3 : UCIP_SP_2024_70668_90744.jpg

Comment Code						
Inspector Comment						
DS_ID:19619 FS_ID:70668 EP_NO: N/A Repair Type: Urgent EVAL Issue: 2b, Levee Integrity Crossing Status: Found UCIP Comments: 12/20/2022 Record remains Urgent. Pipe has been CIPP-lined. LOF of crossing is less or equal to 4. Recommend next video inspection in 5 years. Sloughing on the LS slope above headwall needs to be addressed. (O.Yakimov - DWR UCIP) 10/20/2020 Record has been updated from Non-Urgent to Urgent. Sloughing observed on the LS slope above headwall. DWR DMP has found integrity issues, LOF between 5 and 6. Crossing will be monitored until funding becomes available to address. No permit was found authorizing this encroachment. CVFPB will need to review crossing to determine owner. (B. Singh - GEI, O. Magana - DWR UCIP) 04/08/2014 Dense vegetation limits the inspector's visibility to identify signs of pipe failure (leaks) along the slope. Recommend removing vegetation along pipe alignment to conduct proper inspection of structure. (W. Wylie - DWR UCIP) FIELD_STRUCT_DESC: 24-inch CIPP-lined corrugated metal (CM) gravity drainage pipe through the levee, 10.0 feet below the crown. Flap gate on the waterside (WS) end. Brass cap No. 80 bench mark (BM) on the headwall on the landside (LS). [Additional Reference(s): DWR Levee Log, 2002, (HLM 7.70). USACE San Joaquin O&M Manual, Unit No. 601, Part No. 1, (SJR601.1), 1967, Revised 25 May 2011, (HLM 7.69)]. FS Date: 10/20/2020

Overview of levee crown, looking US

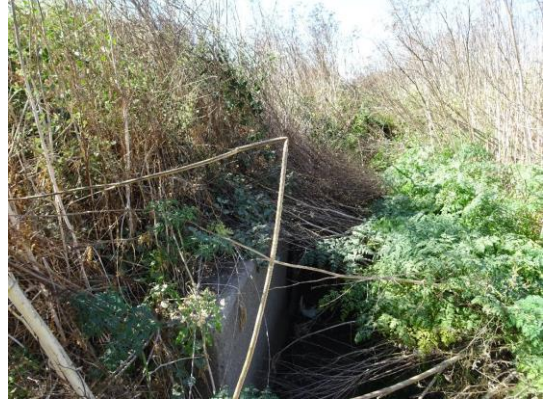
Photo 2 of 3 : UCIP_SP_2024_70668_90747.jpg

LS view: Headwall at LS toe. Dense vegetation blocking view

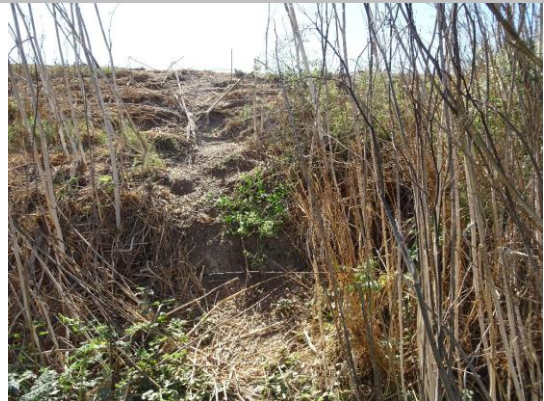
Photo 3 of 3 : UCIP_SP_2024_70668_90749.jpg

LS view: Sloughing above headwall and pipe on LS slope

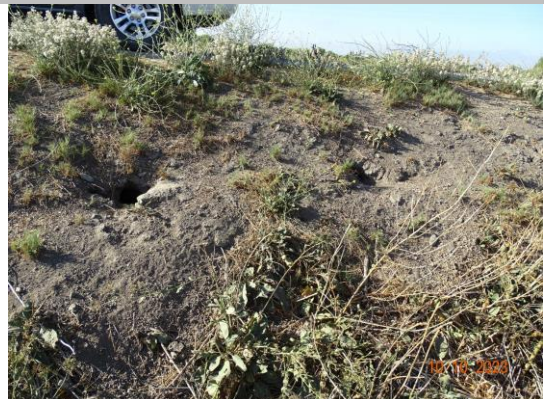
Photo 1 of 1 : SP_2024_NA0010_118_125_20240212_00023.jpg

LM Start	7.69	Rating **	M	Issue No.	125
LM End	7.69	Issue Type +	Ma	Location *	LS
Category	Earthen Levee			GPS Latitude/Longitude	
				Start	End
Item	Animal Control			37.299051°	37.299051°
				-120.873720°	-120.873720°
DWR ID	DWR_NA0010_01_f_2023_125				
Comment Code					
A3 : No rodents visible, but rodent burrows visible; need to backfill and compact or grout burrows.					
Inspector Comment

View of rodent holes in the landside slope. (Fall 2023)

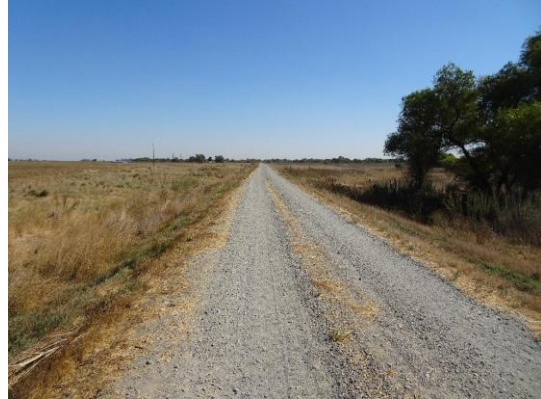
Photo 1 of 3 : UCIP_SP_2024_70669_90750.jpg

Comment Code					
Inspector Comment					
DS_ID:19620 FS_ID:70669 EP_NO: N/A Repair Type: No Action Needed EVAL Issue: Crossing Status: Found UCIP Comments: 09/15/2023 Record updated from Non-Urgent to No Action Needed. Pipe was CIPP lined. DMP internal video inspection has found none or minor pipe defects. Recommend next video inspection in 5 years. (O. Yakimov - DWR UCIP) 10/20/2020 Record remains Non-Urgent. DWR DMP has found integrity issues, LOF between 4 and 5. Corrosion in pipe visible on the LS toe. Crossing will be monitored until funding becomes available for rehabilitation. No permit was found authorizing this encroachment. CVFPB will need to review crossing to determine owner. (B. Singh - GEI, O. Magana - DWR UCIP)04/09/2014 Dense vegetation limits the inspector's visibility to identify signs of pipe failure (leaks) along the slope. Recommend removing vegetation along pipe alignment to conduct proper inspection of structure. (W. Wylie - DWR UCIP) FIELD_STRUCT_DESC: 24-inch CIPP-lined corrugated metal (CM) gravity drainage pipe through the levee, 8.0 feet below the crown. Flap gate on the waterside (WS) end. Brass cap No. 80 bench mark (BM) on the headwall on the landside (LS). [Additional Reference(s): DWR Levee Log, 2002, (HLM 8.09). USACE San Joaquin O&M Manual, Unit No. 601, Part No. 1, (SJR601.1), 1967, Revised 25 May 2011, (HLM 8.07)]. FS Date: 10/20/2020

Overview of levee crown, looking US

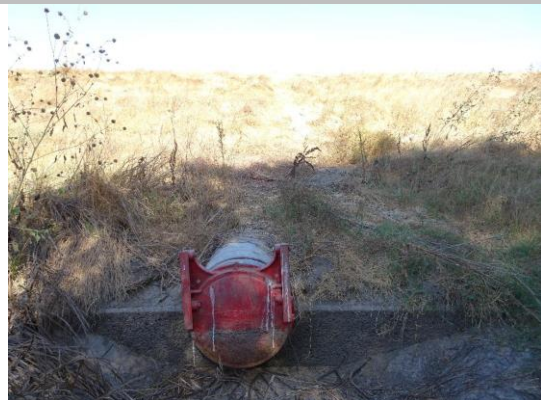
Photo 2 of 3 : UCIP_SP_2024_70669_90755.jpg

Pipe, flapgate, and headwall at WS toe

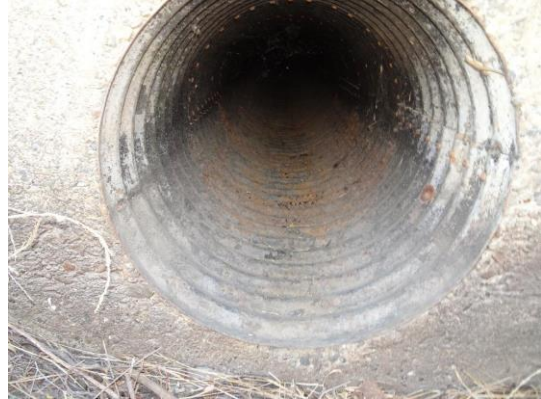
Photo 3 of 3 : UCIP_SP_2024_70669_90753.jpg

Headwall and pipe at LS toe. Visible corrosion in pipe.

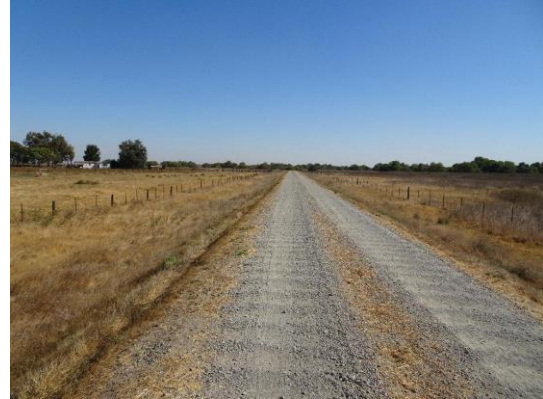
Photo 1 of 3 : UCIP_SP_2024_70670_90757.jpg

Comment Code						
Inspector Comment						
DS_ID:19621 FS_ID:70670 EP_NO: N/A Repair Type: No Action Needed EVAL Issue: Crossing Status: Found UCIP Comments: 09/15/2023 Record updated from Non-Urgent to No Action Needed. Pipe was CIPP lined. DMP internal video inspection has found none or minor pipe defects. Recommend next video inspection in 5 years. (O. Yakimov - DWR UCIP) 10/20/2020 Record remains Non-Urgent. DWR DMP has found integrity issues, LOF between 4 and 5. Crossing will be monitored until funding becomes available for rehabilitation. No permit was found authorizing this encroachment. CVFPB will need to review crossing to determine owner. (B. Singh - GEI, O. Magana - DWR UCIP)04/09/2014 Dense vegetation limits the inspector's visibility to identify signs of pipe failure (leaks) along the slope. Recommend removing vegetation along pipe alignment to conduct proper inspection of structure. Sediment buildup at landward toe. (W. Wylie - DWR UCIP) FIELD_STRUCT_DESC: 24-inch CIPP-lined corrugated metal (CM) gravity drainage pipe through the levee, 9.5 feet below the crown. Flap gate on the waterside (WS) end. Brass cap No. 80 bench mark (BM) on the headwall on the landside (LS). [Additional Reference(s): DWR Levee Log, 2002, (HLM 8.43). USACE San Joaquin O&M Manual, Unit No. 601, Part No. 1, (SJR601.1), 1967, Revised 25 May 2011, (HLM 8.41)]. FS Date: 10/20/2020

Overview of levee crown, looking US

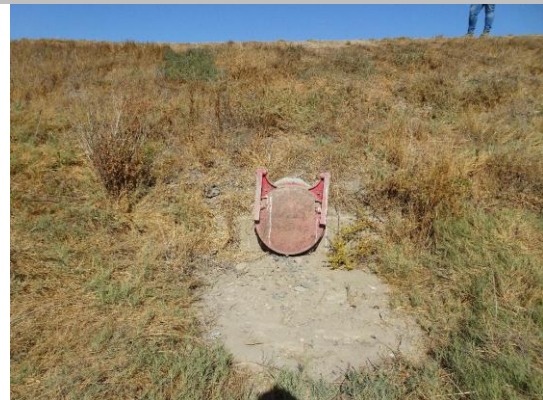
Photo 2 of 3 : UCIP_SP_2024_70670_90756.jpg

WS view: Pipe, flapgate, and headwall at WS toe

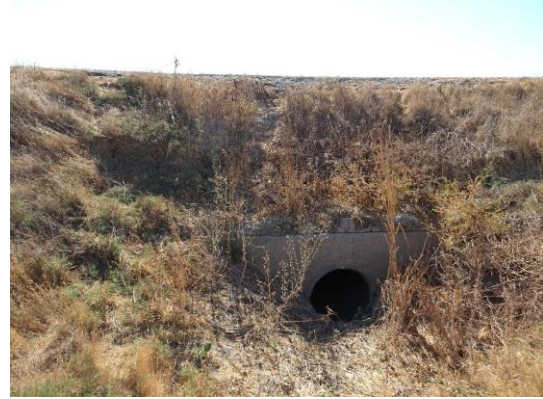
Photo 3 of 3 : UCIP_SP_2024_70670_90762.jpg

LS view: Pipe, headwall, and slope from LS toe

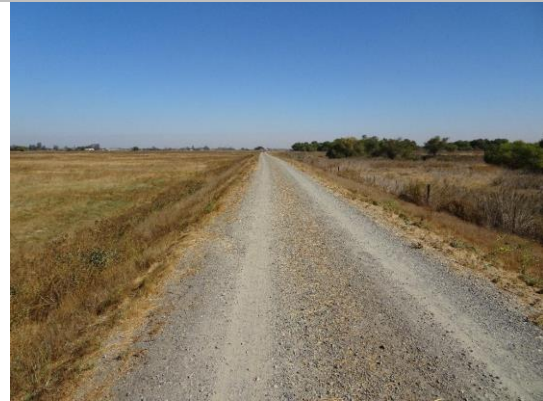
Photo 1 of 3 : UCIP_SP_2024_70672_90770.jpg

Comment Code						
Inspector Comment						
DS_ID:19622 FS_ID:70672 EP_NO: N/A Repair Type: Non-Urgent EVAL Issue: Crossing Status: Found UCIP Comments: 10/20/2020 Record has been updated from No Action Needed to Non-Urgent. Large burrow hole observed approximately 100 feet downstream of the pipe, on LS shoulder of the levee crown. No permit was found authorizing this encroachment. CVFPB will need to review crossing to determine owner. DWR DMP has not found internal issues, LOF between 1 and 2. Recommend inspection in 5 years. (B. Singh - GEI, O. Magana - DWR UCIP) FIELD_STRUCT_DESC: 24-inch corrugated metal (CM) gravity drainage pipe through the levee, 9.0 feet below the crown. Flap gate on the waterside (WS) end. Brass cap No. 80 bench mark (BM) on the headwall on the landside (LS). [Additional Reference(s): DWR Levee Log, 2002, (HLM 8.62). USACE San Joaquin O&M Manual, Unit No. 601, Part No. 1, (SJR601.1), 1967, Revised 25 May 2011, (HLM 8.61)]. FS Date: 10/20/2020

Overview of levee crown, looking US

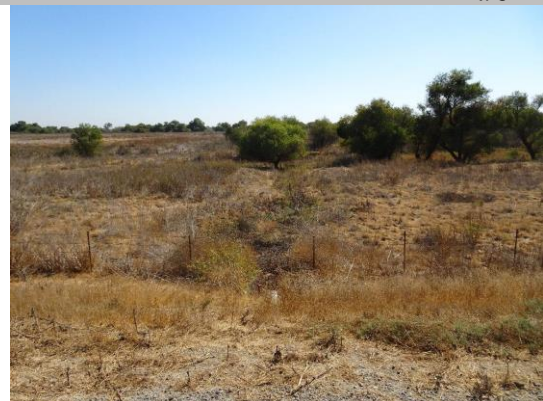
Photo 2 of 3 : UCIP_SP_2024_70672_90772.jpg

WS view: Pipe and flapgate visible on WS toe

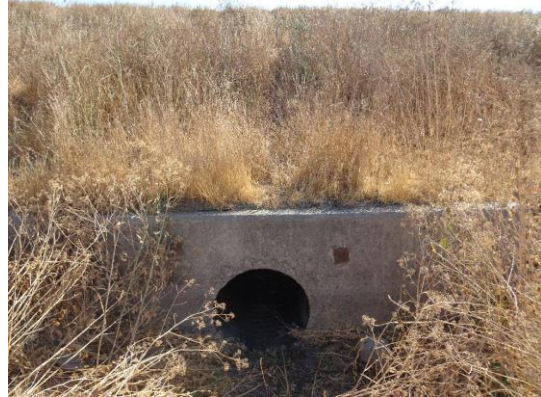
Photo 3 of 3 : UCIP_SP_2024_70672_90773.jpg

LS view: Pipe and headwall on LS toe

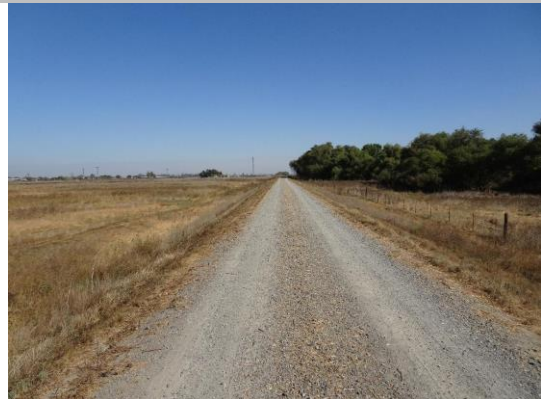
Photo 1 of 3 : UCIP_SP_2024_83245_90778.jpg

DS_ID:19623
 FS_ID:83245
 EP_NO: N/A
 Repair Type: No Action Needed
 EVAL Issue:
 Crossing Status: Found
 UCIP Comments: 04/23/2024 Record updated from Non-Urgent to No Action Needed. DMP internal video inspection has found none or minor pipe defects. (M. Thao - DWR UCIP)
 10/20/2020 Record remains Non-Urgent. No permit was found authorizing this encroachment. CVFPB will need to review crossing to determine owner. DWR DMP has not found internal issues, LOF between 1 and 2. Recommend inspection in 5 years. (B. Singh - GEI, O. Magana - DWR UCIP)
 04/09/2014 Dense vegetation limits the inspector's visibility to identify signs of pipe failure (leaks) along the slope. Recommend removing vegetation along pipe alignment to conduct proper inspection of structure. (W. Wylie - DWR UCIP)
 FIELD_STRUCT_DESC: 24-inch corrugated metal (CM) gravity drainage pipe through the levee, 9.1 feet below the crown. Flap gate on the waterside (WS) end. Brass cap No. 80 bench mark (BM) on the headwall on the landside (LS). [Additional Reference(s): DWR Levee Log, 2002, (HLM 8.95). USACE San Joaquin O&M, Unit No. 601, Part No. 1, (SJR601.1), 1967, Revised 25 May 2011, (HLM 8.93)].

Overview of levee crown, looking US

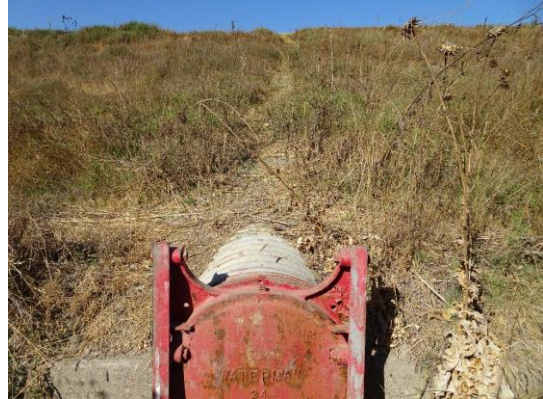
Photo 2 of 3 : UCIP_SP_2024_83245_90777.jpg

WS view: Pipe, flapgate, headwall, and slope at WS toe

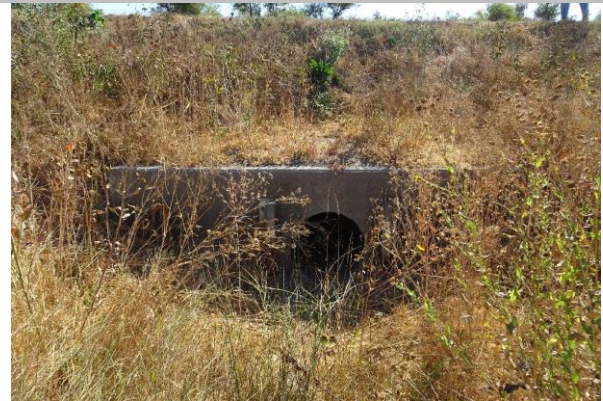
Photo 3 of 3 : UCIP_SP_2024_83245_90781.jpg

LS view: Pipe, headwall, and slope at LS toe

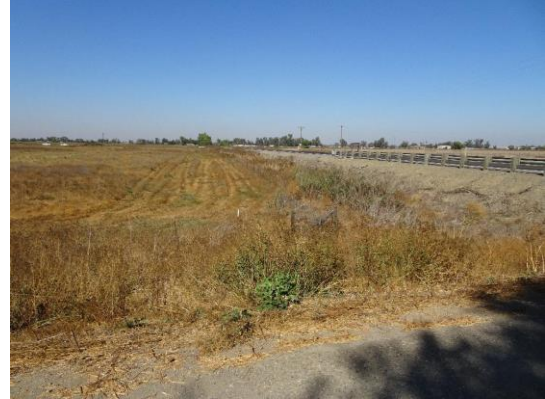
Photo 1 of 3 : UCIP_SP_2024_70675_90789.jpg

Comment Code					
Inspector Comment					
DS_ID:19625 FS_ID:70675 EP_NO: N/A Repair Type: Non-Urgent EVAL Issue: Crossing Status: Found UCIP Comments: 10/20/2020 Record remains Non-Urgent. As in previous inspection, dense vegetation inhibited proper inspection of the pipe and slope. No permit was found authorizing this encroachment. CVFPB will need to review crossing to determine owner. DWR DMP internal inspection is pending and scheduled for 2021. (B. Singh - GEI, O. Magana - DWR UCIP)04/09/2014 Dense vegetation limits the inspector's visibility to identify signs of pipe failure (leaks) along the slope. Recommend removing vegetation along pipe alignment to conduct proper inspection of structure. Some sediment buildup in pipe. (W. Wylie - DWR UCIP) FIELD_STRUCT_DESC: 36-inch corrugated metal (CM) gravity drainage pipe through the levee, 10.0 feet below the crown. Flap gate on the waterside (WS) end. Brass cap No. 80 bench mark (BM) on the headwall on the landside (LS). [Additional Reference(s): DWR Levee Log, 2002, (HLM 9.01). USACE San Joaquin O&M Manual, Unit No. 601, Part No. 1, (SJR601.1), 1967, Revised 25 May 2011, (HLM 9.00)]. FS Date: 10/20/2020

LS view: View toward LS toe. Headwall not visible due to high vegetation.

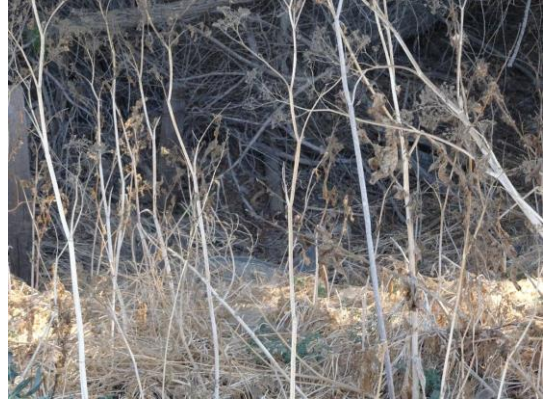
Photo 3 of 3 : UCIP_SP_2024_70675_92420.jpg

WS view: pipe visible through dense vegetation.

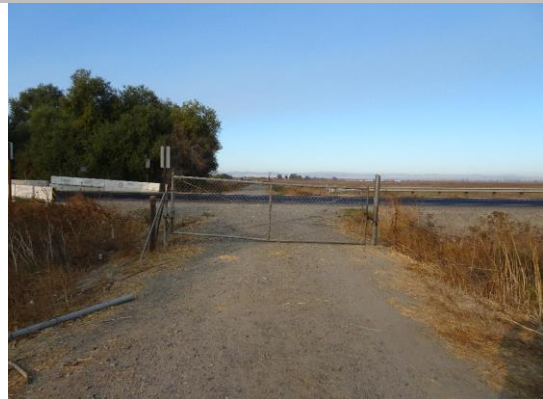
Photo 1 of 3 : UCIP_SP_2024_70676_90906.jpg

DS_ID:19626
FS_ID:70676
EP_NO: N/A
Repair Type: Non-Urgent
EVAL Issue:
Crossing Status: Found
UCIP Comments: 10/21/2020 Record remains Non-Urgent. Dense vegetation inhibited proper inspection of pipe condition. No permit was found authorizing this encroachment. CVFPB will need to review crossing to determine owner. DWR DMP internal inspection is pending and scheduled for 2021. (B. Singh - GEI, O. Magana - DWR UCIP)04/09/2014 Dense vegetation limits the inspector's visibility to identify signs of pipe failure (leaks) along the slope. Recommend removing vegetation along pipe alignment to conduct proper inspection of structure. (W. Wylie - DWR UCIP)
FIELD_STRUCT_DESC: 24-inch corrugated metal (CM) gravity drainage pipe through the levee, 10.0 feet below the crown. Flap gate on the waterside (WS) end. Brass cap No. 80 bench mark (BM) on the headwall on the landside (LS). [Additional Reference(s): DWR Levee Log, 2002, (HLM 9.03). USACE San Joaquin O&M Manual, Unit No. 601, Part No. 1, (SJR601.1), 1967, Revised 25 May 2011, (HLM 9.03)].

Overview of levee crown looking downstream.

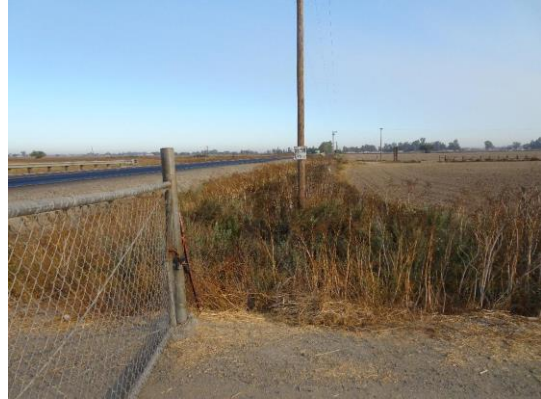
Photo 2 of 3 : UCIP_SP_2024_70676_90907.jpg

LS view: overview of LS

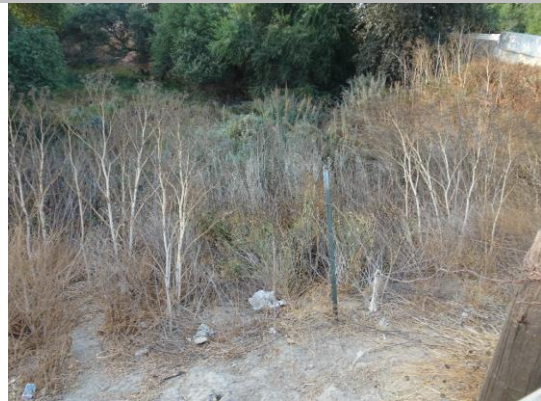
Photo 3 of 3 : UCIP_SP_2024_70676_90909.jpg

WS view: overview of WS

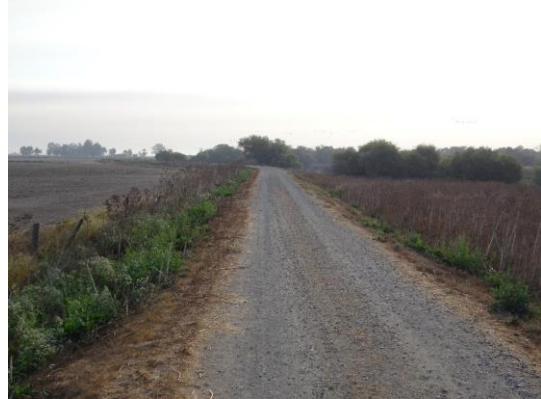
Photo 1 of 3 : UCIP_SP_2024_83466_90910.jpg

Comment Code						
Inspector Comment						
DS_ID:19627 FS_ID:83466 EP_NO: N/A Repair Type: Non-Urgent EVAL Issue: 6, Levee Damage or Threat for Levee Damage Crossing Status: Found UCIP Comments: 12/20/2022 Record updated from Urgent to Non-Urgent. Pipe has been CIPP-lined. LOF of crossing is less or equal to 4. Recommend next video inspection in 5 years. (O.Yakimov - DWR UCIP) 10/21/2020 Record has been updated from Non-Urgent to Urgent. DWR DMP has found integrity issues, LOF between 5 and 6. Scouring observed about 2 feet downstream of pipe at WS toe. Crossing will be monitored until funding becomes available to address. No permit was found authorizing this encroachment. CVFPB will need to review crossing to determine owner. (B. Singh - GEI, O. Magana - DWR UCIP)04/09/2014 Dense vegetation limits the inspector's visibility to identify signs of pipe failure (leaks) along the slope. Recommend removing vegetation along pipe alignment to conduct proper inspection of structure. (W. Wylie - DWR UCIP) FIELD_STRUCT_DESC: 24-inch CIPP-lined corrugated metal (CM) gravity drainage pipe through the levee, 8.6 feet below the crown. Concrete drop inlet at the landside (LS) toe. Flap gate on the waterside (WS) end. Brass cap No. 80 bench mark (BM) on the headwall on the LS. [Additional Reference(s): DWR Levee Log, 2002, (HLM 9.39). USACE San Joaquin O&M Manual, Unit No. 601, Part No. 1, (SJR601.1), 1967, Revised 25 May 2011, (HLM 9.37)]. FS Date: 10/21/2020 8:59:04 AM

Overview of levee crown

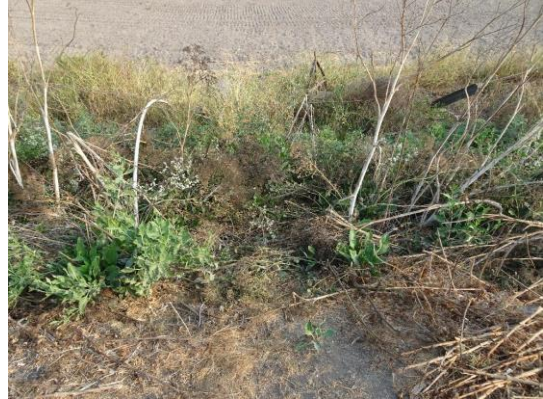
Photo 2 of 3 : UCIP_SP_2024_83466_90911.jpg

LS view: View of LS slope from levee crown

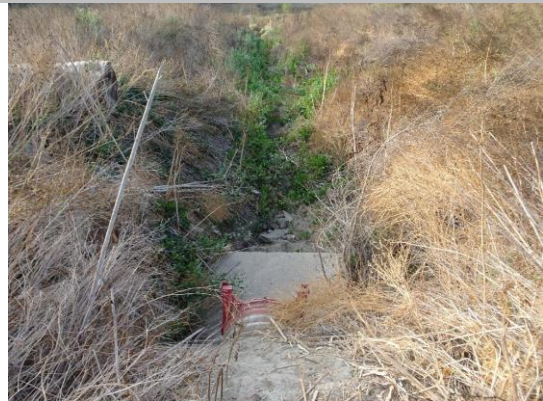
Photo 3 of 3 : UCIP_SP_2024_83466_90914.jpg

WS view: Pipe and flapgate at WS toe

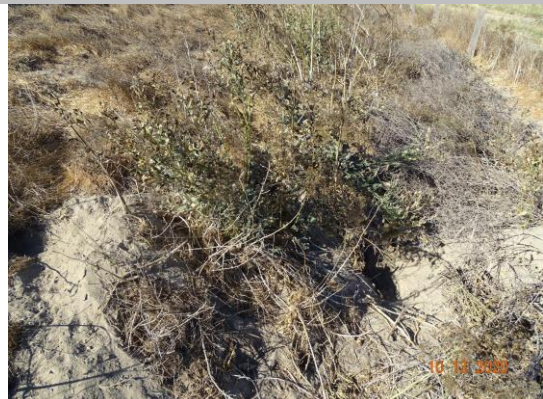
Photo 1 of 1 : SP_2024_NA0010_118_101_20240212_00007.jpg

LM Start	9.56	Rating **	M	Issue No.	101
LM End	9.56	Issue Type +	Ma	Location *	LS
Category	Earthen Levee			GPS Latitude/Longitude	
				Start	End
Item	Animal Control			37.295541°	37.295541°
				-120.841739°	-120.841739°
DWR ID	DWR_NA0010_01_f_2020_101				
Comment Code					
A1 : Exterminate rodents and backfill and compact or grout burrows.					
Inspector Comment

Rodent burrows in the landside slope. (Fall 2020)

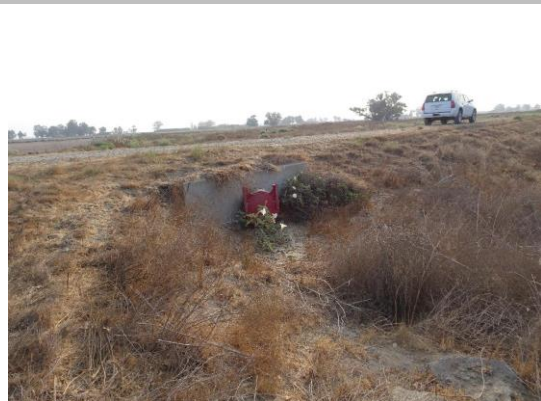
Photo 2 of 3 : UCIP_SP_2024_70678_90917.jpg

WS view: Pipe, flapgate, and headwall at WS toe

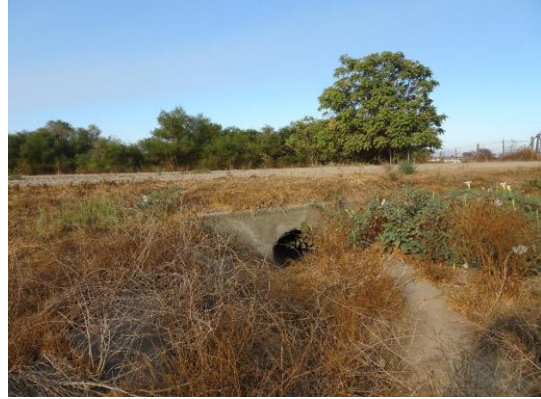
Photo 3 of 3 : UCIP_SP_2024_70678_90920.jpg

LS view: Pipe and headwall at LS toe

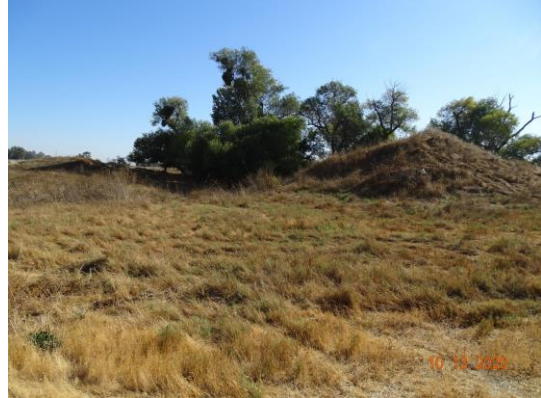
Photo 1 of 1 : SP_2024_NA0010_118_112_20240212_00013.jpg

LM Start	9.89	Rating **	A/W	Issue No.	112
LM End	9.90	Issue Type +	Ma	Location *	CR
Category	Earthen Levee			GPS Latitude/Longitude	
				Start	End
Item	Crown Surface / Depressions / Rutting			37.291796°	37.291581°
				-120.839497°	-120.839718°
DWR ID	DWR_NA0010_01_f_2017_112				
Comment Code					
C1 : Add appropriate material and re-grade the levee to bring the crown above the design elevation.					
Inspector Comment					
Landowner degraded levee in the 1970's because water on LS was flooding his property. Landowner has prevented efforts to restore levee. LMA has stated that no water from the waterside of the levee has ever backed up through the degraded levee and caused flooding.

Looking east at the levee breach. (Fall 2020)

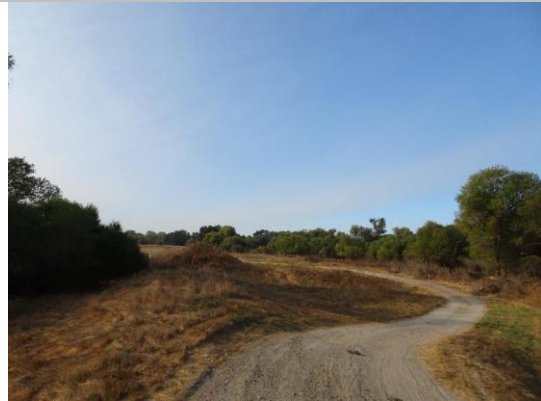
Photo 1 of 3 : UCIP_SP_2024_70680_91045.jpg

Comment Code						
Inspector Comment						
DS_ID:19556 FS_ID:70680 EP_NO: N/A Repair Type: Non-Urgent EVAL Issue: Crossing Status: Indicator Found UCIP Comments: 10/21/2020 Record has been updated from No Action Needed to Non-Urgent. No levee present at this location. This crossing was identified as a System Feature. Pipe not found by visual inspection, only two culverts at grade in the WS. (B. Singh - GEI, O. Magana - DWR UCIP) FIELD_STRUCT_DESC: 24-inch corrugated metal (CM) gravity drainage pipe through the levee, 6.0 feet below the crown. Flap gate on the waterside (WS) end. Brass cap No. 70 bench mark (BM) on the headwall on the landside (LS). [Additional Reference(s): DWR Levee Log, 2002, (HLM 9.91). USACE San Joaquin O&M Manual, Unit No. 601, Part No. 1, (SJR601.1), 1967, Revised 25 May 2011, (HLM 9.93)]. FS Date: 10/21/2020

Overview of area looking upstream at levee breach.

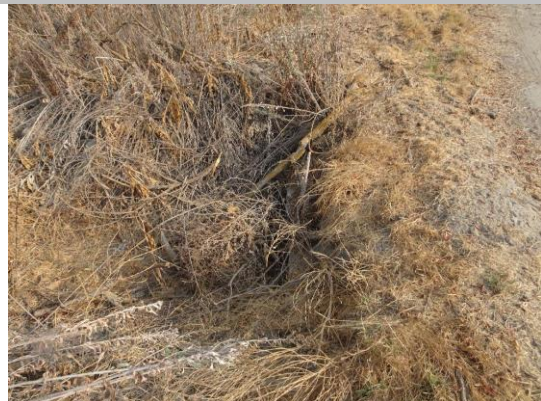
Photo 2 of 3 : UCIP_SP_2024_70680_91047.jpg

Culverts underneath access road visible on WS

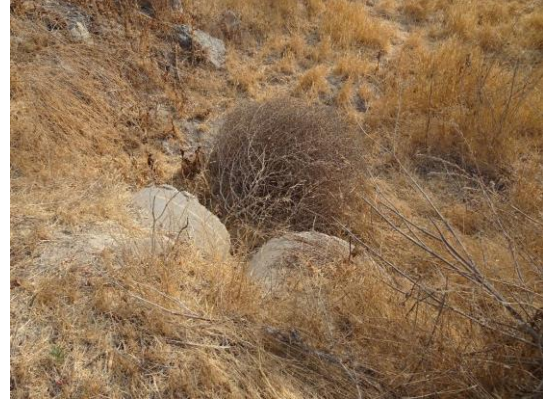
Photo 3 of 3 : UCIP_SP_2024_70680_91049.jpg

Culverts visible past access road.

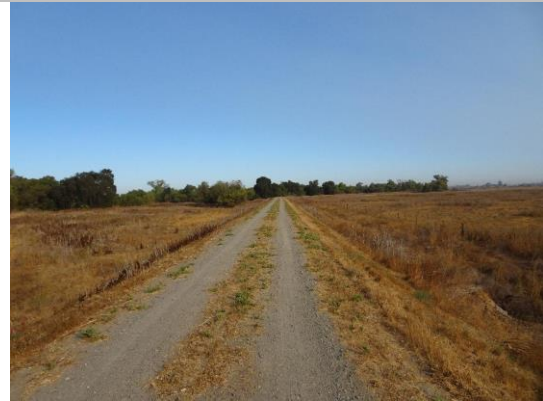
Photo 1 of 3 : UCIP_SP_2024_83246_90922.jpg

Comment Code						
Inspector Comment						
DS_ID:19629 FS_ID:83246 EP_NO: N/A Repair Type: No Action Needed EVAL Issue: Crossing Status: Found UCIP Comments: 04/23/2024 Record updated from Non-Urgent to No Action Needed. DMP internal video inspection has found none or minor pipe defects. (M. Thao - DWR UCIP) 10/21/2020 Record remains Non-Urgent. No permit was found authorizing this encroachment. CVFPB will need to review crossing to determine owner. DWR DMP has not found internal issues, LOF between 1 and 2. Recommend inspection in 5 years. (B. Singh - GEI, O. Magana - DWR UCIP) 04/09/2014 Dense vegetation blocks waterward and landward toes Recommend removing vegetation from both toes. Also sediment buildup in pipe visible from landward side. (W. Wylie - UCIP DMP) FIELD_STRUCT_DESC: 24-inch corrugated metal (CM) gravity drainage pipe through the levee, 9.0 feet below the crown. Flap gate on the waterside (WS) end. Brass cap No. 69 bench mark (BM) on the headwall on the landside (LS). [Additional Reference(s): DWR Levee Log, 2002, (HLM 10.24). USACE San Joaquin O&M Manual, Unit No. 601, Part No. 1, (SJR601.1), 1967, Revised 25 May 2011, (HLM 10.23)]. FS Date: 10/21/2020

Overview of levee crown

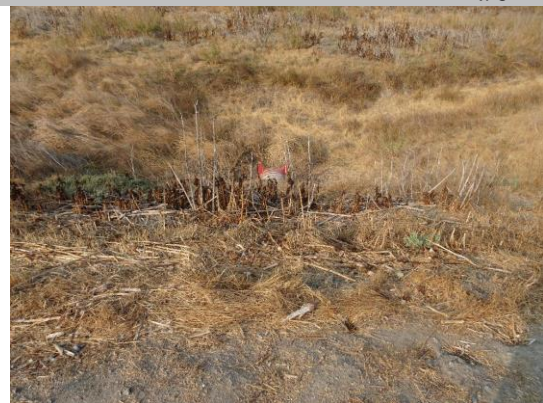
Photo 2 of 3 : UCIP_SP_2024_83246_90923.jpg

WS view: Pipe and flapgate visible at WS toe

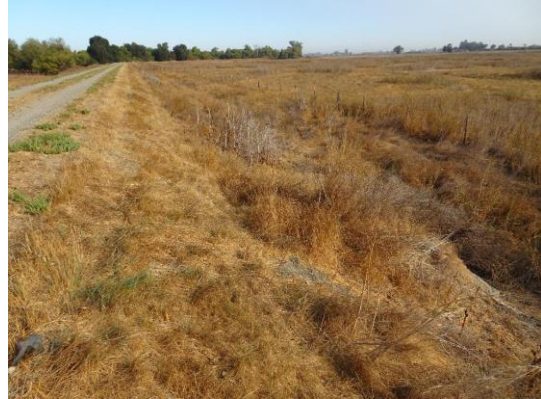
Photo 3 of 3 : UCIP_SP_2024_83246_90925.jpg

LS view: LS toe and pipe headwall

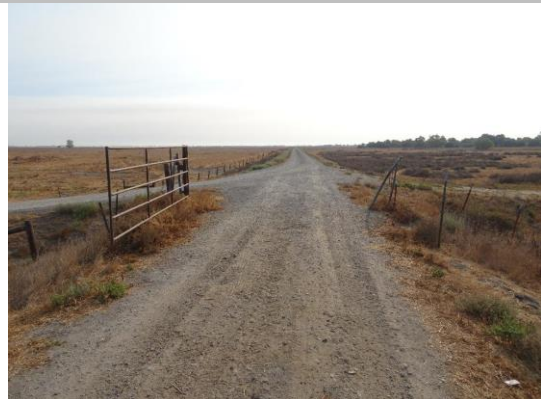
Photo 1 of 2 : UCIP_SP_2024_83254_90999.jpg

DS_ID:19630
FS_ID:83254
EP_NO: N/A
Repair Type: No Action Needed
EVAL Issue:
Crossing Status: Found
UCIP Comments: 04/24/2024 Record updated from Non-Urgent to No Action Needed. DMP internal video inspection has found none or minor pipe defects. (M. Thao - DWR UCIP)
10/21/2020 Record has been updated from No Action Needed to Non-Urgent. No permit was found authorizing this encroachment. CVFPB will need to review crossing to determine owner. DWR DMP has not found internal issues, LOF between 1 and 2. Recommend inspection in 5 years. (B. Singh - GEI, O. Magana - DWR UCIP)
FIELD_STRUCT_DESC: 24-inch corrugated metal (CM) gravity drainage pipe through the levee, 7.0 feet below the crown. Flap gate on the waterside (WS) end. Brass cap No. 68 bench mark (BM) on the headwall on the landside (LS). [Additional Reference(s): DWR Levee Log, 2002, (HLM 10.73). USACE San Joaquin O&M Manual, Unit No. 601, Part No. 1, (SJR601.1), 1967, Revised 25 May 2011, (HLM 10.72)].

Overview of levee crown looking upstream

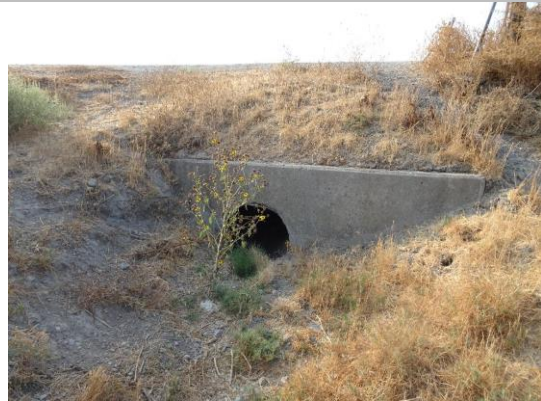
Photo 2 of 2 : UCIP_SP_2024_83254_91003.jpg

LS view: Pipe and headwall at LS toe

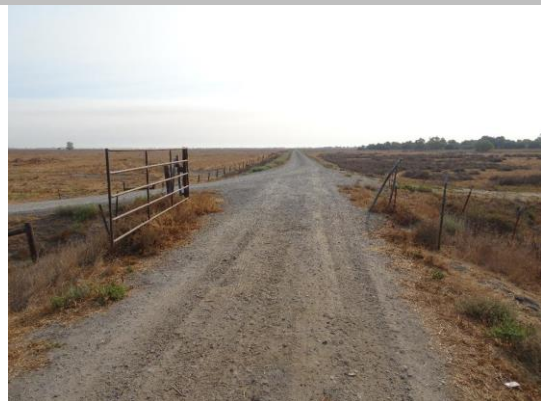
Photo 1 of 3 : UCIP_SP_2024_70683_91009.jpg

DS_ID:19631
FS_ID:70683
EP_NO: N/A
Repair Type: Non-Urgent
EVAL Issue: 5, Pipe Damage
Crossing Status: Found
UCIP Comments: 10/21/2020 Record has been updated from No Action Needed to Non-Urgent. DWR DMP has found integrity issues, LOF between 4 and 5. Crossing will be monitored until funding becomes available for rehabilitation. No permit was found authorizing this encroachment. CVFPB will need to review crossing to determine owner. Pipe material changes from CMP on the WS to concrete on the LS. (B. Singh - GEI, O. Magana - DWR UCIP)
FIELD_STRUCT_DESC: 24-inch corrugated metal (CM) gravity drainage pipe through the levee, 7.0 feet below the crown. Flap gate on the waterside (WS) end. Brass cap No. 67 bench mark (BM) on the headwall on the landside (LS). Pipe material changes from CMP on the WS to concrete on the LS. [Additional Reference(s): DWR Levee Log, 2002, (HLM 10.74). USACE San Joaquin O&M Manual, Unit No. 601, Part No. 1, (SJR601.1), 1967, Revised 25 May 2011, (HLM 10.72)].

Overview of levee crown looking upstream

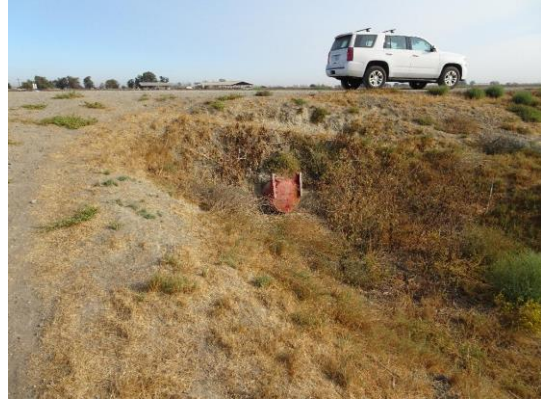
Photo 2 of 3 : UCIP_SP_2024_70683_91010.jpg

WS view: Pipe and flapgate at WS toe

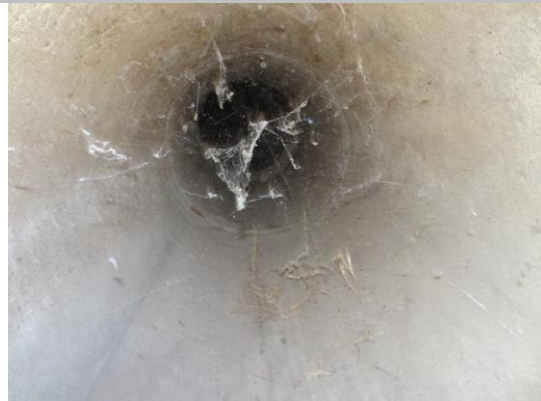
Photo 3 of 3 : UCIP_SP_2024_70683_91013.jpg

LS view: internal view of concrete pipe located on WS.

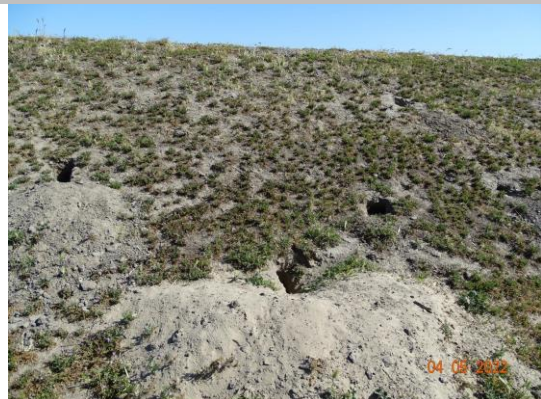
Photo 1 of 1 : SP_2024_NA0010_118_133_20240212_00024.jpg

LM Start	10.90	Rating **	U	Issue No.	133
LM End	10.90	Issue Type +	Ma	Location *	WS
Category	Earthen Levee			GPS Latitude/Longitude	
				Start	End
Item	Animal Control			37.282911°	37.282911°
				-120.829665°	-120.829665°
DWR ID	DWR_NA0010_01_s_2022_133				
Comment Code					
A3 : No rodents visible, but rodent burrows visible; need to backfill and compact or grout burrows.					
Inspector Comment

View of rodent burrows on the waterside slope. (Spring 2022)

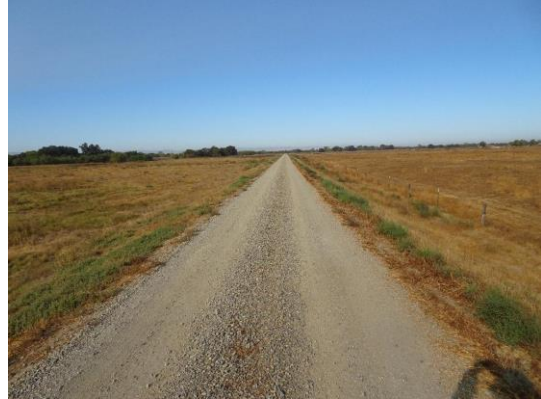
Photo 1 of 3 : UCIP_SP_2024_70684_90929.jpg

Comment Code						
Inspector Comment						
DS_ID:19632						
FS_ID:70684						
EP_NO: N/A						
Repair Type: No Action Needed						
EVAL Issue:						
Crossing Status: Found						
UCIP Comments: 10/21/2020 Record updated from Non-Urgent to No Action Needed. DWR DMP has not found internal issues, LOF between 1 and 2. Recommend inspection in 5 years. Dense vegetation previously recorded in the 2014 UCIP inspection has been cleared. (B. Singh - GEI, O. Magana - DWR UCIP)04/09/2014 Dense vegetation blocks landward headwall. Recommend removing excess vegetation on landward toe. (W. Wylie - DWR UCIP)						
FIELD_STRUCT_DESC: 24-inch corrugated metal (CM) gravity drainage pipe through the levee, 6.0 feet below the crown. Flap gate on the waterside (WS) end. Brass cap No. 66 bench mark (BM) on the headwall on the landside (LS). [Additional Reference(s): DWR Levee Log, 2002, (HLM 11.02). USACE San Joaquin O&M Manual, Unit No. 601, Part No. 1, (SJR601.1), 1967, Revised 25 May 2011, (HLM 11.00)].

Overview of levee crown looking upstream

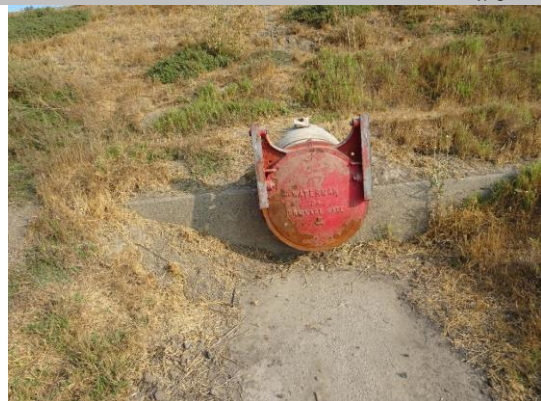
Photo 2 of 3 : UCIP_SP_2024_70684_90933.jpg

WS view: Pipe, flapgate, and headwall at WS toe

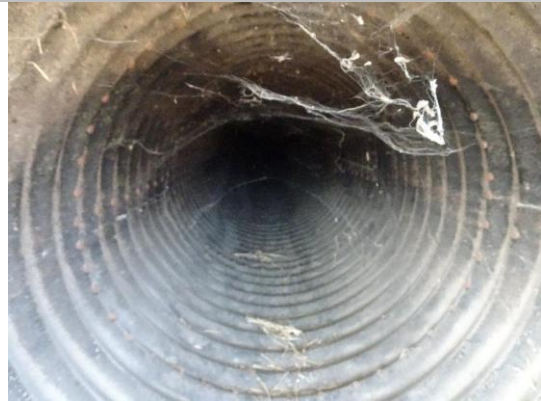
Photo 3 of 3 : UCIP_SP_2024_70684_90928.jpg

LS view: Pipe interior from LS toe

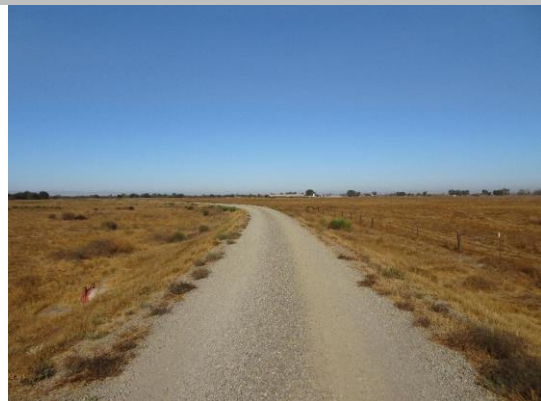
Photo 1 of 3 : UCIP_SP_2024_83255_90935.jpg

DS_ID:19633
 FS_ID:83255
 EP_NO: N/A
 Repair Type: No Action Needed
 EVAL Issue:
 Crossing Status: Found
 UCIP Comments: 04/24/2024 Record updated from Non-Urgent to No Action Needed. DMP internal video inspection has found none or minor pipe defects. (M. Thao - DWR UCIP)
 10/21/2020 Record has been updated from No Action Needed to Non-Urgent. No permit was found authorizing this encroachment. CVFPB will need to review crossing to determine owner. DWR DMP has not found internal issues, LOF between 1 and 2. Recommend inspection in 5 years. (B. Singh - GEI, O. Magana - DWR UCIP)
 FIELD_STRUCT_DESC: 24-inch corrugated metal (CM) gravity drainage pipe through the levee, 5.0 feet below the crown. Flap gate on the waterside (WS) end. Brass cap No. 65 bench mark (BM) on the headwall on the landside (LS). [Additional Reference(s): DWR Levee Log, 2002, (HLM 11.20). USACE San Joaquin O&M Manual, Unit No. 601, Part No. 1, (SJR601.1), 1967, Revised 25 May 2011, (HLM 11.18)].

Overview of levee crown, looking upstream

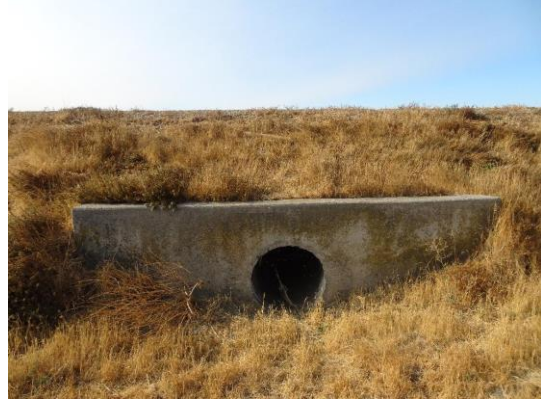
Photo 2 of 3 : UCIP_SP_2024_83255_90938.jpg

LS view: Pipe and headwall at LS toe

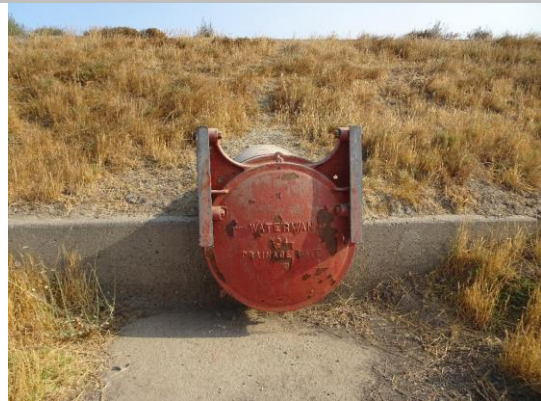
Photo 3 of 3 : UCIP_SP_2024_83255_90934.jpg

WS view: Pipe, flapgate, and headwall at WS toe

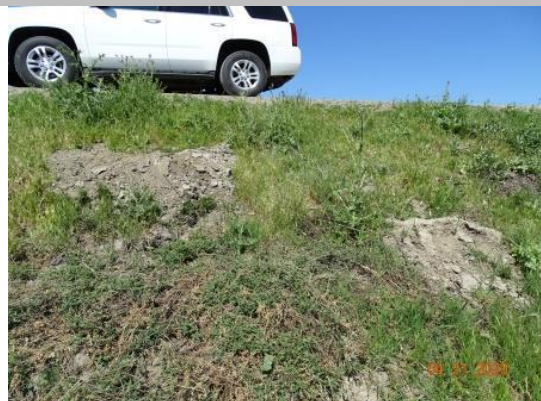
Photo 1 of 1 : SP_2024_NA0010_118_151_20240212_00028.jpg

Rodent burrows in the landside slope. (Spring 2020)

LM Start	11.37	Rating **	M	Issue No.	151
LM End	11.37	Issue Type +	Ma	Location *	LS
Category	Earthen Levee			GPS Latitude/Longitude	
				Start	End
Item	Animal Control			37.275481°	37.275481°
				-120.826042°	-120.826042°
DWR ID	DWR_NA0010_01_s_2020_151				
Comment Code					
A1 : Exterminate rodents and backfill and compact or grout burrows.					
Inspector Comment

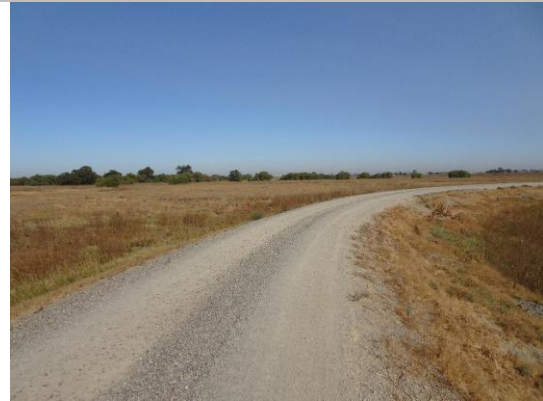
Photo 1 of 3 : UCIP_SP_2024_83256_90940.jpg

Comment Code						
Inspector Comment						
DS_ID:19814 FS_ID:83256 EP_NO: N/A Repair Type: Non-Urgent EVAL Issue: Crossing Status: Found UCIP Comments: 10/21/2020 Record has been updated from No Action Needed to Non-Urgent. Steep slopes prevented further inspection of the WS and LS toes. No permit was found authorizing this encroachment. CVFPB will need to review crossing to determine owner. DWR DMP has not found internal issues, LOF between 1 and 2. Recommend inspection in 5 years. (B. Singh - GEI, O. Magana - DWR UCIP) FIELD_STRUCT_DESC: 24-inch corrugated metal (CM) gravity drainage pipe through the levee, 12.0 feet below the crown. Two metal cutoff walls. Flap gate, concrete saddle, and apron on the waterside (WS) end. Concrete headwall on the landside (LS) end. [Additional Reference(s): DWR Levee Log, 2002. USACE San Joaquin O&M Manual, Unit No. 601, Part No. 1, (SJR601.1), 1967, Revised 25 May 2011, (recorded as Unit 6, HLM 0.05, should be Unit 1, HLM 11.37)]. FS Date: 10/21/2020

Overview of levee crown looking upstream.

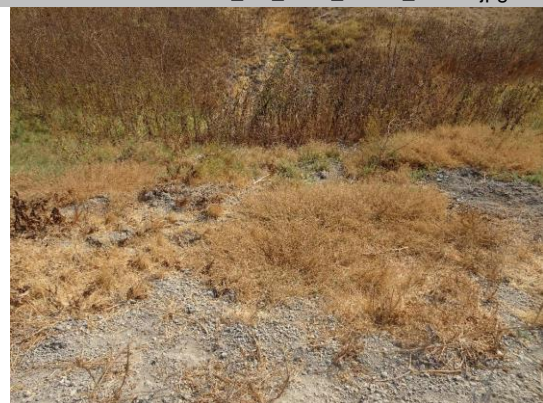
Photo 2 of 3 : UCIP_SP_2024_83256_90943.jpg

LS view: overview of LS slope.

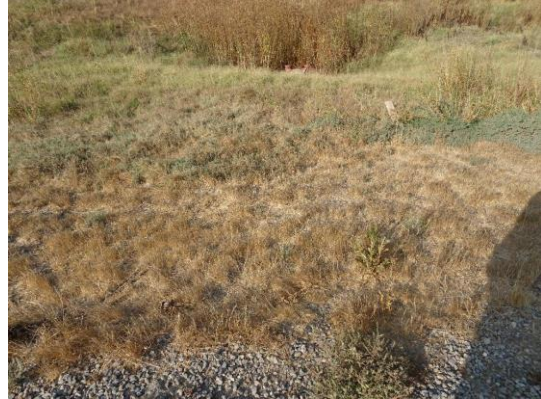
Photo 3 of 3 : UCIP_SP_2024_83256_90942.jpg

WS view: overview of WS slope. Pipe and flapgate visible
