**Flood Control Project Maintenance
Levee Inspections**

Maintenance Issue Types Only, Levee Inspection Report By Mile - Spring 2024

Lower San Joaquin Levee District

Waterway	Bank	Unit Miles	Inspection Start/End	Inspector
Unit No. 01 San Joaquin River	Right	22.52	03/12/2024 03/12/2024	Corey Fujitani

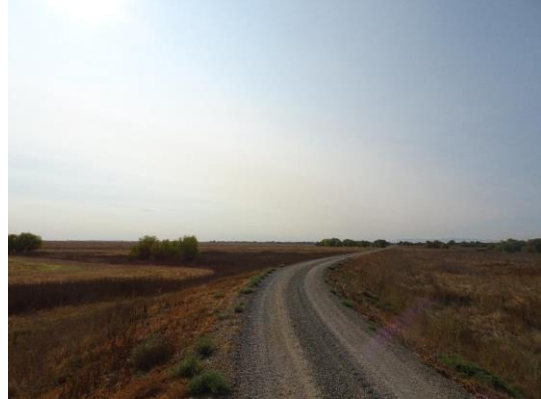
Photo 1 of 3 : UCIP_SP_2024_70687_92836.jpg

Comment Code						
Inspector Comment						
DS_ID:19634 FS_ID:70687 EP_NO: N/A Repair Type: Non-Urgent EVAL Issue: Crossing Status: Found UCIP Comments: 09/18/2023 Pipe was CIPP lined. DMP internal video inspection has found none or minor pipe defects. Recommend next video inspection in 5 years. (O. Yakimov - DWR UCIP) 10/21/2020 Record remains Non-Urgent. Dense vegetation inhibited inspection of pipe and headwall on the LS toe. DWR DMP has found integrity issues, LOF between 4 and 5. Unable to locate pipe inlet on along the LS toe. Crossing will be monitored until funding becomes available for rehabilitation. No permit was found authorizing this encroachment. CVFPB will need to review crossing to determine owner. (B. Singh - GEI, O. Magana - DWR UCIP)04/25/2014 Need to contact owner--landward side has been buried. It appears that soil was removed from levee toe, immediately upstream, and used to pile soil at landward side at crossing. (O. Magana - DWR UCIP) FIELD_STRUCT_DESC: 24-inch CIPP-lined corrugated metal (CM) gravity drainage pipe through the levee, 10.0 feet below the crown. Flap gate on the waterside (WS) end. Brass cap No. 62 bench mark (BM) on the headwall on the landside (LS). [Additional Reference(s): DWR Levee Log, 2002, (HLM 11.48). USACE San Joaquin O&M Manual, Unit No. 601, Part No. 1, (SJR601.1), 1967, Revised 25 May 2011, (HLM 11.48)]. FS Date: 10/21/2020

Overview of levee crown looking upstream towards pipe crossing, photo 1 of 2.

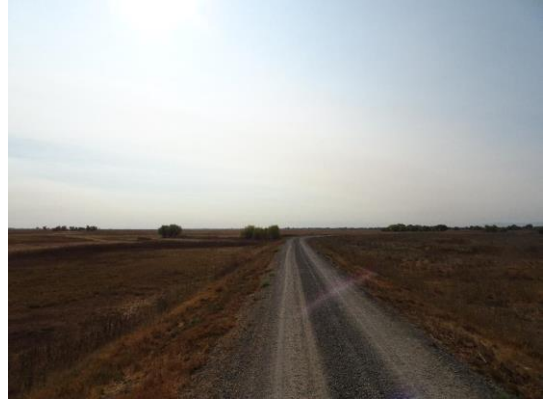
Photo 2 of 3 : UCIP_SP_2024_70687_90946.jpg

Overview of levee crown looking upstream towards pipe crossing, photo 2 of 2.

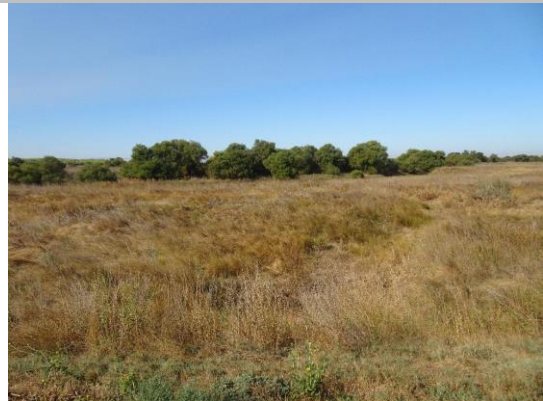
Photo 3 of 3 : UCIP_SP_2024_70687_90947.jpg

WS view: overview of WS.

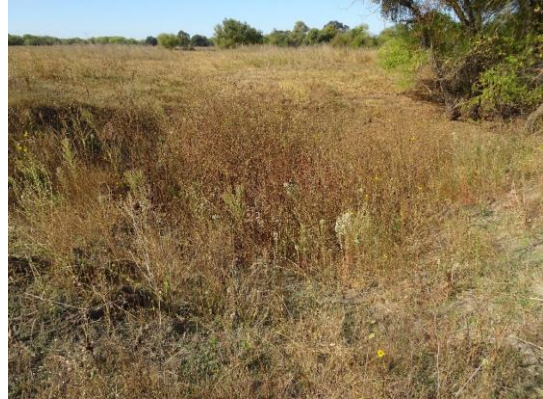
Photo 2 of 3 : UCIP_SP_2024_83257_90954.jpg

WS view: Pipe covered by vegetation at WS toe

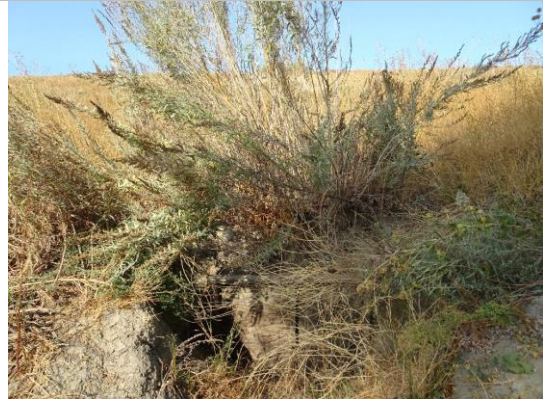
Photo 3 of 3 : UCIP_SP_2024_83257_90955.jpg

LS view: Pipe and headwall blocked by debris at LS toe

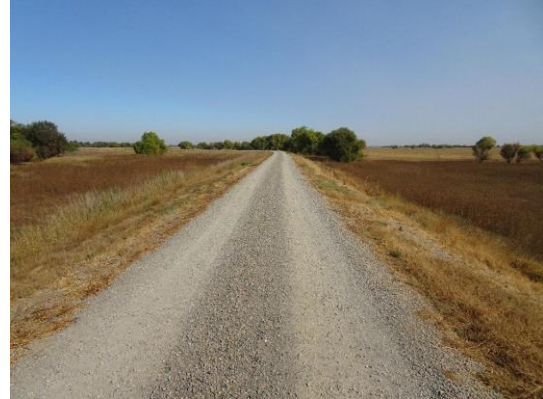
Photo 1 of 3 : UCIP_SP_2024_83274_90956.jpg

Comment Code						
Inspector Comment						
DS_ID:19636 FS_ID:83274 EP_NO: N/A Repair Type: Non-Urgent EVAL Issue: Crossing Status: Found UCIP Comments: 10/21/2020 Record remains Non-Urgent. Dense vegetation inhibited proper inspection of the pipe on the LS and WS toes. No permit was found authorizing this encroachment. CVFPB will need to review crossing to determine owner. DWR DMP internal inspection is pending and scheduled for 2021. (B. Singh - GEI, O. Magana - DWR UCIP) 04/25/2014 Crossing is non-functional --landward side is buried. Dense vegetation found on waterward slope. Recommend contacting owner to determine status of crossing. If crossing is no longer used need to coordinate with CVFPB for proper abandonment. (O. Magana - DWR UCIP) FIELD_STRUCT_DESC: 24-inch corrugated metal (CM) gravity drainage pipe through the levee, 12.4 feet below the crown. Flap gate on the waterside (WS) end. Brass cap No. 60 bench mark (BM) on the headwall on the landside (LS). [Additional Reference(s): DWR Levee Log, 2002, (HLM 12.12). USACE San Joaquin O&M Manual, Unit No. 601, Part No. 1, (SJR601.1), 1967, Revised 25 May 2011, (HLM 12.11)]. FS Date: 10/21/2020

Overview of levee crown looking upstream.

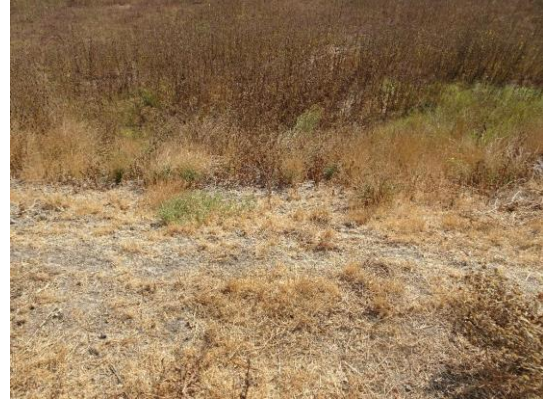
Photo 3 of 3 : UCIP_SP_2024_83274_90961.jpg

LS view: view of LS slope

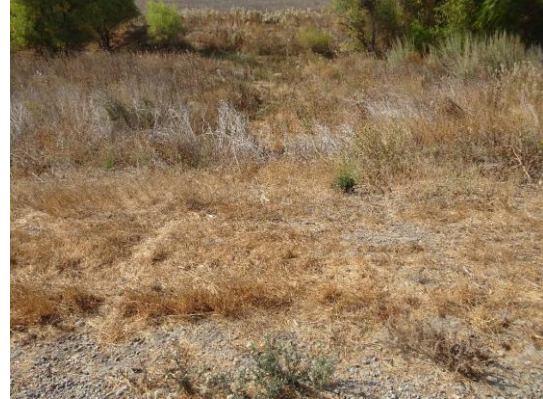
Photo 1 of 3 : UCIP_SP_2024_70690_90966.jpg

Comment Code					
Inspector Comment					
DS_ID:19637 FS_ID:70690 EP_NO: N/A Repair Type: Non-Urgent EVAL Issue: Crossing Status: Found UCIP Comments: 09/15/2023 Pipe was CIPP lined. DMP internal video inspection has found none or minor pipe defects. Recommend next video inspection in 5 years. (O. Yakimov - DWR UCIP) 10/21/2020 Record remains Non-Urgent. DWR DMP has found integrity issues, LOF between 4 and 5. Crossing will be monitored until funding becomes available for rehabilitation. Proper inspection inhibited by dense vegetation. Recommend vegetation removal along pipe alignment. No permit was found authorizing this encroachment. CVFPB will need to review crossing to determine owner. (B. Singh - GEI, O. Magana - DWR UCIP)04/25/2014 Concrete headwall on landward side blocked by debris. Dense vegetation limits the inspector's visibility to identify signs of pipe failure (leaks) along the landward slope. Recommend removing vegetation along pipe alignment to conduct proper inspection of crossing. (O. Magana - DWR UCIP) FIELD_STRUCT_DESC: 24-inch CIPP-lined corrugated metal (CM) gravity drainage pipe through the levee, 9.5 feet below the crown. Flap gate on the waterside (WS) end. Brass cap No. 60 bench mark (BM) on the headwall on the landside (LS). [Additional Reference(s): DWR Levee Log, 2002, (HLM 12.95). USACE San Joaquin O&M Manual, Unit No. 601, Part No. 1, (SJR601.1), 1967, Revised 25 May 2011, (HLM 12.94)]. FS Date: 10/21/2020

WS view: dense vegetation along WS toe. Pipe and flap gate visible on WS toe.

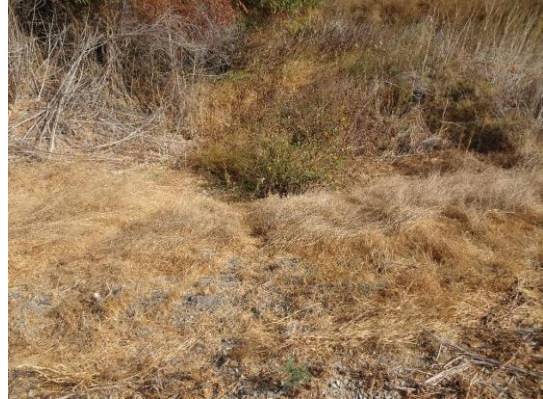
Photo 2 of 3 : UCIP_SP_2024_70690_90964.jpg

LS view: dense vegetation along LS toe. No pipe visible.

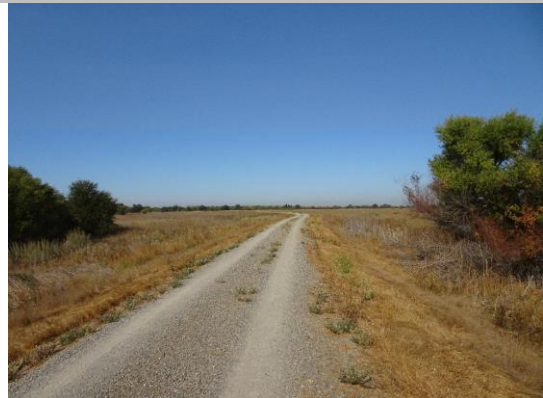
Photo 3 of 3 : UCIP_SP_2024_70690_90962.jpg

Overview of levee crown looking downstream towards pipe crossing.

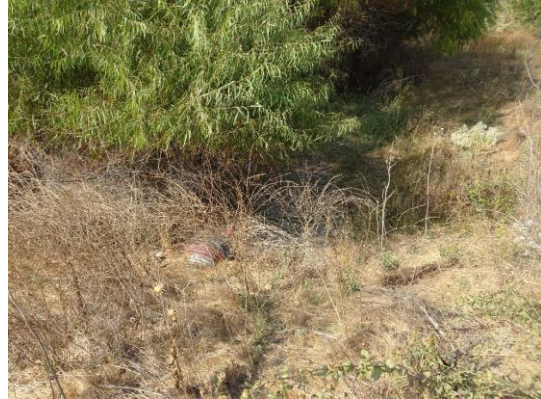
Photo 1 of 2 : UCIP_SP_2024_83258_90969.jpg

Comment Code						
Inspector Comment						
DS_ID:19638 FS_ID:83258 EP_NO: N/A Repair Type: Urgent EVAL Issue: 1, Pipe Integrity Crossing Status: Found UCIP Comments: 12/14/2022 Record updated from Non-Urgent to Urgent. DMP internal video inspection has found pipe integrity issues. LOF of crossing is between 5 and 6. Crossing will be monitored until funding becomes available to address the issues. (O.Yakimov - DWR UCIP) 10/21/2020 Record remains Non-Urgent. No permit was found authorizing this encroachment. CVFPB will need to review crossing to determine owner. DWR DMP internal inspection is pending and scheduled for 2021. (B. Singh - GEI, O. Magana - DWR UCIP)04/25/2014 Dense vegetation limits the inspector's visibility to identify signs of pipe failure (leaks) along the landward slope. Concrete headwall blocked by debris located on landward toe. Recommend clearing debris from landward slope and toe. (O. Magana - DWR UCIP) FIELD_STRUCT_DESC: 24-inch corrugated metal (CM) gravity drainage pipe through the levee, 14.2 feet below the crown. Flap gate on the waterside (WS) end. Brass cap No. 60 bench mark (BM) on the headwall on the landside (LS). [Additional Reference(s): DWR Levee Log, 2002, (HLM 13.48). USACE San Joaquin O&M Manual, Unit No. 601, Part No. 1, (SJR601.1), 1967, Revised 25 May 2011, (HLM 13.48)]. FS Date: 10/21/2020 1:37:19 PM

WS view: pipe and flapgate visible at WS toe

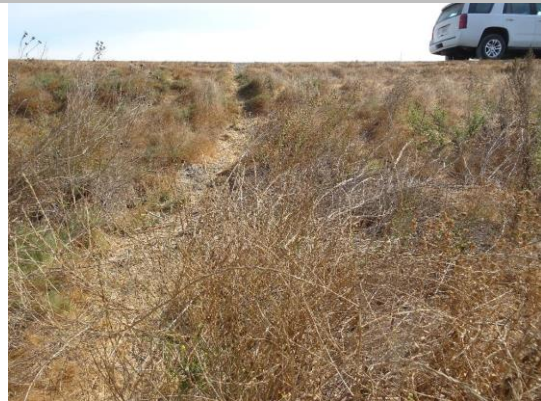
Photo 2 of 2 : UCIP_SP_2024_83258_90970.jpg

LS view: overview of LS slope

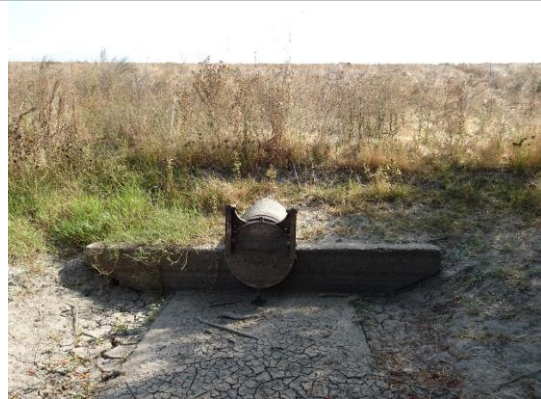
Photo 2 of 3 : UCIP_SP_2024_81163_90974.jpg

WS view: pipe, headwall, and flapgate at WS toe

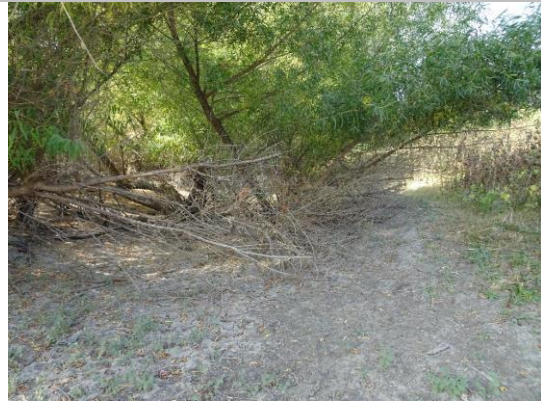
Photo 3 of 3 : UCIP_SP_2024_81163_90975.jpg

WS view: overview looking towards drainage past pipe outlet.

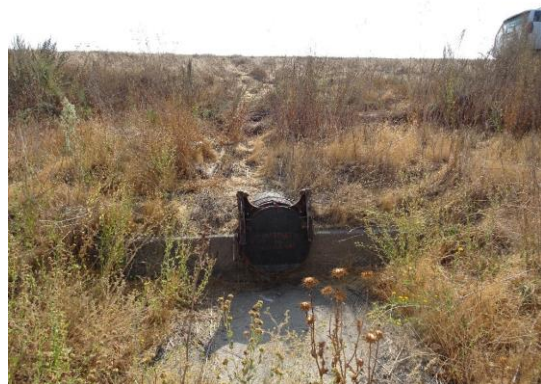
Photo 1 of 3 : UCIP_SP_2024_83261_90984.jpg

DS_ID:19640
FS_ID:83261
EP_NO: N/A
Repair Type: No Action Needed
EVAL Issue:
Crossing Status: Indicator Found
UCIP Comments: 04/24/2024 Record updated from Non-Urgent to No Action Needed. DMP internal video inspection has found none or minor pipe defects. (M. Thao - DWR UCIP)
10/21/2020 Record remains Non-Urgent. No permit was found authorizing this encroachment. CVFPB will need to review crossing to determine owner. DWR DMP has not found internal issues, LOF between 1 and 2. Recommend inspection in 5 years. (B. Singh - GEI, O. Magana - DWR UCIP)
04/25/2014 No photos available--missed crossing. Aerial photograph indicates crossing is present. Need to confirm if crossing is still present on waterward side. (O. Magana - DWR UCIP)
FIELD_STRUCT_DESC: 24-inch corrugated metal (CM) gravity drainage pipe through the levee, 11.0 feet below the crown. Flap gate on the waterside (WS) end. Brass cap No. 60 bench mark (BM) on the headwall on the landside (LS). [Additional Reference(s): DWR Levee Log, 2002, (HLM 13.83). USACE San Joaquin O&M Manual, Unit No. 601, Part No. 1, (SJR601.1), 1967, Revised 25 May 2011, (HLM 13.81)].

WS view: Pipe, flapgate, and headwall at WS toe

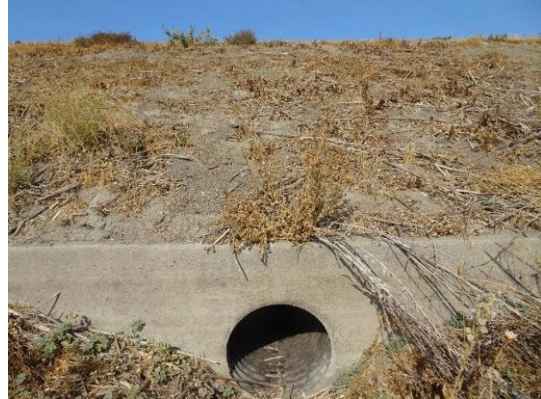
Photo 2 of 3 : UCIP_SP_2024_83261_90982.jpg

LS view: Pipe and headwall at LS toe

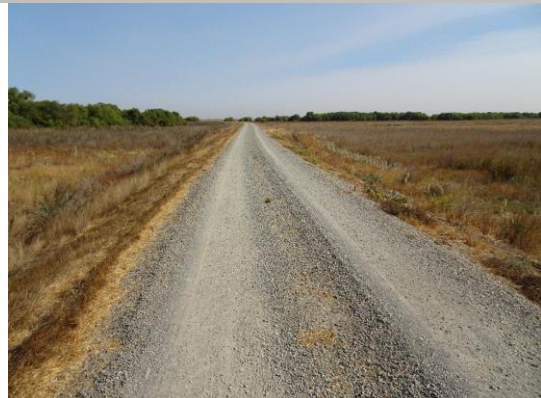
Photo 3 of 3 : UCIP_SP_2024_83261_90977.jpg

Overview of levee crown looking downstream towards crossing.

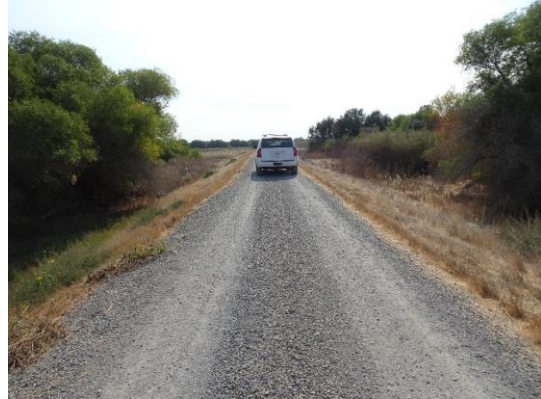
Photo 1 of 3 : UCIP_SP_2024_83262_90986.jpg

Comment Code						
Inspector Comment						
DS_ID:19641 FS_ID:83262 EP_NO: N/A Repair Type: Non-Urgent EVAL Issue: Crossing Status: Found UCIP Comments: 10/21/2020 Record remains Non-Urgent. Dense vegetation at LS and WS toes inhibited proper inspection. No permit was found authorizing this encroachment. CVFPB will need to review crossing to determine owner. DWR DMP has not found internal issues, LOF between 1 and 2. Recommend inspection in 5 years. (B. Singh - GEI, O. Magana - DWR UCIP)04/25/2014 Dense vegetation limits the inspector's visibility to identify signs of pipe failure (leaks) along the slopes. Recommend removing vegetation along pipe alignment to conduct proper inspection of structure. (O. Magana - DWR UCIP) FIELD_STRUCT_DESC: 24-inch corrugated metal (CM) gravity drainage pipe through the levee, 13.0 feet below the crown. Flap gate on the waterside (WS) end. Brass cap No. 60 bench mark (BM) on the headwall on the landside (LS). [Additional Reference(s): DWR Levee Log, 2002, (HLM 14.22). USACE San Joaquin O&M Manual, Unit No. 601, Part No. 1, (SJR601.1), 1967, Revised 25 May 2011, (HLM 14.21)]. FS Date: 10/21/2020

Overview of levee crown looking upstream towards pipe crossing.

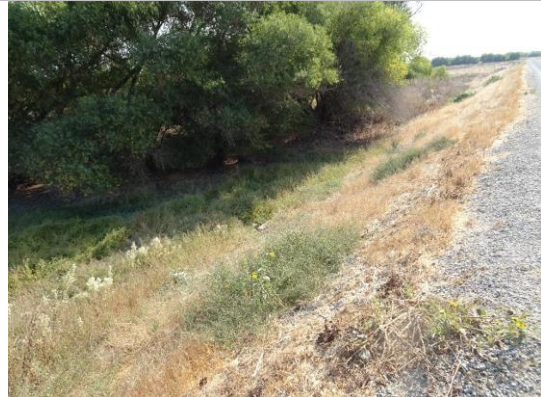
Photo 2 of 3 : UCIP_SP_2024_83262_90988.jpg

LS view: overview of LS

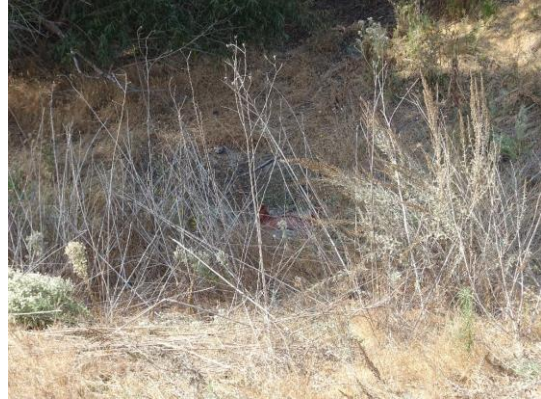
Photo 3 of 3 : UCIP_SP_2024_83262_90985.jpg

WS view: Pipe and flapgate visible through dense vegetation

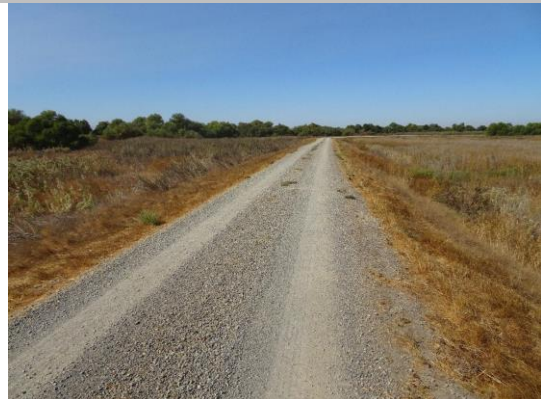
Photo 1 of 3 : UCIP_SP_2024_83263_90992.jpg

DS_ID:19642
FS_ID:83263
EP_NO: N/A
Repair Type: Non-Urgent
EVAL Issue:
Crossing Status: Found
UCIP Comments: 10/21/2020 Record remains Non-Urgent. Dense vegetation along the pipe alignment prevented proper inspection of the levee and pipe. No permit was found authorizing this encroachment. CVFPB will need to review crossing to determine owner. DWR DMP has not found internal issues, LOF between 1 and 2. Recommend inspection in 5 years. (B. Singh - GEI, O. Magana - DWR UCIP)04/25/2014 Dense vegetation limits the inspector's visibility to identify signs of pipe failure (leaks) along the landward slope and toe. Recommend removing vegetation along pipe alignment to conduct proper inspection of structure. (O. Magana - DWR UCIP)
FIELD_STRUCT_DESC: 24-inch corrugated metal (CM) gravity drainage pipe through the levee, 9.7 feet below the crown. Flap gate on the waterside (WS) end. Brass cap No. 60 bench mark (BM) on the headwall on the landside (LS). [Additional Reference(s): DWR Levee Log, 2002, (HLM 14.65). USACE San Joaquin O&M Manual, Unit No. 601, Part No. 1, (SJR601.1), 1967, Revised 25 May 2011, (HLM 14.65)].

Overview of levee crown looking downstream toward crossing.

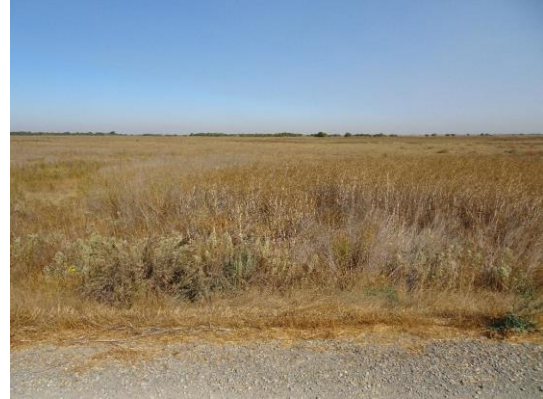
Photo 2 of 3 : UCIP_SP_2024_83263_90995.jpg

LS view: overview of LS

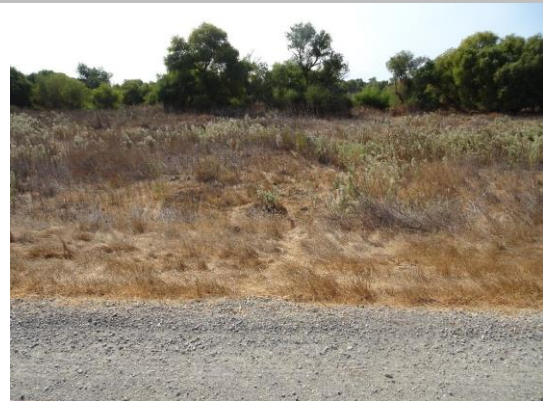
Photo 3 of 3 : UCIP_SP_2024_83263_90997.jpg

WS view: overview of WS

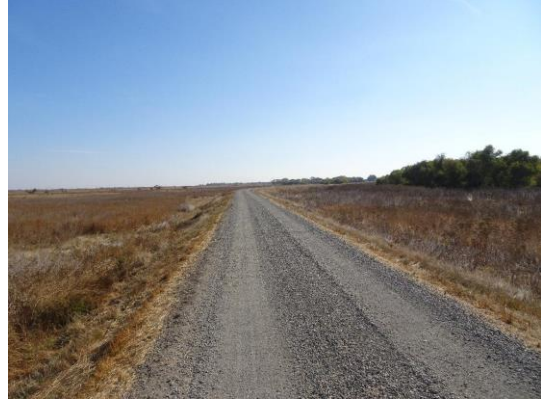
Photo 1 of 3 : UCIP_SP_2024_83264_90792.jpg

Comment Code					
Inspector Comment					
DS_ID:19643 FS_ID:83264 EP_NO: N/A Repair Type: Non-Urgent EVAL Issue: Crossing Status: Found UCIP Comments: 11/16/2020 Record remains Non-Urgent. Dense vegetation on LS toe limited inspection of pipe. Significant burrowing observed on LS and WS slopes. Recommend vegetation removal and rodent mitigation. No permit was found authorizing this encroachment. CVFPB will need to review crossing to determine owner. DWR DMP has not found internal issues, LOF between 1 and 2. Recommend inspection in 5 years. (B. Singh - GEI, O. Magana - DWR UCIP)04/25/2014 Dense vegetation limits the inspector's visibility to identify signs of pipe failure (leaks) along the landward slope. Recommend removing vegetation along pipe alignment to conduct proper inspection of structure. (O. Magana - DWR UCIP) FIELD_STRUCT_DESC: 24-inch corrugated metal (CM) gravity drainage pipe through the levee, 9.2 feet below the crown. Flap gate on the waterside (WS) end. Brass cap No. 60 bench mark (BM) on the headwall on the landside (LS). [Additional Reference(s): DWR Levee Log, 2002, (HLM 15.31). USACE San Joaquin O&M Manual, Unit No. 601, Part No. 1, (SJR601.1), 1967, Revised 25 May 2011, (HLM 15.29)]. FS Date: 11/16/2020

Overview of levee crown, looking US

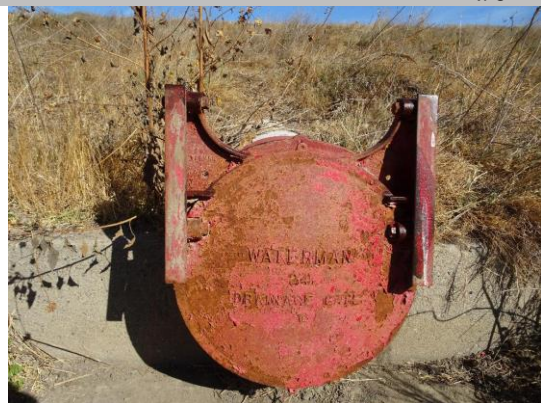
Photo 2 of 3 : UCIP_SP_2024_83264_90794.jpg

WS view: close-up view of pipe, flapgate, and headwall at WS toe

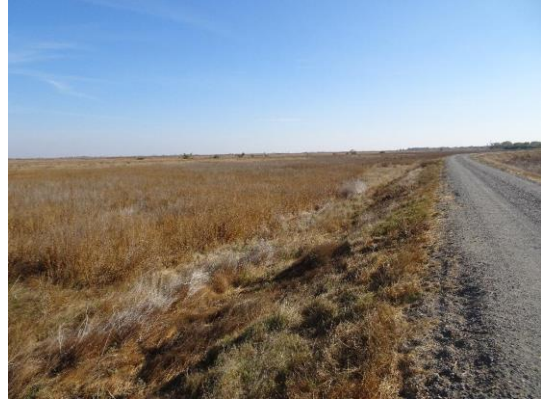
Photo 3 of 3 : UCIP_SP_2024_83264_92867.jpg

LS view: profile view of LS slope

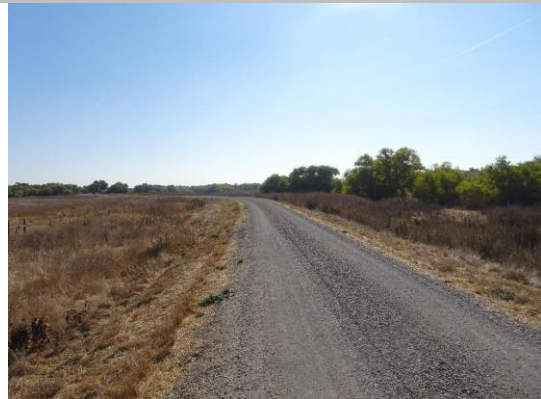
Photo 1 of 3 : UCIP_SP_2024_83265_90797.jpg

DS_ID:19644
 FS_ID:83265
 EP_NO: N/A
 Repair Type: Non-Urgent
 EVAL Issue:
 Crossing Status: Found
 UCIP Comments: 11/16/2020 Recor remains Non-Urgent. Dense vegetation on LS toe and slope inhibited proper inspection of pipe. No permit was found authorizing this encroachment. CVFPB will need to review crossing to determine owner. DWR DMP has not found internal issues, LOF between 1 and 2. Recommend inspection in 5 years. (O. Magana - DWR UCIP, B. Singh - GEI)04/25/2014 Dense vegetation limits the inspector's visibility to identify signs of pipe failure (leaks) along the waterward and landward slopes. Recommend removing vegetation along pipe alignment to conduct proper inspection of structure. (O. Magana - DWR UCIP)
 FIELD_STRUCT_DESC: 24-inch corrugated metal (CM) gravity drainage pipe through the levee, 8.5 feet below the crown. Flap gate on the waterside (WS) end. Brass cap No. 60 bench mark (BM) on the headwall on the landside (LS). [Additional Reference(s): DWR Levee Log, 2002, (HLM 15.57). USACE San Joaquin O&M Manual, Unit No. 601, Part No. 1, (SJR601.1), 1967, Revised 25 May 2011, (HLM 15.57)].

Overview of levee crown, looking US

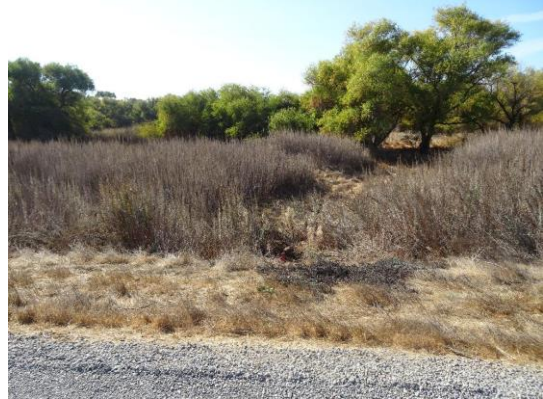
Photo 2 of 3 : UCIP_SP_2024_83265_90798.jpg

WS view: overview of WS. Pipe and flapgate visible at WS toe.

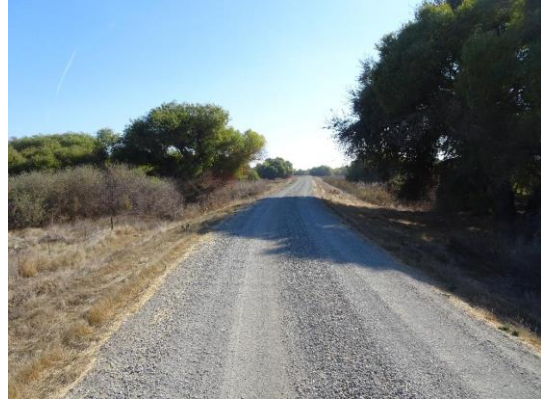
Photo 1 of 3 : UCIP_SP_2024_81164_90803.jpg

DS_ID:19645
FS_ID:81164
EP_NO: N/A
Repair Type: No Action Needed
EVAL Issue:
Crossing Status: Found
UCIP Comments: 09/25/2023 DMP internal video inspection has found none or minor pipe defects. Recommend next video inspection in 5 years. (J. Taylor - DWR UCIP)11/16/2020 Record remains Non-Urgent. Corrosion observed in pipe inlet on the LS toe. Recommend internal inspection of the pipe through the levee to determine extent of damage. Some burrowing activity found on both LS and WS slope. No permit was found authorizing this encroachment. CVFPB will need to review crossing to determine owner. DWR DMP internal inspection is pending and scheduled for 2021. (B. Singh - GEI, O. Magana - DWR UCIP)04/25/2014 Dense vegetation limits the inspector's visibility to identify signs of pipe failure (leaks) along the waterward and landward slope. Recommend removing vegetation along pipe alignment to conduct proper inspection of structure. (O. Magana - DWR UCIP)

Overview of levee crown, looking US

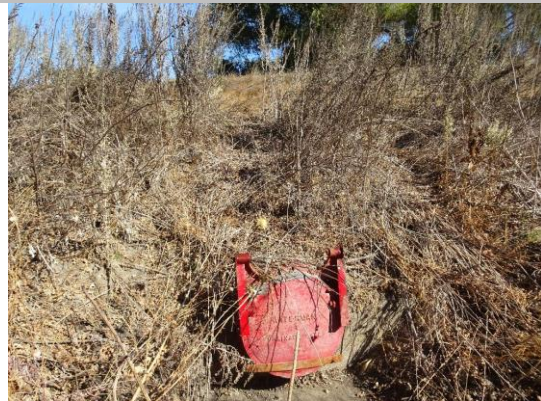
Photo 2 of 3 : UCIP_SP_2024_81164_90806.jpg

WS view: pipe, flapgate, and headwall at WS toe

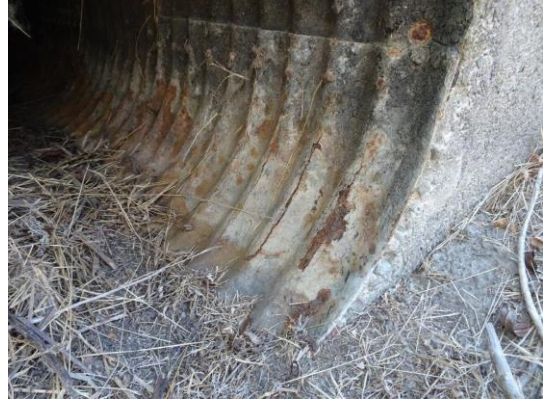
Photo 3 of 3 : UCIP_SP_2024_81164_90801.jpg

LS view: pipe corrosion visible at invert of pipe at LS toe

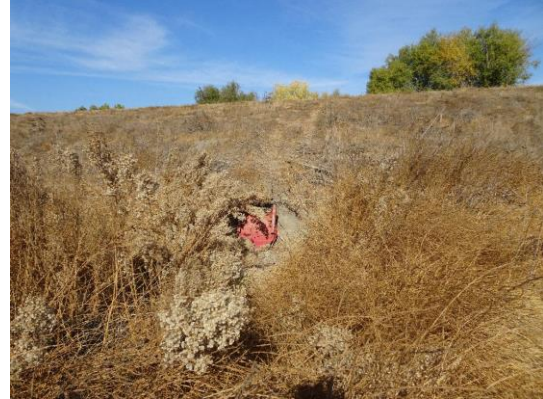
Photo 2 of 3 : UCIP_SP_2024_83267_92965.jpg

WS view: concrete wingwall and pipe with flap gate visible on WS toe.

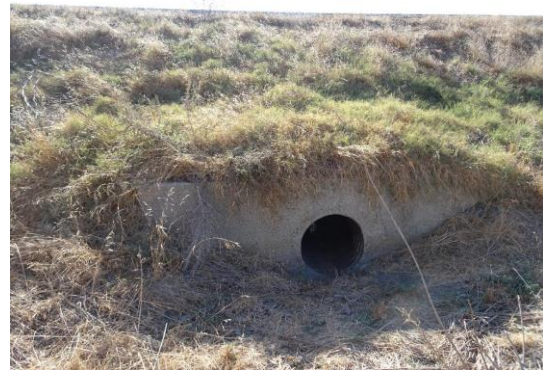
Photo 3 of 3 : UCIP_SP_2024_83267_92964.jpg

LS view: concrete headwall with pipe inlet visible on LS toe.

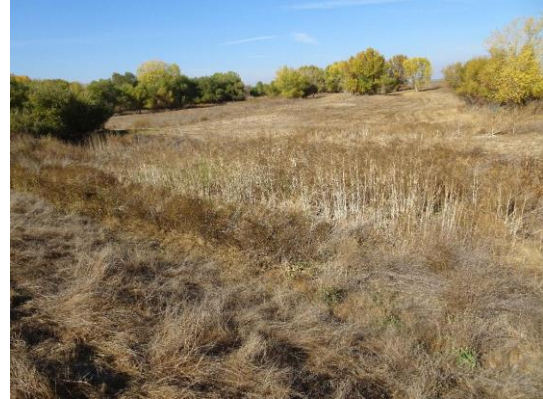
Photo 2 of 3 : UCIP_SP_2024_77854_92980.jpg

LS view: overview of LS.

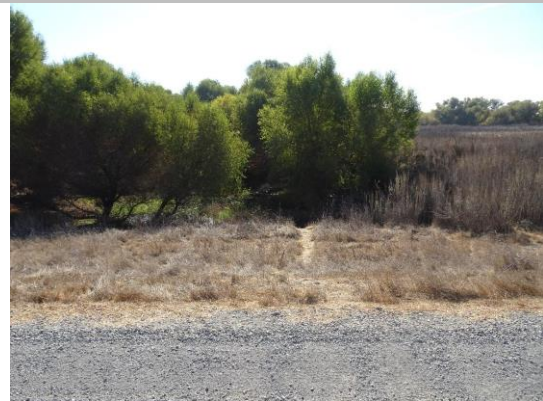
Photo 3 of 3 : UCIP_SP_2024_77854_92978.jpg

WS view: overview of WS.

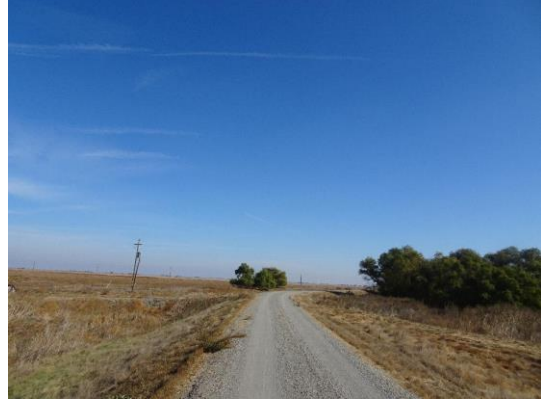
Photo 1 of 3 : UCIP_SP_2024_81165_90820.jpg

Comment Code					
Inspector Comment					
DS_ID:19648 FS_ID:81165 EP_NO: N/A Repair Type: Non-Urgent EVAL Issue: Crossing Status: Found UCIP Comments: 09/25/2023 DMP internal video inspection has found none or minor pipe defects. Recommend next video inspection in 5 years. (J. Taylor - DWR UCIP)11/16/2020 Record remains Non-Urgent. Unable to locate pipe on both LS and WS toes due to dense vegetation. Recommend vegetation removal for proper inspections. DWR DMP internal inspection is pending and scheduled for 2021. No permit was found authorizing this encroachment. CVFPB will need to review crossing to determine owner. (B. Singh - GEI, O. Magana - DWR UCIP)04/25/2014 Dense vegetation limits the inspector's visibility to identify signs of pipe failure (leaks) along the waterward and landward slopes. Recommend removing vegetation along pipe alignment to conduct proper inspection of structure. Unable to find pipe on landward side. (O. Magana - DWR UCIP) FIELD_STRUCT_DESC: 24-inch corrugated metal (CM) gravity drainage pipe through the levee, 11.4 feet below the crown. Flap gate on the waterside (WS) end. Brass cap No. 50 bench mark (BM) on the headwall on the landside (LS). [Additional Reference(s): DWR Levee Log, 2002, (HLM 16.73). USACE San Joaquin O&M Manual, Unit No. 601, Part No. 1, (SJR601.1), 1967, Revised 25 May 2011, (HLM 16.72)]. FS Date: 11/16/2020

Overview of levee crown, looking US

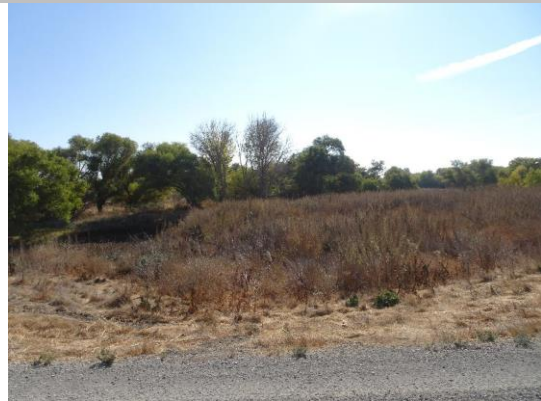
Photo 2 of 3 : UCIP_SP_2024_81165_90821.jpg

WS view: overview of WS. Pipe and flapgate not found; dense vegetation.

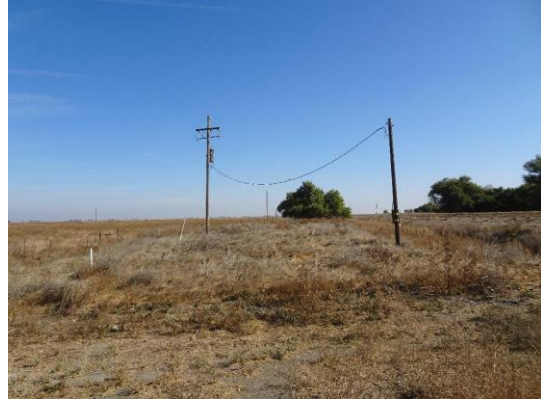
Photo 3 of 3 : UCIP_SP_2024_81165_90823.jpg

LS view: view from LS toe, looking US. Pipe and headwall not found on LS toe.

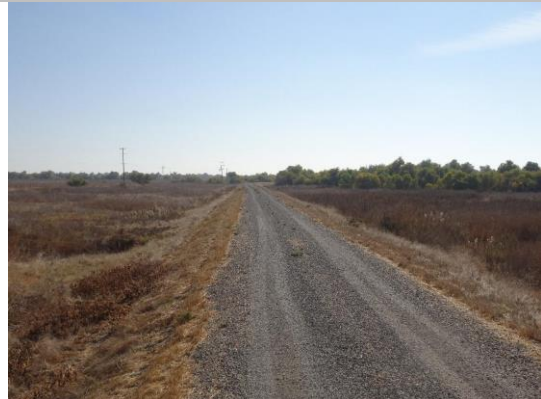
Photo 1 of 3 : UCIP_SP_2024_83268_90825.jpg

DS_ID:19577
FS_ID:83268
EP_NO: N/A
Repair Type: No Action Needed
EVAL Issue:
Crossing Status: Found
UCIP Comments: 04/24/2024 Record updated from Non-Urgent to No Action Needed. DMP internal video inspection has found none or minor pipe defects. (M. Thao - DWR UCIP)
11/16/2020 Record remains Non-Urgent. No permit was found authorizing this encroachment. CVFPB will need to review crossing to determine owner. DWR DMP has not found internal issues, LOF between 1 and 2. Recommend inspection in 5 years. (B. Singh - GEI, O. Magana - DWR UCIP)
04/25/2014 Dense vegetation limits the inspector's visibility to identify signs of pipe failure (leaks) along the waterward and landward slopes. Concrete headwall is buried by dense vegetation. Recommend removing vegetation along pipe alignment to conduct proper inspection of structure. (O. Magana - DWR UCIP)
FIELD_STRUCT_DESC: 24-inch corrugated metal (CM) gravity drainage pipe through the levee, 11.5 feet below the crown. Flap gate on the waterside (WS) end. Brass cap No. 50 bench mark (BM) on the headwall on the landside (LS). [Additional Reference(s): DWR Levee Log, 2002, (HLM 17.01). USACE San Joaquin O&M Manual, Unit No. 601, Part No. 1, (SJR601.1), 1967, Revised 25 May 2011, (HLM 17.01)].

Overview of levee crown, looking US

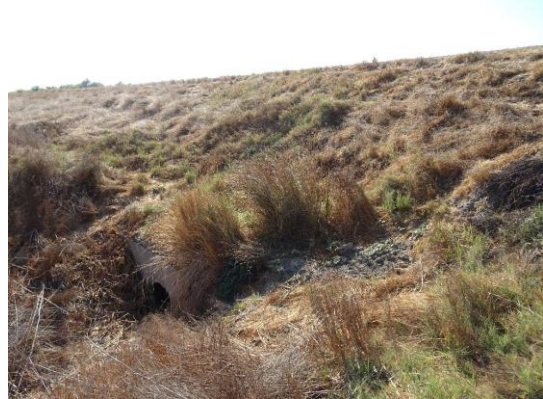
Photo 2 of 3 : UCIP_SP_2024_83268_90827.jpg

LS view: slope above pipe and headwall from LS toe

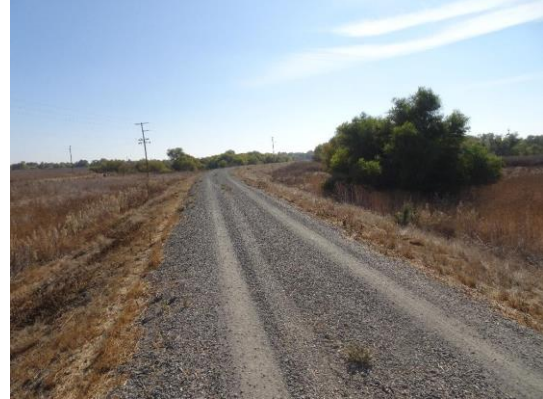
Photo 1 of 3 : UCIP_SP_2024_83270_93002.jpg

Comment Code						
Inspector Comment						
DS_ID:19578 FS_ID:83270 EP_NO: N/A Repair Type: No Action Needed EVAL Issue: Crossing Status: Found UCIP Comments: 04/24/2024 Record updated from Non-Urgent to No Action Needed. DMP internal video inspection has found none or minor pipe defects. (M. Thao - DWR UCIP) 11/16/2020 Record remains Non-Urgent. No permit was found authorizing this encroachment. CVFPB will need to review crossing to determine owner. DWR DMP has not found internal issues, LOF between 1 and 2. Recommend inspection in 5 years. (B. Singh - GEI, O. Magana - DWR UCIP) 04/25/2014 Dense vegetation limits the inspector's visibility to identify signs of pipe failure (leaks) along the waterward and landward slopes. Recommend removing vegetation along pipe alignment to conduct proper inspection of structure. Sediment buildup inside pipe visible from landward side. Recommend clearing pipe. (O. Magana - DWR UCIP) FIELD_STRUCT_DESC: 24-inch corrugated metal (CM) gravity drainage pipe through the levee, 11.5 feet below the crown. Flap gate on the waterside (WS) end. Brass cap No. 50 bench mark (BM) on the headwall on the landside (LS). [Additional Reference(s): DWR Levee Log, 2002, (HLM 17.20). USACE San Joaquin O&M Manual, Unit No. 601, Part No. 1, (SJR601.1), 1967, Revised 25 May 2011, (HLM 17.19)]. FS Date: 11/16/2020

Overview of levee crown looking upstream towards pipe crossing.

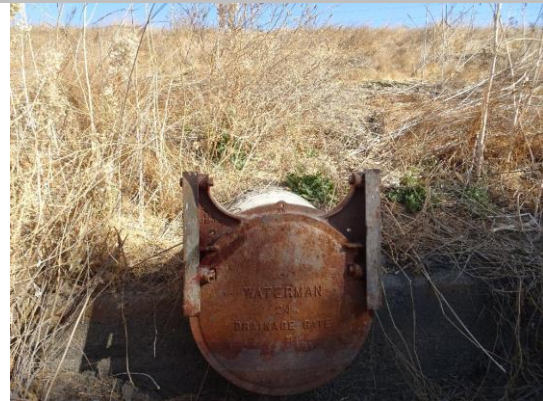
Photo 2 of 3 : UCIP_SP_2024_83270_93001.jpg

WS view: close up of flap gate, pipe, and concrete headwall.

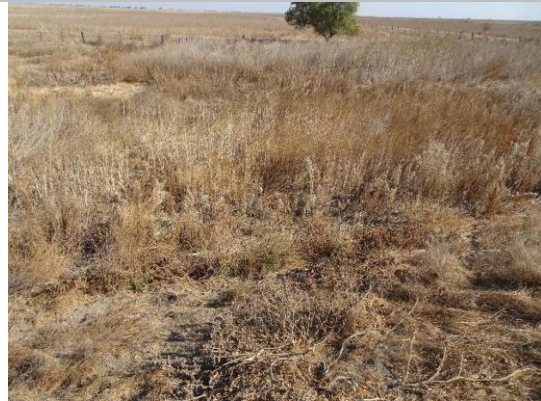
Photo 3 of 3 : UCIP_SP_2024_83270_93005.jpg

LS view: dense vegetation along LS toe.

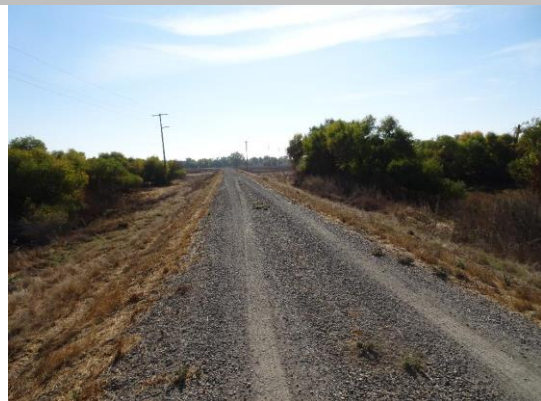
Photo 1 of 3 : UCIP_SP_2024_81000_90834.jpg

DS_ID:19579
FS_ID:81000
EP_NO: N/A
Repair Type: Urgent
EVAL Issue: 1, Pipe Integrity
Crossing Status: Found
UCIP Comments: 09/15/2023 Record updated from Non-Urgent to Urgent. DMP internal video inspection has found severe pipe defects. Crossing will be monitored until funding becomes available to address the issues. (O. Yakimov - DWR UCIP)
11/16/2020 Record remains Non-Urgent. Debris is blocking flapgate on the WS inlet. No permit was found authorizing this encroachment. CVFPB will need to review crossing to determine owner. DWR DMP internal inspection is pending and scheduled for 2021. (B. Singh - GEI, O. Magana - DWR UCIP)04/25/2014 Dense vegetation limits the inspector's visibility to identify signs of pipe failure (leaks) along the waterward and landward slope. Recommend removing vegetation along pipe alignment to conduct proper inspection of structure. (O. Magana - DWR UCIP)
FIELD_STRUCT_DESC: 24-inch corrugated metal (CM) gravity drainage pipe through the levee, 15.8 feet below the crown. Flap gate on the waterside (WS) end. Brass cap No. 50 bench mark (BM) on the headwall on the landside (LS). [Additional Reference(s): DWR Levee Log, 2002, (HLM 17.27). USACE San Joaquin O&M Manual, Unit No. 601, Part No. 1, (SJR601.1), 1967, Revised 25 May 2011, (HLM 17.26)].

Overview of levee crown looking upstream towards crossing.

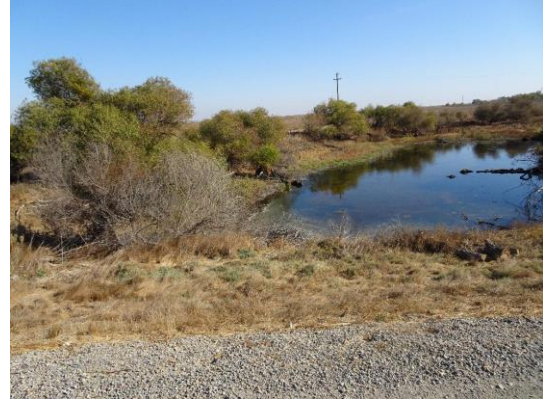
Photo 2 of 3 : UCIP_SP_2024_81000_90835.jpg

LS view: overview of LS

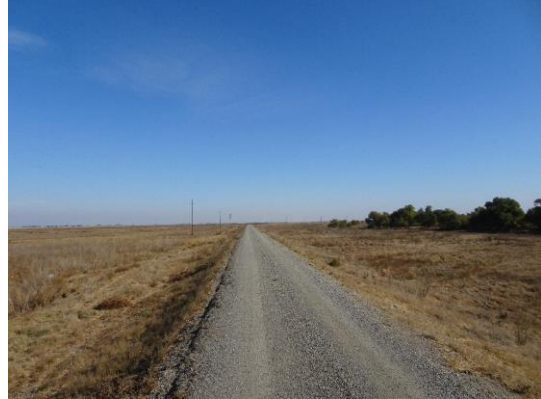
Photo 1 of 3 : UCIP_SP_2024_70707_90843.jpg

Comment Code					
Inspector Comment					
DS_ID:19580 FS_ID:70707 EP_NO: N/A Repair Type: Urgent EVAL Issue: 1, Pipe Integrity Crossing Status: Found UCIP Comments: 11/16/2020 Record has been updated from Non-Urgent to Urgent. Pipe in failed condition on the LS. Potential sink hole located about 1 foot from the LS toe. No permit was found authorizing this encroachment. CVFPB will need to review crossing to determine owner. DWR DMP internal inspection is pending and scheduled for 2021. (B. Singh - GEI, O. Magana - DWR UCIP)04/25/2014 Dense vegetation limits the inspector's visibility to identify signs of pipe failure (leaks) along the landward slope. Recommend removing vegetation along pipe alignment to conduct proper inspection of structure. (O. Magana - DWR UCIP) FIELD_STRUCT_DESC: 24-inch corrugated metal (CM) gravity drainage pipe through the levee, 9.5 feet below the crown. Flap gate on the waterside (WS) end. Brass cap No. 50 bench mark (BM) on the headwall on the landside (LS). [Additional Reference(s): DWR Levee Log, 2002, (HLM 17.53). USACE San Joaquin O&M Manual, Unit No. 601, Part No. 1, (SJR601.1), 1967, Revised 25 May 2011, (HLM 17.53)]. FS Date: 11/16/2020

Overview of levee crown, looking US

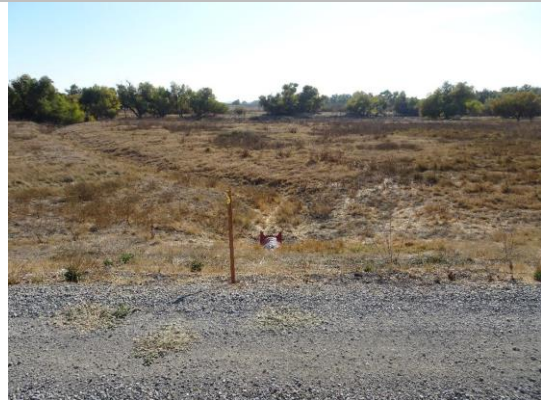
Photo 2 of 3 : UCIP_SP_2024_70707_90844.jpg

WS view: overview of WS. Pipe and flapgate visible on WS toe.

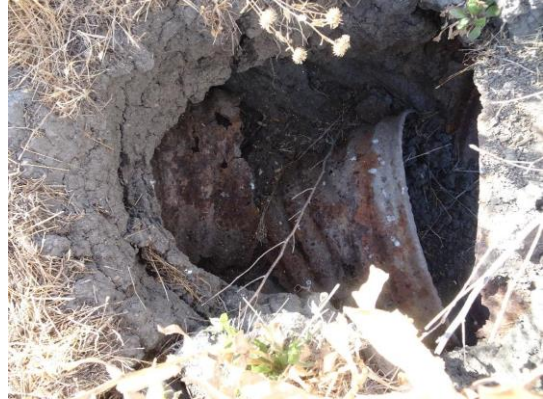
Photo 3 of 3 : UCIP_SP_2024_70707_90838.jpg

LS view: Pipe collapse visible in sinkhole along pipe alignment, photo 2 of 2.

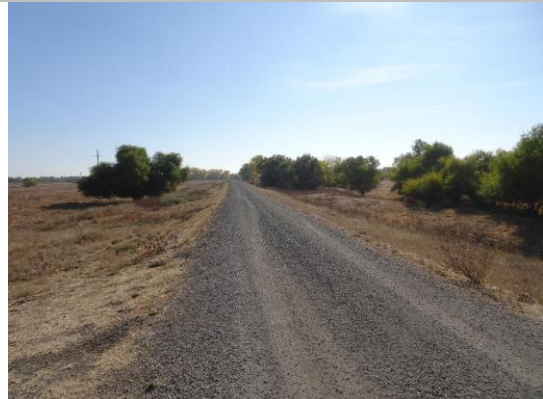
Photo 1 of 3 : UCIP_SP_2024_70708_90849.jpg

DS_ID:19581
FS_ID:70708
EP_NO: N/A
Repair Type: Urgent
EVAL Issue: 1, Pipe Integrity
Crossing Status: Found
UCIP Comments: 11/16/2020 Record has been updated from Non-Urgent to Urgent. Considerable damage to the pipe interior is visible from LS toe. DWR DMP has found integrity issues, LOF between 5 and 6. Crossing will be monitored until funding becomes available to address. No permit was found authorizing this encroachment. CVFPB will need to review crossing to determine owner. (B. Singh - GEI, O. Magana - DWR UCIP)04/25/2014 Need to contact owner.
Recommend investigating integrity of pipe wall through levee heavy corrosion visible from landward side. (O. Magana - DWR UCIP)
FIELD_STRUCT_DESC: 24-inch corrugated metal (CM) gravity drainage pipe through the levee, 11.5 feet below the crown. Flap gate on the waterside (WS) end. Brass cap No. 50 bench mark (BM) on the headwall on the landside (LS). [Additional Reference(s): DWR Levee Log, 2002, (HLM 18.21). USACE San Joaquin O&M Manual, Unit No. 601, Part No. 1, (SJR601.1), 1967, Revised 25 May 2011, (HLM 18.19)].

Overview of levee crown looking upstream, photo 1 of 2.

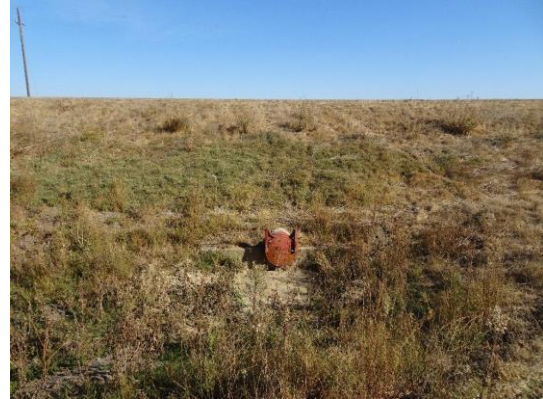
Photo 2 of 3 : UCIP_SP_2024_70708_90850.jpg

WS view: Pipe, flapgate, and headwall at WS toe

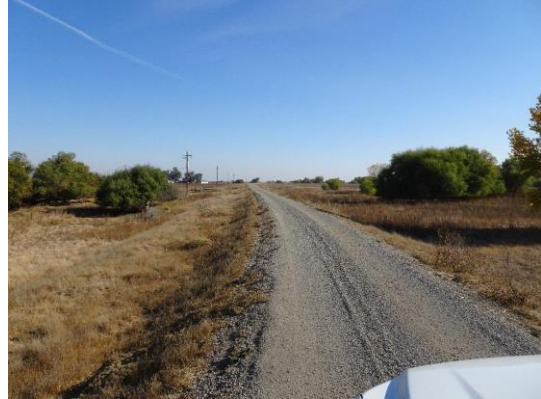
Photo 1 of 3 : UCIP_SP_2024_70709_93037.jpg

Comment Code					
Inspector Comment					
DS_ID:19582 FS_ID:70709 EP_NO: N/A Repair Type: Urgent EVAL Issue: 1, Pipe Integrity Crossing Status: Found UCIP Comments: 11/16/2020 Record has been updated from No Action Needed to Urgent. DWR DMP has found integrity issues, LOF between 5 and 6. No damage observed on the levee during the field inspection. Crossing will be monitored until funding becomes available to address. No permit was found authorizing this encroachment. CVFPB will need to review crossing to determine owner. (B. Singh - GEI, O. Magana - DWR UCIP) FIELD_STRUCT_DESC: 24-inch corrugated metal (CM) gravity drainage pipe through the levee, 9.4 feet below the crown. Flap gate on the waterside (WS) end. Brass cap No. 50 bench mark (BM) on the headwall on the landside (LS). [Additional Reference(s): DWR Levee Log, 2002, (HLM 18.47). USACE San Joaquin O&M Manual, Unit No. 601, Part No. 1, (SJR601.1), 1967, Revised 25 May 2011, (HLM 18.45)]. FS Date: 11/16/2020

Overview of levee crown looking upstream, photo 1 of 2.

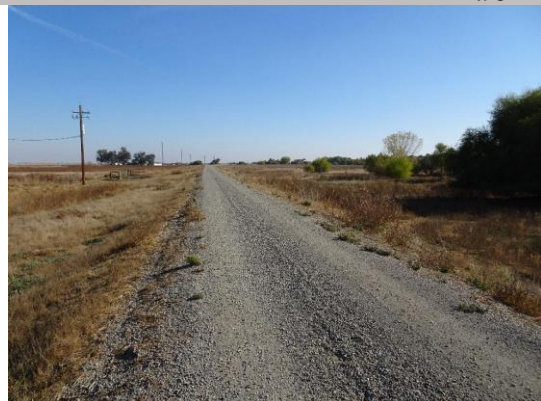
Photo 2 of 3 : UCIP_SP_2024_70709_90856.jpg

Overview of levee crown looking upstream, photo 2 of 2.

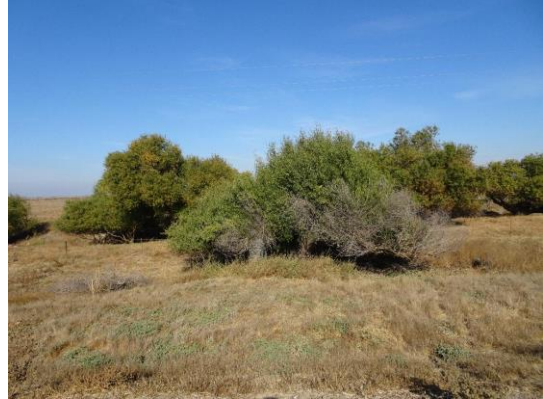
Photo 3 of 3 : UCIP_SP_2024_70709_90854.jpg

LS view: overview of LS.

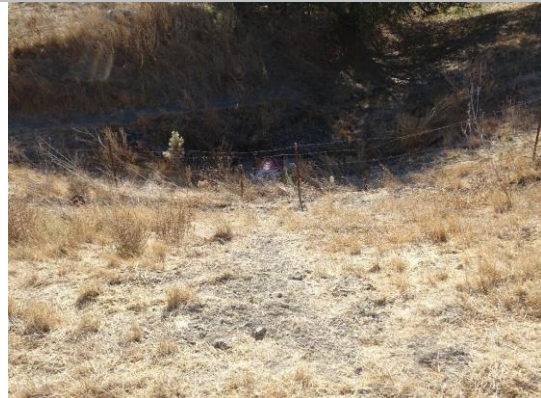
Photo 2 of 3 : UCIP_SP_2024_70711_91061.jpg

Comment Code						
Inspector Comment						
DS_ID:19593 FS_ID:70711 EP_NO: N/A Repair Type: Non-Urgent EVAL Issue: Crossing Status: Found UCIP Comments: 09/18/2023 Pipe was CIPP lined. DMP internal video inspection has found none or minor pipe defects. Recommend next video inspection in 5 years. (O. Yakimov - DWR UCIP) 11/16/2020 Record remains Non-Urgent. DWR DMP has found integrity issues, LOF between 4 and 5. Crossing will be monitored until funding becomes available for rehabilitation. No permit was found authorizing this encroachment. CVFPB will need to review crossing to determine owner. Fence located on the WS prevented access to the pipe. (B. Singh - GEI, O. Magana - DWR UCIP)04/25/2014 Dense vegetation limits the inspector's visibility to identify signs of pipe failure (leaks) along the landward slope. Recommend removing vegetation along pipe alignment to conduct proper inspection of structure. (O. Magana - DWR UCIP) FIELD_STRUCT_DESC: 24-inch CIPP-lined corrugated metal (CM) gravity drainage pipe through the levee, 12.0 feet below the crown. Flap gate on the waterside (WS) end. Brass cap No. 50 bench mark (BM) on the headwall on the landside (LS). [Additional Reference(s): DWR Levee Log, 2002, (HLM 18.80). USACE San Joaquin O&M Manual, Unit No. 601, Part No. 1, (SJR601.1), 1967, Revised 25 May 2011, (HLM 18.79)]. FS Date: 11/16/2020

View waterward

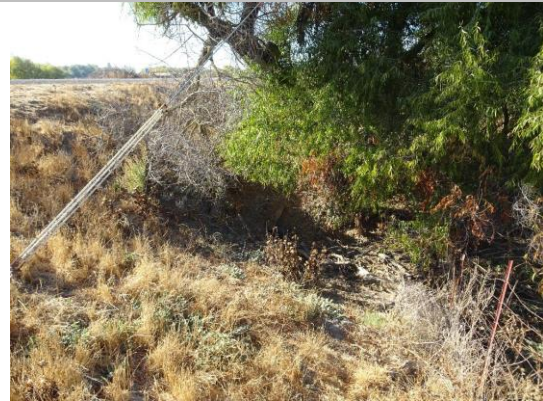
Photo 3 of 3 : UCIP_SP_2024_70711_91062.jpg

Headwall and pipe at LS toe

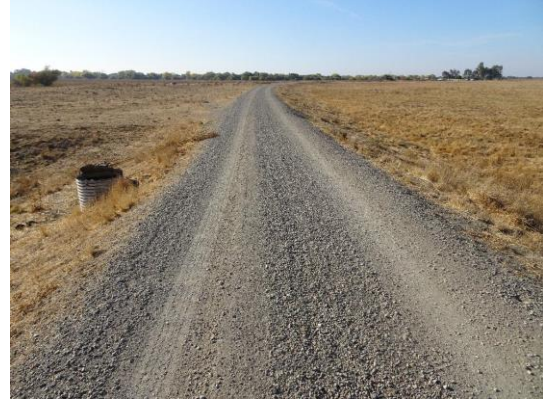
Photo 1 of 3 : UCIP_SP_2024_70712_90861.jpg

Comment Code						
Inspector Comment						
DS_ID:19594 FS_ID:70712 EP_NO: N/A Repair Type: Non-Urgent EVAL Issue: 11, Maintenance Compliance Issue Crossing Status: Found UCIP Comments: 11/16/2020 Record remains Non-Urgent. Unable to locate pipe on the WS. Pipe appears to be buried on WS. Sediment build-up observed at the LS inlet. Recommend sediment removal and evaluation of pipe's purpose. Pipe is currently non-functional. No permit was found authorizing this encroachment. CVFPB will need to review crossing to determine owner. DWR DMP internal inspection is pending and scheduled for 2021. Recommend adding riser cover on the WS as a safety measure. (B. Singh - GEI, O. Magana - DWR UCIP)04/25/2014 Non-functional crossing--pipe is buried on waterward side. Sediment buildup in pipe visible from landward side. Need to coordinate with owner to determine status. If crossing is no longer in use, owner will need to coordinate with DWR Inspector and CVFPB to properly abandon. (O. Magana - DWR UCIP) FIELD_STRUCT_DESC: 24-inch corrugated metal (CM) gravity drainage pipe through the levee, 13.0 feet below the crown. Flap gate on the waterside (WS) end. Brass cap No. 40 bench mark (BM) on the headwall on the landside (LS). [Additional Reference(s): DWR Levee Log, 2002, (HLM 19.18). USACE San Joaquin O&M Manual, Unit No. 601, Part No. 1, (SJR601.1), 1967, Revised 25 May 2011, (HLM 19.17)]. FS Date: 11/16/2020

Overview of levee crown

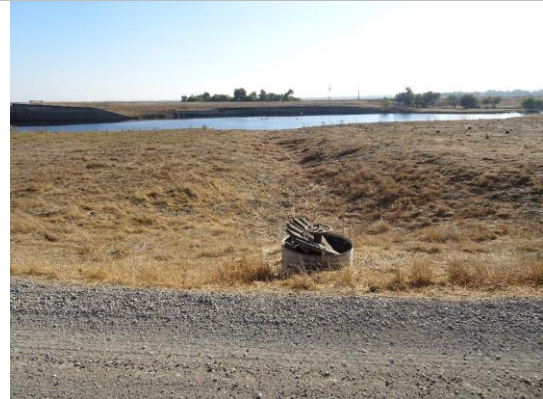
Photo 2 of 3 : UCIP_SP_2024_70712_90862.jpg

Pipe riser visible on WS slope

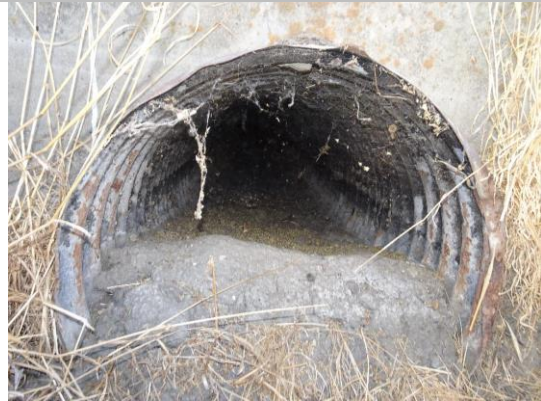
Photo 3 of 3 : UCIP_SP_2024_70712_90857.jpg

Considerable sediment build-up at LS inlet

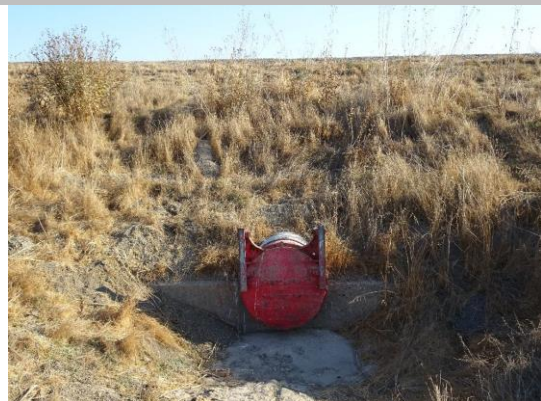
Photo 1 of 2 : UCIP_SP_2024_83271_90889.jpg

DS_ID:19596
FS_ID:83271
EP_NO: N/A
Repair Type: No Action Needed
EVAL Issue:
Crossing Status: Found
UCIP Comments: 11/16/2020 Record remains Non-Urgent. No permit was found authorizing this encroachment. CVFPB will need to review crossing to determine owner. DWR DMP has not found internal issues, LOF between 1 and 2. Recommend inspection in 5 years. (B. Singh - GEI, O. Magana - DWR UCIP)04/25/2014 Dense vegetation limits the inspector's visibility to identify signs of pipe failure (leaks) along the waterward slope. Recommend removing vegetation along pipe alignment to conduct proper inspection of structure. Dense vegetation blocks both waterward and landward headwalls. Sediment buildup in pipe visible from landward side. (O. Magana - DWR UCIP)
FIELD_STRUCT_DESC: 24-inch corrugated metal (CM) gravity drainage pipe through the levee, 8.0 feet below the crown. Flap gate on the waterside (WS) end. Brass cap No. 40 bench mark (BM) on the headwall on the landside (LS). [Additional Reference(s): DWR Levee Log, 2002, (HLM 19.54). USACE San Joaquin O&M Manual, Unit No. 601, Part No. 1, (SJR601.1), 1967, Revised 25 May 2011, (HLM 19.54)].

WS view: concrete headwall, flap gate, and WS slope visible on WS.

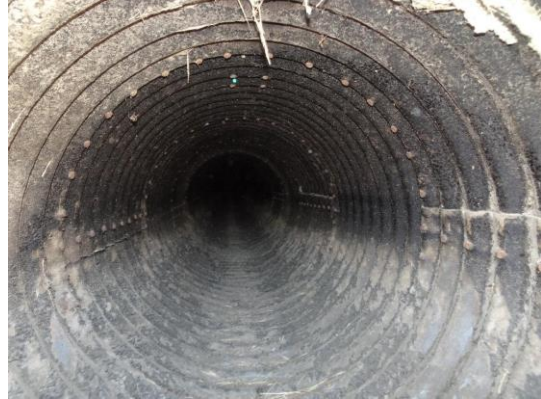
Photo 2 of 2 : UCIP_SP_2024_83271_90894.jpg

LS view: Interior of pipe from LS toe

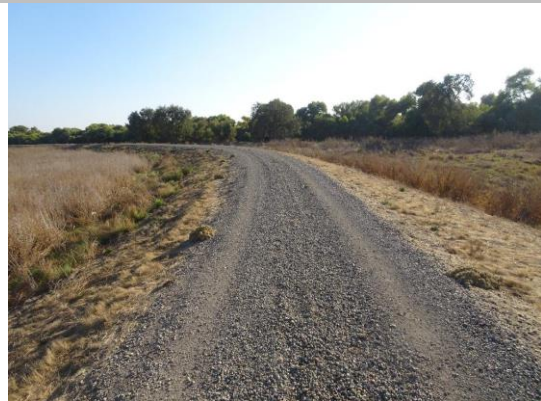
Photo 1 of 3 : UCIP_SP_2024_83272_90896.jpg

DS_ID:19597
 FS_ID:83272
 EP_NO: N/A
 Repair Type: No Action Needed
 EVAL Issue:
 Crossing Status: Found
 UCIP Comments: 04/24/2024 Record updated from Non-Urgent to No Action Needed. DMP internal video inspection has found none or minor pipe defects. (M. Thao - DWR UCIP)
 11/16/2020 Record remains Non-Urgent. No permit was found authorizing this encroachment. CVFPB will need to review crossing to determine owner. DWR DMP internal inspection is pending and scheduled for 2021. (B. Singh - GEI, O. Magana - DWR UCIP)
 04/25/2014 No photos available for crossing--crossing missed. Recommend taking photos to confirm status of crossing. (O. Magana - DWR UCIP)
 FIELD_STRUCT_DESC: 24-inch corrugated metal (CM) gravity drainage pipe through the levee, 8.0 feet below the crown. Flap gate on the waterside (WS) end. Brass cap No. 40 bench mark (BM) on the headwall on the landside (LS). [Additional Reference(s): DWR Levee Log, 2002, (HLM 19.82). USACE San Joaquin O&M Manual, Unit No. 601, Part No. 1, (SJR601.1), 1967, Revised 25 May 2011, (HLM 19.81)].

Overview of levee crown looking u/s
