**Flood Control Project Maintenance
Levee Inspections**

Maintenance Issue Types Only, Levee Inspection Report By Mile - Spring 2024

Lower San Joaquin Levee District

Waterway	Bank	Unit Miles	Inspection Start/End	Inspector
Unit No. 01 San Joaquin River	Right	22.52	03/12/2024 03/12/2024	Corey Fujitani

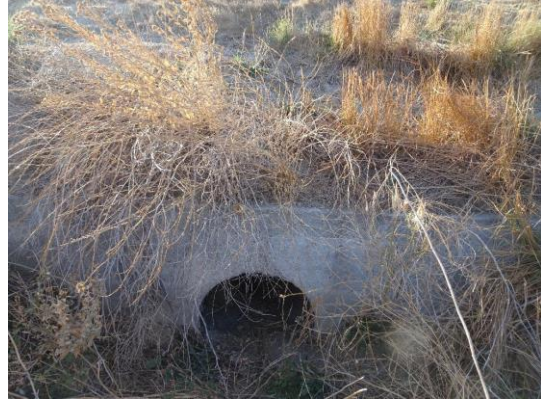
Photo 2 of 3 : UCIP_SP_2024_83272_90899.jpg

DS_ID:19597
 FS_ID:83272
 EP_NO: N/A
 Repair Type: No Action Needed
 EVAL Issue:
 Crossing Status: Found
 UCIP Comments: 04/24/2024 Record updated from Non-Urgent to No Action Needed. DMP internal video inspection has found none or minor pipe defects. (M. Thao - DWR UCIP)
 11/16/2020 Record remains Non-Urgent. No permit was found authorizing this encroachment. CVFPB will need to review crossing to determine owner. DWR DMP internal inspection is pending and scheduled for 2021. (B. Singh - GEI, O. Magana - DWR UCIP)
 04/25/2014 No photos available for crossing--crossing missed. Recommend taking photos to confirm status of crossing. (O. Magana - DWR UCIP)
 FIELD_STRUCT_DESC: 24-inch corrugated metal (CM) gravity drainage pipe through the levee, 8.0 feet below the crown. Flap gate on the waterside (WS) end. Brass cap No. 40 bench mark (BM) on the headwall on the landside (LS). [Additional Reference(s): DWR Levee Log, 2002, (HLM 19.82). USACE San Joaquin O&M Manual, Unit No. 601, Part No. 1, (SJR601.1), 1967, Revised 25 May 2011, (HLM 19.81)].

LS view: pipe and headwall at LS toe

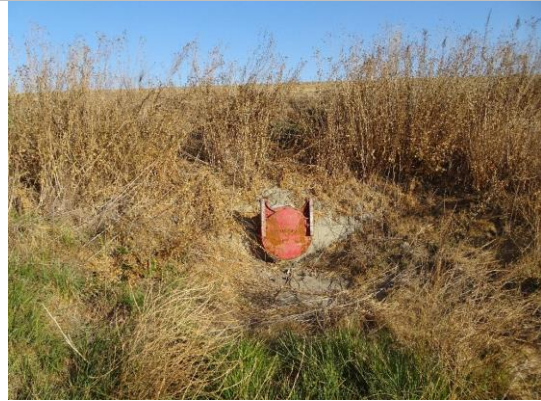
Photo 3 of 3 : UCIP_SP_2024_83272_90902.jpg

WS view: Pipe, flapgate, and headwall at WS toe

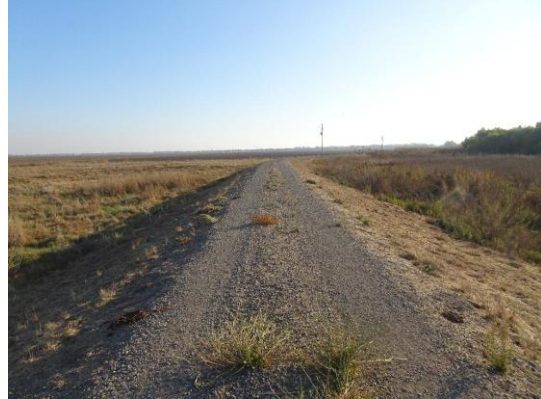
Photo 1 of 3 : UCIP_SP_2024_83273_90903.jpg

Comment Code					
Inspector Comment					
DS_ID:19598 FS_ID:83273 EP_NO: N/A Repair Type: Non-Urgent EVAL Issue: Crossing Status: Found UCIP Comments: 11/16/2020 Record remains Non-Urgent. Limited access due to steep slopes. No permit was found authorizing this encroachment. CVFPB will need to review crossing to determine owner. DWR DMP internal inspection is pending and scheduled for 2021. (B. Singh - GEI, O. Magana - DWR UCIP)04/25/2014 Recommend removing vegetation and sediment buildup from both waterward and landward concrete headwalls. (O. Magana - DWR UCIP) FIELD_STRUCT_DESC: 24-inch corrugated metal (CM) gravity drainage pipe through the levee, 8.5 feet below the crown. Flap gate on the waterside (WS) end. Brass cap No. 40 bench mark (BM) on the headwall on the landside (LS). [Additional Reference(s): DWR Levee Log, 2002, (HLM 20.19). USACE San Joaquin O&M Manual, Unit No. 601, Part No. 1, (SJR601.1), 1967, Revised 25 May 2011, (HLM 20.18)]. FS Date: 11/16/2020

Overview of levee crown looking upstream

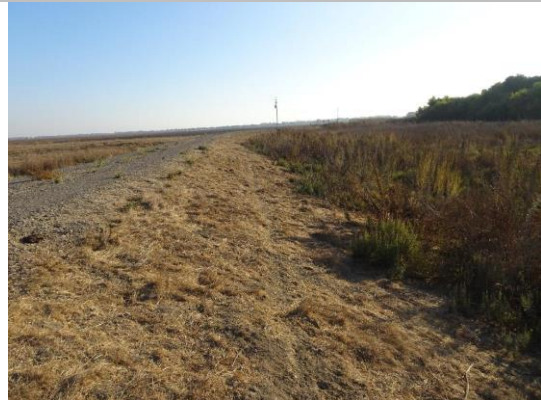
Photo 2 of 3 : UCIP_SP_2024_83273_90904.jpg

WS view: WS slope profile

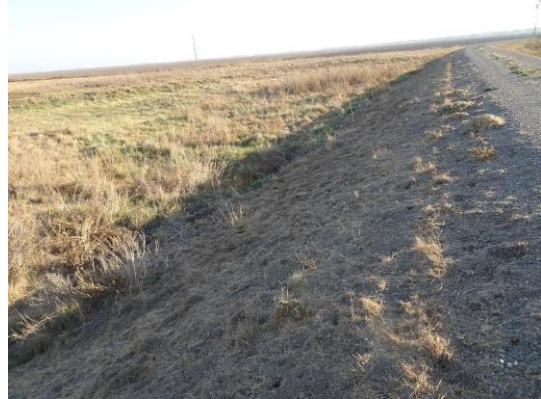
Photo 3 of 3 : UCIP_SP_2024_83273_90905.jpg

LS view: LS slope profile

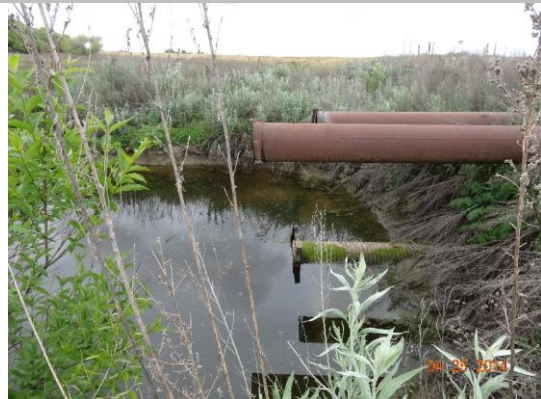
Photo 1 of 2 : UCIP_SP_2024_70721_66309.jpg

DS_ID:19600
FS_ID:70721
EP_NO: N/A
Repair Type: Non-Urgent
EVAL Issue:
Crossing Status: Found
UCIP Comments: 11/16/2020 Record remains Non-Urgent. Dense vegetation and fence on the WS prevented proper inspection of pipe. No permit has been found authorizing this pipe. CVFPB will need to review crossing to determine owner. (O. Magana - DWR UCIP)04/25/2014 Crossing partially submersed--no signs of failure of pipe present along pipe alignment. Recommend contacting owner to determine status of crossing and condition. (O. Magana - DWR UCIP) FIELD_STRUCT_DESC: 36-inch corrugated metal (CM) gravity drainage pipe through the levee, 10.5 feet below the crown. Flap gate on the waterside (WS) end. Brass cap No. 40 bench mark (BM) on the headwall on the landside (LS). [Additional Reference(s): DWR Levee Log, 2002, (HLM 20.28). USACE San Joaquin O&M Manual, Unit No. 601, Part No. 1, (SJR601.1), 1967, Revised 25 May 2011, (HLM 20.27)]. FS Date: 11/6/2020

Multiple crossings visible on waterward side--36 inch CMP is submersed in water.

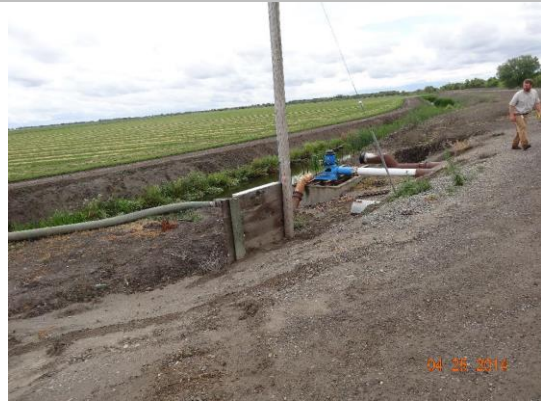
Photo 2 of 2 : UCIP_SP_2024_70721_66307.jpg

View of landward side.

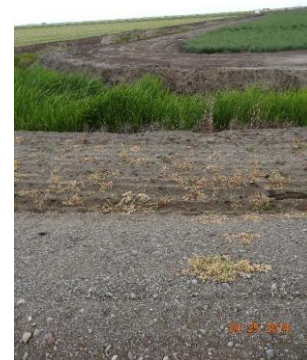
Photo 2 of 3 : UCIP_SP_2024_80999_66311.jpg

Comment Code						
Inspector Comment						
DS_ID:19603 FS_ID:80999 EP_NO: N/A Repair Type: Urgent EVAL Issue: 1, Pipe Integrity Crossing Status: Found UCIP Comments: 09/15/2023 Record updated from Non-Urgent to Urgent. DMP internal video inspection has found severe pipe defects. Crossing will be monitored until funding becomes available to address the issues. (O. Yakimov - DWR UCIP) 05/06/2021 Record remains Non-Urgent. This crossing appears to be non-functional based on the 2014 UCIP inspection. No field inspection has been completed by UCIP. DWR DMP internal inspection is pending and scheduled for 2021. Recommend having UCIP inspector or Levee inspector take current photos of the site. (O. Magana - DWR UCIP)04/25/2014 Crossing is non-functional--crossing buried on landward side. Need to contact owner to determine status of crossing. If crossing is no longer used need to coordinate with CVFPB for proper abandonment. (O. Magana - DWR UCIP) FIELD_STRUCT_DESC: 36-inch corrugated metal (CM) gravity drainage pipe through the levee, 11.5 feet below the crown. Flap gate on the waterside (WS) end. Brass cap No. 40 bench mark (BM) on the headwall on the landside (LS). [Additional Reference(s): DWR Levee Log, 2002, (HLM 21.41). USACE San Joaquin O&M Manual, Unit No. 601, Part No. 1, (SJR601.1), 1967, Revised 25 May 2011, (HLM 21.40)]. FS Date: 5/16/2021

View of landward side.

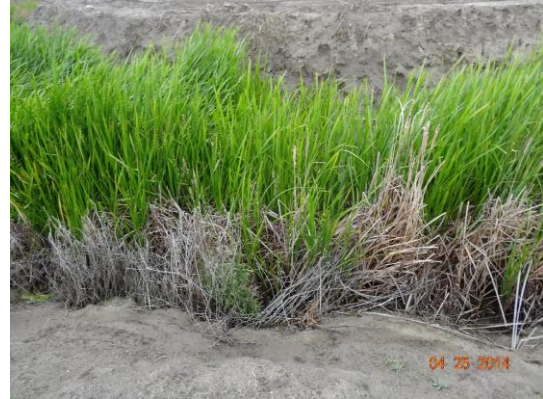
Photo 3 of 3 : UCIP_SP_2024_80999_66310.jpg

No signs of concrete headwall on landward toe.

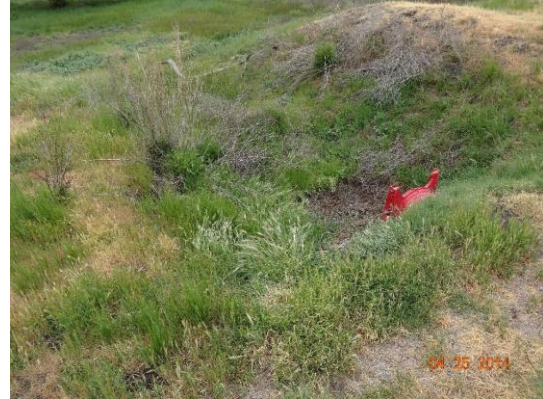
Photo 1 of 2 : UCIP_SP_2024_77848_65695.jpg

Comment Code						
Inspector Comment						
DS_ID:19604 FS_ID:77848 EP_NO: N/A Repair Type: Urgent EVAL Issue: 1, Pipe Integrity Crossing Status: Found UCIP Comments: 12/14/2022 Record updated from Non-Urgent to Urgent. DMP internal video inspection has found pipe integrity issues. LOF of crossing is between 5 and 6. Crossing will be monitored until funding becomes available to address the issues. (O.Yakimov - DWR UCIP) 05/06/2021 Record remains Non-Urgent. This crossing appears to be non-functional based on the 2014 UCIP inspection. No field inspection has been completed by UCIP. DWR DMP internal inspection is pending and scheduled for 2021. Recommend having UCIP inspector or Levee inspector take current photos of the site. (O. Magana - DWR UCIP)04/25/2014 Non-functional crossing-landward side is buried. Need to contact owner to determine status of crossing. If crossing is no longer used need to coordinate with CVFPB for proper abandonment. (O. Magana - DWR UCIP) FIELD_STRUCT_DESC: 24-inch corrugated metal (CM) gravity drainage pipe through the levee, 9.0 feet below the crown. Flap gate on the waterside (WS) end. Brass cap No. 40 bench mark (BM) on the headwall on the landside (LS). [Additional Reference(s): DWR Levee Log, 2002, (HLM 21.78). USACE San Joaquin O&M Manual, Unit No. 601, Part No. 1, (SJR601.1), 1967, Revised 25 May 2011, (HLM 21.76)]. FS Date: 5/6/2021 1:29:33 PM

Flap gate visible on waterward side.

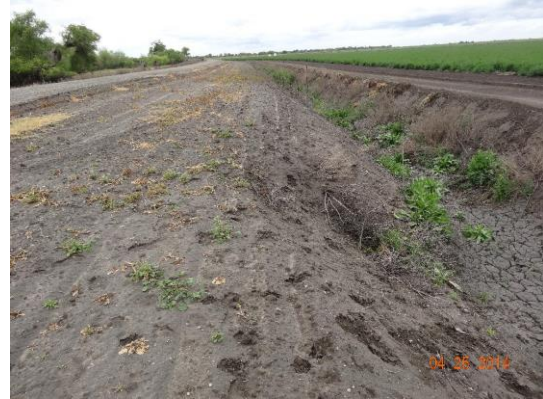
Photo 2 of 2 : UCIP_SP_2024_77848_65698.jpg

Crossing not found on landward side. No signs on canal located on landward side.

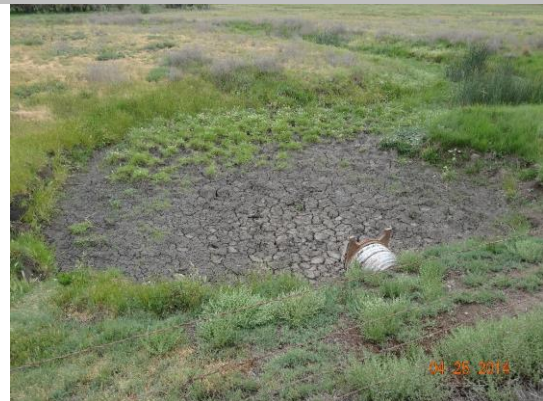
Photo 1 of 2 : UCIP_SP_2024_70729_65707.jpg

DS_ID:19605
 FS_ID:70729
 EP_NO: N/A
 Repair Type: Non-Urgent
 EVAL Issue:
 Crossing Status: Found
 UCIP Comments: 05/06/2021 Record remains Non-Urgent. This crossing appears to be non-functional based on the 2014 UCIP inspection. No field inspection has been completed by UCIP. DWR DMP internal inspection is pending and scheduled for 2021. Recommend having UCIP inspector or Levee inspector take current photos of the site. (O. Magana - DWR UCIP)04/25/2014 Non-functional crossing--landward side is buried. Need to contact owner to determine status. If crossing is no longer used need to coordinate with CVFPB for proper abandonment. (O. Magana - DWR UCIP)
 FIELD_STRUCT_DESC: 24-inch corrugated metal (CM) gravity drainage pipe through the levee, 9.0 feet below the crown. Flap gate on the waterside (WS) end. Wooden headboards on the landside (LS) end. Brass cap No. 31 bench mark (BM) on the headwall on the LS.

Flap gate visible on waterward side.

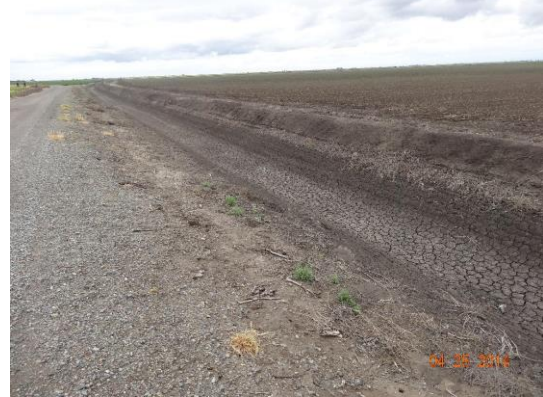
Photo 2 of 2 : UCIP_SP_2024_70729_65710.jpg

View of landward side.

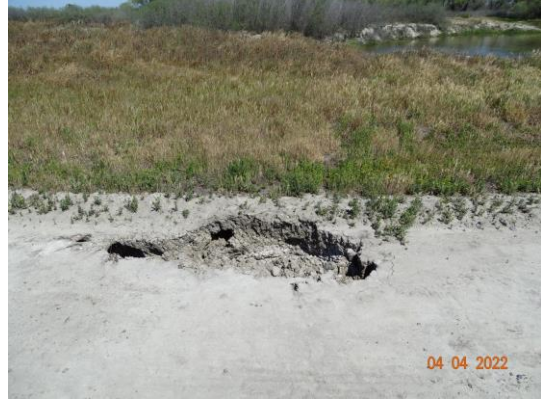
Photo 1 of 1 : SP_2024_NA0010_119_26_20240212_00004.jpg

LM Start	0.74	Rating **	A/W	Issue No.	26
LM End	0.74	Issue Type +	Ma	Location *	LS
Category	Earthen Levee			GPS Latitude/Longitude	
				Start	End
Item	Animal Control			37.287094°	37.287094°
				-120.874422°	-120.874422°
DWR ID	DWR_NA0010_02A_s _ 2022_26				
Comment Code					
A3 : No rodents visible, but rodent burrows visible; need to backfill and compact or grout burrows.					
Inspector Comment					
Rodent burrow caved in along the landside toe. The toe is used in this section to bypass the erosion through the levee crown.

Ground on the landside toe collapsed from rodent activity. (Spring 2022)

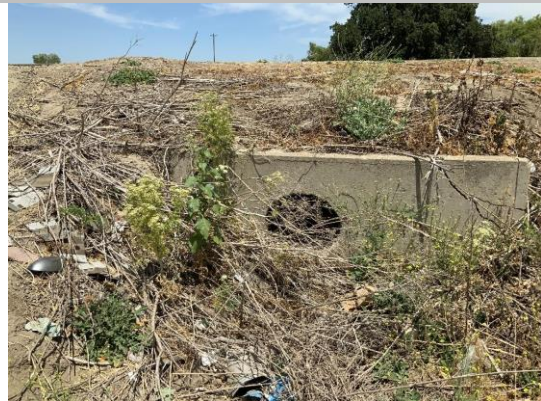
Photo 1 of 1 : UCIP_SP_2024_70941_100118.jpg

Comment Code						
Inspector Comment						
DS_ID:19660 FS_ID:70941 EP_NO: N/A Repair Type: Non-Urgent EVAL Issue: 11, Maintenance Compliance Issue Crossing Status: Found UCIP Comments: 06/8/2021 The record remains Non-Urgent. Vegetation present at pipe inlet on LS, recommend removal. No permit was found authorizing this encroachment. CVFPB will need to review crossing to determine owner. The UCIP inspection was completed with GEI staff, P. Espinoza. (H. Dunn ? GEI) 05/01/2014 Dense vegetation limits the inspector's visibility to identify signs of pipe failure (leaks) along the slope. Recommend removing vegetation along pipe alignment to conduct proper inspection of structure. (O. Magana - DWR UCIP) FIELD_STRUCT_DESC: 24-inch corrugated metal gravity drainage pipe (CMP) through the levee, 7.0 feet below the crown. Flap gate on the waterside (WS) end. Brass cap No. 135 bench mark (BM) on the headwall on the landside (LS). [Additional Reference(s): DWR Levee Log, 2002, (HLM 2.34). USACE San Joaquin O&M Manual, Unit No. 601, Part No. 1, 1967, Amended in 1978, Revised 20 June 1985, (HLM 2.32)]. FS Date: 6/8/2021

LS view: Slope and headwall at toe.

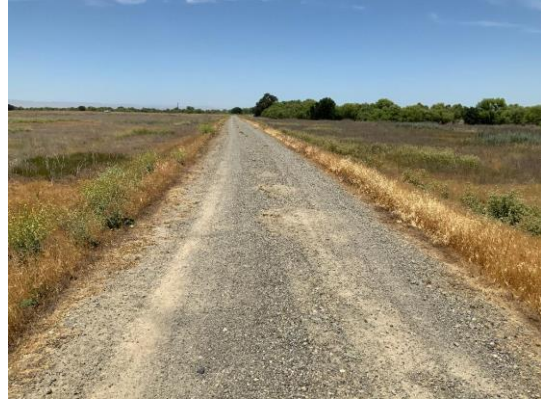
Photo 1 of 3 : UCIP_SP_2024_70942_100127.jpg

Comment Code						
Inspector Comment						
DS_ID:19661 FS_ID:70942 EP_NO: N/A Repair Type: Non-Urgent EVAL Issue: Crossing Status: Found UCIP Comments: 06/8/2021 The record remains Non-Urgent. Vegetation on LS and WS limited close up inspection of flapgate and pipe inlet. No permit was found authorizing this encroachment. CVFPB will need to review crossing to determine owner. The UCIP inspection was completed with GEI staff, P. Espinoza. (H. Dunn – GEI) 05/01/2014 Dense vegetation limits the inspector's visibility to identify signs of pipe failure (leaks) along the slope. Recommend removing vegetation along pipe alignment to conduct proper inspection of structure. (O. Magana - DWR UCIP) FIELD_STRUCT_DESC: 24-inch corrugated metal gravity drainage pipe (CMP) through the levee, 10.0 feet below the crown. Flap gate on the waterside (WS) end. Brass cap No. 130 bench mark (BM) on the headwall on the landside (LS). [Additional Reference(s): DWR Levee Log, 2002, (HLM 2.60). USACE San Joaquin O&M Manual, Unit No. 601, Part No. 1, 1967, Amended in 1978, Revised 20 June 1985, (HLM 2.59)]. FS Date: 6/8/2021

Levee crown looking downstream.

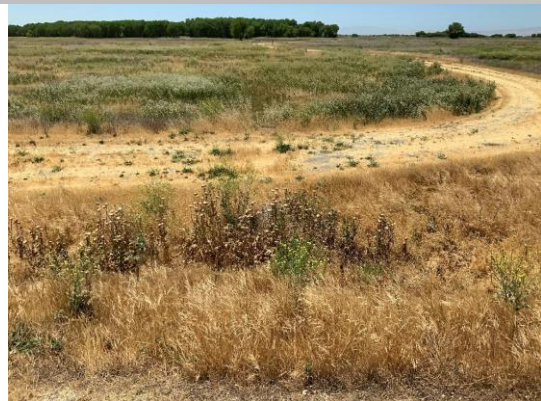
Photo 2 of 3 : UCIP_SP_2024_70942_100126.jpg

LS view: Toe from crown.

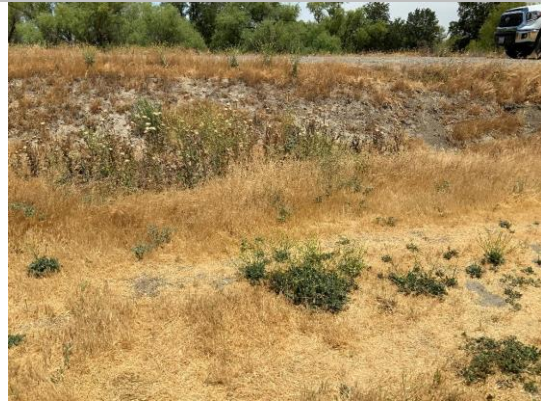
Photo 3 of 3 : UCIP_SP_2024_70942_100121.jpg

LS view: Slope from toe.

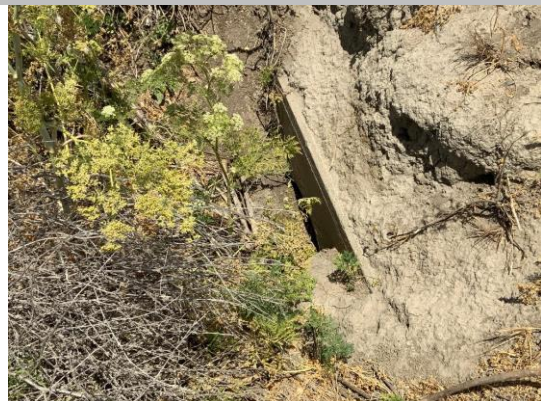
Photo 1 of 1 : UCIP_SP_2024_70943_100135.jpg

DS_ID:19662
 FS_ID:70943
 EP_NO: N/A
 Repair Type: Non-Urgent
 EVAL Issue: 11, Maintenance Compliance Issue
 Crossing Status: Found
 UCIP Comments: 06/7/2021 The record remains Non-Urgent. LS pipe inlet completely buried in sediment, recommend clearing out. No permit was found authorizing this encroachment. CVFPB will need to review crossing to determine owner. The UCIP inspection was completed with GEI staff, P. Espinoza. (H. Dunn – GEI) 05/01/2014 Dense vegetation limits the inspector's visibility to identify signs of pipe failure (leaks) along the slope. Recommend removing vegetation along pipe alignment to conduct proper inspection of structure. (O. Magana - DWR UCIP)
 FIELD_STRUCT_DESC: 24-inch corrugated metal gravity drainage pipe (CMP) through the levee, 10.0 feet below the crown. Flap gate on the waterside (WS) end. Brass cap No. 130 bench mark (BM) on the headwall on the landside (LS). [Additional Reference(s): DWR Levee Log, 2002, (HLM 2.97). USACE San Joaquin O&M Manual, Unit No. 601, Part No. 1, 1967, Amended in 1978, Revised 20 June 1985, (HLM 2.96)].

LS view: Headwall barely visible at toe, covered in sediment.

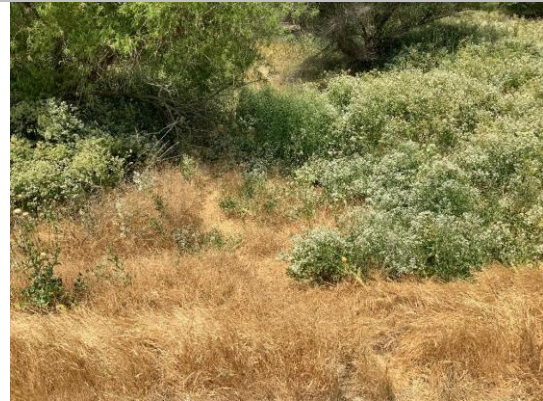
Photo 1 of 1 : UCIP_SP_2024_70944_100142.jpg

Comment Code					
Inspector Comment					
DS_ID:19665 FS_ID:70944 EP_NO: N/A Repair Type: Non-Urgent EVAL Issue: 11, Maintenance Compliance Issue Crossing Status: Found UCIP Comments: 06/7/2021 The record remains Non-Urgent. Dense vegetation limited view and inspection of LS pipe inlet. Recommend removal of LS vegetation. No permit was found authorizing this encroachment. CVFPB will need to review crossing to determine owner. The UCIP inspection was completed with GEI staff, P. Espinoza. (H. Dunn – GEI) 05/01/2014 Dense vegetation limits the inspector's visibility to identify signs of pipe failure (leaks) along the slope. Recommend removing vegetation along pipe alignment to conduct proper inspection of structure. (O. Magana - DWR UCIP) FIELD_STRUCT_DESC: 24-inch corrugated metal gravity drainage pipe (CMP) through the levee, 12.4 feet below the crown. Flap gate on the waterside (WS) end. Brass cap No. 130 bench mark (BM) on the headwall on the landside (LS). [Additional Reference(s): DWR Levee Log, 2002, (HLM 3.31). USACE San Joaquin O&M Manual, Unit No. 601, Part No. 1, 1967, Amended in 1978, Revised 20 June 1985, (HLM 3.29)]. FS Date: 6/7/2021

LS view: Toe from crown, pipe end not visible.

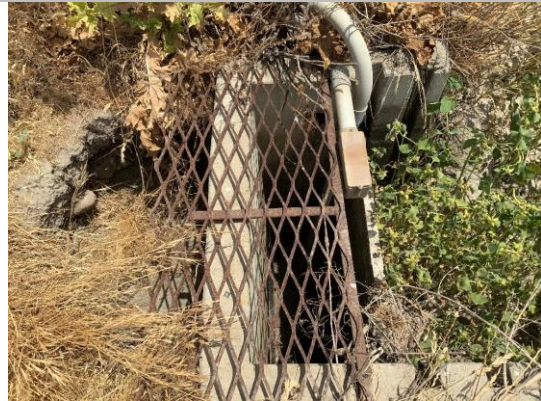
Photo 1 of 1 : UCIP_SP_2024_83301_100143.jpg

Comment Code						
Inspector Comment						
DS_ID:19666 FS_ID:83301 EP_NO: N/A Repair Type: Urgent EVAL Issue: 1, Pipe Integrity Crossing Status: Found UCIP Comments: 12/14/2022 Record updated from Non-Urgent to Urgent. DMP internal video inspection has found pipe integrity issues. LOF of crossing is between 5 and 6. Crossing will be monitored until funding becomes available to address the issues. (O. Yakimov - DWR UCIP) 06/7/2021 The record remains Non-Urgent. LS has boards blocking the open pipe inlet but there is significant sediment and vegetation on the other side of the boards, recommend cleaning around. No permit was found authorizing this encroachment. CVFPB will need to review crossing to determine owner. The UCIP inspection was completed with GEI staff, P. Espinoza. (H. Dunn – GEI)						
05/01/2014 Dense vegetation limits the inspector's visibility to identify signs of pipe failure (leaks) along the slope. Recommend removing vegetation along pipe alignment to conduct proper inspection of structure. (O. Magana - DWR UCIP) FIELD_STRUCT_DESC: 24-inch corrugated metal gravity drainage pipe (CMP) through the levee, 10.0 feet below the crown. Flap gate on the waterside (WS) end. Brass cap No. 130 bench mark (BM) on the headwall on the landside (LS). [Additional Reference(s): DWR Levee Log, 2002, (HLM 3.63). USACE San Joaquin O&M Manual, Unit No. 601, Part No. 1, 1967, Amended in 1978, Revised 20 June 1985, (HLM 3.62)]. FS Date: 6/7/2021 1:46:07 PM

LS view: Close up of pipe inlet and headwall. Sediment behind boards blocking pipe inlet.

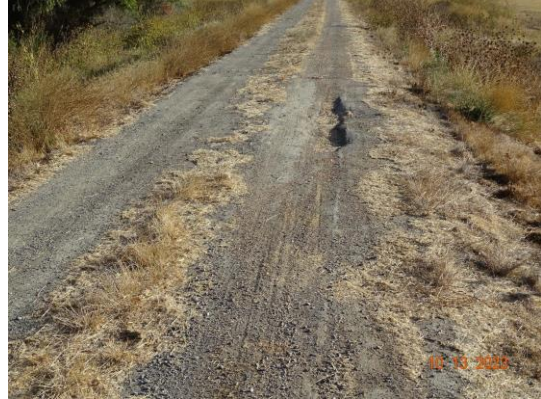
Photo 1 of 1 : SP_2024_NA0010_119_23_20240212_00002.jpg

LM Start	3.69	Rating **	M	Issue No.	23
LM End	3.69	Issue Type +	Ma	Location *	CR
Category	Earthen Levee			GPS Latitude/Longitude	
				Start	End
Item	Crown Surface / Depressions / Rutting			37.278949°	37.278949°
				-120.838776°	-120.838776°
DWR ID	DWR_NA0010_02A_f_2020_23				
Comment Code					
C2 : Repair depressions or ruts in the crown or slope.					
Inspector Comment

Rutting along the levee crown. (Fall 2023)

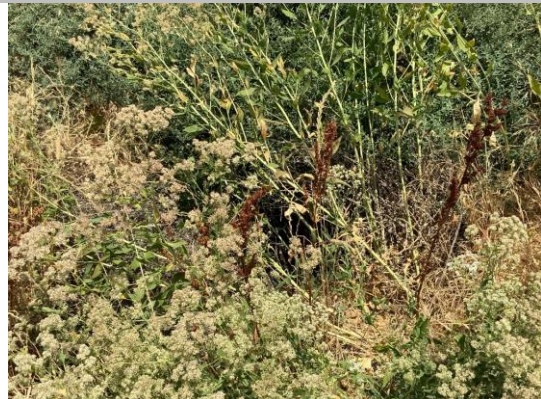
Photo 1 of 1 : UCIP_SP_2024_70946_100157.jpg

Comment Code						
Inspector Comment						
DS_ID:19667						
FS_ID:70946						
EP_NO: N/A						
Repair Type: Non-Urgent						
EVAL Issue: 11, Maintenance Compliance Issue						
Crossing Status: Found						
UCIP Comments: 06/7/2021 The record remains Non-Urgent. Dense vegetation around LS pipe inlet, recommend removal. No permit was found authorizing this encroachment. CVFPB will need to review crossing to determine owner. The UCIP inspection was completed with GEI staff, P. Espinoza. (H. Dunn – GEI) 05/01/2014 Signs of erosion or sink hole present on landward toe--Need to contact owner. Dense vegetation limits the inspector's visibility to identify signs of pipe failure (leaks) along the slope. Recommend removing vegetation along pipe alignment to conduct proper inspection of structure. (O. Magana - DWR UCIP)						
FIELD_STRUCT_DESC: 24-inch corrugated metal gravity drainage pipe (CMP) through the levee, 8.6 feet below the crown. Flap gate on the waterside (WS) end. Brass cap No. 130 bench mark (BM) on the headwall on the landside (LS). [Additional Reference(s): DWR Levee Log, 2002, (HLM 3.96). USACE San Joaquin O&M Manual, Unit No. 601, Part No. 1, 1967, Amended in 1978, Revised 20 June 1985, (HLM 3.95)].

LS view: Close up of pipe inlet at toe covered in vegetation.

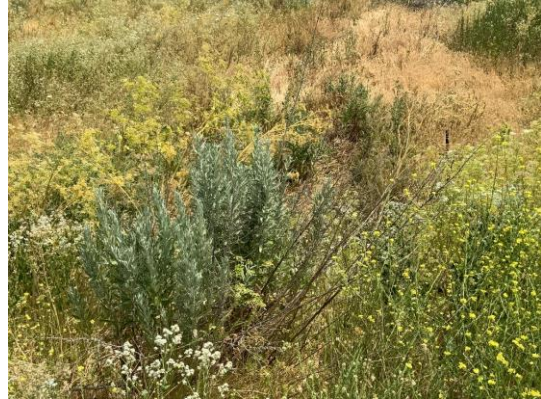
Photo 1 of 1 : UCIP_SP_2024_77860_100161.jpg

Comment Code						
Inspector Comment						
DS_ID:19668 FS_ID:77860 EP_NO: N/A Repair Type: Urgent EVAL Issue: 1, Pipe Integrity Crossing Status: Found UCIP Comments: 12/14/2022 Record updated from Non-Urgent to Urgent. DMP internal video inspection has found pipe integrity issues. LOF of crossing is between 5 and 6. Crossing will be monitored until funding becomes available to address the issues. (O.Yakimov - DWR UCIP) 06/7/2021 The record remains Non-Urgent. Limited inspection on WS due to dense vegetation, flapgate not visible, recommend clearing away. Limited insepction on LS due to canal limiting access to inlet. No permit was found authorizing this encroachment. CVFPB will need to review crossing to determine owner. The UCIP inspection was completed with GEI staff, P. Espinoza. (H. Dunn – GEI) 05/01/2014 Dense vegetation limits the inspector's visibility to identify signs of pipe failure (leaks) along the slope. Recommend removing vegetation along pipe alignment to conduct proper inspection of structure. (O. Magana - DWR UCIP) FIELD_STRUCT_DESC: 24-inch corrugated metal gravity drainage pipe (CMP) through the levee, 8.0 feet below the crown. Flap gate on the waterside (WS) end. Brass cap No. 125 bench mark (BM) on the headwall on the landside (LS). [Additional Reference(s): DWR Levee Log, 2002, (HLM 5.45). USACE San Joaquin O&M Manual, Unit No. 601, Part No. 1, 1967, Amended in 1978, Revised 20 June 1985, (HLM 5.43)]. FS Date: 6/7/2021 1:46:28 PM

WS view: Flapgate completely covered by vegetation at toe.

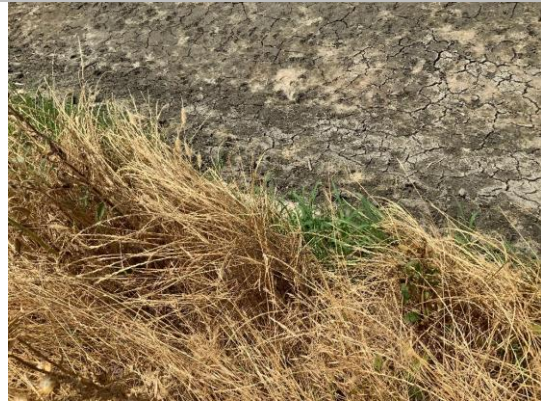
Photo 1 of 1 : UCIP_SP_2024_77861_100170.jpg

Comment Code						
Inspector Comment						
DS_ID:19669 FS_ID:77861 EP_NO: N/A Repair Type: Urgent EVAL Issue: 1, Pipe Integrity Crossing Status: Found UCIP Comments: 12/14/2022 Record updated from Non-Urgent to Urgent. DMP internal video inspection has found pipe integrity issues. LOF of crossing is between 5 and 6. Crossing will be monitored until funding becomes available to address the issues. (O.Yakimov - DWR UCIP) 06/7/2021 The record remains Non-Urgent. LS pipe inlet completely buried under sediment, recommend clearing out. No permit was found authorizing this encroachment. CVFPB will need to review crossing to determine owner. The UCIP inspection was completed with GEI staff, P. Espinoza. (H. Dunn – GEI) 05/01/2014 Dense vegetation limits the inspector's visibility to identify signs of pipe failure (leaks) along the slope. Recommend removing vegetation along pipe alignment to conduct proper inspection of structure. (O. Magana - DWR UCIP) FIELD_STRUCT_DESC: 24-inch corrugated metal gravity drainage pipe (CMP) through the levee, 7.7 feet below the crown. Flap gate on the waterside (WS) end. Brass cap No. 125 bench mark (BM) on the headwall on the landside (LS). [Additional Reference(s): DWR Levee Log, 2002, (HLM 6.06). USACE San Joaquin O&M Manual, Unit No. 601, Part No. 1, 1967, Amended in 1978, Revised 20 June 1985, (HLM 6.06)]. FS Date: 6/7/2021 1:46:46 PM

LS view: Headwall barely visible at toe, buried under sediment.

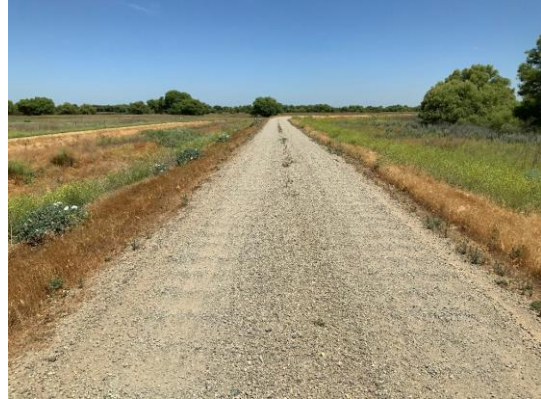
Photo 1 of 3 : UCIP_SP_2024_77862_100173.jpg

Comment Code					
Inspector Comment					
DS_ID:19670 FS_ID:77862 EP_NO: N/A Repair Type: Urgent EVAL Issue: 1, Pipe Integrity Crossing Status: Found UCIP Comments: 12/14/2022 Record updated from Non-Urgent to Urgent. DMP internal video inspection has found pipe integrity issues. LOF of crossing is between 5 and 6. Crossing will be monitored until funding becomes available to address the issues. (O.Yakimov - DWR UCIP) 06/7/2021 The record remains Non-Urgent. Limited inspection on LS due to canal and inability to access. No permit was found authorizing this encroachment. CVFPB will need to review crossing to determine owner. The UCIP inspection was completed with GEI staff, P. Espinoza. (H. Dunn – GEI) 05/01/2014 Dense vegetation limits the inspector's visibility to identify signs of pipe failure (leaks) along the slope. Recommend removing vegetation along pipe alignment to conduct proper inspection of structure. (O. Magana - DWR UCIP) FIELD_STRUCT_DESC: 24-inch corrugated metal gravity drainage pipe (CMP) through the levee, 7.7 feet below the crown. Flap gate on the waterside (WS) end. Brass cap No. 125 bench mark (BM) on the headwall on the landside (LS). [Additional Reference(s): DWR Levee Log, 2002, (HLM 6.50). USACE San Joaquin O&M Manual, Unit No. 601, Part No. 1, 1967, Amended in 1978, Revised 20 June 1985, (HLM 6.50)]. FS Date: 6/7/2021 1:47:06 PM

Levee crown looking downstream.

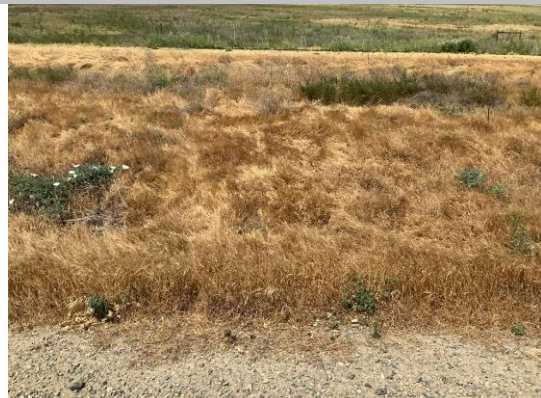
Photo 2 of 3 : UCIP_SP_2024_77862_100177.jpg

LS view: Toe from crown.

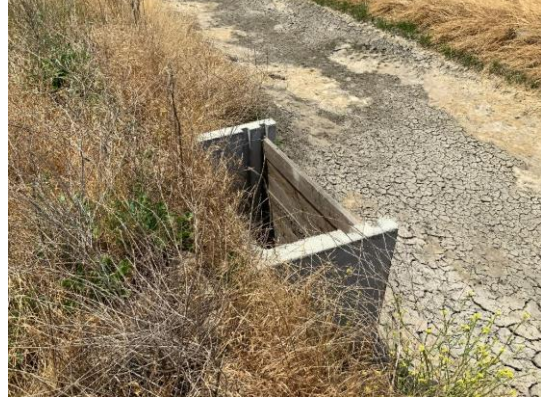
Photo 3 of 3 : UCIP_SP_2024_77862_100171.jpg

LS view: Close up of concrete box and pipe inlet.

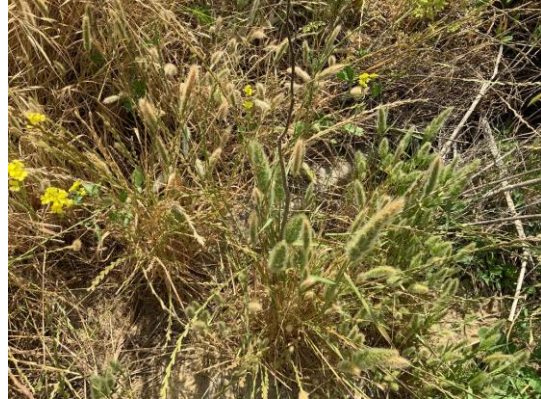
Photo 1 of 2 : UCIP_SP_2024_70950_100183.jpg

Comment Code						
Inspector Comment						
DS_ID:19671 FS_ID:70950 EP_NO: N/A Repair Type: Non-Urgent EVAL Issue: 11, Maintenance Compliance Issue Crossing Status: Found UCIP Comments: 06/7/2021 The record remains Non-Urgent. Dense vegetation on WS limited inspection. LS pipe inlet is completely buried under sediment, recommend cleaning out. No permit was found authorizing this encroachment. CVFPB will need to review crossing to determine owner. The UCIP inspection was completed with GEI staff, P. Espinoza. (H. Dunn – GEI) 05/01/2014 Dense vegetation limits the inspector's visibility to identify signs of pipe failure (leaks) along the slope. Recommend removing vegetation along pipe alignment to conduct proper inspection of structure. Pipe extension visible on landward side--need to contact owner for additional information about extension/modification. (O. Magana - DWR UCIP) FIELD_STRUCT_DESC: 24-inch corrugated metal gravity drainage pipe (CMP) through the levee, 12.6 feet below the crown. Flap gate on the waterside (WS) end. Brass cap No. 125 bench mark (BM) on the headwall on the landside (LS). [Additional Reference(s): DWR Levee Log, 2002, (HLM 7.06). USACE San Joaquin O&M Manual, Unit No. 601, Part No. 1, 1967, Amended in 1978, Revised 20 June 1985, (HLM 7.05)]. FS Date: 6/7/2021

LS view: Headwall and inlet buried at toe.

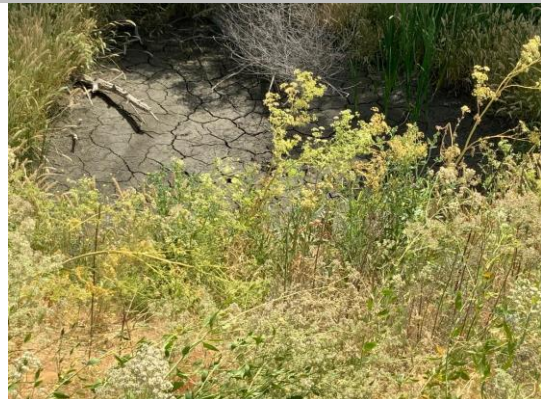
Photo 2 of 2 : UCIP_SP_2024_70950_100178.jpg

WS view: Flapgate barely visible at toe from slope.

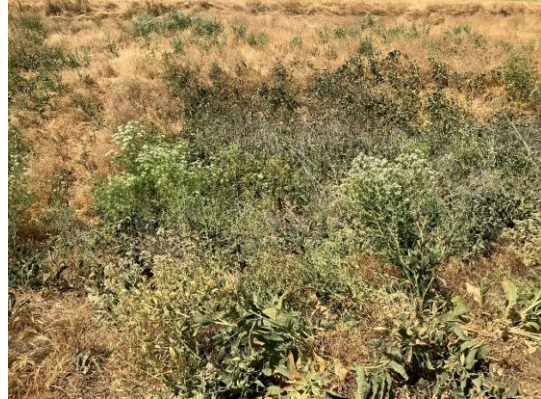
Photo 1 of 2 : UCIP_SP_2024_77863_100190.jpg

Comment Code					
Inspector Comment					
DS_ID:19673 FS_ID:77863 EP_NO: N/A Repair Type: Urgent EVAL Issue: 1, Pipe Integrity Crossing Status: Found UCIP Comments: 12/14/2022 Record updated from Non-Urgent to Urgent. DMP internal video inspection has found pipe integrity issues. LOF of crossing is between 5 and 6. Crossing will be monitored until funding becomes available to address the issues. (O.Yakimov - DWR UCIP) 06/7/2021 The record remains Non-Urgent. LS pipe end not visible, dense vegetation on both WS and LS ends, recommend removal. No permit was found authorizing this encroachment. CVFPB will need to review crossing to determine owner. The UCIP inspection was completed with GEI staff, P. Espinoza. (H. Dunn – GEI)05/01/2014 Dense vegetation limits the inspector's visibility to identify signs of pipe failure (leaks) along the slope. Recommend removing vegetation along pipe alignment to conduct proper inspection of structure. (O. Magana - DWR UCIP) FIELD_STRUCT_DESC: 24-inch corrugated metal gravity drainage pipe (CMP) through the levee, 8.0 feet below the crown. Flap gate on the waterside (WS) end. Brass cap No. 125 bench mark (BM) on the headwall on the landside (LS). [Additional Reference(s): DWR Levee Log, 2002, (HLM 7.78). USACE San Joaquin O&M Manual, Unit No. 601, Part No. 1, 1967, Amended in 1978, Revised 20 June 1985, (HLM 7.77)]. FS Date: 6/7/2021 1:49:23 PM

LS view: Headwall and inlet not visible under vegetation.

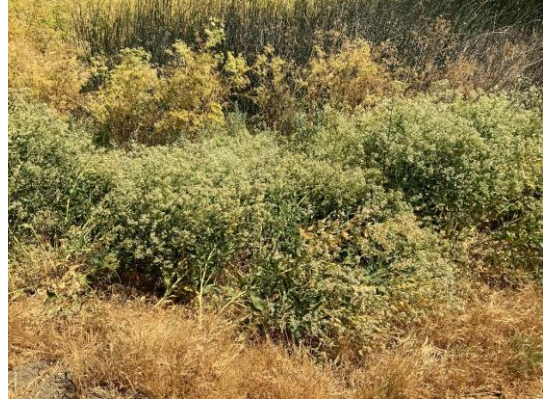
Photo 2 of 2 : UCIP_SP_2024_77863_100188.jpg

WS view: Toe from crown, flapgate covered in vegetation but just visible.

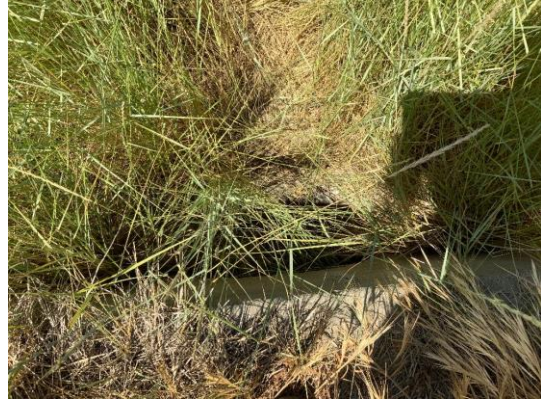
Photo 1 of 2 : UCIP_SP_2024_83302_100043.jpg

Comment Code					
Inspector Comment					
DS_ID:19674 FS_ID:83302 EP_NO: N/A Repair Type: Non-Urgent EVAL Issue: Crossing Status: Found UCIP Comments: 06/7/2021 Record remains Non-Urgent. DWR DMP internal inspection has not found pipe integrity issues. LOF of crossing is less or equal to 4.0. Recommend next video inspection in 5 years. LS headwall barely visible at toe due to dense vegetation. Dense vegetation also over WS flapgate. Limited inspection of both WS and LS pipe ends. Recommend removal of vegetation on both WS and LS. No permit was found authorizing this encroachment. CVFPB will need to review crossing to determine owner. The UCIP inspection was completed with GEI staff, P. Espinoza. (H. Dunn – GEI) 05/14/2014 Dense vegetation limits the inspector's visibility to identify signs of pipe failure (leaks) along the slope and landward headwall. Recommend removing vegetation along pipe alignment and toe to conduct proper inspection of structure. Sediment buildup in pipe visible from landward side--recommend clearing. (O. Magana - DWR UCIP) FIELD_STRUCT_DESC: 24-inch corrugated metal gravity drainage pipe (CMP) through the levee, 9.0 feet below the crown. Flap gate on the waterside (WS) end. Brass cap No. 120 bench mark (BM) on the headwall on the landside (LS). [Additional Reference(s): DWR Levee Log, 2002, (HLM 8.17). USACE San Joaquin O&M Manual, Unit No. 601, Part No. 1, 1967, Amended in 1978, Revised 20 June 1985, (HLM 8.16)]. FS Date: 6/7/2021

LS view: Headwall barely visible at toe.

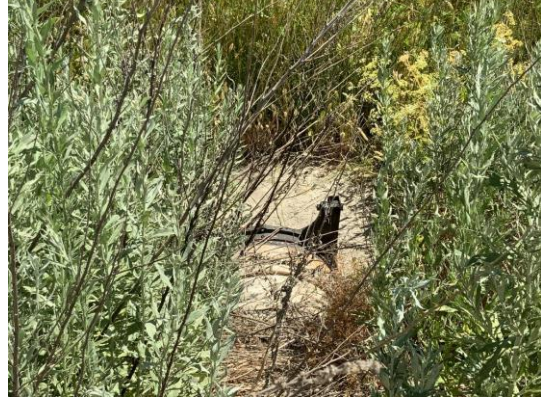
Photo 2 of 2 : UCIP_SP_2024_83302_100046.jpg

WS view: Flapgate visible at toe.

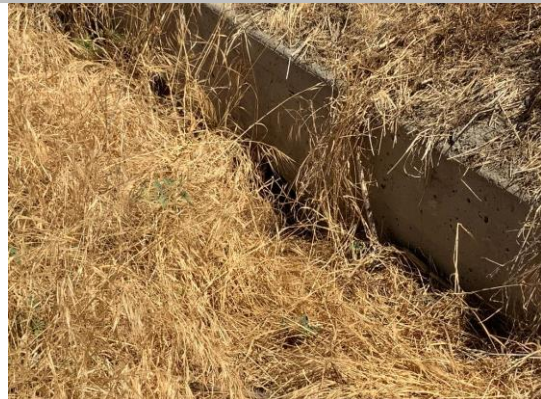
Photo 1 of 2 : UCIP_SP_2024_70954_100343.jpg

DS_ID:19675
 FS_ID:70954
 EP_NO: N/A
 Repair Type: Non-Urgent
 EVAL Issue: 11, Maintenance Compliance Issue
 Crossing Status: Found
 UCIP Comments: 06/7/2021 The record remains Non-Urgent. LS pipe inlet completely buried in dense vegetation, only top of headwall visible. Dense vegetation above WS flapgate. Limited inspection of pipe ends, recommend vegetation removal on both sides. No permit was found authorizing this encroachment. CVFPB will need to review crossing to determine owner. The UCIP inspection was completed with GEI staff, P. Espinoza. (H. Dunn – GEI) 05/14/2014 Dense vegetation on landward toe. Also dense vegetation limits the inspector's visibility to identify signs of pipe failure (leaks) along waterward slope. Recommend removing vegetation along pipe alignment toe to conduct proper inspection of structure. Sediment buildup in pipe--recommend clearing. (O. Magana - DWR UCIP)
 FIELD_STRUCT_DESC: 24-inch corrugated metal gravity drainage pipe (CMP) through the levee, 9.4 feet below the crown. Flap gate on the waterside (WS) end. Brass cap No. 120 bench mark (BM) on the headwall on the landside (LS). [Additional Reference(s): DWR Levee Log, 2002, (HLM 8.49). USACE San Joaquin O&M Manual, Unit No. 601, Part No. 1, 1967, Amended in 1978, Revised 20 June 1985, (HLM 8.48)].

LS view: Close up of pipe inlet, covered in vegetation.

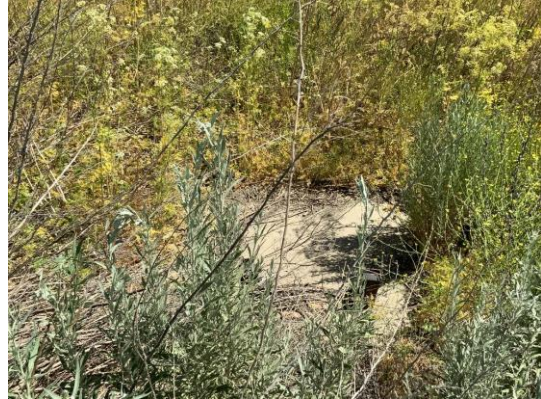
Photo 2 of 2 : UCIP_SP_2024_70954_100338.jpg

WS view: Top of flapgate visible at toe.

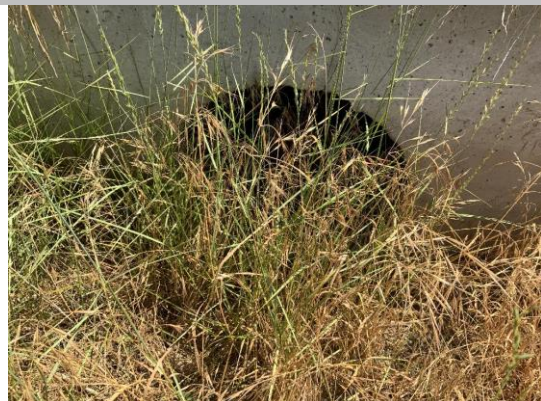
Photo 1 of 1 : UCIP_SP_2024_70955_100350.jpg

DS_ID:19676
 FS_ID:70955
 EP_NO: N/A
 Repair Type: Non-Urgent
 EVAL Issue: 11, Maintenance Compliance Issue
 Crossing Status: Found
 UCIP Comments: 06/7/2021 The record remains Non-Urgent. DWR DMP internal inspection has not found pipe integrity issues. LOF of crossing is less or equal to 4.0. Recommend next video inspection in 5 years. Dense vegetation around LS pipe end, recommend removal. No permit was found authorizing this encroachment. CVFPB will need to review crossing to determine owner. The UCIP inspection was completed with GEI staff, P. Espinoza. (H. Dunn – GEI) 05/14/2014
 Dense vegetation limits the inspector's visibility to identify signs of pipe failure (leaks) along the slope. Recommend removing vegetation along pipe alignment to conduct proper inspection of structure. Burrow activity present on waterward slope. (O. Magana - DWR UCIP)
 FIELD_STRUCT_DESC: 24-inch corrugated metal gravity drainage pipe (CMP) through the levee, 8.8 feet below the crown. Flap gate on the waterside (WS) end. Brass cap No. 120 bench mark (BM) on the headwall on the landside (LS). [Additional Reference(s): DWR Levee Log, 2002, (HLM 8.88). USACE San Joaquin O&M Manual, Unit No. 601, Part No. 1, 1967, Amended in 1978, Revised 20 June 1985, (recorded as HLM 9.86, should be HLM 8.86)].

LS view: Close up of pipe inlet at toe.

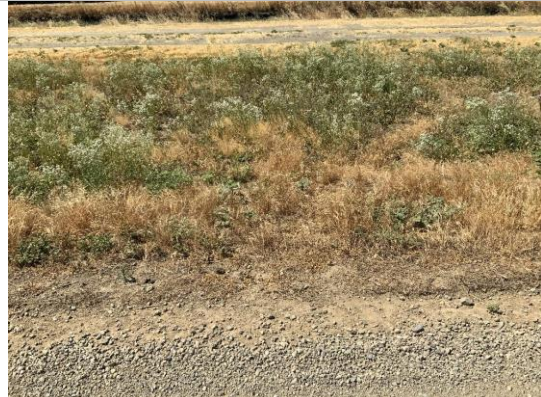
Photo 2 of 3 : UCIP_SP_2024_83303_100354.jpg

LS view: Toe from crown.

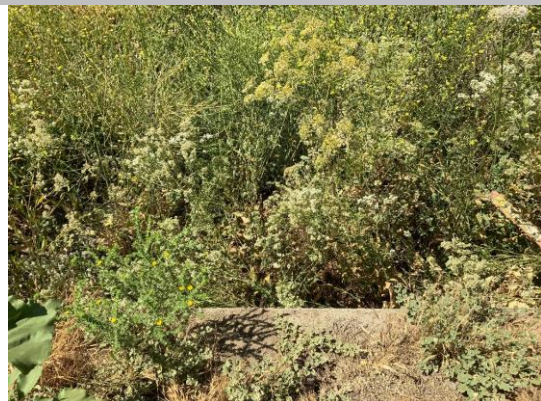
Photo 1 of 1 : UCIP_SP_2024_70957_100363.jpg

DS_ID:19678
FS_ID:70957
EP_NO: N/A
Repair Type: Non-Urgent
EVAL Issue: 11, Maintenance Compliance Issue
Crossing Status: Found
UCIP Comments: 06/7/2021 The record remains Non-Urgent. DWR DMP internal inspection has not found pipe integrity issues. LOF of crossing is less or equal to 4.0. Recommend next video inspection in 5 years. Dense vegetation over LS pipe inlet limited inspection, recommend removal. No permit was found authorizing this encroachment. CVFPB will need to review crossing to determine owner. The UCIP inspection was completed with GEI staff, P. Espinoza. (H. Dunn – GEI) 05/14/2014 Dense vegetation limits the inspector's visibility to identify signs of pipe failure (leaks) along the slope. Recommend removing vegetation along pipe alignment to conduct proper inspection of structure. (O. Magana - DWR UCIP)
FIELD_STRUCT_DESC: 24-inch corrugated metal gravity drainage pipe (CMP) through the levee, 8.0 feet below the crown. Flap gate on the waterside (WS) end. Brass cap No. 120 bench mark (BM) on the headwall on the landside (LS). [Additional Reference(s): DWR Levee Log, 2002, (HLM 9.21). USACE San Joaquin O&M Manual, Unit No. 601, Part No. 1, 1967, Amended in 1978, Revised 20 June 1985, (HLM 9.20)].

LS view: Top of headwall visible, pipe inlet covered with dense vegetation.

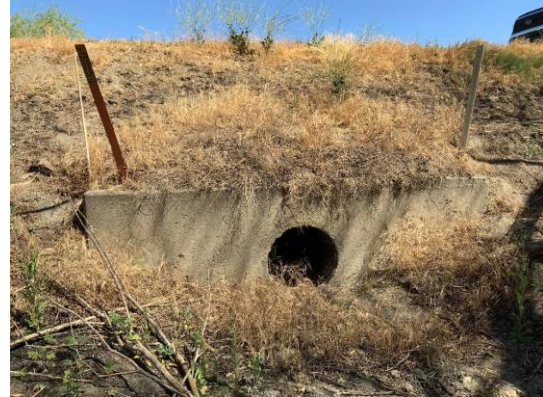
Photo 1 of 2 : UCIP_SP_2024_83304_100371.jpg

Comment Code						
Inspector Comment						
DS_ID:19686						
FS_ID:83304						
EP_NO: N/A						
Repair Type: No Action Needed						
EVAL Issue:						
Crossing Status: Found						
UCIP Comments: 04/25/2024 Record updated from Non-Urgent to No Action Needed. DMP internal video inspection has found none or minor pipe defects. (M. Thao - DWR UCIP)						
12/20/2022 Record updated from Urgent to Non-Urgent. Pipe has been CIPP-lined. LOF of crossing is less or equal to 4. Recommend next video inspection in 5 years. (O. Yakimov - DWR UCIP)						
06/07/2021 The record has been upgraded from Non-Urgent to Urgent. DWR DMP internal inspection has found pipe integrity issues. LOF of crossing is greater than or equal to 5.0. Crossing will be monitored until funding becomes available to address the issues. Some rusting and peeling of liner inside LS pipe inlet. No permit was found authorizing this encroachment. CVFPB will need to review crossing to determine owner. The UCIP inspection was completed with GEI staff, P. Espinoza. (H. Dunn - GEI)

LS view: Slope and headwall at toe.

05/14/2014 Dense vegetation limits the inspector's visibility to identify signs of pipe failure (leaks) along the slope. Recommend removing vegetation along pipe alignment to conduct proper inspection of structure. (O. Magana - DWR UCIP)						
FIELD_STRUCT_DESC: 24-inch CIPP-lined corrugated metal gravity drainage pipe (CMP) through the levee, 9.0 feet below the crown. Flap gate on the waterside (WS) end. Brass cap No. 115 bench mark (BM) on the headwall on the landside (LS). [Additional Reference(s): DWR Levee Log, 2002, (HLM 9.47). USACE San Joaquin O&M Manual, Unit No. 601, Part No. 1, 1967, Amended in 1978, Revised 20 June 1985, (HLM 9.46)].						
FS Date: 12/20/2022 9:08:29 AM

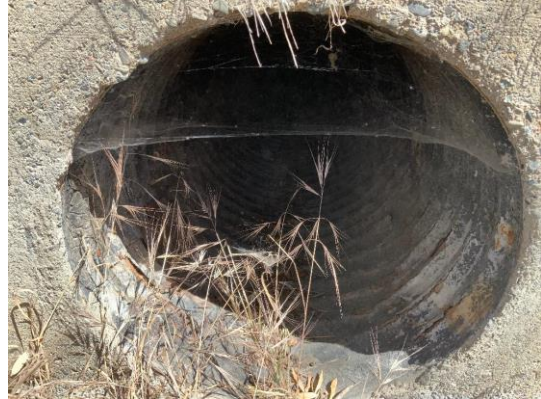
Photo 2 of 2 : UCIP_SP_2024_83304_100372.jpg

LS view: Close up of pipe inlet at toe.

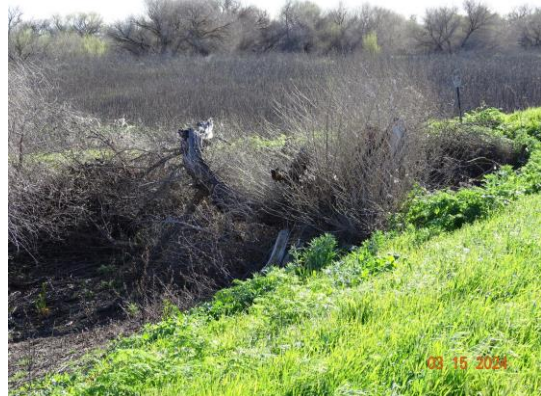
Photo 1 of 1 : SP_2024_NA0010_120_15_20240326_00027.jpg

LM Start	9.60	Rating **	M	Issue No.	15
LM End	9.60	Issue Type +	Ma	Location *	WS
Category	Earthen Levee			GPS Latitude/Longitude	
				Start	End
Item	Trim / Thin Trees			37.220783°	37.220783°
				-120.785729°	-120.785729°
DWR ID	DWR_NA0010_02B_s _ 2024_15				
Comment Code					
T2 : Tree or limb.					
Inspector Comment					
Broken tree limbs on the waterside slope.

View of fallen limb on the waterside slope. (Spring 2024)

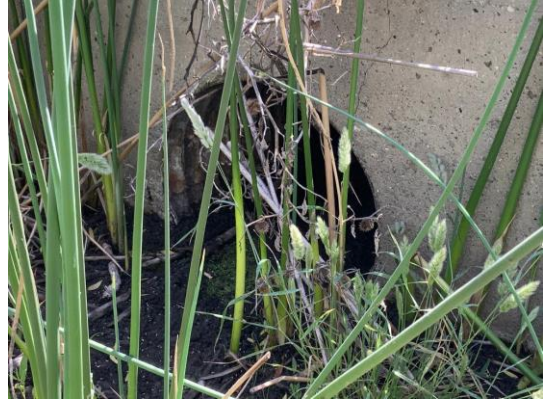
Photo 1 of 2 : UCIP_SP_2024_70959_100379.jpg

Comment Code						
Inspector Comment						
DS_ID:19687 FS_ID:70959 EP_NO: N/A Repair Type: Non-Urgent EVAL Issue: 11, Maintenance Compliance Issue Crossing Status: Found UCIP Comments: 06/7/2021 The record remains Non-Urgent. Some sediment buildup inside LS pipe inlet. LS pipe inlet also covered by some vegetation. Recommend cleaning out sediment and removing vegetation. WS flapgate partially underwater and covered by vegetation, limited inspection of both WS and LS. No permit was found authorizing this encroachment. CVFPB will need to review crossing to determine owner. The UCIP inspection was completed with GEI staff, P. Espinoza. (H. Dunn- GEI) 05/14/2014 Dense vegetation limits the inspector's visibility to identify signs of pipe failure (leaks) along the slope. Recommend removing vegetation along pipe alignment to conduct proper inspection of structure. (O. Magana - DWR UCIP) FIELD_STRUCT_DESC: 24-inch corrugated metal gravity drainage pipe (CMP) through the levee, 11.7 feet below the crown. Flap gate on the waterside (WS) end. Brass cap No. 115 bench mark (BM) on the headwall on the landside (LS). [Additional Reference(s): DWR Levee Log, 2002, (HLM 10.13). USACE San Joaquin O&M Manual, Unit No. 601, Part No. 1, 1967, Amended in 1978, Revised 20 June 1985, (HLM 10.12)]. FS Date: 6/7/2021

LS view: Close up of pipe inlet at toe, sediment built up.

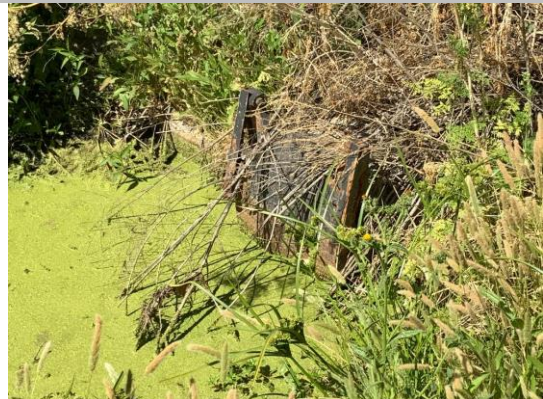
Photo 2 of 2 : UCIP_SP_2024_70959_100374.jpg

WS view: Close up of flapgate partially underwater at toe.

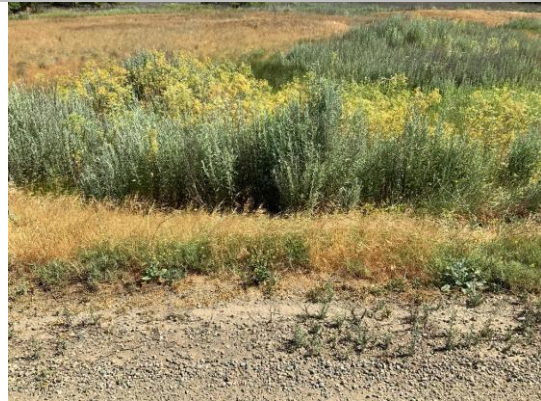
Photo 1 of 2 : UCIP_SP_2024_70960_100381.jpg

Comment Code						
Inspector Comment						
DS_ID:19688 FS_ID:70960 EP_NO: N/A Repair Type: Non-Urgent EVAL Issue: 11, Maintenance Compliance Issue Crossing Status: Found UCIP Comments: 06/7/2021 The record remains Non-Urgent. WS end and flapgate is overgrown with dense vegetation limiting inspection, recommend removal. No permit was found authorizing this encroachment. CVFPB will need to review crossing to determine owner. The UCIP inspection was completed with GEI staff, P. Espinoza. (H. Dunn – GEI) 05/14/2014 Dense vegetation limits the inspector's visibility to identify signs of pipe failure (leaks) along the slope. Recommend removing vegetation along pipe alignment to conduct proper inspection of structure. Sediment buildup in pipe visible on landward side--recommend clearing. (O. Magana - DWR UCIP) FIELD_STRUCT_DESC: 24-inch corrugated metal gravity drainage pipe (CMP) through the levee, 8.0 feet below the crown. Flap gate on the waterside (WS) end. Brass cap No. 115 bench mark (BM) on the headwall on the landside (LS). [Additional Reference(s): DWR Levee Log, 2002, (HLM 10.82). USACE San Joaquin O&M Manual, Unit No. 601, Part No. 1, 1967, Amended in 1978, Revised 20 June 1985, (HLM 10.81)]. FS Date: 6/7/2021

WS view: Toe from crown.

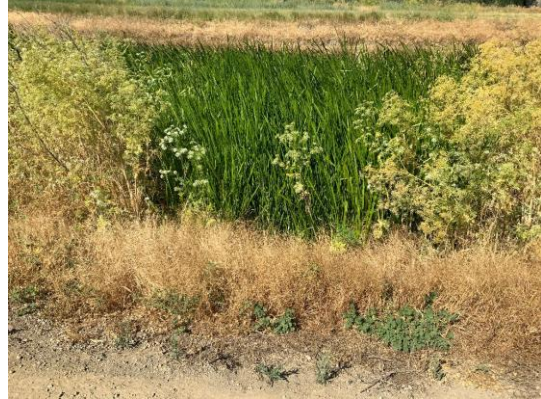
Photo 1 of 2 : UCIP_SP_2024_70962_100395.jpg

Comment Code						
Inspector Comment						
DS_ID:19690 FS_ID:70962 EP_NO: N/A Repair Type: Non-Urgent EVAL Issue: 11, Maintenance Compliance Issue Crossing Status: Found UCIP Comments: 06/7/2021 The record remains Non-Urgent. Dense vegetation over LS end, cannot see pipe inlet, recommend vegetation removal. WS flapgate has some vegetation covering it, recommend clearing. No permit was found authorizing this encroachment. CVFPB will need to review crossing to determine owner. The UCIP inspection was completed with GEI staff, P. Espinoza. (H. Dunn – GEI) 05/14/2014 Dense vegetation limits the inspector's visibility to identify signs of pipe failure (leaks) along the slope. Recommend removing vegetation along pipe alignment to conduct proper inspection of structure. (O. Magana - DWR UCIP) FIELD_STRUCT_DESC: 24-inch corrugated metal gravity drainage pipe (CMP) through the levee, 8.0 feet below the crown. Flap gate on the waterside (WS) end. Screw gate on the landside (LS). [Additional Reference(s): DWR Levee Log, 2002, (HLM 11.45). USACE San Joaquin O&M Manual, Unit No. 601, Part No. 1, 1967, Amended in 1978, Revised 20 June 1985, (HLM 11.43)]. FS Date: 6/7/2021

LS view: Toe from crown, dense vegetation, no pipe visible.

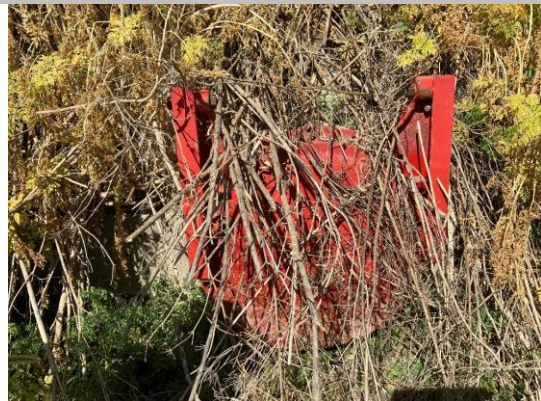
Photo 2 of 2 : UCIP_SP_2024_70962_100398.jpg

WS view: Close up of flapgate at toe.

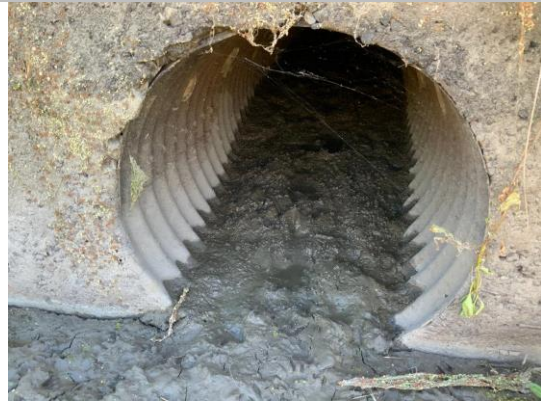
Photo 1 of 2 : UCIP_SP_2024_70963_100404.jpg

Comment Code					
Inspector Comment					
DS_ID:19663 FS_ID:70963 EP_NO: N/A Repair Type: Non-Urgent EVAL Issue: 11, Maintenance Compliance Issue Crossing Status: Found UCIP Comments: 06/7/2021 The record remains Non-Urgent. Sediment buildup inside LS pipe inlet, recommend cleaning out. Dense vegetation over WS end limited inspection, recommend removal. No permit was found authorizing this encroachment. CVFPB will need to review crossing to determine owner. The UCIP inspection was completed with GEI staff, P. Espinoza. (H. Dunn - GEI) 05/14/201 Dense vegetation limits the inspector's visibility to identify signs of pipe failure (leaks) along the slope. Recommend removing vegetation along pipe alignment to conduct proper inspection of structure. Sediment buildup in pipe-- recommend clearing. (O. Magana - DWR UCIP) FIELD_STRUCT_DESC: 24-inch corrugated metal gravity drainage pipe (CMP) through the levee, 6.5 feet below the crown. Slide gate in a pipe riser unit on the waterside (WS) slope. [Additional Reference(s): DWR Levee Log, 2002, (HLM 13.23). USACE San Joaquin O&M Manual, Unit No. 601, Part No. 1, 1967, Amended in 1978, Revised 20 June 1985, (HLM 13.22)]. FS Date: 6/7/2021

LS view: Close up of pipe inlet at toe, sediment buildup.

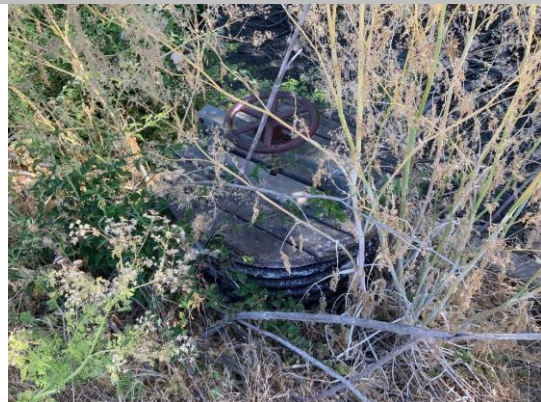
Photo 2 of 2 : UCIP_SP_2024_70963_100399.jpg

WS view: Close up of riser with slidegate on slope.

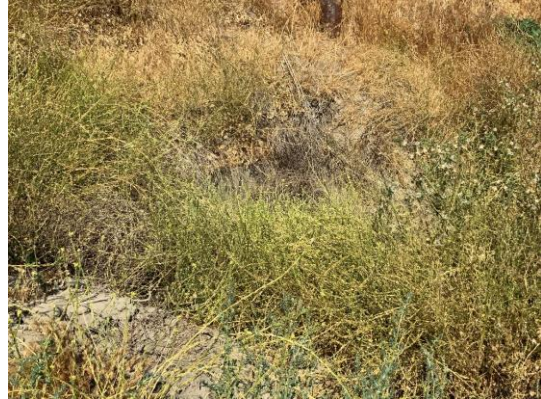
Photo 1 of 1 : UCIP_SP_2024_70965_101342.jpg

Comment Code					
Inspector Comment					
DS_ID:19691 FS_ID:70965 EP_NO: N/A Repair Type: Non-Urgent EVAL Issue: 11, Maintenance Compliance Issue Crossing Status: Found UCIP Comments: 07/12/2021 The record remains Non-Urgent. Dense vegetation over LS pipe inlet, headwall just barely visible, recommend removal. No permit was found authorizing this encroachment. CVFPB will need to review crossing to determine owner. The UCIP inspection was completed with GEI staff, P. Espinoza. (H. Dunn – GEI)					
04/17/2014 Need to contact owner. Recommend removing tall grass on landward slope and clearing sediment build up inside pipe. (O. Magana - DWR UCIP) FIELD_STRUCT_DESC: 24-inch corrugated metal gravity drainage pipe (CMP) through the levee, 11.3 feet below the crown. Flap gate on the waterside (WS) end. [Additional Reference(s): DWR Levee Log, 2002, (HLM 0.43). USACE San Joaquin O&M Manual, Unit No. 601, Part No. 1, 1967, Amended in 1978, Revised 20 June 1985, (HLM 0.43). DWR As-Built Specification No. 62-03, Sheet No. 10, 18 June 1962, (HLM 0.43)]. FS Date: 7/12/2021

LS toe: Headwall buried under vegetation.
