**Flood Control Project Maintenance
Levee Inspections**

Maintenance Issue Types Only, Levee Inspection Report By Mile - Spring 2024

Lower San Joaquin Levee District

Waterway	Bank	Unit Miles	Inspection Start/End	Inspector
Unit No. 01 San Joaquin River	Right	22.52	03/12/2024 03/12/2024	Corey Fujitani

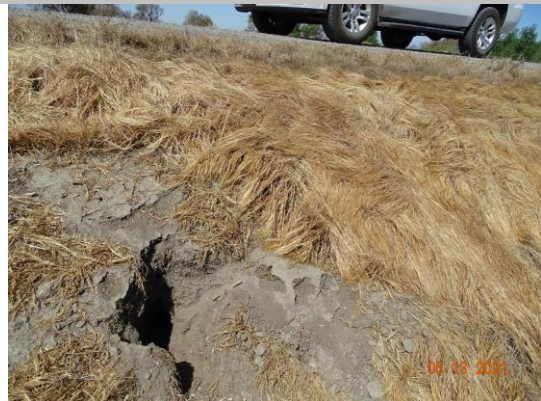
Photo 1 of 1 : SP_2024_NA0010_121_10_20240212_00003.jpg

LM Start	0.57	Rating **	A/W	Issue No.	10
LM End	0.57	Issue Type +	Ma	Location *	LS
Category	Earthen Levee			GPS Latitude/Longitude	
				Start	End
Item	Animal Control			37.104343°	37.104343°
				-120.584348°	-120.584348°
DWR ID	DWR_NA0010_03_s_2021_10				
Comment Code					
A3 : No rodents visible, but rodent burrows visible; need to backfill and compact or grout burrows.					
Inspector Comment

Several large rodent burrows observed at this location. (Spring 2021)

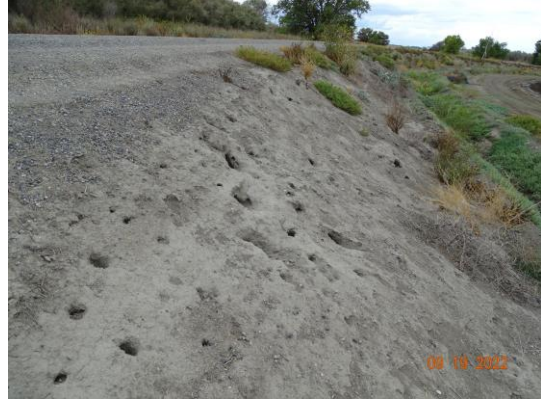
Photo 1 of 1 : SP_2024_NA0010_121_15_20240212_00007.jpg

LM Start	0.64	Rating **	M	Issue No.	15
LM End	0.67	Issue Type +	Ma	Location *	LS
Category	Earthen Levee			GPS Latitude/Longitude	
				Start	End
Item	Animal Control			37.103722°	37.103540°
				-120.583476°	-120.582863°
DWR ID	DWR_NA0010_03_s_2021_15				
Comment Code					
A1 : Exterminate rodents and backfill and compact or grout burrows.					
Inspector Comment

View of rodent holes on the landside slope. (Fall 2022)

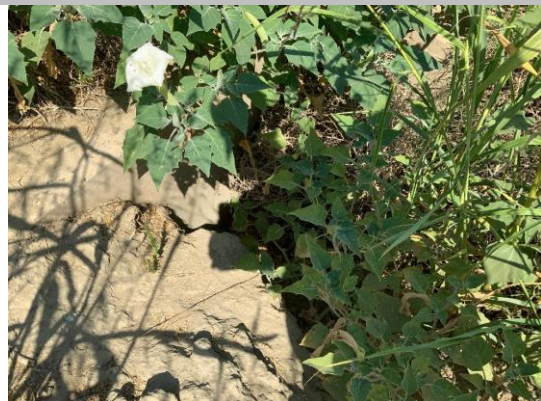
Photo 1 of 2 : UCIP_SP_2024_83306_101351.jpg

Comment Code						
Inspector Comment						
DS_ID:19692 FS_ID:83306 EP_NO: N/A Repair Type: Non-Urgent EVAL Issue: Crossing Status: Found UCIP Comments: 07/12/2021 The record has been upgraded from No Action Needed to Non-Urgent. Dense vegetation over LS pipe inlet, headwall barely visible. Minor vegetation on WS, recommend removal on both ends. No permit was found authorizing this encroachment. CVFPB will need to review crossing to determine owner. The UCIP inspection was completed with GEI staff, P. Espinoza. (H. Dunn – GEI) FIELD_STRUCT_DESC: 24-inch corrugated metal gravity drainage pipe (CMP) through the levee, 9.3 feet below the crown. Flap gate on the waterside (WS) end. [Additional Reference(s): DWR Levee Log, 2002, (HLM 0.78). USACE San Joaquin O&M Manual, Unit No. 601, Part No. 1, 1967, Amended in 1978, Revised 20 June 1985, (HLM 0.77). DWR As-Built Specification No. 62-03, Sheet No. 10, 18 June 1962, (HLM 0.77)]. FS Date: 7/12/2021

LS view: Pipe inlet and headwall covered in vegetation.

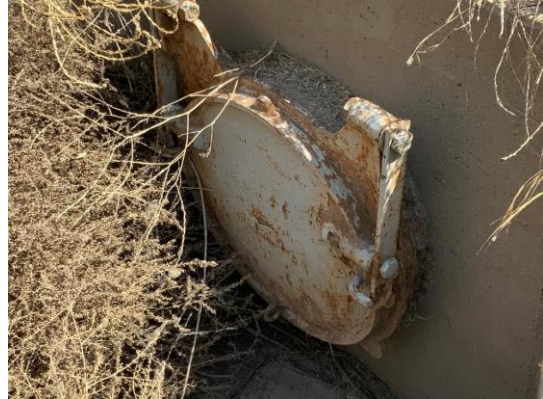
Photo 2 of 2 : UCIP_SP_2024_83306_101353.jpg

WS view: Closeup of flapgate at toe.

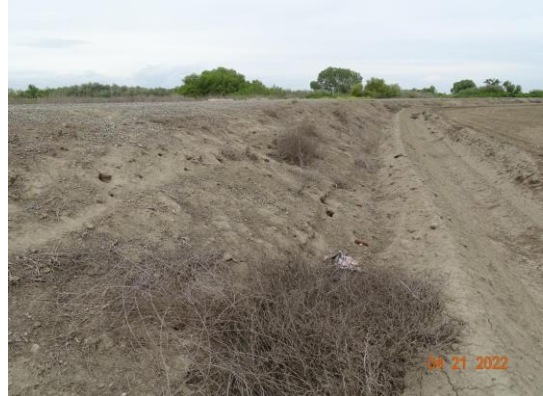
Photo 1 of 1 : SP_2024_NA0010_121_12_20240212_00005.jpg

LM Start	1.70	Rating **	M	Issue No.	12
LM End	1.78	Issue Type +	Ma	Location *	LS
Category	Earthen Levee			GPS Latitude/Longitude	
				Start	End
Item	Animal Control			37.092231°	37.091302°
				-120.572337°	-120.571632°
DWR ID	DWR_NA0010_03_f_2020_12				
Comment Code					
A1 : Exterminate rodents and backfill and compact or grout burrows.					
Inspector Comment

View of several animal holes in the landside slope. (Spring 2022)

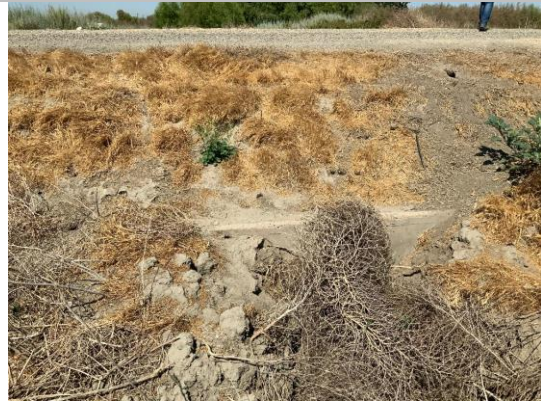
Photo 1 of 2 : UCIP_SP_2024_83307_101359.jpg

Comment Code						
Inspector Comment						
DS_ID:19693 FS_ID:83307 EP_NO: N/A Repair Type: Non-Urgent EVAL Issue: Crossing Status: Found UCIP Comments: 07/12/2021 The record remains Non-Urgent. There is dense vegetation over LS pipe inlet and WS flap gate, recommend removal. No permit was found authorizing this encroachment. CVFPB will need to review crossing to determine owner. The UCIP inspection was completed with GEI staff, P. Espinoza. (H. Dunn – GEI) 04/17/2014 Sediment buildup in pipe visible from landward side-- recommend clearing. (O. Magana - DWR UCIP) FIELD_STRUCT_DESC: 24-inch corrugated metal gravity drainage pipe (CMP) through the levee, 6.8 feet below the crown. Flap gate on the waterside (WS) end. [Additional Reference(s): DWR Levee Log, 2002, (HLM 1.73). USACE San Joaquin O&M Manual, Unit No. 601, Part No. 1, 1967, Amended in 1978, Revised 20 June 1985, (HLM 1.72). DWR As-Built Specification No. 62-03, Sheet No. 11, 18 June 1962, (HLM 1.72)]. FS Date: 7/12/2021

LS view: Slope and headwall from toe.

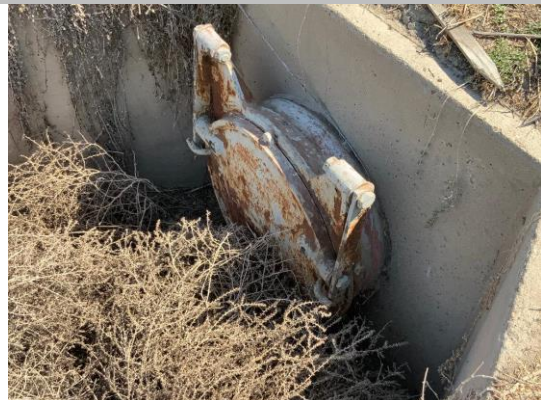
Photo 2 of 2 : UCIP_SP_2024_83307_101356.jpg

WS view: Close up of flapgate at toe.

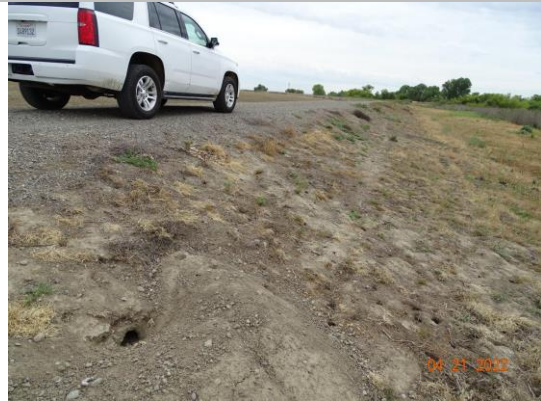
Photo 1 of 1 : SP_2024_NA0010_121_17_20240212_00008.jpg

LM Start	1.77	Rating **	A/W	Issue No.	17
LM End	1.77	Issue Type +	Ma	Location *	WS
Category	Earthen Levee			GPS Latitude/Longitude	
				Start	End
Item	Animal Control			37.091446°	37.091446°
				-120.571777°	-120.571777°
DWR ID	DWR_NA0010_03_s_2022_17				
Comment Code					
A1 : Exterminate rodents and backfill and compact or grout burrows.					
Inspector Comment

Multiple rodent burrows observed on the waterside slope. (Spring 2022)

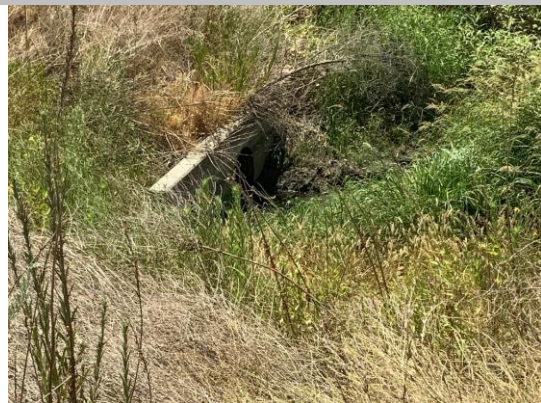
Photo 1 of 2 : UCIP_SP_2024_70974_101406.jpg

Comment Code					
Inspector Comment					
DS_ID:19695 FS_ID:70974 EP_NO: N/A Repair Type: Non-Urgent EVAL Issue: 11, Maintenance Compliance Issue Crossing Status: Found UCIP Comments: 07/12/2021 The record remains Non-Urgent. WS flapgate is underwater and covered by vegetation. LS inlet also covered by vegetation, recommend removal on both ends. No permit was found authorizing this encroachment. CVFPB will need to review crossing to determine owner. The UCIP inspection was completed with GEI staff, P. Espinoza. (H. Dunn – GEI) 04/17/2014 Sediment and debris blocking concrete headwall located on waterward side. During inspection water was flowing from landward side to waterward side. Recommend removing sediment to confirm condition of flap gate and pipe. (O. Magana - DWR UCIP) FIELD_STRUCT_DESC: 36-inch corrugated metal gravity drainage pipe (CMP) through the levee, 18.0 feet below the crown. Flap gate on the waterside (WS) end. Concrete headwall on each end. [Additional Reference(s): DWR Levee Log, 2002, (HLM 0.24). USACE San Joaquin O&M Manual, Unit No. 601, Part No. 1, 1967, Amended in 1978, Revised 20 June 1985, (HLM 0.27)]. FS Date: 7/12/2021

LS view: Pipe inlet with water in it at toe.

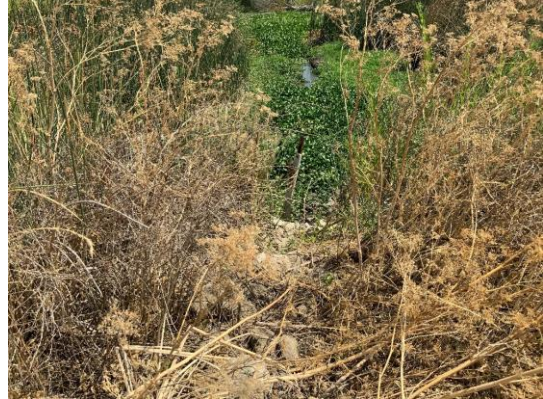
Photo 2 of 2 : UCIP_SP_2024_70974_101408.jpg

WS view: Pipe and flapgate not visible due to dense vegetation and water.

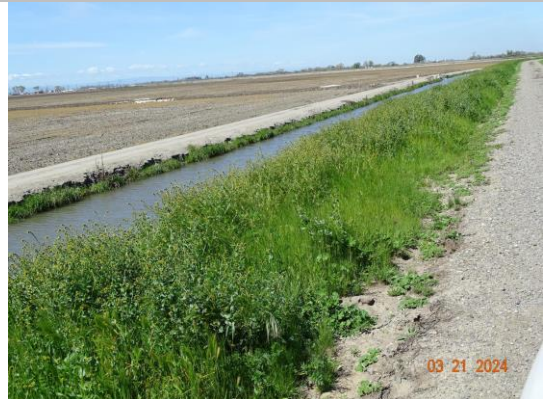
Photo 1 of 1 : SP_2024_NA0010_122_4_20240326_00005.jpg

LM Start	0.56	Rating **	M	Issue No.	4
LM End	1.41	Issue Type +	Ma	Location *	LS
Category	Earthen Levee			GPS Latitude/Longitude	
				Start	End
Item	Vegetation			37.105815°	37.097556°
				-120.588568°	-120.578130°
DWR ID	DWR_NA0010_04_s_2024_4				
Comment Code					
V1 : Control annual grass and weeds on the levee slopes and easements.					
Inspector Comment

View of vegetation on the landside slope. (Spring 2024)

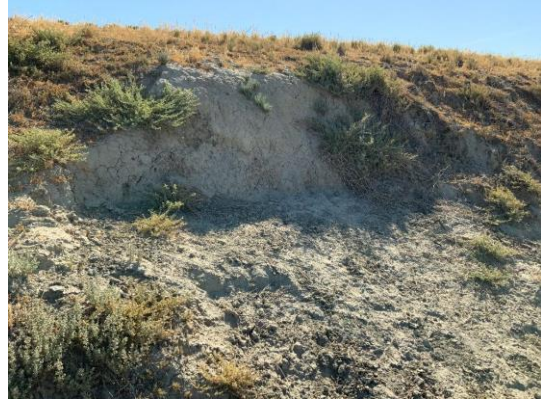
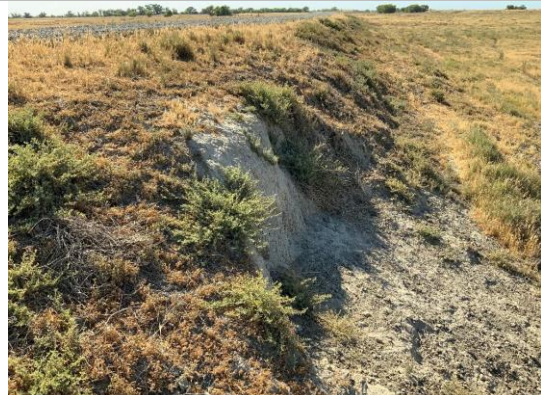
Comment Code					
Inspector Comment					
DS_ID:19756 FS_ID:70983 EP_NO: N/A Repair Type: Non-Urgent EVAL Issue: 6, Levee Damage or Threat for Levee Damage Crossing Status: Found UCIP Comments: 06/1/2021 Record remains Non-Urgent. DWR DMP internal inspection has not found pipe integrity issues. LOF of crossing is less or equal to 4.0. Recommend next video inspection in 5 years. Some soil sloughing/erosion on the WS slope. No permit was found authorizing this encroachment. CVFPB will need to review crossing to determine owner. The UCIP inspection was completed with GEI staff, P. Espinoza. (H. Dunn – GEI) 04/09/2014 Debris blocking landward headwall--recommend clearing. (W. Wylie - DWR UCIP) FIELD_STRUCT_DESC: 24-inch corrugated metal gravity drainage pipe (CMP) through the levee, 8.6 feet below the crown. Concrete U-shaped headwall and flap gate on the waterside (WS) end. Concrete headwall on the landside (LS) end. [Additional Reference(s): DWR Levee Log, 2002, (HLM 0.07). USACE San Joaquin O&M Manual, Unit No. 601, Part No. 1, 1967, Amended in 1978, Revised 20 June 1985, (HLM 0.07)]. FS Date: 6/1/2021

WS view: Sloughing on the slope from toe, 1 of 2 photos.

WS view: Side view of the sloughing on the slope, 2 of 2 photos.

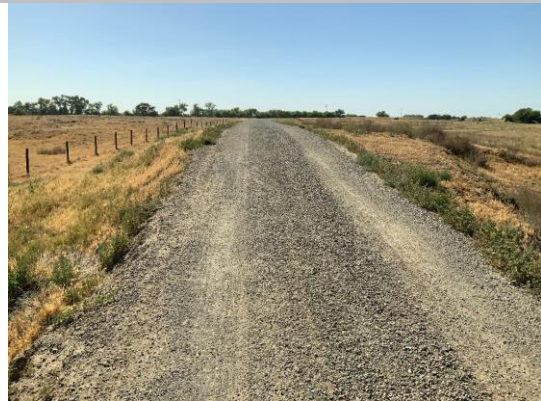
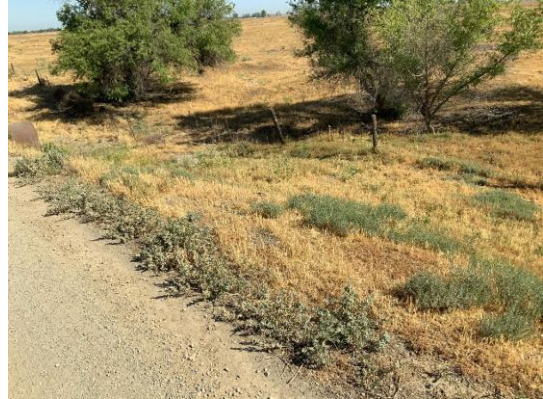
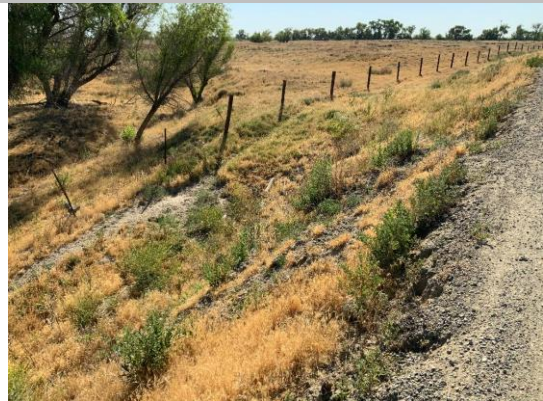
Comment Code					
Inspector Comment					
DS_ID:19557 FS_ID:70985 EP_NO: N/A Repair Type: Non-Urgent EVAL Issue: Crossing Status: Not Found UCIP Comments: 06/1/2021 Record remains Non-Urgent. Pipe not found by visual inspection. No permit was found authorizing this encroachment. CVFPB will need to review crossing to determine owner. The UCIP inspection was completed with GEI staff, P. Espinoza. (H. Dunn – GEI)11/01/2018 24-inch corrugated metal pipe (CMP) section found during pipe inspection of dsid 24867 (see photos); according to LMA representative levee section is the location of levee breach from 1960s; 24-inch pipe was undersized and was replaced after levee breach with a 96-inch CMP and steel pipe. (O. Magana - DWR UCIP) FIELD_STRUCT_DESC: 24-inch corrugated metal gravity drainage pipe (CMP) through the levee, 5.6 feet below the crown. Flap gate on the waterside (WS) end. Large pipe found at this location. [Additional Reference(s): USACE San Joaquin O&M Manual, Unit No. 601, Part No. 1, 1967, Amended in 1978, Revised 20 June 1985, (HLM 0.30)]. FS Date: 6/1/2021

Levee crown looking downstream.

LS view: Slope and toe from crown, no pipe visible.

LS view: Toe from crown, no pipe visible.

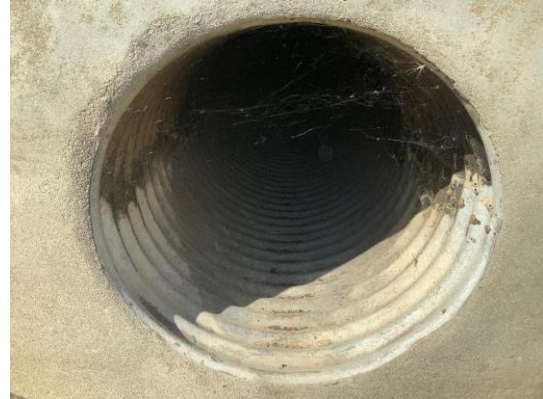
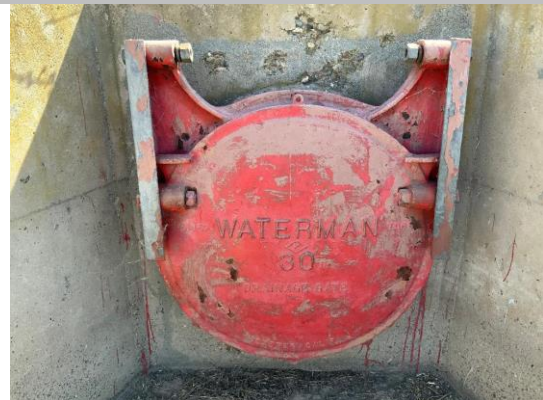
Comment Code						
Inspector Comment						
DS_ID:19757						
FS_ID:70986						
EP_NO: N/A						
Repair Type: No Action Needed						
EVAL Issue:						
Crossing Status: Found						
UCIP Comments: 09/18/2023 Record updated from Non-Urgent to No Action Needed. Pipe was CIPP lined. DMP internal video inspection has found none or minor pipe defects. Recommend next video inspection in 5 years. (O. Yakimov - DWR UCIP)						
06/1/2021 Record remains Non-Urgent. DWR DMP internal inspection has found pipe integrity issues. LOF of crossing is greater than or equal to 4.1 and less than 5. Crossing will be monitored until funding becomes available for rehabilitation. No permit was found authorizing this encroachment. CVFPB will need to review crossing to determine owner. The UCIP inspection was completed with GEI staff, P. Espinoza. (H. Dunn – GEI) 04/09/2014 Excess debris on landward headwall--recommend clearing. (W. Wylie - DWR UCIP)

LS view: Close up of pipe inlet at toe.

WS view: Close up of flapgate at toe.

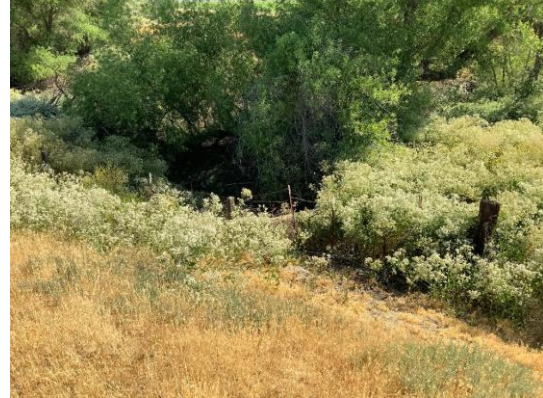
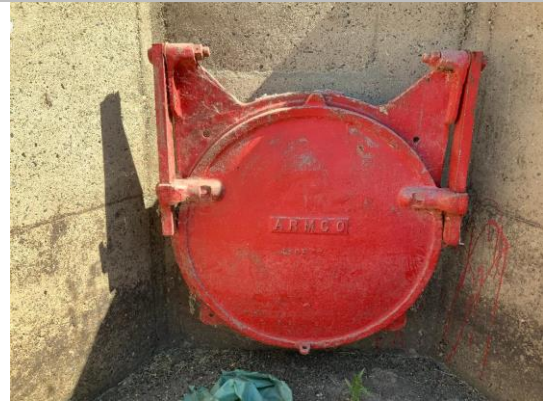
DS_ID:19758
FS_ID:83309
EP_NO: N/A
Repair Type: Non-Urgent
EVAL Issue:
Crossing Status: Found
UCIP Comments: 12/20/2022 Record updated from Urgent to Non-Urgent. Pipe has been CIPP-lined. LOF of crossing is less or equal to 4. Recommend next video inspection in 5 years. (O.Yakimov - DWR UCIP) 06/1/2021 Record has been upgraded from Non-Urgent to Urgent. DWR DMP internal inspection has found pipe integrity issues. LOF of crossing is greater than or equal to 5 and less than 6. Crossing will be monitored until funding becomes available to address the issues. No closeup inspection of LS pipe end due to dense vegetation and barbed wire. No permit was found authorizing this encroachment. CVFPB will need to review crossing to determine owner. The UCIP inspection was completed with GEI staff, P. Espinoza. (H. Dunn – GEI)04/09/2014 Dense vegetation limits the inspector's visibility to identify signs of pipe failure (leaks) along the landward slope. Recommend removing vegetation along pipe alignment to conduct proper inspection of structure. (W. Wylie - DWR UCIP)

LS view: Headwall barely visible at toe from crown.

WS view: Close up of flapgate at toe.

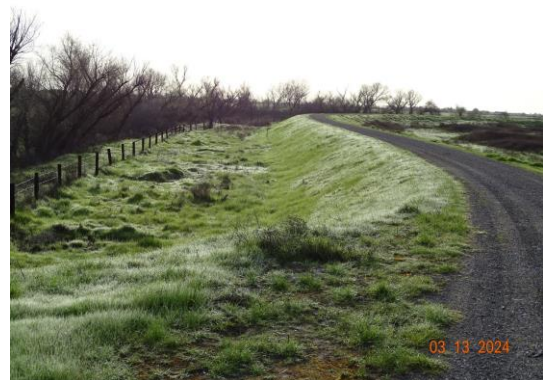
Photo 1 of 1 : SP_2024_NA0010_123_98_20240326_00294.jpg

LM Start	0.69	Rating **	A	Issue No.	98
LM End	0.69	Issue Type +	Ma	Location *	LS
Category	Earthen Levee			GPS Latitude/Longitude	
				Start	End
Item	Vegetation			37.273083°	37.273083°
				-120.814567°	-120.814567°
DWR ID	DWR_NA0010_05_s_2024_98				
Comment Code					
V1 : Control annual grass and weeds on the levee slopes and easements.					
Inspector Comment

View of the landside slope looking upstream. (Spring 2024)

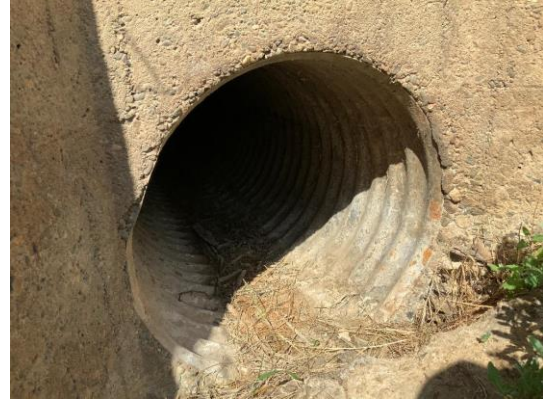
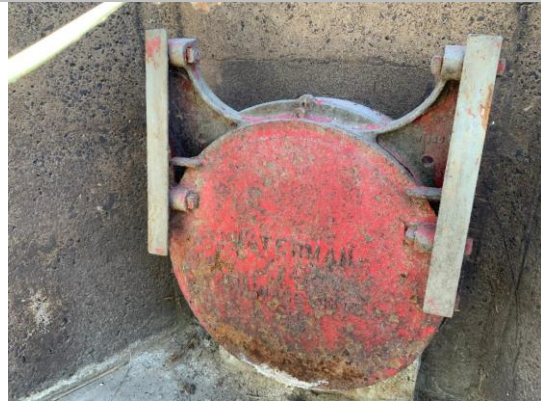
Comment Code					
Inspector Comment					
DS_ID:19759 FS_ID:83314 EP_NO: N/A Repair Type: No Action Needed EVAL Issue: Crossing Status: Found UCIP Comments: 04/25/2024 Record updated from Non-Urgent to No Action Needed. DMP internal video inspection has found none or minor pipe defects. (M. Thao - DWR UCIP) 12/20/2022 Record updated from Urgent to Non-Urgent. Pipe has been CIPP lined. LOF of crossing is less or equal to 4. Recommend next video inspection in 5 years. (O. Yakimov - DWR UCIP) 06/01/2021 Record has been upgraded from No Action Needed to Urgent. DWR DMP internal inspection has found pipe integrity issues. LOF of crossing is greater than or equal to 5 and less than 6. Crossing will be monitored until funding becomes available to address the issues. No permit was found authorizing this encroachment. CVFPB will need to review crossing to determine owner. The UCIP inspection was completed with GEI staff, P. Espinoza. (H. Dunn - GEI) FIELD_STRUCT_DESC: 24-inch CIPP-lined corrugated metal gravity drainage pipe (CMP) through the levee, 14.4 feet below the crown. Flap gate on the waterside (WS) end. Concrete headwall on the landside (LS) end. Concrete U-shaped headwall on the WS end. [Additional Reference(s): DWR Levee Log, 2002, (HLM 0.84). USACE San Joaquin O&M Manual, Unit No. 601, Part No. 1, 1967, Amended in 1978, Revised 20 June 1985, (HLM 0.84). DWR As-Built Specification No. 63-25, Sheet No. 4, 9 May 1963, (HLM 0.84)]. FS Date: 6/1/2021 11:24:27 AM

LS view: Close up of pipe inlet at toe.

WS view: Close up of flapgate at toe.

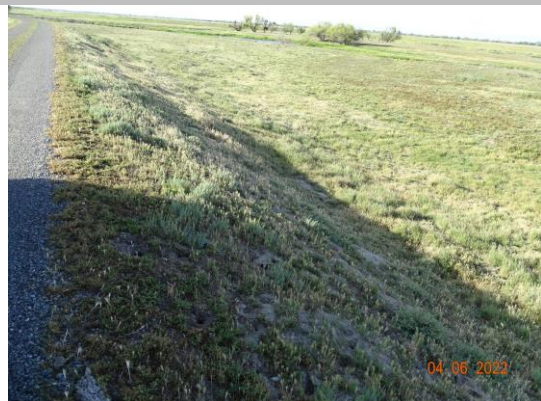
Photo 1 of 1 : SP_2024_NA0010_123_154_20240212_00043.jpg

LM Start	0.90	Rating **	A/W	Issue No.	154
LM End	0.90	Issue Type +	Ma	Location *	WS
Category	Earthen Levee			GPS Latitude/Longitude	
				Start	End
Item	Erosion / Livestock			37.271264°	37.271264°
				-120.811934°	-120.811934°
DWR ID	DWR_NA0010_05_s_2022_154				
Comment Code					
E4 : Repair the levee slope damaged by livestock and prevent large animal access.					
Inspector Comment					
Shallow depression on the lower 1/3 of the waterside slope. Possibly from livestock, but no visible trail leading to the depression. Continue to monitor.

View of minor slope erosion on the waterside. (Spring 2022)

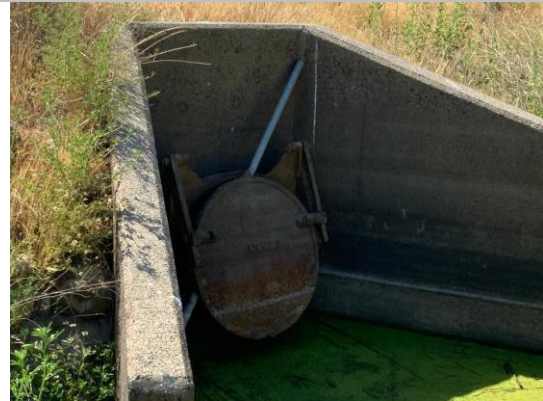
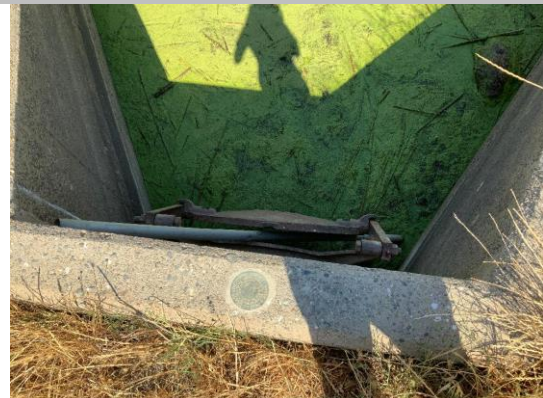
DS_ID:19760
FS_ID:70989
EP_NO: N/A
Repair Type: Non-Urgent
EVAL Issue: 11, Maintenance Compliance Issue
Crossing Status: Found
UCIP Comments: 06/1/2021 The record has been upgraded from No Action Needed to Non-Urgent. LS pipe inlet blocked by barbed wire, could not inspect. Small pipe lodged in the WS flapgate so it cannot be closed all the way, recommend removal before flood season. No permit was found authorizing this encroachment. CVFPB will need to review crossing to determine owner. The UCIP inspection was completed with GEI staff, P. Espinoza. (H. Dunn – GEI)
FIELD_STRUCT_DESC: 36-inch corrugated metal gravity drainage pipe (CMP) through the levee, 21.0 feet below the crown. Flap gate on the waterside (WS) end. Concrete headwall on the landside (LS) end. Concrete U-shaped headwall on the WS end. [Additional Reference(s): DWR Levee Log, 2002, (HLM 1.44). USACE San Joaquin O&M Manual, Unit No. 601, Part No. 1, 1967, Amended in 1978, Revised 20 June 1985, (HLM 1.44). DWR As-Built Specification No. 63-25, Sheet No. 4, 9 May 1963, (HLM 1.44)].

WS view: Close up of flapgate at toe, 1 of 2 photos.

WS view: Close up of flapgate at toe with bar sticking through, 2 of 2 photos.

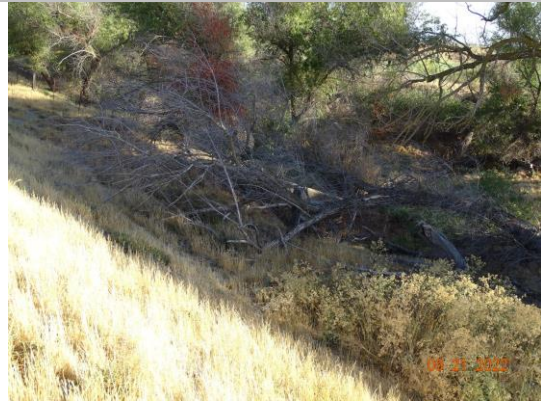
Photo 1 of 1 : SP_2024_NA0010_123_159_20240212_00046.jpg

LM Start	1.47	Rating **	M	Issue No.	159
LM End	1.47	Issue Type +	Ma	Location *	LS
Category	Earthen Levee			GPS Latitude/Longitude	
				Start	End
Item	Trim / Thin Trees			37.265605°	37.265605°
				-120.804784°	-120.804784°
DWR ID	DWR_NA0010_05_f_2022_159				
Comment Code					
T2 : Tree or limb.					
Inspector Comment					
Downed tree branch on the landside toe.

Fallen tree on the landside slope and toe. (Fall 2022)

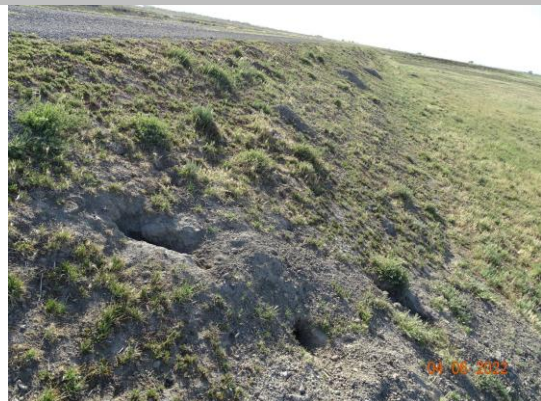
Photo 1 of 1 : SP_2024_NA0010_123_156_20240212_00044.jpg

LM Start	1.53	Rating **	U	Issue No.	156
LM End	1.53	Issue Type +	Ma	Location *	WS
Category	Earthen Levee			GPS Latitude/Longitude	
				Start	End
Item	Animal Control			37.265008°	37.265008°
				-120.804010°	-120.804010°
DWR ID	DWR_NA0010_05_s_2022_156				
Comment Code					
A3 : No rodents visible, but rodent burrows visible; need to backfill and compact or grout burrows.					
Inspector Comment					
Several rodent burrows observed. A few appear to penetrate the levee through to the landside.

Several rodent holes observed on the waterside slope. (Spring 2022)

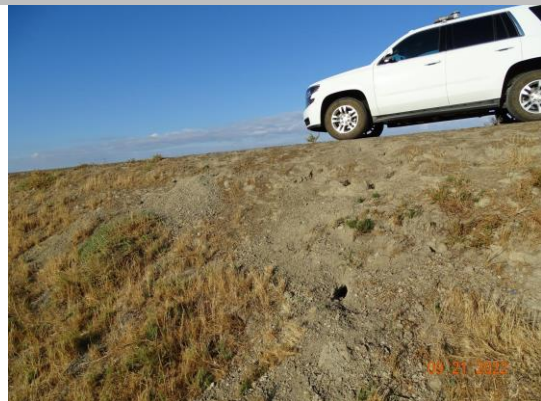
Photo 1 of 1 : SP_2024_NA0010_123_172_20240212_00057.jpg

LM Start	1.67	Rating **	M	Issue No.	172
LM End	1.67	Issue Type +	Ma	Location *	LS
Category	Earthen Levee			GPS Latitude/Longitude	
				Start	End
Item	Animal Control			37.263363°	37.263363°
				-120.802729°	-120.802729°
DWR ID	DWR_NA0010_05_f_2022_172				
Comment Code					
A3 : No rodents visible, but rodent burrows visible; need to backfill and compact or grout burrows.					
Inspector Comment

Rodent burrows on the landside slope. (Fall 2022)

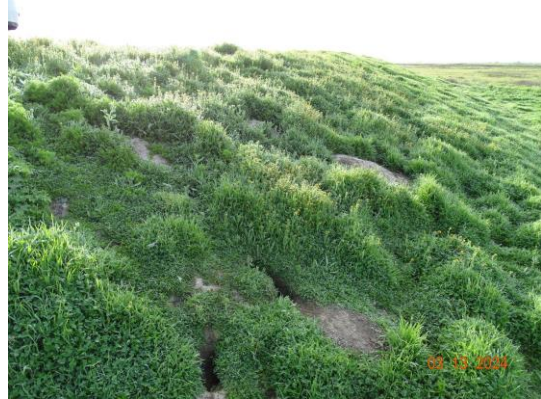
Photo 1 of 1 : SP_2024_NA0010_123_99_20240326_00295.jpg

LM Start	1.74	Rating **	M	Issue No.	99
LM End	1.74	Issue Type +	Ma	Location *	WS
Category	Earthen Levee			GPS Latitude/Longitude	
				Start	End
Item	Animal Control			37.262388°	37.262388°
				-120.802482°	-120.802482°
DWR ID	DWR_NA0010_05_s_2024_99				
Comment Code					
A3 : No rodents visible, but rodent burrows visible; need to backfill and compact or grout burrows.					
Inspector Comment					
Several rodent holes observed and appear to penetrate to the landside slope.

Several rodent holes noted at this section. (Spring 2024)

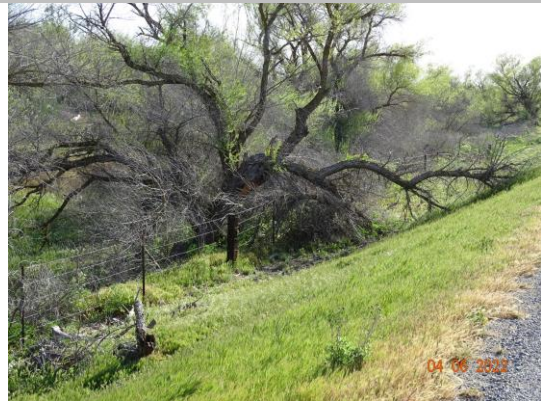
Photo 1 of 1 : SP_2024_NA0010_123_102_20240212_00010.jpg

LM Start	2.82	Rating **	M	Issue No.	102
LM End	2.82	Issue Type +	Ma	Location *	LS
Category	Earthen Levee			GPS Latitude/Longitude	
				Start	End
Item	Trim / Thin Trees			37.256805°	37.256805°
				-120.785434°	-120.785434°
DWR ID	DWR_NA0010_05_s_2019_102				
Comment Code					
T2 : Tree or limb.					
Inspector Comment

Tree limb has fallen on the landside slope and toe. (Spring 2022)

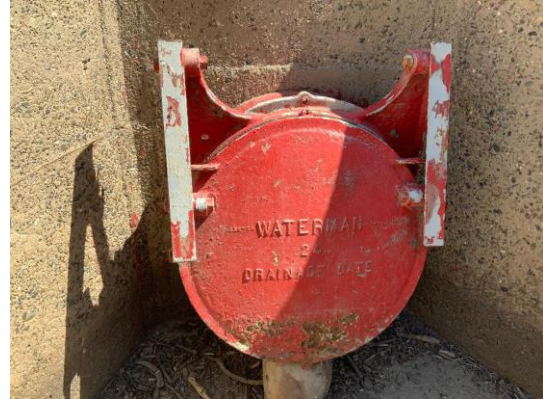
Photo 1 of 1 : UCIP_SP_2024_70990_99683.jpg

Comment Code						
Inspector Comment						
DS_ID:19809 FS_ID:70990 EP_NO: N/A Repair Type: Non-Urgent EVAL Issue: Crossing Status: Found UCIP Comments: 09/18/2023 Pipe was CIPP lined. DMP internal video inspection has found none or minor pipe defects. Recommend next video inspection in 5 years. (O. Yakimov - DWR UCIP) 06/1/2021 Record remains Non-Urgent. DWR DMP internal inspection has found pipe integrity issues. LOF of crossing is between 4.1 and 5. Crossing will be monitored until funding becomes available for rehabilitation. Barbed wire over LS end, could not inspect. No permit was found authorizing this encroachment. CVFPB will need to review crossing to determine owner. The UCIP inspection was completed with GEI staff, P. Espinoza. (H. Dunn – GEI) 04/09/2014 Log partially blocking inlet at LS toe. (W. Wylie - DWR UCIP) FIELD_STRUCT_DESC: 24-inch CIPP-lined corrugated metal gravity drainage pipe (CMP) through the levee, 15.0 feet below the crown. Flap gate on the waterside (WS) end. Concrete U-shaped headwall on each end. [Additional Reference(s): DWR Levee Log, 2002, (HLM 2.83). USACE San Joaquin O&M Manual, Unit No. 601, Part No. 1, 1967, Amended in 1978, Revised 20 June 1985, (HLM 2.85). DWR As-Built Specification No. 63-25, Sheet No. 5, 9 May 1963, (HLM 2.85)]. FS Date: 6/1/2021

WS view: Close up of flapgate at toe.

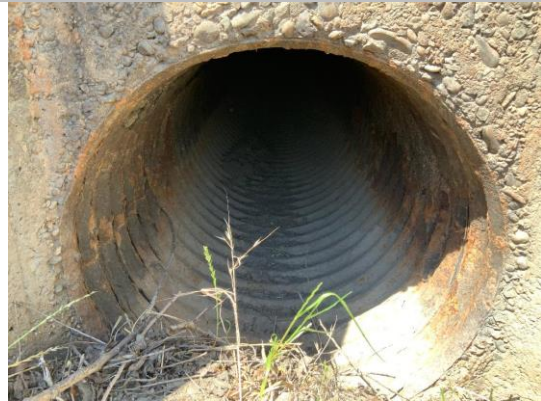
Photo 1 of 3 : UCIP_SP_2024_70991_99684.jpg

Comment Code						
Inspector Comment						
DS_ID:19810 FS_ID:70991 EP_NO: N/A Repair Type: No Action Needed EVAL Issue: Crossing Status: Found UCIP Comments: 09/18/2023 Record updated from Non-Urgent to No Action Needed. Pipe was CIPP lined. DMP internal video inspection has found none or minor pipe defects. Recommend next video inspection in 5 years. (O. Yakimov - DWR UCIP) 06/1/2021 Record remains Non-Urgent. DWR DMP internal inspection has found pipe integrity issues. LOF of crossing is between 4.1 and 5. Crossing will be monitored until funding becomes available for rehabilitation. Pipe is eroded through causing holes just behind the WS flapgate. Metal peeling away inside of pipe outlet. Flapgate is rusted with some corrosion. No permit was found authorizing this encroachment. CVFPB will need to review crossing to determine owner. The UCIP inspection was completed with GEI staff, P. Espinoza. (H. Dunn – GEI) 04/15/2014 Pipe corroded through at flapgate on WS toe. (W. Wylie - DWR UCIP) FIELD_STRUCT_DESC: 24-inch CIPP-lined corrugated metal gravity drainage pipe (CMP) through the levee, 14.7 feet below the crown. Flap gate on the waterside (WS) end. Concrete U-shaped headwall on each end. [Additional Reference(s): DWR Levee Log, 2002, (HLM 3.36). USACE San Joaquin O&M Manual, Unit No. 601, Part No. 1, 1967, Amended in 1978, Revised 20 June 1985, (HLM 3.33). DWR As-Built Specification No. 63-25, Sheet No. 5, 9 May 1963, (HLM 3.33)]. FS Date: 6/1/2021

LS view: Close up of pipe inlet at toe.

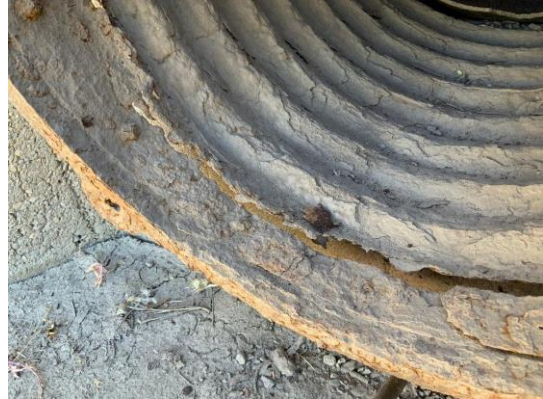
Photo 2 of 3 : UCIP_SP_2024_70991_99688.jpg

WS view: Corroded metal causing holes in pipe outlet at toe.

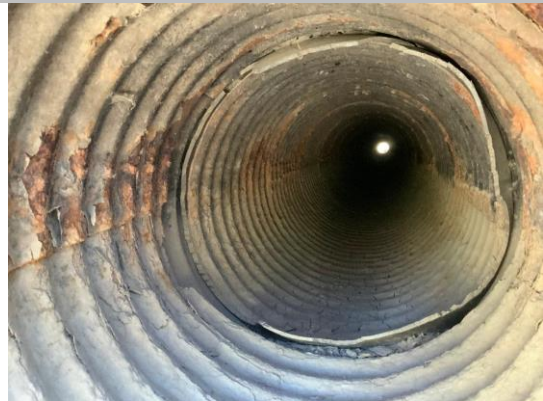
Photo 3 of 3 : UCIP_SP_2024_70991_99692.jpg

WS view: Inside pipe outlet at toe, peeling away of liner or metal, 1 of 2 photos.

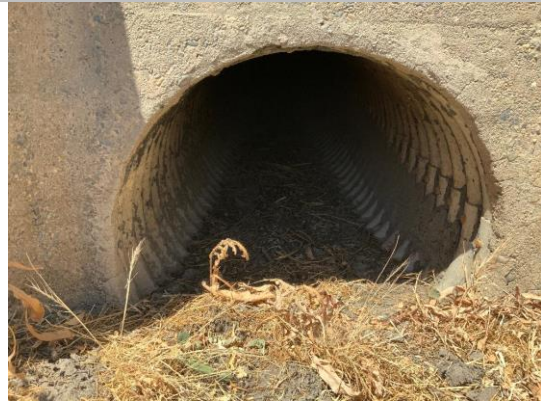
Photo 1 of 1 : UCIP_SP_2024_70992_99695.jpg

Comment Code					
Inspector Comment					
DS_ID:19811 FS_ID:70992 EP_NO: N/A Repair Type: Non-Urgent EVAL Issue: 11, Maintenance Compliance Issue Crossing Status: Found UCIP Comments: 06/1/2021 Record remains Non-Urgent. Some debris buildup within the LS pipe inlet, recommend cleaning out. No permit was found authorizing this encroachment. CVFPB will need to review crossing to determine owner. The UCIP inspection was completed with GEI staff, P. Espinoza. (H. Dunn – GEI) 04/16/2014 Sediment buildup in pipe visible from landward side--recommend contacting owner to clear pipe. (W. Wylie - DWR UCIP) FIELD_STRUCT_DESC: 24-inch corrugated metal gravity drainage pipe (CMP) through the levee, 15.0 feet below the crown. Flap gate on the waterside (WS) end. Concrete headwall on the landside (LS) end. Concrete U-shaped headwall on the WS end. [Additional Reference(s): DWR Levee Log, 2002, (HLM 3.67). USACE San Joaquin O&M Manual, Unit No. 601, Part No. 1, 1967, Amended in 1978, Revised 20 June 1985, (HLM 3.67). DWR As-Built Specification No. 63-25, Sheet No. 6, 9 May 1963, (HLM 3.67)]. FS Date: 6/1/2021

LS view: Close up of pipe inlet at toe, some debris buildup.

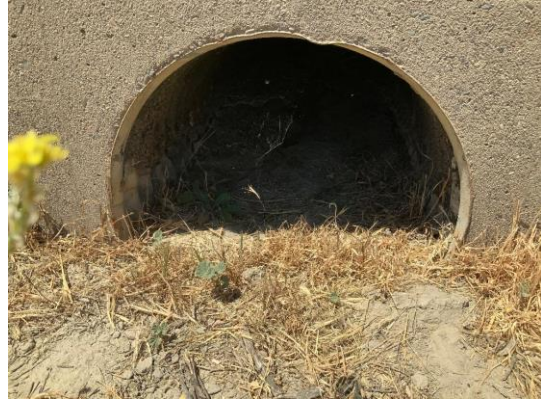
Photo 1 of 3 : UCIP_SP_2024_77866_99715.jpg

Comment Code					
Inspector Comment					
DS_ID:19770 FS_ID:77866 EP_NO: N/A Repair Type: Urgent EVAL Issue: 1, Pipe Integrity Crossing Status: Found UCIP Comments: 12/14/2022 Record updated from Non-Urgent to Urgent. DMP internal video inspection has found pipe integrity issues. LOF of crossing is between 5 and 6. Crossing will be monitored until funding becomes available to address the issues. (O.Yakimov - DWR UCIP) 06/1/2021 Record remains Non-Urgent. Sizable burrow complex on WS slope, with several holes around 3-4 inches wide, recommend filling in for levee integrity. There is also sediment buildup within the LS pipe inlet, recommend cleaning out. No permit was found authorizing this encroachment. CVFPB will need to review crossing to determine owner. The UCIP inspection was completed with GEI staff, P. Espinoza. (H. Dunn – GEI) 04/16/2014 Sediment buildup in pipe visible from landward side--recommend contacting owner to clear pipe. (W. Wylie - DWR UCIP) FIELD_STRUCT_DESC: 24-inch corrugated metal gravity drainage pipe (CMP) through the levee, 11.6 feet below the crown. Flap gate on the waterside (WS) end. Concrete headwall on the landside (LS) end. Concrete U-shaped headwall on the WS end. [Additional Reference(s): DWR Levee Log, 2002, (HLM 4.27). USACE San Joaquin O&M Manual, Unit No. 601, Part No. 1, 1967, Amended in 1978, Revised 20 June 1985, (HLM 4.27). DWR As-Built Specification No. 63-25, Sheet No. 6, 9 May 1963, (HLM 4.27)]. FS Date: 6/1/2021 1:53:07 PM

LS view: Close up of pipe inlet with sediment buildup at toe.

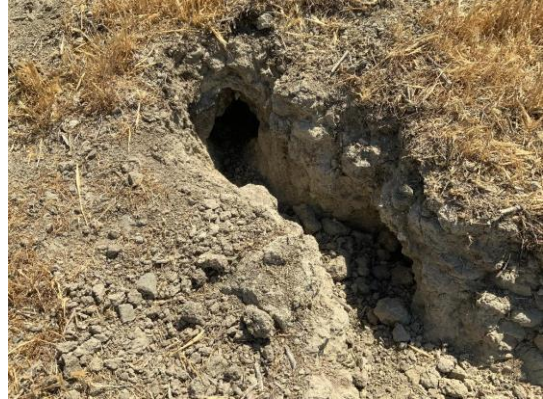
Photo 2 of 3 : UCIP_SP_2024_77866_99713.jpg

WS view: Burrow complex holes, 1 of 3 photos.

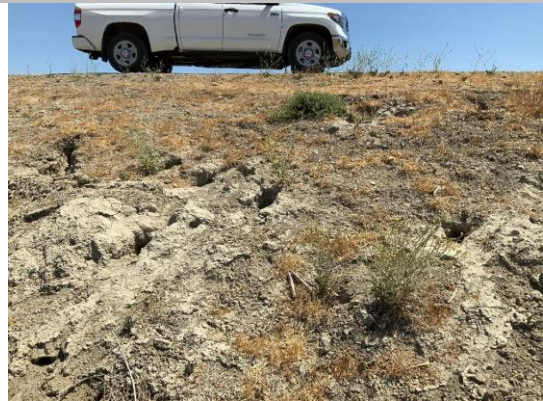
Photo 3 of 3 : UCIP_SP_2024_77866_99709.jpg

WS view: Burrow complex holes on slope from toe, 3 of 3 photos.

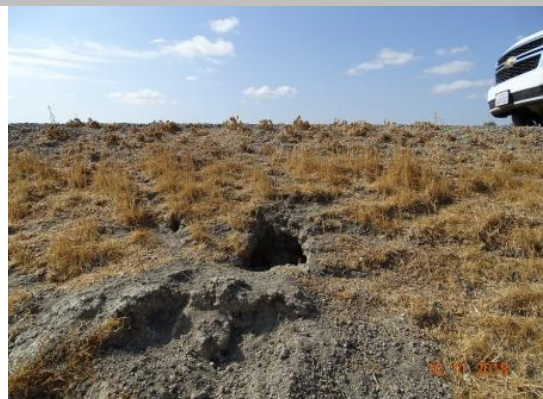
Photo 1 of 1 : SP_2024_NA0010_123_131_20240212_00027.jpg

LM Start	4.33	Rating **	A/W	Issue No.	131
LM End	4.33	Issue Type +	Ma	Location *	LS
Category	Earthen Levee			GPS Latitude/Longitude	
				Start	End
Item	Animal Control			37.245406°	37.245406°
				-120.759971°	-120.759971°
DWR ID	DWR_NA0010_05_f_2018_131				
Comment Code					
A3 : No rodents visible, but rodent burrows visible; need to backfill and compact or grout burrows.					
Inspector Comment					
Several large rodent holes are located on both sides of levee.

View of a large rodent hole in landward slope. (Fall 2018)

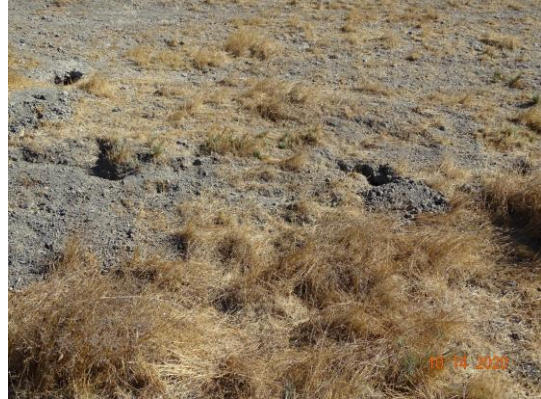
Photo 1 of 1 : SP_2024_NA0010_123_117_20240212_00016.jpg

LM Start	4.33	Rating **	A/W	Issue No.	117
LM End	4.33	Issue Type +	Ma	Location *	WS
Category	Earthen Levee			GPS Latitude/Longitude	
				Start	End
Item	Animal Control			37.245421°	37.245421°
				-120.759943°	-120.759943°
DWR ID	DWR_NA0010_05_f_2017_117				
Comment Code					
A1 : Exterminate rodents and backfill and compact or grout burrows.					
Inspector Comment

Several rodent burrows observed at this location. (Fall 2020)

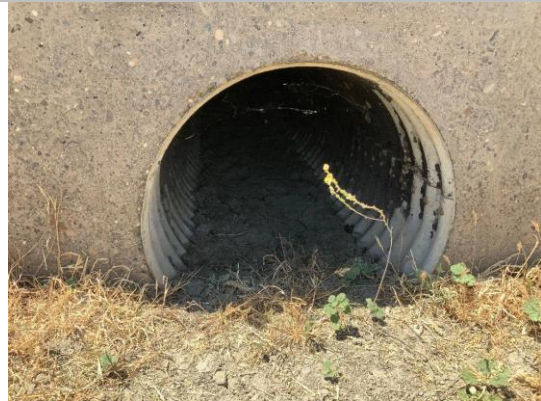
Photo 1 of 1 : UCIP_SP_2024_70995_99718.jpg

Comment Code					
Inspector Comment					
DS_ID:19771 FS_ID:70995 EP_NO: N/A Repair Type: Non-Urgent EVAL Issue: 11, Maintenance Compliance Issue Crossing Status: Found UCIP Comments: 06/1/2021 Record remains Non-Urgent. LS pipe inlet has sediment buildup inside, recommend cleaning out. No permit was found authorizing this encroachment. CVFPB will need to review crossing to determine owner. The UCIP inspection was completed with GEI staff, P. Espinoza. (H. Dunn – GEI) 04/16/2014 Sediment buildup in pipe visible from landward side--recommend contacting owner to clear pipe. (W. Wylie - DWR UCIP) FIELD_STRUCT_DESC: 24-inch corrugated metal gravity drainage pipe (CMP) through the levee, 12.0 feet below the crown. Flap gate on the waterside (WS) end. Concrete headwall on the landside (LS) end. Concrete U-shaped headwall on the WS end. [Additional Reference(s): DWR Levee Log, 2002, (HLM 4.53). USACE San Joaquin O&M Manual, Unit No. 601, Part No. 1, 1967, Amended in 1978, Revised 20 June 1985, (HLM 4.54). DWR As-Built Specification No. 63-25, Sheet No. 6, 9 May 1963, (HLM 4.54)]. FS Date: 6/1/2021

LS view: Close up of pipe inlet with sediment buildup at toe.

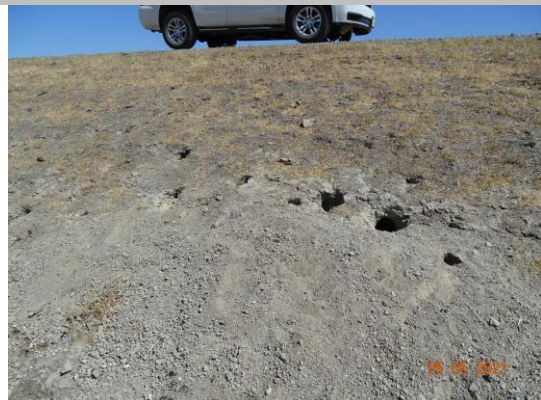
Photo 1 of 1 : SP_2024_NA0010_123_100_20240212_00008.jpg

LM Start	4.85	Rating **	M	Issue No.	100
LM End	4.85	Issue Type +	Ma	Location *	WS
Category	Earthen Levee			GPS Latitude/Longitude	
				Start	End
Item	Animal Control			37.241127°	37.241127°
				-120.752398°	-120.752398°
DWR ID	DWR_NA0010_05_s_2021_100				
Comment Code					
A1 : Exterminate rodents and backfill and compact or grout burrows.					
Inspector Comment					
Several burrows and rodents observed at this location. Bait stations have been set up.

Several rodent burrows noted at this location. (Spring 2021)

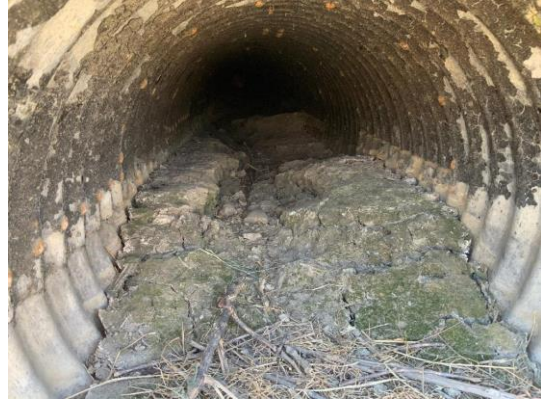
Photo 1 of 1 : UCIP_SP_2024_70996_100748.jpg

Comment Code						
Inspector Comment						
DS_ID:19772						
FS_ID:70996						
EP_NO: N/A						
Repair Type: Non-Urgent						
EVAL Issue: 11, Maintenance Compliance Issue						
Crossing Status: Found						
UCIP Comments: 06/1/2021 The record remains Non-Urgent. LS pipe inlet has sediment buildup, recommend cleaning out. No permit was found authorizing this encroachment. CVFPB will need to review crossing to determine owner. The UCIP inspection was completed with GEI staff, P. Espinoza. (H. Dunn – GEI) 04/16/2014 Heavy sediment buildup in pipe visible from landward side--recommend contacting owner to clear pipe. (W. Wylie - DWR UCIP)						
FIELD_STRUCT_DESC: 24-inch corrugated metal gravity drainage pipe (CMP) through the levee, 12.3 feet below the crown. Flap gate on the waterside (WS) end. Concrete headwall on the landside (LS) end. Concrete U-shaped headwall on the WS end. [Additional Reference(s): DWR Levee Log, 2002, (HLM 4.89). USACE San Joaquin O&M Manual, Unit No. 601, Part No. 1, 1967, Amended in 1978, Revised 20 June 1985, (HLM 4.89). DWR As-Built Specification No. 63-25, Sheet No. 7, 9 May 1963, (HLM 4.89)].

LS view: Inside pipe inlet with sediment buildup at toe.

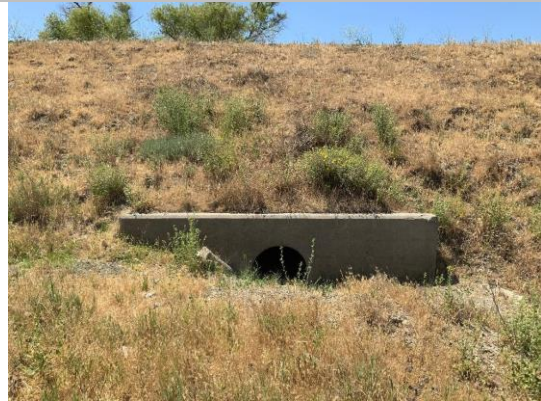
Photo 3 of 3 : UCIP_SP_2024_77867_100754.jpg

Comment Code						
Inspector Comment						
DS_ID:19773 FS_ID:77867 EP_NO: N/A Repair Type: Urgent EVAL Issue: 1, Pipe Integrity Crossing Status: Found UCIP Comments: 12/14/2022 Record updated from Non-Urgent to Urgent. DMP internal video inspection has found pipe integrity issues. LOF of crossing is between 5 and 6. Crossing will be monitored until funding becomes available to address the issues. (O.Yakimov - DWR UCIP) 06/1/2021 The record remains Non-Urgent. Crossing appears to be in good condition. No permit was found authorizing this encroachment. CVFPB will need to review crossing to determine owner. The UCIP inspection was completed with GEI staff, P. Espinoza. (H. Dunn – GEI) 04/16/2014 Heavy sediment buildup in pipe visible from landward side--recommend contacting owner to clear pipe. (W. Wylie - DWR UCIP) FIELD_STRUCT_DESC: 24-inch corrugated metal gravity drainage pipe (CMP) through the levee, 12.2 feet below the crown. Flap gate on the waterside (WS) end. Concrete headwall on the landside (LS) end. Concrete U-shaped headwall on the WS end. [Additional Reference(s): DWR Levee Log, 2002, (HLM 5.14). USACE San Joaquin O&M Manual, Unit No. 601, Part No. 1, 1967, Amended in 1978, Revised 20 June 1985, (HLM 5.15). DWR As-Built Specification No. 63-25, Sheet No. 7, 9 May 1963, (HLM 5.15)]. FS Date: 6/1/2021 1:53:28 PM

LS view: Slope and headwall at toe.

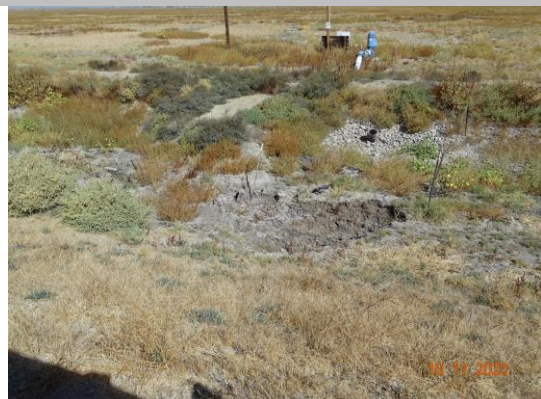
Photo 1 of 1 : SP_2024_NA0010_123_151_20240212_00040.jpg

LM Start	5.83	Rating **	A/W	Issue No.	151
LM End	5.83	Issue Type +	Ma	Location *	LS
Category	Earthen Levee			GPS Latitude/Longitude	
				Start	End
Item	Erosion / Bank Caving			37.236850°	37.236850°
				-120.736157°	-120.736157°
DWR ID	DWR_NA0010_05_f_2023_151				
Comment Code					
E1 : Note and monitor erosion site.					
Inspector Comment					
Erosion pocket appears to be just outside of the levee prism in the levee toe. Recommend repairing before it can worsen.

Erosion on the landside toe just outside the theoretical prism. (Fall 2023)

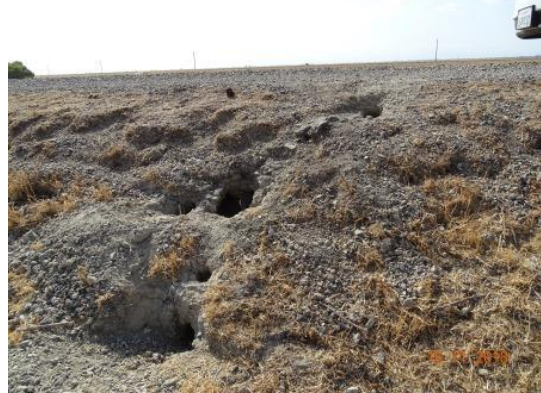
Photo 1 of 1 : SP_2024_NA0010_123_138_20240212_00030.jpg

LM Start	5.94	Rating **	A/W	Issue No.	138
LM End	5.94	Issue Type +	Ma	Location *	LS
Category	Earthen Levee			GPS Latitude/Longitude	
				Start	End
Item	Animal Control			37.236387°	37.236387°
				-120.734164°	-120.734164°
DWR ID	DWR_NA0010_05_f_2018_138				
Comment Code					
A1 : Exterminate rodents and backfill and compact or grout burrows.					
Inspector Comment

View of large rodent holes in landside slope. (Fall 2018)

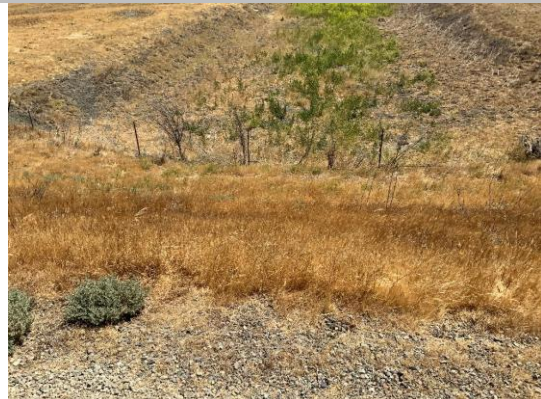
Photo 2 of 3 : UCIP_SP_2024_71001_100784.jpg

Comment Code					
Inspector Comment					
DS_ID:19762 FS_ID:71001 EP_NO: N/A Repair Type: Non-Urgent EVAL Issue: Crossing Status: Indicator Found UCIP Comments: 06/9/2021 The record remains Non-Urgent. No pipe visible on WS or LS during inspection, only indicator found. WS metal riser is bent. DWR DMP Geophysical study indicates possible presence of pipe through levee at (2305907, -13523234), coordinates have been updated. Owner needs to coordinate with the CVFPB to remove or abandon crossing according to Title 23 requirements. No permit was found authorizing this encroachment. CVFPB will need to review crossing to determine owner. The UCIP inspection was completed with GEI staff, P. Espinoza. (H. Dunn – GEI) 04/22/2014 Appears abandoned and if so should be done so properly. Slide gate rusted shut on WS slope. Unable to locate inlet or outlet. (W. Wylie - DWR UCIP) FIELD_STRUCT_DESC: 24-inch corrugated metal gravity drainage pipe (CMP) through the levee, 20.4 feet below the crown. Slide gate in a 36-inch CMP riser unit on the waterside (WS) slope. Concrete U-shaped headwall on each end. [Additional Reference(s): DWR Levee Log, 2002, (HLM 7.57). USACE San Joaquin O&M Manual, Unit No. 601, Part No. 1, 1967, Amended in 1978, Revised 20 June 1985, (HLM 7.58). DWR As-Built Specification No. 63-25, Sheet No. 9, 9 May 1963, (HLM 7.58)]. FS Date: 6/9/2021

LS view: Toe from crown.

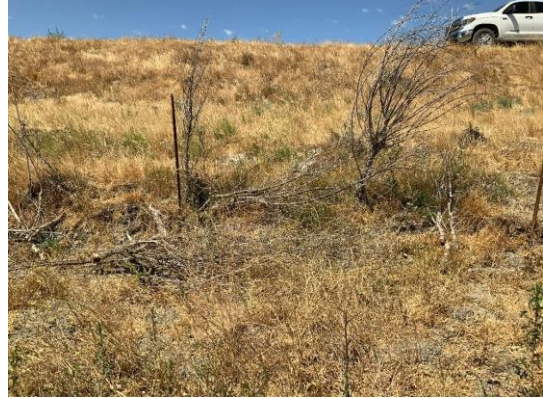
Photo 3 of 3 : UCIP_SP_2024_71001_100785.jpg

LS view: Slope from toe, no pipe visible.

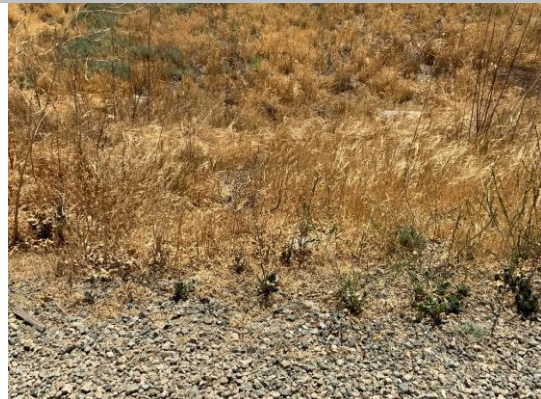
Photo 2 of 3 : UCIP_SP_2024_71002_100809.jpg

Comment Code					
Inspector Comment					
DS_ID:19844 FS_ID:71002 EP_NO: N/A Repair Type: Non-Urgent EVAL Issue: Crossing Status: Found UCIP Comments: 06/9/2021 The record has been upgraded from No Action Needed to Non-Urgent. DWR DMP internal inspection has not found pipe integrity issues. LOF of crossing is less or equal to 4.0. Recommend next video inspection in 5 years. No permit was found authorizing this encroachment. CVFPB will need to review crossing to determine owner. The UCIP inspection was completed with GEI staff, P. Espinoza. (H. Dunn – GEI) 08/01/2018 USACE O&M manual has pipe listed under Unit 10 HLM 0.02, however, based on the current levee alignment pipe is located under Unit 5 CLM 7.68. Discrepancy in pipe O&M reference is based on reference between Historic Levee Alignment and Current Levee Alignment. (DWR UCIP - O. Magana) FIELD_STRUCT_DESC: 24-inch corrugated metal gravity drainage pipe (CMP) through the levee, 9.4 feet below the crown. Flap gate on the waterside (WS) end. Concrete headwall on the landside (LS) end. Concrete U-shaped headwall on the WS end. [Additional Reference(s): DWR Levee Log, 2002. USACE San Joaquin O&M Manual, Unit No. 601, Part No. 1, 1967, Amended in 1978, Revised 20 June 1985, (recorded as Unit 10 HLM 0.02, located in Unit 5 CLM 7.68)]. FS Date: 6/9/2021

LS view: Toe from crown.

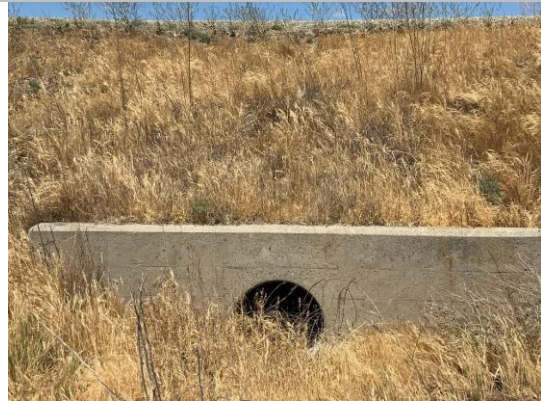
Photo 3 of 3 : UCIP_SP_2024_71002_100803.jpg

LS view: Slope and headwall at toe.

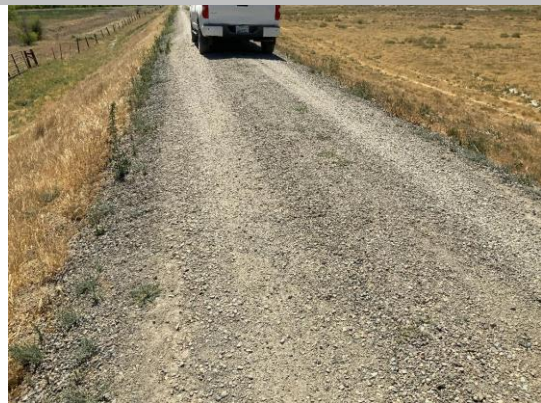
Photo 1 of 3 : UCIP_SP_2024_71003_100811.jpg

DS_ID:19763
 FS_ID:71003
 EP_NO: N/A
 Repair Type: Non-Urgent
 EVAL Issue:
 Crossing Status: Found
 UCIP Comments: 06/9/2021 The record remains Non-Urgent. Barbed wire over LS pipe inlet, limited inspection due to inaccessibility. No permit was found authorizing this encroachment. CVFPB will need to review crossing to determine owner. The UCIP inspection was completed with GEI staff, P. Espinoza. (H. Dunn – GEI) 04/22/2014
 Pipe filled with silt on LS toe and should be cleared. (W. Wylie - DWR UCIP)
 FIELD_STRUCT_DESC: 24-inch corrugated metal gravity drainage pipe (CMP) through the levee, 16.0 feet below the crown. Flap gate on the waterside (WS) end. Concrete headwall on the landside (LS) end. Concrete U-shaped headwall on the WS end. [Additional Reference(s): DWR Levee Log, 2002, (HLM 8.45). USACE San Joaquin O&M Manual, Unit No. 601, Part No. 1, 1967, Amended in 1978, Revised 20 June 1985, (HLM 8.44). DWR As-Built Specification No. 63-25, Sheet No. 9, 9 May 1963, (HLM 8.44)].

Levee crown looking upstream.

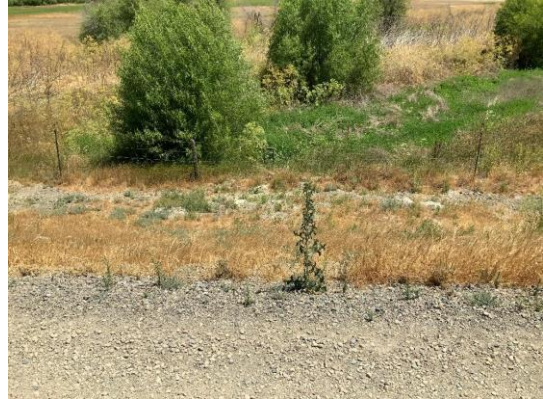
Photo 2 of 3 : UCIP_SP_2024_71003_100815.jpg

LS view: Toe from crown.

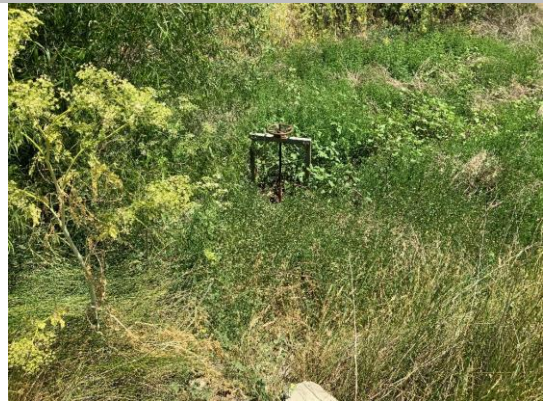
Photo 3 of 3 : UCIP_SP_2024_71003_100816.jpg

LS view: Slidegate visible at the toe behind barbed wire.

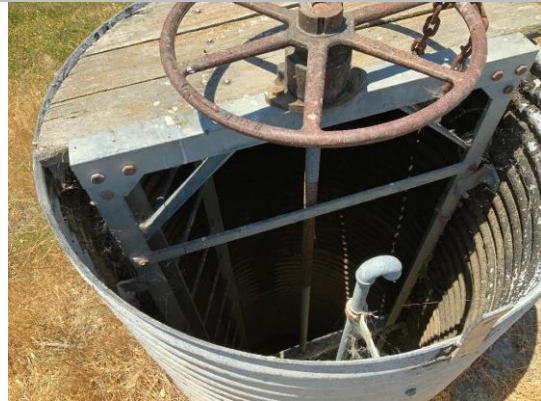
Photo 1 of 2 : UCIP_SP_2024_71009_100872.jpg

Comment Code					
Inspector Comment					
DS_ID:19766 FS_ID:71009 EP_NO: N/A Repair Type: Non-Urgent EVAL Issue: 4b, Safety Issue Crossing Status: Found UCIP Comments: 06/9/2021 The record has been upgraded from No Action Needed to Non-Urgent. LS pipe inlet was underwater during inspection, limited inspection. WS riser is missing half of the cover causing safety hazard. The LS pipe inlet is filled with sediment, recommend removal. No permit was found authorizing this encroachment. CVFPB will need to review crossing to determine owner. The UCIP inspection was completed with GEI staff, P. Espinoza. (H. Dunn – GEI) FIELD_STRUCT_DESC: 36-inch corrugated metal gravity drainage pipe (CMP) through the levee, 14.8 feet below the crown. Slide gate in a 48-inch CMP riser unit on the waterside (WS) slope. Concrete headwall on each end. [Additional Reference(s): DWR Levee Log, 2002, (HLM 9.24). USACE San Joaquin O&M Manual, Unit No. 601, Part No. 1, 1967, Amended in 1978, Revised 20 June 1985, (HLM 9.26). DWR As-Built Specification No. 61-01, Sheet No. 52, 7 March 1961, (HLM 9.26)]. FS Date: 6/9/2021

WS view: Close up of riser and slidegate, missing partial cover.
