**Flood Control Project Maintenance
Levee Inspections**

Maintenance Issue Types Only, Levee Inspection Report By Mile - Spring 2024

Lower San Joaquin Levee District

Waterway	Bank	Unit Miles	Inspection Start/End	Inspector
Unit No. 01 San Joaquin River	Right	22.52	03/12/2024 03/12/2024	Corey Fujitani

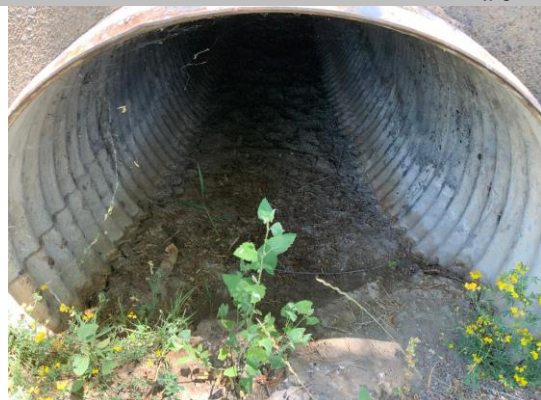
Photo 2 of 2 : UCIP_SP_2024_71009_100874.jpg

Comment Code					
Inspector Comment					
DS_ID:19766 FS_ID:71009 EP_NO: N/A Repair Type: Non-Urgent EVAL Issue: 4b, Safety Issue Crossing Status: Found UCIP Comments: 06/9/2021 The record has been upgraded from No Action Needed to Non-Urgent. LS pipe inlet was underwater during inspection, limited inspection. WS riser is missing half of the cover causing safety hazard. The LS pipe inlet is filled with sediment, recommend removal. No permit was found authorizing this encroachment. CVFPB will need to review crossing to determine owner. The UCIP inspection was completed with GEI staff, P. Espinoza. (H. Dunn – GEI) FIELD_STRUCT_DESC: 36-inch corrugated metal gravity drainage pipe (CMP) through the levee, 14.8 feet below the crown. Slide gate in a 48-inch CMP riser unit on the waterside (WS) slope. Concrete headwall on each end. [Additional Reference(s): DWR Levee Log, 2002, (HLM 9.24). USACE San Joaquin O&M Manual, Unit No. 601, Part No. 1, 1967, Amended in 1978, Revised 20 June 1985, (HLM 9.26). DWR As-Built Specification No. 61-01, Sheet No. 52, 7 March 1961, (HLM 9.26)]. FS Date: 6/9/2021

WS view: Close up of pipe inlet at toe, filled with sediment.

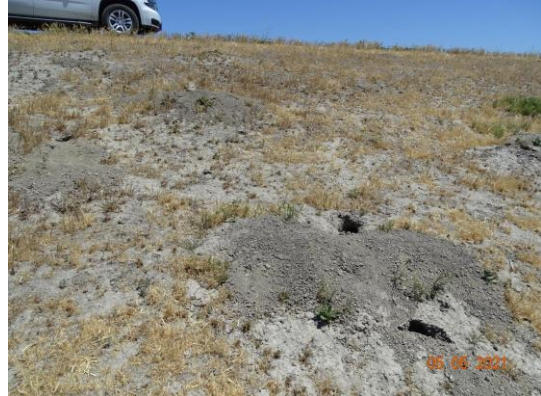
Photo 1 of 1 : SP_2024_NA0010_123_101_20240212_00009.jpg

LM Start	9.41	Rating **	M	Issue No.	101
LM End	9.45	Issue Type +	Ma	Location *	WS
Category	Earthen Levee			GPS Latitude/Longitude	
				Start	End
Item	Animal Control			37.201636°	37.201240°
				-120.688154°	-120.687686°
DWR ID	DWR_NA0010_05_s_2021_101				
Comment Code					
A3 : No rodents visible, but rodent burrows visible; need to backfill and compact or grout burrows.					
Inspector Comment

Multiple rodent holes in the waterside slope. (Spring 2021)

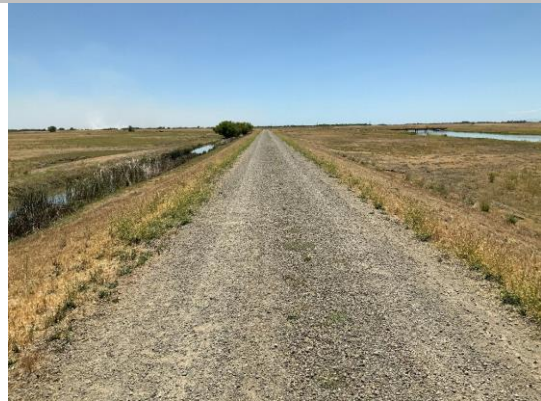
Photo 1 of 3 : UCIP_SP_2024_71010_100878.jpg

Comment Code					
Inspector Comment					
DS_ID:19767 FS_ID:71010 EP_NO: N/A Repair Type: Non-Urgent EVAL Issue: Crossing Status: Found UCIP Comments: 06/9/2021 The record remains Non-Urgent. LS pipe inlet is underwater, could not inspect. No permit was found authorizing this encroachment. CVFPB will need to review crossing to determine owner. The UCIP inspection was completed with GEI staff, P. Espinoza. (H. Dunn – GEI) 04/22/2014 Slidegate actuator appears bent and may not work properly (WS slope). (W. Wylie - DWR UCIP) FIELD_STRUCT_DESC: 24-inch corrugated metal gravity drainage pipe (CMP) through the levee, 15.0 feet below the crown. Slide gate in a 36-inch CMP riser unit on the waterside (WS) slope. Concrete headwall on each end. [Additional Reference(s): DWR Levee Log, 2002 (HLM 10.04). USACE San Joaquin O&M Manual, Unit No. 601, Part No. 1, 1967, Amended in 1978, Revised 20 June 1985, (HLM 10.05). DWR As-Built Specification No. 61-01, Sheet No. 52, 7 March 1961, (HLM 10.05)]. FS Date: 6/9/2021

Levee crown looking upstream.

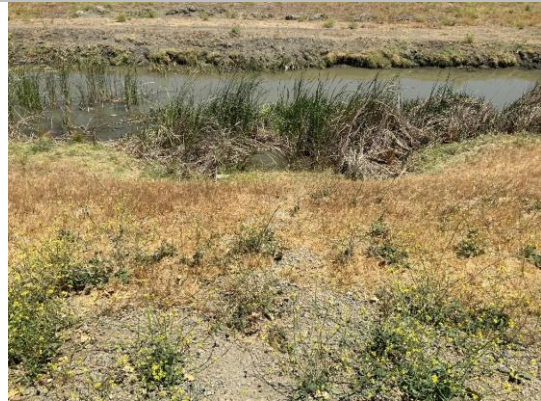
Photo 2 of 3 : UCIP_SP_2024_71010_100883.jpg

LS view: Toe from crown.

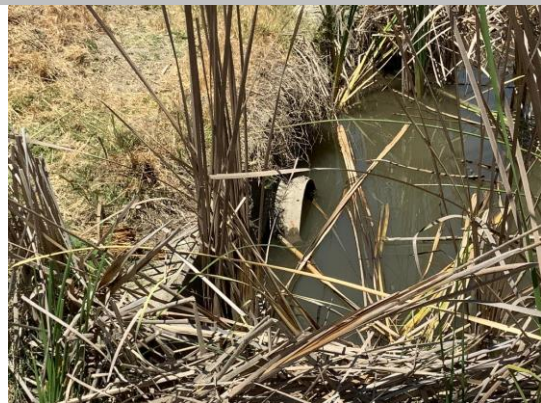
Photo 3 of 3 : UCIP_SP_2024_71010_100876.jpg

LS view: Closeup of pipe inlet at toe, underwater.

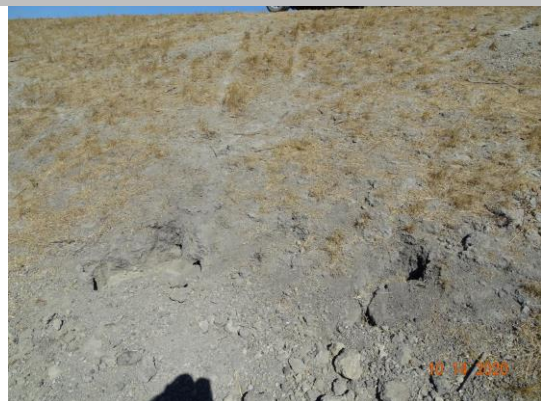
Photo 1 of 1 : SP_2024_NA0010_123_105_20240212_00011.jpg

LM Start	10.10	Rating **	M	Issue No.	105
LM End	10.10	Issue Type +	Ma	Location *	WS
Category	Earthen Levee			GPS Latitude/Longitude	
				Start	End
Item	Animal Control			37.194344°	37.194344°
				-120.679708°	-120.679708°
DWR ID	DWR_NA0010_05_f_2020_105				
Comment Code					
A3 : No rodents visible, but rodent burrows visible; need to backfill and compact or grout burrows.					
Inspector Comment

View of rodent activity in the landside slope. (Fall 2020)

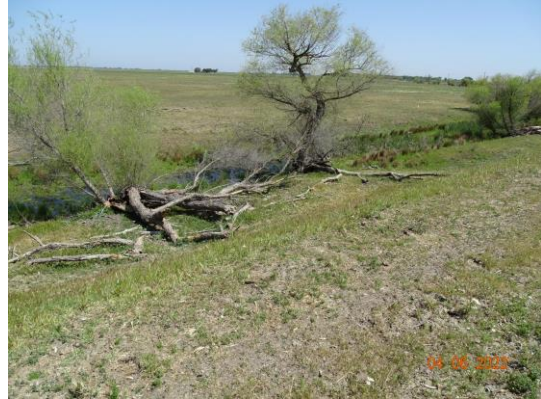
Photo 1 of 1 : SP_2024_NA0010_123_144_20240212_00034.jpg

LM Start	11.37	Rating **	M	Issue No.	144
LM End	11.37	Issue Type +	Ma	Location *	LS
Category	Earthen Levee			GPS Latitude/Longitude	
				Start	End
Item	Trim / Thin Trees			37.187792°	37.187792°
				-120.659454°	-120.659454°
DWR ID	DWR_NA0010_05_f_2018_144				
Comment Code					
T3 : Fallen tree with root ball.					
Inspector Comment					
Tree limbs on the levee toe should be moved from the easement.

View of tree limbs on levee slope. (Spring 2022)

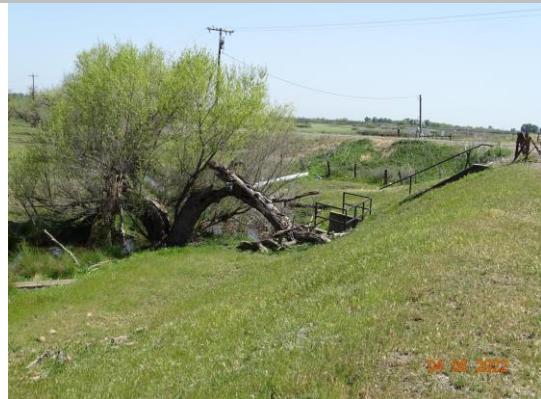
Photo 1 of 1 : SP_2024_NA0010_123_147_20240212_00036.jpg

LM Start	11.49	Rating **	U	Issue No.	147
LM End	11.49	Issue Type +	Ma	Location *	LS
Category	Earthen Levee			GPS Latitude/Longitude	
				Start	End
Item	Trim / Thin Trees			37.186482°	37.186482°
				-120.657935°	-120.657935°
DWR ID	DWR_NA0010_05_f_2021_147				
Comment Code					
T3 : Fallen tree with root ball.					
Inspector Comment					
Tree limbs are located on landside slope and toe.

Tree limbs on levee toe. (Spring 2022)

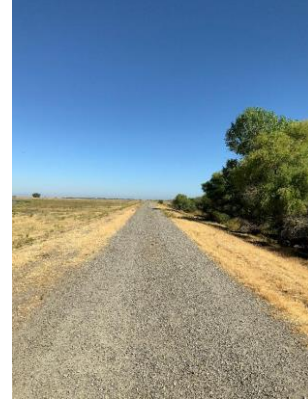
Photo 1 of 3 : UCIP_SP_2024_71012_103968.jpg

Comment Code					
Inspector Comment					
DS_ID:19768 FS_ID:71012 EP_NO: N/A Repair Type: Non-Urgent EVAL Issue: Crossing Status: Found UCIP Comments: 06/22/2021 The record has been upgraded from No Action Needed to Non-Urgent. Crossing appears to be in good condition. No permit was found authorizing this encroachment. CVFPB will need to review crossing to determine owner. The UCIP inspection was completed with GEI staff, H.Dunn. (P.Espinoza – GEI) FIELD_STRUCT_DESC: [Deadman Drain] 1 of 2: 48-inch corrugated metal gravity drainage pipe (CMP) through the levee, 16.0 feet below the crown. Slide gate in a 60-inch CMP riser unit on the waterside (WS) slope. Concrete U-shaped headwall on each end. Stairs on the landside (LS) slope. [Additional Reference(s): DWR Levee Log, 2002, (HLM 11.45). USACE San Joaquin O&M Manual, Unit No. 601, Part No. 1, 1967, Amended in 1978, Revised 20 June 1985, (HLM 11.48). DWR As-Built Specification No. 61-01, Sheet No. 53, 7 March 1961, (HLM 11.48)]. FS Date: 6/22/2021

View from levee crown.

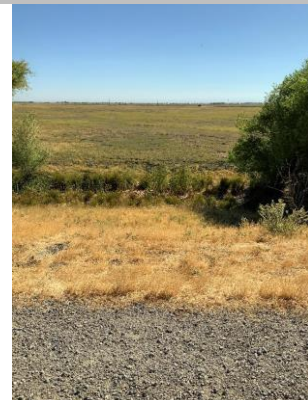
Photo 2 of 3 : UCIP_SP_2024_71012_103970.jpg

LS view of slope from levee crown.

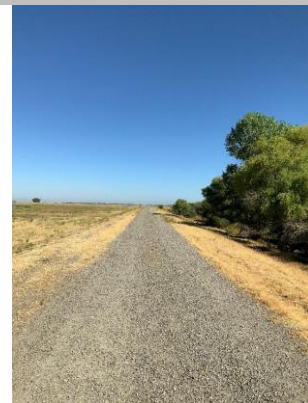
Photo 1 of 3 : UCIP_SP_2024_71013_104487.jpg

DS_ID:19734
FS_ID:71013
EP_NO: N/A
Repair Type: Non-Urgent
EVAL Issue:
Crossing Status: Found
UCIP Comments: 06/22/2021 The record has been upgraded from No Action Needed to Non-Urgent. Crossing appears to be in good condition. No permit was found authorizing this encroachment. CVFPB will need to review crossing to determine owner. The UCIP inspection was completed with GEI staff, P. Espinoza. (H. Dunn – GEI)
FIELD_STRUCT_DESC: [Deadman Drain] 2 of 2: 48-inch corrugated metal gravity drainage pipe (CMP) through the levee, 16.0 feet below the crown. Slide gate in a 60-inch CMP riser unit on the waterside (WS) slope. Concrete U-shaped headwall on each end. Stairs on the landside (LS) slope. [Additional Reference(s): DWR Levee Log, 2002, (HLM 11.45). USACE San Joaquin O&M Manual, Unit No. 601, Part No. 1, 1967, Amended in 1978, Revised 20 June 1985, (HLM 11.48). DWR As-Built Specification No. 61-01, Sheet No. 53, 7 March 1961, (HLM 11.48)].

Levee crown.

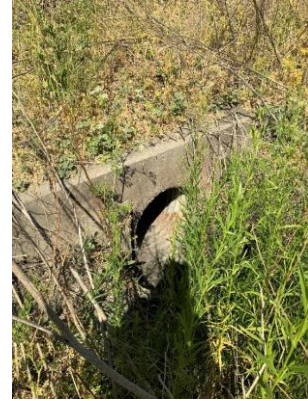
Photo 1 of 2 : UCIP_SP_2024_77929_103981.jpg

Comment Code					
Inspector Comment					
DS_ID:19704 FS_ID:77929 EP_NO: N/A Repair Type: Non-Urgent EVAL Issue: 11, Maintenance Compliance Issue Crossing Status: Found UCIP Comments: 12/20/2022 Record updated from Urgent to Non-Urgent. Pipe has been CIPP lined. LOF of crossing is less or equal to 4. Recommend next video inspection in 5 years. (O.Yakimov - DWR UCIP) 06/22/2021 The record has been upgraded from No Action Needed to Urgent. DWR DMP internal inspection has found pipe integrity issues. LOF of crossing is greater than or equal to 5 and less than 6. Crossing will be monitored until funding becomes available to address the issues. Limited inspection of inlet pipe due to dense vegetation; removal recommended. No permit was found authorizing this encroachment. CVFPB will need to review crossing to determine owner. The UCIP inspection was completed with GEI staff, H.Dunn. (P.Espinoza – GEI) FIELD_STRUCT_DESC: 24-inch CIPP-lined corrugated metal gravity drainage pipe (CMP) through the levee, 11.8 feet below the crown. Flap gate on the waterside (WS) end. Concrete headwall on the landside (LS) end. Concrete saddle and apron on the WS end. [Additional Reference(s): DWR Levee Log, 2002, (HLM 11.60). USACE San Joaquin O&M Manual, Unit No. 601, Part No. 1, 1967, Amended in 1978, Revised 20 June 1985, (HLM 11.63). DWR As-Built Specification No. 61-01, Sheet No. 53, 7 March 1961, (HLM 11.63)]. FS Date: 6/22/2021 11:25:08 AM

LS view: closeup of concrete headwall and inlet pipe.

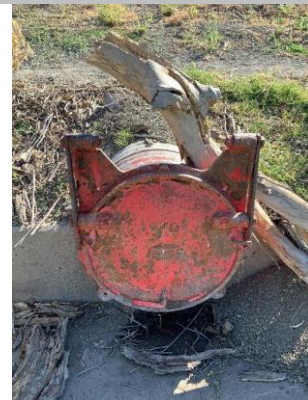
Photo 2 of 2 : UCIP_SP_2024_77929_103979.jpg

WS view: closeup of flapgate.

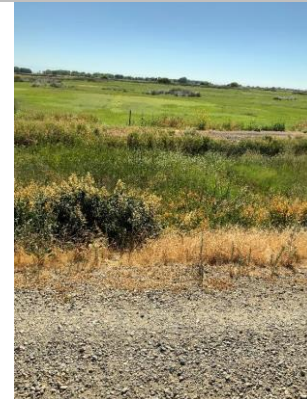
Photo 1 of 2 : UCIP_SP_2024_71016_103983.jpg

Comment Code					
Inspector Comment					
DS_ID:19705 FS_ID:71016 EP_NO: N/A Repair Type: Urgent EVAL Issue: 2b, Levee Integrity Crossing Status: Found UCIP Comments: 12/20/2022 Record remains Urgent. Pipe has been CIPP-lined. LOF of crossing is less or equal to 4. Recommend next video inspection in 5 years. Erosion around concrete headwall on WS needs to be repaired. (O.Yakimov - DWR UCIP) 06/22/2021 The record has been upgraded from No Action Needed to Urgent. DWR DMP internal inspection has found pipe integrity issues. LOF of crossing is between 4.1 and 5. Crossing will be monitored until funding becomes available for rehabilitation. Limited inspection of LS due to dense vegetation; recommend removal. Erosion around concrete headwall on WS, at least 1 foot in depth. No permit was found authorizing this encroachment. CVFPB will need to review crossing to determine owner. The UCIP inspection was completed with GEI staff, H.Dunn. (P.Espinoza – GEI) FIELD_STRUCT_DESC: 24-inch CIPP-lined corrugated metal gravity drainage pipe (CMP) through the levee, 12.5 feet below the crown. Flap gate on the waterside (WS) end. Concrete headwall on the landside (LS) end. Concrete saddle and apron on the WS end. Flashboard attachment on the LS end. [Additional Reference(s): DWR Levee Log, 2002, (HLM 11.98). USACE San Joaquin O&M Manual, Unit No. 601, Part No. 1, 1967, Amended in 1978, Revised 20 June 1985, (HLM 11.99). DWR As-Built Specification No. 61-01, Sheet No. 54, 7 March 1961, (HLM 11.99)]. FS Date: 6/22/2021

LS view: slope from crown.

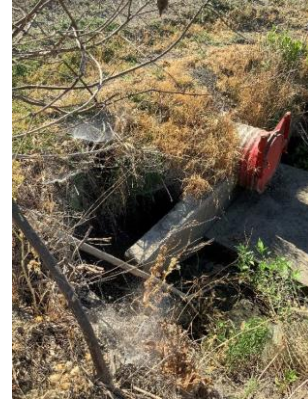
Photo 2 of 2 : UCIP_SP_2024_71016_103986.jpg

WS view: visible erosion around concrete headwall, 1 of 2 photos.

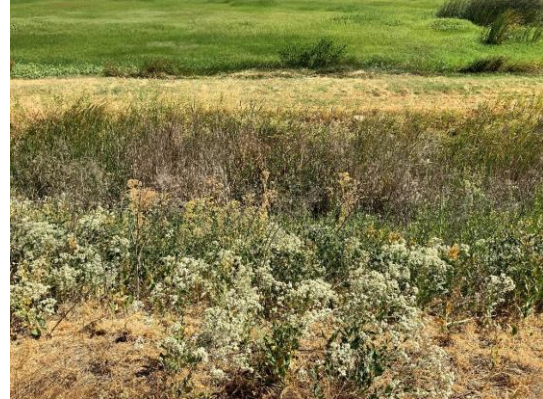
Photo 1 of 3 : UCIP_SP_2024_71017_104007.jpg

Comment Code					
Inspector Comment					
DS_ID:19706 FS_ID:71017 EP_NO: N/A Repair Type: Urgent EVAL Issue: 2b, Levee Integrity Crossing Status: Found UCIP Comments: 12/20/2022 Record remains Urgent. Pipe has been CIPP-lined. LOF of crossing is less or equal to 4. Recommend next video inspection in 5 years. Erosion around flapgate and concrete headwall on waterside needs to be addressed. (O.Yakimov - DWR UCIP) 06/22/2021 The record has been upgraded from No Action Needed to Urgent. DWR DMP internal inspection has found pipe integrity issues. LOF of crossing is between 5 and 6. Crossing will be monitored until funding becomes available to address the issues. Erosion around concrete headwall on WS, at least 1 foot in length. Limited inspection of LS due to vegetation and sediment; recommend removal. No permit was found authorizing this encroachment. CVFPB will need to review crossing to determine owner. The UCIP inspection was completed with GEI staff, H.Dunn. (P.Espinoza – GEI) FIELD_STRUCT_DESC: 24-inch CIPP-lined corrugated metal gravity drainage pipe (CMP) through the levee, 10.2 feet below the crown. Flap gate on the waterside (WS) end. Concrete headwall on the landside (LS) end. Concrete saddle and apron on the WS end. Flashboard attachment on the LS end. Pipe crosses levee at a 45-degree angle. [Additional Reference(s): DWR Levee Log, 2002, (HLM 12.38). USACE San Joaquin O&M Manual, Unit No. 601, Part No. 1, 1967, Amended in 1978, Revised 20 June 1985, (HLM 12.38). DWR As-Built Specification No. 61-01, Sheet No. 54, 7 March 1961, (HLM 12.38)]. FS Date: 6/22/2021

LS view: Slope from crown.

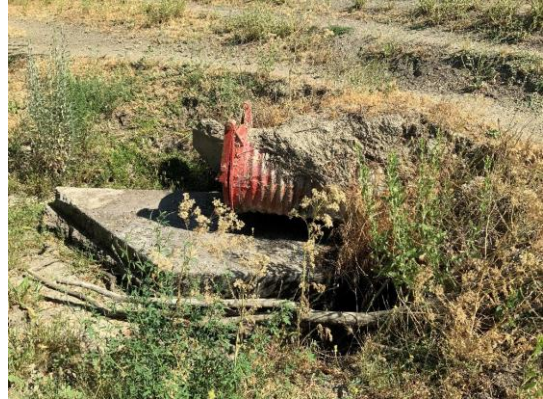
Photo 2 of 3 : UCIP_SP_2024_71017_104003.jpg

LM Start	12.40	Rating **	U	Issue No.	1337 (cont)
LM End	12.40	Issue Type +	Ma	Location *	
Category	Supplemental			GPS Latitude/Longitude	
				Start	End
Item	DWR UCIP LMA Responsibility			37.175958°	37.175958°
				-120.649798°	-120.649798°
DWR ID	19706

WS view: closeup of flapgate and erosion, 1 of 3 photos.

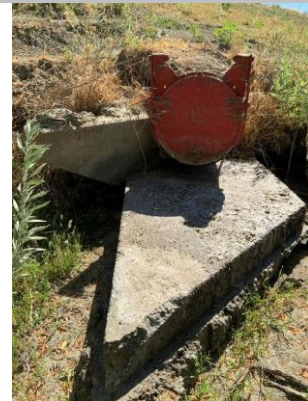
Photo 3 of 3 : UCIP_SP_2024_71017_104004.jpg

WS view: closeup of flapgate and erosion at toe, 2 of 3 photos.

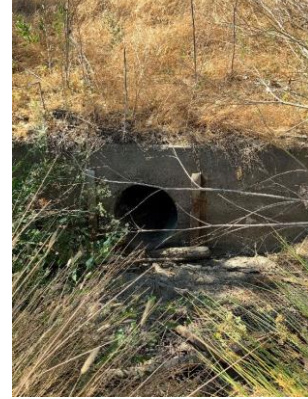
Photo 1 of 3 : UCIP_SP_2024_71018_103998.jpg

Comment Code					
Inspector Comment					
DS_ID:19707 FS_ID:71018 EP_NO: N/A Repair Type: Non-Urgent EVAL Issue: Crossing Status: Found UCIP Comments: 09/18/2023 Pipe was CIPP lined. DMP internal video inspection has found none or minor pipe defects. Recommend next video inspection in 5 years. (O. Yakimov - DWR UCIP) 06/22/2021 The record remains Non-Urgent. DWR DMP internal inspection has found pipe integrity issues. LOF of crossing is between 4.1 and 5. Crossing will be monitored until funding becomes available for rehabilitation. Limited inspection of LS due to vegetation overgrowth; recommend removal. No permit was found authorizing this encroachment. CVFPB will need to review crossing to determine owner. The UCIP inspection was completed with GEI staff, H.Dunn. (P.Espinoza – GEI) 04/22/2014 Sediment buildup in pipe visible from landward side--recommend contacting owner to clear pipe. (W. Wylie - DWR UCIP) FIELD_STRUCT_DESC: 24-inch CIPP-lined corrugated metal gravity drainage pipe (CMP) through the levee, 10.2 feet below the crown. Concrete headwall on the landside (LS) end with flashboards. Concrete saddle and apron on the waterside (WS) end with a flap gate. Metal screen at the LS toe inlet. [Additional Reference(s): DWR Levee Log, 2002, (HLM 12.87). USACE San Joaquin O&M Manual, Unit No. 601, Part No. 1, 1967, Amended in 1978, Revised 20 June 1985, (HLM 12.87). DWR As-Built Specification No. 61-01, Sheet No. 54, 7 March 1961, (HLM 12.87)]. FS Date: 6/22/2021

LS view: concrete headwall and inlet pipe at toe.

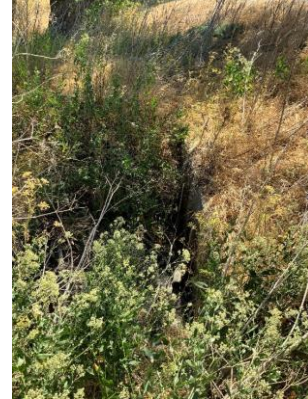
Photo 2 of 3 : UCIP_SP_2024_71018_103996.jpg

LM Start	12.89	Rating **	M	Issue No.	1338 (cont)
LM End	12.89	Issue Type +	Ma	Location *	
Category	Supplemental			GPS Latitude/Longitude	
				Start	End
Item	DWR UCIP LMA Responsibility			37.175816°	37.175816°
				-120.640865°	-120.640865°
DWR ID	19707

LS view: concrete headwall and inlet pipe.

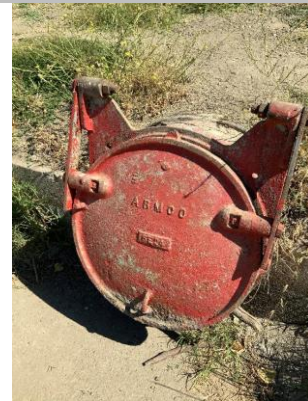
Photo 3 of 3 : UCIP_SP_2024_71018_103995.jpg

WS view: closeup of flapgate.

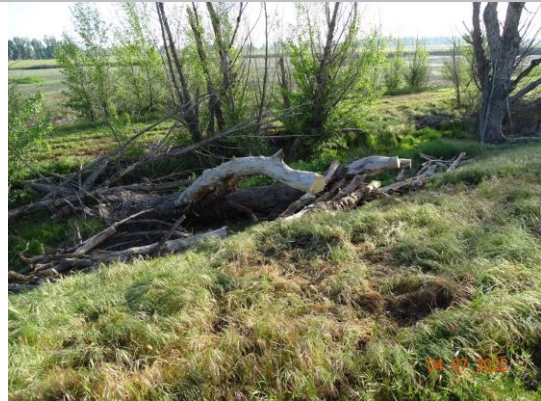
Photo 1 of 1 : SP_2024_NA0010_123_2_20240212_00002.jpg

LM Start	12.99	Rating **	M	Issue No.	2
LM End	13.01	Issue Type +	Ma	Location *	LS
Category	Earthen Levee			GPS Latitude/Longitude	
				Start	End
Item	Trim / Thin Trees			37.175638°	37.175576°
				-120.639076°	-120.638755°
DWR ID	DWR_NA0010_05_s_2016_2				
Comment Code					
T2 : Tree or limb.					
Inspector Comment					
There are several downed trees on landside toe.

Looking west at down tree at landward toe. (Spring 2022)

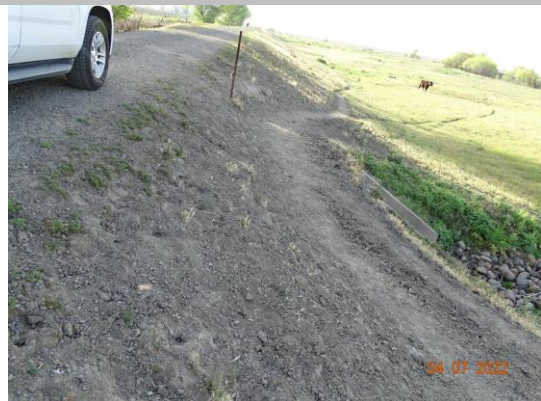
Photo 1 of 1 : SP_2024_NA0010_123_170_20240212_00055.jpg

LM Start	13.42	Rating **	U	Issue No.	170
LM End	13.42	Issue Type +	Ma	Location *	WS
Category	Earthen Levee			GPS Latitude/Longitude	
				Start	End
Item	Erosion / Livestock			37.171545°	37.171545°
				-120.633480°	-120.633480°
DWR ID	DWR_NA0010_05_s_2022_170				
Comment Code					
E4 : Repair the levee slope damaged by livestock and prevent large animal access.					
Inspector Comment

Erosion from livestock on the waterside slope around the pipe crossing. (Spring 2022)

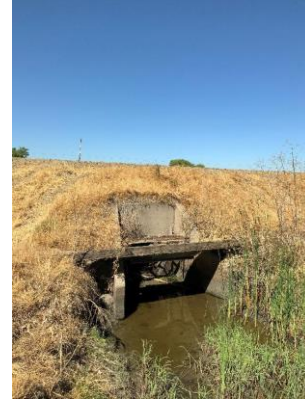
Photo 1 of 2 : UCIP_SP_2024_71019_104014.jpg

Comment Code					
Inspector Comment					
DS_ID:19708 FS_ID:71019 EP_NO: N/A Repair Type: Non-Urgent EVAL Issue: 11, Maintenance Compliance Issue Crossing Status: Found UCIP Comments: 06/22/2021 The record remains Non-Urgent. Limited inspection of LS due to water around the inlet at the time of survey. LS inlet has sediment buildup, recommend removal. No permit was found authorizing this encroachment. CVFPB will need to review crossing to determine owner. The UCIP inspection was completed with GEI staff, H.Dunn. (P.Espinoza – GEI) 04/22/2014 Some erosion around headwall on the WS toe and there are animal burrows on both slopes. (W. Wylie - DWR UCIP) FIELD_STRUCT_DESC: 48-inch corrugated metal gravity drainage pipe (CMP) through the levee, 10.0 feet below the crown. Flap gate on the waterside (WS) end. Flashboard attachment in a concrete U-shaped headwall on the landside (LS) end. Concrete U-shaped headwall on the WS end. [Additional Reference(s): DWR Levee Log, 2002, (HLM 13.40). USACE San Joaquin O&M Manual, Unit No. 601, Part No. 1, 1967, Amended in 1978, Revised 20 June 1985, (HLM 13.40)]. FS Date: 6/22/2021

LS view from toe: concrete headwall and inlet pipe. Slope visible in background.

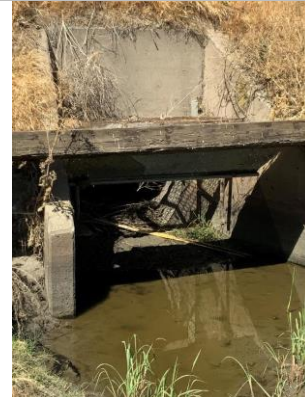
Photo 2 of 2 : UCIP_SP_2024_71019_104015.jpg

LS view from toe: closeup of concrete headwall and inlet.

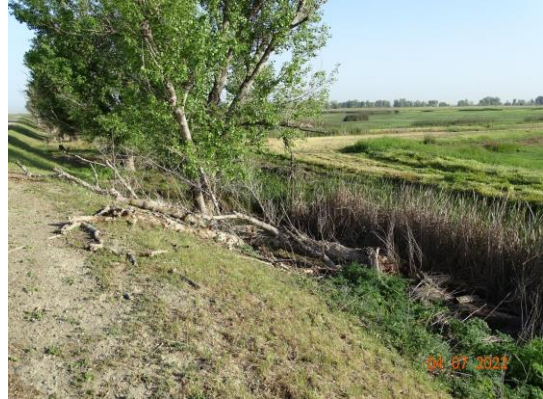
Photo 1 of 1 : SP_2024_NA0010_123_209_20240212_00073.jpg

LM Start	13.44	Rating **	U	Issue No.	209
LM End	13.44	Issue Type +	Ma	Location *	LS
Category	Earthen Levee			GPS Latitude/Longitude	
				Start	End
Item	Trim / Thin Trees			37.171249°	37.171249°
				-120.633157°	-120.633157°
DWR ID	DWR_NA0010_05_s_2020_209				
Comment Code					
T2 : Tree or limb.					
Inspector Comment					
Dead tree should be removed before it can damage the levee.

Dead tree falling over on the landside toe. (Spring 2022)

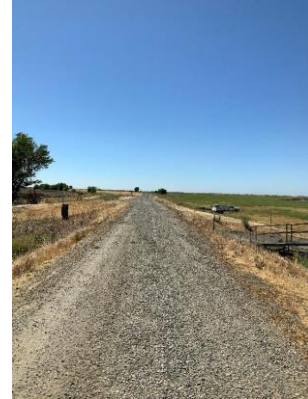
Photo 1 of 3 : UCIP_SP_2024_71020_104016.jpg

Comment Code						
Inspector Comment						
DS_ID:19709 FS_ID:71020 EP_NO: N/A Repair Type: Non-Urgent EVAL Issue: Crossing Status: Indicator Found UCIP Comments: 06/22/2021 The record remains Non-Urgent. Only LS slidegate visible, nothing seen on WS. DWR DMP geophysical study did not confirm presence of pipe through levee. Record will remain in UCIP's inspection records until future Levee Improvement Project can confirm no crossing was found through the levee. No permit was found authorizing this encroachment. CVFPB will need to review crossing to determine owner. The UCIP inspection was completed with GEI staff, H.Dunn. (P.Espinoza – GEI)04/22/2014 Pipe not visible and may need to have silt removed from outlet on WS toe. (W. Wylie - DWR UCIP) FIELD_STRUCT_DESC: 24-inch corrugated metal gravity drainage pipe (CMP) through the levee, 10.0 feet below the crown. Flap gate on the waterside (WS) end. Slide gate on a concrete headwall at the landside (LS) toe. Concrete saddle and apron on the WS end. [Additional Reference(s): DWR Levee Log, 2002, (HLM 13.70). USACE San Joaquin O&M Manual, Unit No. 601, Part No. 1, 1967, Amended in 1978, Revised 20 June 1985, (recorded as HLM 14.72, should be 13.72)]. FS Date: 6/22/2021

View of levee crown.

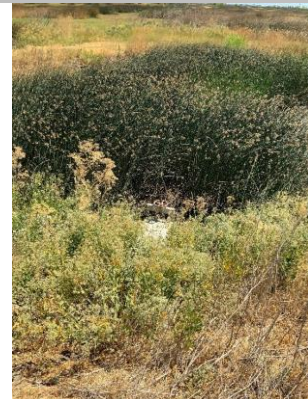
Photo 2 of 3 : UCIP_SP_2024_71020_104017.jpg

LS view of slope to toe from crown.

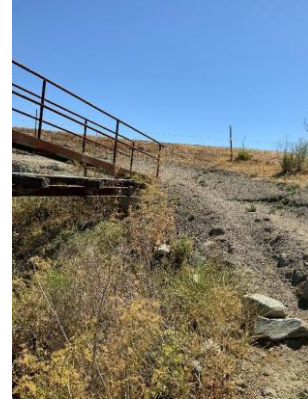
Photo 3 of 3 : UCIP_SP_2024_71020_104018.jpg

WS view of slope from toe.

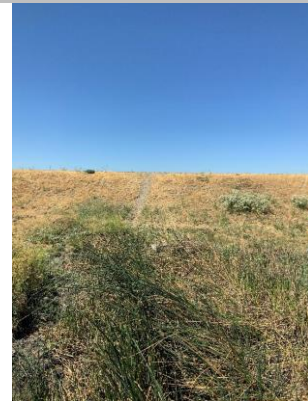
Photo 1 of 3 : UCIP_SP_2024_71023_104025.jpg

DS_ID:19710
 FS_ID:71023
 EP_NO: N/A
 Repair Type: Urgent
 EVAL Issue: 1, Pipe Integrity
 Crossing Status: Found
 UCIP Comments: 09/19/2023 DMP internal video inspection has found severe pipe defects. Crossing will be monitored until funding becomes available to address the issues. (O. Yakimov - DWR UCIP)
 06/22/2021 The record has been upgraded from No Action Needed to Urgent. Subsidence along the WS slope that is at least 1 foot in length. Limited inspection of LS due to vegetation; recommend removal. No permit was found authorizing this encroachment. CVFPB will need to review crossing to determine owner. The UCIP inspection was completed with GEI staff, H.Dunn. (P.Espinoza – GEI)
 FIELD_STRUCT_DESC: 24-inch corrugated metal gravity drainage pipe (CMP) through the levee, 12.4 feet below the crown. Flap gate on the waterside (WS) end. Concrete headwall on each end. [Additional Reference(s): DWR Levee Log, 2002, (HLM 13.84). USACE San Joaquin O&M Manual, Unit No. 601, Part No. 1, 1967, Amended in 1978, Revised 20 June 1985, (HLM 13.83). DWR As-Built Specification No. 61-01, Sheet No. 55, 7 March 1961, (HLM 13.83)].

LS view of slope from toe.

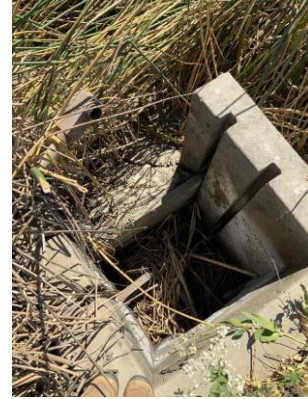
Photo 2 of 3 : UCIP_SP_2024_71023_104026.jpg

LS view: concrete wier intake structure at toe.

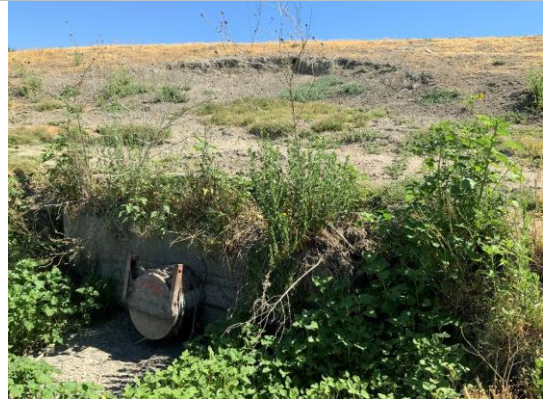
Photo 3 of 3 : UCIP_SP_2024_71023_104024.jpg

WS view from toe: concrete headwall, flapgate, and outlet pipe.
Subsidence along slope in background.

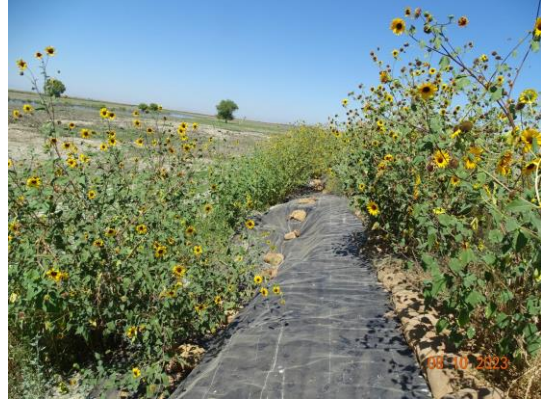
Photo 1 of 1 : SP_2024_NA0010_123_4_20240212_00005.jpg

LM Start	14.38	Rating **	M	Issue No.	4
LM End	14.47	Issue Type +	Ma	Location *	WS
Category	Supplemental			GPS Latitude/Longitude	
Item				Start	End
	37.162949°		37.162949°		
	-120.619138°		-120.619138°		
DWR ID	NA0010U05RM12.22				
Comment Code					
Inspector Comment					
Site ID: NA0010U05RM12.22					
8/10/2023: From 2022 to present, significant changes were observed during the annual survey, scarp increased to 6 feet and length to 500 feet.					
08/03/2022: No significant changes were observed since the previous inspection.					
07/21/2021: This site was discovered during the DWR Spring 2021 Levee Inspections. There is a series of erosion pockets along the lower levee slope and toe, ranging from 3 ft in length to 15 ft and 2 ft to 7 ft in scarp height. There are several of rodent holes on the entire levee slope.

8/10/2023: View of the erosion under wavewash protection.

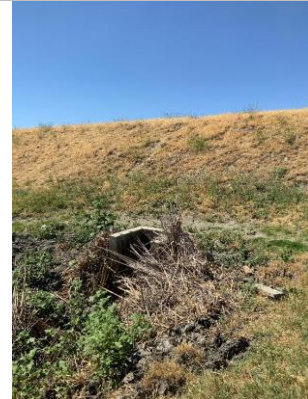
Photo 1 of 1 : UCIP_SP_2024_71024_104033.jpg

Comment Code						
Inspector Comment						
DS_ID:19711						
FS_ID:71024						
EP_NO: N/A						
Repair Type: Non-Urgent						
EVAL Issue: 11, Maintenance Compliance Issue						
Crossing Status: Found						
UCIP Comments: 06/22/2021 The record has been upgraded from No						
Action Needed to Non-Urgent. Dense vegetation on LS; recommend						
removal. No permit was found authorizing this encroachment. CVFPB						
will need to review crossing to determine owner. The UCIP inspection						
was completed with GEI staff, H.Dunn. (P.Espinoza – GEI)						
FIELD_STRUCT_DESC: 24-inch corrugated metal gravity drainage pipe						
(CMP) through the levee, 12.5 feet below the crown. Flap gate on the						
waterside (WS) end. Concrete headwall on each end. Concrete weir						
inlet structure on the landside (LS) toe. [Additional Reference(s): DWR						
Levee Log, 2002, (HLM 14.44). USACE San Joaquin O&M Manual, Unit

LS view of slope from toe: concrete headwall visible in background.

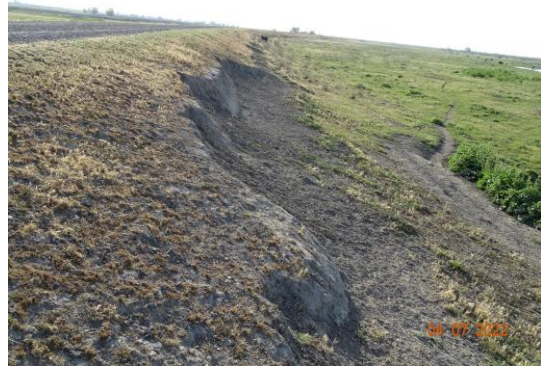
Photo 1 of 1 : SP_2024_NA0010_123_119_20240212_00018.jpg

LM Start	14.47	Rating **	U	Issue No.	119
LM End	14.49	Issue Type +	Ma	Location *	WS
Category	Earthen Levee			GPS Latitude/Longitude	
				Start	End
Item	Erosion / Bank Caving			37.162647°	37.162540°
				-120.618376°	-120.618091°
DWR ID	DWR_NA0010_05_s_2021_119				
Comment Code					
E2 : Schedule repair of erosion site prior to the next inspection.					
Inspector Comment					
Slope erosion on the waterside slope. Possibly caused by livestock.

Looking upstream along the waterside slope at erosion spots. (Spring 2022)

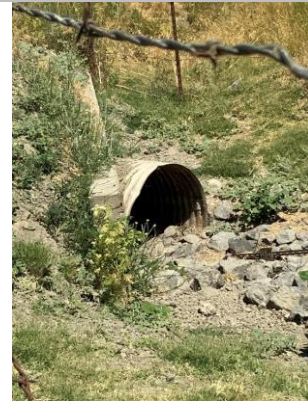
Photo 1 of 3 : UCIP_SP_2024_81020_104051.jpg

Comment Code						
Inspector Comment						
DS_ID:19712 FS_ID:81020 EP_NO: N/A Repair Type: Urgent EVAL Issue: 1, Pipe Integrity Crossing Status: Found UCIP Comments: 09/19/2023 Record updated from Non-Urgent to Urgent. DMP internal video inspection has found severe pipe defects. Crossing will be monitored until funding becomes available to address the issues. (O. Yakimov - DWR UCIP) 06/22/2021 The record remains Non-Urgent. Limited inspection on LS due to barbed wire and access issues. Build up of sediment at WS outlet pipe and LS inlet pipe; recommend removal. Some erosion along the WS slope, less than 1 foot. No permit was found authorizing this encroachment. CVFPB will need to review crossing to determine owner. The UCIP inspection was completed with GEI staff, H.Dunn. (P.Espinoza – GEI) 04/23/2014 Minor erosion at headwall on WS toe. (W. Wylie - DWR UCIP) FIELD_STRUCT_DESC: 36-inch corrugated metal gravity drainage pipe (CMP) through the levee, 11.9 feet below the crown. Flap gate on the waterside (WS) end. Concrete headwall on each end. [Additional Reference(s): DWR Levee Log, 2002, (HLM 15.08). USACE San Joaquin O&M Manual, Unit No. 601, Part No. 1, 1967, Amended in 1978, Revised 20 June 1985, (HLM 15.09)]. FS Date: 6/22/2021

LS view: Closeup of inlet pipe.

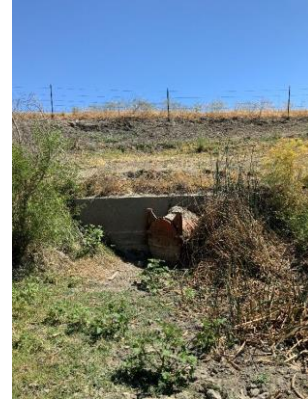
Photo 2 of 3 : UCIP_SP_2024_81020_104048.jpg

WS view from toe: concrete headwall, flapgate, and outlet pipe. Erosion along slope visible in background.

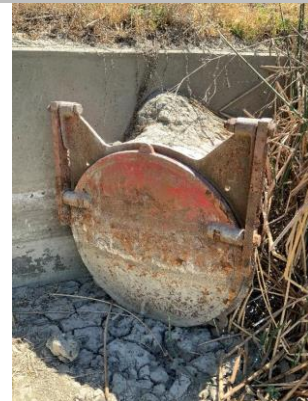
Photo 3 of 3 : UCIP_SP_2024_81020_104049.jpg

WS view from toe: closeup of flapgate and outlet pipe.

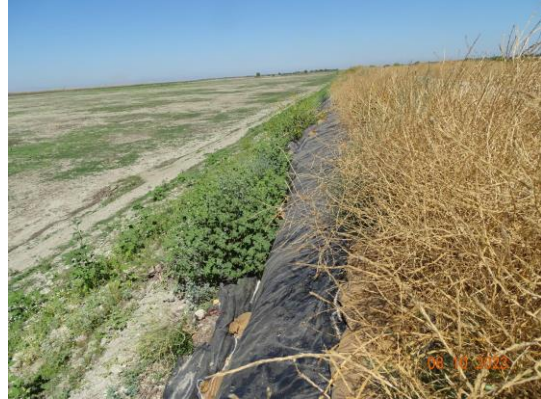
Photo 1 of 2 : SP_2024_NA0010_123_3_20240212_00003.jpg

8/10/2023: From 2022 to present, significant changes were observed during the annual survey, scarp increased to 6 feet.

08/03/2022: From 2021 to present, no significant changes were observed during the annual survey. The erosion length was updated to 80 ft based on more accurate field measurements.

8/10/2023: View of the erosion looking downstream under wavewash protection.

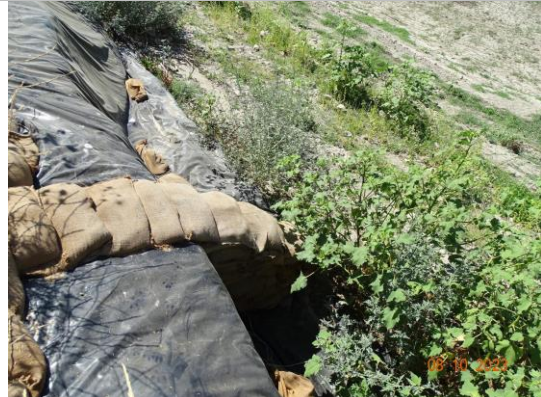
Photo 2 of 2 : SP_2024_NA0010_123_3_20240212_00004.jpg

8/10/2023: Cloes-up view of erosion.

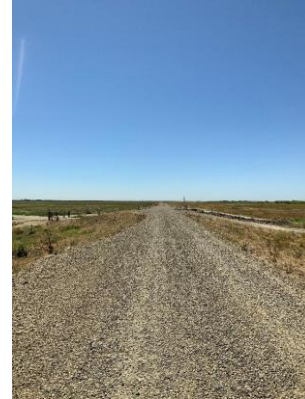
Photo 1 of 3 : UCIP_SP_2024_71026_104037.jpg

Comment Code						
Inspector Comment						
DS_ID:19713 FS_ID:71026 EP_NO: N/A Repair Type: Non-Urgent EVAL Issue: Crossing Status: Found UCIP Comments: 06/22/2021 The record remains Non-Urgent. Crossing appears to be in good condition. No permit was found authorizing this encroachment. CVFPB will need to review crossing to determine owner. The UCIP inspection was completed with GEI staff, H.Dunn. (P.Espinoza – GEI) 04/23/2014 Sediment buildup in pipe visible from landward side--recommend contacting owner to clear pipe. (W. Wylie - DWR UCIP) FIELD_STRUCT_DESC: 24-inch corrugated metal gravity drainage pipe (CMP) through the levee, 11.0 feet below the crown. Flap gate on the waterside (WS) end. Concrete headwall on each end. [Additional Reference(s): DWR Levee Log, 2002, (HLM 15.74). USACE San Joaquin O&M Manual, Unit No. 601, Part No. 1, 1967, Amended in 1978, Revised 20 June 1985, (HLM 15.74)]. FS Date: 6/22/2021

View from levee crown.

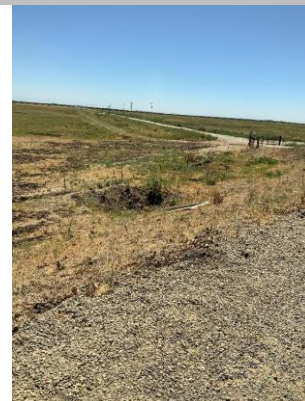
Photo 2 of 3 : UCIP_SP_2024_71026_104039.jpg

LS view of slope to toe from crown.

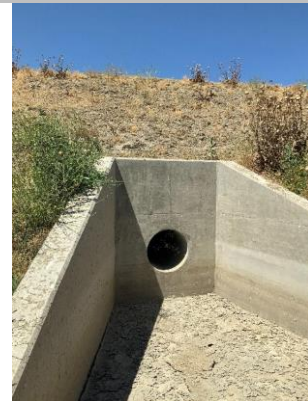
Photo 3 of 3 : UCIP_SP_2024_71028_104061.jpg

LS view from toe: concrete headwall and inlet. Slope visible in background.

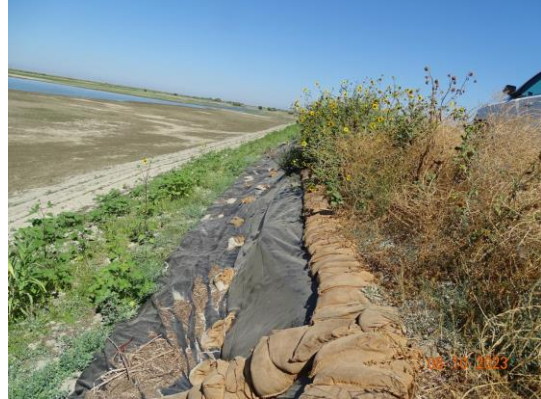
Photo 1 of 1 : SP_2024_NA0010_123_1_20240212_00001.jpg

Comment Code					
Inspector Comment					
Site ID: NA0010U05RM13.85 8/10/2023: From 2022 to present, significant changes were observed during the annual survey, scarp was increased 6 feet. 08/03/2022: The scarp height was updated to 3 ft and there is less vegetation cover than previously. 08/19/2020: Due to ongoing construction both up and downstream, this site could not be accessed and only be viewed from the opposite bank across the bypass. Unable to determine if the conditions changed since the previous inspection. 09/10/2019: The erosion has become worse during the past 2 flood seasons. The erosion length has increased to approximately 200 ft from 55 ft. Signs of animal activity were observed. 09/20/2017: The erosion was discovered during spring levee inspection. The site is covered by dense vegetation and the measurements of the erosion are estimated.

8/10/2023: View of the erosion under wavewash protection.

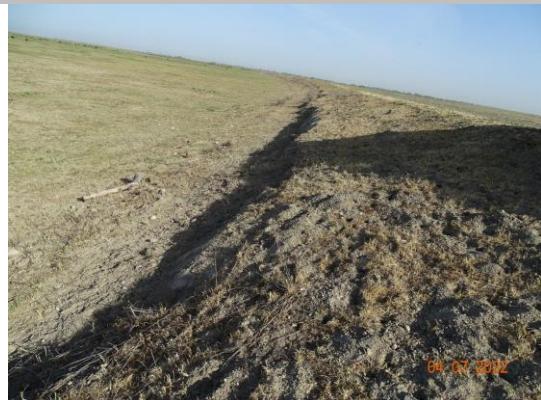
Photo 1 of 1 : SP_2024_NA0010_123_173_20240212_00058.jpg

Looking downstream along the waterside slope at erosion from livestock activity. (Spring 2022)

LM Start	16.34	Rating **	M	Issue No.	173
LM End	16.34	Issue Type +	Ma	Location *	WS
Category	Earthen Levee			GPS Latitude/Longitude	
				Start	End
Item	Erosion / Livestock			37.143141°	37.143141°
				-120.595183°	-120.595183°
DWR ID	DWR_NA0010_05_s_2022_173				
Comment Code					
E4 : Repair the levee slope damaged by livestock and prevent large animal access.					
Inspector Comment

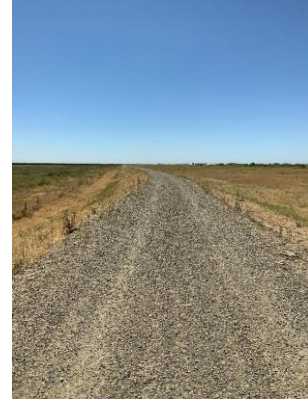
Photo 1 of 3 : UCIP_SP_2024_71029_104063.jpg

Comment Code					
Inspector Comment					
DS_ID:19716 FS_ID:71029 EP_NO: N/A Repair Type: Non-Urgent EVAL Issue: Crossing Status: Found UCIP Comments: 06/22/2021 The record remains Non-Urgent. Crossing appears to be in good condition. No permit was found authorizing this encroachment. CVFPB will need to review crossing to determine owner. The UCIP inspection was completed with GEI staff, H.Dunn. (P.Espinoza – GEI) 04/23/2014 Pipe heavily silted on LS toe. (W. Wylie - DWR UCIP) FIELD_STRUCT_DESC: 24-inch corrugated metal gravity drainage pipe (CMP) through the levee, 10.5 feet below the crown. Flap gate on the waterside (WS) end. Concrete headwall on each end. [Additional Reference(s): DWR Levee Log, 2002, (HLM 16.66). USACE San Joaquin O&M Manual, Unit No. 601, Part No. 1, 1967, Amended in 1978, Revised 20 June 1985, (HLM 16.67). DWR As-Built Specification No. 61-01, Sheet No. 57, 7 March 1961, (HLM 16.67)]. FS Date: 6/22/2021

View from levee crown.

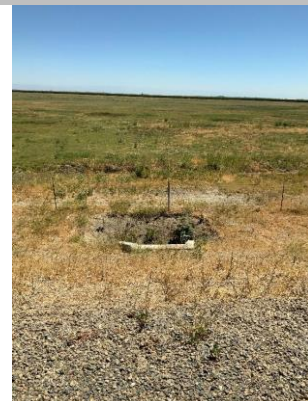
Photo 2 of 3 : UCIP_SP_2024_71029_104064.jpg

LS view of slope to toe from crown.

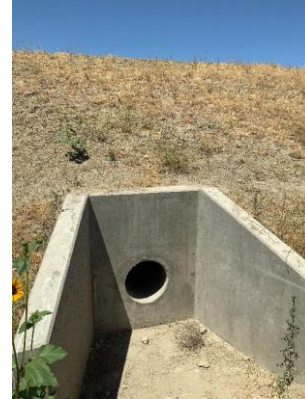
Photo 3 of 3 : UCIP_SP_2024_71029_104068.jpg

LS view from toe: concrete headwall and inlet. Slope visible in background.

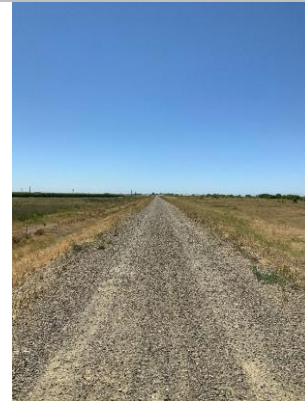
Photo 1 of 3 : UCIP_SP_2024_71030_104070.jpg

DS_ID:19717
FS_ID:71030
EP_NO: N/A
Repair Type: Non-Urgent
EVAL Issue:
Crossing Status: Found
UCIP Comments: 06/22/2021 The record remains Non-Urgent. Crossing appears to be in good condition. No permit was found authorizing this encroachment. CVFPB will need to review crossing to determine owner. The UCIP inspection was completed with GEI staff, H.Dunn. (P.Espinoza – GEI) 04/23/2014 Sediment buildup in pipe visible from landward side--recommend contacting owner to clear pipe. (W. Wylie - DWR UCIP)
FIELD_STRUCT_DESC: 24-inch corrugated metal gravity drainage pipe (CMP) through the levee, 12.0 feet below the crown. Flap gate on the waterside (WS) end. Concrete headwall on each end. [Additional Reference(s): DWR Levee Log, 2002, (HLM 17.21). USACE San Joaquin O&M Manual, Unit No. 601, Part No. 1, 1967, Amended in 1978, Revised 20 June 1985, (HLM 17.20)].
FS Date: 6/22/2021

View from levee crown.

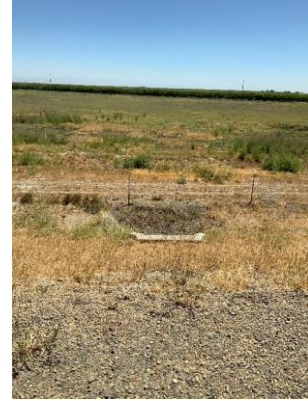
Photo 2 of 3 : UCIP_SP_2024_71030_104071.jpg

LS view of slope to toe from crown.

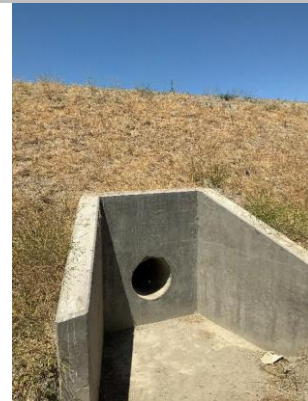
Photo 3 of 3 : UCIP_SP_2024_71030_104075.jpg

LS view at toe: concrete headwall and inlet. Slope visible in background.

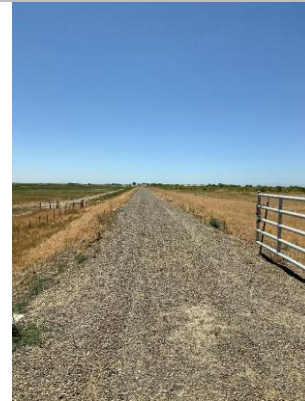
Photo 1 of 3 : UCIP_SP_2024_71031_104077.jpg

Comment Code						
Inspector Comment						
DS_ID:19743 FS_ID:71031 EP_NO: N/A Repair Type: Non-Urgent EVAL Issue: Crossing Status: Found UCIP Comments: 06/22/2021 The record remains Non-Urgent. Crossing appears to be in good condition. No permit was found authorizing this encroachment. CVFPB will need to review crossing to determine owner. The UCIP inspection was completed with GEI staff, H.Dunn. (P.Espinoza – GEI) 04/23/2014 Sediment buildup in pipe visible from landward side--recommend contacting owner to clear pipe. (W. Wylie - DWR UCIP) FIELD_STRUCT_DESC: 24-inch corrugated metal gravity drainage pipe (CMP) through the levee, 9.8 feet below the crown. Flap gate on the waterside (WS) end. Concrete headwall on each end. [Additional Reference(s): DWR Levee Log, 2002, (HLM 17.52). USACE San Joaquin O&M Manual, Unit No. 601, Part No. 1, 1967, Amended in 1978, Revised 20 June 1985, (HLM 17.52). DWR As-Built Specification No. 61-01, Sheet No. 58, 7 March 1961, (HLM 17.52)]. FS Date: 6/22/2021

View from levee crown.

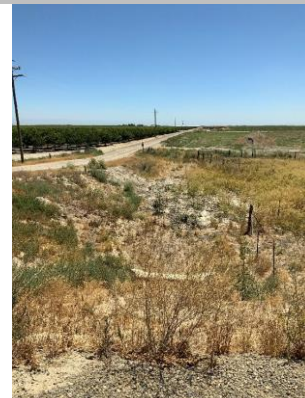
Photo 2 of 3 : UCIP_SP_2024_71031_104078.jpg

LS view of slope to toe from crown. Concrete headwall visible at toe.

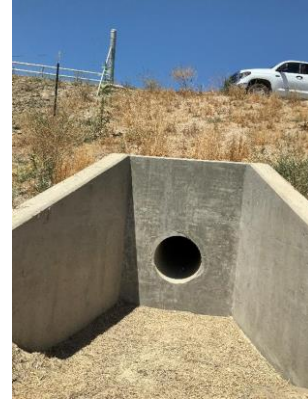
Photo 3 of 3 : UCIP_SP_2024_71031_104082.jpg

LS view from toe: concrete headwall and inlet. Slope visible in background.

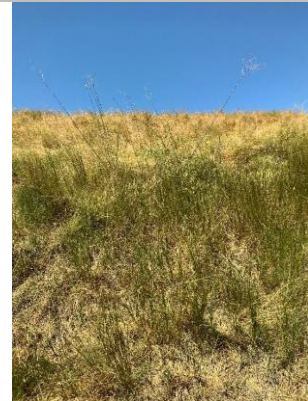
Photo 1 of 2 : UCIP_SP_2024_71033_104113.jpg

DS_ID:19745
 FS_ID:71033
 EP_NO: N/A
 Repair Type: Non-Urgent
 EVAL Issue: 11, Maintenance Compliance Issue
 Crossing Status: Found
 UCIP Comments: 06/22/2021 The record remains Non-Urgent. Limited inspection of LS pipe inlet due to dense vegetation, recommend removal. No permit was found authorizing this encroachment. CVFPB will need to review crossing to determine owner. The UCIP inspection was completed with GEI staff, P. Espinoza. (H. Dunn – GEI)

LS view: Slope from toe.

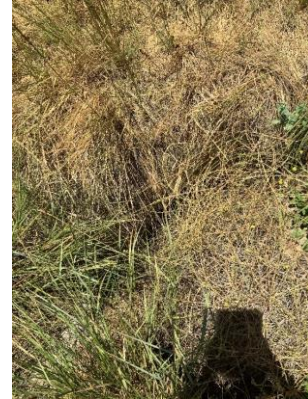
Photo 2 of 2 : UCIP_SP_2024_71033_104114.jpg

LS view: Closeup of headwall and inlet buried under dense vegetation at toe.

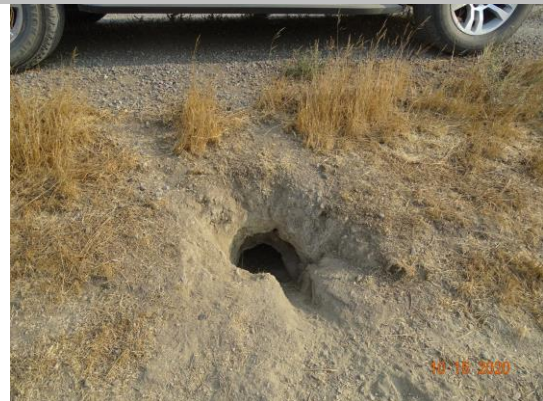
Photo 1 of 1 : SP_2024_NA0010_123_114_20240212_00015.jpg

View of rodent burrow in the waterside shoulder. (Fall 2020)

LM Start	18.50	Rating **	A/W	Issue No.	114
LM End	18.50	Issue Type +	Ma	Location *	WS
Category	Earthen Levee			GPS Latitude/Longitude	
				Start	End
Item	Animal Control			37.115960°	37.115960°
				-120.577170°	-120.577170°
DWR ID	DWR_NA0010_05_f_2020_114				
Comment Code					
A3 : No rodents visible, but rodent burrows visible; need to backfill and compact or grout burrows.					
Inspector Comment					
Burrow appears to connect to hole in landside shoulder.

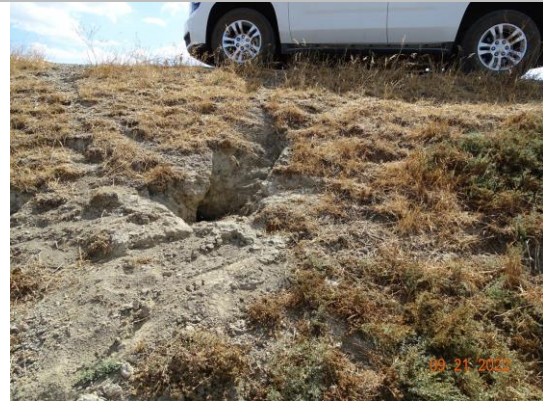
Photo 1 of 1 : SP_2024_NA0010_123_183_20240212_00063.jpg

Large animal burrow on the landside slope. (Fall 2022)

LM Start	18.56	Rating **	A/W	Issue No.	183
LM End	18.56	Issue Type +	Ma	Location *	LS
Category	Earthen Levee			GPS Latitude/Longitude	
				Start	End
Item	Animal Control			37.115653°	37.115653°
				-120.576199°	-120.576199°
DWR ID	DWR_NA0010_05_f_2022_183				
Comment Code					
A3 : No rodents visible, but rodent burrows visible; need to backfill and compact or grout burrows.					
Inspector Comment

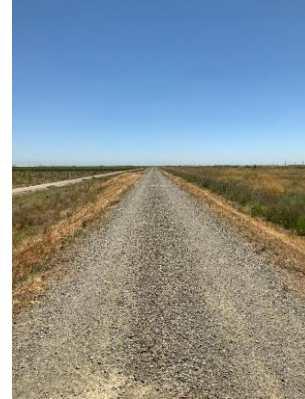
Photo 1 of 3 : UCIP_SP_2024_71034_104120.jpg

Comment Code						
Inspector Comment						
DS_ID:19746 FS_ID:71034 EP_NO: N/A Repair Type: Non-Urgent EVAL Issue: Crossing Status: Found UCIP Comments: 06/22/2021 The record remains Non-Urgent. Crossing appears to be in good condition. No permit was found authorizing this encroachment. CVFPB will need to review crossing to determine owner. The UCIP inspection was completed with GEI staff, P. Espinoza. (H. Dunn – GEI) 04/23/2014 Dense vegetation limits the inspector's visibility to identify signs of pipe failure (leaks) along the landward slope. Recommend removing vegetation along pipe alignment to conduct proper inspection of structure. (W. Wylie - DWR UCIP) FIELD_STRUCT_DESC: 24-inch corrugated metal gravity drainage pipe (CMP) through the levee, 10.0 feet below the crown. Flap gate on the waterside (WS) end. Concrete headwall on the landside (LS) end. Concrete U-shaped headwall on the WS end. [Additional Reference(s): DWR Levee Log, 2002, (HLM 18.68). USACE San Joaquin O&M Manual, Unit No. 601, Part No. 1, 1967, Amended in 1978, Revised 20 June 1985, (HLM 18.68). DWR As-Built Specification No. 64-01, Sheet No. 3, 6 November 1963, (HLM 18.68)]. FS Date: 6/22/2021

Levee crown.

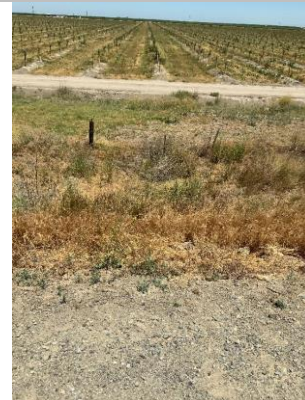
Photo 2 of 3 : UCIP_SP_2024_71034_104121.jpg

LS view: Toe from crown.

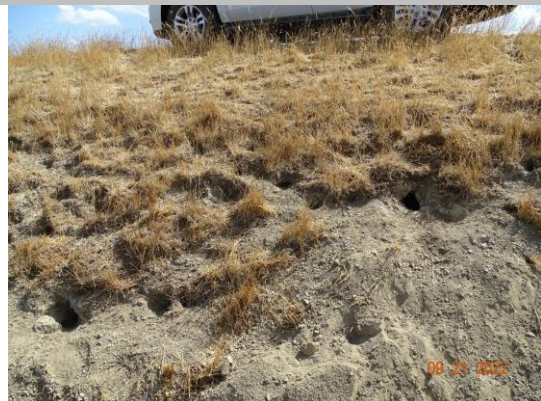
Photo 1 of 1 : SP_2024_NA0010_123_184_20240212_00064.jpg

View of several rodent holes on the landside slope. (Fall 2022)

LM Start	18.85	Rating **	M	Issue No.	184
LM End	19.27	Issue Type +	Ma	Location *	LS
Category	Earthen Levee			GPS Latitude/Longitude	
				Start	End
Item	Animal Control			37.115461°	37.115289°
				-120.570924°	-120.563336°
DWR ID	DWR_NA0010_05_f_2022_184				
Comment Code					
A3 : No rodents visible, but rodent burrows visible; need to backfill and compact or grout burrows.					
Inspector Comment

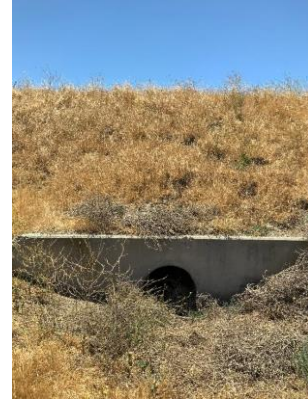
Photo 1 of 2 : UCIP_SP_2024_77864_104125.jpg

Comment Code					
Inspector Comment					
DS_ID:19747 FS_ID:77864 EP_NO: N/A Repair Type: Urgent EVAL Issue: 1, Pipe Integrity Crossing Status: Found UCIP Comments: 12/14/2022 Record updated from Non-Urgent to Urgent. DMP internal video inspection has found pipe integrity issues. LOF of crossing is between 5 and 6. Crossing will be monitored until funding becomes available to address the issues. (O.Yakimov - DWR UCIP) 06/22/2021 The record remains Non-Urgent. Limited inspection due to LS inlet being covered by dense tumbleweeds, recommend removal. No permit was found authorizing this encroachment. CVFPB will need to review crossing to determine owner. The UCIP inspection was completed with GEI staff, P. Espinoza. (H. Dunn – GEI) 04/23/2014 Sediment buildup in pipe visible from landward side--recommend contacting owner to clear pipe. (W. Wylie - DWR UCIP) FIELD_STRUCT_DESC: 24-inch corrugated metal gravity drainage pipe (CMP) through the levee, 10.0 feet below the crown. Flap gate on the waterside (WS) end. Concrete headwall on the landside (LS) end. Concrete U-shaped headwall on the WS end. [Additional Reference(s): DWR Levee Log, 2002, (HLM 19.13). USACE San Joaquin O&M Manual, Unit No. 601, Part No. 1, 1967, Amended in 1978, Revised 20 June 1985, (HLM 19.11). DWR As-Built Specification No. 64-01, Sheet No. 3, 6 November 1963, (HLM 19.11)]. FS Date: 6/22/2021 1:52:17 PM

LS view: Slope and headwall at toe.

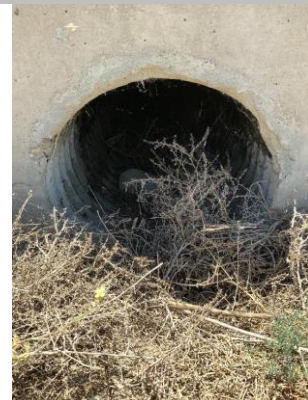
Photo 2 of 2 : UCIP_SP_2024_77864_104126.jpg

LS view: Closeup of inlet at toe.

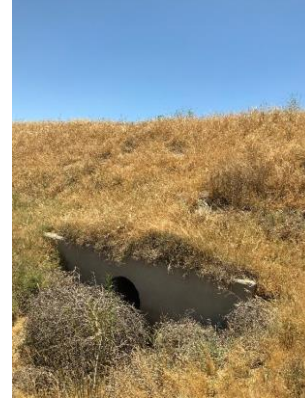
Photo 1 of 2 : UCIP_SP_2024_77869_104132.jpg

DS_ID:19776
FS_ID:77869
EP_NO: N/A
Repair Type: Urgent
EVAL Issue: 1, Pipe Integrity
Crossing Status: Found
UCIP Comments: 12/14/2022 Record updated from Non-Urgent to Urgent. DMP internal video inspection has found pipe integrity issues. LOF of crossing is between 5 and 6. Crossing will be monitored until funding becomes available to address the issues. (O.Yakimov - DWR UCIP)
06/22/2021 The record has been upgraded from No Action Needed to Non-Urgent. Some tumbleweed buildup around LS inlet, recommend removal. No permit was found authorizing this encroachment. CVFPB will need to review crossing to determine owner. The UCIP inspection was completed with GEI staff, P. Espinoza. (H. Dunn – GEI)
FIELD_STRUCT_DESC: 24-inch corrugated metal gravity drainage pipe (CMP) through the levee, 10.3 feet below the crown. Flap gate on the waterside (WS) end. Concrete headwall on the landside (LS) end. Concrete U-shaped headwall on the WS end. [Additional Reference(s): DWR Levee Log, 2002, (HLM 19.15). USACE San Joaquin O&M Manual, Unit No. 601, Part No. 1, 1967, Amended in 1978, Revised 20 June 1985, (HLM 19.15). DWR As-Built Specification No. 64-01, Sheet No. 3, 6 November 1963, (HLM 19.15)].

LS view: Headwall and slope from toe.

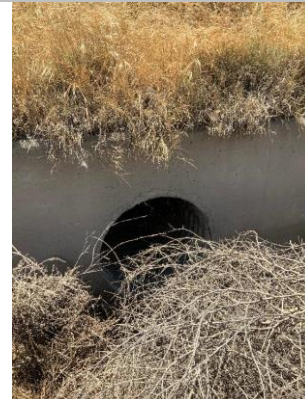
Photo 2 of 2 : UCIP_SP_2024_77869_104133.jpg

LS view: Closeup of inlet covered by tumbleweeds at toe.

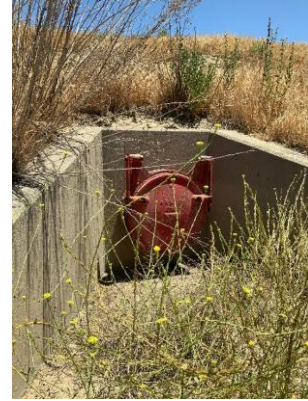
Photo 1 of 2 : UCIP_SP_2024_77906_104141.jpg

Comment Code					
Inspector Comment					
DS_ID:19777 FS_ID:77906 EP_NO: N/A Repair Type: Non-Urgent EVAL Issue: 11, Maintenance Compliance Issue Crossing Status: Found UCIP Comments: 12/20/2022 Record updated from Urgent to Non-Urgent. Pipe has been CIPP-lined. LOF of crossing is less or equal to 4. Recommend next video inspection in 5 years. (O.Yakimov - DWR UCIP) 06/22/2021 The record has been upgraded from Non-Urgent to Urgent. DWR DMP internal inspection has found pipe integrity issues. LOF of crossing is greater than or equal to 5 and less than 6. Crossing will be monitored until funding becomes available to address the issues. Limited inspection of LS inlet due to vegetation, recommend removal. No permit was found authorizing this encroachment. CVFPB will need to review crossing to determine owner. The UCIP inspection was completed with GEI staff, P. Espinoza. (H. Dunn – GEI)04/23/2014 Sediment buildup in pipe visible from landward side--recommend contacting owner to clear pipe. (W. Wylie - DWR UCIP) FIELD_STRUCT_DESC: 24-inch CIPP-lined corrugated metal gravity drainage pipe (CMP) through the levee, 9.0 feet below the crown. Flap gate on the waterside (WS) end. Concrete headwall on the landside (LS) end. Concrete U-shaped headwall on the WS end. [Additional Reference(s): DWR Levee Log, 2002, (HLM 19.46). USACE San Joaquin O&M Manual, Unit No. 601, Part No. 1, 1967, Amended in 1978, Revised 20 June 1985, (HLM 19.46). DWR As-Built Specification No. 64-01, Sheet No. 3, 6 November 1963, (HLM 19.46)]. FS Date: 6/22/2021 10:14:59 AM

WS view: Closeup of flapgate at toe.

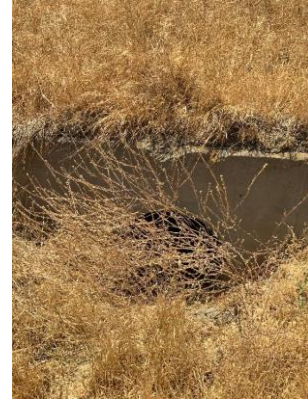
Photo 2 of 2 : UCIP_SP_2024_77906_104143.jpg

LS view: Closeup of inlet covered by vegetation at toe.

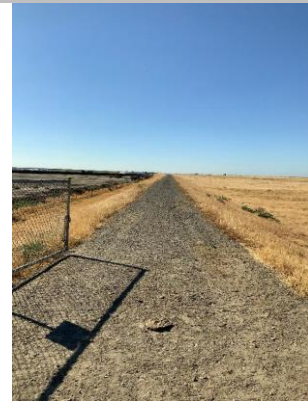
Photo 1 of 3 : UCIP_SP_2024_71039_104146.jpg

Levee crown.

Comment Code					
Inspector Comment					
DS_ID:19778 FS_ID:71039 EP_NO: N/A Repair Type: Non-Urgent EVAL Issue: Crossing Status: Found UCIP Comments: 06/23/2021 The record remains Non-Urgent. DWR DMP internal inspection has not found pipe integrity issues. LOF of crossing is less or equal to 4.0. Recommend next video inspection in 5 years. No permit was found authorizing this encroachment. CVFPB will need to review crossing to determine owner. The UCIP inspection was completed with GEI staff, P. Espinoza. (H. Dunn – GEI) 04/23/2014 Dense vegetation limits the inspector's visibility to identify signs of pipe failure (leaks) along the landward slope. Recommend removing vegetation along pipe alignment to conduct proper inspection of structure. Sediment buildup in pipe visible from landward side-- recommend contacting owner to clear pipe. (W. Wylie - DWR UCIP) FIELD_STRUCT_DESC: 24-inch corrugated metal gravity drainage pipe (CMP) through the levee, 9.7 feet below the crown. Flap gate on the waterside (WS) end. Concrete headwall on the landside (LS) end. Concrete U-shaped headwall on the WS end. [Additional Reference(s): DWR Levee Log, 2002, (HLM 19.50). USACE San Joaquin O&M Manual, Unit No. 601, Part No. 1, 1967, Amended in 1978, Revised 20 June 1985, (HLM 19.50). DWR As-Built Specification No. 64-01, Sheet No. 3, 6 November 1963, (HLM 19.50)]. FS Date: 6/23/2021

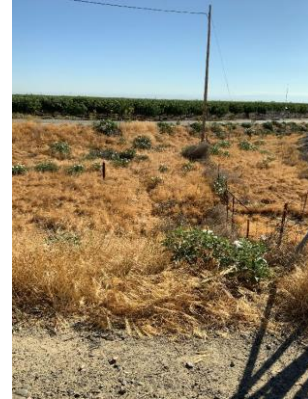
Photo 2 of 3 : UCIP_SP_2024_71039_104147.jpg

LS view: Toe from crown.
