**Flood Control Project Maintenance
Levee Inspections**

Maintenance Issue Types Only, Levee Inspection Report By Mile - Spring 2024

Lower San Joaquin Levee District

Waterway	Bank	Unit Miles	Inspection Start/End	Inspector
Unit No. 01 San Joaquin River	Right	22.52	03/12/2024 03/12/2024	Corey Fujitani

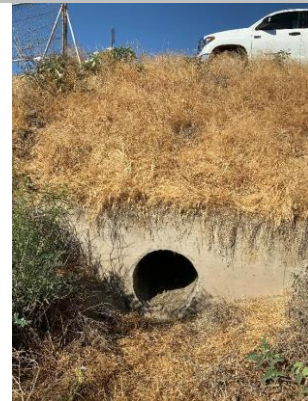
Photo 3 of 3 : UCIP_SP_2024_71039_104144.jpg

LS view: Headwall and slope at toe.

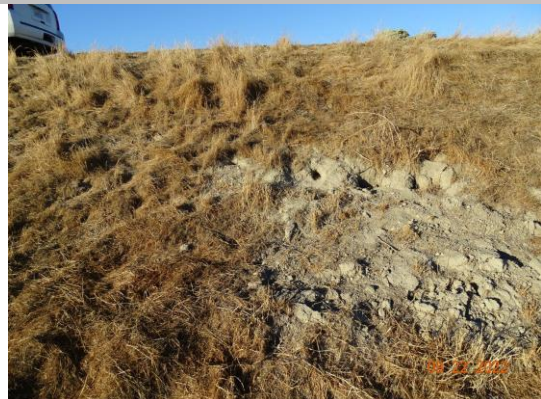
Photo 1 of 1 : SP_2024_NA0010_123_185_20240212_00065.jpg

LM Start	19.55	Rating **	M	Issue No.	185
LM End	19.55	Issue Type +	Ma	Location *	LS
Category	Earthen Levee			GPS Latitude/Longitude	
				Start	End
Item	Animal Control			37.112675°	37.112675°
				-120.559535°	-120.559535°
DWR ID	DWR_NA0010_05_f_2022_185				
Comment Code					
A3 : No rodents visible, but rodent burrows visible; need to backfill and compact or grout burrows.					
Inspector Comment

View of rodent burrows in the landside slope. (Fall 2022)

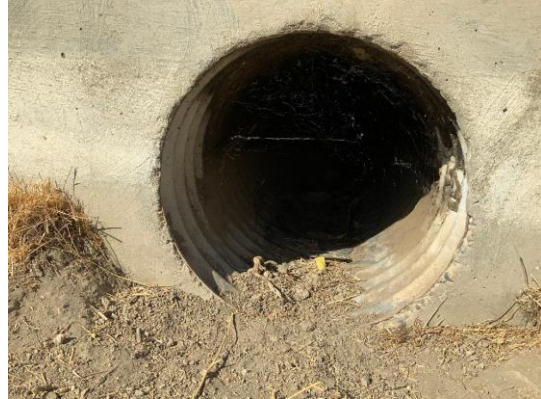
Photo 1 of 3 : UCIP_SP_2024_77907_104154.jpg

Comment Code					
Inspector Comment					
DS_ID:19779 FS_ID:77907 EP_NO: N/A Repair Type: Non-Urgent EVAL Issue: Crossing Status: Found UCIP Comments: 12/20/2022 Record updated from Urgent to Non-Urgent. Pipe has been CIPP-lined. LOF of crossing is less or equal to 4. Recommend next video inspection in 5 years. (O.Yakimov - DWR UCIP) 06/23/2021 The record has been upgraded from No Action Needed to Urgent. DWR DMP internal inspection has found pipe integrity issues. LOF of crossing is greater than or equal to 5 and less than 6. Crossing will be monitored until funding becomes available to address the issues. WS flapgate has holes in it. LS pipe inlet has some minor debris buildup. No permit was found authorizing this encroachment. CVFPB will need to review crossing to determine owner. The UCIP inspection was completed with GEI staff, P. Espinoza. (H. Dunn – GEI) FIELD_STRUCT_DESC: 24-inch CIPP-lined corrugated metal gravity drainage pipe (CMP) through the levee, 10.3 feet below the crown. Flap gate on the waterside (WS) end. Concrete headwall on the landside (LS) end. Concrete U-shaped headwall on the WS end. [Additional Reference(s): DWR Levee Log, 2002, (HLM 19.83). USACE San Joaquin O&M Manual, Unit No. 601, Part No. 1, 1967, Amended in 1978, Revised 20 June 1985, (HLM 19.84). DWR As-Built Specification No. 64-01, Sheet No. 4, 6 November 1963, (HLM 19.84)]. FS Date: 6/23/2021 10:18:21 AM

LS view: Closeup of pipe inlet at toe.

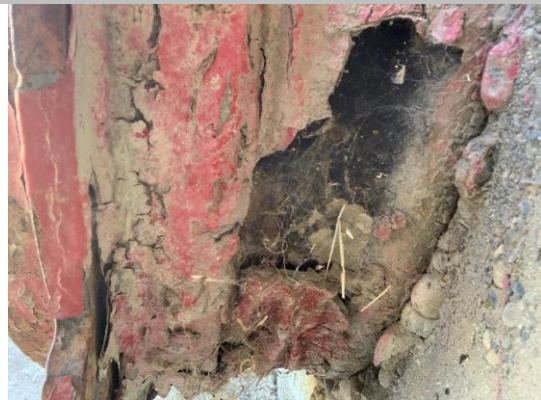
Photo 2 of 3 : UCIP_SP_2024_77907_104110.jpg

WS view: Closeup of deterioration of flapgate at toe.

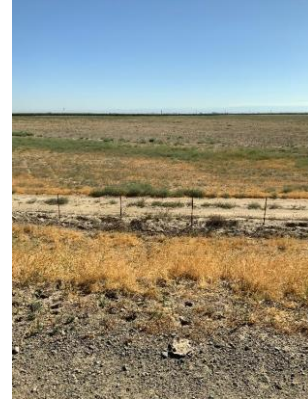
Photo 2 of 3 : UCIP_SP_2024_71041_104157.jpg

LS view: Toe from crown.

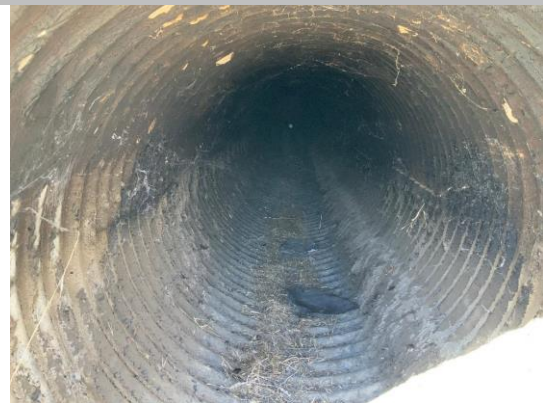
Photo 3 of 3 : UCIP_SP_2024_71041_104155.jpg

LS view: Inside pipe inlet at toe.

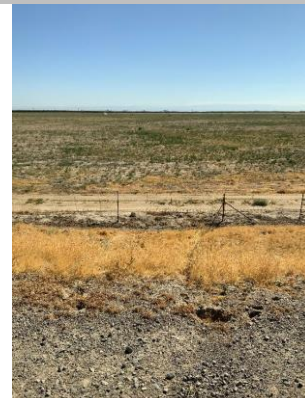
Photo 2 of 3 : UCIP_SP_2024_71042_104164.jpg

LS view: Toe from crown.

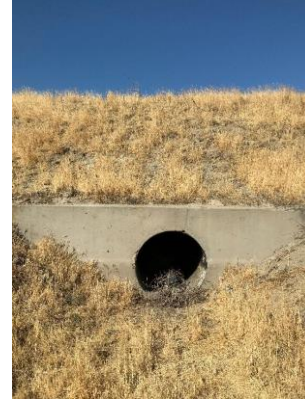
Photo 3 of 3 : UCIP_SP_2024_71042_104161.jpg

LS view: Slope and headwall from toe.

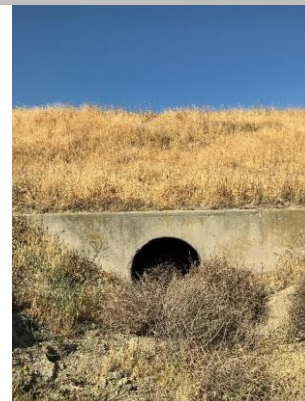
Photo 1 of 2 : UCIP_SP_2024_71043_104168.jpg

DS_ID:19783
 FS_ID:71043
 EP_NO: N/A
 Repair Type: Non-Urgent
 EVAL Issue: 11, Maintenance Compliance Issue
 Crossing Status: Found
 UCIP Comments: 06/23/2021 The record has been upgraded from No Action Needed to Non-Urgent. DWR DMP internal inspection has not found pipe integrity issues. LOF of crossing is less or equal to 4.0. Recommend next video inspection in 5 years. Limited inspection of LS pipe inlet due to tumbleweeds, recommend removal. No permit was found authorizing this encroachment. CVFPB will need to review crossing to determine owner. The UCIP inspection was completed with GEI staff, P. Espinoza. (H. Dunn – GEI)
 FIELD_STRUCT_DESC: 36-inch corrugated metal gravity drainage pipe (CMP) through the levee, 10.6 feet below the crown. Flap gate on the waterside (WS) end. Concrete headwall on each end. [Additional Reference(s): DWR Levee Log, 2002, (HLM 20.18). USACE San Joaquin O&M Manual, Unit No. 601, Part No. 1, 1967, Amended in 1978, Revised 20 June 1985, (HLM 20.18). DWR As-Built Specification No. 64-01, Sheet No. 4, 6 November 1963, (HLM 20.18)].

LS view: Slope and headwall from toe.

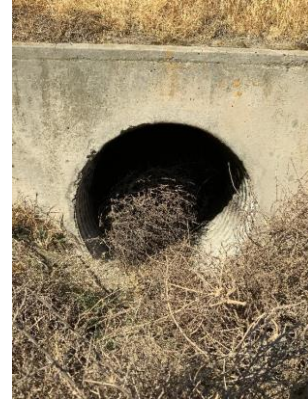
Photo 2 of 2 : UCIP_SP_2024_71043_104169.jpg

LS view: Closeup of pipe inlet at toe.

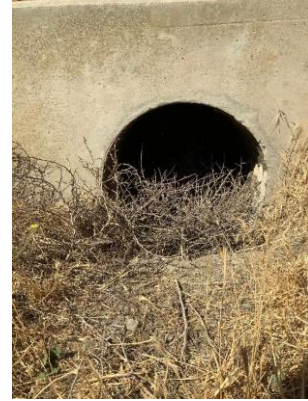
Photo 1 of 1 : UCIP_SP_2024_77908_104180.jpg

Comment Code					
Inspector Comment					
DS_ID:19784 FS_ID:77908 EP_NO: N/A Repair Type: Non-Urgent EVAL Issue: 11, Maintenance Compliance Issue Crossing Status: Found UCIP Comments: 12/20/2022 Record updated from Urgent to Non-Urgent. Pipe has been CIPP-lined. LOF of crossing is less or equal to 4. Recommend next video inspection in 5 years. (O.Yakimov - DWR UCIP) 06/23/2021 The record has been upgraded from Non-Urgent to Urgent. DWR DMP internal inspection has found pipe integrity issues. LOF of crossing is greater than or equal to 5 and less than 6. Crossing will be monitored until funding becomes available to address the issues. Some tumbleweed buildup at LS pipe inlet, recommend removal. No permit was found authorizing this encroachment. CVFPB will need to review crossing to determine owner. The UCIP inspection was completed with GEI staff, P. Espinoza. (H. Dunn – GEI)04/23/2014 Dense vegetation limits the inspector's visibility to identify signs of pipe failure (leaks) along the landward slope. Recommend removing vegetation along pipe alignment to conduct proper inspection of structure. (W. Wylie - DWR UCIP) FIELD_STRUCT_DESC: 24-inch CIPP-lined corrugated metal gravity drainage pipe (CMP) through the levee, 10.5 feet below the crown. Flap gate on the waterside (WS) end. Concrete headwall on the landside (LS) end. Concrete U-shaped headwall on the WS end. [Additional Reference(s): DWR Levee Log, 2002, (HLM 20.58). USACE San Joaquin O&M Manual, Unit No. 601, Part No. 1, 1967, Amended in 1978, Revised 20 June 1985, (HLM 20.59). DWR As-Built Specification No. 64-01, Sheet No. 4, 6 November 1963, (HLM 20.59)]. FS Date: 6/23/2021

LS view: Tumbleweeds in pipe inlet at toe.

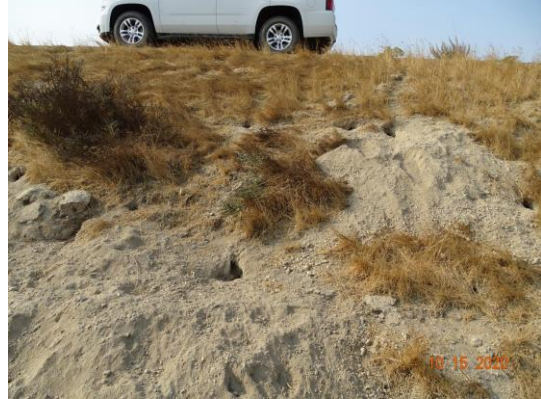
Photo 1 of 1 : SP_2024_NA0010_123_135_20240212_00029.jpg

LM Start	20.93	Rating **	M	Issue No.	135
LM End	20.93	Issue Type +	Ma	Location *	LS
Category	Earthen Levee			GPS Latitude/Longitude	
				Start	End
Item	Animal Control			37.097826°	37.097826°
				-120.543984°	-120.543984°
DWR ID	DWR_NA0010_05_f_2020_135				
Comment Code					
A3 : No rodents visible, but rodent burrows visible; need to backfill and compact or grout burrows.					
Inspector Comment

View of rodent burrow in the landside slope. (Fall 2020)

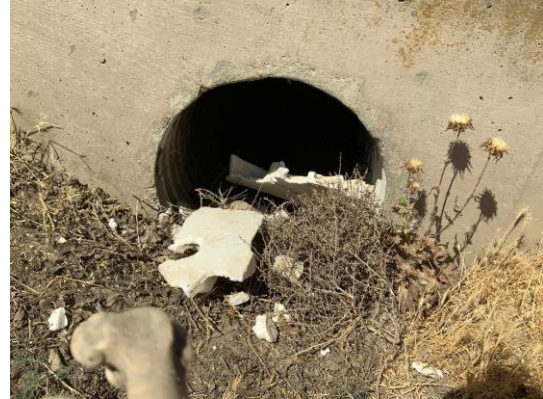
Photo 1 of 2 : UCIP_SP_2024_77909_104182.jpg

Comment Code					
Inspector Comment					
DS_ID:19785 FS_ID:77909 EP_NO: N/A Repair Type: Non-Urgent EVAL Issue: 11, Maintenance Compliance Issue Crossing Status: Found UCIP Comments: 12/20/2022 Record updated from Urgent to Non-Urgent. Pipe has been CIPP-lined. LOF of crossing is less or equal to 4. Recommend next video inspection in 5 years. (O.Yakimov - DWR UCIP) 06/23/2021 The record is being upgraded from Non-Urgent to Urgent. DWR DMP internal inspection has found pipe integrity issues. LOF of crossing is greater than or equal to 5 and less than 6. Crossing will be monitored until funding becomes available to address the issues. Tumbleweed and debris covering LS pipe inlet, recommend removal. No permit was found authorizing this encroachment. CVFPB will need to review crossing to determine owner. The UCIP inspection was completed with GEI staff, P. Espinoza. (H. Dunn – GEI)04/23/2014 Dense vegetation limits the inspector's visibility to identify signs of pipe failure (leaks) along the landward slope. Recommend removing vegetation along pipe alignment to conduct proper inspection of structure. (W. Wylie - DWR UCIP) FIELD_STRUCT_DESC: 24-inch CIPP-lined corrugated metal gravity drainage pipe (CMP) through the levee, 11.8 feet below the crown. Flap gate on the waterside (WS) end. Concrete headwall on the landside (LS) end. Concrete U-shaped headwall on the WS end. [Additional Reference(s): DWR Levee Log, 2002, (HLM 21.07). USACE San Joaquin O&M Manual, Unit No. 601, Part No. 1, 1967, Amended in 1978, Revised 20 June 1985, (HLM 21.08). DWR As-Built Specification No. 64-01, Sheet No. 5, 6 November 1963, (HLM 21.08)]. FS Date: 6/23/2021 10:19:41 AM

LS view: Debris inside pipe inlet at toe.

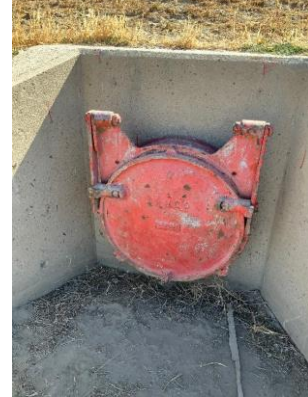
Photo 2 of 2 : UCIP_SP_2024_77909_104187.jpg

WS view: Closeup of flapgate at toe.

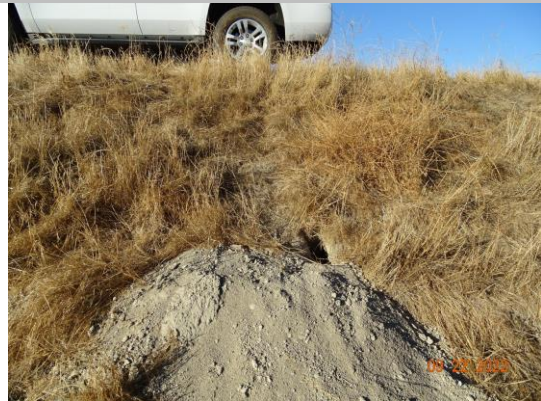
Photo 1 of 1 : SP_2024_NA0010_123_187_20240212_00066.jpg

LM Start	21.32	Rating **	M	Issue No.	187
LM End	21.32	Issue Type +	Ma	Location *	LS
Category	Earthen Levee			GPS Latitude/Longitude	
				Start	End
Item	Animal Control			37.093578°	37.093578°
				-120.539403°	-120.539403°
DWR ID	DWR_NA0010_05_f_2022_187				
Comment Code					
A3 : No rodents visible, but rodent burrows visible; need to backfill and compact or grout burrows.					
Inspector Comment

View of a rodent burrow on the landside slope. (Fall 2022).

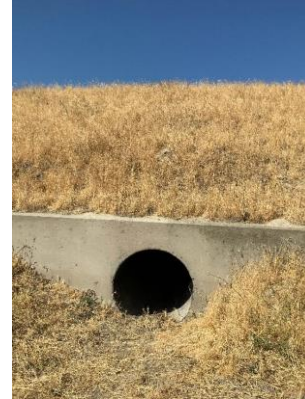
Photo 1 of 3 : UCIP_SP_2024_71046_104190.jpg

Comment Code						
Inspector Comment						
DS_ID:19786 FS_ID:71046 EP_NO: N/A Repair Type: Urgent EVAL Issue: 1, Pipe Integrity Crossing Status: Found UCIP Comments: 06/23/2021 The record has been upgraded from Non-Urgent to Urgent. DWR DMP internal inspection has found pipe integrity issues. LOF of crossing is is greater than or equal to 5 and less than 6. Crossing will be monitored until funding becomes available to address the issues. Potential hole in WS flapgate. Sand buildup around WS flapgate preventing it from opening easily, recommend removal. No permit was found authorizing this encroachment. CVFPB will need to review crossing to determine owner. The UCIP inspection was completed with GEI staff, P. Espinoza. (H. Dunn – GEI)04/23/2014 Dense vegetation limits the inspector's visibility to identify signs of pipe failure (leaks) along the landward slope. Recommend removing vegetation along pipe alignment to conduct proper inspection of structure. (W. Wylie - DWR UCIP) FIELD_STRUCT_DESC: 36-inch corrugated metal gravity drainage pipe (CMP) through the levee, 12.7 feet below the crown. Flap gate on the waterside (WS) end. Concrete headwall on the landside (LS) end. Concrete U-shaped headwall on the WS end. [Additional Reference(s): DWR Levee Log, 2002, (HLM 21.43). USACE San Joaquin O&M Manual, Unit No. 601, Part No. 1, 1967, Amended in 1978, Revised 20 June 1985, (HLM 21.42). DWR As-Built Specification No. 64-01, Sheet No. 5, 6 November 1963, (HLM 21.42)]. FS Date: 6/23/2021

LS view: Slope and headwall at toe.

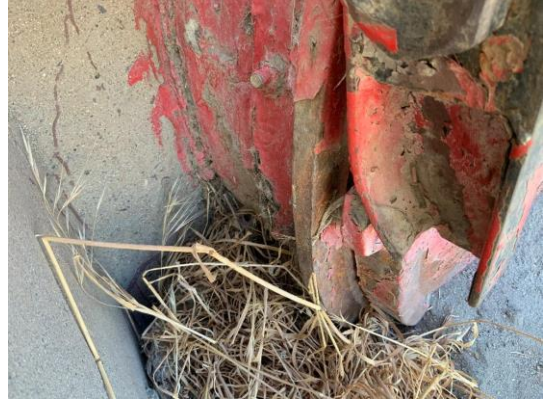
Photo 2 of 3 : UCIP_SP_2024_71046_104188.jpg

LM Start	21.48	Rating **	U	Issue No.	1362 (cont)
LM End	21.48	Issue Type +	Ma	Location *	
Category	Supplemental			GPS Latitude/Longitude	
				Start	End
Item	DWR UCIP LMA Responsibility			37.091755°	37.091755°
				-120.537414°	-120.537414°
DWR ID	19786

WS view: Closeup of potential gap in flapgate at toe.

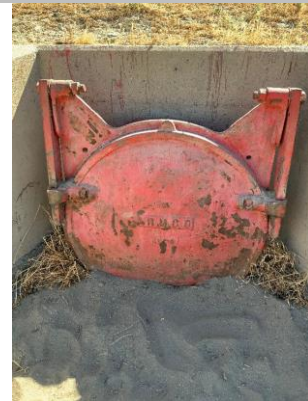
Photo 3 of 3 : UCIP_SP_2024_71046_104189.jpg

WS view: Closeup of flapgate with sand buildup at toe.

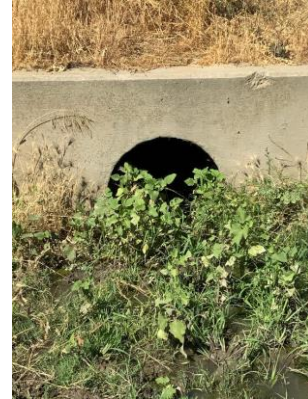
Photo 1 of 2 : UCIP_SP_2024_77910_104197.jpg

DS_ID:19787
 FS_ID:77910
 EP_NO: N/A
 Repair Type: Non-Urgent
 EVAL Issue:
 Crossing Status: Found
 UCIP Comments: 12/20/2022 Record updated from Urgent to Non-Urgent. Pipe has been CIPP-lined. LOF of crossing is less or equal to 4. Recommend next video inspection in 5 years. (O.Yakimov - DWR UCIP)
 06/23/2021 The record has been upgraded from Non-Urgent to Urgent. DWR DMP internal inspection has found pipe integrity issues. LOF of crossing is greater than or equal to 5 and less than 6. Crossing will be monitored until funding becomes available to address the issues. Standing water on both WS outlet and LS inlet, limiting closeup inspection on both sides. Water appeared to be leaking through the WS flapgate, even though it was closed. No permit was found authorizing this encroachment. CVFPB will need to review crossing to determine owner. The UCIP inspection was completed with GEI staff, P. Espinoza. (H. Dunn – GEI)04/23/2014 Dense vegetation limits the inspector's visibility to identify signs of pipe failure (leaks) along the landward slope. Recommend removing vegetation along pipe alignment to conduct proper inspection of structure. (W. Wylie - DWR UCIP)

LS view: Closeup of pipe inlet and water at toe.

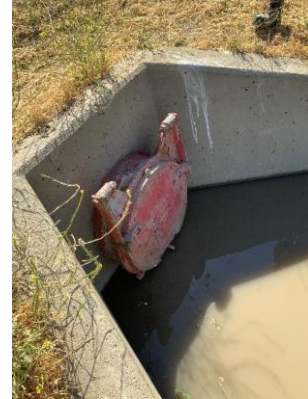
Photo 2 of 2 : UCIP_SP_2024_77910_104202.jpg

WS view: Closeup of flapgate and water at toe.

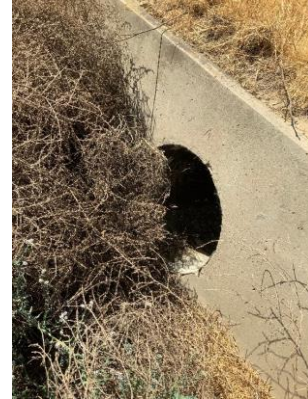
Photo 1 of 1 : UCIP_SP_2024_77911_104204.jpg

Comment Code					
Inspector Comment					
DS_ID:19788 FS_ID:77911 EP_NO: N/A Repair Type: Non-Urgent EVAL Issue: 11, Maintenance Compliance Issue Crossing Status: Found UCIP Comments: 12/20/2022 Record updated from Urgent to Non-Urgent. Pipe has been CIPP-lined. LOF of crossing is less or equal to 4. Recommend next video inspection in 5 years. (O.Yakimov - DWR UCIP) 06/23/2021 The record has been upgraded from Non-Urgent to Urgent. DWR DMP internal inspection has found pipe integrity issues. LOF of crossing is greater than or equal to 5 and less than 6. Crossing will be monitored until funding becomes available to address the issues. Limited inspection of the LS pipe inlet due to dense tumbleweeds and vegetation, recommend removal. No permit was found authorizing this encroachment. CVFPB will need to review crossing to determine owner. The UCIP inspection was completed with GEI staff, P. Espinoza. (H. Dunn – GEI)04/23/2014 Dense vegetation limits the inspector's visibility to identify signs of pipe failure (leaks) along the landward slope. Recommend removing vegetation along pipe alignment to conduct proper inspection of structure. (W. Wylie - DWR UCIP) FIELD_STRUCT_DESC: 24-inch CIPP-lined corrugated metal gravity drainage pipe (CMP) through the levee, 10.7 feet below the crown. Flap gate on the waterside (WS) end. Concrete headwall on the landside (LS) end. Concrete U-shaped headwall on the WS end. [Additional Reference(s): DWR Levee Log, 2002, (HLM 21.85). USACE San Joaquin O&M Manual, Unit No. 601, Part No. 1, 1967, Amended in 1978, Revised 20 June 1985, (HLM 21.85). DWR As-Built Specification No. 64-01, Sheet No. 5, 6 November 1963, (HLM 21.85)]. FS Date: 6/23/2021 10:28:44 AM

LS view: Closeup of pipe inlet and vegetation at toe.

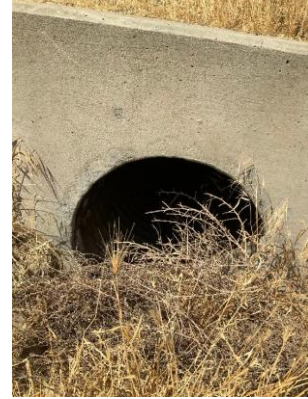
Photo 1 of 2 : UCIP_SP_2024_77912_104210.jpg

Comment Code					
Inspector Comment					
DS_ID:19789 FS_ID:77912 EP_NO: N/A Repair Type: Non-Urgent EVAL Issue: 11, Maintenance Compliance Issue Crossing Status: Found UCIP Comments: 12/20/2022 Record updated from Urgent to Non-Urgent. Pipe has been CIPP-lined. LOF of crossing is less or equal to 4. Recommend next video inspection in 5 years. (O.Yakimov - DWR UCIP) 06/23/2021 The record has been upgraded from Non-Urgent to Urgent. DWR DMP internal inspection has found pipe integrity issues. LOF of crossing is is greater than or equal to 5 and less than 6. Crossing will be monitored until funding becomes available to address the issues. Some vegetation growing over LS pipe inlet, recommend removal. No permit was found authorizing this encroachment. CVFPB will need to review crossing to determine owner. The UCIP inspection was completed with GEI staff, P. Espinoza. (H. Dunn – GEI)04/23/2014 Dense vegetation limits the inspector's visibility to identify signs of pipe failure (leaks) along the landward slope. Recommend removing vegetation along pipe alignment to conduct proper inspection of structure. Sediment buildup in pipe visible from landward side--recommend contacting owner to clear pipe. (W. Wylie - DWR UCIP) FIELD_STRUCT_DESC: 24-inch CIPP-lined corrugated metal gravity drainage pipe (CMP) through the levee, 10.2 feet below the crown. Flap gate on the waterside (WS) end. Concrete headwall on the landside (LS) end. Concrete U-shaped headwall on the WS end. [Additional Reference(s): DWR Levee Log, 2002, (HLM 22.18). USACE San Joaquin O&M Manual, Unit No. 601, Part No. 1, 1967, Amended in 1978, Revised 20 June 1985, (HLM 22.19). DWR As-Built Specification No. 64-01, Sheet No. 5, 6 November 1963, (HLM 22.19)]. FS Date: 6/23/2021 10:29:25 AM

LS view: Closeup of inlet covered by vegetation at toe.

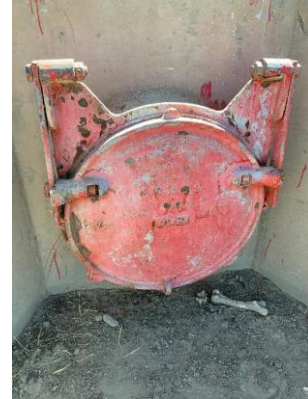
Photo 2 of 2 : UCIP_SP_2024_77912_104215.jpg

WS view: Closeup of flapgate at toe.

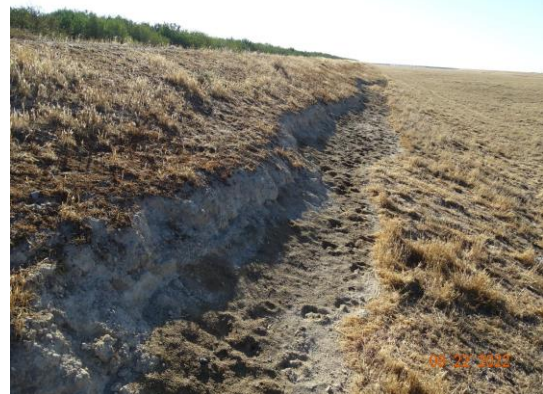
Photo 1 of 1 : SP_2024_NA0010_123_121_20240212_00019.jpg

LM Start	22.28	Rating **	M	Issue No.	121
LM End	22.35	Issue Type +	Ma	Location *	WS
Category	Earthen Levee			GPS Latitude/Longitude	
				Start	End
Item	Erosion / Livestock			37.083388°	37.082696°
				-120.528382°	-120.527620°
DWR ID	DWR_NA0010_05_f_2017_121				
Comment Code					
E4 : Repair the levee slope damaged by livestock and prevent large animal access.					
Inspector Comment					
Waterside slope damaged by animal traffic.

Looking southeast at the waterside slope. (Fall 2022)

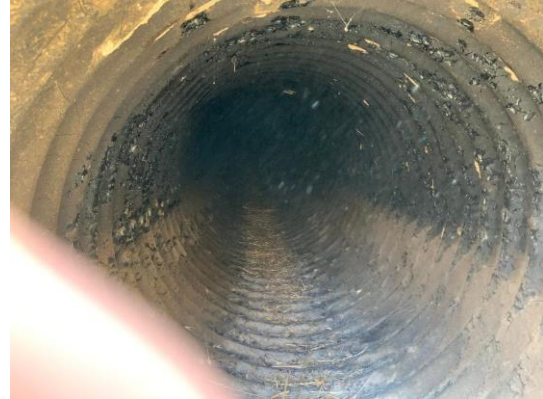
Photo 1 of 3 : UCIP_SP_2024_77913_104218.jpg

Comment Code					
Inspector Comment					
DS_ID:19790 FS_ID:77913 EP_NO: N/A Repair Type: Non-Urgent EVAL Issue: Crossing Status: Found UCIP Comments: 12/20/2022 Record updated from Urgent to Non-Urgent. Pipe has been CIPP-lined. LOF of crossing is less or equal to 4. Recommend next video inspection in 5 years. (O.Yakimov - DWR UCIP) 06/23/2021 The record has been upgraded from Non-Urgent to Urgent. DWR DMP internal inspection has found pipe integrity issues. LOF of crossing is greater than or equal to 5 and less than 6. Crossing will be monitored until funding becomes available to address the issues. Possible hole in WS flapgate. No permit was found authorizing this encroachment. CVFPB will need to review crossing to determine owner. The UCIP inspection was completed with GEI staff, P. Espinoza. (H. Dunn – GEI)04/23/2014 Dense vegetation limits the inspector's visibility to identify signs of pipe failure (leaks) along the landward slope. Recommend removing vegetation along pipe alignment to conduct proper inspection of structure. Sediment buildup in pipe visible from landward side--recommend contacting owner to clear pipe. (W. Wylie - DWR UCIP) FIELD_STRUCT_DESC: 24-inch CIPP-lined corrugated metal gravity drainage pipe (CMP) through the levee, 10.4 feet below the crown. Flap gate on the waterside (WS) end. Concrete headwall on the landside (LS) end. Concrete U-shaped headwall on the WS end. [Additional Reference(s): DWR Levee Log, 2002, (HLM 22.46). USACE San Joaquin O&M Manual, Unit No. 601, Part No. 1, 1967, Amended in 1978, Revised 20 June 1985, (HLM 22.46). DWR As-Built Specification No. 64-01, Sheet No. 6, 6 November 1963, (HLM 22.46)]. FS Date: 6/23/2021 10:30:24 AM

LS view: Inside pipe inlet at toe.

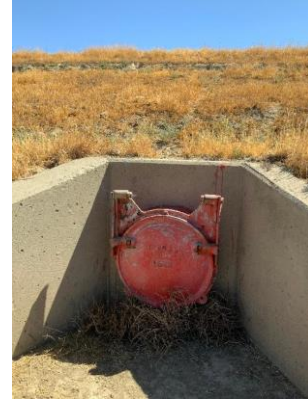
Photo 2 of 3 : UCIP_SP_2024_77913_104222.jpg

WS view: Slope, headwall, and flapgate from toe.

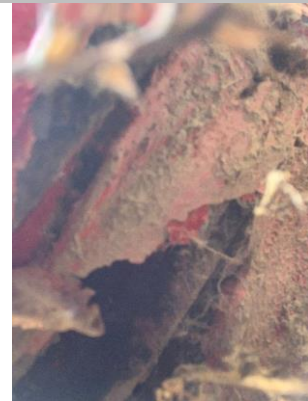
Photo 3 of 3 : UCIP_SP_2024_77913_104223.jpg

WS view: Closeup of hole in flapgate at toe.

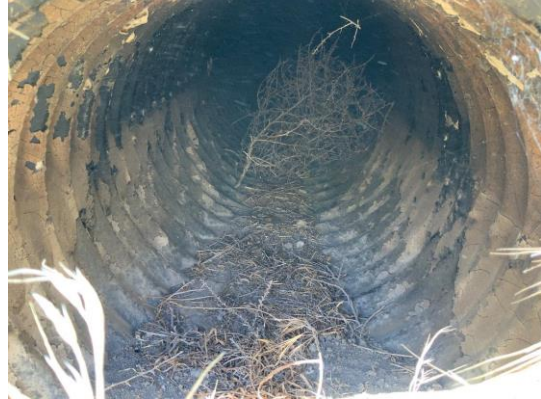
Photo 1 of 3 : UCIP_SP_2024_77914_104228.jpg

DS_ID:19791
 FS_ID:77914
 EP_NO: N/A
 Repair Type: Non-Urgent
 EVAL Issue:
 Crossing Status: Found
 UCIP Comments: 12/20/2022 Record updated from Urgent to Non-Urgent. Pipe has been CIPP-lined. LOF of crossing is less or equal to 4. Recommend next video inspection in 5 years. (O.Yakimov - DWR UCIP)
 06/23/2021 The record has been upgraded from Non-Urgent to Urgent. DWR DMP internal inspection has found pipe integrity issues. LOF of crossing is greater than or equal to 5 and less than 6. Crossing will be monitored until funding becomes available to address the issues. Deterioration of the underside of the WS flapgate. No permit was found authorizing this encroachment. CVFPB will need to review crossing to determine owner. The UCIP inspection was completed with GEI staff, P. Espinoza. (H. Dunn – GEI)04/23/2014 Dense vegetation limits the inspector's visibility to identify signs of pipe failure (leaks) along the landward slope. Recommend removing vegetation along pipe alignment to conduct proper inspection of structure. Sediment buildup in pipe visible from landward side--recommend contacting owner to clear pipe. (W. Wylie - DWR UCIP)

LS view: Inside pipe inlet at toe.

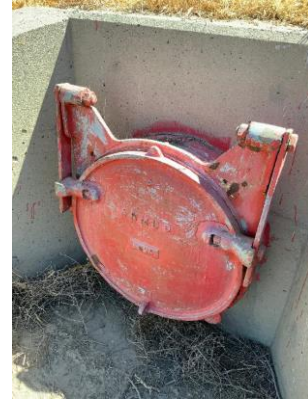
Photo 2 of 3 : UCIP_SP_2024_77914_104224.jpg

WS view: Closeup of flapgate at toe.

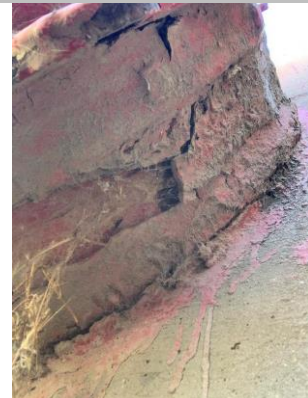
Photo 3 of 3 : UCIP_SP_2024_77914_104225.jpg

WS view: Deterioration and holes underneath flapgate at toe.

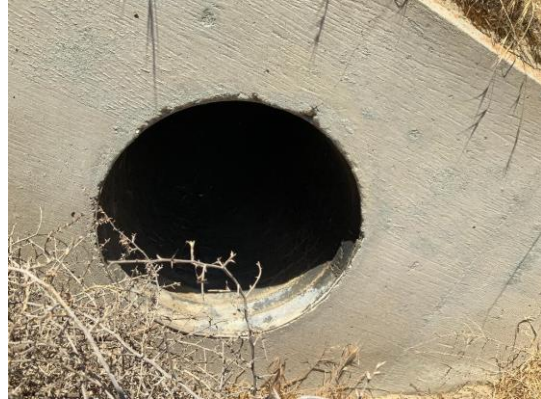
Photo 1 of 3 : UCIP_SP_2024_77915_104234.jpg

Comment Code						
Inspector Comment						
DS_ID:19792 FS_ID:77915 EP_NO: N/A Repair Type: Non-Urgent EVAL Issue: Crossing Status: Found UCIP Comments: 12/20/2022 Record updated from Urgent to Non-Urgent. Pipe has been CIPP lined. LOF of crossing is less or equal to 4. Recommend next video inspection in 5 years. (O.Yakimov - DWR UCIP) 06/23/2021 The record has been upgraded from Non-Urgent to Urgent. DWR DMP internal inspection has found pipe integrity issues. LOF of crossing is greater than or equal to 5 and less than 6. Crossing will be monitored until funding becomes available to address the issues. Deterioration of the underside of the WS flapgate. No permit was found authorizing this encroachment. CVFPB will need to review crossing to determine owner. The UCIP inspection was completed with GEI staff, P. Espinoza. (H. Dunn – GEI)04/23/2014 Dense vegetation limits the inspector's visibility to identify signs of pipe failure (leaks) along the landward slope. Recommend removing vegetation along pipe alignment to conduct proper inspection of structure. (W. Wylie - DWR UCIP) FIELD_STRUCT_DESC: 24-inch CIPP-lined corrugated metal gravity drainage pipe (CMP) through the levee, 11.1 feet below the crown. Flap gate on the waterside (WS) end. Concrete headwall on the landside (LS) end. Concrete U-shaped headwall on the WS end. [Additional Reference(s): DWR Levee Log, 2002, (HLM 22.93). USACE San Joaquin O&M Manual, Unit No. 601, Part No. 1, 1967, Amended in 1978, Revised 20 June 1985, (HLM 22.94). DWR As-Built Specification No. 64-01, Sheet No. 6, 6 November 1963, (HLM 22.94)]. FS Date: 6/23/2021 10:31:37 AM

LS view: Closeup of pipe inlet at toe.

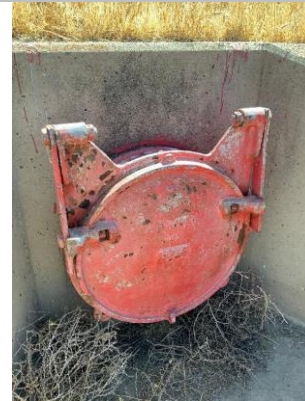
Photo 2 of 3 : UCIP_SP_2024_77915_104239.jpg

WS view: Closeup of flapgate at toe.

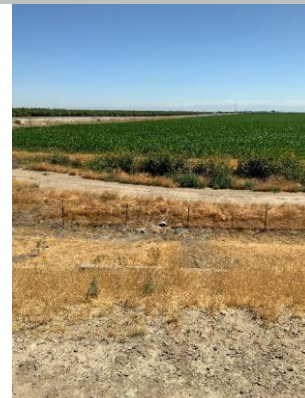
Photo 2 of 3 : UCIP_SP_2024_71054_104343.jpg

LS view: Toe from crown.

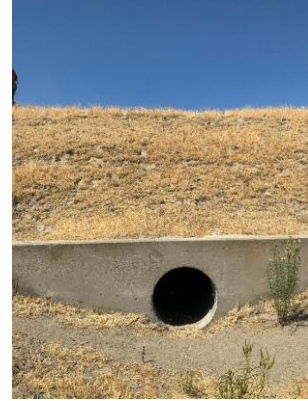
Photo 3 of 3 : UCIP_SP_2024_71054_104345.jpg

LS view: Slope and headwall from toe.

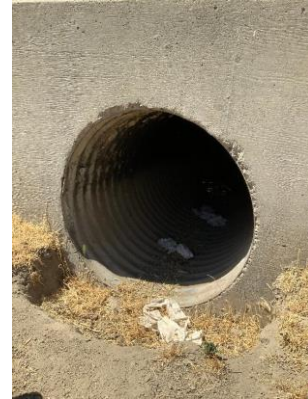
Photo 1 of 2 : UCIP_SP_2024_77916_104378.jpg

Comment Code						
Inspector Comment						
DS_ID:19796 FS_ID:77916 EP_NO: N/A Repair Type: Non-Urgent EVAL Issue: Crossing Status: Found UCIP Comments: 12/20/2022 Record updated from Urgent to Non-Urgent. Pipe has been CIPP lined. LOF of crossing is less or equal to 4. Recommend next video inspection in 5 years. (O.Yakimov - DWR UCIP) 06/23/2021 The record has been upgraded from Non-Urgent to Urgent. DWR DMP internal inspection has found pipe integrity issues. LOF of crossing is greater than or equal to 5 and less than 6. Crossing will be monitored until funding becomes available to address the issues. No permit was found authorizing this encroachment. CVFPB will need to review crossing to determine owner. The UCIP inspection was completed with GEI staff, P. Espinoza. (H. Dunn – GEI)03/25/2014 Sediment buildup in pipe visible from landward side--recommend contacting owner to clear pipe. (W. Wylie - DWR UCIP) FIELD_STRUCT_DESC: 30-inch CIPP-lined corrugated metal gravity drainage pipe (CMP) through the levee, 12.1 feet below the crown. Flap gate on the waterside (WS) end. Concrete U-shaped headwall on the WS end. [Additional Reference(s): DWR Levee Log, 2002, (HLM 23.61). USACE San Joaquin O&M Manual, Unit No. 601, Part No. 1, 1967, Amended in 1978, Revised 20 June 1985, (HLM 23.62). DWR As-Built Specification No. 64-01, Sheet No. 7, 6 November 1963, (HLM 23.62)]. FS Date: 6/23/2021 10:37:56 AM

LS view: Closeup of pipe inlet at toe.

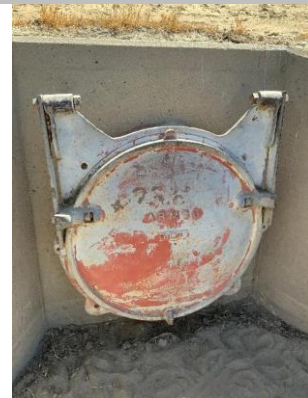
Photo 2 of 2 : UCIP_SP_2024_77916_104383.jpg

WS view: Closeup of flapgate at toe.

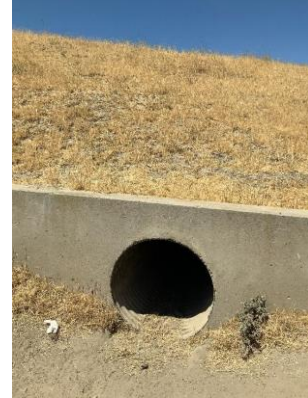
Photo 1 of 3 : UCIP_SP_2024_77917_104384.jpg

Comment Code						
Inspector Comment						
DS_ID:19797 FS_ID:77917 EP_NO: N/A Repair Type: Non-Urgent EVAL Issue: Crossing Status: Found UCIP Comments: 12/20/2022 Record updated from Urgent to Non-Urgent. Pipe has been CIPP lined. LOF of crossing is less or equal to 4. Recommend next video inspection in 5 years. (O.Yakimov - DWR UCIP) 06/23/2021 The record has been upgraded from Non-Urgent to Urgent. DWR DMP internal inspection has found pipe integrity issues. LOF of crossing is greater than or equal to 5 and less than 6. Crossing will be monitored until funding becomes available to address the issues. Small hole seen in the front of the WS flapgate. No permit was found authorizing this encroachment. CVFPB will need to review crossing to determine owner. The UCIP inspection was completed with GEI staff, P. Espinoza. (H. Dunn – GEI)03/25/2014 Minor sediment/debris buildup in pipe visible from landward side--recommend contacting owner to clear pipe. (W. Wylie - DWR UCIP) FIELD_STRUCT_DESC: 36-inch CIPP-lined corrugated metal gravity drainage pipe (CMP) through the levee, 12.1 feet below the crown. Flap gate on the waterside (WS) end. Concrete headwall on the landside (LS) end. Concrete U-shaped headwall on the WS end. [Additional Reference(s): DWR Levee Log, 2002, (HLM 23.92). USACE San Joaquin O&M Manual, Unit No. 601, Part No. 1, 1967, Amended in 1978, Revised 20 June 1985, (HLM 23.85). DWR As-Built Specification No. 64-01, Sheet No. 7, 6 November 1963, (HLM 23.85)]. FS Date: 6/23/2021 10:38:30 AM

LS view: Slope and headwall from toe.

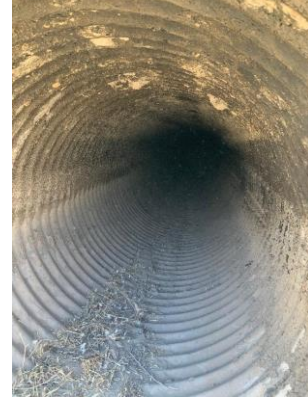
Photo 2 of 3 : UCIP_SP_2024_77917_104385.jpg

LS view: Closeup of inside inlet at toe.

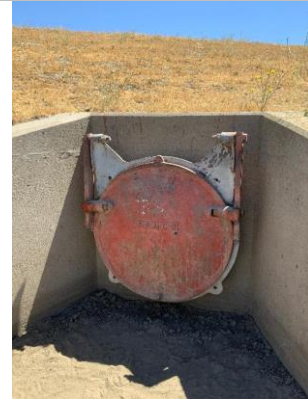
Photo 3 of 3 : UCIP_SP_2024_77917_104390.jpg

WS view: Closeup of flapgate at toe.

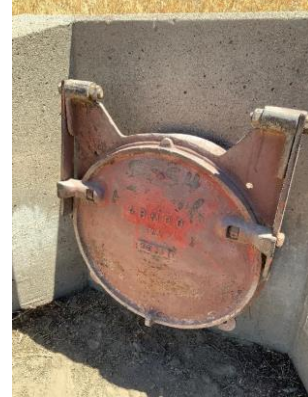
Photo 1 of 3 : UCIP_SP_2024_77918_104406.jpg

Comment Code						
Inspector Comment						
DS_ID:19799 FS_ID:77918 EP_NO: N/A Repair Type: Non-Urgent EVAL Issue: Crossing Status: Found UCIP Comments: 12/20/2022 Record updated from Urgent to Non-Urgent. Pipe has been CIPP lined. LOF of crossing is less or equal to 4. Recommend next video inspection in 5 years. (O.Yakimov - DWR UCIP) 06/23/2021 The record has been upgraded from Non-Urgent to Urgent. DWR DMP internal inspection has found pipe integrity issues. LOF of crossing is greater than or equal to 5 and less than 6. Crossing will be monitored until funding becomes available to address the issues. Hole visible on underneath of flapgate on WS. No permit was found authorizing this encroachment. CVFPB will need to review crossing to determine owner. The UCIP inspection was completed with GEI staff, P. Espinoza. (H. Dunn – GEI)03/25/2014 Dense vegetation limits the inspector's visibility to identify signs of pipe failure (leaks) along the landward slope. Recommend removing vegetation along pipe alignment to conduct proper inspection of structure. (W. Wylie - DWR UCIP) FIELD_STRUCT_DESC: 24-inch CIPP-lined corrugated metal gravity drainage pipe (CMP) through the levee, 11.2 feet below the crown. Flap gate on the waterside (WS) end. Concrete headwall on the landside (LS) end. Concrete U-shaped headwall on the WS end. [Additional Reference(s): DWR Levee Log, 2002, (HLM 24.46). USACE San Joaquin O&M Manual, Unit No. 601, Part No. 1, 1967, Amended in 1978, Revised 20 June 1985, (HLM 24.46). DWR As-Built Specification No. 64-01, Sheet No. 7, 6 November 1963, (HLM 24.46)]. FS Date: 6/23/2021 10:39:09 AM

WS view: Closeup of flapgate at toe.

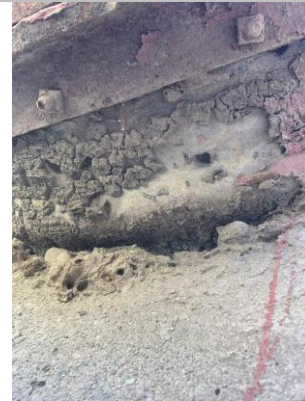
Photo 2 of 3 : UCIP_SP_2024_77918_104398.jpg

WS view: Closeup of hole under flapgate at toe, 1 of 2 photos.

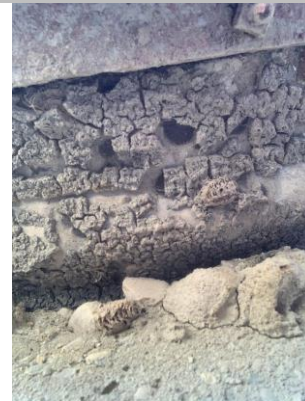
Photo 3 of 3 : UCIP_SP_2024_77918_104399.jpg

WS view: Closeup of hole under flapgate at toe, 2 of 2 photos.

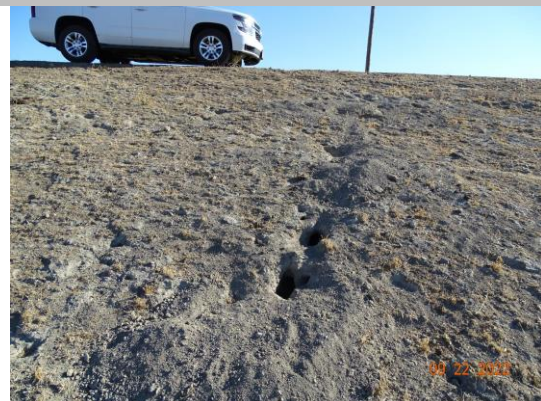
Photo 1 of 1 : SP_2024_NA0010_123_188_20240212_00067.jpg

LM Start	24.79	Rating **	M	Issue No.	188
LM End	24.79	Issue Type +	Ma	Location *	WS
Category	Earthen Levee			GPS Latitude/Longitude	
				Start	End
Item	Animal Control			37.056122°	37.056122°
				-120.498432°	-120.498432°
DWR ID	DWR_NA0010_05_f_2022_188				
Comment Code					
A3 : No rodents visible, but rodent burrows visible; need to backfill and compact or grout burrows.					
Inspector Comment

Several rodent burrows observed on the waterside slope. (Fall 2022)

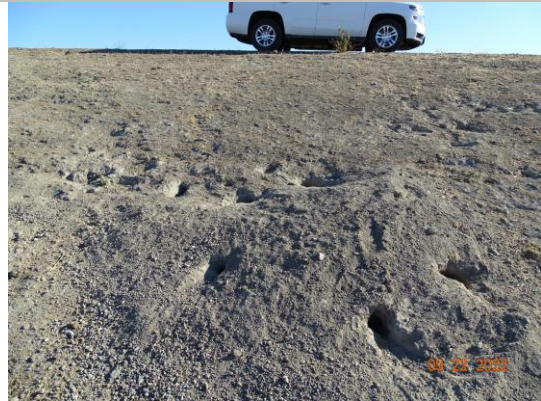
Photo 1 of 1 : SP_2024_NA0010_123_190_20240212_00069.jpg

LM Start	24.84	Rating **	M	Issue No.	190
LM End	24.84	Issue Type +	Ma	Location *	WS
Category	Earthen Levee			GPS Latitude/Longitude	
				Start	End
Item	Animal Control			37.055582°	37.055582°
				-120.497759°	-120.497759°
DWR ID	DWR_NA0010_05_f_2022_190				
Comment Code					
A3 : No rodents visible, but rodent burrows visible; need to backfill and compact or grout burrows.					
Inspector Comment

View of multiple rodent holes on the waterside slope. (Fall 2022)

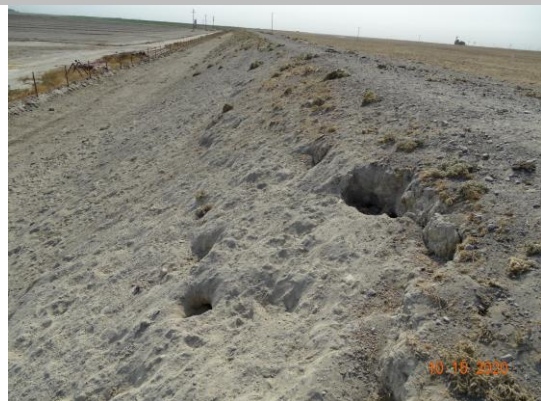
Photo 1 of 1 : SP_2024_NA0010_123_123_20240212_00020.jpg

LM Start	25.09	Rating **	A/W	Issue No.	123
LM End	25.09	Issue Type +	Ma	Location *	LS
Category	Earthen Levee			GPS Latitude/Longitude	
				Start	End
Item	Animal Control			37.053103°	37.053103°
				-120.494651°	-120.494651°
DWR ID	DWR_NA0010_05_f_2017_123				
Comment Code					
A1 : Exterminate rodents and backfill and compact or grout burrows.					
Inspector Comment

View of the landside slope looking upstream. (Fall 2020)

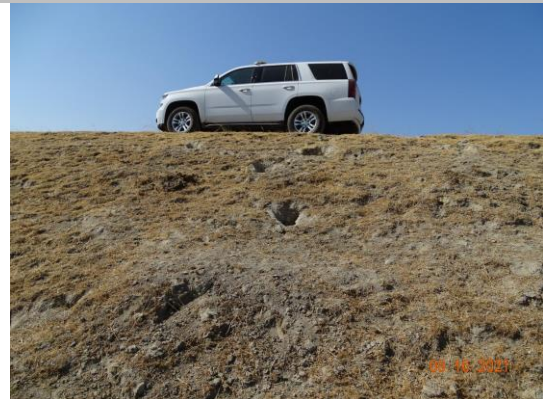
Photo 1 of 1 : SP_2024_NA0010_123_167_20240212_00052.jpg

LM Start	25.46	Rating **	A/W	Issue No.	167
LM End	25.52	Issue Type +	Ma	Location *	LS
Category	Earthen Levee			GPS Latitude/Longitude	
				Start	End
Item	Animal Control			37.049218°	37.048502°
				-120.489883°	-120.489257°
DWR ID	DWR_NA0010_05_f_2021_167				
Comment Code					
A3 : No rodents visible, but rodent burrows visible; need to backfill and compact or grout burrows.					
Inspector Comment

Multiple rodent holes observed on the landside slope. (Fall 2021)

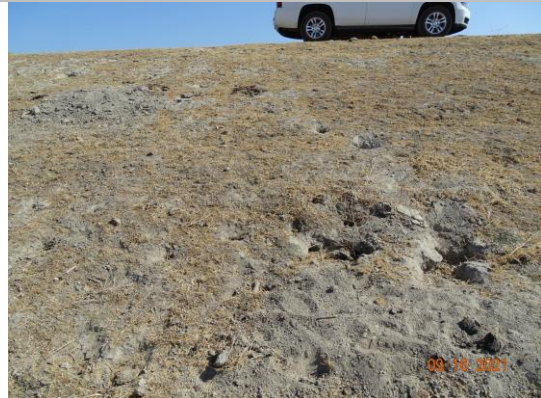
Photo 1 of 1 : SP_2024_NA0010_123_168_20240212_00053.jpg

LM Start	25.46	Rating **	A/W	Issue No.	168
LM End	25.46	Issue Type +	Ma	Location *	WS
Category	Earthen Levee			GPS Latitude/Longitude	
				Start	End
Item	Animal Control			37.049217 °	37.049217 °
				-120.489881 °	-120.489881 °
DWR ID	DWR_NA0010_05_f_2021_168				
Comment Code					
A3 : No rodents visible, but rodent burrows visible; need to backfill and compact or grout burrows.					
Inspector Comment

View of rodent burrows on the waterside slope. (Fall 2021)

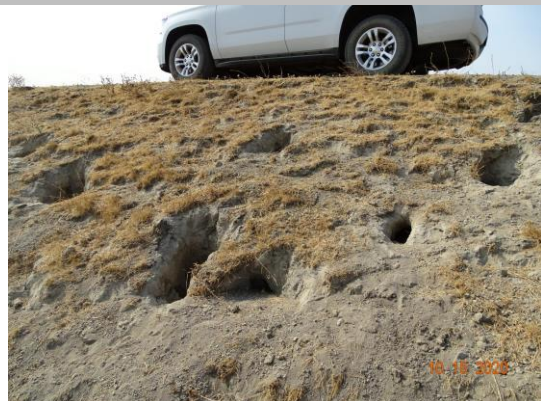
Photo 1 of 1 : SP_2024_NA0010_123_148_20240212_00037.jpg

LM Start	25.58	Rating **	U	Issue No.	148
LM End	25.60	Issue Type +	Ma	Location *	LS
Category	Earthen Levee			GPS Latitude/Longitude	
				Start	End
Item	Animal Control			37.047827°	37.047551°
				-120.488738°	-120.488527°
DWR ID	DWR_NA0010_05_f_2020_148				
Comment Code					
A3 : No rodents visible, but rodent burrows visible; need to backfill and compact or grout burrows.					
Inspector Comment

View of burrows in the landside. (Fall 2020)

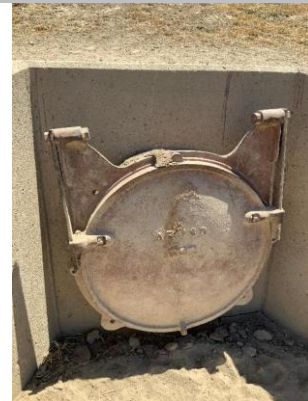
Photo 3 of 3 : UCIP_SP_2024_77919_104435.jpg

Comment Code					
Inspector Comment					
DS_ID:19804 FS_ID:77919 EP_NO: N/A Repair Type: Non-Urgent EVAL Issue: Crossing Status: Found UCIP Comments: 12/20/2022 Record updated from Urgent to Non-Urgent. Pipe has been CIPP lined. LOF of crossing is less or equal to 4. Recommend next video inspection in 5 years. (O.Yakimov - DWR UCIP) 06/23/2021 The record has been upgraded from Non-Urgent to Urgent. DWR DMP internal inspection has found pipe integrity issues. LOF of crossing is greater than or equal to 5 and less than 6. Crossing will be monitored until funding becomes available to address the issues. No permit was found authorizing this encroachment. CVFPB will need to review crossing to determine owner. The UCIP inspection was completed with GEI staff, P. Espinoza. (H. Dunn – GEI)03/25/2014 Dense vegetation limits the inspector's visibility to identify signs of pipe failure (leaks) along the landward slope. Recommend removing vegetation along pipe alignment to conduct proper inspection of structure. Sediment buildup in pipe visible from landward side-- recommend contacting owner to clear pipe. (W. Wylie - DWR UCIP) FIELD_STRUCT_DESC: 30-inch CIPP-lined corrugated metal gravity drainage pipe (CMP) through the levee, 12.0 feet below the crown. Flap gate on the waterside (WS) end. Concrete headwall on the landside (LS) end. Concrete U-shaped headwall on the WS end. [Additional Reference(s): DWR Levee Log, 2002, (HLM 25.51). USACE San Joaquin O&M Manual, Unit No. 601, Part No. 1, 1967, Amended in 1978, Revised 20 June 1985, (HLM 25.51). DWR As-Built Specification No. 64-01, Sheet No. 8, 6 November 1963, (HLM 25.51)]. FS Date: 6/23/2021 10:39:43 AM

WS view: Closeup of flapgate at toe.

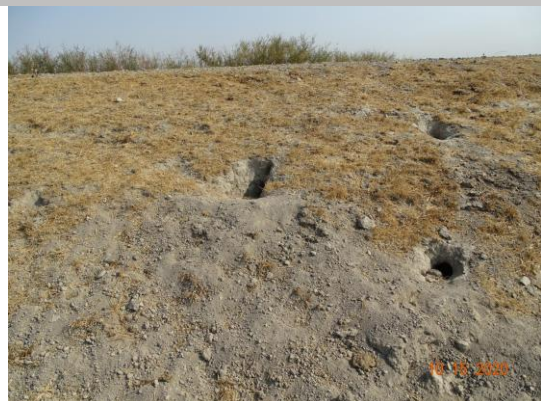
Photo 1 of 1 : SP_2024_NA0010_123_124_20240212_00021.jpg

LM Start	25.61	Rating **	M	Issue No.	124
LM End	25.61	Issue Type +	Ma	Location *	WS
Category	Earthen Levee			GPS Latitude/Longitude	
				Start	End
Item	Animal Control			37.047416°	37.047416°
				-120.488411°	-120.488411°
DWR ID	DWR_NA0010_05_f_2017_124				
Comment Code					
A1 : Exterminate rodents and backfill and compact or grout burrows.					
Inspector Comment

Looking east at the waterside slope. (Fall 2020)

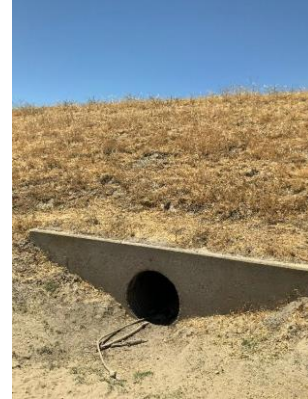
Photo 1 of 2 : UCIP_SP_2024_77920_104440.jpg

Comment Code						
Inspector Comment						
DS_ID:19805 FS_ID:77920 EP_NO: N/A Repair Type: Non-Urgent EVAL Issue: Crossing Status: Found UCIP Comments: 12/20/2022 Record updated from Urgent to Non-Urgent. Pipe has been CIPP lined. LOF of crossing is less or equal to 4. Recommend next video inspection in 5 years. (O.Yakimov - DWR UCIP) 06/23/2021 The record has been upgraded from Non-Urgent to Urgent. DWR DMP internal inspection has found pipe integrity issues. LOF of crossing is greater than or equal to 5 and less than 6. Crossing will be monitored until funding becomes available to address the issues. No permit was found authorizing this encroachment. CVFPB will need to review crossing to determine owner. The UCIP inspection was completed with GEI staff, P. Espinoza. (H. Dunn – GEI)03/25/2014 Sediment buildup in pipe visible from landward side--recommend contacting owner to clear pipe. (W. Wylie - DWR UCIP) FIELD_STRUCT_DESC: 30-inch CIPP-lined corrugated metal gravity drainage pipe (CMP) through the levee, 12.1 feet below the crown. Flap gate on the waterside (WS) end. Concrete headwall on the landside (LS) end. Concrete U-shaped headwall on the WS end. [Additional Reference(s): DWR Levee Log, 2002, (HLM 25.53). USACE San Joaquin O&M Manual, Unit No. 601, Part No. 1, 1967, Amended in 1978, Revised 20 June 1985, (HLM 25.53). DWR As-Built Specification No. 64-01, Sheet No. 8, 6 November 1963, (HLM 25.53)]. FS Date: 6/23/2021 10:40:17 AM

LS view: Slope and headwall from toe.

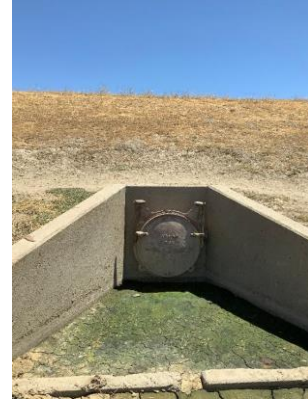
Photo 2 of 2 : UCIP_SP_2024_77920_104439.jpg

WS view: Slope, headwall, and flapgate from toe.

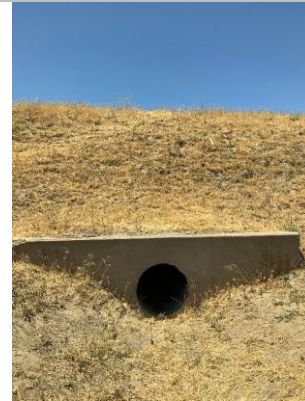
Photo 1 of 3 : UCIP_SP_2024_77921_104448.jpg

Comment Code						
Inspector Comment						
DS_ID:19806 FS_ID:77921 EP_NO: N/A Repair Type: Non-Urgent EVAL Issue: Crossing Status: Found UCIP Comments: 12/20/2022 Record updated from Urgent to Non-Urgent. Pipe has been CIPP lined. LOF of crossing is less or equal to 4. Recommend next video inspection in 5 years. (O.Yakimov - DWR UCIP) 06/23/2021 The record has been upgraded from Non-Urgent to Urgent. DWR DMP internal inspection has found pipe integrity issues. LOF of crossing is greater than or equal to 5 and less than 6. Crossing will be monitored until funding becomes available to address the issues. No permit was found authorizing this encroachment. CVFPB will need to review crossing to determine owner. The UCIP inspection was completed with GEI staff, P. Espinoza. (H. Dunn – GEI)03/25/2014 Sediment buildup in pipe visible from landward side--recommend contacting owner to clear pipe. (W. Wylie - DWR UCIP) FIELD_STRUCT_DESC: 24-inch CIPP-lined corrugated metal gravity drainage pipe (CMP) through the levee, 10.0 feet below the crown. Flap gate on the waterside (WS) end. Concrete headwall on the landside (LS) end. Concrete U-shaped headwall on the WS end. [Additional Reference(s): DWR Levee Log, 2002, (HLM 26.10). USACE San Joaquin O&M Manual, Unit No. 601, Part No. 1, 1967, Amended in 1978, Revised 20 June 1985, (HLM 26.11). DWR As-Built Specification No. 64-01, Sheet No. 8, 6 November 1963, (HLM 26.11)]. FS Date: 6/23/2021 10:41:07 AM

LS view: Slope and headwall from toe.

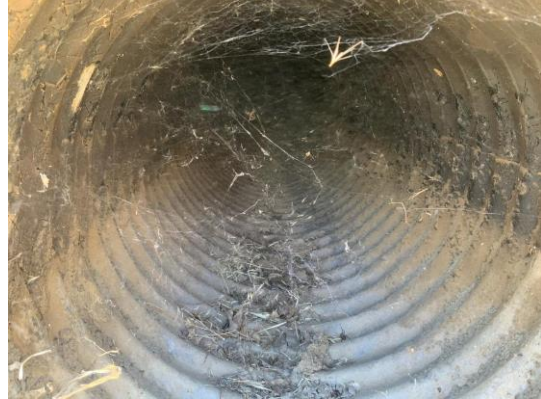
Photo 2 of 3 : UCIP_SP_2024_77921_104449.jpg

LS view: Inside pipe inlet at toe.

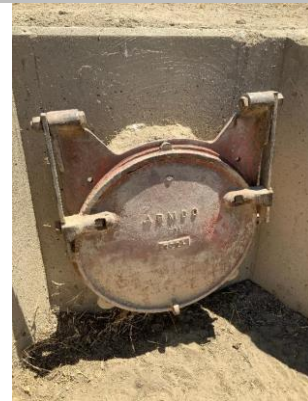
Photo 3 of 3 : UCIP_SP_2024_77921_104454.jpg

WS view: Closeup of flapgate at toe.

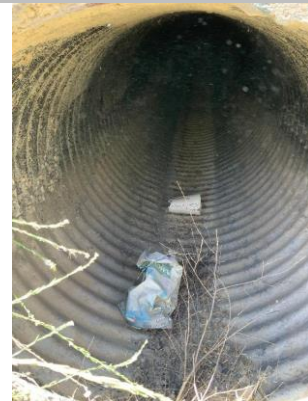
Photo 2 of 3 : UCIP_SP_2024_77930_104460.jpg

LS view: Inside of inlet at toe.

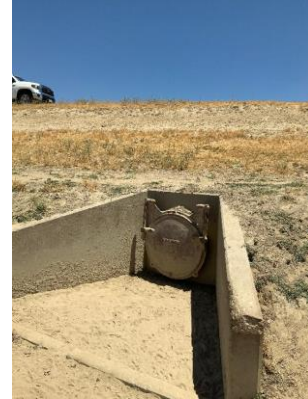
Photo 3 of 3 : UCIP_SP_2024_77930_104458.jpg

WS view: Slope, headwall, and flapgate from toe.

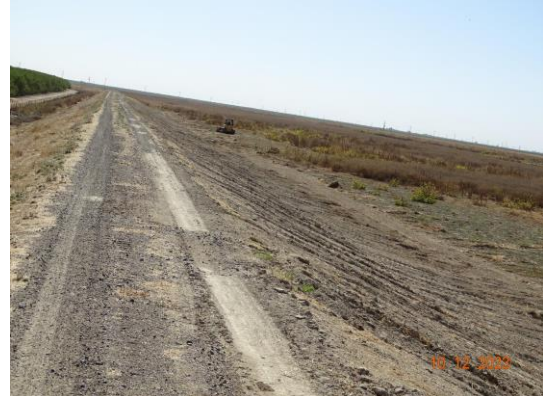
Photo 1 of 1 : SP_2024_NA0010_123_169_20240212_00054.jpg

LM Start	26.59	Rating **	A/W	Issue No.	169
LM End	26.69	Issue Type +	Ma	Location *	WS
Category	Earthen Levee			GPS Latitude/Longitude	
				Start	End
Item	Erosion / Livestock			37.035301°	37.034140°
				-120.479144°	-120.478076°
DWR ID	DWR_NA0010_05_f_2021_169				
Comment Code					
E4 : Repair the levee slope damaged by livestock and prevent large animal access.					
Inspector Comment					
Damage to the slope has been repaired. Monitor for potential settlement.

View of repaired waterside slope. (Fall 2023)

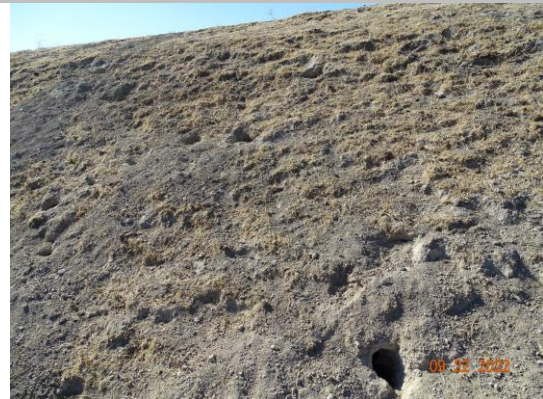
Photo 1 of 1 : SP_2024_NA0010_123_191_20240212_00070.jpg

LM Start	26.85	Rating **	M	Issue No.	191
LM End	26.92	Issue Type +	Ma	Location *	LS
Category	Earthen Levee			GPS Latitude/Longitude	
				Start	End
Item	Animal Control			37.032891°	37.032685°
				-120.475608°	-120.474378°
DWR ID	DWR_NA0010_05_f_2022_191				
Comment Code					
A3 : No rodents visible, but rodent burrows visible; need to backfill and compact or grout burrows.					
Inspector Comment

View of rodent burrows in the landside slope. (Fall 2022)

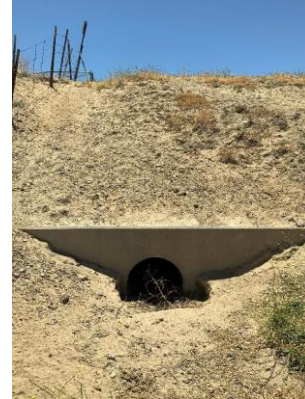
Photo 1 of 3 : UCIP_SP_2024_77922_104463.jpg

Comment Code						
Inspector Comment						
DS_ID:19808 FS_ID:77922 EP_NO: N/A Repair Type: Non-Urgent EVAL Issue: Crossing Status: Found UCIP Comments: 12/20/2022 Record updated from Urgent to Non-Urgent. Pipe has been CIPP lined. LOF of crossing is less or equal to 4. Recommend next video inspection in 5 years. (O.Yakimov - DWR UCIP) 06/23/2021 The record has been upgraded from Non-Urgent to Urgent. LOF of crossing is greater than or equal to 5 and less than 6. Crossing will be monitored until funding becomes available to address issues. No permit was found authorizing this encroachment. CVFPB will need to review crossing to determine owner. The UCIP inspection was completed with GEI staff, P. Espinoza. (H. Dunn – GEI)03/25/2014 Pipe has heavy silt buildup visible from landward side--recommend contacting owner to clear pipe. (W. Wylie - DWR UCIP) FIELD_STRUCT_DESC: 24-inch CIPP-lined corrugated metal gravity drainage pipe (CMP) through the levee, 11.4 feet below the crown. Flap gate on the waterside (WS) end. Concrete headwall on the landside (LS) end. Concrete U-shaped headwall on the WS end. [Additional Reference(s): DWR Levee Log, 2002, (HLM 26.85). USACE San Joaquin O&M Manual, Unit No. 601, Part No. 1, 1967, Amended in 1978, Revised 20 June 1985, (HLM 26.85). DWR As-Built Specification No. 64-01, Sheet No. 9, 6 November 1963, (HLM 26.85)]. FS Date: 6/23/2021 10:41:40 AM

LS view: Slope and headwall from toe.

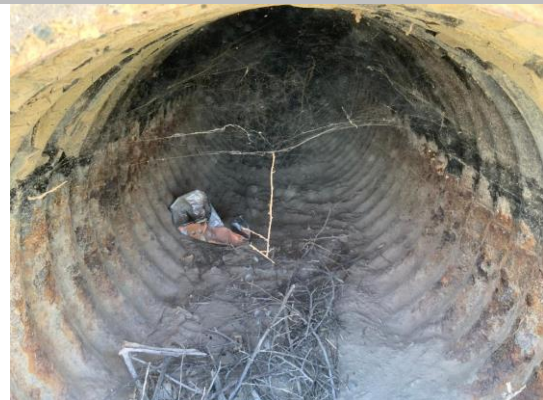
Photo 2 of 3 : UCIP_SP_2024_77922_104464.jpg

LS view: Inside of pipe inlet at toe.

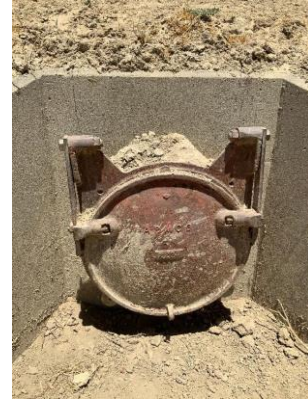
Photo 3 of 3 : UCIP_SP_2024_77922_104466.jpg

WS view: Closeup of flapgate at toe.

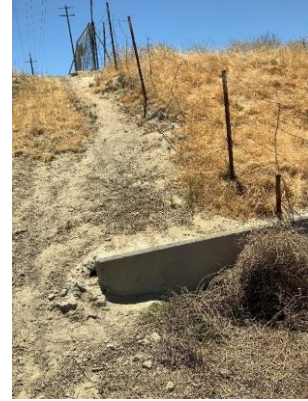
Photo 1 of 2 : UCIP_SP_2024_77902_104361.jpg

Comment Code					
Inspector Comment					
DS_ID:19748 FS_ID:77902 EP_NO: N/A Repair Type: Non-Urgent EVAL Issue: 11, Maintenance Compliance Issue Crossing Status: Found UCIP Comments: 12/20/2022 Record updated from Urgent to Non-Urgent. Pipe has been CIPP-lined. LOF of crossing is less or equal to 4. Recommend next video inspection in 5 years. (O.Yakimov - DWR UCIP) 06/23/2021 Record has been upgraded from Non-Urgent to Urgent. DWR DMP internal inspection has found pipe integrity issues. LOF of crossing is greater than or equal to 5 and less than 6. Crossing will be monitored until funding becomes available to address the issues. Limited inspection of LS inlet due to dirt and tumbleweeds, recommend removal. Unidentified PVC pipe installed at mouth of inlet pipe on LS. No permit was found authorizing this encroachment. CVFPB will need to review crossing to determine owner. The UCIP inspection was completed with GEI staff, H.Dunn. (P.Espinoza – GEI)03/25/2014 Tumble weed buildup at inlet mat create blockage and should be removed. (W. Wylie - DWR UCIP) FIELD_STRUCT_DESC: 24-inch CIPP-lined corrugated metal gravity drainage pipe (CMP) through the levee, 11.3 feet below the crown. Flap gate on the waterside (WS) end. Concrete headwall on the landside (LS) end. Concrete U-shaped headwall on the WS end. [Additional Reference(s): DWR Levee Log, 2002, (HLM 26.87). USACE San Joaquin O&M Manual, Unit No. 601, Part No. 1, 1967, Amended in 1978, Revised 20 June 1985, (HLM 26.87). DWR As-Built Specification No. 64-01, Sheet No. 9, 6 November 1963, (HLM 26.87)]. FS Date: 6/23/2021 9:44:25 AM

LS view from toe: concrete headwall at inlet

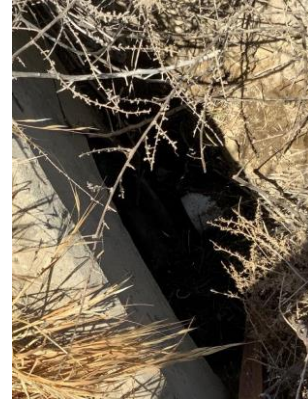
Photo 2 of 2 : UCIP_SP_2024_77902_104362.jpg

LS view from toe: close up of inlet. PVC pipe at entrance.

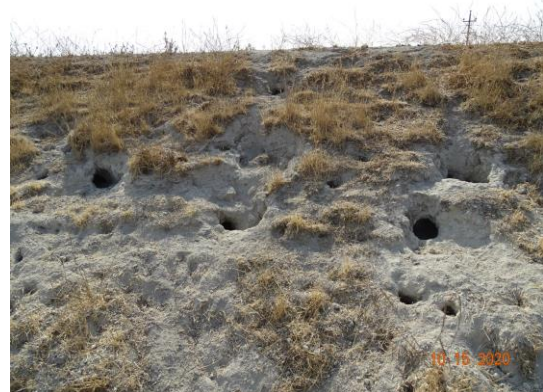
Photo 1 of 1 : SP_2024_NA0010_123_162_20240212_00049.jpg

LM Start	26.99	Rating **	U	Issue No.	162
LM End	27.04	Issue Type +	Ma	Location *	LS
Category	Earthen Levee			GPS Latitude/Longitude	
				Start	End
Item	Animal Control			37.032651°	37.032659°
				-120.473205°	-120.472190°
DWR ID	DWR_NA0010_05_f_2018_162				
Comment Code					
A1 : Exterminate rodents and backfill and compact or grout burrows.					
Inspector Comment					
Several rodent burrows with large quantities of material displaced noted in this section.

Several rodent burrows noted in this section of the levee. (Fall 2020)

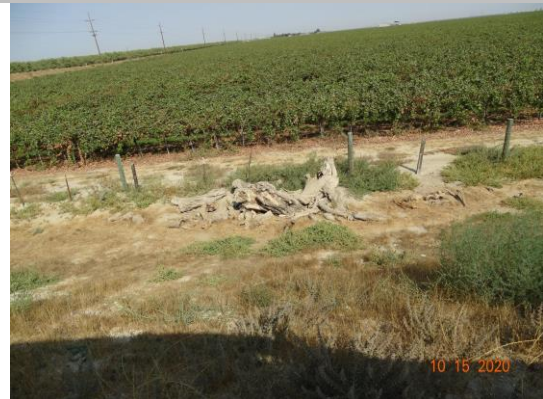
Photo 1 of 1 : SP_2024_NA0010_123_125_20240212_00022.jpg

LM Start	27.01	Rating **	A/W	Issue No.	125
LM End	27.01	Issue Type +	Ma	Location *	LS
Category	Earthen Levee			GPS Latitude/Longitude	
				Start	End
Item	Trim / Thin Trees			37.032675°	37.032675°
				-120.472841°	-120.472841°
DWR ID	DWR_NA0010_05_s_2021_125				
Comment Code					
T2 : Tree or limb.					
Inspector Comment

Prunings left on the landside toe. (Fall 2020)
