**Flood Control Project Maintenance
Levee Inspections**

Maintenance Issue Types Only, Levee Inspection Report By Mile - Spring 2024

Lower San Joaquin Levee District

Waterway	Bank	Unit Miles	Inspection Start/End	Inspector
Unit No. 01 San Joaquin River	Right	22.52	03/12/2024 03/12/2024	Corey Fujitani

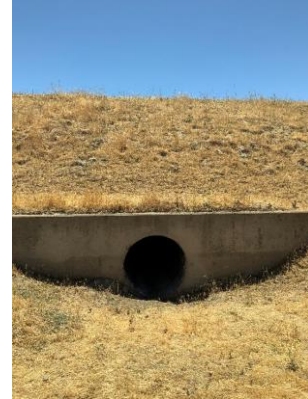
Photo 1 of 3 : UCIP_SP_2024_77903_104356.jpg

Comment Code						
Inspector Comment						
DS_ID:19749 FS_ID:77903 EP_NO: N/A Repair Type: Non-Urgent EVAL Issue: Crossing Status: Found UCIP Comments: 12/20/2022 Record updated from Urgent to Non-Urgent. Pipe has been CIPP-lined. LOF of crossing is less or equal to 4. Recommend next video inspection in 5 years. (O.Yakimov - DWR UCIP) 06/23/2021 The record has been upgraded from No Action Needed to Urgent. DWR DMP internal inspection has found pipe integrity issues. LOF of crossing is greater than or equal to 5 and less than 6. Crossing will be monitored until funding becomes available to address the issues. No permit was found authorizing this encroachment. CVFPB will need to review crossing to determine owner. The UCIP inspection was completed with GEI staff, H.Dunn. (P.Espinoza – GEI) FIELD_STRUCT_DESC: 36-inch CIPP-lined corrugated metal gravity drainage pipe (CMP) through the levee, 12.0 feet below the crown. Flap gate on the waterside (WS) end. Concrete headwall on the landside (LS) end. Concrete U-shaped headwall on the WS end. [Additional Reference(s): DWR Levee Log, 2002, (HLM 27.21). USACE San Joaquin O&M Manual, Unit No. 601, Part No. 1, 1967, Amended in 1978, Revised 20 June 1985, (HLM 27.22). DWR As-Built Specification No. 64-01, Sheet No. 10, 6 November 1963, (HLM 27.22)]. FS Date: 6/23/2021 9:46:35 AM

LS view from toe: concrete headwall at inlet.

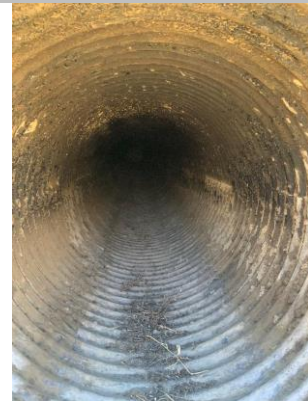
Photo 2 of 3 : UCIP_SP_2024_77903_104357.jpg

LS view from toe: inside of inlet.

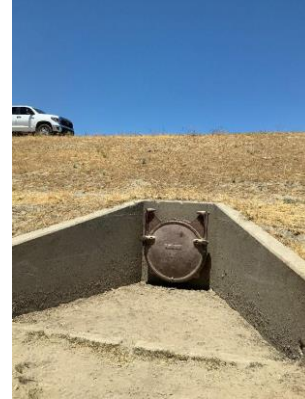
Photo 3 of 3 : UCIP_SP_2024_77903_104355.jpg

WS view from toe: flapgate on concrete headwall at outlet.

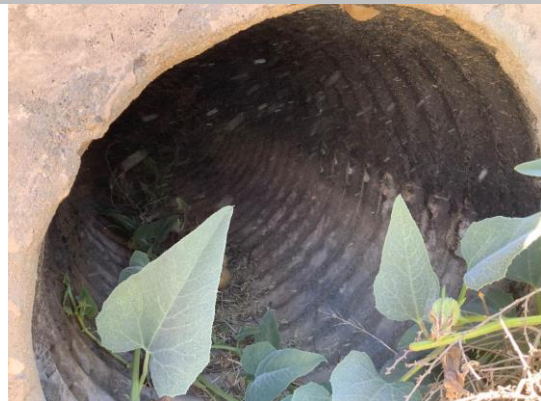
Photo 2 of 2 : UCIP_SP_2024_71073_104351.jpg

LS view from toe: inside of inlet pipe.

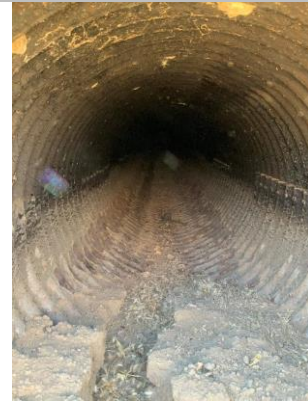
Photo 1 of 3 : UCIP_SP_2024_77904_104322.jpg

Comment Code						
Inspector Comment						
DS_ID:19751 FS_ID:77904 EP_NO: N/A Repair Type: Non-Urgent EVAL Issue: 11, Maintenance Compliance Issue Crossing Status: Found UCIP Comments: 12/20/2022 Record updated from Urgent to Non-Urgent. Pipe has been CIPP-lined. LOF of crossing is less or equal to 4. Recommend next video inspection in 5 years. (O.Yakimov - DWR UCIP) 06/23/2021 The record has been upgraded from No Action Needed to Urgent. DWR DMP internal inspection has found pipe integrity issues. LOF of crossing is between 5 and 6. Crossing will be monitored until funding becomes available to address the issues. Sediment build up in LS pipe inlet; recommend removal. No permit was found authorizing this encroachment. CVFPB will need to review crossing to determine owner. The UCIP inspection was completed with GEI staff, H.Dunn. (P.Espinoza – GEI) FIELD_STRUCT_DESC: 30-inch CIPP-lined corrugated metal gravity drainage pipe (CMP) through the levee, 9.8 feet below the crown. Flap gate on the waterside (WS) end. Concrete headwall on the landside (LS) end. Concrete U-shaped headwall on the WS end. [Additional Reference(s): DWR Levee Log, 2002, (HLM 28.69). USACE San Joaquin O&M Manual, Unit No. 601, Part No. 1, 1967, Amended in 1978, Revised 20 June 1985, (HLM 28.69). DWR As-Built Specification No. 64-01, Sheet No. 11, 6 November 1963, (HLM 28.69)]. FS Date: 6/23/2021 9:47:13 AM

LS view: inside of pipe.

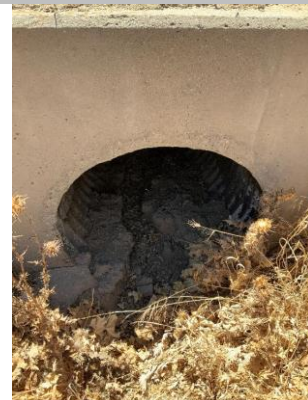
Photo 2 of 3 : UCIP_SP_2024_77904_104323.jpg

LS view from toe: closeup of entrance to pipe.

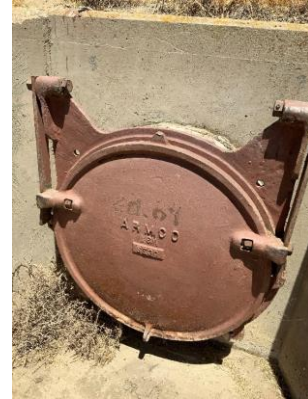
Photo 3 of 3 : UCIP_SP_2024_77904_104325.jpg

WS view from toe: closeup of flapgate.

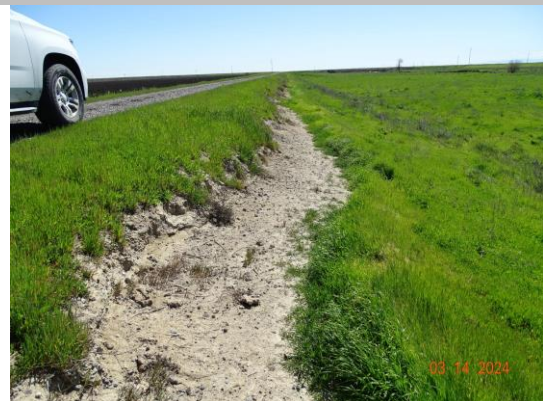
Photo 1 of 1 : SP_2024_NA0010_123_164_20240326_00296.jpg

LM Start	29.43	Rating **	M	Issue No.	164
LM End	29.56	Issue Type +	Ma	Location *	WS
Category	Earthen Levee			GPS Latitude/Longitude	
				Start	End
Item	Erosion / Livestock			37.023481°	37.021794°
				-120.435960°	-120.434769°
DWR ID	DWR_NA0010_05_f_2018_164				
Comment Code					
E4 : Repair the levee slope damaged by livestock and prevent large animal access.					
Inspector Comment					
There is slope damage on waterside from livestock traffic.

Looking upstream along the waterside slope.

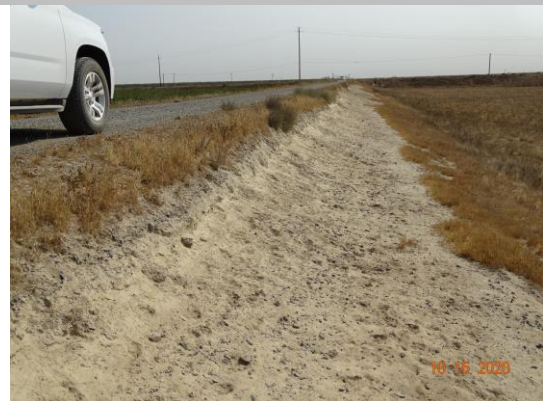
Photo 1 of 1 : SP_2024_NA0010_123_171_20240212_00056.jpg

LM Start	29.58	Rating **	U	Issue No.	171
LM End	29.80	Issue Type +	Ma	Location *	WS
Category	Earthen Levee			GPS Latitude/Longitude	
				Start	End
Item	Erosion / Livestock			37.021534°	37.018712°
				-120.434592°	-120.432682°
DWR ID	DWR_NA0010_05_s_2014_171				
Comment Code					
E4 : Repair the levee slope damaged by livestock and prevent large animal access.					
Inspector Comment					
There is waterside erosion caused by livestock.

Looking south at livestock erosion on the waterside slope. (Fall 2020)

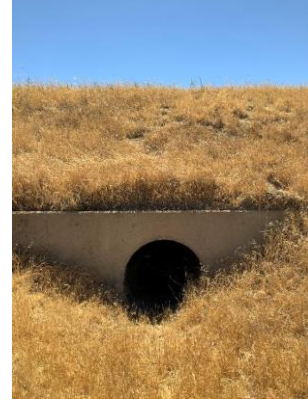
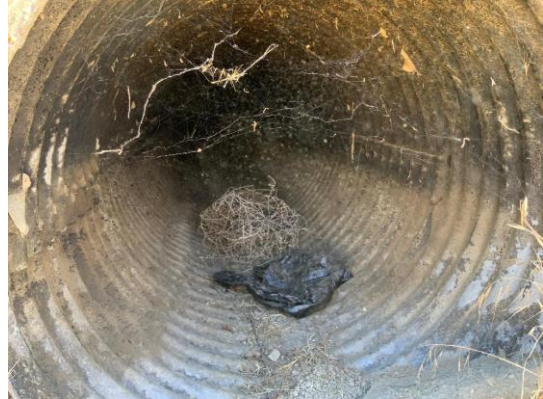
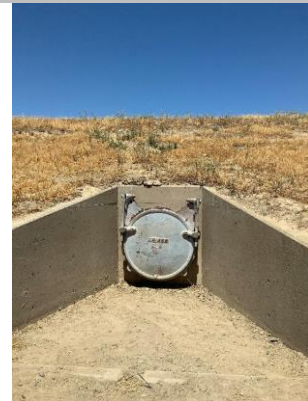
Comment Code					
Inspector Comment					
DS_ID:19753 FS_ID:71076 EP_NO: N/A Repair Type: No Action Needed EVAL Issue: Crossing Status: Found UCIP Comments: 09/18/2023 Record updated from Non-Urgent to No Action Needed. Pipe was CIPP lined. DMP internal video inspection has found none or minor pipe defects. Recommend next video inspection in 5 years. (O. Yakimov - DWR UCIP) 06/23/2021 The record remains Non-Urgent. DWR DMP internal inspection has found pipe integrity issues. LOF of crossing is between 4.1 and 5. Crossing will be monitored until funding becomes available for rehabilitation. No permit was found authorizing this encroachment. CVFPB will need to review crossing to determine owner. The UCIP inspection was completed with GEI staff, H.Dunn. (P.Espinoza – GEI) 03/27/2014 Dense vegetation limits the inspector's visibility to identify signs of pipe failure (leaks) along the landward slope. Recommend removing vegetation along pipe alignment to conduct proper inspection of structure. Sediment buildup in pipe visible from landward side--recommend contacting owner to clear pipe. (W. Wylie - DWR UCIP) FIELD_STRUCT_DESC: 36-inch CIPP-lined corrugated metal gravity drainage pipe (CMP) through the levee, 10.2 feet below the crown. Flap gate on the waterside (WS) end. Concrete headwall on the landside (LS) end. Concrete U-shaped headwall on the WS end. [Additional Reference(s): DWR Levee Log, 2002, (HLM 29.49). USACE San Joaquin O&M Manual, Unit No. 601, Part No. 1, 1967, Amended in 1978, Revised 20 June 1985, (HLM 29.49). DWR As-Built Specification No. 64-01, Sheet No. 12, 6 November 1963, (HLM 29.49)]. FS Date: 6/23/2021

LS view from toe: concrete headwall at inlet.

LS view from toe: inside of inlet pipe.

WS view from toe: flapgate on concrete headwall at outlet.

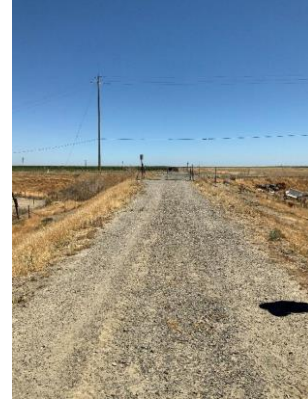
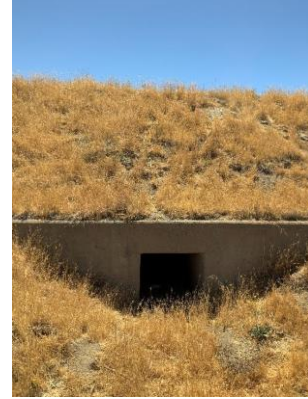
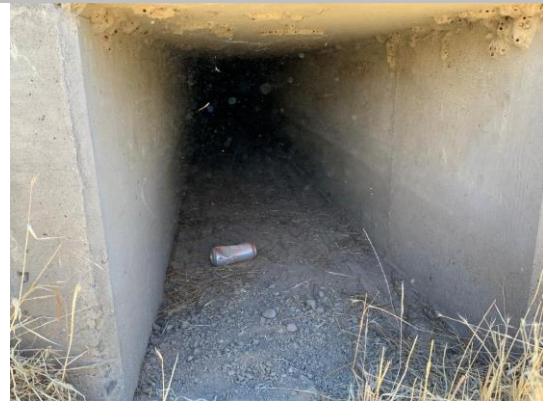
Comment Code					
Inspector Comment					
DS_ID:19754 FS_ID:77865 EP_NO: N/A Repair Type: Urgent EVAL Issue: 1, Pipe Integrity Crossing Status: Found UCIP Comments: 12/14/2022 Record updated from Non-Urgent to Urgent. DMP internal video inspection has found pipe integrity issues. LOF of crossing is between 5 and 6. Crossing will be monitored until funding becomes available to address the issues. (O.Yakimov - DWR UCIP) 06/23/2021 The record remains Non-Urgent. Crossing appears to be in good condition. No permit was found authorizing this encroachment. CVFPB will need to review crossing to determine owner. The UCIP inspection was completed with GEI staff, H.Dunn. (P.Espinoza – GEI) 03/27/2014 Dense vegetation limits the inspector's visibility to identify signs of pipe failure (leaks) along the landward slope. Recommend removing vegetation along pipe alignment to conduct proper inspection of structure. (W. Wylie - DWR UCIP) FIELD_STRUCT_DESC: 30-inch by 30-inch reinforced concrete box gravity drainage culvert (RCBC) through the levee, 12.0 feet below the crown. Flap gate on the waterside (WS) end. Concrete headwall on the landside (LS) end. Concrete U-shaped headwall on the WS end. [Additional Reference(s): DWR Levee Log, 2002, (HLM 29.72). USACE San Joaquin O&M Manual, Unit No. 601, Part No. 1, 1967, Amended in 1978, Revised 20 June 1985, (HLM 29.72). DWR As-Built Specification No. 64-42, Sheet No. 6, 13 August 1964, (HLM 29.72)]. FS Date: 6/23/2021 1:52:38 PM

View from levee crown.

LS view from toe: concrete headwall at inlet.

LS view from toe: inside of inlet.

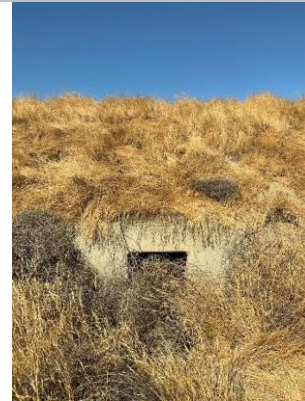
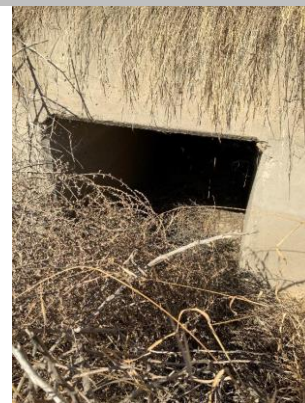
Comment Code						
Inspector Comment						
DS_ID:19696 FS_ID:71078 EP_NO: N/A Repair Type: Non-Urgent EVAL Issue: 11, Maintenance Compliance Issue Crossing Status: Found UCIP Comments: 06/24/2021 The record remains Non-Urgent. Limited inspection of LS due to dense vegetation; recommend removal. No permit was found authorizing this encroachment. CVFPB will need to review crossing to determine owner. The UCIP inspection was completed with GEI staff, H.Dunn. (P.Espinoza – GEI) 03/27/2014 Dense vegetation limits the inspector's visibility to identify signs of pipe failure (leaks) along the landward slope. Recommend removing vegetation along pipe alignment to conduct proper inspection of structure. (W. Wylie - DWR UCIP) FIELD_STRUCT_DESC: 30-inch by 30-inch reinforced concrete box gravity drainage culvert (RCBC) through the levee, 13.1 feet below the crown. Flap gate on the waterside (WS) end. Concrete headwall on the landside (LS) end. Concrete U-shaped headwall on the WS end. [Additional Reference(s): DWR Levee Log, 2002, (HLM 30.04). USACE San Joaquin O&M Manual, Unit No. 601, Part No. 1, 1967, Amended in 1978, Revised 20 June 1985, (HLM 30.04). DWR As-Built Specification No. 64-42, Sheet No. 6, 13 August 1964, (HLM 30.04)]. FS Date: 6/24/2021

LS view from toe: concrete headwall at inlet.

LS view from toe: closeup of inlet.

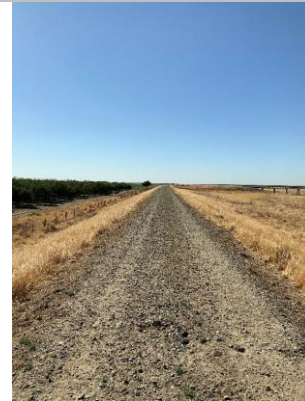
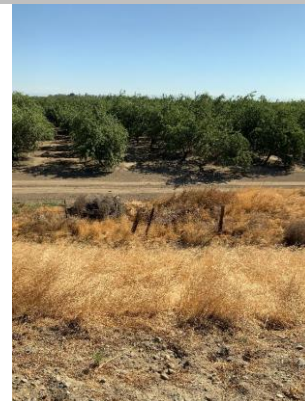
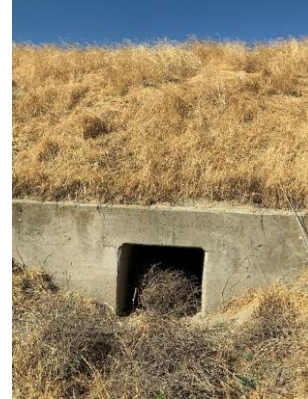
Comment Code						
Inspector Comment						
DS_ID:19697						
FS_ID:71079						
EP_NO: N/A						
Repair Type: Non-Urgent						
EVAL Issue:						
Crossing Status: Found						
UCIP Comments: 06/24/2021 The record remains Non-Urgent.						
Crossing appears to be in good condition. No permit was found authorizing this encroachment. CVFPB will need to review crossing to determine owner. The UCIP inspection was completed with GEI staff, H.Dunn. (P.Espinoza – GEI) 03/27/2014 Some debris buildup at LS toe. Dense vegetation limits the inspector's visibility to identify signs of pipe failure (leaks) along the landward slope. Recommend removing vegetation along pipe alignment to conduct proper inspection of structure. (W. Wylie - DWR UCIP)						
FIELD_STRUCT_DESC: 30-inch by 30-inch reinforced concrete box gravity drainage culvert (RCBC) through the levee, 13.3 feet below the crown. Flap gate on the waterside (WS) end. Concrete headwall on the landside (LS) end. Concrete U-shaped headwall on the WS end.

Levee crown.

LS view from crown.

LS view from toe: concrete headwall at inlet.

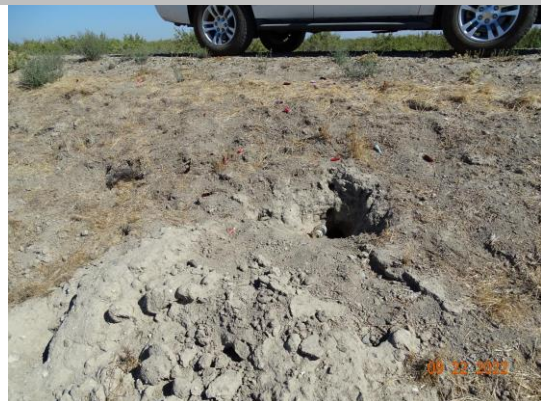
Photo 1 of 1 : SP_2024_NA0010_123_193_20240212_00071.jpg

LM Start	31.17	Rating **	M	Issue No.	193
LM End	31.17	Issue Type +	Ma	Location *	WS
Category	Earthen Levee			GPS Latitude/Longitude	
				Start	End
Item	Animal Control			37.003104°	37.003104°
				-120.417833°	-120.417833°
DWR ID	DWR_NA0010_05_f_2022_193				
Comment Code					
A3 : No rodents visible, but rodent burrows visible; need to backfill and compact or grout burrows.					
Inspector Comment

View of animal burrow in the waterside slope. (Fall 2022)

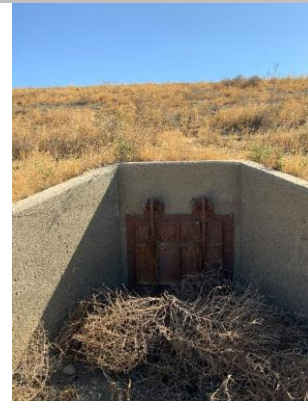
Comment Code						
Inspector Comment						
DS_ID:19698 FS_ID:71080 EP_NO: N/A Repair Type: Non-Urgent EVAL Issue: 11, Maintenance Compliance Issue Crossing Status: Found UCIP Comments: 06/24/2021 The record remains Non-Urgent. Some tumbleweed buildup over WS flapgate and LS inlet, recommend removal. No permit was found authorizing this encroachment. CVFPB will need to review crossing to determine owner. The UCIP inspection was completed with GEI staff, H.Dunn. (P.Espinoza – GEI)						
03/27/2014 Excess vegetation buildup at inlet on LS toe. Dense vegetation limits the inspector's visibility to identify signs of pipe failure (leaks) along the landward slope. Recommend removing vegetation along pipe alignment to conduct proper inspection of structure. (W. Wylie - DWR UCIP)						
FIELD_STRUCT_DESC: 30-inch by 30-inch reinforced concrete box gravity drainage culvert (RCBC) through the levee, 13.4 feet below the crown. Flap gate on the waterside (WS) end. Concrete headwall on the landside (LS) end. Concrete U-shaped headwall on the WS end. [Additional Reference(s): DWR Levee Log, 2002, (HLM 31.20). USACE San Joaquin O&M Manual, Unit No. 601, Part No. 1, 1967, Amended in 1978, Revised 20 June 1985, (HLM 31.19). DWR As-Built Specification No. 64-42, Sheet No. 7, 13 August 1964, (HLM 31.19)]. FS Date: 6/24/2021 2:32:00 PM

LS view from toe: concrete headwall at inlet.

WS view from toe: flapgate on concrete headwall at outlet.

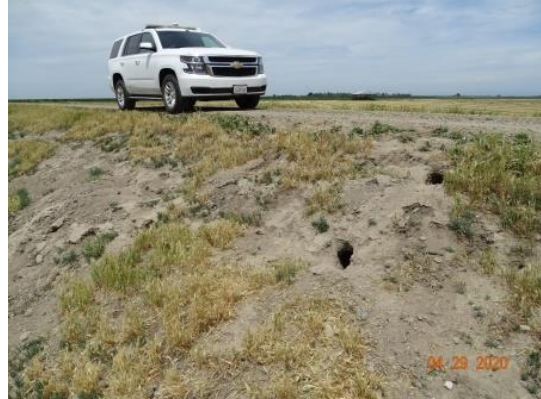
Photo 1 of 1 : SP_2024_NA0010_123_230_20240212_00074.jpg

LM Start	31.66	Rating **	U	Issue No.	230
LM End	31.66	Issue Type +	Ma	Location *	WS
Category	Earthen Levee			GPS Latitude/Longitude	
				Start	End
Item	Animal Control			36.997828°	36.997828°
				-120.411920°	-120.411920°
DWR ID	DWR_NA0010_05_s_2020_230				
Comment Code					
A3 : No rodents visible, but rodent burrows visible; need to backfill and compact or grout burrows.					
Inspector Comment					
Several rodent burrows in the waterside slope and shoulder.

Rodent burrows in the waterside slope. (Spring 2020)

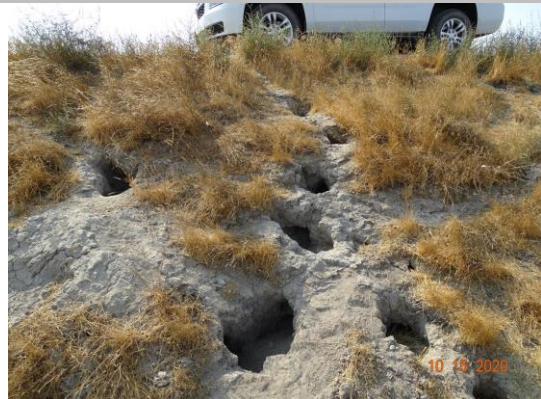
Photo 1 of 1 : SP_2024_NA0010_123_129_20240212_00025.jpg

LM Start	31.70	Rating **	U	Issue No.	129
LM End	31.73	Issue Type +	Ma	Location *	LS
Category	Earthen Levee			GPS Latitude/Longitude	
				Start	End
Item	Animal Control			36.997410°	36.997108°
				-120.411437°	-120.411092°
DWR ID	DWR_NA0010_05_f_2020_129				
Comment Code					
A3 : No rodents visible, but rodent burrows visible; need to backfill and compact or grout burrows.					
Inspector Comment

Several large rodent holes noted at this location. (Fall 2020)

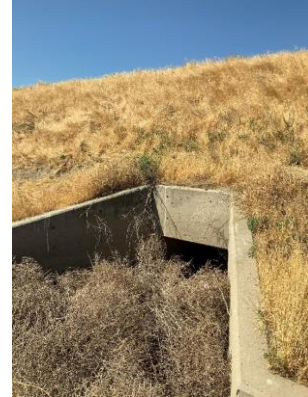
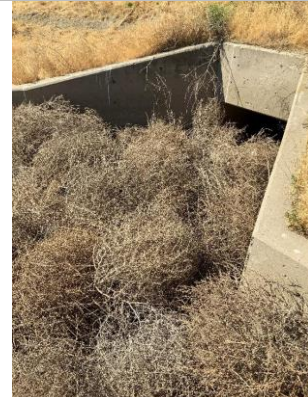
Comment Code						
Inspector Comment						
DS_ID:19699 FS_ID:71081 EP_NO: N/A Repair Type: Non-Urgent EVAL Issue: 11, Maintenance Compliance Issue Crossing Status: Found UCIP Comments: 06/24/2021 The record has been upgraded from No Action Needed to Non-Urgent. Limited inspection of LS due to dense vegetation; recommend removal. Wooden planks propping flapgate on WS open; recommend removal before flood season. No permit was found authorizing this encroachment. CVFPB will need to review crossing to determine owner. The UCIP inspection was completed with GEI staff, H.Dunn. (P.Espinoza – GEI) FIELD_STRUCT_DESC: 48-inch by 36-inch reinforced concrete box gravity drainage culvert (RCBC) through the levee, 14.5 feet below the crown. Flap gate on the waterside (WS) end. Concrete U-shaped headwall on each end. [Additional Reference(s): DWR Levee Log, 2002, (HLM 31.64). USACE San Joaquin O&M Manual, Unit No. 601, Part No. 1, 1967, Amended in 1978, Revised 20 June 1985, (HLM 31.64). DWR As-Built Specification No. 64-42, Sheet No. 8, 13 August 1964, (HLM 31.64)]. FS Date: 6/24/2021 2:15:00 PM

LS view from toe: concrete headwall at inlet.

LS view from toe: closeup of inlet.

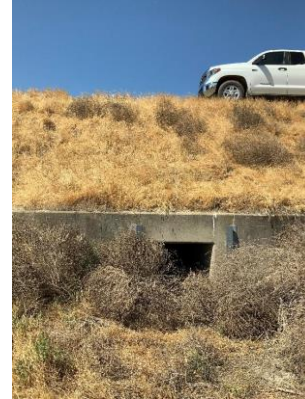
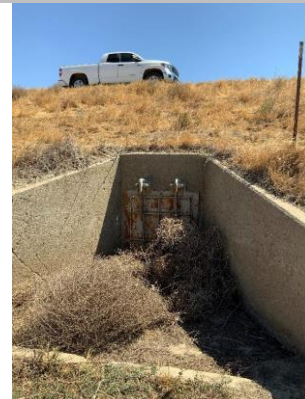
Comment Code						
Inspector Comment						
DS_ID:19700 FS_ID:71082 EP_NO: N/A Repair Type: Non-Urgent EVAL Issue: 11, Maintenance Compliance Issue Crossing Status: Found UCIP Comments: 06/23/2021 The record remains Non-Urgent. Some tumbleweed buildup at LS inlet and WS flapgate, recommend removal. No permit was found authorizing this encroachment. CVFPB will need to review crossing to determine owner. The UCIP inspection was completed with GEI staff, H.Dunn. (P.Espinoza – GEI) 04/01/2014 Dense vegetation limits the inspector's visibility to identify signs of pipe failure (leaks) along the landward slope. Recommend removing vegetation along pipe alignment to conduct proper inspection of structure. (W. Wylie - DWR UCIP) FIELD_STRUCT_DESC: 30-inch by 30-inch reinforced concrete box gravity drainage culvert (RCBC) through the levee, 13.0 feet below the crown. Flap gate on the waterside (WS) end. Concrete headwall on the landside (LS) end with flashboard attachment. Concrete U-shaped headwall on the WS end. [Additional Reference(s): DWR Levee Log, 2002, (HLM 31.69). USACE San Joaquin O&M Manual, Unit No. 601, Part No. 1, 1967, Amended in 1978, Revised 20 June 1985, (HLM 31.71). DWR As-Built Specification No. 64-42, Sheet No. 8, 13 August 1964, (HLM 31.71)]. FS Date: 6/23/2021 2:03:00 PM

LS view from toe: concrete headwall and inlet.

WS view from toe: flapgate on concrete headwall at outlet.

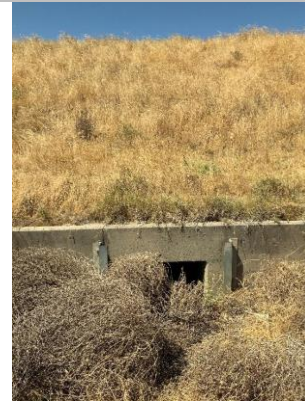
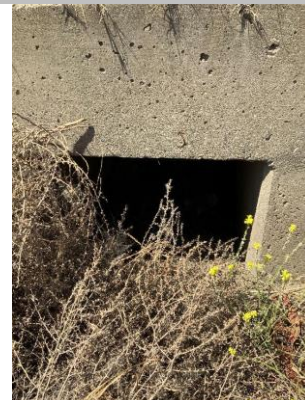
Comment Code						
Inspector Comment						
DS_ID:19701 FS_ID:71083 EP_NO: N/A Repair Type: Non-Urgent EVAL Issue: 11, Maintenance Compliance Issue Crossing Status: Found UCIP Comments: 06/23/2021 The record remains Non-Urgent. Limited inspection of LS inlet due to dense vegetation; recommend removal. No permit was found authorizing this encroachment. CVFPB will need to review crossing to determine owner. The UCIP inspection was completed with GEI staff, H.Dunn. (P.Espinoza – GEI) 04/01/2014 Some silt buildup inside culvert. (W. Wylie - DWR UCIP) FIELD_STRUCT_DESC: 30-inch by 30-inch reinforced concrete box gravity drainage culvert (RCBC) through the levee, 14.2 feet below the crown. Flap gate on the waterside (WS) end. Concrete headwall on the landside (LS) end with flashboard attachment. Concrete U-shaped headwall on the WS end. [Additional Reference(s): DWR Levee Log, 2002, (HLM 32.22). USACE San Joaquin O&M Manual, Unit No. 601, Part No. 1, 1967, Amended in 1978, Revised 20 June 1985, (HLM 32.22). DWR As-Built Specification No. 64-42, Sheet No. 8, 13 August 1964, (HLM 32.22)]. FS Date: 6/23/2021 1:18:00 PM

LS view from toe: concrete headwall at inlet.

LS view from toe: closeup of inlet.

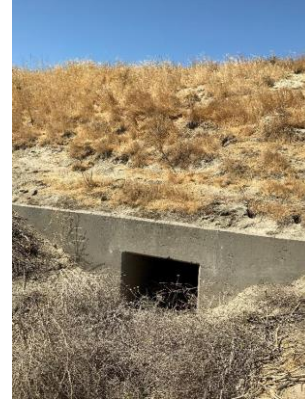
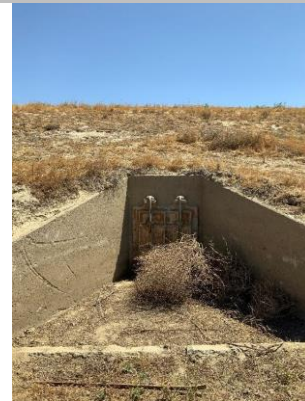
Comment Code						
Inspector Comment						
DS_ID:19702 FS_ID:71084 EP_NO: N/A Repair Type: Non-Urgent EVAL Issue: 11, Maintenance Compliance Issue Crossing Status: Found UCIP Comments: 06/23/2021 The record remains Non-Urgent. Some tumbleweed buildup over WS flapgate and LS inlet, recommend removal. No permit was found authorizing this encroachment. CVFPB will need to review crossing to determine owner. The UCIP inspection was completed with GEI staff, H.Dunn. (P.Espinoza – GEI)						
04/01/2014 Dense vegetation limits the inspector's visibility to identify signs of pipe failure (leaks) along the landward slope. Recommend removing vegetation along pipe alignment to conduct proper inspection of structure. Debris buildup blocking landward headwall--recommend contacting owner to clear debris. (W. Wylie - DWR UCIP) FIELD_STRUCT_DESC: 30-inch by 30-inch reinforced concrete box gravity drainage culvert (RCBC) through the levee, 12.2 feet below the crown. Flap gate on the waterside (WS) end. Concrete headwall on the landside (LS) end. Concrete U-shaped headwall on the WS end. [Additional Reference(s): DWR Levee Log, 2002, (HLM 33.02). USACE San Joaquin O&M Manual, Unit No. 601, Part No. 1, 1967, Amended in 1978, Revised 20 June 1985, (HLM 33.01). DWR As-Built Specification No. 64-42, Sheet No. 9, 13 August 1964, (HLM 33.01)]. FS Date: 6/23/2021 12:49:00 PM

LS view from toe: concrete headwall at inlet.

WS view from toe: flapgate on concrete headwall at outlet.

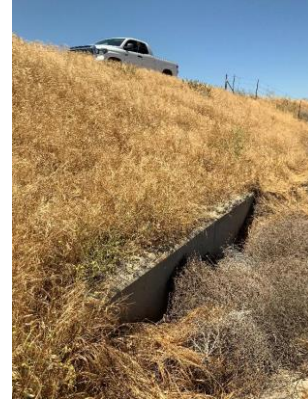
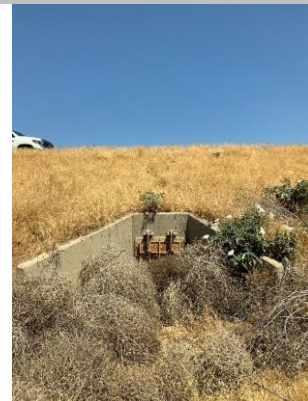
Comment Code						
Inspector Comment						
DS_ID:19703						
FS_ID:71085						
EP_NO: N/A						
Repair Type: Non-Urgent						
EVAL Issue: 11, Maintenance Compliance Issue						
Crossing Status: Found						
UCIP Comments: 06/24/2021 The record remains Non-Urgent. Limited inspection of LS and WS due to dense vegetation; recommend removal. No permit was found authorizing this encroachment. CVFPB will need to review crossing to determine owner. The UCIP inspection was completed with GEI staff, H.Dunn. (P.Espinoza – GEI) 04/01/2014 Dense vegetation limits the inspector's visibility to identify signs of pipe failure (leaks) along the slopes. Recommend removing vegetation along pipe alignment to conduct proper inspection of structure. (W. Wylie - DWR UCIP)						
FIELD_STRUCT_DESC: 30-inch by 30-inch reinforced concrete box gravity drainage culvert (RCBC) through the levee, 13.9 feet below the crown. Flap gate on the waterside (WS) end. Concrete headwall on the landside (LS) end. Concrete U-shaped headwall on the WS end. [Additional Reference(s): DWR Levee Log, 2002, (HLM 33.72). USACE San Joaquin O&M Manual, Unit No. 601, Part No. 1, 1967, Amended in 1978, Revised 20 June 1985, (HLM 33.72). DWR As-Built Specification No. 64-42, Sheet No. 9, 13 August 1964, (HLM 33.72)].

LS view from toe: concrete headwall and inlet.

WS view from toe: flapgate on concrete headwall.

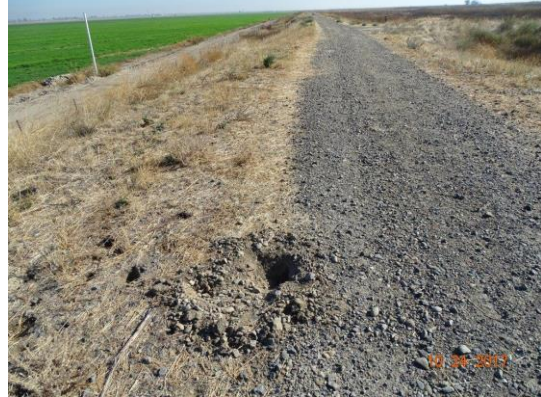
Photo 1 of 1 : SP_2024_NA0010_123_130_20240212_00026.jpg

LM Start	33.82	Rating **	M	Issue No.	130
LM End	33.82	Issue Type +	Ma	Location *	LS
Category	Earthen Levee			GPS Latitude/Longitude	
				Start	End
Item	Animal Control			36.976849°	36.976849°
				-120.382393°	-120.382393°
DWR ID	DWR_NA0010_05_f_2017_130				
Comment Code					
A3 : No rodents visible, but rodent burrows visible; need to backfill and compact or grout burrows.					
Inspector Comment

Looking east at the landside shoulder.

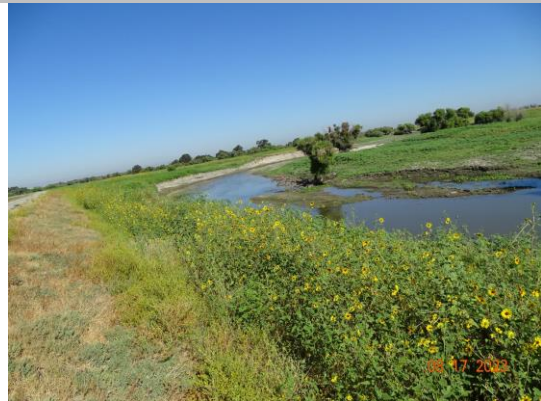
Photo 1 of 2 : SP_2024_NA0010_124_2_20240212_00003.jpg

LM Start	0.10	Rating **	U	Issue No.	2
LM End	0.14	Issue Type +	Ma	Location *	WS
Category	Supplemental			GPS Latitude/Longitude	
				Start	End
Item	DWR Erosion Survey			37.275701°	37.275701°
				-120.823773°	-120.823773°
DWR ID	NA0010U06RM0.41				
Comment Code					
Inspector Comment					
Site ID: NA0010U06RM0.41					
8/17/2023: From 2022 to present, no significant changes were observed during the annual survey.					
08/09/2022: The site was discovered by the LMA and visited during the annual field survey. There is a 20-ft vertical scarp running along the bank and encroaching into the extended levee prism. The berm is 10-12 ft wide.

8/17/2023: View of the erosion looking downstream.

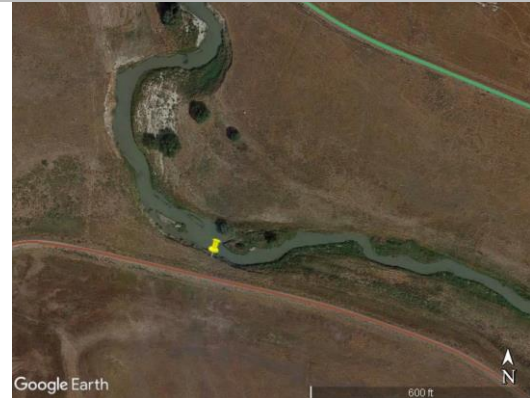
Photo 2 of 2 : SP_2024_NA0010_124_2_20240212_00004.jpg

9/13/2022: Aerial view of the erosion site (Google Earth Imagery from 9/27/2020).

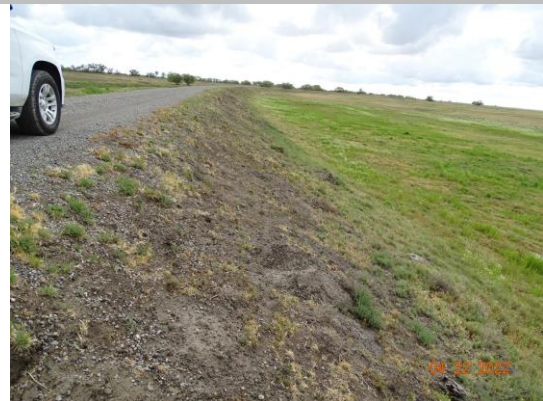
Photo 1 of 1 : SP_2024_NA0010_124_147_20240212_00065.jpg

LM Start	0.14	Rating **	M	Issue No.	147
LM End	0.14	Issue Type +	Ma	Location *	LS
Category	Earthen Levee			GPS Latitude/Longitude	
				Start	End
Item	Animal Control			37.275637°	37.275637°
				-120.823438°	-120.823438°
DWR ID	DWR_NA0010_06_s_2022_147				
Comment Code					
A3 : No rodents visible, but rodent burrows visible; need to backfill and compact or grout burrows.					
Inspector Comment

View of rodent burrows on the landside slope. (Spring 2022)

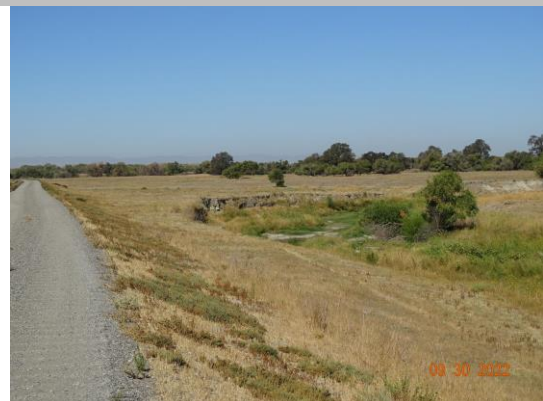
Photo 1 of 1 : SP_2024_NA0010_124_106_20240212_00033.jpg

LM Start	0.14	Rating **	A/W	Issue No.	106
LM End	0.17	Issue Type +	Ma	Location *	WS
Category	Earthen Levee			GPS Latitude/Longitude	
				Start	End
Item	Erosion / Bank Caving			37.275640°	37.275541°
				-120.823419°	-120.822833°
DWR ID	DWR_NA0010_06_f_ 2022_106				
Comment Code					
E2 : Schedule repair of erosion site prior to the next inspection.					
Inspector Comment					
Erosion is approximately 10 feet from toe. It is within the theoretical prism. Erosion is approximately 20 feet in height and 250 feet in length.

Erosion on the waterside toe has cut into the theoretical prism. (Fall 2022)

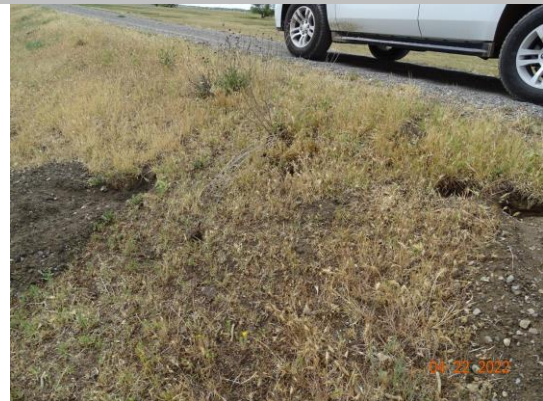
Photo 1 of 1 : SP_2024_NA0010_124_148_20240212_00066.jpg

LM Start	0.43	Rating **	M	Issue No.	148
LM End	0.43	Issue Type +	Ma	Location *	WS
Category	Earthen Levee			GPS Latitude/Longitude	
				Start	End
Item	Animal Control			37.273651°	37.273651°
				-120.818813°	-120.818813°
DWR ID	DWR_NA0010_06_s_2022_148				
Comment Code					
A1 : Exterminate rodents and backfill and compact or grout burrows.					
Inspector Comment

View of active rodent burrows on waterside slope. (Spring 2022)

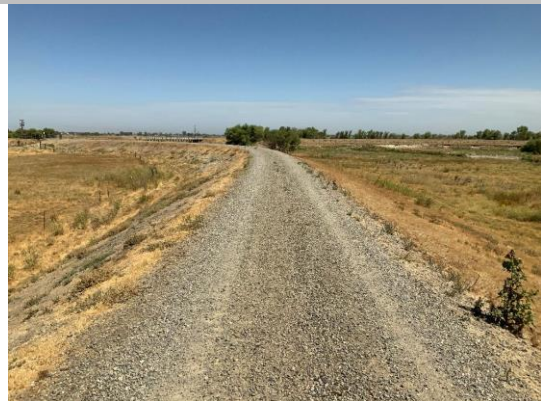
Photo 1 of 3 : UCIP_SP_2024_71092_102876.jpg

Comment Code						
Inspector Comment						
DS_ID:19816						
FS_ID:71092						
EP_NO: N/A						
Repair Type: Non-Urgent						
EVAL Issue:						
Crossing Status: Found						
UCIP Comments: 07/27/2021 The record remains Non-Urgent. LS pipe inlet is blocked by barbed wire, limited access and inspection. No permit was found authorizing this encroachment. CVFPB will need to review crossing to determine owner. The UCIP inspection was completed with GEI staff, P. Espinoza. (H. Dunn – GEI) 04/18/2014 Landward side blocked--need to contact owner to determine status of crossing. (O. Magana - DWR UCIP)						
FIELD_STRUCT_DESC: 24-inch corrugated metal gravity drainage pipe (CMP) through the levee, 16.2 feet below the crown. Flap gate on the waterside (WS) end. Concrete U-shaped headwall on each end.						
[Additional Reference(s): DWR Levee Log, 2002, (HLM 0.86). USACE San Joaquin O&M Manual, Unit No. 601, Part No. 1, 1967, Amended in 1978, Revised 20 June 1985, (HLM 0.86). DWR As-Built Specification No. 61-01, Sheet No. 45, 7 March 1961, (HLM 0.86)].

Levee crown.

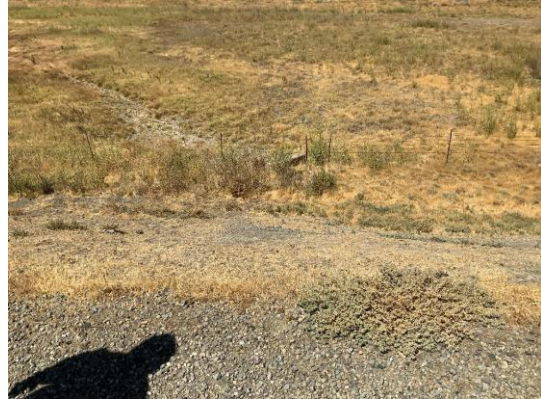
Photo 2 of 3 : UCIP_SP_2024_71092_102877.jpg

LS view: Toe from crown.

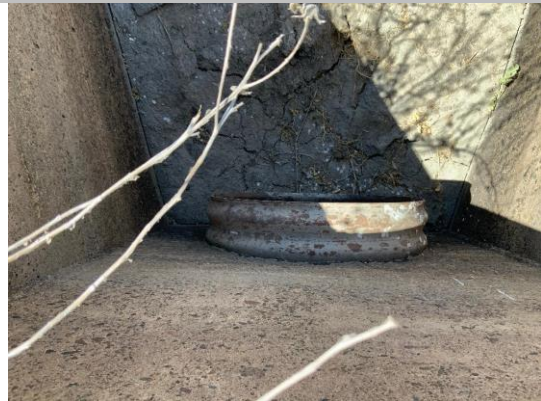
Photo 3 of 3 : UCIP_SP_2024_71092_102879.jpg

LS view: Top view of pipe inlet at toe.

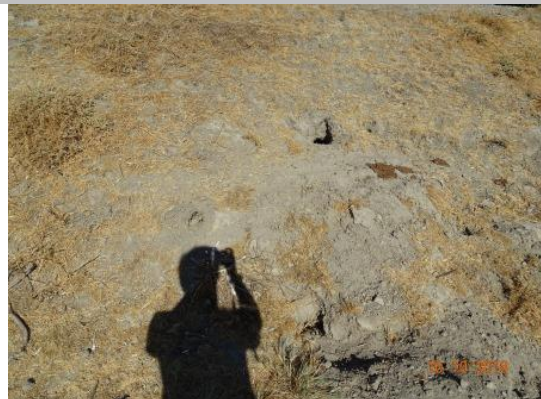
Photo 1 of 1 : SP_2024_NA0010_124_93_20240212_00028.jpg

LM Start	1.18	Rating **	A/W	Issue No.	93
LM End	1.18	Issue Type +	Ma	Location *	LS
Category	Earthen Levee			GPS Latitude/Longitude	
				Start	End
Item	Animal Control			37.267101°	37.267101°
				-120.809603°	-120.809603°
DWR ID	DWR_NA0010_06_f_2018_93				
Comment Code					
A1 : Exterminate rodents and backfill and compact or grout burrows.					
Inspector Comment					
Several rodent burrows including large burrows were observed at this location.

View of landside slope. (Fall 2018)

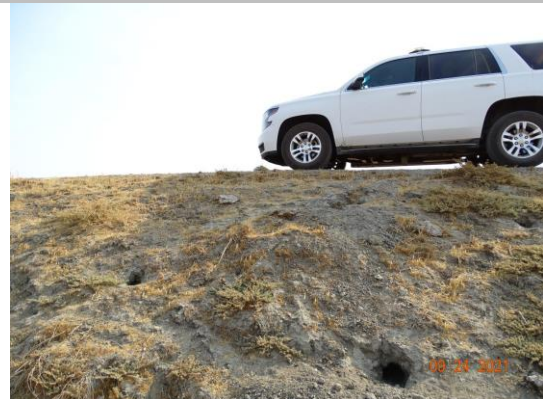
Photo 1 of 1 : SP_2024_NA0010_124_127_20240212_00047.jpg

LM Start	1.52	Rating **	M	Issue No.	127
LM End	1.52	Issue Type +	Ma	Location *	LS
Category	Earthen Levee			GPS Latitude/Longitude	
				Start	End
Item	Animal Control			37.263176°	37.263176°
				-120.805983°	-120.805983°
DWR ID	DWR_NA0010_06_f_2021_127				
Comment Code					
A3 : No rodents visible, but rodent burrows visible; need to backfill and compact or grout burrows.					
Inspector Comment

View of rodent burrows in the landside slope. (Fall 2021)

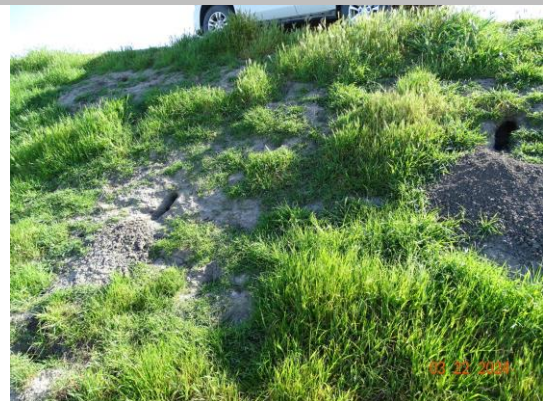
Photo 1 of 1 : SP_2024_NA0010_124_58_20240326_00151.jpg

LM Start	1.60	Rating **	M	Issue No.	58
LM End	1.60	Issue Type +	Ma	Location *	LS
Category	Earthen Levee			GPS Latitude/Longitude	
				Start	End
Item	Animal Control			37.261952°	37.261952°
				-120.805894°	-120.805894°
DWR ID	DWR_NA0010_06_s_2024_58				
Comment Code					
A3 : No rodents visible, but rodent burrows visible; need to backfill and compact or grout burrows.					
Inspector Comment

View of multiple rodent burrows on the landside slope. (Spring 2024)

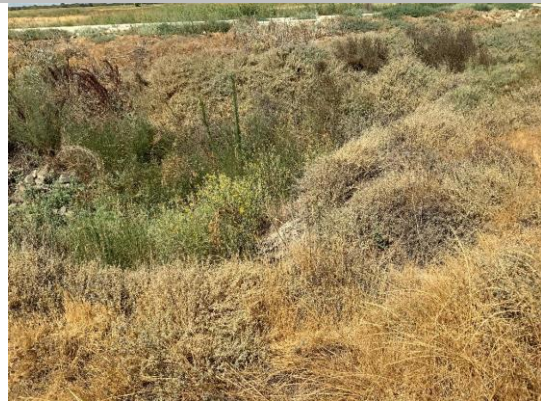
Photo 1 of 1 : UCIP_SP_2024_81166_102904.jpg

Comment Code					
Inspector Comment					
DS_ID:19817 FS_ID:81166 EP_NO: N/A Repair Type: Non-Urgent EVAL Issue: 11, Maintenance Compliance Issue Crossing Status: Found UCIP Comments: 09/25/2023 DMP internal video inspection has found none or minor pipe defects. Recommend next video inspection in 5 years. (J. Taylor - DWR UCIP)07/27/2021 The record remains Non-Urgent. LS pipe inlet inaccessible due to barbed wire and not visible due to dense vegetation, limited inspection and recommend removing vegetation. No permit was found authorizing this encroachment. CVFPB will need to review crossing to determine owner. The UCIP inspection was completed with GEI staff, P. Espinoza. (H. Dunn – GEI) 04/18/2014 No access was available to landward side due to fence. Recommend removing some of the vegetation on waterward toe. (O. Magana - DWR UCIP) FIELD_STRUCT_DESC: 24-inch corrugated metal gravity drainage pipe (CMP) through the levee, 13.5 feet below the crown. Flap gate on the waterside (WS) end. Concrete headwall on each end. [Additional Reference(s): DWR Levee Log, 2002, (HLM 1.96). USACE San Joaquin O&M Manual, Unit No. 601, Part No. 1, 1967, Amended in 1978, Revised 20 June 1985, (HLM 1.95). DWR As-Built Specification No. 61-01, Sheet No. 46, 7 March 1961, (HLM 1.95)]. FS Date: 7/27/2021

LS view: Inlet hidden by dense vegetation at toe.

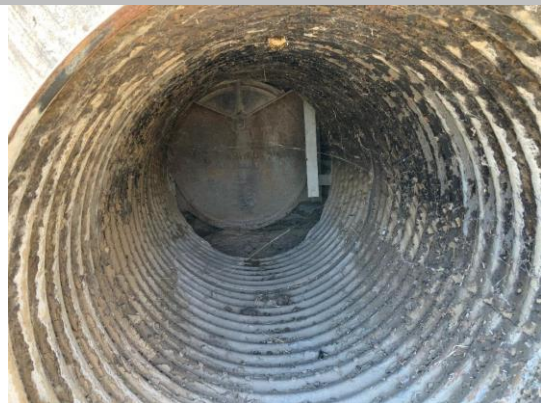
Photo 1 of 1 : UCIP_SP_2024_71094_102912.jpg

Comment Code					
Inspector Comment					
DS_ID:19818 FS_ID:71094 EP_NO: N/A Repair Type: Non-Urgent EVAL Issue: 5, Pipe Damage Crossing Status: Found UCIP Comments: 07/27/2021 The record remains Non-Urgent. DWR DMP internal inspection has found pipe integrity issues. LOF of crossing is between 4.1 and 5. Crossing will be monitored until funding becomes available for rehabilitation. No permit was found authorizing this encroachment. CVFPB will need to review crossing to determine owner. The UCIP inspection was completed with GEI staff, P. Espinoza. (H. Dunn – GEI) 04/18/2014 Need to contact owner. Sediment buildup in pipe visible on landward side. (O. Magana - DWR UCIP) FIELD_STRUCT_DESC: 36-inch corrugated metal gravity drainage pipe (CMP) through the levee, 6.9 feet below the crown. Slide gate in a 48-inch CMP riser unit on the waterside (WS) slope. Concrete headwall on each end. [Additional Reference(s): DWR Levee Log, 2002, (HLM 2.61). USACE San Joaquin O&M Manual, Unit No. 601, Part No. 1, 1967, Amended in 1978, Revised 20 June 1985, (HLM 2.61). DWR As-Built Specification No. 61-01, Sheet No. 46, 7 March 1961, (HLM 2.61)]. FS Date: 7/27/2021

WS view: Inside pipe outlet at toe.

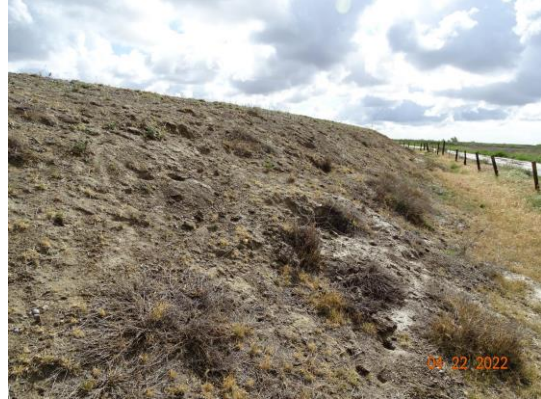
Photo 1 of 1 : SP_2024_NA0010_124_76_20240212_00017.jpg

LM Start	2.54	Rating **	A/W	Issue No.	76
LM End	2.54	Issue Type +	Ma	Location *	LS
Category	Earthen Levee			GPS Latitude/Longitude	
				Start	End
Item	Animal Control			37.252874°	37.252874°
				-120.794192°	-120.794192°
DWR ID	DWR_NA0010_06_f_2016_76				
Comment Code					
A3 : No rodents visible, but rodent burrows visible; need to backfill and compact or grout burrows.					
Inspector Comment					
There are several rodent burrows in the landside slope at this location.

View of rodent holes on the landside slope looking upstream. (Spring 2022)

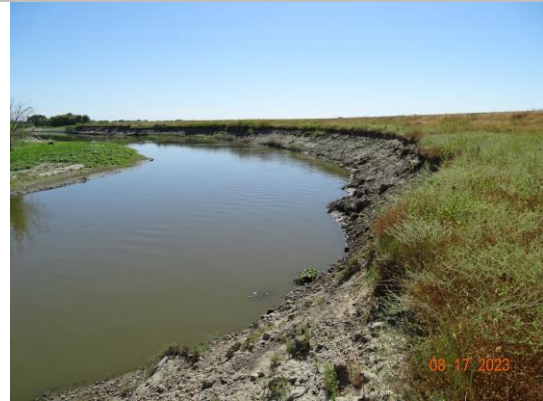
Photo 1 of 2 : SP_2024_NA0010_124_1_20240212_00001.jpg

LM Start	2.61	Rating **	U	Issue No.	1
LM End	2.68	Issue Type +	Ma	Location *	WS
Category	Supplemental			GPS Latitude/Longitude	
				Start	End
Item	DWR Erosion Survey			37.252596°	37.252596°
				-120.792504°	-120.792504°
DWR ID	NA0010U06RM3.01				
Comment Code					
Inspector Comment					
Site ID: NA0010U06RM3.01					
8/17/2023: From 2022 to present, no significant changes were observed during the annual survey.					
08/09/2022: The site was discovered by the LMA and visited during the annual field survey. There is a 15-20 ft scarp, vertical in some locations, running along the bank. The berm is 15 ft wide at the narrowst section.

8/17/2023: View of the erosion looking upstream.

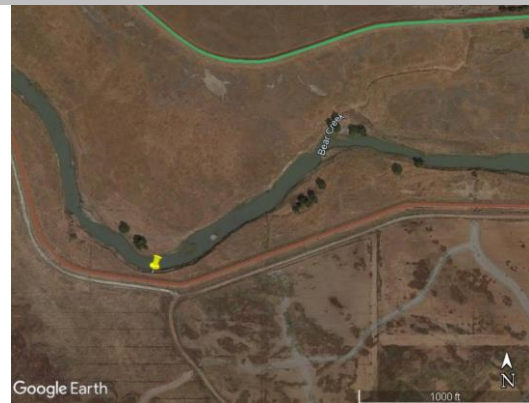
Photo 2 of 2 : SP_2024_NA0010_124_1_20240212_00002.jpg

9/13/2022: Aerial view of the erosion site (Google Earth Imagery from 9/27/2020).

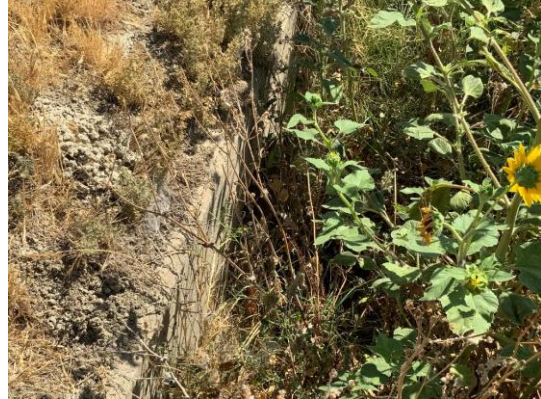
Photo 1 of 2 : UCIP_SP_2024_77923_102930.jpg

Comment Code					
Inspector Comment					
DS_ID:19820 FS_ID:77923 EP_NO: N/A Repair Type: Non-Urgent EVAL Issue: 6, Levee Damage or Threat for Levee Damage Crossing Status: Found UCIP Comments: 12/20/2022 Record updated from Urgent to Non-Urgent. Pipe has been CIPP lined. LOF of crossing is less or equal to 4. Recommend next video inspection in 5 years. (O.Yakimov - DWR UCIP) 07/27/2021 The record has been upgraded from Non-Urgent to Urgent. DWR DMP internal inspection has found pipe integrity issues. LOF of crossing is greater than or equal to 5 and less than 6. Crossing will be monitored until funding becomes available to address the issues. Dense vegetation covering LS pipe inlet, limited inspection and recommend removal of vegetation. Some minor erosion under WS concrete pad, less than a foot in length. No permit was found authorizing this encroachment. CVFPB will need to review crossing to determine owner. The UCIP inspection was completed with GEI staff, P. Espinoza. (H. Dunn – GEI) 04/18/2014 Dense vegetation limits the inspector's visibility to identify signs of pipe condition on landward toe--headwall blocked by dense vegetation. Recommend removing vegetation from landward toe. (O. Magana - DWR UCIP) FIELD_STRUCT_DESC: 24-inch CIPP-lined corrugated metal gravity drainage pipe (CMP) through the levee, 10.5 feet below the crown. Flap gate on the waterside (WS) end. Concrete headwall on each end. [Additional Reference(s): DWR Levee Log, 2002, (HLM 2.85). USACE San Joaquin O&M Manual, Unit No. 601, Part No. 1, 1967, Amended in 1978, Revised 20 June 1985, (HLM 2.85). DWR As-Built Specification No. 61-01, Sheet No. 47, 7 March 1961, (HLM 2.85)]. FS Date: 7/27/2021 10:45:23 AM

LS view: Closeup of pipe inlet at toe covered with vegetation.

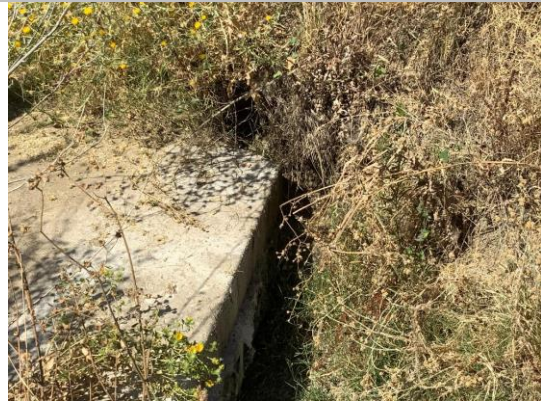
Photo 2 of 2 : UCIP_SP_2024_77923_102927.jpg

WS view: Some erosion underneath concrete pad.

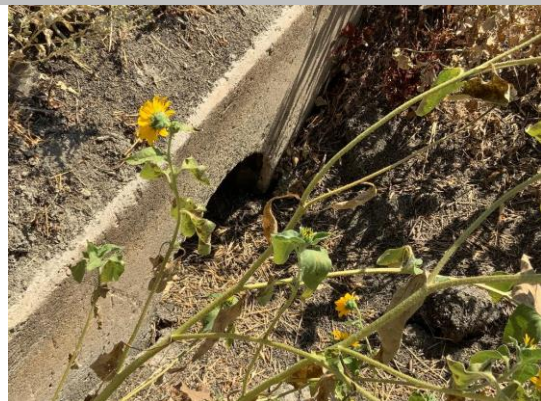
Photo 1 of 2 : UCIP_SP_2024_71097_102947.jpg

DS_ID:19821
FS_ID:71097
EP_NO: N/A
Repair Type: Non-Urgent
EVAL Issue: 11, Maintenance Compliance Issue
Crossing Status: Found
UCIP Comments: 07/27/2021 The record remains Non-Urgent. Limited inspection due to sediment and debris buildup inside LS pipe inlet, recommend removal. Sediment buildup keeping WS flapgate open, recommend removal. No permit was found authorizing this encroachment. CVFPB will need to review crossing to determine owner. The UCIP inspection was completed with GEI staff, P. Espinoza. (H. Dunn – GEI) 04/18/2014 Dense vegetation limits the inspector's visibility to identify signs of pipe condition on landward toe--headwall blocked by dense vegetation. Recommend removing vegetation from landward toe. (O. Magana - DWR UCIP)
FIELD_STRUCT_DESC: 24-inch corrugated metal gravity drainage pipe (CMP) through the levee, 11.2 feet below the crown. Flap gate on the waterside (WS) end. Concrete headwall on each end. [Additional Reference(s): DWR Levee Log, 2002, (HLM 3.09). USACE San Joaquin O&M Manual, Unit No. 601, Part No. 1, 1967, Amended in 1978, Revised 20 June 1985, (HLM 3.09). DWR As-Built Specification No. 61-01, Sheet No. 47, 7 March 1961, (HLM 3.09)].

LS view: Closeup of pipe inlet at toe with dense sediment and debris inside.

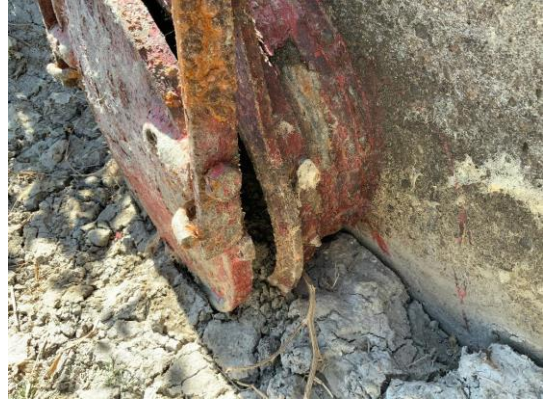
Photo 2 of 2 : UCIP_SP_2024_71097_102943.jpg

WS view: Closeup of flapgate at toe with sediment buildup keeping it open, 2 of 2 photos.

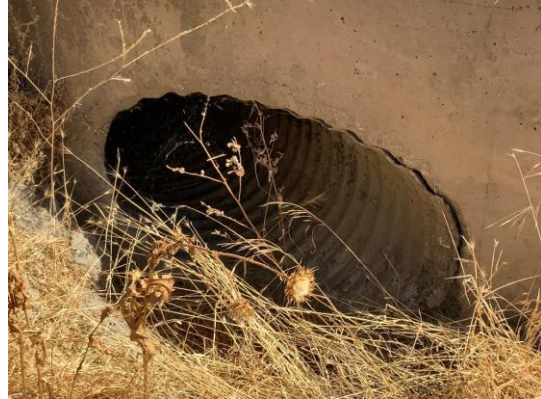
Photo 1 of 2 : UCIP_SP_2024_71098_102955.jpg

Comment Code						
Inspector Comment						
DS_ID:19822 FS_ID:71098 EP_NO: N/A Repair Type: No Action Needed EVAL Issue: Crossing Status: Found UCIP Comments: 09/18/2023 Record updated from Non-Urgent to No Action Needed. Pipe was CIPP lined. DMP internal video inspection has found none or minor pipe defects. Recommend next video inspection in 5 years. (O. Yakimov - DWR UCIP) 07/27/2021 The record remains Non-Urgent. DWR DMP internal inspection has found pipe integrity issues. LOF of crossing is between 4.1 and 5. Crossing will be monitored until funding becomes available for rehabilitation. There is minor separation of the CMP and concrete headwall on the LS toe. No permit was found authorizing this encroachment. CVFPB will need to review crossing to determine owner. The UCIP inspection was completed with GEI staff, P. Espinoza. (H. Dunn – GEI) 04/18/2014 Dense vegetation limits the inspector's visibility to identify signs of pipe condition on waterward slope and landward toe (headwall blocked by dense vegetation). Recommend removing vegetation from landward toe. (O. Magana - DWR UCIP) FIELD_STRUCT_DESC: 24-inch CIPP-lined corrugated metal gravity drainage pipe (CMP) through the levee, 10.4 feet below the crown. Flap gate on the waterside (WS) end. Concrete headwall on each end. [Additional Reference(s): DWR Levee Log, 2002, (HLM 3.29). USACE San Joaquin O&M Manual, Unit No. 601, Part No. 1, 1967, Amended in 1978, Revised 20 June 1985, (HLM 3.29). DWR As-Built Specification No. 61-01, Sheet No. 47, 7 March 1961, (HLM 3.29)]. FS Date: 7/27/2021

LS view: Closeup of pipe inlet at toe.

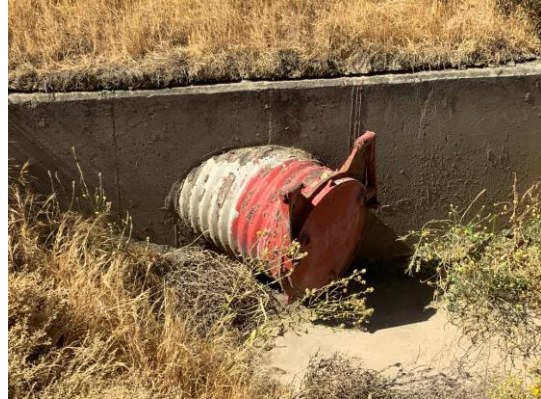
Photo 2 of 2 : UCIP_SP_2024_71098_102951.jpg

WS view: Closeup of flapgate at toe.

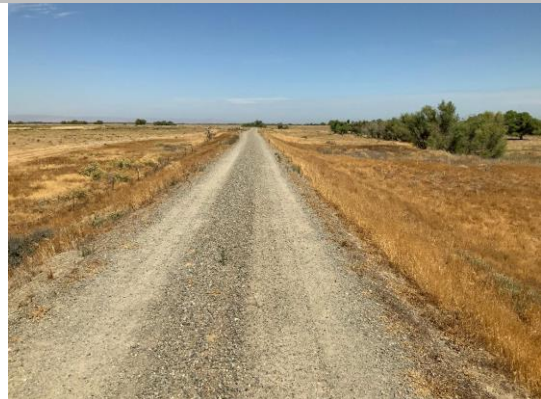
Photo 1 of 3 : UCIP_SP_2024_71099_102957.jpg

DS_ID:19823
FS_ID:71099
EP_NO: N/A
Repair Type: Non-Urgent
EVAL Issue:
Crossing Status: Not Found
UCIP Comments: 07/27/2021 The record remains Non-Urgent. No signs of pipe, headwalls, or flapgate found on WS or LS. Confirm with owner on the status of this pipe. No permit was found authorizing this encroachment. CVFPB will need to review crossing to determine owner. The UCIP inspection was completed with GEI staff, P. Espinoza. (H. Dunn – GEI) 04/18/2014 Alignment of crossing unknown--altered crossing. No headwall found on landward side only siphon breaker found a short distance from landward toe. Tall grass observed on waterward slope and some burrow activity also noticed. Need to contact owner to determine alignment of crossing and status of crossing. (O. Magana - DWR UCIP)
FIELD_STRUCT_DESC: 36-inch corrugated metal gravity drainage pipe (CMP) through the levee, 15.7 feet below the crown. Flap gate on the waterside (WS) end. Concrete U-shaped headwall on each end. Bench mark (BM) stamped 9770-152 on top of the WS headwall. [Additional Reference(s): DWR Levee Log, 2002, (HLM 3.44). USACE San Joaquin O&M Manual, Unit No. 601, Part No. 1, 1967, Amended in 1978, Revised 20 June 1985, (HLM 3.43). DWR As-Built Specification No. 61-01, Sheet No. 47, 7 March 1961, (HLM 3.43)].

Levee crown.

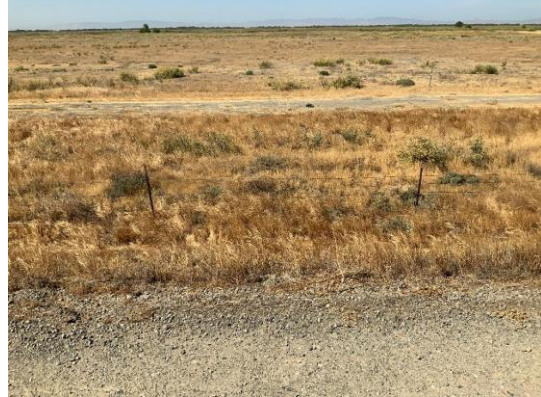
Photo 2 of 3 : UCIP_SP_2024_71099_102958.jpg

LS view: Toe from crown.

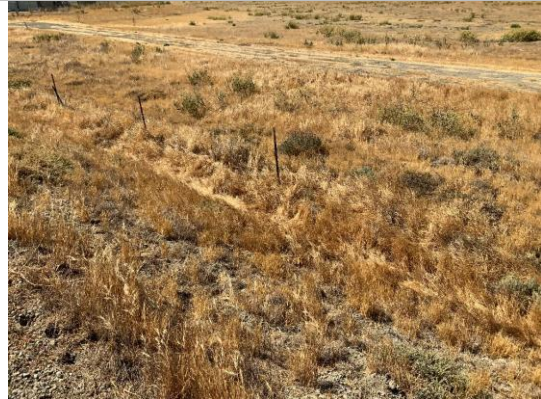
Photo 3 of 3 : UCIP_SP_2024_71099_102959.jpg

LS view: Slope from the crown, no pipe visible.

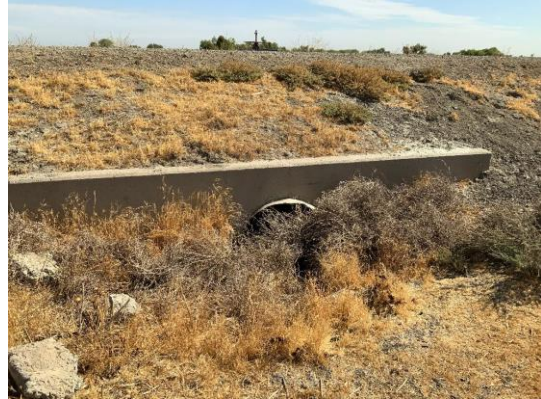
Photo 1 of 3 : UCIP_SP_2024_71101_102973.jpg

Comment Code						
Inspector Comment						
DS_ID:19825 FS_ID:71101 EP_NO: N/A Repair Type: Non-Urgent EVAL Issue: 4b, Safety Issue Crossing Status: Found UCIP Comments: 07/27/2021 The record remains Non-Urgent. DWR DMP internal inspection has found pipe integrity issues. LOF of crossing is between 4.1 and 5. Crossing will be monitored until funding becomes available for rehabilitation. WS riser has broken cover, creating a safety hazard. Limited inspection due to dense tumbleweeds over LS inlet, recommend removal. No permit was found authorizing this encroachment. CVFPB will need to review crossing to determine owner. The UCIP inspection was completed with GEI staff, P. Espinoza. (H. Dunn – GEI) 04/18/2014 Sediment buildup inside pipe visible from landward side. Excess soil is also present on landward toe partially blocking concrete headwall and inlet. Recommend removing soil from landward toe and clear buildup inside. (O. Magana - DWR UCIP) FIELD_STRUCT_DESC: 36-inch corrugated metal gravity drainage pipe (CMP) through the levee, 6.8 feet below the crown. Slide gate in a 48-inch CMP riser unit on the waterside (WS) slope. Concrete headwall on each end. Pipe connects to a 30-inch steel drainage pipe on the WS. Drainage pipe extends to the pump on the WS on a support platform in the channel. (30-inch drainage pipe and pump authorized under Permit No. 12527, 1979 - Joseph Gallo). [Additional Reference(s): DWR Levee Log, 2002, (HLM 3.54). USACE San Joaquin O&M Manual, Unit No. 601, Part No. 1, 1967, Amended in 1978, Revised 20 June 1985, (HLM 3.54). DWR As-Built Specification No. 61-01, Sheet No. 47, 7 March 1961, (HLM 3.54)]. FS Date: 7/27/2021

LS view: Headwall and slope from toe.

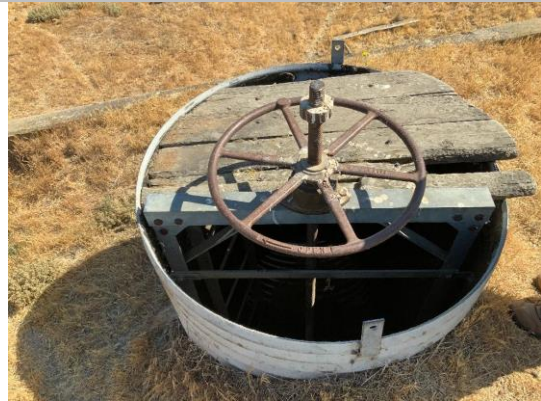
Photo 2 of 3 : UCIP_SP_2024_71101_102977.jpg

WS view: Closeup of the riser on the slope with missing cover.

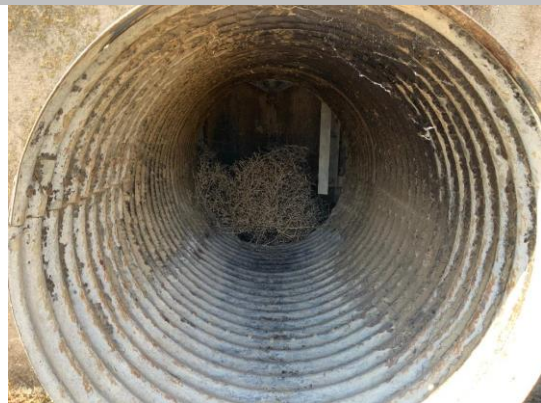
Photo 3 of 3 : UCIP_SP_2024_71101_102971.jpg

WS view: Inside of pipe outlet at toe.
