**Flood Control Project Maintenance
Levee Inspections**

Maintenance Issue Types Only, Levee Inspection Report By Mile - Spring 2024

Lower San Joaquin Levee District

Waterway	Bank	Unit Miles	Inspection Start/End	Inspector
Unit No. 01 San Joaquin River	Right	22.52	03/12/2024 03/12/2024	Corey Fujitani

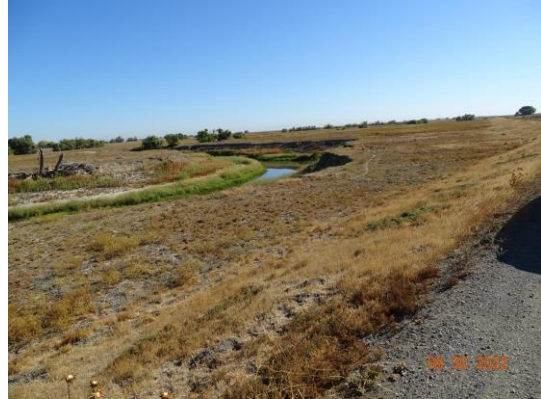
Photo 1 of 1 : SP_2024_NA0010_124_96_20240212_00029.jpg

LM Start	3.62	Rating **	A/W	Issue No.	96
LM End	3.67	Issue Type +	Ma	Location *	WS
Category	Earthen Levee			GPS Latitude/Longitude	
				Start	End
Item	Erosion / Bank Caving			37.251226°	37.251140°
				-120.775774°	-120.774900°
DWR ID	DWR_NA0010_06_f_2022_96				
Comment Code					
E1 : Note and monitor erosion site.					
Inspector Comment					
Erosion is approximately 30 ft from levee toe, 18 ft in height, and 150 ft in length.

View of erosion on the waterside berm. (Fall 2022)

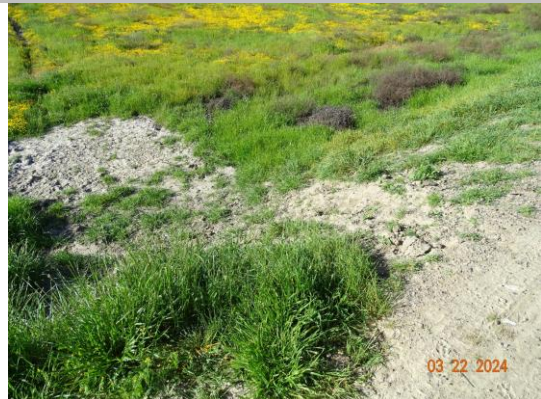
Photo 1 of 1 : SP_2024_NA0010_124_122_20240326_00152.jpg

LM Start	3.68	Rating **	A/W	Issue No.	122
LM End	3.68	Issue Type +	Ma	Location *	LS
Category	Earthen Levee			GPS Latitude/Longitude	
				Start	End
Item	Erosion / Livestock			37.251161°	37.251161°
				-120.774659°	-120.774659°
DWR ID	DWR_NA0010_06_f_2021_122				
Comment Code					
E4 : Repair the levee slope damaged by livestock and prevent large animal access.					
Inspector Comment

View of slope damage due to animal traffic. (Spring 2024)

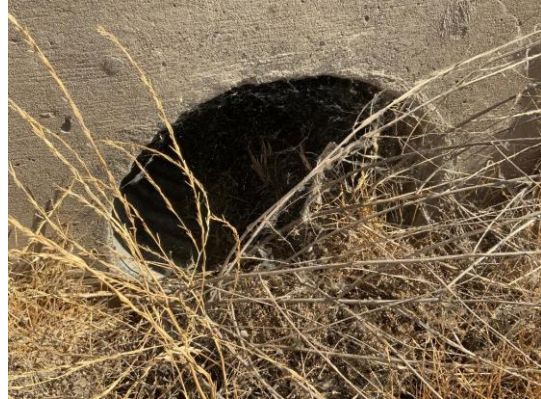
Photo 1 of 2 : UCIP_SP_2024_71102_102984.jpg

Comment Code					
Inspector Comment					
DS_ID:19826 FS_ID:71102 EP_NO: N/A Repair Type: Non-Urgent EVAL Issue: Crossing Status: Found UCIP Comments: 09/18/2023 Pipe was CIPP lined. DMP internal video inspection has found none or minor pipe defects. Recommend next video inspection in 5 years. (O. Yakimov - DWR UCIP) 07/27/2021 The record remains Non-Urgent. DWR DMP internal inspection has found pipe integrity issues. LOF of crossing is between 4.1 and 5. Crossing will be monitored until funding becomes available for rehabilitation. Limited inspection of LS pipe inlet due to vegetation covering it, recommend removal. Exterior liner of WS flapgate is significantly chipping off. No permit was found authorizing this encroachment. CVFPB will need to review crossing to determine owner. The UCIP inspection was completed with GEI staff, P. Espinoza. (H. Dunn – GEI) 04/18/2014 Sediment buildup inside crossing and is visible from landward side. Recommend clearing sediment buildup inside pipe and check wall integrity to determine condition. (O. Magana - DWR UCIP) FIELD_STRUCT_DESC: 24-inch CIPP-lined corrugated metal gravity drainage pipe (CMP) through the levee, 7.0 feet below the crown. Flap gate on the waterside (WS) end. Concrete headwall on each end. [Additional Reference(s): DWR Levee Log, 2002, (HLM 3.78). USACE San Joaquin O&M Manual, Unit No. 601, Part No. 1, 1967, Amended in 1978, Revised 20 June 1985, (HLM 3.77). DWR As-Built Specification No. 61-01, Sheet No. 47, 7 March 1961, (HLM 3.77)]. FS Date: 7/27/2021

LS view: Closeup of pipe inlet at toe with vegetation cover.

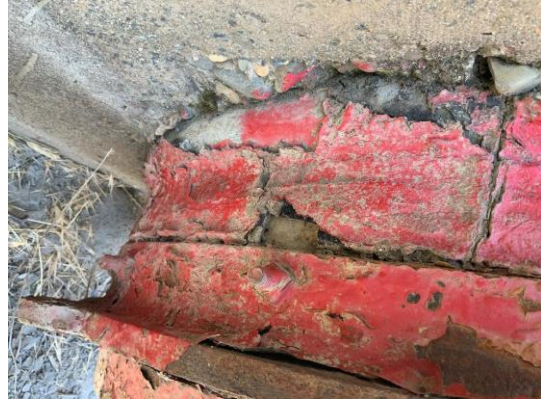
Photo 2 of 2 : UCIP_SP_2024_71102_102980.jpg

WS view: Closeup of liner deterioration on flapgate at toe.

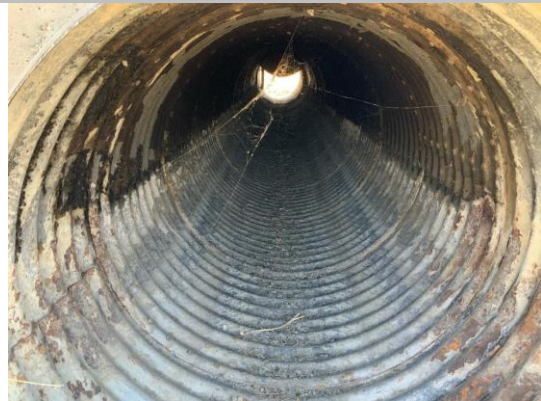
Photo 1 of 2 : UCIP_SP_2024_71103_102997.jpg

DS_ID:19827
 FS_ID:71103
 EP_NO: N/A
 Repair Type: Non-Urgent
 EVAL Issue: 5, Pipe Damage
 Crossing Status: Found
 UCIP Comments: 07/27/2021 The record remains Non-Urgent. DWR DMP internal inspection has found pipe integrity issues. LOF of crossing is between 4.1 and 5. Crossing will be monitored until funding becomes available for rehabilitation. No permit was found authorizing this encroachment. CVFPB will need to review crossing to determine owner. The UCIP inspection was completed with GEI staff, P. Espinoza. (H. Dunn – GEI) 04/18/2014 Sediment buildup inside crossing and is visible from landward side. Recommend clearing sediment buildup inside pipe and check wall integrity to determine condition. (O. Magana - DWR UCIP)
 FIELD_STRUCT_DESC: 36-inch corrugated metal gravity drainage pipe (CMP) through the levee, 6.7 feet below the crown. Slide gate in a 48-inch CMP riser unit on the waterside (WS) slope. [Additional Reference(s): DWR Levee Log, 2002, (HLM 3.98). USACE San Joaquin O&M Manual, Unit No. 601, Part No. 1, 1967, Amended in 1978, Revised 20 June 1985, (HLM 3.97). DWR As-Built Specification No. 61-01, Sheet No. 47, 7 March 1961, (HLM 3.97)].

LS view: Inside pipe inlet at toe.

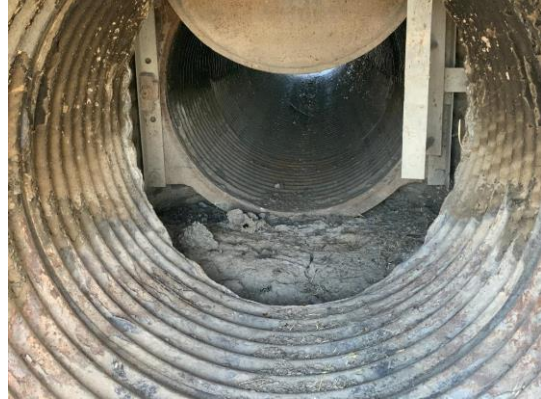
Photo 2 of 2 : UCIP_SP_2024_71103_102993.jpg

WS view: Inside pipe outlet at toe.

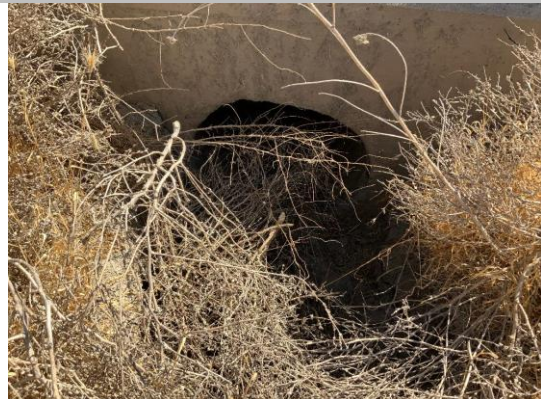
Photo 1 of 1 : UCIP_SP_2024_71104_103008.jpg

DS_ID:19828
 FS_ID:71104
 EP_NO: N/A
 Repair Type: Non-Urgent
 EVAL Issue: 11, Maintenance Compliance Issue
 Crossing Status: Found
 UCIP Comments: 07/27/2021 The record remains Non-Urgent. Limited inspection due to LS pipe inlet being covered by dense tumbleweeds, recommend removal. No permit was found authorizing this encroachment. CVFPB will need to review crossing to determine owner. The UCIP inspection was completed with GEI staff, P. Espinoza. (H. Dunn – GEI) 04/18/2014 Dense vegetation limits the inspector's visibility to identify signs of pipe condition on landward toe--headwall blocked by dense vegetation. Recommend removing vegetation from landward toe. (O. Magana - DWR UCIP)
 FIELD_STRUCT_DESC: 24-inch corrugated metal gravity drainage pipe (CMP) through the levee, 10.8 feet below the crown. Flap gate on the waterside (WS) end. Concrete headwall on each end. [Additional Reference(s): DWR Levee Log, 2002, (HLM 4.17). USACE San Joaquin O&M Manual, Unit No. 601, Part No. 1, 1967, Amended in 1978, Revised 20 June 1985, (HLM 4.17). DWR As-Built Specification No. 61-01, Sheet No. 48, 7 March 1961, (HLM 4.17)].

LS view: Closeup of pipe inlet at toe covered by tumbleweeds.

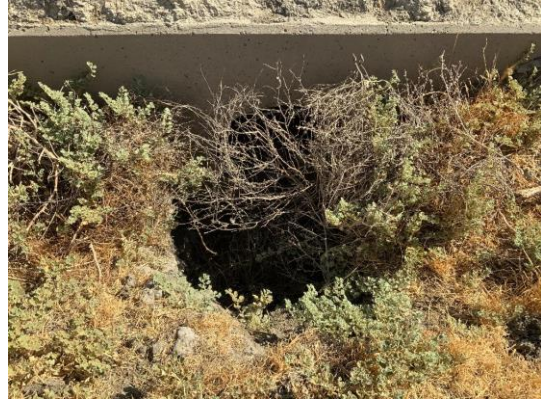
Photo 1 of 1 : UCIP_SP_2024_71105_103022.jpg

Comment Code					
Inspector Comment					
DS_ID:19829 FS_ID:71105 EP_NO: N/A Repair Type: Non-Urgent EVAL Issue: Crossing Status: Found UCIP Comments: 09/18/2023 Pipe was CIPP lined. DMP internal video inspection has found none or minor pipe defects. Recommend next video inspection in 5 years. (O. Yakimov - DWR UCIP) 07/27/2021 The record remains Non-Urgent. DWR DMP internal inspection has found pipe integrity issues. LOF of crossing is between 4.1 and 5. Crossing will be monitored until funding becomes available for rehabilitation. Limited inspection due to LS pipe inlet having some vegetation overgrowth over it, recommend removal. No permit was found authorizing this encroachment. CVFPB will need to review crossing to determine owner. The UCIP inspection was completed with GEI staff, P. Espinoza. (H. Dunn – GEI) 04/18/2014 Dense vegetation limits the inspector's visibility to identify signs of pipe condition on landward toe--headwall blocked by dense vegetation. Recommend removing vegetation from landward toe. (O. Magana - DWR UCIP) FIELD_STRUCT_DESC: 24-inch CIPP-lined corrugated metal gravity drainage pipe (CMP) through the levee, 11.3 feet below the crown. Flap gate on the waterside (WS) end. Concrete headwall on each end. [Additional Reference(s): DWR Levee Log, 2002, (HLM 4.43). USACE San Joaquin O&M Manual, Unit No. 601, Part No. 1, 1967, Amended in 1978, Revised 20 June 1985, (HLM 4.41). DWR As-Built Specification No. 61-01, Sheet No. 48, 7 March 1961, (HLM 4.41)]. FS Date: 7/27/2021

LS view: Closeup of pipe inlet at toe covered by vegetation.

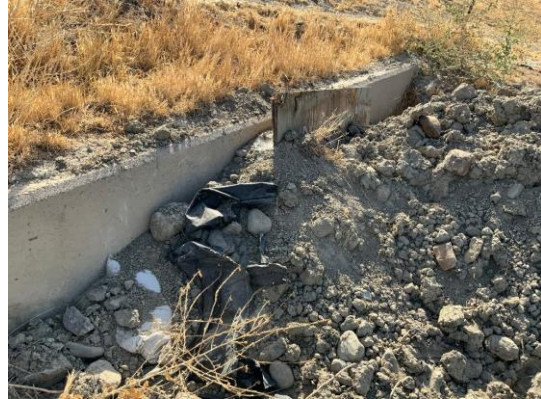
Photo 1 of 2 : UCIP_SP_2024_71106_103032.jpg

Comment Code					
Inspector Comment					
DS_ID:19830 FS_ID:71106 EP_NO: N/A Repair Type: Non-Urgent EVAL Issue: 4b, Safety Issue Crossing Status: Found UCIP Comments: 07/27/2021 The record remains Non-Urgent. WS riser has no cover, causing safety hazard. Limited inspection due to LS pipe inlet completely buried within large dirt pile, recommend clearing out. No permit was found authorizing this encroachment. CVFPB will need to review crossing to determine owner. The UCIP inspection was completed with GEI staff, P. Espinoza. (H. Dunn – GEI) 04/18/2014 Sediment buildup inside crossing visible from landward side. Recommend clearing sediment buildup inside pipe and check wall integrity to determine condition. (O. Magana - DWR UCIP) FIELD_STRUCT_DESC: 36-inch corrugated metal gravity drainage pipe (CMP) through the levee, 6.9 feet below the crown. Slide gate in a 48-inch CMP riser unit on the waterside (WS) slope. Concrete headwall on the landside (LS) end. Concrete saddle and apron on the WS end. [Additional Reference(s): DWR Levee Log, 2002, (HLM 4.69). USACE San Joaquin O&M Manual, Unit No. 601, Part No. 1, 1967, Amended in 1978, Revised 20 June 1985, (HLM 4.70). DWR As-Built Specification No. 61-01, Sheet No. 48, 7 March 1961, (HLM 4.70)]. FS Date: 7/27/2021

LS view: Pile of dirt completely covering pipe inlet at toe.

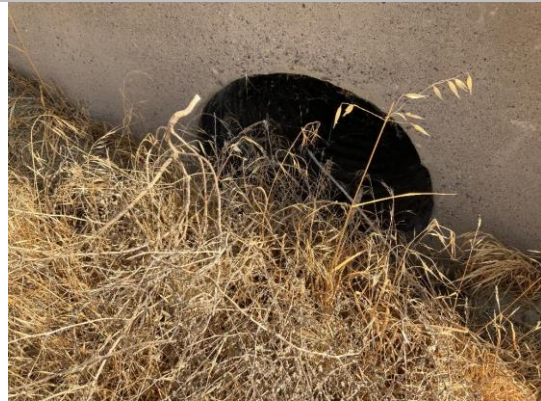
Photo 1 of 1 : UCIP_SP_2024_77931_103040.jpg

Comment Code						
Inspector Comment						
DS_ID:19831 FS_ID:77931 EP_NO: N/A Repair Type: Non-Urgent EVAL Issue: 11, Maintenance Compliance Issue Crossing Status: Found UCIP Comments: 12/20/2022 Record updated from Urgent to Non-Urgent. Pipe has been CIPP lined. LOF of crossing is less or equal to 4. Recommend next video inspection in 5 years. (O.Yakimov - DWR UCIP) 07/27/2021 The record has been upgraded from Non-Urgent to Urgent. DWR DMP internal inspection has found pipe integrity issues. LOF of crossing is greater than or equal to 5. Crossing will be monitored until funding becomes available to address the issues. Vegetation over LS pipe inlet, recommend removal. No permit was found authorizing this encroachment. CVFPB will need to review crossing to determine owner. The UCIP inspection was completed with GEI staff, P. Espinoza. (H. Dunn – GEI)04/18/2014 Need to contact owner. Recommend removing tall grass on landward toe to determine condition of crossing from landward side. (O. Magana - DWR UCIP) FIELD_STRUCT_DESC: 24-inch CIPP-lined corrugated metal gravity drainage pipe (CMP) through the levee, 11.8 feet below the crown. Flap gate on the waterside (WS) end. Concrete headwall on each end. [Additional Reference(s): DWR Levee Log, 2002, (HLM 4.75). USACE San Joaquin O&M Manual, Unit No. 601, Part No. 1, 1967, Amended in 1978, Revised 20 June 1985, (HLM 4.75). DWR As-Built Specification No. 61-01, Sheet No. 48, 7 March 1961, (HLM 4.75)]. FS Date: 7/27/2021 11:29:56 AM

LS view: Closeup of pipe inlet at toe with minor vegetation growth.

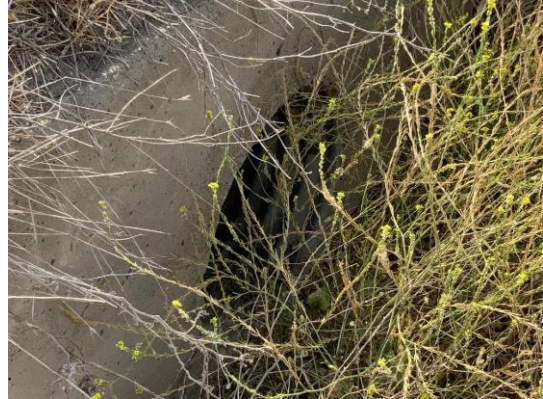
Photo 1 of 1 : UCIP_SP_2024_71108_103049.jpg

Comment Code					
Inspector Comment					
DS_ID:19862 FS_ID:71108 EP_NO: N/A Repair Type: Non-Urgent EVAL Issue: Crossing Status: Found UCIP Comments: 09/18/2023 Pipe was CIPP lined. DMP internal video inspection has found none or minor pipe defects. Recommend next video inspection in 5 years. (O. Yakimov - DWR UCIP) 07/27/2021 The record remains Non-Urgent. DWR DMP internal inspection has found pipe integrity issues. LOF of crossing is between 4.1 and 5. Crossing will be monitored until funding becomes available for rehabilitation. Limited inspection due to dense vegetation over LS pipe inlet, recommend removal. No permit was found authorizing this encroachment. CVFPB will need to review crossing to determine owner. The UCIP inspection was completed with GEI staff, P. Espinoza. (H. Dunn – GEI) 04/18/2014 Dense vegetation limits the inspector's visibility to identify signs of pipe failure (leaks) along the waterward slope. Recommend removing vegetation along waterward slope to conduct proper inspection of structure. Also recommend removing dense vegetation blocking landward headwall. (O. Magana - DWR UCIP) FIELD_STRUCT_DESC: 24-inch CIPP-lined corrugated metal gravity drainage pipe (CMP) through the levee, 10.8 feet below the crown. Flap gate on the waterside (WS) end. Concrete headwall on each end. [Additional Reference(s): DWR Levee Log, 2002, (HLM 4.95). USACE San Joaquin O&M Manual, Unit No. 601, Part No. 1, 1967, Amended in 1978, Revised 20 June 1985, (HLM 4.94). DWR As-Built Specification No. 61-01, Sheet No. 48, 7 March 1961, (HLM 4.94)]. FS Date: 7/27/2021

LS view: Closeup of pipe inlet at toe covered by vegetation.

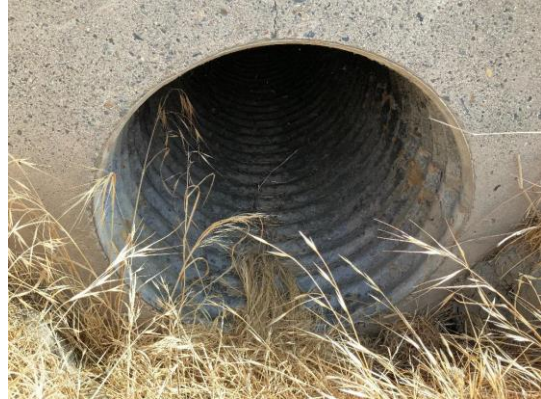
Photo 1 of 2 : UCIP_SP_2024_71109_103070.jpg

Comment Code						
Inspector Comment						
DS_ID:19863 FS_ID:71109 EP_NO: N/A Repair Type: No Action Needed EVAL Issue: Crossing Status: Found UCIP Comments: 09/18/2023 Record updated from Non-Urgent to No Action Needed. Pipe was CIPP lined. DMP internal video inspection has found none or minor pipe defects. Recommend next video inspection in 5 years. (O. Yakimov - DWR UCIP) 07/27/2021 The record remains Non-Urgent. DWR DMP internal inspection has found pipe integrity issues. LOF of crossing is greater than or equal to 4.1 and less than 5. Crossing will be monitored until funding becomes available for rehabilitation. No permit was found authorizing this encroachment. CVFPB will need to review crossing to determine owner. The UCIP inspection was completed with GEI staff, P. Espinoza. (H. Dunn – GEI) 04/18/2014 Clear vegetation from waterward slope and landward headwall. (O. Magana - DWR UCIP) FIELD_STRUCT_DESC: 24-inch CIPP-lined corrugated metal gravity drainage pipe (CMP) through the levee, 10.9 feet below the crown. Flap gate on the waterside (WS) end. Concrete headwall on each end. [Additional Reference(s): DWR Levee Log, 2002, (HLM 5.35). USACE San Joaquin O&M Manual, Unit No. 601, Part No. 1, 1967, Amended in 1978, Revised 20 June 1985, (HLM 5.34). DWR As-Built Specification No. 61-01, Sheet No. 48, 7 March 1961, (HLM 5.34)]. FS Date: 7/27/2021

LS view: Closeup of pipe inlet at toe.

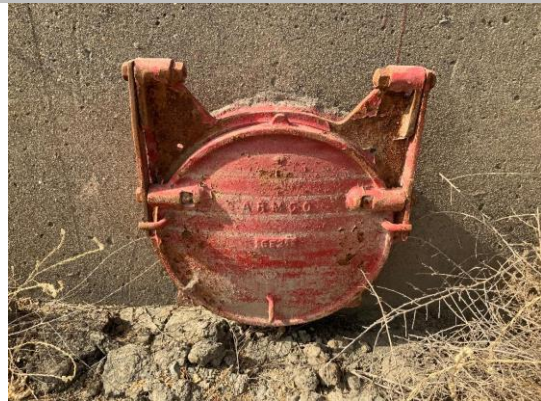
Photo 2 of 2 : UCIP_SP_2024_71109_103066.jpg

WS view: Closeup of flapgate at toe.

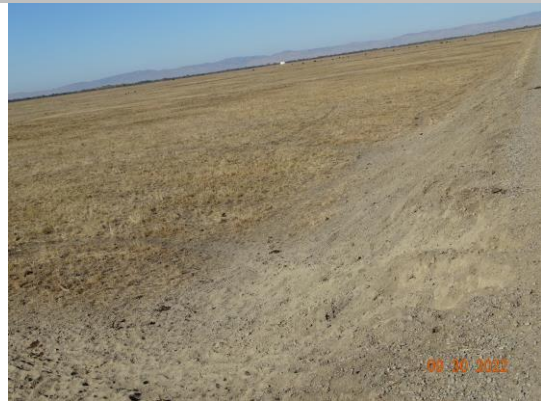
Photo 1 of 1 : SP_2024_NA0010_124_161_20240212_00072.jpg

LM Start	5.42	Rating **	A/W	Issue No.	161
LM End	5.42	Issue Type +	Ma	Location *	LS
Category	Earthen Levee			GPS Latitude/Longitude	
				Start	End
Item	Erosion / Livestock			37.238729°	37.238729°
				-120.748884°	-120.748884°
DWR ID	DWR_NA0010_06_f_2022_161				
Comment Code					
E4 : Repair the levee slope damaged by livestock and prevent large animal access.					
Inspector Comment					
Monitor repair for settlement.

Deep livestock trail on the landside slope. (Fall 2022)

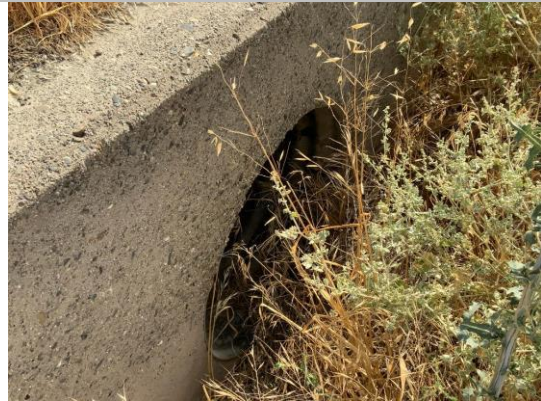
Photo 1 of 1 : UCIP_SP_2024_71110_103078.jpg

Comment Code					
Inspector Comment					
DS_ID:19864 FS_ID:71110 EP_NO: N/A Repair Type: Non-Urgent EVAL Issue: 11, Maintenance Compliance Issue Crossing Status: Found UCIP Comments: 07/27/2021 The record remains Non-Urgent. DWR DMP internal inspection has not found pipe integrity issues. LOF of crossing is less or equal to 4.0. Recommend next video inspection in 5 years. Limited inspection due to vegetation over LS pipe inlet, recommend removal. No permit was found authorizing this encroachment. CVFPB will need to review crossing to determine owner. The UCIP inspection was completed with GEI staff, P. Espinoza. (H. Dunn – GEI) 04/18/2014 Dense vegetation limits the inspector's visibility to identify signs of pipe failure (leaks) along the waterward slope. Recommend removing vegetation along pipe alignment to conduct proper inspection of structure. Also recommend removing excess vegetation at landward headwall. (O. Magana - DWR UCIP) FIELD_STRUCT_DESC: 24-inch corrugated metal gravity drainage pipe (CMP) through the levee, 11.0 feet below the crown. Flap gate on the waterside (WS) end. Concrete headwall on each end. [Additional Reference(s): DWR Levee Log, 2002, (HLM 5.63). USACE San Joaquin O&M Manual, Unit No. 601, Part No. 1, 1967, Amended in 1978, Revised 20 June 1985, (HLM 5.63). DWR As-Built Specification No. 61-01, Sheet No. 49, 7 March 1961, (HLM 5.63)]. FS Date: 7/27/2021

LS view: Closeup of pipe inlet at toe with vegetation growth.

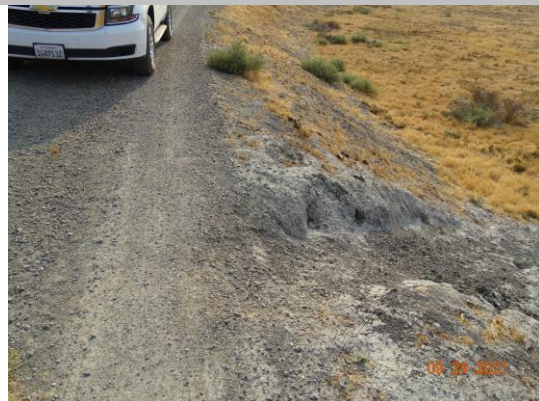
Photo 1 of 1 : SP_2024_NA0010_124_66_20240212_00010.jpg

LM Start	5.77	Rating **	A/W	Issue No.	66
LM End	5.77	Issue Type +	Ma	Location *	LS
Category	Earthen Levee			GPS Latitude/Longitude	
				Start	End
Item	Erosion / Livestock			37.238354°	37.238354°
				-120.742480°	-120.742480°
DWR ID	DWR_NA0010_06_f_2017_66				
Comment Code					
E4 : Repair the levee slope damaged by livestock and prevent large animal access.					
Inspector Comment					
Material has been place to repair the damage. Montior for settlement.

View of damage to landside slope from livestock traffic looking downstream. (Fall 2021)

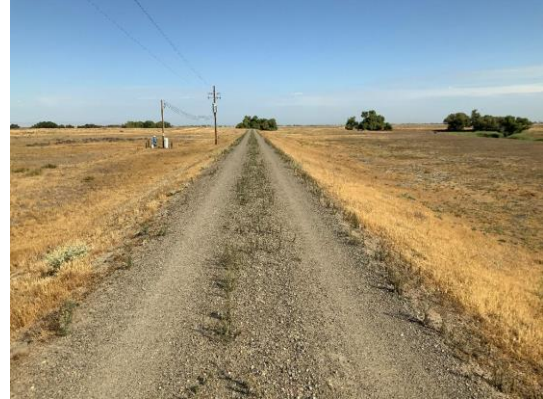
Photo 1 of 3 : UCIP_SP_2024_71111_103092.jpg

Comment Code						
Inspector Comment						
DS_ID:19865 FS_ID:71111 EP_NO: N/A Repair Type: Non-Urgent EVAL Issue: Crossing Status: Found UCIP Comments: 07/27/2021 The record has been upgraded from No Action Needed to Non-Urgent. No permit was found authorizing this encroachment. CVFPB will need to review crossing to determine owner. Crossing appears to be in good condition. Separate 10 inch plastic pipe inlet and flowmeter off the LS toe across this Crossing's inlet. The UCIP inspection was completed with GEI staff, P. Espinoza. (H. Dunn – GEI) 7/19/2016 Site has been repaired on WS and LS (see photos below). (O. Magana - DWR UCIP)5/26/2016 Erosion is undermining the WS headwall of drainage structure (photos of WS headwall provided by DWR Inspector R. Willoughby). Potential pipe failure at the outlet just behind headwall, recommend completing internal wall integrity of pipe length through levee to determine extent of damage to pipe. (O. Magana - DWR UCIP)4/18/2014 Need to contact owner. Sediment buildup in pipe visible on landside--recommend clearing. (O. Magana - DWR UCIP) FIELD_STRUCT_DESC: 24-inch corrugated metal gravity drainage pipe (CMP) through the levee, 9.0 feet below the crown. Flap gate on the waterside (WS) end. Concrete headwall on each end. [Additional Reference(s): DWR Levee Log, 2002, (HLM 6.06). USACE San Joaquin O&M Manual, Unit No. 601, Part No. 1, 1967, Amended in 1978, Revised 20 June 1985, (HLM 6.06). DWR As-Built Specification No. 61-01, Sheet No. 49, 7 March 1961, (HLM 6.06)]. FS Date: 7/27/2021

Levee crown.

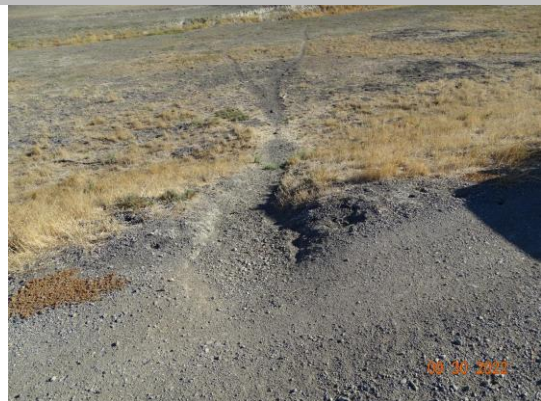
Photo 1 of 1 : SP_2024_NA0010_124_85_20240212_00021.jpg

LM Start	6.09	Rating **	A/W	Issue No.	85
LM End	6.09	Issue Type +	Ma	Location *	WS
Category	Earthen Levee			GPS Latitude/Longitude	
				Start	End
Item	Erosion / Livestock			37.235572°	37.235572°
				-120.738002°	-120.738002°
DWR ID	DWR_NA0010_06_f_2018_85				
Comment Code					
E4 : Repair the levee slope damaged by livestock and prevent large animal access.					
Inspector Comment					
Livestock damage to slope and shoulder of levee.

View of livestock damage on waterside slope. (Fall 2022)

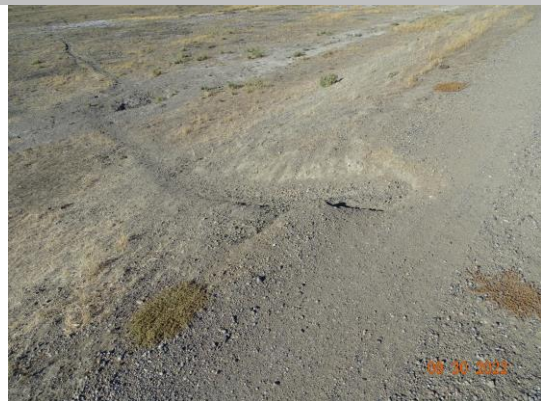
Photo 1 of 1 : SP_2024_NA0010_124_84_20240212_00020.jpg

LM Start	6.10	Rating **	A/W	Issue No.	84
LM End	6.10	Issue Type +	Ma	Location *	LS
Category	Earthen Levee			GPS Latitude/Longitude	
				Start	End
Item	Erosion / Livestock			37.235570°	37.235570°
				-120.737998°	-120.737998°
DWR ID	DWR_NA0010_06_f_2018_84				
Comment Code					
E4 : Repair the levee slope damaged by livestock and prevent large animal access.					
Inspector Comment					
Material has been placed to repair the slope damage. Monitor for settlement.

Erosion to slope and into crown from livestock. (Fall 2022)

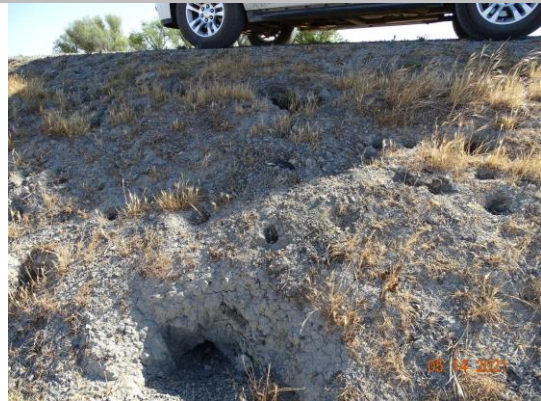
Photo 1 of 1 : SP_2024_NA0010_124_90_20240212_00025.jpg

LM Start	6.63	Rating **	M	Issue No.	90
LM End	6.63	Issue Type +	Ma	Location *	LS
Category	Earthen Levee			GPS Latitude/Longitude	
				Start	End
Item	Animal Control			37.231384°	37.231384°
				-120.730297°	-120.730297°
DWR ID	DWR_NA0010_06_s_2021_90				
Comment Code					
A3 : No rodents visible, but rodent burrows visible; need to backfill and compact or grout burrows.					
Inspector Comment

Looking at multiple rodent holes in the landside slope. (Spring 2021)

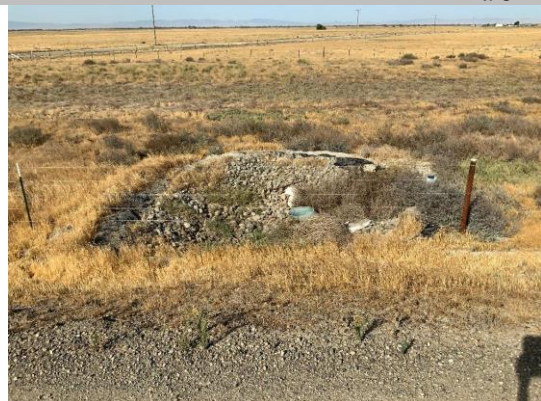
Photo 2 of 3 : UCIP_SP_2024_71112_103106.jpg

LS view: Toe from crown.

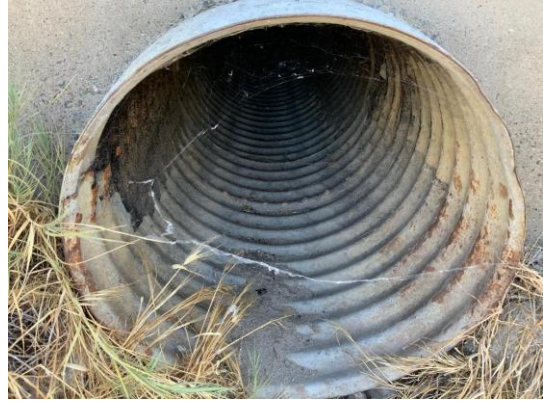
Photo 3 of 3 : UCIP_SP_2024_71112_103107.jpg

LS view: Closeup of pipe inlet at toe.

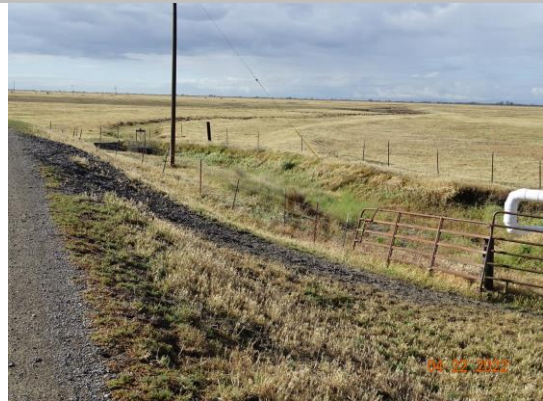
Photo 1 of 1 : SP_2024_NA0010_124_143_20240212_00061.jpg

LM Start	6.88	Rating **	M	Issue No.	143
LM End	6.88	Issue Type +	Ma	Location *	LS
Category	Earthen Levee			GPS Latitude/Longitude	
				Start	End
Item	Erosion / Livestock			37.228370°	37.228370°
				-120.728004°	-120.728004°
DWR ID	DWR_NA0010_06_s_2022_143				
Comment Code					
E4 : Repair the levee slope damaged by livestock and prevent large animal access.					
Inspector Comment

Levee damage on the landside slope from livestock activity. (Spring 2022)

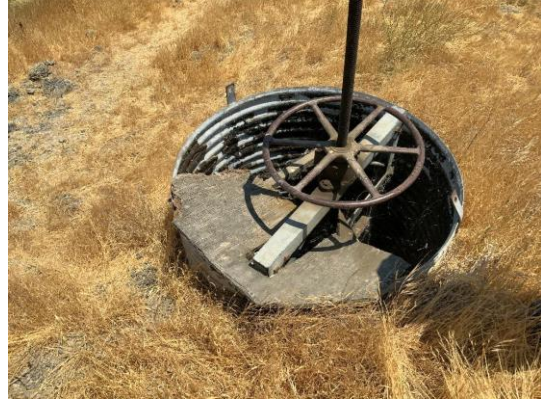
Photo 1 of 1 : UCIP_SP_2024_71113_101626.jpg

Comment Code						
Inspector Comment						
DS_ID:19867 FS_ID:71113 EP_NO: N/A Repair Type: Non-Urgent EVAL Issue: 4b, Safety Issue Crossing Status: Found UCIP Comments: 07/13/2021 The record has been upgraded from No Action Needed to Non-Urgent. The cover on the WS riser is broken, causing a safety concern. There is another riser, pump, and pipe out closer to the channel on the WS but is not within 15 feet of the toe. No permit was found authorizing this encroachment. CVFPB will need to review crossing to determine owner. The UCIP inspection was completed with GEI staff, P. Espinoza. (H. Dunn – GEI) FIELD_STRUCT_DESC: 36-inch corrugated metal gravity drainage pipe (CMP) through the levee, 10.7 feet below the crown. Slide gate in a 48-inch CMP riser unit on the waterside (WS) slope. Concrete headwall on the landside (LS) end. Concrete U-shaped headwall on the WS end. [Additional Reference(s): DWR Levee Log, 2002, (HLM 6.97). USACE San Joaquin O&M Manual, Unit No. 601, Part No. 1, 1967, Amended in 1978, Revised 20 June 1985, (HLM 6.97). DWR As-Built Specification No. 61-01, Sheet No. 50, 7 March 1961, (HLM 6.97)]. FS Date: 7/13/2021

WS view: Closeup of riser on slope with broken lid.

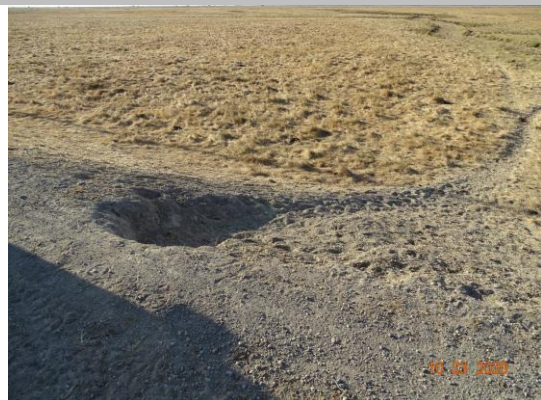
Photo 1 of 1 : SP_2024_NA0010_124_79_20240212_00018.jpg

LM Start	6.92	Rating **	M	Issue No.	79
LM End	6.92	Issue Type +	Ma	Location *	LS
Category	Earthen Levee			GPS Latitude/Longitude	
				Start	End
Item	Erosion / Livestock			37.228054°	37.228054°
				-120.727428°	-120.727428°
DWR ID	DWR_NA0010_06_f_2018_79				
Comment Code					
E4 : Repair the levee slope damaged by livestock and prevent large animal access.					
Inspector Comment					
Slope damage has been repaired with loose soil.

View down the landside slope of damage from livestock. (Fall 2020)

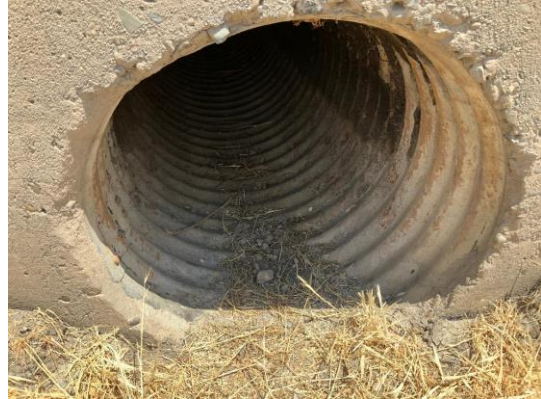
Photo 1 of 2 : UCIP_SP_2024_71114_101633.jpg

Comment Code					
Inspector Comment					
DS_ID:19868 FS_ID:71114 EP_NO: N/A Repair Type: No Action Needed EVAL Issue: Crossing Status: Found UCIP Comments: 09/18/2023 Record updated from Non-Urgent to No Action Needed. Pipe was CIPP lined. DMP internal video inspection has found none or minor pipe defects. Recommend next video inspection in 5 years. (O. Yakimov - DWR UCIP) 07/13/2021 Record is still Non-Urgent. DWR DMP internal inspection has found pipe integrity issues. LOF of crossing is between 4.1 and 5. Crossing will be monitored until funding becomes available for rehabilitation. No permit was found authorizing this encroachment. CVFPB will need to review crossing to determine owner. The UCIP inspection was completed with GEI staff, P. Espinoza. (H. Dunn – GEI) 04/18/2014 Need to contact owner. Clear animal from waterward side. Some sediment buildup in pipe visible landward side--recommend clearing. (O. Magana - DWR UCIP) FIELD_STRUCT_DESC: 24-inch CIPP-lined corrugated metal gravity drainage pipe (CMP) through the levee, 10.6 feet below the crown. Flap gate on the waterside (WS) end. Concrete headwall on each end. [Additional Reference(s): DWR Levee Log, 2002, (HLM 7.29). USACE San Joaquin O&M Manual, Unit No. 601, Part No. 1, 1967, Amended in 1978, Revised 20 June 1985, (HLM 7.29). DWR As-Built Specification No. 61-01, Sheet No. 50, 7 March 1961, (HLM 7.29)]. FS Date: 7/13/2021

LS view: Closeup of pipe inlet at toe.

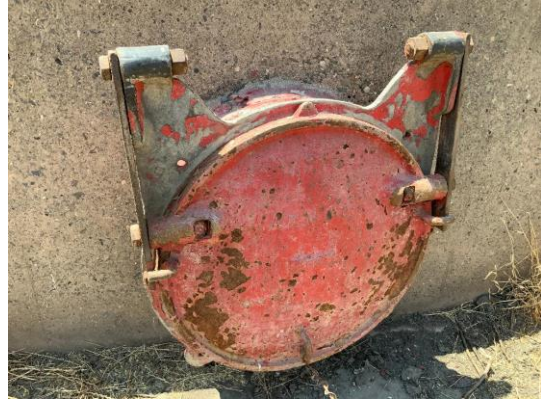
Photo 2 of 2 : UCIP_SP_2024_71114_101637.jpg

WS view: Closeup of flapgate at toe.

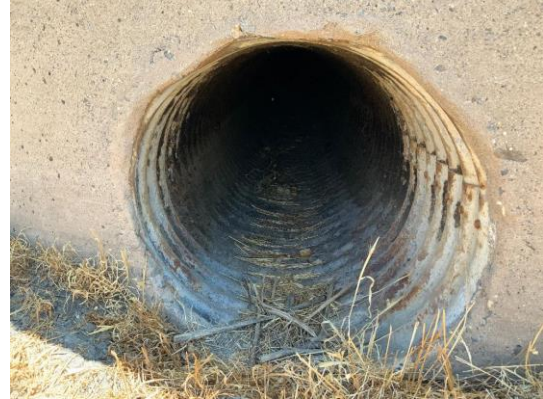
Photo 1 of 2 : UCIP_SP_2024_71115_101646.jpg

Comment Code					
Inspector Comment					
DS_ID:19869 FS_ID:71115 EP_NO: N/A Repair Type: No Action Needed EVAL Issue: Crossing Status: Found UCIP Comments: 09/18/2023 Record updated from Non-Urgent to No Action Needed. Pipe was CIPP lined. DMP internal video inspection has found none or minor pipe defects. Recommend next video inspection in 5 years. (O. Yakimov - DWR UCIP) 07/13/2021 Record remains Non-Urgent. DWR DMP internal inspection has found pipe integrity issues. LOF of crossing is greater than or equal to 4.1 and less than 5. Crossing will be monitored until funding becomes available for rehabilitation. No longer sediment buildup as mentioned in previous inspection. No permit was found authorizing this encroachment. CVFPB will need to review crossing to determine owner. The UCIP inspection was completed with GEI staff, P. Espinoza. (H. Dunn – GEI) 04/18/2014 Some sediment buildup in pipe visible on landward side--recommend clearing. (O. Magana - DWR UCIP) FIELD_STRUCT_DESC: 24-inch CIPP-lined corrugated metal gravity drainage pipe (CMP) through the levee, 11.8 feet below the crown. Flap gate on the waterside (WS) end. Concrete headwall on each end. Skewed crossing. [Additional Reference(s): DWR Levee Log, 2002, (HLM 7.74). USACE San Joaquin O&M Manual, Unit No. 601, Part No. 1, 1967, Amended in 1978, Revised 20 June 1985, (HLM 7.74). DWR As-Built Specification No. 61-01, Sheet No. 50, 7 March 1961, (HLM 7.74)]. FS Date: 7/13/2021

LS view: Closeup of pipe inlet at toe.

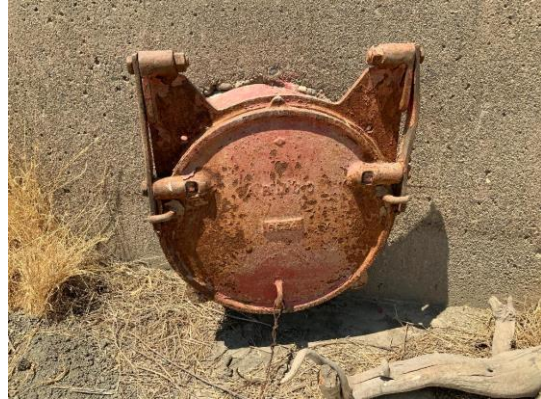
Photo 2 of 2 : UCIP_SP_2024_71115_101642.jpg

WS view: Closeup of flapgate at toe.

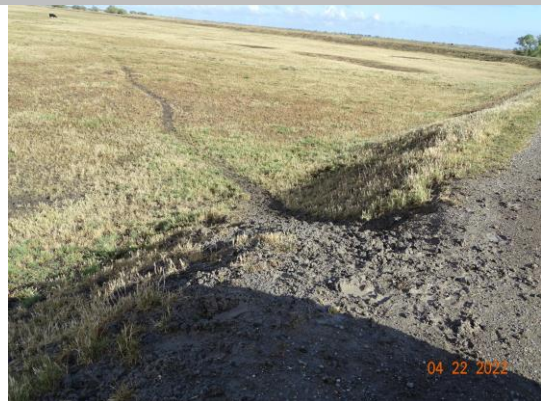
Photo 1 of 1 : SP_2024_NA0010_124_74_20240212_00016.jpg

LM Start	7.66	Rating **	A/W	Issue No.	74
LM End	7.66	Issue Type +	Ma	Location *	LS
Category	Earthen Levee			GPS Latitude/Longitude	
				Start	End
Item	Erosion / Livestock			37.222689°	37.222689°
				-120.716400°	-120.716400°
DWR ID	DWR_NA0010_06_f_2018_74				
Comment Code					
E4 : Repair the levee slope damaged by livestock and prevent large animal access.					
Inspector Comment					
Damage to levee slope from livestock access.

Slope damage from livestock. (Spring 2022)

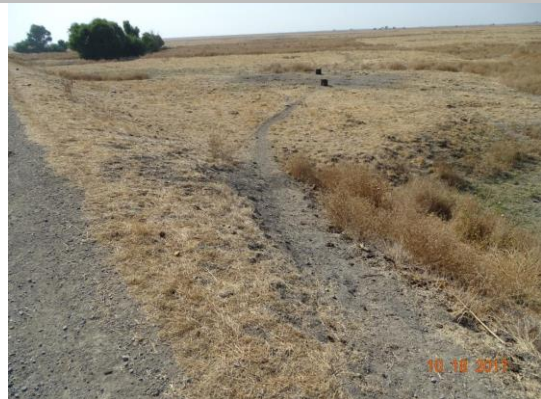
Photo 1 of 1 : SP_2024_NA0010_124_65_20240212_00009.jpg

LM Start	8.08	Rating **	A/W	Issue No.	65
LM End	8.08	Issue Type +	Ma	Location *	LS
Category	Earthen Levee			GPS Latitude/Longitude	
				Start	End
Item	Erosion / Livestock			37.217199°	37.217199°
				-120.713374°	-120.713374°
DWR ID	DWR_NA0010_06_f_2017_65				
Comment Code					
E4 : Repair the levee slope damaged by livestock and prevent large animal access.					
Inspector Comment					
Livestock damage to levee slope but the integrity of the levee is not compromised. Continue to monitor.

Looking southwest at the landside slope.

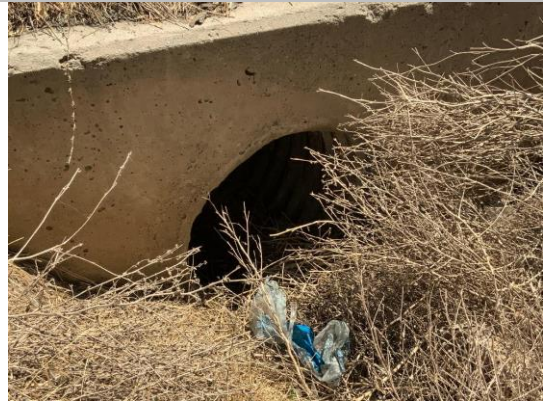
Photo 1 of 2 : UCIP_SP_2024_71116_102250.jpg

Comment Code					
Inspector Comment					
DS_ID:19870 FS_ID:71116 EP_NO: N/A Repair Type: No Action Needed EVAL Issue: Crossing Status: Found UCIP Comments: 09/18/2023 Record updated from Non-Urgent to No Action Needed. Pipe was CIPP lined. DMP internal video inspection has found none or minor pipe defects. Recommend next video inspection in 5 years. (O. Yakimov - DWR UCIP) 07/13/2021 Record remains Non-Urgent. DWR DMP internal inspection has found pipe integrity issues. LOF of crossing is greater than or equal to 4.1 and less than 5. Crossing will be monitored until funding becomes available for rehabilitation. Some vegetation buildup over LS pipe inlet and WS flapgate, recommend removal of vegetation on both ends. No permit was found authorizing this encroachment. CVFPB will need to review crossing to determine owner. The UCIP inspection was completed with GEI staff, P. Espinoza. (H. Dunn – GEI) 04/18/2014 Sediment buildup in pipe--recommend contacting owner to clear sediment. (O. Magana - DWR UCIP) FIELD_STRUCT_DESC: 24-inch CIPP-lined corrugated metal gravity drainage pipe (CMP) through the levee, 16.5 feet below the crown. Flap gate on the waterside (WS) end. Concrete headwall on each end. [Additional Reference(s): DWR Levee Log, 2002, (HLM 8.22). USACE San Joaquin O&M Manual, Unit No. 601, Part No. 1, 1967, Amended in 1978, Revised 20 June 1985, (HLM 8.21). DWR As-Built Specification No. 61-01, Sheet No. 51, 7 March 1961, (HLM 8.21)]. FS Date: 7/13/2021

LS view: Closeup of pipe inlet at toe. Some vegetation blocking.

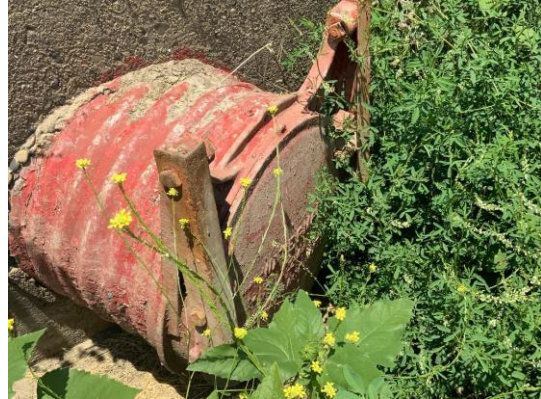
Photo 2 of 2 : UCIP_SP_2024_71116_102246.jpg

WS view: Closeup of flapgate at toe.

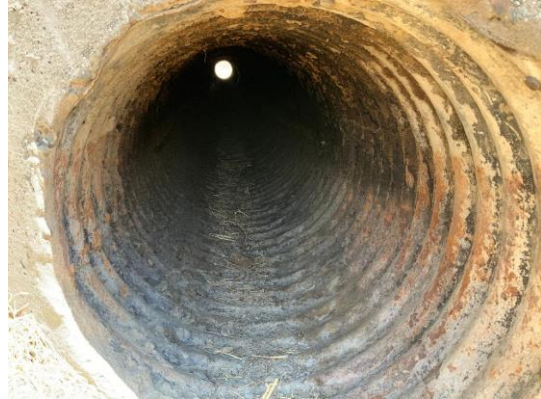
Photo 1 of 2 : UCIP_SP_2024_71117_102257.jpg

Comment Code					
Inspector Comment					
DS_ID:19871 FS_ID:71117 EP_NO: N/A Repair Type: No Action Needed EVAL Issue: Crossing Status: Found UCIP Comments: 09/18/2023 Record updated from Non-Urgent to No Action Needed. Pipe was CIPP lined. DMP internal video inspection has found none or minor pipe defects. Recommend next video inspection in 5 years. (O. Yakimov - DWR UCIP) 07/13/2021 Record remains Non-Urgent. DWR DMP internal inspection has found pipe integrity issues. LOF of crossing is between 4.1 and 5. Crossing will be monitored until funding becomes available for rehabilitation. Inside of LS pipe inlet is rusted but no visible holes or deterioration. No permit was found authorizing this encroachment. CVFPB will need to review crossing to determine owner. The UCIP inspection was completed with GEI staff, P. Espinoza. (H. Dunn – GEI) 04/18/2014 Need to contact owner. Sediment buildup in pipe visible on landward side--recommend clearing. Good candidate for pressure test or video inspection due to signs of heavy corrosion. If no leaks after tests this crossing would be a good candidate for rehabilitation. (O. Magana - DWR UCIP) FIELD_STRUCT_DESC: 24-inch CIPP-lined corrugated metal gravity drainage pipe (CMP) through the levee, 9.2 feet below the crown. Flap gate on the waterside (WS) end. Concrete headwall on each end. [Additional Reference(s): DWR Levee Log, 2002, (HLM 8.51). USACE San Joaquin O&M Manual, Unit No. 601, Part No. 1, 1967, Amended in 1978, Revised 20 June 1985, (HLM 8.51). DWR As-Built Specification No. 61-01, Sheet No. 51, 7 March 1961, (HLM 8.51)]. FS Date: 7/13/2021

LS view: Inside pipe inlet at toe, slightly rusted inside.

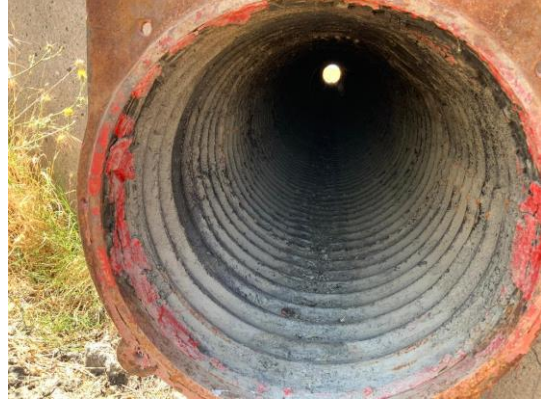
Photo 2 of 2 : UCIP_SP_2024_71117_102253.jpg

WS view: Inside pipe outlet at toe.

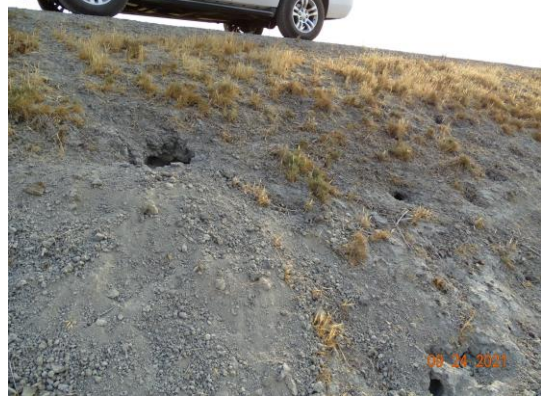
Photo 1 of 1 : SP_2024_NA0010_124_121_20240212_00044.jpg

LM Start	8.61	Rating **	A/W	Issue No.	121
LM End	8.69	Issue Type +	Ma	Location *	LS
Category	Earthen Levee			GPS Latitude/Longitude	
				Start	End
Item	Animal Control			37.211700°	37.210809°
				-120.706976°	-120.706106°
DWR ID	DWR_NA0010_06_f_2021_121				
Comment Code					
A1 : Exterminate rodents and backfill and compact or grout burrows.					
Inspector Comment

Looking at rodent holes in the landside slope. (Fall 2021)

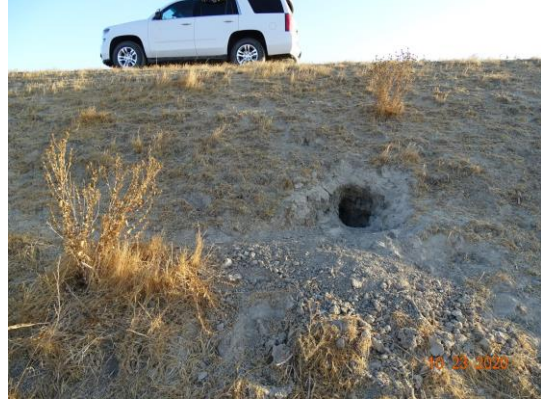
Photo 1 of 1 : SP_2024_NA0010_124_102_20240212_00030.jpg

LM Start	10.12	Rating **	U	Issue No.	102
LM End	10.12	Issue Type +	Ma	Location *	LS
Category	Earthen Levee			GPS Latitude/Longitude	
				Start	End
Item	Animal Control			37.196845°	37.196845°
				-120.687892°	-120.687892°
DWR ID	DWR_NA0010_06_f_2020_102				
Comment Code					
A3 : No rodents visible, but rodent burrows visible; need to backfill and compact or grout burrows.					
Inspector Comment

View of large animal burrow in the landside slope. (Fall 2020)

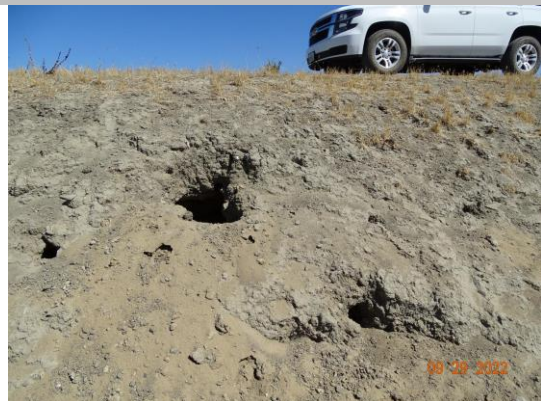
Photo 1 of 1 : SP_2024_NA0010_124_156_20240212_00069.jpg

LM Start	10.78	Rating **	U	Issue No.	156
LM End	10.78	Issue Type +	Ma	Location *	LS
Category	Earthen Levee			GPS Latitude/Longitude	
				Start	End
Item	Animal Control			37.189849°	37.189849°
				-120.679749°	-120.679749°
DWR ID	DWR_NA0010_06_f_2022_156				
Comment Code					
A3 : No rodents visible, but rodent burrows visible; need to backfill and compact or grout burrows.					
Inspector Comment					
Several rodent holes in the landside slope and landside access ramp.

Representative view of animal burrows on the landside slope. (Fall 2022)

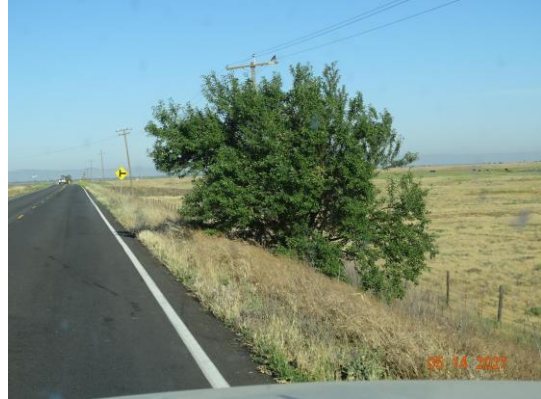
Photo 1 of 1 : SP_2024_NA0010_124_14_20240212_00007.jpg

LM Start	11.49	Rating **	M	Issue No.	14
LM End	11.49	Issue Type +	Ma	Location *	WS
Category	Earthen Levee			GPS Latitude/Longitude	
				Start	End
Item	Trim / Thin Trees			37.186189°	37.186189°
				-120.668476°	-120.668476°
DWR ID	DWR_NA0010_06_s_2015_14				
Comment Code					
T1 : Trim and thin trees to at least five feet above ground level to allow visibility of the ground and room to flood fight.					
Inspector Comment					
Almond tree located along Sandy Mush Road on waterside slope.

Looking west at tree on waterward slope. (Spring 2021)

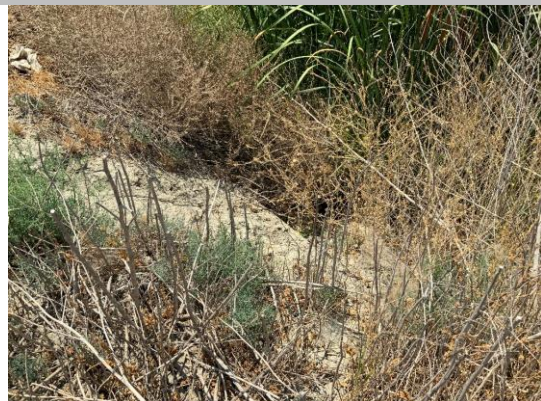
Photo 1 of 2 : UCIP_SP_2024_71150_102326.jpg

Comment Code						
Inspector Comment						
DS_ID:19875 FS_ID:71150 EP_NO: N/A Repair Type: Non-Urgent EVAL Issue: 11, Maintenance Compliance Issue Crossing Status: Indicator Found UCIP Comments: 07/13/2021 The record remains Non-Urgent. Limited inspection due to dense vegetation over both LS inlet/headwall and WS flapgate, recommend removal of vegetation on both ends. WS toe is also covered by barbed wire. No permit was found authorizing this encroachment. CVFPB will need to review crossing to determine owner. The UCIP inspection was completed with GEI staff, P. Espinoza. (H. Dunn – GEI) 04/17/2014 Unable to stop--high traffic area--safety issue. Crossing needs to be evaluated. (O. Magana - DWR UCIP) FIELD_STRUCT_DESC: 24-inch corrugated metal gravity drainage pipe (CMP) through the levee, 16.6 feet below the crown. Flap gate on the waterside (WS) end. [Additional Reference(s): DWR Levee Log, 2002, (HLM 11.65). USACE San Joaquin O&M Manual, Unit No. 601, Part No. 1, 1967, Amended in 1978, Revised 20 June 1985, (HLM 11.64). DWR As-Built Specification No. 59-01, Sheet No. 66, 10 December 1958, (HLM 11.64)]. FS Date: 7/13/2021

LS view: Top of headwall barely visible under dense vegetation.

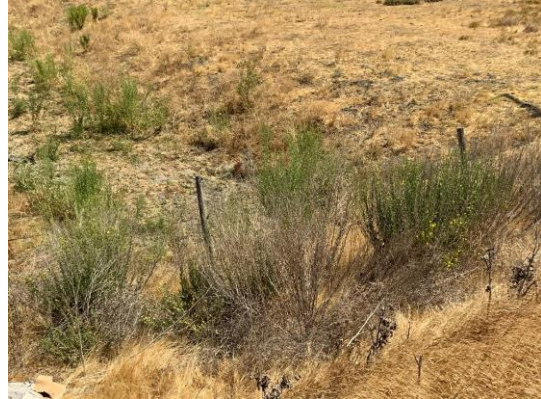
Photo 2 of 2 : UCIP_SP_2024_71150_102323.jpg

WS view: Lower slope, flapgate covered by barbed wire and dense vegetation.

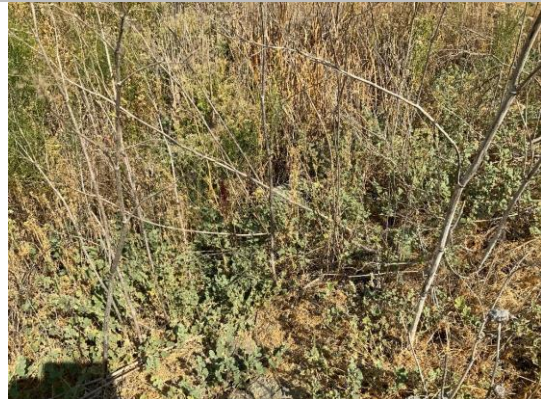
Photo 1 of 2 : UCIP_SP_2024_81022_102328.jpg

DS_ID:19876
 FS_ID:81022
 EP_NO: N/A
 Repair Type: Urgent
 EVAL Issue: 1, Pipe Integrity
 Crossing Status: Found
 UCIP Comments: 09/19/2023 Record updated from Non-Urgent to Urgent. DMP internal video inspection has found severe pipe defects. Crossing will be monitored until funding becomes available to address the issues. (O. Yakimov - DWR UCIP)
 07/13/2021 The record remains Non-Urgent. Dense vegetation over LS inlet and WS outlet, recommend removal of vegetation from both sides. Limited inspection of both inlet and outlet. No permit was found authorizing this encroachment. CVFPB will need to review crossing to determine owner. The UCIP inspection was completed with GEI staff, P. Espinoza. (H. Dunn – GEI) 04/17/2014 Clear debris from waterward and landward toes. (O. Magana - DWR UCIP)
 FIELD_STRUCT_DESC: 36-inch corrugated metal gravity drainage pipe (CMP) through the levee, 17.0 feet below the crown. Slide gate in a pipe riser unit on the waterside (WS) slope. [Additional Reference(s): DWR Levee Log, 2002, (HLM 11.83). USACE San Joaquin O&M Manual, Unit No. 601, Part No. 1, 1967, Amended in 1978, Revised 20 June 1985, (HLM 11.82). DWR As-Built Specification No. 59-01, Sheet No. 66, 10 December 1958, (HLM 11.82)].

WS view: Flapgate barely visible under dense vegetation at toe.

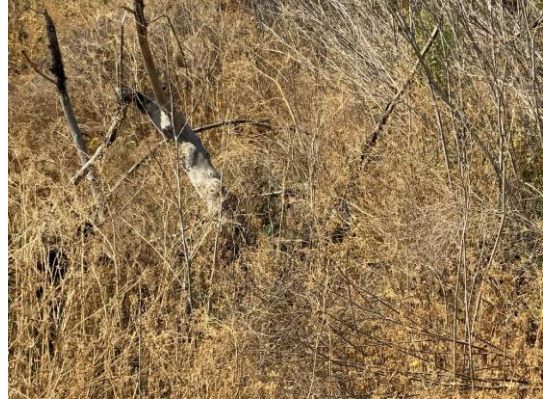
Photo 2 of 2 : UCIP_SP_2024_81022_102333.jpg

LS view: Headwall and inlet covered by dense vegetation at toe.

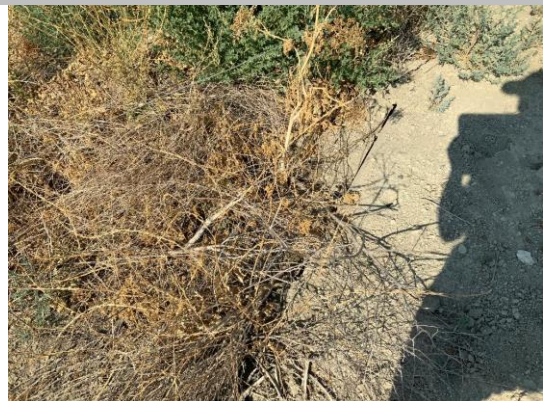
Photo 1 of 3 : UCIP_SP_2024_71152_102340.jpg

UCIP Comments: 07/13/2021 The record remains Non-Urgent. Partial cover on WS riser, recommend repair for safety reasons. Limited inspection due to LS pipe inlet being overed with vegetation, headwall barely visible, recommend removal. WS outlet not found, possibly buried under dirt or vegetaion. Recommend removal of vegetation and dirt to uncover WS pipe outlet. No permit was found authorizing this encroachment. CVFPB will need to review crossing to determine owner. The UCIP inspection was completed with GEI staff, P. Espinoza. (H. Dunn – GEI) 04/17/2014 Not accessible--crossing is buried on landward side. Need to contact owner to determine status. (O. Magana - DWR UCIP)

LS view: Top of headwall at toe, inlet covered with vegetation.

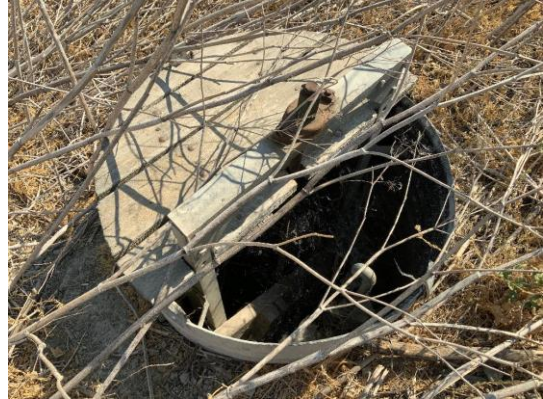
Photo 2 of 3 : UCIP_SP_2024_71152_102337.jpg

WS view: Closeup of riser on slope, broken lid.

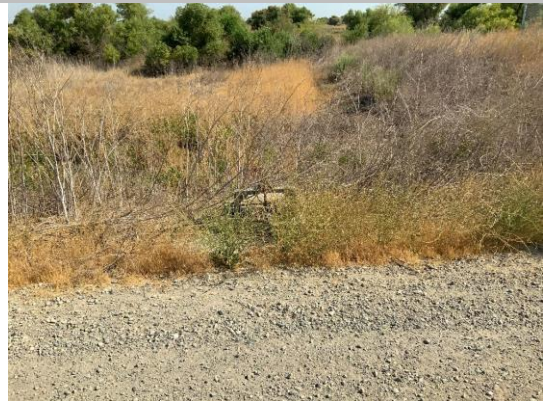
Photo 3 of 3 : UCIP_SP_2024_71152_102336.jpg

WS view: Riser visible on slope from crown.

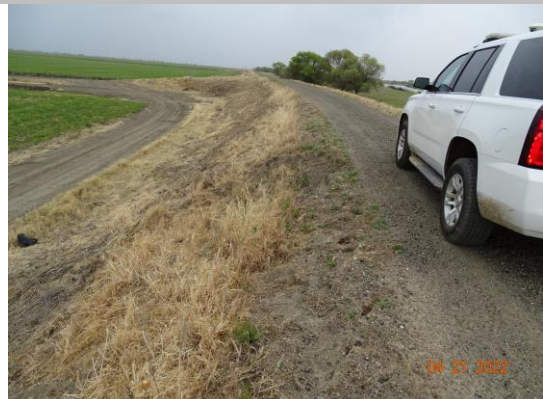
Photo 1 of 1 : SP_2024_NA0010_124_120_20240212_00043.jpg

LM Start	14.00	Rating **	U	Issue No.	120
LM End	14.00	Issue Type +	Ma	Location *	LS
Category	Earthen Levee			GPS Latitude/Longitude	
				Start	End
Item	Slope Stability			37.171591°	37.171591°
				-120.640938°	-120.640938°
DWR ID	DWR_NA0010_06_f_2021_120				
Comment Code					
S1 : Repair slope instability.					
Inspector Comment					
Caving has eaten approximately 1 foot into the levee crown.

View of slope stability issue on the landside slope. (Spring 2022)

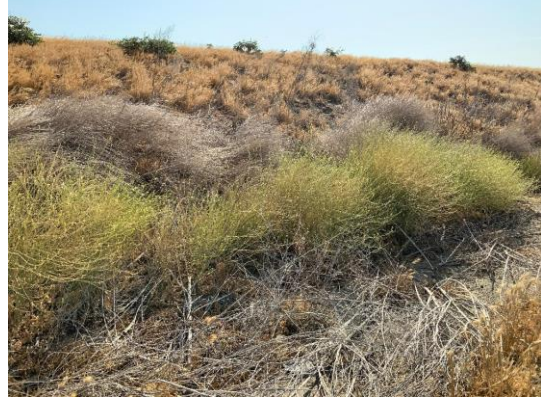
Photo 1 of 1 : UCIP_SP_2024_71153_102397.jpg

Comment Code					
Inspector Comment					
DS_ID:19878 FS_ID:71153 EP_NO: N/A Repair Type: Non-Urgent EVAL Issue: 11, Maintenance Compliance Issue Crossing Status: Found UCIP Comments: 07/13/2021 The record remains Non-Urgent. Limited inspection due to LS pipe inlet not being found, assuming its completely buried. Recommend removing dirt and vegetation to find alignment and confirming with owner on the status of this pipe. No permit was found authorizing this encroachment. CVFPB will need to review crossing to determine owner. The UCIP inspection was completed with GEI staff, P. Espinoza. (H. Dunn – GEI) 04/17/2014 Not accessible--crossing is buried on landward side. Need to contact owner to determine status. (O. Magana - DWR UCIP) FIELD_STRUCT_DESC: 24-inch corrugated metal gravity drainage pipe (CMP) through the levee, 12.3 feet below the crown. Flap gate on the waterside (WS) end. [Additional Reference(s): DWR Levee Log, 2002 (HLM 14.45). USACE San Joaquin O&M Manual, Unit No. 601, Part No. 1, 1967, Amended in 1978, Revised 20 June 1985, (HLM 14.44). DWR As-Built Specification No. 59-01, Sheet No. 68, 10 December 1958, (HLM 14.44)]. FS Date: 7/13/2021

LS view: Slope from toe, no pipe visible.

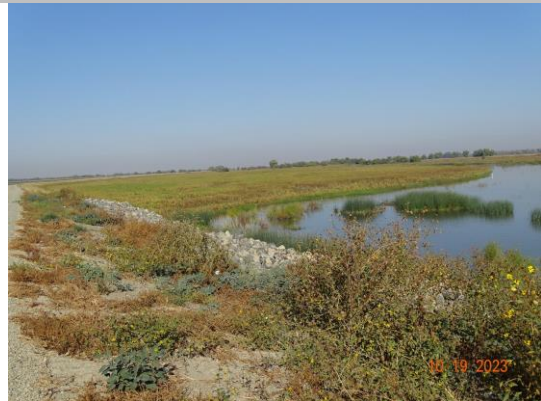
Photo 1 of 1 : SP_2024_NA0010_124_144_20240212_00062.jpg

LM Start	14.93	Rating **	A/W	Issue No.	144
LM End	15.00	Issue Type +	Ma	Location *	WS
Category	Earthen Levee			GPS Latitude/Longitude	
				Start	End
Item	Riprap Revetments			37.162295°	37.161858°
				-120.628897°	-120.627784°
DWR ID	DWR_NA0010_06_f_2023_144				
Comment Code					
RR : Riprap Revetments					
Inspector Comment

View of revetment protected waterside slope. (Fall 2023)

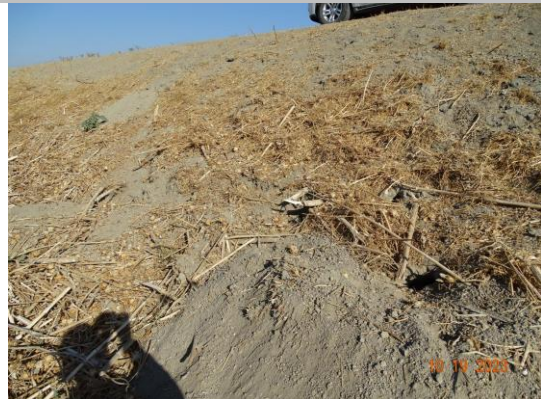
Photo 1 of 1 : SP_2024_NA0010_124_134_20240212_00052.jpg

LM Start	15.12	Rating **	U	Issue No.	134
LM End	15.12	Issue Type +	Ma	Location *	LS
Category	Earthen Levee			GPS Latitude/Longitude	
				Start	End
Item	Animal Control			37.161098°	37.161098°
				-120.625870°	-120.625870°
DWR ID	DWR_NA0010_06_f_2023_134				
Comment Code					
A3 : No rodents visible, but rodent burrows visible; need to backfill and compact or grout burrows.					
Inspector Comment

View of several rodent burrows in the landside slope. (Fall 2023)
