**Flood Control Project Maintenance
Levee Inspections**

Maintenance Issue Types Only, Levee Inspection Report By Mile - Spring 2024

Lower San Joaquin Levee District

Waterway	Bank	Unit Miles	Inspection Start/End	Inspector
Unit No. 01 San Joaquin River	Right	22.52	03/12/2024 03/12/2024	Corey Fujitani

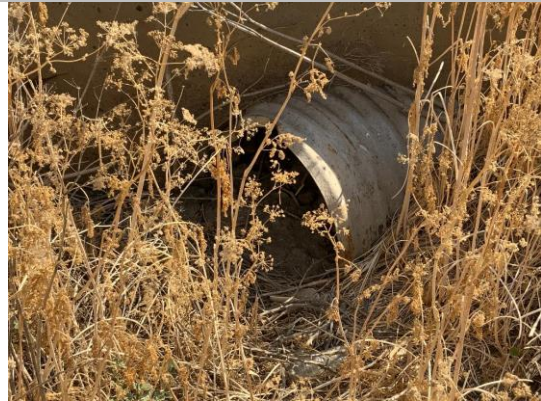
Photo 1 of 2 : UCIP_SP_2024_77870_102351.jpg

Comment Code						
Inspector Comment						
DS_ID:19884 FS_ID:77870 EP_NO: N/A Repair Type: Urgent EVAL Issue: 1, Pipe Integrity Crossing Status: Found UCIP Comments: 12/14/2022 Record updated from Non-Urgent to Urgent. DMP internal video inspection has found pipe integrity issues. LOF of crossing is between 5 and 6. Crossing will be monitored until funding becomes available to address the issues. (O.Yakimov - DWR UCIP) 07/13/2021 The record remains Non-Urgent. Limited inspection of LS pipe inlet. LS pipe edges are warped and inlet filled with sediment and some vegetation, recommend cleaning out. No permit was found authorizing this encroachment. CVFPB will need to review crossing to determine owner. The UCIP inspection was completed with GEI staff, P. Espinoza. (H. Dunn – GEI) 04/17/2014 Need to contact owner. Sediment buildup on both the waterward and landward side. Recommend removing sediment buildup from both side. Also recommend clearing excess sediment inside crossing. (O. Magana - DWR UCIP) FIELD_STRUCT_DESC: 24-inch corrugated metal gravity drainage pipe (CMP) through the levee, 14.0 feet below the crown. Flap gate on the waterside (WS) end. [Additional Reference(s): DWR Levee Log, 2002, (HLM 15.78). USACE San Joaquin O&M Manual, Unit No. 601, Part No. 1, 1967, Amended in 1978, Revised 20 June 1985, (HLM 15.76). DWR As-Built Specification No. 59-01, Sheet No. 69, 10 December 1958, (HLM 15.76)]. FS Date: 7/13/2021 2:03:17 PM

LS view: Closeup of pipe inlet at toe with sediment buildup.

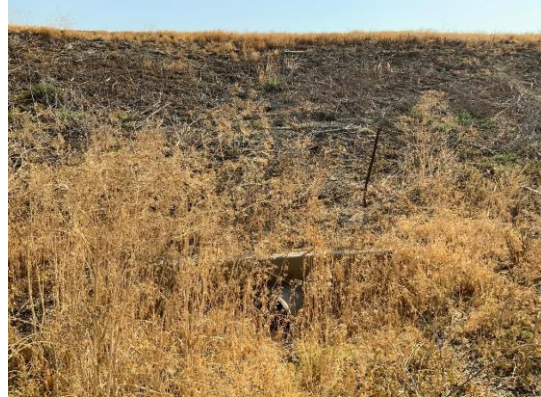
Photo 2 of 2 : UCIP_SP_2024_77870_102350.jpg

LM Start	15.68	Rating **	U	Issue No.	1241 (cont)
LM End	15.68	Issue Type +	Ma	Location *	
Category	Supplemental			GPS Latitude/Longitude	
				Start	End
Item	DWR UCIP LMA Responsibility			37.156934°	37.156934°
				-120.617210°	-120.617210°
DWR ID	19884

LS view: Headwall visible at toe.

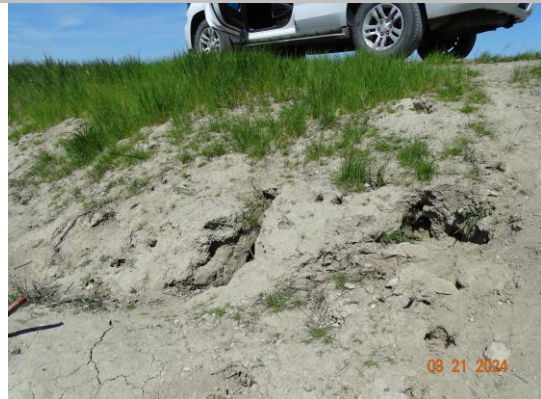
Photo 1 of 1 : SP_2024_NA0010_124_56_20240326_00153.jpg

LM Start	15.68	Rating **	M	Issue No.	56
LM End	15.68	Issue Type +	Ma	Location *	LS
Category	Earthen Levee			GPS Latitude/Longitude	
				Start	End
Item	Animal Control			37.156889°	37.156889°
				-120.617165°	-120.617165°
DWR ID	DWR_NA0010_06_s_2024_56				
Comment Code					
A3 : No rodents visible, but rodent burrows visible; need to backfill and compact or grout burrows.					
Inspector Comment

View of rodent burrows on the landside slope. (Spring 2024)

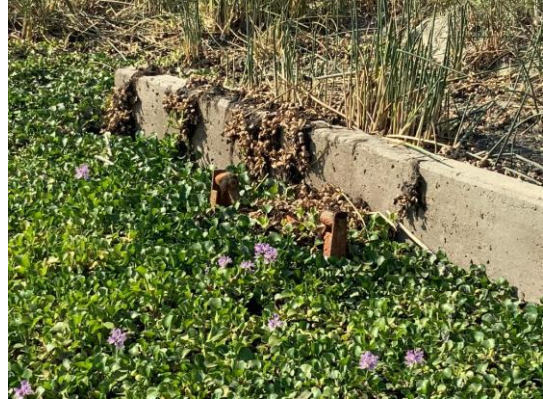
Photo 1 of 1 : UCIP_SP_2024_71134_102360.jpg

Comment Code					
Inspector Comment					
DS_ID:19885 FS_ID:71134 EP_NO: N/A Repair Type: Non-Urgent EVAL Issue: 11, Maintenance Compliance Issue Crossing Status: Found UCIP Comments: 07/13/2021 The record remains Non-Urgent. LS pipe inlet was underwater at time of inspection. WS flapgate was buried under sediment, limited inspection on both ends. Recommend removal of sediment covering flapgate on WS. No permit was found authorizing this encroachment. CVFPB will need to review crossing to determine owner. The UCIP inspection was completed with GEI staff, P. Espinoza. (H. Dunn – GEI) 04/17/2014 Need to contact owner to determine status of crossing. Waterward side is buried and not accessible. Landward side headwall is blocked by dense vegetation. Recommend confirming status of flap gate on waterward side and removing dense vegetation form landward side. (O. Magana - DWR UCIP) FIELD_STRUCT_DESC: 36-inch corrugated metal gravity drainage pipe (CMP) through the levee, 16.6 feet below the crown. Flap gate on the waterside (WS) end. [Additional Reference(s): DWR Levee Log, 2002, (HLM 15.93). USACE San Joaquin O&M Manual, Unit No. 601, Part No. 1, 1967, Amended in 1978, Revised 20 June 1985, (HLM 15.91). DWR As-Built Specification No. 59-01, Sheet No. 69, 10 December 1958, (HLM 15.91)]. FS Date: 7/13/2021

WS view: Closeup of headwall and flapgate covered by dirt at toe.

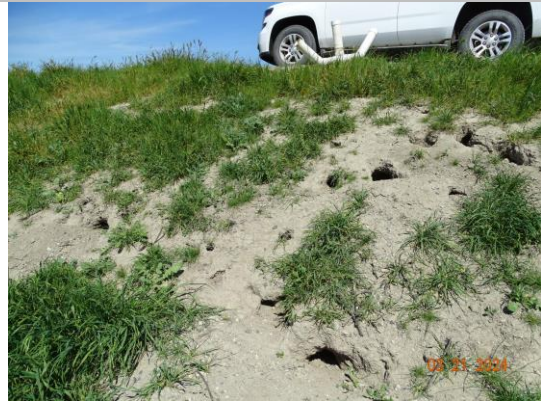
Photo 1 of 1 : SP_2024_NA0010_124_54_20240326_00154.jpg

LM Start	16.33	Rating **	M	Issue No.	54
LM End	16.33	Issue Type +	Ma	Location *	LS
Category	Earthen Levee			GPS Latitude/Longitude	
				Start	End
Item	Animal Control			37.150606°	37.150606°
				-120.608552°	-120.608552°
DWR ID	DWR_NA0010_06_s_2024_54				
Comment Code					
A3 : No rodents visible, but rodent burrows visible; need to backfill and compact or grout burrows.					
Inspector Comment					
LMA has placed bait stations along this section.

Several rodent burrows observed along this section. (Spring 2024)

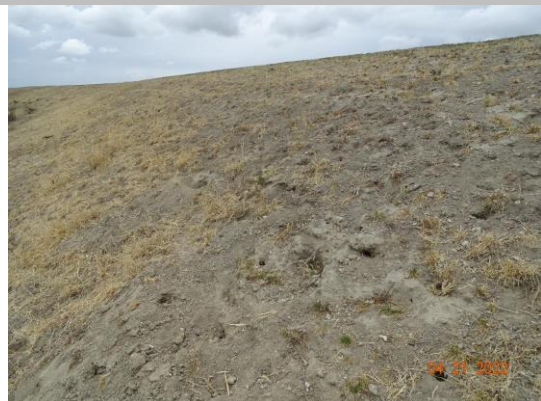
Photo 1 of 1 : SP_2024_NA0010_124_115_20240212_00039.jpg

LM Start	17.10	Rating **	M	Issue No.	115
LM End	17.13	Issue Type +	Ma	Location *	LS
Category	Earthen Levee			GPS Latitude/Longitude	
				Start	End
Item	Animal Control			37.141678°	37.141305°
				-120.600221°	-120.599949°
DWR ID	DWR_NA0010_06_f_2021_115				
Comment Code					
A1 : Exterminate rodents and backfill and compact or grout burrows.					
Inspector Comment

Looking along the landside slope at rodent burrows. (Spring 2022)

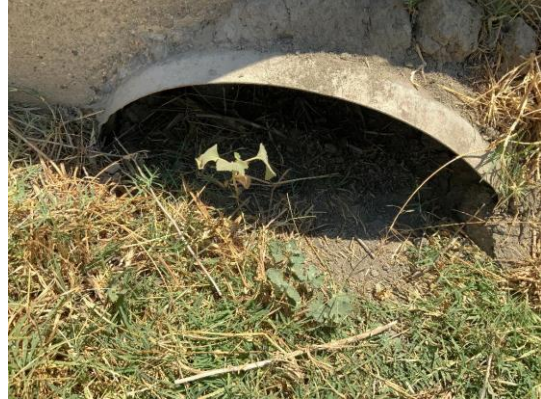
Photo 1 of 2 : UCIP_SP_2024_77871_101421.jpg

Comment Code					
Inspector Comment					
DS_ID:19887 FS_ID:77871 EP_NO: N/A Repair Type: Urgent EVAL Issue: 1, Pipe Integrity Crossing Status: Found UCIP Comments: 12/14/2022 Record updated from Non-Urgent to Urgent. DMP internal video inspection has found pipe integrity issues. LOF of crossing is between 5 and 6. Crossing will be monitored until funding becomes available to address the issues. (O.Yakimov - DWR UCIP) 07/12/2021 The record remains Non-Urgent. LS pipe inlet filled with sediment, recommend removal. WS flapgate has some vegetation over it, recommend removal. Limited inspection on both WS and LS. No permit was found authorizing this encroachment. CVFPB will need to review crossing to determine owner. The UCIP inspection was completed with GEI staff, P. Espinoza. (H. Dunn – GEI) 04/17/2014 Sediment build up on landward side toe -- debris blockage. No photos available. Recommend taking photos of crossing. (O. Magana - DWR UCIP) FIELD_STRUCT_DESC: 24-inch corrugated metal gravity drainage pipe (CMP) through the levee, 11.5 feet below the crown. Flap gate on the waterside (WS) end. [Additional Reference(s): DWR Levee Log, 2002, (HLM 18.29). USACE San Joaquin O&M Manual, Unit No. 601, Part No. 1, 1967, Amended in 1978, Revised 20 June 1985, (HLM 18.27). DWR As-Built Specification No. 59-01, Sheet No. 70, 10 December 1958, (HLM 18.27)]. FS Date: 7/13/2021 2:03:37 PM

LS view: Closeup of pipe inlet at toe filled with sediment.

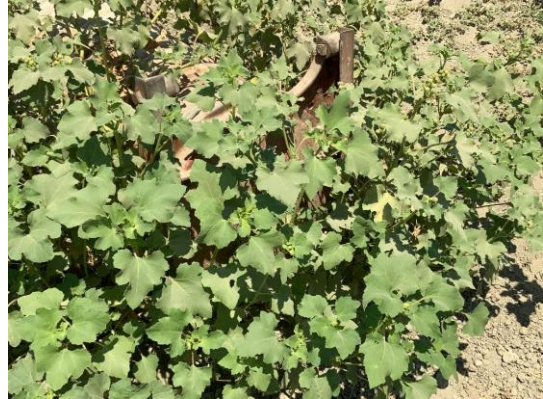
Photo 2 of 2 : UCIP_SP_2024_77871_101424.jpg

LM Start	18.20	Rating **	U	Issue No.	1243 (cont)
LM End	18.20	Issue Type +	Ma	Location *	
Category	Supplemental			GPS Latitude/Longitude	
				Start	End
Item	DWR UCIP LMA Responsibility			37.127773°	37.127773°
				-120.590809°	-120.590809°
DWR ID	19887

WS view: Closeup of flapgate at toe covered with vegetation.

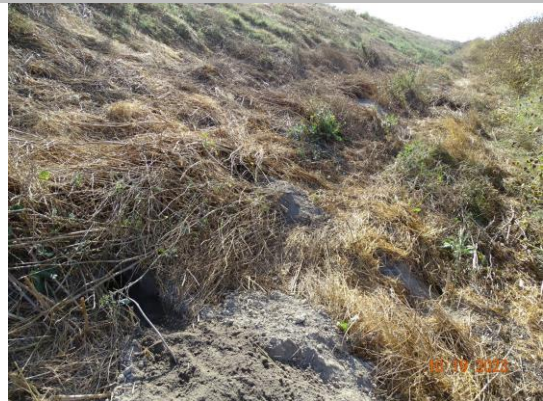
Photo 1 of 1 : SP_2024_NA0010_124_128_20240212_00048.jpg

LM Start	18.70	Rating **	M	Issue No.	128
LM End	18.70	Issue Type +	Ma	Location *	LS
Category	Earthen Levee			GPS Latitude/Longitude	
				Start	End
Item	Animal Control			37.120792°	37.120792°
				-120.587878°	-120.587878°
DWR ID	DWR_NA0010_06_f_2023_128				
Comment Code					
A3 : No rodents visible, but rodent burrows visible; need to backfill and compact or grout burrows.					
Inspector Comment

View of rodent holes along the landside slope. (Fall 2023)

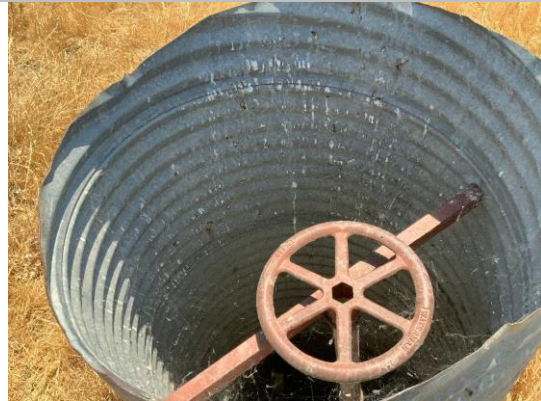
Photo 1 of 2 : UCIP_SP_2024_71139_101555.jpg

Comment Code					
Inspector Comment					
DS_ID:19889 FS_ID:71139 EP_NO: N/A Repair Type: Non-Urgent EVAL Issue: 4b, Safety Issue Crossing Status: Found UCIP Comments: 07/12/2021 The record remains Non-Urgent. Barbed wire over LS end, could not inspect closely. No cover over WS riser, causing safety hazard. Slightly warped edges on both WS and LS pipe inlet/outlet. No permit was found authorizing this encroachment. CVFPB will need to review crossing to determine owner. The UCIP inspection was completed with GEI staff, P. Espinoza. (H. Dunn – GEI) 04/17/2014 Dense vegetation limits the inspector's visibility to identify signs of pipe failure (leaks) along the landward slope. Recommend removing vegetation along pipe alignment to conduct proper inspection of structure. (O. Magana - DWR UCIP) FIELD_STRUCT_DESC: 24-inch corrugated metal gravity drainage pipe (CMP) through the levee, 10.2 feet below the crown. Slide gate in a pipe riser unit on the waterside (WS) slope. [Additional Reference(s): DWR Levee Log, 2002, (HLM 18.98). USACE San Joaquin O&M Manual, Unit No. 601, Part No. 1, 1967, Amended in 1978, Revised 20 June 1985, (HLM 18.97). DWR As-Built Specification No. 59-01, Sheet No. 71, 10 December 1958, (HLM 18.97)]. FS Date: 7/12/2021

WS view: Riser missing cover on slope.

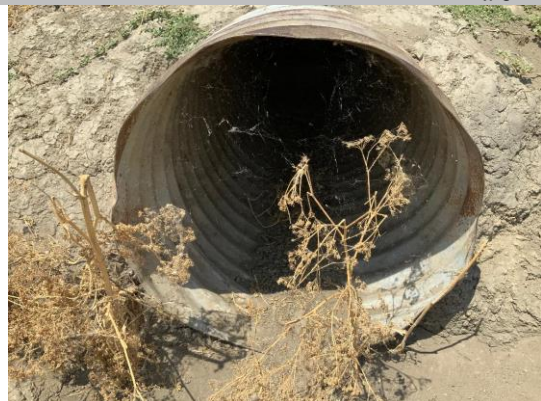
Photo 2 of 2 : UCIP_SP_2024_71139_101557.jpg

WS view: Closeup of pipe outlet at toe with slightly warped edges.

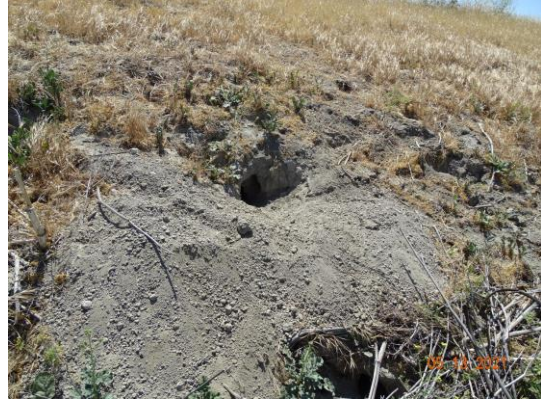
Photo 1 of 1 : SP_2024_NA0010_124_72_20240212_00015.jpg

LM Start	19.07	Rating **	U	Issue No.	72
LM End	19.07	Issue Type +	Ma	Location *	LS
Category	Earthen Levee			GPS Latitude/Longitude	
				Start	End
Item	Animal Control			37.115706°	37.115706°
				-120.587036°	-120.587036°
DWR ID	DWR_NA0010_06_s_2021_72				
Comment Code					
A1 : Exterminate rodents and backfill and compact or grout burrows.					
Inspector Comment

Large rodent burrows observed in the landside slope. (Spring 2021)

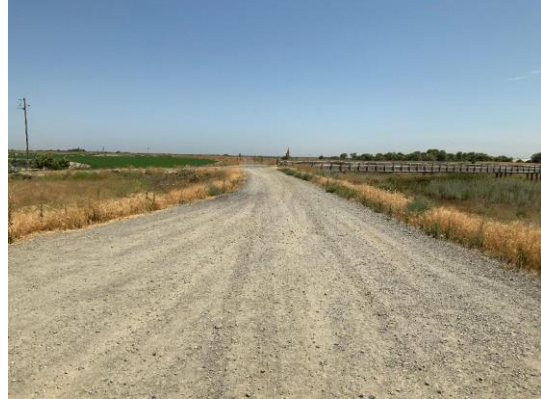
Photo 1 of 3 : UCIP_SP_2024_81021_101574.jpg

Comment Code						
Inspector Comment						
DS_ID:19890 FS_ID:81021 EP_NO: N/A Repair Type: Urgent EVAL Issue: 1, Pipe Integrity Crossing Status: Found UCIP Comments: 09/19/2023 Record updated from Non-Urgent to Urgent. DMP internal video inspection has found severe pipe defects. Crossing will be monitored until funding becomes available to address the issues. (O. Yakimov - DWR UCIP) 07/12/2021 The record remains Non-Urgent. WS pipe outlet visible but underwater, unable to inspect closely. LS pipe inlet was not seen, but likely underwater. No permit was found authorizing this encroachment. CVFPB will need to review crossing to determine owner. The UCIP inspection was completed with GEI staff, P. Espinoza. (H. Dunn – GEI) 04/17/2014 Dense vegetation limits the inspector's visibility to identify signs of pipe failure (leaks) along the slopes. Recommend removing vegetation along pipe alignment to conduct proper inspection of structure. (O. Magana - DWR UCIP) FIELD_STRUCT_DESC: 48-inch corrugated metal gravity drainage pipe (CMP) through the levee, 20.0 feet below the crown. Slide gate in a pipe riser unit on the waterside (WS) slope. Riprap along the landside (LS) slope. [Additional Reference(s): DWR Levee Log, 2002, (HLM 19.36). USACE San Joaquin O&M Manual, Unit No. 601, Part No. 1, 1967, Amended in 1978, Revised 20 June 1985, (HLM 19.36). DWR As-Built Specification No. 59-01, Sheet No. 72, 10 December 1958, (HLM 19.36)]. FS Date: 7/12/2021

Levee crown.

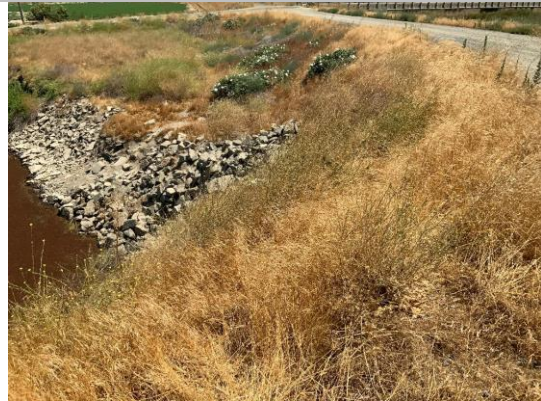
Photo 2 of 3 : UCIP_SP_2024_81021_101575.jpg

LS view: Slope from crown, no pipe visible.

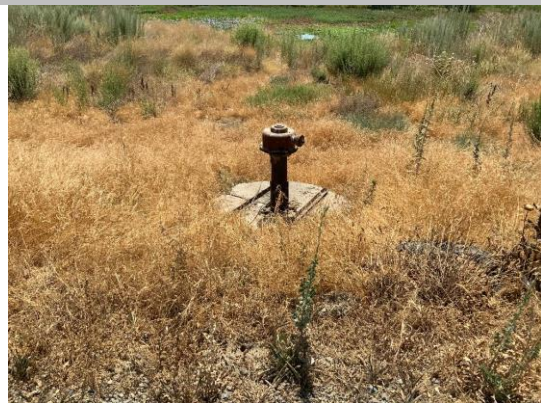
Photo 3 of 3 : UCIP_SP_2024_81021_101576.jpg

WS view: Slidegate visible on slope from crown.

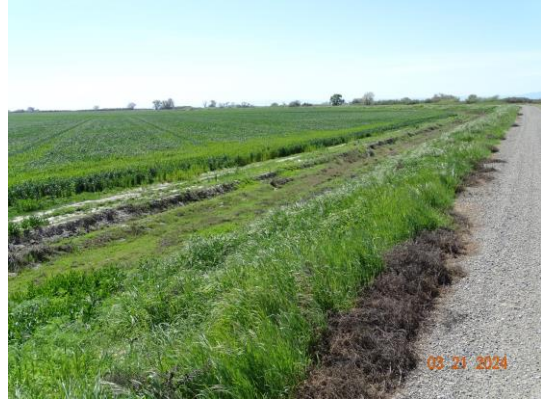
Photo 1 of 1 : SP_2024_NA0010_124_53_20240326_00155.jpg

View of vegetation on the landside slope. (Spring 2024)

LM Start	19.41	Rating **	M	Issue No.	53
LM End	19.51	Issue Type +	Ma	Location *	LS
Category	Earthen Levee			GPS Latitude/Longitude	
				Start	End
Item	Vegetation			37.111443°	37.113019°
				-120.587718°	-120.586566°
DWR ID	DWR_NA0010_06_s_2024_53				
Comment Code					
V1 : Control annual grass and weeds on the levee slopes and easements.					
Inspector Comment

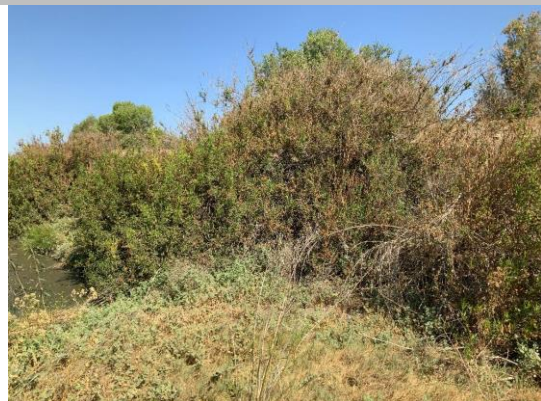
Photo 1 of 2 : UCIP_SP_2024_71141_101579.jpg

Comment Code						
Inspector Comment						
DS_ID:19891 FS_ID:71141 EP_NO: N/A Repair Type: Non-Urgent EVAL Issue: 11, Maintenance Compliance Issue Crossing Status: Found UCIP Comments: 07/12/2021 The record remains Non-Urgent. Limited inspection due to dense vegetation on LS and WS ends, LS headwall just barely visible, recommend removal of vegetation. No permit was found authorizing this encroachment. CVFPB will need to review crossing to determine owner. The UCIP inspection was completed with GEI staff, P. Espinoza. (H. Dunn – GEI) 04/17/2014 Dense vegetation limits the inspector's visibility to identify signs of pipe failure (leaks) along the slopes. Recommend removing vegetation along pipe alignment to conduct proper inspection of structure. (O. Magana - DWR UCIP) FIELD_STRUCT_DESC: 30-inch by 30-inch reinforced concrete box gravity drainage culvert (RCBC) through the levee, 14.0 feet below the crown. Flap gate on the waterside (WS) end. [Additional Reference(s): DWR Levee Log, 2002, (HLM 19.82). USACE San Joaquin O&M Manual, Unit No. 601, Part No. 1, 1967, Amended in 1978, Revised 20 June 1985, (HLM 19.85). DWR As-Built Specification No. 59-01, Sheet No. 73, 10 December 1958, (HLM 19.85)]. FS Date: 7/12/2021

LS view: Dense vegetation over pipe inlet at toe, pipe not visible.

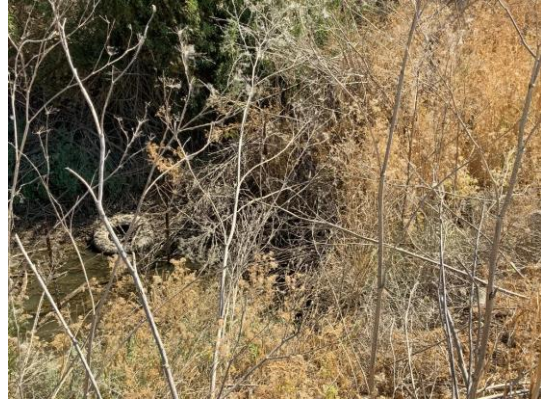
Photo 2 of 2 : UCIP_SP_2024_71141_101584.jpg

WS view: Close up of pipe outlet area covered with vegetation.

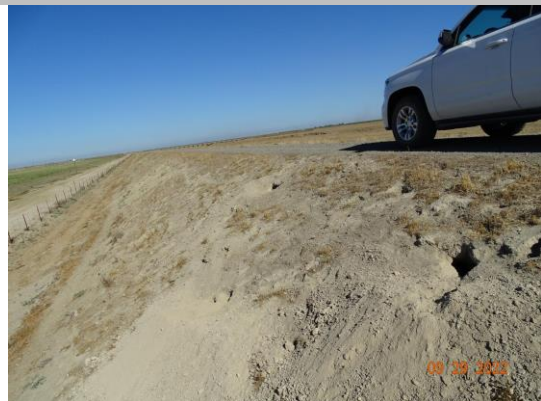
Photo 1 of 1 : SP_2024_NA0010_124_149_20240212_00067.jpg

View of multiple rodent holes on the landside slope. (Fall 2022)

LM Start	21.24	Rating **	M	Issue No.	149
LM End	21.24	Issue Type +	Ma	Location *	LS
Category	Earthen Levee			GPS Latitude/Longitude	
				Start	End
Item	Animal Control			37.108126°	37.108126°
				-120.558461°	-120.558461°
DWR ID	DWR_NA0010_06_f_2022_149				
Comment Code					
A1 : Exterminate rodents and backfill and compact or grout burrows.					
Inspector Comment

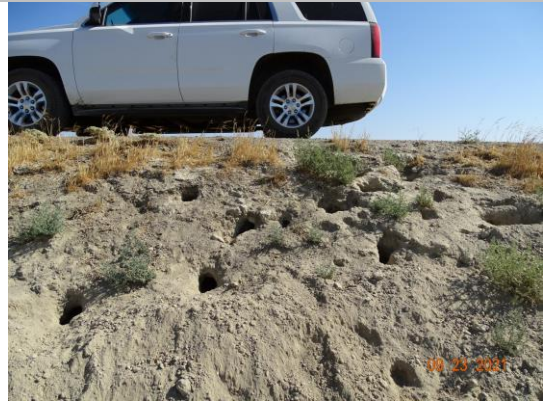
Photo 1 of 1 : SP_2024_NA0010_124_113_20240212_00037.jpg

Several rodent holes observed at this location. (Fall 2021)

LM Start	21.30	Rating **	U	Issue No.	113
LM End	21.30	Issue Type +	Ma	Location *	LS
Category	Earthen Levee			GPS Latitude/Longitude	
				Start	End
Item	Animal Control			37.107502°	37.107502°
				-120.557813°	-120.557813°
DWR ID	DWR_NA0010_06_f_2021_113				
Comment Code					
A3 : No rodents visible, but rodent burrows visible; need to backfill and compact or grout burrows.					
Inspector Comment

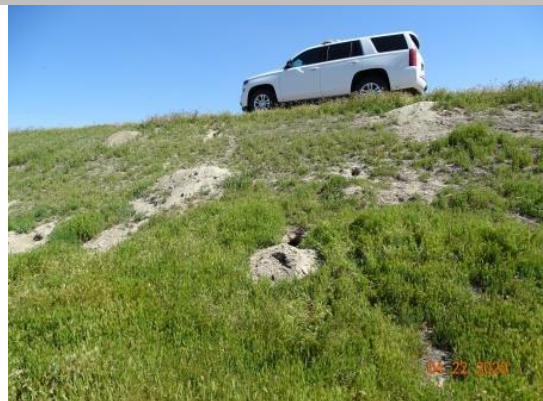
Photo 1 of 1 : SP_2024_NA0010_124_114_20240212_00038.jpg

View of rodent burrows on the landside slope. (Spring 2020)

LM Start	21.39	Rating **	M	Issue No.	114
LM End	21.39	Issue Type +	Ma	Location *	LS
Category	Earthen Levee			GPS Latitude/Longitude	
				Start	End
Item	Animal Control			37.106397°	37.106397°
				-120.556727°	-120.556727°
DWR ID	DWR_NA0010_06_f_2019_114				
Comment Code					
A3 : No rodents visible, but rodent burrows visible; need to backfill and compact or grout burrows.					
Inspector Comment

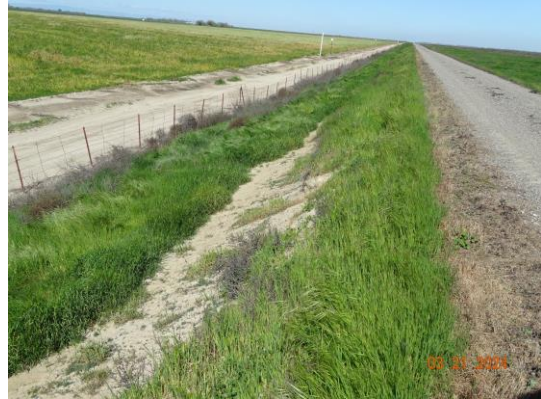
Photo 1 of 1 : SP_2024_NA0010_124_107_20240326_00156.jpg

LM Start	21.71	Rating **	M	Issue No.	107
LM End	21.78	Issue Type +	Ma	Location *	LS
Category	Earthen Levee			GPS Latitude/Longitude	
				Start	End
Item	Erosion / Livestock			37.102844°	37.102002°
				-120.553160°	-120.552314°
DWR ID	DWR_NA0010_06_f_2018_107				
Comment Code					
E4 : Repair the levee slope damaged by livestock and prevent large animal access.					
Inspector Comment					
Erosion into levee prism due to livestock activities.

View of erosion in landside levee prism. (Spring 2024)

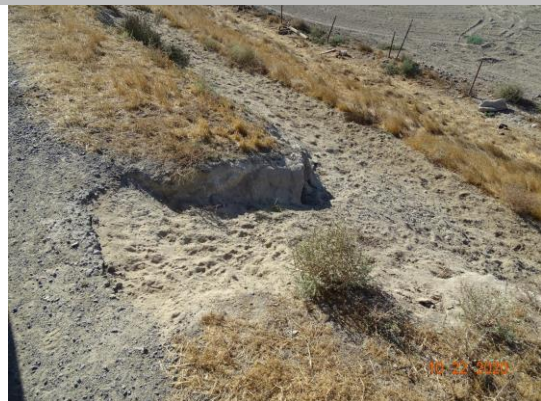
Photo 1 of 1 : SP_2024_NA0010_124_91_20240212_00026.jpg

Cattle trail damage to the landside slope and shoulder. (Fall 2020)

LM Start	21.82	Rating **	M	Issue No.	91
LM End	22.06	Issue Type +	Ma	Location *	LS
Category	Earthen Levee			GPS Latitude/Longitude	
				Start	End
Item	Erosion / Livestock			37.101617°	37.098894°
				-120.551909°	-120.549178°
DWR ID	DWR_NA0010_06_f_2020_91				
Comment Code					
E4 : Repair the levee slope damaged by livestock and prevent large animal access.					
Inspector Comment

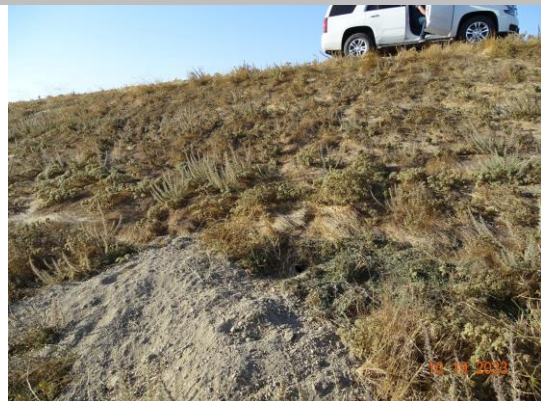
Photo 1 of 1 : SP_2024_NA0010_124_123_20240212_00045.jpg

View of large animal burrow in the landside slope. (Fall 2023)

LM Start	22.00	Rating **	M	Issue No.	123
LM End	22.00	Issue Type +	Ma	Location *	WS
Category	Earthen Levee			GPS Latitude/Longitude	
				Start	End
Item	Animal Control			37.099556°	37.099556°
				-120.549876°	-120.549876°
DWR ID	DWR_NA0010_06_f_2023_123				
Comment Code					
A1 : Exterminate rodents and backfill and compact or grout burrows.					
Inspector Comment

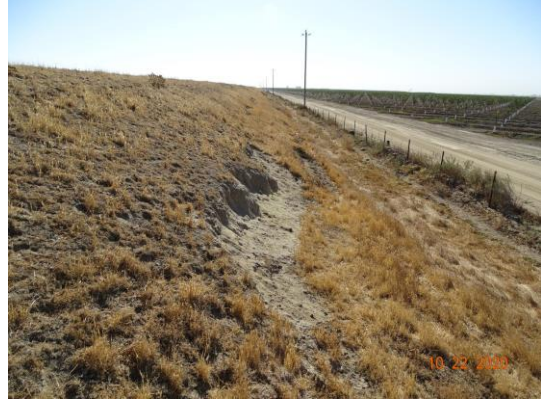
Photo 1 of 1 : SP_2024_NA0010_124_86_20240212_00022.jpg

LM Start	22.09	Rating **	M	Issue No.	86
LM End	22.46	Issue Type +	Ma	Location *	LS
Category	Earthen Levee			GPS Latitude/Longitude	
				Start	End
Item	Erosion / Livestock			37.098524°	37.094479°
				-120.548781°	-120.544435°
DWR ID	DWR_NA0010_06_f_2017_86				
Comment Code					
E4 : Repair the levee slope damaged by livestock and prevent large animal access.					
Inspector Comment					
Erosion greater than 3 inches on landside slope caused by livestock.

Looking upstream along the landside slope. (Fall 2020)

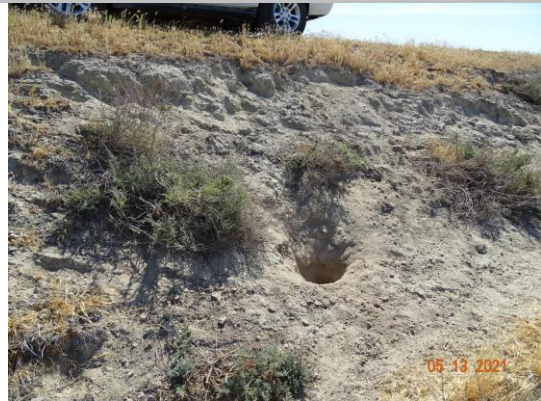
Photo 1 of 1 : SP_2024_NA0010_124_70_20240212_00014.jpg

View of large rodent burrows in the landside slope. (Spring 2021)

LM Start	22.15	Rating **	U	Issue No.	70
LM End	22.15	Issue Type +	Ma	Location *	LS
Category	Earthen Levee			GPS Latitude/Longitude	
				Start	End
Item	Animal Control			37.097885°	37.097885°
				-120.548108°	-120.548108°
DWR ID	DWR_NA0010_06_s_2021_70				
Comment Code					
A3 : No rodents visible, but rodent burrows visible; need to backfill and compact or grout burrows.					
Inspector Comment

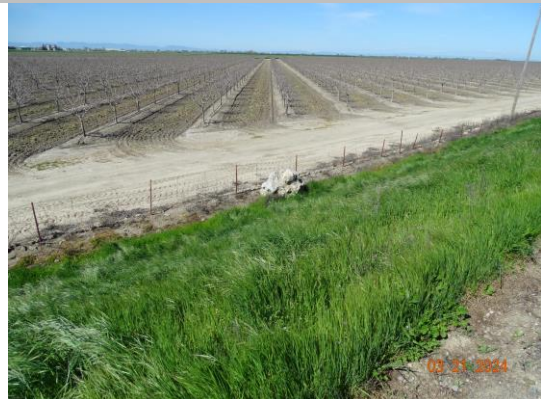
Photo 1 of 1 : SP_2024_NA0010_124_117_20240326_00157.jpg

LM Start	22.87	Rating **	M	Issue No.	117
LM End	22.87	Issue Type +	Ma	Location *	LS
Category	Earthen Levee			GPS Latitude/Longitude	
				Start	End
Item	Encroachments			37.089954°	37.089954°
				-120.539535°	-120.539535°
DWR ID	DWR_NA0010_06_f_2019_117				
Comment Code					
DE : Debris					
Inspector Comment					
Large block of concrete left on the landside toe.

Large concrete block left on the landside toe. (Spring 2024)

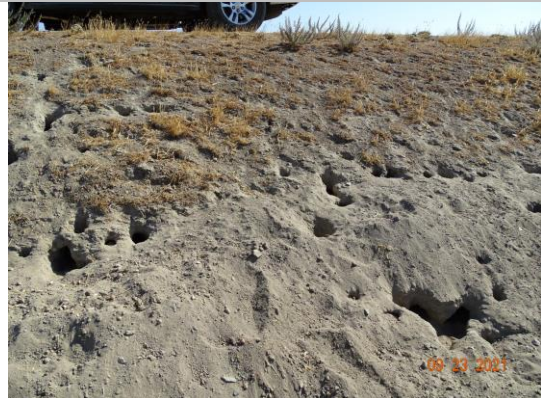
Photo 1 of 1 : SP_2024_NA0010_124_110_20240212_00036.jpg

View of rodent burrows on the landside slope. (Fall 2021)

LM Start	23.11	Rating **	M	Issue No.	110
LM End	23.11	Issue Type +	Ma	Location *	LS
Category	Earthen Levee			GPS Latitude/Longitude	
				Start	End
Item	Animal Control			37.087312°	37.087312°
				-120.536662°	-120.536662°
DWR ID	DWR_NA0010_06_f_2021_110				
Comment Code					
A3 : No rodents visible, but rodent burrows visible; need to backfill and compact or grout burrows.					
Inspector Comment

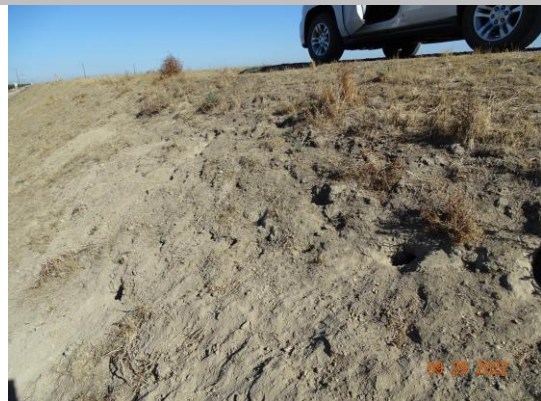
Photo 1 of 1 : SP_2024_NA0010_124_145_20240212_00063.jpg

Several rodent holes observed at this location. (Fall 2022)

LM Start	24.06	Rating **	M	Issue No.	145
LM End	24.06	Issue Type +	Ma	Location *	LS
Category	Earthen Levee			GPS Latitude/Longitude	
				Start	End
Item	Animal Control			37.076933°	37.076933°
				-120.525444°	-120.525444°
DWR ID	DWR_NA0010_06_f_2022_145				
Comment Code					
A3 : No rodents visible, but rodent burrows visible; need to backfill and compact or grout burrows.					
Inspector Comment

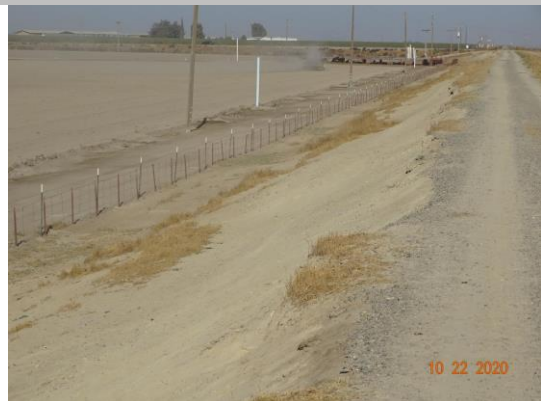
Photo 1 of 1 : SP_2024_NA0010_124_5_20240212_00006.jpg

LM Start	24.36	Rating **	U	Issue No.	5
LM End	25.01	Issue Type +	Ma	Location *	LS
Category	Earthen Levee			GPS Latitude/Longitude	
				Start	End
Item	Erosion / Livestock			37.073621°	37.066501°
				-120.521848°	-120.514193°
DWR ID	DWR_NA0010_06_s_2012_5				
Comment Code					
E4 : Repair the levee slope damaged by livestock and prevent large animal access.					
Inspector Comment					
Landside erosion and slope instability caused by livestock extends into levee crown. At the worst locations erosion extends 2.5 feet to 3 feet from the shoulder into the crown.

Looking downstream at erosion from livestock. (Fall 2020)

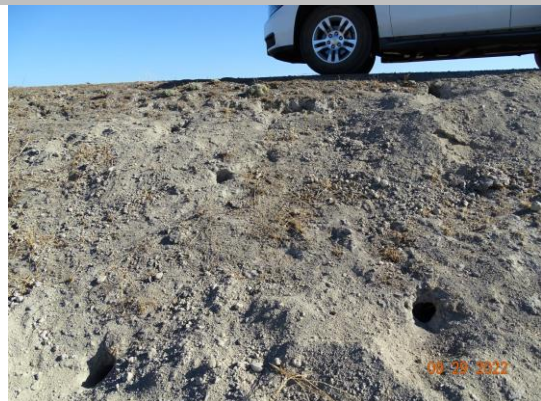
Photo 1 of 1 : SP_2024_NA0010_124_140_20240212_00058.jpg

View of multiple animal holes in the landside slope. (Fall 2022)

LM Start	26.37	Rating **	A/W	Issue No.	140
LM End	26.37	Issue Type +	Ma	Location *	LS
Category	Earthen Levee			GPS Latitude/Longitude	
				Start	End
Item	Animal Control			37.051751°	37.051751°
				-120.497801°	-120.497801°
DWR ID	DWR_NA0010_06_f_2022_140				
Comment Code					
A3 : No rodents visible, but rodent burrows visible; need to backfill and compact or grout burrows.					
Inspector Comment

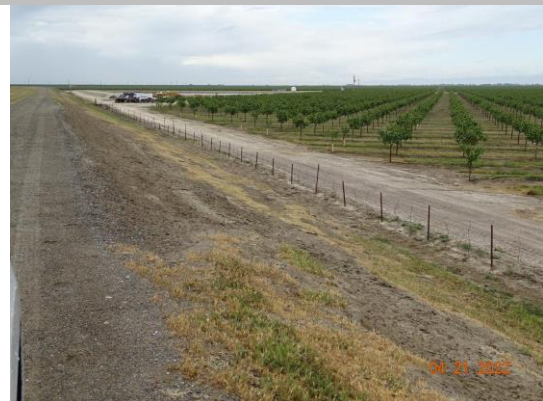
Photo 1 of 1 : SP_2024_NA0010_124_3_20240212_00005.jpg

LM Start	27.43	Rating **	U	Issue No.	3
LM End	27.99	Issue Type +	Ma	Location *	LS
Category	Earthen Levee			GPS Latitude/Longitude	
				Start	End
Item	Erosion / Livestock			37.036955°	37.032762°
				-120.484395°	-120.481078°
DWR ID	DWR_NA0010_06_s_2012_3				
Comment Code					
E4 : Repair the levee slope damaged by livestock and prevent large animal access.					
Inspector Comment					
Landside erosion and slope instability caused by livestock. Erosion greater than 3" in depth on landside slope. Levee crown has narrowed within this reach.

Looking south along landside slope. (Spring 2022)

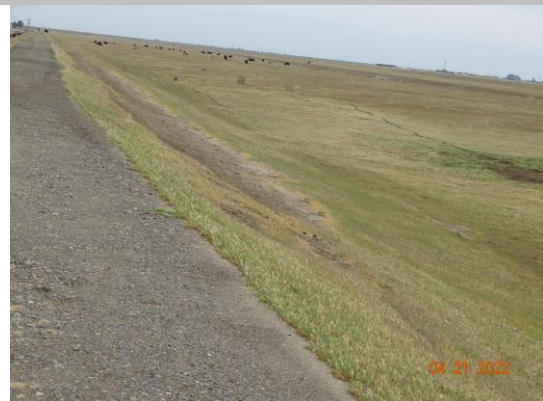
Photo 1 of 1 : SP_2024_NA0010_124_132_20240212_00051.jpg

View of erosion on the waterside slope. (Spring 2022)

LM Start	27.65	Rating **	M	Issue No.	132
LM End	27.93	Issue Type +	Ma	Location *	WS
Category	Earthen Levee			GPS Latitude/Longitude	
				Start	End
Item	Erosion / Livestock			37.036856°	37.033468°
				-120.484309°	-120.481709°
DWR ID	DWR_NA0010_06_s_2022_132				
Comment Code					
E4 : Repair the levee slope damaged by livestock and prevent large animal access.					
Inspector Comment

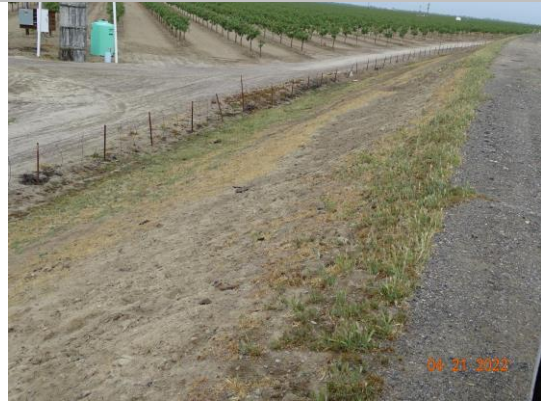
Photo 1 of 1 : SP_2024_NA0010_124_131_20240212_00050.jpg

View of damage to the landside slope. (Spring 2022)

LM Start	28.18	Rating **	A/W	Issue No.	131
LM End	28.18	Issue Type +	Ma	Location *	LS
Category	Earthen Levee			GPS Latitude/Longitude	
				Start	End
Item	Erosion / Livestock			37.030925°	37.030925°
				-120.478368°	-120.478368°
DWR ID	DWR_NA0010_06_s_2022_131				
Comment Code					
E4 : Repair the levee slope damaged by livestock and prevent large animal access.					
Inspector Comment

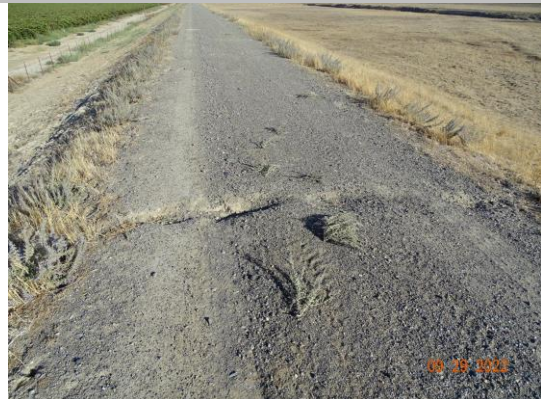
LM Start	0.00	Rating **	A	Issue No.	1185	
LM End	0.00	Issue Type +	Ma	Location *		
Category	Supplemental			GPS Latitude/Longitude		
				Start	End	
Item	DWR UCIP LMA Responsibility			37.348637°	37.348637°	
				-120.958834°	-120.958834°	
DWR ID	19650

Waterway	Bank	Unit Miles	Inspection Start/End	Inspector
Unit No. 01 San Joaquin River	Right	22.52	03/12/2024 03/12/2024	Corey Fujitani

Photo 1 of 3 : UCIP_SP_2024_70636_92086.jpg

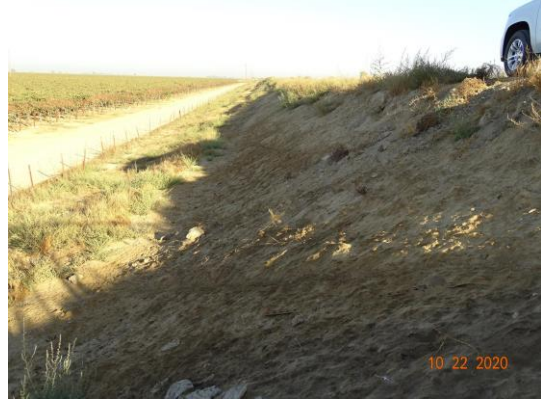
Photo 2 of 3 : UCIP_SP_2024_70636_92088.jpg

LM Start	0.00	Rating **	A	Issue No.	1185 (cont)
LM End	0.00	Issue Type +	Ma	Location *	
Category	Supplemental			GPS Latitude/Longitude	
				Start	End
Item	DWR UCIP LMA Responsibility			37.348637°	37.348637°
				-120.958834°	-120.958834°
DWR ID	19650

LS view: overview of LS, dense vegetation on slope and levee toe.

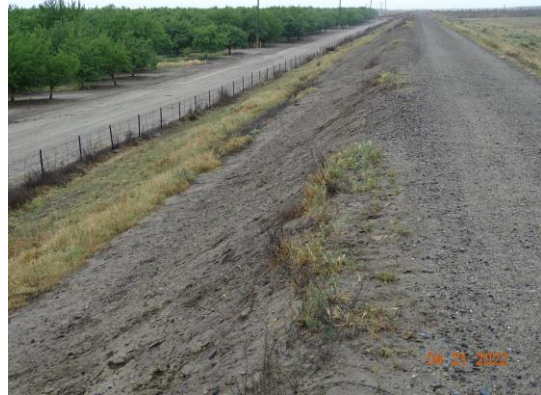
Maintenance Issue Types Only, Levee Inspection Report By Mile - Spring 2024

**Flood Control Project Maintenance
Levee Inspections**

Waterway	Bank	Unit Miles	Inspection Start/End	Inspector
Unit No. 01 San Joaquin River	Right	22.52	03/12/2024 03/12/2024	Corey Fujitani

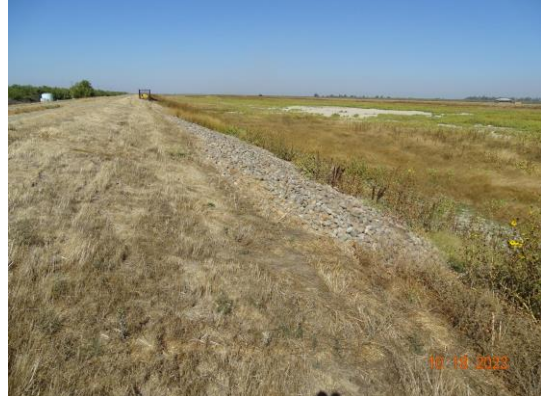
LM Start	0.34	Rating **	M	Issue No.	1186
LM End	0.34	Issue Type +	Ma	Location *	
Category	Supplemental			GPS Latitude/Longitude	
				Start	End
Item	DWR UCIP LMA Responsibility			37.344705°	37.344705°
				-120.962176°	-120.962176°
DWR ID	19651

Photo 1 of 3 : UCIP_SP_2024_70637_90529.jpg

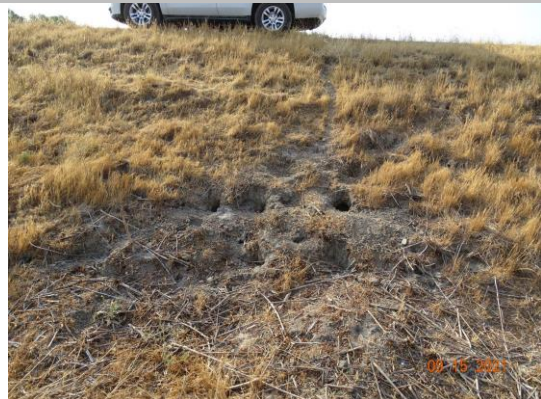
Photo 1 of 1 : SP_2024_NA0010_118_95_20240212_00005.jpg

LM Start	0.36	Rating **	M	Issue No.	95
LM End	0.36	Issue Type +	Ma	Location *	LS
Category	Earthen Levee			GPS Latitude/Longitude	
				Start	End
Item	Animal Control			37.344312°	37.344312°
				-120.962361°	-120.962361°
DWR ID	DWR_NA0010_01_f_2020_95				
Comment Code					
A3 : No rodents visible, but rodent burrows visible; need to backfill and compact or grout burrows.					
Inspector Comment

Several rodent holes observed in the landside slope. (Fall 2020)

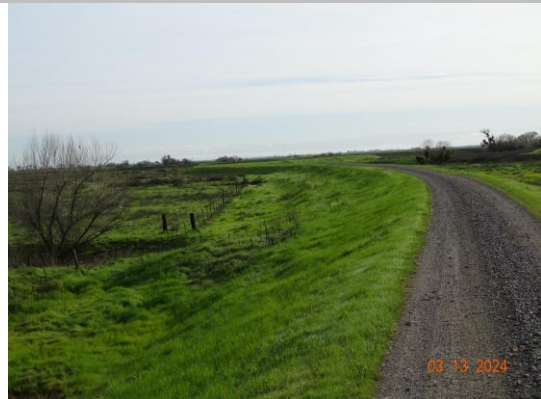
Photo 1 of 1 : SP_2024_NA0010_118_97_20240212_00006.jpg

LM Start	0.45	Rating **	M	Issue No.	97
LM End	0.45	Issue Type +	Ma	Location *	WS
Category	Earthen Levee			GPS Latitude/Longitude	
				Start	End
Item	Animal Control			37.343243°	37.343243°
				-120.962159°	-120.962159°
DWR ID	DWR_NA0010_01_s_2021_97				
Comment Code					
A1 : Exterminate rodents and backfill and compact or grout burrows.					
Inspector Comment

View of rodent burrows in the waterside slope. (Spring 2021)

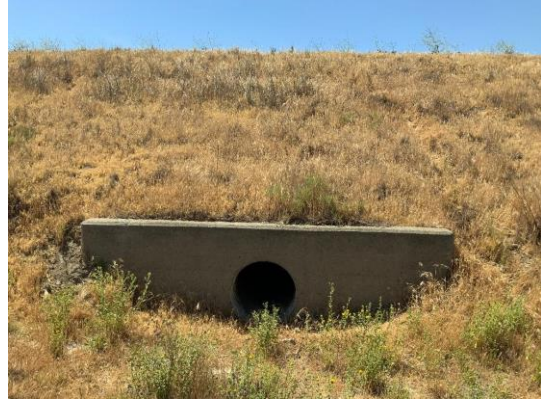
Photo 1 of 3 : UCIP_SP_2024_83224_90537.jpg

Comment Code						
Inspector Comment						
DS_ID:19583 FS_ID:83224 EP_NO: N/A Repair Type: Non-Urgent EVAL Issue: Crossing Status: Found UCIP Comments: 04/23/2024 Record updated from Non-Urgent to No Action Needed. DMP internal video inspection has found none or minor pipe defects. (M. Thao - DWR UCIP) 10/06/2020 Record remains Non-Urgent. No permit was found authorizing this encroachment. Rodent activity found near pipe location. CVFPB will need to review crossing to determine owner. DWR DMP has not found internal issues, LOF between 1 and 2. Recommend inspection in 5 years. (B. Singh - GEI, O. Magana - DWR UCIP) 04/08/2014 Recommend removing vegetation pile from waterward toe. (W. Wylie - DWR UCIP) FIELD_STRUCT_DESC: 24-inch corrugated metal (CM) gravity drainage pipe through the levee, 8.5 feet below the crown. Flap gate on the waterside (WS) end. Brass cap No. 108 bench mark (BM) on the headwall on the landside (LS). [Additional Reference(s): DWR Levee Log, 2002, (HLM 0.62). USACE San Joaquin O&M Manual, Unit No. 601, Part No. 1, (SJR601.1), 1967, Revised 25 May 2011, (HLM 0.62)]. FS Date: 10/6/2020

Overview of levee crown, looking US

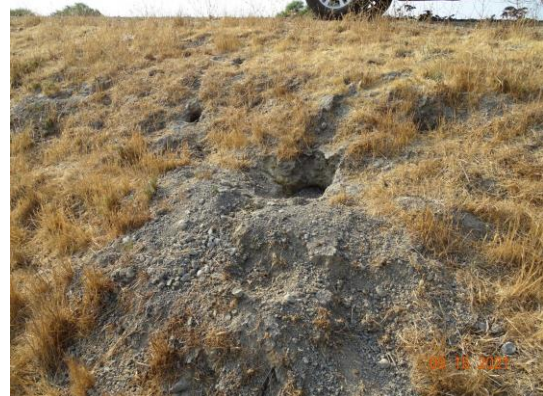
Comment Code

LM Start	0.85	Rating **	M	Issue No.	1188
LM End	0.85	Issue Type +	Ma	Location *	
Category	Supplemental			GPS Latitude/Longitude	
				Start	End
Item	DWR UCIP LMA Responsibility			37.339829°	37.339829°
				-120.958621°	-120.958621°
DWR ID	19584

DS_ID:19584
 FS_ID:70639
 EP_NO: N/A
 Repair Type: Non-Urgent
 EVAL Issue:
 Crossing Status: Found
 UCIP Comments: 10/06/2020 Record has been updated from No Action Needed to Non-Urgent. No permit was found authorizing this encroachment. CVFPB will need to review crossing to determine owner. Rodent activity found near this stretch of levee. DWR DMP has not found internal issues, LOF between 1 and 2. Recommend inspection in 5 years. (B. Singh - GEI, O. Magana - DWR UCIP)
 FIELD_STRUCT_DESC: 24-inch corrugated metal (CM) gravity drainage pipe through the levee, 7.0 feet below the crown. Flap gate on the waterside (WS) end. Brass cap No. 108 bench mark (BM) on the headwall on the landside (LS). [Additional Reference(s): DWR Levee Log, 2002, (HLM 0.88). USACE San Joaquin O&M Manual, Unit No. 601, Part No. 1, (SJR601.1), 1967, Revised 25 May 2011, (HLM 0.87)].
 FS Date: 10/6/2020

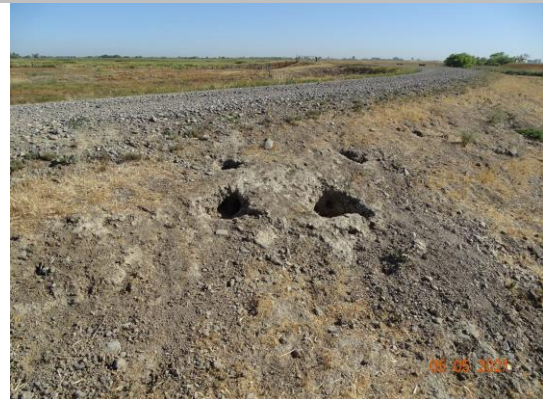
Photo 1 of 3 : UCIP_SP_2024_70639_90541.jpg

* Location	** Rating	+ Issue Type
LS: Land Side WS: Water Side CR: Crown	A: Acceptable M: Minimally Acceptable U: Unacceptable	Ma: Maintenance Deficiency Ob: Design & System Obsolescence En: Enforcement
N/A: Not Applicable	N: Not Inspected/Rated C: Corrected A/W: Acceptable but Monitor & Maintain

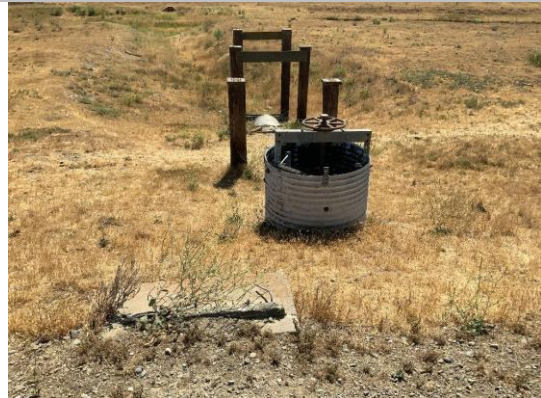
**Flood Control Project Maintenance
Levee Inspections****Maintenance Issue Types Only, Levee Inspection Report By Mile - Spring 2024****Lower San Joaquin Levee District**

LM Start	0.85	Rating **	M	Issue No.	1188 (cont)
LM End	0.85	Issue Type +	Ma	Location *

LM Start	0.93	Rating **	A	Issue No.	1189
LM End	0.93	Issue Type +	Ma	Location *	
Category	Supplemental			GPS Latitude/Longitude	
				Start	End
Item	DWR UCIP LMA Responsibility			37.339598°	37.339598°
				-120.957202°	-120.957202°
DWR ID	19585

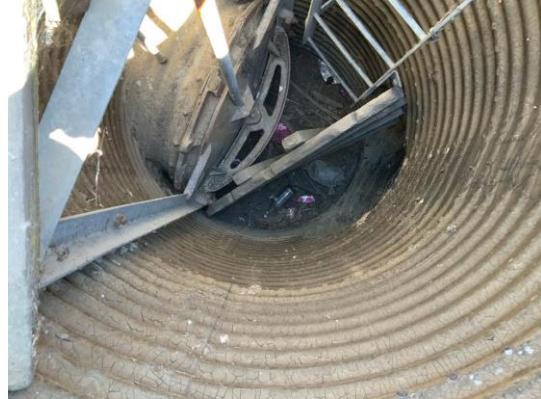
Waterway	Bank	Unit Miles	Inspection Start/End	Inspector
Unit No. 01 San Joaquin River	Right	22.52	03/12/2024 03/12/2024	Corey Fujitani

**Flood Control Project Maintenance
Levee Inspections****Maintenance Issue Types Only, Levee Inspection Report By Mile - Spring 2024****Lower San Joaquin Levee District**

Photo 2 of 3 : UCIP_SP_2024_83233_90550.jpg

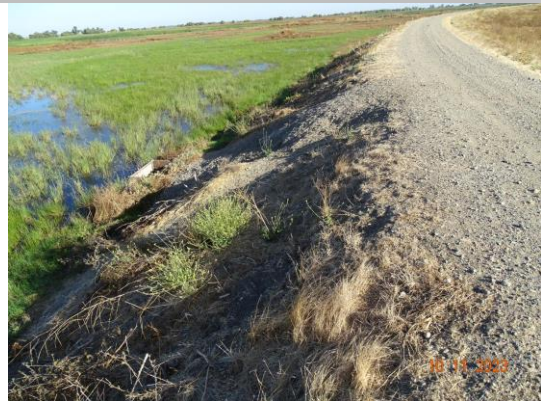
Overview of levee crown, looking US

Photo 3 of 3 : UCIP_SP_2024_83233_90552.jpg

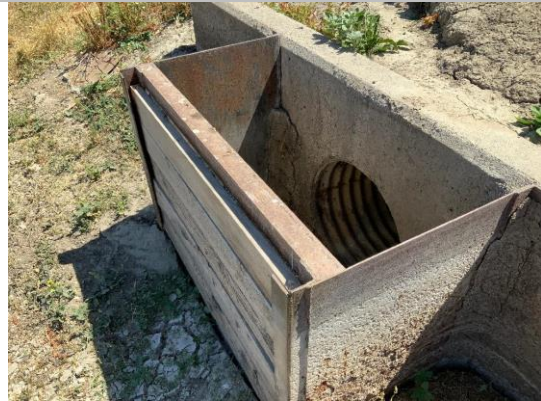
Photo 2 of 3 : UCIP_SP_2024_83235_90553.jpg

Photo 1 of 3 : UCIP_SP_2024_83235_90554.jpg

Pipe, flapgate and headwall on WS toe

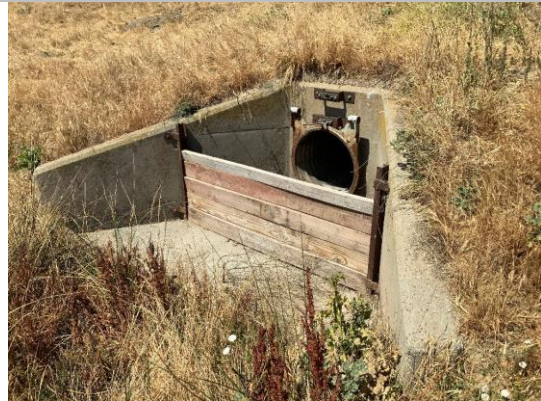
LM Start	1.32	Rating **	A	Issue No.	1191
LM End	1.32	Issue Type +	Ma	Location *	
Category	Supplemental			GPS Latitude/Longitude	
				Start	End
Item	DWR UCIP LMA Responsibility			37.337361°	37.337361°
				-120.950879°	-120.950879°
DWR ID	19587

Headwall and pipe at LS toe

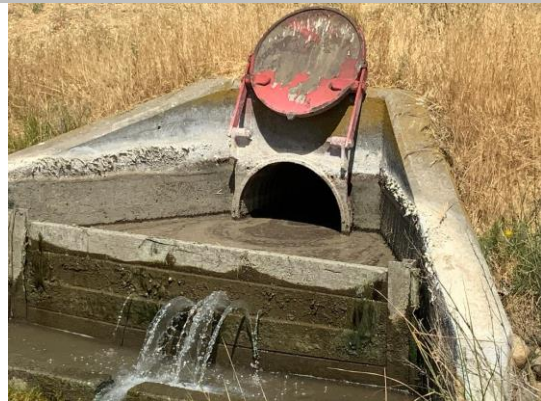
Photo 3 of 3 : UCIP_SP_2024_71169_99470.jpg

Comment Code						
Inspector Comment						
DS_ID:19896 FS_ID:71169 EP_NO: N/A Repair Type: Non-Urgent EVAL Issue: 5, Pipe Damage Crossing Status: Found UCIP Comments: 05/04/2023 Enforcement Case No. 2023-15633 was issued to this crossing for unauthorized modifications that include: Cutting out the pipe to install a concrete riser with water meter inside, adding flashboards and metal brackets to landside and waterside concrete headwalls. (O.Yakimov - DWR UCIP) 06/2/2021 Record remains Non-Urgent. Limited inspection due to water flowing through the pipe during inspection. At the time of inspection, the wooden flashboards were not in place on the LS end. DMP internal video inspection has found moderate pipe defects. Crossing will be monitored until funding becomes available for rehabilitation. The UCIP inspection was completed with GEI staff, P. Espinoza. (H. Dunn – GEI) 04/15/2014 Need to contact owner. Heavy sediment buildup at inlet due to animal activity should be cleared. (W. Wylie - DWR UCIP) FIELD_STRUCT_DESC: 24-inch corrugated metal gravity drainage pipe (CMP) through the levee, 9.8 feet below the crown. Flap gate on the waterside (WS) end. Wooden weir on a concrete headwall at the landside (LS) toe. 36-inch concrete riser unit at the LS toe. Concrete U-shaped headwall on the WS end. Concrete standpipe on the LS. [Additional Reference(s): DWR Levee Log, 2002, (HLM 0.86). USACE San Joaquin O&M Manual, Unit No. 601, Part No. 1, 1967, Amended in 1978, Revised 20 June 1985, (HLM 0.85). DWR As-Built Specification No. 63-25, Sheet No. 11, 9 May 1963, (HLM 0.85)]. FS Date: 6/2/2021

WS view: Close up of flapgate at toe.

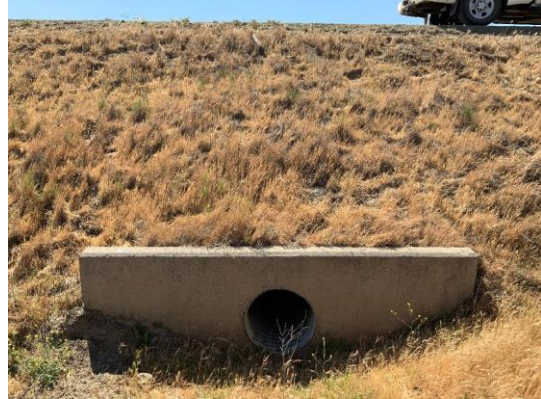
Photo 1 of 3 : UCIP_SP_2024_71170_99472.jpg

Comment Code						
Inspector Comment						
DS_ID:19897 FS_ID:71170 EP_NO: N/A Repair Type: Non-Urgent EVAL Issue: Crossing Status: Found UCIP Comments: 06/2/2021 The record has been upgraded from No Action Needed to Non-Urgent. DWR DMP internal inspection has not found pipe integrity issues. LOF of crossing is less or equal to 4.0. Recommend next video inspection in 5 years. No permit was found authorizing this encroachment. CVFPB will need to review crossing to determine owner. The UCIP inspection was completed with GEI staff, P. Espinoza. (H. Dunn – GEI) FIELD_STRUCT_DESC: 24-inch corrugated metal gravity drainage pipe (CMP) through the levee, 11.5 feet below the crown. Flap gate on the waterside (WS) end. Concrete headwall on the landside (LS) end. Concrete U-shaped headwall on the WS end. [Additional Reference(s): DWR Levee Log, 2002, (HLM 0.94). USACE San Joaquin O&M Manual, Unit No. 601, Part No. 1, 1967, Amended in 1978, Revised 20 June 1985, (HLM 0.94). DWR As-Built Specification No. 63-25, Sheet No. 11, 9 May 1963, (HLM 0.94)]. FS Date: 6/2/2021

LS view: Slope and headwall at toe.

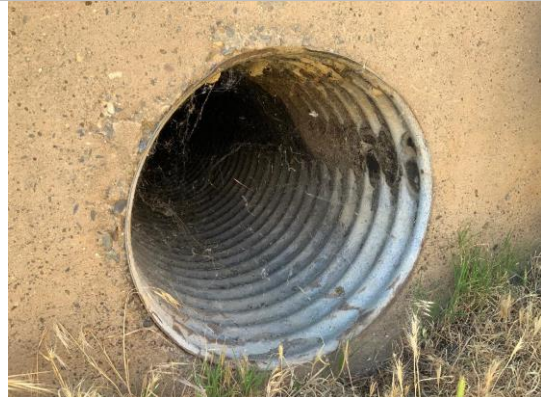
Photo 2 of 3 : UCIP_SP_2024_71170_99473.jpg

LS view: Close up of pipe inlet.

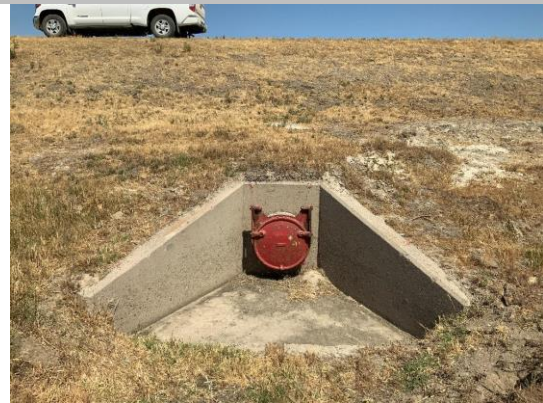
Photo 3 of 3 : UCIP_SP_2024_71170_99476.jpg

WS view: Slope, headwall, and flapgate at toe.

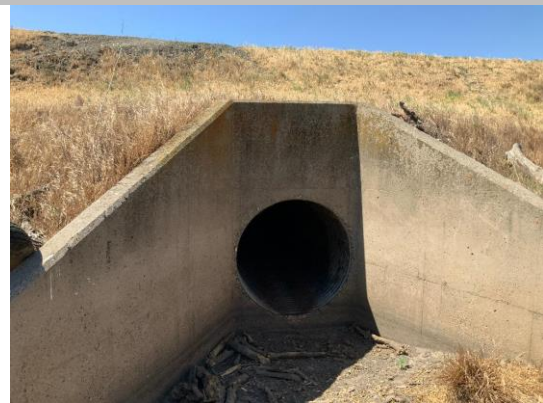
Photo 1 of 3 : UCIP_SP_2024_81167_99483.jpg

DS_ID:19898
 FS_ID:81167
 EP_NO: N/A
 Repair Type: No Action Needed
 EVAL Issue:
 Crossing Status: Found
 UCIP Comments: 09/25/2023 DMP internal video inspection has found none or minor pipe defects. Recommend next video inspection in 5 years. (J. Taylor - DWR UCIP)06/2/2021 The record has been upgraded from No Action Needed to Non-Urgent. No permit was found authorizing this encroachment. CVFPB will need to review crossing to determine owner. The UCIP inspection was completed with GEI staff, P. Espinoza. (H. Dunn – GEI)
 FIELD_STRUCT_DESC: 48-inch CIPP lined corrugated metal gravity drainage pipe (CMP) through the levee, 14.6 feet below the crown. Flap gate on the waterside (WS) end. Concrete U-shaped headwall on each end. [Additional Reference(s): DWR Levee Log, 2002, (HLM 1.17). USACE San Joaquin O&M Manual, Unit No. 601, Part No. 1, 1967, Amended in 1978, Revised 20 June 1985, (HLM 1.17). DWR As-Built Specification No. 63-25, Sheet No. 11, 9 May 1963, (HLM 1.17)].

LS view: Slope and headwall at toe.

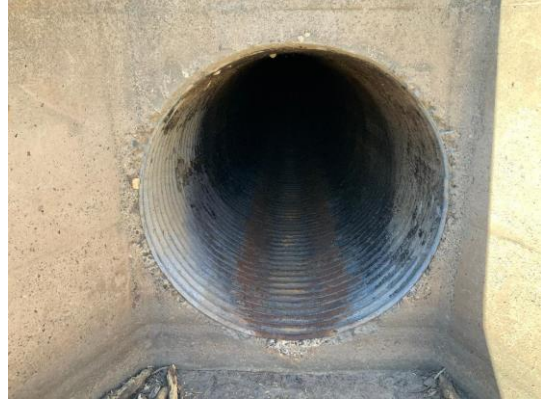
Photo 2 of 3 : UCIP_SP_2024_81167_99484.jpg

LS view: Close up of pipe inlet at toe.

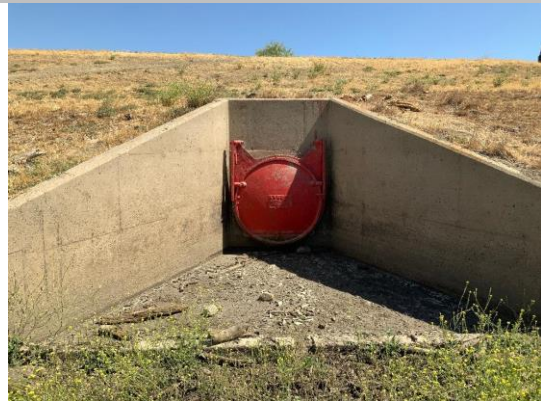
Photo 3 of 3 : UCIP_SP_2024_81167_99479.jpg

WS view: Slope, headwall, and flapgate at toe.

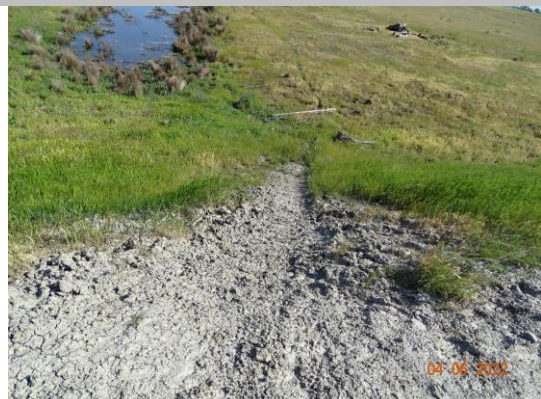
Photo 1 of 1 : SP_2024_NA0010_125_25_20240212_00011.jpg

Looking down the landside slope at erosion from livestock traffic. (Spring 2022)

LM Start	1.24	Rating **	A/W	Issue No.	25
LM End	1.24	Issue Type +	Ma	Location *	LS
Category	Earthen Levee			GPS Latitude/Longitude	
				Start	End
Item	Erosion / Livestock			37.264365°	37.264365°
				-120.755358°	-120.755358°
DWR ID	DWR_NA0010_07_s_2022_25				
Comment Code					
E4 : Repair the levee slope damaged by livestock and prevent large animal access.					
Inspector Comment

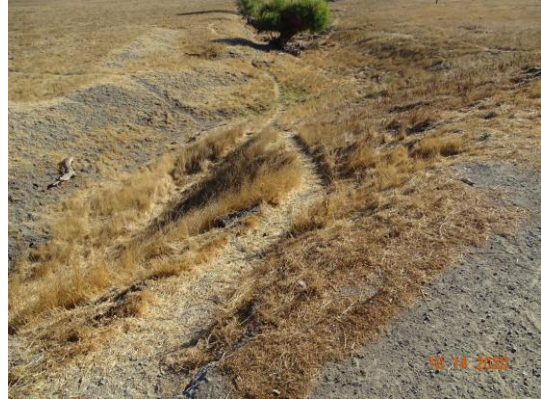
Photo 1 of 1 : SP_2024_NA0010_125_16_20240212_00004.jpg

LM Start	1.49	Rating **	A/W	Issue No.	16
LM End	1.49	Issue Type +	Ma	Location *	LS
Category	Earthen Levee			GPS Latitude/Longitude	
				Start	End
Item	Erosion / Livestock			37.263999°	37.263999°
				-120.750854°	-120.750854°
DWR ID	DWR_NA0010_07_f_2017_16				
Comment Code					
E4 : Repair the levee slope damaged by livestock and prevent large animal access.					
Inspector Comment					
Monitor the slope damaged by animal traffic.

Cattle trail on the landside slope. (Fall 2020)

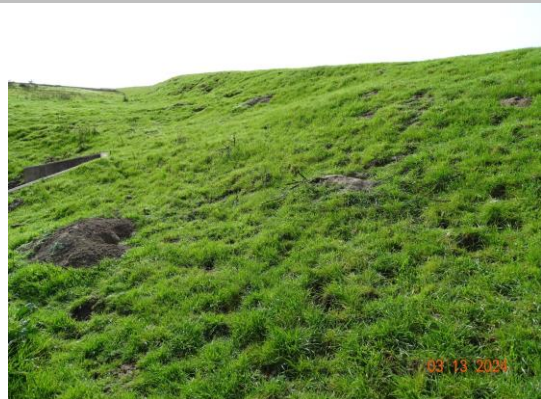
Photo 1 of 1 : SP_2024_NA0010_125_6_20240326_00047.jpg

View of rodent holes on the landside slope. (Spring 2024)

LM Start	1.50	Rating **	M	Issue No.	6
LM End	1.51	Issue Type +	Ma	Location *	LS
Category	Earthen Levee			GPS Latitude/Longitude	
				Start	End
Item	Animal Control			37.263955°	37.263885°
				-120.750751°	-120.750527°
DWR ID	DWR_NA0010_07_s_2014_6				
Comment Code					
A1 : Exterminate rodents and backfill and compact or grout burrows.					
Inspector Comment

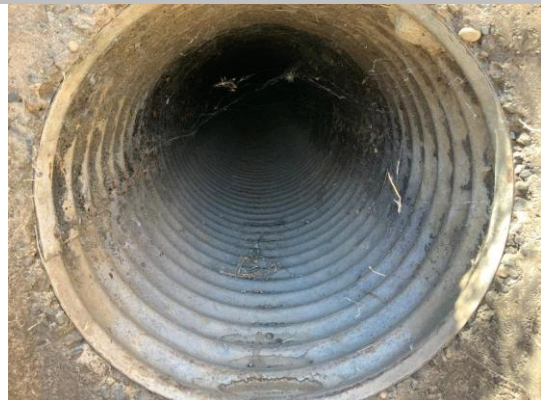
Photo 2 of 3 : UCIP_SP_2024_71172_99487.jpg

LS view: Close up of pipe inlet at toe.
