**Flood Control Project Maintenance
Levee Inspections**

Maintenance Issue Types Only, Levee Inspection Report By Mile - Spring 2024

Lower San Joaquin Levee District

Waterway	Bank	Unit Miles	Inspection Start/End	Inspector
Unit No. 01 San Joaquin River	Right	22.52	03/12/2024 03/12/2024	Corey Fujitani

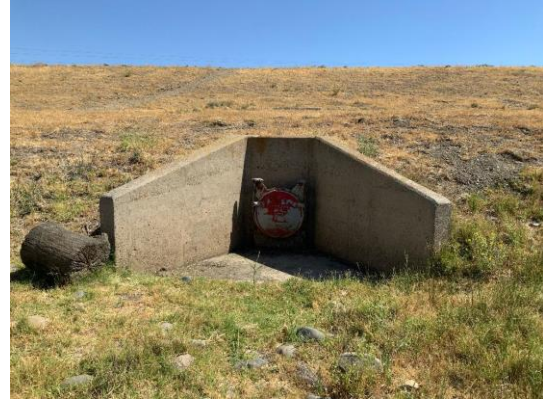
Photo 3 of 3 : UCIP_SP_2024_71172_99489.jpg

WS view: Slope, headwall, and flapgate at toe.

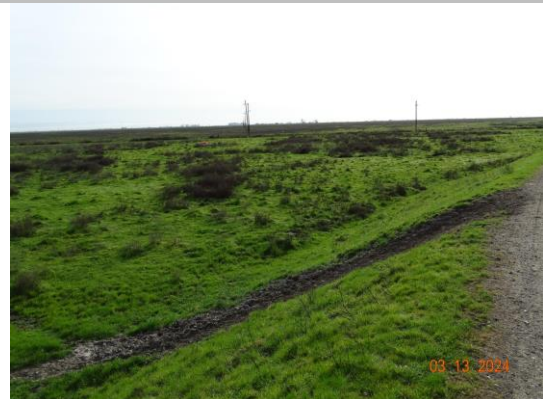
Photo 1 of 1 : SP_2024_NA0010_125_21_20240326_00048.jpg

View of damage to the landside slope. (Spring 2024)

LM Start	1.90	Rating **	M	Issue No.	21
LM End	1.90	Issue Type +	Ma	Location *	LS
Category	Earthen Levee			GPS Latitude/Longitude	
				Start	End
Item	Erosion / Livestock			37.261379°	37.261379°
				-120.744228°	-120.744228°
DWR ID	DWR_NA0010_07_f_2018_21				
Comment Code					
E4 : Repair the levee slope damaged by livestock and prevent large animal access.					
Inspector Comment

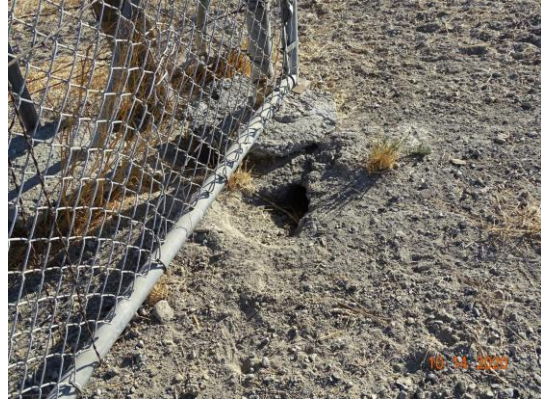
Photo 1 of 1 : SP_2024_NA0010_125_12_20240212_00002.jpg

View of rodent hole at the fence post on the landside shoulder. (Fall 2020)

LM Start	2.09	Rating **	A/W	Issue No.	12
LM End	2.09	Issue Type +	Ma	Location *	LS
Category	Earthen Levee			GPS Latitude/Longitude	
				Start	End
Item	Animal Control			37.259187°	37.259187°
				-120.742551°	-120.742551°
DWR ID	DWR_NA0010_07_f_2018_12				
Comment Code					
A3 : No rodents visible, but rodent burrows visible; need to backfill and compact or grout burrows.					
Inspector Comment

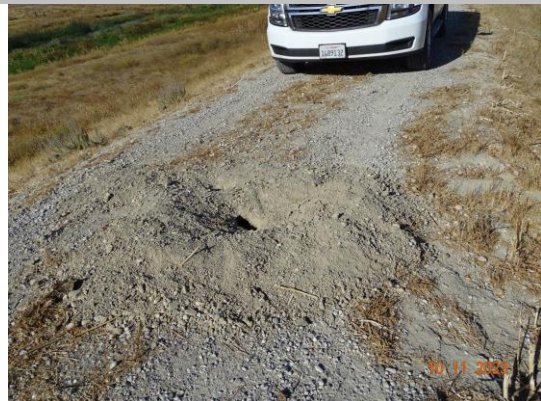
Photo 1 of 1 : SP_2024_NA0010_125_15_20240212_00003.jpg

LM Start	2.17	Rating **	A/W	Issue No.	15
LM End	2.17	Issue Type +	Ma	Location *	CR
Category	Earthen Levee			GPS Latitude/Longitude	
				Start	End
Item	Animal Control			37.258774°	37.258774°
				-120.741236°	-120.741236°
DWR ID	DWR_NA0010_07_f_2023_15				
Comment Code					
A3 : No rodents visible, but rodent burrows visible; need to backfill and compact or grout burrows.					
Inspector Comment					
Rodent holes with large amount of material displaced in the levee crown.

View of rodent hole with significant material displaced in the levee crown. (Fall 2023)

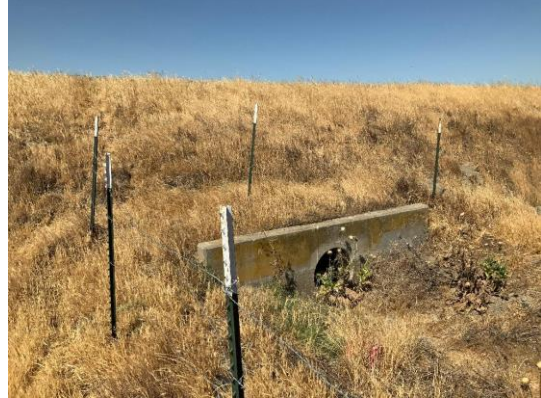
Photo 1 of 3 : UCIP_SP_2024_71173_99499.jpg

Comment Code						
Inspector Comment						
DS_ID:19899 FS_ID:71173 EP_NO: N/A Repair Type: Non-Urgent EVAL Issue: Crossing Status: Found UCIP Comments: 06/2/2021 The record has been upgraded from No Action Needed to Non-Urgent. LS pipe end surrounded by barbed wire, could not inspect closely. Metal pipe and plastic riser with flowmeter off the LS toe. DWR DMP internal inspection has not found pipe integrity issues. LOF of crossing is less or equal to 4.0. Recommend next video inspection in 5 years. No permit was found authorizing this encroachment. CVFPB will need to review crossing to determine owner. The UCIP inspection was completed with GEI staff, P. Espinoza. (H. Dunn – GEI) FIELD_STRUCT_DESC: 24-inch corrugated metal gravity drainage pipe (CMP) through the levee, 9.5 feet below the crown. Flap gate on the waterside (WS) end. Concrete headwall on the landside (LS) end. Concrete U-shaped headwall on the WS end. [Additional Reference(s): DWR Levee Log, 2002, (HLM 2.49). USACE San Joaquin O&M Manual, Unit No. 601, Part No. 1, 1967, Amended in 1978, Revised 20 June 1985, (HLM 2.48). DWR As-Built Specification No. 63-25, Sheet No. 12, 9 May 1963, (HLM 2.48)]. FS Date: 6/2/2021

LS view: Slope and headwall at toe.

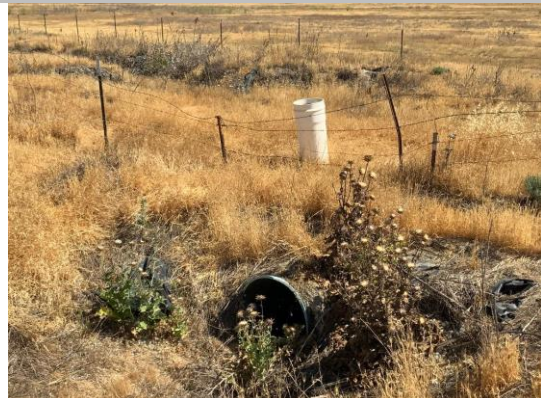
Photo 2 of 3 : UCIP_SP_2024_71173_99493.jpg

LS view: Pipe inlet and riser with flowmeter off toe.

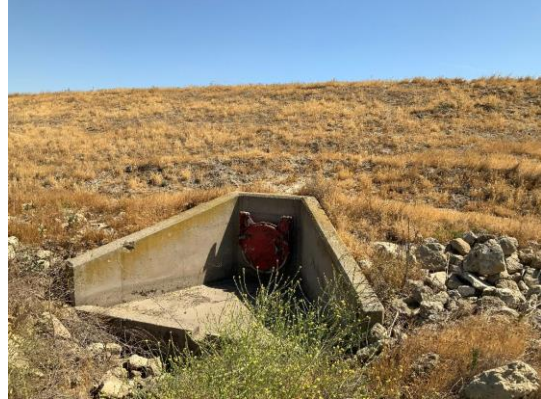
Photo 3 of 3 : UCIP_SP_2024_71173_99495.jpg

WS view: Slope, headwall, and flapgate at toe.

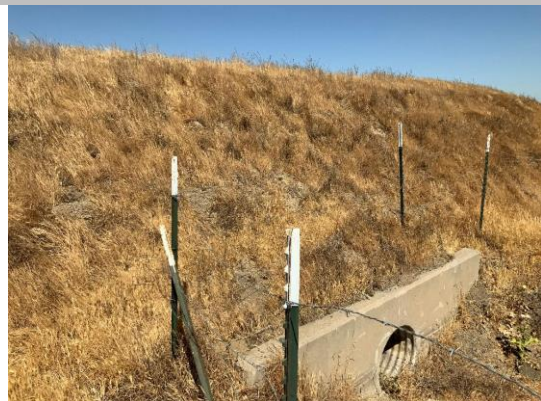
Photo 1 of 3 : UCIP_SP_2024_71174_99502.jpg

DS_ID:19900
 FS_ID:71174
 EP_NO: N/A
 Repair Type: Non-Urgent
 EVAL Issue:
 Crossing Status: Found
 UCIP Comments: 06/2/2021 The record has been upgraded from No Action Needed to Non-Urgent. LS pipe end surrounded by barbed wire, inspection was limited. No permit was found authorizing this encroachment. CVFPB will need to review crossing to determine owner. The UCIP inspection was completed with GEI staff, P. Espinoza. (H. Dunn – GEI)
 FIELD_STRUCT_DESC: 24-inch corrugated metal gravity drainage pipe (CMP) through the levee, 11.5 feet below the crown. Flap gate on the waterside (WS) end. Concrete headwall on the landside (LS) end. Concrete U-shaped headwall on the WS end. [Additional Reference(s): DWR Levee Log, 2002, (HLM 2.65). USACE San Joaquin O&M Manual, Unit No. 601, Part No. 1, 1967, Amended in 1978, Revised 20 June 1985, (HLM 2.64). DWR As-Built Specification No. 63-25, Sheet No. 12, 9 May 1963, (HLM 2.64)].

LS view: Slope and headwall at toe.

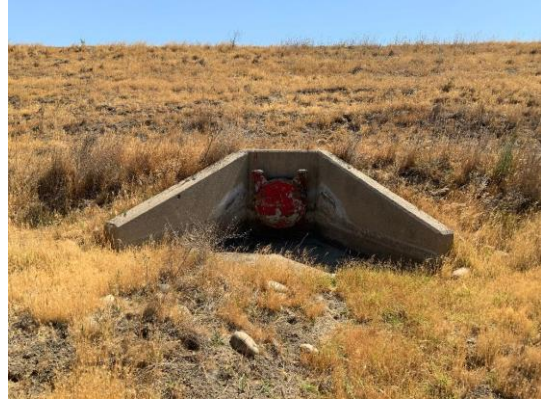
Photo 2 of 3 : UCIP_SP_2024_71174_99505.jpg

WS view: Slope, headwall, and flapgate at toe.

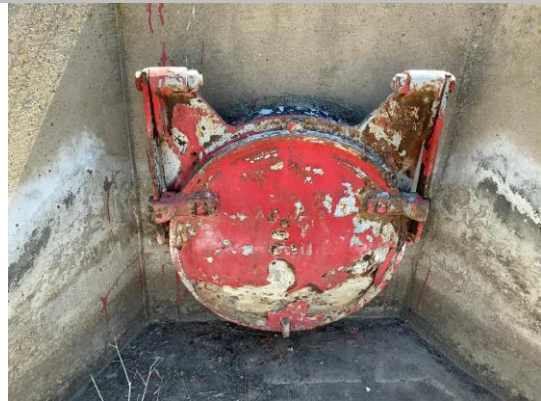
Photo 3 of 3 : UCIP_SP_2024_71174_99506.jpg

WS view: Close up of flapgate at toe.

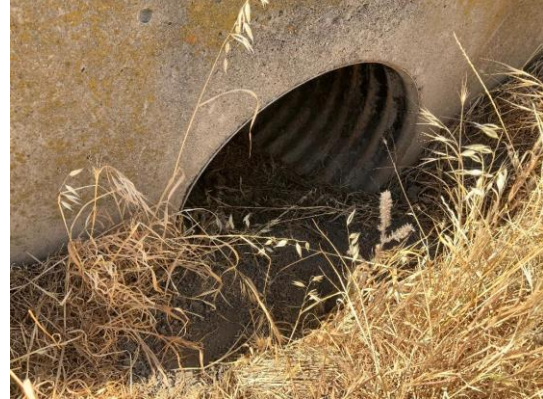
Photo 1 of 3 : UCIP_SP_2024_71175_99514.jpg

Comment Code						
Inspector Comment						
DS_ID:19901 FS_ID:71175 EP_NO: N/A Repair Type: No Action Needed EVAL Issue: Crossing Status: Found UCIP Comments: 09/18/2023 Record updated from Non-Urgent to No Action Needed. Pipe was CIPP lined. DMP internal video inspection has found none or minor pipe defects. Recommend next video inspection in 5 years. (O. Yakimov - DWR UCIP) 06/2/2021 Record remains Non-Urgent. DWR DMP internal inspection has found pipe integrity issues. LOF of crossing is equal to 4.1 and less than 5. Crossing will be monitored until funding becomes available for rehabilitation. Some sediment buildup in the inlet of the pipe on the LS, recommend cleaning out. No permit was found authorizing this encroachment. CVFPB will need to review crossing to determine owner. The UCIP inspection was completed with GEI staff, P. Espinoza. (H. Dunn – GEI) 04/15/2014 Some sediment buildup at landward toe and inside pipe--recommend clearing. (W. Wylie - DWR UCIP) FIELD_STRUCT_DESC: 24-inch CIPP-lined corrugated metal gravity drainage pipe (CMP) through the levee, 10.4 feet below the crown. Flap gate on the waterside (WS) end. Concrete headwall on the landside (LS) end. Concrete U-shaped headwall on the WS end. [Additional Reference(s): DWR Levee Log, 2002, (HLM 3.09). USACE San Joaquin O&M Manual, Unit No. 601, Part No. 1, 1967, Amended in 1978, Revised 20 June 1985, (HLM 3.09). DWR As-Built Specification No. 63-25, Sheet No. 13, 9 May 1963, (HLM 3.09)]. FS Date: 6/2/2021

LS view: Close up of pipe inlet at toe.

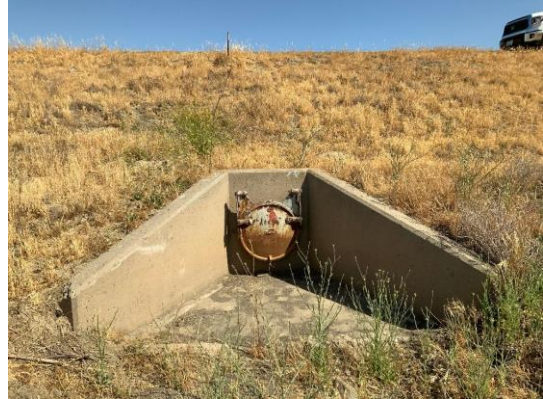
Photo 2 of 3 : UCIP_SP_2024_71175_99508.jpg

WS view: Slope, headwall, and flapgate at toe.

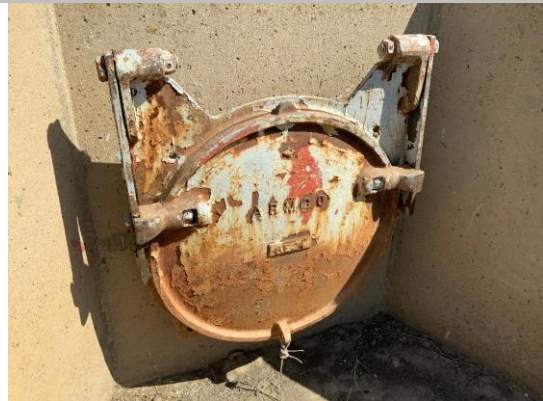
Photo 3 of 3 : UCIP_SP_2024_71175_99509.jpg

WS view: Close up of flapgate at toe.

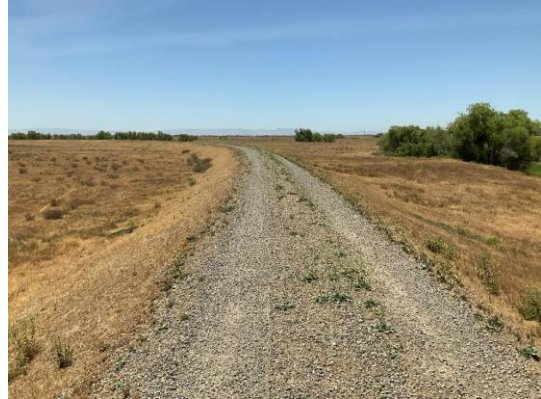
Photo 1 of 3 : UCIP_SP_2024_71177_99546.jpg

Comment Code					
Inspector Comment					
DS_ID:19903 FS_ID:71177 EP_NO: N/A Repair Type: Non-Urgent EVAL Issue: Crossing Status: Found UCIP Comments: 06/2/2021 The record has been upgraded from No Action Needed to Non-Urgent. DWR DMP internal inspection has not found pipe integrity issues. LOF of crossing is less or equal to 4.0. Recommend next video inspection in 5 years. No permit was found authorizing this encroachment. CVFPB will need to review crossing to determine owner. The UCIP inspection was completed with GEI staff, P. Espinoza. (H. Dunn – GEI) FIELD_STRUCT_DESC: 24-inch corrugated metal gravity drainage pipe (CMP) through the levee, 9.6 feet below the crown. Flap gate on the waterside (WS) end. Concrete headwall on the landside (LS) end. Concrete U-shaped headwall on the WS end. [Additional Reference(s): DWR Levee Log, 2002, (HLM 0.23). USACE San Joaquin O&M Manual, Unit No. 601, Part No. 1, 1967, Amended in 1978, Revised 20 June 1985, (HLM 0.23). DWR As-Built Specification No. 63-25, Sheet No. 11, 9 May 1963, (HLM 0.23)]. FS Date: 6/2/2021

Levee crown looking downstream.

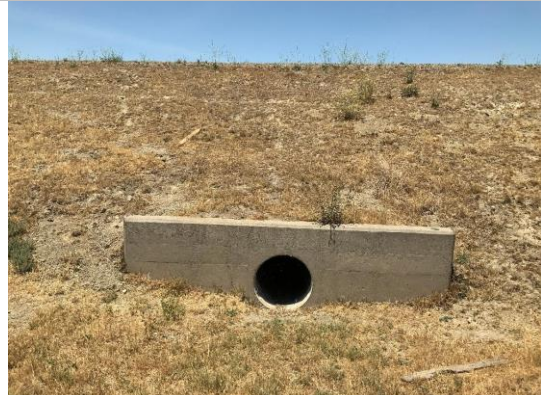
Photo 2 of 3 : UCIP_SP_2024_71177_99547.jpg

LS view: Slope and headwall at toe.

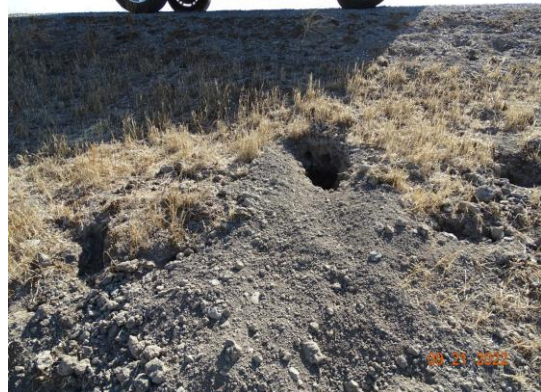
Photo 1 of 1 : SP_2024_NA0010_126_16_20240212_00001.jpg

LM Start	0.49	Rating **	U	Issue No.	16
LM End	0.49	Issue Type +	Ma	Location *	WS
Category	Earthen Levee			GPS Latitude/Longitude	
				Start	End
Item	Animal Control			37.257458°	37.257458°
				-120.763682°	-120.763682°
DWR ID	DWR_NA0010_08_f_2022_16				
Comment Code					
A3 : No rodents visible, but rodent burrows visible; need to backfill and compact or grout burrows.					
Inspector Comment

View of animal holes with large quantities of material displaced. (Fall 2022)

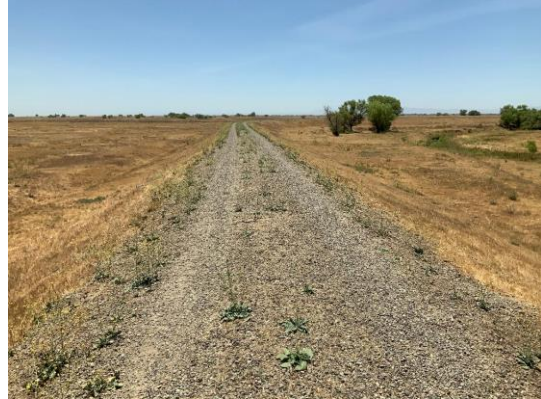
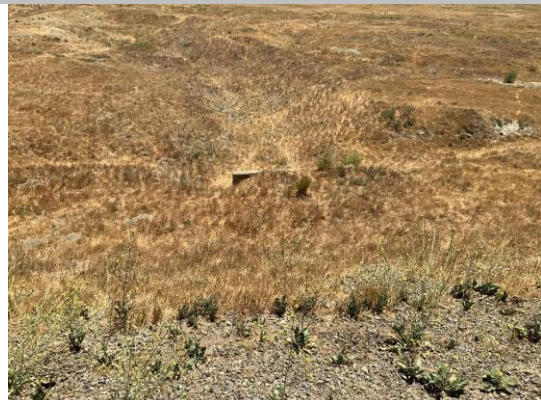
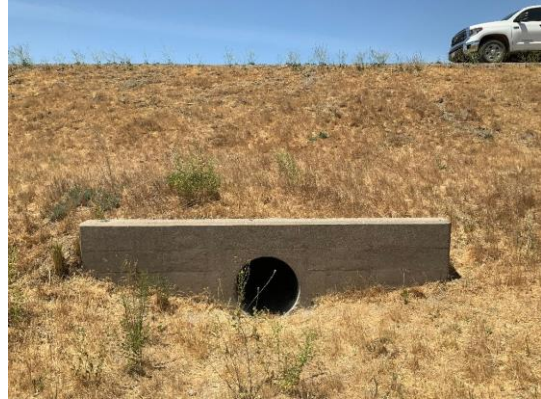
Comment Code					
Inspector Comment					
DS_ID:19904 FS_ID:71178 EP_NO: N/A Repair Type: Non-Urgent EVAL Issue: Crossing Status: Found UCIP Comments: 06/2/2021 The record has been upgraded from No Action Needed to Non-Urgent. DWR DMP internal inspection has not found pipe integrity issues. LOF of crossing is less or equal to 4.0. Recommend next video inspection in 5 years. No permit was found authorizing this encroachment. CVFPB will need to review crossing to determine owner. The UCIP inspection was completed with GEI staff, P. Espinoza. (H. Dunn – GEI) FIELD_STRUCT_DESC: 24-inch corrugated metal gravity drainage pipe (CMP) through the levee, 12.4 feet below the crown. Flap gate on the waterside (WS) end. Concrete headwall on each end. [Additional Reference(s): DWR Levee Log, 2002, (HLM 0.55). USACE San Joaquin O&M Manual, Unit No. 601, Part No. 1, 1967, Amended in 1978, Revised 20 June 1985, (HLM 0.57). DWR As-Built Specification No. 63-25, Sheet No. 11, 9 May 1963, (HLM 0.57)]. FS Date: 6/2/2021

Levee crown looking downstream.

LS view: Headwall visible at toe from crown.

LS view: Slope and headwall at toe.

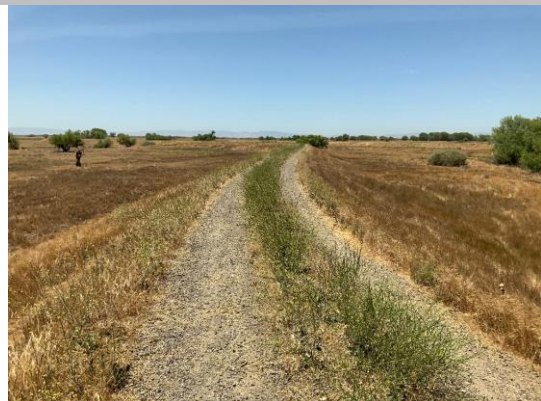
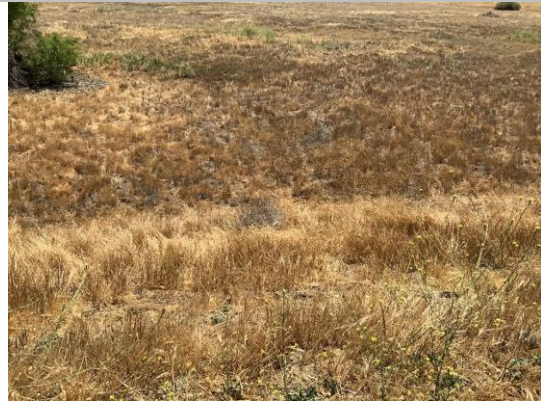
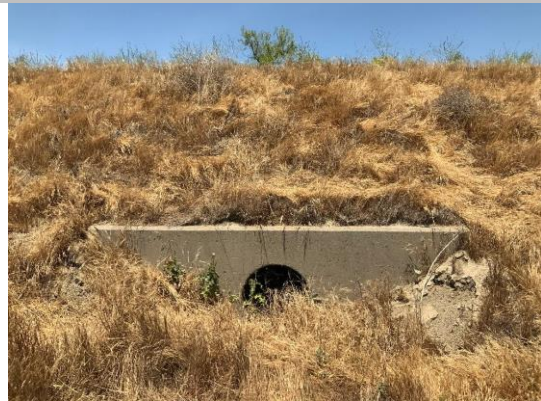
DS_ID:19905
FS_ID:71179
EP_NO: N/A
Repair Type: Non-Urgent
EVAL Issue:
Crossing Status: Found
UCIP Comments: 06/2/2021 The record has been upgraded from No Action Needed to Non-Urgent. DWR DMP internal inspection has not found pipe integrity issues. LOF of crossing is less or equal to 4.0. Recommend next video inspection in 5 years. No permit was found authorizing this encroachment. CVFPB will need to review crossing to determine owner. The UCIP inspection was completed with GEI staff, P. Espinoza. (H. Dunn – GEI)
FIELD_STRUCT_DESC: 24-inch corrugated metal gravity drainage pipe (CMP) through the levee, 10.0 feet below the crown. Flap gate on the waterside (WS) end. Concrete headwall on each end. [Additional Reference(s): DWR Levee Log, 2002, (HLM 0.70). USACE San Joaquin O&M Manual, Unit No. 601, Part No. 1, 1967, Amended in 1978, Revised 20 June 1985, (HLM 0.72). DWR As-Built Specification No. 63-25, Sheet No. 11, 9 May 1963, (HLM 0.72)].

Levee crown looking downstream.

LS view: Toe from crown.

LS view: Slope and headwall at toe.

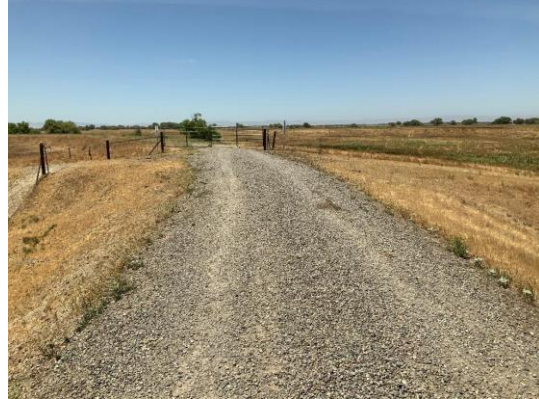
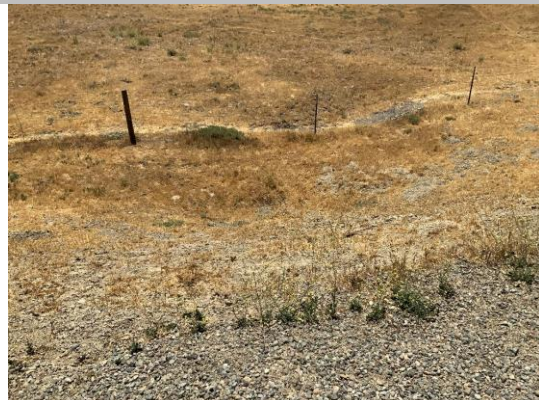
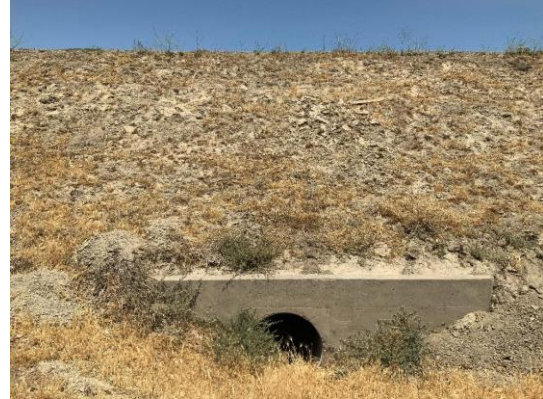
Comment Code					
Inspector Comment					
DS_ID:19832 FS_ID:71180 EP_NO: N/A Repair Type: Non-Urgent EVAL Issue: Crossing Status: Found UCIP Comments: 06/2/2021 Record remains Non-Urgent. DWR DMP internal inspection has not found pipe integrity issues. LOF of crossing is less or equal to 4.0. Recommend next video inspection in 5 years. No permit was found authorizing this encroachment. CVFPB will need to review crossing to determine owner. The UCIP inspection was completed with GEI staff, P. Espinoza. (H. Dunn – GEI) 04/16/2014 Some sediment buildup at inlet on LS toe. (W. Wylie - DWR UCIP) FIELD_STRUCT_DESC: 24-inch corrugated metal gravity drainage pipe (CMP) through the levee, 11.5 feet below the crown. Flap gate on the waterside (WS) end. Concrete headwall on each end. [Additional Reference(s): DWR Levee Log, 2002, (HLM 0.88). USACE San Joaquin O&M Manual, Unit No. 601, Part No. 1, 1967, Amended in 1978, Revised 20 June 1985, (HLM 0.89). DWR As-Built Specification No. 63-25, Sheet No. 11, 9 May 1963, (HLM 0.89)]. FS Date: 6/2/2021

Levee crown looking downstream.

LS view: Toe from crown.

LS view: Slope and headwall at toe.

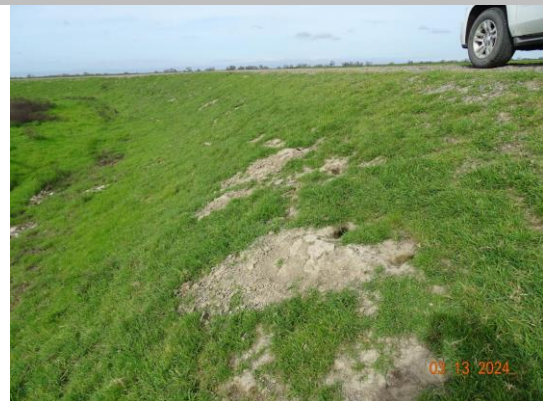
Photo 1 of 1 : SP_2024_NA0010_126_15_20240326_00037.jpg

LM Start	1.02	Rating **	M	Issue No.	15
LM End	1.02	Issue Type +	Ma	Location *	LS
Category	Earthen Levee			GPS Latitude/Longitude	
				Start	End
Item	Animal Control			37.263372°	37.263372°
				-120.758742°	-120.758742°
DWR ID	DWR_NA0010_08_s_2024_15				
Comment Code					
A3 : No rodents visible, but rodent burrows visible; need to backfill and compact or grout burrows.					
Inspector Comment

View of rodent burrows on the landside slope. (Spring 2024)

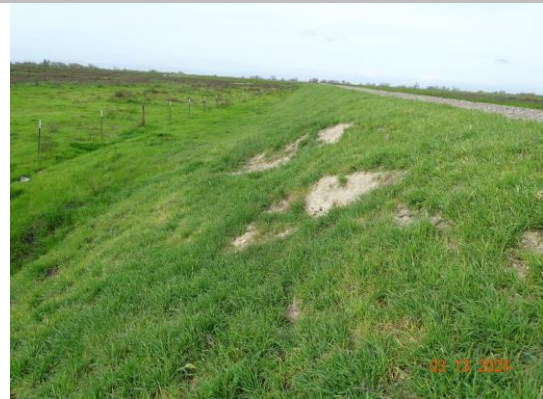
Photo 1 of 1 : SP_2024_NA0010_126_28_20240326_00038.jpg

LM Start	1.21	Rating **	M	Issue No.	28
LM End	1.21	Issue Type +	Ma	Location *	LS
Category	Earthen Levee			GPS Latitude/Longitude	
				Start	End
Item	Erosion / Livestock			37.263179°	37.263179°
				-120.755444°	-120.755444°
DWR ID	DWR_NA0010_08_f_2019_28				
Comment Code					
E4 : Repair the levee slope damaged by livestock and prevent large animal access.					
Inspector Comment

View of damage to the landside slope looking downstream. (Spring 2024)

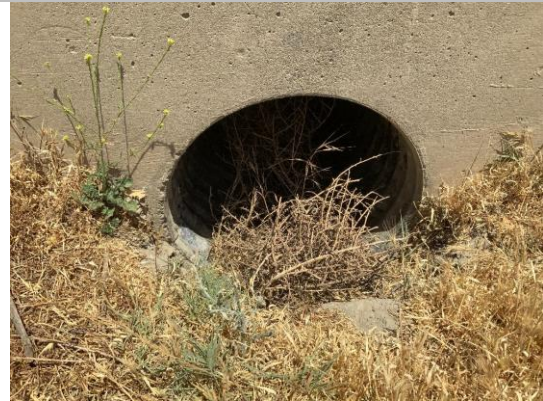
Photo 1 of 1 : UCIP_SP_2024_71181_99576.jpg

Comment Code					
Inspector Comment					
DS_ID:19833 FS_ID:71181 EP_NO: N/A Repair Type: Non-Urgent EVAL Issue: 11, Maintenance Compliance Issue Crossing Status: Found UCIP Comments: 06/2/2021 Record remains Non-Urgent. Some vegetation in LS pipe inlet, recommend clearing out. DWR DMP internal inspection has not found pipe integrity issues. LOF of crossing is less or equal to 4.0. Recommend next video inspection in 5 years. No permit was found authorizing this encroachment. CVFPB will need to review crossing to determine owner. The UCIP inspection was completed with GEI staff, P. Espinoza. (H. Dunn – GEI) 04/16/2014 Debris blocking landward headwall--recommend clearing. (W. Wylie - DWR UCIP) FIELD_STRUCT_DESC: 24-inch corrugated metal gravity drainage pipe (CMP) through the levee, 11.6 feet below the crown. Flap gate on the waterside (WS) end. Concrete headwall on each end. [Additional Reference(s): DWR Levee Log, 2002, (HLM 1.20). USACE San Joaquin O&M Manual, Unit No. 601, Part No. 1, 1967, Amended in 1978, Revised 20 June 1985, (HLM 1.21). DWR As-Built Specification No. 63-25, Sheet No. 11, 9 May 1963, (HLM 1.21)]. FS Date: 6/2/2021

LS view: Close up of pipe inlet at toe, some vegetation inside pipe.

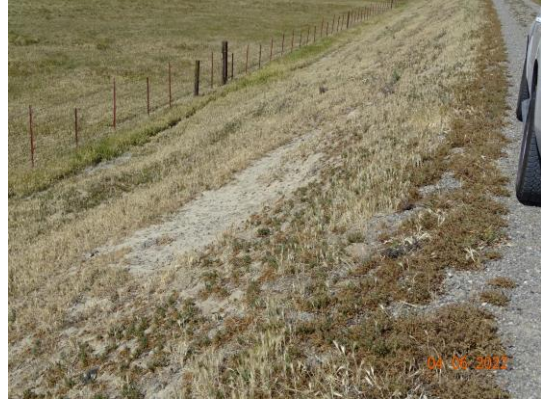
Photo 1 of 1 : SP_2024_NA0010_126_26_20240212_00005.jpg

LM Start	1.81	Rating **	M	Issue No.	26
LM End	1.81	Issue Type +	Ma	Location *	LS
Category	Earthen Levee			GPS Latitude/Longitude	
				Start	End
Item	Erosion / Livestock			37.260673°	37.260673°
				-120.745290°	-120.745290°
DWR ID	DWR_NA0010_08_f_2019_26				
Comment Code					
E4 : Repair the levee slope damaged by livestock and prevent large animal access.					
Inspector Comment

Looking downstream at erosion spot on the landside slope. (Spring 2022)

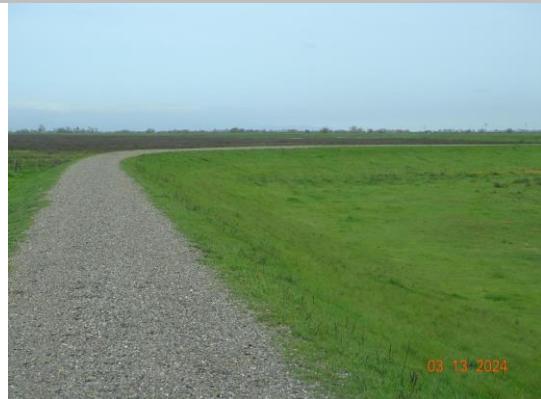
Photo 1 of 1 : SP_2024_NA0010_126_14_20240326_00039.jpg

LM Start	2.01	Rating **	A	Issue No.	14
LM End	2.01	Issue Type +	Ma	Location *	WS
Category	Earthen Levee			GPS Latitude/Longitude	
				Start	End
Item	Vegetation			37.258443°	37.258443°
				-120.743543°	-120.743543°
DWR ID	DWR_NA0010_08_s_2024_14				
Comment Code					
V1 : Control annual grass and weeds on the levee slopes and easements.					
Inspector Comment

View of the waterside slope looking downstream. (Spring 2024)

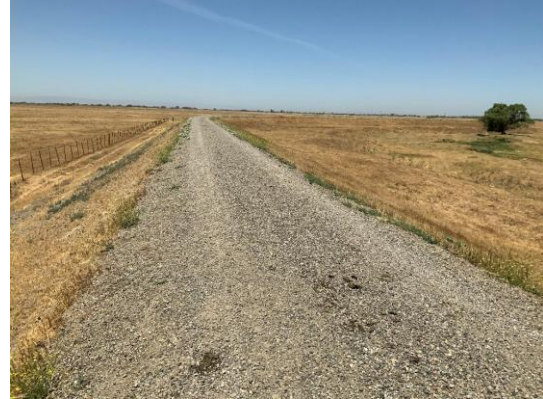
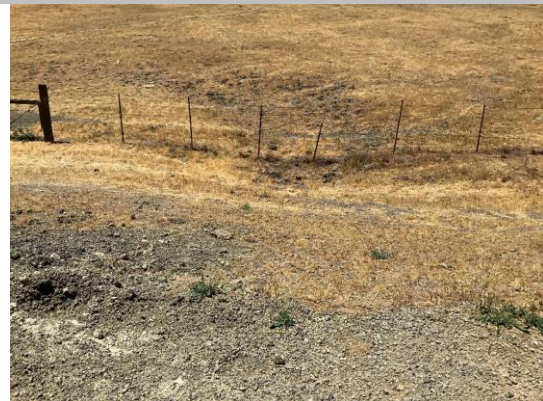
Comment Code					
Inspector Comment					
DS_ID:19835 FS_ID:71183 EP_NO: N/A Repair Type: Non-Urgent EVAL Issue: Crossing Status: Found UCIP Comments: 06/2/2021 Record remains Non-Urgent. LS pipe end not visible at all, appears to be buried or removed. Need to contact owner to determine status of pipe. DWR DMP internal inspection has not found pipe integrity issues. LOF of crossing is less or equal to 4.0. Recommend next video inspection in 5 years. No permit was found authorizing this encroachment. CVFPB will need to review crossing to determine owner. The UCIP inspection was completed with GEI staff, P. Espinoza. (H. Dunn – GEI) 04/16/2014 Non-functional landward inlet is buried in sediment. Need to contact owner to determine status. (W. Wylie - DWR UCIP) FIELD_STRUCT_DESC: 24-inch corrugated metal gravity drainage pipe (CMP) through the levee, 12.0 feet below the crown. Flap gate on the waterside (WS) end. Concrete headwall on each end. [Additional Reference(s): DWR Levee Log, 2002, (HLM 2.04). USACE San Joaquin O&M Manual, Unit No. 601, Part No. 1, 1967, Amended in 1978, Revised 20 June 1985, (HLM 2.05). DWR As-Built Specification No. 63-25, Sheet No. 12, 9 May 1963, (HLM 2.05)]. FS Date: 6/2/2021

Levee crown looking downstream.

LS view: Toe from crown, no pipe visible.

LS view: Slope from toe, no pipe visible.

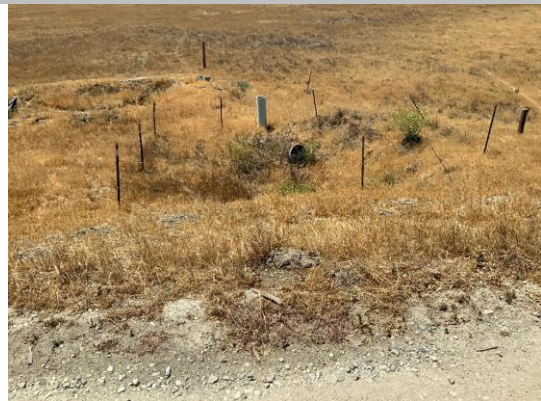
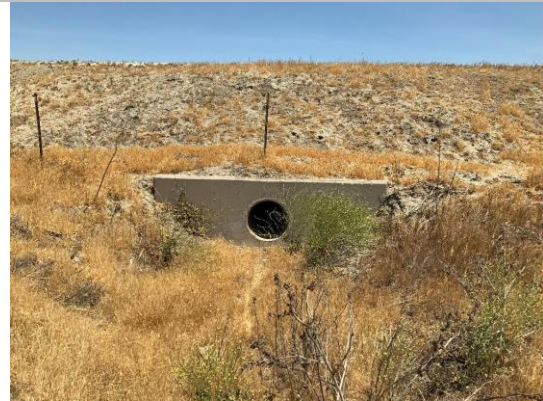
Comment Code						
Inspector Comment						
DS_ID:19836 FS_ID:71184 EP_NO: N/A Repair Type: Non-Urgent EVAL Issue: Crossing Status: Found UCIP Comments: 06/2/2021 The record remains Non-Urgent. DWR DMP internal inspection has not found pipe integrity issues. LOF of crossing is less or equal to 4.0. Recommend next video inspection in 5 years. New 6 inch plastic riser with flowmeter and 24 inch metal pipe underground off the LS toe, directly opposite of the LS pipe inlet of this DSID. No permit was found authorizing this encroachment. CVFPB will need to review crossing to determine owner. The UCIP inspection was completed with GEI staff, P. Espinoza. (H. Dunn – GEI) 04/16/2014 Sediment buildup in pipe visible from landward side. (W. Wylie - DWR UCIP) FIELD_STRUCT_DESC: 24-inch corrugated metal gravity drainage pipe (CMP) through the levee, 9.5 feet below the crown. Flap gate on the waterside (WS) end. Concrete headwall on each end. [Additional Reference(s): DWR Levee Log, 2002, (HLM 2.12). USACE San Joaquin O&M Manual, Unit No. 601, Part No. 1, 1967, Amended in 1978, Revised 20 June 1985, (HLM 2.12). DWR As-Built Specification No. 63-25, Sheet No. 12, 9 May 1963, (HLM 2.12)]. FS Date: 6/2/2021

Levee crown looking downstream.

LS view: Toe from crown.

LS view: Slope and headwall at toe.

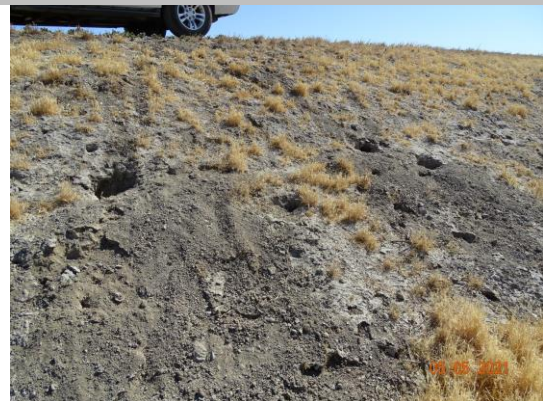
Photo 1 of 1 : SP_2024_NA0010_126_18_20240212_00003.jpg

LM Start	2.29	Rating **	A/W	Issue No.	18
LM End	2.43	Issue Type +	Ma	Location *	LS
Category	Earthen Levee			GPS Latitude/Longitude	
				Start	End
Item	Animal Control			37.256251°	37.254767°
				-120.739280°	-120.737772°
DWR ID	DWR_NA0010_08_s_2021_18				
Comment Code					
A1 : Exterminate rodents and backfill and compact or grout burrows.					
Inspector Comment

View of rodent holes in the landside slope. (Spring 2021)

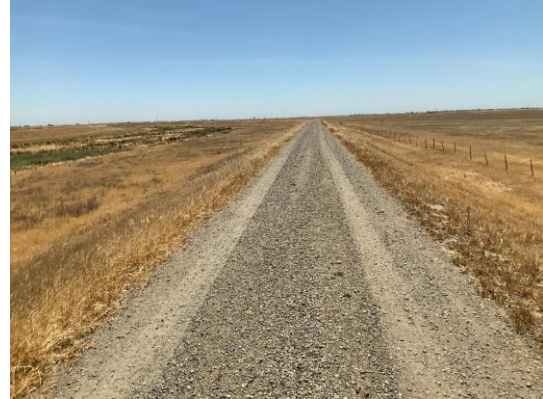
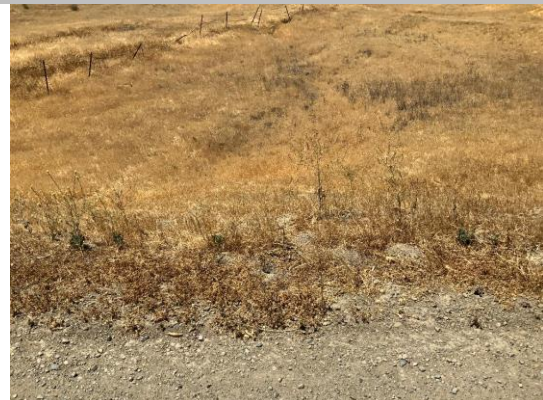
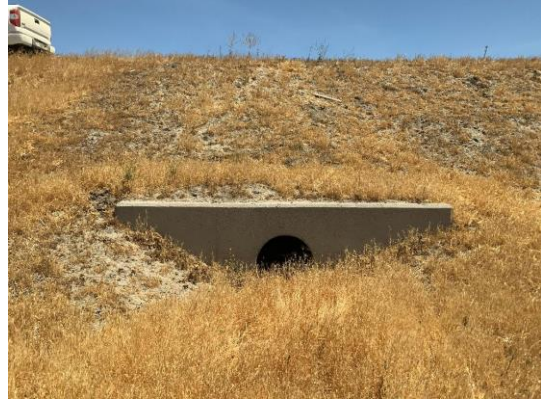
Comment Code					
Inspector Comment					
DS_ID:19837 FS_ID:71185 EP_NO: N/A Repair Type: Non-Urgent EVAL Issue: Crossing Status: Found UCIP Comments: 06/2/2021 The record has been upgraded from No Action Needed to Non-Urgent. DWR DMP internal inspection has not found pipe integrity issues. LOF of crossing is less or equal to 4.0. Recommend next video inspection in 5 years. No permit was found authorizing this encroachment. CVFPB will need to review crossing to determine owner. The UCIP inspection was completed with GEI staff, P. Espinoza. (H. Dunn – GEI) FIELD_STRUCT_DESC: 24-inch corrugated metal gravity drainage pipe (CMP) through the levee, 10.5 feet below the crown. Flap gate on the waterside (WS) end. Concrete headwall on each end. [Additional Reference(s): DWR Levee Log, 2002, (HLM 2.77). USACE San Joaquin O&M Manual, Unit No. 601, Part No. 1, 1967, Amended in 1978, Revised 20 June 1985, (HLM 2.77). DWR As-Built Specification No. 63-25, Sheet No. 13, 9 May 1963, (HLM 2.77)]. FS Date: 6/2/2021

Levee crown looking downstream.

LS view: Toe from crown.

LS view: Slope and headwall at toe.

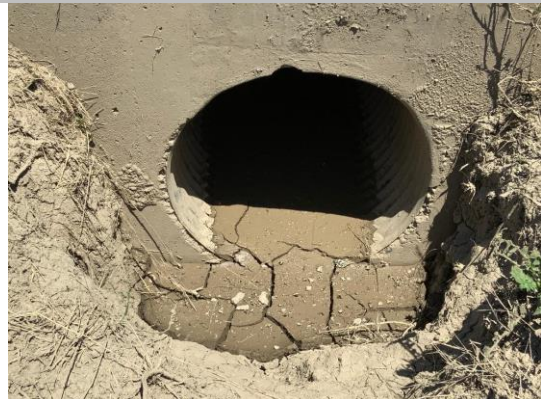
Photo 1 of 1 : UCIP_SP_2024_71186_99610.jpg

DS_ID:19838
 FS_ID:71186
 EP_NO: N/A
 Repair Type: Non-Urgent
 EVAL Issue: 11, Maintenance Compliance Issue
 Crossing Status: Found
 UCIP Comments: 06/2/2021 Record remains Non-Urgent. LS pipe inlet has some sediment buildup, recommend cleaning out. No permit was found authorizing this encroachment. CVFPB will need to review crossing to determine owner. The UCIP inspection was completed with GEI staff, P. Espinoza. (H. Dunn – GEI) 7/20/2016 LS inlet buried under dense vegetation. Dense vegetation limits the inspector's visibility to identify signs of pipe failure (leaks) along the WS and LS slope. Recommend removing vegetation along pipe alignment to conduct proper inspection of structure and appurtenances. (O. Magana - DWR UCIP)4/16/2014 Pipe blocked by silt on LS toe. Flapgate rusty and does not operate correctly. (W. Wylie - DWR UCIP)
 FIELD_STRUCT_DESC: 36-inch corrugated metal gravity drainage pipe (CMP) through the levee, 13.4 feet below the crown. Flap gate on the waterside (WS) end. Concrete headwall on each end. [Additional Reference(s): DWR Levee Log, 2002, (HLM 3.06). USACE San Joaquin O&M Manual, Unit No. 601, Part No. 1, 1967, Amended in 1978, Revised 20 June 1985, (HLM 3.06). DWR As-Built Specification No. 63-25, Sheet No. 13, 9 May 1963, (HLM 3.06)].

LS view: Close up of pipe inlet at toe, some sediment buildup.

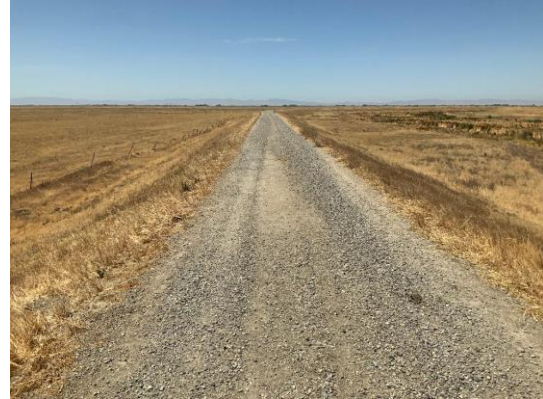
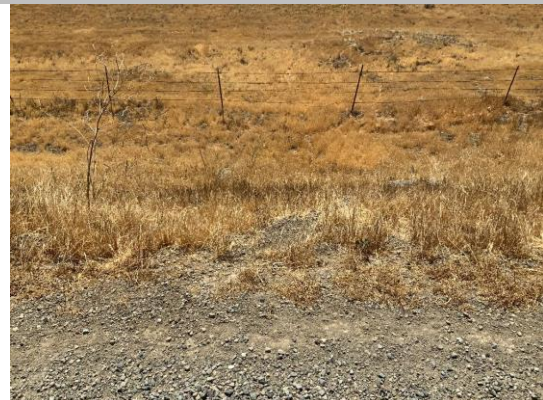
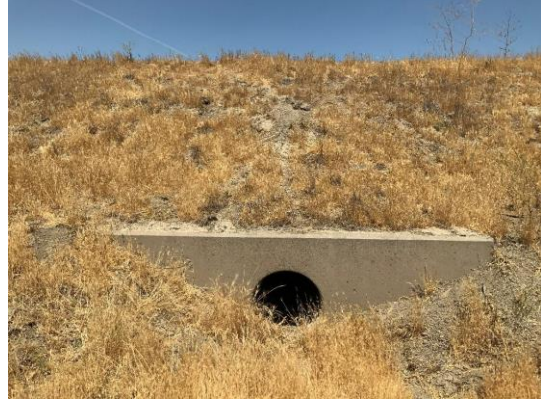
Comment Code						
Inspector Comment						
DS_ID:19839 FS_ID:71187 EP_NO: N/A Repair Type: Non-Urgent EVAL Issue: Crossing Status: Found UCIP Comments: 06/2/2021 The record has been upgraded from No Action Needed to Non-Urgent. DWR DMP internal inspection has not found pipe integrity issues. LOF of crossing is less or equal to 4.0. Recommend next video inspection in 5 years. No permit was found authorizing this encroachment. CVFPB will need to review crossing to determine owner. The UCIP inspection was completed with GEI staff, P. Espinoza. (H. Dunn – GEI) FIELD_STRUCT_DESC: 24-inch corrugated metal gravity drainage pipe (CMP) through the levee, 10.0 feet below the crown. Flap gate on the waterside (WS) end. Concrete headwall on each end. [Additional Reference(s): DWR Levee Log, 2002, (HLM 3.23). USACE San Joaquin O&M Manual, Unit No. 601, Part No. 1, 1967, Amended in 1978, Revised 20 June 1985, (HLM 3.24). DWR As-Built Specification No. 63-25, Sheet No. 13, 9 May 1963, (HLM 3.24)]. FS Date: 6/2/2021

Levee crown looking downstream

LS view: Toe from crown.

LS view: Slope and headwall at toe.

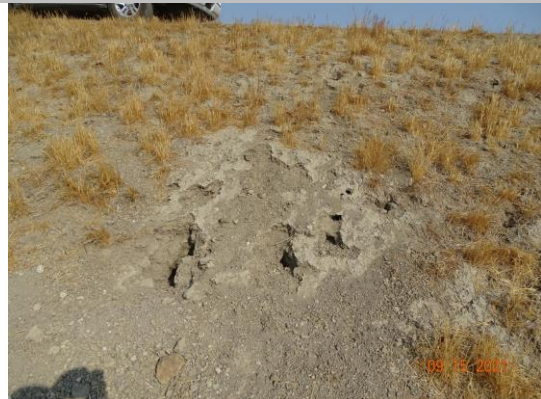
LM Start	3.28	Rating **	A/W	Issue No.	17
LM End	3.28	Issue Type +	Ma	Location *	LS
Category	Earthen Levee			GPS Latitude/Longitude	
				Start	End
Item	Animal Control			37.252537°	37.252537°
				-120.724795°	-120.724795°
DWR ID	DWR_NA0010_08_f_2021_17				
Comment Code					
A3 : No rodents visible, but rodent burrows visible; need to backfill and compact or grout burrows.					
Inspector Comment

View of animal burrows in the landside slope. (Fall 2021)

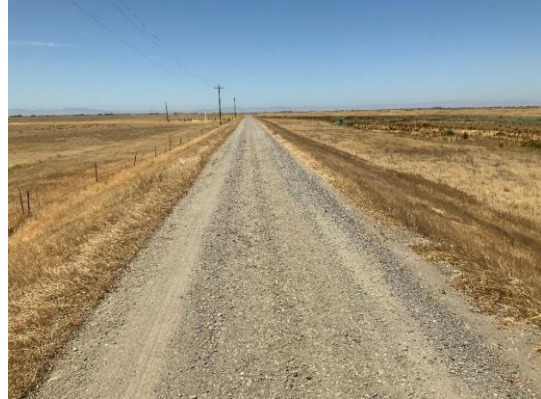
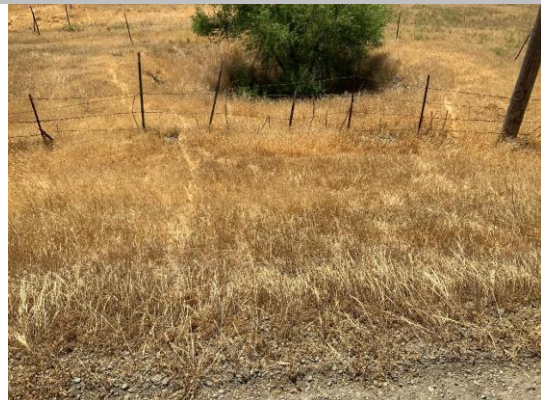
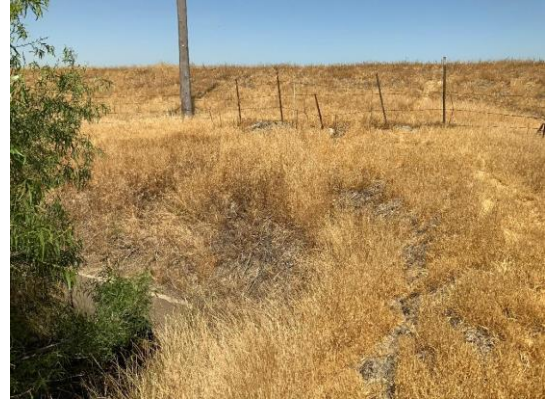
Comment Code					
Inspector Comment					
DS_ID:19840 FS_ID:71188 EP_NO: N/A Repair Type: Non-Urgent EVAL Issue: Crossing Status: Found UCIP Comments: 06/2/2021 Record remains Non-Urgent. LS pipe inlet blocked by barbed wire and both ends blocked by water, so limited inspection was done. No permit was found authorizing this encroachment. CVFPB will need to review crossing to determine owner. The UCIP inspection was completed with GEI staff, P. Espinoza. (H. Dunn – GEI) 04/16/2014 No access available on landward side. Need to confirm status of crossing. (W. Wylie - DWR UCIP) FIELD_STRUCT_DESC: 24-inch corrugated metal gravity drainage pipe (CMP) through the levee, 13.0 feet below the crown. Flap gate on the waterside (WS) end. Concrete headwall on each end. [Additional Reference(s): DWR Levee Log, 2002, (HLM 3.43). USACE San Joaquin O&M Manual, Unit No. 601, Part No. 1, 1967, Amended in 1978, Revised 20 June 1985, (HLM 3.43). DWR As-Built Specification No. 63-25, Sheet No. 13, 9 May 1963, (HLM 3.43)]. FS Date: 6/2/2021

Levee crown looking downstream.

LS view: Toe from crown.

LS view: Slope from toe.

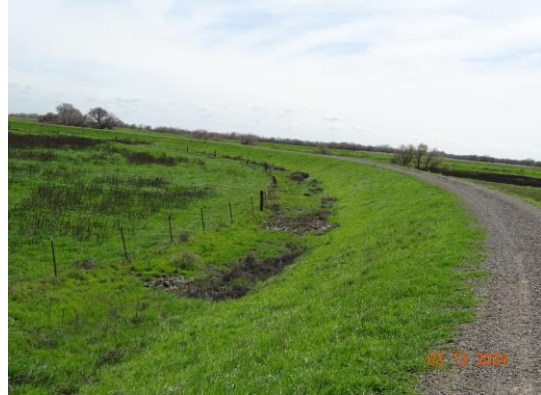
LM Start	0.05	Rating **	A	Issue No.	4
LM End	0.05	Issue Type +	Ma	Location *	LS
Category	Earthen Levee			GPS Latitude/Longitude	
				Start	End
Item	Vegetation			37.219730°	37.219730°
				-120.712440°	-120.712440°
DWR ID	DWR_NA0010_09_s_2024_4				
Comment Code					
V1 : Control annual grass and weeds on the levee slopes and easements.					
Inspector Comment

View of vegetation management on the landside slope. (Spring 2024)

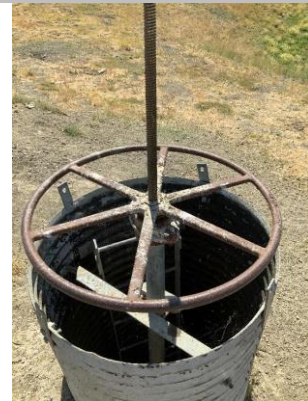
Comment Code					
Inspector Comment					
DS_ID:19841 FS_ID:73203 EP_NO: N/A Repair Type: Non-Urgent EVAL Issue: 4b, Safety Issue Crossing Status: Found UCIP Comments: 06/09/2021 The record remains Non-Urgent. Limited inspection of landside (LS) and WS due to water and mud. LS CMP riser has missing lid. WS outlet pipe edges are warped. No permit was found authorizing this encroachment. CVFPB will need to review crossing to determine owner. The UCIP inspection was completed with GEI staff, H.Dunn. (P.Espinoza – GEI) 04/22/2014 Concrete headwalls on landward and waterward under water. Need photo to confirm condition of concrete headwalls, pipe, and gate on both toes. (W. Wylie - DWR UCIP) FIELD_STRUCT_DESC: 24-inch corrugated metal gravity drainage pipe (CMP) through the levee, 18.7 feet below the crown. Slide gate in a 36-inch CMP riser unit on the waterside (WS) slope. Concrete U-shaped headwall on each end. [Additional Reference(s): DWR Levee Log, 2002, (HLM 0.48). USACE San Joaquin O&M Manual, Unit No. 601, Part No. 1, 1967, Amended in 1978, Revised 20 June 1985, (HLM 0.47). DWR As-Built Specification No. 63-25, Sheet No. 14, 9 May 1963, (HLM 0.47)]. FS Date: 6/9/2021 2:41:00 PM

WS view: Close-up of slide gate in CMP riser on slope.

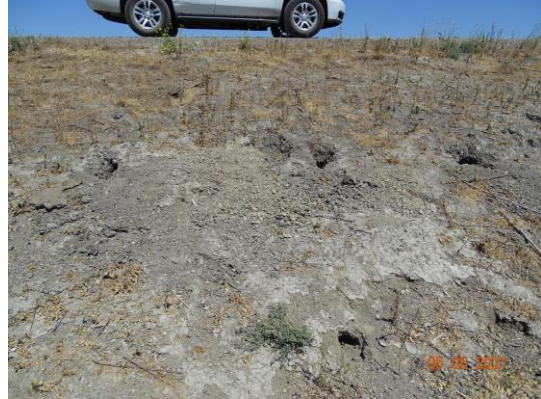
LM Start	0.48	Rating **	M	Issue No.	6
LM End	0.48	Issue Type +	Ma	Location *	WS
Category	Earthen Levee			GPS Latitude/Longitude	
				Start	End
Item	Animal Control			37.220489°	37.220489°
				-120.705021°	-120.705021°
DWR ID	DWR_NA0010_09_s_2021_6				
Comment Code					
A1 : Exterminate rodents and backfill and compact or grout burrows.					
Inspector Comment

View of rodent burrows in the waterside slope. (Spring 2021)

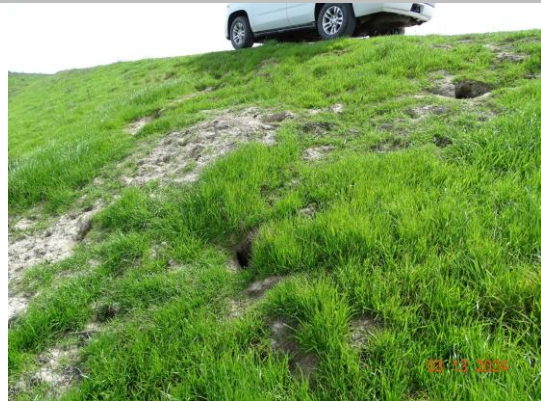
LM Start	0.49	Rating **	M	Issue No.	5
LM End	0.49	Issue Type +	Ma	Location *	LS
Category	Earthen Levee			GPS Latitude/Longitude	
				Start	End
Item	Animal Control			37.220549°	37.220549°
				-120.704842°	-120.704842°
DWR ID	DWR_NA0010_09_s_2024_5				
Comment Code					
A1 : Exterminate rodents and backfill and compact or grout burrows.					
Inspector Comment

View of multiple rodent holes on the landside slope. (Spring 2024)

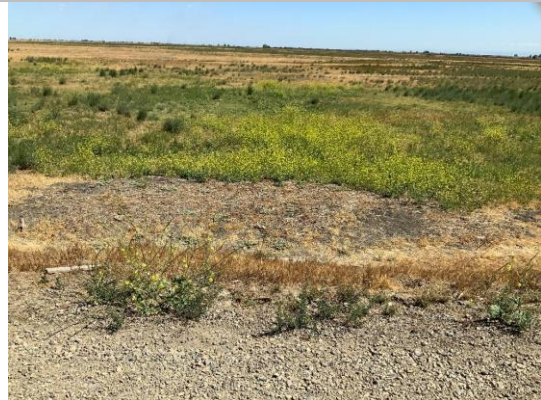
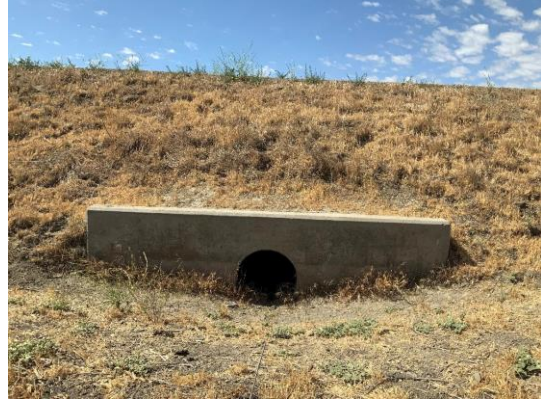
Comment Code					
Inspector Comment					
DS_ID:19842 FS_ID:73202 EP_NO: N/A Repair Type: Non-Urgent EVAL Issue: Crossing Status: Found UCIP Comments: 06/09/2021 The record remains Non-Urgent. DWR DMP internal inspection has not found pipe integrity issues. LOF of crossing is less or equal to 4.0. Recommend next video inspection in 5 years. No permit was found authorizing this encroachment. CVFPB will need to review crossing to determine owner. The UCIP inspection was completed with GEI staff, H.Dunn. (P.Espinoza – GEI) 04/22/2014 Animal burrows in area on LS slope. Minor sediment buildup in pipe visible on landward side--recommend clearing. (W. Wylie - DWR UCIP) FIELD_STRUCT_DESC: 24-inch corrugated metal gravity drainage pipe (CMP) through the levee, 8.7 feet below the crown. Flap gate on the waterside (WS) end. Concrete headwall on the landside (LS) end. Concrete U-shaped headwall on the WS end. [Additional Reference(s): DWR Levee Log, 2002, (HLM 0.70). USACE San Joaquin O&M Manual, Unit No. 601, Part No. 1, 1967, Amended in 1978, Revised 20 June 1985, (HLM 0.70). DWR As-Built Specification No. 63-25, Sheet No. 14, 9 May 1963, (HLM 0.70)]. FS Date: 6/9/2021

View of levee crown.

LS view: Slope from crown.

LS view: Concrete headwall and inlet pipe at toe.

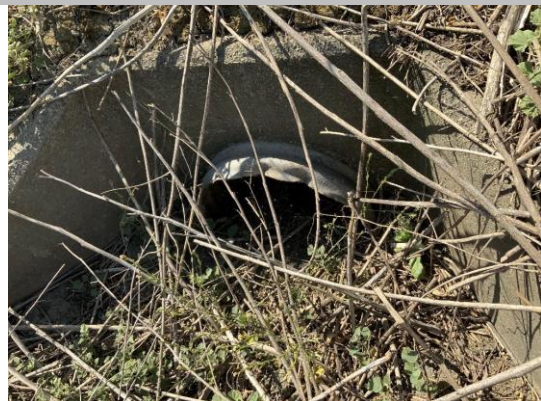
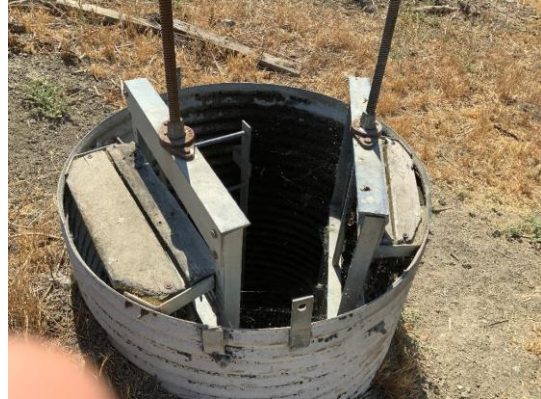
LS view: concrete headwall and inlet at LS toe.

DS_ID:19843
 FS_ID:73200
 EP_NO: N/A
 Repair Type: Non-Urgent
 EVAL Issue: 4b, Safety Issue
 Crossing Status: Found
 UCIP Comments: 06/09/2021 The record has been upgraded from No Action Needed to Non-Urgent. No cover or handle on CMP riser on WS slope. Water in riser shows evidence that flapgate is open. Outlet pipe on WS toe not found. Dense vegetation and sediment limits inspectors ability to identify signs of inlet pipe condition on LS toe recommend removal of vegetation and sediment. LS inlet pipe appears to have slight warping around edges. No permit was found authorizing this encroachment. CVFPB will need to review crossing to determine owner. The UCIP inspection was completed with GEI staff, H.Dunn.
 (P.Espinoza – GEI)
 FIELD_STRUCT_DESC: [Crane Irrigation Structure] 24-inch corrugated metal gravity drainage pipe (CMP) through the levee, 9.7 feet below the crown. Two slide gates in a 48-inch CMP riser unit on the waterside (WS) slope. Concrete U-shaped headwall on the landside (LS) end. WS end cobble revetted on the bank and in the outlet drain. [Additional Reference(s): DWR Levee Log, 2002, (HLM 0.87). USACE San Joaquin O&M Manual, Unit No. 601, Part No. 1, 1967, Amended in 1978, Revised 20 June 1985, (HLM 0.87). DWR As-Built Specification No. 63-25, Sheet No. 14, 9 May 1963, (HLM 0.87)].

WS view: CMP riser with slide gate on slope.

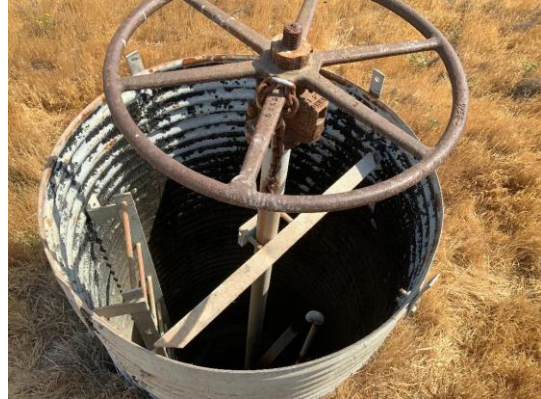
Comment Code					
Inspector Comment					
DS_ID:19845 FS_ID:81002 EP_NO: N/A Repair Type: Urgent EVAL Issue: 1, Pipe Integrity Crossing Status: Found UCIP Comments: 09/15/2023 Record updated from Non-Urgent to Urgent. DMP internal video inspection has found severe pipe defects. Crossing will be monitored until funding becomes available to address the issues. (O. Yakimov - DWR UCIP) 06/09/2021 The record remains Non-Urgent. No cover on CMP riser on WS slope, creating a safety hazard. Limited inspection of inlet pipe on LS and outlet pipe on WS due to elevated water levels around the headwalls and inlet/outlets, limiting the ability to inspect pipes at a close proximity. No permit was found authorizing this encroachment. CVFPB will need to review crossing to determine owner. The UCIP inspection was completed with GEI staff, H.Dunn. (P.Espinoza – GEI) 04/22/2014 Inlet blocked at LS toe by wooden gate. Need to contact owner to determine status. (W. Wylie - DWR UCIP) FIELD_STRUCT_DESC: 36-inch corrugated metal gravity drainage pipe (CMP) through the levee, 19.6 feet below the crown. Slide gate in a 48-inch CMP riser unit on the waterside (WS) slope. Concrete U-shaped headwall on each end. [Additional Reference(s): DWR Levee Log, 2002, (HLM 0.31). USACE San Joaquin O&M Manual, Unit No. 601, Part No. 1, 1967, Amended in 1978, Revised 20 June 1985, (HLM 0.31). DWR As-Built Specification No. 63-25, Sheet No. 14, 9 May 1963, (HLM 0.31)]. FS Date: 6/9/2021 11:34:00 AM

WS view: Closeup of CMP riser with slidegate on slope.

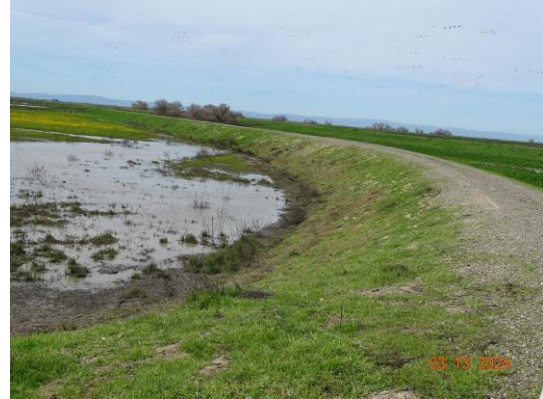
LM Start	0.44	Rating **	A	Issue No.	3
LM End	0.44	Issue Type +	Ma	Location *	LS
Category	Earthen Levee			GPS Latitude/Longitude	
				Start	End
Item	Vegetation			37.219687°	37.219687°
				-120.704115°	-120.704115°
DWR ID	DWR_NA0010_10_s_2024_3				
Comment Code					
V1 : Control annual grass and weeds on the levee slopes and easements.					
Inspector Comment

View of the landside slope vegetation management. (Spring 2024)

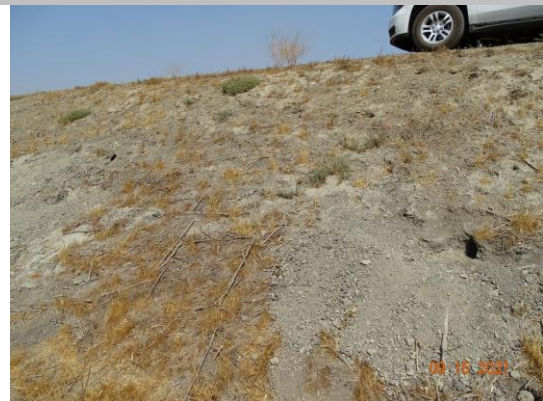
LM Start	0.51	Rating **	M	Issue No.	2
LM End	0.51	Issue Type +	Ma	Location *	LS
Category	Earthen Levee			GPS Latitude/Longitude	
				Start	End
Item	Animal Control			37.219268°	37.219268°
				-120.703046°	-120.703046°
DWR ID	DWR_NA0010_10_f_2021_2				
Comment Code					
A3 : No rodents visible, but rodent burrows visible; need to backfill and compact or grout burrows.					
Inspector Comment

View of squirrel holes on the landside slope. (Fall 2021)

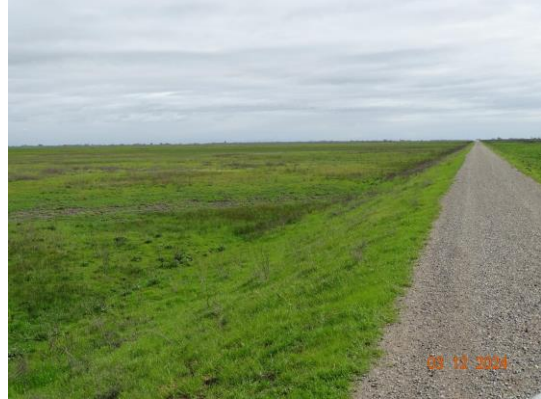
LM Start	0.02	Rating **	A	Issue No.	14
LM End	0.02	Issue Type +	Ma	Location *	LS
Category	Earthen Levee			GPS Latitude/Longitude	
				Start	End
Item	Vegetation			37.202738°	37.202738°
				-120.754910°	-120.754910°
DWR ID	DWR_NA0010_11_s_2024_14				
Comment Code					
V1 : Control annual grass and weeds on the levee slopes and easements.					
Inspector Comment

View of the landside slope vegetation mangement. (Spring 2024)

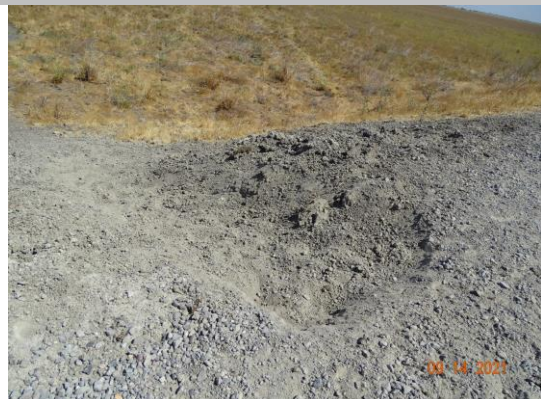
LM Start	0.16	Rating **	A/W	Issue No.	10
LM End	0.16	Issue Type +	Ma	Location *	LS
Category	Earthen Levee			GPS Latitude/Longitude	
				Start	End
Item	Erosion / Livestock			37.202730°	37.202730°
				-120.752270°	-120.752270°
DWR ID	DWR_NA0010_11_f_2018_10				
Comment Code					
E4 : Repair the levee slope damaged by livestock and prevent large animal access.					
Inspector Comment					
Damage has been repaired. Suggest monitoring for settlement.

View of livestock damage to the landside slope. (Fall 2021)

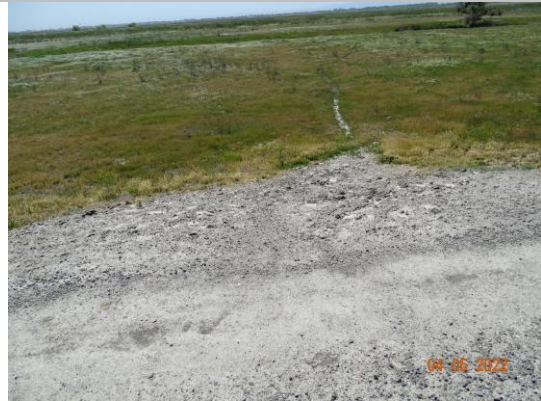
LM Start	0.21	Rating **	A/W	Issue No.	13
LM End	0.21	Issue Type +	Ma	Location *	WS
Category	Earthen Levee			GPS Latitude/Longitude	
				Start	End
Item	Erosion / Livestock			37.202731°	37.202731°
				-120.751389°	-120.751389°
DWR ID	DWR_NA0010_11_s_2020_13				
Comment Code					
E4 : Repair the levee slope damaged by livestock and prevent large animal access.					
Inspector Comment					
Material has been placed on the levee damage. Monitor for settlement.

View of damage on waterside shoulder and slope. (Spring 2022)
