**Flood Control Project Maintenance
Levee Inspections**

Maintenance Issue Types Only, Levee Inspection Report By Mile - Spring 2024

Lower San Joaquin Levee District

Waterway	Bank	Unit Miles	Inspection Start/End	Inspector
Unit No. 01 San Joaquin River	Right	22.52	03/12/2024 03/12/2024	Corey Fujitani

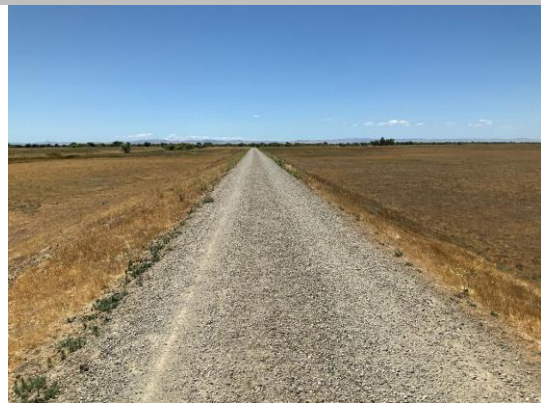
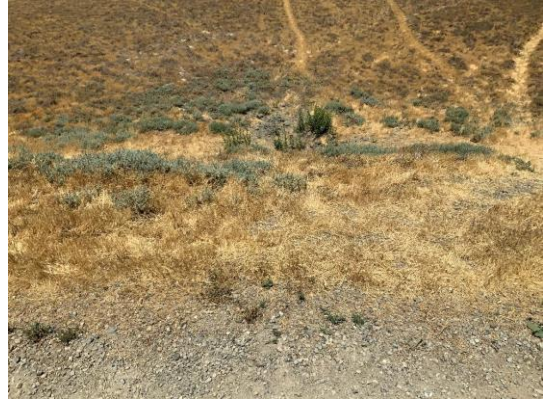
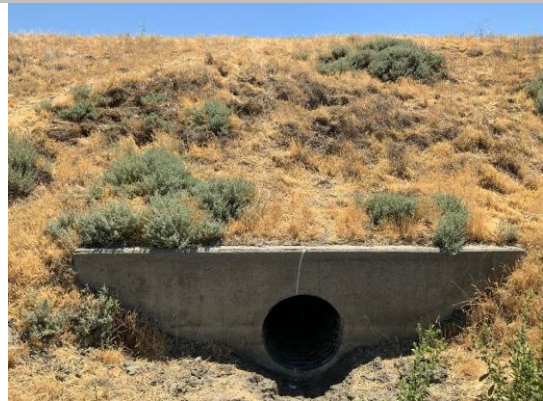
Comment Code					
Inspector Comment					
DS_ID:19846 FS_ID:73267 EP_NO: N/A Repair Type: Non-Urgent EVAL Issue: Crossing Status: Found UCIP Comments: 06/8/2021 The record remains Non-Urgent. WS pipe end either completely buried under dirt or has been removed. Only riser visible on WS slope, pipe end not visible at all. Recommend contacting owner to determine status of pipe. No permit was found authorizing this encroachment. CVFPB will need to review crossing to determine owner. The UCIP inspection was completed with GEI staff, P. Espinoza. (H. Dunn- GEI) 04/18/201 Need to contact owner. Recommend clearing sediment deposit inside pipe. (O. Magana - DWR UCIP) FIELD_STRUCT_DESC: 24-inch corrugated metal gravity drainage pipe (CMP) through the levee, 11.0 feet below the crown. Slide gate in a CMP riser unit on the waterside (WS) end. [Additional Reference(s): DWR Levee Log, 2002, (HLM 0.43). USACE San Joaquin O&M Manual, Unit No. 601, Part No. 1, 1967, Amended in 1978, Revised 20 June 1985, (HLM 0.42). DWR As-Built Specification No. 59-01, Sheet No. 61, 10 December 1958, (HLM 0.42)]. FS Date: 6/8/2021

Levee crown looking downstream.

LS view: Toe from crown.

LS view: Slope and headwall at toe.

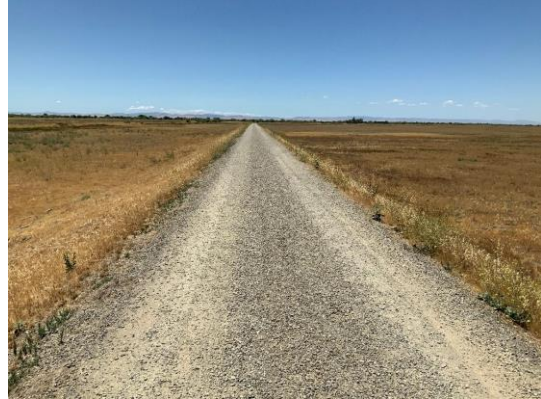
Photo 1 of 3 : UCIP_SP_2024_73268_100419.jpg

Comment Code					
Inspector Comment					
DS_ID:19847 FS_ID:73268 EP_NO: N/A Repair Type: Non-Urgent EVAL Issue: Crossing Status: Found UCIP Comments: 06/8/2021 The record remains Non-Urgent. DWR DMP internal inspection has not found pipe integrity issues. LOF of crossing is less or equal to 4.0. Recommend next video inspection in 5 years. No permit was found authorizing this encroachment. CVFPB will need to review crossing to determine owner. The UCIP inspection was completed with GEI staff, P. Espinoza. (H. Dunn - GEI) 04/18/201 Need to contact owner. Recommend clearing sediment deposit inside pipe. (O. Magana - DWR UCIP) FIELD_STRUCT_DESC: 24-inch corrugated metal gravity drainage pipe (CMP) through the levee, 10.0 feet below the crown. Flap gate on the waterside (WS) end. [Additional Reference(s): DWR Levee Log, 2002, (HLM 0.65). USACE San Joaquin O&M Manual, Unit No. 601, Part No. 1, 1967, Amended in 1978, Revised 20 June 1985, (HLM 0.65). DWR As-Built Specification No. 59-01, Sheet No. 61, 10 December 1958, (HLM 0.65)]. FS Date: 6/8/2021

Levee crown looking downstream.

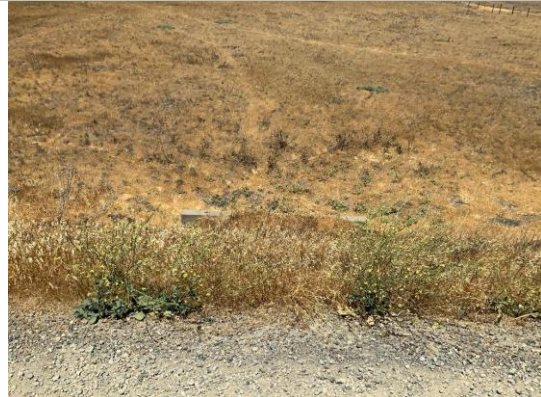
Photo 2 of 3 : UCIP_SP_2024_73268_100416.jpg

LS view: Headwall visible at toe from crown.

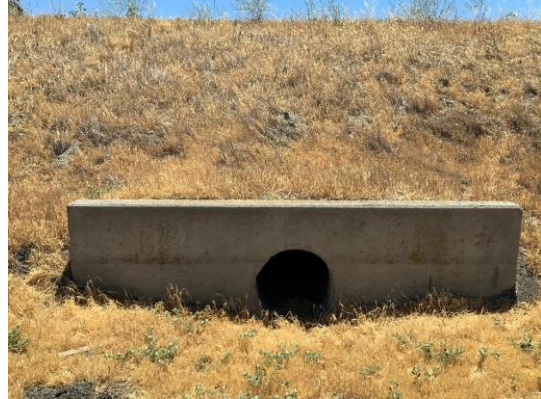
Photo 3 of 3 : UCIP_SP_2024_73268_100417.jpg

LS view: Slope and headwall at toe.

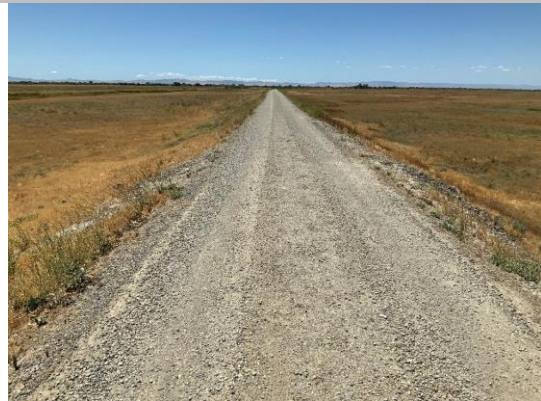
Photo 1 of 3 : UCIP_SP_2024_73269_100425.jpg

DS_ID:19848
 FS_ID:73269
 EP_NO: N/A
 Repair Type: Non-Urgent
 EVAL Issue:
 Crossing Status: Found
 UCIP Comments: 06/8/2021 The record remains Non-Urgent. DWR DMP internal inspection has not found pipe integrity issues. LOF of crossing is less or equal to 4.0. Recommend next video inspection in 5 years. No permit was found authorizing this encroachment. CVFPB will need to review crossing to determine owner. The UCIP inspection was completed with GEI staff, P. Espinoza. (H. Dunn - GEI) 04/18/201
 Need to contact owner. Recommend clearing sediment deposit inside pipe. (O. Magana - DWR UCIP)
 FIELD_STRUCT_DESC: 24-inch corrugated metal gravity drainage pipe (CMP) through the levee, 10.3 feet below the crown. Flap gate on the waterside (WS) end. [Additional Reference(s): DWR Levee Log, 2002, (HLM 0.85). USACE San Joaquin O&M Manual, Unit No. 601, Part No. 1, 1967, Amended in 1978, Revised 20 June 1985, (HLM 0.84). DWR As-Built Specification No. 59-01, Sheet No. 61, 10 December 1958, (HLM 0.84)].

Levee crown looking downstream.

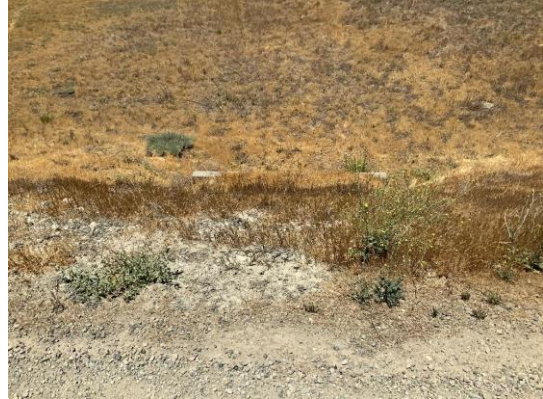
Photo 2 of 3 : UCIP_SP_2024_73269_100429.jpg

LS view: Toe from crown.

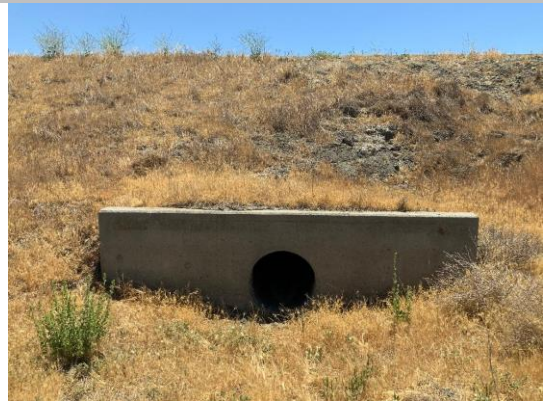
Photo 3 of 3 : UCIP_SP_2024_73269_100423.jpg

LS view: Headwall and slope from toe.

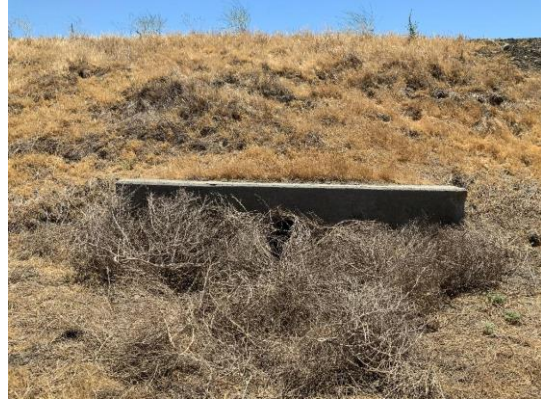
Photo 1 of 2 : UCIP_SP_2024_73270_100436.jpg

Comment Code					
Inspector Comment					
DS_ID:19849 FS_ID:73270 EP_NO: N/A Repair Type: Non-Urgent EVAL Issue: 11, Maintenance Compliance Issue Crossing Status: Found UCIP Comments: 06/8/2021 The record remains Non-Urgent. DWR DMP internal inspection has not found pipe integrity issues. LOF of crossing is less or equal to 4.0. Recommend next video inspection in 5 years. Dense tumbleweeds blocking both LS and WS ends, recommend removal. No permit was found authorizing this encroachment. CVFPB will need to review crossing to determine owner. The UCIP inspection was completed with GEI staff, P. Espinoza. (H. Dunn - GEI) 04/18/2014 Need to contact owner. Recommend clearing sediment deposit inside pipe. (O. Magana - DWR UCIP) FIELD_STRUCT_DESC: 24-inch corrugated metal gravity drainage pipe (CMP) through the levee, 9.0 feet below the crown. Flap gate on the waterside (WS) end. [Additional Reference(s): DWR Levee Log, 2002, (HLM 1.13). USACE San Joaquin O&M Manual, Unit No. 601, Part No. 1, 1967, Amended in 1978, Revised 20 June 1985, (HLM 1.13). DWR As-Built Specification No. 59-01, Sheet No. 61, 10 December 1958, (HLM 1.13)]. FS Date: 6/8/2021

LS view: Headwall and slope at toe.

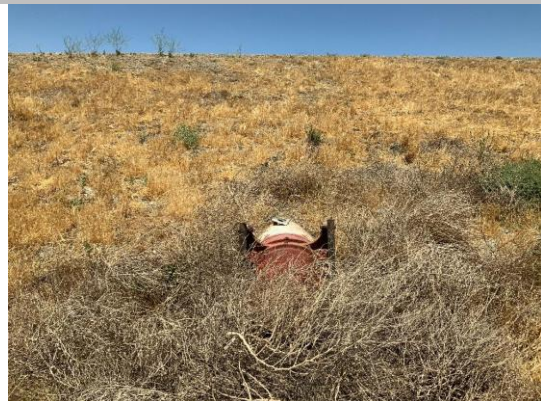
Photo 2 of 2 : UCIP_SP_2024_73270_100433.jpg

WS view: Flapgate and slope from toe. Dense tumbleweeds at toe.

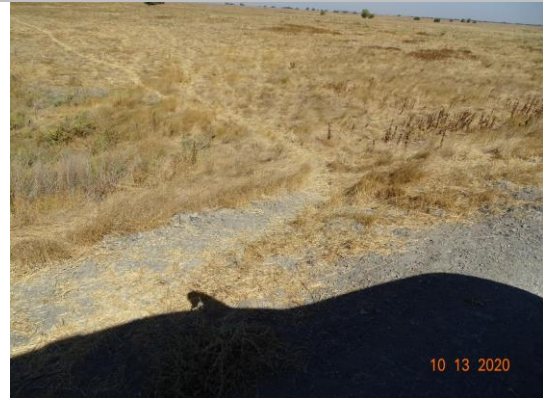
Photo 1 of 1 : SP_2024_NA0010_129_9_20240212_00001.jpg

LM Start	1.49	Rating **	A/W	Issue No.	9
LM End	1.49	Issue Type +	Ma	Location *	LS
Category	Earthen Levee			GPS Latitude/Longitude	
				Start	End
Item	Erosion / Livestock			37.202748°	37.202748°
				-120.728182°	-120.728182°
DWR ID	DWR_NA0010_11_f_2017_9				
Comment Code					
E4 : Repair the levee slope damaged by livestock and prevent large animal access.					
Inspector Comment

View of livestock trail on the landside slope. (Fall 2020)

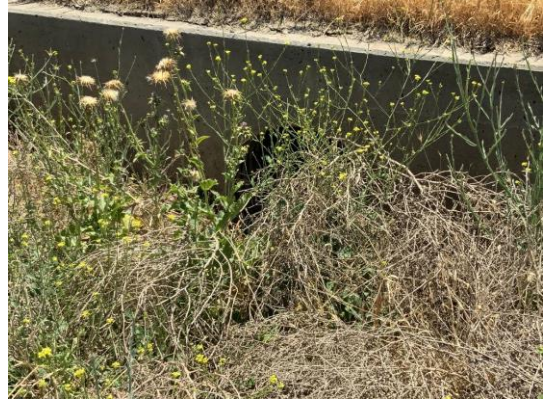
Photo 1 of 2 : UCIP_SP_2024_73272_100446.jpg

Comment Code						
Inspector Comment						
DS_ID:19851 FS_ID:73272 EP_NO: N/A Repair Type: Non-Urgent EVAL Issue: Crossing Status: Found UCIP Comments: 09/18/2023 Pipe was CIPP lined. DMP internal video inspection has found none or minor pipe defects. Recommend next video inspection in 5 years. (O. Yakimov - DWR UCIP) 06/8/2021 The record remains Non-Urgent. DWR DMP internal inspection has found pipe integrity issues. LOF of crossing is between 4.1 and 5. Crossing will be monitored until funding becomes available for rehabilitation. Vegetation on both WS and LS ends, recommend removal. No permit was found authorizing this encroachment. CVFPB will need to review crossing to determine owner. The UCIP inspection was completed with GEI staff, P. Espinoza. (H. Dunn - GEI) 04/18/201 Need to contact owner. Recommend clearing sediment deposit inside pipe. (O. Magana - DWR UCIP) FIELD_STRUCT_DESC: 24-inch CIPP-lined corrugated metal gravity drainage pipe (CMP) through the levee, 12.8 feet below the crown. Flap gate on the waterside (WS) end. [Additional Reference(s): DWR Levee Log, 2002, (HLM 1.99). USACE San Joaquin O&M Manual, Unit No. 601, Part No. 1, 1967, Amended in 1978, Revised 20 June 1985, (HLM 1.99). DWR As-Built Specification No. 59-01, Sheet No. 62, 10 December 1958, (HLM 1.99)]. FS Date: 6/8/2021

LS view: Close up of pipe inlet at toe, covered by vegetation.

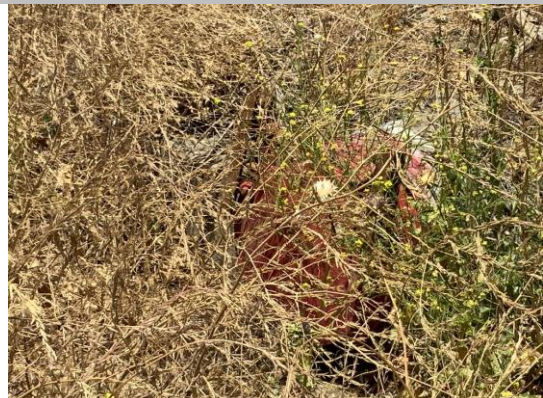
Photo 2 of 2 : UCIP_SP_2024_73272_100450.jpg

WS view: Close up of flapgate at toe, covered by vegetation.

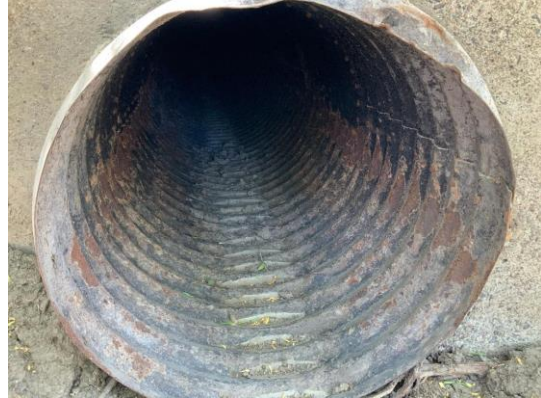
Photo 1 of 2 : UCIP_SP_2024_77932_100451.jpg

Comment Code						
Inspector Comment						
DS_ID:19852 FS_ID:77932 EP_NO: N/A Repair Type: Non-Urgent EVAL Issue: Crossing Status: Found UCIP Comments: 12/20/2022 Record updated from Urgent to Non-Urgent. Pipe has been CIPP lined. LOF of crossing is less or equal to 4. Recommend next video inspection in 5 years. (O.Yakimov - DWR UCIP) 06/8/2021 The record has been upgraded from Non-Urgent to Urgent. DWR DMP internal inspection has found pipe integrity issues. LOF of crossing is between 5 and 6. Crossing will be monitored until funding becomes available to address the issues. No permit was found authorizing this encroachment. CVFPB will need to review crossing to determine owner. Pipe has since been cleared out of sediment since previous inspection. The UCIP inspection was completed with GEI staff, P. Espinoza. (H. Dunn- GE)04/18/201 Need to contact owner. Recommend clearing sediment deposit inside pipe. (O. Magana - DWR UCIP) FIELD_STRUCT_DESC: 24-inch CIPP-lined corrugated metal gravity drainage pipe (CMP) through the levee, 15.0 feet below the crown. Flap gate on the waterside (WS) end. [Additional Reference(s): DWR Levee Log, 2002, (HLM 3.04). USACE San Joaquin O&M Manual, Unit No. 601, Part No. 1, 1967, Amended in 1978, Revised 20 June 1985, (HLM 3.04). DWR As-Built Specification No. 59-01, Sheet No. 63, 10 December 1958, (HLM 3.04)]. FS Date: 6/8/2021 11:31:05 AM

LS view: Close up of pipe inlet at toe.

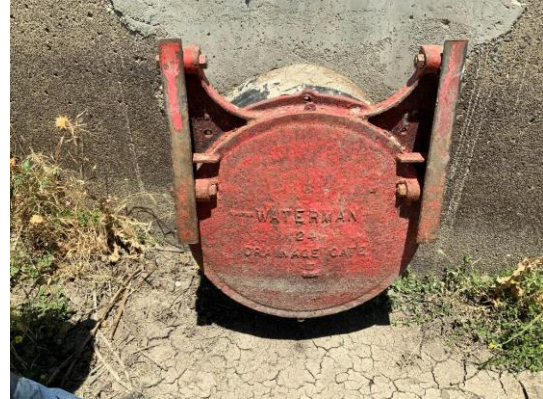
Photo 2 of 2 : UCIP_SP_2024_77932_100455.jpg

WS view: Close up of flapgate at toe.

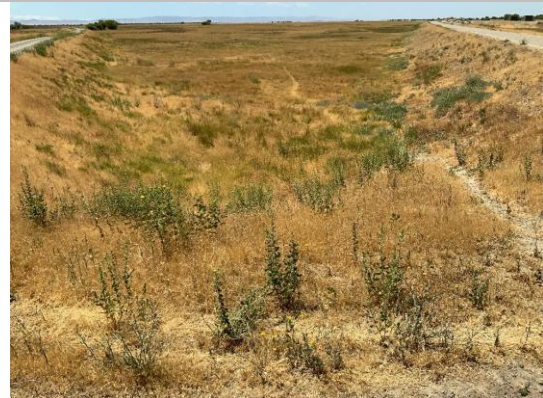
Photo 2 of 3 : UCIP_SP_2024_79244_100460.jpg

LS view: Slope from toe, no pipe visible.

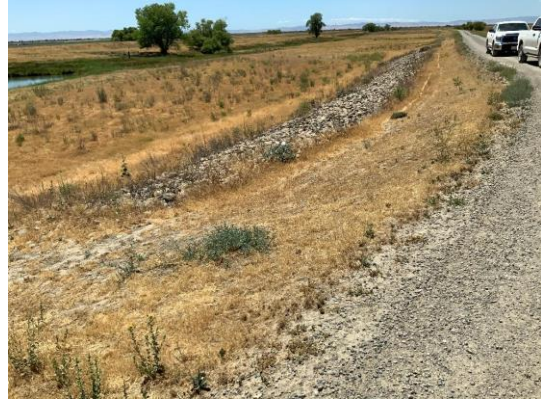
Photo 3 of 3 : UCIP_SP_2024_79244_100459.jpg

WS view: Slope from toe, no pipe visible.

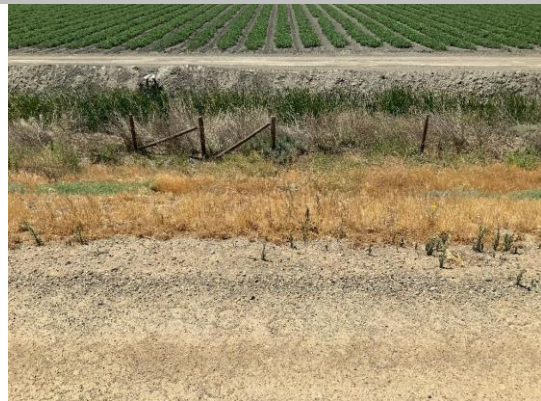
Photo 2 of 3 : UCIP_SP_2024_73304_100630.jpg

LS view: Toe from crown.

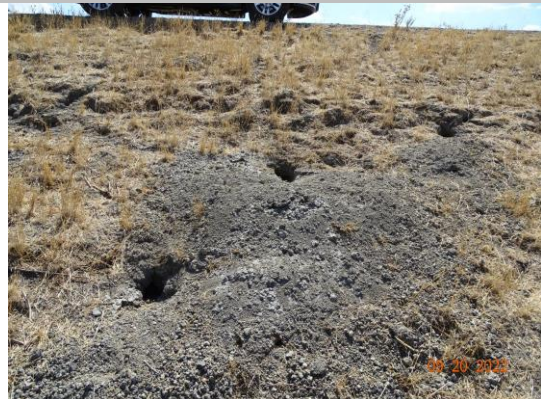
Photo 1 of 1 : SP_2024_NA0010_130_12_20240212_00002.jpg

LM Start	1.05	Rating **	M	Issue No.	12
LM End	1.05	Issue Type +	Ma	Location *	WS
Category	Earthen Levee			GPS Latitude/Longitude	
				Start	End
Item	Animal Control			37.200910°	37.200910°
				-120.736271°	-120.736271°
DWR ID	DWR_NA0010_12_f_2022_12				
Comment Code					
A3 : No rodents visible, but rodent burrows visible; need to backfill and compact or grout burrows.					
Inspector Comment

View of rodent burrows on the waterside slope. (Fall 2022)

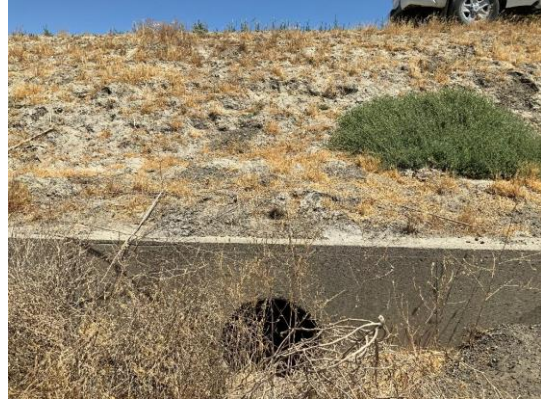
Photo 1 of 2 : UCIP_SP_2024_73305_100631.jpg

Comment Code					
Inspector Comment					
DS_ID:19856 FS_ID:73305 EP_NO: N/A Repair Type: Non-Urgent EVAL Issue: 11, Maintenance Compliance Issue Crossing Status: Found UCIP Comments: 06/8/2021 The record remains Non-Urgent. DWR DMP internal inspection has not found pipe integrity issues. LOF of crossing is less or equal to 4.0. Recommend next video inspection in 5 years. Some vegetation growth starting over WS flapgate and LS pipe inlet, recommend removal. No permit was found authorizing this encroachment. CVFPB will need to review crossing to determine owner. The UCIP inspection was completed with GEI staff, P. Espinoza. (H. Dunn – GEI) 04/18/2014 Need to contact owner. Recommend clearing sediment deposit inside pipe. (O. Magana - DWR UCIP) FIELD_STRUCT_DESC: 24-inch corrugated metal gravity drainage pipe (CMP) through the levee, 10.5 feet below the crown. Flap gate on the waterside (WS) end. [Additional Reference(s): DWR Levee Log, 2002, (HLM 1.06). USACE San Joaquin O&M Manual, Unit No. 601, Part No. 1, 1967, Amended in 1978, Revised 20 June 1985, (HLM 1.06). DWR As-Built Specification No. 59-01, Sheet No. 61, 10 December 1958, (HLM 1.06)]. FS Date: 6/8/2021

LS view: Slope and headwall at toe.

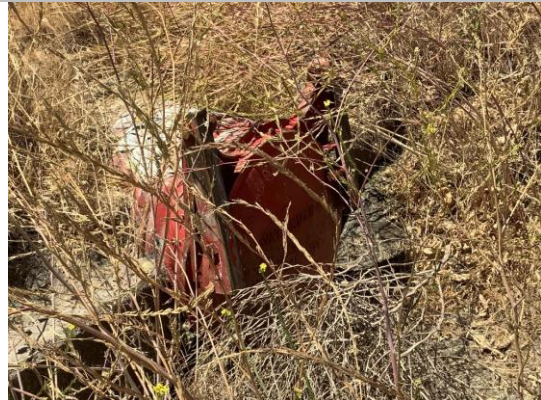
Photo 2 of 2 : UCIP_SP_2024_73305_100636.jpg

WS view: Close up of flapgate at toe.

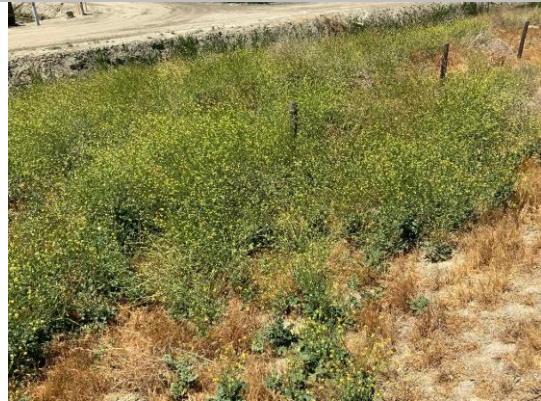
Photo 1 of 2 : UCIP_SP_2024_73306_100638.jpg

Comment Code						
Inspector Comment						
DS_ID:19857 FS_ID:73306 EP_NO: N/A Repair Type: Non-Urgent EVAL Issue: 11, Maintenance Compliance Issue Crossing Status: Not Found UCIP Comments: 06/8/2021 The record remains Non-Urgent. Pipe not found during visual inspection due to dense vegetation on both WS and LS ends. LS end was also blocked off by barbed wire which limited inspection. Recommend removing vegetation in order to assess condition of pipe. No permit was found authorizing this encroachment. CVFPB will need to review crossing to determine owner. The UCIP inspection was completed with GEI staff, P. Espinoza. (H. Dunn – GEI) 04/18/2014 Landward side not accessible due to dense vegetation and fence. Concrete headwall and flap gate under water therefore not able to evaluate condition. Will need to coordinate with owner to evaluate condition of crossing on waterward side and obtain access to evaluate landward side. (O. Magana - DWR UCIP) FIELD_STRUCT_DESC: 24-inch corrugated metal gravity drainage pipe (CMP) through the levee, 17.4 feet below the crown. Flap gate on the waterside (WS) end. [Additional Reference(s): DWR Levee Log, 2002, (HLM 1.28). USACE San Joaquin O&M Manual, Unit No. 601, Part No. 1, 1967, Amended in 1978, Revised 20 June 1985, (HLM 1.27). DWR As-Built Specification No. 59-01, Sheet No. 61, 10 December 1958, (HLM 1.27)]. FS Date: 6/8/2021

LS view: Dense vegetation and barbed wire at the toe, no pipe visible.

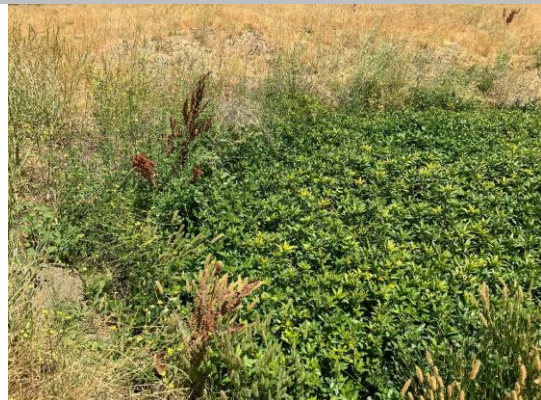
Photo 2 of 2 : UCIP_SP_2024_73306_100641.jpg

WS view: Dense vegetation covering the water at the toe, no pipe visible.

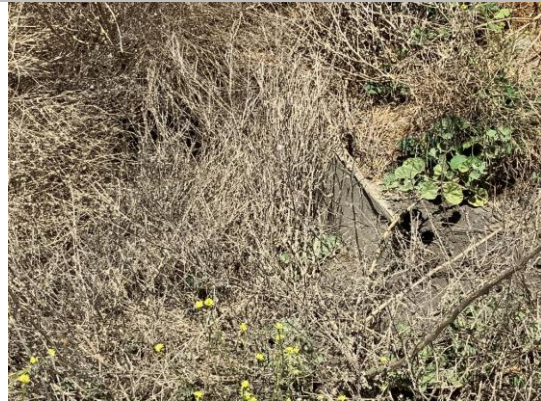
Photo 1 of 1 : UCIP_SP_2024_73307_100645.jpg

Comment Code					
Inspector Comment					
DS_ID:19858 FS_ID:73307 EP_NO: N/A Repair Type: Non-Urgent EVAL Issue: 11, Maintenance Compliance Issue Crossing Status: Found UCIP Comments: 06/8/2021 The record remains Non-Urgent. DWR DMP internal inspection has not found pipe integrity issues. LOF of crossing is less or equal to 4.0. Recommend next video inspection in 5 years. Dense vegetation over LS pipe inlet, headwall barely visible. Recommend removal of vegetation. No permit was found authorizing this encroachment. CVFPB will need to review crossing to determine owner. The UCIP inspection was completed with GEI staff, P. Espinoza. (H. Dunn – GEI) 04/18/2014 Limited access on landward side due to fence and dense vegetation. Recommend obtaining access to landward side and clear vegetation on landward side. (O. Magana - DWR UCIP) FIELD_STRUCT_DESC: 24-inch corrugated metal gravity drainage pipe (CMP) through the levee, 10.7 feet below the crown. Flap gate on the waterside (WS) end. [Additional Reference(s): DWR Levee Log, 2002, (HLM 1.53). USACE San Joaquin O&M Manual, Unit No. 601, Part No. 1, 1967, Amended in 1978, Revised 20 June 1985, (HLM 1.53). DWR As-Built Specification No. 59-01, Sheet No. 62, 10 December 1958, (HLM 1.53)]. FS Date: 6/8/2021

LS view: Headwall barely visible at toe due to dense vegetation.

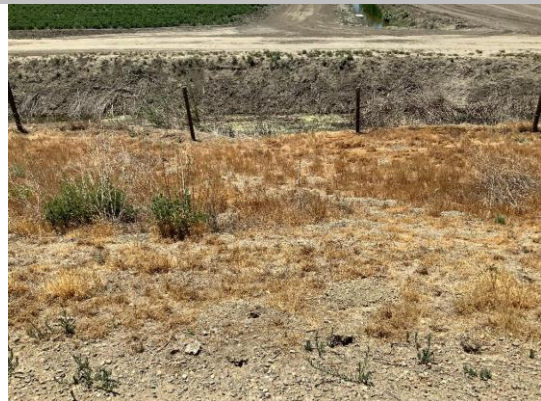
Photo 2 of 3 : UCIP_SP_2024_73308_100659.jpg

LS view: Toe from crown.

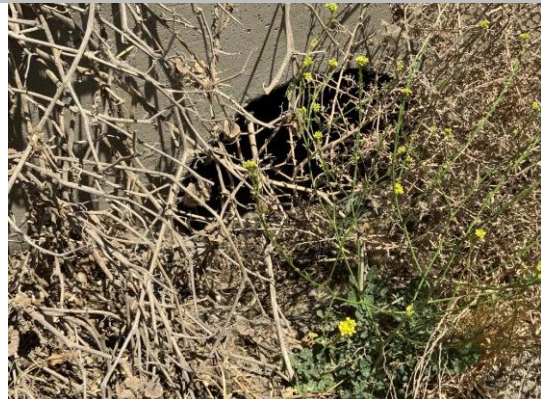
Photo 1 of 1 : UCIP_SP_2024_73309_100661.jpg

DS_ID:19860
FS_ID:73309
EP_NO: N/A
Repair Type: Non-Urgent
EVAL Issue: 11, Maintenance Compliance Issue
Crossing Status: Found
UCIP Comments: 06/8/2021 The record remains Non-Urgent. DWR DMP internal inspection has not found pipe integrity issues. LOF of crossing is less or equal to 4.0. Recommend next video inspection in 5 years. LS pipe inlet covered with vegetation, recommend removal. No permit was found authorizing this encroachment. CVFPB will need to review crossing to determine owner. The UCIP inspection was completed with GEI staff, P. Espinoza. (H. Dunn – GEI) 04/18/2014
Need to contact owner. Recommend clearing sediment deposit inside pipe. (O. Magana - DWR UCIP)
FIELD_STRUCT_DESC: 24-inch corrugated metal gravity drainage pipe (CMP) through the levee, 10.7 feet below the crown. Flap gate on the waterside (WS) end. [Additional Reference(s): DWR Levee Log, 2002, (HLM 2.70). USACE San Joaquin O&M Manual, Unit No. 601, Part No. 1, 1967, Amended in 1978, Revised 20 June 1985, (HLM 2.70). DWR As-Built Specification No. 59-01, Sheet No. 62, 10 December 1958, (HLM 2.70)].

LS view: Close up of pipe inlet covered with vegetation.

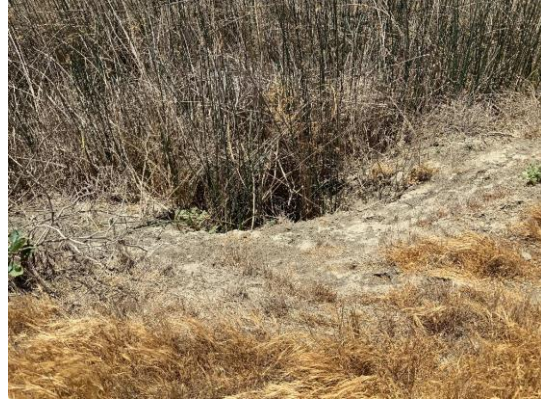
Photo 1 of 1 : UCIP_SP_2024_73310_100669.jpg

Comment Code					
Inspector Comment					
DS_ID:19861 FS_ID:73310 EP_NO: N/A Repair Type: Non-Urgent EVAL Issue: 11, Maintenance Compliance Issue Crossing Status: Found UCIP Comments: 06/8/2021 The record remains Non-Urgent. DWR DMP internal inspection has not found pipe integrity issues. LOF of crossing is less or equal to 4.0. Recommend next video inspection in 5 years. LS pipe inlet inaccessible due to barbed wire and WS flapgate surrounded by water, limited inspection for both. LS pipe inlet also has dense vegetation covering it, recommend removal. No permit was found authorizing this encroachment. CVFPB will need to review crossing to determine owner. The UCIP inspection was completed with GEI staff, P. Espinoza. (H. Dunn – GEI) 11/09/2015 DWR Inspection section confirmed issue has been addressed. Need to coordinate with LMA to determine additional details for extent of repair. (O. Magana - DWR UCIP)04/18/2014 Soil missing behind concrete headwall on waterward side. Unable to determine if missing soil is due to sink holes, rodent activity, or due to erosion. Headwall appears to be leaning slightly forward. Reason why this crossing was labelled urgent was due to the uncertainty of damage to concrete headwall and reason for soil missing behind concrete. Need to coordinate with LMA to determine more information about repair at this location. (O. Magana -DWR UCIP) FIELD_STRUCT_DESC: 24-inch corrugated metal gravity drainage pipe (CMP) through the levee, 2.0 feet below the crown. Flap gate on the waterside (WS) end. [Additional Reference(s): DWR Levee Log, 2002, (HLM 3.00). USACE San Joaquin O&M Manual, Unit No. 601, Part No. 1, 1967, Amended in 1978, Revised 20 June 1985, (HLM 3.00). DWR As-Built Specification No. 59-01, Sheet No. 63, 10 December 1958, (HLM 3.00)]. FS Date: 6/8/2021

LS view: Top of headwall visible at toe.

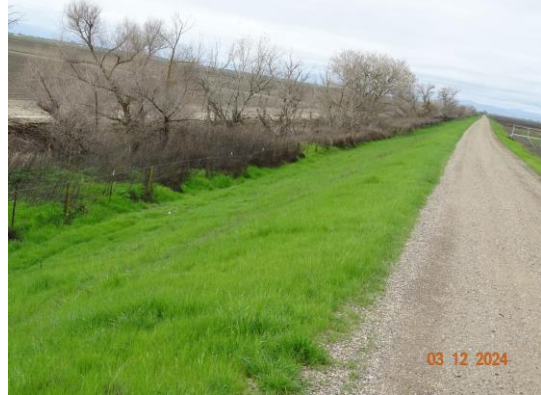
Photo 1 of 1 : SP_2024_NA0010_130_8_20240326_00016.jpg

LM Start	3.28	Rating **	A	Issue No.	8
LM End	3.28	Issue Type +	Ma	Location *	LS
Category	Earthen Levee			GPS Latitude/Longitude	
				Start	End
Item	Vegetation			37.200967°	37.200967°
				-120.695688°	-120.695688°
DWR ID	DWR_NA0010_12_s_2024_8				
Comment Code					
V1 : Control annual grass and weeds on the levee slopes and easements.					
Inspector Comment

View of the landside slope looking downstream. (Spring 2024)

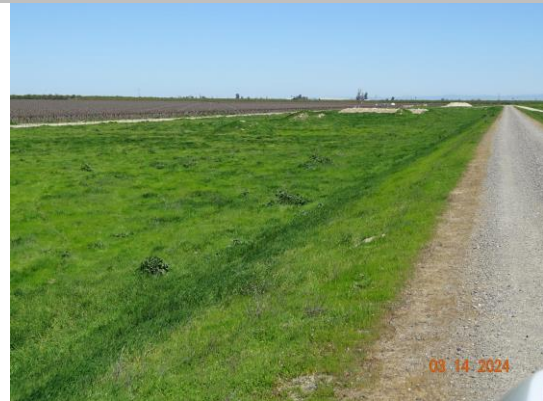
Photo 1 of 1 : SP_2024_NA0010_131_3_20240327_00012.jpg

LM Start	0.03	Rating **	A	Issue No.	3
LM End	0.03	Issue Type +	Ma	Location *	LS
Category	Earthen Levee			GPS Latitude/Longitude	
				Start	End
Item	Vegetation			37.034164°	37.034164°
				-120.441956°	-120.441956°
DWR ID	DWR_NA0010_13_s_2024_3				
Comment Code					
V1 : Control annual grass and weeds on the levee slopes and easements.					
Inspector Comment

View of the vegetation management on the landside slope. (Spring 2024)

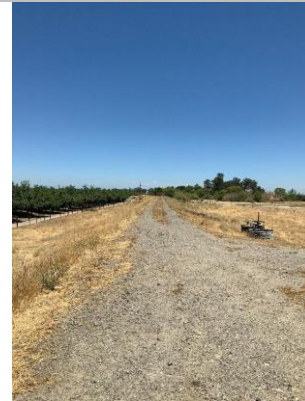
Photo 1 of 3 : UCIP_SP_2024_73336_103411.jpg

Comment Code						
Inspector Comment						
DS_ID:19727 FS_ID:73336 EP_NO: N/A Repair Type: Non-Urgent EVAL Issue: Crossing Status: Found UCIP Comments: 06/23/2021 The record remains Non-Urgent. Appears abandoned due to actuator missing on slidegate on the WS shoulder and if abandoned, should be done properly. Limited inspection of inlet and outlet due to standing water over concrete platforms surrounding pipe inlet/outlet, creating inability to inspect closely. No permit was found authorizing this encroachment. CVFPB will need to review crossing to determine owner. The UCIP inspection was completed with GEI staff, H.Dunn. (P.Espinoza – GEI)03/27/2014 Appears abandoned and if so should be done so properly. Pipe filled with soil on WS at outlet. Actuator missing from slide gate on WS shoulder. (W. Wylie - DWR UCIP) FIELD_STRUCT_DESC: [Rounder Irrigation Structure] 1 of 2: 36-inch corrugated metal gravity drainage pipe (CMP) through the levee, 12.3 feet below the crown. Slide gate in a 48-inch CMP riser unit on the waterside (WS) slope. 6-foot by 12-foot concrete distribution box on the landside (LS). 7-foot by 14-foot concrete outlet structure on the WS toe. [Additional Reference(s): DWR Levee Log, 2002, (HLM 1.14). USACE San Joaquin O&M Manual, Unit No. 601, Part No. 1, 1967, Amended in 1978, Revised 20 June 1985, (HLM 1.14). DWR As-Built Specification No. 64-01, Sheet No. 13, 6 November 1963, (HLM 1.14)]. FS Date: 6/23/2021 1:08:00 PM

View of levee crown.

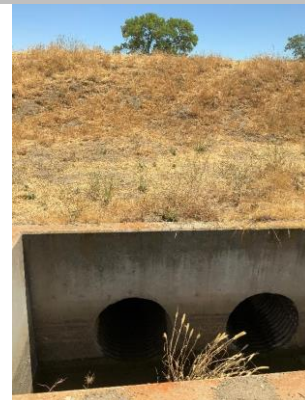
Photo 2 of 3 : UCIP_SP_2024_73336_103418.jpg

LS view: concrete inlet pipe on LS toe.

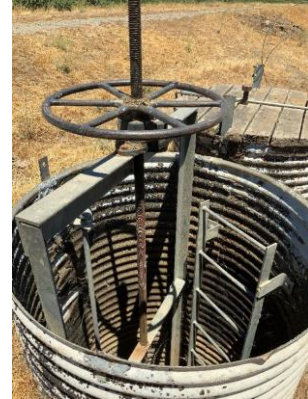
Photo 1 of 1 : UCIP_SP_2024_73337_103428.jpg

Comment Code					
Inspector Comment					
DS_ID:19908 FS_ID:73337 EP_NO: N/A Repair Type: Non-Urgent EVAL Issue: 4b, Safety Issue Crossing Status: Found UCIP Comments: 09/18/2023 Pipe was CIPP lined. DMP internal video inspection has found none or minor pipe defects. Recommend next video inspection in 5 years. (O. Yakimov - DWR UCIP) 06/23/2021 The record remains Non-Urgent. DWR DMP internal inspection has found pipe integrity issues. LOF of crossing is between 4.1 and 5. Crossing will be monitored until funding becomes available for rehabilitation. No lid on riser at WS shoulder, causing safety hazard. Limited inspection of both inlet and outlet due to standing water over concrete pads around the pipe inlet/out. Outlet also has metal grate over it, limiting ability to inspect pipe closely. No permit was found authorizing this encroachment. CVFPB will need to review crossing to determine owner. The UCIP inspection was completed with GEI staff, H.Dunn. (P.Espinoza – GEI)03/27/2014 No lid on riser at WS shoulder could be safety issue. (W. Wylie - DWR UCIP) FIELD_STRUCT_DESC: [Rounder Irrigation Structure] 2 of 2: 36-inch CIPP-lined corrugated metal gravity drainage pipe (CMP) through the levee, 12.3 feet below the crown. Slide gate in a 48-inch CMP riser unit on the waterside (WS) slope. 6-foot by 12-foot concrete distribution box on the landside (LS). 7-foot by 14-foot concrete outlet structure on the WS toe. [Additional Reference(s): DWR Levee Log, 2002, (HLM 1.14). USACE San Joaquin O&M Manual, Unit No. 601, Part No. 1, 1967, Amended in 1978, Revised 20 June 1985, (HLM 1.14). DWR As-Built Specification No. 64-01, Sheet No. 13, 6 November 1963, (HLM 1.14)]. FS Date: 6/23/2021 2:23:00 PM

WS view: close up of CMP riser.

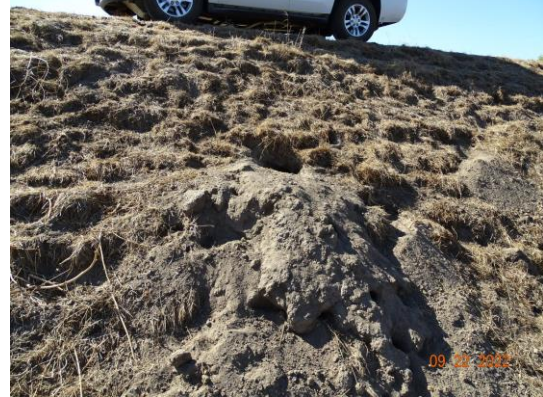
Photo 1 of 1 : SP_2024_NA0010_131_7_20240212_00004.jpg

LM Start	1.21	Rating **	M	Issue No.	7
LM End	1.24	Issue Type +	Ma	Location *	LS
Category	Earthen Levee			GPS Latitude/Longitude	
				Start	End
Item	Animal Control			37.046142°	37.046229°
				-120.428848°	-120.428448°
DWR ID	DWR_NA0010_13_f_2022_7				
Comment Code					
A3 : No rodents visible, but rodent burrows visible; need to backfill and compact or grout burrows.					
Inspector Comment

Several rodent burrows observed in this section. (Fall 2022)

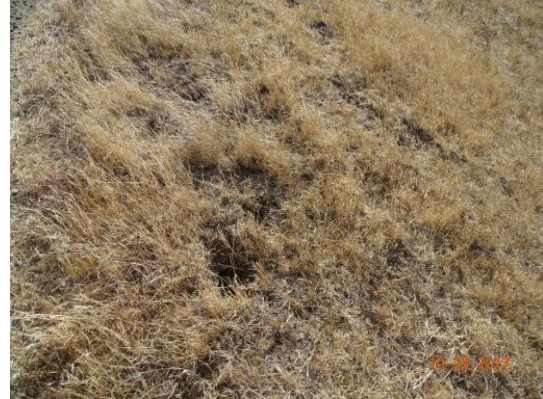
Photo 1 of 1 : SP_2024_NA0010_132_5_20240212_00002.jpg

LM Start	0.25	Rating **	A/W	Issue No.	5
LM End	0.25	Issue Type +	Ma	Location *	LS
Category	Earthen Levee			GPS Latitude/Longitude	
				Start	End
Item	Animal Control			37.035841°	37.035841°
				-120.439795°	-120.439795°
DWR ID	DWR_NA0010_14_f_2017_5				
Comment Code					
A3 : No rodents visible, but rodent burrows visible; need to backfill and compact or grout burrows.					
Inspector Comment

Looking at the landside slope.

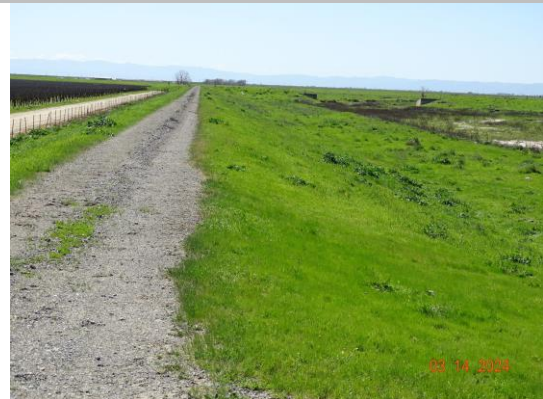
Photo 1 of 1 : SP_2024_NA0010_132_6_20240327_00006.jpg

LM Start	0.33	Rating **	A	Issue No.	6
LM End	0.33	Issue Type +	Ma	Location *	WS
Category	Earthen Levee			GPS Latitude/Longitude	
				Start	End
Item	Vegetation			37.036822°	37.036822°
				-120.439381°	-120.439381°
DWR ID	DWR_NA0010_14_s_2024_6				
Comment Code					
V1 : Control annual grass and weeds on the levee slopes and easements.					
Inspector Comment

View of vegetation on the waterside slope. (Spring 2024)

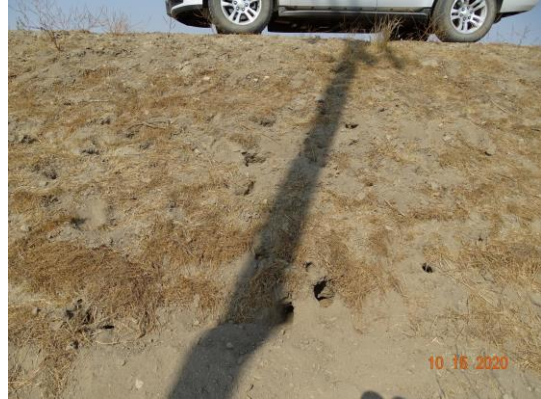
Photo 1 of 1 : SP_2024_NA0010_132_79_20240212_00003.jpg

LM Start	1.24	Rating **	M	Issue No.	79
LM End	1.24	Issue Type +	Ma	Location *	LS
Category	Earthen Levee			GPS Latitude/Longitude	
				Start	End
Item	Animal Control			37.045343°	37.045343°
				-120.428007°	-120.428007°
DWR ID	DWR_NA0010_14_s_2021_79				
Comment Code					
A3 : No rodents visible, but rodent burrows visible; need to backfill and compact or grout burrows.					
Inspector Comment					
Several rodent holes are noted on the landside at this location.

View of rodent burrows on the landside slope. (Fall 2020)

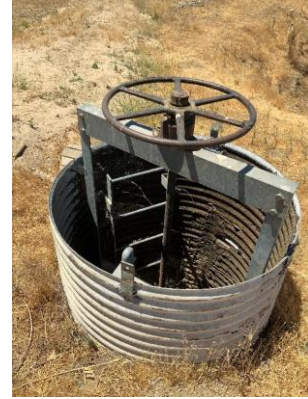
Photo 1 of 1 : UCIP_SP_2024_77924_103812.jpg

Comment Code						
Inspector Comment						
DS_ID:19910 FS_ID:77924 EP_NO: N/A Repair Type: Non-Urgent EVAL Issue: 4b, Safety Issue Crossing Status: Found UCIP Comments: 12/20/2022 Record updated from Urgent to Non-Urgent. Pipe has been CIPP lined. LOF of crossing is less or equal to 4. Recommend next video inspection in 5 years. (O.Yakimov - DWR UCIP) 06/23/2021 Record has been upgraded from No Action Needed to Urgent. DWR DMP internal inspection has found pipe integrity issues. LOF of crossing is between 5 and 6. Crossing will be monitored until funding becomes available to address the issues. Lid missing from CMP riser on WS slope, causing safety concern. LS not accessible; limited inspection due to barbed wire. No permit was found authorizing this encroachment. CVFPB will need to review crossing to determine owner. The UCIP inspection was completed with GEI staff, H.Dunn. (P.Espinoza – GEI) FIELD_STRUCT_DESC: 36-inch CIPP-lined corrugated metal gravity drainage pipe (CMP) through the levee, 9.0 feet below the crown. Slide gate in a 42-inch CMP riser unit on the waterside (WS) slope. Concrete U-shaped headwall on the WS end. Pipe terminates into a concrete ditch on the landside (LS). [Additional Reference(s): DWR Levee Log, 2002, (HLM 1.26). USACE San Joaquin O&M Manual, Unit No. 601, Part No. 1, 1967, Amended in 1978, Revised 20 June 1985, (HLM 1.26). DWR As-Built Specification No. 64-01, Sheet No. 13, 6 November 1963, (HLM 1.26)]. FS Date: 6/23/2021 10:53:01 AM

WS view: close up of CMP riser on slope.

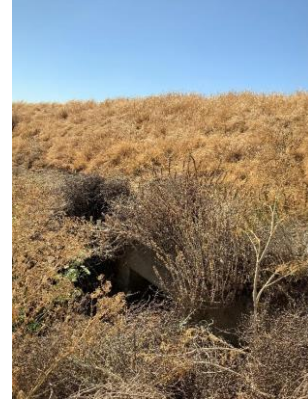
Photo 1 of 1 : UCIP_SP_2024_73365_103819.jpg

Comment Code						
Inspector Comment						
DS_ID:19911 FS_ID:73365 EP_NO: N/A Repair Type: Non-Urgent EVAL Issue: 11, Maintenance Compliance Issue Crossing Status: Indicator Found UCIP Comments: 06/24/2021 The record has been upgraded from No Action Needed to Non-Urgent. Limited inspection of LS due to vegetation overgrowth; recommend removal. Water was actively flowing through WS pipe. No permit was found authorizing this encroachment. CVFPB will need to review crossing to determine owner. The UCIP inspection was completed with GEI staff, H.Dunn. (P.Espinoza – GEI) FIELD_STRUCT_DESC: 30-inch by 30-inch square reinforced concrete box gravity drainage culvert (RCBC) through the levee, 10.1 feet below the crown. Flap gate on the waterside (WS) end. Concrete headwall on the landside (LS) end. Concrete U-shaped headwall on the WS end. [Additional Reference(s): DWR Levee Log, 2002, (HLM 0.49). USACE San Joaquin O&M Manual, Unit No. 601, Part No. 1, 1967, Amended in 1978, Revised 20 June 1985, (HLM 0.48). DWR As-Built Specification No. 64-42, Sheet No. 23, 13 August 1964, (HLM 0.48)]. FS Date: 6/24/2021 2:52:00 PM

LS view: concrete wall and entrance to pipe from toe. View of slope in background.

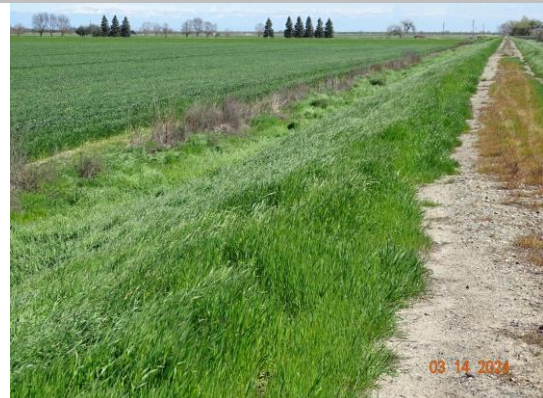
Photo 1 of 1 : SP_2024_NA0010_133_7_20240327_00007.jpg

LM Start	0.73	Rating **	M	Issue No.	7
LM End	2.01	Issue Type +	Ma	Location *	LS
Category	Earthen Levee			GPS Latitude/Longitude	
				Start	End
Item	Vegetation			36.996539°	36.996587°
				-120.397320°	-120.374053°
DWR ID	DWR_NA0010_15_s_2024_7				
Comment Code					
V1 : Control annual grass and weeds on the levee slopes and easements.					
Inspector Comment

View of vegetation on the landside slope. (Spring 2024)

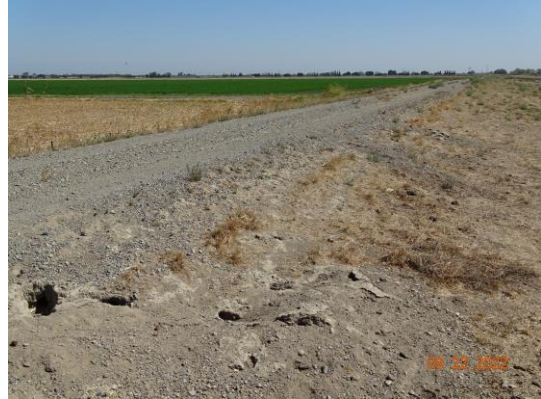
Photo 1 of 1 : SP_2024_NA0010_133_6_20240212_00002.jpg

LM Start	0.95	Rating **	M	Issue No.	6
LM End	0.95	Issue Type +	Ma	Location *	WS
Category	Earthen Levee			GPS Latitude/Longitude	
				Start	End
Item	Animal Control			36.996555°	36.996555°
				-120.393195°	-120.393195°
DWR ID	DWR_NA0010_15_s_2022_6				
Comment Code					
A1 : Exterminate rodents and backfill and compact or grout burrows.					
Inspector Comment					
Burrows on both landside and waterside slopes.

View of rodent holes in the waterside slope. (Fall 2022)

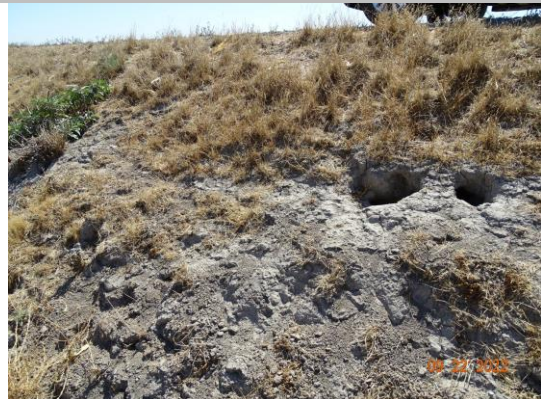
Photo 1 of 1 : SP_2024_NA0010_133_4_20240212_00001.jpg

LM Start	0.96	Rating **	M	Issue No.	4
LM End	0.96	Issue Type +	Ma	Location *	LS
Category	Earthen Levee			GPS Latitude/Longitude	
				Start	End
Item	Animal Control			36.996557°	36.996557°
				-120.393095°	-120.393095°
DWR ID	DWR_NA0010_15_f_2022_4				
Comment Code					
A3 : No rodents visible, but rodent burrows visible; need to backfill and compact or grout burrows.					
Inspector Comment

View of rodent holes on the landside slope. (Fall 2022)

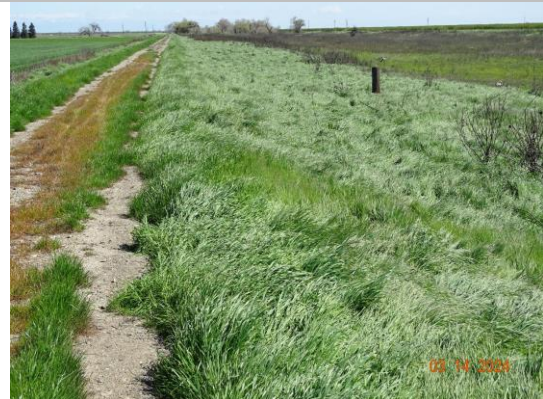
Photo 1 of 1 : SP_2024_NA0010_133_8_20240327_00008.jpg

LM Start	1.52	Rating **	M	Issue No.	8
LM End	2.01	Issue Type +	Ma	Location *	WS
Category	Earthen Levee			GPS Latitude/Longitude	
				Start	End
Item	Vegetation			36.996571°	36.996584°
				-120.382916°	-120.374059°
DWR ID	DWR_NA0010_15_s_2024_8				
Comment Code					
V1 : Control annual grass and weeds on the levee slopes and easements.					
Inspector Comment

Looking upstream along the waterside slope. (Spring 2024)

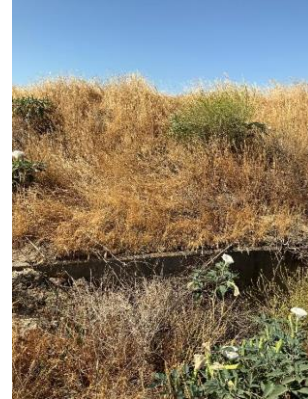
Photo 1 of 2 : UCIP_SP_2024_73367_103831.jpg

Comment Code						
Inspector Comment						
DS_ID:19913 FS_ID:73367 EP_NO: N/A Repair Type: Non-Urgent EVAL Issue: 11, Maintenance Compliance Issue Crossing Status: Found UCIP Comments: 06/24/2021 The record remains Non-Urgent. Limited inspection of LS pipe due to vegetation overgrowth; recommend removal. Note that wooden board is holding flapgate closed on WS; recommend removing before flood season to allow for flow. No permit was found authorizing this encroachment. CVFPB will need to review crossing to determine owner. The UCIP inspection was completed with GEI staff, H.Dunn. (P.Espinoza – GEI) 03/27/2014 Excessive vegetation at inlet on LS toe. (W. Wylie - DWR UCIP) FIELD_STRUCT_DESC: 30-inch by 30-inch square reinforced concrete box gravity drainage culvert (RCBC) through the levee, 8.9 feet below the crown. Flap gate on the waterside (WS) end. Concrete headwall on the landside (LS) end. Concrete U-shaped headwall on the WS end. [Additional Reference(s): DWR Levee Log, 2002, (HLM 1.54). USACE San Joaquin O&M Manual, Unit No. 601, Part No. 1, 1967, Amended in 1978, Revised 20 June 1985, (HLM 1.53). DWR As-Built Specification No. 64-42, Sheet No. 24, 13 August 1964, (HLM 1.53)]. FS Date: 6/24/2021 3:47:00 PM

LS view: concrete headwall from toe.

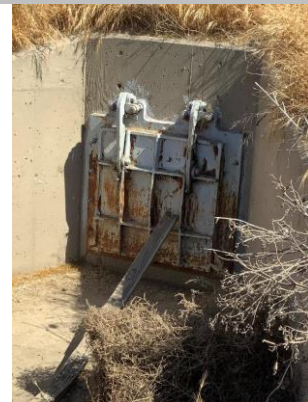
Photo 2 of 2 : UCIP_SP_2024_73367_103833.jpg

WS view: closeup of flapgate.

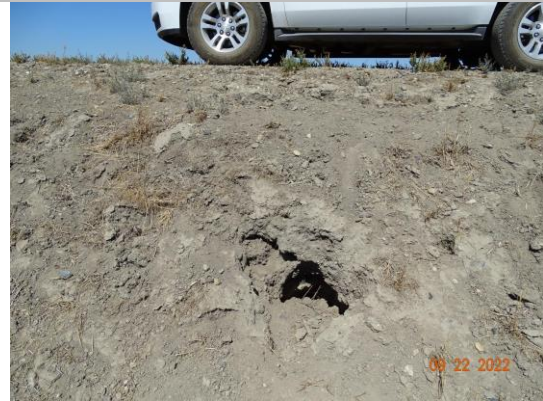
Photo 1 of 1 : SP_2024_NA0010_134_7_20240212_00003.jpg

LM Start	0.22	Rating **	M	Issue No.	7
LM End	0.22	Issue Type +	Ma	Location *	LS
Category	Earthen Levee			GPS Latitude/Longitude	
				Start	End
Item	Animal Control			36.995421°	36.995421°
				-120.404956°	-120.404956°
DWR ID	DWR_NA0010_16_f _ 2022_7				
Comment Code					
A3 : No rodents visible, but rodent burrows visible; need to backfill and compact or grout burrows.					
Inspector Comment

Animal burrows on the landside slope. (Fall 2022)

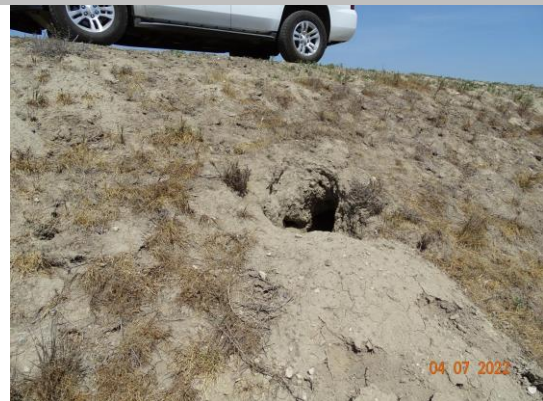
Photo 1 of 1 : SP_2024_NA0010_134_10_20240212_00004.jpg

LM Start	0.30	Rating **	U	Issue No.	10
LM End	0.30	Issue Type +	Ma	Location *	LS
Category	Earthen Levee			GPS Latitude/Longitude	
				Start	End
Item	Animal Control			36.995433°	36.995433°
				-120.403543°	-120.403543°
DWR ID	DWR_NA0010_16_s_2022_10				
Comment Code					
A3 : No rodents visible, but rodent burrows visible; need to backfill and compact or grout burrows.					
Inspector Comment					
Burrow is approximately 18-inches across.

Large animal burrow on the landside slope. (Spring 2022)

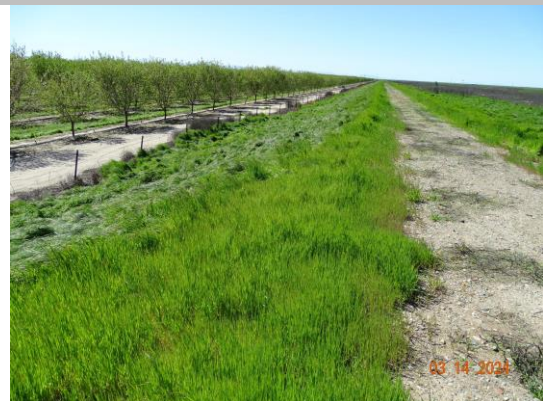
Photo 1 of 1 : SP_2024_NA0010_134_3_20240327_00009.jpg

LM Start	0.76	Rating **	M	Issue No.	3
LM End	1.95	Issue Type +	Ma	Location *	LS
Category	Earthen Levee			GPS Latitude/Longitude	
				Start	End
Item	Vegetation			36.995425°	36.995482°
				-120.395245°	-120.373795°
DWR ID	DWR_NA0010_16_s_2024_3				
Comment Code					
V1 : Control annual grass and weeds on the levee slopes and easements.					
Inspector Comment

View of vegetation on the landside slope. (Spring 2024)

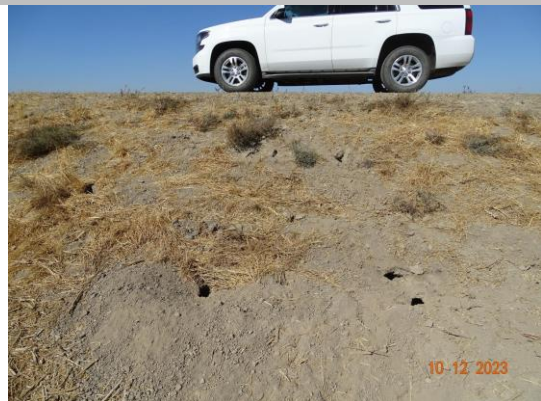
Photo 1 of 1 : SP_2024_NA0010_134_5_20240212_00002.jpg

LM Start	1.27	Rating **	M	Issue No.	5
LM End	1.27	Issue Type +	Ma	Location *	LS
Category	Earthen Levee			GPS Latitude/Longitude	
				Start	End
Item	Animal Control			36.995461°	36.995461°
				-120.386068°	-120.386068°
DWR ID	DWR_NA0010_16_f_2023_5				
Comment Code					
A3 : No rodents visible, but rodent burrows visible; need to backfill and compact or grout burrows.					
Inspector Comment

Multiple rodent burrows in the landside slope. (Fall 2023)

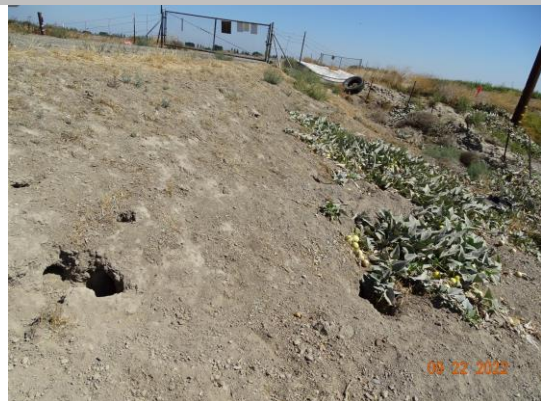
Photo 1 of 1 : SP_2024_NA0010_134_12_20240212_00005.jpg

LM Start	1.41	Rating **	U	Issue No.	12
LM End	1.41	Issue Type +	Ma	Location *	LS
Category	Earthen Levee			GPS Latitude/Longitude	
				Start	End
Item	Animal Control			36.995467°	36.995467°
				-120.383492°	-120.383492°
DWR ID	DWR_NA0010_16_s_2022_12				
Comment Code					
A3 : No rodents visible, but rodent burrows visible; need to backfill and compact or grout burrows.					
Inspector Comment

Large rodent holes in the landside slope. (Fall 2022)

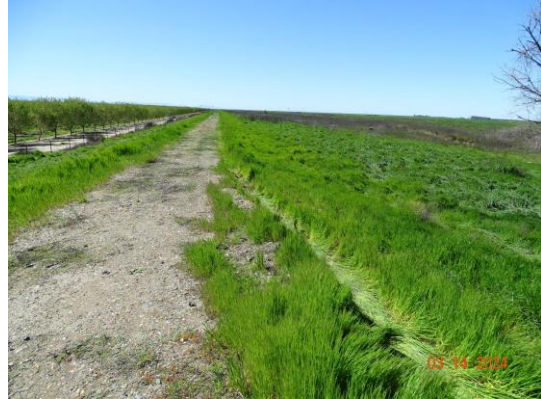
Photo 1 of 1 : SP_2024_NA0010_134_6_20240327_00010.jpg

LM Start	1.42	Rating **	M	Issue No.	6
LM End	1.95	Issue Type +	Ma	Location *	WS
Category	Earthen Levee			GPS Latitude/Longitude	
				Start	End
Item	Vegetation			36.995453°	36.995477°
				-120.383334°	-120.373797°
DWR ID	DWR_NA0010_16_s_2024_6				
Comment Code					
V1 : Control annual grass and weeds on the levee slopes and easements.					
Inspector Comment

Looking downstream along the waterside slope. (Spring 2024)

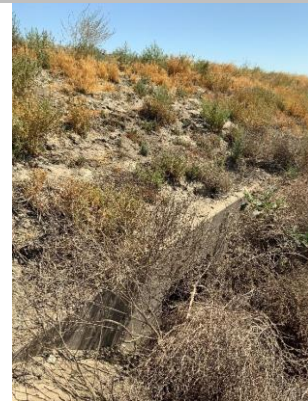
Photo 1 of 2 : UCIP_SP_2024_73370_103851.jpg

Comment Code						
Inspector Comment						
DS_ID:19915 FS_ID:73370 EP_NO: N/A Repair Type: Non-Urgent EVAL Issue: 11, Maintenance Compliance Issue Crossing Status: Found UCIP Comments: 06/24/2021 The record remains Non-Urgent. Limited inspection on LS and WS due to vegetation overgrowth, recommend removal. No permit was found authorizing this encroachment. CVFPB will need to review crossing to determine owner. The UCIP inspection was completed with GEI staff, H.Dunn. (P.Espinoza – GEI) 04/01/2014 Dense vegetation buildup at landside toe--recommend clearing. (W. Wylie - DWR UCIP) FIELD_STRUCT_DESC: 30-inch by 30-inch square reinforced concrete box gravity drainage culvert (RCBC) through the levee, 8.5 feet below the crown. Two concrete cutoff walls. Flap gate on the waterside (WS) end. Concrete headwall on the landside (LS) end. Concrete U-shaped headwall on the WS end. [Additional Reference(s): DWR Levee Log, 2002, (HLM 1.46). USACE San Joaquin O&M Manual, Unit No. 601, Part No. 1, 1967, Amended in 1978, Revised 20 June 1985, (HLM 1.46). DWR As-Built Specification No. 64-42, Sheet No. 24, 13 August 1964, (HLM 1.46)]. FS Date: 6/24/2021 11:09:00 AM

LS view: Slope and concrete headwall at inlet, covered by heavy vegetation.

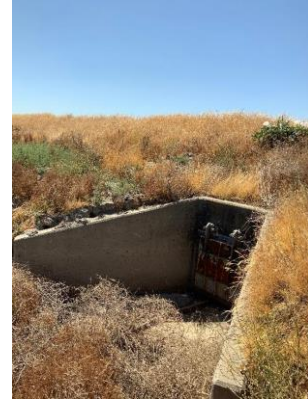
Photo 2 of 2 : UCIP_SP_2024_73370_103849.jpg

LM Start	1.44	Rating **	M	Issue No.	93 (cont)
LM End	1.44	Issue Type +	Ma	Location *	
Category	Supplemental			GPS Latitude/Longitude	
				Start	End
Item	DWR UCIP LMA Responsibility			36.995473°	36.995473°
				-120.382872°	-120.382872°
DWR ID	19915

WS view: Slope, flapgate, and concrete headwall at toe.

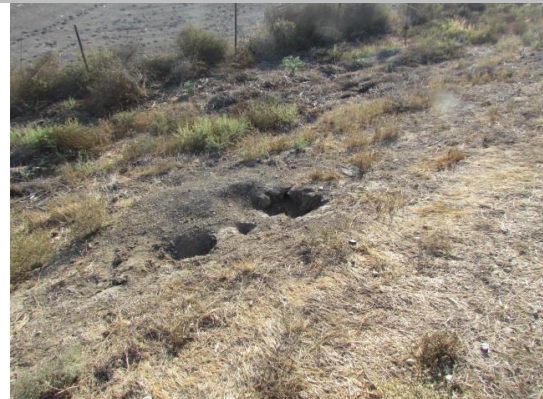
Photo 1 of 1 : SP_2024_NA0010_134_2_20240212_00001.jpg

LM Start	1.77	Rating **	U	Issue No.	2
LM End	1.77	Issue Type +	Ma	Location *	LS
Category	Earthen Levee			GPS Latitude/Longitude	
				Start	End
Item	Animal Control			36.995487°	36.995487°
				-120.377054°	-120.377054°
DWR ID	DWR_NA0010_16_f_2014_2				
Comment Code					
A3 : No rodents visible, but rodent burrows visible; need to backfill and compact or grout burrows.					
Inspector Comment					
Large rodent holes are on the landside slope.

Looking southwest at several rodent holes on landward slope.

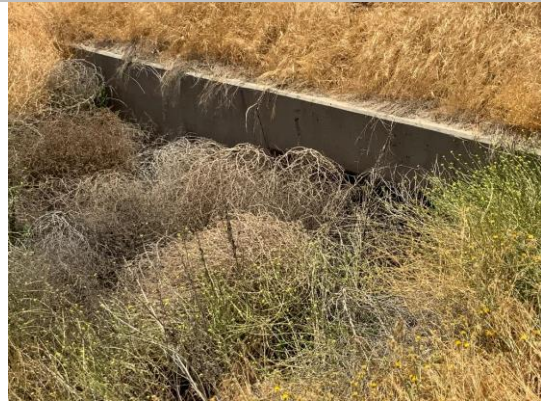
Photo 1 of 1 : UCIP_SP_2024_73434_102398.jpg

Comment Code						
Inspector Comment						
DS_ID:19916 FS_ID:73434 EP_NO: N/A Repair Type: Non-Urgent EVAL Issue: 11, Maintenance Compliance Issue Crossing Status: Found UCIP Comments: 07/13/2021 The record remains Non-Urgent. Limited inspection due to tumbleweeds blocking LS pipe inlet, recommend removal. No permit was found authorizing this encroachment. CVFPB will need to review crossing to determine owner. The UCIP inspection was completed with GEI staff, P. Espinoza. (H. Dunn – GEI) 04/01/2014 Dense vegetation limits the inspector's visibility to identify signs of pipe failure (leaks) along the landward slope. Recommend removing vegetation along pipe alignment to conduct proper inspection of structure. (W. Wylie - DWR UCIP) FIELD_STRUCT_DESC: 48-inch by 60-inch reinforced concrete box gravity drainage culvert (RCBC) through the levee, 14.6 feet below the crown. Flap gate on the waterside (WS) end. Concrete headwall on the landside (LS) end. Concrete U-shaped headwall on the WS end. [Additional Reference(s): DWR Levee Log, 2002, (HLM 2.58). USACE San Joaquin O&M Manual, Unit No. 601, Part No. 1, 1967, Amended in 1978, Revised 20 June 1985, (HLM 2.58). DWR As-Built Specification No. 64-42, Sheet No. 13, 13 August 1964, (HLM 2.58)]. FS Date: 7/19/2021

LS view: Tumbleweeds blocking pipe inlet at toe.

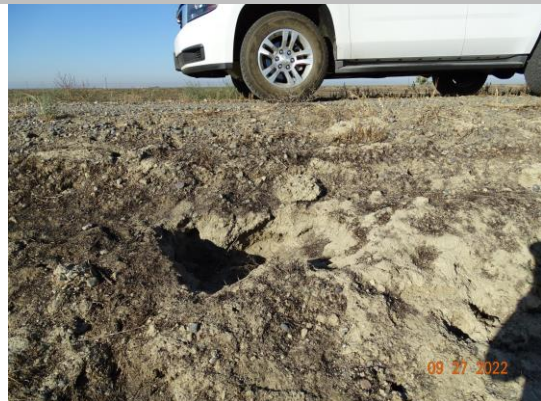
Photo 1 of 1 : SP_2024_NA0010_135_21_20240212_00010.jpg

LM Start	2.88	Rating **	M	Issue No.	21
LM End	2.88	Issue Type +	Ma	Location *	LS
Category	Earthen Levee			GPS Latitude/Longitude	
				Start	End
Item	Animal Control			36.948301°	36.948301°
				-120.346357°	-120.346357°
DWR ID	DWR_NA0010_17_f_2022_21				
Comment Code					
A3 : No rodents visible, but rodent burrows visible; need to backfill and compact or grout burrows.					
Inspector Comment					
Depression in the landside slope appears to be caused by collapsed rodent burrows. Recommend backfilling and compacting.

Representative animal burrow on the landside slope. (Fall 2022)

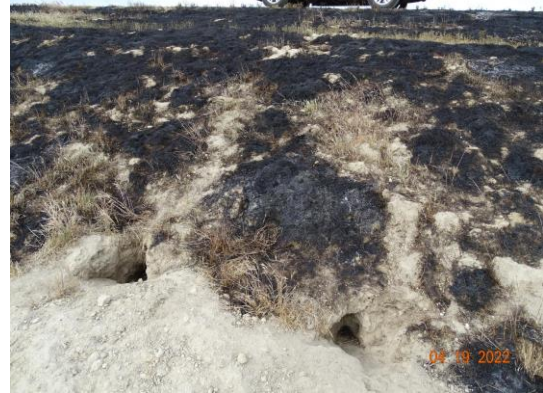
Photo 1 of 1 : SP_2024_NA0010_135_8_20240212_00004.jpg

LM Start	5.75	Rating **	A/W	Issue No.	8
LM End	5.90	Issue Type +	Ma	Location *	LS
Category	Earthen Levee			GPS Latitude/Longitude	
				Start	End
Item	Animal Control			36.908605°	36.906507°
				-120.331112°	-120.330353°
DWR ID	DWR_NA0010_17_s_2012_8				
Comment Code					
A1 : Exterminate rodents and backfill and compact or grout burrows.					
Inspector Comment					
Multiple rodent holes are noted on the landside slope and toe.

Looking at several rodent holes on landside slope. (Spring 2022)
