**Flood Control Project Maintenance
Levee Inspections**

Maintenance Issue Types Only, Levee Inspection Report By Mile - Spring 2024

Lower San Joaquin Levee District

Waterway	Bank	Unit Miles	Inspection Start/End	Inspector
Unit No. 01 San Joaquin River	Right	22.52	03/12/2024 03/12/2024	Corey Fujitani

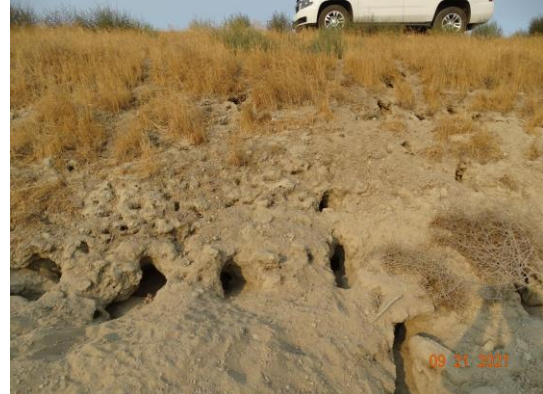
Photo 1 of 1 : SP_2024_NA0010_135_17_20240212_00007.jpg

LM Start	5.92	Rating **	U	Issue No.	17
LM End	5.92	Issue Type +	Ma	Location *	LS
Category	Earthen Levee			GPS Latitude/Longitude	
				Start	End
Item	Animal Control			36.906162°	36.906162°
				-120.330258°	-120.330258°
DWR ID	DWR_NA0010_17_f_2021_17				
Comment Code					
A3 : No rodents visible, but rodent burrows visible; need to backfill and compact or grout burrows.					
Inspector Comment

View of rodent damage to the landside slope. (Fall 2021)

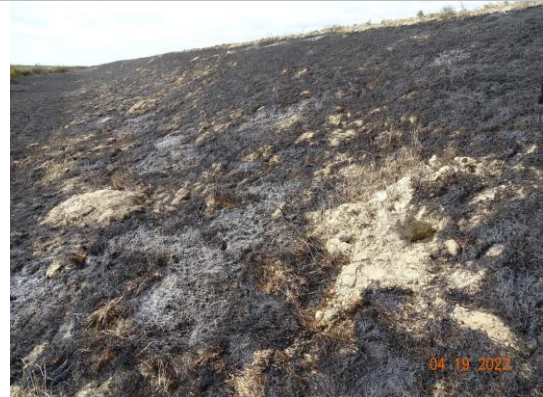
Photo 1 of 1 : SP_2024_NA0010_135_4_20240212_00002.jpg

LM Start	6.60	Rating **	A/W	Issue No.	4
LM End	6.80	Issue Type +	Ma	Location *	LS
Category	Earthen Levee			GPS Latitude/Longitude	
				Start	End
Item	Animal Control			36.896968°	36.894147°
				-120.326126°	-120.324763°
DWR ID	DWR_NA0010_17_s_2012_4				
Comment Code					
A1 : Exterminate rodents and backfill and compact or grout burrows.					
Inspector Comment					
Several rodent holes are identified within this reach.

View of rodent holes on the landside slope. (Spring 2022)

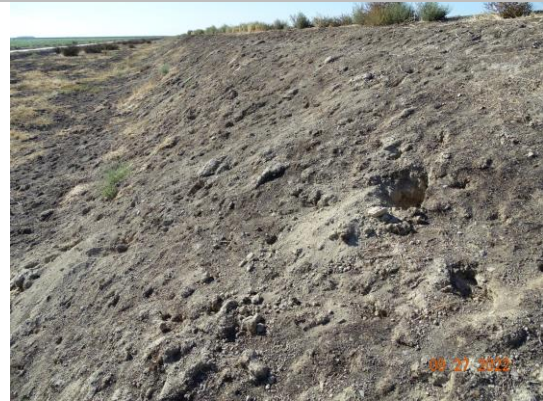
Photo 1 of 1 : SP_2024_NA0010_135_5_20240212_00003.jpg

LM Start	7.27	Rating **	M	Issue No.	5
LM End	7.38	Issue Type +	Ma	Location *	LS
Category	Earthen Levee			GPS Latitude/Longitude	
				Start	End
Item	Animal Control			36.887852°	36.886388°
				-120.321668°	-120.320950°
DWR ID	DWR_NA0010_17_s_2012_5				
Comment Code					
A3 : No rodents visible, but rodent burrows visible; need to backfill and compact or grout burrows.					
Inspector Comment					
Several rodent holes are identified within this reach.

Looking at typical view of rodent holes on landward slope. (Fall 2022)

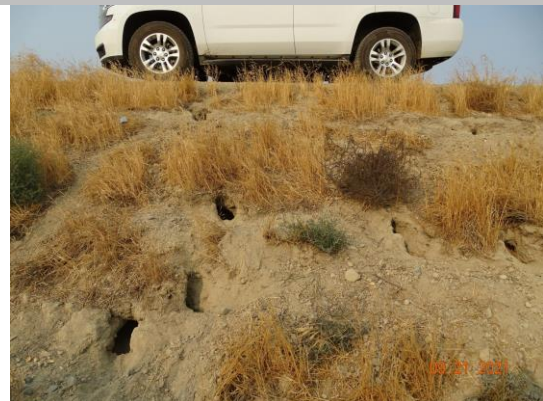
Photo 1 of 1 : SP_2024_NA0010_135_18_20240212_00008.jpg

LM Start	7.74	Rating **	U	Issue No.	18
LM End	7.74	Issue Type +	Ma	Location *	LS
Category	Earthen Levee			GPS Latitude/Longitude	
				Start	End
Item	Animal Control			36.881470°	36.881470°
				-120.318961°	-120.318961°
DWR ID	DWR_NA0010_17_f_2021_18				
Comment Code					
A3 : No rodents visible, but rodent burrows visible; need to backfill and compact or grout burrows.					
Inspector Comment

Looking up the landside slope at several rodent holes. (Fall 2021)

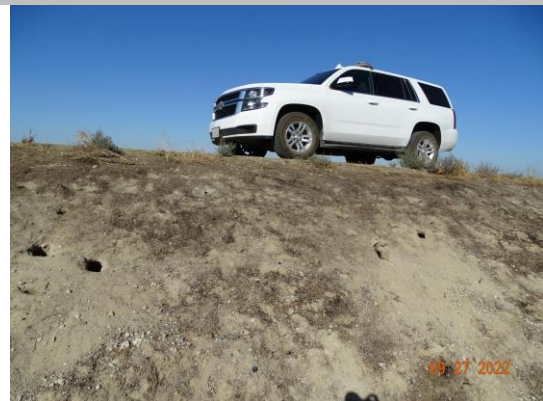
Photo 1 of 1 : SP_2024_NA0010_135_24_20240212_00011.jpg

LM Start	8.15	Rating **	M	Issue No.	24
LM End	8.15	Issue Type +	Ma	Location *	LS
Category	Earthen Levee			GPS Latitude/Longitude	
				Start	End
Item	Animal Control			36.875525°	36.875525°
				-120.317788°	-120.317788°
DWR ID	DWR_NA0010_17_f_2017_24				
Comment Code					
A3 : No rodents visible, but rodent burrows visible; need to backfill and compact or grout burrows.					
Inspector Comment					
Rodent holes are on the landside and crown of levee. Rodent holes have caused some erosion on the landside slope.

Looking east at the landside slope. (Fall 2022)

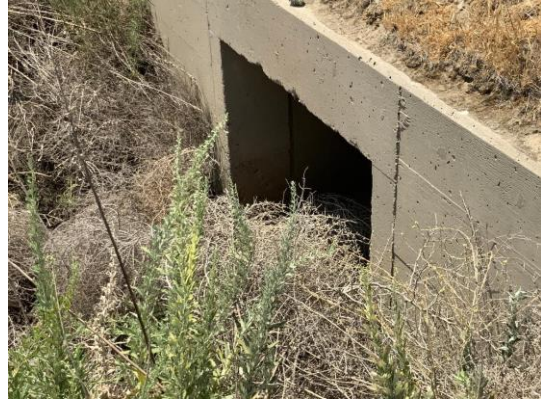
Photo 1 of 1 : UCIP_SP_2024_73437_102420.jpg

Comment Code						
Inspector Comment						
DS_ID:19922						
FS_ID:73437						
EP_NO: N/A						
Repair Type: Non-Urgent						
EVAL Issue: 11, Maintenance Compliance Issue						
Crossing Status: Found						
UCIP Comments: 07/13/2021 The record has been upgraded from No Action Needed to Non-Urgent. Limited inspection due to dense tumbleweeds over LS pipe inlet, recommend removal. No permit was found authorizing this encroachment. CVFPB will need to review crossing to determine owner. The UCIP inspection was completed with GEI staff, P. Espinoza. (H. Dunn – GEI)						
FIELD_STRUCT_DESC: 48-inch by 60-inch reinforced concrete box gravity drainage culvert (RCBC) through the levee, 16.5 feet below the crown. Flap gate on the waterside (WS) end. Concrete headwall on the landside (LS) end. Concrete U-shaped headwall on the WS end.						
[Additional Reference(s): DWR Levee Log, 2002, (HLM 8.38). USACE San Joaquin O&M Manual, Unit No. 601, Part No. 1, 1967, Amended in 1978, Revised 20 June 1985, (HLM 8.38). DWR As-Built Specification No. 64-42, Sheet No. 17, 13 August 1964, (HLM 8.38)].

LS view: Closeup of pipe inlet at toe.

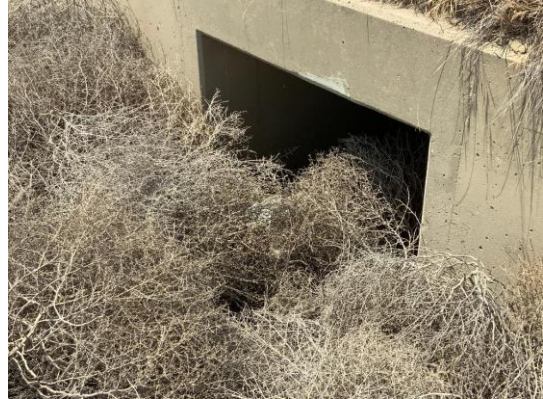
Photo 1 of 1 : UCIP_SP_2024_73439_102427.jpg

Comment Code						
Inspector Comment						
DS_ID:19917 FS_ID:73439 EP_NO: N/A Repair Type: Non-Urgent EVAL Issue: 11, Maintenance Compliance Issue Crossing Status: Found UCIP Comments: 07/13/2021 The record remains Non-Urgent. Limited inspection due to dense tumbleweeds over LS pipe inlet, recommend removal. No permit was found authorizing this encroachment. CVFPB will need to review crossing to determine owner. The UCIP inspection was completed with GEI staff, P. Espinoza. (H. Dunn – GEI) 04/01/2014 Dense vegetation limits the inspector's visibility to identify signs of pipe failure (leaks) along the landward slope. Recommend removing vegetation along pipe alignment to conduct proper inspection of structure. (W. Wylie - DWR UCIP) FIELD_STRUCT_DESC: 48-inch by 60-inch reinforced concrete box gravity drainage culvert (RCBC) through the levee, 15.0 feet below the crown. Concrete headwall on the landside (LS) end. Concrete U-shaped headwall on the waterside (WS) end. [Additional Reference(s): DWR Levee Log, 2002, (HLM 9.89). USACE San Joaquin O&M Manual, Unit No. 601, Part No. 1, 1967, Amended in 1978, Revised 20 June 1985, (HLM 9.89). DWR As-Built Specification No. 64-42, Sheet No. 18, 13 August 1964, (HLM 9.89)]. FS Date: 7/19/2021

LS view: Closeup of inlet at toe covered by tumbleweeds.

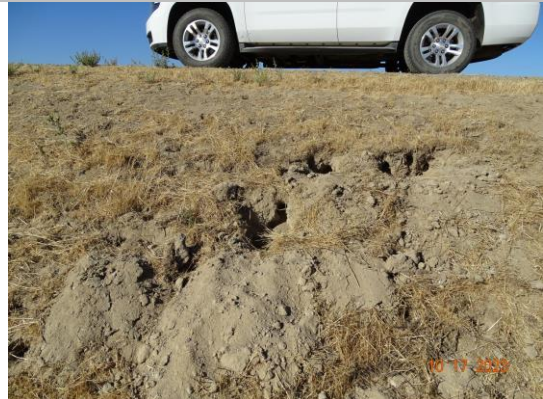
Photo 1 of 1 : SP_2024_NA0010_135_15_20240212_00005.jpg

LM Start	9.92	Rating **	M	Issue No.	15
LM End	9.92	Issue Type +	Ma	Location *	LS
Category	Earthen Levee			GPS Latitude/Longitude	
				Start	End
Item	Animal Control			36.850063°	36.850063°
				-120.314122°	-120.314122°
DWR ID	DWR_NA0010_17_f_2023_15				
Comment Code					
A3 : No rodents visible, but rodent burrows visible; need to backfill and compact or grout burrows.					
Inspector Comment

Multiple rodent holes observed in the landside slope. (Fall 2023)

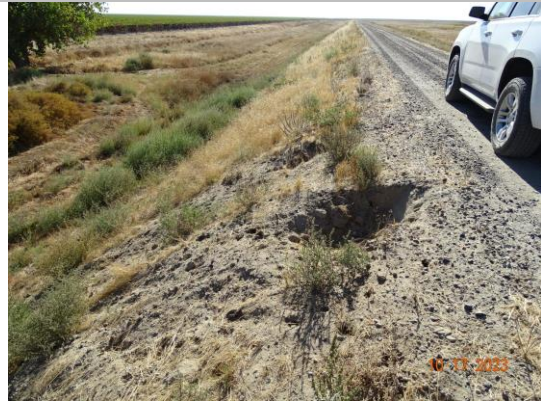
Photo 1 of 1 : SP_2024_NA0010_135_16_20240212_00006.jpg

LM Start	11.10	Rating **	M	Issue No.	16
LM End	11.10	Issue Type +	Ma	Location *	LS
Category	Earthen Levee			GPS Latitude/Longitude	
				Start	End
Item	Erosion / Vehicle Traffic			36.836100°	36.836100°
				-120.304535°	-120.304535°
DWR ID	DWR_NA0010_17_s_2024_16				
Comment Code					
E6 : Repair the levee slope damaged by vehicle traffic and prevent access where possible.					
Inspector Comment

Vehicle damage to the landside slope and shoulder. (Fall 2023)

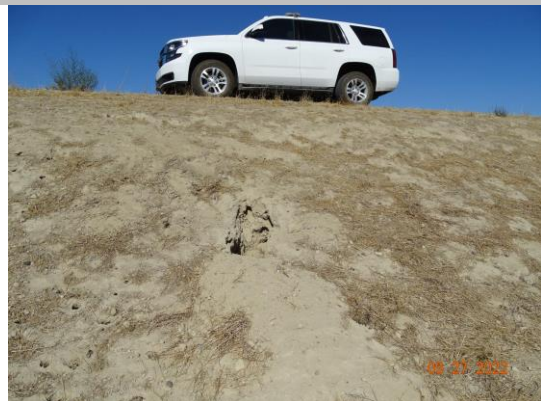
Photo 1 of 1 : SP_2024_NA0010_135_26_20240212_00012.jpg

LM Start	12.10	Rating **	U	Issue No.	26
LM End	12.10	Issue Type +	Ma	Location *	LS
Category	Earthen Levee			GPS Latitude/Longitude	
				Start	End
Item	Animal Control			36.823794°	36.823794°
				-120.299278°	-120.299278°
DWR ID	DWR_NA0010_17_f_2022_26				
Comment Code					
A3 : No rodents visible, but rodent burrows visible; need to backfill and compact or grout burrows.					
Inspector Comment

Large animal burrow in the landside slope. (Fall 2022)

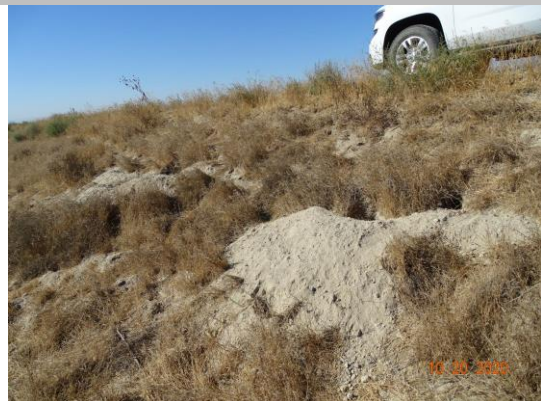
Photo 1 of 1 : SP_2024_NA0010_135_19_20240212_00009.jpg

LM Start	12.25	Rating **	U	Issue No.	19
LM End	12.25	Issue Type +	Ma	Location *	LS
Category	Earthen Levee			GPS Latitude/Longitude	
				Start	End
Item	Animal Control			36.821776°	36.821776°
				-120.300137°	-120.300137°
DWR ID	DWR_NA0010_17_f_2022_19				
Comment Code					
A3 : No rodents visible, but rodent burrows visible; need to backfill and compact or grout burrows.					
Inspector Comment

View of rodent burrows on the landside slope. (Fall 2020)

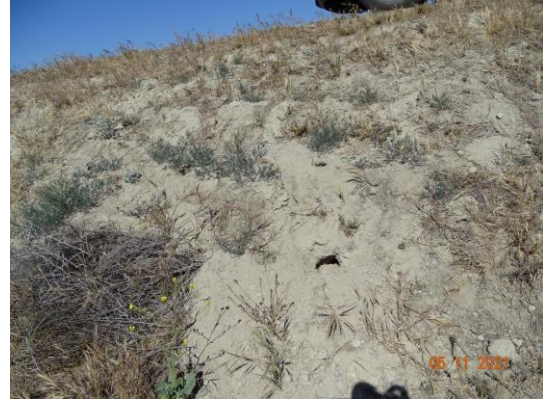
Photo 1 of 1 : SP_2024_NA0010_135_3_20240212_00001.jpg

LM Start	12.28	Rating **	M	Issue No.	3
LM End	12.32	Issue Type +	Ma	Location *	LS
Category	Earthen Levee			GPS Latitude/Longitude	
				Start	End
Item	Animal Control			36.821368°	36.820843°
				-120.300283°	-120.300469°
DWR ID	DWR_NA0010_17_s_2014_3				
Comment Code					
A3 : No rodents visible, but rodent burrows visible; need to backfill and compact or grout burrows.					
Inspector Comment

View of multiple rodent holes in the landside slope. (Spring 2021)

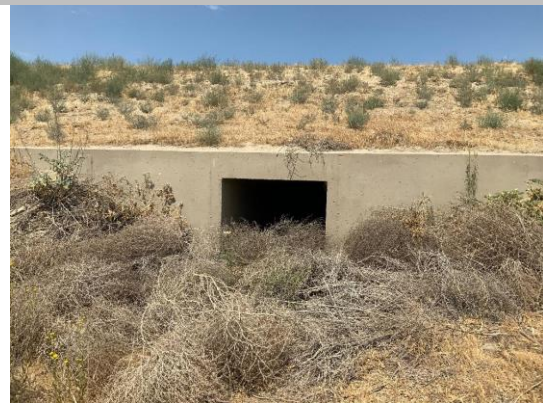
Photo 1 of 2 : UCIP_SP_2024_73440_102440.jpg

Comment Code						
Inspector Comment						
DS_ID:19918 FS_ID:73440 EP_NO: N/A Repair Type: Non-Urgent EVAL Issue: 11, Maintenance Compliance Issue Crossing Status: Found UCIP Comments: 07/13/2021 The record remains Non-Urgent. WS flapgate has plank holding it shut, remove before flood season. Limited inspection due to dense tumbleweeds covering LS pipe inlet, recommend removal. No permit was found authorizing this encroachment. CVFPB will need to review crossing to determine owner. The UCIP inspection was completed with GEI staff, P. Espinoza. (H. Dunn – GEI) 04/01/2014 Some vegetation buildup at inlet-- recommend clearing. (W. Wylie - DWR UCIP) FIELD_STRUCT_DESC: 48-inch by 60-inch reinforced concrete box gravity drainage culvert (RCBC) through the levee, 15.3 feet below the crown. Flap gate on the waterside (WS) end. Concrete headwall on the landside (LS) end. Concrete U-shaped headwall on the WS end. [Additional Reference(s): DWR Levee Log, 2002, (HLM 13.29). USACE San Joaquin O&M Manual, Unit No. 601, Part No. 1, 1967, Amended in 1978, Revised 20 June 1985, (HLM 13.30). DWR As-Built Specification No. 64-42, Sheet No. 21, 13 August 1964, (HLM 13.30)]. FS Date: 7/19/2021

LS view: Headwall and slope from toe.

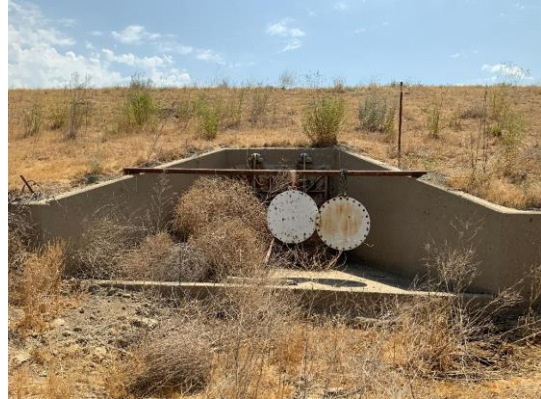
Photo 2 of 2 : UCIP_SP_2024_73440_102437.jpg

WS view: Headwall, flapgate, and slope from toe.

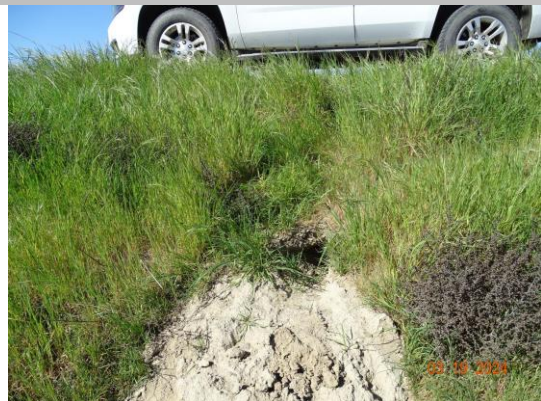
Photo 1 of 1 : SP_2024_NA0010_135_12_20240327_00023.jpg

LM Start	13.64	Rating **	M	Issue No.	12
LM End	13.64	Issue Type +	Ma	Location *	LS
Category	Earthen Levee			GPS Latitude/Longitude	
				Start	End
Item	Animal Control			36.802650°	36.802650°
				-120.306999°	-120.306999°
DWR ID	DWR_NA0010_17_s_2024_12				
Comment Code					
A3 : No rodents visible, but rodent burrows visible; need to backfill and compact or grout burrows.					
Inspector Comment

Representative view of rodent holes on the landside slope. (Spring 2024)

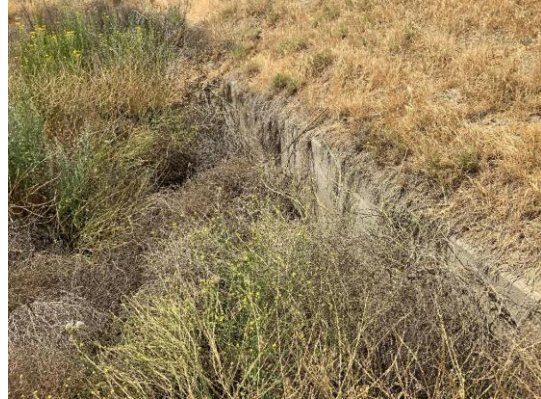
Photo 1 of 2 : UCIP_SP_2024_77872_102476.jpg

Comment Code						
Inspector Comment						
DS_ID:19920 FS_ID:77872 EP_NO: N/A Repair Type: Urgent EVAL Issue: 1, Pipe Integrity Crossing Status: Found UCIP Comments: 12/14/2022 Record updated from Non-Urgent to Urgent. DMP internal video inspection has found pipe integrity issues. LOF of crossing is between 5 and 6. Crossing will be monitored until funding becomes available to address the issues. (O.Yakimov - DWR UCIP) 07/19/2021 The record remains Non-Urgent. Dense tumbleweeds over WS flapgate and LS inlet, recommend removal of both sides. Limited inspection on both WS and LS ends. No permit was found authorizing this encroachment. CVFPB will need to review crossing to determine owner. The UCIP inspection was completed with GEI staff, P. Espinoza. (H. Dunn – GEI) 04/01/2014 Heavy vegetation buildup at LS toe-- recommend clearing. (W. Wylie - DWR UCIP) FIELD_STRUCT_DESC: 30-inch by 30-inch square reinforced concrete box gravity drainage culvert (RCBC) through the levee, 14.0 feet below the crown. Flap gate on the waterside (WS) end. Concrete headwall on the landside (LS) end. Concrete U-shaped headwall on the WS end. [Additional Reference(s): DWR Levee Log, 2002, (HLM 14.70). USACE San Joaquin O&M Manual, Unit No. 601, Part No. 1, 1967, Amended in 1978, Revised 20 June 1985, (HLM 14.69). DWR As-Built Specification No. 64-42, Sheet No. 22, 13 August 1964, (HLM 14.69)]. FS Date: 7/19/2021 2:07:23 PM

LS view: Headwall barely visible at toe due to dense vegetation.

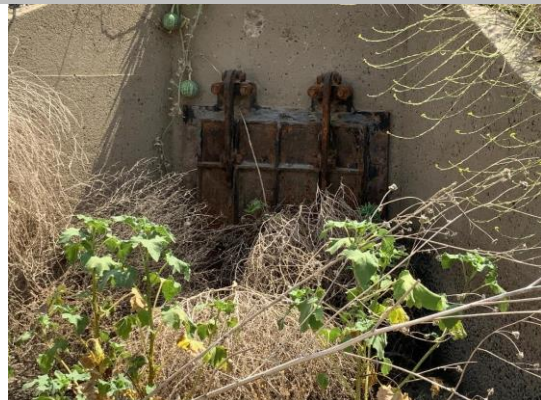
Photo 2 of 2 : UCIP_SP_2024_77872_102473.jpg

WS view: Closeup of flapgate at toe.

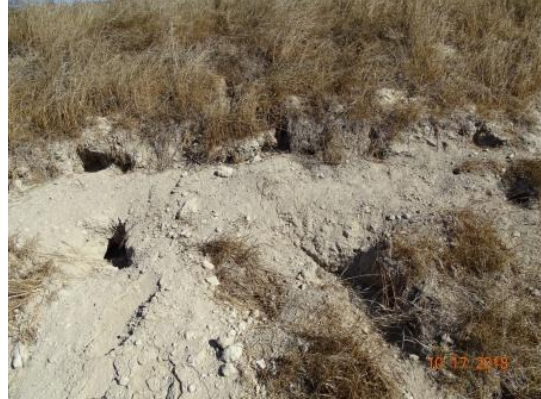
Photo 1 of 1 : SP_2024_NA0010_137_55_20240212_00014.jpg

LM Start	0.78	Rating **	M	Issue No.	55
LM End	0.78	Issue Type +	Ma	Location *	LS
Category	Earthen Levee			GPS Latitude/Longitude	
				Start	End
Item	Animal Control			36.964824 °	36.964824 °
				-120.358065 °	-120.358065 °
DWR ID	DWR_NA0010_18_f_2018_55				
Comment Code					
A3 : No rodents visible, but rodent burrows visible; need to backfill and compact or grout burrows.					
Inspector Comment

View of rodent holes from levee toe looking towards centerline. (Fall 2018)

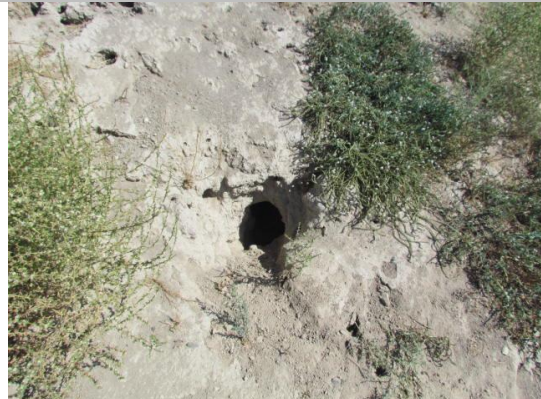
Photo 1 of 1 : SP_2024_NA0010_137_8_20240212_00001.jpg

LM Start	2.25	Rating **	A/W	Issue No.	8
LM End	2.25	Issue Type +	Ma	Location *	LS
Category	Earthen Levee			GPS Latitude/Longitude	
				Start	End
Item	Animal Control			36.945563 °	36.945563 °
				-120.347121 °	-120.347121 °
DWR ID	DWR_NA0010_18_f_2015_8				
Comment Code					
A3 : No rodents visible, but rodent burrows visible; need to backfill and compact or grout burrows.					
Inspector Comment					
There is one large rodent hole and other smaller rodent holes within this area.

Looking at large rodent hole on landward slope.

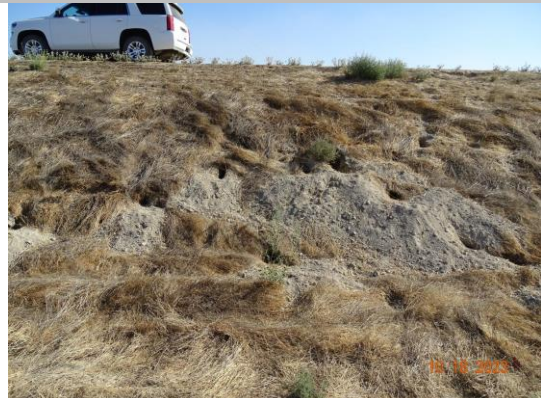
Photo 1 of 1 : SP_2024_NA0010_137_32_20240212_00009.jpg

LM Start	3.34	Rating **	M	Issue No.	32
LM End	3.34	Issue Type +	Ma	Location *	LS
Category	Earthen Levee			GPS Latitude/Longitude	
				Start	End
Item	Animal Control			36.930419°	36.930419°
				-120.341433°	-120.341433°
DWR ID	DWR_NA0010_18_f_2023_32				
Comment Code					
A3 : No rodents visible, but rodent burrows visible; need to backfill and compact or grout burrows.					
Inspector Comment

View of rodent holes on the landside slope. (Fall 2023)

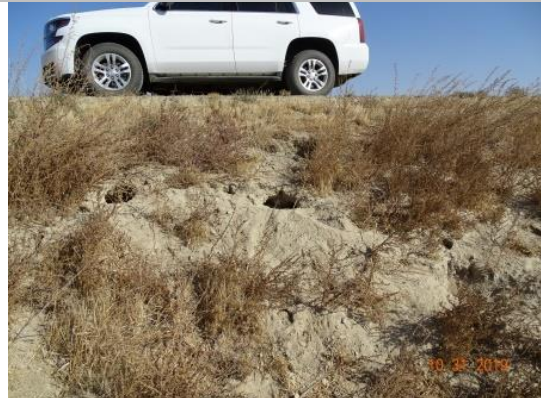
Photo 1 of 1 : SP_2024_NA0010_137_31_20240212_00008.jpg

LM Start	3.41	Rating **	U	Issue No.	31
LM End	3.44	Issue Type +	Ma	Location *	LS
Category	Earthen Levee			GPS Latitude/Longitude	
				Start	End
Item	Animal Control			36.929498°	36.929093°
				-120.341091°	-120.340920°
DWR ID	DWR_NA0010_18_f_2019_31				
Comment Code					
A3 : No rodents visible, but rodent burrows visible; need to backfill and compact or grout burrows.					
Inspector Comment

View of rodent burrows in the landside slope. (Fall 2019)

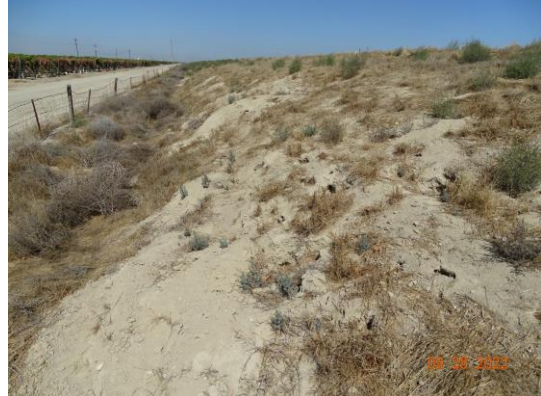
Photo 1 of 1 : SP_2024_NA0010_137_44_20240212_00012.jpg

LM Start	3.93	Rating **	U	Issue No.	44
LM End	3.98	Issue Type +	Ma	Location *	LS
Category	Earthen Levee			GPS Latitude/Longitude	
				Start	End
Item	Animal Control			36.922195°	36.921549°
				-120.338412°	-120.338173°
DWR ID	DWR_NA0010_18_f_2022_44				
Comment Code					
A3 : No rodents visible, but rodent burrows visible; need to backfill and compact or grout burrows.					
Inspector Comment					
Several rodent burrows observed in the landside slope and berm.

Several rodent holes noted in this section. (Fall 2022)

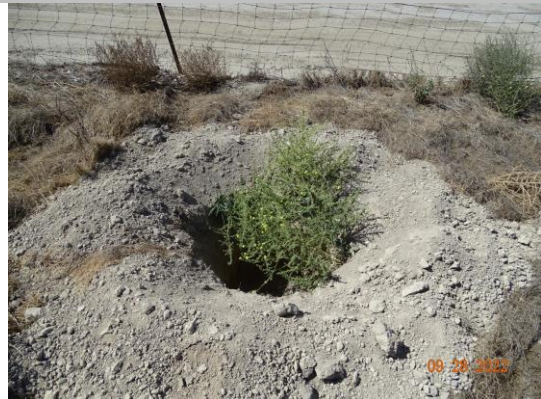
Photo 1 of 1 : SP_2024_NA0010_137_43_20240212_00011.jpg

LM Start	4.58	Rating **	U	Issue No.	43
LM End	4.58	Issue Type +	Ma	Location *	LS
Category	Earthen Levee			GPS Latitude/Longitude	
				Start	End
Item	Animal Control			36.913142°	36.913142°
				-120.335093°	-120.335093°
DWR ID	DWR_NA0010_18_f_2022_43				
Comment Code					
A3 : No rodents visible, but rodent burrows visible; need to backfill and compact or grout burrows.					
Inspector Comment					
Large hole at the landside toe of the levee.

Large animal hole on the landside toe. (Fall 2022)

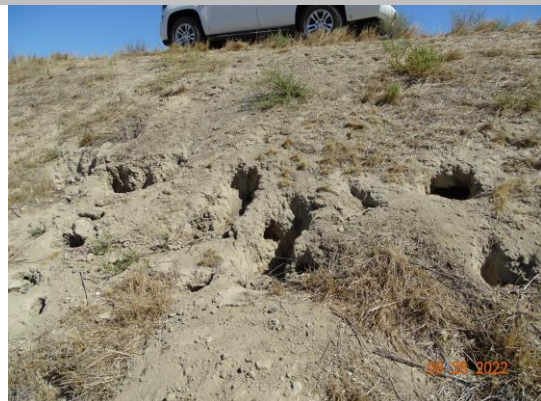
Photo 1 of 1 : SP_2024_NA0010_137_15_20240212_00004.jpg

LM Start	5.74	Rating **	U	Issue No.	15
LM End	5.99	Issue Type +	Ma	Location *	LS
Category	Earthen Levee			GPS Latitude/Longitude	
				Start	End
Item	Animal Control			36.897237°	36.893924°
				-120.328633°	-120.327020°
DWR ID	DWR_NA0010_18_f_2017_15				
Comment Code					
A3 : No rodents visible, but rodent burrows visible; need to backfill and compact or grout burrows.					
Inspector Comment					
There are multiple large rodent holes at the landside toe.

Several rodent holes noted in the landside slope. (Fall 2022)

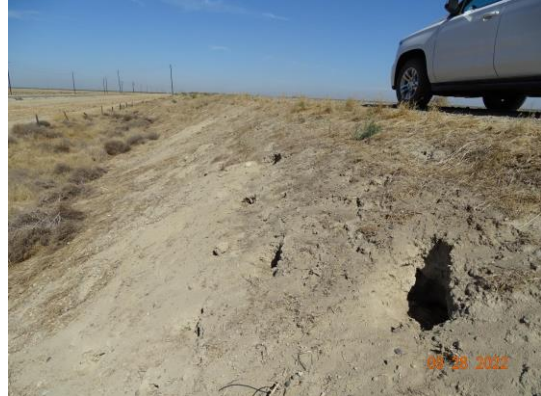
Photo 1 of 1 : SP_2024_NA0010_137_38_20240212_00010.jpg

LM Start	6.62	Rating **	U	Issue No.	38
LM End	6.67	Issue Type +	Ma	Location *	LS
Category	Earthen Levee			GPS Latitude/Longitude	
				Start	End
Item	Animal Control			36.885376°	36.884648°
				-120.322820°	-120.322466°
DWR ID	DWR_NA0010_18_f_2022_38				
Comment Code					
A3 : No rodents visible, but rodent burrows visible; need to backfill and compact or grout burrows.					
Inspector Comment

Several rodent holes observed in this section. (Fall 2022)

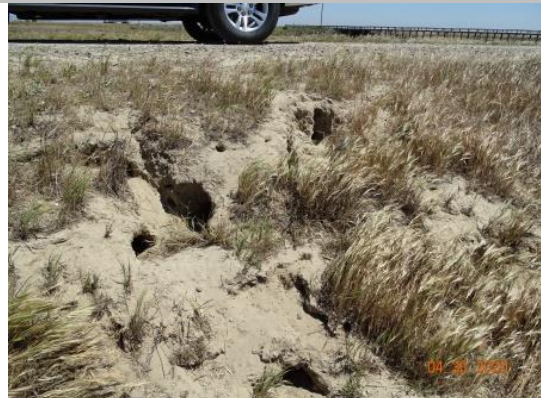
Photo 1 of 1 : SP_2024_NA0010_137_14_20240212_00003.jpg

LM Start	7.39	Rating **	U	Issue No.	14
LM End	7.53	Issue Type +	Ma	Location *	LS
Category	Earthen Levee			GPS Latitude/Longitude	
				Start	End
Item	Animal Control			36.874479°	36.872503°
				-120.319831°	-120.319438°
DWR ID	DWR_NA0010_18_f_2017_14				
Comment Code					
A3 : No rodents visible, but rodent burrows visible; need to backfill and compact or grout burrows.					
Inspector Comment					
There are several rodent holes noted along the landside slope in this area.

View of rodent burrows in the landside slope. (Spring 2020)

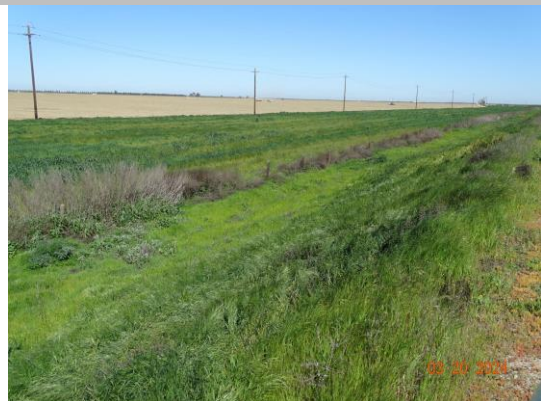
Photo 1 of 1 : SP_2024_NA0010_137_10_20240327_00019.jpg

LM Start	8.31	Rating **	M	Issue No.	10
LM End	8.97	Issue Type +	Ma	Location *	LS
Category	Earthen Levee			GPS Latitude/Longitude	
				Start	End
Item	Vegetation			36.861354°	36.851803°
				-120.317290°	-120.316433°
DWR ID	DWR_NA0010_18_s_2024_10				
Comment Code					
V1 : Control annual grass and weeds on the levee slopes and easements.					
Inspector Comment

View of vegetation on the landside slope. (Spring 2024)

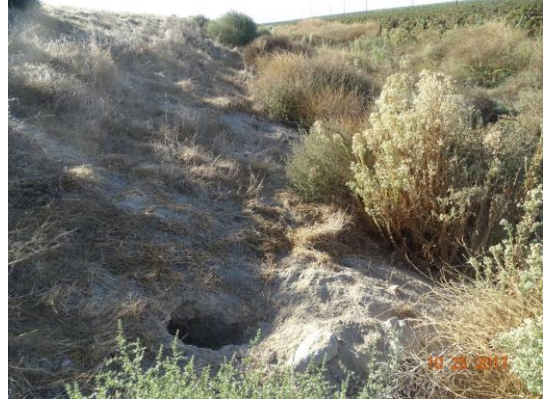
Photo 1 of 1 : SP_2024_NA0010_137_13_20240212_00002.jpg

LM Start	8.67	Rating **	U	Issue No.	13
LM End	8.67	Issue Type +	Ma	Location *	LS
Category	Earthen Levee			GPS Latitude/Longitude	
				Start	End
Item	Animal Control			36.856115°	36.856115°
				-120.316595°	-120.316595°
DWR ID	DWR_NA0010_18_f_2017_13				
Comment Code					
A3 : No rodents visible, but rodent burrows visible; need to backfill and compact or grout burrows.					
Inspector Comment

Looking south at the landside slope.

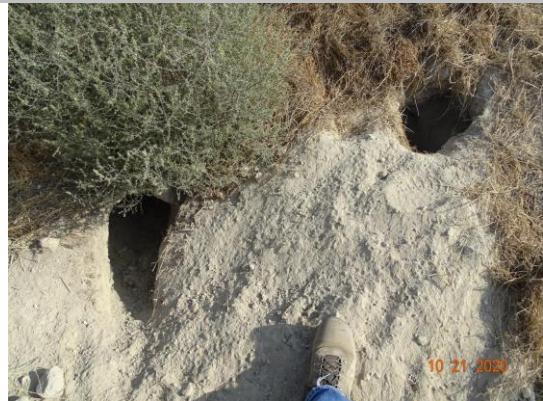
Photo 1 of 1 : SP_2024_NA0010_137_18_20240212_00005.jpg

LM Start	8.89	Rating **	U	Issue No.	18
LM End	8.89	Issue Type +	Ma	Location *	LS
Category	Earthen Levee			GPS Latitude/Longitude	
				Start	End
Item	Animal Control			36.852936°	36.852936°
				-120.316451°	-120.316451°
DWR ID	DWR_NA0010_18_f_2020_18				
Comment Code					
A3 : No rodents visible, but rodent burrows visible; need to backfill and compact or grout burrows.					
Inspector Comment

Large rodent holes in the landside slope. (Fall 2020)

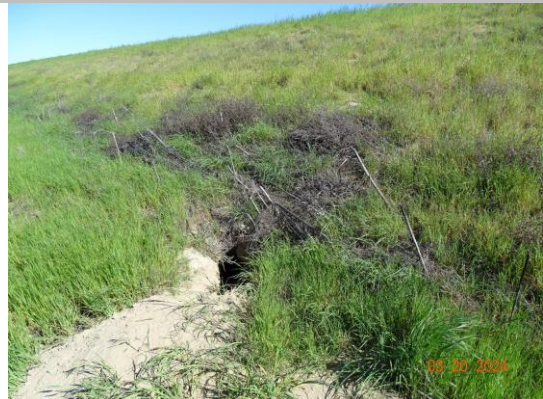
Photo 1 of 1 : SP_2024_NA0010_137_7_20240327_00020.jpg

LM Start	10.49	Rating **	M	Issue No.	7
LM End	10.49	Issue Type +	Ma	Location *	LS
Category	Earthen Levee			GPS Latitude/Longitude	
				Start	End
Item	Animal Control			36.833491°	36.833491°
				-120.304470°	-120.304470°
DWR ID	DWR_NA0010_18_s_2024_7				
Comment Code					
A3 : No rodents visible, but rodent burrows visible; need to backfill and compact or grout burrows.					
Inspector Comment					
Large burrow observed at the landside toe.

Large rodent hole observed at the landside toe. (Spring 2024)

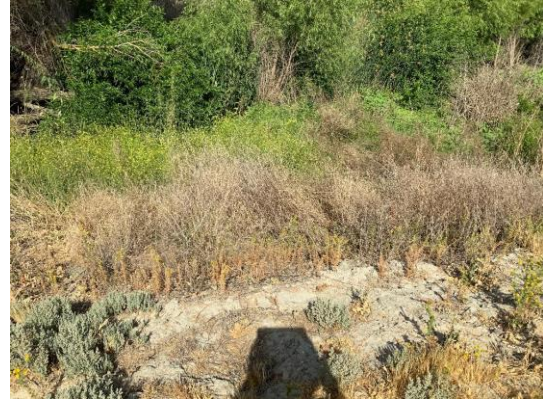
Photo 1 of 2 : UCIP_SP_2024_73507_103856.jpg

Comment Code						
Inspector Comment						
DS_ID:19933 FS_ID:73507 EP_NO: N/A Repair Type: Non-Urgent EVAL Issue: 4b, Safety Issue Crossing Status: Found UCIP Comments: 06/09/2021 The record remains Non-Urgent. Limited inspection of LS due to dense vegetation; recommend removal. Limited inspection on WS due to elevated water level. No pipe inlet or outlet was visible on LS or WS. Riser on WS missing lid, causing a safety hazard. No permit was found authorizing this encroachment. CVFPB will need to review crossing to determine owner. The UCIP inspection was completed with GEI staff, H.Dunn. (P.Espinoza – GEI) 07/19/2016 Gate inside riser appears operable--riser lid damage. Crossing is not visible on LS due to dense vegetation. Recommend clearing dense vegetation along WS and LS slope and repairing riser cover. (O. Magana - DWR UCIP)04/15/2014 No actuator wheel on slide gate at WS shoulder. (W. Wylie - DWR UCIP) FIELD_STRUCT_DESC: 24-inch corrugated metal gravity drainage pipe (CMP) through the levee, 14.8 feet below the crown. Slide gate in a 36-inch CMP riser unit on the waterside (WS) slope. Concrete U-shaped headwall on each end. [Additional Reference(s): DWR Levee Log, 2002, (HLM 0.10). USACE San Joaquin O&M Manual, Unit No. 601, Part No. 1, 1967, Amended in 1978, Revised 20 June 1985, (HLM 0.10). DWR As-Built Specification No. 63-25, Sheet No. 15, 9 May 1963, (HLM 0.10)]. FS Date: 6/9/2021 12:38:00 PM

LS view: Toe from crown, dense vegetation.

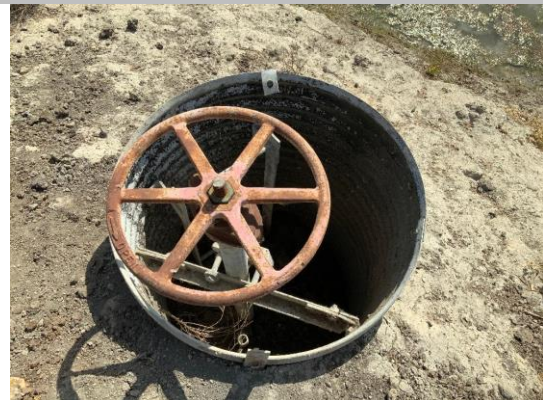
Photo 2 of 2 : UCIP_SP_2024_73507_103855.jpg

WS view: close up of CMP riser on slope.

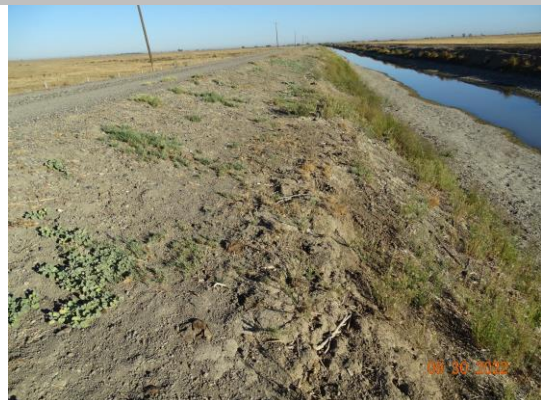
Photo 1 of 1 : SP_2024_NA0010_138_29_20240212_00016.jpg

LM Start	2.25	Rating **	M	Issue No.	29
LM End	2.37	Issue Type +	Ma	Location *	WS
Category	Earthen Levee			GPS Latitude/Longitude	
				Start	End
Item	Erosion / Livestock			37.237050°	37.238776°
				-120.704393°	-120.705028°
DWR ID	DWR_NA0010_22A_f_2018_29				
Comment Code					
E4 : Repair the levee slope damaged by livestock and prevent large animal access.					
Inspector Comment					
There is slope erosion from livestock, the slope is no longer 3:1.

View of damage to the waterside slope looking downstream. (Fall 2022)

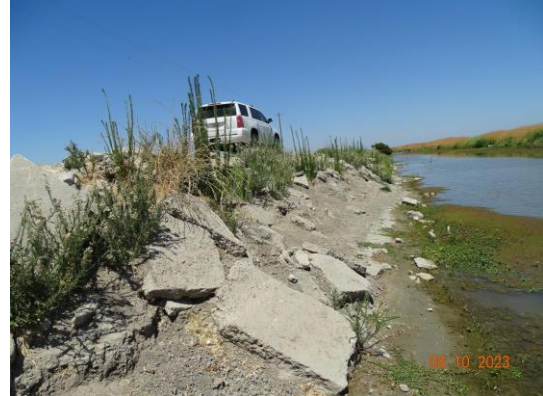
Photo 1 of 1 : SP_2024_NA0010_138_1_20240212_00001.jpg

LM Start	2.65	Rating **	U	Issue No.	1
LM End	2.66	Issue Type +	Ma	Location *	WS
Category	Supplemental			GPS Latitude/Longitude	
				Start	End
Item	DWR Erosion Survey			37.242595°	37.242595°
				-120.706470°	-120.706470°
DWR ID	NA0010U22RM3.87				
Comment Code					
Inspector Comment					
Site ID: NA0010U22RM3.87					
8/10/2023: From 2020 to present, no significant changes were observed during the annual survey.					
08/18/2020: The site has been covered with loose fill and crushed concrete pieces. The erosion will likely worsen again during the next high water.					
09/12/2019: The erosion has cut into the levee prism and damaged almost half of the levee. The livestock traffic has likely caused the erosion.

8/10/2023: View of the erosion with fill and concrete looking downstream.

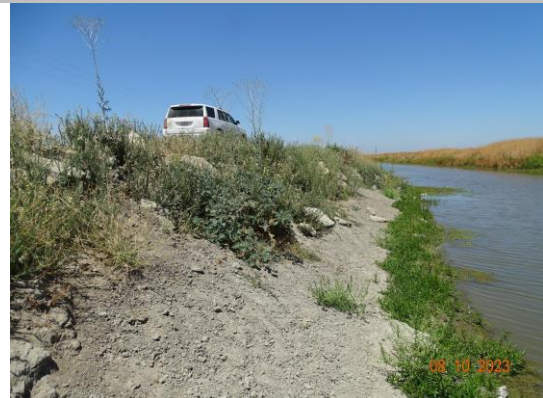
Photo 1 of 1 : SP_2024_NA0010_138_2_20240212_00002.jpg

LM Start	2.82	Rating **	U	Issue No.	2
LM End	2.83	Issue Type +	Ma	Location *	WS
Category	Supplemental			GPS Latitude/Longitude	
				Start	End
Item	DWR Erosion Survey			37.244940°	37.244940°
				-120.707467°	-120.707467°
DWR ID	NA0010U22RM3.7				
Comment Code					
Inspector Comment					
Site ID: NA0010U22RM3.7					
8/10/2023: From 2019 to present, no significant changes were observed during the annual survey. In some areas, the levee shoulder width is up to 8 ft. There is some crushed concrete on the levee slope.					
09/12/2019: The erosion has damaged entire levee slope. The livestock traffic likely has caused the erosion.

8/10/2023: View of the erosion looking downstream.

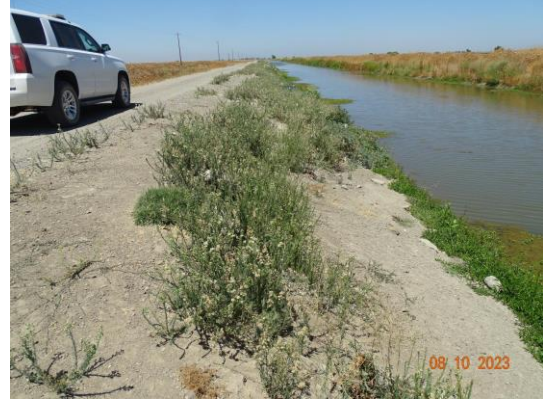
Photo 1 of 1 : SP_2024_NA0010_138_26_20240212_00014.jpg

LM Start	2.87	Rating **	A/W	Issue No.	26
LM End	2.87	Issue Type +	Ma	Location *	WS
Category	Earthen Levee			GPS Latitude/Longitude	
				Start	End
Item	Erosion / Bank Caving			37.245536°	37.245536°
				-120.708119°	-120.708119°
DWR ID	DWR_NA0010_22A_f_2023_26				
Comment Code					
E1 : Note and monitor erosion site.					
Inspector Comment					
Site ID: NA0010U22RM3.65					
10/30/23: Issue transferred from Erosion Survey and will continue to be monitored.					
08/03/2022: From 2021 to present, no significant changes were observed during the annual survey.					
08/18/2020: No vegetation visible in the area of the erosion. Noticed some crushed concrete pieces on the levee slope and a small amount of loose fill.					
09/12/2019: The erosion has damaged entire levee slope. The livestock traffic likely has caused the erosion.

View of erosion on the waterside slope. (Fall 2023)

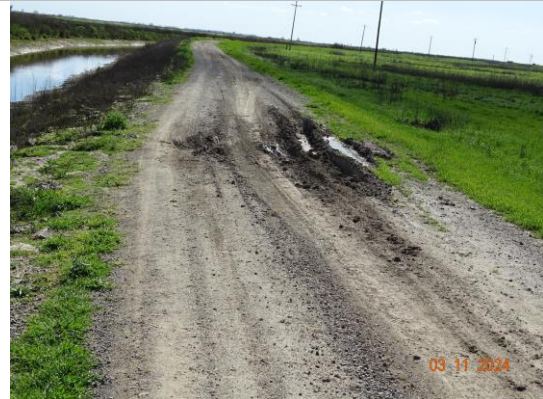
Photo 1 of 1 : SP_2024_NA0010_138_32_20240327_00029.jpg

LM Start	2.94	Rating **	M	Issue No.	32
LM End	2.94	Issue Type +	Ma	Location *	CR
Category	Earthen Levee			GPS Latitude/Longitude	
				Start	End
Item	Crown Surface / Depressions / Rutting			37.246217°	37.246217°
				-120.708970°	-120.708970°
DWR ID	DWR_NA0010_22A_f_2023_32				
Comment Code					
C2 : Repair depressions or ruts in the crown or slope.					
Inspector Comment

View of rutting in the levee crown. (Spring 2024)

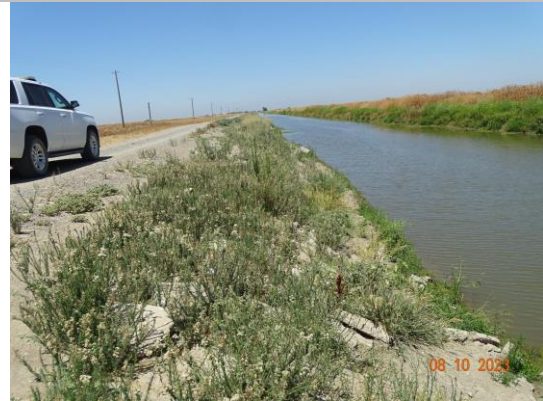
Photo 1 of 1 : SP_2024_NA0010_138_4_20240212_00004.jpg

LM Start	2.96	Rating **	A/W	Issue No.	4
LM End	2.96	Issue Type +	Ma	Location *	WS
Category	Earthen Levee			GPS Latitude/Longitude	
				Start	End
Item	Erosion / Bank Caving			37.246408°	37.246408°
				-120.709197°	-120.709197°
DWR ID	DWR_NA0010_22A_f_2023_4				
Comment Code					
E1 : Note and monitor erosion site.					
Inspector Comment					
Site ID: NA0010U22RM3.56					
10/30/23: Issue transferred from Erosion Survey and will continue to be monitored.					
08/03/2022: From 2021 to present, no significant changes were observed during the annual survey.					
08/18/2020: The erosion has been covered with loose fill and crushed concrete pieces. A nearly vertical slope remains at the levee toe in some sections. The site will likely worsen again during the next high water.					
09/12/2019: The erosion has damaged entire levee slope. The livestock activity likely has caused the erosion.

View of erosion site on the waterside slope. (Fall 2023)

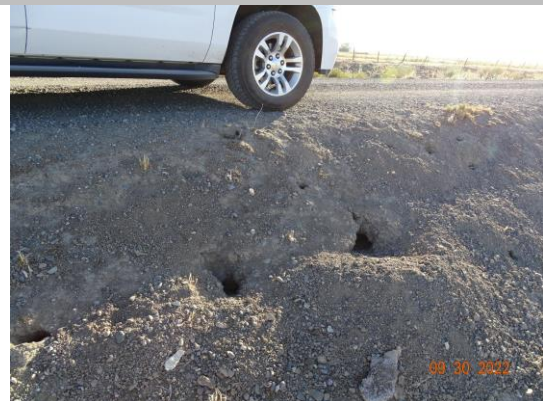
Photo 1 of 1 : SP_2024_NA0010_138_30_20240212_00017.jpg

LM Start	3.38	Rating **	M	Issue No.	30
LM End	3.38	Issue Type +	Ma	Location *	LS
Category	Earthen Levee			GPS Latitude/Longitude	
				Start	End
Item	Animal Control			37.250687°	37.250687°
				-120.714559°	-120.714559°
DWR ID	DWR_NA0010_22A_f _ 2022_30				
Comment Code					
A3 : No rodents visible, but rodent burrows visible; need to backfill and compact or grout burrows.					
Inspector Comment

View of rodent holes in the landside slope. (Fall 2022)

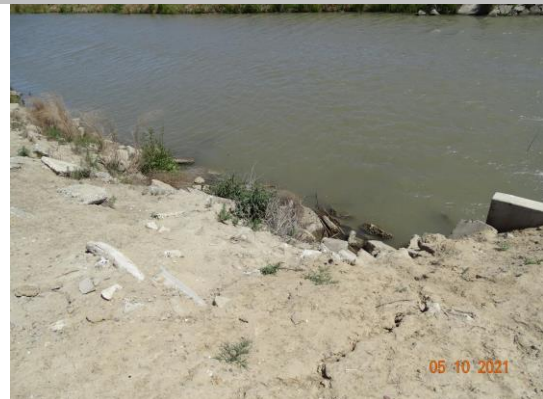
Photo 1 of 1 : SP_2024_NA0010_138_14_20240212_00008.jpg

LM Start	3.82	Rating **	M	Issue No.	14
LM End	3.82	Issue Type +	Ma	Location *	WS
Category	Earthen Levee			GPS Latitude/Longitude	
				Start	End
Item	Erosion / Livestock			37.255239°	37.255239°
				-120.720142°	-120.720142°
DWR ID	DWR_NA0010_22A_f_2017_14				
Comment Code					
E4 : Repair the levee slope damaged by livestock and prevent large animal access.					
Inspector Comment					
Broken concrete previously placed to stabilize the slope has washed out.

Damage to the waterside slope. (Spring 2021)

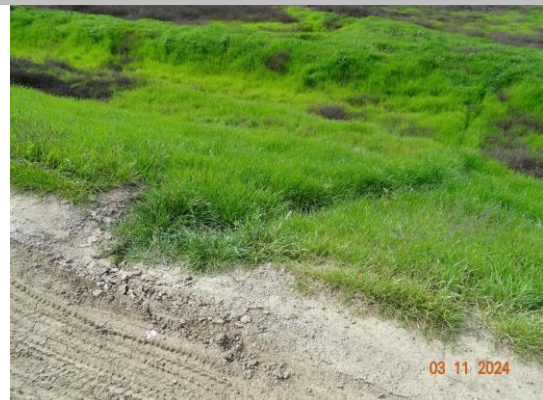
Photo 1 of 1 : SP_2024_NA0010_138_15_20240327_00030.jpg

LM Start	4.11	Rating **	M	Issue No.	15
LM End	4.11	Issue Type +	Ma	Location *	LS
Category	Earthen Levee			GPS Latitude/Longitude	
				Start	End
Item	Erosion / Livestock			37.258353°	37.258353°
				-120.723824°	-120.723824°
DWR ID	DWR_NA0010_22A_f_2019_15				
Comment Code					
E4 : Repair the levee slope damaged by livestock and prevent large animal access.					
Inspector Comment

View of erosion in the landside slope and shoulder from livestock traffic. (Spring 2024)

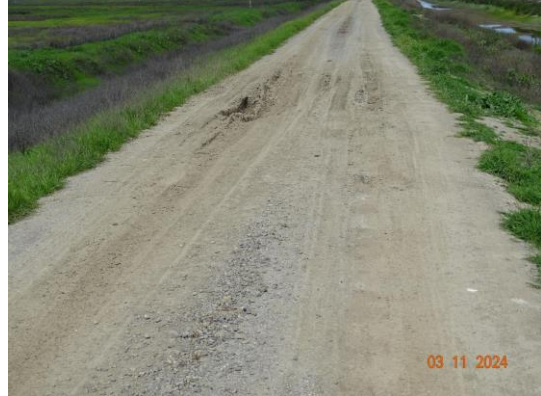
Photo 1 of 1 : SP_2024_NA0010_138_17_20240327_00031.jpg

LM Start	4.13	Rating **	M	Issue No.	17
LM End	4.13	Issue Type +	Ma	Location *	CR
Category	Earthen Levee			GPS Latitude/Longitude	
				Start	End
Item	Crown Surface / Depressions / Rutting			37.258490°	37.258490°
				-120.724015°	-120.724015°
DWR ID	DWR_NA0010_22A_s_2024_17				
Comment Code					
C2 : Repair depressions or ruts in the crown or slope.					
Inspector Comment

View of rutting in the levee crown. (Spring 2024)

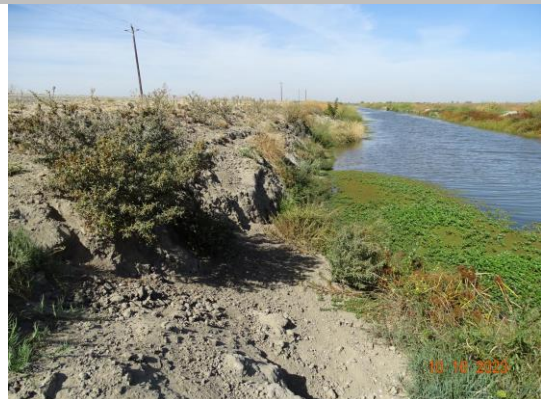
Photo 1 of 1 : SP_2024_NA0010_138_31_20240212_00018.jpg

LM Start	4.21	Rating **	U	Issue No.	31
LM End	4.21	Issue Type +	Ma	Location *	WS
Category	Earthen Levee			GPS Latitude/Longitude	
				Start	End
Item	Erosion / Livestock			37.259370°	37.259370°
				-120.725012°	-120.725012°
DWR ID	DWR_NA0010_22A_f_2023_31				
Comment Code					
E4 : Repair the levee slope damaged by livestock and prevent large animal access.					
Inspector Comment

View of levee waterside slope erosion looking downstream. (Fall 2023)

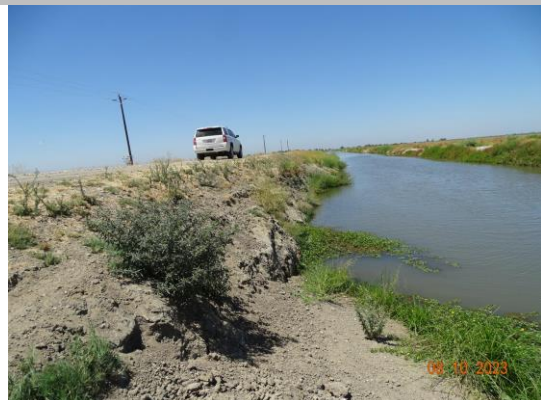
Photo 1 of 1 : SP_2024_NA0010_138_3_20240212_00003.jpg

LM Start	4.26	Rating **	U	Issue No.	3
LM End	4.30	Issue Type +	Ma	Location *	WS
Category	Supplemental			GPS Latitude/Longitude	
				Start	End
Item	DWR Erosion Survey			37.260111°	37.260111°
				-120.725900°	-120.725900°
DWR ID	NA0010U22RM2.25				
Comment Code					
Inspector Comment					
Site ID: NA0010U22RM2.25					
8/10/2023: From 2019 to present, no significant changes were observed during the annual survey.					
09/12/2019: Erosion has developed into the lower levee slope. Loose material was observed at the site.

8/10/2023: View of the erosion looking downstream.

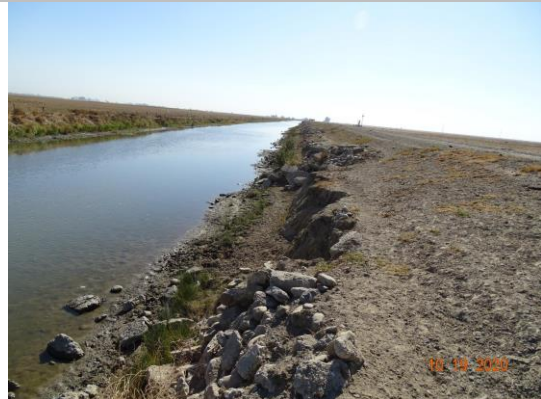
Photo 1 of 1 : SP_2024_NA0010_138_37_20240212_00021.jpg

LM Start	4.30	Rating **	U	Issue No.	37
LM End	5.11	Issue Type +	Ma	Location *	WS
Category	Earthen Levee			GPS Latitude/Longitude	
				Start	End
Item	Erosion / Livestock			37.260111°	37.268135°
				-120.725900°	-120.737130°
DWR ID	DWR_NA0010_22A_f_2018_37				
Comment Code					
E4 : Repair the levee slope damaged by livestock and prevent large animal access.					
Inspector Comment					
Erosion is cutting into the waterside slope. Some sections have been stabilized with cobble stone and broken concrete.

View of waterside slope damage looking upstream. (Fall 2020)

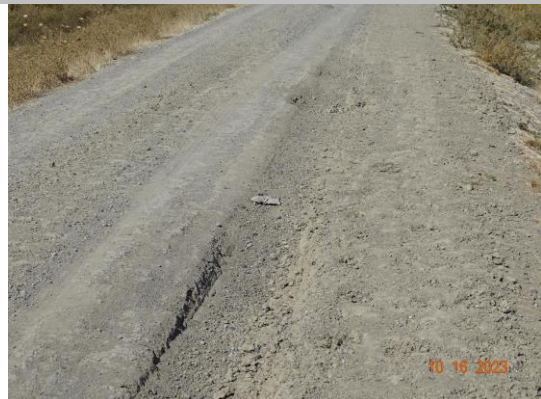
Photo 1 of 1 : SP_2024_NA0010_138_8_20240212_00006.jpg

LM Start	4.36	Rating **	M	Issue No.	8
LM End	4.36	Issue Type +	Ma	Location *	CR
Category	Earthen Levee			GPS Latitude/Longitude	
				Start	End
Item	Crown Surface / Depressions / Rutting			37.260919°	37.260919°
				-120.726838°	-120.726838°
DWR ID	DWR_NA0010_22A_f_2023_8				
Comment Code					
C2 : Repair depressions or ruts in the crown or slope.					
Inspector Comment

View of rutting in the levee crown. (Fall 2023)

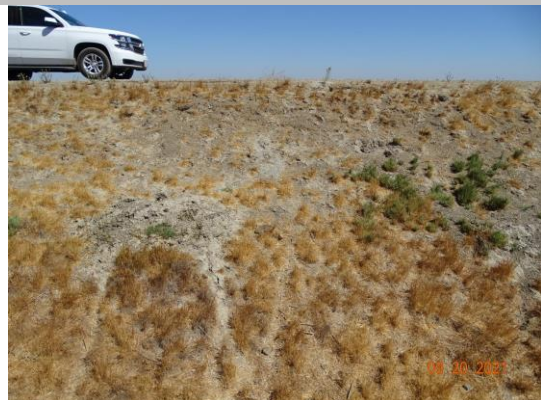
Photo 1 of 1 : SP_2024_NA0010_138_21_20240212_00011.jpg

LM Start	4.42	Rating **	M	Issue No.	21
LM End	4.42	Issue Type +	Ma	Location *	LS
Category	Earthen Levee			GPS Latitude/Longitude	
				Start	End
Item	Animal Control			37.261573°	37.261573°
				-120.727622°	-120.727622°
DWR ID	DWR_NA0010_22A_f_2021_21				
Comment Code					
A3 : No rodents visible, but rodent burrows visible; need to backfill and compact or grout burrows.					
Inspector Comment					
District has placed a bait station at the location.

View of displaced earth and rodent holes in the landside slope. (Fall 2021)

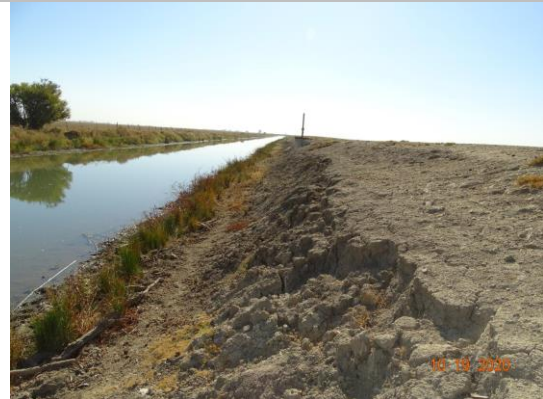
Photo 1 of 1 : SP_2024_NA0010_138_6_20240212_00005.jpg

LM Start	5.12	Rating **	M	Issue No.	6
LM End	5.49	Issue Type +	Ma	Location *	WS
Category	Earthen Levee			GPS Latitude/Longitude	
				Start	End
Item	Erosion / Livestock			37.268236°	37.272262°
				-120.737210°	-120.741778°
DWR ID	DWR_NA0010_22A_s_2022_6				
Comment Code					
E4 : Repair the levee slope damaged by livestock and prevent large animal access.					
Inspector Comment					
Slope damage is caused by livestock on waterside toe.

Looking southeast at livestock erosion on waterward toe. (Fall 2020)

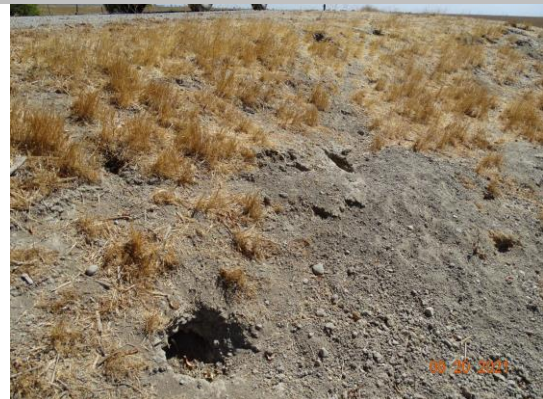
Photo 1 of 1 : SP_2024_NA0010_138_20_20240212_00010.jpg

LM Start	5.50	Rating **	M	Issue No.	20
LM End	5.50	Issue Type +	Ma	Location *	LS
Category	Earthen Levee			GPS Latitude/Longitude	
				Start	End
Item	Animal Control			37.272345°	37.272345°
				-120.741883°	-120.741883°
DWR ID	DWR_NA0010_22A_f_2021_20				
Comment Code					
A3 : No rodents visible, but rodent burrows visible; need to backfill and compact or grout burrows.					
Inspector Comment					
Rodent burrows observed on the landside turnout slope.

View of rodent holes in the landside slope looking upstream. (Fall 2021)

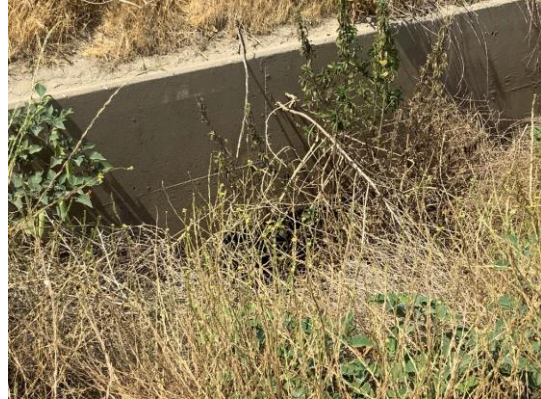
Photo 1 of 1 : UCIP_SP_2024_77877_102579.jpg

Comment Code						
Inspector Comment						
DS_ID:19945 FS_ID:77877 EP_NO: N/A Repair Type: Urgent EVAL Issue: 1, Pipe Integrity Crossing Status: Found UCIP Comments: 12/14/2022 Record updated from Non-Urgent to Urgent. DMP internal video inspection has found pipe integrity issues. LOF of crossing is between 5 and 6. Crossing will be monitored until funding becomes available to address the issues. (O.Yakimov - DWR UCIP) 07/19/2021 The record remains Non-Urgent. Dense LS vegetation over pipe inlet, recommend removal. No permit was found authorizing this encroachment. CVFPB will need to review crossing to determine owner. The UCIP inspection was completed with GEI staff, P. Espinoza. (H. Dunn – GEI) 04/03/2014 Excessive vegetation at inlet--recommend clearing. (W. Wylie - DWR UCIP) FIELD_STRUCT_DESC: 30-inch by 30-inch square reinforced concrete box gravity drainage culvert (RCBC) through the levee, 13.0 feet below the crown. Flap gate on the waterside (WS) end. Concrete headwall on the landside (LS) end. Concrete U-shaped headwall on the WS end. (Construction of a new discharge structure and rehabilitation of an existing diversion structure to return intercepted seepage to the San Joaquin River authorized under Permit No. 13085, 1981 - Diener, Dry River Farms). [Additional Reference(s): DWR Levee Log, 2002, (HLM 0.21). USACE San Joaquin O&M Manual, Unit No. 601, Part No. 1, 1967, Amended in 1978, Revised 20 June 1985, (HLM 0.21). DWR As-Built Specification No. 65-30, Sheet No. 7, 27 April 1965, (HLM 0.21), listed as 2'- 6" x 2'- 6" drainage structure]. FS Date: 7/19/2021 3:07:37 PM

LS view: Closeup of pipe inlet at toe covered with vegetation.

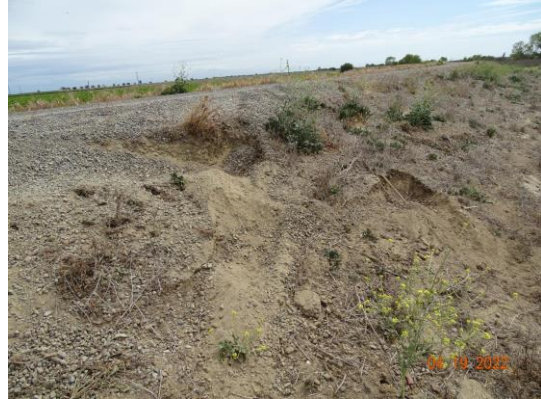
Photo 1 of 1 : SP_2024_NA0010_139_40_20240212_00007.jpg

LM Start	1.00	Rating **	M	Issue No.	40
LM End	1.00	Issue Type +	Ma	Location *	WS
Category	Earthen Levee			GPS Latitude/Longitude	
				Start	End
Item	Erosion / Vehicle Traffic			36.772875°	36.772875°
				-120.268436°	-120.268436°
DWR ID	DWR_NA0010_23_s_2022_40				
Comment Code					
E6 : Repair the levee slope damaged by vehicle traffic and prevent access where possible.					
Inspector Comment

Damage from vehicle traffic to the waterside slope. (Spring 2022)

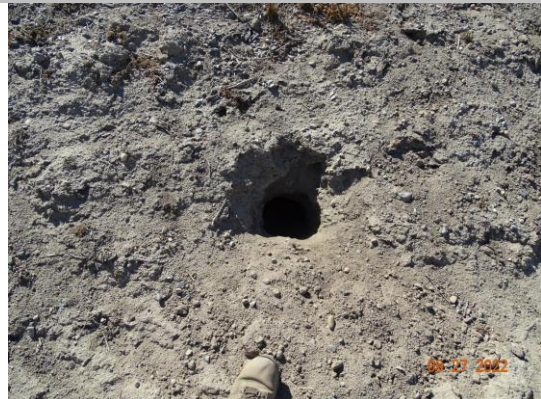
Photo 1 of 1 : SP_2024_NA0010_139_43_20240212_00009.jpg

LM Start	2.24	Rating **	A/W	Issue No.	43
LM End	2.24	Issue Type +	Ma	Location *	LS
Category	Earthen Levee			GPS Latitude/Longitude	
				Start	End
Item	Animal Control			36.775659°	36.775659°
				-120.249645°	-120.249645°
DWR ID	DWR_NA0010_23_f_2022_43				
Comment Code					
A3 : No rodents visible, but rodent burrows visible; need to backfill and compact or grout burrows.					
Inspector Comment

Large animal hole in the landside slope. (Fall 2022)

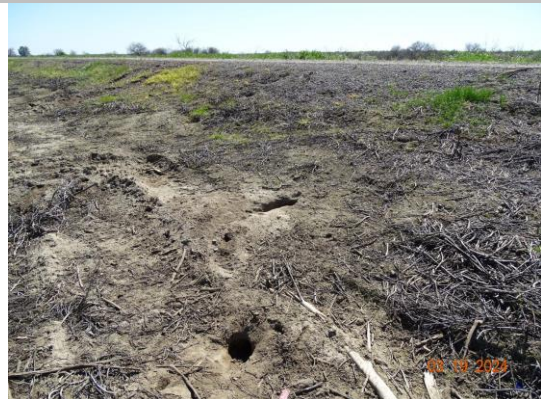
Photo 1 of 1 : SP_2024_NA0010_139_22_20240327_00036.jpg

LM Start	2.84	Rating **	M	Issue No.	22
LM End	2.84	Issue Type +	Ma	Location *	LS
Category	Earthen Levee			GPS Latitude/Longitude	
				Start	End
Item	Animal Control			36.771568°	36.771568°
				-120.240941°	-120.240941°
DWR ID	DWR_NA0010_23_s_2024_22				
Comment Code					
A3 : No rodents visible, but rodent burrows visible; need to backfill and compact or grout burrows.					
Inspector Comment

View of multiple rodent burrows on the landside slope. (Spring 2024)

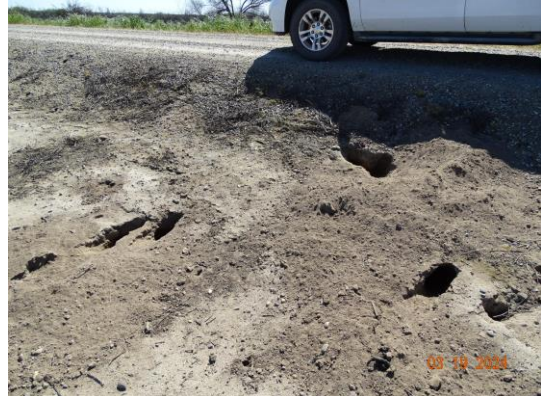
Photo 1 of 1 : SP_2024_NA0010_139_27_20240327_00037.jpg

LM Start	4.34	Rating **	M	Issue No.	27
LM End	4.34	Issue Type +	Ma	Location *	LS
Category	Earthen Levee			GPS Latitude/Longitude	
				Start	End
Item	Animal Control			36.783871°	36.783871°
				-120.225046°	-120.225046°
DWR ID	DWR_NA0010_23_s_2024_27				
Comment Code					
A3 : No rodents visible, but rodent burrows visible; need to backfill and compact or grout burrows.					
Inspector Comment

Multiple rodent holes observed at this section. (Spring 2024)

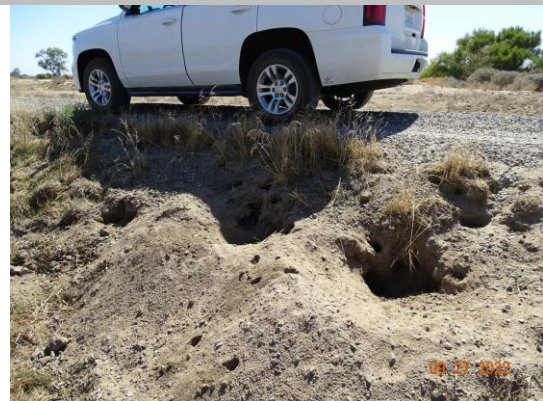
Photo 1 of 1 : SP_2024_NA0010_139_50_20240212_00014.jpg

LM Start	5.21	Rating **	U	Issue No.	50
LM End	5.21	Issue Type +	Ma	Location *	LS
Category	Earthen Levee			GPS Latitude/Longitude	
				Start	End
Item	Animal Control			36.791383°	36.791383°
				-120.214560°	-120.214560°
DWR ID	DWR_NA0010_23_f_2022_50				
Comment Code					
A3 : No rodents visible, but rodent burrows visible; need to backfill and compact or grout burrows.					
Inspector Comment

Multiple large animal burrows on the landside slope. (Fall 2022)

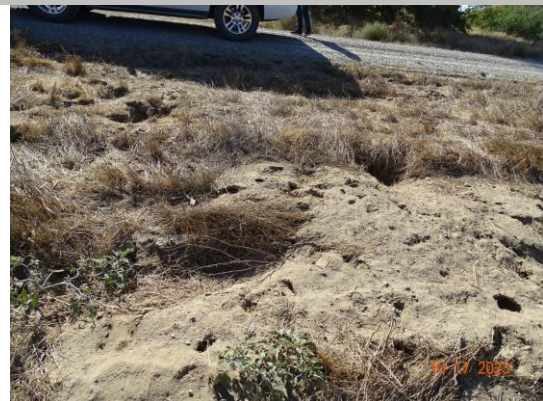
Photo 1 of 1 : SP_2024_NA0010_139_44_20240212_00010.jpg

LM Start	5.45	Rating **	U	Issue No.	44
LM End	5.45	Issue Type +	Ma	Location *	LS
Category	Earthen Levee			GPS Latitude/Longitude	
				Start	End
Item	Animal Control			36.791818°	36.791818°
				-120.210281°	-120.210281°
DWR ID	DWR_NA0010_23_f_2023_44				
Comment Code					
A3 : No rodents visible, but rodent burrows visible; need to backfill and compact or grout burrows.					
Inspector Comment

Several large rodent holes observed in the landside toe. (Fall 2023)
