**Flood Control Project Maintenance
Levee Inspections**

Maintenance Issue Types Only, Levee Inspection Report By Mile - Spring 2024

Lower San Joaquin Levee District

Waterway	Bank	Unit Miles	Inspection Start/End	Inspector
Unit No. 01 San Joaquin River	Right	22.52	03/12/2024 03/12/2024	Corey Fujitani

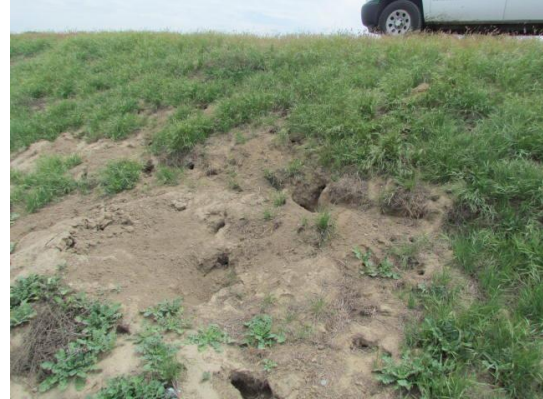
Photo 1 of 1 : SP_2024_NA0010_139_5_20240212_00001.jpg

LM Start	5.68	Rating **	M	Issue No.	5
LM End	5.68	Issue Type +	Ma	Location *	LS
Category	Earthen Levee			GPS Latitude/Longitude	
				Start	End
Item	Animal Control			36.791981°	36.791981°
				-120.206274°	-120.206274°
DWR ID	DWR_NA0010_23_s_2012_5				
Comment Code					
A1 : Exterminate rodents and backfill and compact or grout burrows.					
Inspector Comment					
There are several large rodent holes in this area.

Looking at several rodent holes on landside slope.

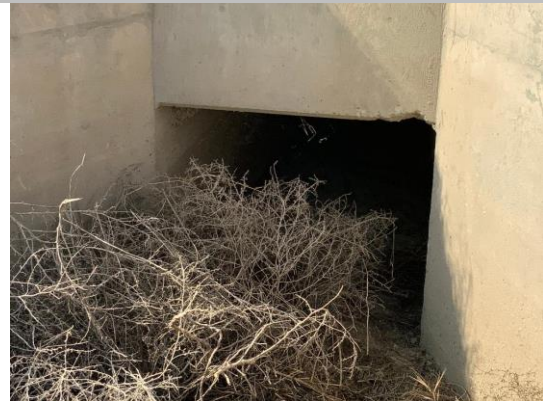
Photo 1 of 1 : UCIP_SP_2024_73582_102645.jpg

Comment Code						
Inspector Comment						
DS_ID:19954 FS_ID:73582 EP_NO: N/A Repair Type: Non-Urgent EVAL Issue: 11, Maintenance Compliance Issue Crossing Status: Found UCIP Comments: 07/19/2021 The record remains Non-Urgent. LS has sediment buildup in pipe inlet and buildup of tumbleweeds around pipe inlet, recommend clearing out. No permit was found authorizing this encroachment. CVFPB will need to review crossing to determine owner. The UCIP inspection was completed with GEI staff, P. Espinoza. (H. Dunn – GEI) 04/03/2014 Dense vegetation limits the inspector's visibility to identify signs of pipe failure (leaks) along the landward slope. Recommend removing vegetation along pipe alignment to conduct proper inspection of structure. (W. Wylie - DWR UCIP) FIELD_STRUCT_DESC: 36-inch by 36-inch square reinforced concrete box gravity drainage culvert (RCBC) through the levee, 9.0 feet below the crown. Flap gate on the waterside (WS) end. Concrete U-shaped headwall on each end. 5-foot-long cobble revetted outlet channel. [Additional Reference(s): DWR Levee Log, 2002, (HLM 5.71). USACE San Joaquin O&M Manual, Unit No. 601, Part No. 1, 1967, Amended in 1978, Revised 20 June 1985, (HLM 5.71). DWR As-Built Specification No. 65-30, Sheet No. 13, 27 April 1965, (HLM 5.71)]. FS Date: 7/19/2021

LS view: Closeup of pipe inlet at toe with sediment and tumbleweed buildup.

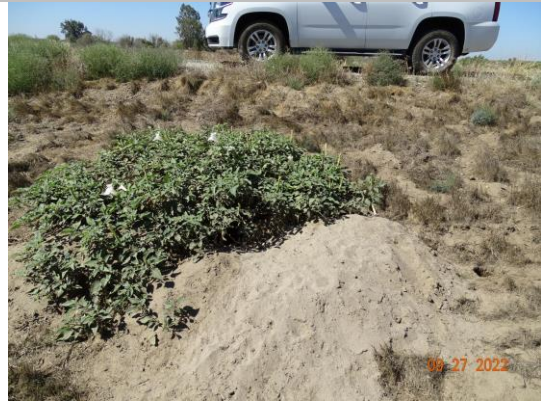
Photo 1 of 1 : SP_2024_NA0010_139_51_20240212_00015.jpg

LM Start	6.10	Rating **	U	Issue No.	51
LM End	6.10	Issue Type +	Ma	Location *	LS
Category	Earthen Levee			GPS Latitude/Longitude	
				Start	End
Item	Animal Control			36.788806°	36.788806°
				-120.200824°	-120.200824°
DWR ID	DWR_NA0010_23_f_2022_51				
Comment Code					
A3 : No rodents visible, but rodent burrows visible; need to backfill and compact or grout burrows.					
Inspector Comment

View of rodent burrow underneath vegetation growth on the landside slope. (Fall 2022)

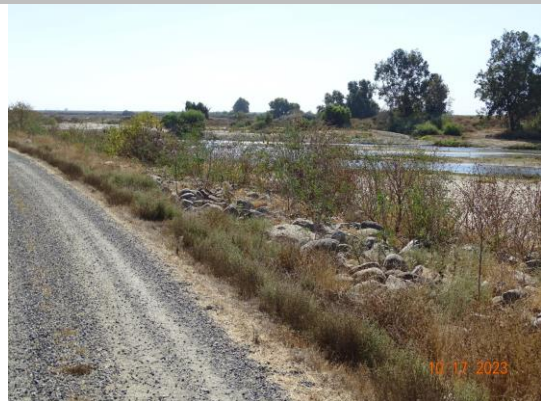
Photo 1 of 1 : SP_2024_NA0010_139_48_20240212_00012.jpg

LM Start	6.62	Rating **	A/W	Issue No.	48
LM End	6.71	Issue Type +	Ma	Location *	WS
Category	Earthen Levee			GPS Latitude/Longitude	
				Start	End
Item	Riprap Revetments			36.781585°	36.780866°
				-120.199345°	-120.198009°
DWR ID	DWR_NA0010_23_f_2023_48				
Comment Code					
RR : Riprap Revetments					
Inspector Comment

View of revetment placed on the waterside slope. (Fall 2023)

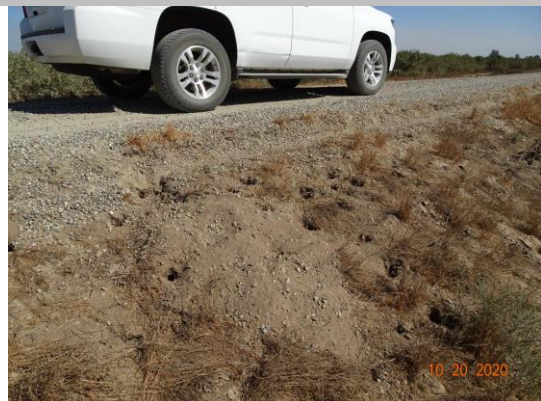
Photo 1 of 1 : SP_2024_NA0010_139_24_20240212_00003.jpg

LM Start	6.85	Rating **	A/W	Issue No.	24
LM End	6.85	Issue Type +	Ma	Location *	WS
Category	Earthen Levee			GPS Latitude/Longitude	
				Start	End
Item	Animal Control			36.780282°	36.780282°
				-120.195583°	-120.195583°
DWR ID	DWR_NA0010_23_f_2020_24				
Comment Code					
A3 : No rodents visible, but rodent burrows visible; need to backfill and compact or grout burrows.					
Inspector Comment

Several rodent holes noted at this location. (Fall 2020)

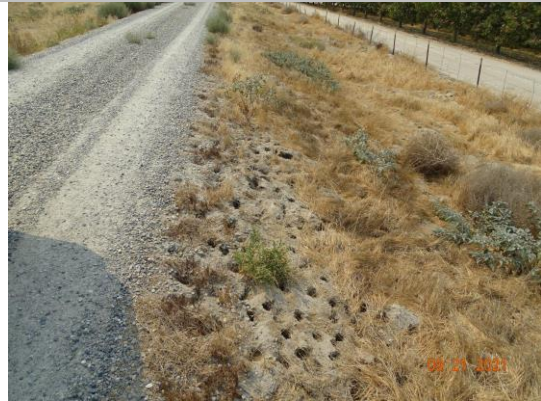
Photo 1 of 1 : SP_2024_NA0010_139_46_20240212_00011.jpg

LM Start	7.52	Rating **	M	Issue No.	46
LM End	7.72	Issue Type +	Ma	Location *	LS
Category	Earthen Levee			GPS Latitude/Longitude	
				Start	End
Item	Animal Control			36.781983°	36.784231°
				-120.186095°	-120.184096°
DWR ID	DWR_NA0010_23_f_2021_46				
Comment Code					
A3 : No rodents visible, but rodent burrows visible; need to backfill and compact or grout burrows.					
Inspector Comment					
Several burrows in the landside slope.

View of several rodent burrows in the landside slope. (Fall 2021)

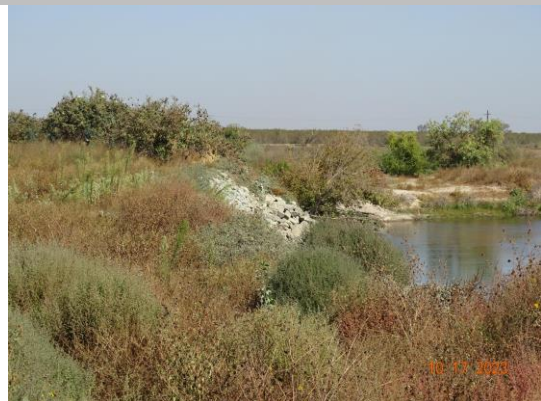
Photo 1 of 1 : SP_2024_NA0010_139_49_20240212_00013.jpg

LM Start	8.06	Rating **	A/W	Issue No.	49
LM End	8.13	Issue Type +	Ma	Location *	WS
Category	Earthen Levee			GPS Latitude/Longitude	
				Start	End
Item	Riprap Revetments			36.788957°	36.789846°
				-120.182361°	-120.182235°
DWR ID	DWR_NA0010_23_f_2023_49				
Comment Code					
RR : Riprap Revetments					
Inspector Comment

View of rock slope protection placed on the waterside berm. (Fall 2023)

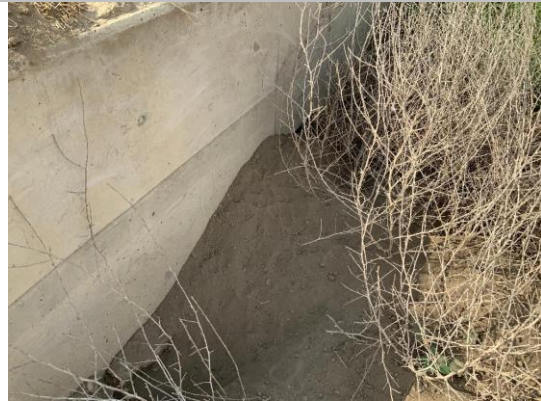
Photo 1 of 3 : UCIP_SP_2024_77875_102672.jpg

Comment Code					
Inspector Comment					
<p>DS_ID:19940 FS_ID:77875 EP_NO: N/A Repair Type: Urgent EVAL Issue: 1, Pipe Integrity Crossing Status: Found UCIP Comments: 12/14/2022 Record updated from Non-Urgent to Urgent. DMP internal video inspection has found pipe integrity issues. LOF of crossing is between 5 and 6. Crossing will be monitored until funding becomes available to address the issues. (O.Yakimov - DWR UCIP) 07/19/2021 The record remains Non-Urgent. LS pipe inlet almost completely covered by sediment, recommend clearing out. Some minor erosion along one side of the WS headwall as well as some burrow complexes on the slope adjacent to same headwall side. No permit was found authorizing this encroachment. CVFPB will need to review crossing to determine owner. The UCIP inspection was completed with GEI staff, P. Espinoza. (H. Dunn – GEI) 04/03/2014 Some sediment buildup at inlet at LS toe. Also dense vegetation limits the inspector's visibility to identify signs of pipe failure (leaks) along the landward slope. Recommend removing vegetation along pipe alignment to conduct proper inspection of structure. (W. Wylie - DWR UCIP) FIELD_STRUCT_DESC: 30-inch by 30-inch square reinforced concrete box gravity drainage culvert (RCBC) through the levee, 5.2 feet below the crown. Flap gate on the waterside (WS) end. Concrete headwall on the landside (LS) end. Concrete U-shaped headwall on the WS end. [Additional Reference(s): DWR Levee Log, 2002, (HLM 8.33). USACE San Joaquin O&M Manual, Unit No. 601, Part No. 1, 1967, Amended in 1978, Revised 20 June 1985, (HLM 8.33). DWR As-Built Specification No. 65-30, Sheet No. 15, 27 April 1965, (HLM 8.33)]. FS Date: 7/19/2021 3:06:54 PM</p>

LS view: Closeup of pipe inlet blocked by sediment.

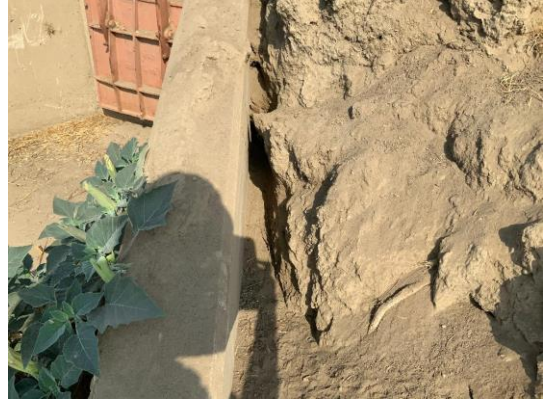
Photo 2 of 3 : UCIP_SP_2024_77875_102673.jpg

WS view: Minor erosion along the side of the headwall at toe.

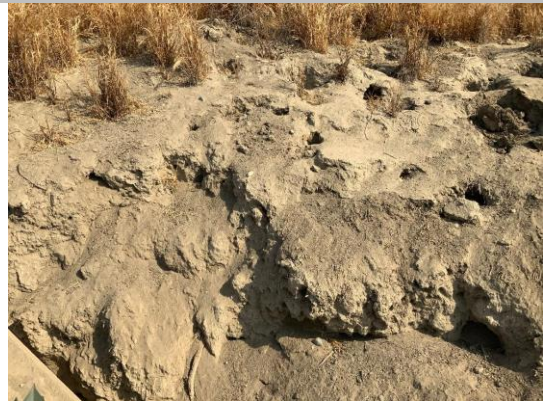
Photo 3 of 3 : UCIP_SP_2024_77875_102668.jpg

WS view: Burrow holes and erosion along the side of the headwall from toe.

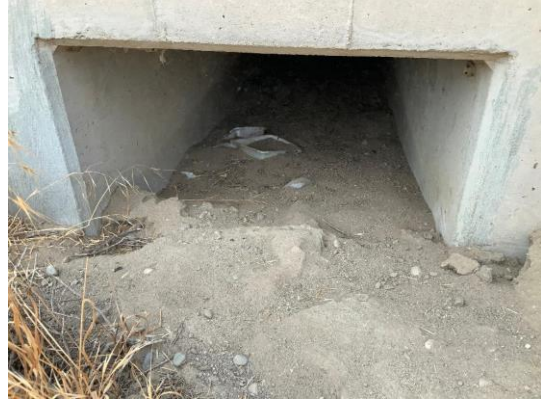
Photo 2 of 2 : UCIP_SP_2024_77876_102675.jpg

LS view: Closeup of pipe inlet at toe with sediment buildup.

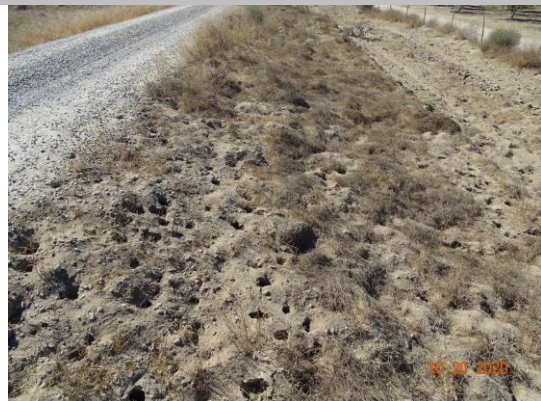
Photo 1 of 1 : SP_2024_NA0010_139_29_20240212_00005.jpg

LM Start	8.55	Rating **	M	Issue No.	29
LM End	8.66	Issue Type +	Ma	Location *	LS
Category	Earthen Levee			GPS Latitude/Longitude	
				Start	End
Item	Animal Control			36.794284°	36.795288°
				-120.177783°	-120.176146°
DWR ID	DWR_NA0010_23_f_2020_29				
Comment Code					
A3 : No rodents visible, but rodent burrows visible; need to backfill and compact or grout burrows.					
Inspector Comment

Several rodent holes observed along this section of the landside slope. (Fall 2020)

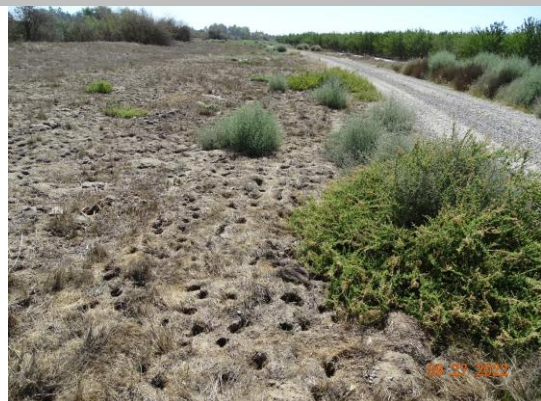
Photo 1 of 1 : SP_2024_NA0010_139_25_20240212_00004.jpg

LM Start	8.97	Rating **	M	Issue No.	25
LM End	8.97	Issue Type +	Ma	Location *	WS
Category	Earthen Levee			GPS Latitude/Longitude	
				Start	End
Item	Animal Control			36.799606°	36.799606°
				-120.175395°	-120.175395°
DWR ID	DWR_NA0010_23_f_2016_25				
Comment Code					
A3 : No rodents visible, but rodent burrows visible; need to backfill and compact or grout burrows.					
Inspector Comment					
There are rodent holes on the waterside shoulder.

Several rodent holes observed on the waterside slope in this section. (Fall 2022)

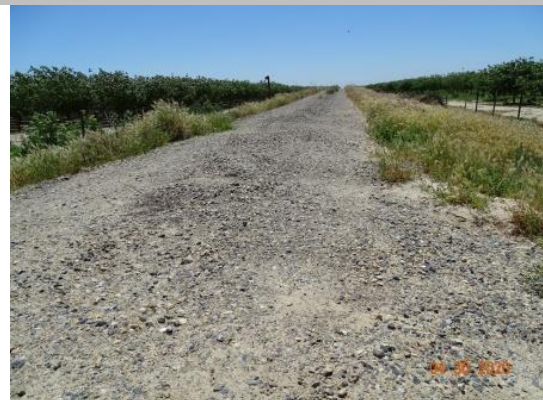
Photo 1 of 1 : SP_2024_NA0010_139_65_20240212_00019.jpg

LM Start	9.74	Rating **	M	Issue No.	65
LM End	9.74	Issue Type +	Ma	Location *	CR
Category	Earthen Levee			GPS Latitude/Longitude	
				Start	End
Item	Crown Surface / Depressions / Rutting			36.807603°	36.807603°
				-120.168825°	-120.168825°
DWR ID	DWR_NA0010_23_s_2019_65				
Comment Code					
C2 : Repair depressions or ruts in the crown or slope.					
Inspector Comment

Depressions forming in the levee crown. (Spring 2020)

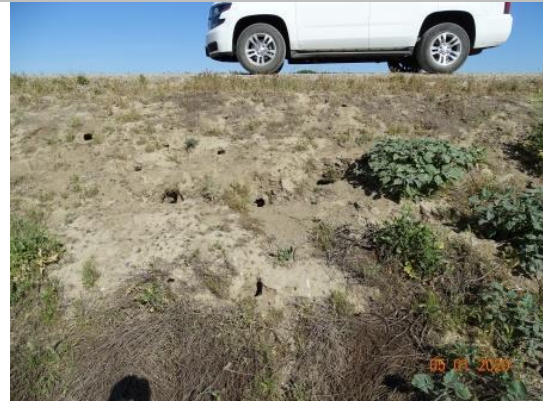
Photo 1 of 1 : SP_2024_NA0010_140_6_20240212_00001.jpg

LM Start	0.80	Rating **	M	Issue No.	6
LM End	0.84	Issue Type +	Ma	Location *	LS
Category	Earthen Levee			GPS Latitude/Longitude	
				Start	End
Item	Animal Control			36.766553°	36.766962°
				-120.278947°	-120.278602°
DWR ID	DWR_NA0010_24_s_2013_6				
Comment Code					
A1 : Exterminate rodents and backfill and compact or grout burrows.					
Inspector Comment					
There are several rodent holes identified within this section.

Rodent burrows in the landside slope. (Spring 2020)

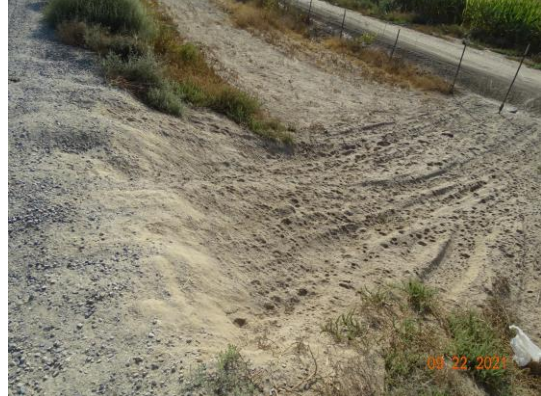
Photo 1 of 1 : SP_2024_NA0010_140_39_20240212_00014.jpg

LM Start	2.77	Rating **	A/W	Issue No.	39
LM End	2.77	Issue Type +	Ma	Location *	LS
Category	Earthen Levee			GPS Latitude/Longitude	
				Start	End
Item	Erosion / Vehicle Traffic			36.772289°	36.772289°
				-120.249693°	-120.249693°
DWR ID	DWR_NA0010_24_f_2021_39				
Comment Code					
E6 : Repair the levee slope damaged by vehicle traffic and prevent access where possible.					
Inspector Comment

View of the vehicle traffic on the landside slope. (Fall 2021)

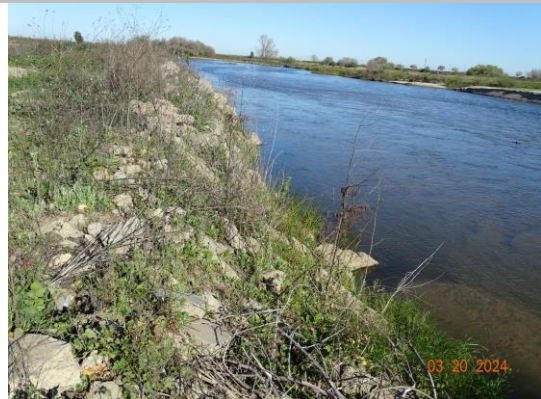
Photo 1 of 1 : SP_2024_NA0010_140_17_20240327_00028.jpg

LM Start	2.79	Rating **	A/W	Issue No.	17
LM End	2.87	Issue Type +	Ma	Location *	WS
Category	Earthen Levee			GPS Latitude/Longitude	
				Start	End
Item	Riprap Revetments			36.772501°	36.771801°
				-120.249368°	-120.248057°
DWR ID	DWR_NA0010_24_s_2024_17				
Comment Code					
RR : Riprap Revetments					
Inspector Comment

View of revetment placed on the waterside slope and berm. (Spring 2024)

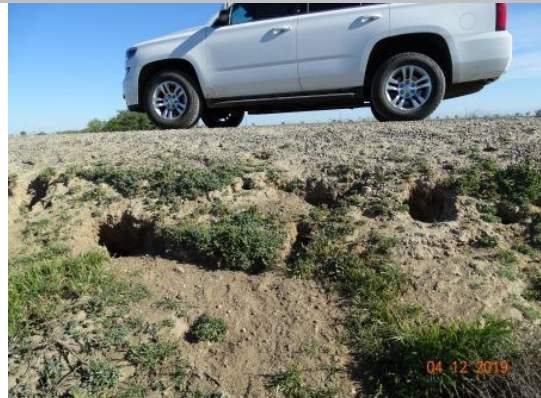
Photo 1 of 1 : SP_2024_NA0010_140_51_20240212_00016.jpg

LM Start	3.05	Rating **	U	Issue No.	51
LM End	3.20	Issue Type +	Ma	Location *	LS
Category	Earthen Levee			GPS Latitude/Longitude	
				Start	End
Item	Animal Control			36.770146°	36.769796°
				-120.245703°	-120.243035°
DWR ID	DWR_NA0010_24_s_2019_51				
Comment Code					
A3 : No rodents visible, but rodent burrows visible; need to backfill and compact or grout burrows.					
Inspector Comment

View of rodent holes in landside slope. (Spring 2019)

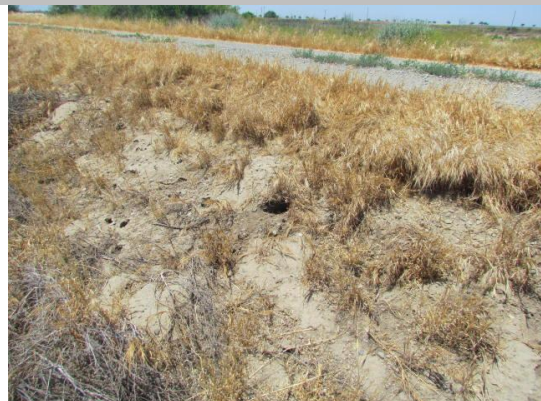
Photo 1 of 1 : SP_2024_NA0010_140_7_20240212_00002.jpg

LM Start	3.46	Rating **	M	Issue No.	7
LM End	3.46	Issue Type +	Ma	Location *	LS
Category	Earthen Levee			GPS Latitude/Longitude	
				Start	End
Item	Animal Control			36.769345°	36.769345°
				-120.238370°	-120.238370°
DWR ID	DWR_NA0010_24_s_2012_7				
Comment Code					
A3 : No rodents visible, but rodent burrows visible; need to backfill and compact or grout burrows.					
Inspector Comment					
There are several rodent holes on the landside slope.

Looking east at one of several rodent holes on landward slope.

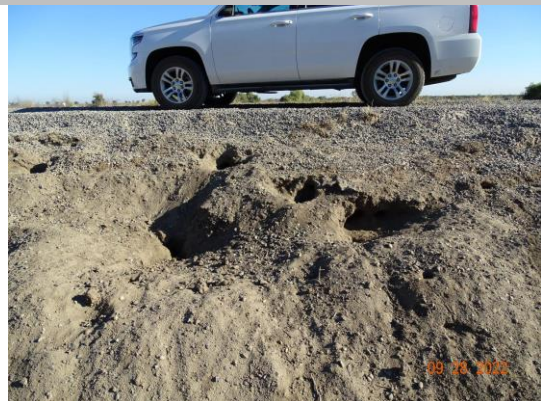
Photo 1 of 1 : SP_2024_NA0010_140_28_20240212_00010.jpg

LM Start	3.53	Rating **	U	Issue No.	28
LM End	3.59	Issue Type +	Ma	Location *	LS
Category	Earthen Levee			GPS Latitude/Longitude	
				Start	End
Item	Animal Control			36.768886°	36.768531°
				-120.237154°	-120.236226°
DWR ID	DWR_NA0010_24_f_2019_28				
Comment Code					
A3 : No rodents visible, but rodent burrows visible; need to backfill and compact or grout burrows.					
Inspector Comment

View of rodent burrows in the landside slope. (Fall 2022)

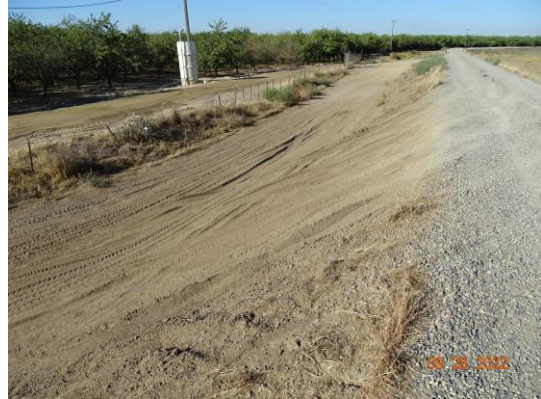
Photo 1 of 1 : SP_2024_NA0010_140_37_20240212_00013.jpg

LM Start	3.84	Rating **	A/W	Issue No.	37
LM End	3.84	Issue Type +	Ma	Location *	LS
Category	Earthen Levee			GPS Latitude/Longitude	
				Start	End
Item	Erosion / Vehicle Traffic			36.768024°	36.768024°
				-120.231896°	-120.231896°
DWR ID	DWR_NA0010_24_f_2022_37				
Comment Code					
E6 : Repair the levee slope damaged by vehicle traffic and prevent access where possible.					
Inspector Comment

View of the vehicle paths on the landside slope. (Fall 2022)

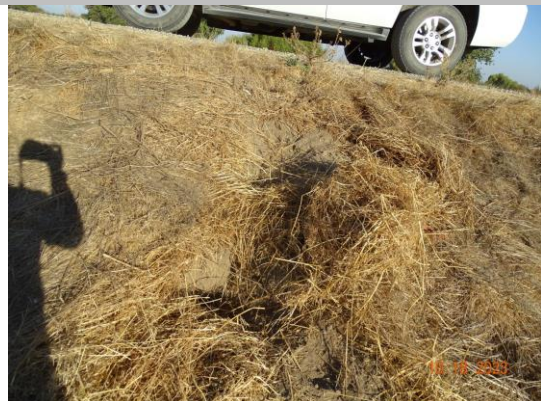
Photo 1 of 1 : SP_2024_NA0010_140_33_20240212_00012.jpg

LM Start	4.01	Rating **	M	Issue No.	33
LM End	4.01	Issue Type +	Ma	Location *	LS
Category	Earthen Levee			GPS Latitude/Longitude	
				Start	End
Item	Animal Control			36.768686°	36.768686°
				-120.229036°	-120.229036°
DWR ID	DWR_NA0010_24_f_2023_33				
Comment Code					
A3 : No rodents visible, but rodent burrows visible; need to backfill and compact or grout burrows.					
Inspector Comment

View of rodent burrows on the landside slope. (Fall 2023)

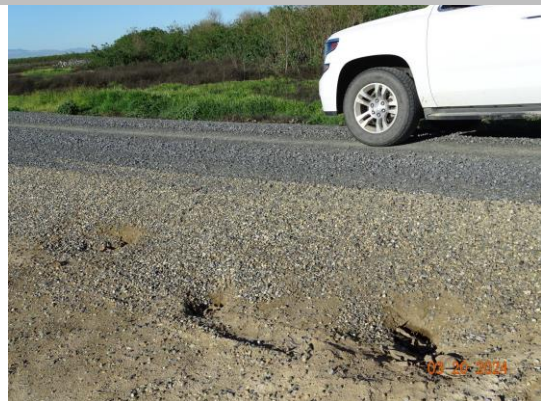
Photo 1 of 1 : SP_2024_NA0010_140_20_20240327_00029.jpg

LM Start	5.66	Rating **	M	Issue No.	20
LM End	5.66	Issue Type +	Ma	Location *	LS
Category	Earthen Levee			GPS Latitude/Longitude	
				Start	End
Item	Animal Control			36.784215°	36.784215°
				-120.218882°	-120.218882°
DWR ID	DWR_NA0010_24_f_2020_20				
Comment Code					
A3 : No rodents visible, but rodent burrows visible; need to backfill and compact or grout burrows.					
Inspector Comment

View of rodent holes at the landside toe. (Spring 2024)

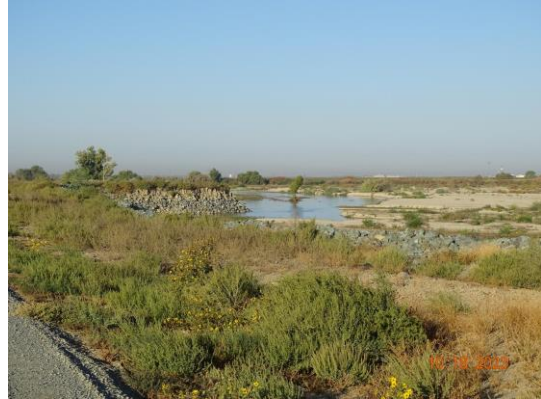
Photo 1 of 1 : SP_2024_NA0010_140_32_20240212_00011.jpg

LM Start	5.99	Rating **	A/W	Issue No.	32
LM End	6.10	Issue Type +	Ma	Location *	WS
Category	Earthen Levee			GPS Latitude/Longitude	
				Start	End
Item	Riprap Revetments			36.787422°	36.787874°
				-120.215689°	-120.213838°
DWR ID	DWR_NA0010_24_f_2023_32				
Comment Code					
RR : Riprap Revetments					
Inspector Comment

View of revetment placed on the waterside berm. (Fall 2023)

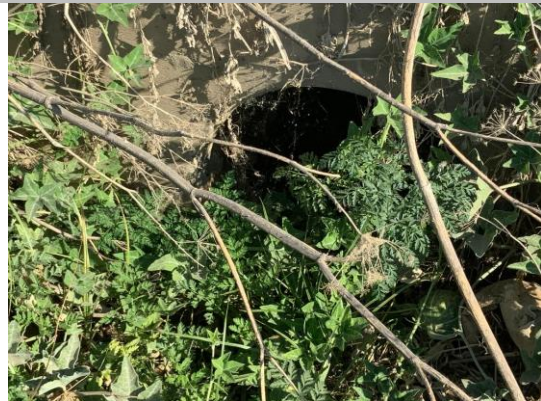
Photo 1 of 1 : UCIP_SP_2024_73634_102808.jpg

Comment Code						
Inspector Comment						
DS_ID:19956						
FS_ID:73634						
EP_NO: N/A						
Repair Type: Non-Urgent						
EVAL Issue: 11, Maintenance Compliance Issue						
Crossing Status: Found						
UCIP Comments: 07/20/2021 The record has been upgraded from No						
Action Needed to Non-Urgent. Limited inspection due to some						
vegetation covering LS pipe inlet, recommend removal. No permit has						
been identified authorizing pipe. Levee prism appears less than 3 feet in						
height. The UCIP inspection was completed with GEI staff, P. Espinoza.

(H. Dunn – GEI)						
FIELD_STRUCT_DESC: 24-inch corrugated metal gravity drainage pipe						
(CMP) through the levee, 5.0 feet below the crown. Flap gate on the						
waterside (WS) end. Concrete headwall on the landside (LS) end.						
Concrete U-shaped headwall on the WS end. [Additional Reference(s):						
DWR Levee Log, 2002, (HLM 6.09). DWR As-Built Drawing No. 65-30,						
27 April 1965, Sheet 12, STA 331+25].						
FS Date: 7/20/2021

LS view: Closeup of pipe inlet at toe covered by vegetation.

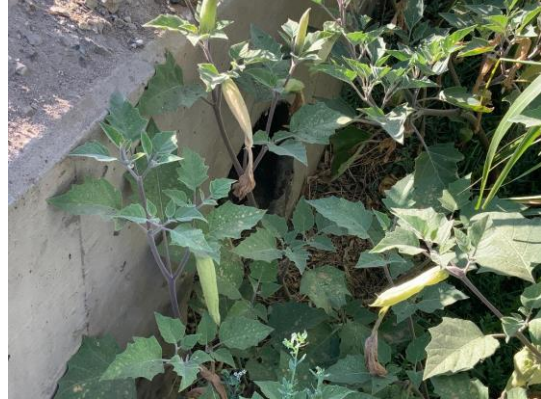
Photo 1 of 1 : UCIP_SP_2024_73635_102814.jpg

Comment Code					
Inspector Comment					
DS_ID:19957 FS_ID:73635 EP_NO: N/A Repair Type: Non-Urgent EVAL Issue: 11, Maintenance Compliance Issue Crossing Status: Found UCIP Comments: 07/20/2021 The record remains Non-Urgent. Limited inspection due to some vegetation covering LS pipe inlet, recommend removal. No permit was found authorizing this encroachment. The levee prism appears to be less than 3 feet. The UCIP inspection was completed with GEI staff, P. Espinoza. (H. Dunn – GEI) 7/20/2016 same as previous inspection. Crossing has been downgraded from Urgent to Non-Urgent PVC does not prevent WS flap gate from closing. (O. Magana - DWR UCIP)4/08/2014 Unauthorized PVC pipe through existing crossing. PVC distorted inside--Need to contact owner to correct issue. If crossing was allowed need to contact owner for permit number issue for crossing variance. (O. Magana - DWR UCIP) FIELD_STRUCT_DESC: 24-inch corrugated metal gravity drainage pipe (CMP) through the levee, 3.6 feet below the crown. Flap gate on the waterside (WS) end. Concrete headwall on the landside (LS) end. Concrete U-shaped headwall on the WS end. [Additional Reference(s): DWR Levee Log, 2002, (HLM 6.72). DWR As-Built Drawing No. 65-30, 27 April 1965, Sheet 13, STA 364+00]. FS Date: 7/20/2021

LS view: Closeup of pipe inlet at toe with vegetation overgrowth.

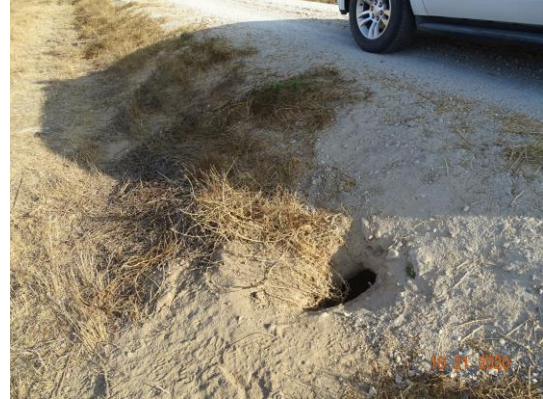
Photo 1 of 1 : SP_2024_NA0010_140_14_20240212_00005.jpg

LM Start	6.86	Rating **	M	Issue No.	14
LM End	6.86	Issue Type +	Ma	Location *	LS
Category	Earthen Levee			GPS Latitude/Longitude	
				Start	End
Item	Animal Control			36.784716°	36.784716°
				-120.204043°	-120.204043°
DWR ID	DWR_NA0010_24_f_2020_14				
Comment Code					
A3 : No rodents visible, but rodent burrows visible; need to backfill and compact or grout burrows.					
Inspector Comment

Rodent burrow on the landside slope. (Fall 2020)

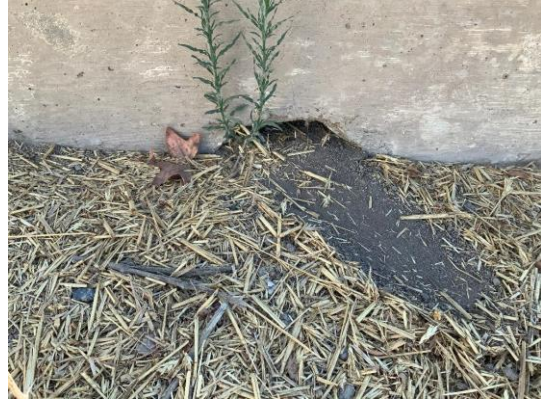
Photo 1 of 2 : UCIP_SP_2024_73636_102830.jpg

Comment Code					
Inspector Comment					
DS_ID:19958 FS_ID:73636 EP_NO: N/A Repair Type: Non-Urgent EVAL Issue: 11, Maintenance Compliance Issue Crossing Status: Found UCIP Comments: 07/20/2021 The record has been upgraded from No Action Needed to Non-Urgent. Limited inspection due to LS pipe inlet covered by sediment and WS flapgate covered by vegetation debris, recommend clearing out both sides. Levee prism appears to be less than 3 feet in height. The UCIP inspection was completed with GEI staff, P. Espinoza. (H. Dunn – GEI) FIELD_STRUCT_DESC: 12-inch corrugated metal gravity drainage pipe (CMP) through the levee, 2.5 feet below the crown. Flap gate on the waterside (WS) end. Concrete headwall on each end. [Additional Reference(s): DWR Levee Log, 2002, (HLM 7.63). DWR As-Built Drawing No. 65-30, 27 April 1965, Sheet 14, STA 412+70]. FS Date: 7/20/2021

LS view: Closeup of pipe inlet buried with sediment.

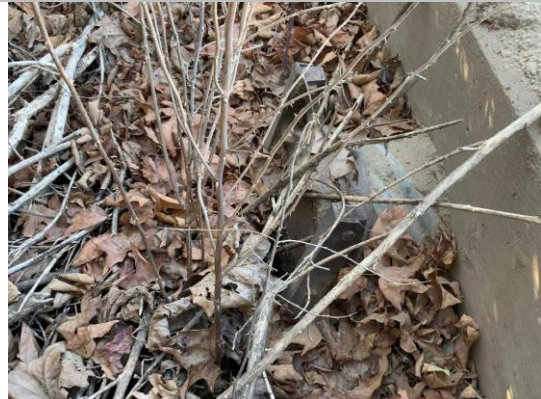
Photo 2 of 2 : UCIP_SP_2024_73636_102832.jpg

WS view: Closeup of flapgate at toe with vegetation debris.

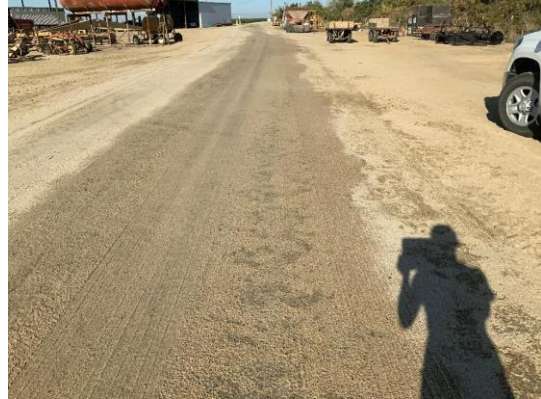
Photo 1 of 3 : UCIP_SP_2024_73637_102857.jpg

Comment Code						
Inspector Comment						
DS_ID:19959 FS_ID:73637 EP_NO: N/A Repair Type: Non-Urgent EVAL Issue: Crossing Status: Indicator Found UCIP Comments: 07/20/2021 The record is Non-Urgent. Possible WS headwall visible from the crown but inaccessible due to fences, limited inspection. Appears removed or abandoned due to no cobble outlet channel or outlet visible on the LS. LS end is completely flat and adjacent to a working farm. DWR DMP geophysical study did not confirm presence of pipe through levee. Record will remain in UCIP's inspection records until future Levee Improvement Project can confirm no crossing was found through the levee. No permit was found authorizing this encroachment. CVFPB will need to review crossing to determine owner. Levee prism appears to be less than 3 feet in height. The UCIP inspection was completed with GEI staff, P. Espinoza. (H. Dunn – GEI) FIELD_STRUCT_DESC: 36-inch reinforced concrete gravity drainage pipe (RCP) through the levee, 10.5 feet below the crown. Flap gate on the waterside (WS) end. Concrete headwall on the WS end. 10-foot cobble revetted outlet channel. [Additional Reference(s): DWR Levee Log, 2002, (HLM 8.16). USACE San Joaquin O&M Manual, Unit No. 601, Part No. 1, 1967, Amended in 1978, Revised 20 June 1985, (HLM 8.15). DWR As-Built Specification No. 65-30, Sheet No. 14, 27 April 1965, (HLM 8.15)]. FS Date: 7/20/2021

Levee crown.

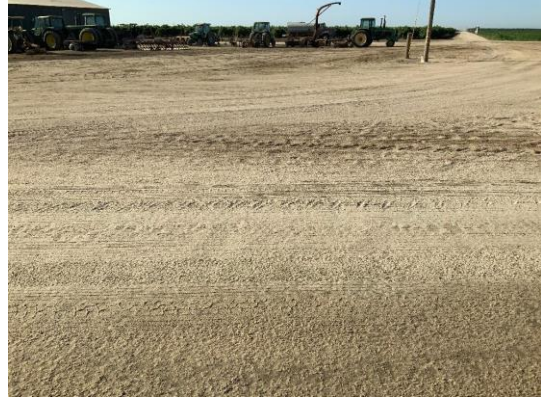
Photo 3 of 3 : UCIP_SP_2024_73637_102858.jpg

WS view: Toe from crown, no pipe visible.

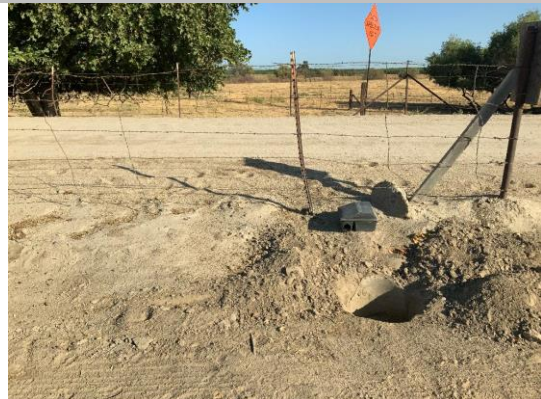
Photo 1 of 2 : UCIP_SP_2024_73638_102864.jpg

LS view: Slope from toe, no pipe visible.

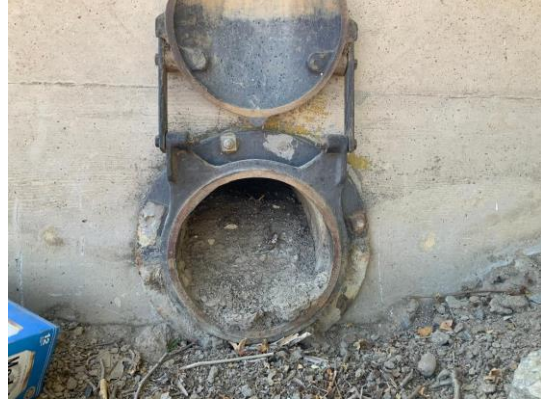
Photo 2 of 2 : UCIP_SP_2024_73638_102862.jpg

DS_ID:19960
FS_ID:73638
EP_NO: N/A
Repair Type: Non-Urgent
EVAL Issue: 11, Maintenance Compliance Issue
Crossing Status: Found
UCIP Comments: 07/20/2021 The record remains Non-Urgent. WS outlet filled with sediment, recommend cleaning out. LS pipe inlet not found, likely buried under dirt, recommend removal. No permit was found authorizing this encroachment. CVFPB will need to review crossing to determine owner. Levee prism appears to be less than 3 feet in height. The UCIP inspection was completed with GEI staff, P. Espinoza. (H. Dunn – GEI) 04/08/2014 Barbed wire along levee shoulder--no access. Need to confirm crossing size and condition of crossing. (O. Magana - DWR UCIP)
FIELD_STRUCT_DESC: 12-inch reinforced concrete gravity drainage pipe (RCP) through the levee, 3.0 feet below the crown. Flap gate on the waterside (WS) end. Concrete headwall on the WS end. [Additional Reference(s): DWR Levee Log, 2002, (HLM 8.33). USACE San Joaquin O&M Manual, Unit No. 601, Part No. 1, 1967, Amended in 1978, Revised 20 June 1985, (HLM 8.32). DWR As-Built Specification No. 65-30, Sheet No. 14, 27 April 1965, (HLM 8.32)].

WS view: Closeup of flapgate and outlet filled with sediment at toe.
