Flood Control Project Maintenance**2011 Structure Summary Report****Overall Unit and Item Ratings****Lower San Joaquin Levee District****Ash Slough Drop Structure No. 1**

Flood Control Project Maintenance

2011 Structure Summary Report

Overall Unit and Item Ratings

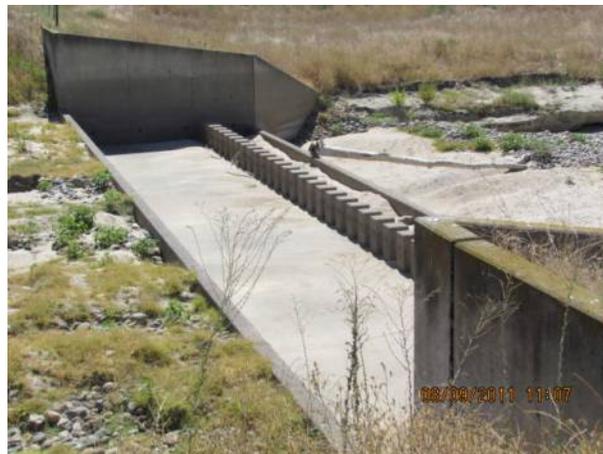
Levee Mile Report Line	5
Start Levee Mile	0.00
End Levee Mile	0.00
Location	
Category	Structures
Item	Revetments
Looking southwest a riprap displacement on downstream and upstream side of structure.	
richard_t_20110831_081.jpg

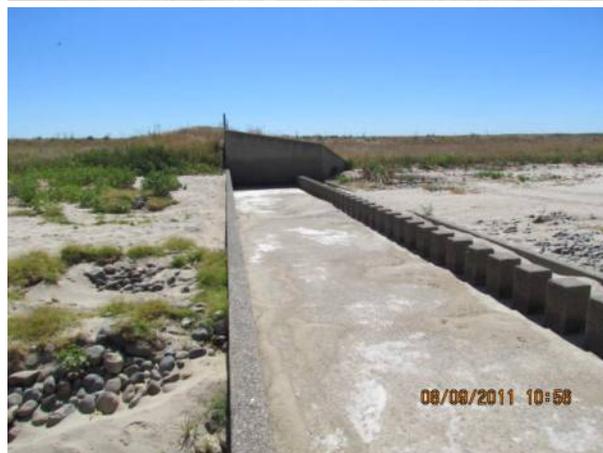
Levee Mile Report Line	1
Start Levee Mile	
End Levee Mile	
Location	
Category	Structures
Item	Photo Documentation
Looking south at close-up view of structure.	
richard_t_20110830_077.jpg

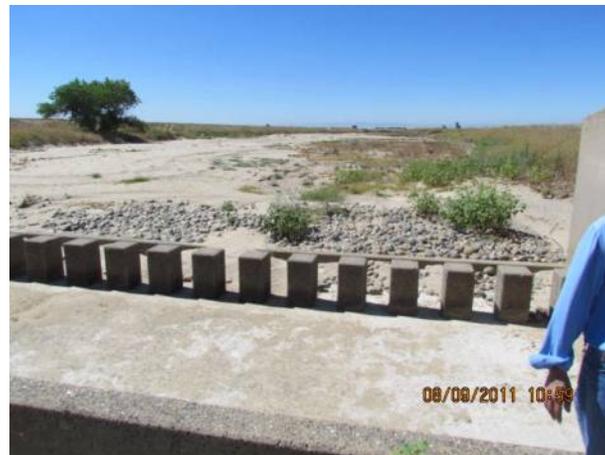
Levee Mile Report Line	5
Start Levee Mile	0.00
End Levee Mile	0.00
Location	
Category	Structures
Item	Revetments
Looking west at revetment on downstream side of structure.	
richard_t_20110830_079.jpg

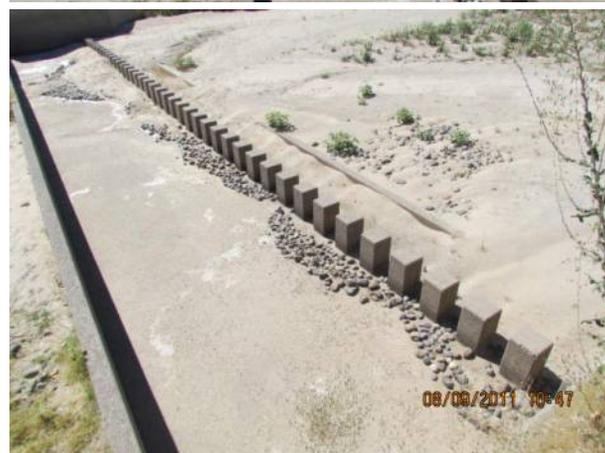
Levee Mile Report Line	1
Start Levee Mile	
End Levee Mile	
Location	
Category	Structures
Item	Photo Documentation
Looking southeast at upstream side of structure.	
richard_t_20110830_074.jpg

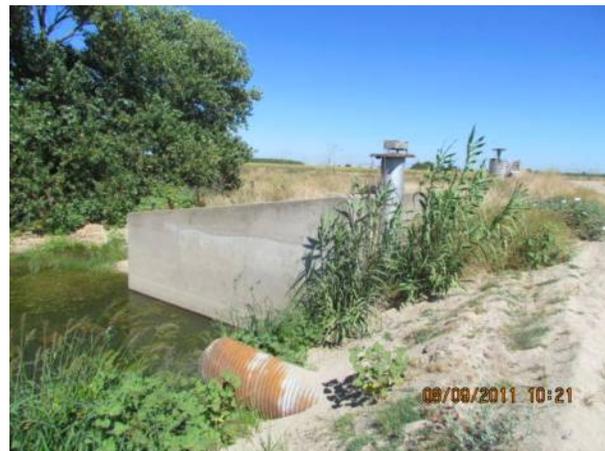
Levee Mile Report Line	6
Start Levee Mile	0.00
End Levee Mile	0.00
Location	
Category	Structures
Item	Encroachments
Looking north at sand dam and pipe through sand dam.	
richard_t_20110830_069.jpg

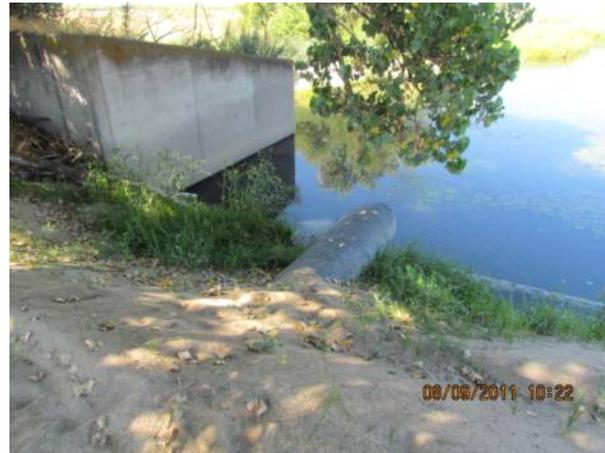
Levee Mile Report Line	6
Start Levee Mile	0.00
End Levee Mile	0.00
Location	
Category	Structures
Item	Encroachments
Looking west a pipe through sand dam.	
richard_t_20110830_070.jpg

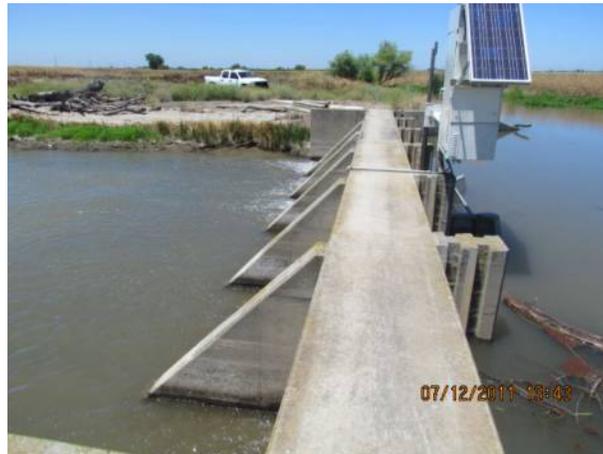
Levee Mile Report Line	1
Start Levee Mile	
End Levee Mile	
Location	
Category	Structures
Item	Photo Documentation
Looking north at overview of structure.	
richard_t_20110725_007.jpg

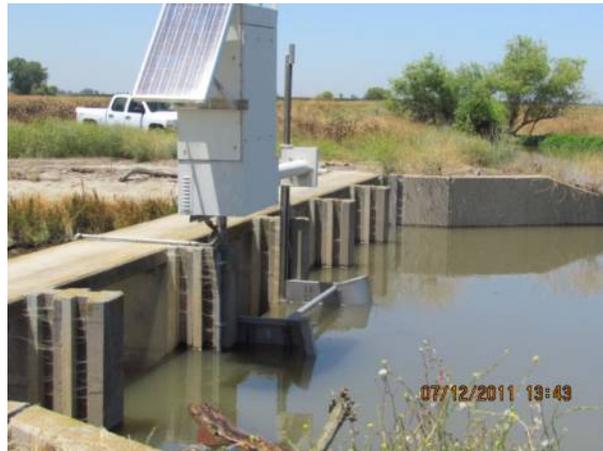
Levee Mile Report Line	6
Start Levee Mile	0.00
End Levee Mile	0.00
Location	
Category	Structures
Item	Encroachments
Looking northwest at remote control gate on upstream side of structure.	
richard_t_20110725_004.jpg

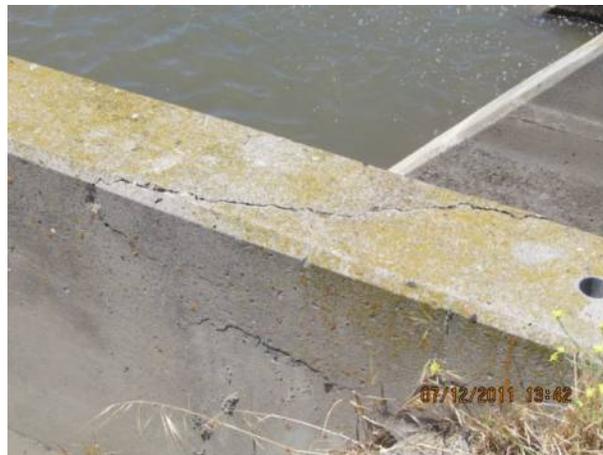
Levee Mile Report Line	15
Start Levee Mile	0.00
End Levee Mile	0.00
Location	
Category	Structures
Item	Concrete Surfaces
Looking northwest at cracking on left wing wall	
richard_t_20110725_002.jpg

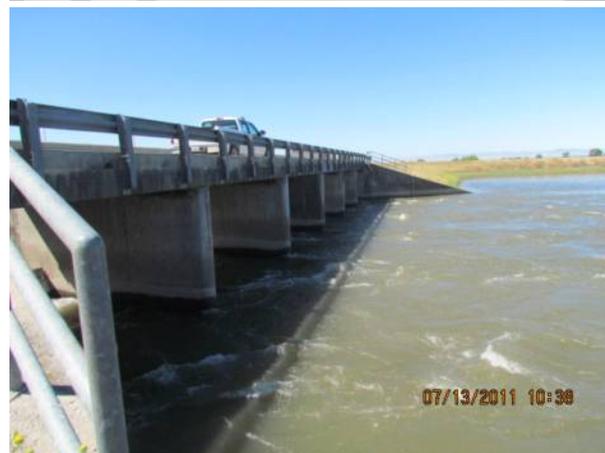
Levee Mile Report Line	1
Start Levee Mile	
End Levee Mile	
Location	
Category	Structures
Item	Photo Documentation
Looking south at downstream side of structure.	
richard_t_20110726_018.jpg

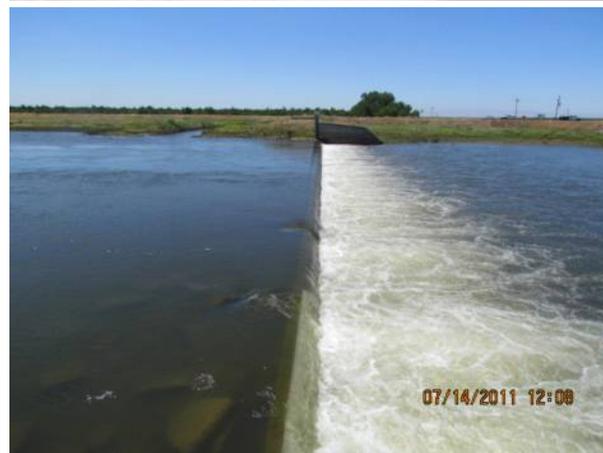
Levee Mile Report Line	1
Start Levee Mile	
End Levee Mile	
Location	
Category	Structures
Item	Photo Documentation
Looking south at close-up view of downstream side of structure.	
richard_t_20110727_058.jpg

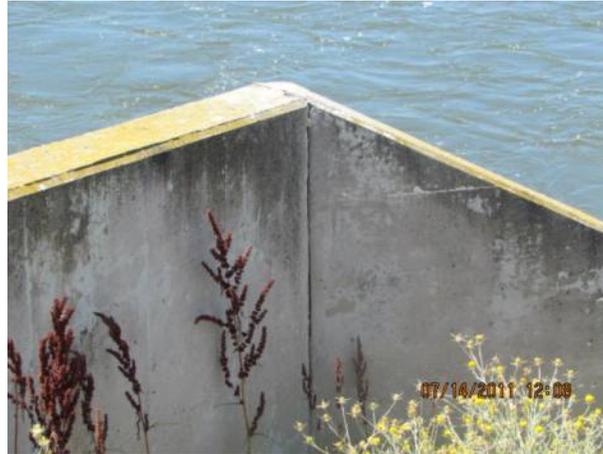
Levee Mile Report Line	22
Start Levee Mile	0.00
End Levee Mile	0.00
Location	
Category	Structures
Item	Monolith Joints
Looking west on downstream side at right wing wall.	
richard_t_20110727_055.jpg

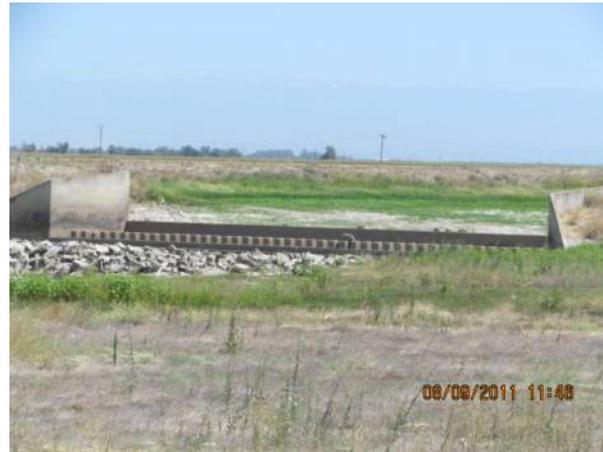
Levee Mile Report Line	1
Start Levee Mile	
End Levee Mile	
Location	
Category	Structures
Item	Photo Documentation
Looking east at downstream side of structure.	
richard_t_20110831_082.jpg

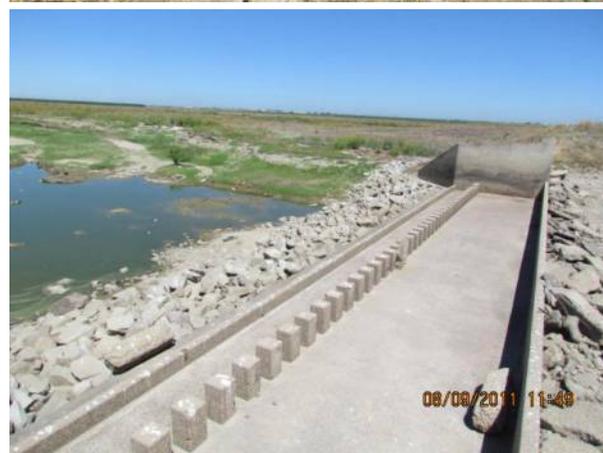
Levee Mile Report Line	1
Start Levee Mile	
End Levee Mile	
Location	
Category	Structures
Item	Photo Documentation
Looking northeast at downstream side of structure.	
richard_t_20110831_084.jpg

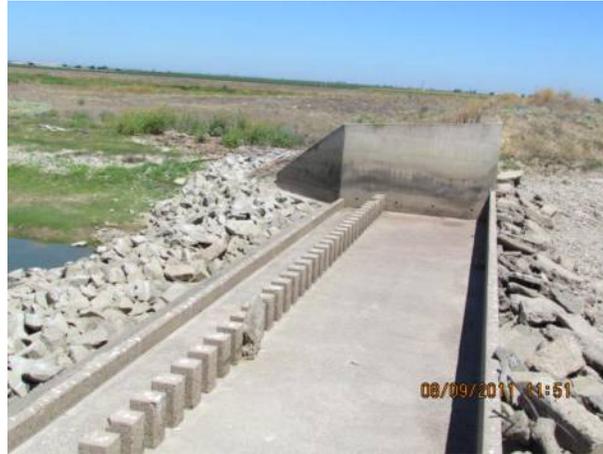
Levee Mile Report Line	1
Start Levee Mile	
End Levee Mile	
Location	
Category	Structures
Item	Photo Documentation
Looking northeast at close-up view of structure.	
richard_t_20110831_085.jpg

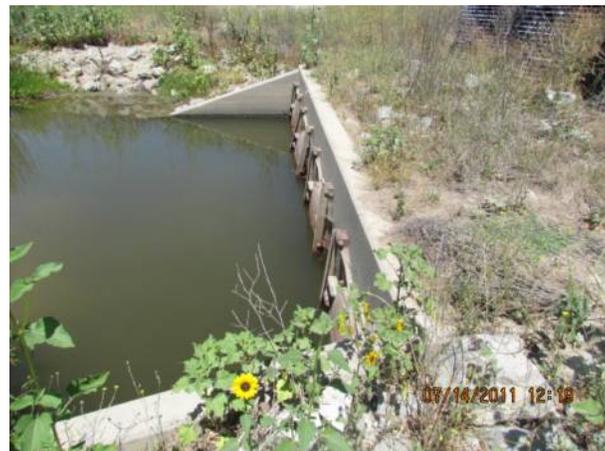
Levee Mile Report Line	11
Start Levee Mile	0.00
End Levee Mile	0.00
Location	
Category	Structures
Item	Flap Gates
Looking northwest on downstream side at flap gates.	
richard_t_20110728_061.jpg

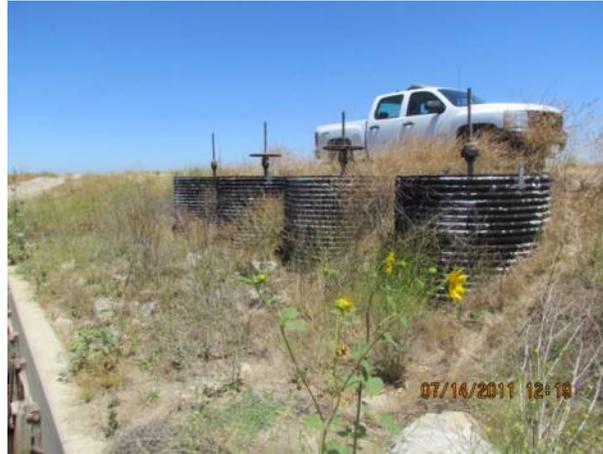
Levee Mile Report Line	14
Start Levee Mile	0.00
End Levee Mile	0.00
Location	
Category	Structures
Item	Manual Gate Operators
Looking north on downstream side at manual screw gates with two missing wheels.	
richard_t_20110728_059.jpg

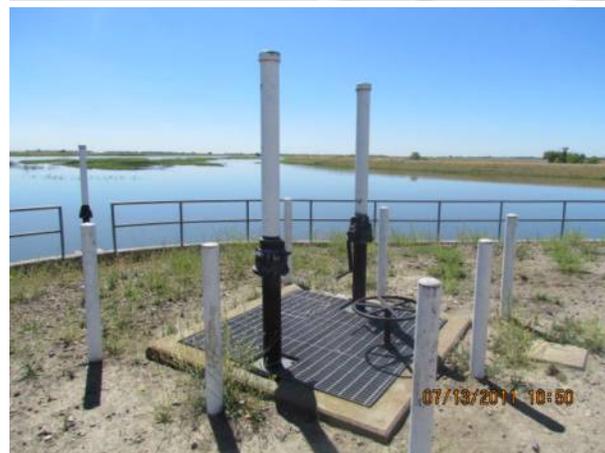
Levee Mile Report Line	1
Start Levee Mile	
End Levee Mile	
Location	
Category	Structures
Item	Photo Documentation
Looking east at three (3) screw gates on north side of the structure.	
richard_t_20110726_021.jpg

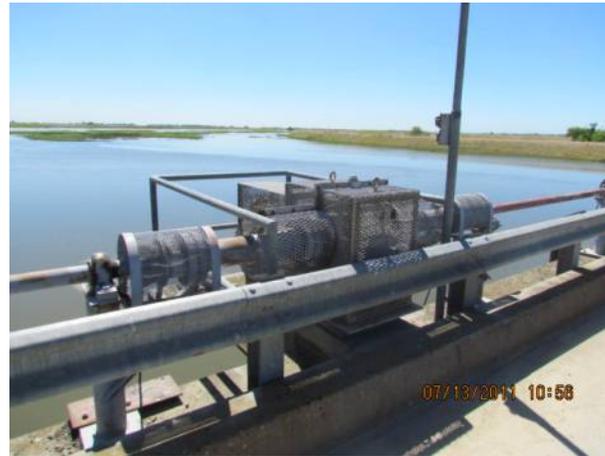
Looking at one of six motors on upstream side of structure.

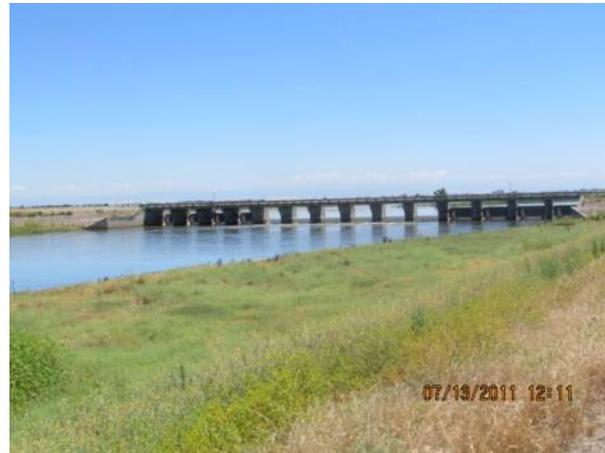
Looking east at downstream side of structure.

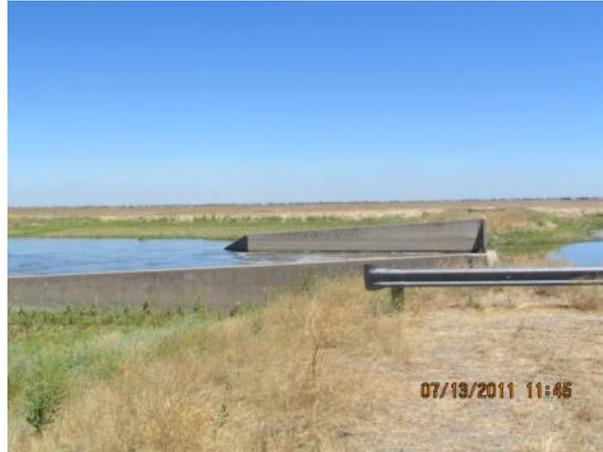
Levee Mile Report Line	1
Start Levee Mile	
End Levee Mile	
Location	
Category	Structures
Item	Photo Documentation
Looking north at overview of structure.	
richard_t_20110726_024.jpg

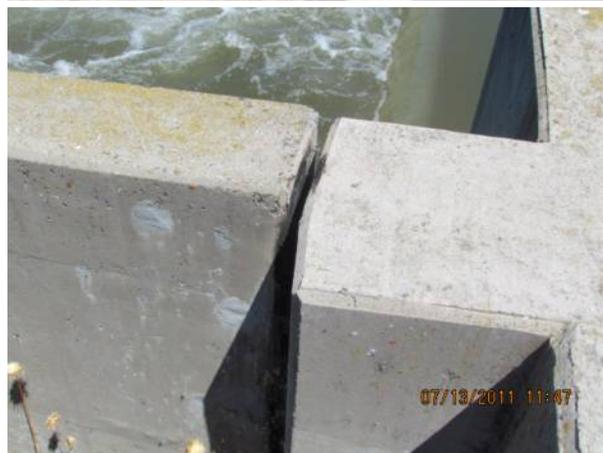
Levee Mile Report Line	22
Start Levee Mile	0.00
End Levee Mile	0.00
Location	
Category	Structures
Item	Monolith Joints
Looking east at left wing wall joint.	
richard_t_20110726_027.jpg

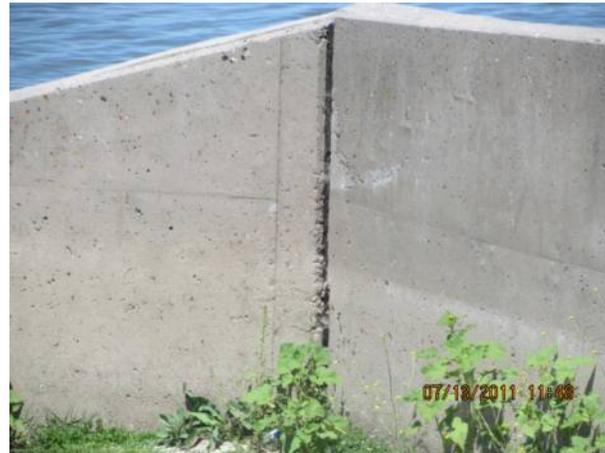
Looking at left wing wall joint.

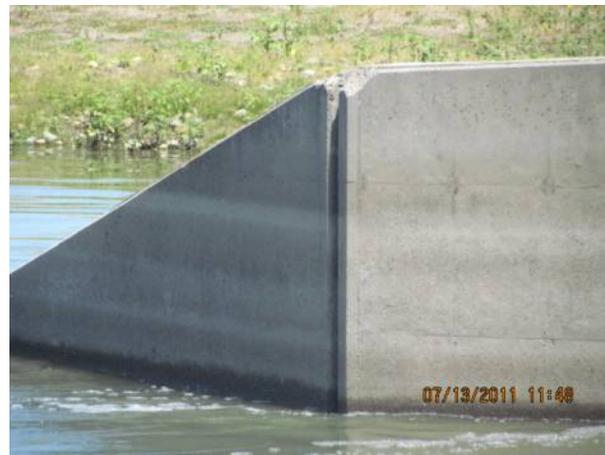
Looking east at right wing wall joint.

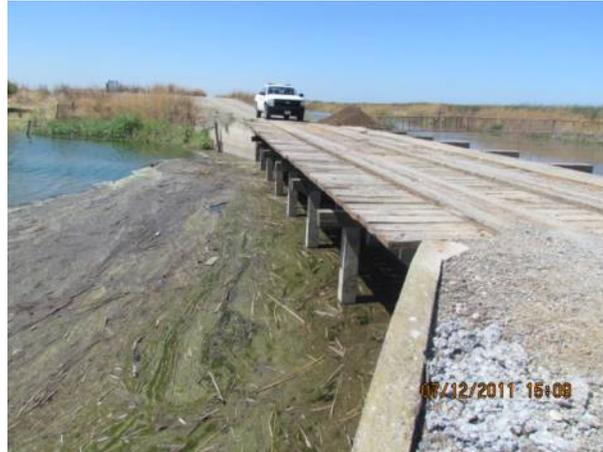
Levee Mile Report Line	1
Start Levee Mile	
End Levee Mile	
Location	
Category	Structures
Item	Photo Documentation
Looking north at downstream side overview of structure.	
richard_t_20110725_011.jpg

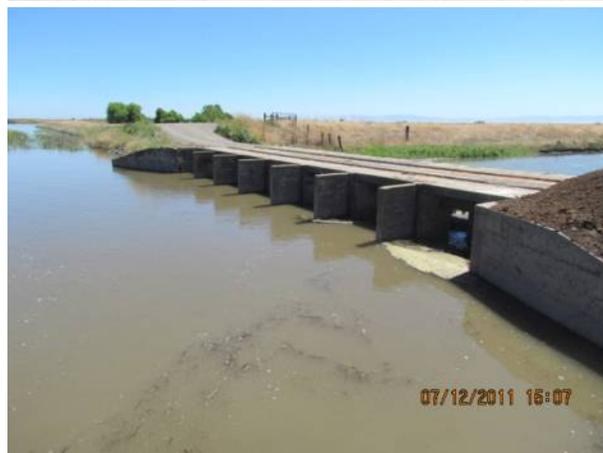
Levee Mile Report Line	1
Start Levee Mile	
End Levee Mile	
Location	
Category	Structures
Item	Photo Documentation
Looking at upstream side overview of structure.	
richard_t_20110726_031.jpg

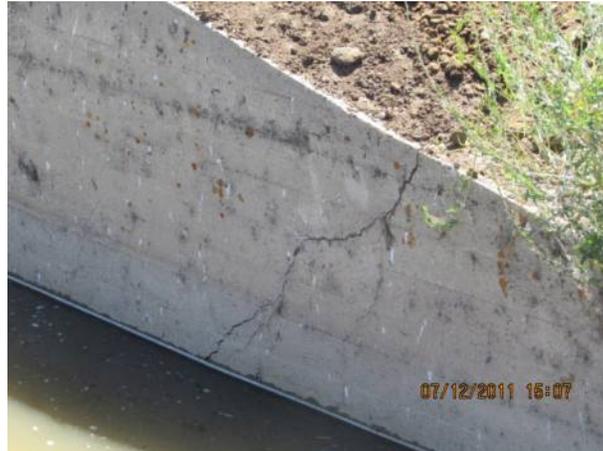
Levee Mile Report Line	15
Start Levee Mile	0.00
End Levee Mile	0.00
Location	
Category	Structures
Item	Concrete Surfaces
Looking at cracking on upstream side right wing wall.	
richard_t_20110726_033.jpg

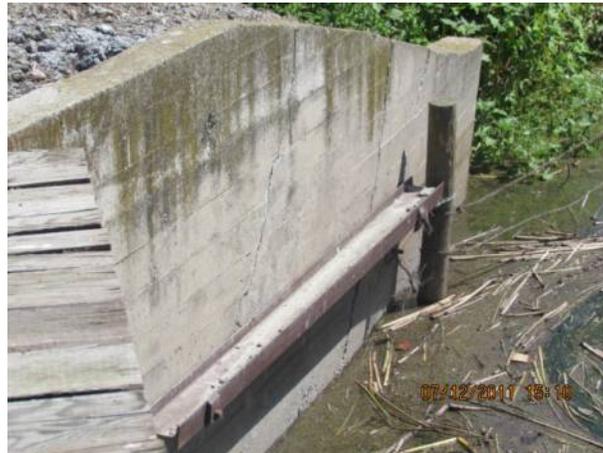
richard_t_20110725_010.jpg

Looking at cracking and movement of the left downstream wing wall.

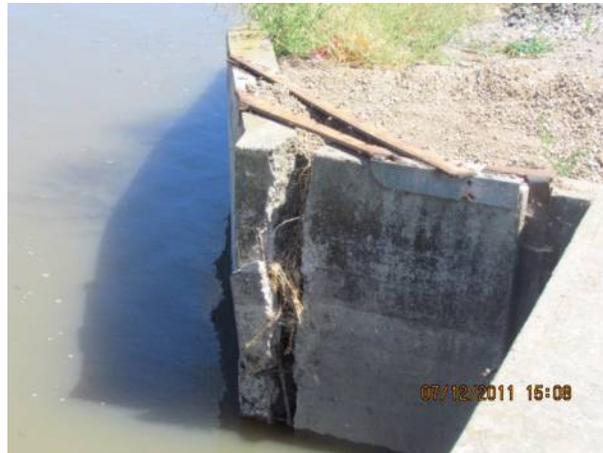
richard_t_20110829_034.jpg

Levee Mile Report Line	22
Start Levee Mile	0.00
End Levee Mile	0.00
Location	
Category	Structures
Item	Monolith Joints

Looking at left wing wall on upstream side joint seperation

22	0.00	0.00	Structures	Monolith Joints		M	Inspector Comments: Left wing wall joint should be repaired.	37.219788 ° -120.698058 °	37.219788 ° -120.698058 °	22 Y
23	0.00	0.00	Structures	Safety		A	Inspector Comments: No visible hazards.	37.219788 ° -120.698058 °	37.219788 ° -120.698058 °	23

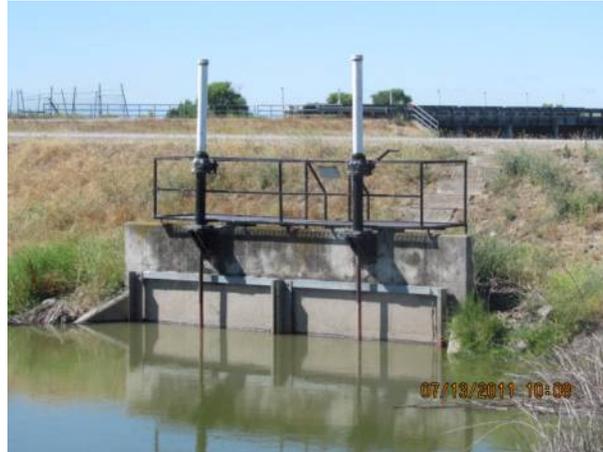
Levee Mile Report Line	1
Start Levee Mile	
End Levee Mile	
Location	
Category	Structures
Item	Photo Documentation
Looking south at upstream side at overview of structure.	
richard_t_20110725_013.jpg

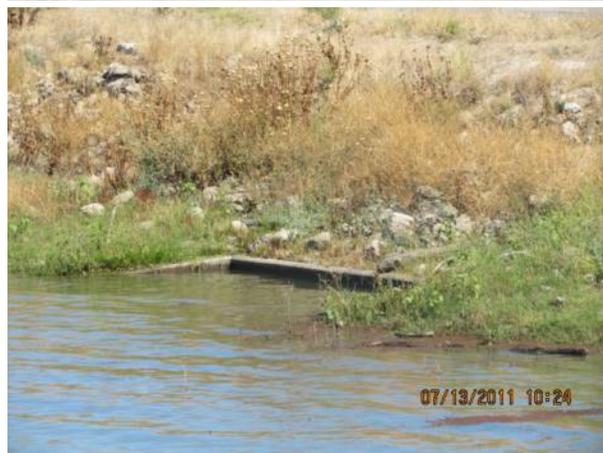
Levee Mile Report Line	7
Start Levee Mile	0.00
End Levee Mile	0.00
Location	
Category	Structures
Item	Culverts: Inlets / Outlets
Looking southwest at outlet of structure.	
richard_t_20110727_034.jpg

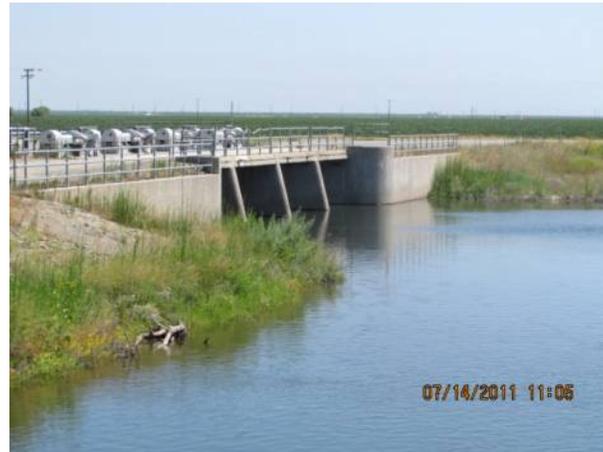
Levee Mile Report Line	1
Start Levee Mile	0.00
End Levee Mile	0.00
Location	
Category	Structures
Item	Photo Documentation
Looking north at Chowchilla Bypass Control Structure upstream side general overview of structure.	
richard_t_20110727_044.jpg

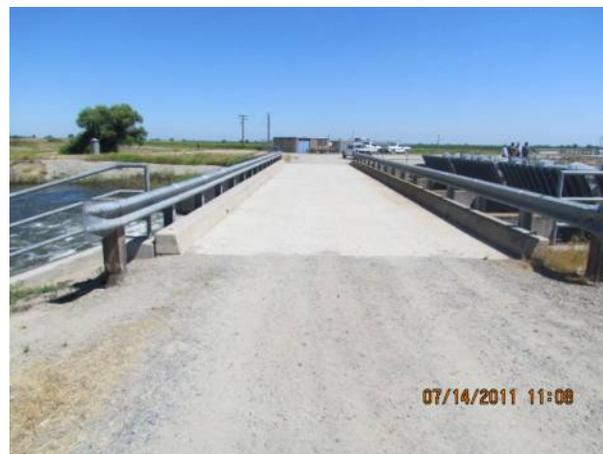
Levee Mile Report Line	1
Start Levee Mile	0.00
End Levee Mile	0.00
Location	
Category	Structures
Item	Photo Documentation
Looking north at a general overview of San Joaquin River Control Structure.	
richard_t_20110727_048.jpg

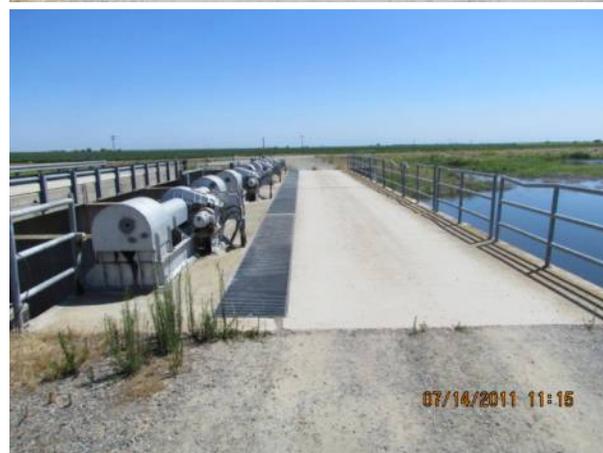
Levee Mile Report Line	1
Start Levee Mile	0.00
End Levee Mile	0.00
Location	
Category	Structures
Item	Photo Documentation
Looking northeast at general overview of a Chowchilla Bypass Control Structure.	
richard_t_20110727_049.jpg

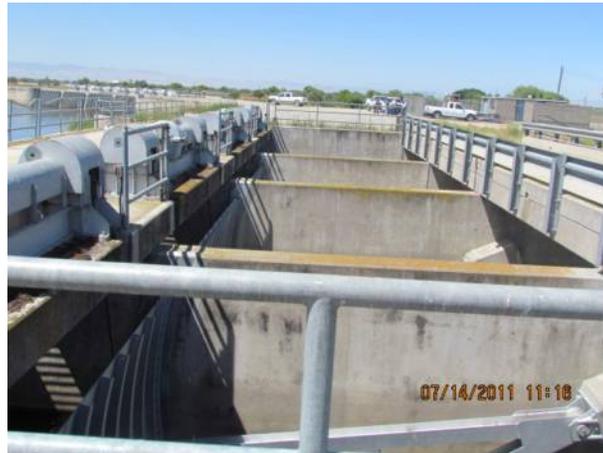
Levee Mile Report Line	1
Start Levee Mile	0.00
End Levee Mile	0.00
Location	
Category	Structures
Item	Photo Documentation
Looking west at general overview of Chowchilla Bypass Control Structure.	
richard_t_20110727_052.jpg

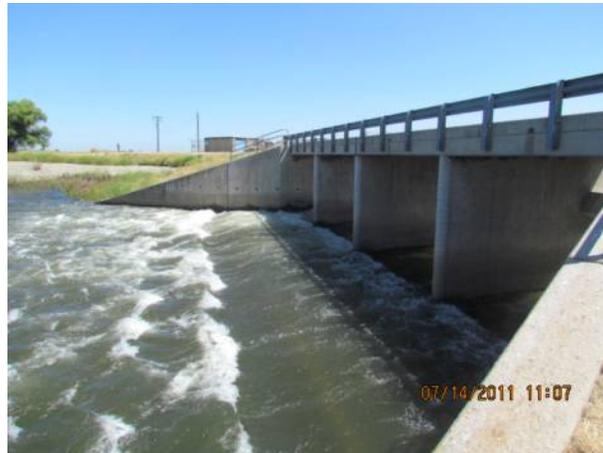
Levee Mile Report Line	7
Start Levee Mile	0.00
End Levee Mile	0.00
Location	
Category	Structures
Item	Culverts: Inlets / Outlets
Looking north at outlet on the San Joaquin River Control Structure overview.	
richard_t_20110727_047.jpg

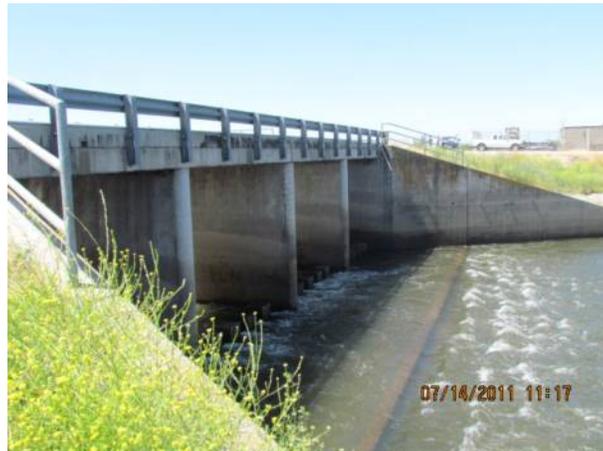
Levee Mile Report Line	7
Start Levee Mile	0.00
End Levee Mile	0.00
Location	
Category	Structures
Item	Culverts: Inlets / Outlets
Looking west at general overview of outlet on Chowchilla Bypass Control Structure.	
richard_t_20110727_053.jpg

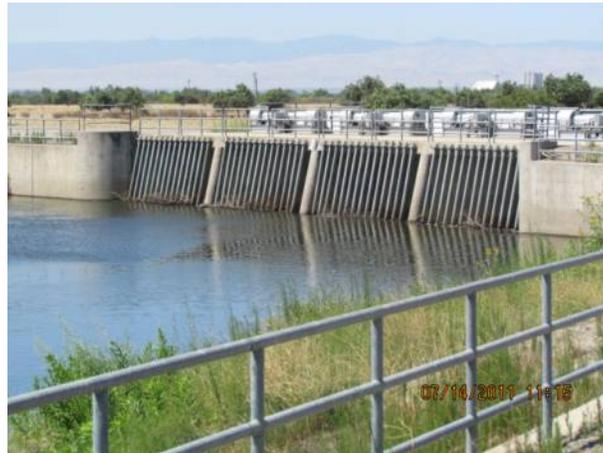
Levee Mile Report Line	10
Start Levee Mile	0.00
End Levee Mile	0.00
Location	
Category	Structures
Item	Trash Racks
Looking west at trash racks and general overview of San Joaquin River Control Structure.	
richard_t_20110727_050.jpg

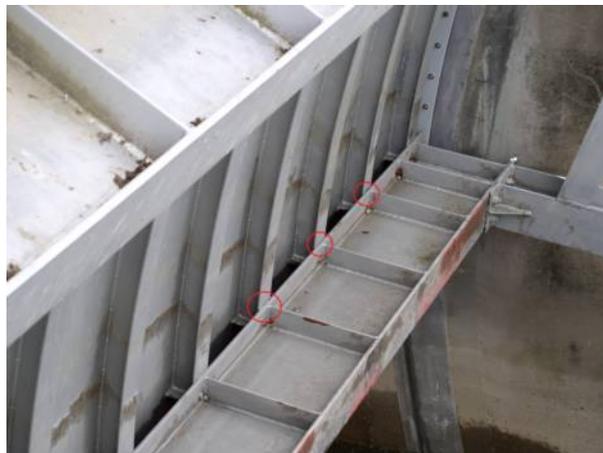
Levee Mile Report Line	12
Start Levee Mile	0.00
End Levee Mile	0.00
Location	
Category	Structures
Item	Sluice/Slide Gates
Looking at gate #1 with some slight cracking along I-beams.	
richard_t_20110727_042.jpg

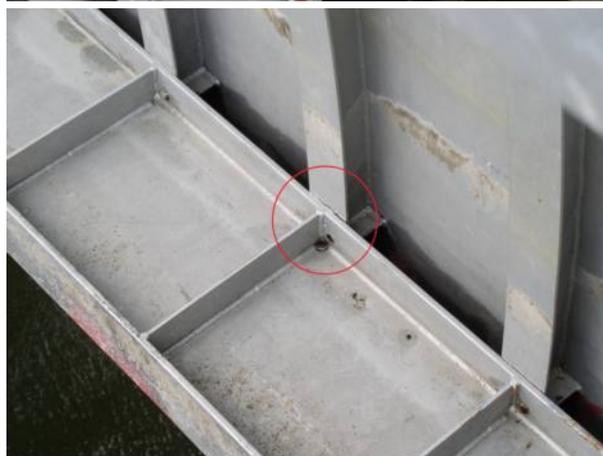
Levee Mile Report Line	12
Start Levee Mile	0.00
End Levee Mile	0.00
Location	
Category	Structures
Item	Sluice/Slide Gates
Looking at gate # 4 with sheared bolt and cracking along I-beam.	
richard_t_20110727_043.jpg

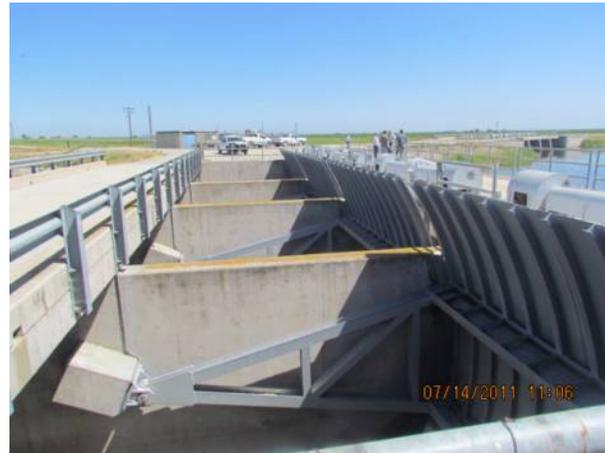
Levee Mile Report Line	12
Start Levee Mile	0.00
End Levee Mile	0.00
Location	
Category	Structures
Item	Sluice/Slide Gates
Looking north at gates on the San Joaquin River Control Structure.	
richard_t_20110727_046.jpg

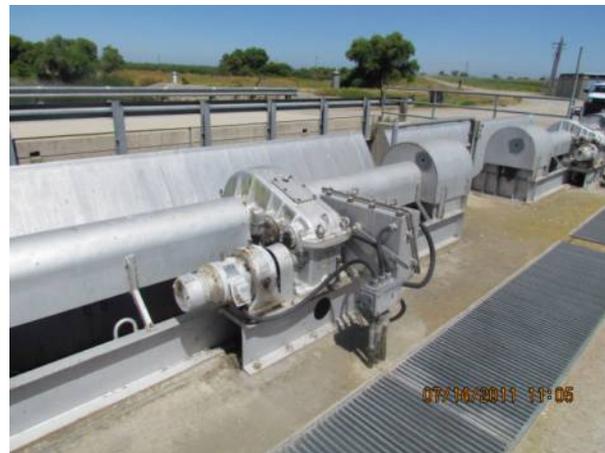
Levee Mile Report Line	13
Start Levee Mile	0.00
End Levee Mile	0.00
Location	
Category	Structures
Item	Electric Gate Operators
Looking at one of several motor on San Joaquin River Control Structure.	
richard_t_20110727_045.jpg

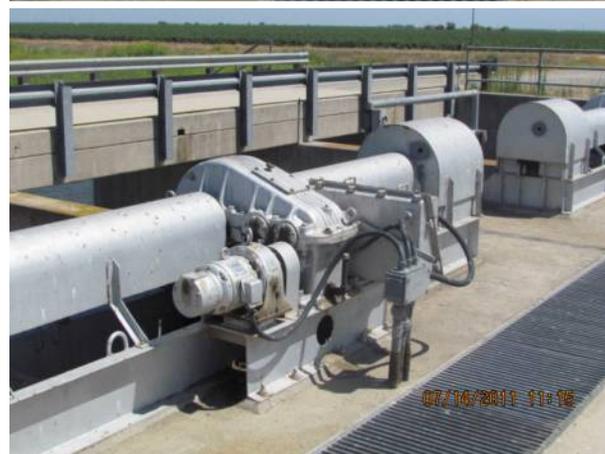
Levee Mile Report Line	13
Start Levee Mile	0.00
End Levee Mile	0.00
Location	
Category	Structures
Item	Electric Gate Operators
Looking north at one of several motors on the Chowchilla Bypass Control Structure.	
richard_t_20110727_051.jpg

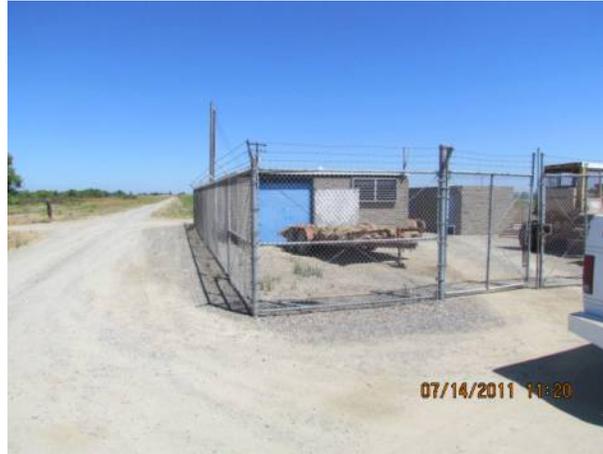
Levee Mile Report Line	18
Start Levee Mile	0.00
End Levee Mile	0.00
Location	
Category	Structures
Item	Security Fencing
Looking north at security fencing around maintenance facilities.	
richard_t_20110727_054.jpg

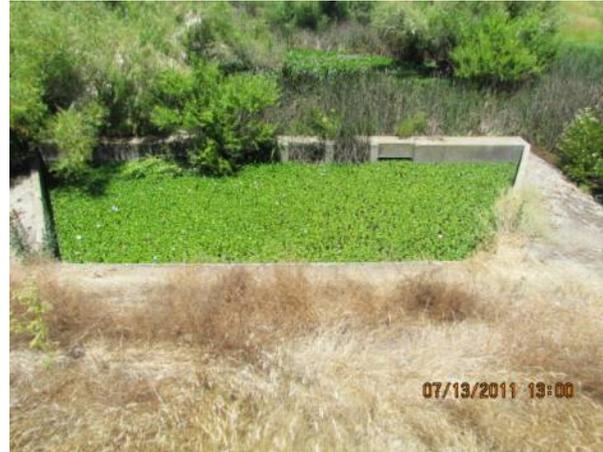
Levee Mile Report Line	7
Start Levee Mile	0.00
End Levee Mile	0.00
Location	
Category	Structures
Item	Culverts: Inlets / Outlets
Looking north at inlet side of structure.	
richard_t_20110727_039.jpg

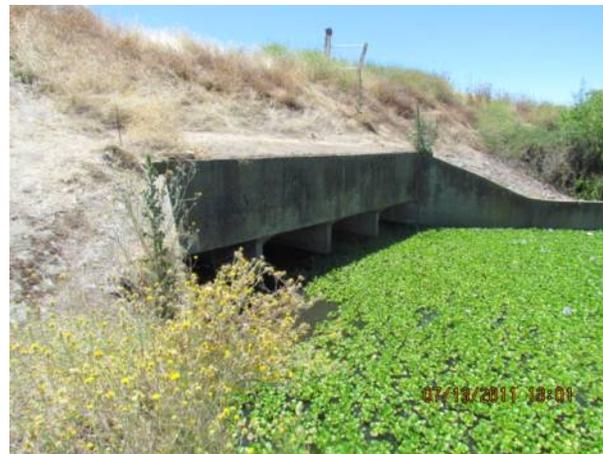
Levee Mile Report Line	7
Start Levee Mile	0.00
End Levee Mile	0.00
Location	
Category	Structures
Item	Culverts: Inlets / Outlets
Looking east at inlet side of structure.	
richard_t_20110727_040.jpg

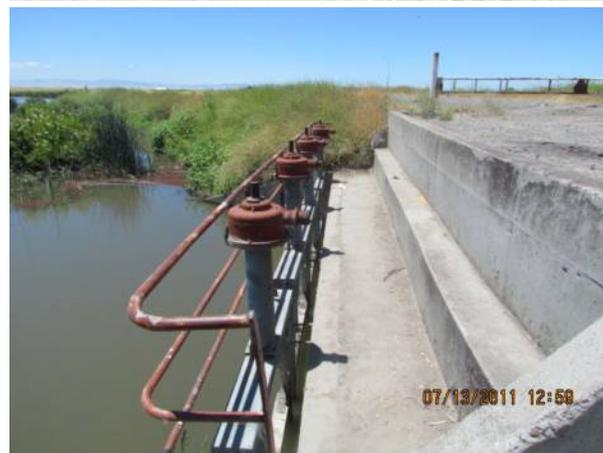
Levee Mile Report Line	12
Start Levee Mile	0.00
End Levee Mile	0.00
Location	
Category	Structures
Item	Sluice/Slide Gates
Looking east at gates on downstream side of structure.	
richard_t_20110727_038.jpg

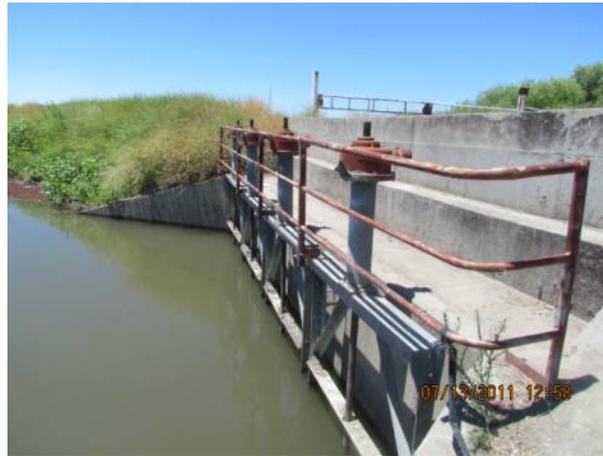
Levee Mile Report Line	12
Start Levee Mile	0.00
End Levee Mile	0.00
Location	
Category	Structures
Item	Sluice/Slide Gates
Looking at slide gates on outlet side of structure.	
richard_t_20110727_041.jpg

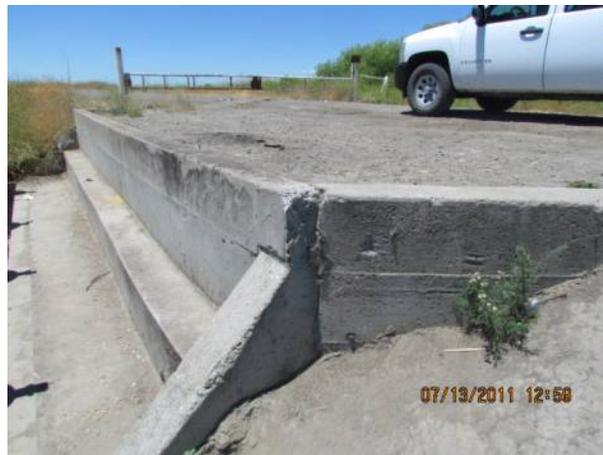
Levee Mile Report Line	15
Start Levee Mile	0.00
End Levee Mile	0.00
Location	
Category	Structures
Item	Concrete Surfaces
Looking southeast at left corner with slight chipping at joint.	
richard_t_20110727_035.jpg

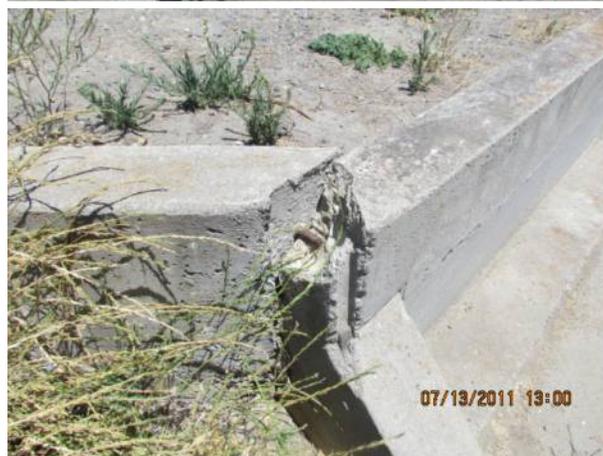
Levee Mile Report Line	15
Start Levee Mile	0.00
End Levee Mile	0.00
Location	
Category	Structures
Item	Concrete Surfaces
Looking west at right corner on outlet side with chipping at joint.	
richard_t_20110727_036.jpg

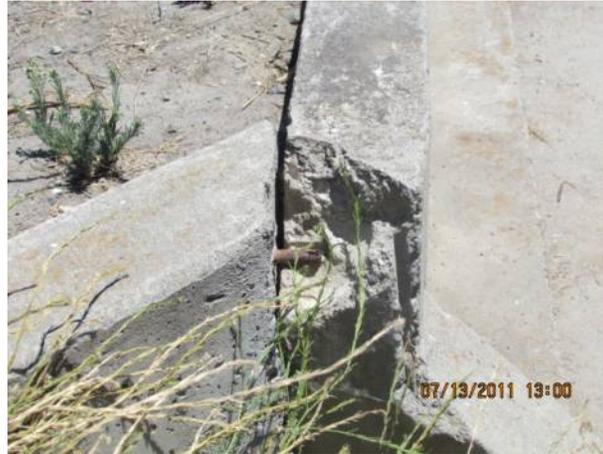
Levee Mile Report Line	15
Start Levee Mile	0.00
End Levee Mile	0.00
Location	
Category	Structures
Item	Concrete Surfaces
Looking at close-up view of chipping on right corner joint on outlet side.	
richard_t_20110727_037.jpg
