**Flood Control Project Maintenance
Levee Inspections**

2009 Channel Summary Report

Madera County FCWCA

Flood Control Project Maintenance
Unit Cover Sheet
2009 Channel Inspection Results

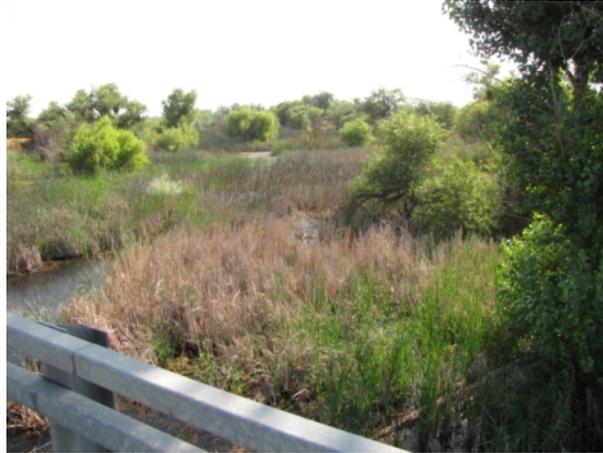
Levee Mile Report Line	28
Start Levee Mile	0.00
End Levee Mile	0.00
Location	
Category	Channels
Item	Encroachments
Down stream from Road 19 trash amd old furniture domped rightbank of bridge.	
phillips_20090831_39.jpg

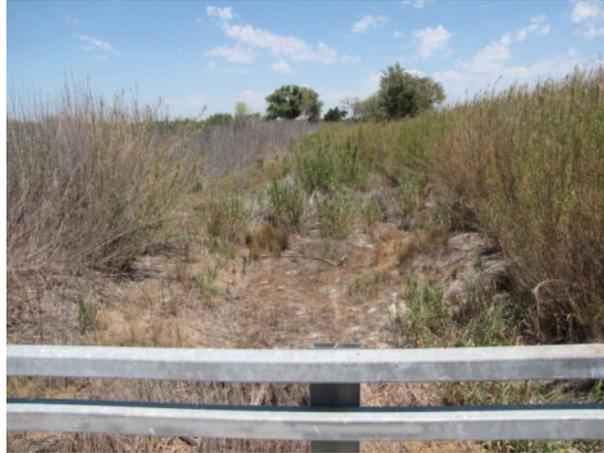
Levee Mile Report Line	44
Start Levee Mile	0.00
End Levee Mile	0.00
Location	
Category	Channels
Item	Vegetation & Obstructions
Downstream from Avenue 20. Orundo present in channel and on both banks.	
phillips_20090903_53.jpg

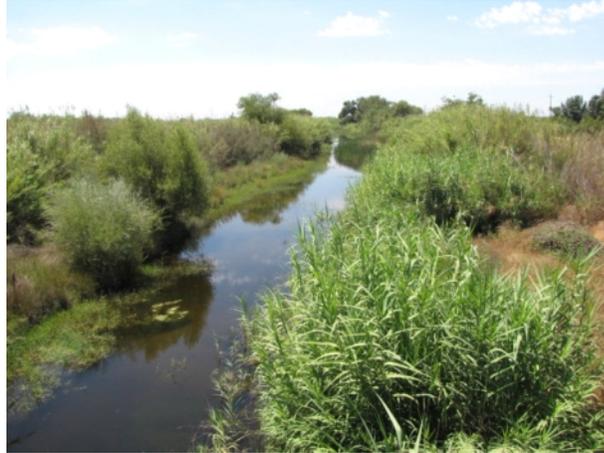
Levee Mile Report Line	59
Start Levee Mile	0.00
End Levee Mile	0.00
Location	
Category	Channels
Item	Vegetation & Obstructions
Upstream from Avenue 18 1/2. Bambo and small trees in channel.	
phillips_20090901_41.jpg

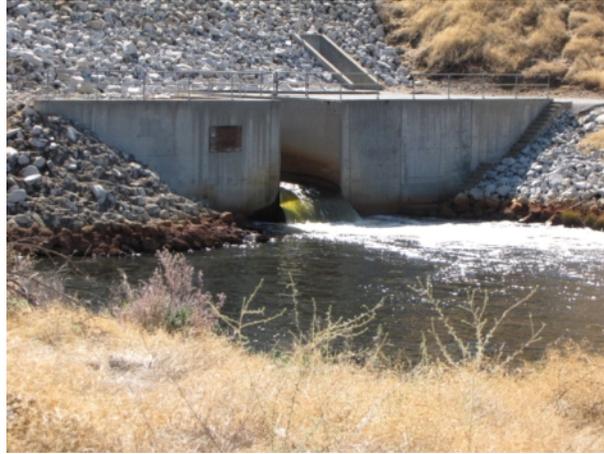
Levee Mile Report Line	1
Start Levee Mile	0.00
End Levee Mile	0.00
Location	
Category	Channels
Item	Vegetation & Obstructions
Downstream at Buchanan Dam.	
phillips_20090824_1.jpg

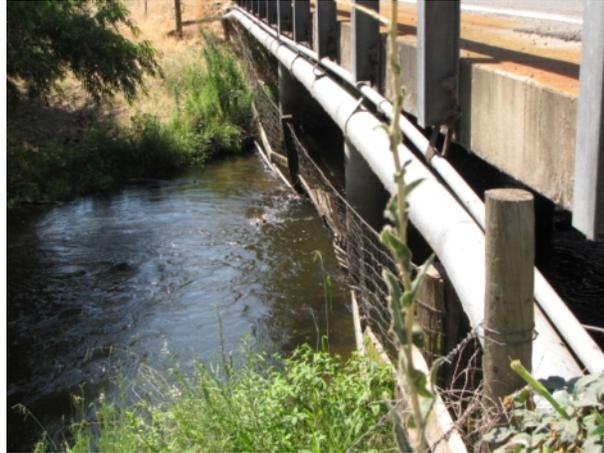
Levee Mile Report Line	12
Start Levee Mile	0.00
End Levee Mile	0.00
Location	
Category	Channels
Item	Shoaling / Sedimentation
Upstream of bridge at Santa Fe Drive there is a fence stretched across the channel.	
phillips_20090824_4.jpg

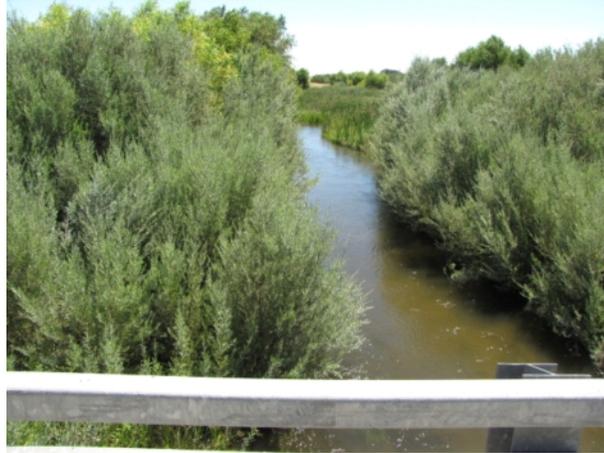
Levee Mile Report Line	26
Start Levee Mile	0.00
End Levee Mile	0.00
Location	
Category	Channels
Item	Vegetation & Obstructions
This photo shws the wild growth within channel.	
phillips_20090824_7.jpg

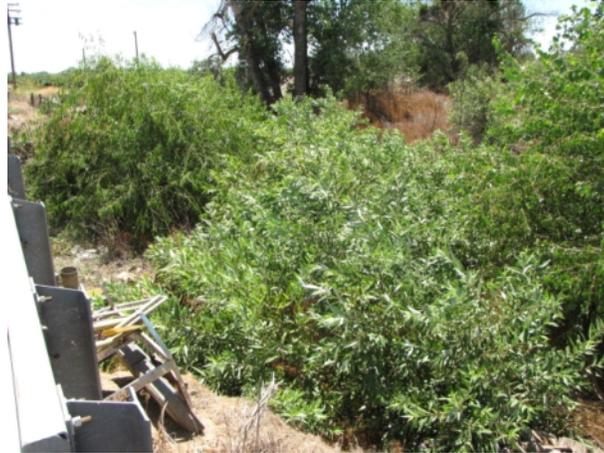
Levee Mile Report Line	35
Start Levee Mile	0.00
End Levee Mile	0.00
Location	
Category	Channels
Item	Encroachments
Garbage dumped upstream amd downstream of this bridge.	
phillips_20090824_9.jpg

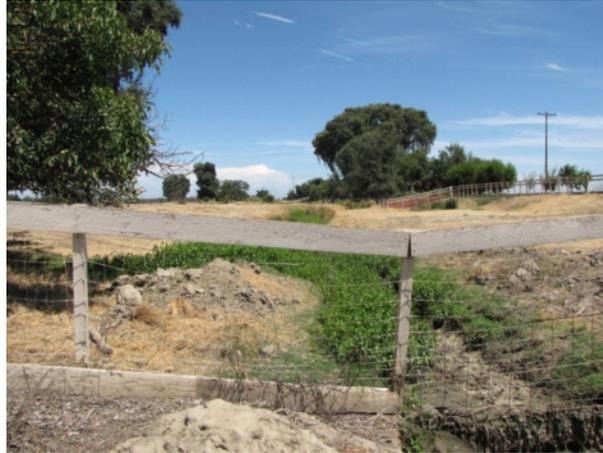
Levee Mile Report Line	45
Start Levee Mile	0.00
End Levee Mile	0.00
Location	
Category	Channels
Item	Encroachments
Upstream Road 11 Fencing across the channel.	
phillips_20090825_17.jpg

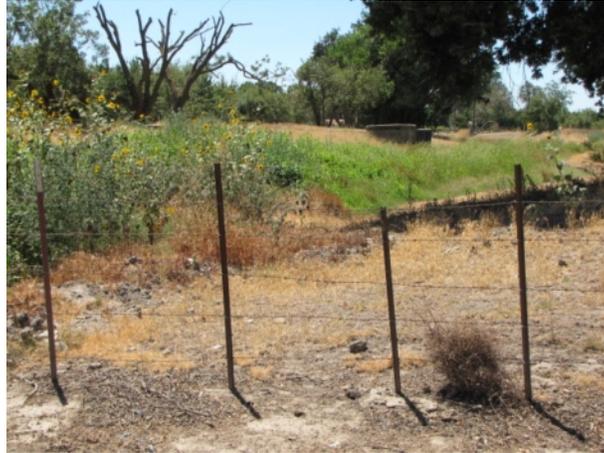
Levee Mile Report Line	55
Start Levee Mile	0.00
End Levee Mile	0.00
Location	
Category	Channels
Item	Encroachments
Downstream from Road 9 (Bliss Road). Fence in view is unauthorized.	
phillips_20090825_15.jpg

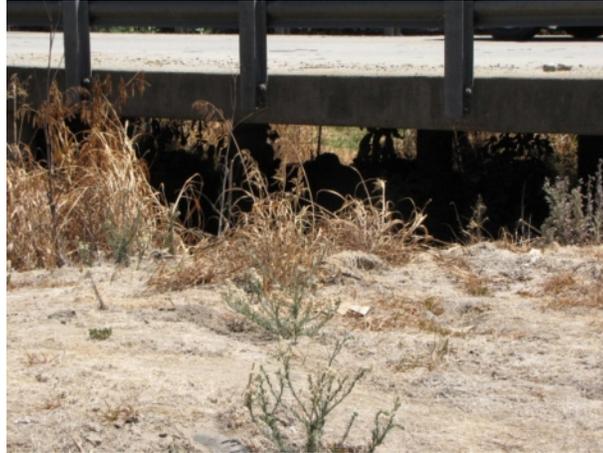
Levee Mile Report Line	65
Start Levee Mile	0.00
End Levee Mile	0.00
Location	
Category	Channels
Item	Encroachments
earthen dam pushed up against upstream side of bridge, this could restrict flow capacity.	
phillips_20090825_18.jpg

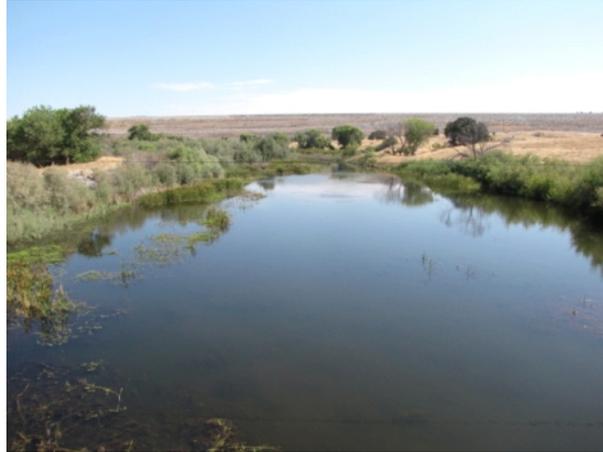
Levee Mile Report Line	1
Start Levee Mile	0.00
End Levee Mile	0.00
Location	
Category	Channels
Item	Vegetation & Obstructions
From road 603 looking upstream at Hidden Dam.	
phillips_20090826_21.jpg

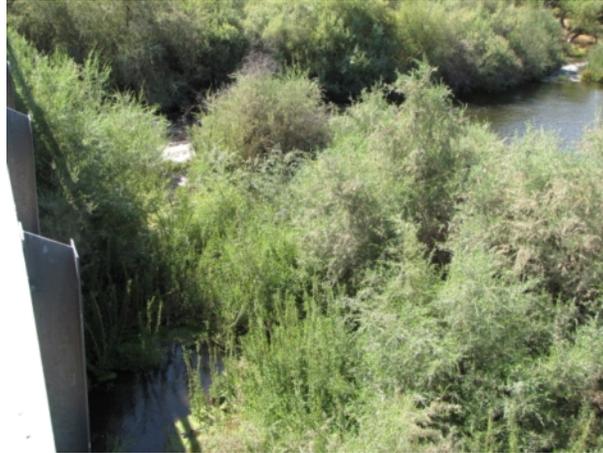
Levee Mile Report Line	16
Start Levee Mile	0.00
End Levee Mile	0.00
Location	
Category	Channels
Item	Vegetation & Obstructions
Wild growth downstream of bridge.	
phillips_20090826_24.jpg

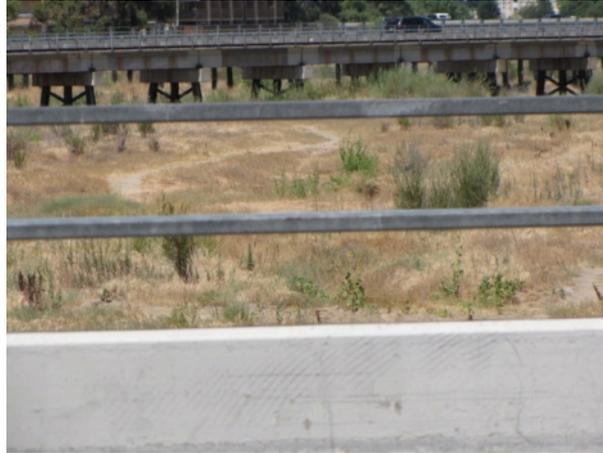
Levee Mile Report Line	36
Start Levee Mile	0.00
End Levee Mile	0.00
Location	
Category	Channels
Item	Vegetation & Obstructions
Downstream from D. street looking at the Gate way bridge.	
phillips_20090826_27.jpg

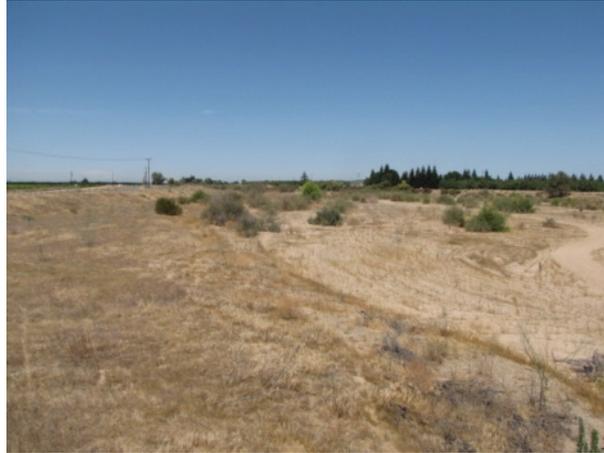
Levee Mile Report Line	51
Start Levee Mile	0.00
End Levee Mile	0.00
Location	
Category	Channels
Item	Vegetation & Obstructions
Downstream from Road 23.	
phillips_20090827_28.jpg

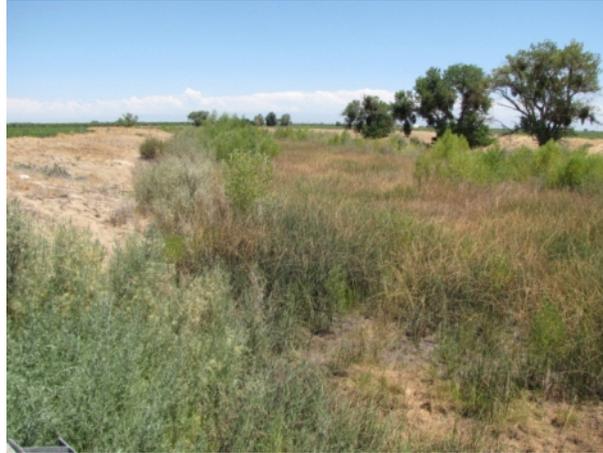
Levee Mile Report Line	76
Start Levee Mile	0.00
End Levee Mile	0.00
Location	
Category	Channels
Item	Vegetation & Obstructions
looking downstream of channel, there are small trees of willows and tulies within channel.	
phillips_20090827_33.jpg
