**Flood Control Project Maintenance
Levee Inspections**

2012 Channel Summary Report

Madera County FCWCA

**Flood Control Project Maintenance
Channel Inspections**

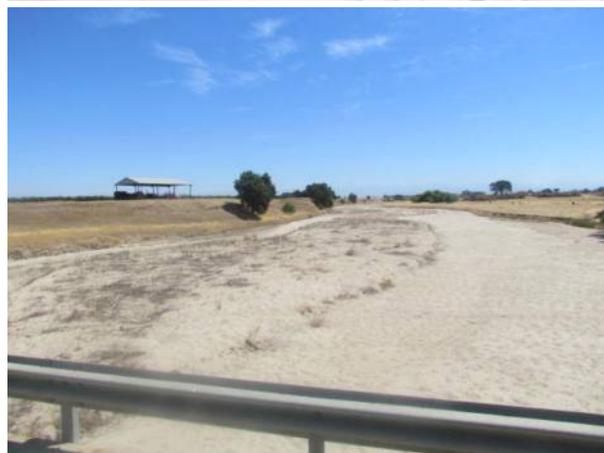
Levee Mile Report Line	11
Start Levee Mile	0.00
End Levee Mile	0.00
Location	
Category	Channels
Item	Vegetation & Obstructions
Looking east (upstream) from Santa Fe Dr. (2012 Inspection)	
richard_c_20120808_065.JPG

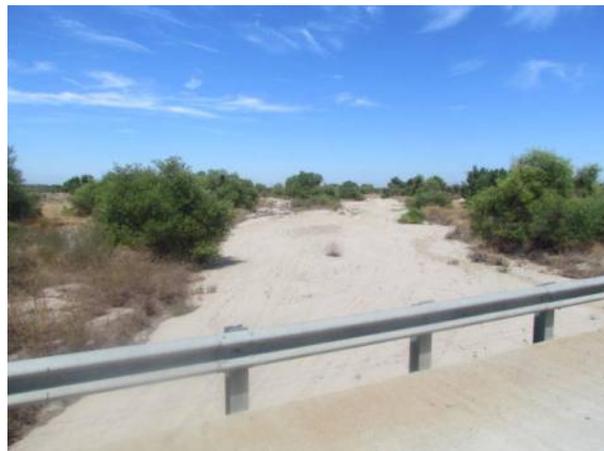
Levee Mile Report Line	26
Start Levee Mile	0.00
End Levee Mile	0.00
Location	
Category	Channels
Item	Vegetation & Obstructions
Looking west (downstream) from White Rock Rd/Road 19.(2012 Inspection)	
richard_c_20120808_068.JPG

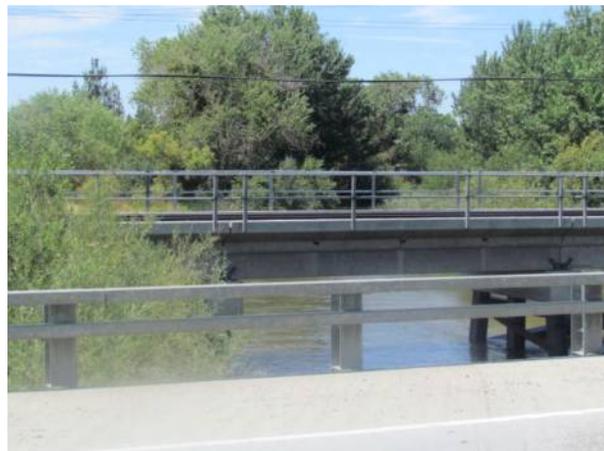
Levee Mile Report Line	35
Start Levee Mile	0.00
End Levee Mile	0.00
Location	
Category	Channels
Item	Vegetation & Obstructions
Looking west (downstream) from Road 13.	
richard_c_20120808_071.JPG

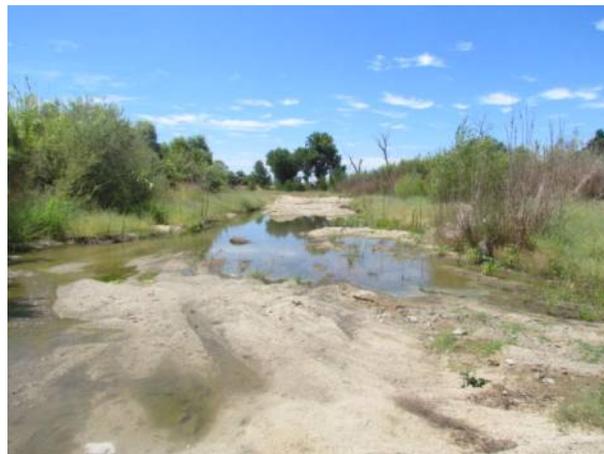
Levee Mile Report Line	55
Start Levee Mile	0.00
End Levee Mile	0.00
Location	
Category	Channels
Item	Vegetation & Obstructions
Looking west (downstream) from Road 12. (2012 Inspection)	
richard_c_20120808_074.JPG

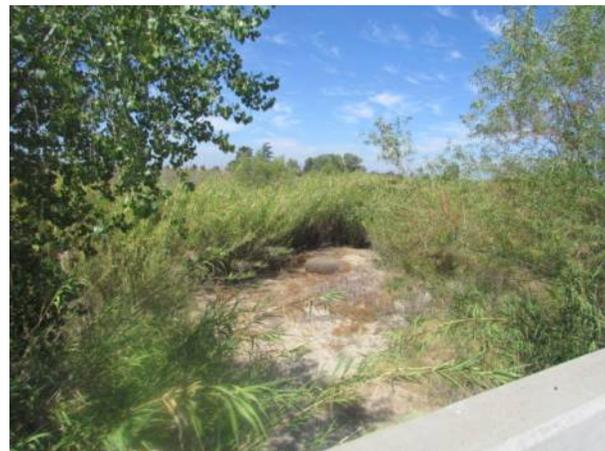
Levee Mile Report Line	70
Start Levee Mile	0.00
End Levee Mile	0.00
Location	
Category	Channels
Item	Vegetation & Obstructions
Looking east (upstream) from Hwy 152. (2012 Inspection)	
richard_c_20120808_077.JPG

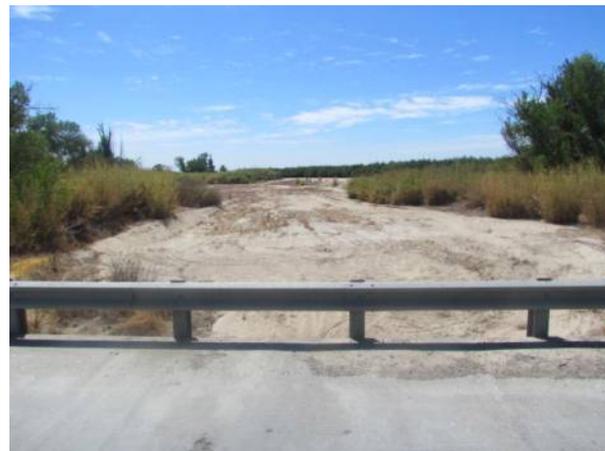
Levee Mile Report Line	85
Start Levee Mile	0.00
End Levee Mile	0.00
Location	
Category	Channels
Item	Vegetation & Obstructions
Looking west (downstream) from Road 19. (2012 Inspection)	
richard_c_20120808_080.JPG

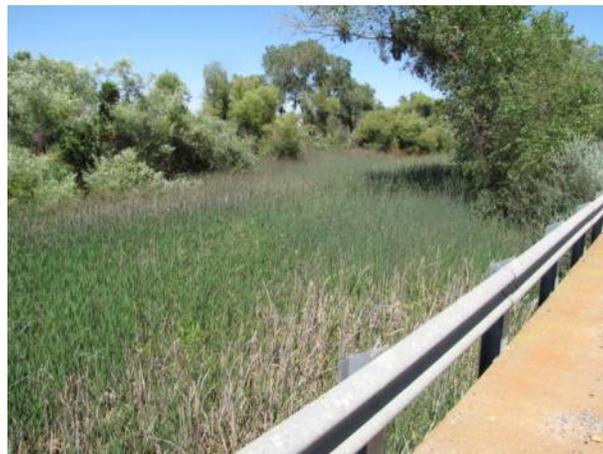
Levee Mile Report Line	11
Start Levee Mile	0.00
End Levee Mile	0.00
Location	
Category	Channels
Item	Vegetation & Obstructions
Berenda Slough looking from 26 Avenue. Channel completely overgrown with tullies and other plant growth. Photo taken 7-24-2012.	
phillips_c_20120822_145.jpg

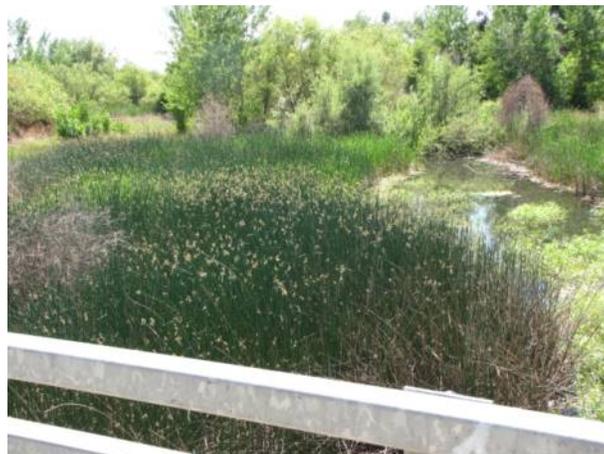
Levee Mile Report Line	26
Start Levee Mile	0.00
End Levee Mile	0.00
Location	
Category	Channels
Item	Vegetation & Obstructions
<p>Berenda Slough looking downstream from Road 19. Channel choked with tullies and other wild growth. Photo taken 7-24-2012.</p>	
<p>phillips_c_20120823_148.jpg</p>

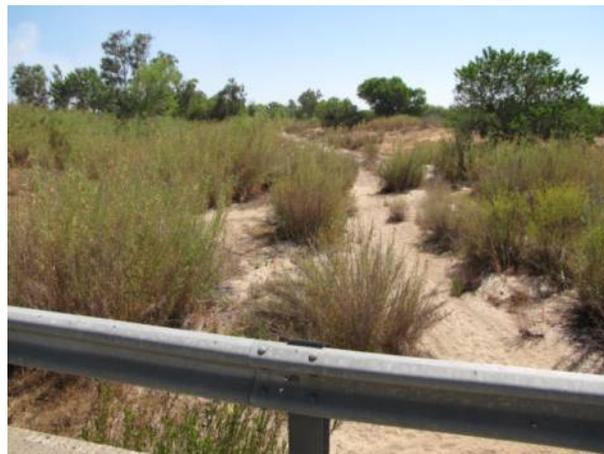
Levee Mile Report Line	41
Start Levee Mile	0.00
End Levee Mile	0.00
Location	
Category	Channels
Item	Vegetation & Obstructions
Berenda Slough looking upstream from Road 16 crossing. Photo taken 7-24-2012.	
phillips_c_20120827_151.jpg

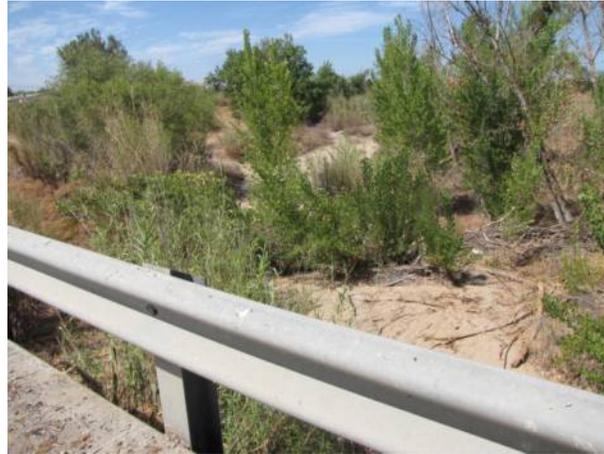
phillips_c_20120827_152.jpg

Berenda Slough downstream of Road 16 crossing. Photo taken 7-24-2012.

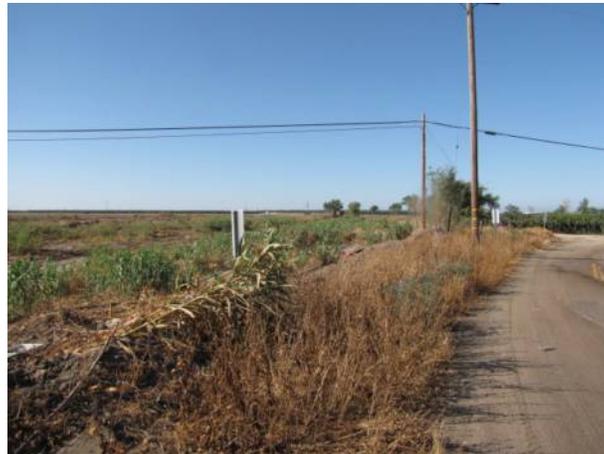
phillips_c_20120827_153.jpg

Berenda Slough viewed from Road 8 looking upstream of channel. Photo taken 7-24-2012.

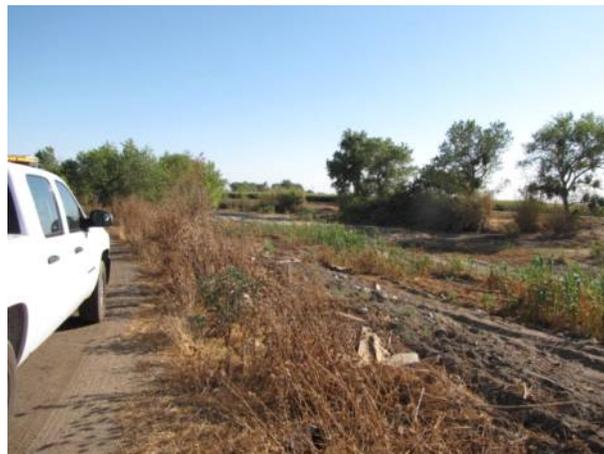
phillips_c_20120827_154.jpg

Berenda Slough looking downstream from a point off Road 8. Photo taken 7-24-2012.

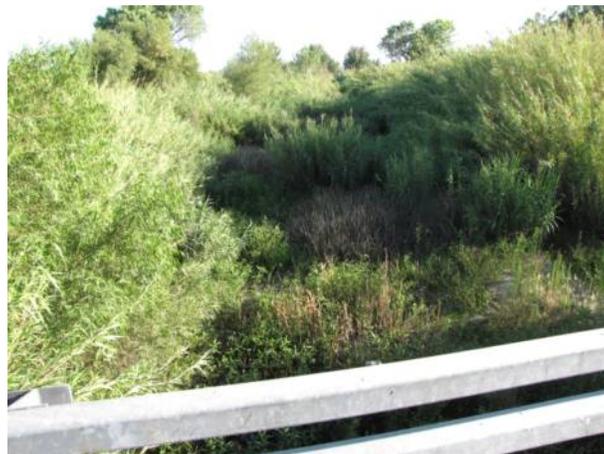
Levee Mile Report Line	71
Start Levee Mile	0.00
End Levee Mile	0.00
Location	
Category	Channels
Item	Vegetation & Obstructions
Berenda Slough looking upstream from Ave. 20. Photo taken 7-24-2012.	
phillips_c_20120827_157.jpg

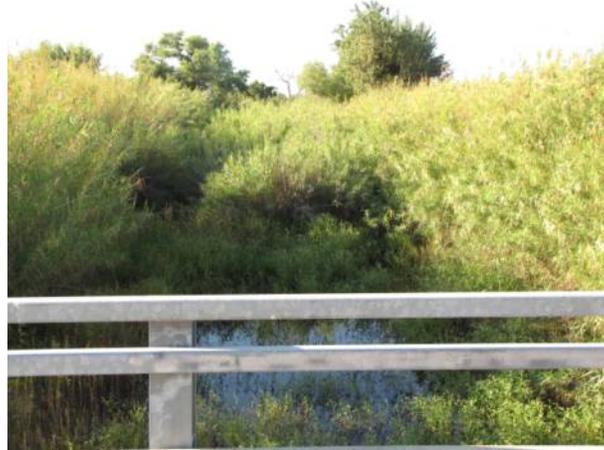
phillips_c_20120827_158.jpg

Berenda Slough looking downstream from Ave. 20 channel completely overgrown. Photo taken 7-24-2012.

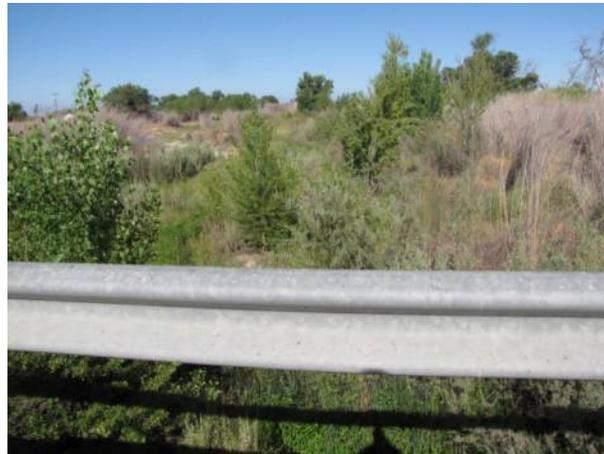
phillips_c_20120827_159.jpg

Berenda Slough looking upstream from Road 13. Channel overgrown. Photo taken 7-24-2012.

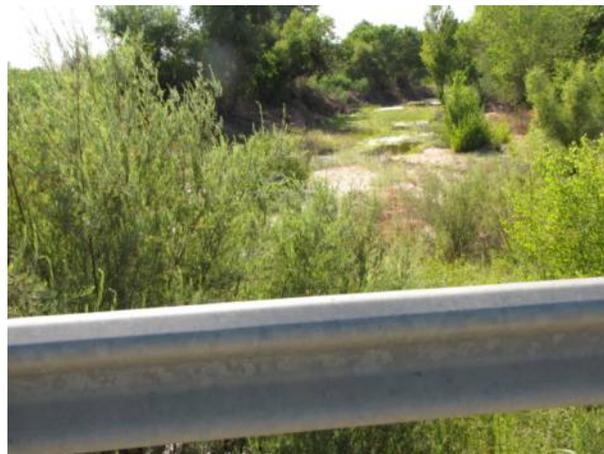
phillips_c_20120827_160.jpg

Berenda Slough looking downstream from Road 13. Photo taken 7-24-2012.

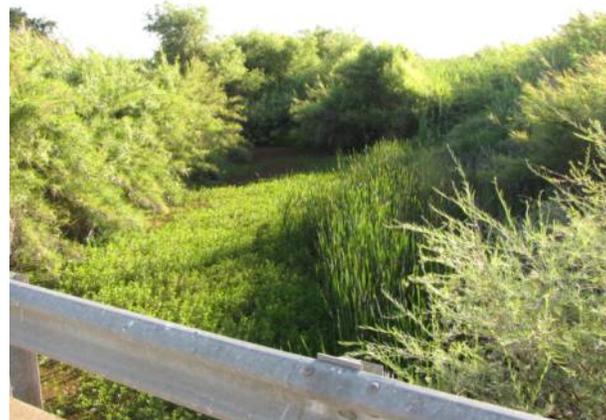
Levee Mile Report Line	96
Start Levee Mile	0.00
End Levee Mile	0.00
Location	
Category	Channels
Item	Vegetation & Obstructions
Berenda slough looking downstream from Road 14.	
phillips_c_20120827_161.jpg

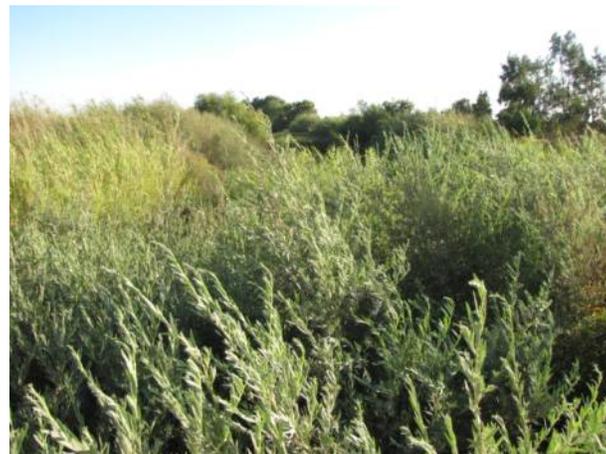
Levee Mile Report Line	101
Start Levee Mile	0.00
End Levee Mile	0.00
Location	
Category	Channels
Item	Vegetation & Obstructions
Berenda Slough looking upstream from Ave 18 1/2. Photo taken 7-24-2012.	
phillips_c_20120827_163.jpg

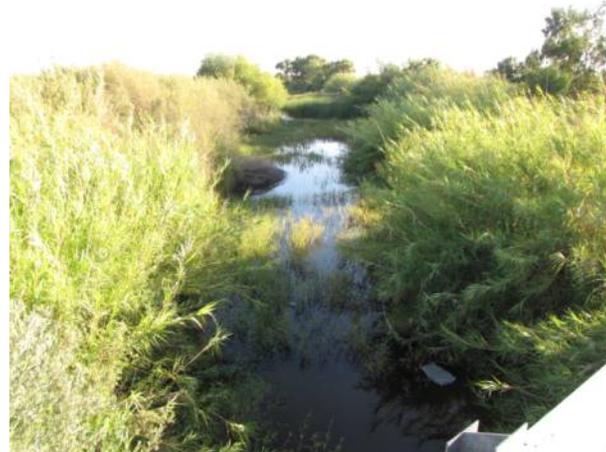
Levee Mile Report Line	105
Start Levee Mile	0.00
End Levee Mile	0.00
Location	
Category	Channels
Item	Vegetation & Obstructions
Berenda Slough Looking downstream from Ave 18 1/2. Photo taken 7-24-2012.	
phillips_c_20120827_164.jpg

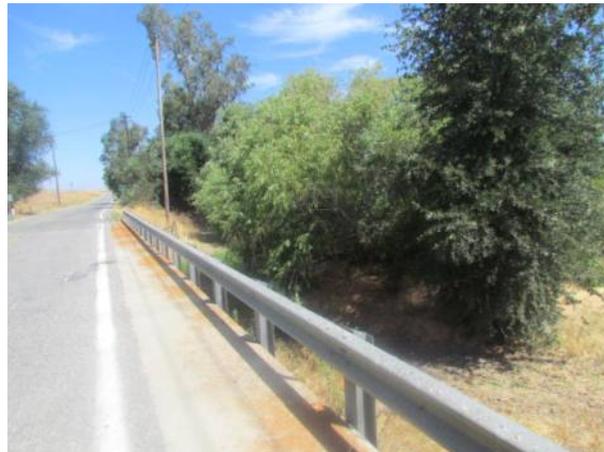
Levee Mile Report Line	11
Start Levee Mile	
End Levee Mile	
Location	
Category	Channels
Item	Vegetation & Obstructions
Looking northeast (upstream) from Santa Fe Dr.	
richard_c_20120806_044.JPG

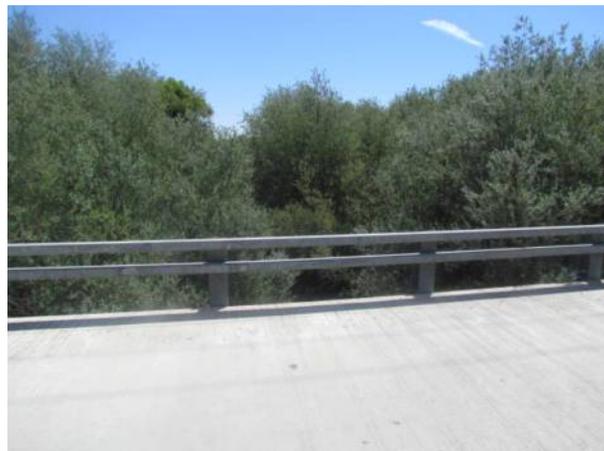
Levee Mile Report Line	21
Start Levee Mile	
End Levee Mile	
Location	
Category	Channels
Item	Vegetation & Obstructions
Looking east (upstream) from White Rock Rd/Road 19.	
richard_c_20120806_047.JPG

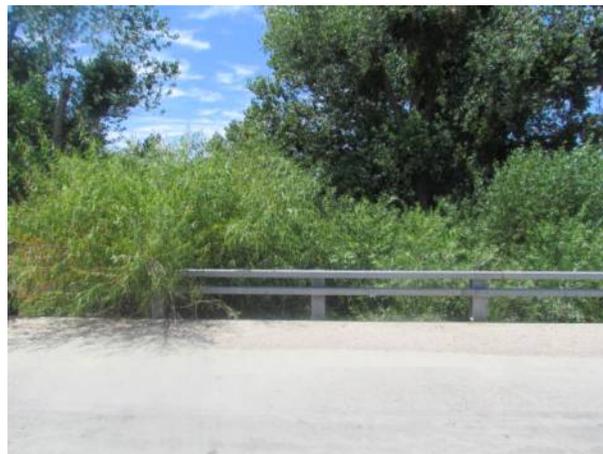
Levee Mile Report Line	36
Start Levee Mile	
End Levee Mile	
Location	
Category	Channels
Item	Vegetation & Obstructions
Looking west (downstream) from Road 13 1/2 Vista Ave.	
richard_c_20120806_050.JPG

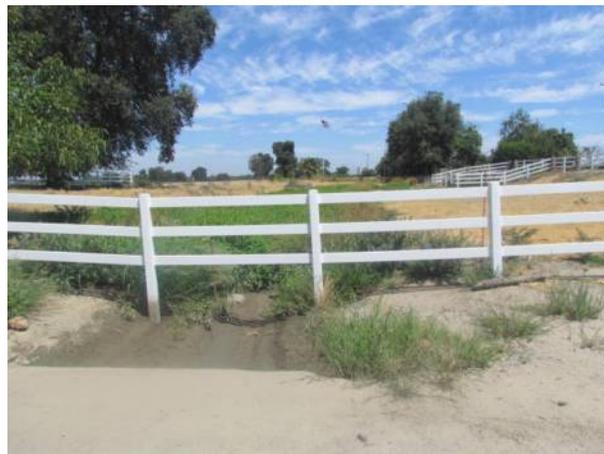
Levee Mile Report Line	51
Start Levee Mile	
End Levee Mile	
Location	
Category	Channels
Item	Vegetation & Obstructions
Looking east (upstream) from Low-water crossing at Road 11	
richard_c_20120806_053.JPG

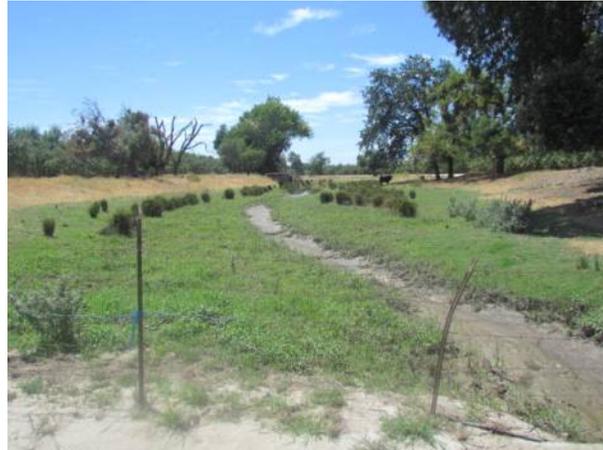
Levee Mile Report Line	56
Start Levee Mile	
End Levee Mile	
Location	
Category	Channels
Item	Vegetation & Obstructions
Looking west (downstream) from Low-water crossing at Road 11	
richard_c_20120806_054.JPG

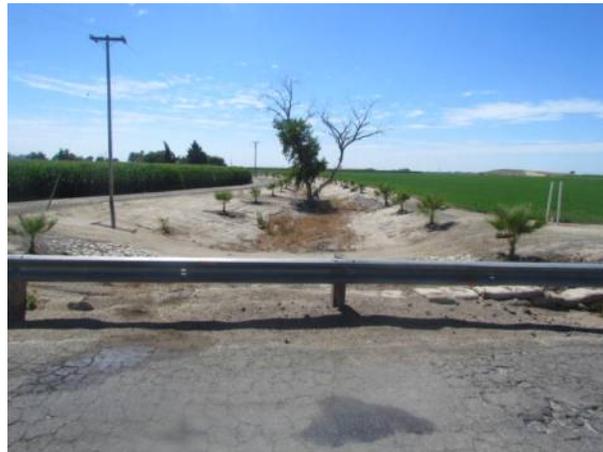
Levee Mile Report Line	70
Start Levee Mile	
End Levee Mile	
Location	
Category	Channels
Item	Encroachments
Looking downstream at palm trees planted in channel.	
richard_c_20120827_062.JPG

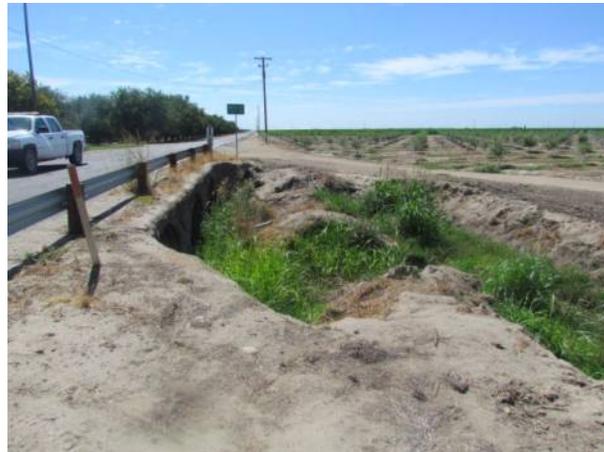
Levee Mile Report Line	72
Start Levee Mile	
End Levee Mile	
Location	
Category	Channels
Item	Shoaling / Sedimentation
Looking northwest at sedimentation in channel upstream of Washington Rd.	
richard_c_20120806_058.JPG

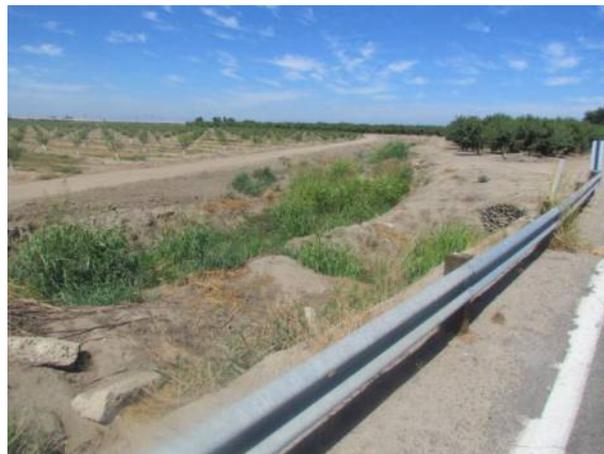
Levee Mile Report Line	76
Start Levee Mile	
End Levee Mile	
Location	
Category	Channels
Item	Vegetation & Obstructions
Looking west (downstream) of Washington Rd/Avenue 25	
richard_c_20120806_059.JPG

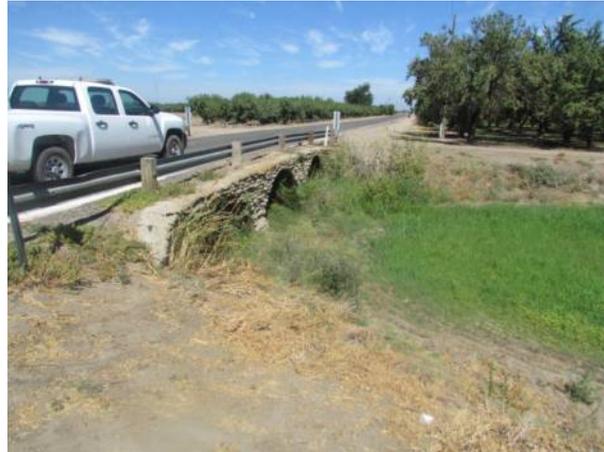
Levee Mile Report Line	77
Start Levee Mile	
End Levee Mile	
Location	
Category	Channels
Item	Shoaling / Sedimentation
Looking southeast at sedimentation in channel downstream of Washington Rd/Avenue 25	
richard_c_20120806_060.JPG

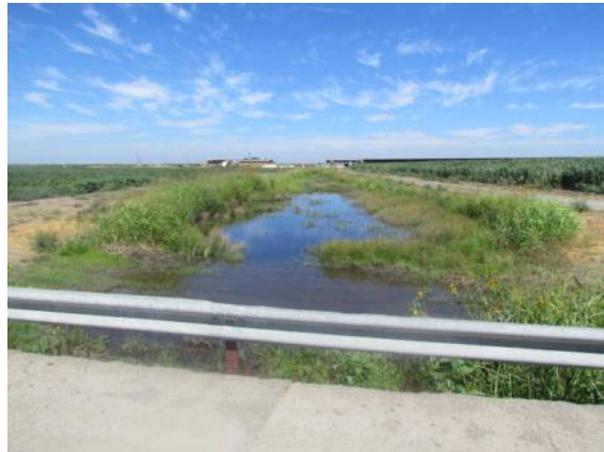
Levee Mile Report Line	81
Start Levee Mile	
End Levee Mile	
Location	
Category	Channels
Item	Vegetation & Obstructions
Looking east (upstream) from Shultz Rd/Road 5 1/2	
richard_c_20120806_055.JPG

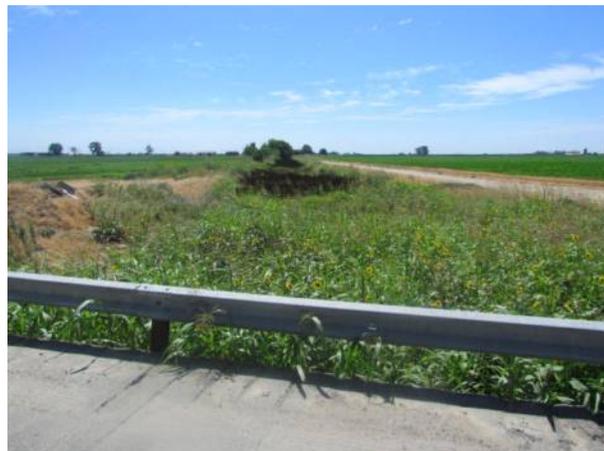
Levee Mile Report Line	86
Start Levee Mile	
End Levee Mile	
Location	
Category	Channels
Item	Vegetation & Obstructions
Looking (west) downstream from Shultz Rd/Road 5 1/2	
richard_c_20120806_056.JPG

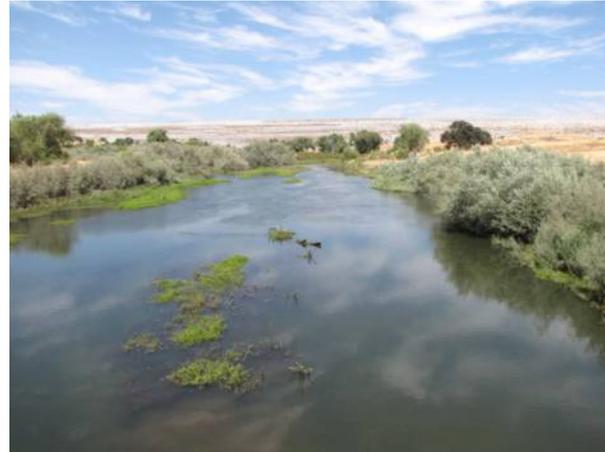
Levee Mile Report Line	1
Start Levee Mile	0.00
End Levee Mile	0.00
Location	
Category	Channels
Item	Vegetation & Obstructions
Looking upstream of the Fresno River from bridge, dam in far background. Photo taken 7-24-2012.	
phillips_c_20120809_112.jpg

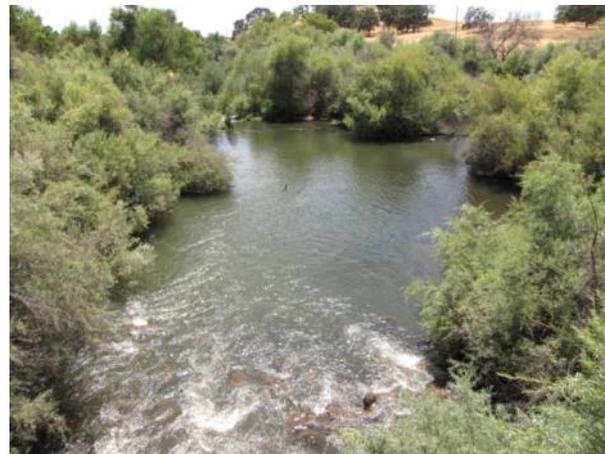
Levee Mile Report Line	6
Start Levee Mile	0.00
End Levee Mile	0.00
Location	
Category	Channels
Item	Vegetation & Obstructions
Fresno River downstream from bridge crossing. Photo taken 7-24-2012.	
phillips_c_20120809_113.jpg

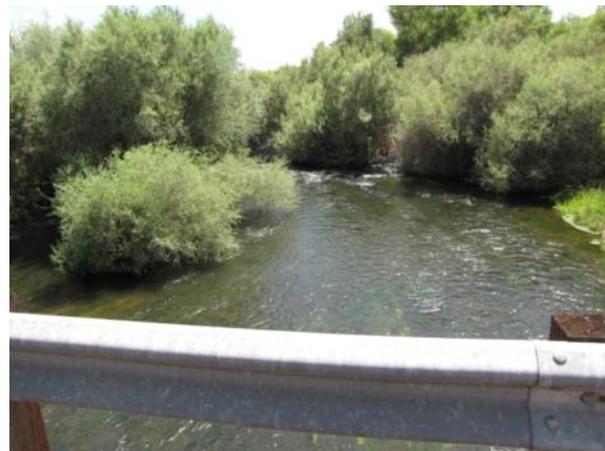
Levee Mile Report Line	16
Start Levee Mile	0.00
End Levee Mile	0.00
Location	
Category	Channels
Item	Vegetation & Obstructions
Looking downstream from timber bridge. Photo taken 7-24-2012.	
phillips_c_20120813_114.jpg

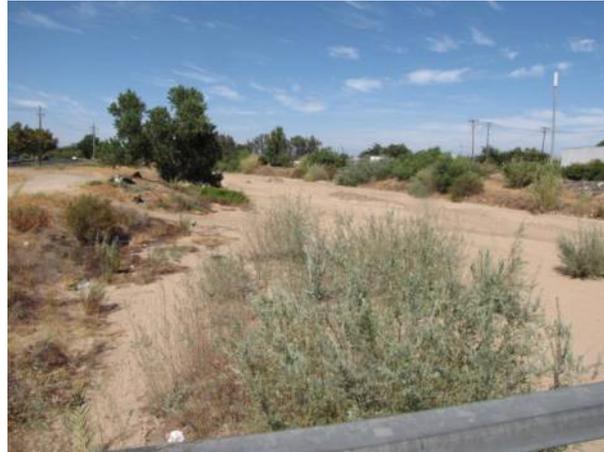
Levee Mile Report Line	21
Start Levee Mile	0.00
End Levee Mile	0.00
Location	
Category	Channels
Item	Vegetation & Obstructions
Fresno River looking upstream from Cleveland Ave. crossing. Photo taken 7-24-2012.	
phillips_c_20120815_115.jpg

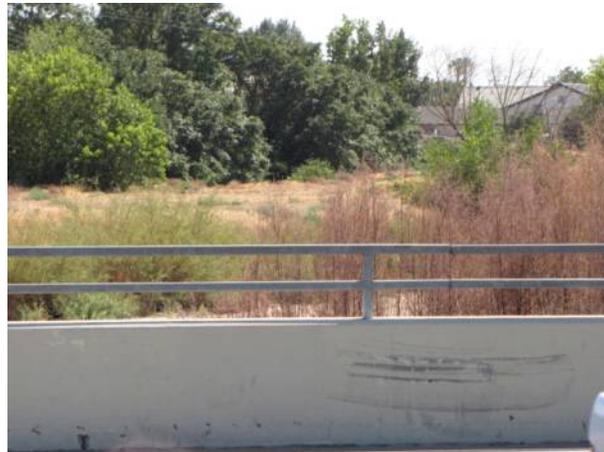
Levee Mile Report Line	26
Start Levee Mile	0.00
End Levee Mile	0.00
Location	
Category	Channels
Item	Vegetation & Obstructions
Fresno River from Cleveland Ave. bridge crossing looking downstream vegetation in channel. Photo taken 7-24-2012.	
phillips_c_20120815_117.jpg

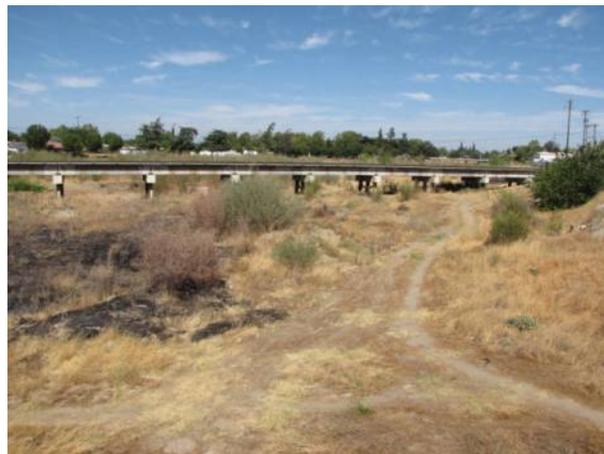
Levee Mile Report Line	31
Start Levee Mile	0.00
End Levee Mile	0.00
Location	
Category	Channels
Item	Vegetation & Obstructions
Fresno River from Gateway crossing looking upstream. Photo taken 7-24-2012.	
phillips_c_20120815_118.jpg

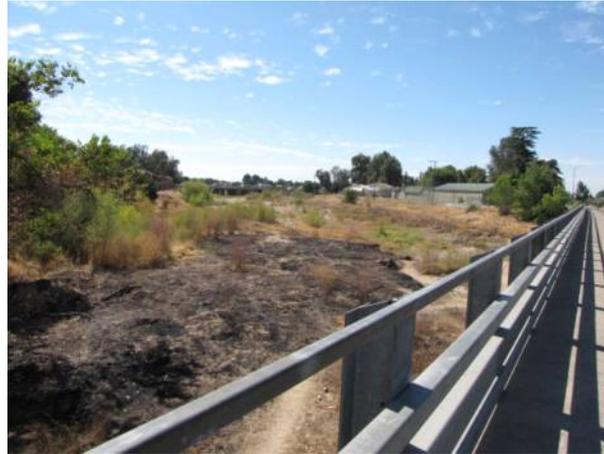
phillips_c_20120815_119.jpg

Fresno River from Gateway Bridge crossing looking downstream. Photo taken 7-24-2012.

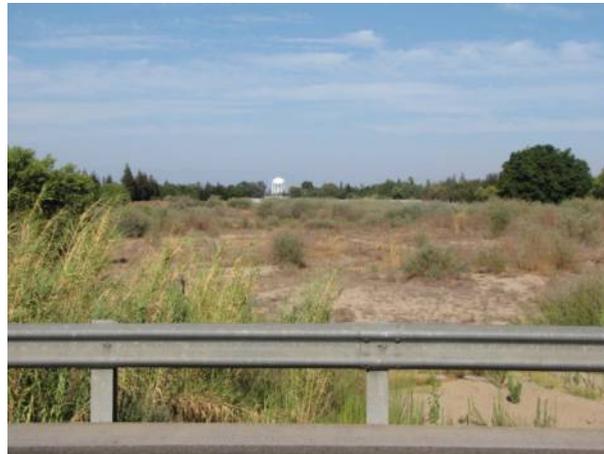
phillips_c_20120815_120.jpg

Fresno River from Granada Avenue crossing looking upstream. Photo taken 7-25-2012.

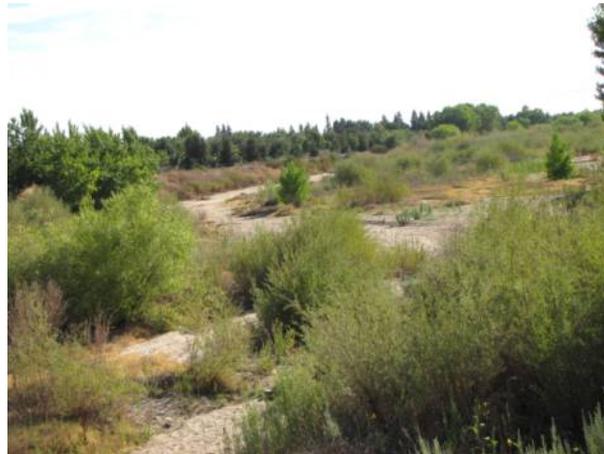
phillips_c_20120815_121.jpg

Fresno River Looking downstream from Granada Ave. bridge crossing. Photo taken 7-25-2012.

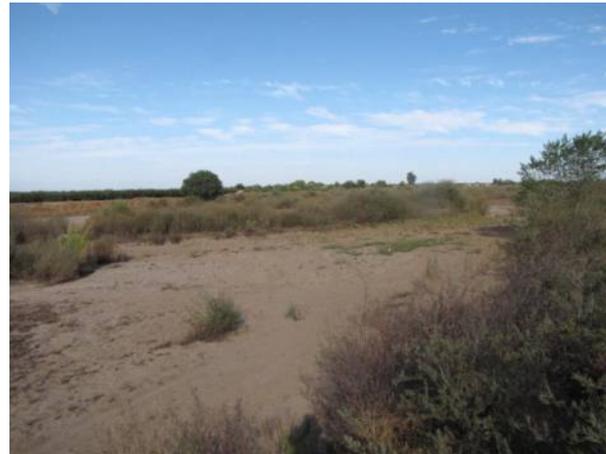
Levee Mile Report Line	51
Start Levee Mile	0.00
End Levee Mile	0.00
Location	
Category	Channels
Item	Vegetation & Obstructions
Fresno River crossing from Road 23 crossing looking upstream. Photo taken 7-25-2012.	
phillips_c_20120815_122.jpg

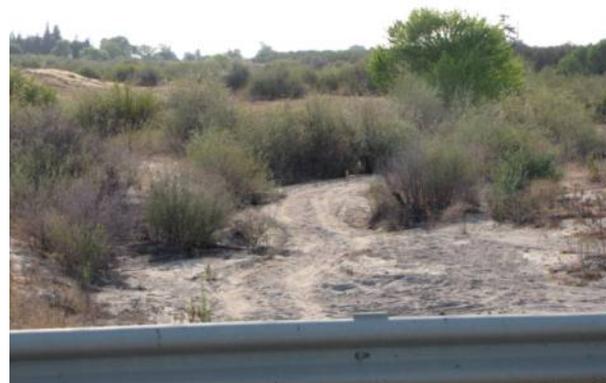
Levee Mile Report Line	56
Start Levee Mile	0.00
End Levee Mile	0.00
Location	
Category	Channels
Item	Vegetation & Obstructions
Fresno River looking downstream from Road 23 crossing. Photo taken 7-25-2012.	
phillips_c_20120815_123.jpg

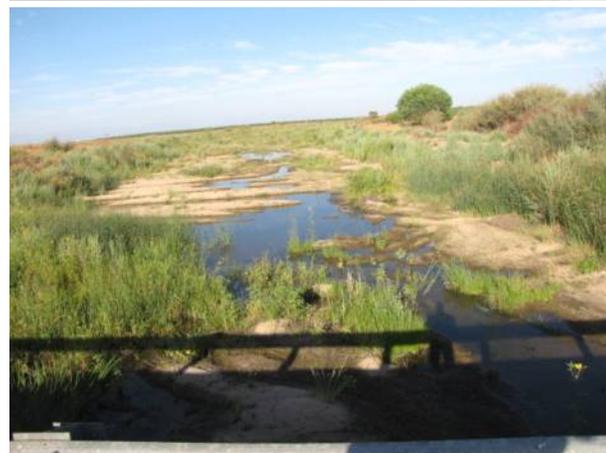
Levee Mile Report Line	61
Start Levee Mile	0.00
End Levee Mile	0.00
Location	
Category	Channels
Item	Vegetation & Obstructions
Fresno River looking upstream from Road 20. Photo taken 7-25-2012.	
phillips_c_20120815_125.jpg

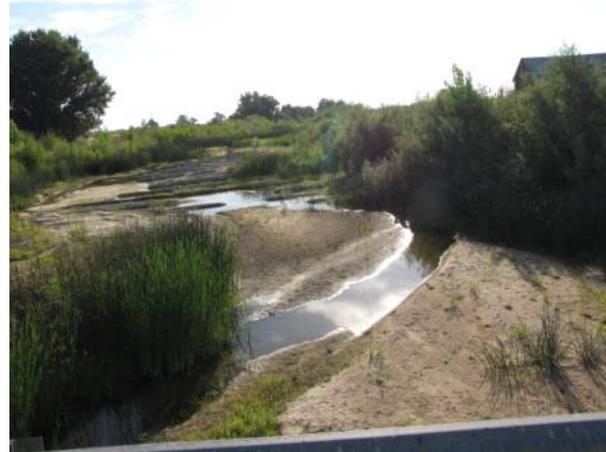
Levee Mile Report Line	66
Start Levee Mile	0.00
End Levee Mile	0.00
Location	
Category	Channels
Item	Vegetation & Obstructions
Fresno River looking downstream from Road 20. Photo taken 7-25-2012.	
phillips_c_20120815_124.jpg

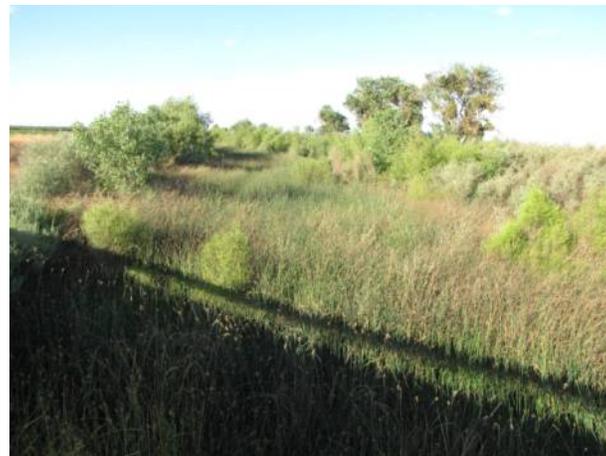
Levee Mile Report Line	71
Start Levee Mile	0.00
End Levee Mile	0.00
Location	
Category	Channels
Item	Vegetation & Obstructions
Fresno River looking upstream from Road 19 D/S Limits. Photo taken 7-26-2012.	
phillips_c_20120815_126.jpg

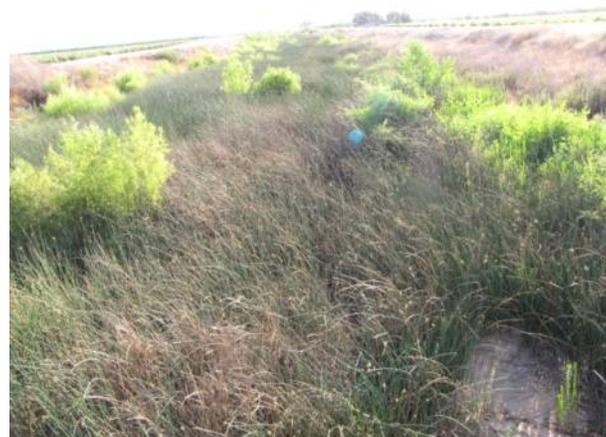
Levee Mile Report Line	75
Start Levee Mile	0.00
End Levee Mile	0.00
Location	
Category	Channels
Item	Vegetation & Obstructions
Fresno River Looking downstream from Road 19 D/S Limits. Photo taken 7-26-2012.	
phillips_c_20120815_127.jpg

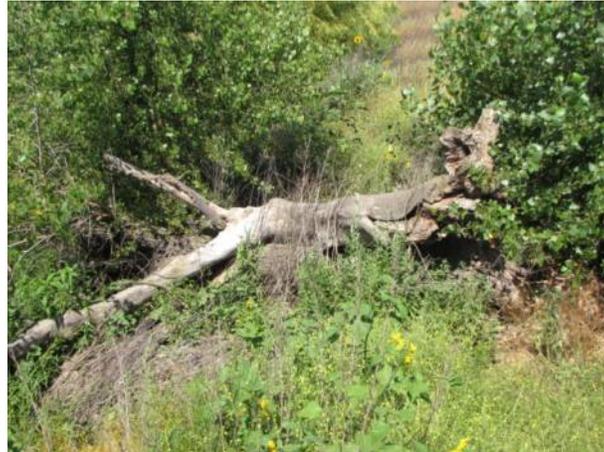
Levee Mile Report Line	79
Start Levee Mile	0.00
End Levee Mile	0.00
Location	
Category	Channels
Item	Encroachments
This dead tree is located at the bridge in channel.	
phillips_c_20120611_041.jpg
