**Flood Control Project Maintenance  
Levee Inspections**

**2015 Channel Summary Report**

**Madera County FCWCA**

**2015 Channel Inspection Results**

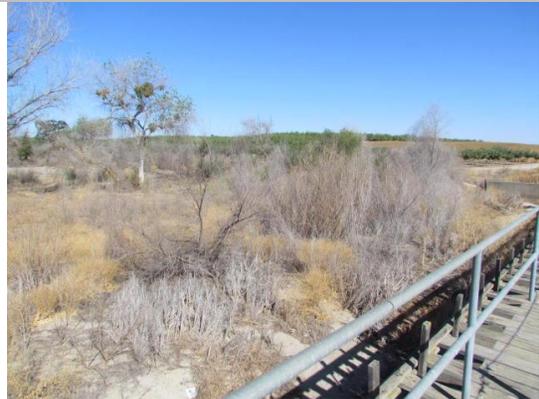
Photo 1 of 1 : CH\_2015\_NA0011\_38\_91\_20150813\_00020.jpg

Check Point / View				
<b>Low Water Crossing / Down</b>				
Rating **	A	Issue No.	<b>91</b>	GPS Lat/Long
Issue Type +	Ma	Location *		37.157888 °
Category	Rivers, Channels & Designated Flood			-120.124010 °
Item	Vegetation & Obstructions			
DWR ID	DWR_NA0011_38_c_2012_91			
Action/Comments				
Inspector Comments: No vegetation or obstruction present to impede flow.

Looking west (downstream) at channel from low water crossing.

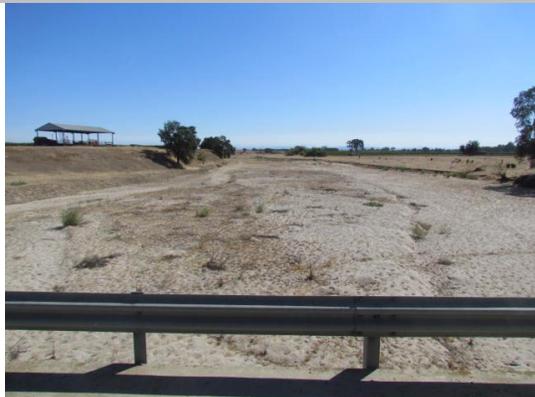
Photo 1 of 1 : CH\_2015\_NA0011\_38\_11\_20150813\_00021.jpg

Check Point / View			
<b>Santa Fe Dr / Up</b>			
Rating **	A	Issue No.	11
Issue Type +	Ma	Location *	GPS Lat/Long
Category	Rivers, Channels & Designated Flood		37.146700 °
Item	Vegetation & Obstructions		-120.164240 °
DWR ID	DWR_NA0011_38_c_2012_11		
Action/Comments			
Inspector Comments: No vegetation or obstructions present to impede flow.

Looking east (upstream) at channel from Santa Fe Dr.

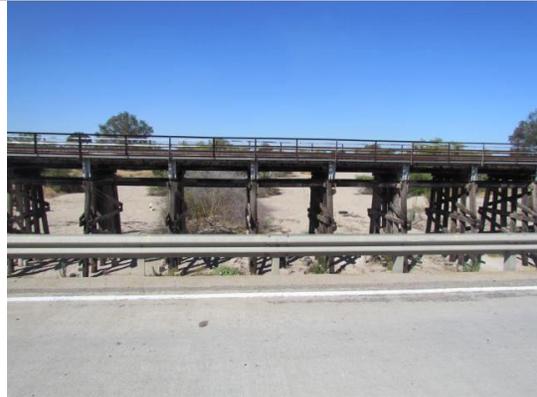
Photo 1 of 1 : CH\_2015\_NA0011\_38\_16\_20150813\_00022.jpg

Check Point / View			
<b>Santa Fe Dr / Down</b>			
Rating **	A	Issue No.	16
Issue Type +	Ma	Location *	37.146700 °
Category	Rivers, Channels & Designated Flood		-120.164240 °
Item	Vegetation & Obstructions		
DWR ID	DWR_NA0011_38_c_2012_16		
Action/Comments			
Inspector Comments: No vegetation or obstructions present to impede flow.

Looking west (downstream) at channel from Santa Fe Dr.

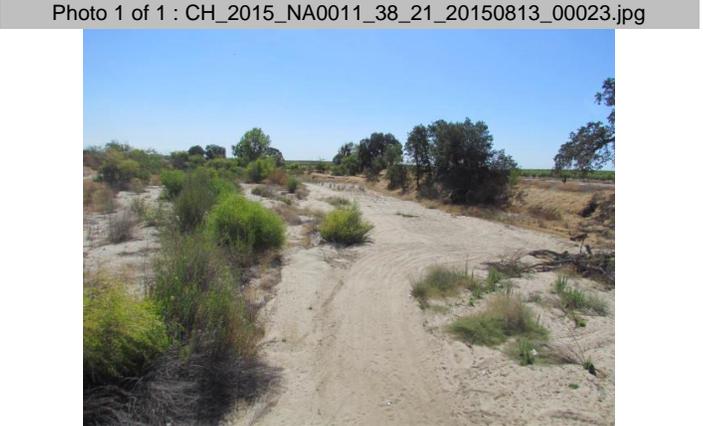
Check Point / View				
<b>Rd 19 / Up</b>				
Rating **	A	Issue No.	21	GPS Lat/Long
Issue Type +	Ma	Location *		37.138373 °
Category	Rivers, Channels & Designated Flood			-120.202057 °
Item	Vegetation & Obstructions			
DWR ID	DWR_NA0011_38_c_2012_21			
Action/Comments				
Inspector Comments: No vegetation or obstructions present to impede channel flow.

Looking east (upstream) at channel from Rd. 19.

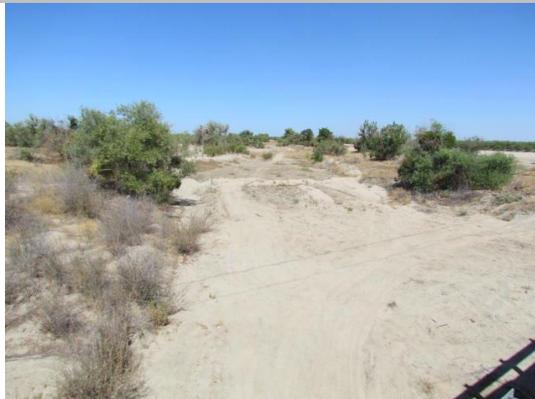
Photo 1 of 1 : CH\_2015\_NA0011\_38\_26\_20150813\_00024.jpg

Check Point / View				
<b>Rd 19 / Down</b>				
Rating **	A	Issue No.	26	GPS Lat/Long
Issue Type +	Ma	Location *		37.138373 °
Category	Rivers, Channels & Designated Flood			-120.202057 °
Item	Vegetation & Obstructions			
DWR ID	DWR_NA0011_38_c _ 2012_26			
Action/Comments				
Inspector Comments: No vegetation or obstructions present to impede channel flow.

Looking west (downstream) at channel from Rd. 19.

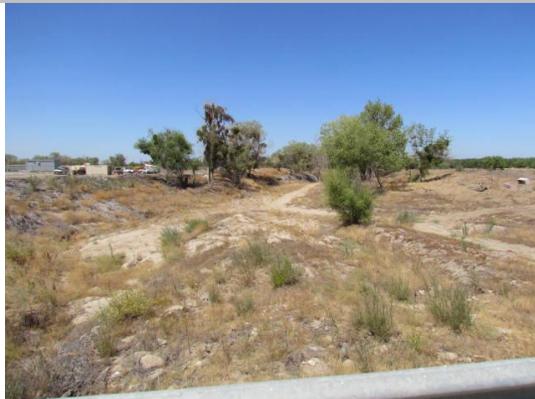
Photo 1 of 1 : CH\_2015\_NA0011\_38\_36\_20150814\_00035.jpg

Check Point / View				
<b>Rd 13 / Down</b>				
Rating **	A	Issue No.	<b>36</b>	GPS Lat/Long
Issue Type +	Ma	Location *		37.120400 °
Category	Rivers, Channels & Designated Flood			-120.310890 °
Item	Vegetation & Obstructions			
DWR ID	DWR_NA0011_38_c _ 2012_36			
Action/Comments				
Inspector Comments: Established vegetation near bridge should be controlled.

Looking downstream at channel from Rd. 13

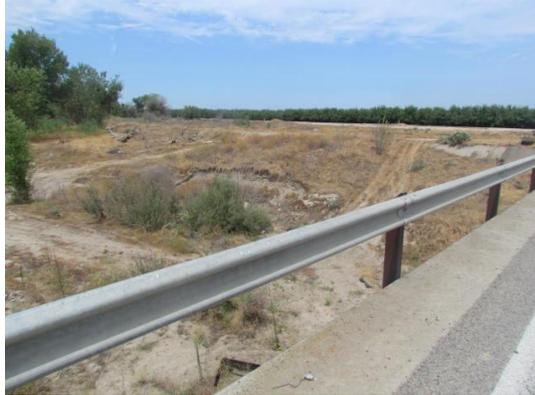
Photo 1 of 1 : CH\_2015\_NA0011\_38\_29\_20150610\_00005.jpg

Rating **	M	Issue No.	<b>29</b>	GPS Lat/Long
Issue Type +	Ob	Location *		37.120400 °
Category	Rivers, Channels & Designated Flood			-120.310890 °
Item	Erosion / Bank Caving			
DWR ID	DWR_NA0011_38_c_2012_29			
Action/Comments				
Inspector Comments: Minor erosion on right bank.

Looking southwest at small erosion in channel from Road 13.

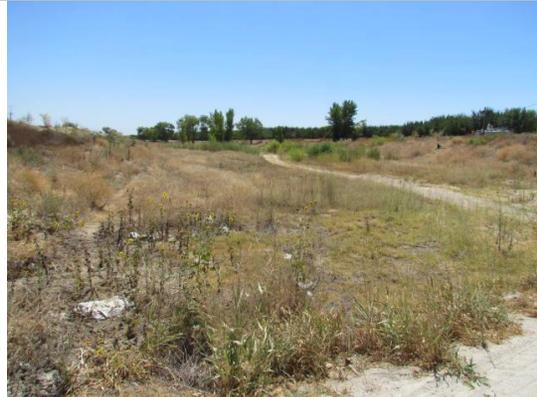
Photo 1 of 1 : CH\_2015\_NA0011\_38\_51\_20150813\_00026.jpg

Check Point / View				
<b>Rd 12 / Up</b>				
Rating **	A	Issue No.	<b>51</b>	GPS Lat/Long
Issue Type +	Ma	Location *		37.010800 °
Category	Rivers, Channels & Designated Flood			-120.328280 °
Item	Vegetation & Obstructions			
DWR ID	DWR_NA0011_38_c_2012_51			
Action/Comments				
Inspector Comments: No vegetation or obstructions present that would impede channel flow.

Looking east (upstream) at channel from Road 12.

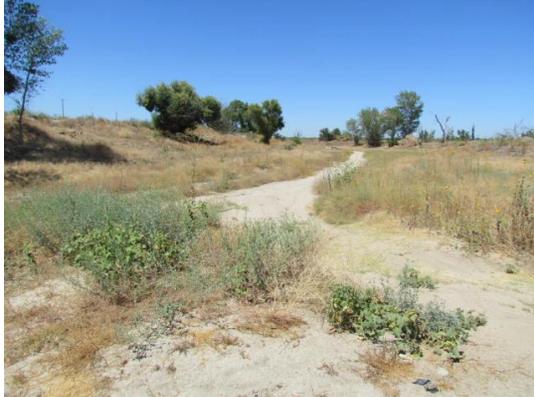
Photo 1 of 1 : CH\_2015\_NA0011\_38\_56\_20150813\_00027.jpg

Check Point / View				
<b>Rd 12 / Down</b>				
Rating **	A	Issue No.	<b>56</b>	GPS Lat/Long
Issue Type +	Ma	Location *		37.010800 °
Category	Rivers, Channels & Designated Flood			-120.328280 °
Item	Vegetation & Obstructions			
DWR ID	DWR_NA0011_38_c _ 2012_56			
Action/Comments				
Inspector Comments: No vegetation or obstruction present to impeded channel flow.

Looking west (downstream) at channel from Road 12.

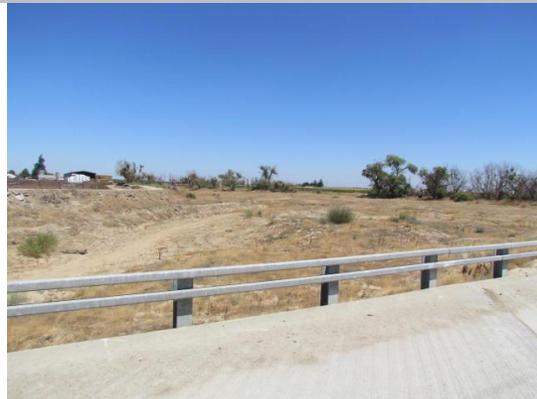
Photo 1 of 1 : CH\_2015\_NA0011\_38\_61\_20150813\_00028.jpg

Check Point / View				
<b>Ave 23 1/2 / Up</b>				
Rating **	A	Issue No.	61	GPS Lat/Long
Issue Type +	Ma	Location *		37.090920 °
Category	Rivers, Channels & Designated Flood			-120.268370 °
Item	Vegetation & Obstructions			
DWR ID	DWR_NA0011_38_c_2012_61			
Action/Comments				
Inspector Comments: No vegetation or obstruction present to impeded channel flow.

Looking east (upstream) at channel from Avenue 23 1/2.

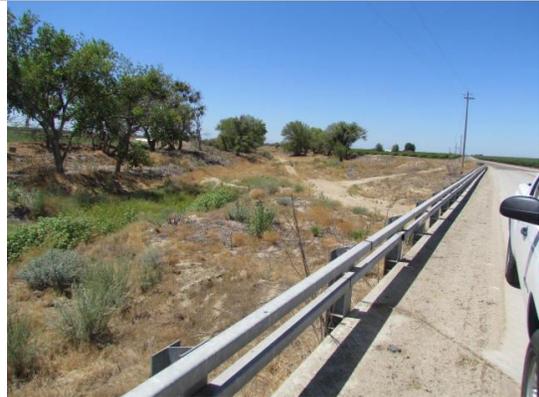
Photo 1 of 1 : CH\_2015\_NA0011\_38\_66\_20150813\_00029.jpg

Check Point / View				
<b>Ave 23 1/2 / Down</b>				
Rating **	A	Issue No.	<b>66</b>	GPS Lat/Long
Issue Type +	Ma	Location *		37.090920 °
Category	Rivers, Channels & Designated Flood			-120.268370 °
Item	Vegetation & Obstructions			
DWR ID	DWR_NA0011_38_c_2012_66			
Action/Comments				
Inspector Comments: No vegetation issues.

Looking west (downstream) at channel from Avenue 23 1/2.

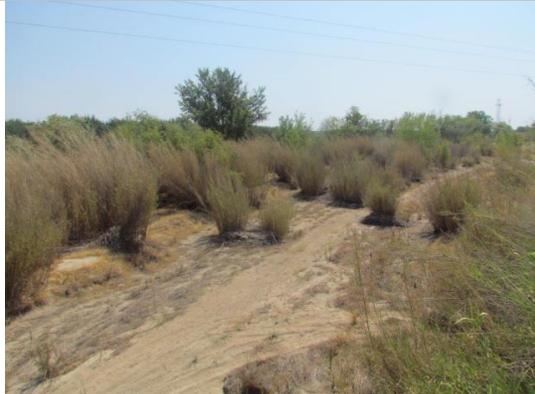
Photo 1 of 1 : CH\_2015\_NA0011\_38\_76\_20150610\_00012.jpg

Check Point / View				
<b>Hwy 152 / Down</b>				
Rating **	A	Issue No.	<b>76</b>	GPS Lat/Long
Issue Type +	Ma	Location *		37.083010 °
Category	Rivers, Channels & Designated Flood			-120.361040 °
Item	Vegetation & Obstructions			
DWR ID	DWR_NA0011_38_c_2012_76			
Action/Comments				
Inspector Comments: Bamboo near bridge should be controlled.

Looking west (downstream) at channel from Hwy 152.

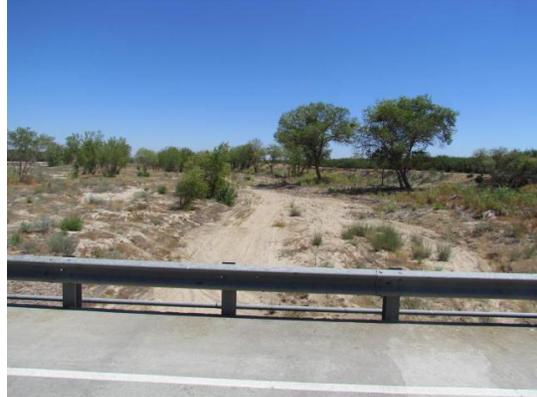
Photo 1 of 1 : CH\_2015\_NA0011\_38\_81\_20150813\_00033.jpg

Check Point / View				
<b>Rd 9 / Up</b>				
Rating **	A	Issue No.	<b>81</b>	GPS Lat/Long
Issue Type +	Ma	Location *		37.077870 °
Category	Rivers, Channels & Designated Flood			-120.382770 °
Item	Vegetation & Obstructions			
DWR ID	DWR_NA0011_38_c_2012_81			
Action/Comments				
Inspector Comments: No vegetation or obstructions present to impede channel flow.

Looking east (upstream) at channel from Road 9.

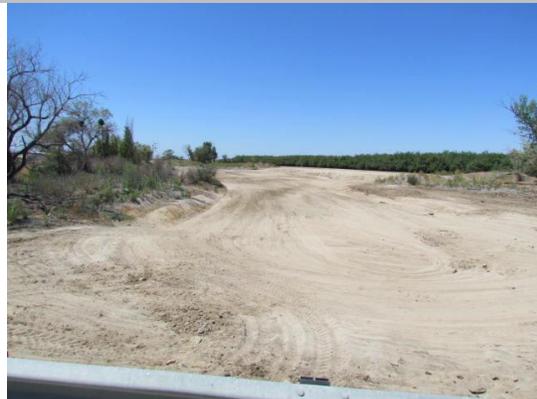
Photo 1 of 1 : CH\_2015\_NA0011\_38\_86\_20150813\_00034.jpg

Check Point / View				
<b>Rd 9 / Down</b>				
Rating **	A	Issue No.	<b>86</b>	GPS Lat/Long
Issue Type +	Ma	Location *		37.077870 °
Category	Rivers, Channels & Designated Flood			-120.382770 °
Item	Vegetation & Obstructions			
DWR ID	DWR_NA0011_38_c_2012_86			
Action/Comments				
Inspector Comments: No vegetation or obstructions present to impede channel flow.

Looking west (downstream) at channel from Road 9.

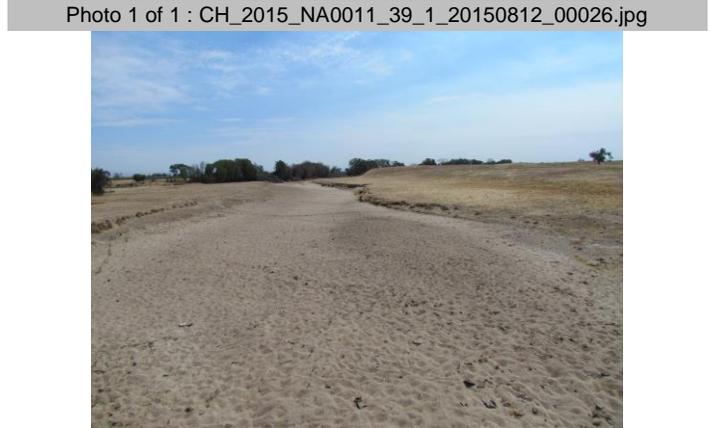
Check Point / View				
<b>Santa Fe Dr / Up</b>				
Rating **	A	Issue No.	1	GPS Lat/Long
Issue Type +	Ma	Location *		37.143420 °
Category	Rivers, Channels & Designated Flood			-120.162110 °
Item	Vegetation & Obstructions			
DWR ID	DWR_NA0011_39_c_2012_1			
Action/Comments				
Inspector Comments: No vegetation, no obstructions to channel at this location.

Berenda Slough looking upstream from Santa Fe crossing. No vegetation in channel and no water at this location.

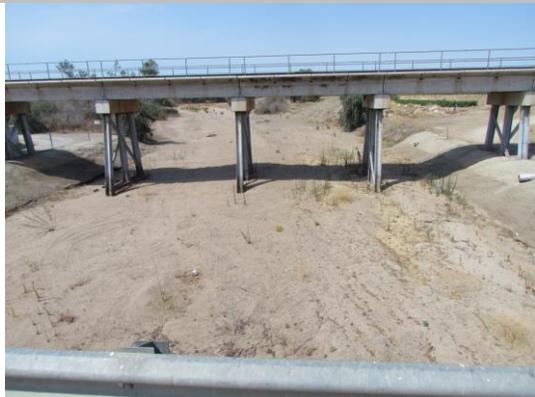
Photo 1 of 1 : CH\_2015\_NA0011\_39\_6\_20150812\_00027.jpg

Check Point / View			
<b>Santa Fe Dr / Down</b>			
Rating **	A	Issue No. <b>6</b>	GPS Lat/Long
Issue Type +	Ma	Location *	37.143420 °
Category	Rivers, Channels & Designated Flood		-120.162110 °
Item	Vegetation & Obstructions		
DWR ID	DWR_NA0011_39_c_2012_6		
Action/Comments			
Inspector Comments: Minimal, scattered obstructions or vegetation. The flow is not impeded.

Brenda slough looking downstream Santa Fe Drive. Open channel no vegetation and no water at this location.

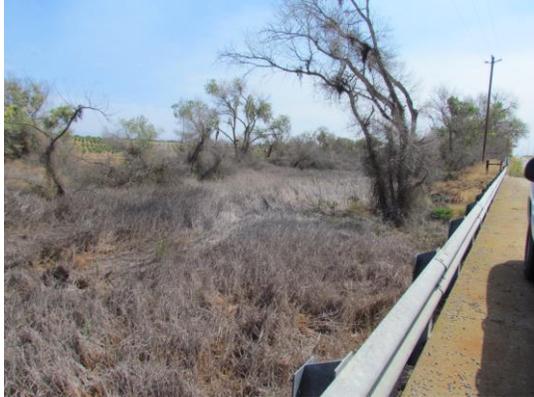
Photo 1 of 1 : CH\_2015\_NA0011\_39\_11\_20150812\_00030.jpg

Check Point / View				
<b>Ave 26 / Up</b>				
Rating **	U	Issue No.	11	GPS Lat/Long
Issue Type +	Ma	Location *		37.127300 °
Category	Rivers, Channels & Designated Flood			-120.193040 °
Item	Vegetation & Obstructions			
DWR ID	DWR_NA0011_39_c_2012_11			
Action/Comments				
Inspector Comments: Log jams, snags, vegetation growth (such as cat tails, bull rushes, bushes or saplings) or other obstructions block approximately 50% of the FCW.

Brenda Slough looking upstream from 26 Avenue, channel overgrown with cat tails.

Rating **	M	Issue No.	12	GPS Lat/Long
Issue Type +	Ma	Location *		37.127300 °
Category	Rivers, Channels & Designated Flood			-120.193040 °
Item	Shoaling / Sedimentation			
DWR ID	DWR_NA0011_39_c_2012_12			
Action/Comments				
Inspector Comments: The wild growth covering the channel need to be maintained.

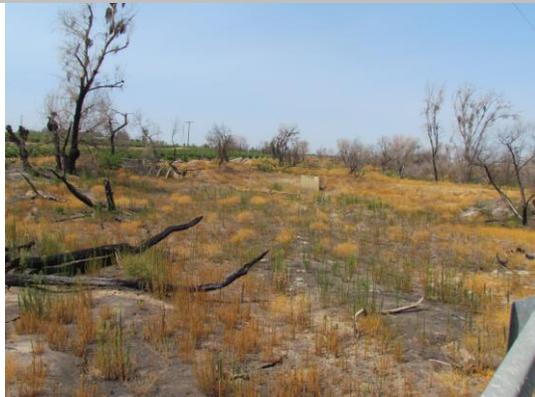
Photo 1 of 1 : CH\_2015\_NA0011\_39\_16\_20150814\_00031.jpg

Check Point / View				
<b>Ave 26 / Down</b>				
Rating **	A	Issue No.	<b>16</b>	GPS Lat/Long
Issue Type +	Ma	Location *		37.127300 °
Category	Rivers, Channels & Designated Flood			-120.193040 °
Item	Vegetation & Obstructions			
DWR ID	DWR_NA0011_39_c _ 2012_16			
Action/Comments				
Inspector Comments: The channel downstream of Avenue 26 was burned. The wild growth reported last inspection is removed.

Brenda Slough looking downstream from Avenue 26 bridge crossing.

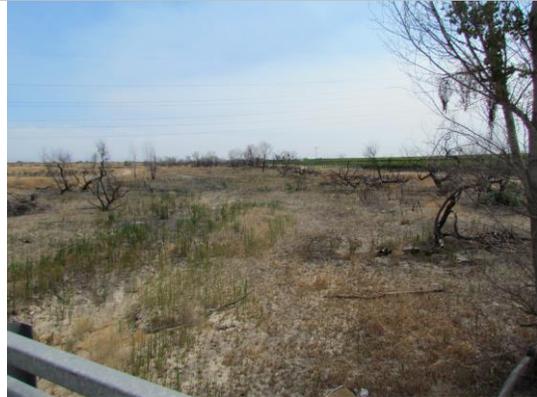
Photo 1 of 1 : CH\_2015\_NA0011\_39\_21\_20150814\_00032.jpg

Check Point / View				
<b>Rd 19 / Up</b>				
Rating **	A	Issue No.	21	GPS Lat/Long
Issue Type +	Ma	Location *		37.122250 °
Category	Rivers, Channels & Designated Flood			-120.202280 °
Item	Vegetation & Obstructions			
DWR ID	DWR_NA0011_39_c_2012_21			
Action/Comments				
Inspector Comments: There was a fire in channel that burned up the wild growth reported last inspection.

Brenda Slough looking upstream from Road 19.

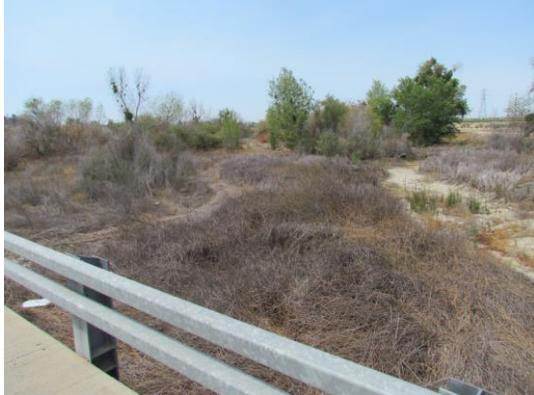
Photo 1 of 1 : CH\_2015\_NA0011\_39\_26\_20150814\_00033.jpg

Check Point / View				
<b>Rd 19 / Down</b>				
Rating **	M	Issue No.	<b>26</b>	GPS Lat/Long
Issue Type +	Ma	Location *		37.122250 °
Category	Rivers, Channels & Designated Flood			-120.202280 °
Item	Vegetation & Obstructions			
DWR ID	DWR_NA0011_39_c_2012_26			
Action/Comments				
Inspector Comments: Channel is overgrown with vegetation.

Brenda Slough looking downstream from Road 19, wild growth of tule and willow trees in channel.

Rating **	M	Issue No.	<b>27</b>	GPS Lat/Long
Issue Type +	Ma	Location *		37.122250 °
Category	Rivers, Channels & Designated Flood			-120.202280 °
Item	Shoaling / Sedimentation			
DWR ID	DWR_NA0011_39_c_2012_27			
Action/Comments				
Inspector Comments: Shoaling is well established, stabilized by trees, brush or other vegetation. Shoals are diverting flow to channel. Refer to photo of issue # 26.

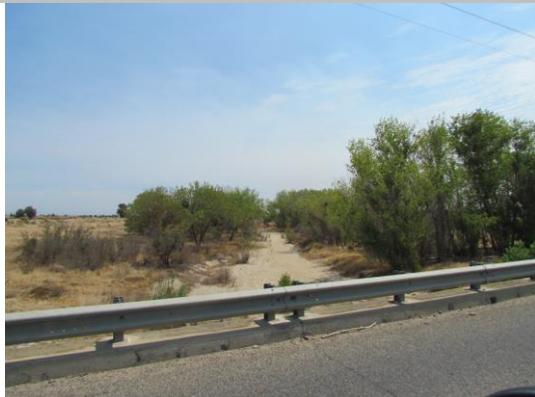
Photo 1 of 1 : CH\_2015\_NA0011\_39\_31\_20150814\_00034.jpg

Check Point / View				
<b>Chowchilla Blvd / Up</b>				
Rating **	A	Issue No.	<b>31</b>	GPS Lat/Long
Issue Type +	Ma	Location *		37.106310 °
Category	Rivers, Channels & Designated Flood			-120.234140 °
Item	Vegetation & Obstructions			
DWR ID	DWR_NA0011_39_c_2012_31			
Action/Comments				
Inspector Comments: Minimal, scattered obstructions or vegetation. The flow is not impeded.

Brenda Slough looking upstream from the Chowchilla Blvd. crossing.

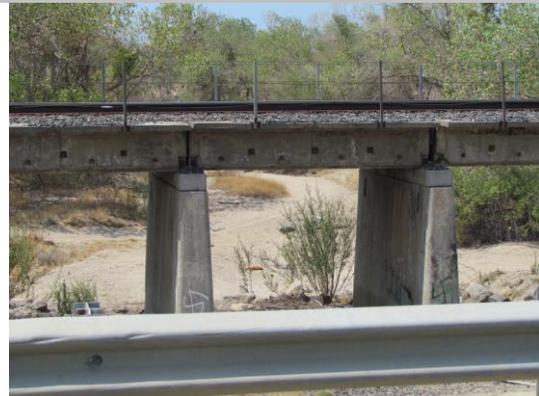
Photo 1 of 1 : CH\_2015\_NA0011\_39\_36\_20150814\_00035.jpg

Check Point / View				
<b>Chowchilla Blvd / Down</b>				
Rating **	A	Issue No.	36	GPS Lat/Long
Issue Type +	Ma	Location *		37.106310 °
Category	Rivers, Channels & Designated Flood			-120.234140 °
Item	Vegetation & Obstructions			
DWR ID	DWR_NA0011_39_c_2012_36			
Action/Comments				
Inspector Comments: No vegetation in channel.

Brenda Slough looking downstream from Chowchilla Blvd.

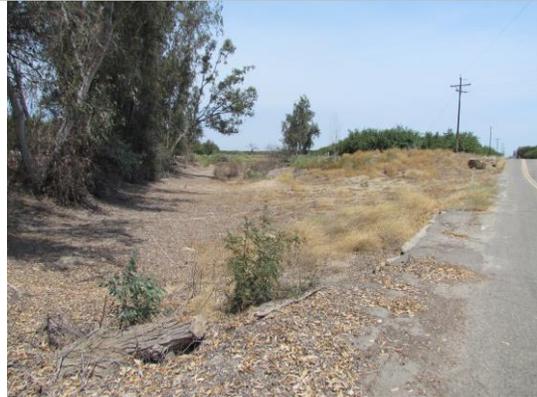
Photo 1 of 1 : CH\_2015\_NA0011\_39\_61\_20150817\_00038.jpg

Check Point / View				
<b>Ave 22 / Up</b>				
Rating **	A	Issue No.	<b>61</b>	GPS Lat/Long
Issue Type +	Ma	Location *		37.069003 °
Category	Rivers, Channels & Designated Flood			-120.278523 °
Item	Vegetation & Obstructions			
DWR ID	DWR_NA0011_39_c_2012_61			
Action/Comments				
Inspector Comments: No vegetation at this site.

Brenda Slough from Ave. 22.

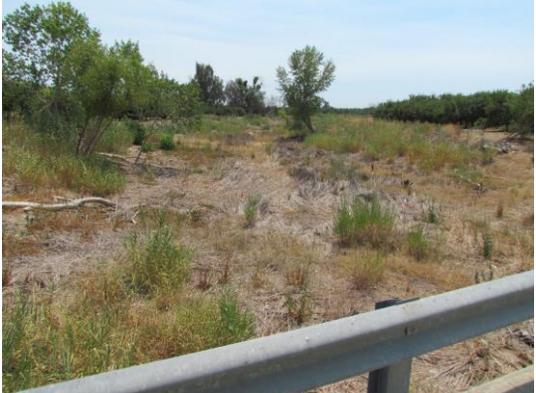
Photo 1 of 1 : CH\_2015\_NA0011\_39\_111\_20150817\_00043.jpg

Check Point / View				
<b>Ave 21 / Up</b>				
Rating **	A	Issue No.	111	GPS Lat/Long
Issue Type +	Ma	Location *		37.054470 °
Category	Rivers, Channels & Designated Flood			-120.284380 °
Item	Vegetation & Obstructions			
DWR ID	DWR_NA0011_39_c_2012_111			
Action/Comments				
Inspector Comments: Channel was recently burned off weeds are re appearing.

Berenda Slough looking upstream from Avenue 21.

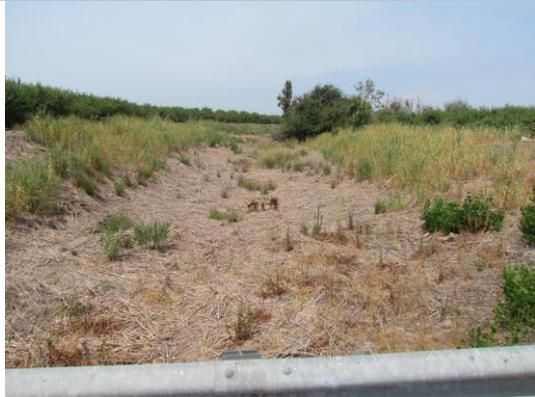
Photo 1 of 1 : CH\_2015\_NA0011\_39\_116\_20150817\_00042.jpg

Check Point / View				
<b>Ave 21 / Down</b>				
Rating **	A	Issue No.	<b>116</b>	GPS Lat/Long
Issue Type +	Ma	Location *		37.054470 °
Category	Rivers, Channels & Designated Flood			-120.284380 °
Item	Vegetation & Obstructions			
DWR ID	DWR_NA0011_39_c_2012_116			
Action/Comments				
Inspector Comments: Minimal, scattered obstructions or vegetation. The flow is not impeded.

Brenda Slough looking downstream from Avenue 21.

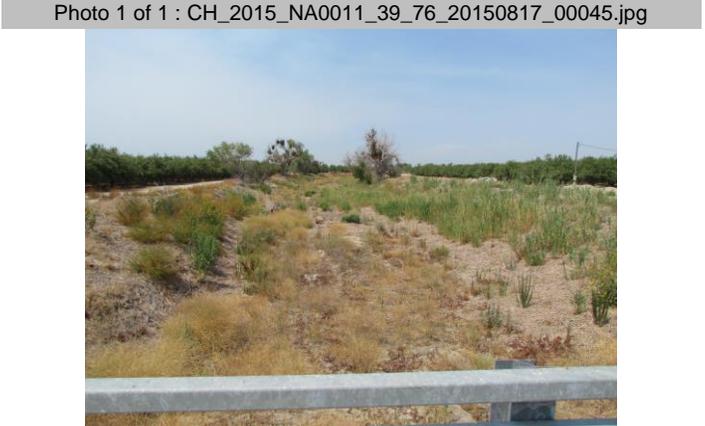
Check Point / View				
<b>Ave 20 / Up</b>				
Rating **	A	Issue No.	<b>76</b>	GPS Lat/Long
Issue Type +	Ma	Location *		37.039900 °
Category	Rivers, Channels & Designated Flood			-120.296300 °
Item	Vegetation & Obstructions			
DWR ID	DWR_NA0011_39_c _ 2012_76			
Action/Comments				
Inspector Comments: Minimal, scattered obstructions or vegetation. The flow is not impeded.

Brenda Slough looking upstream from Avenue 20.

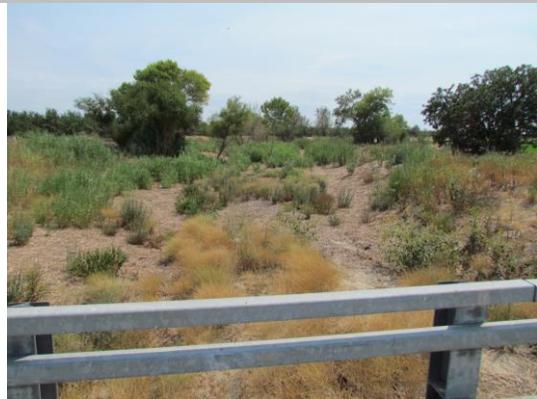
Photo 1 of 1 : CH\_2015\_NA0011\_39\_71\_20150817\_00046.jpg

Check Point / View				
<b>Ave 20 / Down</b>				
Rating **	A	Issue No.	<b>71</b>	GPS Lat/Long
Issue Type +	Ma	Location *		37.039900 °
Category	Rivers, Channels & Designated Flood			-120.296300 °
Item	Vegetation & Obstructions			
DWR ID	DWR_NA0011_39_c_2012_71			
Action/Comments				
Inspector Comments: Minimal, scattered obstructions or vegetation. The flow is not impeded.

Brenda Slough looking downstream from Avenue 20.

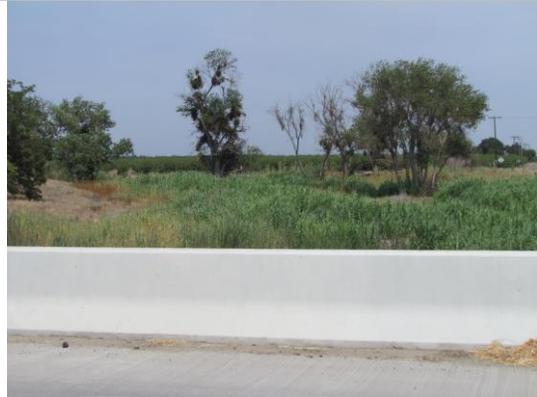
Photo 1 of 1 : CH\_2015\_NA0011\_39\_81\_20150817\_00047.jpg

Check Point / View				
<b>Rd 13 / Up</b>				
Rating **	A	Issue No.	<b>81</b>	GPS Lat/Long
Issue Type +	Ma	Location *		37.025350 °
Category	Rivers, Channels & Designated Flood			-120.310447 °
Item	Vegetation & Obstructions			
DWR ID	DWR_NA0011_39_c_2012_81			
Action/Comments				
Inspector Comments: Minimal, scattered obstructions or vegetation. The flow is not impeded.

Brenda Slough at Road 13 looking upstream.

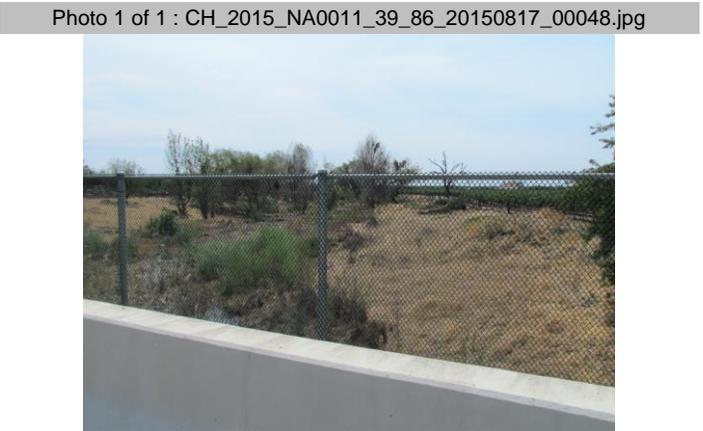
Check Point / View				
<b>Rd 13 / Down</b>				
Rating **	A	Issue No.	<b>86</b>	GPS Lat/Long
Issue Type +	Ma	Location *		37.025350 °
Category	Rivers, Channels & Designated Flood			-120.310447 °
Item	Vegetation & Obstructions			
DWR ID	DWR_NA0011_39_c _ 2012_86			
Action/Comments				
Inspector Comments: Minimal, scattered obstructions or vegetation. The flow is not impeded.

Brenda Slough from Road 13.

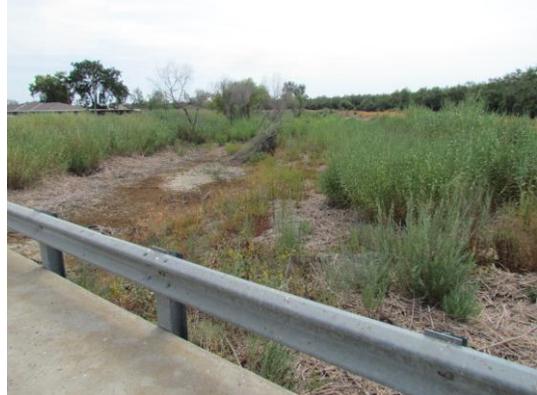
Photo 1 of 1 : CH\_2015\_NA0011\_39\_91\_20150817\_00049.jpg

Check Point / View				
<b>Road 14 / Up</b>				
Rating **	M	Issue No.	<b>91</b>	GPS Lat/Long
Issue Type +	Ma	Location *		37.050214 °
Category	Rivers, Channels & Designated Flood			-120.292481 °
Item	Vegetation & Obstructions			
DWR ID	DWR_NA0011_39_c _ 2012_91			
Action/Comments				
Inspector Comments: Log jams, snags, vegetation growth (such as cat tails, bull rushes, bushes or saplings) or other obstructions block approximately 25% of the capacity.

Brenda Slough looking upstream from Road 14.

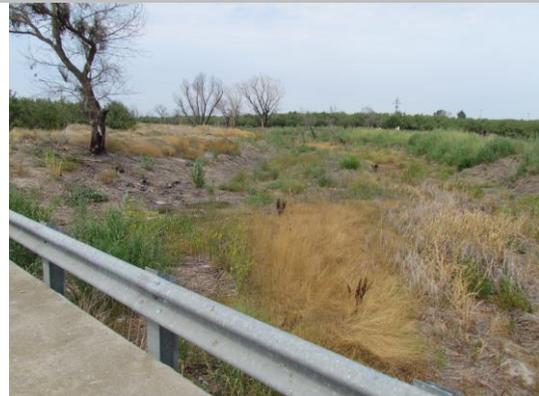
Photo 1 of 1 : CH\_2015\_NA0011\_39\_96\_20150817\_00050.jpg

Check Point / View				
<b>Road 14 / Down</b>				
Rating **	A	Issue No.	<b>96</b>	GPS Lat/Long
Issue Type +	Ma	Location *		37.050214 °
Category	Rivers, Channels & Designated Flood			-120.292481 °
Item	Vegetation & Obstructions			
DWR ID	DWR_NA0011_39_c_2012_96			
Action/Comments				
Inspector Comments: Minimal, scattered obstructions or vegetation. The flow is not impeded.

Brenda Slough at Road 14 looking downstream.

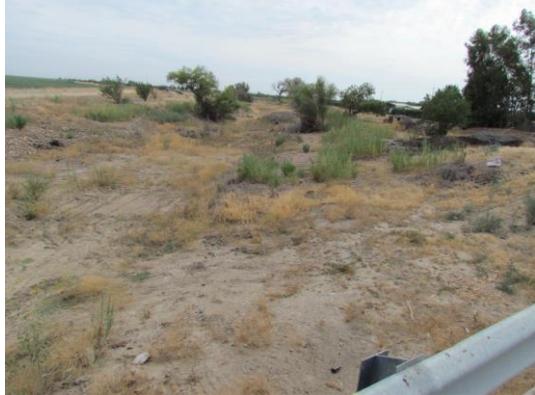
Photo 1 of 1 : CH\_2015\_NA0011\_39\_101\_20150817\_00051.jpg

Check Point / View				
<b>Ave 18 1/2 / Up</b>				
Rating **	A	Issue No.	<b>101</b>	GPS Lat/Long
Issue Type +	Ma	Location *		37.018173 °
Category	Rivers, Channels & Designated Flood			-120.326250 °
Item	Vegetation & Obstructions			
DWR ID	DWR_NA0011_39_c_2012_101			
Action/Comments				
Inspector Comments: Minimal, scattered obstructions of vegetation. The flow is not impeded.

Brenda Slough looking upstream from Avenue 18 1/2 crossing.

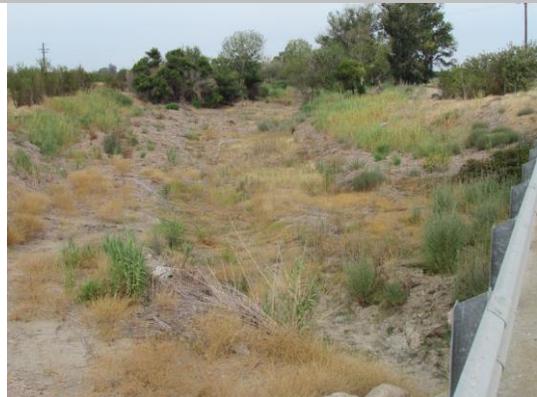
Photo 1 of 1 : CH\_2015\_NA0011\_39\_106\_20150818\_00052.jpg

Check Point / View			
<b>Ave 18 1/2 / Down</b>			
Rating **	A	Issue No.	106
Issue Type +	Ma	Location *	37.018173 °
Category	Rivers, Channels & Designated Flood		-120.326250 °
Item	Vegetation & Obstructions		
DWR ID	DWR_NA0011_39_c_2012_106		
Action/Comments			
Inspector Comments: Minimal ,scattered obstructions or vegetation. The flow is not impeded.

Berenda Slough looking downstream from Avenue 18 1/2.

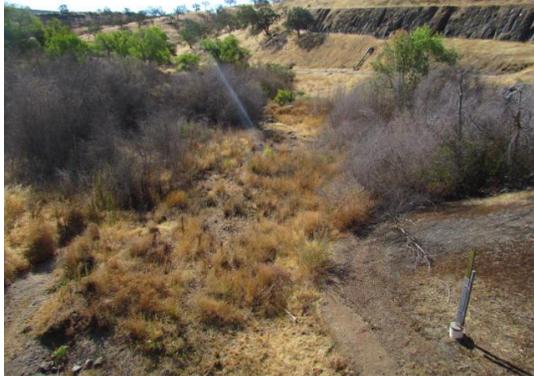
Photo 1 of 1 : CH\_2015\_NA0011\_40\_1\_20150813\_00026.jpg

Check Point / View			
<b>Downstream Buchanan Dam / Up</b>			
Rating **	A	Issue No.	1
Issue Type +	Ma	Location *	-121.215880 °
Category	Rivers, Channels & Designated Flood		119.991490 °
Item	Vegetation & Obstructions		
DWR ID	DWR_NA0011_40_c_2012_1		
Action/Comments			
Inspector Comments: No vegetation or obstructions present that would impede the flow.

Looking east (upstream) at channel downstream from Dam.

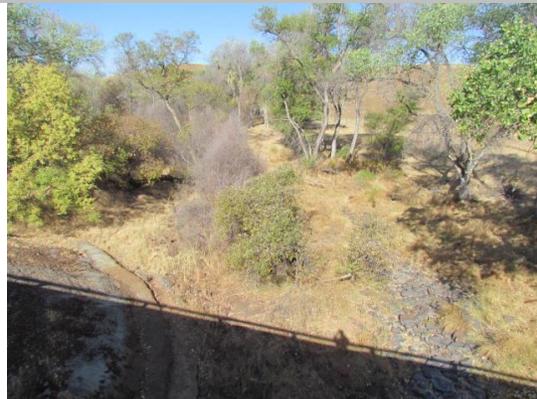
Photo 1 of 1 : CH\_2015\_NA0011\_40\_2\_20150813\_00027.jpg

Check Point / View			
<b>Downstream Buchanan Dam / Down</b>			
Rating **	A	Issue No.	2
Issue Type +	Ma	Location *	-121.215880 °
Category	Rivers, Channels & Designated Flood		119.991490 °
Item	Vegetation & Obstructions		
DWR ID	DWR_NA0011_40_c_2012_2		
Action/Comments			
Inspector Comments: No vegetation or obstructions present that would impede the flow.

Looking west (downstream) at channel downstream from Dam.

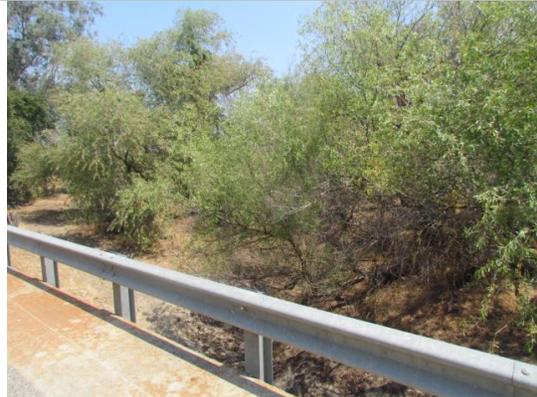
Photo 1 of 1 : CH\_2015\_NA0011\_40\_3\_20150610\_00003.jpg

Check Point / View			
<b>Santa Fe Dr / Up</b>			
Rating **	A	Issue No.	3
Issue Type +	Ma	Location *	37.164710 °
Category	Rivers, Channels & Designated Flood		-120.174880 °
Item	Vegetation & Obstructions		
DWR ID	DWR_NA0011_40_c_2012_3		
Action/Comments			
Inspector Comments: Trees established in channel near bridge should be removed for better view of channel and flow.

Looking east (upstream) at channel from Santa Fe Dr.

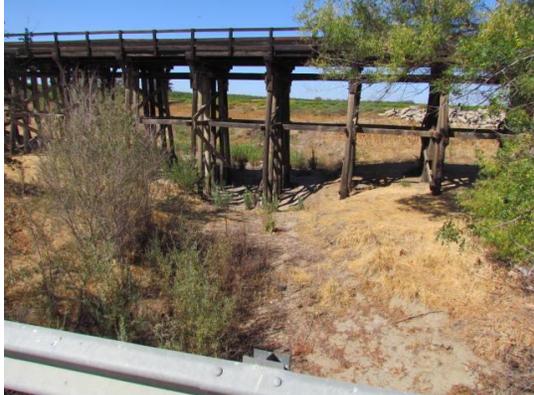
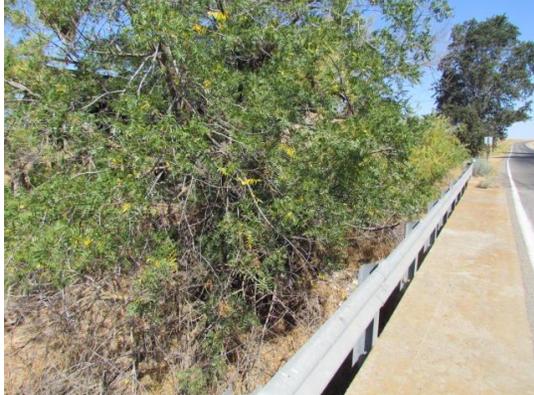
Check Point / View				
<b>Santa Fe Dr / Down</b>				
Rating **	M	Issue No.	<b>5</b>	GPS Lat/Long
Issue Type +	Ma	Location *		37.164710 °
Category	Rivers, Channels & Designated Flood			-120.174880 °
Item	Vegetation & Obstructions			
DWR ID	DWR_NA0011_40_c_2012_5			
Action/Comments				
Inspector Comments: Control tree growth in channel near bridge.

Looking west (downstream) at channel from Santa Fe Dr.

Looking northwest at vegetation near bridge crossing.

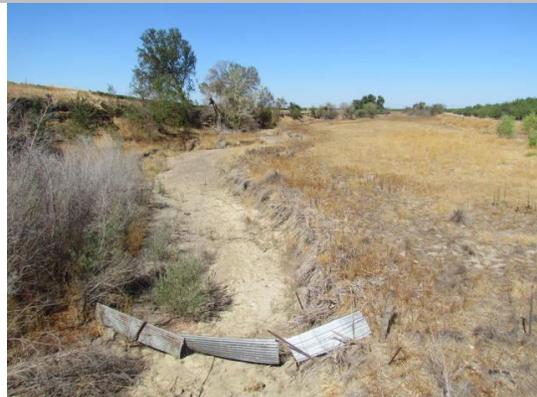
Photo 1 of 1 : CH\_2015\_NA0011\_40\_12\_20150813\_00030.jpg

Check Point / View				
<b>White Rock Rd / Down</b>				
Rating **	A	Issue No.	12	GPS Lat/Long
Issue Type +	Ma	Location *		37.161820 °
Category	Rivers, Channels & Designated Flood			-120.202050 °
Item	Vegetation & Obstructions			
DWR ID	DWR_NA0011_40_c_2012_12			
Action/Comments				
Inspector Comments: Minimal vegetation or obstructions present that should not impede the flow.

Looking west (downstream) at channel from Road 19.

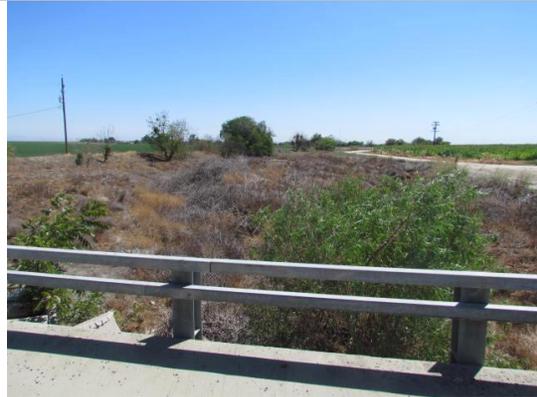
Photo 1 of 1 : CH\_2015\_NA0011\_40\_21\_20150813\_00031.jpg

Check Point / View				
<b>Rd 13/ Vista Ave / Up</b>				
Rating **	A	Issue No.	21	GPS Lat/Long
Issue Type +	Ma	Location *		37.120660 °
Category	Rivers, Channels & Designated Flood			-120.310850 °
Item	Vegetation & Obstructions			
DWR ID	DWR_NA0011_40_c_2012_21			
Action/Comments				
Inspector Comments: Some minor vegetation near bridge.

Looking east (upstream) at channel from Road 13.

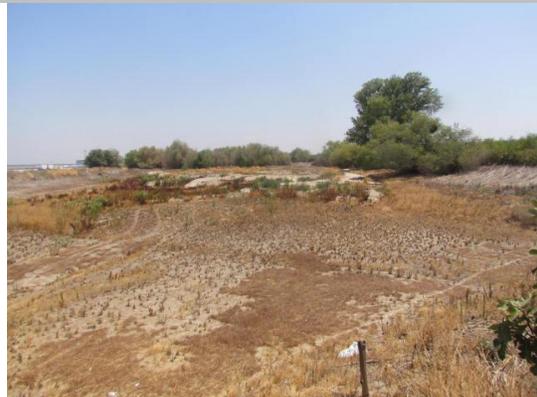
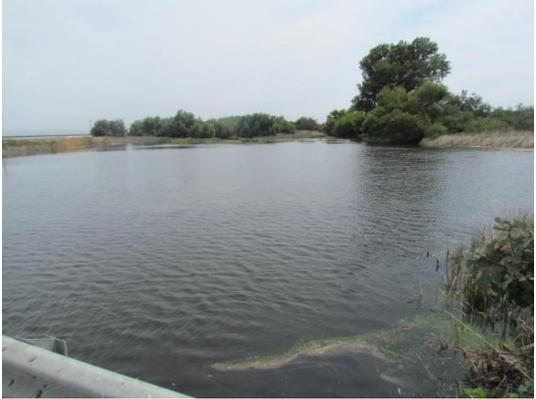
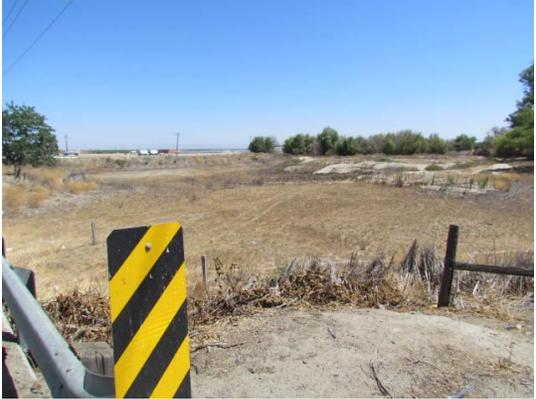
Check Point / View				
<b>RD 15 / Up</b>				
Rating **	A	Issue No.	15	GPS Lat/Long
Issue Type +	Ma	Location *		37.151660 °
Category	Rivers, Channels & Designated Flood			-120.274370 °
Item	Vegetation & Obstructions			
DWR ID	DWR_NA0011_40_c_2012_15			
Action/Comments				
Inspector Comments: No vegetation issues present.

Looking east (upstream) at channel from Road 15. (2014)

Looking east (upstream) at channel from Road 15. (2013)

Looking east (upstream) at channel from Road 15. (2015)

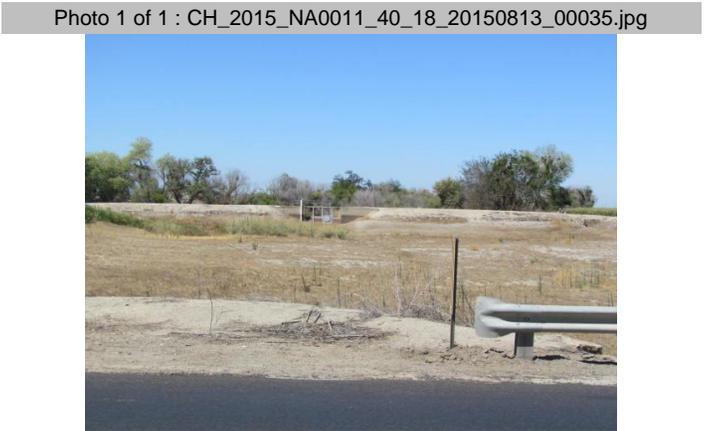
Check Point / View			
<b>RD 15 / Down</b>			
Rating **	A	Issue No.	<b>18</b>
Issue Type +	Ma	Location *	GPS Lat/Long
Category	Rivers, Channels & Designated Flood		37.151660 °
Item	Vegetation & Obstructions		-120.274370 °
DWR ID	DWR_NA0011_40_c_2012_18		
Action/Comments			
Inspector Comments: No vegetation or obstructions present to impede flow.

Looking west (downstream) at Check Dam from Road 15.

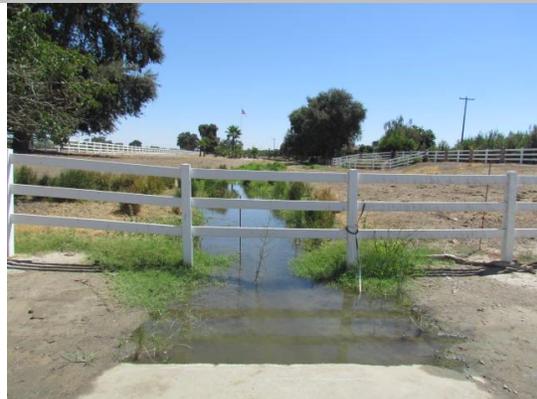
Photo 1 of 1 : CH\_2015\_NA0011\_40\_27\_20150813\_00036.jpg

Check Point / View				
<b>Low Water Crossing at Rd 11 / Up</b>				
Rating **	A	Issue No.	27	GPS Lat/Long
Issue Type +	Ma	Location *		37.123770 °
Category	Rivers, Channels & Designated Flood			-120.347120 °
Item	Vegetation & Obstructions			
DWR ID	DWR_NA0011_40_c_2012_27			
Action/Comments				
Inspector Comments: No vegetation or obstruction that would impede the flow present.

Looking east (upstream) at channel from Road 11.

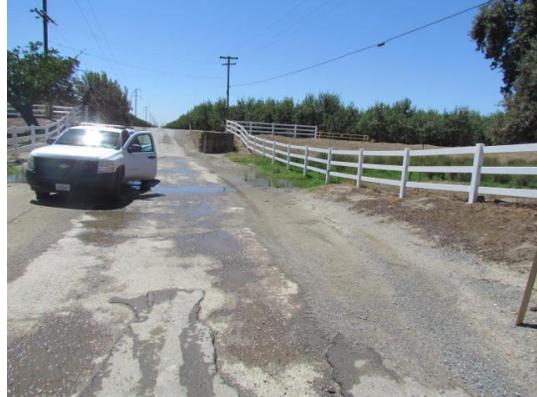
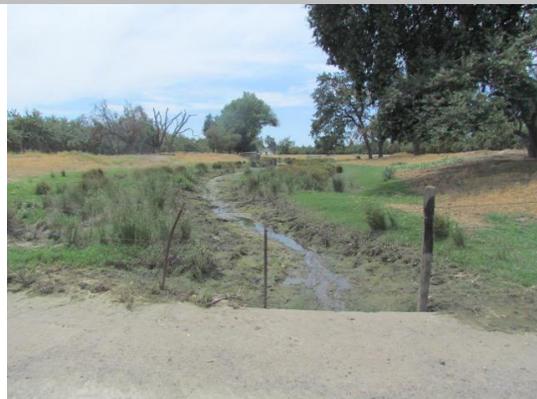
Check Point / View				
<b>Low Water Crossing at Rd 11 / Up (cont)</b>				
Rating **	M	Issue No.	<b>29</b>	GPS Lat/Long
Issue Type +	En	Location *		37.123770 °
Category	Rivers, Channels & Designated Flood			-120.347120 °
Item	Encroachments			
DWR ID	DWR_NA0011_40_c_2012_29			
Action/Comments				
Inspector Comments: Fence across channel should be breakway fence.

Looking south at fence running across channel (2015).

Looking at picture of fence from 2013.

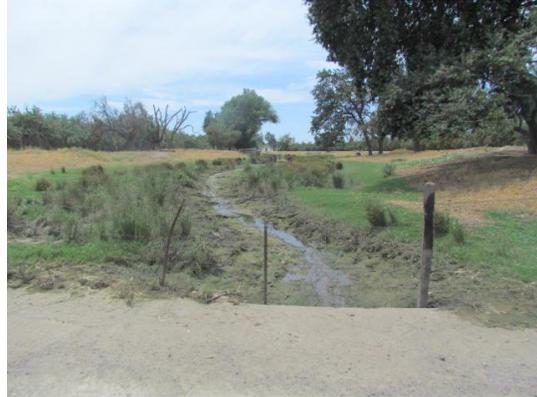
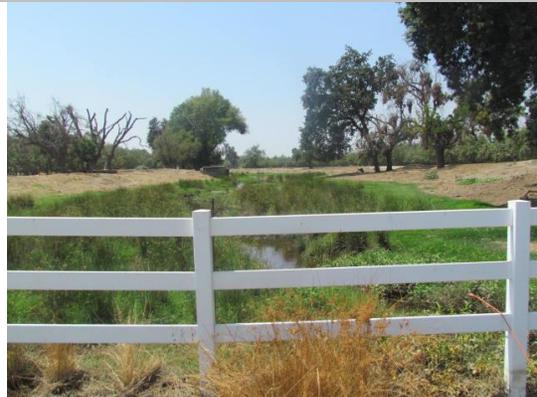
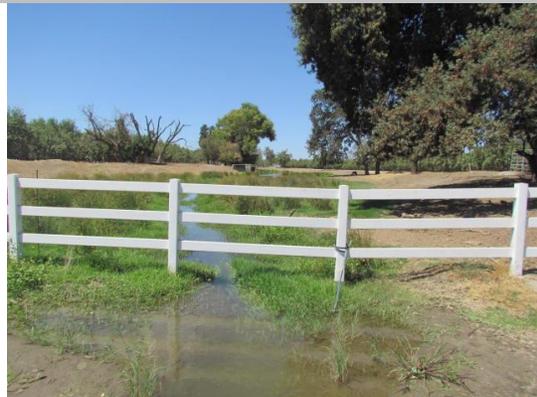
Check Point / View				
<b>Low Water Crossing at Rd 11 / Down</b>				
Rating **	A	Issue No.	<b>30</b>	GPS Lat/Long
Issue Type +	Ma	Location *		37.123770 °
Category	Rivers, Channels & Designated Flood			-120.347120 °
Item	Vegetation & Obstructions			
DWR ID	DWR_NA0011_40_c_2012_30			
Action/Comments				
Inspector Comments: No vegetation or obstructions present to impede flow.

Looking west (downstream) at channel from Road 11. (2013)

Looking west (downstream) at channel from Road 11. (2014)

Looking west (downstream) at channel from Road 11. (2015)

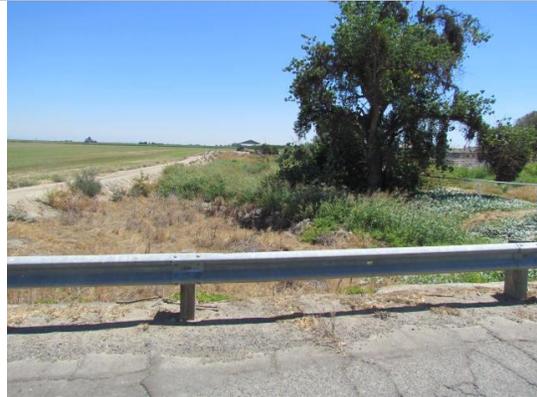
Photo 1 of 1 : CH\_2015\_NA0011\_40\_39\_20150813\_00040.jpg

Check Point / View				
<b>Rd 9 &amp; Bliss Rd / Up</b>				
Rating **	A	Issue No.	39	GPS Lat/Long
Issue Type +	Ma	Location *		37.124145 °
Category	Rivers, Channels & Designated Flood			-120.382724 °
Item	Vegetation & Obstructions			
DWR ID	DWR_NA0011_40_c_2012_39			
Action/Comments				
Inspector Comments: Minor vegetation present that should not impeded flow.

Looking east (upstream) at channel from Road 9.

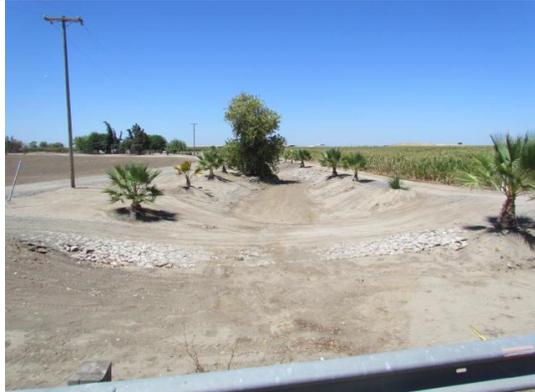
Photo 1 of 2 : CH\_2015\_NA0011\_40\_44\_20150813\_00041.jpg

Rating **	M	Issue No.	<b>44</b>	GPS Lat/Long
Issue Type +	En	Location *		37.124145 °
Category	Rivers, Channels & Designated Flood			-120.382724 °
Item	Encroachments			
DWR ID	DWR_NA0011_40_c_2012_44			
Action/Comments				
Inspector Comments: Landowner has planted palm trees in the channel.

Looking west at plam trees in channel from Rd 9 (2015)

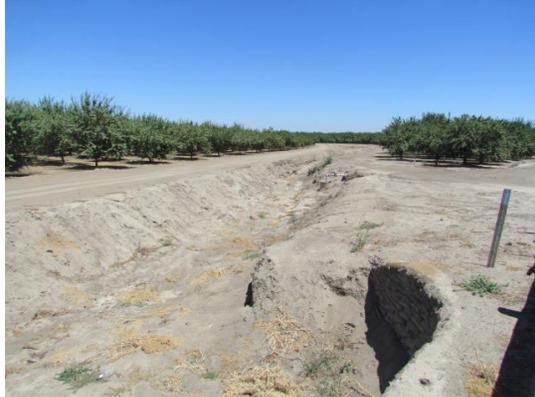
Photo 1 of 1 : CH\_2015\_NA0011\_40\_33\_20150813\_00042.jpg

Check Point / View				
<b>Ave 25 &amp; Washington Rd / Up</b>				
Rating **	A	Issue No.	<b>33</b>	GPS Lat/Long
Issue Type +	Ma	Location *		37.112750 °
Category	Rivers, Channels & Designated Flood			-120.405860 °
Item	Vegetation & Obstructions			
DWR ID	DWR_NA0011_40_c_2012_33			
Action/Comments				
Inspector Comments: No vegetation or obstructions present to impede channel flow.

Looking east (upstream) at channel from Avenue 25 & Washington Road.

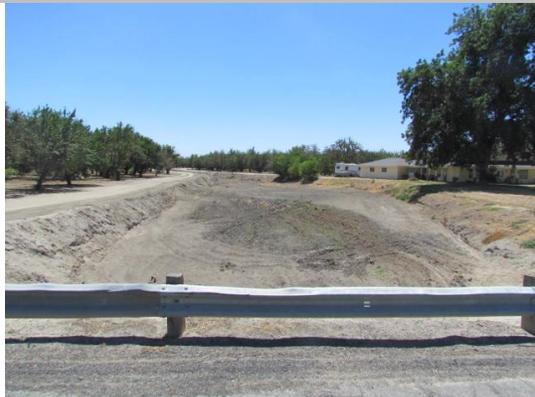
Photo 1 of 1 : CH\_2015\_NA0011\_40\_36\_20150813\_00043.jpg

Check Point / View				
<b>Ave 25 &amp; Washington Rd / Down</b>				
Rating **	A	Issue No.	36	GPS Lat/Long
Issue Type +	Ma	Location *		37.112750 °
Category	Rivers, Channels & Designated Flood			-120.405860 °
Item	Vegetation & Obstructions			
DWR ID	DWR_NA0011_40_c_2012_36			
Action/Comments				
Inspector Comments: No vegetation or obstructions present to impede channel flow.

Looking west (downstream) at channel from Avenue 25 & Washington Road.

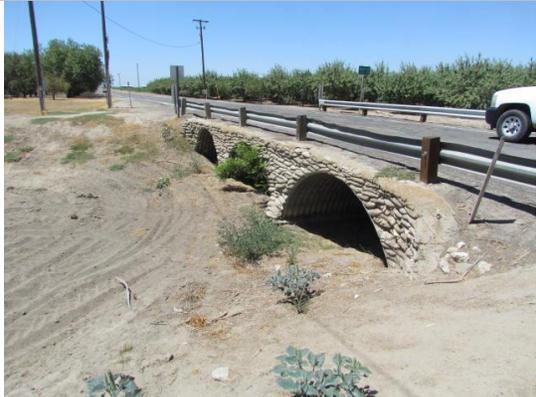
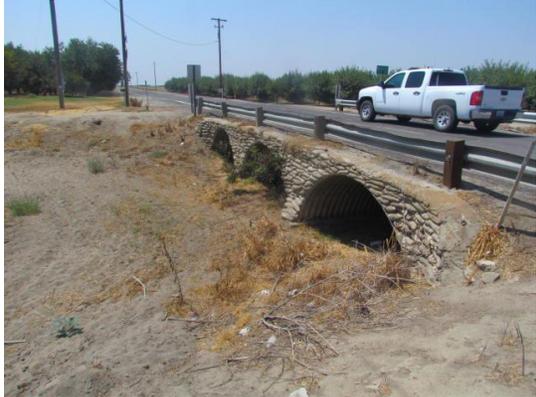
Rating **	A	Issue No.	<b>37</b>	GPS Lat/Long
Issue Type +	Ma	Location *		37.112750 °
Category	Rivers, Channels & Designated Flood			-120.405860 °
Item	Shoaling / Sedimentation			
DWR ID	DWR_NA0011_40_c_2012_37			
Action/Comments				
Inspector Comments: No shoaling or sedimentation present.

Looking north at culverts on west side of Avenue 25 & Washington Rd. (2015)

Looking north at culverts on west side of Avenue 25 & Washington Rd.(2014)

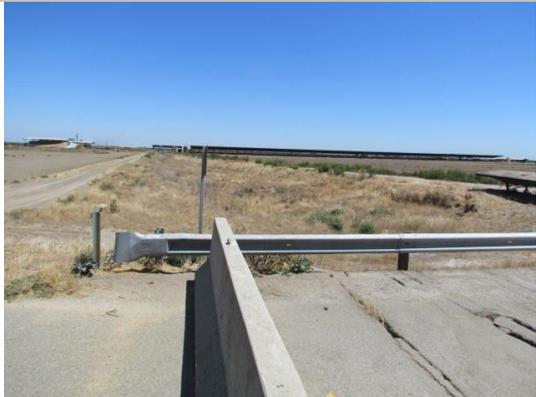
Photo 1 of 1 : CH\_2015\_NA0011\_40\_45\_20150813\_00045.jpg

Rating **	A	Issue No.	45	GPS Lat/Long
Issue Type +	Ma	Location *		37.101570 °
Category	Rivers, Channels & Designated Flood			-120.446260 °
Item	Vegetation & Obstructions			
DWR ID	DWR_NA0011_40_c_2012_45			
Action/Comments				
Inspector Comments: No vegetation or obstructions present to impede flow.

Looking east (upstream) at channel from Shultz Road.

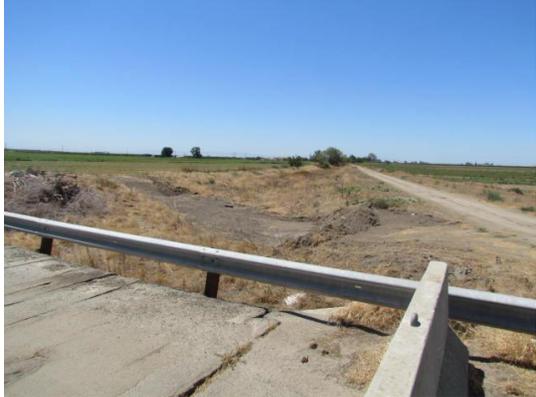
Photo 1 of 1 : CH\_2015\_NA0011\_40\_48\_20150813\_00046.jpg

Check Point / View				
<b>Shultz Rd &amp; Rd 5 1/2 / Down</b>				
Rating **	A	Issue No.	<b>48</b>	GPS Lat/Long
Issue Type +	Ma	Location *		37.101570 °
Category	Rivers, Channels & Designated Flood			-120.446260 °
Item	Vegetation & Obstructions			
DWR ID	DWR_NA0011_40_c_2012_48			
Action/Comments				
Inspector Comments: Minimal amount of vegetation that should not impede channel flow.

Looking west (downstream) at channel from Shultz Rd.

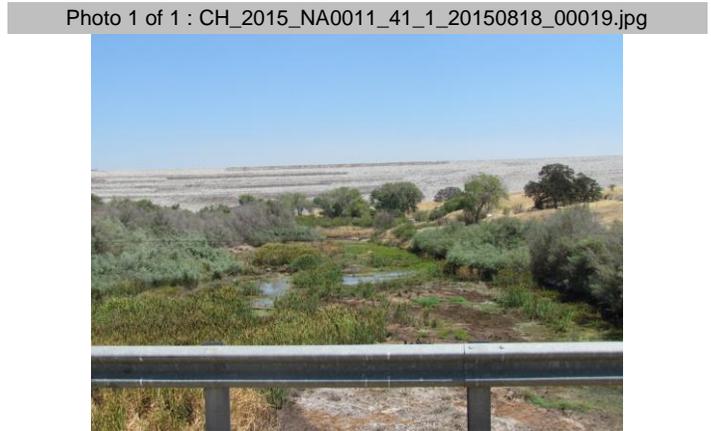
Check Point / View			
<b>U/S Limit @ Hidden Dam, Daulton Dr. / Up</b>			
Rating **	A	Issue No.	1
Issue Type +	Ma	Location *	37.103916 °
Category	Rivers, Channels & Designated Flood		-119.888060 °
Item	Vegetation & Obstructions		
DWR ID	DWR_NA0011_41_c _ 2014_1		
Action/Comments			
Inspector Comments: Very little vegetation in the channel upstream side of bridge crossing.

Fresno River Looking upstream from Daulton Drive bridge crossing.

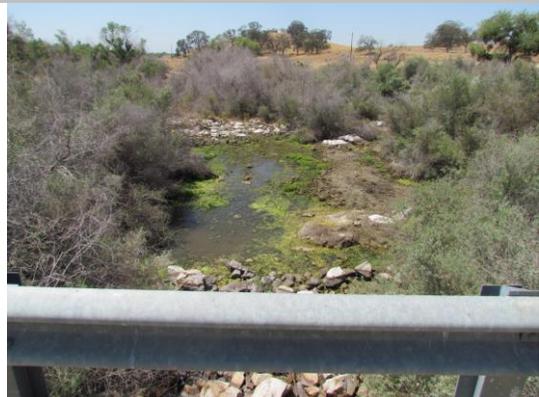
Photo 1 of 1 : CH\_2015\_NA0011\_41\_6\_20150818\_00020.jpg

Check Point / View			
<b>U/S Limit @ Hidden Dam, Daulton Dr. / Down</b>			
Rating **	M	Issue No.	6
Issue Type +	Ma	Location *	37.103916 °
Category	Rivers, Channels & Designated Flood		-119.888060 °
Item	Vegetation & Obstructions		
DWR ID	DWR_NA0011_41_c_2012_6		
Action/Comments			
Inspector Comments: Log jams, snags, vegetation growth (such as cat tails, bull rushes, bushes or saplings) or other obstructions

Fresno River downstream from bridge crossing Daulton Drive.

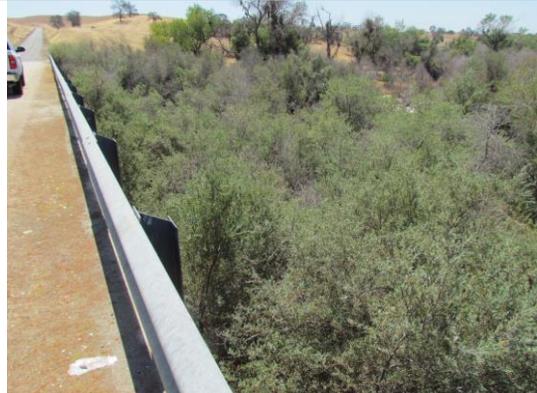
Photo 1 of 1 : CH\_2015\_NA0011\_41\_9\_20150825\_00036.jpg

Rating **	U	Issue No.	9	GPS Lat/Long
Issue Type +	Ma	Location *		37.103916 °
Category	Rivers, Channels & Designated Flood			-119.888060 °
Item	Revetments			
DWR ID	DWR_NA0011_41_c_2012_9			
Action/Comments				
Inspector Comments: Dense brush, trees, or grasses hide the rock protection, or meandering and/or scour activity is undercutting banks, eroding embankments, or impairing channel flows by causing turbulence or shoaling. Cavities may exist under the revetment.

Fresno River looking downstream from Daulton Drive from the right bank across the river channel to the left bank.

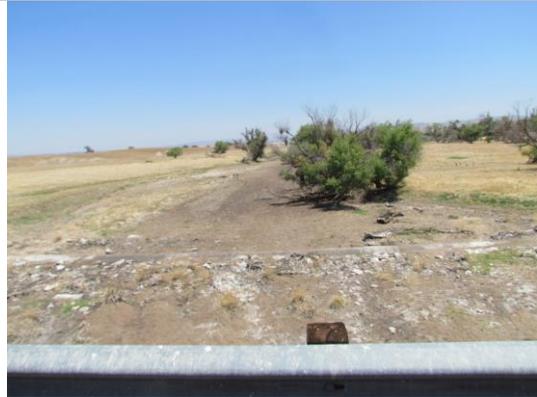
Photo 1 of 1 : CH\_2015\_NA0011\_41\_11\_20150818\_00021.jpg

Check Point / View			
<b>Timber Bridge at Madera Canal / Up</b>			
Rating **	A	Issue No.	11
Issue Type +	Ma	Location *	37.070110°
Category	Rivers, Channels & Designated Flood		-119.910220°
Item	Vegetation & Obstructions		
DWR ID	DWR_NA0011_41_c_2012_11		
Action/Comments			
Inspector Comments: No vegetation in channel upstream of Timber Bridge.

Fresno River looking upstream from the timber bridge crossing.

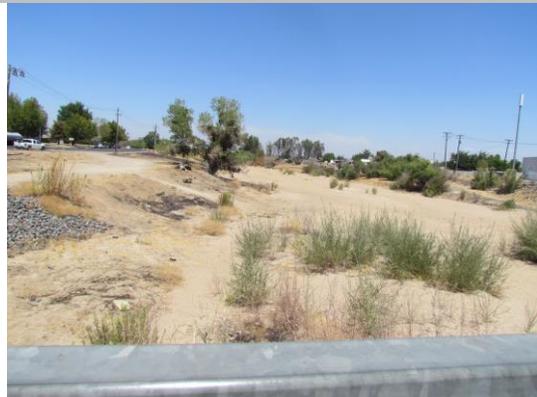
Photo 1 of 1 : CH\_2015\_NA0011\_41\_21\_20150818\_00023.jpg

Check Point / View				
<b>Cleveland Ave / Up</b>				
Rating **	A	Issue No.	21	GPS Lat/Long
Issue Type +	Ma	Location *		36.974320 °
Category	Rivers, Channels & Designated Flood			-120.043320 °
Item	Vegetation & Obstructions			
DWR ID	DWR_NA0011_41_c_2012_21			
Action/Comments				
Inspector Comments: Minimal, scattered obstructions or vegetation. The flow is not impeded. The channel is dry at this crossing.

Fresno River looking upstream from Cleveland Avenue crossing.

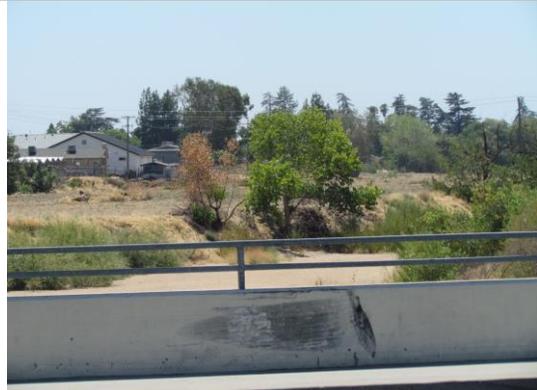
Photo 1 of 1 : CH\_2015\_NA0011\_41\_26\_20150818\_00024.jpg

Check Point / View				
<b>Cleveland Ave / Down</b>				
Rating **	M	Issue No.	<b>26</b>	GPS Lat/Long
Issue Type +	Ma	Location *		36.974320 °
Category	Rivers, Channels & Designated Flood			-120.043320 °
Item	Vegetation & Obstructions			
DWR ID	DWR_NA0011_41_c_2012_26			
Action/Comments				
Inspector Comments: Minimal scattered obstructions or vegetation. The flow is not impeded.

Fresno River looking downstream from Cleveland Avenue.

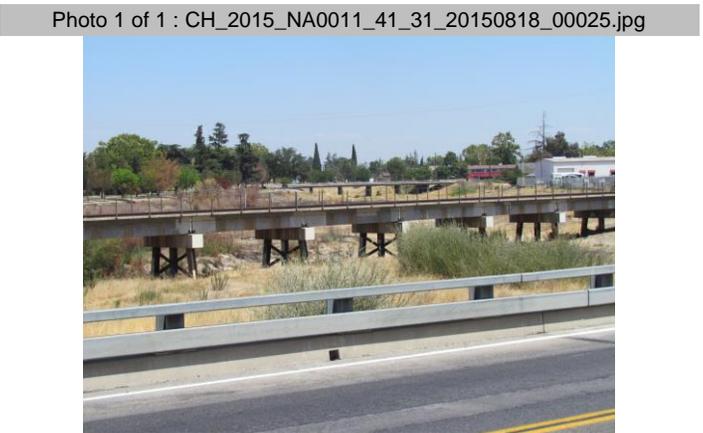
Check Point / View				
<b>Gateway Dr / Up</b>				
Rating **	A	Issue No.	31	GPS Lat/Long
Issue Type +	Ma	Location *		36.968760 °
Category	Rivers, Channels & Designated Flood			-120.067840 °
Item	Vegetation & Obstructions			
DWR ID	DWR_NA0011_41_c_2012_31			
Action/Comments				
Inspector Comments: Minimal, scattered obstructions or vegetation. The flow is not impeded.

Fresno River From Gateway crossing looking upstream of the channel.
