**Flood Control Project Maintenance  
Levee Inspections**

**2015 Channel Summary Report**

**Madera County FCWCA**

**2015 Channel Inspection Results**

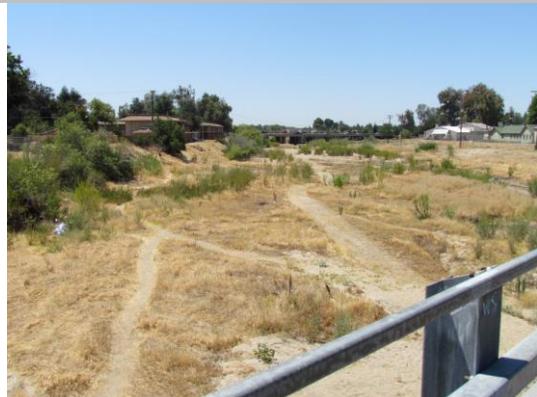
Photo 1 of 1 : CH\_2015\_NA0011\_41\_36\_20150818\_00026.jpg

Check Point / View			
<b>Gateway Dr / Down</b>			
Rating **	A	Issue No.	36
Issue Type +	Ma	Location *	36.968760 °
Category	Rivers, Channels & Designated Flood		-120.067840 °
Item	Vegetation & Obstructions		
DWR ID	DWR_NA0011_41_c_2012_36		
Action/Comments			
Inspector Comments: Minimal, scattered obstructions or vegetation. The flow is not impeded.

Fresno River from Gateway Bridge crossing looking downstream.

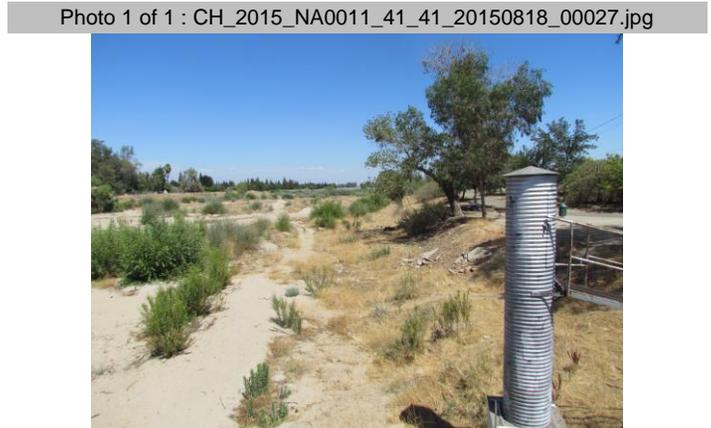
Check Point / View				
<b>Granada Ave / Up</b>				
Rating **	A	Issue No.	<b>41</b>	GPS Lat/Long
Issue Type +	Ma	Location *		36.967550 °
Category	Rivers, Channels & Designated Flood			-120.128450 °
Item	Vegetation & Obstructions			
DWR ID	DWR_NA0011_41_c_2012_41			
Action/Comments				
Inspector Comments: Minimal, scattered obstructions or vegetation. The flow is not impeded.

Fresno River from Granada Avenue crossing looking upstream.

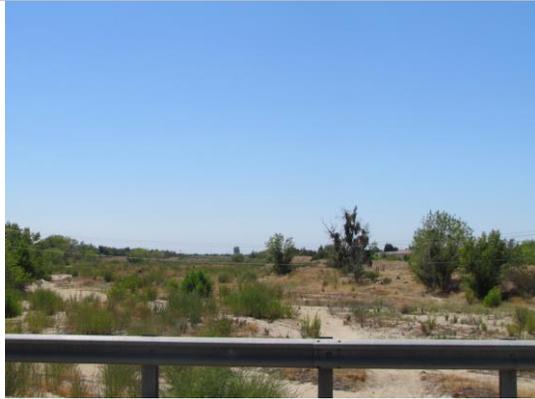
Photo 1 of 1 : CH\_2015\_NA0011\_41\_46\_20150818\_00028.jpg

Check Point / View			
<b>Granada Ave / Down</b>			
Rating **	A	Issue No.	46
Issue Type +	Ma	Location *	36.967550 °
Category	Rivers, Channels & Designated Flood		-120.128450 °
Item	Vegetation & Obstructions		
DWR ID	DWR_NA0011_41_c_2012_46		
Action/Comments			
Inspector Comments: Minimal, scattered obstructions or vegetation. The flow is not impeded.

Fresno River downstream from Granada Avenue crossing.

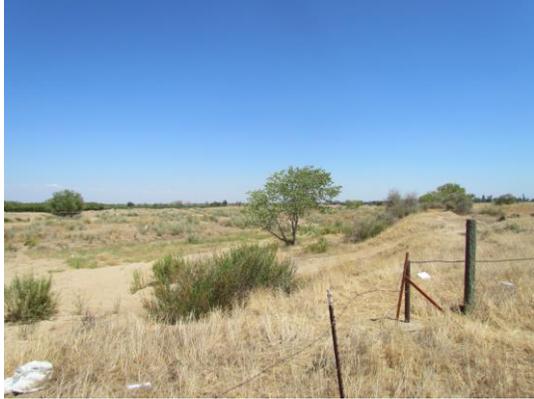
Photo 1 of 1 : CH\_2015\_NA0011\_41\_51\_20150818\_00029.jpg

Check Point / View				
<b>Rd 23 / Up</b>				
Rating **	A	Issue No.	51	GPS Lat/Long
Issue Type +	Ma	Location *		36.967900 °
Category	Rivers, Channels & Designated Flood			-120.128770 °
Item	Vegetation & Obstructions			
DWR ID	DWR_NA0011_41_c _ 2012_51			
Action/Comments				
Inspector Comments: Minimal scattered growth of vegetation in channel, the flow is not impeded.

Fresno River crossing looking upstream from Road 23.

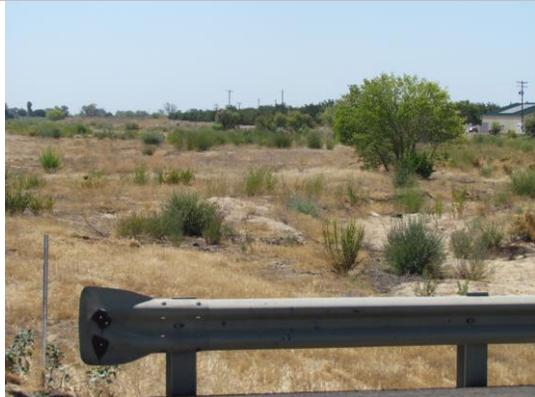
Photo 1 of 1 : CH\_2015\_NA0011\_41\_56\_20150818\_00030.jpg

Check Point / View				
<b>Rd 23 / Down</b>				
Rating **	A	Issue No.	56	GPS Lat/Long
Issue Type +	Ma	Location *		36.967900 °
Category	Rivers, Channels & Designated Flood			-120.128770 °
Item	Vegetation & Obstructions			
DWR ID	DWR_NA0011_41_c_2012_56			
Action/Comments				
Inspector Comments: Minimal, scattered obstructions or vegetation. The flow is not impeded.

Fresno River looking downstream from Road 23.

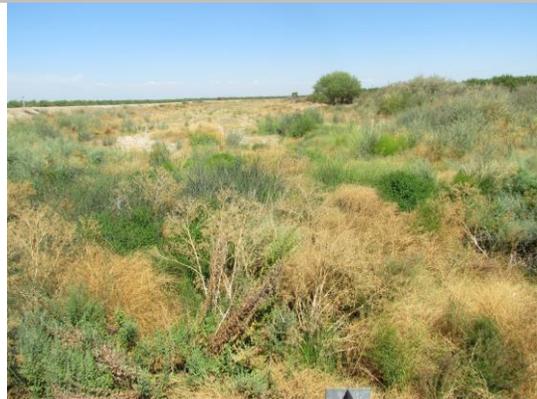
Photo 1 of 1 : CH\_2015\_NA0011\_41\_61\_20150818\_00032.jpg

Check Point / View				
<b>Rd 20 / Up</b>				
Rating **	M	Issue No.	<b>61</b>	GPS Lat/Long
Issue Type +	Ma	Location *		36.982340 °
Category	Rivers, Channels & Designated Flood			-120.184160 °
Item	Vegetation & Obstructions			
DWR ID	DWR_NA0011_41_c_2012_61			
Action/Comments				
Inspector Comments: Log jams, snags, vegetation growth (such as cat tails, bull rushes, brushes or saplings) or other obstructions blocks less than 25% of channel capacity.

Fresno River looking upstream from Road 20 bridge crossing.

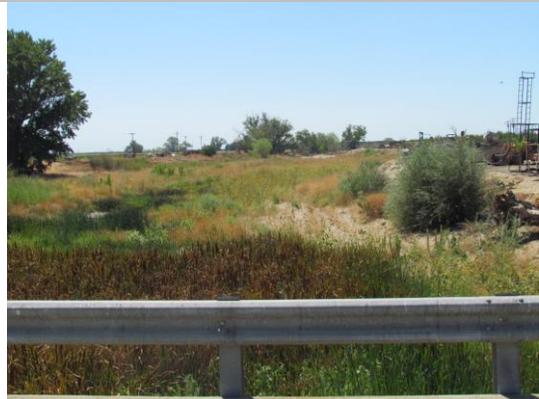
Photo 1 of 1 : CH\_2015\_NA0011\_41\_66\_20150818\_00033.jpg

Check Point / View				
<b>Rd 20 / Down</b>				
Rating **	M	Issue No.	<b>66</b>	GPS Lat/Long
Issue Type +	Ma	Location *		36.982340 °
Category	Rivers, Channels & Designated Flood			-120.184160 °
Item	Vegetation & Obstructions			
DWR ID	DWR_NA0011_41_c _ 2012_66			
Action/Comments				
Inspector Comments: Growth in channel.

Fresno River looking downstream from Road 20.

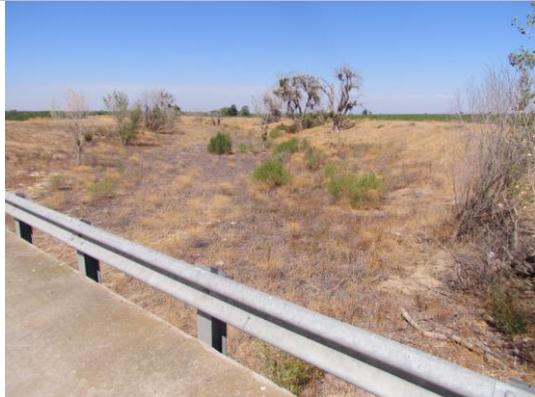
Photo 1 of 1 : CH\_2015\_NA0011\_41\_71\_20150818\_00034.jpg

Check Point / View				
<b>Rd 19, D/S Limit / Up</b>				
Rating **	A	Issue No.	<b>71</b>	GPS Lat/Long
Issue Type +	Ma	Location *		36.975478 °
Category	Rivers, Channels & Designated Flood			-120.202359 °
Item	Vegetation & Obstructions			
DWR ID	DWR_NA0011_41_c_2012_71			
Action/Comments				
Inspector Comments: Minimal, scattered obstructions or vegetation. The flow is not impeded.

Fresno River looking upstream from Road 19, D/S Limits of the River Channel.

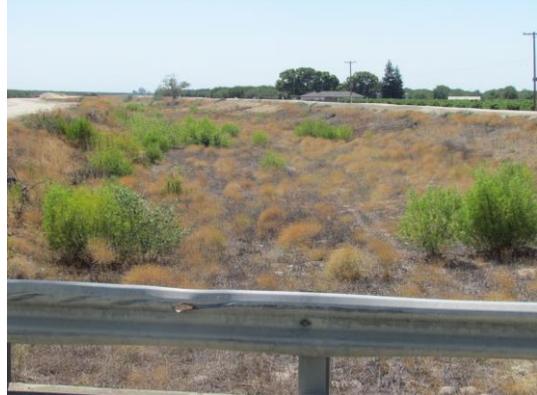
Photo 1 of 1 : CH\_2015\_NA0011\_41\_76\_20150818\_00035.jpg

Check Point / View				
<b>Rd 19, D/S Limit / Down</b>				
Rating **	A	Issue No.	<b>76</b>	GPS Lat/Long
Issue Type +	Ma	Location *		36.975478 °
Category	Rivers, Channels & Designated Flood			-120.202359 °
Item	Vegetation & Obstructions			
DWR ID	DWR_NA0011_41_c_2012_76			
Action/Comments				
Inspector Comments: Minimal, scattered obstructions or vegetation. The flow is not impeded.

Fresno River looking downstream from Road 19.
