**Flood Control Project Maintenance
Levee Inspections**

Fall 2011 Levee Maintenance Deficiency Summary Report

Levee Inspection Report By Mile - Fall 2011

Madera County FCWCA

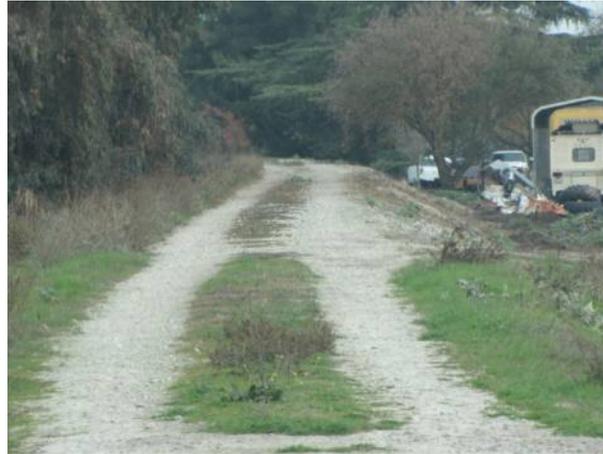
phillips_f_20111208_133.jpg

Unit 2 Ash Slough looking downstream from levee mile 0.00 landwardward. Photo taken 11-23-2011.

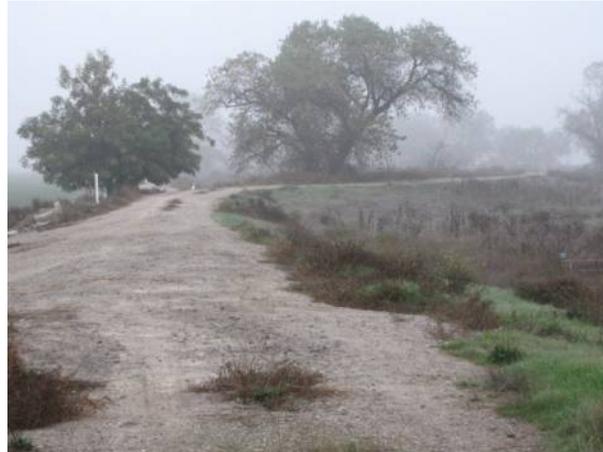
phillips_f_20111209_146.jpg

Unit 3 Berenda Slough 0.00 looking downstream. Photo taken 11-23-2011
