**Flood Control Project Maintenance
Levee Inspections**

Fall 2015 Levee Maintenance Deficiency Summary Report

San Joaquin River Basin

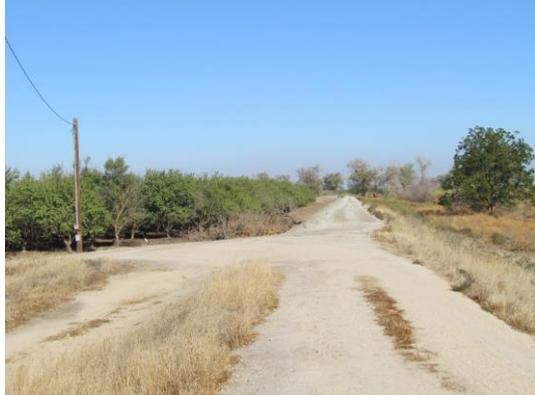
Photo 1 of 1 : FA_2015_NA0011_142_34_20151021_00013.jpg

LM Start	0.01	Rating **	A	Issue No.	34
LM End	0.25	Issue Type +	Ma	Location *	LS
Category	Earthen Levee		GPS Latitude/Longitude		
			Start	End	
Item	Vegetation		37.046495 °	37.047545 °	
			-120.427787 °	-120.423650 °	
DWR ID	DWR_NA0011_01_f_2015_34				
Action/Comments					
Control annual grass and weeds on the levee slopes and easements. Inspector Comments: Looking upstream from the landside slope no unwanted vegetation.

Ash Slough looking upstream from landside levee shoulder.

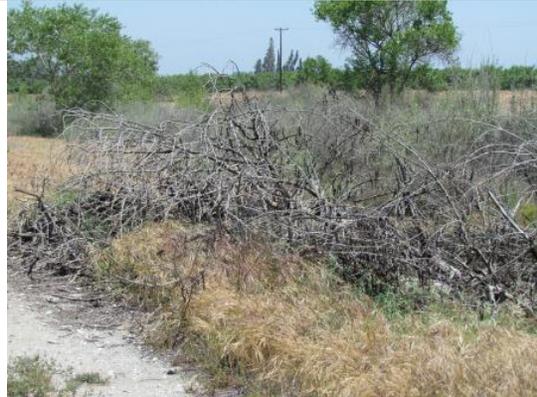
Photo 1 of 1 : FA_2015_NA0011_142_16_20150915_00003.jpg

LM Start	0.70	Rating **	U	Issue No.	16
LM End	0.70	Issue Type +	Ma	Location *	CR
Category	Earthen Levee		GPS Latitude/Longitude		
			Start	End	
Item	Encroachments		37.052175 °	37.052175 °	
			-120.417998 °	-120.417998 °	
DWR ID	DWR_NA0011_01_s_2013_16				
Action/Comments					
Tree or limb					
Inspector Comments: This tree was blown down by high winds, District needs to completely remove from levee section. Issue not corrected.

This dead tree has not been removed from the levee section, the shoulder, slope and toe is blocked. Photo taken 4-29-2014. There is no new picture for this issue. No change has been made prior to Fall inspection 2014.

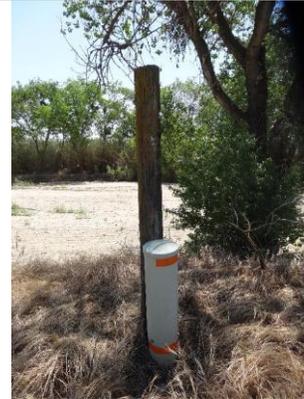
Photo 1 of 1 : UCIP_FA_2015_6795.jpg

LM Start	2.09	Rating **	M	Issue No.	46
LM End	2.09	Issue Type +	En	Location *	WS
Category	Supplemental			GPS Latitude/Longitude	
				Start	End
Item	DWR UCIP Field Study			37.065569 °	37.065569 °
				-120.400752 °	-120.400752 °
DWR ID					
Action/Comments					
Inspector Comments: FS_ID:39846 DS_ID:21511 EP_NO: N/A FS_HLM: 2.12 Repair Type: Non-Urgent Crossing Status: Indicator Found UCIP Comments: Need to contact to owner to get contact information. FIELD_STRUCT_DESC: Underground telephone cable crosses through levee. FS Date: 05/06/2014

Conduit box located on waterward side.

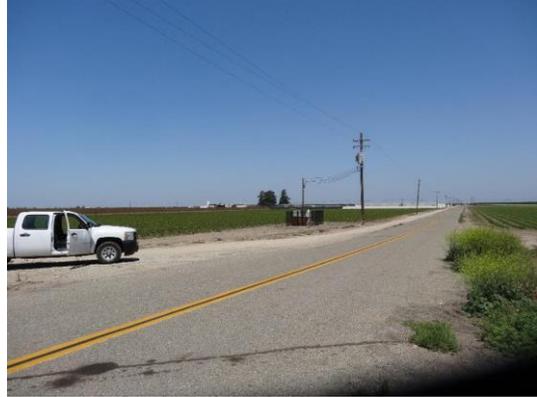
Photo 1 of 3 : UCIP_FA_2015_6793.jpg

LM Start	2.10	Rating **	M	Issue No.	47
LM End	2.10	Issue Type +	En	Location *	WS
Category	Supplemental			GPS Latitude/Longitude	
				Start	End
Item	DWR UCIP Field Study			37.065649 °	37.065649 °
				-120.400663 °	-120.400663 °
DWR ID					
Action/Comments					
Inspector Comments: FS_ID:39845 DS_ID:25042 EP_NO: N/A FS_HLM: 2.13 Repair Type: Non-Urgent Crossing Status: Found UCIP Comments: Need to contact owner to determine if crossing goes through levee. FIELD_STRUCT_DESC: 10-inch or 12-inch pipe through levee crossing visible inside concrete standpipe on waterward side. Potential pump station located on landward side approximately 100 feet from standpipe. FS Date: 05/06/2014

Pump station visible approximately 100 feet from concrete standpipe.

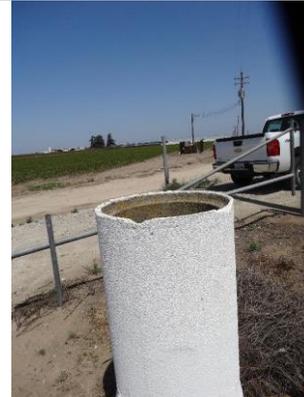
Photo 2 of 3 : UCIP_FA_2015_6796.jpg

Standpipe visible on waterward side.

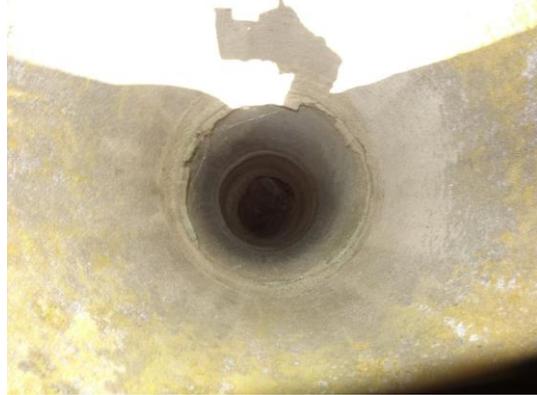
Photo 3 of 3 : UCIP_FA_2015_6797.jpg

LM Start	2.10	Rating **	M	Issue No.	47 (cont)
LM End	2.10	Issue Type +	En	Location *	WS
Category	Supplemental			GPS Latitude/Longitude	
				Start	End
Item	DWR UCIP Field Study			37.065649 °	37.065649 °
				-120.400663 °	-120.400663 °
DWR ID					
Action/Comments					
Inspector Comments: FS_ID:39845 DS_ID:25042 EP_NO: N/A FS_HLM: 2.13 Repair Type: Non-Urgent Crossing Status: Found

Inside view of concrete standpipe.

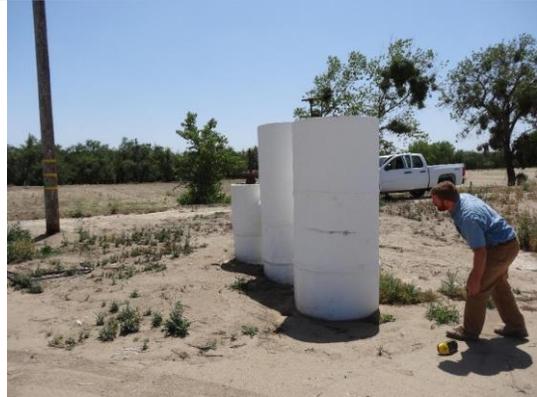
Photo 1 of 3 : UCIP_FA_2015_4890.jpg

LM Start	2.37	Rating **	M	Issue No.	48
LM End	2.37	Issue Type +	En	Location *	WS
Category	Supplemental			GPS Latitude/Longitude	
				Start	End
Item	DWR UCIP Field Study			37.068763 °	37.068763 °
				-120.398523 °	-120.398523 °
DWR ID					
Action/Comments					
Inspector Comments: FS_ID:38226 DS_ID:21512 EP_NO: N/A FS_HLM: 2.4 Repair Type: Non-Urgent Crossing Status: Found UCIP Comments: Unable to determine details of crossing and whether crossing has been abandoned. Need to find owner and determine the alignment of crossing to confirm if pipe is being extended from opposite levee. FIELD_STRUCT_DESC: Abandoned service pole, pump and two 36-inch standpipes on landward side. Pump not found in 2014 inspection. Three stand pipes found on landward side. FS Date: 05/06/2014

Three stand pipes visible on landward side.

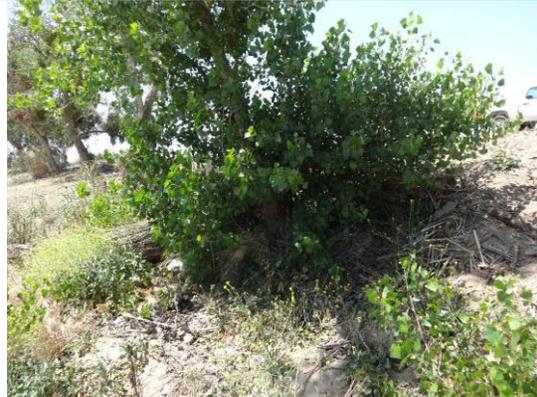
Photo 2 of 3 : UCIP_FA_2015_4891.jpg

View of waterward slope--no signs of crossing visible.

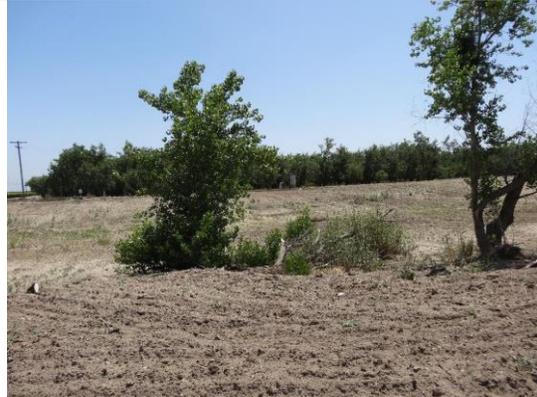
Photo 3 of 3 : UCIP_FA_2015_4892.jpg

LM Start	2.37	Rating **	M	Issue No.	48 (cont)
LM End	2.37	Issue Type +	En	Location *	WS
Category	Supplemental			GPS Latitude/Longitude	
				Start	End
Item	DWR UCIP Field Study			37.068763 °	37.068763 °
				-120.398523 °	-120.398523 °
DWR ID					
Action/Comments					
Inspector Comments: FS_ID:38226 DS_ID:21512 EP_NO: N/A FS_HLM: 2.4 Repair Type: Non-Urgent Crossing Status: Found

View of waterward side.

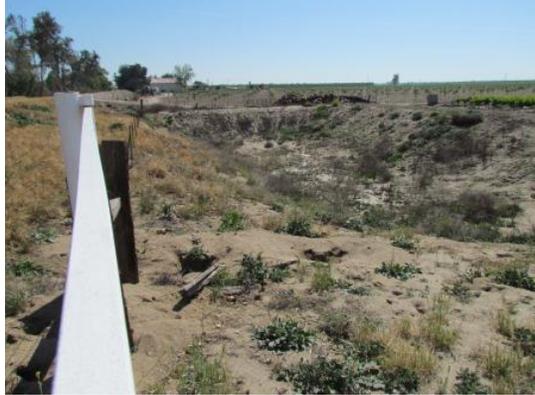
Photo 1 of 1 : FA_2015_NA0011_143_32_20150915_00005.jpg

LM Start	0.00	Rating **	U	Issue No.	32
LM End	0.00	Issue Type +	En	Location *	LS
Category	Earthen Levee		GPS Latitude/Longitude		
			Start	End	
Item	Encroachments		37.045539 °	37.045505 °	
			-120.427444 °	-120.427473 °	
DWR ID	DWR_NA0011_02_f_2012_32				
Action/Comments					
Ditch Inspector Comments: There is a settling basin on the landward side of the levee. This basin is very close to the landside easement.

Ash Slough at levee mile 0.01-0.03 there is a settling basin on the landside. First reported this issue on 2012 levee inspection. Photo taken 4-29-2014.

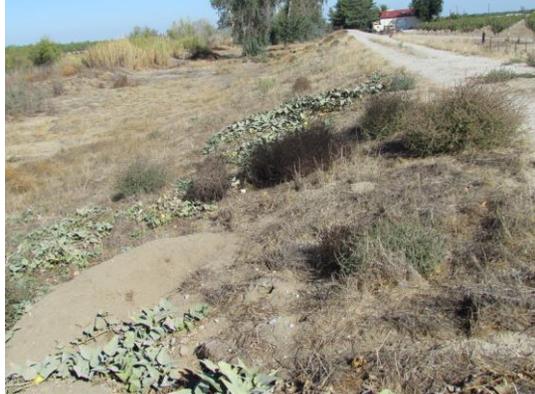
Photo 1 of 1 : FA_2015_NA0011_143_39_20151027_00010.jpg

LM Start	0.00	Rating **	U	Issue No.	39
LM End	1.67	Issue Type +	Ma	Location *	WS
Category	Earthen Levee		GPS Latitude/Longitude		
			Start	End	
Item	Animal Control		37.045485 °	37.060091 °	
			-120.427423 °	-120.405340 °	
DWR ID	DWR_NA0011_02_f_2015_39				
Action/Comments					
Exterminate rodents and backfill and compact or grout burrows. Inspector Comments: The levee section waterside is covered with rodents and rodent holes.

Ash Slough looking upstream from levee mile 0.00-1.67 waterside slope.

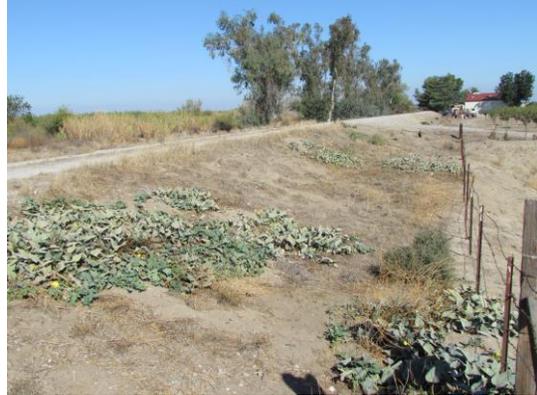
Photo 1 of 1 : FA_2015_NA0011_143_30_20151026_00009.jpg

LM Start	0.00	Rating **	U	Issue No.	30
LM End	2.04	Issue Type +	Ma	Location *	LS
Category	Earthen Levee			GPS Latitude/Longitude	
				Start	End
Item	Vegetation			37.045485 °	37.064122 °
				-120.427423 °	-120.401030 °
DWR ID	DWR_NA0011_02_f_2015_30				
Action/Comments					
Control annual grass and weeds on the levee slopes and easements. Inspector Comments: Control the wild vegetation on the landside levee slope. This vegetation is providing habitat for rodents.

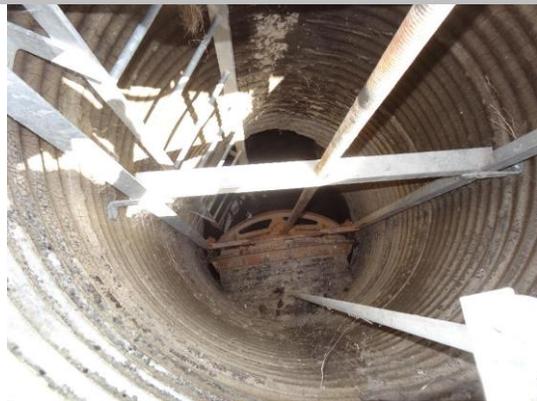
Photo 1 of 3 : UCIP_FA_2015_6121.jpg

LM Start	0.01	Rating **	M	Issue No.	47
LM End	0.01	Issue Type +	En	Location *	LS
Category	Supplemental			GPS Latitude/Longitude	
				Start	End
Item	DWR UCIP Field Study			37.045532 °	37.045532 °
				-120.427268 °	-120.427268 °
DWR ID					
Action/Comments					
Inspector Comments: FS_ID:39686 DS_ID:21585 EP_NO: 8068 FS_HLM: 0 Repair Type: Non-Urgent Crossing Status: Found UCIP Comments: Unable to confirm if crossing found in the field corresponds to the crossing described under Permit 8068. Only 1 crossing found permit indicates 2 irrigation culverst. Need to contact owner to obtain additional details of crossing. FIELD_STRUCT_DESC: To retain two irrigation culverts and siphons located at the intersection of Ash Slough and the Chowchilla Canal. FS Date: 05/06/2014

View of riser located on waterward side.

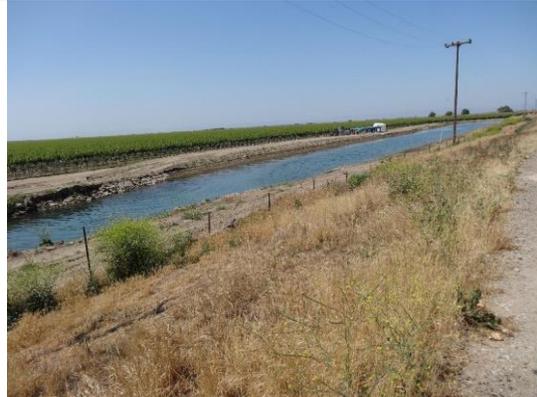
Photo 2 of 3 : UCIP_FA_2015_6124.jpg

LM Start	0.01	Rating **	M	Issue No.	47 (cont)
LM End	0.01	Issue Type +	En	Location *	LS
Category	Supplemental			GPS Latitude/Longitude	
				Start	End
Item	DWR UCIP Field Study			37.045532 °	37.045532 °
				-120.427268 °	-120.427268 °
DWR ID					
Action/Comments					
Inspector Comments: FS_ID:39686 DS_ID:21585 EP_NO: 8068 FS_HLM: 0 Repair Type: Non-Urgent Crossing Status: Found UCIP Comments: Unable to confirm if crossing found in the field corresponds to the crossing described under Permit 8068. Only 1 crossing found permit indicates 2 irrigation culverst. Need to contact owner to obtain additional details of crossing. FIELD_STRUCT_DESC: To retain two irrigation culverts and siphons located at the intersection of Ash Slough and the Chowchilla Canal. FS Date: 05/06/2014

View of landward side.

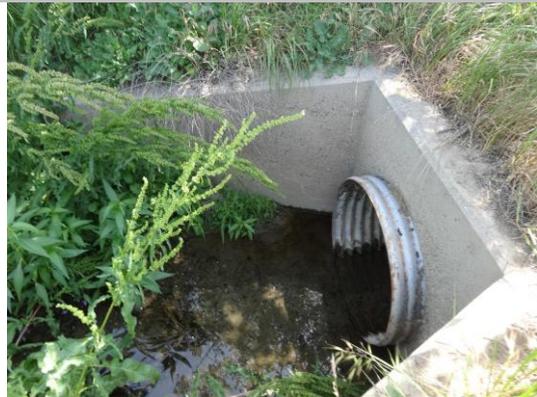
Photo 3 of 3 : UCIP_FA_2015_6125.jpg

Pipe outlet on waterward side.

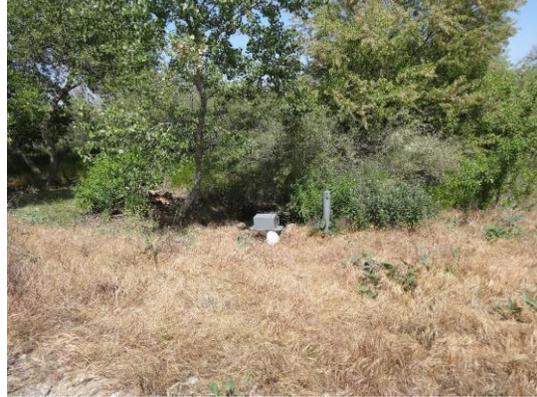
Photo 1 of 3 : UCIP_FA_2015_4048.jpg

LM Start	0.31	Rating **	M	Issue No.	48
LM End	0.31	Issue Type +	En	Location *	WS
Category	Supplemental			GPS Latitude/Longitude	
				Start	End
Item	DWR UCIP Field Study			37.047245 °	37.047245 °
				-120.422403 °	-120.422403 °
DWR ID					
Action/Comments					
Inspector Comments: FS_ID:35764 DS_ID:21514 EP_NO: N/A FS_HLM: 0.3 Repair Type: Non-Urgent Crossing Status: Found UCIP Comments: Need to contact owner to determine details of crossing and permit information authorizing crossing. Dense vegetation limits the inspector's visibility to identify signs of pipe failure (leaks) along the slope. Recommend removing vegetation along pipe alignment to conduct proper inspection of structure and appurtenances. FIELD_STRUCT_DESC: Pipe through levee at a skew. Concrete discharge structure at waterward end. Standpipe with gage house landward of the levee. No gage house found on landward side. FS Date: 05/06/2014

View of waterward side.

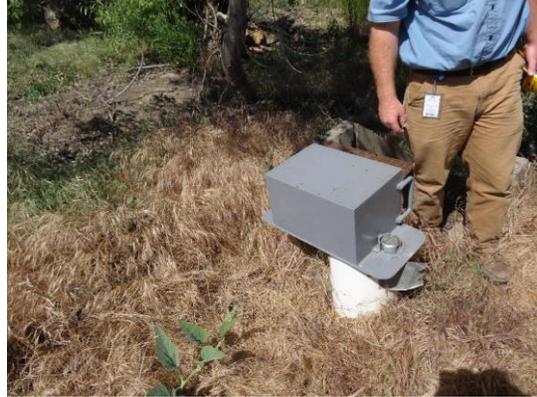
Photo 3 of 3 : UCIP_FA_2015_4050.jpg

LM Start	0.31	Rating **	M	Issue No.	48 (cont)
LM End	0.31	Issue Type +	En	Location *	WS
Category	Supplemental			GPS Latitude/Longitude	
				Start	End
Item	DWR UCIP Field Study			37.047245 °	37.047245 °
				-120.422403 °	-120.422403 °
DWR ID					
Action/Comments					
Inspector Comments: FS_ID:35764 DS_ID:21514 EP_NO: N/A FS_HLM: 0.3 Repair Type: Non-Urgent Crossing Status: Found

Locked box (unknown purpose) located on waterward side.

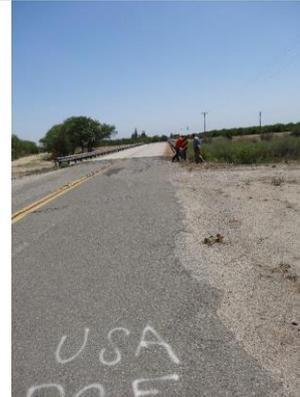
Photo 1 of 3 : UCIP_FA_2015_6800.jpg

LM Start	0.94	Rating **	M	Issue No.	49
LM End	0.94	Issue Type +	En	Location *	WS
Category	Supplemental			GPS Latitude/Longitude	
				Start	End
Item	DWR UCIP Field Study			37.054547 °	37.054547 °
				-120.415826 °	-120.415826 °
DWR ID					
Action/Comments					
Inspector Comments: FS_ID:39923 DS_ID:25043 EP_NO: N/A FS_HLM: 0.88 Repair Type: Non-Urgent Crossing Status: Found UCIP Comments: Need to contact owner to determine status. Need permit authorizing work. FIELD_STRUCT_DESC: 5-inch steel conduit along bridge downstream face. Upstream face has 2-inch pipe cut at the corner. FS Date: 05/06/2014

Overview of bridge.

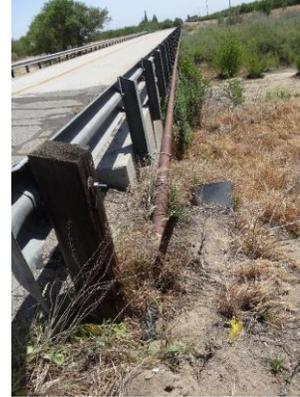
Photo 2 of 3 : UCIP_FA_2015_6801.jpg

LM Start	0.94	Rating **	M	Issue No.	49 (cont)
LM End	0.94	Issue Type +	En	Location *	WS
Category	Supplemental			GPS Latitude/Longitude	
				Start	End
Item	DWR UCIP Field Study			37.054547 °	37.054547 °
				-120.415826 °	-120.415826 °
DWR ID					
Action/Comments					
Inspector Comments: FS_ID:39923 DS_ID:25043 EP_NO: N/A FS_HLM: 0.88 Repair Type: Non-Urgent Crossing Status: Found UCIP Comments: Need to contact owner to determine status. Need permit authorizing work. FIELD_STRUCT_DESC: 5-inch steel conduit along bridge downstream face. Upstream face has 2-inch pipe cut at the corner. FS Date: 05/06/2014

View of steel conduit through levee and above channel.

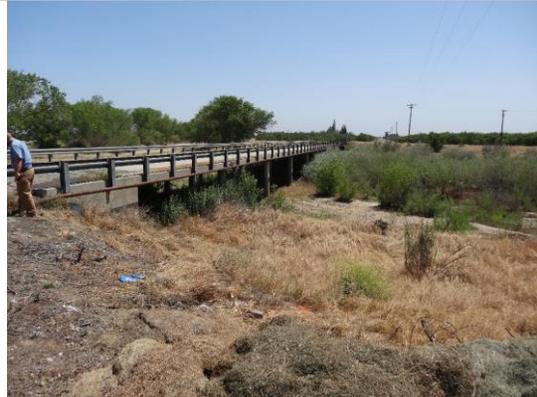
Photo 3 of 3 : UCIP_FA_2015_6803.jpg

Conduit along face of bridge.

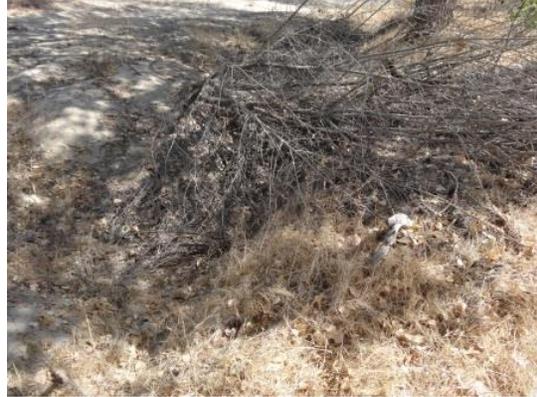
Photo 1 of 2 : SJR2015_NA0011U02RM2.57_3.jpg

LM Start	1.10	Rating **	U	Issue No.	1
LM End	1.19	Issue Type +	Ma	Location *	WS
Category	Supplemental			GPS Latitude/Longitude	
				Start	End
Item	DWR Erosion Survey			37.055596 °	37.055596 °
				-120.412647 °	-120.412647 °
DWR ID

Debris at the site.

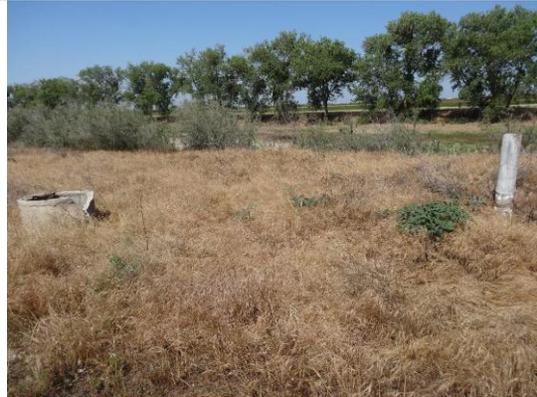
Photo 1 of 3 : UCIP_FA_2015_6802.jpg

LM Start	2.02	Rating **	M	Issue No.	50
LM End	2.02	Issue Type +	En	Location *	WS
Category	Supplemental			GPS Latitude/Longitude	
				Start	End
Item	DWR UCIP Field Study			37.063982 °	37.063982 °
				-120.401165 °	-120.401165 °
DWR ID					
Action/Comments					
Inspector Comments: FS_ID:39925 DS_ID:25045 EP_NO: N/A FS_HLM: 2.06 Repair Type: Non-Urgent Crossing Status: Indicator Found UCIP Comments: Need to contact owner to determine additional information about crossing and potential appurtenances. FIELD_STRUCT_DESC: 36-inch filled with concrete. FS Date: 05/06/2014

Standpipes visible on waterward side.

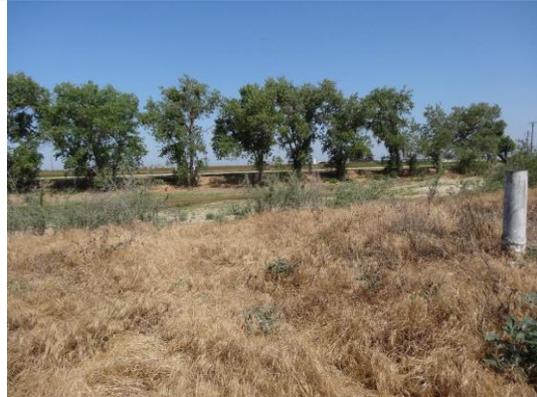
Photo 2 of 3 : UCIP_FA_2015_6804.jpg

LM Start	2.02	Rating **	M	Issue No.	50 (cont)
LM End	2.02	Issue Type +	En	Location *	WS
Category	Supplemental			GPS Latitude/Longitude	
				Start	End
Item	DWR UCIP Field Study			37.063982 °	37.063982 °
				-120.401165 °	-120.401165 °
DWR ID					
Action/Comments					
Inspector Comments: FS_ID:39925 DS_ID:25045 EP_NO: N/A FS_HLM: 2.06 Repair Type: Non-Urgent Crossing Status: Indicator Found UCIP Comments: Need to contact owner to determine additional information about crossing and potential appurtenances. FIELD_STRUCT_DESC: 36-inch filled with concrete. FS Date: 05/06/2014

View of waterward side.

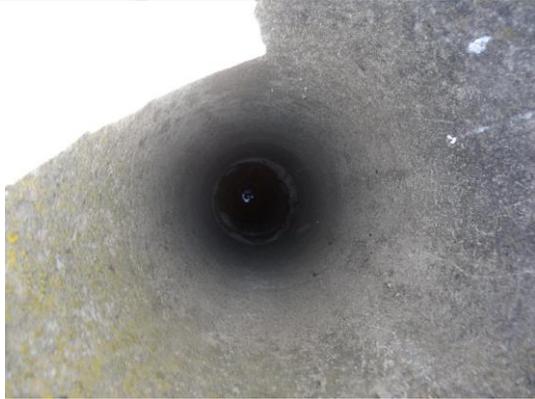
Photo 2 of 3 : UCIP_FA_2015_6798.jpg

LM Start	2.03	Rating **	M	Issue No.	51
LM End	2.03	Issue Type +	En	Location *	WS
Category	Supplemental			GPS Latitude/Longitude	
				Start	End
Item	DWR UCIP Field Study			37.064087 °	37.064087 °
				-120.401194 °	-120.401194 °
DWR ID					
Action/Comments					
Inspector Comments: FS_ID:39924 DS_ID:25044 EP_NO: N/A FS_HLM: 2.061 Repair Type: Non-Urgent Crossing Status: Found

Inside view of 10-inch concrete standpipe.

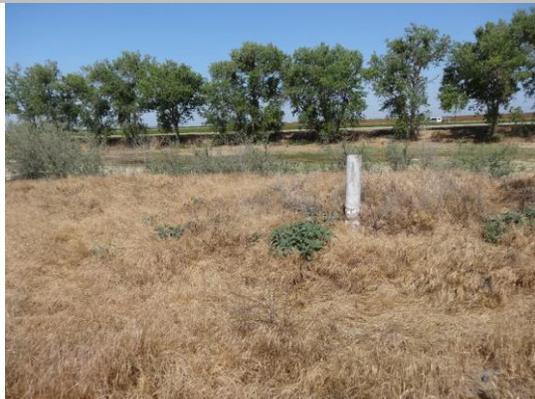
Photo 3 of 3 : UCIP_FA_2015_6799.jpg

Tall concrete standpipe visible on waterward side.

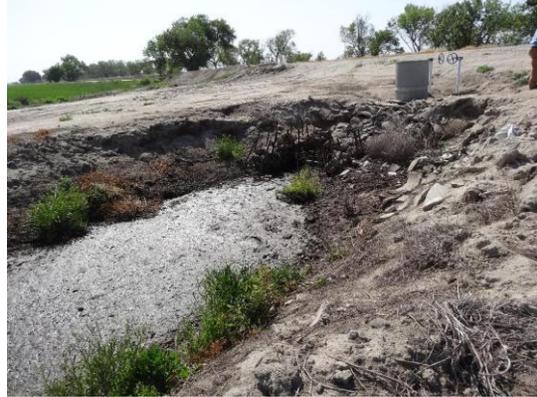
Photo 1 of 3 : UCIP_FA_2015_4054.jpg

LM Start	0.00	Rating **	M	Issue No.	49
LM End	0.00	Issue Type +	En	Location *	LS
Category	Supplemental			GPS Latitude/Longitude	
				Start	End
Item	DWR UCIP Field Study			36.996593 °	36.996593 °
				-120.373636 °	-120.373636 °
DWR ID					
Action/Comments					
Inspector Comments: FS_ID:35767 DS_ID:21516 EP_NO: N/A FS_HLM: 0.01 Repair Type: Non-Urgent Crossing Status: Found UCIP Comments: Unable to confirm if crossing is still being used. Need to contact owner to determine status of crossing. FIELD_STRUCT_DESC: 18-inch steel pipe through levee at unknown depth. Levee log records indicate the abandonment of the Chowchilla Canal Siphon was backfilled through the levee section. Pipe through levee slant pump on waterward slope. FS Date: 05/06/2014

Canal located on landward side.

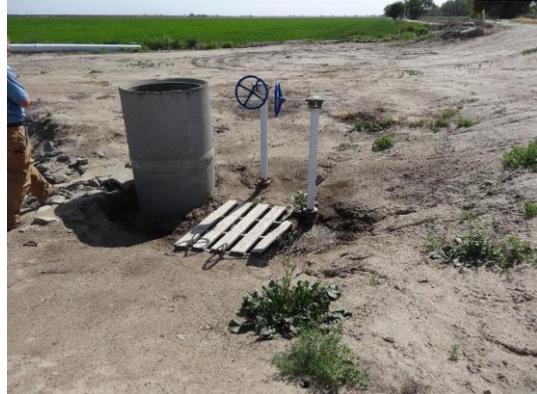
Photo 2 of 3 : UCIP_FA_2015_4055.jpg

Close up of concrete standpipe and multiple positive closure devices.

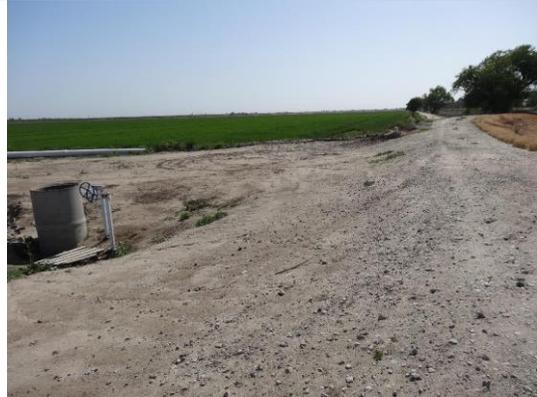
Photo 3 of 3 : UCIP_FA_2015_4056.jpg

LM Start	0.00	Rating **	M	Issue No.	49 (cont)
LM End	0.00	Issue Type +	En	Location *	LS
Category	Supplemental			GPS Latitude/Longitude	
				Start	End
Item	DWR UCIP Field Study			36.996593 °	36.996593 °
				-120.373636 °	-120.373636 °
DWR ID					
Action/Comments					
Inspector Comments: FS_ID:35767 DS_ID:21516 EP_NO: N/A FS_HLM: 0.01 Repair Type: Non-Urgent Crossing Status: Found

View of landward side.

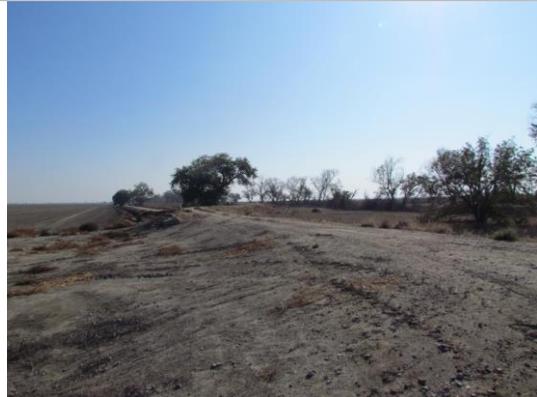
Photo 1 of 1 : FA_2015_NA0011_144_1_20151026_00009.jpg

LM Start	0.01	Rating **	M	Issue No.	1
LM End	1.04	Issue Type +	Ma	Location *	LS
Category	Earthen Levee			GPS Latitude/Longitude	
				Start	End
Item	Vegetation			36.996606 °	36.996592 °
				-120.373860 °	-120.355160 °
DWR ID	DWR_NA0011_03_s_2013_1				
Action/Comments					
Remove the wild growth other than native grasses from the levee slopes. Inspector Comments: Remove the unwanted tumble weeds and other weeds from the land side levee section.

Berenda Slough Unit 3 levee mile 0.01 looking upstream from the landside slope to levee mile 1.04.

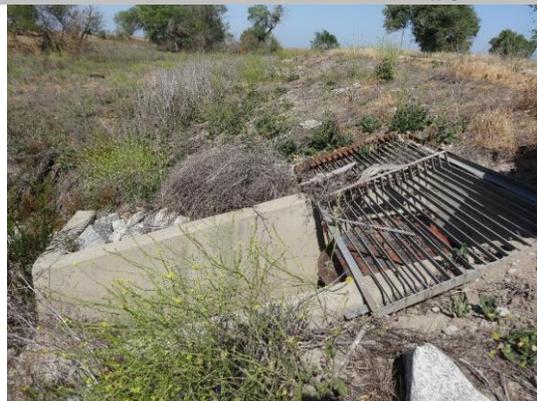
Photo 1 of 3 : UCIP_FA_2015_5000.jpg

LM Start	0.10	Rating **	M	Issue No.	50
LM End	0.10	Issue Type +	En	Location *	LS
Category	Supplemental			GPS Latitude/Longitude	
				Start	End
Item	DWR UCIP Field Study			36.996177 °	36.996177 °
				-120.371967 °	-120.371967 °
DWR ID					
Action/Comments					
Inspector Comments: FS_ID:38228 DS_ID:21517 EP_NO: N/A FS_HLM: 0.11 Repair Type: Non-Urgent Crossing Status: Found UCIP Comments: Need to contact owner to determine status of crossing. Unable to determine if crossing is in use. FIELD_STRUCT_DESC: 36-inch CM pipe through the levee, 7.3 feet below the crown. Headwalls and wing walls on both ends. Flap gate on waterward end. FS Date: 05/06/2014

Debris screen visible on waterward headwall.

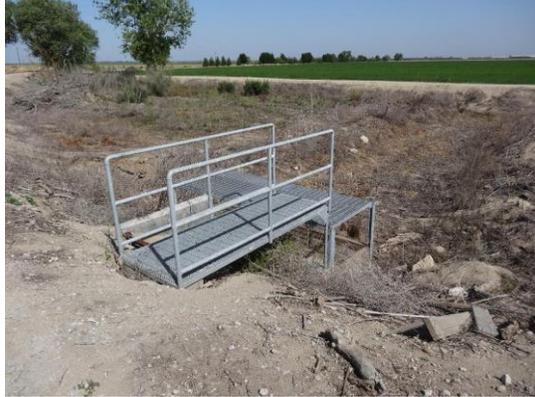
Photo 2 of 3 : UCIP_FA_2015_5001.jpg

LM Start	0.10	Rating **	M	Issue No.	50 (cont)
LM End	0.10	Issue Type +	En	Location *	LS
Category	Supplemental			GPS Latitude/Longitude	
				Start	End
Item	DWR UCIP Field Study			36.996177 °	36.996177 °
				-120.371967 °	-120.371967 °
DWR ID					
Action/Comments					
Inspector Comments: FS_ID:38228 DS_ID:21517 EP_NO: N/A FS_HLM: 0.11 Repair Type: Non-Urgent Crossing Status: Found UCIP Comments: Need to contact owner to determine status of crossing. Unable to determine if crossing is in use. FIELD_STRUCT_DESC: 36-inch CM pipe through the levee, 7.3 feet below the crown. Headwalls and wing walls on both ends. Flap gate on waterward end. FS Date: 05/06/2014

View of landward side.

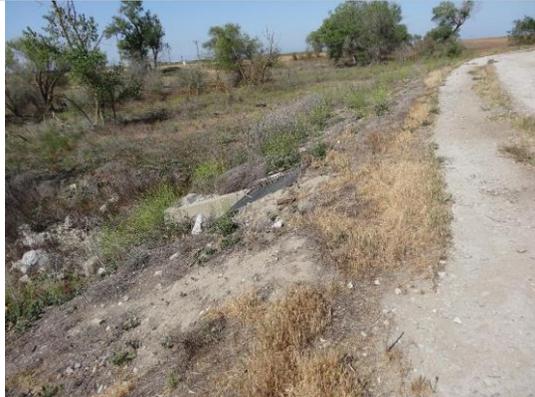
Photo 3 of 3 : UCIP_FA_2015_5002.jpg

View of waterward side.

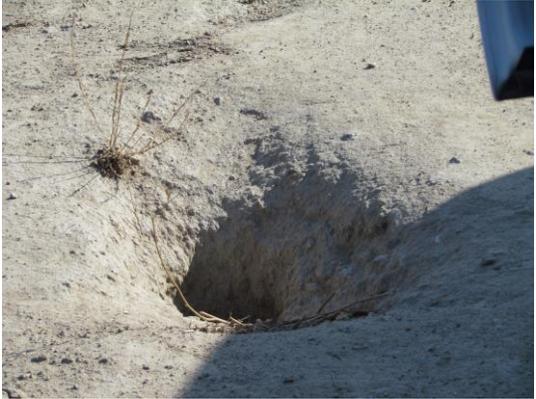
Photo 2 of 2 : FA_2015_NA0011_144_41_20151026_00011.jpg

LM Start	0.71	Rating **	U	Issue No.	41
LM End	1.51	Issue Type +	Ma	Location *	LS
Category	Earthen Levee		GPS Latitude/Longitude		
			Start	End	
Item	Animal Control		36.996240 °	36.996583 °	
			-120.361028 °	-120.346680 °	
DWR ID	DWR_NA0011_03_f_2014_41				
Action/Comments					
Repair the levee slope damaged by livestock and prevent large animal access. Inspector Comments: Need bait stations present where rodents are active.

View of other rodent holes in the landside levee slope.

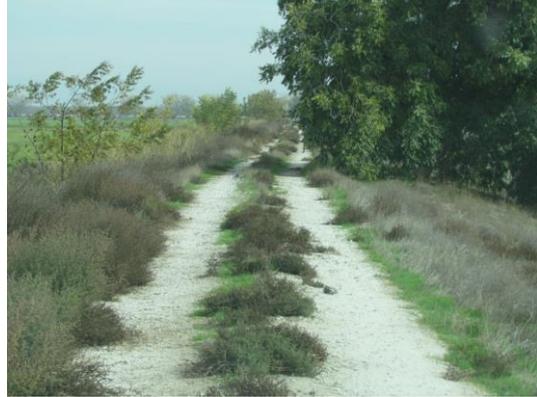
Photo 1 of 1 : FA_2015_NA0011_144_44_20150915_00007.jpg

LM Start	1.04	Rating **	U	Issue No.	44
LM End	1.51	Issue Type +	Ma	Location *	CR
Category	Earthen Levee			GPS Latitude/Longitude	
				Start	End
Item	Vegetation			36.996592 °	36.996583 °
				-120.355155 °	-120.346680 °
DWR ID	DWR_NA0011_03_s_2014_44				
Action/Comments					
Keep the crown roadway free of vegetation. Inspector Comments: Keep crown roadway free of vegetation.

Looking upstream from levee mile 1.04 to levee mile 1.52 crown roadway overgrown with tall weeds.

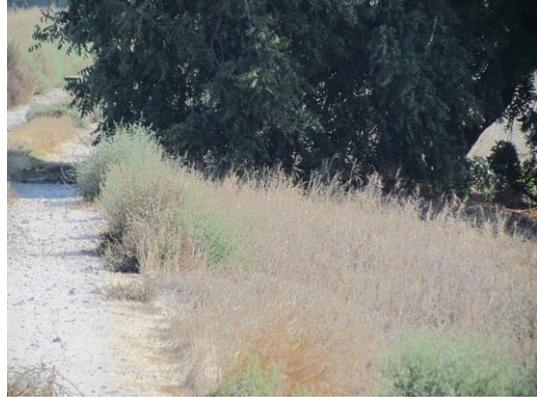
Photo 1 of 1 : FA_2015_NA0011_144_4_20151026_00012.jpg

LM Start	1.04	Rating **	U	Issue No.	4
LM End	1.51	Issue Type +	Ma	Location *	WS
Category	Earthen Levee		GPS Latitude/Longitude		
			Start	End	
Item	Vegetation		36.996568 °	36.996583 °	
			-120.355028 °	-120.346680 °	
DWR ID	DWR_NA0011_03_s_2012_4				
Action/Comments					
Remove the wild growth other than native grasses from the levee slopes. Inspector Comments: Tall unwanted weeds and trees on the slope and shoulder waterside looking upstream.

Berenda Slough looking downstream from the waterside levee slope and shoulder.

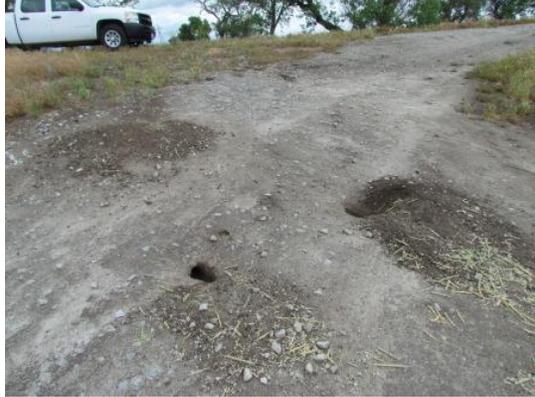
Photo 1 of 1 : FA_2015_NA0011_145_2_20150915_00002.jpg

LM Start	0.01	Rating **	U	Issue No.	2
LM End	0.45	Issue Type +	Ma	Location *	LS
Category	Earthen Levee		GPS Latitude/Longitude		
			Start	End	
Item	Animal Control		36.995499 °	36.995610 °	
			-121.373370 °	-120.365297 °	
DWR ID	DWR_NA0011_04_s_2012_2				
Action/Comments					
Exterminate rodents and backfill and compact or grout burrows. Inspector Comments: Did not see any rodents but there is activity here at location, fresh holes present along slope and toe. No new photo taken here.

Large rodent holes on landside slope looking upstream from levee mile 0.01. Photo taken 4-24-2014. No new photo taken no maintenance has been done Fall 2014.

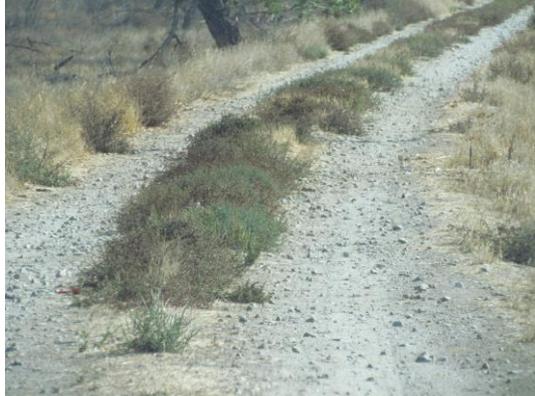
Photo 1 of 1 : FA_2015_NA0011_145_5_20151026_00016.jpg

LM Start	0.01	Rating **	U	Issue No.	5
LM End	1.49	Issue Type +	Ma	Location *	CR
Category	Earthen Levee		GPS Latitude/Longitude		
			Start	End	
Item	Vegetation		36.995507 °	36.995597 °	
			-120.373318 °	-120.346548 °	
DWR ID	DWR_NA0011_04_f_2015_5				
Action/Comments					
Keep the crown roadway free of vegetation.

Berenda Slough looking upstream

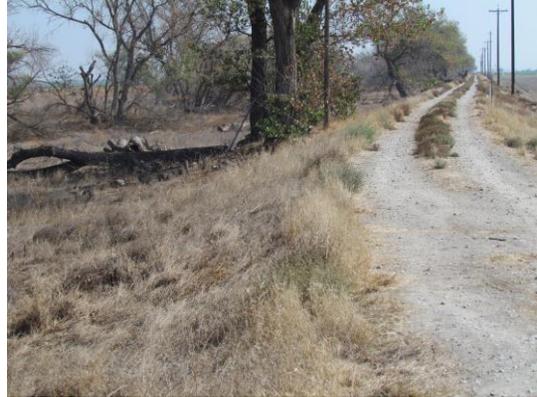
Photo 1 of 1 : FA_2015_NA0011_145_4_20151026_00014.jpg

LM Start	0.01	Rating **	U	Issue No.	4
LM End	1.60	Issue Type +	Ma	Location *	WS
Category	Earthen Levee			GPS Latitude/Longitude	
				Start	End
Item	Vegetation			36.995493 °	36.996215 °
				-120.373242 °	-120.344808 °
DWR ID	DWR_NA0011_04_f_2014_4				
Action/Comments					
Remove the wild growth other than native grasses from the levee slopes. Inspector Comments: No maintenance has been done in several years, the weeds are 3.0 feet tall. The condition of the levee slopes can't be seen through wild weeds.

Berenda Slough looking upstream at the waterside levee slope and shoulder levee mile 0.01- 1.60.

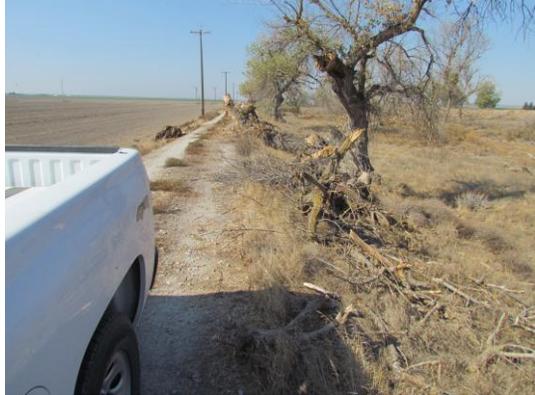
Photo 1 of 1 : FA_2015_NA0011_145_15_20151026_00017.jpg

LM Start	0.14	Rating **	U	Issue No.	15
LM End	0.14	Issue Type +	Ma	Location *	CR
Category	Earthen Levee			GPS Latitude/Longitude	
				Start	End
Item	Encroachments			36.995528 °	36.995528 °
				-120.370922 °	-120.370922 °
DWR ID	DWR_NA0011_04_f_2015_15				
Action/Comments					
Tree or limb Inspector Comments: There are many dead trees in the area. This one happened to be blocking the crown roadway. Remove the dead trees from the levee section. Many more are subject to fall and further block access to the levee crown.

Berenda Slough looking upstream from levee mile 0.14 at dead tree blocking the levee crown roadway.

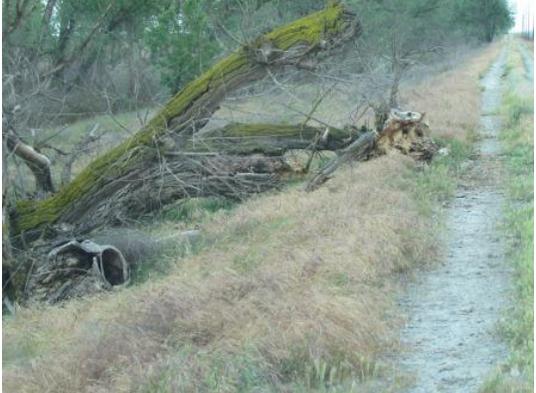
Photo 1 of 1 : FA_2015_NA0011_145_16_20150915_00008.jpg

LM Start	0.47	Rating **	U	Issue No.	16
LM End	0.47	Issue Type +	Ma	Location *	WS
Category	Earthen Levee		GPS Latitude/Longitude		
			Start	End	
Item	Encroachments		36.995603 °	36.995603 °	
			-120.364978 °	-120.364978 °	
DWR ID	DWR_NA0011_04_s_2014_16				
Action/Comments					
Tree or limb Inspector Comments: This dead tree on water ward slope should be removed from levee section. Not removed during fall inspection 2015.

A large cottonwood tree has fallen down across levee slope and shoulder should be removed from levee section. Tree not removed during Fall 2014.

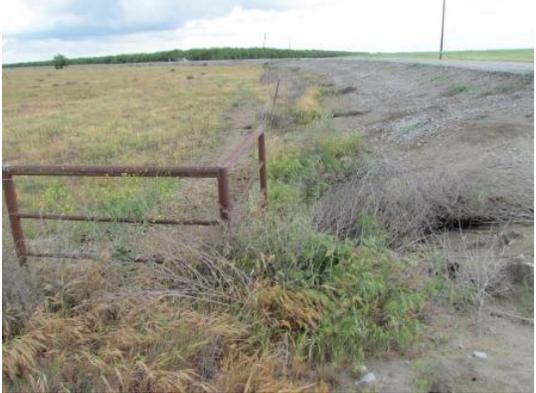
Photo 1 of 1 : FA_2015_NA0011_145_56_20150915_00012.jpg

LM Start	1.51	Rating **	M	Issue No.	56
LM End	2.28	Issue Type +	En	Location *	WS
Category	Earthen Levee		GPS Latitude/Longitude		
			Start	End	
Item	Encroachments		36.995615 °	37.003441 °	
			-120.346296 °	-121.337349 °	
DWR ID	DWR_NA0011_04_s_2012_56				
Action/Comments					
Fence Inspector Comments: No new photo was taken Fall 2014.

Fence within the 10-foot of levee toe. This encroachment was recorded on 11-01-2012. Photo was taken 4-24-2014.

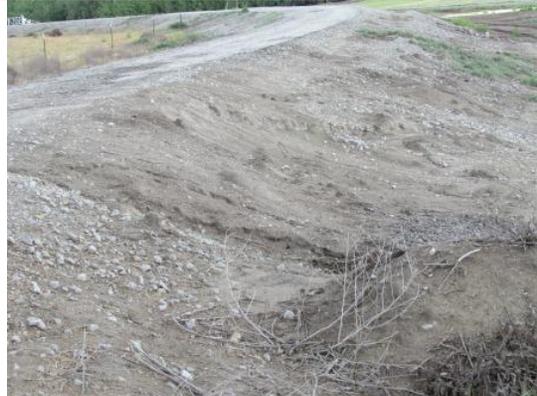
Photo 2 of 2 : FA_2015_NA0011_145_9_20150915_00006.jpg

LM Start	1.51	Rating **	U	Issue No.	9 (cont)
LM End	1.51	Issue Type +	Ma	Location *	LS

Levee mile 1.51 landward slope remains unrepaired by the landowner. Photo taken 4-24-2014. No new photo taken Fall 2014. no change.

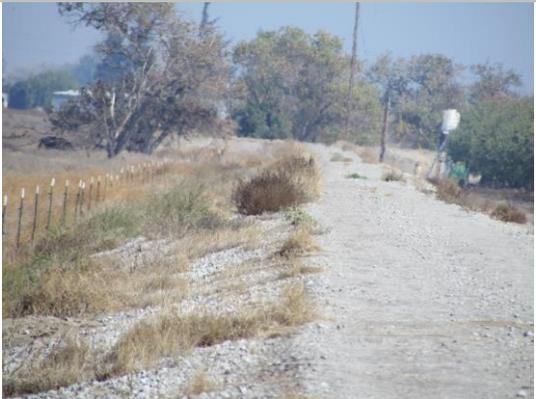
Photo 2 of 2 : FA_2015_NA0011_145_30_20151026_00019.jpg

LM Start	1.63	Rating **	U	Issue No.	30 (cont)
LM End	2.23	Issue Type +	Ma	Location *	WS
Category	Earthen Levee		GPS Latitude/Longitude		
			Start	End	
Item	Animal Control		36.996503 °	37.003308 °	
			-120.344465 °	-120.337550 °	
DWR ID	DWR_NA0011_04_f_2014_30				
Action/Comments					
Exterminate rodents and backfill and compact or grout burrows. Inspector Comments: Bait stations are needed in Rodent infested area.

Berenda Slough looking upstream water side levee slope covered with rodent holes.

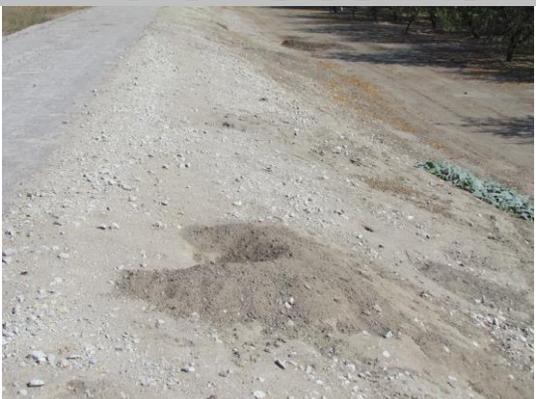
Photo 1 of 1 : FA_2015_NA0011_145_57_20151026_00018.jpg

LM Start	1.63	Rating **	U	Issue No.	57
LM End	2.23	Issue Type +	Ma	Location *	LS
Category	Earthen Levee		GPS Latitude/Longitude		
			Start	End	
Item	Animal Control		36.996574 °	37.003328 °	
			-120.344430 °	-120.337604 °	
DWR ID	DWR_NA0011_04_s_2012_57				
Action/Comments					
Exterminate rodents and backfill and compact or grout burrows. Inspector Comments: The District really needs to do a better job of controlling the rodents. There should be bait stations with rodent bait in place. (2013).

Berenda Slough looking downstream from the landside slope at large rodent holes on the slope shoulder and crown roadway.

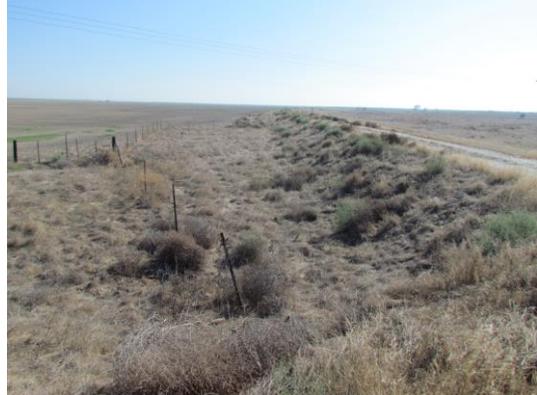
Photo 1 of 1 : FA_2015_NA0011_146_7_20151022_00011.jpg

LM Start	0.00	Rating **	U	Issue No.	7
LM End	4.05	Issue Type +	Ma	Location *	LS
Category	Earthen Levee		GPS Latitude/Longitude		
			Start	End	
Item	Vegetation		36.978557 °	36.968152 °	
			-120.368423 °	-120.301103 °	
DWR ID	DWR_NA0011_05_f_2015_7				
Action/Comments					
Control annual grass and weeds on the levee slopes and easements. Inspector Comments: Remove the unsatisfactory tall tumble weed from the landside slope.

Fresno River levee mile 0.00 looking downstream landside slope.

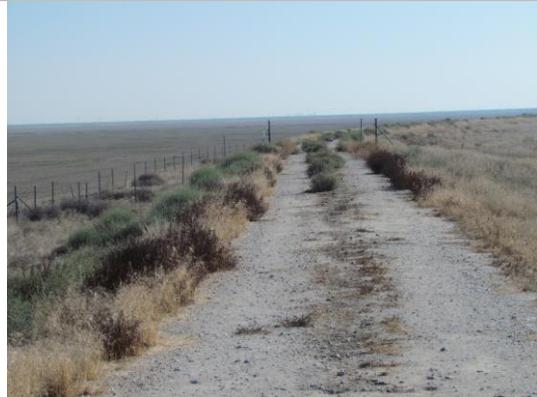
Photo 1 of 1 : FA_2015_NA0011_146_8_20151022_00010.jpg

LM Start	0.00	Rating **	U	Issue No.	8
LM End	4.05	Issue Type +	Ma	Location *	CR
Category	Earthen Levee		GPS Latitude/Longitude		
			Start	End	
Item	Vegetation		36.978557 °	36.968152 °	
			-120.368423 °	-120.301103 °	
DWR ID	DWR_NA0011_05_f_2015_8				
Action/Comments					
Keep the crown roadway free of vegetation. Inspector Comments: Looking downstream from levee mile 0.00 crown roadway overgrown with tumble weeds.

Remove the unsatisfactory weeds from the crown roadway from 0.00 to 4.05.

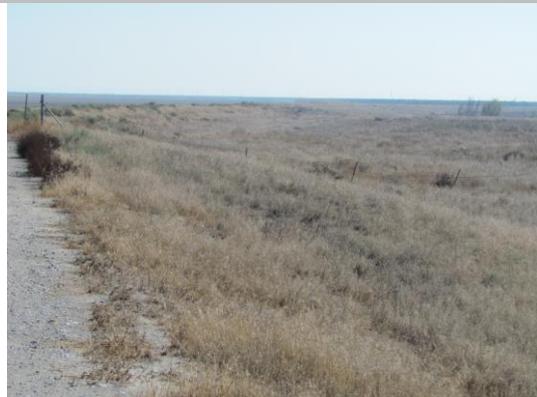
Photo 1 of 1 : FA_2015_NA0011_146_9_20151027_00019.jpg

LM Start	0.00	Rating **	U	Issue No.	9
LM End	4.06	Issue Type +	Ma	Location *	WS
Category	Earthen Levee		GPS Latitude/Longitude		
			Start	End	
Item	Vegetation		36.978557 °	36.968192 °	
			-120.368423 °	-120.300930 °	
DWR ID	DWR_NA0011_05_f_2015_9				
Action/Comments					
Control annual grass and weeds on the levee slopes and easements. Inspector Comments: Remove the tumble weed and other tall unwanted weeds from the landside levee slope and toe.

Fresno River looking downstream from levee mile 0.00 waterside slope.

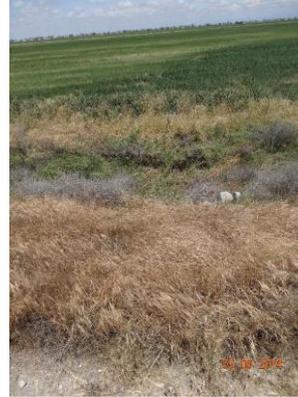
Photo 1 of 3 : UCIP_FA_2015_5012.jpg

LM Start	0.18	Rating **	M	Issue No.	46
LM End	0.18	Issue Type +	En	Location *	WS
Category	Supplemental			GPS Latitude/Longitude	
				Start	End
Item	DWR UCIP Field Study			36.978036 °	36.978036 °
				-120.365246 °	-120.365246 °
DWR ID					
Action/Comments					
Inspector Comments: FS_ID:35795 DS_ID:21520 EP_NO: N/A FS_HLM: 0.19 Repair Type: Non-Urgent Crossing Status: Found UCIP Comments: Need to contact owner. Dense vegetation limits the inspector's visibility to identify signs of pipe failure (leaks) along the landward slope. Recommend removing vegetation along pipe alignment to conduct proper inspection of structure. FIELD_STRUCT_DESC: 36-inch CM pipe through the levee, 10.8 feet below the crown. Headwalls and wing walls on both ends. Flap gate on waterward end. FS Date: 05/06/2014

View of landward side.

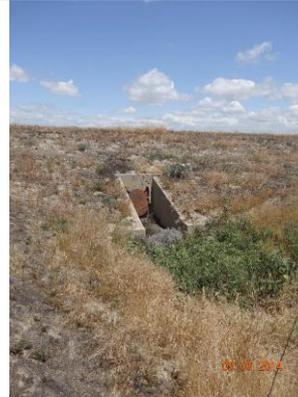
Photo 2 of 3 : UCIP_FA_2015_5022.jpg

LM Start	0.18	Rating **	M	Issue No.	46 (cont)
LM End	0.18	Issue Type +	En	Location *	WS

View of flap gate and concrete headwall located on waterward side.

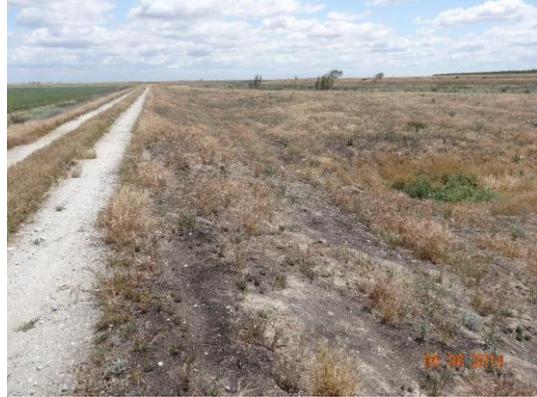
Photo 3 of 3 : UCIP_FA_2015_5023.jpg

LM Start	0.18	Rating **	M	Issue No.	46 (cont)
LM End	0.18	Issue Type +	En	Location *	WS
Category	Supplemental			GPS Latitude/Longitude	
				Start	End
Item	DWR UCIP Field Study			36.978036 °	36.978036 °
				-120.365246 °	-120.365246 °
DWR ID					
Action/Comments					
Inspector Comments: FS_ID:35795 DS_ID:21520 EP_NO: N/A FS_HLM: 0.19 Repair Type: Non-Urgent Crossing Status: Found

View of waterward side.

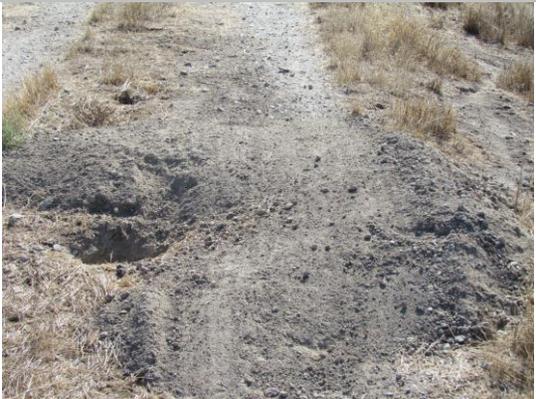
Photo 1 of 1 : FA_2015_NA0011_146_10_20151022_00012.jpg

LM Start	0.39	Rating **	U	Issue No.	10
LM End	0.43	Issue Type +	Ma	Location *	CR
Category	Earthen Levee		GPS Latitude/Longitude		
			Start	End	
Item	Animal Control		36.976962 °	36.976635 °	
			-120.361762 °	-120.361193 °	
DWR ID	DWR_NA0011_05_f_2015_10				
Action/Comments					
Exterminate rodents and backfill and compact or grout burrows. Inspector Comments: Exterminate the rodents and back fill the holes. Bait stations are needed in this area.

Huge rodent holes in the crown road way levee mile 0.39 to 0.43.

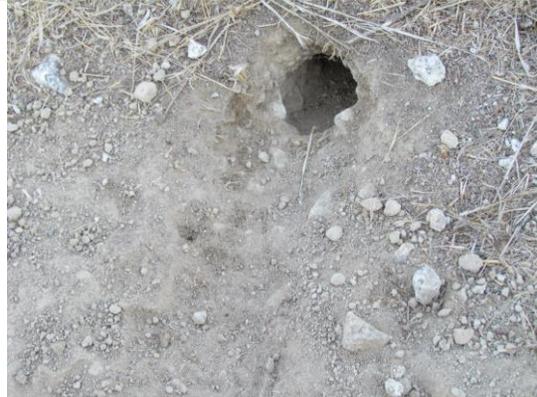
Photo 2 of 2 : FA_2015_NA0011_146_24_20151022_00014.jpg

LM Start	2.80	Rating **	U	Issue No.	24 (cont)
LM End	3.23	Issue Type +	Ma	Location *	CR
Category	Earthen Levee			GPS Latitude/Longitude	
				Start	End
Item	Animal Control			36.968030 °	36.968082 °
				-120.323677 °	-120.315832 °
DWR ID	DWR_NA0011_05_f_2015_24				
Action/Comments					
Exterminate rodents and backfill and compact or grout burrows. Inspector Comments: Exterminate the rodents at this location.

More holes that shows activity.

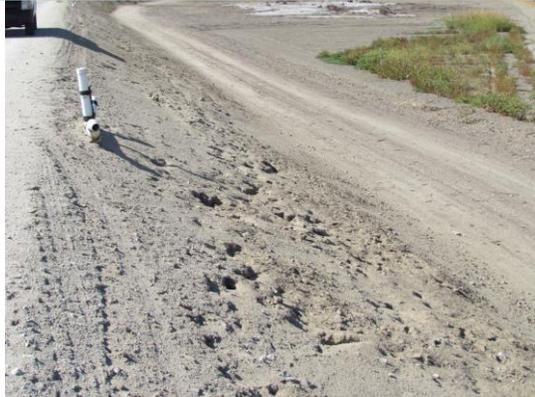
Photo 1 of 1 : FA_2015_NA0011_146_44_20151022_00015.jpg

LM Start	6.63	Rating **	U	Issue No.	44
LM End	6.82	Issue Type +	Ma	Location *	LS
Category	Earthen Levee			GPS Latitude/Longitude	
				Start	End
Item	Animal Control			36.968585 °	36.969465 °
				-120.254425 °	-120.251303 °
DWR ID	DWR_NA0011_05_f_2014_44				
Action/Comments					
Exterminate rodents and backfill and compact or grout burrows.

This area was inundated with rodents from 6.63 to 6.82.

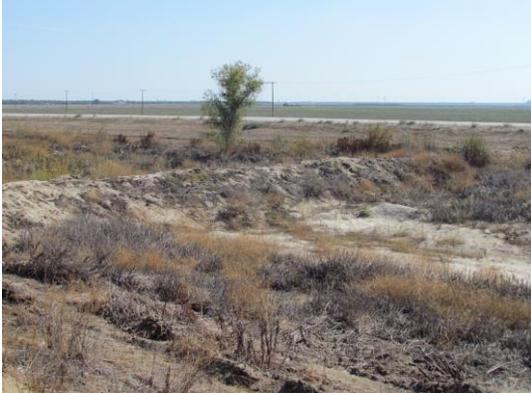
Photo 1 of 1 : FA_2015_NA0011_146_34_20151022_00017.jpg

LM Start	6.65	Rating **	U	Issue No.	34
LM End	6.65	Issue Type +	En	Location *	WS
Category	Rivers, Channels & Designated Floodways			GPS Latitude/Longitude	
				Start	End
Item	Encroachments			36.968625 °	36.968625 °
				-120.254185 °	-120.254185 °
DWR ID	DWR_NA0011_05_f_2015_34				
Action/Comments					
Inspector Comments: This earthen Dam was placed at this location by Chowchilla Flood Control and Public Works Department. I called the Superintendent in the past and reported this as an Unauthorized Encroachment across the Fresno River. He sent out a crew and removed the Dam, the following year they replaced it. This Dam should not be allowed across the channel during Flood season.

Looking at the earthen dam upstream of the Fresno River flood control structure levee mile 6.65.

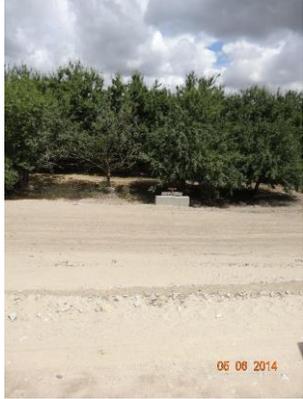
Photo 1 of 3 : UCIP_FA_2015_5003.jpg

LM Start	6.87	Rating **	M	Issue No.	47
LM End	6.87	Issue Type +	En	Location *	WS
Category	Supplemental			GPS Latitude/Longitude	
				Start	End
Item	DWR UCIP Field Study			36.969520 °	36.969520 °
				-120.250311 °	-120.250311 °
DWR ID					
Action/Comments					
Inspector Comments: FS_ID:39006 DS_ID:21527 EP_NO: N/A FS_HLM: 6.94 Repair Type: Non-Urgent Crossing Status: Found UCIP Comments: Need to contact owner. Dense vegetation limits the inspector's visibility to identify signs of pipe failure (leaks) along the waterward slope. Recommend removing vegetation along pipe alignment to conduct proper inspection of structure and appurtenances. Slide gate buried on landward side. Recommend clearing sediment deposit on landward side. FIELD_STRUCT_DESC: 30-inch CM pipe through levee, 9.4 feet below the crown. Headwalls and wingwalls on both ends. Slide gate on landward end. Flap gate on waterward end. FS Date: 05/06/2014

View of landward side.

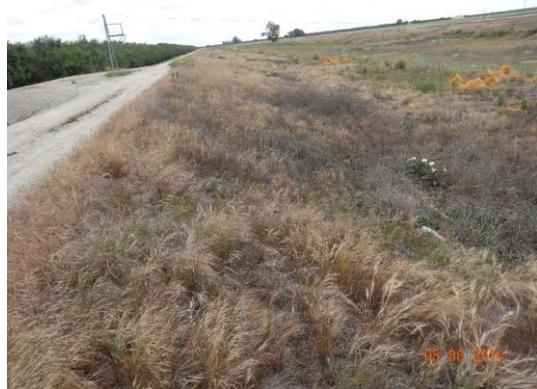
Photo 3 of 3 : UCIP_FA_2015_5005.jpg

LM Start	6.87	Rating **	M	Issue No.	47 (cont)
LM End	6.87	Issue Type +	En	Location *	WS
Category	Supplemental			GPS Latitude/Longitude	
				Start	End
Item	DWR UCIP Field Study			36.969520 °	36.969520 °
				-120.250311 °	-120.250311 °
DWR ID					
Action/Comments					
Inspector Comments: FS_ID:39006 DS_ID:21527 EP_NO: N/A FS_HLM: 6.94 Repair Type: Non-Urgent Crossing Status: Found UCIP Comments: Need to contact owner. Dense vegetation limits the inspector's visibility to identify signs of pipe failure (leaks) along the waterward slope. Recommend removing vegetation along pipe alignment to conduct proper inspection of structure and appurtenances. Slide gate buried on landward side. Recommend clearing sediment deposit on landward side. FIELD_STRUCT_DESC: 30-inch CM pipe through levee, 9.4 feet below the crown. Headwalls and wingwalls on both ends. Slide gate on landward end. Flap gate on waterward end. FS Date: 05/06/2014

View of waterwar side.

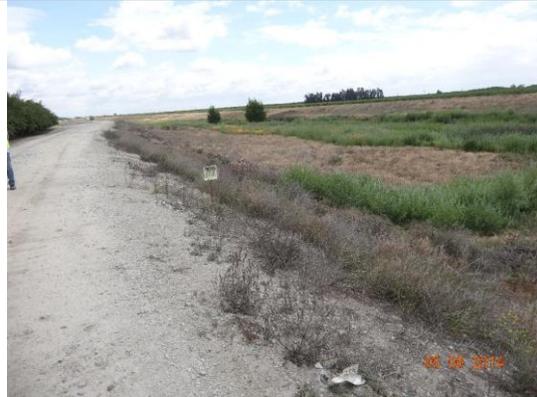
Photo 1 of 3 : UCIP_FA_2015_5006.jpg

LM Start	8.09	Rating **	M	Issue No.	48
LM End	8.09	Issue Type +	En	Location *	CR
Category	Supplemental			GPS Latitude/Longitude	
				Start	End
Item	DWR UCIP Field Study			36.972415 °	36.972415 °
				-120.229285 °	-120.229285 °
DWR ID					
Action/Comments					
Inspector Comments: FS_ID:38235 DS_ID:21528 EP_NO: N/A FS_HLM: 8.171 Repair Type: Non-Urgent Crossing Status: Found UCIP Comments: Need to contact owner. Dense vegetation limits the inspector's visibility to identify signs of pipe failure (leaks) along the waterward slope. Recommend removing vegetation along pipe alignment to conduct proper inspection of structure and appurtenances. FIELD_STRUCT_DESC: 30-inch CM pipe through levee, 8.3 feet below the levee crown. Headwalls and wingwalls on both ends. Flap gate on waterward end. FS Date: 05/06/2014

View of waterward side.

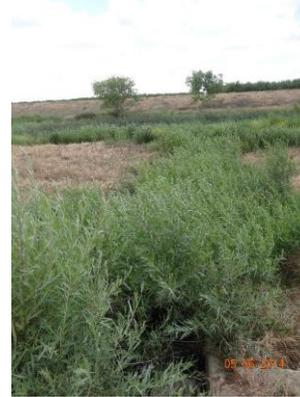
Photo 2 of 3 : UCIP_FA_2015_5007.jpg

LM Start	8.09	Rating **	M	Issue No.	48 (cont)
LM End	8.09	Issue Type +	En	Location *	CR
Category	Supplemental			GPS Latitude/Longitude	
				Start	End
Item	DWR UCIP Field Study			36.972415 °	36.972415 °
				-120.229285 °	-120.229285 °
DWR ID					
Action/Comments					
Inspector Comments: FS_ID:38235 DS_ID:21528 EP_NO: N/A FS_HLM: 8.171 Repair Type: Non-Urgent Crossing Status: Found UCIP Comments: Need to contact owner. Dense vegetation limits the inspector's visibility to identify signs of pipe failure (leaks) along the waterward slope. Recommend removing vegetation along pipe alignment to conduct proper inspection of structure and appurtenances. FIELD_STRUCT_DESC: 30-inch CM pipe through levee, 8.3 feet below the levee crown. Headwalls and wingwalls on both ends. Flap gate on waterward end. FS Date: 05/06/2014

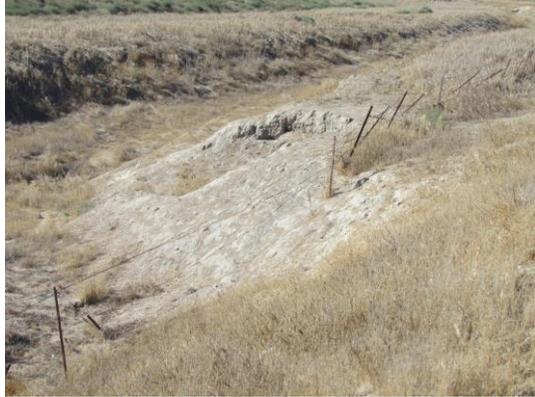
Photo 1 of 1 : FA_2015_NA0011_147_20_20151027_00022.jpg

LM Start	0.44	Rating **	U	Issue No.	20
LM End	0.44	Issue Type +	Ob	Location *	LS
Category	Earthen Levee		GPS Latitude/Longitude		
			Start	End	
Item	Erosion / Bank Caving		36.975030 °	36.975014 °	
			-120.360382 °	-120.360401 °	
DWR ID	DWR_NA0011_06_f_2012_20				
Action/Comments					
Schedule repair of erosion site prior to the next inspection. Inspector Comments: This erosion should be taken care of before it gets worse. During the spring inspection on 4-24-2014 the erosion couldn't be seen as the area was overtaken with weeds.

Looking upstream at the old erosion site landside slope.

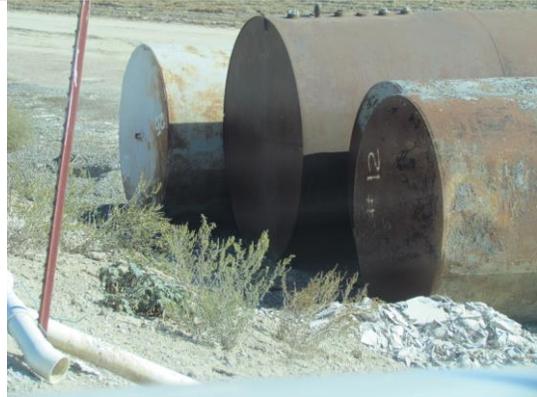
Photo 1 of 1 : FA_2015_NA0011_147_39_20151027_00019.jpg

LM Start	1.16	Rating **	U	Issue No.	39
LM End	1.16	Issue Type +	En	Location *	LS
Category	Earthen Levee		GPS Latitude/Longitude		
			Start	End	
Item	Encroachments		36.967299 °	36.967299 °	
			-120.352014 °	-120.352014 °	
DWR ID	DWR_NA0011_06_s_2014_39				
Action/Comments					
Tank Inspector Comments: Four metal storage tanks are placed on the easement of the landward toe. Move them outside the levee section.

Metal storage tanks within the landside easement.

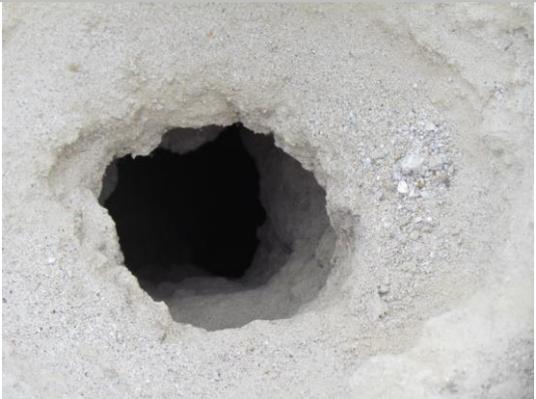
Photo 1 of 1 : FA_2015_NA0011_147_48_20150915_00012.jpg

LM Start	4.13	Rating **	U	Issue No.	48
LM End	4.13	Issue Type +	Ma	Location *	LS
Category	Earthen Levee		GPS Latitude/Longitude		
			Start	End	
Item	Animal Control		36.967465 °	36.967465 °	
			-120.298415 °	-120.298415 °	
DWR ID	DWR_NA0011_06_f_2014_48				
Action/Comments					
Exterminate rodents and backfill and compact or grout burrows. Inspector Comments: Huge rodent hole in crown roadway landward..

Huge Rodent hole in crown roadway and many other holes at this location on the slope and toe.

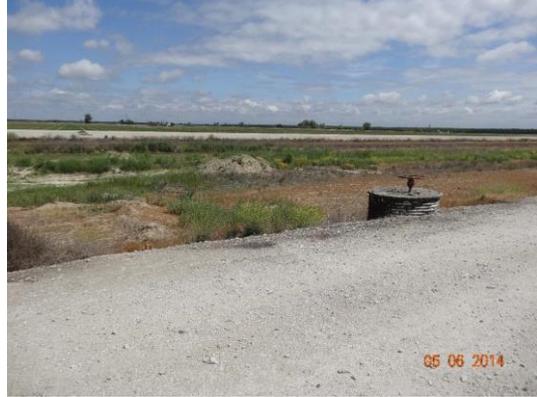
Photo 1 of 3 : UCIP_FA_2015_5024.jpg

LM Start	6.17	Rating **	M	Issue No.	51
LM End	6.17	Issue Type +	En	Location *	LS
Category	Supplemental			GPS Latitude/Longitude	
				Start	End
Item	DWR UCIP Field Study			36.967568 °	36.967568 °
				-120.261594 °	-120.261594 °
DWR ID					
Action/Comments					
Inspector Comments: FS_ID:39008 DS_ID:21531 EP_NO: N/A FS_HLM: 6.24 Repair Type: Non-Urgent Crossing Status: Found UCIP Comments: Need to contact owner. Recommend removing sediment built up on landward side. FIELD_STRUCT_DESC: 48-inch CM pipe through levee, 11.5 feet below the crown. Slide gate on waterward shoulder. Headwalls and wingwalls on both ends. Flap gate on waterward end. FS Date: 05/06/2014

View of waterward side.
