**Flood Control Project Maintenance
Levee Inspections**

Fall 2015 Levee Maintenance Deficiency Summary Report

San Joaquin River Basin

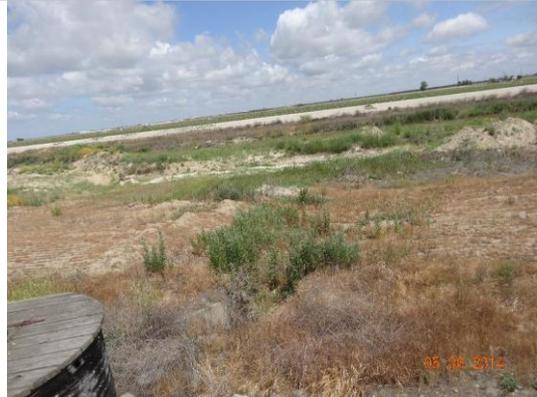
Photo 2 of 3 : UCIP_FA_2015_5025.jpg

Overview of channel at crossing.

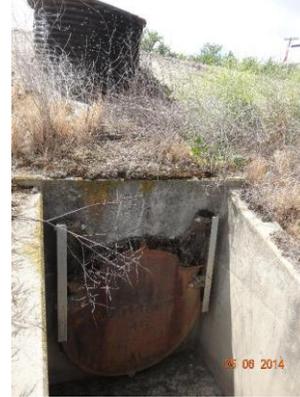
Photo 3 of 3 : UCIP_FA_2015_5026.jpg

LM Start	6.17	Rating **	M	Issue No.	51 (cont)
LM End	6.17	Issue Type +	En	Location *	LS
Category	Supplemental			GPS Latitude/Longitude	
				Start	End
Item	DWR UCIP Field Study			36.967568 °	36.967568 °
				-120.261594 °	-120.261594 °
DWR ID					
Action/Comments					
Inspector Comments: FS_ID:39008 DS_ID:21531 EP_NO: N/A FS_HLM: 6.24 Repair Type: Non-Urgent Crossing Status: Found

Flap gate, concrete headwall, and standpipe on waterward side.

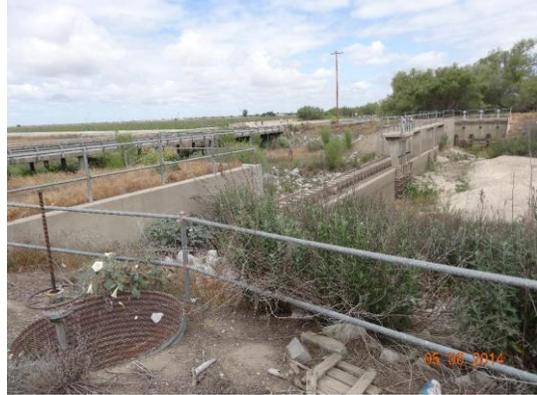
Photo 1 of 3 : UCIP_FA_2015_5009.jpg

LM Start	6.51	Rating **	U	Issue No.	52
LM End	6.51	Issue Type +	En	Location *	LS
Category	Supplemental			GPS Latitude/Longitude	
				Start	End
Item	DWR UCIP Field Study			36.967941 °	36.967941 °
				-120.255467 °	-120.255467 °
DWR ID					
Action/Comments					
Inspector Comments: FS_ID:38237 DS_ID:21532 EP_NO: N/A FS_HLM: 6.59 Repair Type: Urgent Crossing Status: Found UCIP Comments: Need to contact owner. Crossing on landward side appears to be modified--no headwall found on landward end. FIELD_STRUCT_DESC: 30-inch CM pipe through levee 12 feet below crown. Slide gate in 5-foot CM pipe riser on waterward shoulder. Headwalls and wingwalls on waterward end. Headwall on landward end. FS Date: 05/06/2014

View of waterward side.

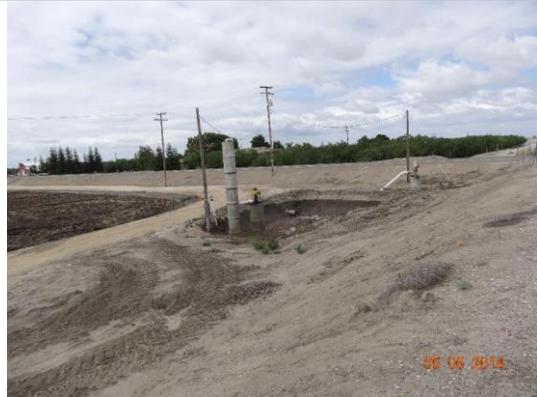
Photo 2 of 3 : UCIP_FA_2015_5010.jpg

Additional structures found on landward side.

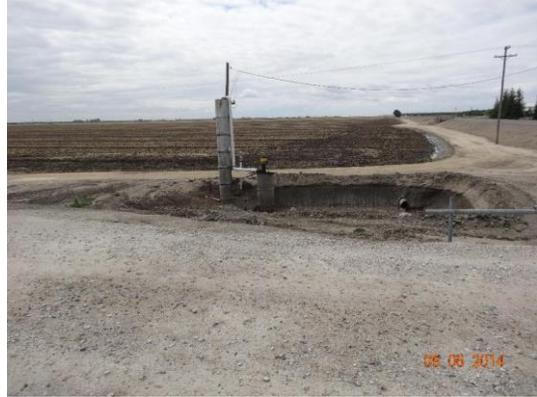
Photo 3 of 3 : UCIP_FA_2015_5011.jpg

LM Start	6.51	Rating **	U	Issue No.	52 (cont)
LM End	6.51	Issue Type +	En	Location *	LS
Category	Supplemental			GPS Latitude/Longitude	
				Start	End
Item	DWR UCIP Field Study			36.967941 °	36.967941 °
				-120.255467 °	-120.255467 °
DWR ID					
Action/Comments					
Inspector Comments: FS_ID:38237 DS_ID:21532 EP_NO: N/A FS_HLM: 6.59 Repair Type: Urgent Crossing Status: Found

View of landward side.

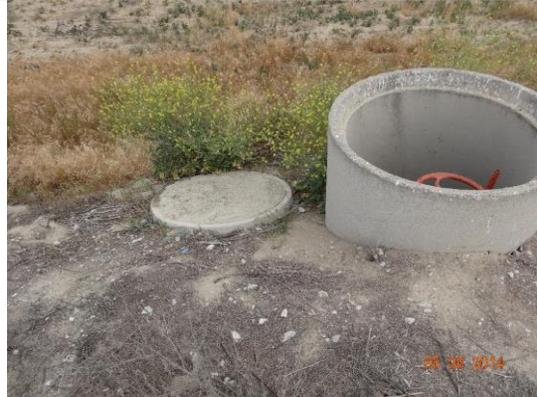
Photo 3 of 3 : UCIP_FA_2015_5029.jpg

LM Start	6.96	Rating **	M	Issue No.	53 (cont)
LM End	6.96	Issue Type +	En	Location *	WS
Category	Supplemental			GPS Latitude/Longitude	
				Start	End
Item	DWR UCIP Field Study			36.968786 °	36.968786 °
				-120.247473 °	-120.247473 °
DWR ID					
Action/Comments					
Inspector Comments: FS_ID:35804 DS_ID:21587 EP_NO: 13837 FS_HLM: 7.04 Repair Type: Non-Urgent Crossing Status: Found

View of concrete standpipe and lid found on waterward shoulder.

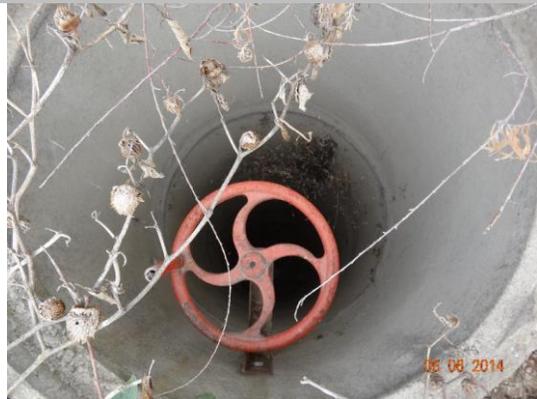
Photo 1 of 3 : UCIP_FA_2015_4728.jpg

LM Start	7.42	Rating **	M	Issue No.	54
LM End	7.42	Issue Type +	En	Location *	WS
Category	Supplemental			GPS Latitude/Longitude	
				Start	End
Item	DWR UCIP Field Study			36.968853 °	36.968853 °
				-120.239154 °	-120.239154 °
DWR ID					
Action/Comments					
Inspector Comments: FS_ID:35805 DS_ID:21588 EP_NO: 13856 FS_HLM: 7.51 Repair Type: Non-Urgent Crossing Status: Found UCIP Comments: Need to contact owner. Dense vegetation limits the inspector's visibility to identify signs of pipe failure (leaks) along the waterward slope. Recommend removing vegetation along pipe alignment to conduct proper inspection of structure and appurtenances. FIELD_STRUCT_DESC: 12 inch diameter gravity reinforced concrete irrigation pipe through levee approximately 4 feet below crown. The pipeline extend from a 24 inch diameter standpipe, located within the overflow area, through the levee section to a 36 inch diameter standpipe located on landward side. Positive closure devise located on waterward side of the levee with an accessible walkway. (Permit No. 13856, Averill Ranch-1984) FS Date: 05/06/2014

Inside view of standpipe located on waterward side.

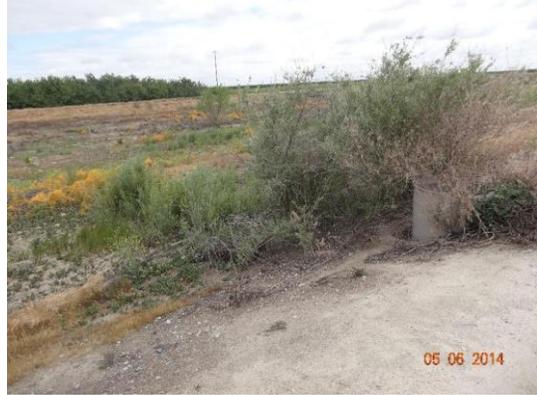
Photo 2 of 3 : UCIP_FA_2015_4729.jpg

View of waterward side.

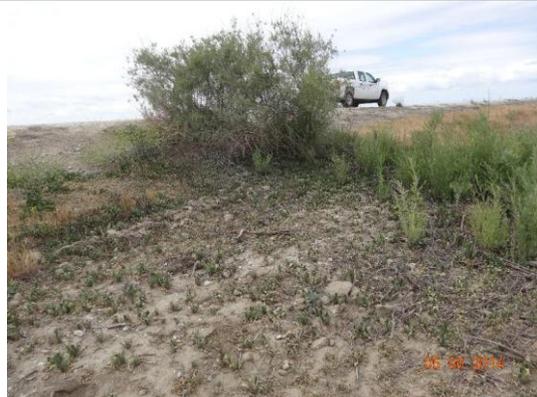
Photo 3 of 3 : UCIP_FA_2015_4730.jpg

View of waterward slope.

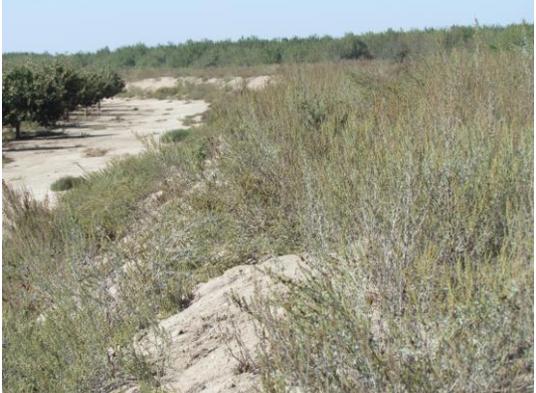
Photo 1 of 1 : FA_2015_NA0011_147_27_20151027_00020.jpg

LM Start	7.63	Rating **	U	Issue No.	27
LM End	8.52	Issue Type +	Ma	Location *	LS
Category	Earthen Levee		GPS Latitude/Longitude		
			Start	End	
Item	Vegetation		36.969052 °	36.971510 °	
			-120.235442 °	-120.220425 °	
DWR ID	DWR_NA0011_06_f_2015_27				
Action/Comments					
Control annual grass and weeds on the levee slopes and easements. Inspector Comments: Remove the tumble weed and other unwanted tall weeds from the landside levee section.

Fresno River Looking at the landside levee slope unsatisfactory tall weeds has covered the slope, shoulder and crown.

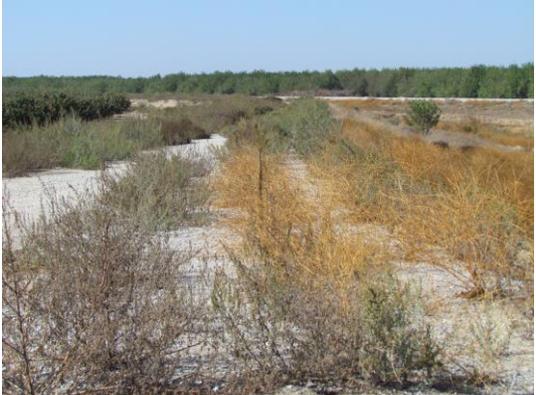
Photo 1 of 1 : FA_2015_NA0011_147_26_20151027_00014.jpg

LM Start	7.68	Rating **	U	Issue No.	26
LM End	8.52	Issue Type +	Ma	Location *	CR
Category	Earthen Levee		GPS Latitude/Longitude		
			Start	End	
Item	Vegetation		36.969402 °	36.971510 °	
			-120.234570 °	-120.220425 °	
DWR ID	DWR_NA0011_06_f_2015_26				
Action/Comments					
Keep the crown roadway free of vegetation. Inspector Comments: Remove the tumble weed and other vegetation from the crown roadway.

Looking downstream from levee mile 7.68 to 8.52 tumble weed and other vegetation has covered the crown roadway.

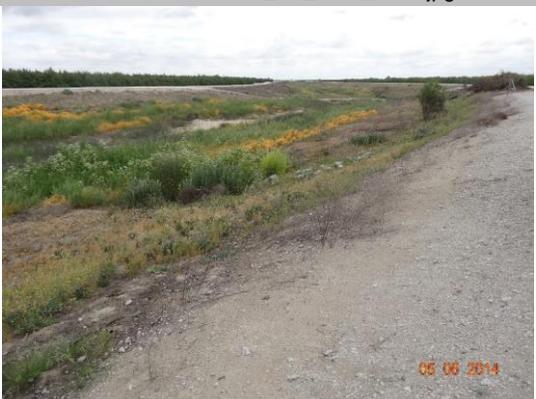
Photo 1 of 3 : UCIP_FA_2015_5168.jpg

LM Start	8.53	Rating **	M	Issue No.	55
LM End	8.53	Issue Type +	En	Location *	WS
Category	Supplemental			GPS Latitude/Longitude	
				Start	End
Item	DWR UCIP Field Study			36.971462 °	36.971462 °
				-120.220276 °	-120.220276 °
DWR ID					
Action/Comments					
Inspector Comments: FS_ID:35806 DS_ID:21534 EP_NO: N/A FS_HLM: 8.64 Repair Type: Non-Urgent Crossing Status: Found UCIP Comments: Need to contact owner. Rip rap has been added around concrete headwall on waterward side--need to determine details for rip rap around structure. FIELD_STRUCT_DESC: 30-inch CM pipe through levee, 11.0 feet below crown. Headwalls and wingwalls on both ends. Flap gate on waterward end. FS Date: 05/06/2014

View of waterward side.

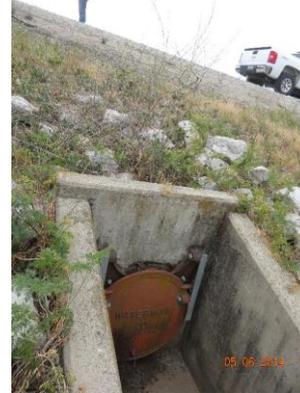
Photo 2 of 3 : UCIP_FA_2015_5169.jpg

Flap gate visible on waterward side.

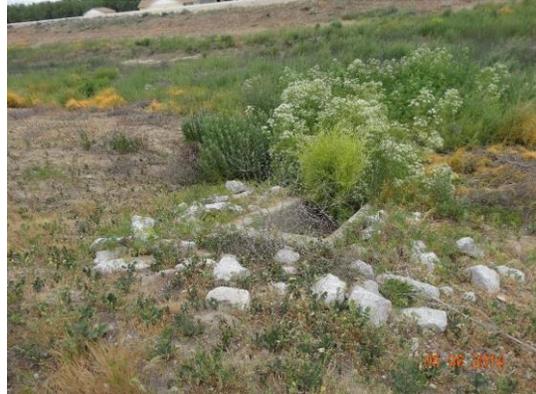
Photo 3 of 3 : UCIP_FA_2015_5170.jpg

Rip rap around concrete headwall located on waterward side.

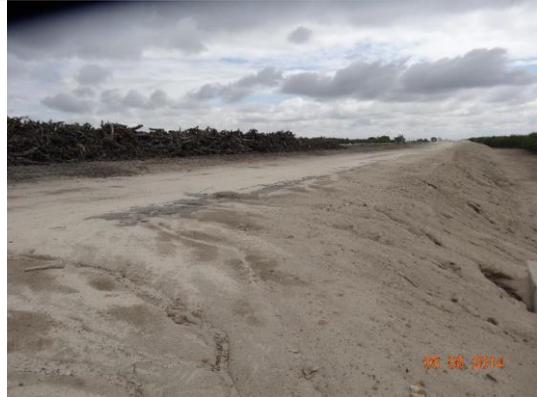
Photo 1 of 3 : UCIP_FA_2015_5171.jpg

LM Start	8.94	Rating **	U	Issue No.	56
LM End	8.94	Issue Type +	En	Location *	WS
Category	Supplemental			GPS Latitude/Longitude	
				Start	End
Item	DWR UCIP Field Study			36.972307 °	36.972307 °
				-120.213185 °	-120.213185 °
DWR ID					
Action/Comments					
Inspector Comments: FS_ID:42857 DS_ID:21530 EP_NO: N/A FS_HLM: 9.05 Repair Type: Urgent Crossing Status: Found UCIP Comments: Need to contact owner. Surface erosion on landward slope unable to determine if pipe failed or if rodent activity burrow hole has caused collapse on slope. Need to determine cause for erosion. FIELD_STRUCT_DESC: 30-inch CM pipe through levee, 10.2 feet below crown. Headwalls and wingwalls on both ends. Flap gate on waterward end. FS Date: 05/06/2014

View of landward side.

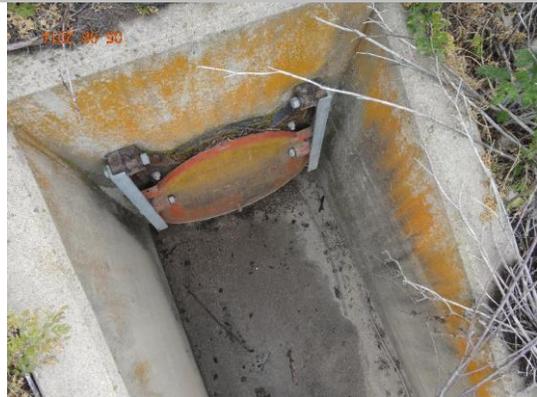
Photo 2 of 3 : UCIP_FA_2015_5172.jpg

Flap gate visible on waterward side.

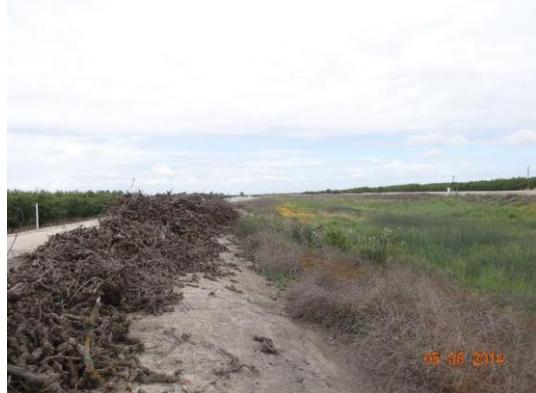
Photo 3 of 3 : UCIP_FA_2015_5173.jpg

LM Start	8.94	Rating **	U	Issue No.	56 (cont)
LM End	8.94	Issue Type +	En	Location *	WS
Category	Supplemental			GPS Latitude/Longitude	
				Start	End
Item	DWR UCIP Field Study			36.972307 °	36.972307 °
				-120.213185 °	-120.213185 °
DWR ID					
Action/Comments					
Inspector Comments: FS_ID:42857 DS_ID:21530 EP_NO: N/A FS_HLM: 9.05 Repair Type: Urgent Crossing Status: Found

View of waterward side.
