**Flood Control Project Maintenance  
Levee Inspections**  
**LMA District Cover Sheet**  
**Spring 2015 Levee Inspection Results**  
**Madera County FCWCA**

**Spring 2015 Levee Inspection Results**

**Madera County FCWCA**

Waterway	Bank	Unit Miles
Unit No. 01 Ash Slough	Right	2.37

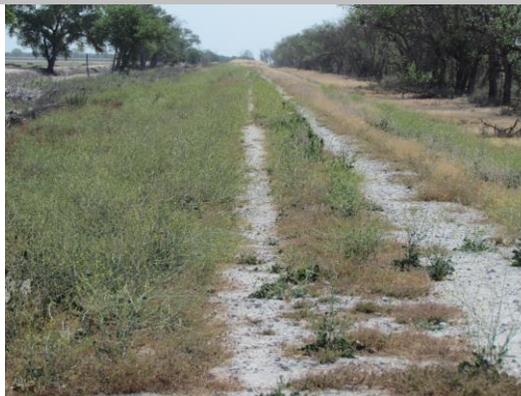
Photo 1 of 1 : SP\_2015\_NA0011\_144\_121\_20150513\_00028.jpg

LM Start	<b>0.15</b>	Rating **	U	Issue No.	<b>121</b>
LM End	<b>0.45</b>	Issue Type +	Ma	Location *	CR
Category	Earthen Levee			GPS Latitude/Longitude	
				Start	End
Item	Vegetation			36.996172 °	36.996213 °
				-120.371185 °	-120.365713 °
DWR ID	DWR_NA0011_03_s_2015_121				
Action/Comments					
Keep the crown roadway free of vegetation. Inspector Comments: Remove the vegetation from the crown roadway.

Crown roadway need to be free of vegetation.

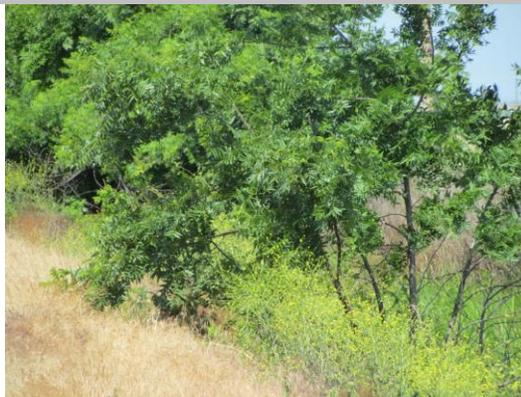
Photo 1 of 1 : SP\_2015\_NA0011\_144\_15\_20150513\_00032.jpg

LM Start	<b>1.07</b>	Rating **	M	Issue No.	<b>15</b>
LM End	<b>1.10</b>	Issue Type +	Ma	Location *	LS
Category	Earthen Levee		GPS Latitude/Longitude		
			Start	End	
Item	Trim / Thin Trees		36.996618 °	36.996633 °	
			-120.354538 °	-120.354012 °	
DWR ID	DWR_NA0011_03_s_2012_15				
Action/Comments					
Trim trees to at least five feet above ground level. Inspector Comments: Remove the small nut trees from the levee slope.

Unacceptable nut trees on the landside levee slope.

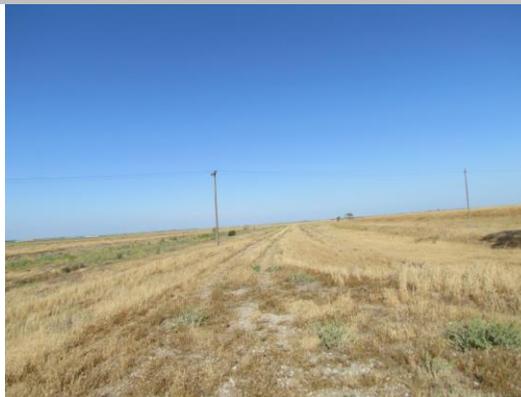
Photo 1 of 1 : SP\_2015\_NA0011\_147\_21\_20150528\_00137.jpg

LM Start	<b>0.00</b>	Rating **	M	Issue No.	<b>21</b>
LM End	<b>1.06</b>	Issue Type +	Ma	Location *	LS
Category	Earthen Levee		GPS Latitude/Longitude		
			Start	End	
Item	Vegetation		36.976994 °	36.968011 °	
			-120.367549 °	-120.353556 °	
DWR ID	DWR_NA0011_06_s_2012_21				
Action/Comments					
Remove the wild growth other than native grasses from the levee slopes. Inspector Comments: Remove the tall weeds from the slopes and from crown roadway.

View of weeds on both slopes and crown roadway.

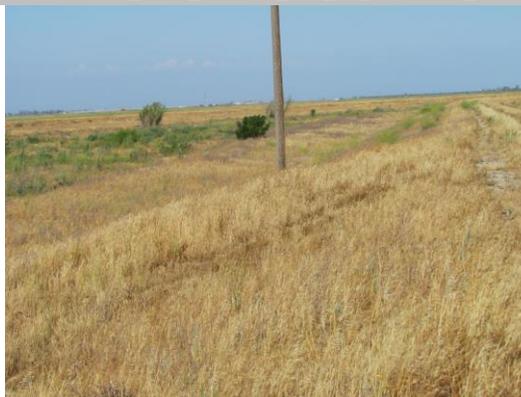
Photo 1 of 1 : SP\_2015\_NA0011\_147\_23\_20150528\_00138.jpg

LM Start	<b>0.00</b>	Rating **	U	Issue No.	<b>23</b>
LM End	<b>3.42</b>	Issue Type +	Ma	Location *	WS
Category	Earthen Levee		GPS Latitude/Longitude		
			Start	End	
Item	Vegetation		36.976994 °	36.967421 °	
			-120.367548 °	-120.311329 °	
DWR ID	DWR_NA0011_06_s_2012_23				
Action/Comments					
Remove the wild growth other than native grasses from the levee slopes. Inspector Comments: Remove the wild growth of weeds from waterside levee shoulder and slope.

Fresno River looking upstream at tall weeds on the waterside slope.
