**Flood Control Project Maintenance  
Levee Inspections**

## Maintenance Issue Types Only, Levee Inspection Report By Mile - Fall 2015

### Madera County FCWCA

Waterway	Bank	Unit Miles	Inspection Start/End	Inspector
Unit No. 01 Ash Slough	Right	2.37	10/21/2015 10/21/2015	Herman Phillips

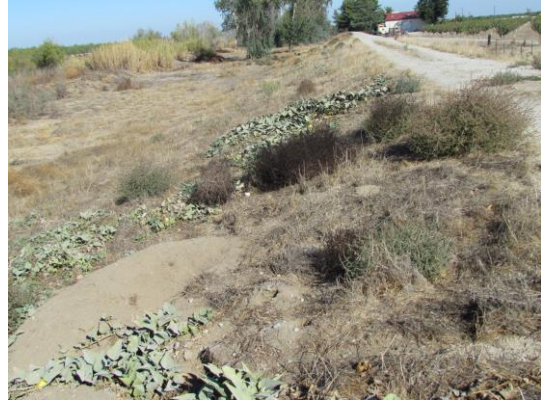
Photo 1 of 1 : FA\_2015\_NA0011\_143\_39\_20151027\_00010.jpg

LM Start	0.00	Rating **	U	Issue No.	39
LM End	1.67	Issue Type +	Ma	Location *	WS
Category	Earthen Levee			GPS Latitude/Longitude	
				Start	End
Item	Animal Control			37.045485 °	37.060091 °
				-120.427423 °	-120.405340 °
DWR ID	DWR_NA0011_02_f _ 2015_39				
Action/Comments					
Exterminate rodents and backfill and compact or grout burrows. Inspector Comments: The levee section waterside is covered with rodents and rodent holes.

Ash Slough looking upstream from levee mile 0.00-1.67 waterside slope.

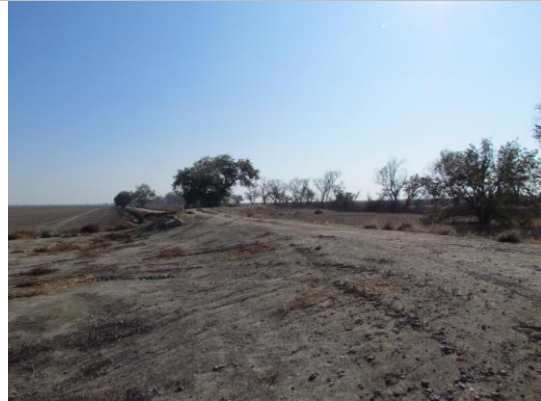
Photo 1 of 1 : FA\_2015\_NA0011\_144\_1\_20151026\_00009.jpg

LM Start	0.01	Rating **	M	Issue No.	1
LM End	1.04	Issue Type +	Ma	Location *	LS
Category	Earthen Levee			GPS Latitude/Longitude	
				Start	End
Item	Vegetation			36.996606 °	36.996592 °
				-120.373860 °	-120.355160 °
DWR ID	DWR_NA0011_03_s _ 2013_1				
Action/Comments					
Remove the wild growth other than native grasses from the levee slopes.					
Inspector Comments: Remove the unwanted tumble weeds and other weeds from the land side levee section.

Berenda Slough Unit 3 levee mile 0.01 looking upstream from the  
landside slope to levee mile 1.04.

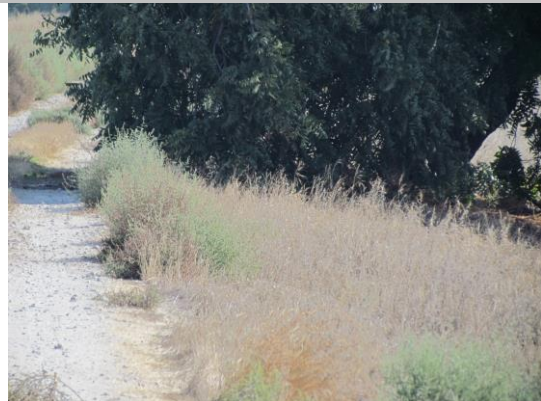
Photo 1 of 1 : FA\_2015\_NA0011\_144\_4\_20151026\_00012.jpg

LM Start	1.04	Rating **	U	Issue No.	4
LM End	1.51	Issue Type +	Ma	Location *	WS
Category	Earthen Levee			GPS Latitude/Longitude	
				Start	End
Item	Vegetation			36.996568 °	36.996583 °
				-120.355028 °	-120.346680 °
DWR ID	DWR_NA0011_03_s_2012_4				
Action/Comments					
Remove the wild growth other than native grasses from the levee slopes.					
Inspector Comments: Tall unwanted weeds and trees on the slope and shoulder waterside looking upstream.

Berenda Slough looking downstream from the waterside levee slope and shoulder.

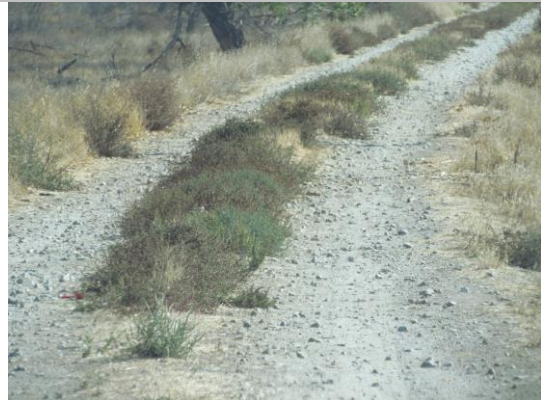
Photo 1 of 1 : FA\_2015\_NA0011\_145\_5\_20151026\_00016.jpg

LM Start	0.01	Rating **	U	Issue No.	5
LM End	1.49	Issue Type +	Ma	Location *	CR
Category	Earthen Levee			GPS Latitude/Longitude	
				Start	End
Item	Vegetation			36.995507 °	36.995597 °
				-120.373318 °	-120.346548 °
DWR ID	DWR_NA0011_04_f_2015_5				
Action/Comments					
Keep the crown roadway free of vegetation.

Berenda Slough looking upstream

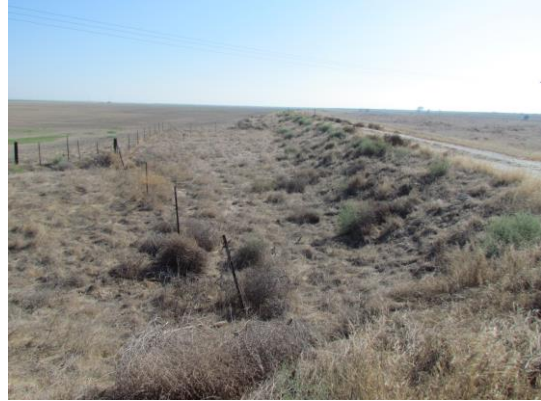
Photo 1 of 1 : FA\_2015\_NA0011\_146\_7\_20151022\_00011.jpg

LM Start	0.00	Rating **	U	Issue No.	7
LM End	4.05	Issue Type +	Ma	Location *	LS
Category	Earthen Levee			GPS Latitude/Longitude	
				Start	End
Item	Vegetation			36.978557 °	36.968152 °
				-120.368423 °	-120.301103 °
DWR ID	DWR_NA0011_05_f _ 2015_7				
Action/Comments					
Control annual grass and weeds on the levee slopes and easements. Inspector Comments: Remove the unsatisfactory tall tumble weed from the landside slope.

Fresno River levee mile 0.00 looking downstream landside slope.

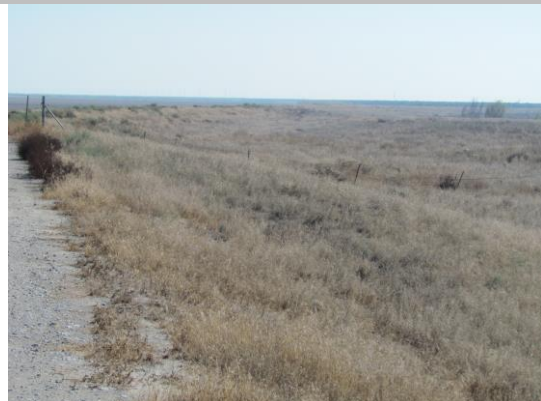
Photo 1 of 1 : FA\_2015\_NA0011\_146\_9\_20151027\_00019.jpg

LM Start	0.00	Rating **	U	Issue No.	9
LM End	4.06	Issue Type +	Ma	Location *	WS
Category	Earthen Levee			GPS Latitude/Longitude	
				Start	End
Item	Vegetation			36.978557 °	36.968192 °
				-120.368423 °	-120.300930 °
DWR ID	DWR_NA0011_05_f_2015_9				
Action/Comments					
Control annual grass and weeds on the levee slopes and easements. Inspector Comments: Remove the tumble weed and other tall unwanted weeds from the landside levee slope and toe.

Fresno River looking downstream from levee mile 0.00 waterside slope.
