**Flood Control Project Maintenance
Levee Inspections**

Maintenance Issue Types Only, Levee Inspection Report By Mile - Fall 2017

Madera County FCWCA

Waterway	Bank	Unit Miles	Inspection Start/End	Inspector
Unit No. 01 Ash Slough	Right	2.37	10/04/2017 10/04/2017	Keith Millard

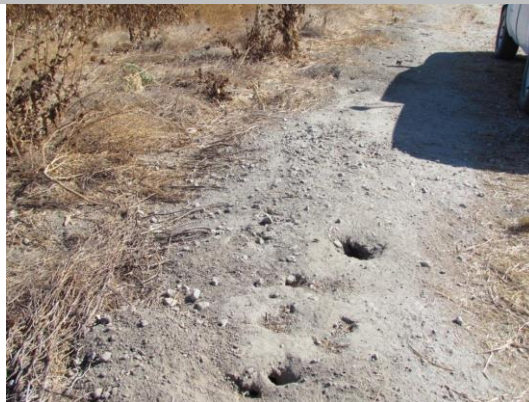
Photo 1 of 3 : FA_2017_NA0011_144_6_20171002_00002.jpg

LM Start	0.40	Rating **	U	Issue No.	6
LM End	1.51	Issue Type +	Ma	Location *	LS
Category	Earthen Levee			GPS Latitude/Longitude	
				Start	End
Item	Animal Control			36.996208 °	36.996607 °
				-120.366550 °	-120.346568 °
DWR ID	DWR_NA0011_03_f_2016_6				
Comment Code					
A1 : Exterminate rodents and backfill and compact or grout burrows.					
Inspector Comment					
There need to be rodent bait stations placed along the landside slope and or shoulder at levee miles listed. No new photo was taken. Unable to see the ground, observed rodents running across the roadway.

Berenda Slough Unit 3 levee miles 0.40-1.51 landside shoulder and slope.

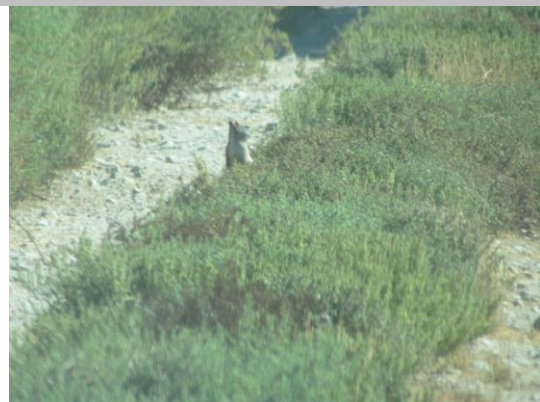
Photo 1 of 1 : FA_2017_NA0011_144_8_20171002_00004.jpg

LM Start	0.71	Rating **	M	Issue No.	8
LM End	1.51	Issue Type +	Ma	Location *	CR
Category	Earthen Levee			GPS Latitude/Longitude	
				Start	End
Item	Animal Control			36.996257 °	36.996607 °
				-120.361025 °	-120.346568 °
DWR ID	DWR_NA0011_03_f_2016_8				
Comment Code					
A1 : Exterminate rodents and backfill and compact or grout burrows.					
Inspector Comment					
Exterminate rodents from the crown roadway in the area listed. Active rodents observed during inspection at this site.

Berenda Slough Unit 3 looking upstream from levee miles 0.71 - to 1.51.

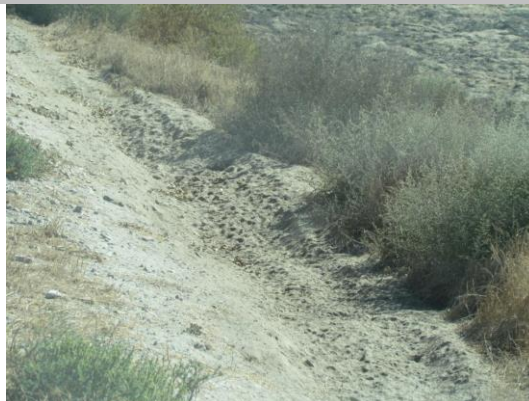
Photo 1 of 1 : FA_2017_NA0011_144_4_20171002_00001.jpg

LM Start	1.24	Rating **	M	Issue No.	4
LM End	1.25	Issue Type +	Ma	Location *	CR
Category	Earthen Levee			GPS Latitude/Longitude	
				Start	End
Item	Slope Stability			36.996582 °	36.996582 °
				-120.351482 °	-120.351258 °
DWR ID	DWR_NA0011_03_f_2016_4				
Comment Code					
S1 : Repair slope instability.					
Inspector Comment					
Repair the slope instability and damaged shoulder at this location. The cause for this damage is the walnut trees landside encroaching onto the levee crown forcing the traffic to vere around.

Berenda Slough looking back upstream waterside at the shoulder and slope levee miles 1.24-1.25.

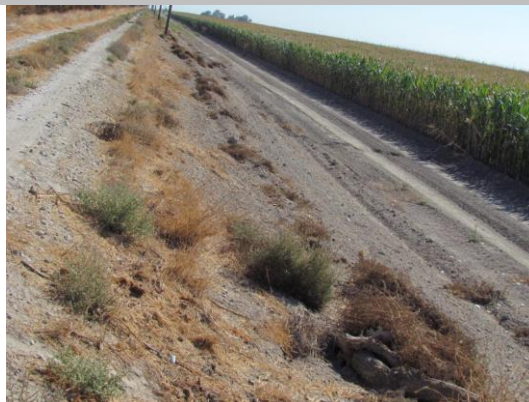
Photo 1 of 1 : FA_2017_NA0011_145_3_20171002_00001.jpg

LM Start	0.02	Rating **	U	Issue No.	3
LM End	0.97	Issue Type +	Ma	Location *	LS
Category	Earthen Levee			GPS Latitude/Longitude	
				Start	End
Item	Slope Stability			36.995506 °	36.995550 °
				-120.373233 °	-120.355935 °
DWR ID	DWR_NA0011_04_f_2016_3				
Comment Code					
S1 : Repair slope instability.					
Inspector Comment					
The slope in this area has been damaged by farm equipment on the slope.

Berenda Slough Unit 4 Looking upstream from levee mile 0.14-0.97.

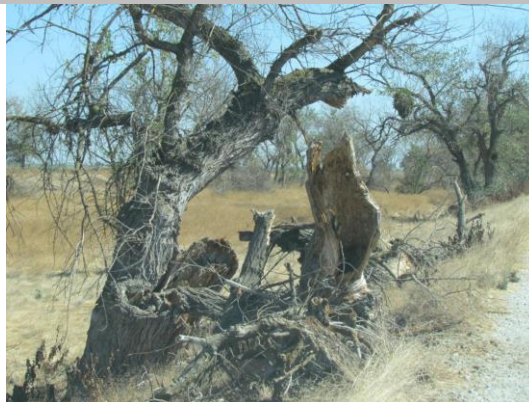
Photo 1 of 1 : FA_2017_NA0011_145_15_20171002_00006.jpg

LM Start	0.14	Rating **	U	Issue No.	15
LM End	0.14	Issue Type +	Ma	Location *	CR
Category	Earthen Levee			GPS Latitude/Longitude	
				Start	End
Item	Encroachments			36.995528 °	36.995528 °
				-120.370922 °	-120.370922 °
DWR ID	DWR_NA0011_04_f_2015_15				
Comment Code					
TR : Tree or limb					
Inspector Comment					
There are many dead trees in the area. This one happened to be blocking the crown roadway. Remove the dead trees from the levee section. Many more are subject to fall and further block access to the levee crown.

Berenda Slough looking upstream from the levee mile 0.14.

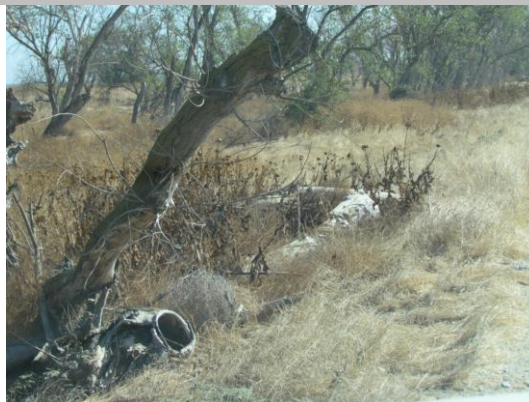
Photo 1 of 1 : FA_2017_NA0011_145_16_20171002_00007.jpg

LM Start	0.47	Rating **	U	Issue No.	16
LM End	0.47	Issue Type +	Ma	Location *	WS
Category	Earthen Levee			GPS Latitude/Longitude	
				Start	End
Item	Encroachments			36.995603 °	36.995603 °
				-120.364978 °	-120.364978 °
DWR ID	DWR_NA0011_04_s_2014_16				
Comment Code					
TR : Tree or limb					
Inspector Comment					
This dead tree on water ward slope should be removed from levee section. No change. 2017

Berenda Slough Unit 4 levee mile 0.47 looking back upstream.

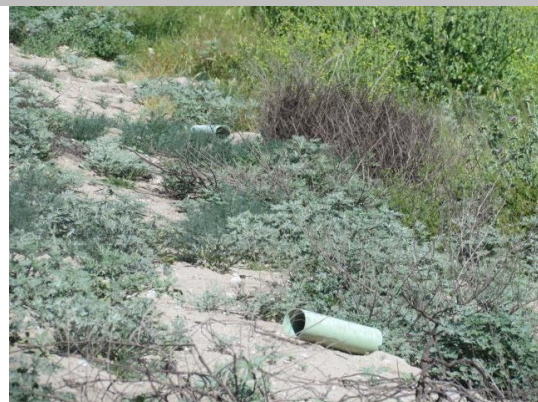
Photo 1 of 5 : FA_2017_NA0011_145_11_20171002_00003.jpg

LM Start	1.50	Rating **	U	Issue No.	11
LM End	2.28	Issue Type +	Ma	Location *	LS
Category	Earthen Levee			GPS Latitude/Longitude	
				Start	End
Item	Animal Control			36.995590 °	37.003740 °
				-120.346406 °	-120.336877 °
DWR ID	DWR_NA0011_04_f_2016_11				
Comment Code					
A1 : Exterminate rodents and backfill and compact or grout burrows.					
Inspector Comment					
Exterminate the rodents and backfill and compact or grout the burrows in this area listed.

Berenda Slough looking upstream levee mile 0.62 landward.

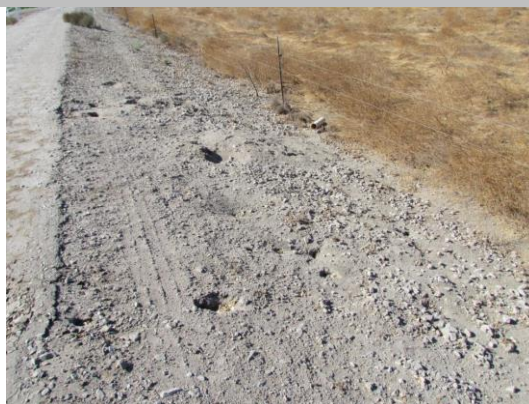
Photo 1 of 1 : FA_2017_NA0011_145_30_20171002_00008.jpg

LM Start	1.50	Rating **	U	Issue No.	30
LM End	2.28	Issue Type +	Ma	Location *	WS
Category	Earthen Levee			GPS Latitude/Longitude	
				Start	End
Item	Animal Control			36.995590 °	37.003740 °
				-120.346406 °	-120.336877 °
DWR ID	DWR_NA0011_04_f_2014_30				
Comment Code					
A1 : Exterminate rodents and backfill and compact or grout burrows.					
Inspector Comment					
Bait stations are needed in Rodent infested area waterside slope and toe. No new photo.

Berenda Slough levee mile 1.63-2.23 looking upstream at waterside slope.

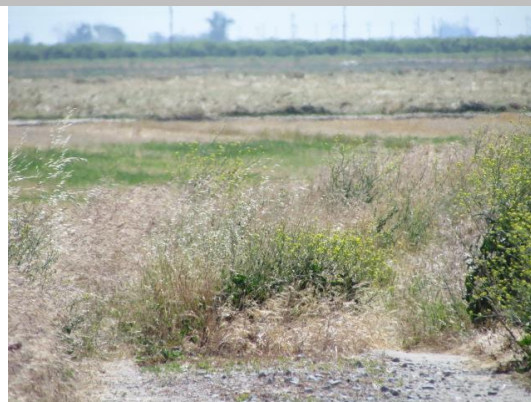
Photo 1 of 1 : FA_2017_NA0011_146_8_20171002_00002.jpg

LM Start	0.00	Rating **	U	Issue No.	8
LM End	4.05	Issue Type +	Ma	Location *	CR
Category	Earthen Levee		GPS Latitude/Longitude		
			Start	End	
Item	Vegetation		36.978557 °	36.968152 °	
			-120.368423 °	-120.301103 °	
DWR ID	DWR_NA0011_05_f_2015_8				
Comment Code					
V9 : Keep the crown roadway free of vegetation.					
Inspector Comment					
The crown roadway must be free of all vegetation. Tall weeds blocking view of crown roadway.

Fresno River looking upstream levee mile 0.00.

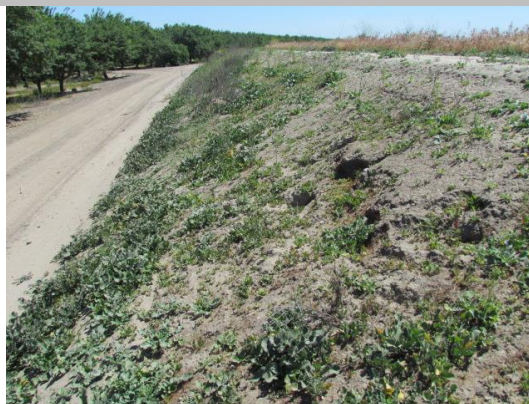
Photo 1 of 1 : FA_2017_NA0011_146_28_20171002_00005.jpg

LM Start	6.75	Rating **	U	Issue No.	28
LM End	6.95	Issue Type +	Ma	Location *	LS
Category	Earthen Levee			GPS Latitude/Longitude	
				Start	End
Item	Animal Control			36.969200 °	36.969507 °
				-120.252462 °	-120.248893 °
DWR ID	DWR_NA0011_05_f_2016_28				
Comment Code					
A1 : Exterminate rodents and backfill and compact or grout burrows.					
Inspector Comment					
Exterminate the rodents in the area listed and place bait stations along the shoulder and or slope.

Fresno River landside levee slope levee mile 6.75-6.95.

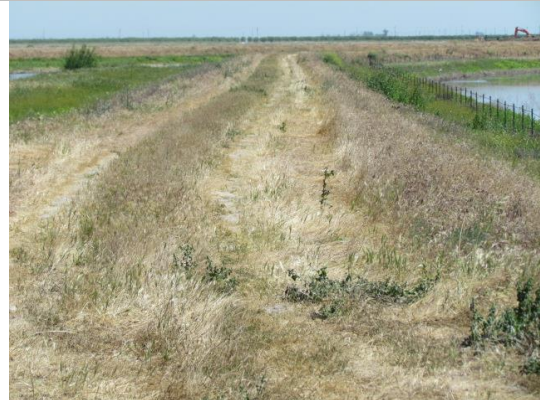
Photo 1 of 1 : FA_2017_NA0011_147_12_20171002_00003.jpg

LM Start	0.01	Rating **	U	Issue No.	12
LM End	1.02	Issue Type +	Ma	Location *	CR
Category	Earthen Levee			GPS Latitude/Longitude	
				Start	End
Item	Vegetation			36.976960 °	36.968529 °
				-120.367233 °	-120.354011 °
DWR ID	DWR_NA0011_06_s_2017_12				
Comment Code					
V9 : Keep the crown roadway free of vegetation.					
Inspector Comment					
Keep the crown roadway free of vegetation.

Fresno River looking upstream from levee mile 0.01 to 0.95.

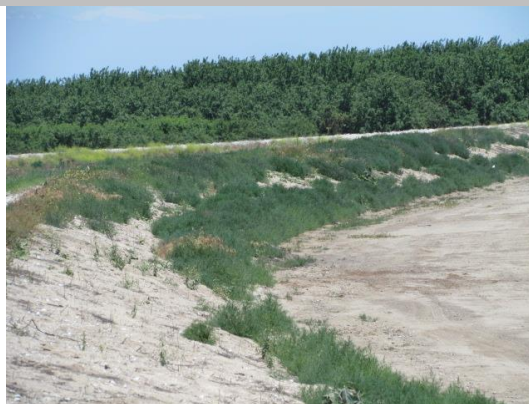
Photo 1 of 1 : FA_2017_NA0011_147_29_20171002_00005.jpg

LM Start	7.70	Rating **	M	Issue No.	29
LM End	8.52	Issue Type +	Ma	Location *	LS
Category	Earthen Levee			GPS Latitude/Longitude	
				Start	End
Item	Vegetation			36.969591 °	36.971509 °
				-120.234235 °	-120.220438 °
DWR ID	DWR_NA0011_06_s_2017_29				
Comment Code					
V2 : Remove the wild growth other than native grasses from the levee slopes.					
Inspector Comment					
Remove the wild growth from the landside slope.

Fresno River landside levee mile 7.71-8.59.

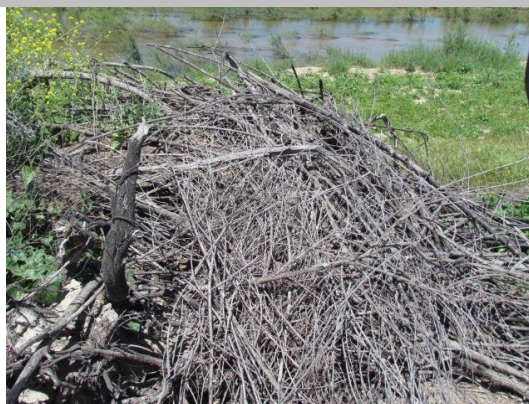
Photo 1 of 1 : FA_2017_NA0011_147_32_20171002_00007.jpg

LM Start	7.96	Rating **	M	Issue No.	32
LM End	7.96	Issue Type +	Ma	Location *	WS
Category	Earthen Levee			GPS Latitude/Longitude	
				Start	End
Item	Encroachments			36.971543 °	36.971543 °
				-120.230285 °	-120.230285 °
DWR ID	DWR_NA0011_06_s_2017_32				
Comment Code					
PR : Prunings					
Inspector Comment					
Remove the brush pile from the levee slope. This pile is providing habitat for rodents.

Fresno River waterside levee mile 7.96.

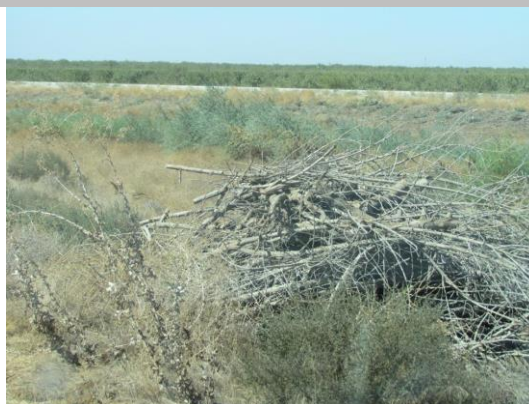
Photo 2 of 2 : FA_2017_NA0011_147_36_20171002_00009.jpg

LM Start	8.03	Rating **	U	Issue No.	36 (cont)
LM End	8.03	Issue Type +	Ma	Location *	WS

Fresno River levee mile 8.03 waterside slope and shoulder.

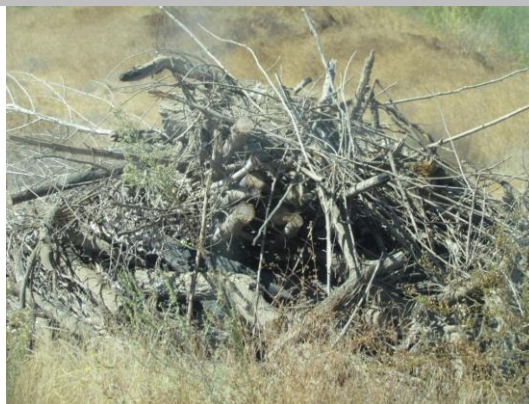
Photo 1 of 1 : FA_2017_NA0011_147_31_20171002_00006.jpg

LM Start	8.09	Rating **	U	Issue No.	31
LM End	8.09	Issue Type +	Ma	Location *	WS
Category	Earthen Levee			GPS Latitude/Longitude	
				Start	End
Item	Encroachments			36.971692 °	36.971692 °
				-120.227957 °	-120.227957 °
DWR ID	DWR_NA0011_06_f_2015_31				
Comment Code					
TR : Tree or limb					
Inspector Comment					
Remove the dead tree off the slope and shoulder, this has been reported in the last two inspections.

Fresno River levee mile 8.09.
