**Flood Control Project Maintenance
Levee Inspections**

Maintenance Issue Types Only, Levee Inspection Report By Mile - Fall 2018

Madera County FCWCA

Waterway	Bank	Unit Miles	Inspection Start/End	Inspector
Unit No. 01 Ash Slough	Right	2.37	10/24/2018 10/24/2018	Corey Fujitani

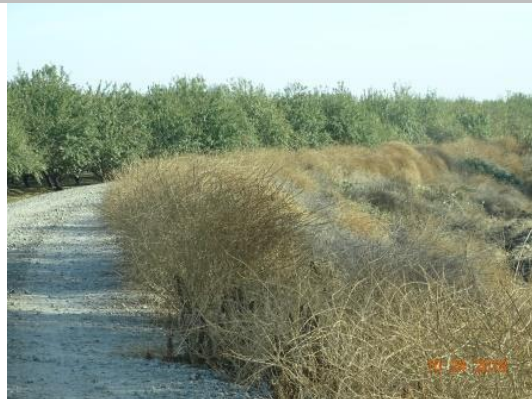
Photo 1 of 1 : FA_2018_NA0011_142_27_20181108_00034.jpg

LM Start	0.90	Rating **	U	Issue No.	27
LM End	1.36	Issue Type +	Ma	Location *	WS
Category	Earthen Levee			GPS Latitude/Longitude	
				Start	End
Item	Vegetation			37.054841 °	37.058519 °
				-120.416842 °	-120.410276 °
DWR ID	DWR_NA0011_01_f_2018_27				
Comment Code					
V1 : Control annual grass and weeds on the levee slopes and easements.					
Inspector Comment

Tall dense brush on waterside shoulder and slope. (Fall 2018)

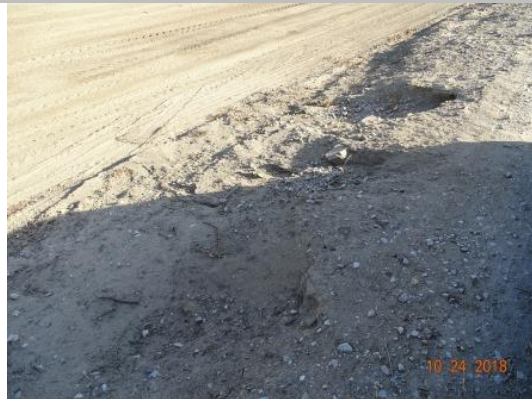
Photo 1 of 2 : FA_2018_NA0011_142_29_20181108_00035.jpg

LM Start	1.04	Rating **	M	Issue No.	29
LM End	1.04	Issue Type +	Ma	Location *	LS
Category	Earthen Levee			GPS Latitude/Longitude	
				Start	End
Item	Erosion / Bank Caving			37.055880 °	37.055880 °
				-120.414628 °	-120.414628 °
DWR ID	DWR_NA0011_01_f_2018_29				
Comment Code					
E1 : Note and monitor erosion site.					
Inspector Comment

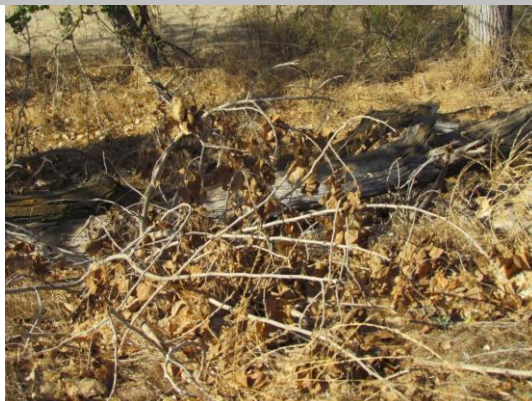
Photo 1 of 2 : FA_2018_NA0011_143_27_20180905_00017.jpg

LM Start	0.98	Rating **	U	Issue No.	27
LM End	1.52	Issue Type +	Ma	Location *	WS
Category	Earthen Levee			GPS Latitude/Longitude	
				Start	End
Item	Encroachments			37.054928 °	37.058752 °
				-120.415482 °	-120.407323 °
DWR ID	DWR_NA0011_02_s_2017_27				
Comment Code					
TR : Tree or limb					
Inspector Comment					
Remove the dead trees from the waterside slope and shoulder.

Unit 2 Ash Slough Levee mile 0.98 waterside shoulder and slope

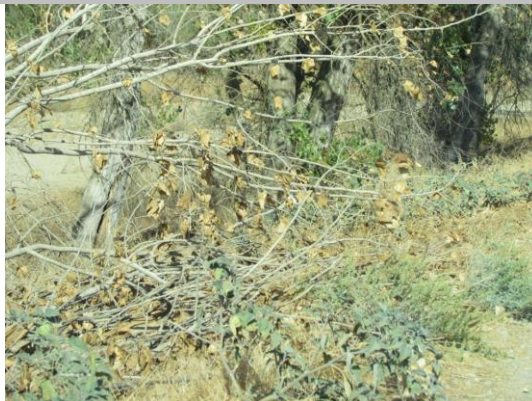
Photo 2 of 2 : FA_2018_NA0011_143_27_20180905_00018.jpg

LM Start	0.98	Rating **	U	Issue No.	27 (cont)
LM End	1.52	Issue Type +	Ma	Location *	WS

Levee slope and shoulder looking upstream waterside levee section.

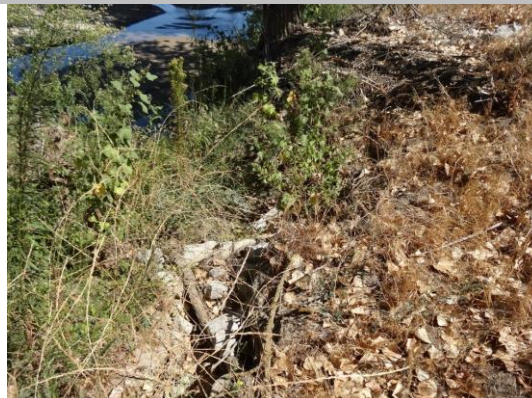
Photo 3 of 4 : FA_2018_NA0011_143_1_20180905_00003.jpg

LM Start	1.10	Rating **	U	Issue No.	1 (cont)
LM End	1.19	Issue Type +	Ma	Location *	WS

Vegetation debris at the site.

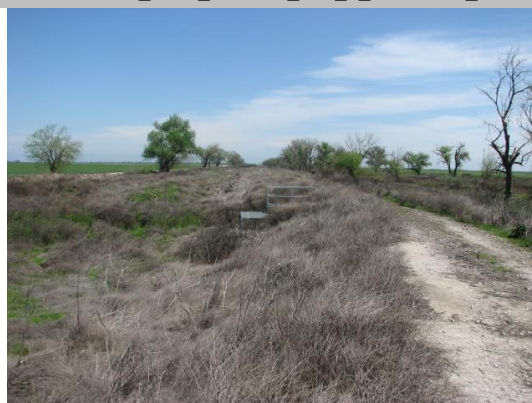
Photo 2 of 2 : FA_2018_NA0011_144_3_20180905_00001.jpg

LM Start	0.00	Rating **	U	Issue No.	3 (cont)
LM End	1.51	Issue Type +	Ma	Location *	LS

Looking downstream at landward slope. (Spring 2018)

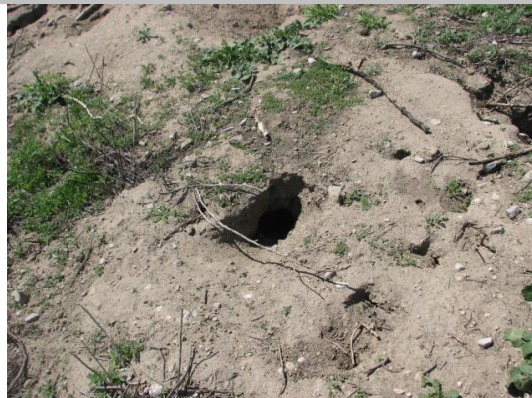
Photo 1 of 1 : FA_2018_NA0011_145_19_20180905_00017.jpg

LM Start	0.12	Rating **	U	Issue No.	19
LM End	0.94	Issue Type +	Ma	Location *	LS
Category	Earthen Levee			GPS Latitude/Longitude	
				Start	End
Item	Animal Control			36.995547 °	36.995586 °
				-120.371410 °	-120.356589 °
DWR ID	DWR_NA0011_04_s_2018_19				
Comment Code					
A3 : No rodents visible, but rodent burrows visible; need to backfill and compact or grout burrows.					
Inspector Comment

Looking at large rodent hole on landward slope. (Spring 2018)

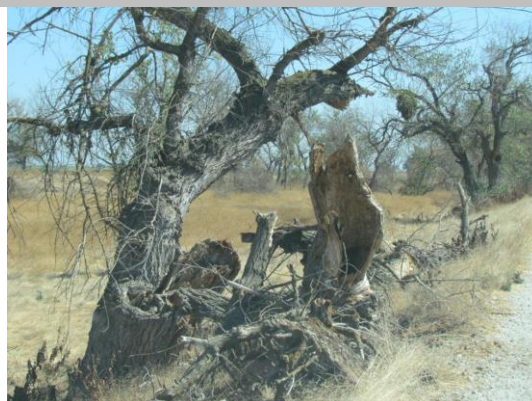
Photo 1 of 1 : FA_2018_NA0011_145_15_20180905_00015.jpg

LM Start	0.14	Rating **	U	Issue No.	15
LM End	0.14	Issue Type +	Ma	Location *	CR
Category	Earthen Levee			GPS Latitude/Longitude	
				Start	End
Item	Encroachments			36.995528 °	36.995528 °
				-120.370922 °	-120.370922 °
DWR ID	DWR_NA0011_04_f_2015_15				
Comment Code					
TR : Tree or limb					
Inspector Comment					
There are many dead trees in the area. This one happened to be blocking the crown roadway. Remove the dead trees from the levee section. Many more are subject to fall and further block access to the levee crown.

Berenda Slough looking upstream from the levee mile 0.14.

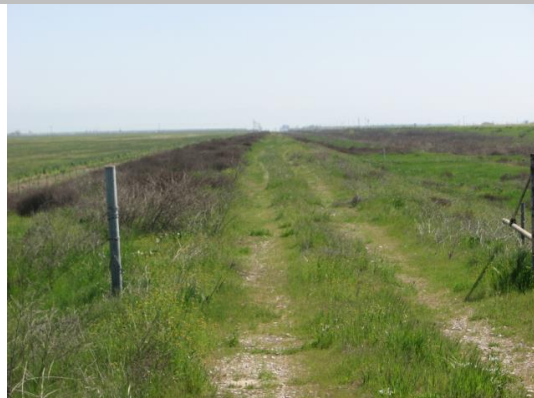
Photo 1 of 1 : FA_2018_NA0011_146_13_20180905_00002.jpg

LM Start	0.00	Rating **	M	Issue No.	13
LM End	4.05	Issue Type +	Ma	Location *	CR
Category	Earthen Levee			GPS Latitude/Longitude	
				Start	End
Item	Crown Surface / Depressions / Rutting			36.978548 °	36.968165 °
				-120.368454 °	-120.301151 °
DWR ID	DWR_NA0011_05_s_2012_13				
Comment Code					
C1 : Add appropriate material and re-grade the levee to bring the crown above the design elevation.					
Inspector Comment					
Regrade the crown for proper drainage. And add appropriate gravel or road base.

Looking downstream at levee crown from 0.00. (Spring 2018)

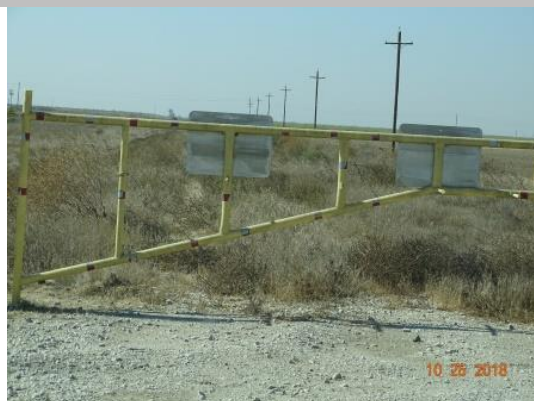
Photo 1 of 2 : FA_2018_NA0011_146_8_20181109_00027.jpg

LM Start	0.00	Rating **	U	Issue No.	8
LM End	4.05	Issue Type +	Ma	Location *	CR
Category	Earthen Levee			GPS Latitude/Longitude	
				Start	End
Item	Vegetation			36.978557 °	36.968152 °
				-120.368423 °	-120.301103 °
DWR ID	DWR_NA0011_05_f_2015_8				
Comment Code					
V9 : Keep the crown roadway free of vegetation.					
Inspector Comment					
The crown roadway must be free of all vegetation. Tall weeds hinder inspection, provide cover for burrowing rodents, and create a fire hazard.

Looking downstream at levee mile 4.05. (Fall 2018)

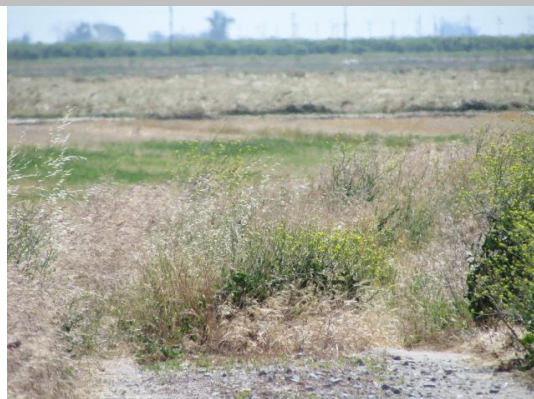
Photo 2 of 2 : FA_2018_NA0011_146_8_20180905_00001.jpg

LM Start	0.00	Rating **	U	Issue No.	8 (cont)
LM End	4.05	Issue Type +	Ma	Location *	CR

Fresno River looking upstream levee mile 0.00.

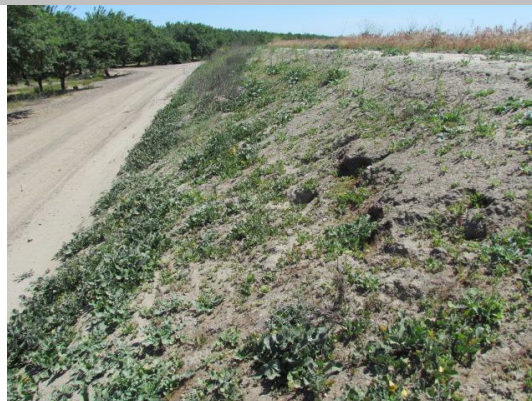
Photo 1 of 1 : FA_2018_NA0011_146_28_20180905_00011.jpg

LM Start	6.75	Rating **	U	Issue No.	28
LM End	6.95	Issue Type +	Ma	Location *	LS
Category	Earthen Levee		GPS Latitude/Longitude		
			Start	End	
Item	Animal Control		36.969200°	36.969507°	
			-120.252462°	-120.248893°	
DWR ID	DWR_NA0011_05_f_2016_28				
Comment Code					
A1 : Exterminate rodents and backfill and compact or grout burrows.					
Inspector Comment					
Exterminate the rodents in the area listed and place bait stations along the shoulder and or slope.

Fresno River landside levee slope levee mile 6.75-6.95.

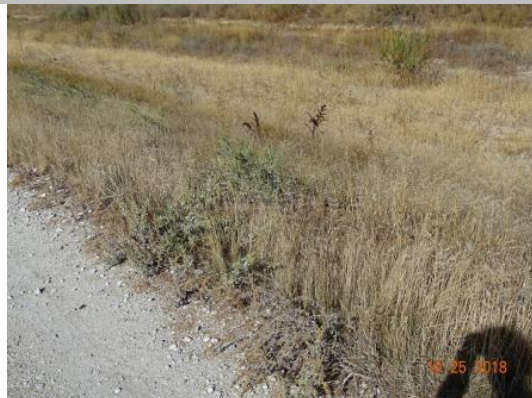
Photo 1 of 1 : FA_2018_NA0011_147_61_20181109_00049.jpg

LM Start	5.47	Rating **	U	Issue No.	61
LM End	5.97	Issue Type +	Ma	Location *	WS
Category	Earthen Levee		GPS Latitude/Longitude		
			Start	End	
Item	Vegetation		36.967504 °	36.967486 °	
			-120.274232 °	-120.265254 °	
DWR ID	DWR_NA0011_06_f_2018_61				
Comment Code					
V1 : Control annual grass and weeds on the levee slopes and easements.					
Inspector Comment

vegetation on waterside slope. (Fall 2018)

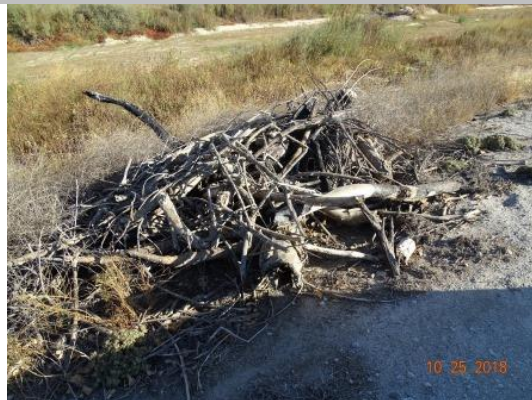
Photo 1 of 1 : FA_2018_NA0011_147_40_20181109_00052.jpg

LM Start	6.72	Rating **	M	Issue No.	40
LM End	6.72	Issue Type +	Ma	Location *	WS
Category	Earthen Levee			GPS Latitude/Longitude	
				Start	End
Item	Encroachments			36.968670 °	36.968670 °
				-120.251717 °	-120.251717 °
DWR ID	DWR_NA0011_06_f_2017_40				
Comment Code					
PR : Prunings					
Inspector Comment					
Remove collected wood debris on waterside shoulder.

dead tree limbs on waterside shoulder. (Fall 2018)

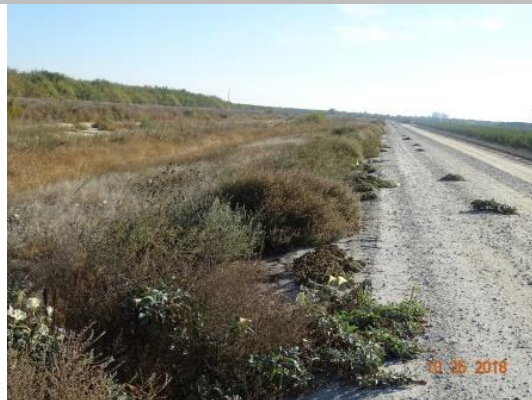
Photo 1 of 1 : FA_2018_NA0011_147_15_20181109_00053.jpg

LM Start	7.17	Rating **	U	Issue No.	15
LM End	7.48	Issue Type +	Ma	Location *	WS
Category	Earthen Levee			GPS Latitude/Longitude	
				Start	End
Item	Vegetation			36.968803 °	36.968851 °
				-120.243721 °	-120.238156 °
DWR ID	DWR_NA0011_06_f_2018_15				
Comment Code					
V1 : Control annual grass and weeds on the levee slopes and easements.					
Inspector Comment

dense vegetation on waterside slope. (Fall 2018)

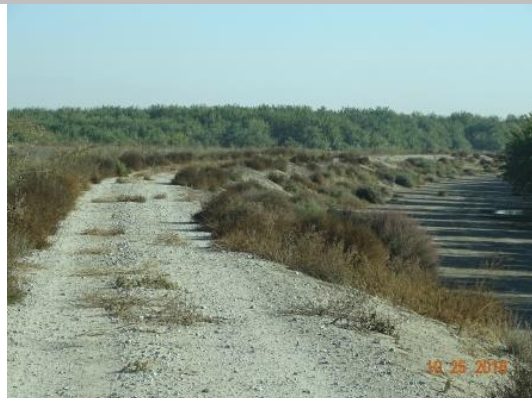
Photo 1 of 1 : FA_2018_NA0011_147_29_20181109_00054.jpg

LM Start	7.70	Rating **	M	Issue No.	29
LM End	8.17	Issue Type +	Ma	Location *	LS
Category	Earthen Levee			GPS Latitude/Longitude	
				Start	End
Item	Vegetation			36.969591 °	36.971888 °
				-120.234235 °	-120.226591 °
DWR ID	DWR_NA0011_06_s_2017_29				
Comment Code					
V2 : Remove the wild growth other than native grasses from the levee slopes.					
Inspector Comment					
Remove the wild growth from the landside slope.

patches of vegetation on landside slope. (Fall 2018)

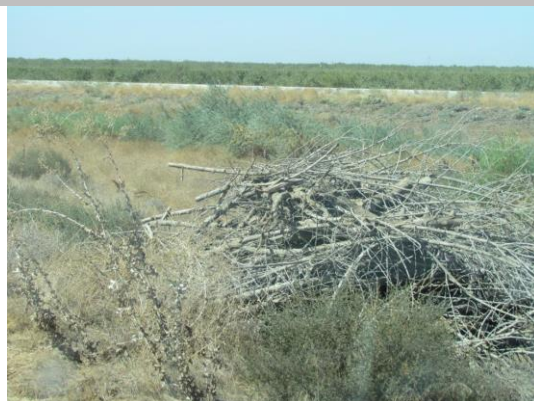
Photo 2 of 2 : FA_2018_NA0011_147_36_20180905_00014.jpg

LM Start	8.03	Rating **	M	Issue No.	36 (cont)
LM End	8.03	Issue Type +	Ma	Location *	WS

Fresno River levee mile 8.03 waterside slope and shoulder.
