**Flood Control Project Maintenance
Levee Inspections**

Maintenance Issue Types Only, Levee Inspection Report By Mile - Fall 2019

Madera County FCWCA

Waterway	Bank	Unit Miles	Inspection Start/End	Inspector
Unit No. 01 Ash Slough	Right	2.37	10/02/2019 10/02/2019	Corey Fujitani

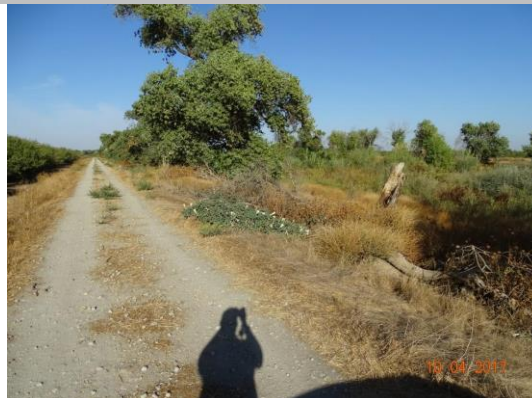
Photo 1 of 1 : FA_2019_NA0011_142_11_20190912_00001.jpg

LM Start	0.44	Rating **	M	Issue No.	11
LM End	0.44	Issue Type +	Ma	Location *	WS
Category	Earthen Levee			GPS Latitude/Longitude	
				Start	End
Item	Encroachments			37.049455 °	37.049455 °
				-120.421218 °	-120.421218 °
DWR ID	DWR_NA0011_01_s_2012_11				
Comment Code					
TR : Tree or limb					
Inspector Comment					
Remove the dead tree from the waterside slope.

Remove downed tree from waterside slope.

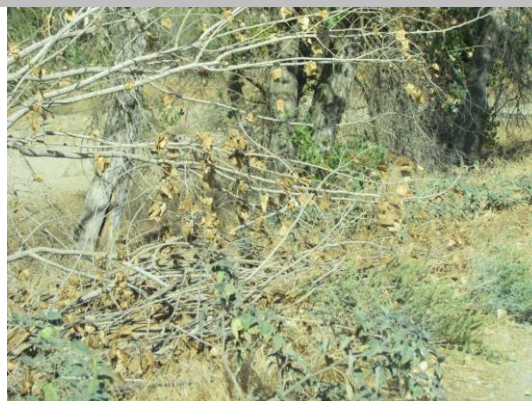
Photo 2 of 2 : FA_2019_NA0011_143_27_20190912_00019.jpg

LM Start	0.98	Rating **	U	Issue No.	27 (cont)	
LM End	1.52	Issue Type +	Ma	Location *	WS	
Category	Earthen Levee			GPS Latitude/Longitude		
				Start		End
Item	Encroachments			37.054928 °		37.058752 °
				-120.415482 °		-120.407323 °
DWR ID	DWR_NA0011_02_s_2017_27					
Comment Code						
TR : Tree or limb						
Inspector Comment						
Remove the dead trees from the waterside slope and shoulder.

Levee slope and shoulder looking upstream waterside levee section.

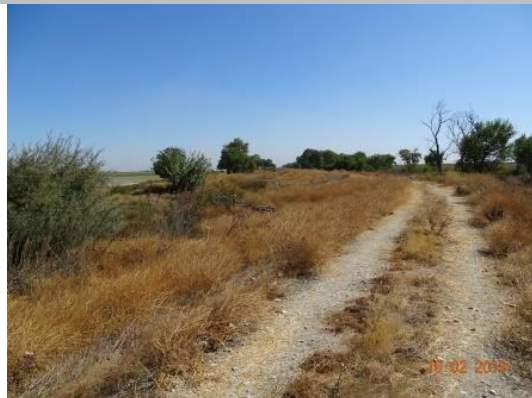
Photo 1 of 1 : FA_2019_NA0011_144_9_20191009_00025.jpg

LM Start	0.04	Rating **	U	Issue No.	9
LM End	1.51	Issue Type +	Ma	Location *	LS
Category	Earthen Levee			GPS Latitude/Longitude	
				Start	End
Item	Vegetation			36.996543 °	36.996607 °
				-120.373043 °	-120.346570 °
DWR ID	DWR_NA0011_03_f_2019_9				
Comment Code					
V1 : Control annual grass and weeds on the levee slopes and easements.					
Inspector Comment

View of landside slope looking upstream. (Fall 2019)

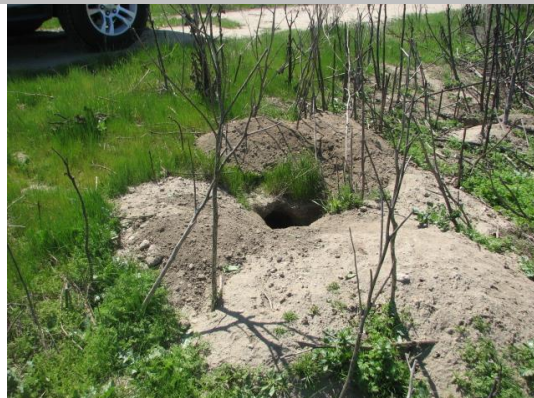
Photo 1 of 6 : FA_2019_NA0011_144_6_20190912_00003.jpg

Looking at rodent hole on landward slope. (Spring 2018)

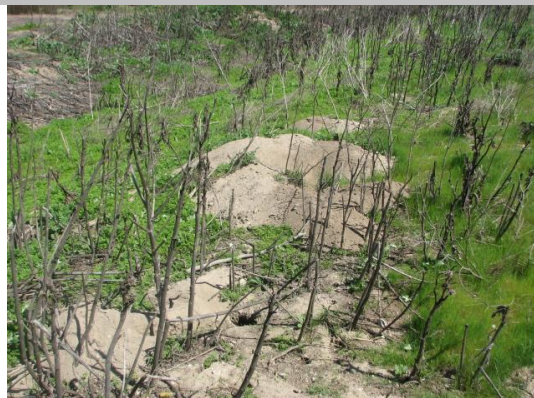
Photo 2 of 6 : FA_2019_NA0011_144_6_20190912_00004.jpg

Looking at typical rodent holes within this section (Spring 2018)

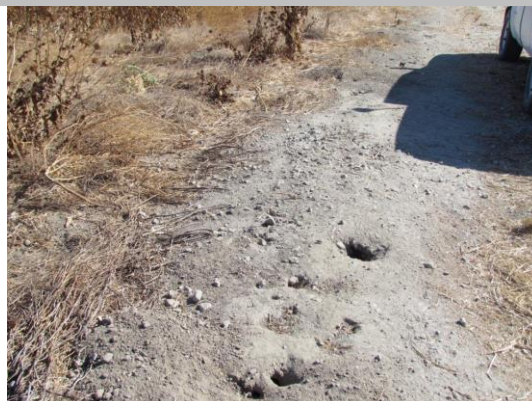
Photo 6 of 6 : FA_2019_NA0011_144_6_20190912_00008.jpg

LM Start	0.40	Rating **	U	Issue No.	6 (cont)
LM End	1.51	Issue Type +	Ma	Location *	LS

Berenda Slough Unit 3 landside shoulder and slope.

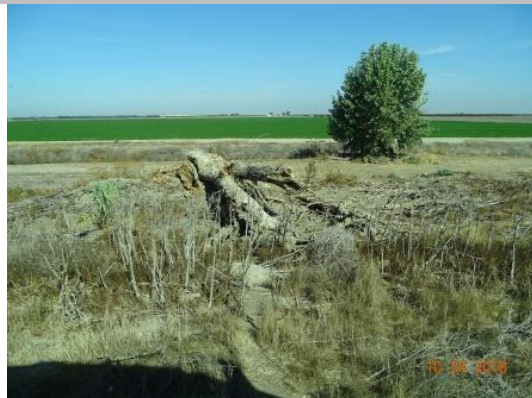
Photo 1 of 1 : FA_2019_NA0011_144_10_20190912_00010.jpg

LM Start	0.45	Rating **	U	Issue No.	10
LM End	0.45	Issue Type +	Ma	Location *	LS
Category	Earthen Levee			GPS Latitude/Longitude	
				Start	End
Item	Encroachments			36.996224 °	36.996224 °
				-120.365692 °	-120.365692 °
DWR ID	DWR_NA0011_03_f_2018_10				
Comment Code					
TR : Tree or limb					
Inspector Comment					
Remove the dead tree from the landside slope.

View of dead tree on the landside slope. (Fall 2018)

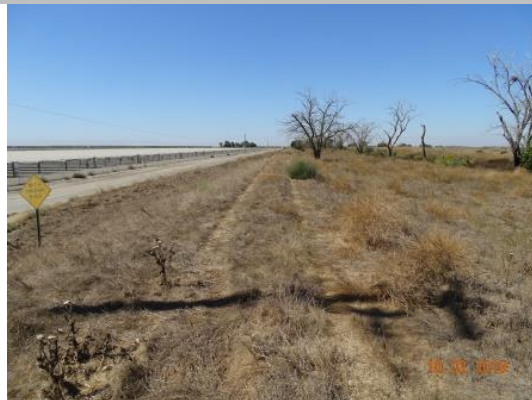
Photo 1 of 2 : FA_2019_NA0011_145_8_20191009_00033.jpg

LM Start	0.01	Rating **	U	Issue No.	8
LM End	1.49	Issue Type +	Ma	Location *	CR
Category	Earthen Levee			GPS Latitude/Longitude	
				Start	End
Item	Vegetation			36.995503 °	36.995580 °
				-120.373417 °	-120.346588 °
DWR ID	DWR_NA0011_04_s_2017_8				
Comment Code					
V9 : Keep the crown roadway free of vegetation.					
Inspector Comment					
Keep the crown roadway free of vegetation.

Looking downstream from LM 1.49 at vegetation on levee crown. (Spring 2019)

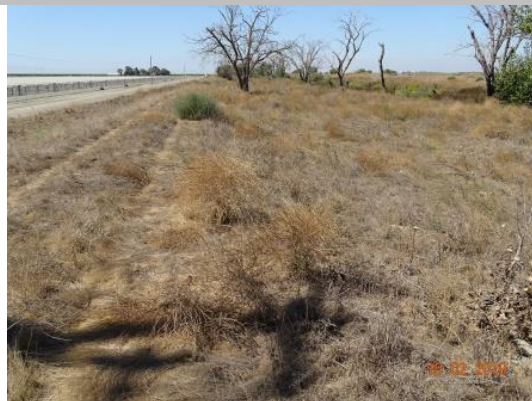
Photo 1 of 1 : FA_2019_NA0011_145_25_20191009_00034.jpg

LM Start	0.02	Rating **	U	Issue No.	25
LM End	1.60	Issue Type +	Ma	Location *	WS
Category	Earthen Levee			GPS Latitude/Longitude	
				Start	End
Item	Vegetation			36.995504°	36.996217°
				-120.373234°	-120.344760°
DWR ID	DWR_NA0011_04_f_2019_25				
Comment Code					
V1 : Control annual grass and weeds on the levee slopes and easements.					
Inspector Comment

Looking downstream along the waterside slope. (Fall 2019)

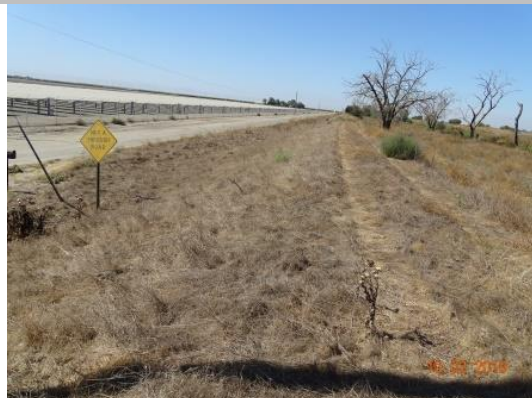
Photo 1 of 2 : FA_2019_NA0011_145_5_20191009_00035.jpg

LM Start	0.02	Rating **	U	Issue No.	5
LM End	1.49	Issue Type +	Ma	Location *	LS
Category	Earthen Levee			GPS Latitude/Longitude	
				Start	End
Item	Vegetation			36.995504 °	36.995582 °
				-120.373233 °	-120.346586 °
DWR ID	DWR_NA0011_04_f_2017_5				
Comment Code					
V1 : Control annual grass and weeds on the levee slopes and easements.					
Inspector Comment

View of vegetation along the landside slope looking downstream. (Fall 2019)

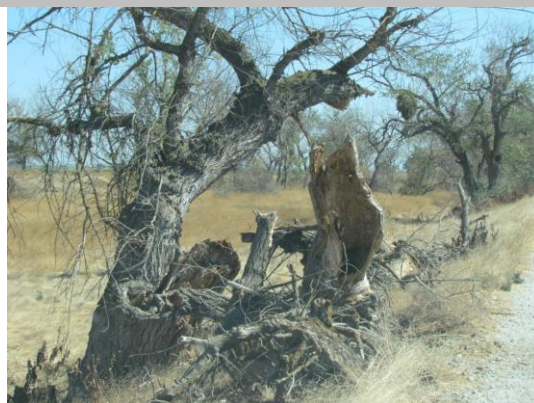
Photo 1 of 1 : FA_2019_NA0011_145_15_20190912_00016.jpg

LM Start	0.14	Rating **	U	Issue No.	15
LM End	0.14	Issue Type +	Ma	Location *	WS
Category	Earthen Levee			GPS Latitude/Longitude	
				Start	End
Item	Encroachments			36.995528 °	36.995528 °
				-120.370922 °	-120.370922 °
DWR ID	DWR_NA0011_04_f_2015_15				
Comment Code					
TR : Tree or limb					
Inspector Comment					
There are many dead trees in the area. Remove the dead trees from the levee section. Many more are subject to fall and possibly block access to the levee crown.

Berenda Slough looking upstream from the levee mile 0.14.

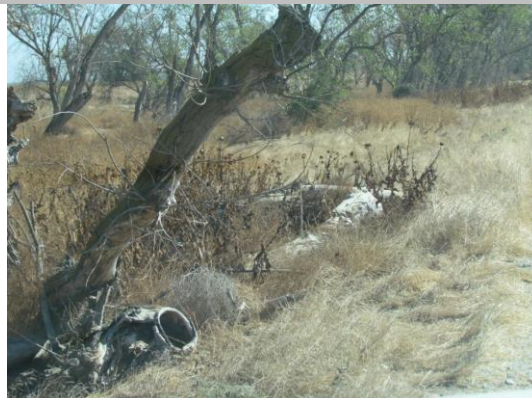
Photo 1 of 1 : FA_2019_NA0011_145_16_20190912_00017.jpg

LM Start	0.47	Rating **	M	Issue No.	16
LM End	0.47	Issue Type +	Ma	Location *	WS
Category	Earthen Levee			GPS Latitude/Longitude	
				Start	End
Item	Encroachments			36.995603 °	36.995603 °
				-120.364978 °	-120.364978 °
DWR ID	DWR_NA0011_04_s_2014_16				
Comment Code					
TR : Tree or limb					
Inspector Comment					
This dead tree on the waterward slope should be removed from the levee section.

Tree on WS shoulder.

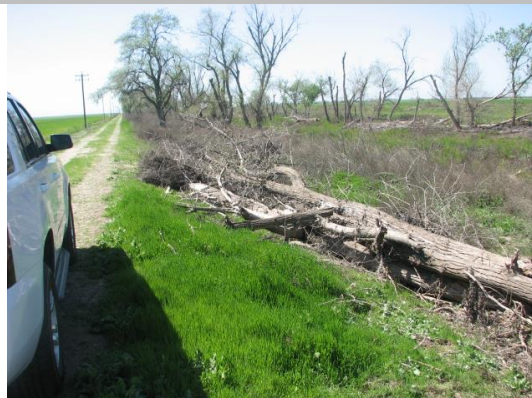
Photo 1 of 1 : FA_2019_NA0011_145_14_20190912_00015.jpg

LM Start	0.94	Rating **	M	Issue No.	14
LM End	0.94	Issue Type +	Ma	Location *	WS
Category	Earthen Levee			GPS Latitude/Longitude	
				Start	End
Item	Encroachments			36.995573 °	36.995573 °
				-120.356601 °	-120.356601 °
DWR ID	DWR_NA0011_04_f_2017_14				
Comment Code					
TR : Tree or limb					
Inspector Comment					
Remove the downed tree from the waterside slope.

Looking upstream at fallen tree on waterward slope. (Spring 2018)

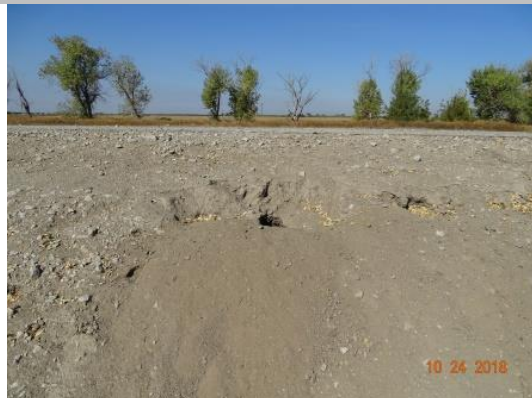
Photo 2 of 2 : FA_2019_NA0011_145_11_20190912_00010.jpg

LM Start	1.50	Rating **	U	Issue No.	11 (cont)	
LM End	2.28	Issue Type +	Ma	Location *	LS	
Category	Earthen Levee			GPS Latitude/Longitude		
				Start		End
Item	Animal Control			36.995590 °		37.003740 °
				-120.346406 °		-120.336877 °
DWR ID	DWR_NA0011_04_f_2016_11					
Comment Code						
A1 : Exterminate rodents and backfill and compact or grout burrows.						
Inspector Comment						
Exterminate the rodents and backfill and compact the burrows or grout the burrows in this area.

Large rodent holes along this section. (Fall 2018)

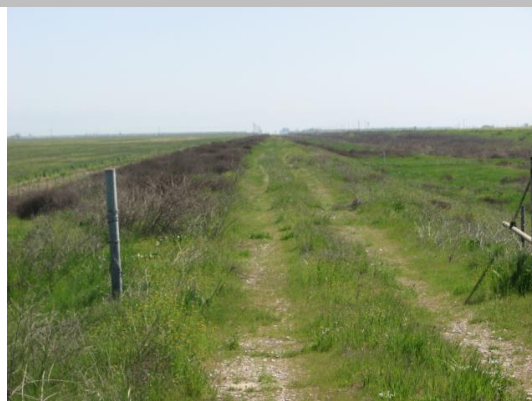
Photo 1 of 1 : FA_2019_NA0011_146_13_20190912_00005.jpg

LM Start	0.00	Rating **	M	Issue No.	13
LM End	4.05	Issue Type +	Ma	Location *	CR
Category	Earthen Levee			GPS Latitude/Longitude	
				Start	End
Item	Crown Surface / Depressions / Rutting			36.978548 °	36.968165 °
				-120.368454 °	-120.301151 °
DWR ID	DWR_NA0011_05_s_2012_13				
Comment Code					
C1 : Add appropriate material and re-grade the levee to bring the crown above the design elevation.					
Inspector Comment					
Regrade the crown for proper drainage. And add appropriate gravel or road base.

Looking downstream at levee crown from 0.00. (Spring 2018)

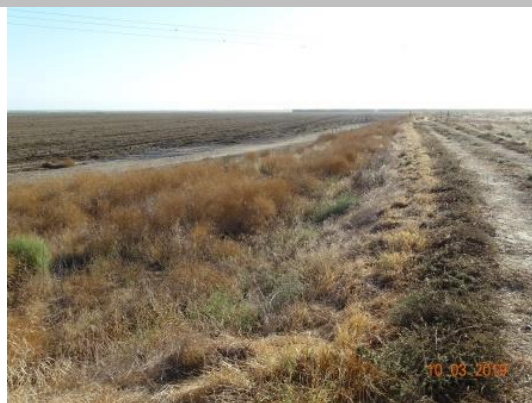
Photo 1 of 2 : FA_2019_NA0011_146_7_20191009_00034.jpg

LM Start	0.01	Rating **	U	Issue No.	7
LM End	4.06	Issue Type +	Ma	Location *	LS
Category	Earthen Levee			GPS Latitude/Longitude	
				Start	End
Item	Vegetation			36.978438 °	36.968155 °
				-120.368405 °	-120.300968 °
DWR ID	DWR_NA0011_05_f_2019_7				
Comment Code					
V1 : Control annual grass and weeds on the levee slopes and easements.					
Inspector Comment

View of landside slope looking upstream. (Fall 2019)

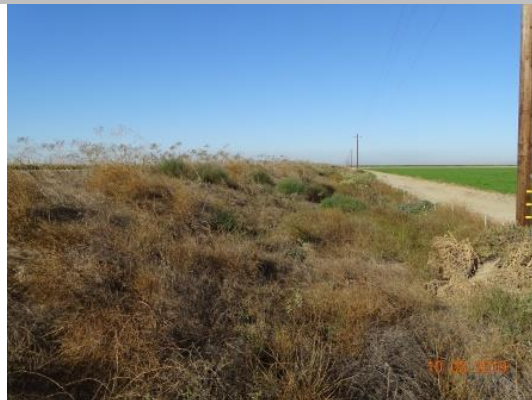
Photo 2 of 2 : FA_2019_NA0011_146_7_20191009_00035.jpg

LM Start	0.01	Rating **	U	Issue No.	7 (cont)	
LM End	4.06	Issue Type +	Ma	Location *	LS	
Category	Earthen Levee			GPS Latitude/Longitude		
				Start		End
Item	Vegetation			36.978438 °		36.968155 °
				-120.368405 °		-120.300968 °
DWR ID	DWR_NA0011_05_f_2019_7					
Comment Code						
V1 : Control annual grass and weeds on the levee slopes and easements.						
Inspector Comment

Looking downstream along the landside slope at LM 4.06. (Fall 2019)

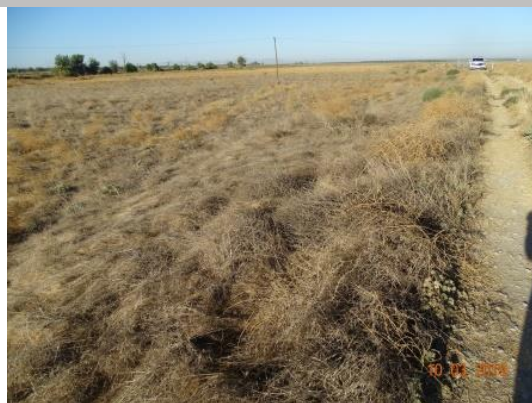
Photo 1 of 2 : FA_2019_NA0011_146_8_20191009_00032.jpg

LM Start	0.01	Rating **	U	Issue No.	8
LM End	4.06	Issue Type +	Ma	Location *	WS
Category	Earthen Levee			GPS Latitude/Longitude	
				Start	End
Item	Vegetation			36.978438 °	36.968155 °
				-120.368405 °	-120.300968 °
DWR ID	DWR_NA0011_05_f_2019_8				
Comment Code					
V1 : Control annual grass and weeds on the levee slopes and easements.					
Inspector Comment

Looking downstream along waterside slope. (Fall 2019)

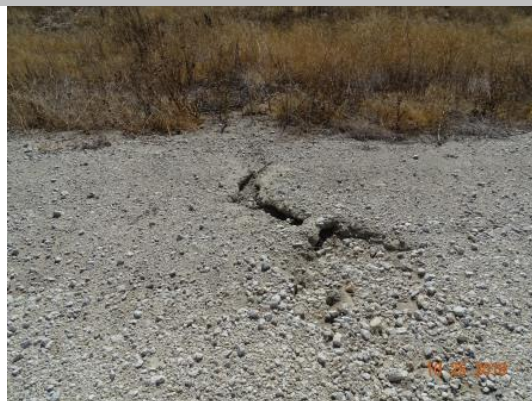
Photo 2 of 2 : FA_2019_NA0011_146_38_20190912_00018.jpg

LM Start	5.67	Rating **	M	Issue No.	38 (cont)
LM End	5.67	Issue Type +	Ma	Location *	WS

Finger erosion on waterside slope. (Fall 2018)

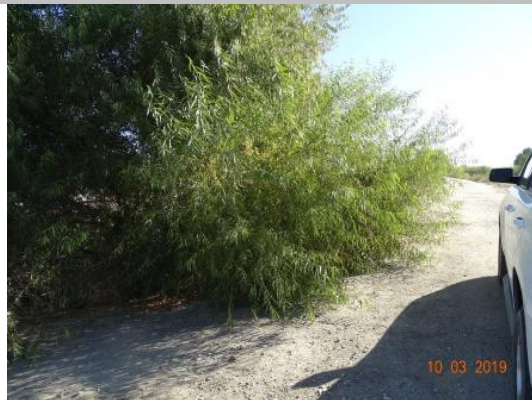
Photo 1 of 1 : FA_2019_NA0011_146_29_20191009_00043.jpg

LM Start	6.57	Rating **	U	Issue No.	29
LM End	6.57	Issue Type +	Ma	Location *	LS
Category	Earthen Levee			GPS Latitude/Longitude	
				Start	End
Item	Trim / Thin Trees			36.968477 °	36.968477 °
				-120.255557 °	-120.255557 °
DWR ID	DWR_NA0011_05_f_2019_29				
Comment Code					
T2 : Thin trees to allow visibility of the ground and room to flood fight.					
Inspector Comment					
Tree should be trimmed above the levee crown and 5 feet above the slope.

View of tree growing on landside slope looking upstream. (Fall 2019)

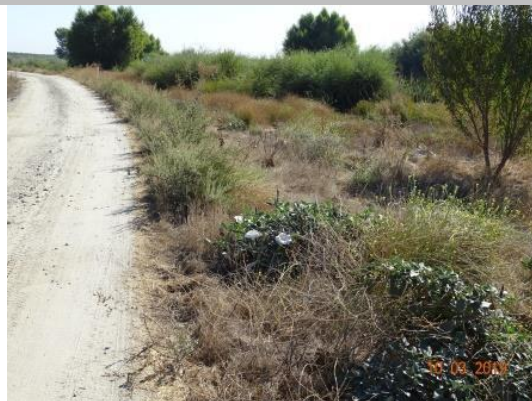
Photo 1 of 1 : FA_2019_NA0011_146_33_20191009_00044.jpg

LM Start	6.58	Rating **	U	Issue No.	33
LM End	7.70	Issue Type +	Ma	Location *	WS
Category	Earthen Levee			GPS Latitude/Longitude	
				Start	End
Item	Vegetation			36.968493 °	36.969800 °
				-120.255322 °	-120.235388 °
DWR ID	DWR_NA0011_05_f_2019_33				
Comment Code					
V1 : Control annual grass and weeds on the levee slopes and easements.					
Inspector Comment

View of waterside slope looking upstream. (Fall 2019)

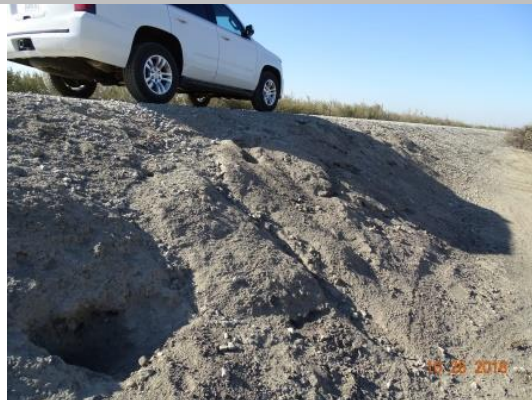
Photo 1 of 1 : FA_2019_NA0011_146_24_20190912_00009.jpg

LM Start	7.66	Rating **	U	Issue No.	24
LM End	7.66	Issue Type +	Ma	Location *	LS
Category	Earthen Levee			GPS Latitude/Longitude	
				Start	End
Item	Animal Control			36.969606 °	36.969606 °
				-120.236091 °	-120.236091 °
DWR ID	DWR_NA0011_05_f_2018_24				
Comment Code					
A3 : No rodents visible, but rodent burrows visible; need to backfill and compact or grout burrows.					
Inspector Comment					
Rodent burrows and associated erosion due to rodent activity.

Rodent activity on landside slope. (Fall 2018)

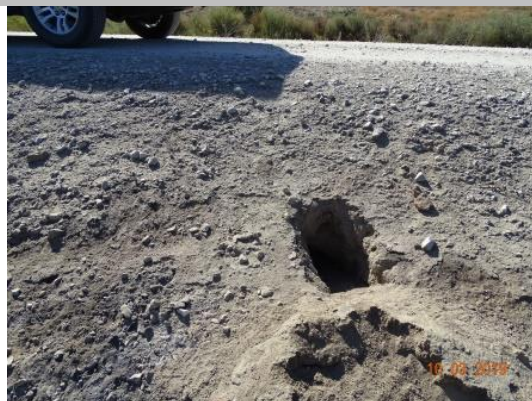
Photo 2 of 2 : FA_2019_NA0011_146_51_20191009_00047.jpg

LM Start	8.40	Rating **	U	Issue No.	51 (cont)
LM End	8.40	Issue Type +	Ma	Location *	LS

View of rodent burrow in landside slope. (Fall 2019)

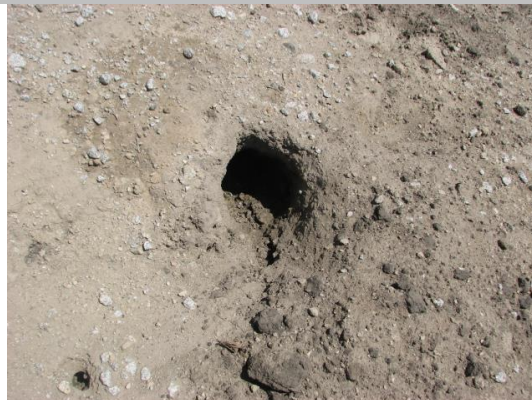
Photo 1 of 1 : FA_2019_NA0011_147_53_20190912_00022.jpg

LM Start	5.44	Rating **	U	Issue No.	53
LM End	5.44	Issue Type +	Ma	Location *	LS
Category	Earthen Levee			GPS Latitude/Longitude	
				Start	End
Item	Animal Control			36.967514 °	36.967514 °
				-120.274810 °	-120.274810 °
DWR ID	DWR_NA0011_06_s_2018_53				
Comment Code					
A3 : No rodents visible, but rodent burrows visible; need to backfill and compact or grout burrows.					
Inspector Comment					
Control rodents within this section.

Looking at typical rodent hole on landward slope. (Spring 2018)

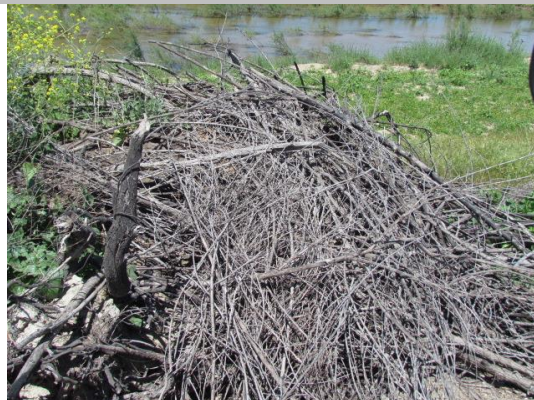
Photo 1 of 1 : FA_2019_NA0011_147_32_20190912_00010.jpg

LM Start	7.96	Rating **	M	Issue No.	32
LM End	7.96	Issue Type +	Ma	Location *	WS
Category	Earthen Levee			GPS Latitude/Longitude	
				Start	End
Item	Encroachments			36.971543 °	36.971543 °
				-120.230285 °	-120.230285 °
DWR ID	DWR_NA0011_06_s_2017_32				
Comment Code					
PR : Prunings					
Inspector Comment					
Remove the brush pile from the levee slope. This pile is providing habitat for rodents.

Fresno River waterside levee mile 7.96.
