**Flood Control Project Maintenance
Levee Inspections**

Maintenance Issue Types Only, Levee Inspection Report By Mile - Fall 2020

Madera County FCWCA

Waterway	Bank	Unit Miles	Inspection Start/End	Inspector
Unit No. 01 Ash Slough	Right	2.37	09/24/2020 09/24/2020	Corey Fujitani

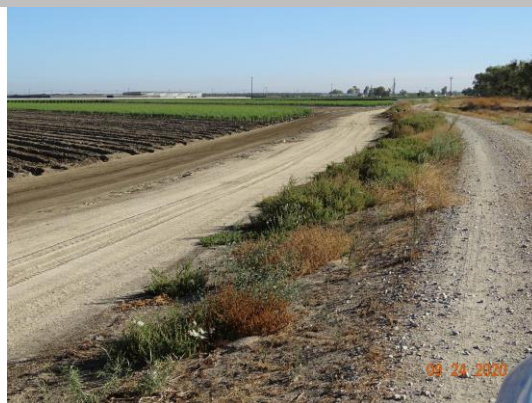
Photo 1 of 1 : FA_2020_NA0011_142_9_20201005_00033.jpg

LM Start	1.93	Rating **	M	Issue No.	9
LM End	2.04	Issue Type +	Ma	Location *	LS
Category	Earthen Levee			GPS Latitude/Longitude	
				Start	End
Item	Vegetation			37.063792 °	37.065008 °
				-120.402687 °	-120.401461 °
DWR ID	DWR_NA0011_01_f_2020_9				
Comment Code					
V1 : Control annual grass and weeds on the levee slopes and easements.					
Inspector Comment

View of the landside slope looking upstream. (Fall 2020)

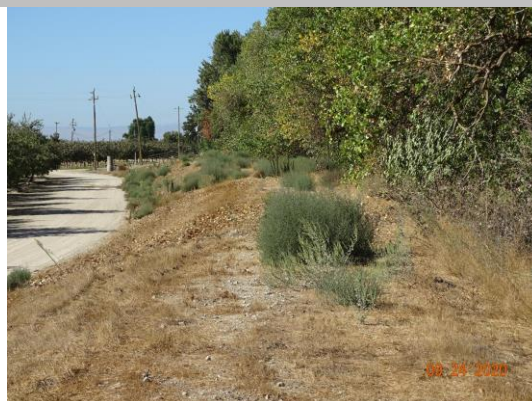
Photo 1 of 1 : FA_2020_NA0011_143_42_20201005_00040.jpg

LM Start	0.32	Rating **	U	Issue No.	42
LM End	0.44	Issue Type +	Ma	Location *	CR
Category	Earthen Levee			GPS Latitude/Longitude	
				Start	End
Item	Vegetation			37.047265 °	37.048561 °
				-120.422125 °	-120.420562 °
DWR ID	DWR_NA0011_02_s_2020_42				
Comment Code					
V9 : Keep the crown roadway free of vegetation.					
Inspector Comment

View of levee crown looking downstream. (Fall 2020)

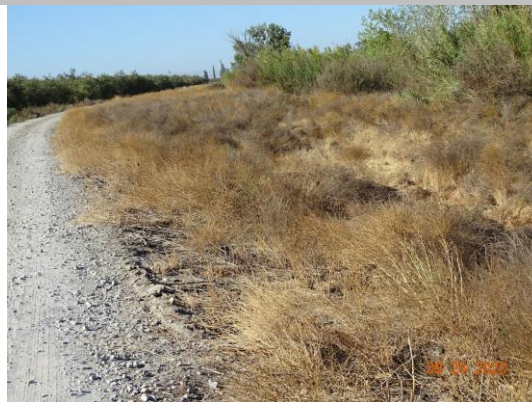
Photo 1 of 1 : FA_2020_NA0011_143_9_20201005_00041.jpg

LM Start	0.86	Rating **	U	Issue No.	9
LM End	2.02	Issue Type +	Ma	Location *	WS
Category	Earthen Levee			GPS Latitude/Longitude	
				Start	End
Item	Vegetation			37.053450 °	37.063911 °
				-120.416290 °	-120.401227 °
DWR ID	DWR_NA0011_02_f_2020_9				
Comment Code					
V1 : Control annual grass and weeds on the levee slopes and easements.					
Inspector Comment

View of waterside slope looking downstream. (Fall 2020)

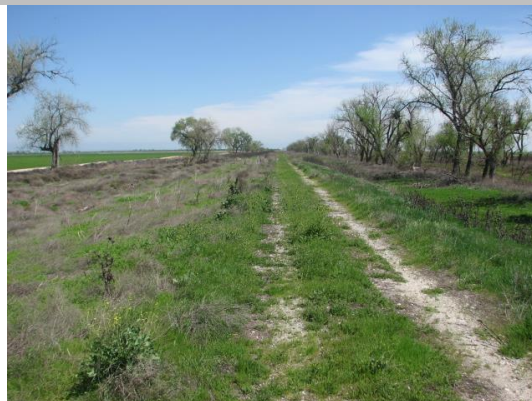
Photo 1 of 1 : FA_2020_NA0011_144_32_20200901_00011.jpg

LM Start	0.08	Rating **	M	Issue No.	32
LM End	1.51	Issue Type +	Ma	Location *	CR
Category	Earthen Levee			GPS Latitude/Longitude	
				Start	End
Item	Crown Surface / Depressions / Rutting			36.996264 °	36.996613 °
				-120.372350 °	-120.346570 °
DWR ID	DWR_NA0011_03_s_2014_32				
Comment Code					
C3 : Add appropriate gravel or road base. Grade and compact.					
Inspector Comment					
Regrade the crown for proper drainage and add more rock to crown.

Looking downstream at levee crown. (Spring 2018)

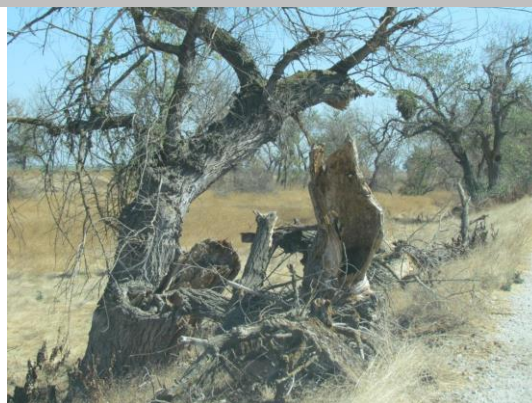
Photo 1 of 1 : FA_2020_NA0011_145_15_20200901_00008.jpg

LM Start	0.14	Rating **	U	Issue No.	15
LM End	0.14	Issue Type +	Ma	Location *	WS
Category	Earthen Levee			GPS Latitude/Longitude	
				Start	End
Item	Encroachments			36.995528 °	36.995528 °
				-120.370922 °	-120.370922 °
DWR ID	DWR_NA0011_04_f_2015_15				
Comment Code					
TR : Tree or limb					
Inspector Comment					
There are many dead trees in the area. Remove the dead trees from the levee section. Many more are subject to fall and possibly block access to the levee crown.

Berenda Slough looking upstream from the levee mile 0.14.

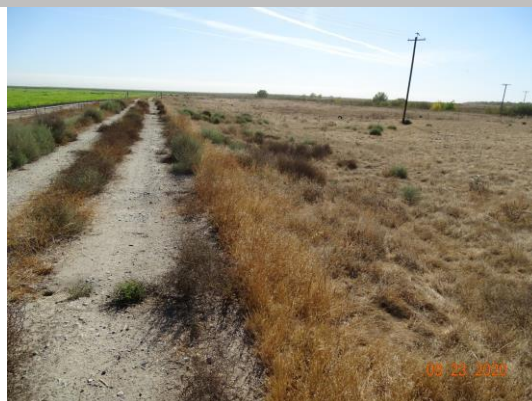
Photo 1 of 1 : FA_2020_NA0011_146_8_20201006_00033.jpg

LM Start	0.00	Rating **	U	Issue No.	8	
LM End	2.27	Issue Type +	Ma	Location *	WS	
Category	Earthen Levee			GPS Latitude/Longitude		
				Start		End
Item	Vegetation			36.978539 °		36.967973 °
				-120.368431 °		-120.333207 °
DWR ID	DWR_NA0011_05_f_2020_8					
Comment Code						
V1 : Control annual grass and weeds on the levee slopes and easements.						
Inspector Comment

View of the waterside slope looking upstream. (Fall 2020)

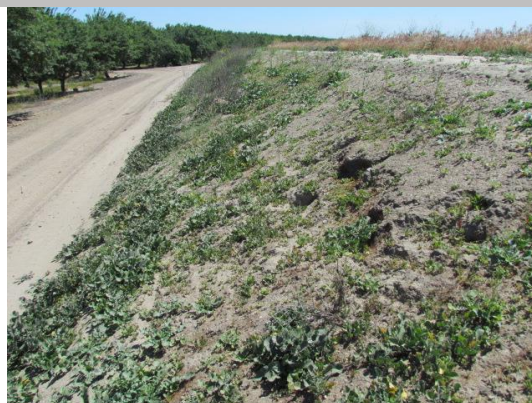
Photo 1 of 1 : FA_2020_NA0011_146_28_20200901_00012.jpg

LM Start	6.75	Rating **	M	Issue No.	28
LM End	6.95	Issue Type +	Ma	Location *	LS
Category	Earthen Levee			GPS Latitude/Longitude	
				Start	End
Item	Animal Control			36.969200 °	36.969507 °
				-120.252462 °	-120.248893 °
DWR ID	DWR_NA0011_05_f_2016_28				
Comment Code					
A1 : Exterminate rodents and backfill and compact or grout burrows.					
Inspector Comment					
Exterminate the rodents in the area listed and place bait stations along the shoulder and/or slope.

Fresno River landside levee slope levee mile 6.75-6.95.

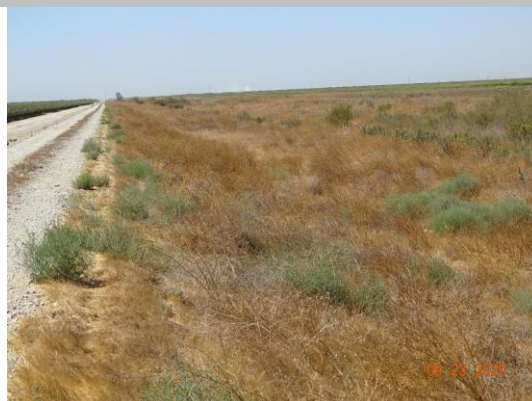
Photo 1 of 1 : FA_2020_NA0011_147_30_20201006_00048.jpg

LM Start	2.59	Rating **	M	Issue No.	30							
LM End	3.45	Issue Type +	Ma	Location *	WS							
Category	Earthen Levee		GPS Latitude/Longitude									
			Start	End								
Item	Vegetation		36.967280 °	36.967389 °								
			-120.326264 °	-120.310681 °								
DWR ID	DWR_NA0011_06_f_2020_30											
Comment Code												
V1 : Control annual grass and weeds on the levee slopes and easements.												
Inspector Comment

Looking upstream along the waterside slope. (Fall 2020)

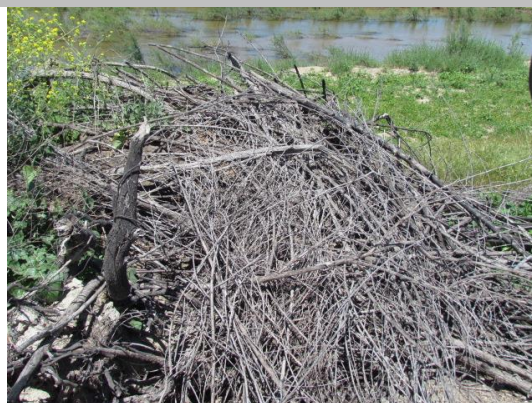
Photo 1 of 1 : FA_2020_NA0011_147_32_20200901_00010.jpg

LM Start	7.96	Rating **	M	Issue No.	32
LM End	7.96	Issue Type +	Ma	Location *	WS
Category	Earthen Levee			GPS Latitude/Longitude	
				Start	End
Item	Encroachments			36.971543 °	36.971543 °
				-120.230285 °	-120.230285 °
DWR ID	DWR_NA0011_06_s_2017_32				
Comment Code					
PR : Prunings					
Inspector Comment					
Remove the brush pile from the levee slope. This pile is providing habitat for rodents.

Fresno River waterside levee mile 7.96.

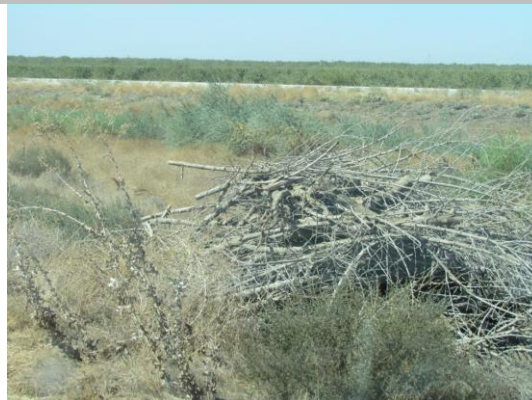
Photo 1 of 1 : FA_2020_NA0011_147_36_20200901_00011.jpg

LM Start	8.03	Rating **	M	Issue No.	36
LM End	8.03	Issue Type +	Ma	Location *	WS
Category	Earthen Levee			GPS Latitude/Longitude	
				Start	End
Item	Encroachments			36.971582 °	36.971582 °
				-120.229180 °	-120.229180 °
DWR ID	DWR_NA0011_06_f_2015_36				
Comment Code					
TR : Tree or limb					
Inspector Comment					
The dead tree has been removed from blocking the roadway but still needs to be removed from the levee section.

Fresno River levee mile 8.03 waterside slope and shoulder.

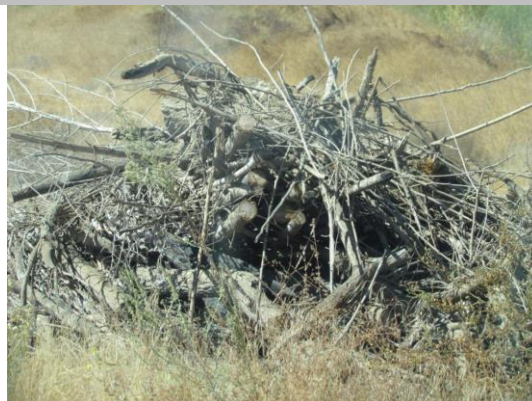
Photo 1 of 1 : FA_2020_NA0011_147_31_20200901_00009.jpg

LM Start	8.09	Rating **	U	Issue No.	31
LM End	8.09	Issue Type +	Ma	Location *	WS
Category	Earthen Levee			GPS Latitude/Longitude	
				Start	End
Item	Encroachments			36.971692 °	36.971692 °
				-120.227957 °	-120.227957 °
DWR ID	DWR_NA0011_06_f_2015_31				
Comment Code					
TR : Tree or limb					
Inspector Comment					
Remove the dead tree off the slope and shoulder.

Fresno River levee mile 8.09.
