**Flood Control Project Maintenance
Levee Inspections**

Maintenance Issue Types Only, Levee Inspection Report By Mile - Fall 2021

Madera County FCWCA

Waterway	Bank	Unit Miles	Inspection Start/End	Inspector
Unit No. 01 Ash Slough	Right	2.37	10/14/2021 10/14/2021	Corey Fujitani

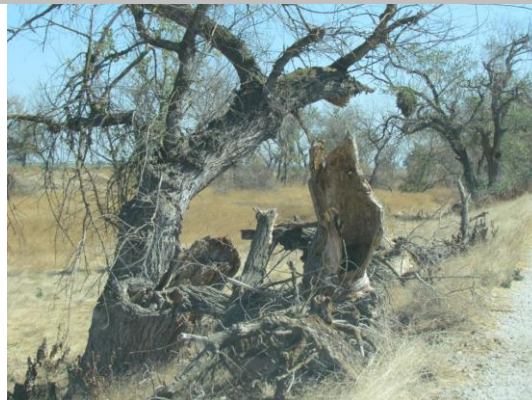
Photo 1 of 1 : FA_2021_NA0011_145_15_20210830_00009.jpg

LM Start	0.14	Rating **	U	Issue No.	15
LM End	0.14	Issue Type +	Ma	Location *	WS
Category	Earthen Levee			GPS Latitude/Longitude	
				Start	End
Item	Encroachments			36.995528 °	36.995528 °
				-120.370922 °	-120.370922 °
DWR ID	DWR_NA0011_04_f_2015_15				
Comment Code					
TR : Tree or limb					
Inspector Comment					
There are many dead trees in the area. Remove the dead trees from the levee section. Many more are subject to fall and possibly block access to the levee crown.

Berenda Slough looking upstream from the levee mile 0.14.
