**Flood Control Project Maintenance  
Levee Inspections**

**Maintenance Issue Types Only, Levee Inspection Report By Mile - Fall 2022**

**Madera County FCWCA**

Waterway	Bank	Unit Miles	Inspection Start/End	Inspector
Unit No. 01 Ash Slough	Right	2.37	10/05/2022 10/05/2022	Corey Fujitani

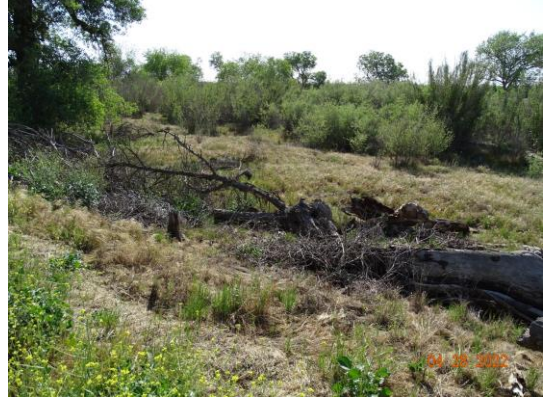
Photo 1 of 1 : FA\_2022\_NA0011\_142\_11\_20220822\_00002.jpg

LM Start	0.44	Rating **	M	Issue No.	11
LM End	0.44	Issue Type +	Ma	Location *	WS
Category	Earthen Levee			GPS Latitude/Longitude	
				Start	End
Item	Trim / Thin Trees			37.049455 °	37.049455 °
				-120.421218 °	-120.421218 °
DWR ID	DWR_NA0011_01_s_2012_11				
Comment Code					
T2 : Tree or limb.					
Inspector Comment					
Remove the dead tree from the waterside slope.

Remove downed tree from waterside slope. (Spring 2022)

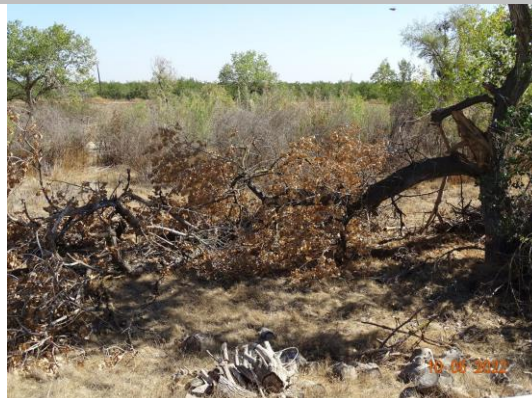
Photo 1 of 1 : FA\_2022\_NA0011\_142\_37\_20221020\_00018.jpg

LM Start	0.62	Rating **	M	Issue No.	37
LM End	0.62	Issue Type +	Ma	Location *	WS
Category	Earthen Levee			GPS Latitude/Longitude	
				Start	End
Item	Trim / Thin Trees			37.051222 °	37.051222 °
				-120.418810 °	-120.418810 °
DWR ID	DWR_NA0011_01_f_2015_37				
Comment Code					
T2 : Tree or limb.					
Inspector Comment					
Remove the tree branches from the waterside slope.

Downed tree limbs on the waterside berm should be removed. (Fall 2022)

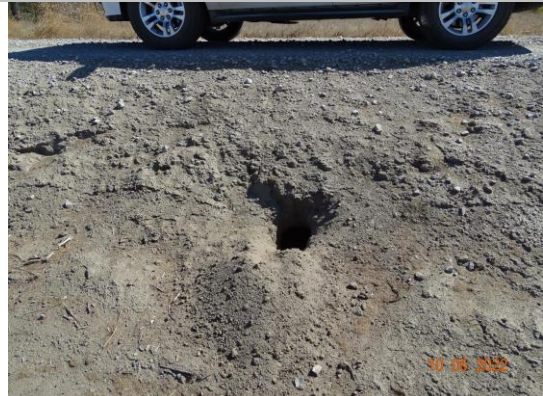
Photo 1 of 1 : FA\_2022\_NA0011\_142\_33\_20221020\_00022.jpg

LM Start	1.51	Rating **	M	Issue No.	33
LM End	1.51	Issue Type +	Ma	Location *	LS
Category	Earthen Levee			GPS Latitude/Longitude	
				Start	End
Item	Animal Control			37.059440 °	37.059440 °
				-120.407896 °	-120.407896 °
DWR ID	DWR_NA0011_01_f_2022_33				
Comment Code					
A3 : No rodents visible, but rodent burrows visible; need to backfill and compact or grout burrows.					
Inspector Comment

View of animal burrow on the landside slope. (Fall 2022)

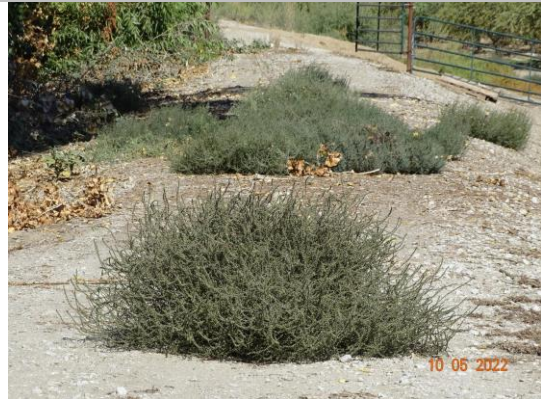
Photo 1 of 1 : FA\_2022\_NA0011\_143\_35\_20221020\_00025.jpg

LM Start	0.25	Rating **	U	Issue No.	35
LM End	0.25	Issue Type +	Ma	Location *	CR
Category	Earthen Levee			GPS Latitude/Longitude	
				Start	End
Item	Vegetation			37.046795 °	37.046795 °
				-120.423172 °	-120.423172 °
DWR ID	DWR_NA0011_02_f_2022_35				
Comment Code					
V3 : Keep the crown roadway free of vegetation.					
Inspector Comment

View of vegetation growing on the levee crown. (Fall 2022)

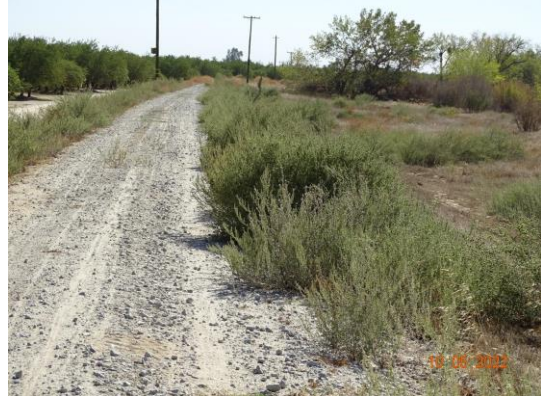
Photo 1 of 1 : FA\_2022\_NA0011\_143\_25\_20221020\_00023.jpg

LM Start	0.29	Rating **	M	Issue No.	25
LM End	0.90	Issue Type +	Ma	Location *	WS
Category	Earthen Levee			GPS Latitude/Longitude	
				Start	End
Item	Vegetation			37.047089 °	37.054041 °
				-120.422666 °	-120.416114 °
DWR ID	DWR_NA0011_02_f _ 2022_25				
Comment Code					
V1 : Control annual grass and weeds on the levee slopes and easements.					
Inspector Comment

View of vegetation on the waterside slope. (Fall 2022)

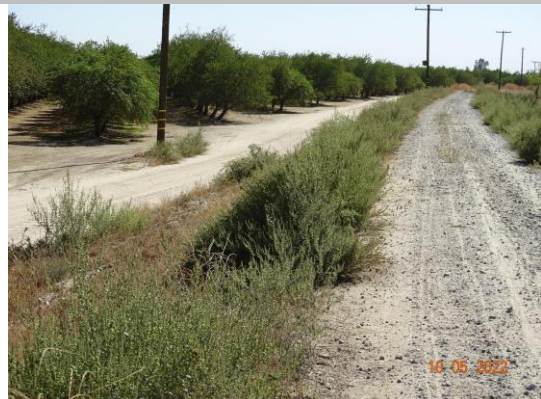
Photo 1 of 1 : FA\_2022\_NA0011\_143\_28\_20221020\_00024.jpg

LM Start	0.29	Rating **	M	Issue No.	28
LM End	0.90	Issue Type +	Ma	Location *	LS
Category	Earthen Levee			GPS Latitude/Longitude	
				Start	End
Item	Vegetation			37.047090 °	37.054040 °
				-120.422666 °	-120.416114 °
DWR ID	DWR_NA0011_02_f_2022_28				
Comment Code					
V1 : Control annual grass and weeds on the levee slopes and easements.					
Inspector Comment

Looking downstream along the landside slope. (Fall 2022)

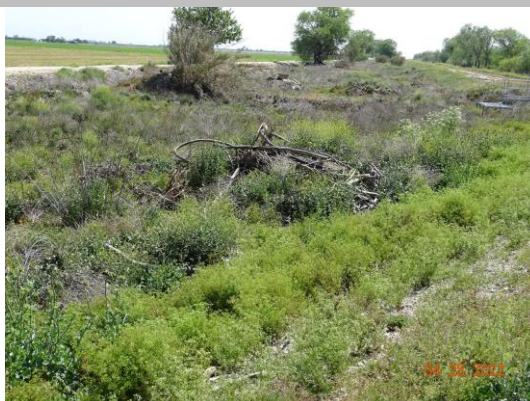
Photo 1 of 1 : FA\_2022\_NA0011\_144\_20\_20220822\_00006.jpg

LM Start	0.08	Rating **	U	Issue No.	20
LM End	0.08	Issue Type +	Ma	Location *	LS
Category	Earthen Levee			GPS Latitude/Longitude	
				Start	End
Item	Encroachments			36.996204 °	36.996201 °
				-120.372352 °	-120.372345 °
DWR ID	DWR_NA0011_03_s_2012_20				
Comment Code					
PR : Prunings					
Inspector Comment					
Remove the prunings from the landside slope.

Looking at prunings on landward slope. (Spring 2022)

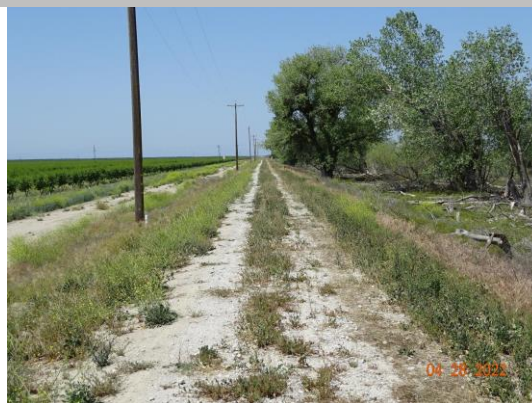
Photo 1 of 1 : FA\_2022\_NA0011\_145\_35\_20220822\_00023.jpg

LM Start	0.06	Rating **	M	Issue No.	35
LM End	0.50	Issue Type +	Ma	Location *	CR
Category	Earthen Levee			GPS Latitude/Longitude	
				Start	End
Item	Vegetation			36.995560 °	36.995580 °
				-120.372469 °	-120.364450 °
DWR ID	DWR_NA0011_04_s_2022_35				
Comment Code					
V3 : Keep the crown roadway free of vegetation.					
Inspector Comment

View of vegetation growing along the levee crown. (Spring 2022)

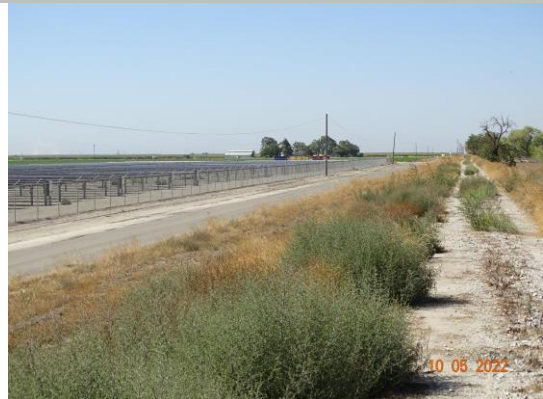
Photo 1 of 1 : FA\_2022\_NA0011\_145\_28\_20221020\_00029.jpg

LM Start	0.96	Rating **	U	Issue No.	28
LM End	1.59	Issue Type +	Ma	Location *	LS
Category	Earthen Levee			GPS Latitude/Longitude	
				Start	End
Item	Vegetation			36.995585 °	36.996085 °
				-120.356197 °	-120.344945 °
DWR ID	DWR_NA0011_04_f_2022_28				
Comment Code					
V1 : Control annual grass and weeds on the levee slopes and easements.					
Inspector Comment

View of the landside slope looking downstream. (Fall 2022)

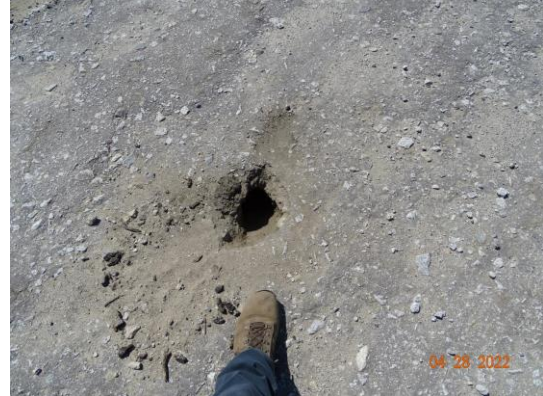
Photo 1 of 1 : FA\_2022\_NA0011\_145\_59\_20220822\_00025.jpg

LM Start	1.63	Rating **	U	Issue No.	59
LM End	1.67	Issue Type +	Ma	Location *	CR
Category	Earthen Levee			GPS Latitude/Longitude	
				Start	End
Item	Animal Control			36.996573 °	36.997002 °
				-120.344428 °	-120.343977 °
DWR ID	DWR_NA0011_04_s_2012_59				
Comment Code					
A1 : Exterminate rodents and backfill and compact or grout burrows.					
Inspector Comment					
Exterminate rodents in this area.

Representative rodent hole in the levee crown along this section. (Spring 2022)

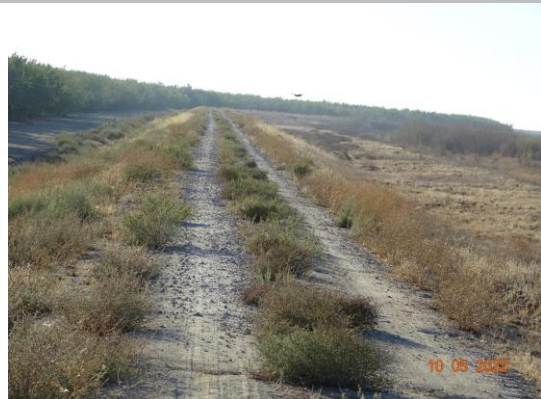
Photo 1 of 1 : FA\_2022\_NA0011\_146\_7\_20221020\_00025.jpg

LM Start	0.05	Rating **	M	Issue No.	7
LM End	4.05	Issue Type +	Ma	Location *	CR
Category	Earthen Levee			GPS Latitude/Longitude	
				Start	End
Item	Vegetation			36.978493 °	36.968171 °
				-120.367529 °	-120.301129 °
DWR ID	DWR_NA0011_05_s_2022_7				
Comment Code					
V3 : Keep the crown roadway free of vegetation.					
Inspector Comment

Looking upstream along the levee crown. (Fall 2022)

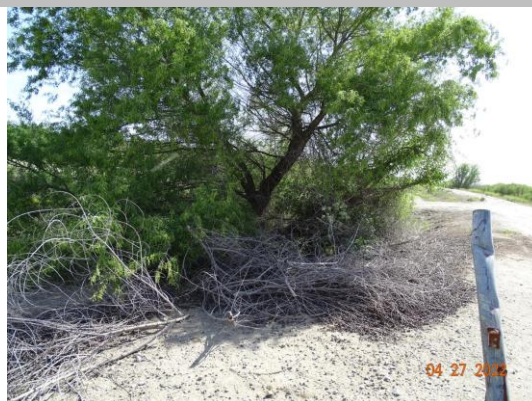
Photo 1 of 1 : FA\_2022\_NA0011\_146\_29\_20220822\_00015.jpg

LM Start	6.57	Rating **	M	Issue No.	29
LM End	6.57	Issue Type +	Ma	Location *	LS
Category	Earthen Levee			GPS Latitude/Longitude	
				Start	End
Item	Trim / Thin Trees			36.968477 °	36.968477 °
				-120.255557 °	-120.255557 °
DWR ID	DWR_NA0011_05_f_2019_29				
Comment Code					
T1 : Trim and thin trees to at least five feet above ground level to allow visibility of the ground and room to flood fight.					
Inspector Comment					
Tree should be trimmed above the levee crown and 5 feet above the slope.

View of tree growing on the landside slope. (Spring 2022)

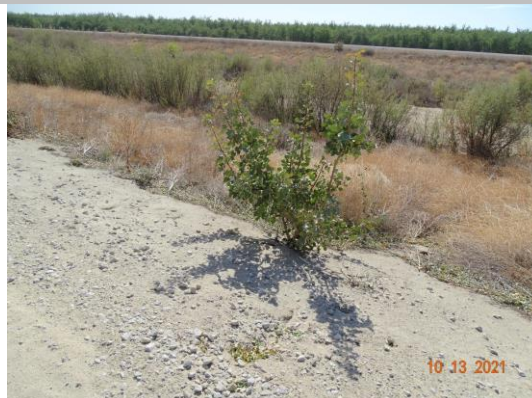
Photo 1 of 1 : FA\_2022\_NA0011\_146\_8\_20220822\_00002.jpg

LM Start	8.70	Rating **	M	Issue No.	8
LM End	8.70	Issue Type +	Ma	Location *	WS
Category	Earthen Levee			GPS Latitude/Longitude	
				Start	End
Item	Trim / Thin Trees			36.971970 °	36.971970 °
				-120.218647 °	-120.218647 °
DWR ID	DWR_NA0011_05_f_2021_8				
Comment Code					
T1 : Trim and thin trees to at least five feet above ground level to allow visibility of the ground and room to flood fight.					
Inspector Comment

Sapling growing on the waterside shoulder. (Fall 2021)

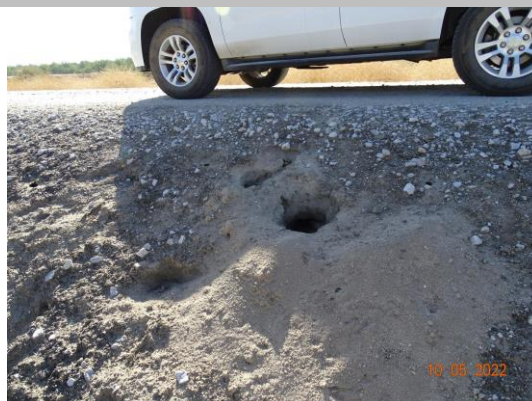
Photo 1 of 1 : FA\_2022\_NA0011\_146\_48\_20221020\_00031.jpg

LM Start	9.00	Rating **	M	Issue No.	48
LM End	9.00	Issue Type +	Ma	Location *	LS
Category	Earthen Levee			GPS Latitude/Longitude	
				Start	End
Item	Animal Control			36.972896 °	36.972896 °
				-120.213267 °	-120.213267 °
DWR ID	DWR_NA0011_05_f_2022_48				
Comment Code					
A3 : No rodents visible, but rodent burrows visible; need to backfill and compact or grout burrows.					
Inspector Comment

View of rodent holes on the landside slope. (Fall 2022)

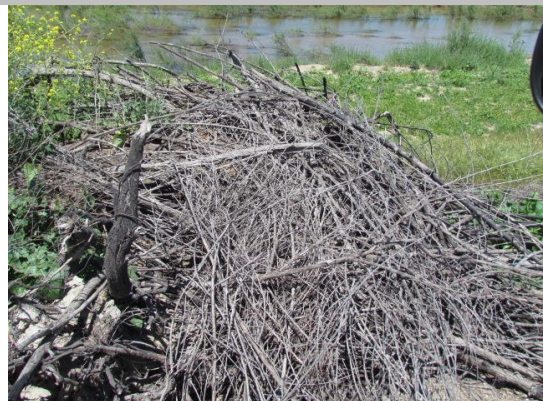
Photo 1 of 1 : FA\_2022\_NA0011\_147\_32\_20220822\_00014.jpg

LM Start	7.96	Rating **	M	Issue No.	32
LM End	7.96	Issue Type +	Ma	Location *	WS
Category	Earthen Levee			GPS Latitude/Longitude	
				Start	End
Item	Encroachments			36.971543 °	36.971543 °
				-120.230285 °	-120.230285 °
DWR ID	DWR_NA0011_06_s_2017_32				
Comment Code					
PR : Prunings					
Inspector Comment					
Remove the brush pile from the levee slope. This pile is providing habitat for rodents.

Fresno River waterside levee mile 7.96.
