**Flood Control Project Maintenance  
Levee Inspections**

**Maintenance Issue Types Only, Levee Inspection Report By Mile - Fall 2023**

**Madera County FCWCA**

Waterway	Bank	Unit Miles	Inspection Start/End	Inspector
Unit No. 01 Ash Slough	Right	2.37	10/26/2023 10/26/2023	Corey Fujitani

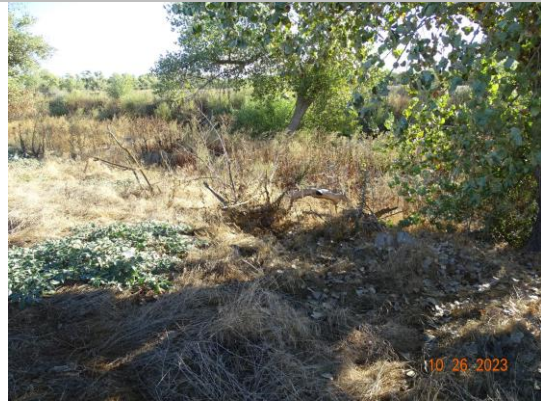
Photo 1 of 1 : FA\_2023\_NA0011\_142\_21\_20231101\_00025.jpg

LM Start	0.75	Rating **	M	Issue No.	21
LM End	0.75	Issue Type +	Ma	Location *	WS
Category	Earthen Levee			GPS Latitude/Longitude	
				Start	End
Item	Trim / Thin Trees			37.052796°	37.052796°
				-120.417641°	-120.417640°
DWR ID	DWR_NA0011_01_f_2023_21				
Comment Code					
T2 : Tree or limb.					
Inspector Comment					
Remove tree limbs from waterside slope.

View of tree limbs on the waterside slope. (Fall 2023)

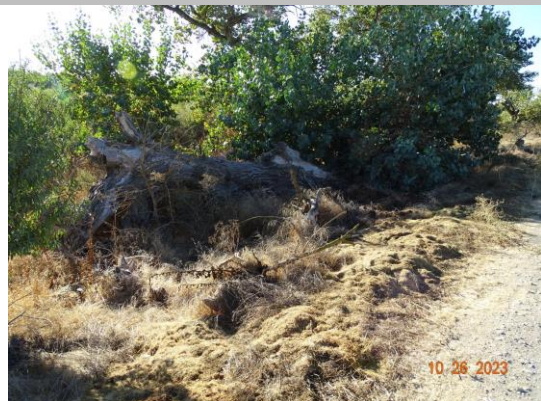
Photo 1 of 1 : FA\_2023\_NA0011\_142\_25\_20231101\_00026.jpg

LM Start	0.79	Rating **	U	Issue No.	25
LM End	0.79	Issue Type +	Ma	Location *	WS
Category	Earthen Levee			GPS Latitude/Longitude	
				Start	End
Item	Trim / Thin Trees			37.053329°	37.053329°
				-120.417448°	-120.417448°
DWR ID	DWR_NA0011_01_f_2018_25				
Comment Code					
T2 : Tree or limb.					
Inspector Comment					
There is a fallen tree blocking the waterside slope.

Tree limbs and trunks are on the waterside shoulder and slope. (Fall 2023)

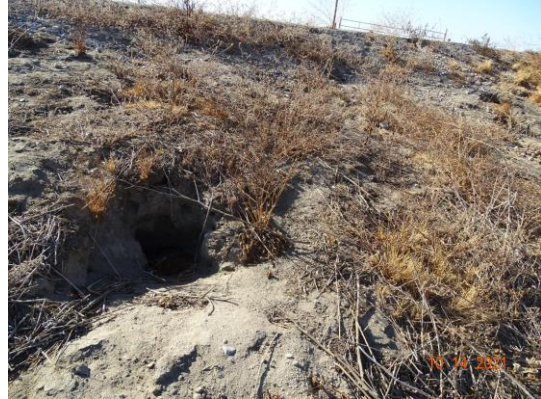
Photo 1 of 1 : FA\_2023\_NA0011\_143\_20\_20230821\_00010.jpg

LM Start	0.00	Rating **	U	Issue No.	20
LM End	0.03	Issue Type +	Ma	Location *	WS
Category	Earthen Levee			GPS Latitude/Longitude	
				Start	End
Item	Animal Control			37.045485°	37.045650°
				-120.427415°	-120.426836°
DWR ID	DWR_NA0011_02_f_2021_20				
Comment Code					
A3 : No rodents visible, but rodent burrows visible; need to backfill and compact or grout burrows.					
Inspector Comment

Representative view of rodent burrows on the waterside slope. (Fall 2021)

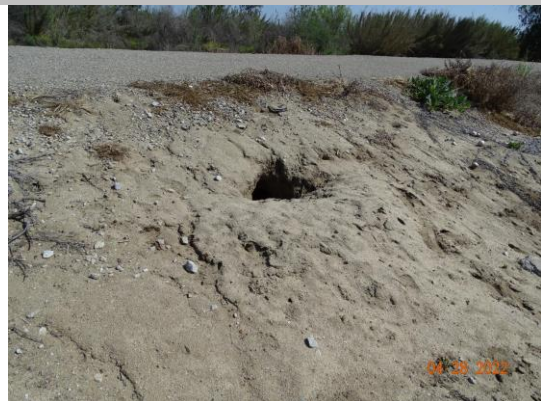
Photo 1 of 1 : FA\_2023\_NA0011\_143\_30\_20230821\_00016.jpg

LM Start	0.01	Rating **	U	Issue No.	30
LM End	0.01	Issue Type +	Ma	Location *	LS
Category	Earthen Levee			GPS Latitude/Longitude	
				Start	End
Item	Animal Control			37.045531°	37.045531°
				-120.427244°	-120.427244°
DWR ID	DWR_NA0011_02_s_2022_30				
Comment Code					
A3 : No rodents visible, but rodent burrows visible; need to backfill and compact or grout burrows.					
Inspector Comment

View of animal burrow on the landside slope. (Spring 2022)

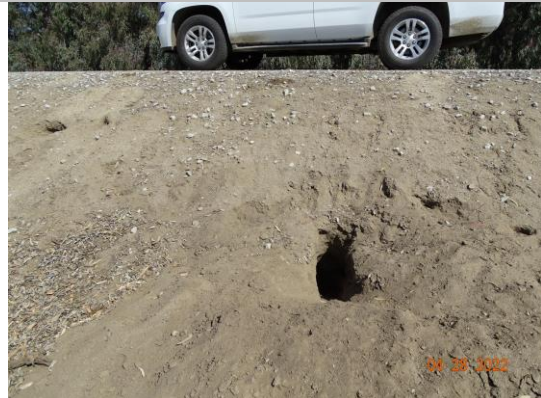
Photo 1 of 1 : FA\_2023\_NA0011\_143\_26\_20230821\_00013.jpg

LM Start	0.08	Rating **	A/W	Issue No.	26
LM End	0.08	Issue Type +	Ma	Location *	LS
Category	Earthen Levee			GPS Latitude/Longitude	
				Start	End
Item	Animal Control			37.045874°	37.045874°
				-120.426013°	-120.426013°
DWR ID	DWR_NA0011_02_s _ 2022_26				
Comment Code					
A3 : No rodents visible, but rodent burrows visible; need to backfill and compact or grout burrows.					
Inspector Comment					
Large animal hole on the landside slope. There is the possibility the burrow penetrates onto the waterside as there are a couple of smaller holes located on the waterside slope.

Large rodent burrow observed on the landside toe. (Spring 2022)

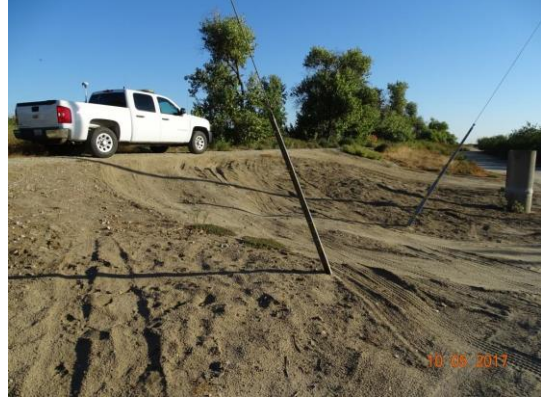
Photo 1 of 1 : FA\_2023\_NA0011\_143\_13\_20230821\_00007.jpg

LM Start	0.31	Rating **	M	Issue No.	13
LM End	0.31	Issue Type +	Ma	Location *	LS
Category	Earthen Levee			GPS Latitude/Longitude	
				Start	End
Item	Erosion / Vehicle Traffic			37.047266°	37.047266°
				-120.422393°	-120.422393°
DWR ID	DWR_NA0011_02_f_2017_13				
Comment Code					
E6 : Repair the levee slope damaged by vehicle traffic and prevent access where possible.					
Inspector Comment

Vehicle access to levee slope should be prevented and erosion repaired.

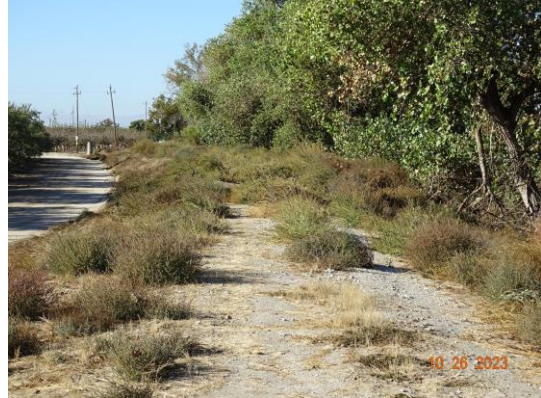
Photo 1 of 1 : FA\_2023\_NA0011\_143\_17\_20231101\_00024.jpg

LM Start	0.31	Rating **	U	Issue No.	17
LM End	0.44	Issue Type +	Ma	Location *	WS
Category	Earthen Levee			GPS Latitude/Longitude	
				Start	End
Item	Vegetation			37.047162°	37.048521°
				-120.422274°	-120.420595°
DWR ID	DWR_NA0011_02_f_2023_17				
Comment Code					
V1 : Control annual grass and weeds on the levee slopes and easements.					
Inspector Comment

View of vegetation growing on the waterside shoulder and slope. (Fall 2023)

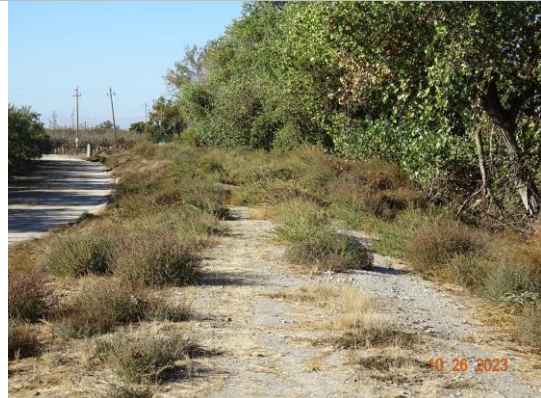
Photo 1 of 1 : FA\_2023\_NA0011\_143\_15\_20231101\_00025.jpg

LM Start	0.31	Rating **	U	Issue No.	15
LM End	0.44	Issue Type +	Ma	Location *	CR
Category	Earthen Levee			GPS Latitude/Longitude	
				Start	End
Item	Vegetation			37.047195°	37.048524°
				-120.422188°	-120.420595°
DWR ID	DWR_NA0011_02_f_2023_15				
Comment Code					
V3 : Keep the crown roadway free of vegetation.					
Inspector Comment

View of vegetation growing along the levee crown. (Fall 2023)

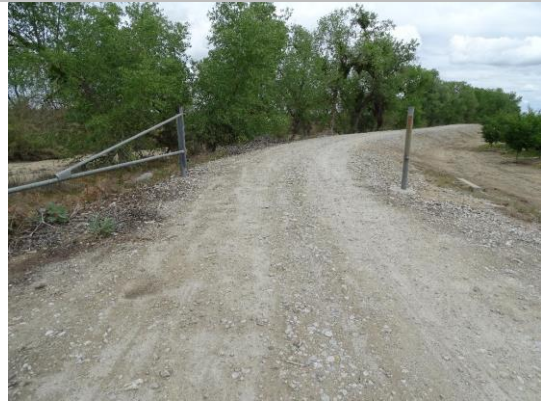
Photo 1 of 3 : UCIP\_FA\_2023\_77411\_112199.jpg

Comment Code						
Inspector Comment						
DS_ID:21515 FS_ID:77411 EP_NO: N/A Repair Type: No Action Needed EVAL Issue: Crossing Status: Found UCIP Comments: 04/19/2022 Record updated from No Action Needed to Non-Urgent. Owner needs to coordinate with CVFPB to authorize crossing. DMP internal video inspection has not found pipe integrity issues. LOF of crossing is less or equal to 4. Recommend next video inspection in 5 years. No issues observed during inspection. (M.Thao - DWR UCIP) FIELD_STRUCT_DESC: 36-inch corrugated metal gravity drainage pipe through the levee, 7.3 feet below the crown. Headwall and wing wall on each end. Flap gate on the waterside (WS) end. [Additional Reference(s): Levee Log, 2005 (HLM 0.99). USACE San Joaquin O&M Manual 605 (Station 52+50), listed as 36-inch pipe]. FS Date: 4/19/2022

Levee crown looking upstream.

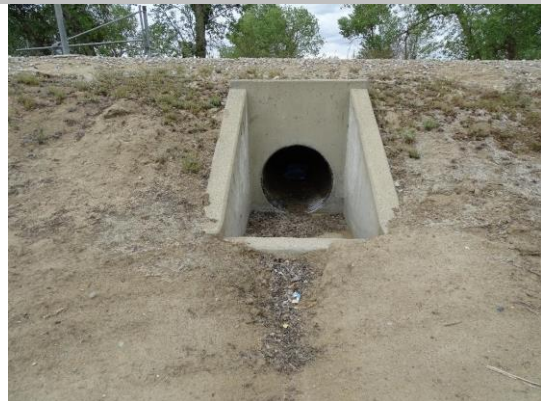
Photo 2 of 3 : UCIP\_FA\_2023\_77411\_112200.jpg

LS view: Concrete headwall and pipe inlet on toe.

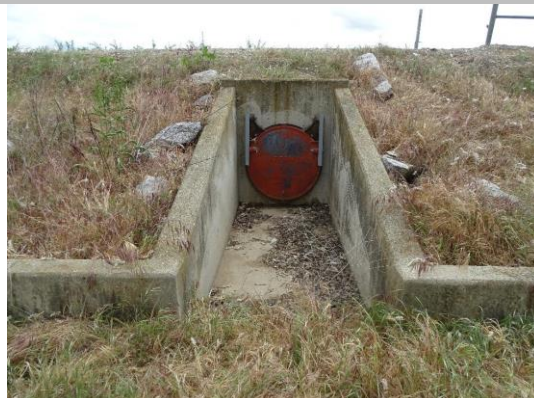
Photo 3 of 3 : UCIP\_FA\_2023\_77411\_112201.jpg

WS view: Concrete headwall and flap gate on toe.

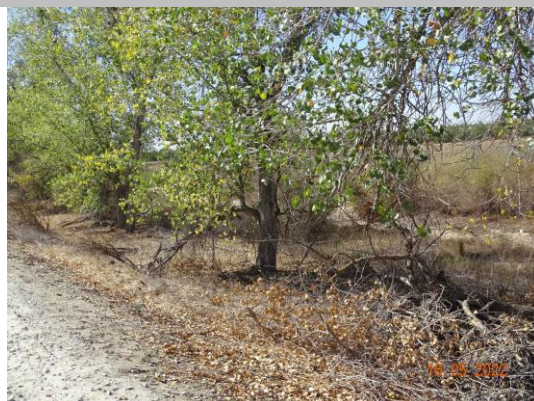
Photo 1 of 1 : FA\_2023\_NA0011\_143\_27\_20230821\_00014.jpg

LM Start	0.98	Rating **	M	Issue No.	27
LM End	1.52	Issue Type +	Ma	Location *	WS
Category	Earthen Levee			GPS Latitude/Longitude	
				Start	End
Item	Trim / Thin Trees			37.054928°	37.058752°
				-120.415482°	-120.407323°
DWR ID	DWR_NA0011_02_s_2017_27				
Comment Code					
T2 : Tree or limb.					
Inspector Comment					
Remove the dead trees from the waterside slope and shoulder.

Branches left along the waterside slope from high flow. (Fall 2022)

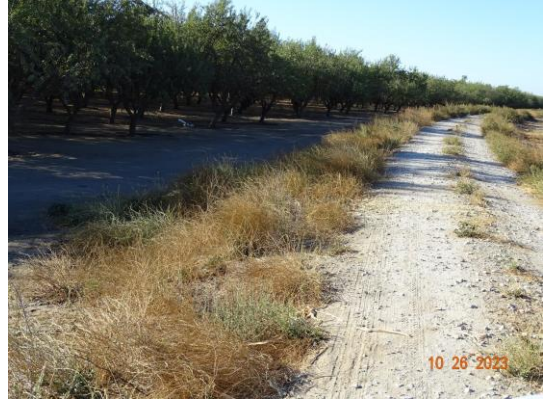
Photo 1 of 1 : FA\_2023\_NA0011\_143\_14\_20231101\_00026.jpg

LM Start	1.90	Rating **	M	Issue No.	14
LM End	2.00	Issue Type +	Ma	Location *	LS
Category	Earthen Levee			GPS Latitude/Longitude	
				Start	End
Item	Vegetation			37.062592°	37.063672°
				-120.402449°	-120.401394°
DWR ID	DWR_NA0011_02_f_2023_14				
Comment Code					
V1 : Control annual grass and weeds on the levee slopes and easements.					
Inspector Comment

Looking downstream along the landside slope. (Fall 2023)

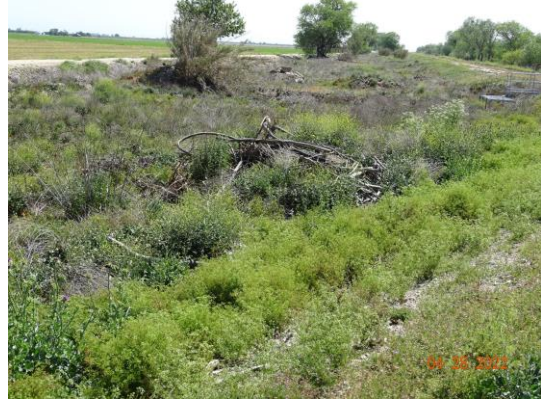
Photo 1 of 1 : FA\_2023\_NA0011\_144\_20\_20230821\_00007.jpg

LM Start	0.08	Rating **	A/W	Issue No.	20
LM End	0.08	Issue Type +	Ma	Location *	LS
Category	Earthen Levee			GPS Latitude/Longitude	
				Start	End
Item	Encroachments			36.996204°	36.996201°
				-120.372352°	-120.372345°
DWR ID	DWR_NA0011_03_s_2012_20				
Comment Code					
PR : Prunings					
Inspector Comment					
Remove the prunings from the landside slope.

Looking at prunings on landward slope. (Spring 2022)

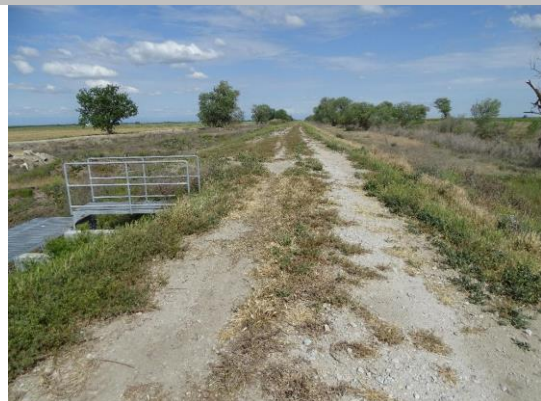
Photo 1 of 3 : UCIP\_FA\_2023\_77412\_112270.jpg

Comment Code					
Inspector Comment					
DS_ID:21517 FS_ID:77412 EP_NO: N/A Repair Type: No Action Needed EVAL Issue: Crossing Status: Found UCIP Comments: 04/19/2022 Record updated from Non-Urgent to No Action Needed. Flap gate on the WS was held open by a chain; recommend owner close flap gate prior to flood season to prevent uncontrolled flows from WS to LS during high-water events. DMP internal video inspection has not found pipe integrity issues. LOF of crossing is less or equal to 4. Recommend next video inspection in 5 years. (M.Thao - DWR UCIP) 05/06/2014 Need to contact owner to determine status of crossing. Unable to determine if crossing is in use. (DWR UCIP - O. Magana) FIELD_STRUCT_DESC: 36-inch corrugated metal gravity drainage pipe through the levee, 7.3 feet below the crown. Headwall and wing wall on each end. Debris screen at pipe inlet and walkway on landside (LS). Flap gate on the waterside (WS) end. [Additional Reference(s): DWR Levee Log, 2005 (HLM 0.11). USACE San Joaquin O&M Manual 605 (Station 5+50), listed as 36-inch pipe]. FS Date: 4/19/2022

Levee crown looking upstream.

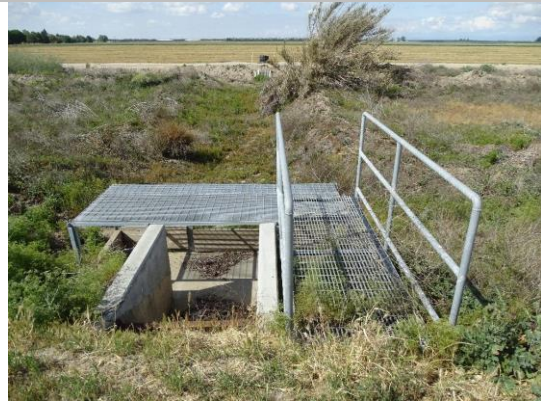
Photo 2 of 3 : UCIP\_FA\_2023\_77412\_112271.jpg

LS view: Looking from crown; concrete headwall and walk way.

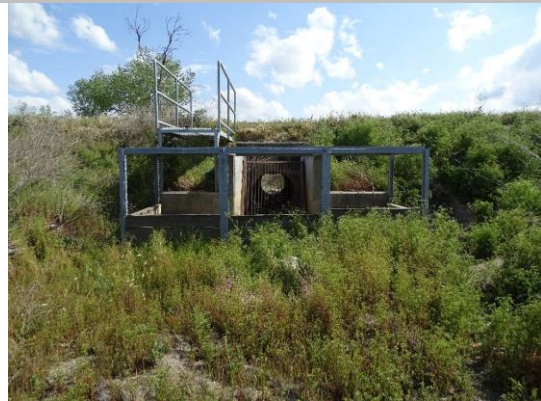
Photo 3 of 3 : UCIP\_FA\_2023\_77412\_112272.jpg

LS view: Looking into pipe through levee; flap gate is open on WS.

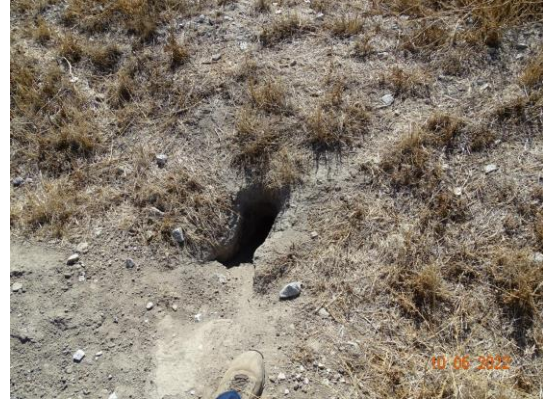
Photo 1 of 1 : FA\_2023\_NA0011\_144\_9\_20230821\_00004.jpg

LM Start	0.19	Rating **	M	Issue No.	9
LM End	0.27	Issue Type +	Ma	Location *	LS
Category	Earthen Levee			GPS Latitude/Longitude	
				Start	End
Item	Animal Control			36.996196°	36.996202°
				-120.370404°	-120.368996°
DWR ID	DWR_NA0011_03_f_2022_9				
Comment Code					
A3 : No rodents visible, but rodent burrows visible; need to backfill and compact or grout burrows.					
Inspector Comment

Representative view of rodent holes on the landside slope. (Fall 2022)

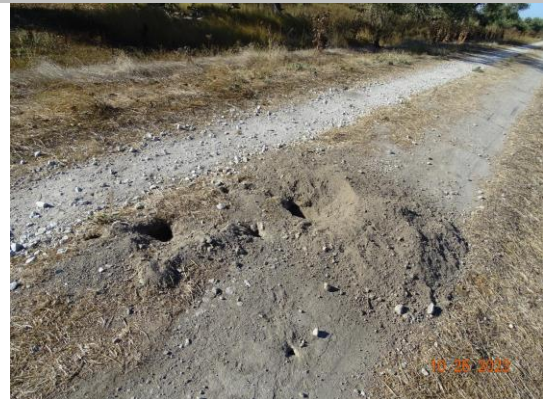
Photo 1 of 1 : FA\_2023\_NA0011\_144\_4\_20231102\_00010.jpg

LM Start	0.33	Rating **	M	Issue No.	4
LM End	0.33	Issue Type +	Ma	Location *	CR
Category	Earthen Levee			GPS Latitude/Longitude	
				Start	End
Item	Animal Control			36.996189°	36.996189°
				-120.367776°	-120.367776°
DWR ID	DWR_NA0011_03_f_2023_4				
Comment Code					
A3 : No rodents visible, but rodent burrows visible; need to backfill and compact or grout burrows.					
Inspector Comment

Rodent burrows with large amount of material displaced in the levee crown. (Fall 2023)

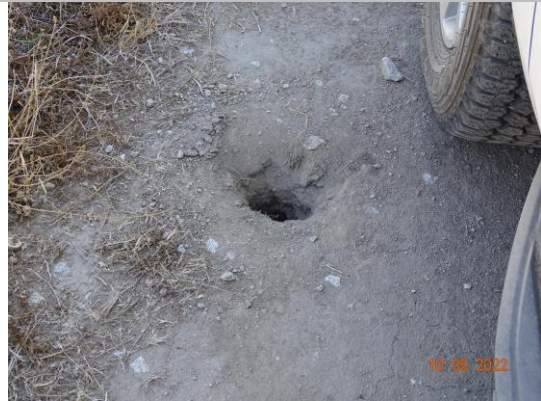
Photo 1 of 1 : FA\_2023\_NA0011\_144\_5\_20230821\_00001.jpg

LM Start	0.46	Rating **	M	Issue No.	5
LM End	0.46	Issue Type +	Ma	Location *	CR
Category	Earthen Levee			GPS Latitude/Longitude	
				Start	End
Item	Animal Control			36.996238°	36.996238°
				-120.365563°	-120.365563°
DWR ID	DWR_NA0011_03_s_2018_5				
Comment Code					
A3 : No rodents visible, but rodent burrows visible; need to backfill and compact or grout burrows.					
Inspector Comment					
There is a large rodent hole on the crown of the levee.

View of a rodent hole on levee crown. (Fall 2022)

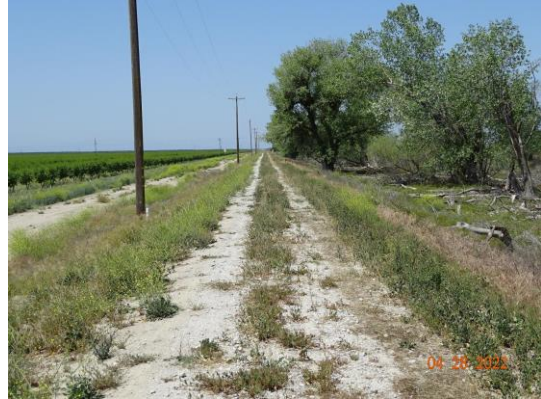
Photo 1 of 1 : FA\_2023\_NA0011\_145\_35\_20230821\_00024.jpg

LM Start	0.06	Rating **	M	Issue No.	35
LM End	0.50	Issue Type +	Ma	Location *	CR
Category	Earthen Levee			GPS Latitude/Longitude	
				Start	End
Item	Vegetation			36.995560°	36.995580°
				-120.372469°	-120.364450°
DWR ID	DWR_NA0011_04_s_2022_35				
Comment Code					
V3 : Keep the crown roadway free of vegetation.					
Inspector Comment

View of vegetation growing along the levee crown. (Spring 2022)

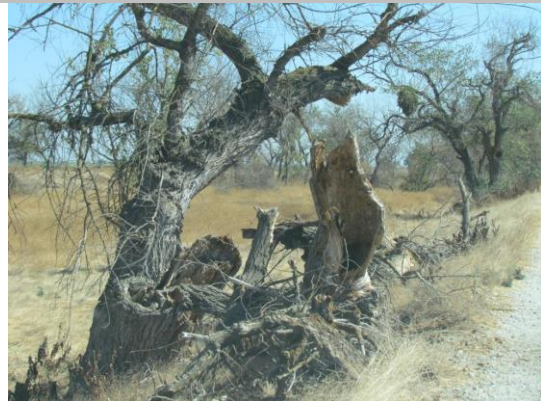
Photo 1 of 1 : FA\_2023\_NA0011\_145\_15\_20230821\_00011.jpg

LM Start	0.10	Rating **	U	Issue No.	15
LM End	0.14	Issue Type +	Ma	Location *	WS
Category	Earthen Levee			GPS Latitude/Longitude	
				Start	End
Item	Trim / Thin Trees			36.995548°	36.995528°
				-120.371628°	-120.370922°
DWR ID	DWR_NA0011_04_f_2015_15				
Comment Code					
T2 : Tree or limb.					
Inspector Comment					
There are many dead trees in the area. Remove the dead trees from the levee section. Many more are subject to fall and possibly block access to the levee crown.

Berenda Slough looking upstream from the levee mile 0.14.

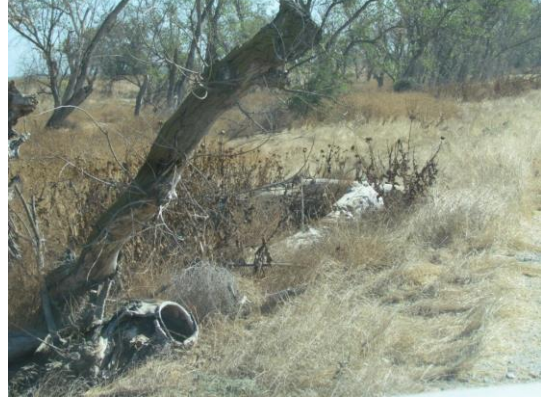
Photo 1 of 1 : FA\_2023\_NA0011\_145\_16\_20230821\_00012.jpg

LM Start	0.47	Rating **	M	Issue No.	16
LM End	0.49	Issue Type +	Ma	Location *	WS
Category	Earthen Levee			GPS Latitude/Longitude	
				Start	End
Item	Trim / Thin Trees			36.995603°	36.995568°
				-120.364978°	-120.364634°
DWR ID	DWR_NA0011_04_s_2014_16				
Comment Code					
T2 : Tree or limb.					
Inspector Comment					
This dead tree on the waterward slope should be removed from the levee section.

Tree on WS shoulder.

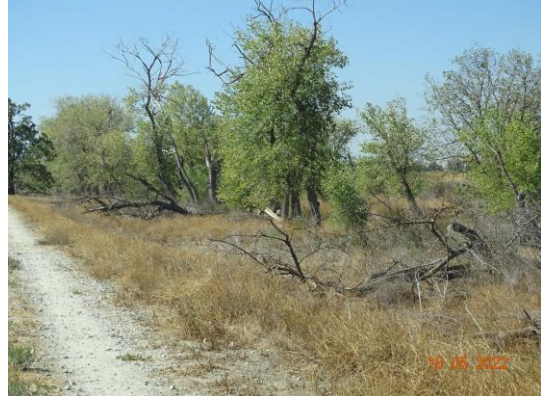
Photo 1 of 1 : FA\_2023\_NA0011\_145\_39\_20230821\_00026.jpg

LM Start	0.54	Rating **	M	Issue No.	39
LM End	0.71	Issue Type +	Ma	Location *	WS
Category	Earthen Levee			GPS Latitude/Longitude	
				Start	End
Item	Trim / Thin Trees			36.995565°	36.995574°
				-120.363779°	-120.360695°
DWR ID	DWR_NA0011_04_f_2022_39				
Comment Code					
T2 : Tree or limb.					
Inspector Comment					
Several fallen trees in this section.

Fallen trees washed up on the waterside slope and berm from high water. (Fall 2022)

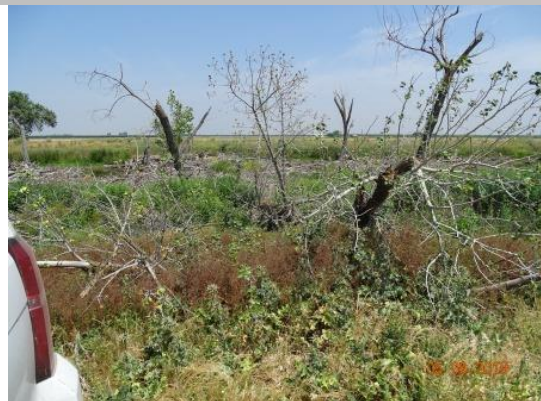
Photo 1 of 1 : FA\_2023\_NA0011\_145\_6\_20230821\_00003.jpg

LM Start	0.78	Rating **	U	Issue No.	6
LM End	0.78	Issue Type +	Ma	Location *	WS
Category	Earthen Levee			GPS Latitude/Longitude	
				Start	End
Item	Trim / Thin Trees			36.995582°	36.995582°
				-120.359451°	-120.359451°
DWR ID	DWR_NA0011_04_s_2019_6				
Comment Code					
T2 : Tree or limb.					
Inspector Comment

View of fallen tree on waterside slope. (Spring 2019)

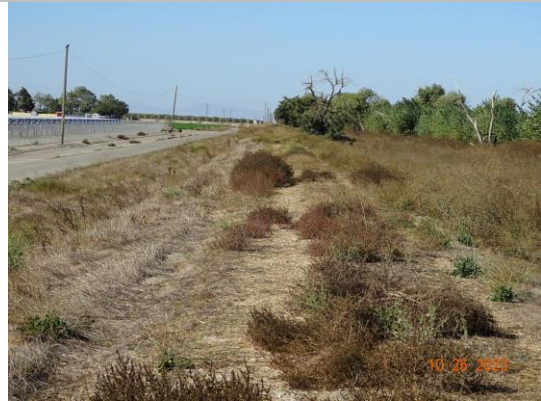
Photo 1 of 1 : FA\_2023\_NA0011\_145\_26\_20231102\_00029.jpg

LM Start	0.96	Rating **	U	Issue No.	26
LM End	1.28	Issue Type +	Ma	Location *	CR
Category	Earthen Levee			GPS Latitude/Longitude	
				Start	End
Item	Vegetation			36.995599°	36.995606°
				-120.356155°	-120.350297°
DWR ID	DWR_NA0011_04_s_2022_26				
Comment Code					
V3 : Keep the crown roadway free of vegetation.					
Inspector Comment

View of vegetation growing along the levee crown. (Fall 2023)

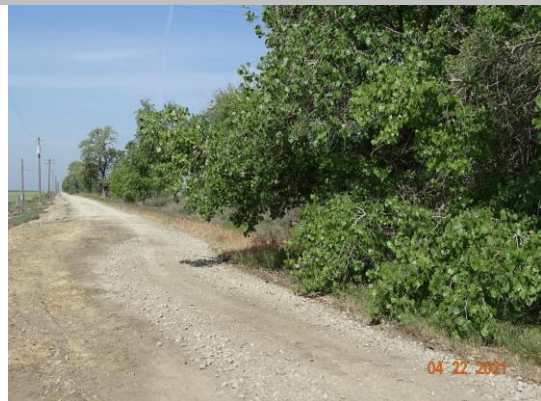
Photo 1 of 1 : FA\_2023\_NA0011\_145\_12\_20230821\_00008.jpg

LM Start	1.01	Rating **	U	Issue No.	12
LM End	1.01	Issue Type +	Ma	Location *	WS
Category	Earthen Levee			GPS Latitude/Longitude	
				Start	End
Item	Trim / Thin Trees			36.995537°	36.995537°
				-120.355261°	-120.355261°
DWR ID	DWR_NA0011_04_f_2017_12				
Comment Code					
T1 : Trim and thin trees to at least five feet above ground level to allow visibility of the ground and room to flood fight.					
Inspector Comment					
Branches from waterside tree are blocking visibility of waterside slope and crown. Levee crown is nearly impassible.

Trim trees to at least 5' above levee slope and 12' above levee crown to allow inspection and access. (Spring 2021)

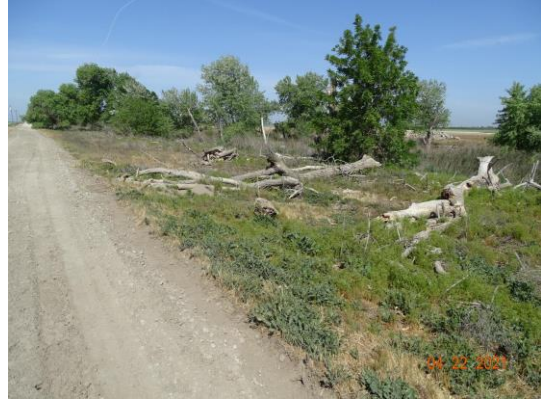
Photo 1 of 1 : FA\_2023\_NA0011\_145\_24\_20230821\_00016.jpg

LM Start	1.07	Rating **	U	Issue No.	24
LM End	1.07	Issue Type +	Ma	Location *	WS
Category	Earthen Levee			GPS Latitude/Longitude	
				Start	End
Item	Trim / Thin Trees			36.995587°	36.995587°
				-120.354128°	-120.354128°
DWR ID	DWR_NA0011_04_s_2021_24				
Comment Code					
T2 : Tree or limb.					
Inspector Comment

View of fallen trees on the waterside slope and berm. (Spring 2021)

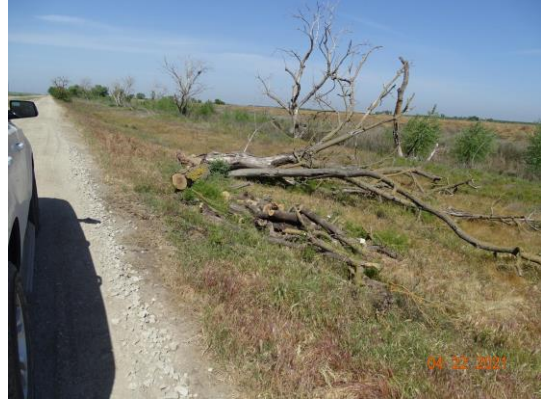
Photo 1 of 1 : FA\_2023\_NA0011\_145\_7\_20230821\_00004.jpg

LM Start	1.46	Rating **	M	Issue No.	7
LM End	1.46	Issue Type +	Ma	Location *	WS
Category	Earthen Levee			GPS Latitude/Longitude	
				Start	End
Item	Trim / Thin Trees			36.995600°	36.995600°
				-120.347175°	-120.347175°
DWR ID	DWR_NA0011_04_s_2021_7				
Comment Code					
T2 : Tree or limb.					
Inspector Comment

View of tree limbs on the waterside slope. (Spring 2021)

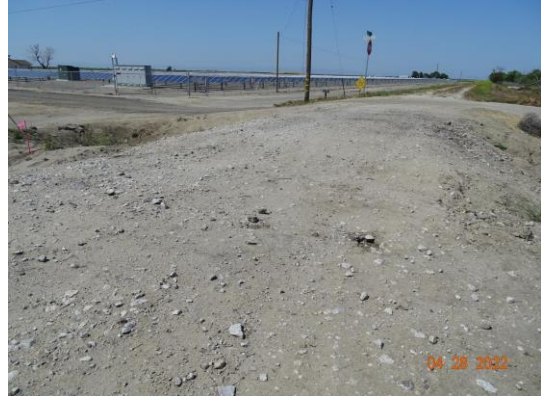
Photo 1 of 1 : FA\_2023\_NA0011\_145\_10\_20230821\_00006.jpg

LM Start	1.50	Rating **	M	Issue No.	10
LM End	1.50	Issue Type +	Ma	Location *	CR
Category	Earthen Levee			GPS Latitude/Longitude	
				Start	End
Item	Crown Surface / Depressions / Rutting			36.995629°	36.995629°
				-120.346319°	-120.346319°
DWR ID	DWR_NA0011_04_s_2022_10				
Comment Code					
C1 : Add appropriate material and re-grade the levee to bring the crown above the design elevation.					
Inspector Comment					
Depression is in line with pipe crossing and could be related to a potential issue with the pipe.

Depression in the levee crown should be brought to level with appropriate material. (Spring 2022)

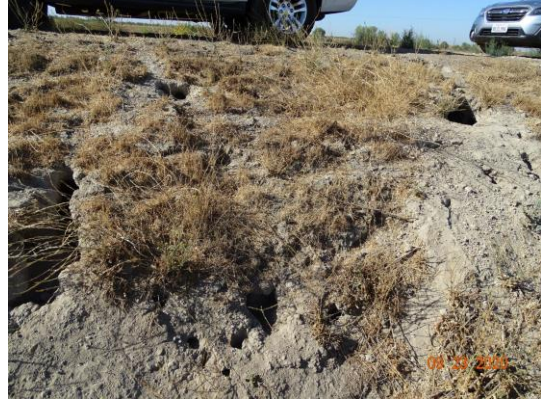
Photo 1 of 1 : FA\_2023\_NA0011\_146\_14\_20230821\_00006.jpg

LM Start	0.00	Rating **	M	Issue No.	14
LM End	4.05	Issue Type +	Ma	Location *	LS
Category	Earthen Levee			GPS Latitude/Longitude	
				Start	End
Item	Animal Control			36.978520°	36.968168°
				-120.368567°	-120.301035°
DWR ID	DWR_NA0011_05_f_2016_14				
Comment Code					
A1 : Exterminate rodents and backfill and compact or grout burrows.					
Inspector Comment					
Exterminate the rodents along the landside slope and toe throughout the area to levee mile 4.05. Bait stations are needed in infested areas.

Rodent activity on the landside slope. (Fall 2020)

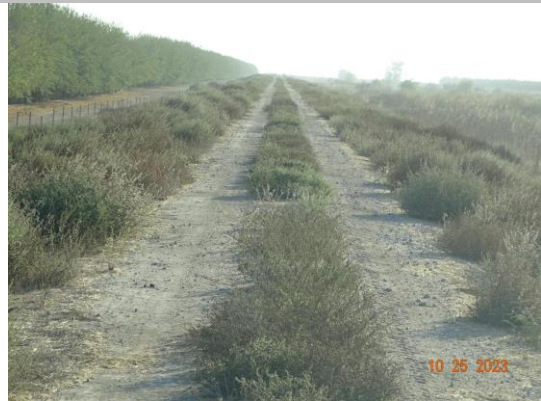
Photo 1 of 1 : FA\_2023\_NA0011\_146\_7\_20231102\_00027.jpg

LM Start	0.05	Rating **	M	Issue No.	7
LM End	2.57	Issue Type +	Ma	Location *	CR
Category	Earthen Levee			GPS Latitude/Longitude	
				Start	End
Item	Vegetation			36.978493°	36.968014°
				-120.367529°	-120.327776°
DWR ID	DWR_NA0011_05_s_2022_7				
Comment Code					
V3 : Keep the crown roadway free of vegetation.					
Inspector Comment

Looking upstream along the levee crown. (Fall 2023)

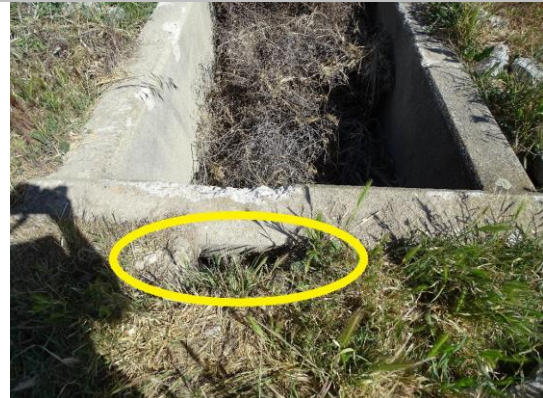
Photo 1 of 3 : UCIP\_FA\_2023\_81023\_112417.jpg

DS\_ID:21520  
FS\_ID:81023  
EP\_NO: N/A  
Repair Type: Urgent  
EVAL Issue: 1, Pipe Integrity  
Crossing Status: Found  
UCIP Comments: 09/19/2023 Record updated from Non-Urgent to Urgent. DMP internal video inspection has found severe pipe defects. Crossing will be monitored until funding becomes available to address the issues. (O. Yakimov - DWR UCIP)  
04/20/2022 Record remains Non-Urgent. Tumbleweeds are blocking the pipe inlet and outlet; recommend removal. Minor rodent activity was observed behind the LS headwall. DMP internal video inspection has not found pipe integrity issues. LOF of crossing is less or equal to 4. Recommend next video inspection in 5 years. (M.Thao - DWR UCIP)  
05/06/2014 Need to contact owner. Dense vegetation limits the inspector's visibility to identify signs of pipe failure (leaks) along the landward slope. Recommend removing vegetation along pipe alignment to conduct proper inspection of structure. (DWR UCIP - O. Magana)

LS view: Rodent activity behind headwall on slope.

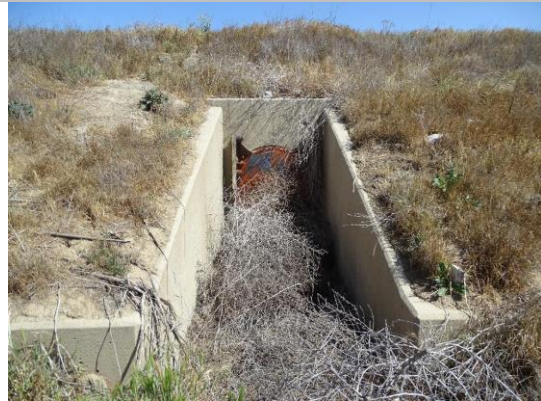
Photo 3 of 3 : UCIP\_FA\_2023\_81023\_112412.jpg

WS view: Concrete headwall and flap gate on toe; tumbleweeds at pipe outlet.

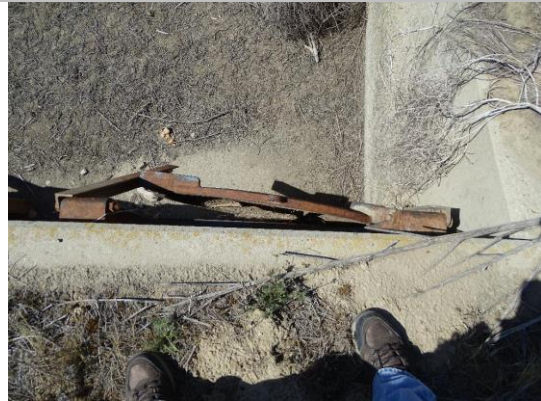
Photo 2 of 2 : UCIP\_FA\_2023\_80592\_112480.jpg

DS\_ID:21623  
 FS\_ID:80592  
 EP\_NO: N/A  
 Repair Type: Urgent  
 EVAL Issue: 3a, Flood Risk  
 Crossing Status: Found  
 UCIP Comments: 04/20/2022 Record updated from No Action Needed to Urgent. Flap gate on WS does not close properly and does not appear to be propped open with anything; flap gate hinges appear skewed. Recommend flap gate be repaired. (M.Thao - DWR UCIP)  
 10/27/2017 This structure is inspected annually under the Structure and Channel Summer Inspection (part of the Levee Inspection Program) conducted by the DWR Flood Project Integrity and Inspection Branch (FPIIB). (DWR UCIP - O. Magana)  
 FIELD\_STRUCT\_DESC: [Fresno River Drainage Structure] 1 of 4: 48-inch corrugated metal gravity drainage pipe through the levee, 11.5 feet below the crown. Concrete headwall and wing wall on each end.  
 [Additional Reference(s): DWR Levee Log, 2005 (HLM 0.55). USACE San Joaquin O&M Manual, Unit 606. USACE As-Built Drawing No. 07-04-0085, Sheets 85/3.1 and 85/25.2, (Station 29+20), March 1975].

WS view: View from above; flap gate does not close properly and appears not to be propped open with anything.

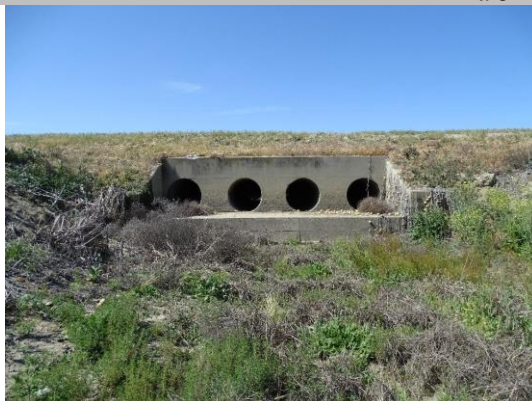
Photo 3 of 3 : UCIP\_FA\_2023\_80589\_112504.jpg

LS view: Looking toward levee; concrete headwall and pipe inlet of drainage structure.

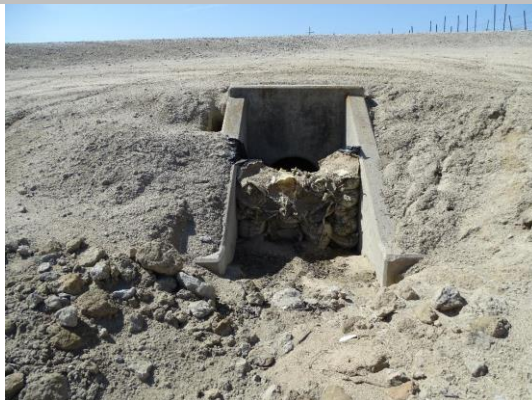
Photo 3 of 3 : UCIP\_FA\_2023\_80588\_112421.jpg

Comment Code						
Inspector Comment						
DS_ID:21529 FS_ID:80588 EP_NO: N/A Repair Type: Non-Urgent EVAL Issue: 11, Maintenance Compliance Issue Crossing Status: Found UCIP Comments: 04/20/2022 Record updated from No Action Needed to Non-Urgent. Pipe inlet on LS is being blocked with sandbags; recommend removal for crossing to function properly. DMP internal video inspection has not found pipe integrity issues. LOF of crossing is less or equal to 4. Recommend next video inspection in 5 years. (M.Thao - DWR UCIP) FIELD_STRUCT_DESC: 30-inch corrugated metal gravity drainage pipe through the levee, 9 feet below the crown. Concrete headwall and wing wall on each end. Flap gate on waterside (WS) end. [Additional Reference(s): DWR Levee Log, 2005 (HLM 4.10). USACE San Joaquin O&M Manual, Unit 606. USACE As-Built Drawing No. 07-04-0085, (Station 214+20), Sheets 85/6.1 and 85/31.1, March 1975]. FS Date: 4/20/2022

LS view: Concrete headwall at toe; stacked sandbags are blocking pipe inlet.

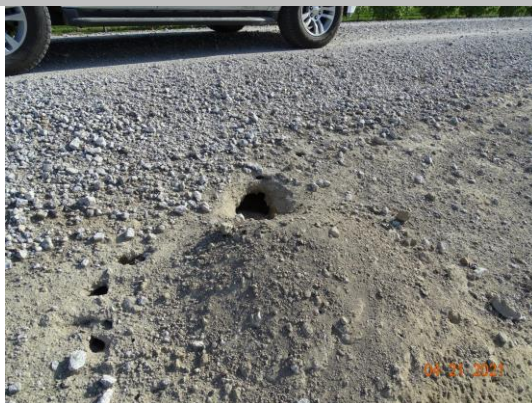
Photo 1 of 1 : FA\_2023\_NA0011\_146\_23\_20230821\_00012.jpg

LM Start	4.34	Rating **	M	Issue No.	23
LM End	4.34	Issue Type +	Ma	Location *	WS
Category	Earthen Levee			GPS Latitude/Longitude	
				Start	End
Item	Animal Control			36.968189°	36.968189°
				-120.295782°	-120.295782°
DWR ID	DWR_NA0011_05_s_2021_23				
Comment Code					
A3 : No rodents visible, but rodent burrows visible; need to backfill and compact or grout burrows.					
Inspector Comment

Large rodent hole observed on the waterside slope. (Spring 2021)

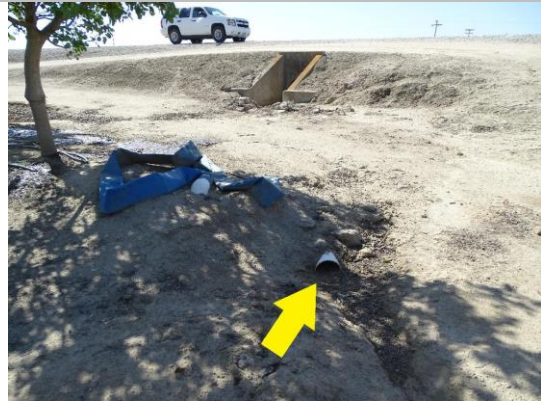
Photo 3 of 3 : UCIP\_FA\_2023\_80587\_112431.jpg

Comment Code						
Inspector Comment						
DS_ID:21522 FS_ID:80587 EP_NO: N/A Repair Type: No Action Needed EVAL Issue: Crossing Status: Found UCIP Comments: 04/20/2022 Record remains No Action Needed. A PVC pipe buried off LS toe was observed and appears to be for drainage purposes. DMP internal video inspection has not found pipe integrity issues. LOF of crossing is less or equal to 4. Recommend next video inspection in 5 years. (M.Thao - DWR UCIP) FIELD_STRUCT_DESC: 30-inch corrugated metal gravity drainage pipe through the levee, 7.8 feet below the crown. Concrete headwall and wing wall on each end. Flap gate on the waterside (WS) end propped open. [Additional Reference(s): DWR Levee Log, 2005 (HLM 4.60). USACE San Joaquin O&M Manual, Unit 606. USACE As-Built Drawing No. 07-04-0085, Sheets 85/7.1 and 85/31.1, (Station 240+20), March 1975]. FS Date: 4/20/2022

LS view: PVC drainage pipe inlet (yellow arrow) leading to headwall.

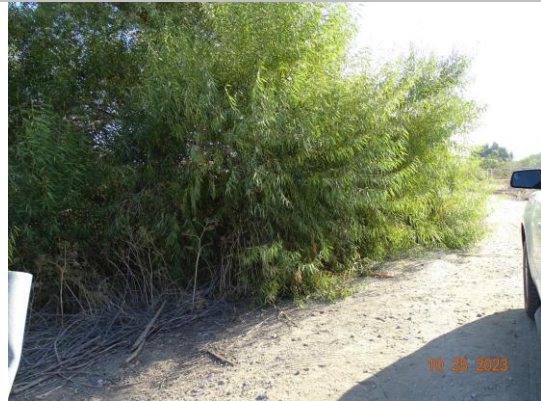
Photo 1 of 1 : FA\_2023\_NA0011\_146\_29\_20231102\_00028.jpg

LM Start	6.57	Rating **	M	Issue No.	29
LM End	6.57	Issue Type +	Ma	Location *	LS
Category	Earthen Levee			GPS Latitude/Longitude	
				Start	End
Item	Trim / Thin Trees			36.968477°	36.968477°
				-120.255557°	-120.255557°
DWR ID	DWR_NA0011_05_f_2019_29				
Comment Code					
T1 : Trim and thin trees to at least five feet above ground level to allow visibility of the ground and room to flood fight.					
Inspector Comment					
Tree should be trimmed above the levee crown and 5 feet above the slope.

View of tree growing on the landside slope. (Fall 2023)

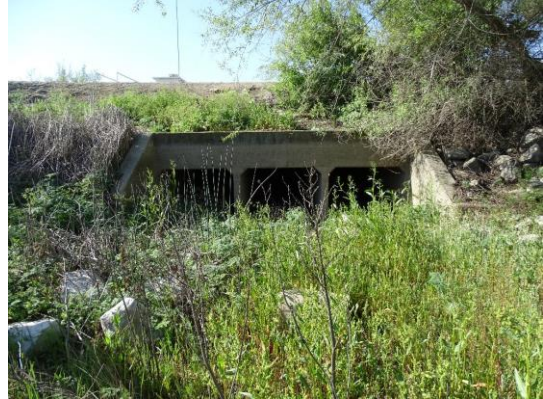
Photo 2 of 3 : UCIP\_FA\_2023\_80623\_112450.jpg

LS view: Looking toward levee; inlet of reinforced concrete box culvert.

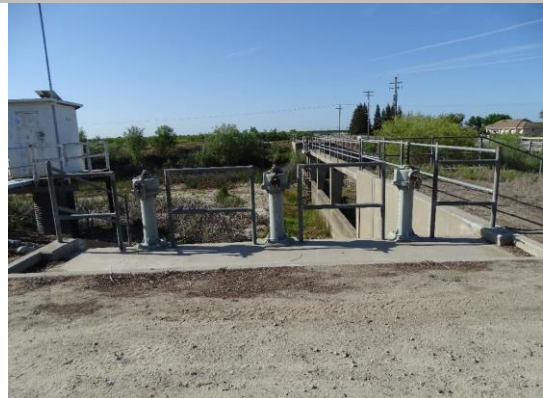
Photo 3 of 3 : UCIP\_FA\_2023\_80623\_112451.jpg

WS view: Looking from crown; slide gate operator on shoulder.

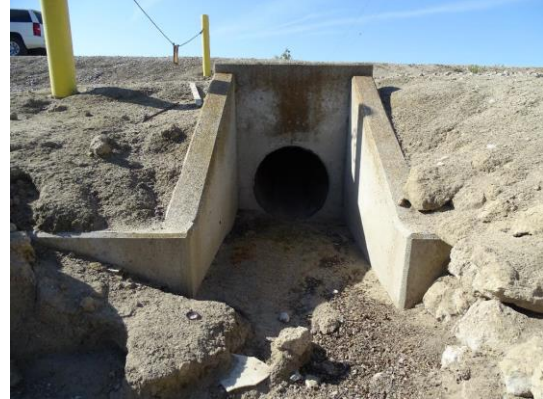
Photo 3 of 3 : UCIP\_FA\_2023\_80579\_112467.jpg

LS view: Concrete headwall and pipe inlet.

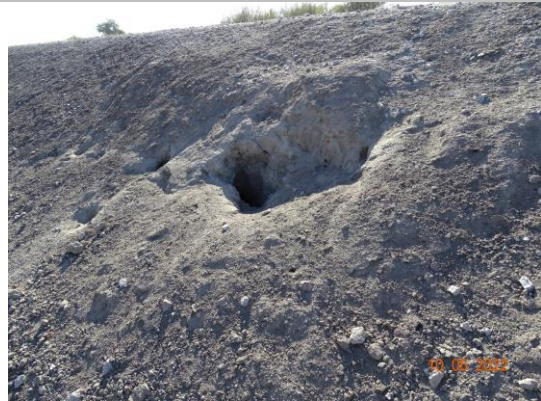
Photo 1 of 1 : FA\_2023\_NA0011\_146\_24\_20230821\_00013.jpg

LM Start	7.62	Rating **	U	Issue No.	24
LM End	7.66	Issue Type +	Ma	Location *	LS
Category	Earthen Levee			GPS Latitude/Longitude	
				Start	End
Item	Animal Control			36.969543°	36.969606°
				-120.236801°	-120.236091°
DWR ID	DWR_NA0011_05_f_2018_24				
Comment Code					
A3 : No rodents visible, but rodent burrows visible; need to backfill and compact or grout burrows.					
Inspector Comment					
Large rodent burrows on the landside slope should be backfilled and compacted.

Representative burrow on the landside slope. (Fall 2022)

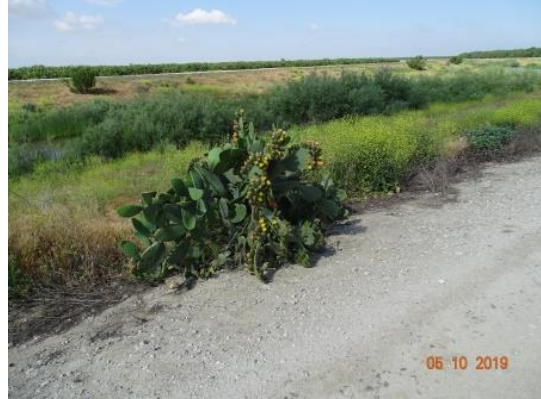
Photo 1 of 1 : FA\_2023\_NA0011\_146\_10\_20230821\_00003.jpg

LM Start	8.57	Rating **	U	Issue No.	10
LM End	8.57	Issue Type +	Ma	Location *	WS
Category	Earthen Levee			GPS Latitude/Longitude	
				Start	End
Item	Vegetation			36.972355°	36.972355°
				-120.220878°	-120.220878°
DWR ID	DWR_NA0011_05_f_2018_10				
Comment Code					
V2 : Remove the wild growth and woody vegetation other than native grasses from the levee slopes.					
Inspector Comment					
Cactus growing on waterside slope.

Cactus growing on waterside shoulder. (Spring 2019)

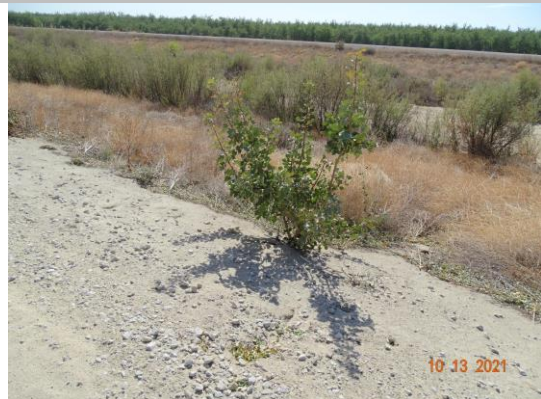
Photo 1 of 1 : FA\_2023\_NA0011\_146\_8\_20230821\_00002.jpg

LM Start	8.70	Rating **	M	Issue No.	8
LM End	8.70	Issue Type +	Ma	Location *	WS
Category	Earthen Levee			GPS Latitude/Longitude	
				Start	End
Item	Trim / Thin Trees			36.971970°	36.971970°
				-120.218647°	-120.218647°
DWR ID	DWR_NA0011_05_f_2021_8				
Comment Code					
T1 : Trim and thin trees to at least five feet above ground level to allow visibility of the ground and room to flood fight.					
Inspector Comment

Sapling growing on the waterside shoulder. (Fall 2021)

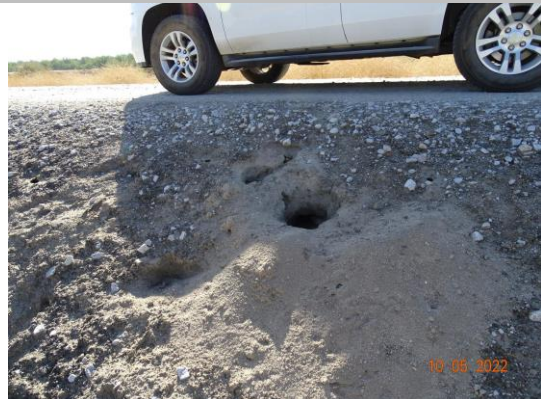
Photo 1 of 1 : FA\_2023\_NA0011\_146\_48\_20230821\_00025.jpg

LM Start	9.00	Rating **	A/W	Issue No.	48
LM End	9.00	Issue Type +	Ma	Location *	LS
Category	Earthen Levee			GPS Latitude/Longitude	
				Start	End
Item	Animal Control			36.972896°	36.972896°
				-120.213267°	-120.213267°
DWR ID	DWR_NA0011_05_f_2022_48				
Comment Code					
A3 : No rodents visible, but rodent burrows visible; need to backfill and compact or grout burrows.					
Inspector Comment					
Rodent burrows have been collapsed.

View of rodent holes on the landside slope. (Fall 2022)

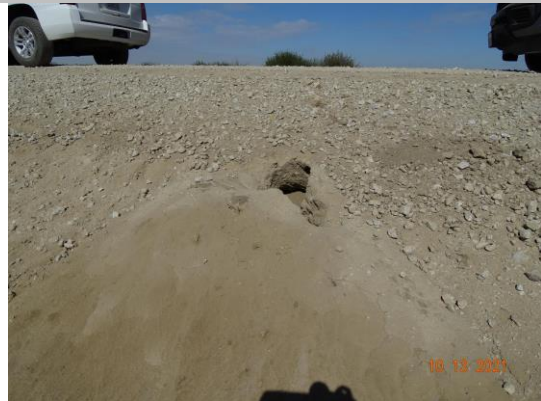
Photo 1 of 1 : FA\_2023\_NA0011\_147\_78\_20230821\_00024.jpg

LM Start	4.74	Rating **	A/W	Issue No.	78
LM End	4.74	Issue Type +	Ma	Location *	LS
Category	Earthen Levee			GPS Latitude/Longitude	
				Start	End
Item	Animal Control			36.967508°	36.967508°
				-120.287446°	-120.287446°
DWR ID	DWR_NA0011_06_s_2019_78				
Comment Code					
A3 : No rodents visible, but rodent burrows visible; need to backfill and compact or grout burrows.					
Inspector Comment

View of large rodent hole in the landside slope. (Fall 2021)

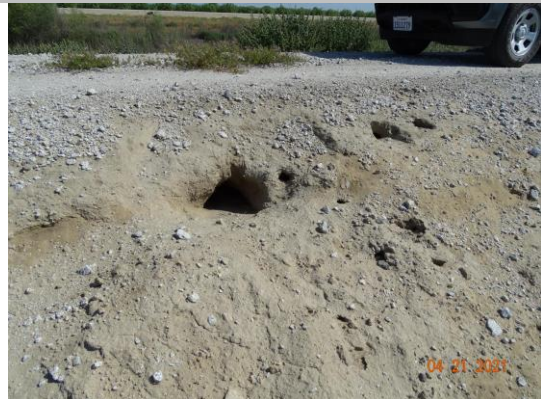
Photo 1 of 1 : FA\_2023\_NA0011\_147\_25\_20230821\_00010.jpg

LM Start	4.90	Rating **	M	Issue No.	25
LM End	4.90	Issue Type +	Ma	Location *	LS
Category	Earthen Levee			GPS Latitude/Longitude	
				Start	End
Item	Animal Control			36.967517°	36.967517°
				-120.284470°	-120.284470°
DWR ID	DWR_NA0011_06_s_2021_25				
Comment Code					
A3 : No rodents visible, but rodent burrows visible; need to backfill and compact or grout burrows.					
Inspector Comment

Rodent activity along the landside shoulder should be repaired. (Spring 2021)

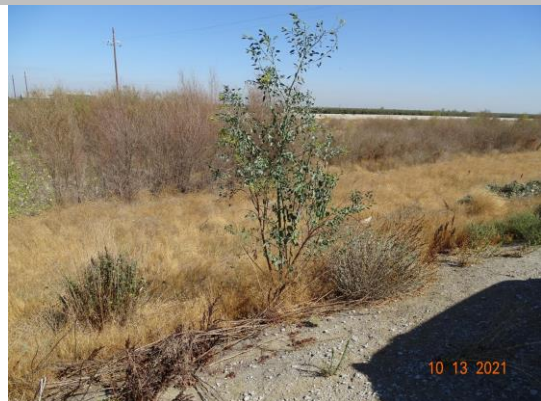
Photo 1 of 1 : FA\_2023\_NA0011\_147\_16\_20230821\_00005.jpg

LM Start	5.48	Rating **	M	Issue No.	16
LM End	5.48	Issue Type +	Ma	Location *	WS
Category	Earthen Levee			GPS Latitude/Longitude	
				Start	End
Item	Trim / Thin Trees			36.967494°	36.967494°
				-120.274037°	-120.274037°
DWR ID	DWR_NA0011_06_f_2021_16				
Comment Code					
T1 : Trim and thin trees to at least five feet above ground level to allow visibility of the ground and room to flood fight.					
Inspector Comment					
Sapling should be removed before it can establish.

View of sapling growing in the waterside shoulder. (Fall 2021)

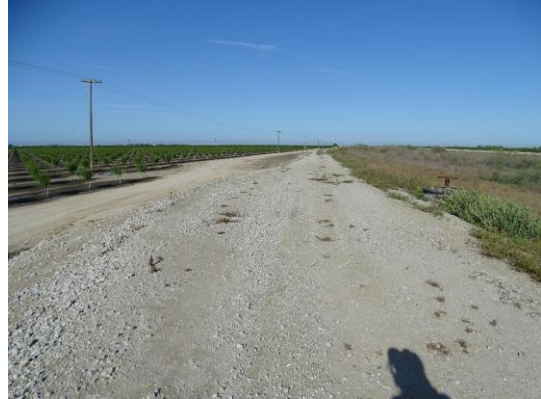
Photo 1 of 3 : UCIP\_FA\_2023\_80596\_112509.jpg

Comment Code					
Inspector Comment					
DS_ID:21531 FS_ID:80596 EP_NO: N/A Repair Type: No Action Needed EVAL Issue: Crossing Status: Found UCIP Comments: 04/20/2022 Record updated from Non-Urgent to No Action Needed. Sediment build up on LS has been removed since last inspection. DMP internal video inspection has not found pipe integrity issues. LOF of crossing is less or equal to 4. Recommend next video inspection in 5 years. (M.Thao - DWR UCIP) 05/06/2014 Need to contact owner. Recommend removing sediment built up on landward side. (DWR UCIP - O. Magana) FIELD_STRUCT_DESC: 48-inch corrugated metal gravity drainage pipe through the levee, 11.5 feet below the crown. Slide gate in a 60-inch CMP riser on the waterside (WS) shoulder. Concrete headwall and wing wall on each end. Flap gate on the WS end. [Additional Reference(s): DWR Levee Log, 2005 (HLM 6.24). USACE San Joaquin O&M Manual, Unit 606. USACE As-Built Drawing No. 07-04-0085, Sheets 85/8A.1 and 85/26, Station 325+50, March 1975]. FS Date: 4/20/2022

Levee crown looking downstream.

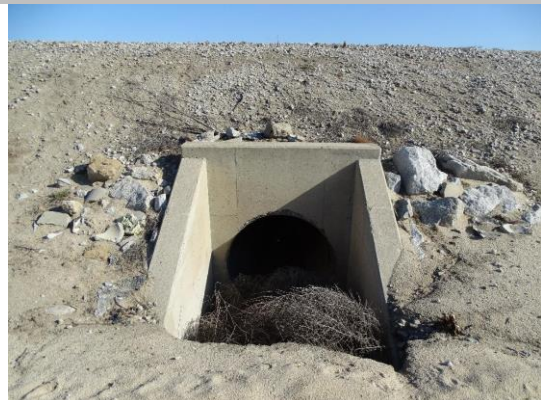
Photo 2 of 3 : UCIP\_FA\_2023\_80596\_112510.jpg

LS view: Concrete headwall and pipe inlet on toe.

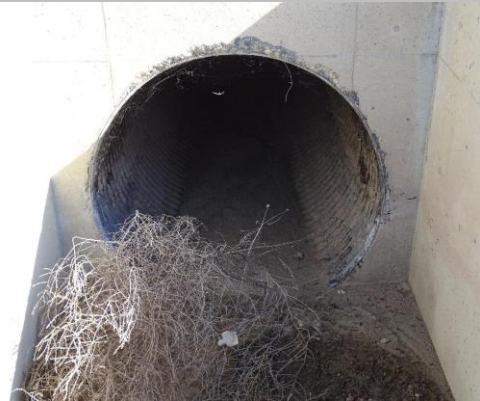
Photo 3 of 3 : UCIP\_FA\_2023\_80596\_112508.jpg

LS view: Close-up view of CMP inlet; cleared of sediment.

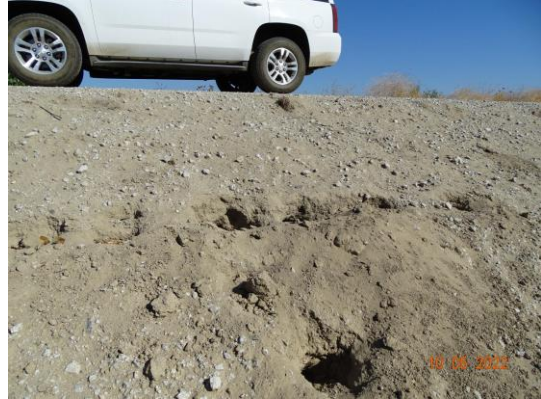
Photo 1 of 1 : FA\_2023\_NA0011\_147\_28\_20230821\_00012.jpg

LM Start	6.61	Rating **	M	Issue No.	28
LM End	6.72	Issue Type +	Ma	Location *	LS
Category	Earthen Levee			GPS Latitude/Longitude	
				Start	End
Item	Animal Control			36.968063°	36.968629°
				-120.253678°	-120.251785°
DWR ID	DWR_NA0011_06_f_2022_28				
Comment Code					
A3 : No rodents visible, but rodent burrows visible; need to backfill and compact or grout burrows.					
Inspector Comment

Multiple rodent holes observed in the landside slope. (Fall 2022)

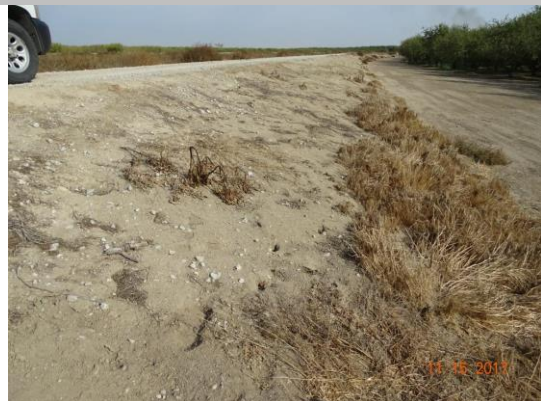
Photo 1 of 1 : FA\_2023\_NA0011\_147\_47\_20230821\_00018.jpg

LM Start	7.71	Rating **	M	Issue No.	47
LM End	8.18	Issue Type +	Ma	Location *	LS
Category	Earthen Levee			GPS Latitude/Longitude	
				Start	End
Item	Animal Control			36.969600°	36.971842°
				-120.234229°	-120.226393°
DWR ID	DWR_NA0011_06_f_2017_47				
Comment Code					
A3 : No rodents visible, but rodent burrows visible; need to backfill and compact or grout burrows.					
Inspector Comment

Bait traps should be maintained and rodent holes should be backfilled.

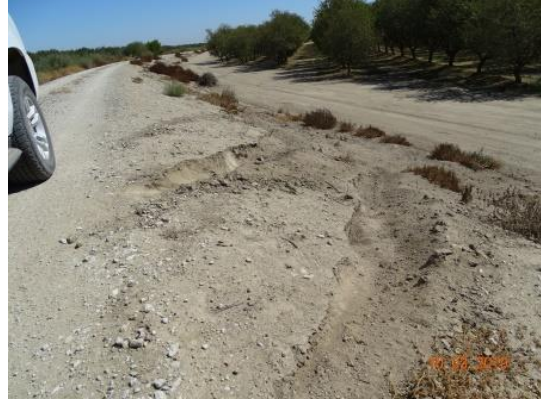
Photo 1 of 1 : FA\_2023\_NA0011\_147\_23\_20230821\_00008.jpg

LM Start	7.91	Rating **	M	Issue No.	23
LM End	7.91	Issue Type +	Ma	Location *	LS
Category	Earthen Levee			GPS Latitude/Longitude	
				Start	End
Item	Erosion / Vehicle Traffic			36.971293°	36.971293°
				-120.231180°	-120.231180°
DWR ID	DWR_NA0011_06_f_2019_23				
Comment Code					
E6 : Repair the levee slope damaged by vehicle traffic and prevent access where possible.					
Inspector Comment

Damage to landside slope from vehicle traffic. (Fall 2019)

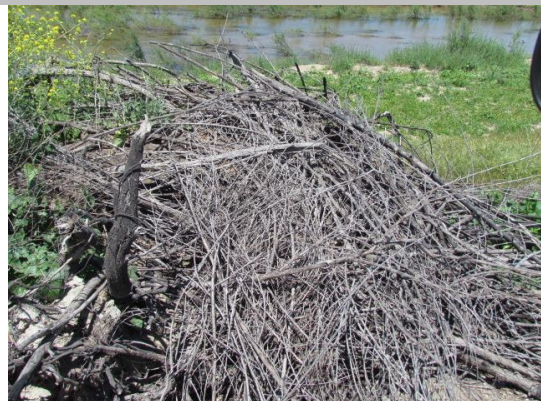
Photo 1 of 1 : FA\_2023\_NA0011\_147\_32\_20230821\_00014.jpg

LM Start	7.96	Rating **	M	Issue No.	32
LM End	7.96	Issue Type +	Ma	Location *	WS
Category	Earthen Levee			GPS Latitude/Longitude	
				Start	End
Item	Encroachments			36.971543°	36.971543°
				-120.230285°	-120.230285°
DWR ID	DWR_NA0011_06_s_2017_32				
Comment Code					
PR : Prunings					
Inspector Comment					
Remove the brush pile from the levee slope. This pile is providing habitat for rodents.

Fresno River waterside levee mile 7.96.

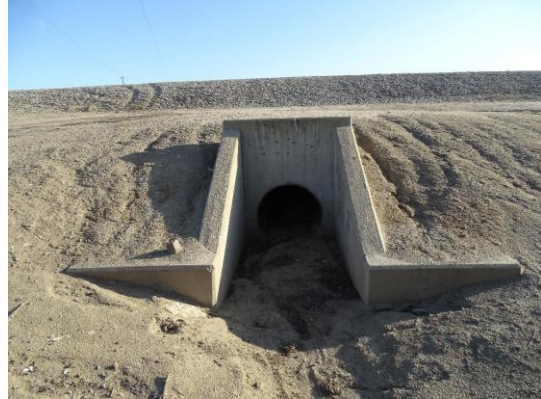
Photo 1 of 2 : UCIP\_FA\_2023\_80595\_113270.jpg

Comment Code						
Inspector Comment						
DS_ID:21534 FS_ID:80595 EP_NO: N/A Repair Type: Non-Urgent EVAL Issue: 5, Pipe Damage Crossing Status: Found UCIP Comments: 04/20/2022 Record remains Non-Urgent. DMP internal video inspection has found pipe integrity issues. LOF of crossing is greater than or equal to 4.1 and less than 5. Crossing will be monitored until funding becomes available for rehabilitation. (M.Thao - DWR UCIP) 05/06/2014 Need to contact owner. Rip rap has been added around concrete headwall on waterward side--need to determine details for rip rap around structure. (DWR UCIP - O. Magana) FIELD_STRUCT_DESC: 30-inch corrugated metal gravity drainage pipe through the levee, 11 feet below the crown. Concrete headwall and wing wall on each end. Flap gate on the waterside (WS) end. [Additional Reference(s): DWR Levee Log, 2005 (8.64). USACE San Joaquin O&M Manual, Unit 606. USACE As-Built Drawing 07-04-0085, Sheets 85/10.2 and 85/31.1, Station 450+10, March 1975]. FS Date: 4/20/2022

LS view: Concrete headwall and pipe inlet approximately 30 feet off toe.

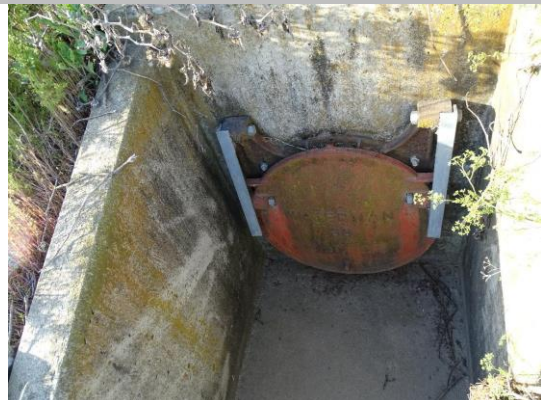
Photo 2 of 2 : UCIP\_FA\_2023\_80595\_113267.jpg

WS view: Concrete headwall and flap gate.

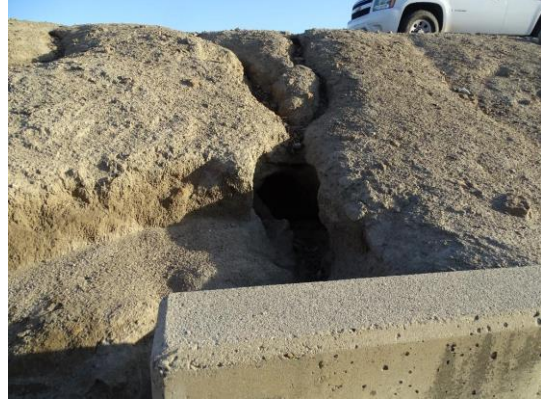
Photo 1 of 1 : UCIP\_FA\_2023\_80594\_113279.jpg

Comment Code						
Inspector Comment						
DS_ID:21530 FS_ID:80594 EP_NO: N/A Repair Type: Non-Urgent EVAL Issue: 6, Levee Damage or Threat for Levee Damage Crossing Status: Found UCIP Comments: 04/20/2022 Record updated from Urgent to Non-Urgent. Surface erosion and the deep hole on the LS slope behind the concrete headwall is still present; however, condition of the pipe is known. DMP internal video inspection has not found pipe integrity issues. LOF of crossing is less or equal to 4. Recommend next video inspection in 5 years. (M.Thao - DWR UCIP) 10/31/2018 Same as last inspection. Surface erosion present due to highly erodible soil. Deep hole behind concrete headwall presently unable to confirm if hole is associated with burrow activity or sink hole. Recommend internal inspection to determine pipe integrity through the levee. Crossing remains Urgent due to the unknown condition of the pipe integrity through the levee. (O. Magana - DWR UCIP) 07/14/2016 Surface erosion still present on LS shoulder. Unable to determine if surface erosion is due to internal pipe failure. Unable to locate concrete headwall on WS toe. Need to coordinate with owner to address erosion or potential pipe failure. Also recommend removing dense vegetation on WS. (DWR UCIP - omagana) 05/06/2014 Need to contact owner. Surface erosion on landward slope unable to determine if pipe failed or if rodent activity burrow hole has caused collapse on slope. Need to determine cause for erosion. (DWR UCIP - omagana) FIELD_STRUCT_DESC: 30-inch corrugated metal gravity drainage pipe through the levee, 10.2 feet below the crown. Concrete headwall and wing wall on each end. Flap gate on the waterside (WS) end. [Additional Reference(s): DWR Levee Log, 2005 (9.05). USACE San Joaquin O&M Manual, Unit 606. USACE As-Built Drawing No. 07-04-0085, Sheets 85/10.2 and 85/31.1, Station 471+50, March 1975]. FS Date: 4/20/2022

LS view: Surface erosion on slope; deep hole located behind concrete headwall.
