**Flood Control Project Maintenance
Levee Inspections****Maintenance Issue Types Only, Levee Inspection Report By Mile - Fall 2024****Madera County FCWCA**

Waterway	Bank	Unit Miles	Inspection Start/End	Inspector
Unit No. 01 Ash Slough	Right	2.37	10/18/2024 10/18/2024	Corey Fujitani

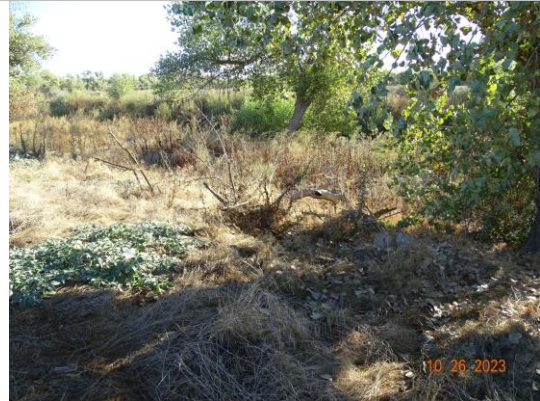
Photo 1 of 1 : FA_2024_NA0011_142_21_20240828_00010.jpg

LM Start	0.75	Rating **	M	Issue No.	21
LM End	0.75	Issue Type +	Ma	Location *	WS
Category	Earthen Levee			GPS Latitude/Longitude	
				Start	End
Item	Trim / Thin Trees			37.052796°	37.052796°
				-120.417641°	-120.417640°
DWR ID	DWR_NA0011_01_f_2023_21				
Comment Code					
T2 : Tree or limb.					
Inspector Comment					
Remove tree limbs from waterside slope.

View of tree limbs on the waterside slope. (Fall 2023)

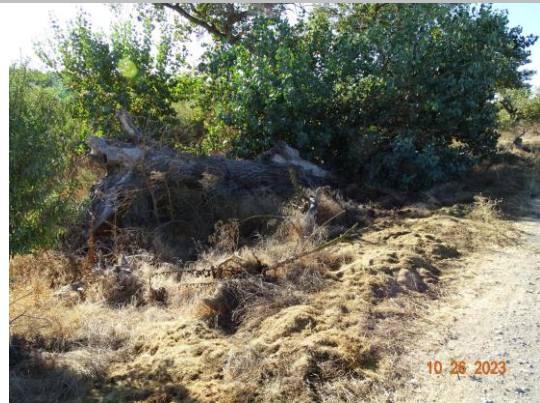
Photo 1 of 1 : FA_2024_NA0011_142_25_20240828_00012.jpg

LM Start	0.79	Rating **	U	Issue No.	25
LM End	0.79	Issue Type +	Ma	Location *	WS
Category	Earthen Levee			GPS Latitude/Longitude	
				Start	End
Item	Trim / Thin Trees			37.053329°	37.053329°
				-120.417448°	-120.417448°
DWR ID	DWR_NA0011_01_f_2018_25				
Comment Code					
T2 : Tree or limb.					
Inspector Comment					
There is a fallen tree blocking the waterside slope.

Tree limbs and trunks are on the waterside shoulder and slope. (Fall 2023)

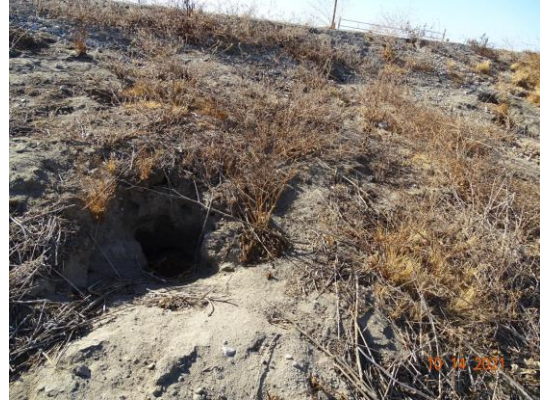
Photo 1 of 1 : FA_2024_NA0011_143_20_20240828_00010.jpg

LM Start	0.00	Rating **	U	Issue No.	20
LM End	0.03	Issue Type +	Ma	Location *	WS
Category	Earthen Levee			GPS Latitude/Longitude	
				Start	End
Item	Animal Control			37.045485°	37.045650°
				-120.427415°	-120.426836°
DWR ID	DWR_NA0011_02_f_2021_20				
Comment Code					
A3 : No rodents visible, but rodent burrows visible; need to backfill and compact or grout burrows.					
Inspector Comment

Representative view of rodent burrows on the waterside slope. (Fall 2021)

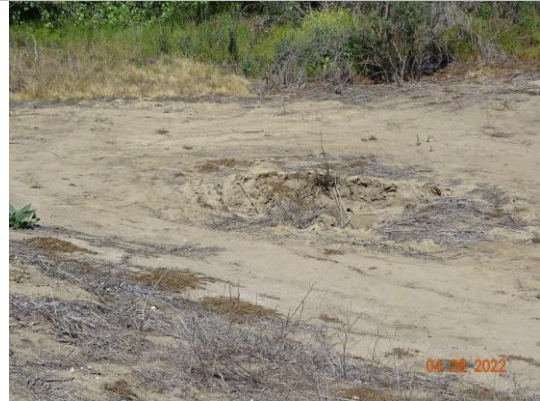
Photo 1 of 1 : FA_2024_NA0011_143_31_20240828_00015.jpg

LM Start	0.01	Rating **	A/W	Issue No.	31
LM End	0.01	Issue Type +	Ma	Location *	WS
Category	Earthen Levee			GPS Latitude/Longitude	
				Start	End
Item	Erosion / Bank Caving			37.045531°	-120.427244°
				37.045531°	-120.427244°
DWR ID	DWR_NA0011_02_f_2024_31				
Comment Code					
E1 : Note and monitor erosion site.					
Inspector Comment					
Large hole within the channel roughly 15 feet off waterside toe. Does not appear to penetrate towards levee. Hole should be backfilled and compacted.

Large hole in the channel approximately 15 feet from the waterside toe. (Spring 2022)

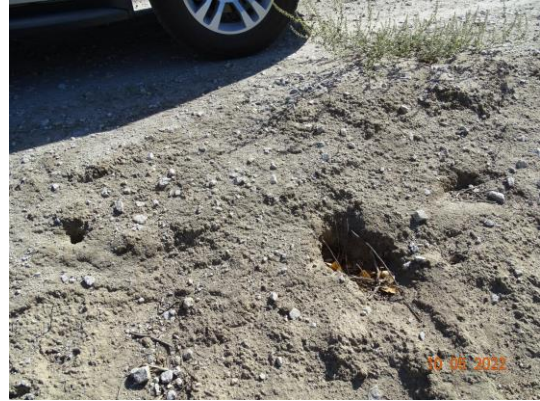
Photo 1 of 1 : FA_2024_NA0011_143_39_20240828_00019.jpg

LM Start	0.32	Rating **	A/W	Issue No.	39
LM End	1.67	Issue Type +	Ma	Location *	WS
Category	Earthen Levee			GPS Latitude/Longitude	
				Start	End
Item	Animal Control			37.047376°	37.060091°
				-120.422190°	-120.405340°
DWR ID	DWR_NA0011_02_f_2015_39				
Comment Code					
A1 : Exterminate rodents and backfill and compact or grout burrows.					
Inspector Comment

Representative view of burrows on the waterside slope in this section.
(Fall 2022)

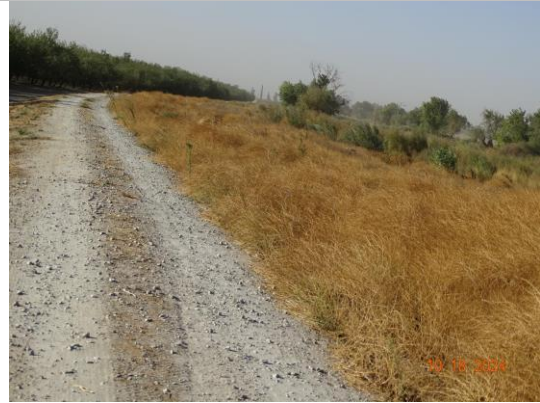
Photo 1 of 1 : FA_2024_NA0011_143_6_20241025_00028.jpg

LM Start	0.48	Rating **	M	Issue No.	6
LM End	2.02	Issue Type +	Ma	Location *	WS
Category	Earthen Levee			GPS Latitude/Longitude	
				Start	End
Item	Vegetation			37.048987°	37.063943°
				-120.420007°	-120.401206°
DWR ID	DWR_NA0011_02_f_2024_6				
Comment Code					
V1 : Control annual grass and weeds on the levee slopes and easements.					
Inspector Comment

View of vegetation on the waterside slope. (Fall 2024)

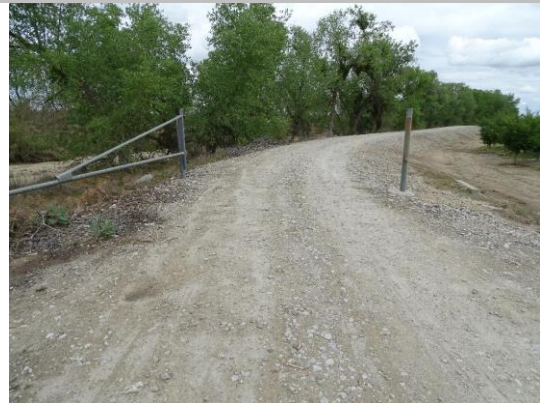
Photo 1 of 3 : UCIP_FA_2024_77411_112199.jpg

Comment Code						
Inspector Comment						
DS_ID:21515 FS_ID:77411 EP_NO: N/A Repair Type: No Action Needed EVAL Issue: Crossing Status: Found UCIP Comments: 04/19/2022 Record updated from No Action Needed to Non-Urgent. Owner needs to coordinate with CVFPB to authorize crossing. DMP internal video inspection has not found pipe integrity issues. LOF of crossing is less or equal to 4. Recommend next video inspection in 5 years. No issues observed during inspection. (M.Thao - DWR UCIP) FIELD_STRUCT_DESC: 36-inch corrugated metal gravity drainage pipe through the levee, 7.3 feet below the crown. Headwall and wing wall on each end. Flap gate on the waterside (WS) end. [Additional Reference(s): Levee Log, 2005 (HLM 0.99). USACE San Joaquin O&M Manual 605 (Station 52+50), listed as 36-inch pipe]. FS Date: 4/19/2022

Levee crown looking upstream.

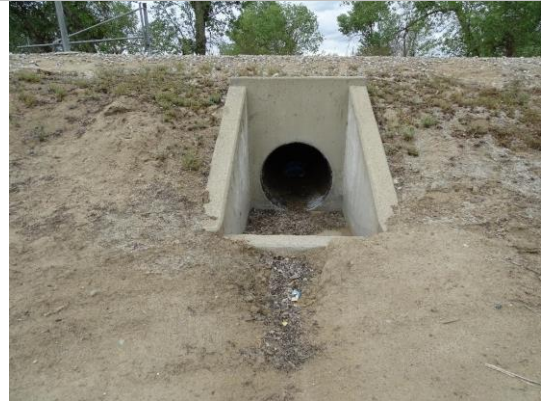
Photo 2 of 3 : UCIP_FA_2024_77411_112200.jpg

LS view: Concrete headwall and pipe inlet on toe.

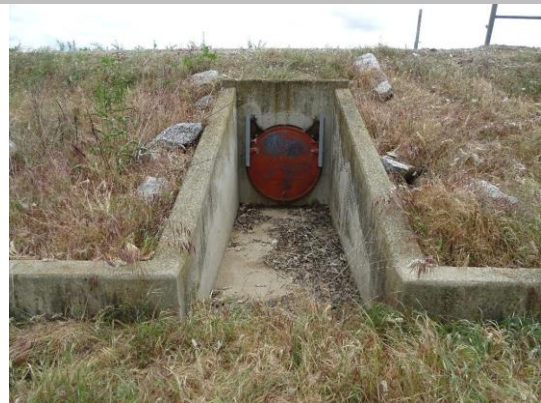
Photo 3 of 3 : UCIP_FA_2024_77411_112201.jpg

WS view: Concrete headwall and flap gate on toe.

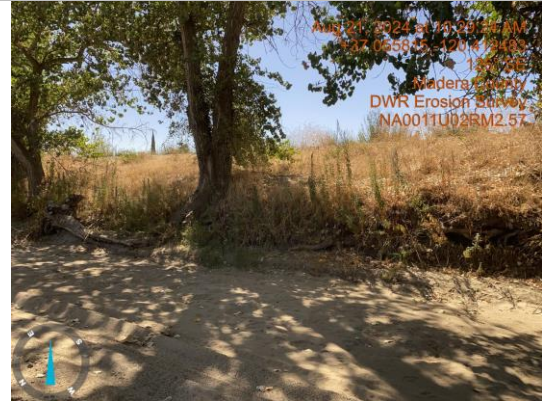
Photo 1 of 2 : SJR2024_NA0011U02RM2.57_3.JPG

Comment Code					
Inspector Comment					
Site ID: NA0011U02RM2.57 8/21/2024: From 2012 to present, no significant changes were observed during the annual survey. Vegetation is obscuring the views of the erosion. 07/24/2012: Dense vegetation around the site. 08/09/2011: A fallen tree was seen at the levee toe about 20 feet upstream, and tree root exposed. There has been no report from the district that this site was corrected. 11/30/2010: Site was not inspected due to time constraints. There have been no reports from the district that the site was corrected. Continue to monitor site during flood events. 08/05/2010: Recommended for annual assessment and monitoring during flood events, per CLRO. 2009: Site is recommended as a local maintenance issue, per Critical Levee Repair Office, Critical Erosion Sites Evaluation 2008 Report; site was previously rated "M" 09/6/2007: Undercutting of the toe; several trees along the WS slope with roots exposed.

8/21/2024: View of the erosion on the levee toe.

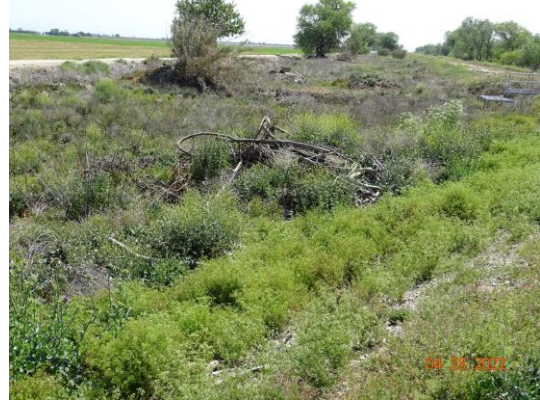
Photo 1 of 1 : FA_2024_NA0011_144_20_20240828_00008.jpg

LM Start	0.08	Rating **	M	Issue No.	20
LM End	0.08	Issue Type +	Ma	Location *	LS
Category	Earthen Levee			GPS Latitude/Longitude	
				Start	End
Item	Encroachments			36.996204°	36.996201°
				-120.372352°	-120.372345°
DWR ID	DWR_NA0011_03_s_2012_20				
Comment Code					
PR : Prunings					
Inspector Comment					
Remove the prunings from the landside slope.

Looking at prunings on landward slope. (Spring 2022)

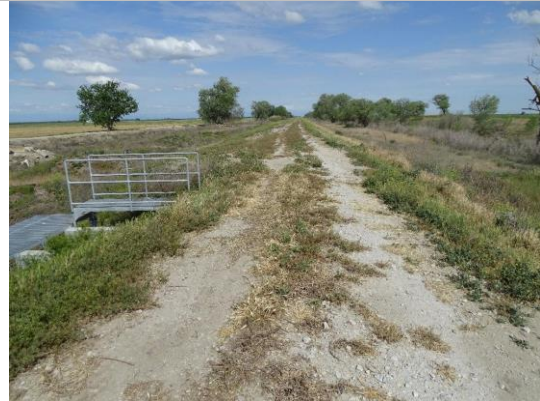
Photo 1 of 3 : UCIP_FA_2024_77412_112270.jpg

Comment Code						
Inspector Comment						
DS_ID:21517 FS_ID:77412 EP_NO: N/A Repair Type: No Action Needed EVAL Issue: Crossing Status: Found UCIP Comments: 04/19/2022 Record updated from Non-Urgent to No Action Needed. Flap gate on the WS was held open by a chain; recommend owner close flap gate prior to flood season to prevent uncontrolled flows from WS to LS during high-water events. DMP internal video inspection has not found pipe integrity issues. LOF of crossing is less or equal to 4. Recommend next video inspection in 5 years. (M.Thao - DWR UCIP) 05/06/2014 Need to contact owner to determine status of crossing. Unable to determine if crossing is in use. (DWR UCIP - O. Magana) FIELD_STRUCT_DESC: 36-inch corrugated metal gravity drainage pipe through the levee, 7.3 feet below the crown. Headwall and wing wall on each end. Debris screen at pipe inlet and walkway on landside (LS). Flap gate on the waterside (WS) end. [Additional Reference(s): DWR Levee Log, 2005 (HLM 0.11). USACE San Joaquin O&M Manual 605 (Station 5+50), listed as 36-inch pipe]. FS Date: 4/19/2022

Levee crown looking upstream.

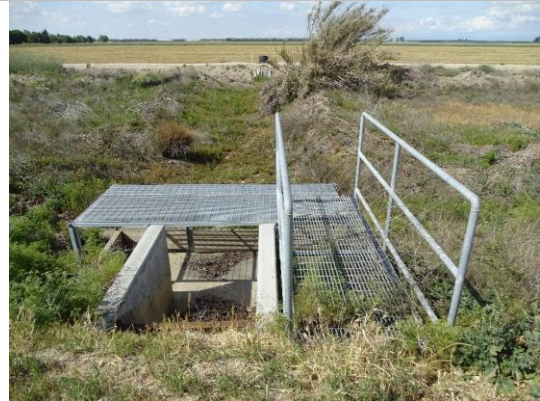
Photo 2 of 3 : UCIP_FA_2024_77412_112271.jpg

LS view: Looking from crown; concrete headwall and walk way.

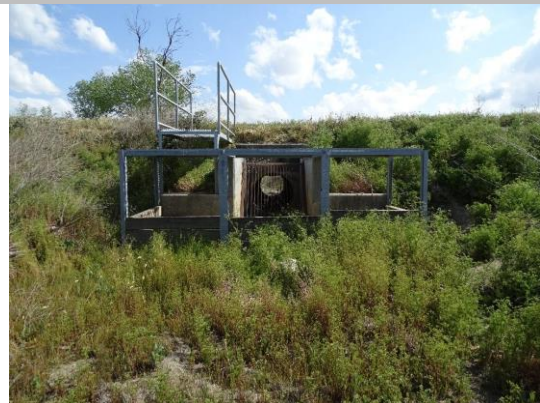
Photo 3 of 3 : UCIP_FA_2024_77412_112272.jpg

LS view: Looking into pipe through levee; flap gate is open on WS.

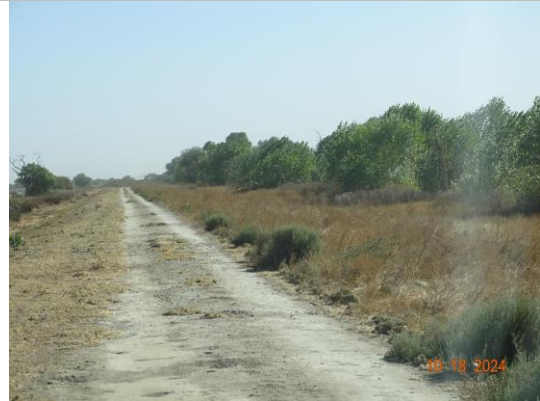
Photo 1 of 1 : FA_2024_NA0011_144_8_20241025_00014.jpg

LM Start	0.56	Rating **	M	Issue No.	8
LM End	1.50	Issue Type +	Ma	Location *	WS
Category	Earthen Levee			GPS Latitude/Longitude	
				Start	End
Item	Vegetation			36.996245°	36.996605°
				-120.363732°	-120.346844°
DWR ID	DWR_NA0011_03_f_2024_8				
Comment Code					
V1 : Control annual grass and weeds on the levee slopes and easements.					
Inspector Comment

View of vegetation on the waterside slope and shoulder. (Fall 2024)

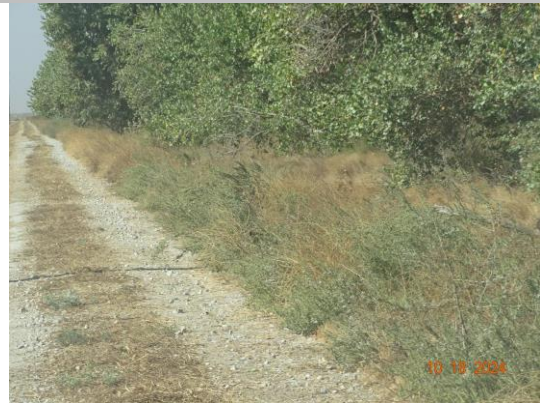
Photo 1 of 1 : FA_2024_NA0011_145_22_20241025_00032.jpg

LM Start	0.02	Rating **	M	Issue No.	22
LM End	0.42	Issue Type +	Ma	Location *	WS
Category	Earthen Levee			GPS Latitude/Longitude	
				Start	End
Item	Vegetation			36.995516°	36.995544°
				-120.373080°	-120.365847°
DWR ID	DWR_NA0011_04_f_2024_22				
Comment Code					
V1 : Control annual grass and weeds on the levee slopes and easements.					
Inspector Comment

View of vegetation on the waterside slope. (Fall 2024)

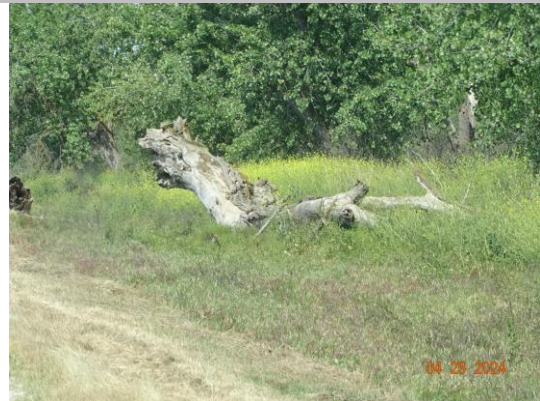
Photo 1 of 1 : FA_2024_NA0011_145_16_20240828_00011.jpg

LM Start	0.47	Rating **	M	Issue No.	16
LM End	0.49	Issue Type +	Ma	Location *	WS
Category	Earthen Levee			GPS Latitude/Longitude	
				Start	End
Item	Trim / Thin Trees			36.995603°	36.995568°
				-120.364978°	-120.364634°
DWR ID	DWR_NA0011_04_s_2014_16				
Comment Code					
T2 : Tree or limb.					
Inspector Comment					
This dead tree on the waterward slope should be removed from the levee section.

View of tree trunk on the waterside slope. (Spring 2024)

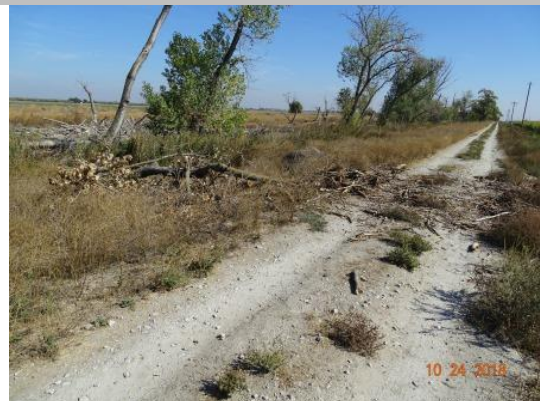
Photo 1 of 1 : FA_2024_NA0011_145_31_20240828_00020.jpg

LM Start	0.75	Rating **	M	Issue No.	31
LM End	0.75	Issue Type +	Ma	Location *	WS
Category	Earthen Levee			GPS Latitude/Longitude	
				Start	End
Item	Trim / Thin Trees			36.995582°	36.995582°
				-120.360028°	-120.360028°
DWR ID	DWR_NA0011_04_f_2018_31				
Comment Code					
T2 : Tree or limb.					
Inspector Comment

Tree branches strewn across levee crown and both shoulders. (Fall 2018)

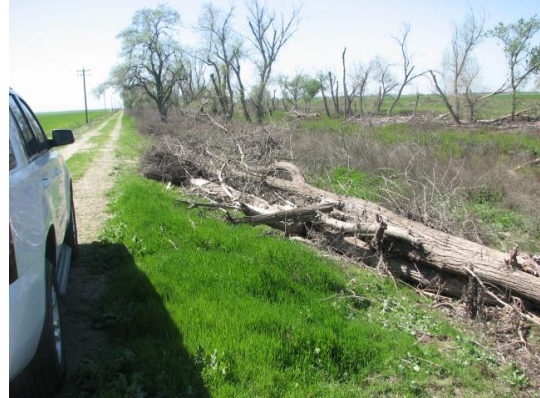
Photo 1 of 1 : FA_2024_NA0011_145_14_20240828_00009.jpg

LM Start	0.94	Rating **	U	Issue No.	14
LM End	0.94	Issue Type +	Ma	Location *	WS
Category	Earthen Levee			GPS Latitude/Longitude	
				Start	End
Item	Trim / Thin Trees			36.995573°	36.995573°
				-120.356601°	-120.356601°
DWR ID	DWR_NA0011_04_f_2017_14				
Comment Code					
T2 : Tree or limb.					
Inspector Comment					
Remove the downed tree from the waterside slope.

Looking upstream at fallen tree on waterward slope. (Spring 2018)

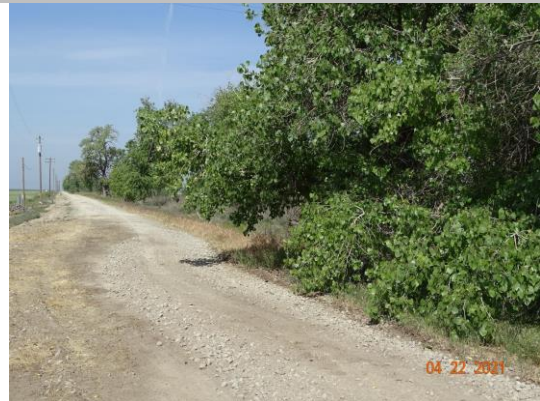
Photo 1 of 1 : FA_2024_NA0011_145_12_20240828_00007.jpg

LM Start	1.01	Rating **	U	Issue No.	12
LM End	1.01	Issue Type +	Ma	Location *	WS
Category	Earthen Levee			GPS Latitude/Longitude	
				Start	End
Item	Trim / Thin Trees			36.995537°	36.995537°
				-120.355261°	-120.355261°
DWR ID	DWR_NA0011_04_f_2017_12				
Comment Code					
T1 : Trim and thin trees to at least five feet above ground level to allow visibility of the ground and room to flood fight.					
Inspector Comment					
Branches from waterside tree are blocking visibility of waterside slope and crown. Levee crown is nearly impassible.

Trim trees to at least 5' above levee slope and 12' above levee crown to allow inspection and access. (Spring 2021)

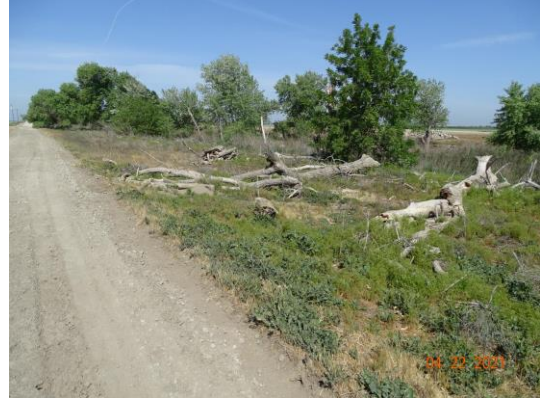
Photo 1 of 1 : FA_2024_NA0011_145_24_20240828_00015.jpg

LM Start	1.07	Rating **	U	Issue No.	24
LM End	1.07	Issue Type +	Ma	Location *	WS
Category	Earthen Levee			GPS Latitude/Longitude	
				Start	End
Item	Trim / Thin Trees			36.995587°	36.995587°
				-120.354128°	-120.354128°
DWR ID	DWR_NA0011_04_s_2021_24				
Comment Code					
T2 : Tree or limb.					
Inspector Comment

View of fallen trees on the waterside slope and berm. (Spring 2021)

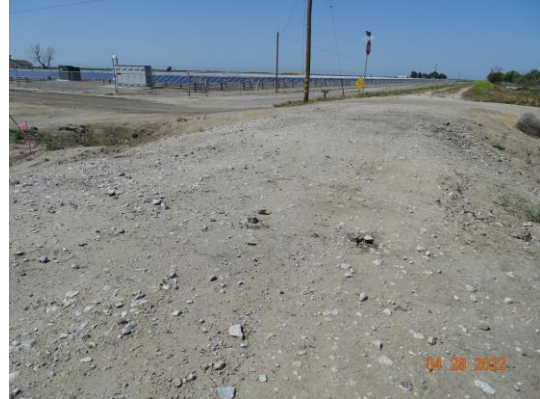
Photo 1 of 1 : FA_2024_NA0011_145_10_20240828_00005.jpg

LM Start	1.50	Rating **	M	Issue No.	10
LM End	1.50	Issue Type +	Ma	Location *	CR
Category	Earthen Levee			GPS Latitude/Longitude	
				Start	End
Item	Crown Surface / Depressions / Rutting			36.995629°	36.995629°
				-120.346319°	-120.346319°
DWR ID	DWR_NA0011_04_s_2022_10				
Comment Code					
C1 : Add appropriate material and re-grade the levee to bring the crown above the design elevation.					
Inspector Comment					
Depression is in line with pipe crossing and could be related to a potential issue with the pipe.

Depression in the levee crown should be brought to level with appropriate material. (Spring 2022)

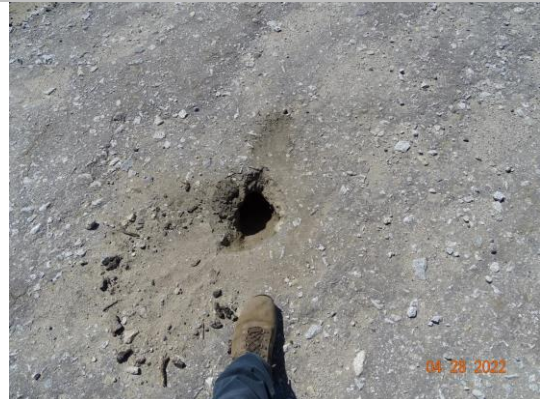
Photo 1 of 1 : FA_2024_NA0011_145_59_20240828_00026.jpg

LM Start	1.63	Rating **	U	Issue No.	59
LM End	1.67	Issue Type +	Ma	Location *	CR
Category	Earthen Levee			GPS Latitude/Longitude	
				Start	End
Item	Animal Control			36.996573°	36.997002°
				-120.344428°	-120.343977°
DWR ID	DWR_NA0011_04_s_2012_59				
Comment Code					
A3 : No rodents visible, but rodent burrows visible; need to backfill and compact or grout burrows.					
Inspector Comment					
Rodent holes should be backfilled and compacted or grouted.

Representative rodent hole in the levee crown along this section. (Spring 2022)

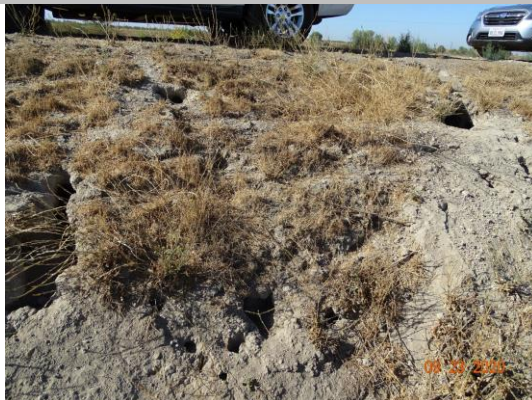
Photo 1 of 1 : FA_2024_NA0011_146_14_20240828_00003.jpg

LM Start	0.00	Rating **	M	Issue No.	14
LM End	1.49	Issue Type +	Ma	Location *	LS
Category	Earthen Levee			GPS Latitude/Longitude	
				Start	End
Item	Animal Control			36.978520°	36.967896°
				-120.368567°	-120.347376°
DWR ID	DWR_NA0011_05_f_2016_14				
Comment Code					
A1 : Exterminate rodents and backfill and compact or grout burrows.					
Inspector Comment					
Exterminate the rodents along the landside slope and toe throughout the area. Bait stations are needed in infested areas.

Rodent activity on the landside slope. (Fall 2020)

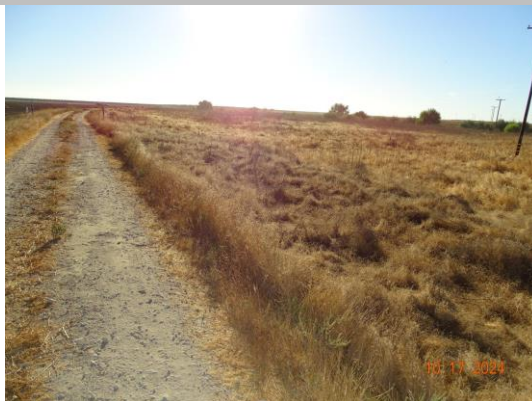
Photo 1 of 1 : FA_2024_NA0011_146_49_20241025_00061.jpg

LM Start	0.02	Rating **	M	Issue No.	49
LM End	0.25	Issue Type +	Ma	Location *	WS
Category	Earthen Levee			GPS Latitude/Longitude	
				Start	End
Item	Vegetation			36.978534°	36.977769°
				-120.368157°	-120.364098°
DWR ID	DWR_NA0011_05_f_2024_49				
Comment Code					
V1 : Control annual grass and weeds on the levee slopes and easements.					
Inspector Comment

View of vegetation on the waterside slope and shoulder. (Fall 2024)

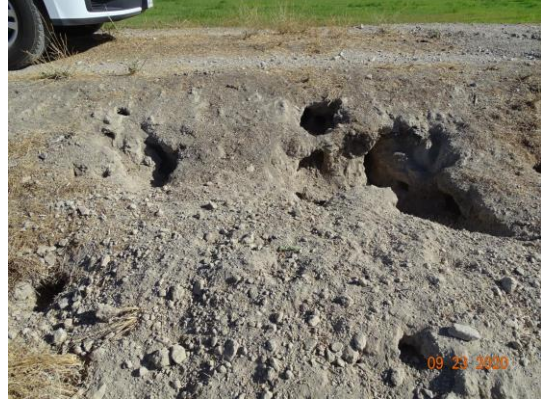
Photo 1 of 1 : FA_2024_NA0011_146_21_20240828_00007.jpg

LM Start	0.12	Rating **	U	Issue No.	21
LM End	0.12	Issue Type +	Ma	Location *	WS
Category	Earthen Levee			GPS Latitude/Longitude	
				Start	End
Item	Animal Control			36.978327°	36.978327°
				-120.366440°	-120.366440°
DWR ID	DWR_NA0011_05_f_2020_21				
Comment Code					
A1 : Exterminate rodents and backfill and compact or grout burrows.					
Inspector Comment

Rodent burrows in the waterside slope. (Fall 2020)

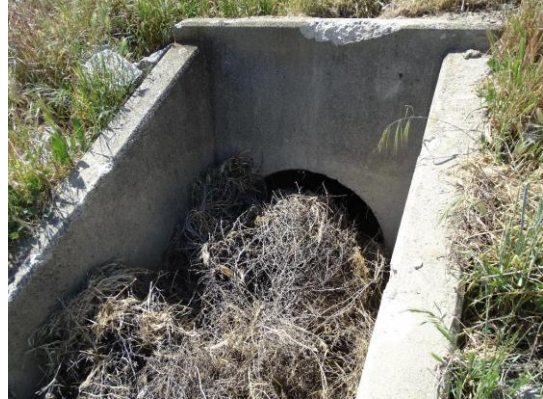
Photo 2 of 3 : UCIP_FA_2024_81023_112410.jpg

DS_ID:21520
 FS_ID:81023
 EP_NO: N/A
 Repair Type: Urgent
 EVAL Issue: 1, Pipe Integrity
 Crossing Status: Found
 UCIP Comments: 09/19/2023 Record updated from Non-Urgent to Urgent. DMP internal video inspection has found severe pipe defects. Crossing will be monitored until funding becomes available to address the issues. (O. Yakimov - DWR UCIP)
 04/20/2022 Record remains Non-Urgent. Tumbleweeds are blocking the pipe inlet and outlet; recommend removal. Minor rodent activity was observed behind the LS headwall. DMP internal video inspection has not found pipe integrity issues. LOF of crossing is less or equal to 4. Recommend next video inspection in 5 years. (M.Thao - DWR UCIP)
 05/06/2014 Need to contact owner. Dense vegetation limits the inspector's visibility to identify signs of pipe failure (leaks) along the landward slope. Recommend removing vegetation along pipe alignment to conduct proper inspection of structure. (DWR UCIP - O. Magana)

LS view: Concrete headwall and pipe inlet; tumbleweeds in front of inlet.

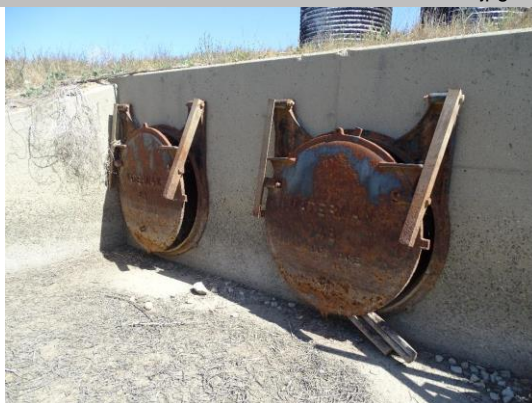
Photo 1 of 2 : UCIP_FA_2024_82670_112507.jpg

Comment Code						
Inspector Comment						
DS_ID:21623 FS_ID:82670 EP_NO: N/A Repair Type: Non-Urgent EVAL Issue: 11, Maintenance Compliance Issue Crossing Status: Found UCIP Comments: 04/20/2022 Record updated from No Action Needed to Non-Urgent. Flap gate on WS does not close properly and does not appear to be propped open with anything; flap gate hinges appear skewed. Recommend flap gate be repaired. (M. Thao - DWR UCIP) 10/27/2017 This structure is inspected annually under the Structure and Channel Summer Inspection (part of the Levee Inspection Program) conducted by the DWR Flood Project Integrity and Inspection Branch (FPIIB). (DWR UCIP - O. Magana) FIELD_STRUCT_DESC: 1 of 4: 48-inch corrugated metal gravity drainage pipe through the levee, 11.5 feet below the crown. Concrete headwall and wing wall on each end. [Additional Reference(s): DWR Levee Log, 2005 (HLM 0.55). USACE San Joaquin O&M Manual, Unit 606. USACE As-Built Drawing No. 07-04-0085, Sheets 85/3.1 and 85/25.2, (Station 29+20), March 1975]. FS Date: 4/20/2022

WS view: Flap gate not closed properly and appears not to be propped open. Record associated with flap gate on the left side.

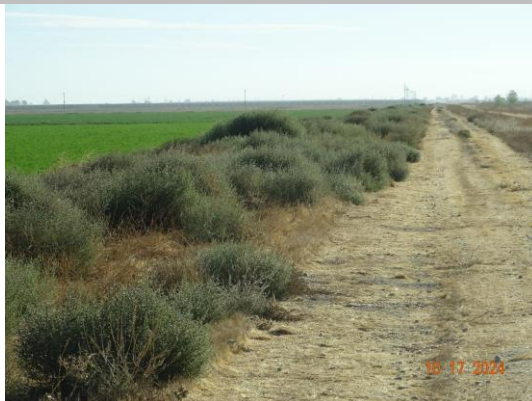
Photo 1 of 1 : FA_2024_NA0011_146_50_20241025_00059.jpg

LM Start	2.57	Rating **	U	Issue No.	50
LM End	3.12	Issue Type +	Ma	Location *	LS
Category	Earthen Levee			GPS Latitude/Longitude	
				Start	End
Item	Vegetation			36.968008°	36.968057°
				-120.327776°	-120.317801°
DWR ID	DWR_NA0011_05_f_2024_50				
Comment Code					
V1 : Control annual grass and weeds on the levee slopes and easements.					
Inspector Comment

Looking upstream along the landside slope. (Fall 2024)

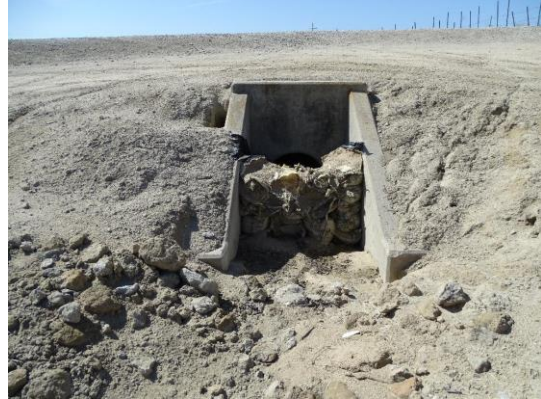
Photo 3 of 3 : UCIP_FA_2024_80588_112421.jpg

Comment Code						
Inspector Comment						
DS_ID:21529 FS_ID:80588 EP_NO: N/A Repair Type: Non-Urgent EVAL Issue: 11, Maintenance Compliance Issue Crossing Status: Found UCIP Comments: 04/20/2022 Record updated from No Action Needed to Non-Urgent. Pipe inlet on LS is being blocked with sandbags; recommend removal for crossing to function properly. DMP internal video inspection has not found pipe integrity issues. LOF of crossing is less or equal to 4. Recommend next video inspection in 5 years. (M.Thao - DWR UCIP) FIELD_STRUCT_DESC: 30-inch corrugated metal gravity drainage pipe through the levee, 9 feet below the crown. Concrete headwall and wing wall on each end. Flap gate on waterside (WS) end. [Additional Reference(s): DWR Levee Log, 2005 (HLM 4.10). USACE San Joaquin O&M Manual, Unit 606. USACE As-Built Drawing No. 07-04-0085, (Station 214+20), Sheets 85/6.1 and 85/31.1, March 1975]. FS Date: 4/20/2022

LS view: Concrete headwall at toe; stacked sandbags are blocking pipe inlet.

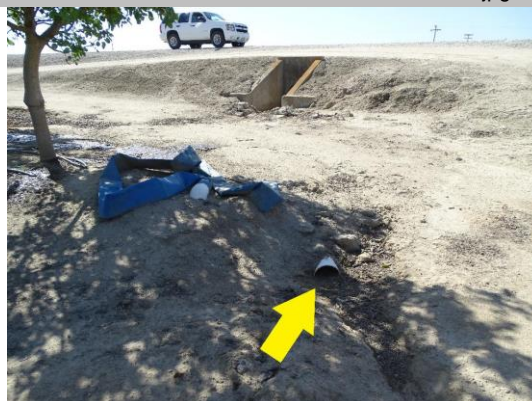
Photo 3 of 3 : UCIP_FA_2024_80587_112431.jpg

Comment Code						
Inspector Comment						
DS_ID:21522						
FS_ID:80587						
EP_NO: N/A						
Repair Type: No Action Needed						
EVAL Issue:						
Crossing Status: Found						
UCIP Comments: 04/20/2022 Record remains No Action Needed. A PVC pipe buried off LS toe was observed and appears to be for drainage purposes. DMP internal video inspection has not found pipe integrity issues. LOF of crossing is less or equal to 4. Recommend next video inspection in 5 years. (M.Thao - DWR UCIP)						
FIELD_STRUCT_DESC: 30-inch corrugated metal gravity drainage pipe through the levee, 7.8 feet below the crown. Concrete headwall and wing wall on each end. Flap gate on the waterside (WS) end propped open. [Additional Reference(s): DWR Levee Log, 2005 (HLM 4.60). USACE San Joaquin O&M Manual, Unit 606. USACE As-Built Drawing No. 07-04-0085, Sheets 85/7.1 and 85/31.1, (Station 240+20), March 1975].						
FS Date: 4/20/2022

LS view: PVC drainage pipe inlet (yellow arrow) leading to headwall.

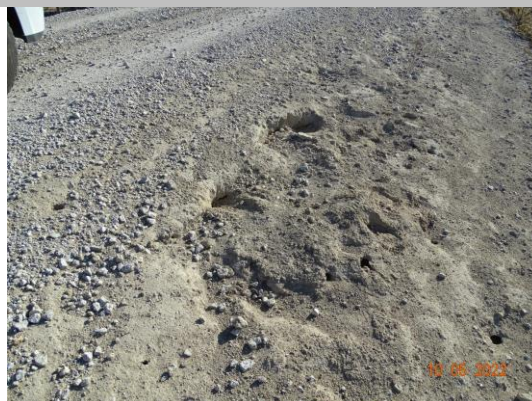
Photo 1 of 1 : FA_2024_NA0011_146_41_20240828_00016.jpg

LM Start	5.17	Rating **	A/W	Issue No.	41
LM End	5.17	Issue Type +	Ma	Location *	WS
Category	Earthen Levee			GPS Latitude/Longitude	
				Start	End
Item	Animal Control			36.968219°	36.968219°
				-120.280871°	-120.280871°
DWR ID	DWR_NA0011_05_f_2022_41				
Comment Code					
A3 : No rodents visible, but rodent burrows visible; need to backfill and compact or grout burrows.					
Inspector Comment

Partially collapsed rodent holes on the waterside slope. (Fall 2022)

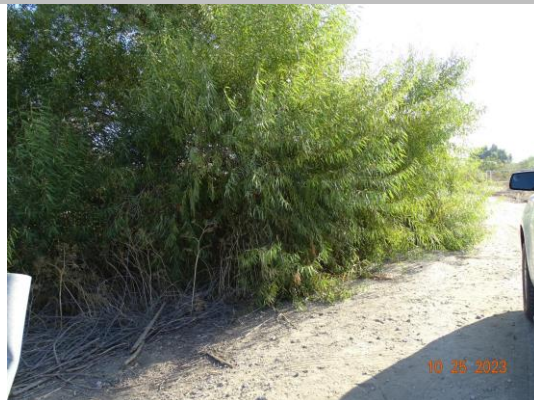
Photo 1 of 1 : FA_2024_NA0011_146_29_20240828_00010.jpg

LM Start	6.57	Rating **	M	Issue No.	29
LM End	6.57	Issue Type +	Ma	Location *	LS
Category	Earthen Levee			GPS Latitude/Longitude	
				Start	End
Item	Trim / Thin Trees			36.968477°	36.968477°
				-120.255557°	-120.255557°
DWR ID	DWR_NA0011_05_f_2019_29				
Comment Code					
T1 : Trim and thin trees to at least five feet above ground level to allow visibility of the ground and room to flood fight.					
Inspector Comment					
Tree should be trimmed above the levee crown and 5 feet above the slope.

View of tree growing on the landside slope. (Fall 2023)

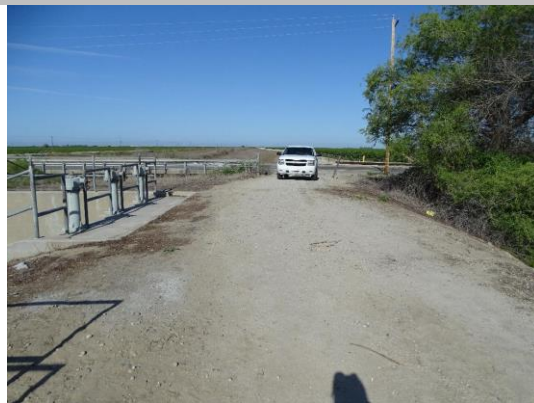
Photo 1 of 3 : UCIP_FA_2024_80623_112448.jpg

Comment Code						
Inspector Comment						
DS_ID:21625						
FS_ID:80623						
EP_NO: N/A						
Repair Type: No Action Needed						
EVAL Issue:						
Crossing Status: Found						
UCIP Comments: 04/20/2022 Record remains No Action Needed. No issues observed during inspection. (M.Thao - DWR UCIP)						
FIELD_STRUCT_DESC: [Fresno Diversion Weir] 1 of 3: 60-inch by 48-inch reinforced concrete box gravity drainage culvert through the levee, 13 feet below the crown. Concrete headwall and wing wall on the landside (LS) shoulder. Slide gate on the waterside (WS). [Additional Reference(s): DWR Levee Log, 2005 (HLM 6.64). USACE San Joaquin O&M Manual, Unit 606, (located just upstream from Road 16), listed as diversion dam].						
FS Date: 4/20/2022

Levee crown looking downstream.

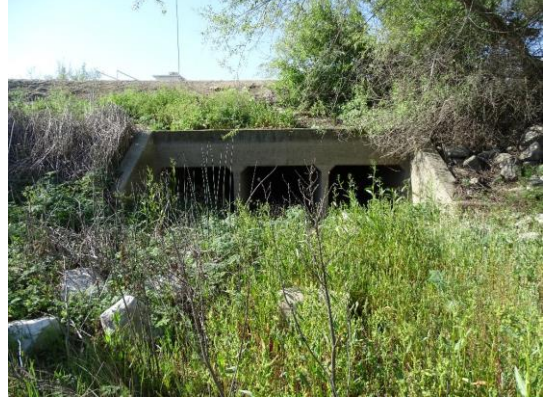
Photo 2 of 3 : UCIP_FA_2024_80623_112450.jpg

LS view: Looking toward levee; inlet of reinforced concrete box culvert.

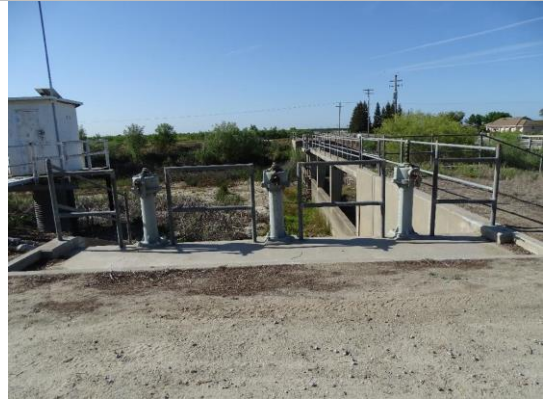
Photo 3 of 3 : UCIP_FA_2024_80623_112451.jpg

WS view: Looking from crown; slide gate operator on shoulder.

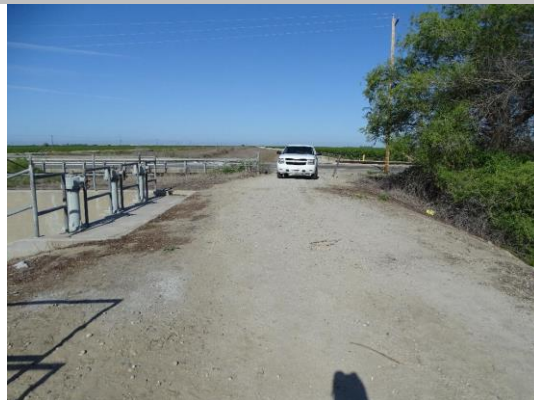
Photo 1 of 3 : UCIP_FA_2024_80624_112452.jpg

Comment Code						
Inspector Comment						
DS_ID:21624 FS_ID:80624 EP_NO: N/A Repair Type: No Action Needed EVAL Issue: Crossing Status: Found UCIP Comments: 04/20/2022 Record remains No Action Needed. No issues observed during inspection. (M.Thao - DWR UCIP) FIELD_STRUCT_DESC: [Fresno Diversion Weir] 2 of 3: 60-inch by 48-inch reinforced concrete box gravity drainage culvert through the levee, 13 feet below the crown. Concrete headwall and wing wall on the landside (LS) shoulder. Slide gate on the waterside (WS). [Additional Reference(s): DWR Levee Log, 2005 (HLM 6.64). USACE San Joaquin O&M Manual, Unit 606, (located just upstream from Road 16), listed as diversion dam]. FS Date: 4/20/2022

Levee crown looking downstream.

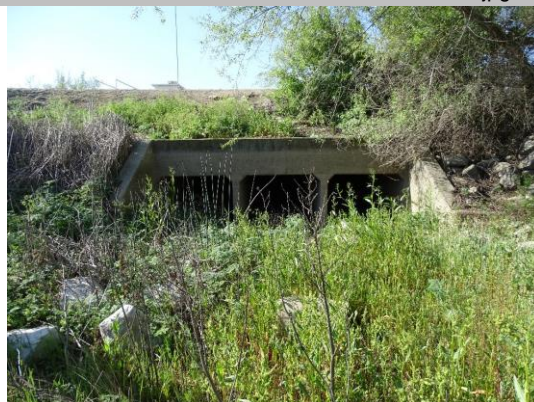
Photo 2 of 3 : UCIP_FA_2024_80624_112453.jpg

LS view: Looking toward levee; inlet of reinforced concrete box culvert.

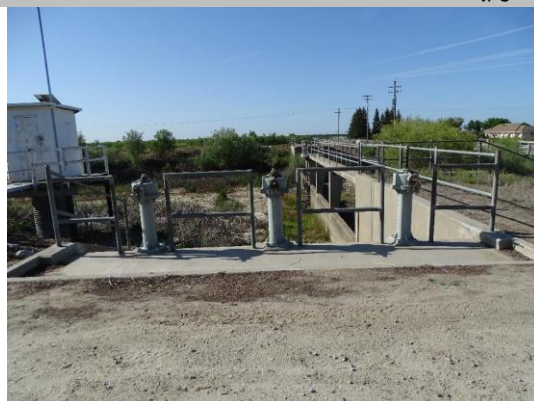
Photo 3 of 3 : UCIP_FA_2024_80624_112454.jpg

WS view: Looking from crown; slide gate operator on shoulder.

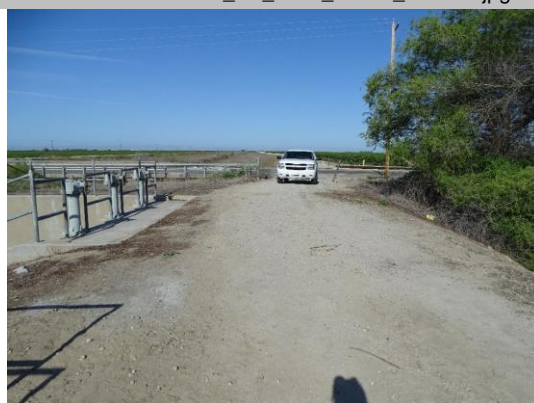
Photo 1 of 3 : UCIP_FA_2024_80625_112456.jpg

Levee crown looking downstream.

Comment Code					
Inspector Comment					
DS_ID:21525 FS_ID:80625 EP_NO: N/A Repair Type: No Action Needed EVAL Issue: Crossing Status: Found UCIP Comments: 04/20/2022 Record remains No Action Needed. No issues observed during inspection. (M.Thao - DWR UCIP) FIELD_STRUCT_DESC: [Fresno Diversion Weir] 3 of 3: 60-inch by 48-inch reinforced concrete box gravity drainage culvert through the levee, 13 feet below the crown. Concrete headwall and wing wall on the landside (LS) shoulder. Slide gate on the waterside (WS). [Additional Reference(s): DWR Levee Log, 2005 (HLM 6.64). USACE San Joaquin O&M Manual, Unit 606, (located just upstream from Road 16), listed as diversion dam]. FS Date: 4/20/2022

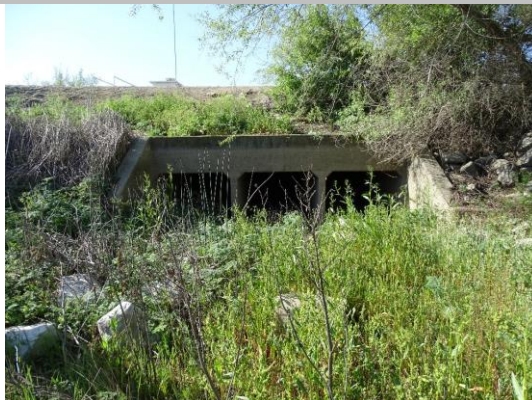
Photo 2 of 3 : UCIP_FA_2024_80625_112457.jpg

LS view: Looking toward levee; inlet of reinforced concrete box culvert.

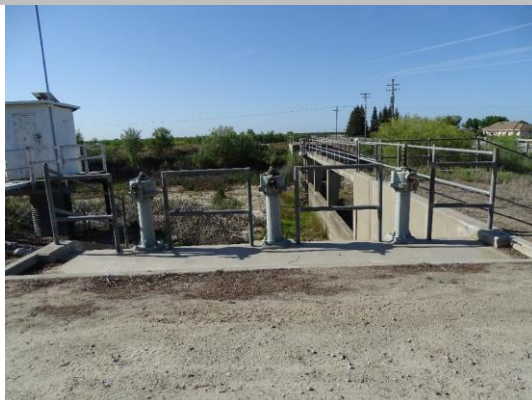
Photo 3 of 3 : UCIP_FA_2024_80625_112458.jpg

WS view: Looking from crown; slide gate operator on shoulder.

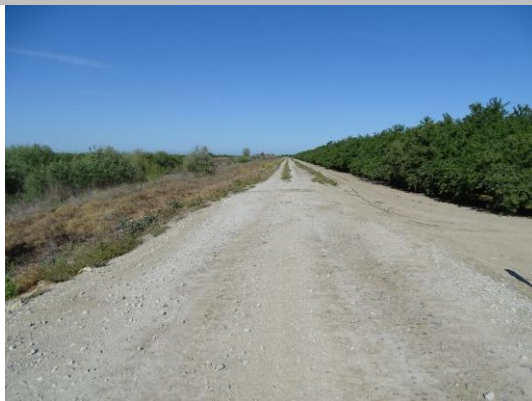
Photo 1 of 3 : UCIP_FA_2024_80579_112465.jpg

Comment Code						
Inspector Comment						
DS_ID:21526 FS_ID:80579 EP_NO: N/A Repair Type: No Action Needed EVAL Issue: Crossing Status: Found UCIP Comments: 04/20/2022 Record remains No Action Needed. DMP internal video inspection has not found pipe integrity issues. LOF of crossing is less or equal to 4. Recommend next video inspection in 5 years. (M. Thao - DWR UCIP) 05/06/2014 Descriptions modified based on field confirmation. (DWR UCIP - O. Magana) FIELD_STRUCT_DESC: 30-inch corrugated metal gravity drainage pipe through the levee, 9.4 feet below the crown. Concrete headwall and wing wall on each end. Flap gate on the waterside (WS) end. [Additional Reference(s): DWR Levee Log, 2005 (HLM 7.61). USACE San Joaquin O&M Manual, Unit 606. USACE As-Built Drawing No. 07-04-0085, Sheets 85/8A.1 and 85/31.1, (Station 397+16), March 1975]. FS Date: 4/20/2022

Levee crown looking downstream.

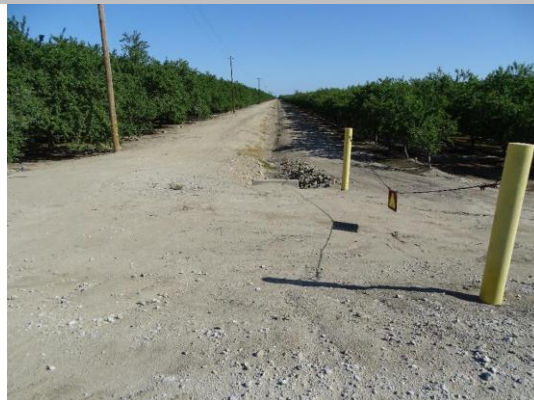
Photo 2 of 3 : UCIP_FA_2024_80579_112466.jpg

LS view: Looking from crown; concrete headwall approximately 20 feet off toe.

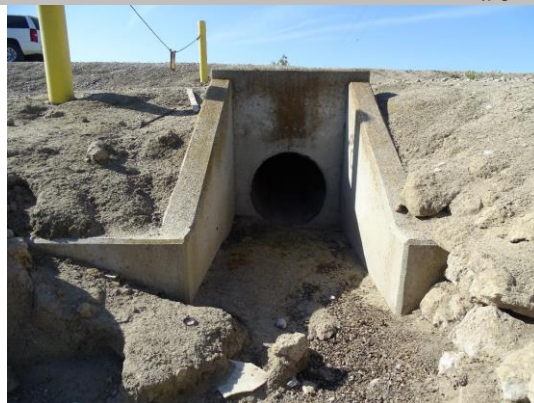
Photo 3 of 3 : UCIP_FA_2024_80579_112467.jpg

LS view: Concrete headwall and pipe inlet.

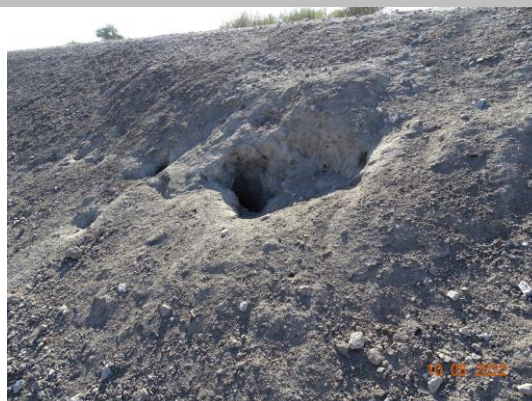
Photo 1 of 1 : FA_2024_NA0011_146_24_20240828_00009.jpg

LM Start	7.62	Rating **	U	Issue No.	24
LM End	7.66	Issue Type +	Ma	Location *	LS
Category	Earthen Levee			GPS Latitude/Longitude	
				Start	End
Item	Animal Control			36.969543°	36.969606°
				-120.236801°	-120.236091°
DWR ID	DWR_NA0011_05_f_2018_24				
Comment Code					
A3 : No rodents visible, but rodent burrows visible; need to backfill and compact or grout burrows.					
Inspector Comment					
Large rodent burrows on the landside slope should be backfilled and compacted.

Representative burrow on the landside slope. (Fall 2022)

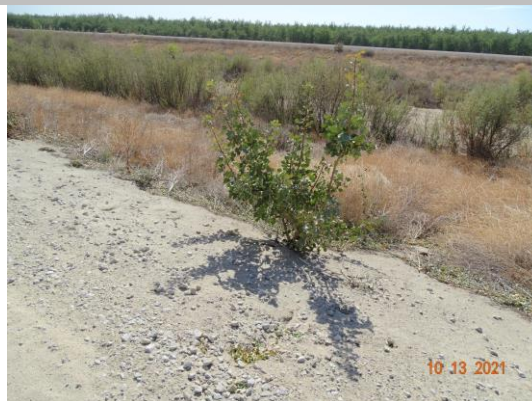
Photo 1 of 1 : FA_2024_NA0011_146_8_20240828_00001.jpg

LM Start	8.70	Rating **	M	Issue No.	8
LM End	8.70	Issue Type +	Ma	Location *	WS
Category	Earthen Levee			GPS Latitude/Longitude	
				Start	End
Item	Trim / Thin Trees			36.971970°	36.971970°
				-120.218647°	-120.218647°
DWR ID	DWR_NA0011_05_f_2021_8				
Comment Code					
T1 : Trim and thin trees to at least five feet above ground level to allow visibility of the ground and room to flood fight.					
Inspector Comment

Sapling growing on the waterside shoulder. (Fall 2021)

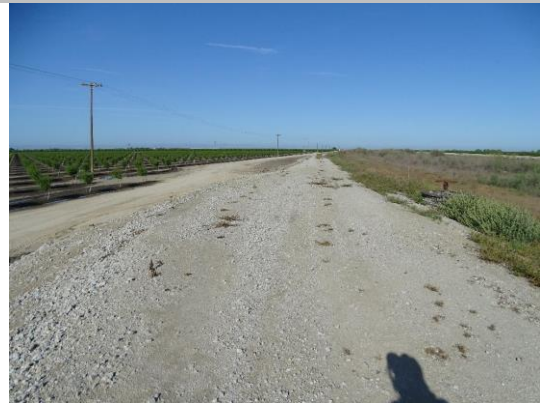
Photo 1 of 3 : UCIP_FA_2024_80596_112509.jpg

Comment Code						
Inspector Comment						
DS_ID:21531						
FS_ID:80596						
EP_NO: N/A						
Repair Type: No Action Needed						
EVAL Issue:						
Crossing Status: Found						
UCIP Comments: 04/20/2022 Record updated from Non-Urgent to No Action Needed. Sediment build up on LS has been removed since last inspection. DMP internal video inspection has not found pipe integrity issues. LOF of crossing is less or equal to 4. Recommend next video inspection in 5 years. (M.Thao - DWR UCIP 05/06/2014 Need to contact owner. Recommend removing sediment built up on landward side. (DWR UCIP - O. Magana)						
FIELD_STRUCT_DESC: 48-inch corrugated metal gravity drainage pipe through the levee, 11.5 feet below the crown. Slide gate in a 60-inch CMP riser on the waterside (WS) shoulder. Concrete headwall and wing wall on each end. Flap gate on the WS end. [Additional Reference(s): DWR Levee Log, 2005 (HLM 6.24). USACE San Joaquin O&M Manual, Unit 606. USACE As-Built Drawing No. 07-04-0085, Sheets 85/8A.1 and 85/26, Station 325+50, March 1975].

Levee crown looking downstream.

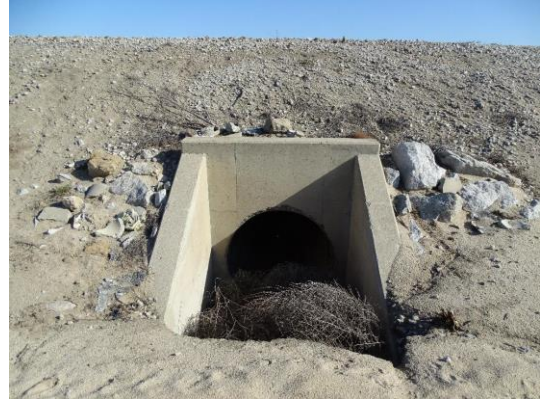
Photo 2 of 3 : UCIP_FA_2024_80596_112510.jpg

LS view: Concrete headwall and pipe inlet on toe.

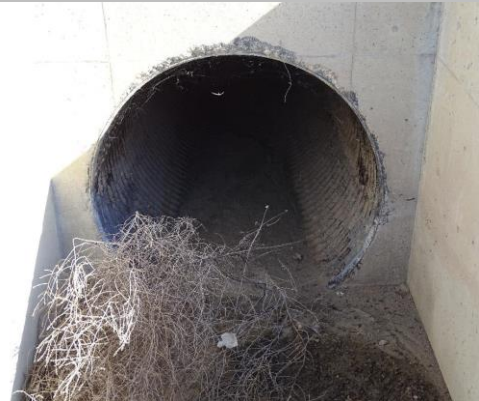
Photo 3 of 3 : UCIP_FA_2024_80596_112508.jpg

LS view: Close-up view of CMP inlet; cleared of sediment.

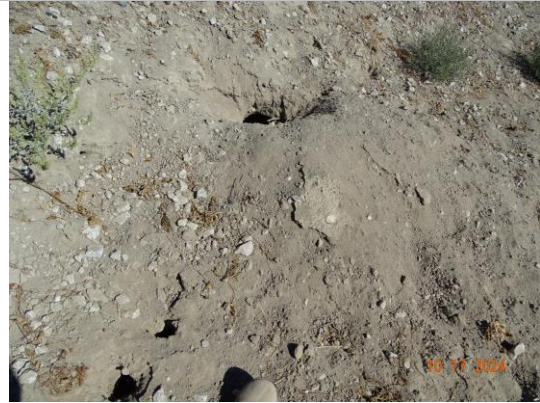
Photo 1 of 1 : FA_2024_NA0011_147_47_20241025_00040.jpg

LM Start	7.71	Rating **	M	Issue No.	47
LM End	7.94	Issue Type +	Ma	Location *	LS
Category	Earthen Levee			GPS Latitude/Longitude	
				Start	End
Item	Animal Control			36.969600°	36.971428°
				-120.234229°	-120.230728°
DWR ID	DWR_NA0011_06_f_2017_47				
Comment Code					
A3 : No rodents visible, but rodent burrows visible; need to backfill and compact or grout burrows.					
Inspector Comment

Rodent burrow with significant amount of material displaced should be backfilled and compacted. (Fall 2024)

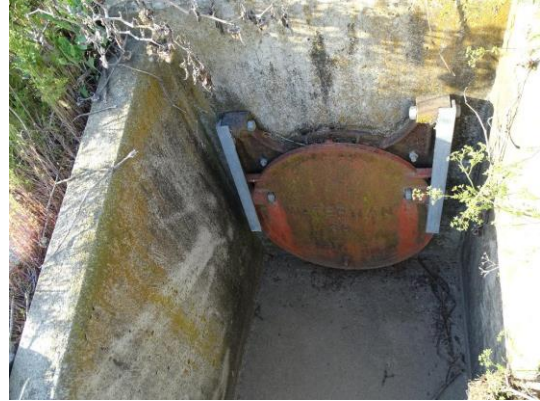
Photo 2 of 2 : UCIP_FA_2024_80595_113267.jpg

WS view: Concrete headwall and flap gate.
