**Flood Control Project Maintenance
Levee Inspections**

Maintenance Issue Types Only, Levee Inspection Report By Mile - Spring 2017

Madera County FCWCA

Waterway	Bank	Unit Miles	Inspection Start/End	Inspector
Unit No. 01 Ash Slough	Right	2.37	05/04/2017 05/04/2017	Herman Phillips

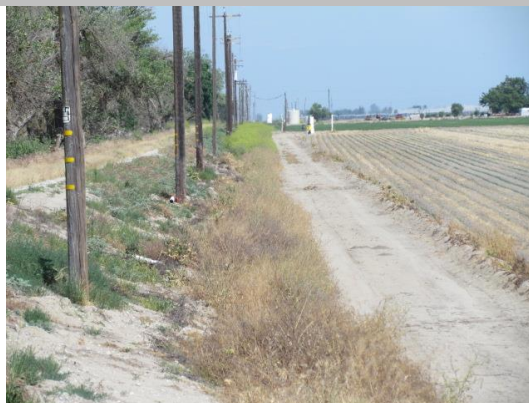
Photo 1 of 1 : SP_2017_NA0011_145_6_20170510_00019.jpg

LM Start	0.01	Rating **	U	Issue No.	6
LM End	1.50	Issue Type +	Ma	Location *	LS
Category	Earthen Levee			GPS Latitude/Longitude	
				Start	End
Item	Vegetation			36.995503 °	36.995583 °
				-120.373417 °	-120.346448 °
DWR ID	DWR_NA0011_04_s_2017_6				
Comment Code					
V1 : Control annual grass and weeds on the levee slopes and easements.					
Inspector Comment
