**Flood Control Project Maintenance
Levee Inspections**

Maintenance Issue Types Only, Levee Inspection Report By Mile - Spring 2018

Madera County FCWCA

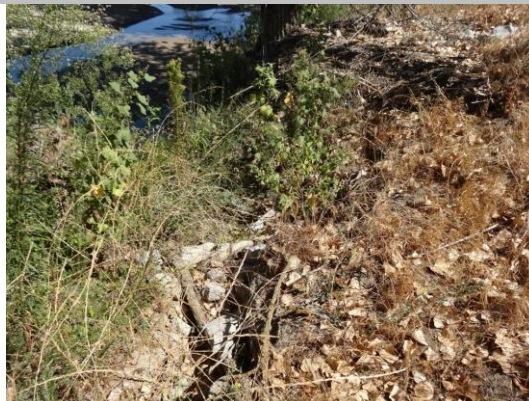
Photo 3 of 4 : SP_2018_NA0011_143_1_20180307_00003.jpg

LM Start	1.10	Rating **	U	Issue No.	1 (cont)
LM End	1.19	Issue Type +	Ma	Location *	WS

Vegetation debris at the site.

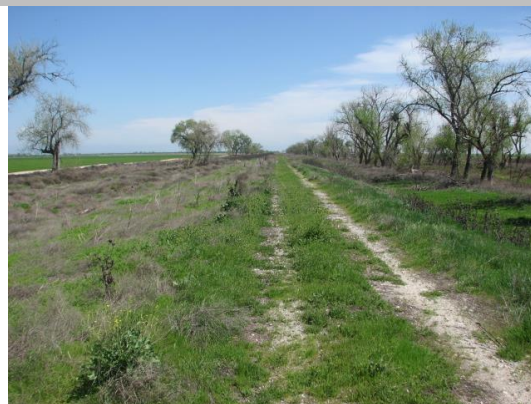
Photo 1 of 1 : SP_2018_NA0011_144_32_20180411_00020.jpg

LM Start	0.08	Rating **	M	Issue No.	32
LM End	1.51	Issue Type +	Ma	Location *	CR
Category	Earthen Levee			GPS Latitude/Longitude	
				Start	End
Item	Crown Surface / Depressions / Rutting			36.996264 °	36.996613 °
				-120.372350 °	-120.346570 °
DWR ID	DWR_NA0011_03_s_2014_32				
Comment Code					
C3 : Add appropriate gravel or road base. Grade and compact.					
Inspector Comment					
Regrade the crown for proper drainage and add more rock to crown.

Looking downstream at levee crown. (Spring 2018)

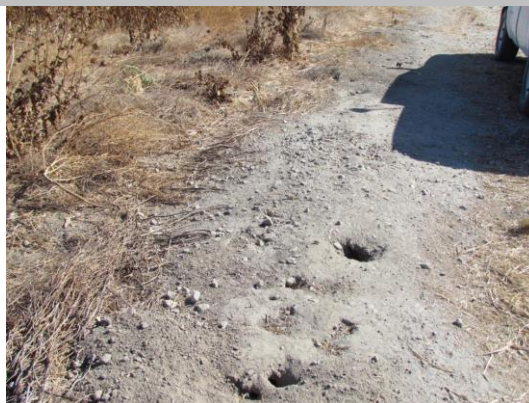
Photo 6 of 6 : SP_2018_NA0011_144_6_20180307_00003.jpg

LM Start	0.40	Rating **	U	Issue No.	6 (cont)	
LM End	1.51	Issue Type +	Ma	Location *	LS	
Category	Earthen Levee			GPS Latitude/Longitude		
				Start		End
Item	Animal Control			36.996208 °		36.996607 °
				-120.366550 °		-120.346568 °
DWR ID	DWR_NA0011_03_f_2016_6					
Comment Code						
A1 : Exterminate rodents and backfill and compact or grout burrows.						
Inspector Comment						
LMA should install rodent bait stations placed along the landside slope and or shoulder at levee miles listed. No new photo was taken. Unable to see the ground, observed rodents running across the roadway.

Berenda Slough Unit 3 levee miles 0.40-1.51 landside shoulder and slope.

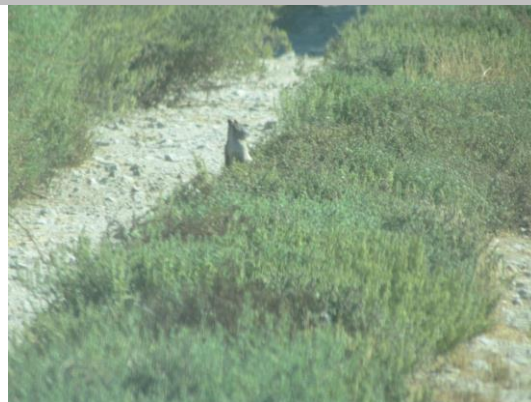
Photo 1 of 1 : SP_2018_NA0011_144_8_20180307_00006.jpg

LM Start	0.71	Rating **	M	Issue No.	8
LM End	1.51	Issue Type +	Ma	Location *	CR
Category	Earthen Levee			GPS Latitude/Longitude	
				Start	End
Item	Animal Control			36.996257 °	36.996607 °
				-120.361025 °	-120.346568 °
DWR ID	DWR_NA0011_03_f_2016_8				
Comment Code					
A1 : Exterminate rodents and backfill and compact or grout burrows.					
Inspector Comment					
Exterminate rodents from the crown roadway in the area listed. Active rodents observed during inspection at this site.

Berenda Slough Unit 3 looking upstream from levee miles 0.71 - to 1.51.

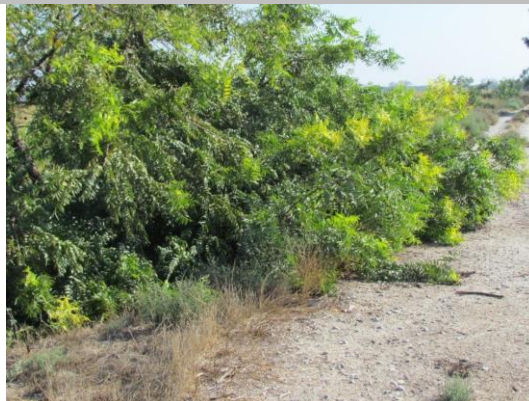
Photo 1 of 2 : SP_2018_NA0011_144_11_20180307_00008.jpg

LM Start	1.04	Rating **	U	Issue No.	11
LM End	1.05	Issue Type +	Ma	Location *	LS
Category	Earthen Levee			GPS Latitude/Longitude	
				Start	End
Item	Trim / Thin Trees			36.996613 °	36.996610 °
				-120.355055 °	-120.354995 °
DWR ID	DWR_NA0011_03_s_2012_11				
Comment Code					
T1 : Trim trees to at least five feet above ground level.					
Inspector Comment					
Take these walnuts off the levee section.

Berenda Slough Unit 3 looking upstream from levee mile 1.04-1.05 walnut trees blocking the view of the landside levee section.

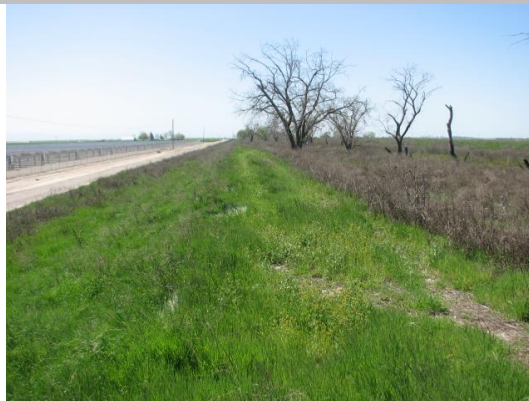
Photo 1 of 2 : SP_2018_NA0011_145_8_20180411_00019.jpg

LM Start	0.01	Rating **	U	Issue No.	8 (cont)
LM End	1.49	Issue Type +	Ma	Location *	CR

Looking upstream from 0.00 at wild growth on levee crown. (Spring 2018)

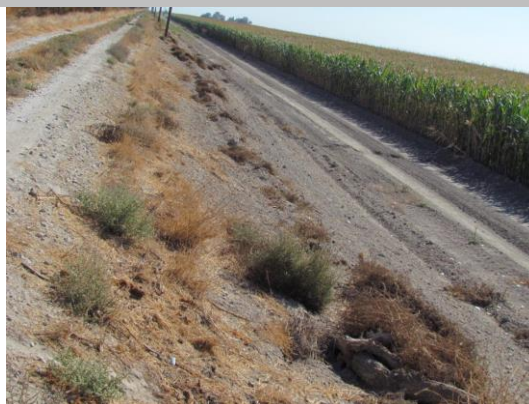
Photo 1 of 1 : SP_2018_NA0011_145_3_20180307_00001.jpg

LM Start	0.02	Rating **	U	Issue No.	3
LM End	0.97	Issue Type +	Ma	Location *	LS
Category	Earthen Levee			GPS Latitude/Longitude	
				Start	End
Item	Slope Stability			36.995506 °	36.995550 °
				-120.373233 °	-120.355935 °
DWR ID	DWR_NA0011_04_f_2016_3				
Comment Code					
S1 : Repair slope instability.					
Inspector Comment					
The slope in this area has been damaged by farm equipment on the slope.

Berenda Slough Unit 4 Looking upstream from levee mile 0.14-0.97.

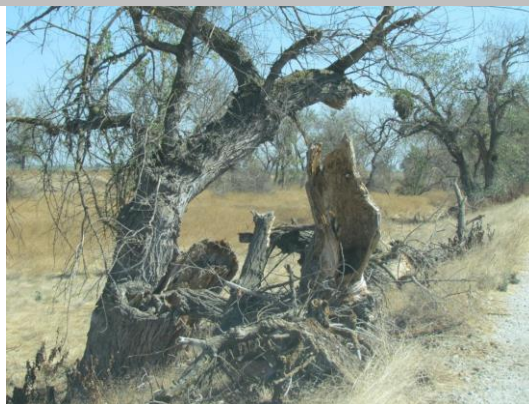
Photo 1 of 1 : SP_2018_NA0011_145_15_20180307_00012.jpg

LM Start	0.14	Rating **	U	Issue No.	15
LM End	0.14	Issue Type +	Ma	Location *	CR
Category	Earthen Levee			GPS Latitude/Longitude	
				Start	End
Item	Encroachments			36.995528 °	36.995528 °
				-120.370922 °	-120.370922 °
DWR ID	DWR_NA0011_04_f_2015_15				
Comment Code					
TR : Tree or limb					
Inspector Comment					
There are many dead trees in the area. This one happened to be blocking the crown roadway. Remove the dead trees from the levee section. Many more are subject to fall and further block access to the levee crown.

Berenda Slough looking upstream from the levee mile 0.14.

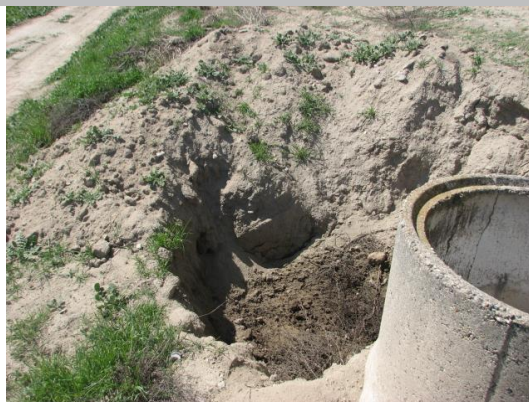
Photo 2 of 3 : SP_2018_NA0011_145_22_20180411_00023.jpg

LM Start	0.44	Rating **	U	Issue No.	22
LM End	0.44	Issue Type +	Ma	Location *	LS
Category	Earthen Levee			GPS Latitude/Longitude	
				Start	End
Item	Erosion / Bank Caving			36.995560 °	36.995560 °
				-120.365614 °	-120.365614 °
DWR ID	DWR_NA0011_04_s_2018_22				
Comment Code					
E2 : Schedule repair of erosion site prior to the next inspection.					
Inspector Comment					
Someone dug large hole on landward slope next to concrete riser. No visible pipe at the site.

LM Start	0.44	Rating **	U	Issue No.	22 (cont)
LM End	0.44	Issue Type +	Ma	Location *	LS

Looking upstream at large hole on landward slope. (Spring 2018)

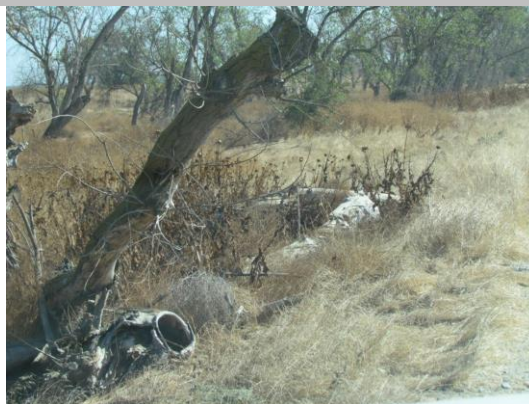
Photo 1 of 1 : SP_2018_NA0011_145_16_20180307_00013.jpg

LM Start	0.47	Rating **	U	Issue No.	16
LM End	0.47	Issue Type +	Ma	Location *	WS
Category	Earthen Levee			GPS Latitude/Longitude	
				Start	End
Item	Encroachments			36.995603 °	36.995603 °
				-120.364978 °	-120.364978 °
DWR ID	DWR_NA0011_04_s_2014_16				
Comment Code					
TR : Tree or limb					
Inspector Comment					
This dead tree on water ward slope should be removed from levee section. No change. 2017

Berenda Slough Unit 4 levee mile 0.47 looking back upstream.

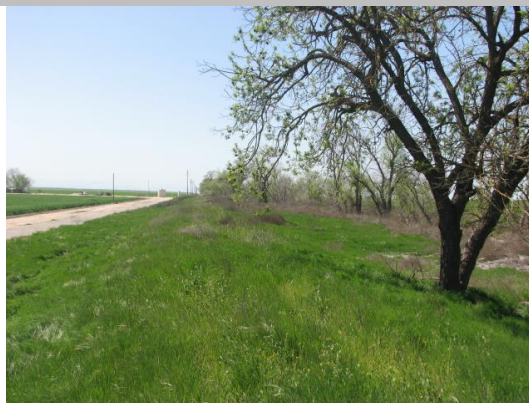
Photo 1 of 1 : SP_2018_NA0011_145_10_20180411_00026.jpg

LM Start	1.19	Rating **	U	Issue No.	10
LM End	1.19	Issue Type +	Ma	Location *	WS
Category	Earthen Levee			GPS Latitude/Longitude	
				Start	End
Item	Trim / Thin Trees			36.995566 °	36.995566 °
				-120.352038 °	-120.352038 °
DWR ID	DWR_NA0011_04_f_2017_10				
Comment Code					
T4 : Trim trees over roadway to at least 12 feet above ground level.					
Inspector Comment					
Trim branches hanging over crown inhibiting access.

Looking upstream at tree on waterward slope. (Spring 2018)

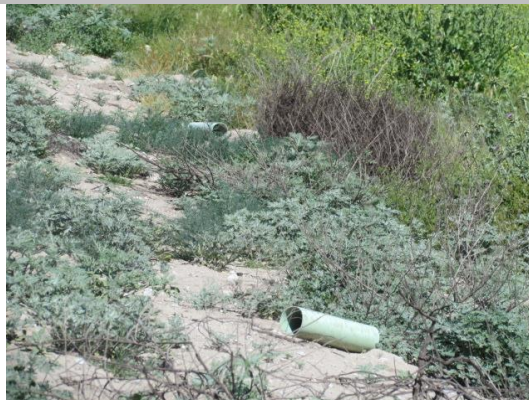
Photo 1 of 5 : SP_2018_NA0011_145_11_20180307_00004.jpg

LM Start	1.50	Rating **	U	Issue No.	11
LM End	2.28	Issue Type +	Ma	Location *	LS
Category	Earthen Levee			GPS Latitude/Longitude	
				Start	End
Item	Animal Control			36.995590 °	37.003740 °
				-120.346406 °	-120.336877 °
DWR ID	DWR_NA0011_04_f_2016_11				
Comment Code					
A1 : Exterminate rodents and backfill and compact or grout burrows.					
Inspector Comment					
Exterminate the rodents and backfill and compact or grout the burrows in this area listed.

Berenda Slough looking upstream levee mile 0.62 landward.

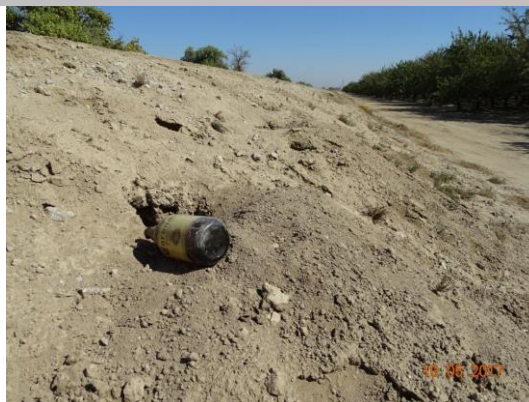
Photo 4 of 5 : SP_2018_NA0011_145_11_20180307_00007.jpg

LM Start	1.50	Rating **	U	Issue No.	11 (cont)
LM End	2.28	Issue Type +	Ma	Location *	LS

Rodent activity at LM 2.27.

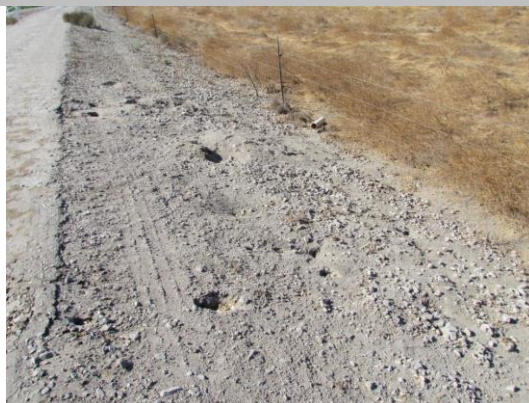
Photo 1 of 1 : SP_2018_NA0011_145_30_20180307_00014.jpg

LM Start	1.50	Rating **	U	Issue No.	30
LM End	2.28	Issue Type +	Ma	Location *	WS
Category	Earthen Levee			GPS Latitude/Longitude	
				Start	End
Item	Animal Control			36.995590 °	37.003740 °
				-120.346406 °	-120.336877 °
DWR ID	DWR_NA0011_04_f_2014_30				
Comment Code					
A1 : Exterminate rodents and backfill and compact or grout burrows.					
Inspector Comment					
Bait stations are needed in Rodent infested area waterside slope and toe. No new photo.

Berenda Slough levee mile 1.63-2.23 looking upstream at waterside slope.

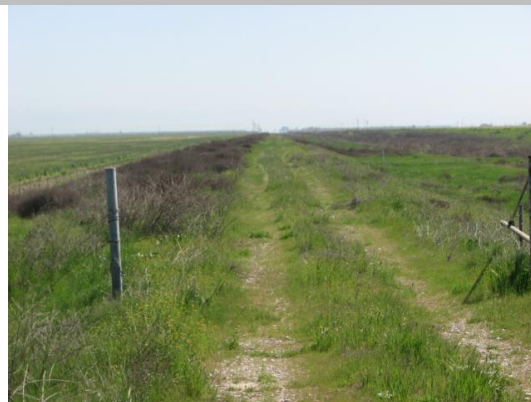
Photo 1 of 1 : SP_2018_NA0011_146_13_20180411_00020.jpg

LM Start	0.00	Rating **	M	Issue No.	13
LM End	4.05	Issue Type +	Ma	Location *	CR
Category	Earthen Levee			GPS Latitude/Longitude	
				Start	End
Item	Crown Surface / Depressions / Rutting			36.978548 °	36.968165 °
				-120.368454 °	-120.301151 °
DWR ID	DWR_NA0011_05_s_2012_13				
Comment Code					
C1 : Add appropriate material and re-grade the levee to bring the crown above the design elevation.					
Inspector Comment					
Regrade the crown for proper drainage. And add appropriate gravel or road base.

Looking downstream at levee crown from 0.00. (Spring 2018)

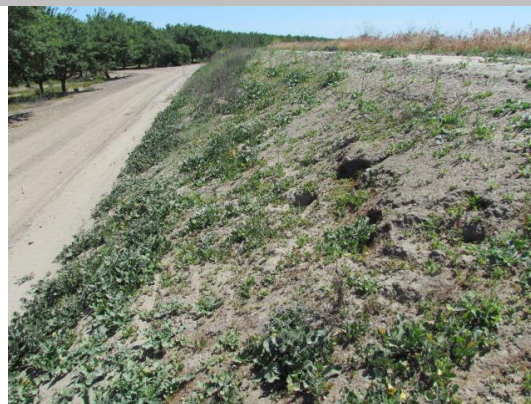
Photo 1 of 1 : SP_2018_NA0011_146_28_20180307_00009.jpg

LM Start	6.75	Rating **	U	Issue No.	28
LM End	6.95	Issue Type +	Ma	Location *	LS
Category	Earthen Levee			GPS Latitude/Longitude	
				Start	End
Item	Animal Control			36.969200 °	36.969507 °
				-120.252462 °	-120.248893 °
DWR ID	DWR_NA0011_05_f_2016_28				
Comment Code					
A1 : Exterminate rodents and backfill and compact or grout burrows.					
Inspector Comment					
Exterminate the rodents in the area listed and place bait stations along the shoulder and or slope.

Fresno River landside levee slope levee mile 6.75-6.95.

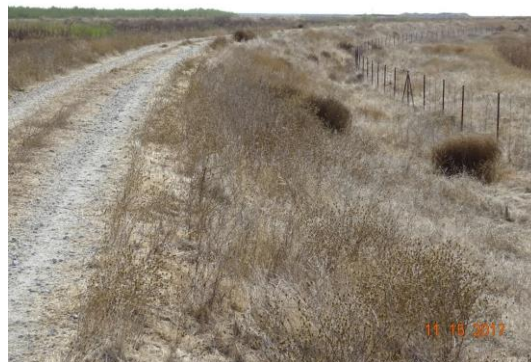
Photo 1 of 1 : SP_2018_NA0011_147_15_20180307_00004.jpg

LM Start	0.01	Rating **	M	Issue No.	15
LM End	0.99	Issue Type +	Ma	Location *	LS
Category	Earthen Levee			GPS Latitude/Longitude	
				Start	End
Item	Vegetation			36.976937 °	36.968862 °
				-120.367310 °	-120.354232 °
DWR ID	DWR_NA0011_06_f_2017_15				
Comment Code					
V1 : Control annual grass and weeds on the levee slopes and easements.					
Inspector Comment

Landside vegetation should be managed to allow inspection and access.

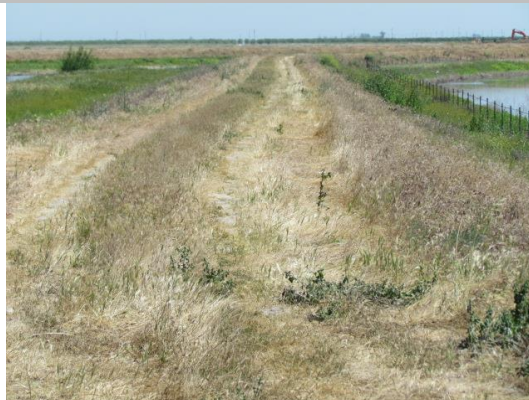
Photo 1 of 1 : SP_2018_NA0011_147_12_20180307_00003.jpg

LM Start	0.01	Rating **	M	Issue No.	12
LM End	1.02	Issue Type +	Ma	Location *	CR
Category	Earthen Levee			GPS Latitude/Longitude	
				Start	End
Item	Vegetation			36.976960 °	36.968529 °
				-120.367233 °	-120.354011 °
DWR ID	DWR_NA0011_06_s_2017_12				
Comment Code					
V9 : Keep the crown roadway free of vegetation.					
Inspector Comment					
Keep the crown roadway free of vegetation.

Fresno River looking upstream from levee mile 0.01 to 0.95.

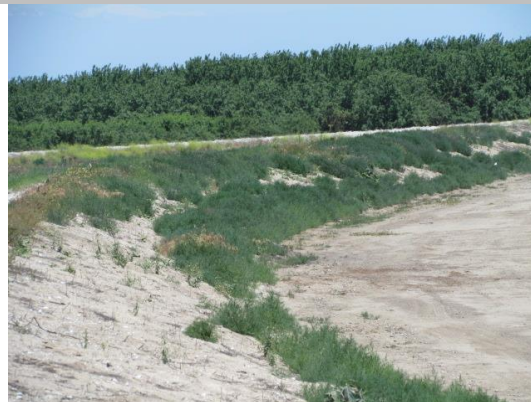
Photo 1 of 1 : SP_2018_NA0011_147_29_20180307_00010.jpg

LM Start	7.70	Rating **	M	Issue No.	29
LM End	8.52	Issue Type +	Ma	Location *	LS
Category	Earthen Levee			GPS Latitude/Longitude	
				Start	End
Item	Vegetation			36.969591 °	36.971509 °
				-120.234235 °	-120.220438 °
DWR ID	DWR_NA0011_06_s_2017_29				
Comment Code					
V2 : Remove the wild growth other than native grasses from the levee slopes.					
Inspector Comment					
Remove the wild growth from the landside slope.

Fresno River landside levee mile 7.71-8.59.

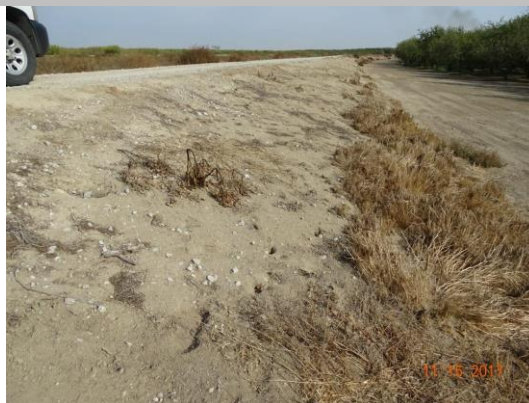
Photo 1 of 1 : SP_2018_NA0011_147_47_20180307_00018.jpg

LM Start	7.71	Rating **	U	Issue No.	47
LM End	8.52	Issue Type +	Ma	Location *	LS
Category	Earthen Levee			GPS Latitude/Longitude	
				Start	End
Item	Animal Control			36.969600 °	36.971509 °
				-120.234229 °	-120.220438 °
DWR ID	DWR_NA0011_06_f_2017_47				
Comment Code					
A3 : No rodents visible, but rodent burrows visible; need to backfill and compact or grout burrows.					
Inspector Comment

Bait traps should be maintained and rodent holes should be backfilled.

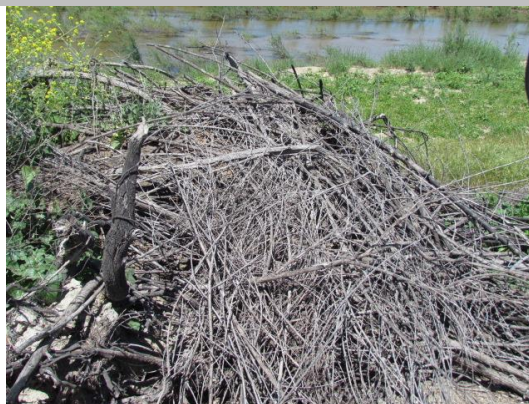
Photo 1 of 1 : SP_2018_NA0011_147_32_20180307_00012.jpg

LM Start	7.96	Rating **	M	Issue No.	32
LM End	7.96	Issue Type +	Ma	Location *	WS
Category	Earthen Levee			GPS Latitude/Longitude	
				Start	End
Item	Encroachments			36.971543 °	36.971543 °
				-120.230285 °	-120.230285 °
DWR ID	DWR_NA0011_06_s_2017_32				
Comment Code					
PR : Prunings					
Inspector Comment					
Remove the brush pile from the levee slope. This pile is providing habitat for rodents.

Fresno River waterside levee mile 7.96.

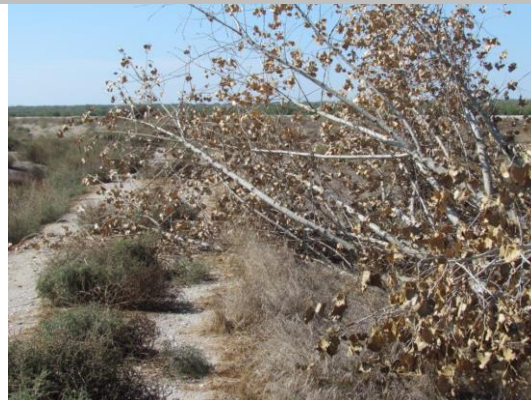
Photo 1 of 2 : SP_2018_NA0011_147_36_20180307_00014.jpg

LM Start	8.03	Rating **	M	Issue No.	36
LM End	8.03	Issue Type +	Ma	Location *	WS
Category	Earthen Levee			GPS Latitude/Longitude	
				Start	End
Item	Encroachments			36.971582 °	36.971582 °
				-120.229180 °	-120.229180 °
DWR ID	DWR_NA0011_06_f_2015_36				
Comment Code					
TR : Tree or limb					
Inspector Comment					
The dead tree has been removed from blocking the roadway but still need to be removed from the levee section.

Dead tree pushed upon the waterside slope and blocking the crown.

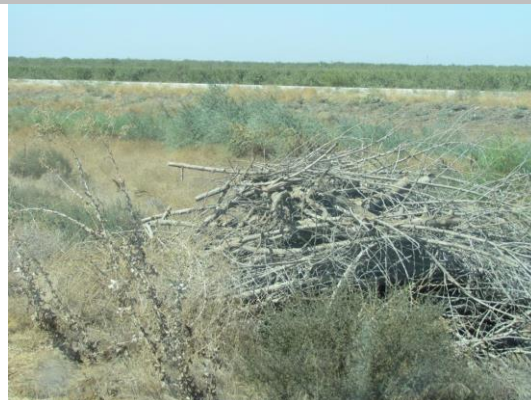
Photo 2 of 2 : SP_2018_NA0011_147_36_20180307_00015.jpg

LM Start	8.03	Rating **	M	Issue No.	36 (cont)
LM End	8.03	Issue Type +	Ma	Location *	WS

Fresno River levee mile 8.03 waterside slope and shoulder.
