**Flood Control Project Maintenance
Levee Inspections**

Maintenance Issue Types Only, Levee Inspection Report By Mile - Spring 2019

Madera County FCWCA

Waterway	Bank	Unit Miles	Inspection Start/End	Inspector
Unit No. 01 Ash Slough	Right	2.37	05/09/2019 05/09/2019	Corey Fujitani

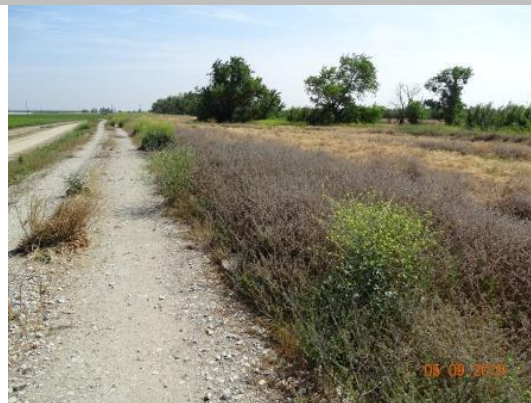
Photo 1 of 1 : SP_2019_NA0011_142_33_20190513_00035.jpg

LM Start	1.73	Rating **	U	Issue No.	33
LM End	2.35	Issue Type +	Ma	Location *	WS
Category	Earthen Levee			GPS Latitude/Longitude	
				Start	End
Item	Vegetation			37.061654 °	37.068526 °
				-120.405154 °	-120.398645 °
DWR ID	DWR_NA0011_01_s_2019_33				
Comment Code					
V1 : Control annual grass and weeds on the levee slopes and easements.					
Inspector Comment

View of waterside slope looking upstream. (Spring 2019)

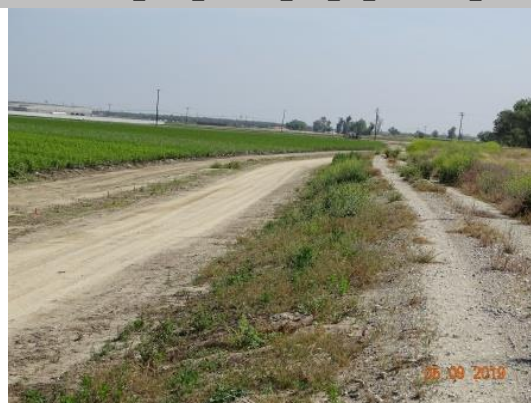
Photo 1 of 1 : SP_2019_NA0011_142_34_20190513_00036.jpg

LM Start	1.75	Rating **	M	Issue No.	34
LM End	1.84	Issue Type +	Ma	Location *	LS
Category	Earthen Levee			GPS Latitude/Longitude	
				Start	End
Item	Vegetation			37.061913 °	37.062881 °
				-120.404827 °	-120.403836 °
DWR ID	DWR_NA0011_01_s_2019_34				
Comment Code					
V1 : Control annual grass and weeds on the levee slopes and easements.					
Inspector Comment

View along landside slope looking upstream. (Spring 2019)

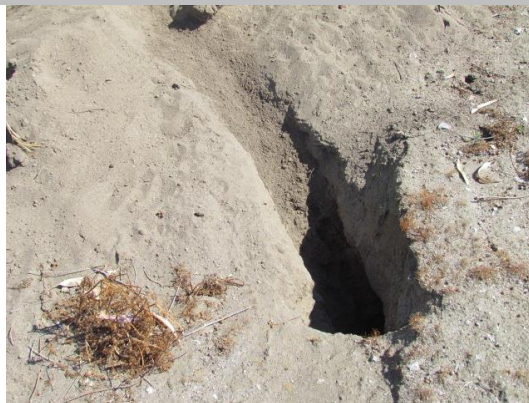
Photo 1 of 2 : SP_2019_NA0011_143_39_20190307_00030.jpg

LM Start	0.00	Rating **	U	Issue No.	39
LM End	1.67	Issue Type +	Ma	Location *	WS
Category	Earthen Levee			GPS Latitude/Longitude	
				Start	End
Item	Animal Control			37.045485 °	37.060091 °
				-120.427423 °	-120.405340 °
DWR ID	DWR_NA0011_02_f_2015_39				
Comment Code					
A1 : Exterminate rodents and backfill and compact or grout burrows.					
Inspector Comment					
The levee section waterside is covered with rodent holes.

Active rodents spotted in the area waterside slope levee mile 0.00- 1.67.

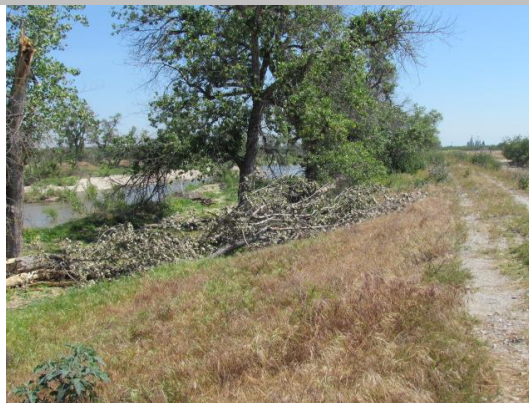
Photo 1 of 1 : SP_2019_NA0011_143_33_20190307_00026.jpg

LM Start	0.33	Rating **	U	Issue No.	33
LM End	0.42	Issue Type +	Ma	Location *	WS
Category	Earthen Levee			GPS Latitude/Longitude	
				Start	End
Item	Encroachments			37.047485 °	37.048403 °
				-120.422037 °	-120.420810 °
DWR ID	DWR_NA0011_02_s_2017_33				
Comment Code					
TR : Tree or limb					
Inspector Comment					
Remove the dead fallen trees from the water side slope.

Dead fallen trees on the waterside levee slope and shoulder.

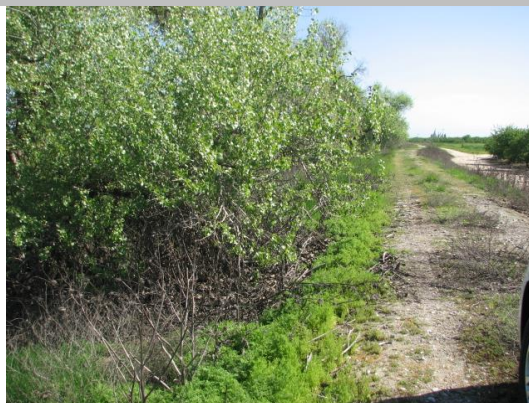
Photo 1 of 1 : SP_2019_NA0011_143_14_20190307_00011.jpg

LM Start	0.35	Rating **	M	Issue No.	14
LM End	0.41	Issue Type +	Ma	Location *	WS
Category	Earthen Levee			GPS Latitude/Longitude	
				Start	End
Item	Trim / Thin Trees			37.047653 °	37.048304 °
				-120.421813 °	-120.420967 °
DWR ID	DWR_NA0011_02_f_2017_14				
Comment Code					
T1 : Trim trees to at least five feet above ground level.					
Inspector Comment					
Waterside tree branches hanging over crown interfere with crown access and waterside visibility.

Looking downstream at untrimmed tree on waterward shoulder and slope. (Spring 2018)

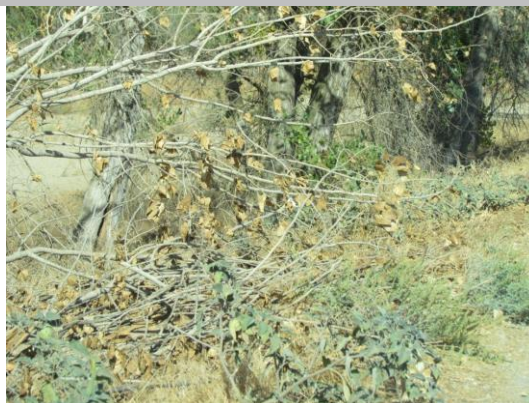
Photo 1 of 2 : SP_2019_NA0011_143_27_20190307_00020.jpg

LM Start	0.98	Rating **	U	Issue No.	27
LM End	1.52	Issue Type +	Ma	Location *	WS
Category	Earthen Levee			GPS Latitude/Longitude	
				Start	End
Item	Encroachments			37.054928 °	37.058752 °
				-120.415482 °	-120.407323 °
DWR ID	DWR_NA0011_02_s_2017_27				
Comment Code					
TR : Tree or limb					
Inspector Comment					
Remove the dead trees from the waterside slope and shoulder.

Levee slope and shoulder looking upstream waterside levee section.

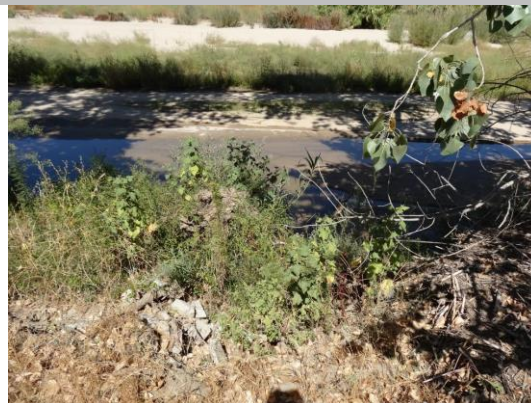
Photo 1 of 4 : SP_2019_NA0011_143_1_20190307_00001.jpg

Comment Code					
Inspector Comment					
09/20/2017: No significant change observed.					
07/22/2016: No significant change observed.					
09/08/2015: No significant change observed.					
07/22/2014: No significant change observed.					
08/30/2013: No significant change observed.					
07/31/2012: Site was visited on 07/24/2012. No significant change observed. Dense vegetation around the site					
08/09/2011: Site was inspected. No visible change was observed from the previous condition. A fallen tree was seen at the levee toe about 20 feet upstream, and tree root exposed. There has been no report from the district that this site was corrected.					
11/30/2010: Site was not inspected due to time constraints. There have been no reports from the district that the site was corrected. Continue to monitor site during flood events.					
08/05/2010: Recommended for annual assessment and monitoring during flood events, per CLRO.

2009: Site is recommended as a local maintenance issue, per Critical Levee Repair Office, Critical Erosion Sites Evaluation 2008 Report; site was previously rated "M"					
9/6/2007: Undercutting of the toe; several trees along the WS slope with roots exposed. [2017 Site ID:NA0011U02RM2.57]

View of the erosion site from the levee crest.

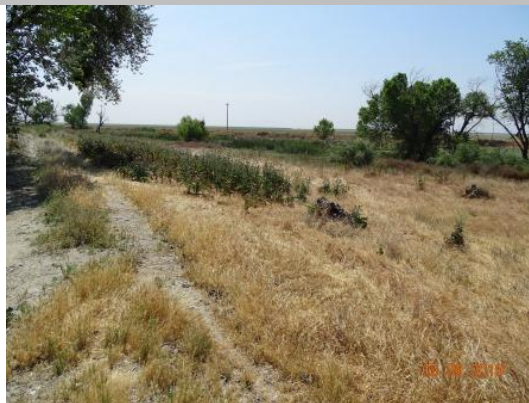
Photo 1 of 1 : SP_2019_NA0011_144_13_20190514_00029.jpg

LM Start	0.01	Rating **	U	Issue No.	13
LM End	1.51	Issue Type +	Ma	Location *	WS
Category	Earthen Levee			GPS Latitude/Longitude	
				Start	End
Item	Vegetation			36.996594 °	36.996602 °
				-120.373546 °	-120.346627 °
DWR ID	DWR_NA0011_03_s_2019_13				
Comment Code					
V1 : Control annual grass and weeds on the levee slopes and easements.					
Inspector Comment

View of waterside slope looking upstream. (Spring 2019)

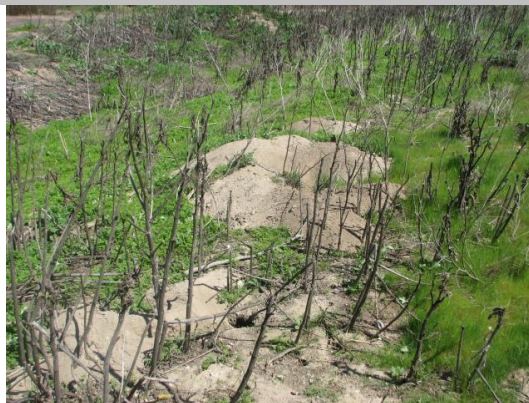
Photo 2 of 6 : SP_2019_NA0011_144_6_20190307_00006.jpg

Looking at typical rodent holes within this section (Spring 2018)

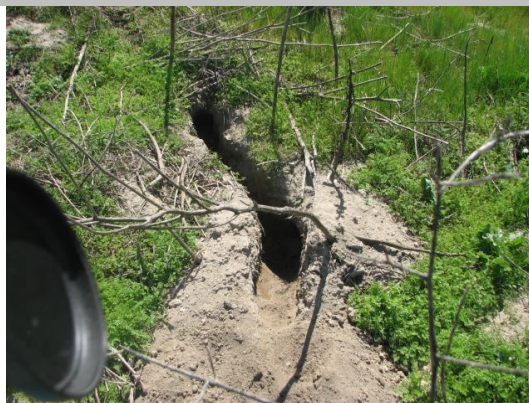
Photo 3 of 6 : SP_2019_NA0011_144_6_20190307_00007.jpg

Looking at rodent hole on landward slope. (Spring 2018)

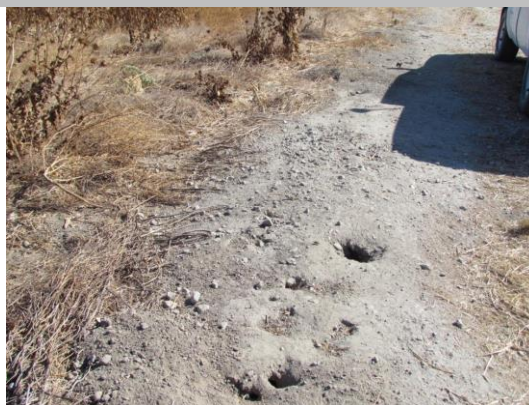
Photo 6 of 6 : SP_2019_NA0011_144_6_20190307_00010.jpg

Berenda Slough Unit 3 landside shoulder and slope.

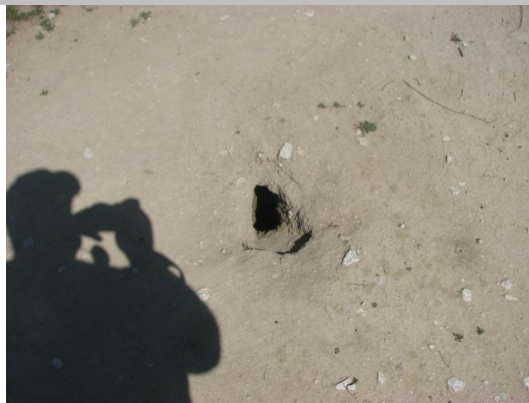
Photo 1 of 1 : SP_2019_NA0011_144_5_20190307_00004.jpg

LM Start	0.46	Rating **	U	Issue No.	5
LM End	0.46	Issue Type +	Ma	Location *	CR
Category	Earthen Levee			GPS Latitude/Longitude	
				Start	End
Item	Animal Control			36.996238 °	36.996238 °
				-120.365563 °	-120.365563 °
DWR ID	DWR_NA0011_03_s_2018_5				
Comment Code					
A3 : No rodents visible, but rodent burrows visible; need to backfill and compact or grout burrows.					
Inspector Comment					
There is a large rodent hole on the crown of the levee.

Looking at rodent hole on levee crown. (Spring 2018)

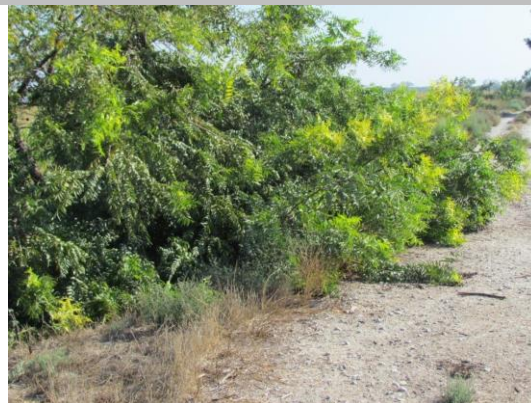
Photo 1 of 1 : SP_2019_NA0011_144_11_20190307_00015.jpg

LM Start	1.04	Rating **	U	Issue No.	11
LM End	1.05	Issue Type +	Ma	Location *	LS
Category	Earthen Levee			GPS Latitude/Longitude	
				Start	End
Item	Trim / Thin Trees			36.996613 °	36.996610 °
				-120.355055 °	-120.354995 °
DWR ID	DWR_NA0011_03_s_2012_11				
Comment Code					
T1 : Trim trees to at least five feet above ground level.					
Inspector Comment					
Remove nut tree from the slope.

Walnut trees blocking the view of the landside levee section.

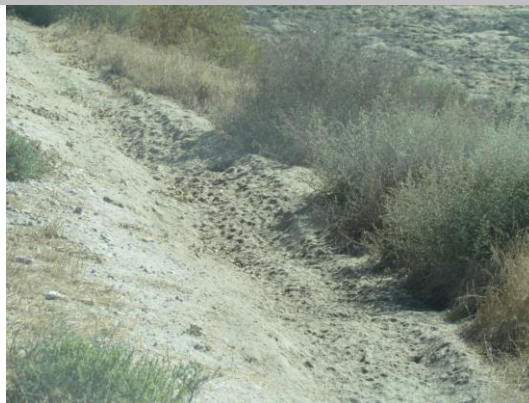
Photo 1 of 1 : SP_2019_NA0011_144_4_20190307_00003.jpg

LM Start	1.24	Rating **	M	Issue No.	4
LM End	1.25	Issue Type +	Ma	Location *	CR
Category	Earthen Levee			GPS Latitude/Longitude	
				Start	End
Item	Slope Stability			36.996582 °	36.996582 °
				-120.351482 °	-120.351258 °
DWR ID	DWR_NA0011_03_f_2016_4				
Comment Code					
S1 : Repair slope instability.					
Inspector Comment					
Repair the slope instability and damaged shoulder at this location.

Berenda Slough looking back upstream waterside at the shoulder and slope.

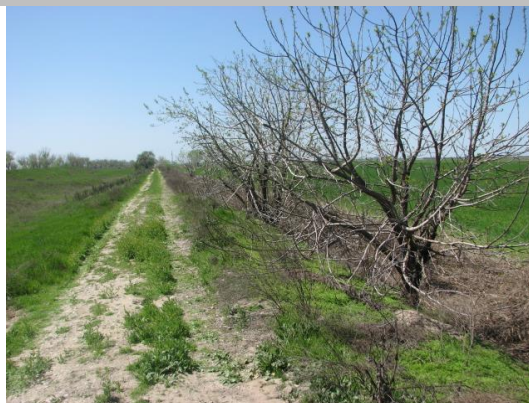
Photo 1 of 2 : SP_2019_NA0011_144_17_20190307_00018.jpg

LM Start	1.24	Rating **	U	Issue No.	17
LM End	1.29	Issue Type +	Ma	Location *	LS
Category	Earthen Levee			GPS Latitude/Longitude	
				Start	End
Item	Trim / Thin Trees			36.996632 °	36.996600 °
				-120.351463 °	-120.350539 °
DWR ID	DWR_NA0011_03_s_2012_17				
Comment Code					
T2 : Thin trees to allow visibility of the ground and room to flood fight.					
Inspector Comment					
Remove nut trees from the landside slope.

Looking at cluster of walnut trees on landward slope. (Spring 2018)

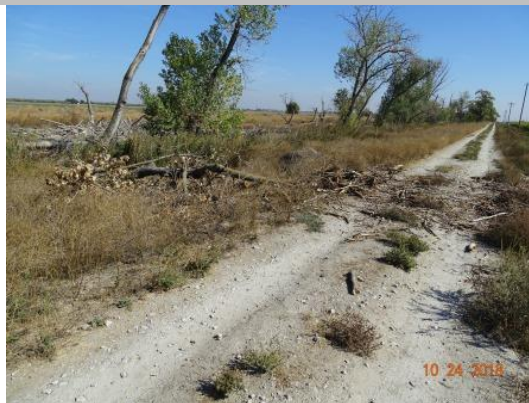
Photo 1 of 1 : SP_2019_NA0011_145_31_20190307_00024.jpg

LM Start	0.75	Rating **	M	Issue No.	31
LM End	0.75	Issue Type +	Ma	Location *	CR
Category	Earthen Levee			GPS Latitude/Longitude	
				Start	End
Item	Encroachments			36.995582 °	36.995582 °
				-120.360028 °	-120.360028 °
DWR ID	DWR_NA0011_04_f_2018_31				
Comment Code					
TR : Tree or limb					
Inspector Comment

Tree branches strewn across levee crown and both shoulders. (Fall 2018)

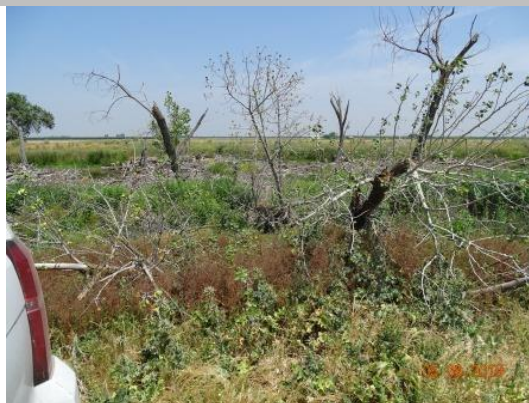
Photo 1 of 1 : SP_2019_NA0011_145_6_20190514_00033.jpg

LM Start	0.78	Rating **	U	Issue No.	6
LM End	0.78	Issue Type +	Ma	Location *	WS
Category	Earthen Levee			GPS Latitude/Longitude	
				Start	End
Item	Encroachments			36.995582 °	36.995582 °
				-120.359451 °	-120.359451 °
DWR ID	DWR_NA0011_04_s_2019_6				
Comment Code					
TR : Tree or limb					
Inspector Comment

View of fallen tree on waterside slope. (Spring 2019)

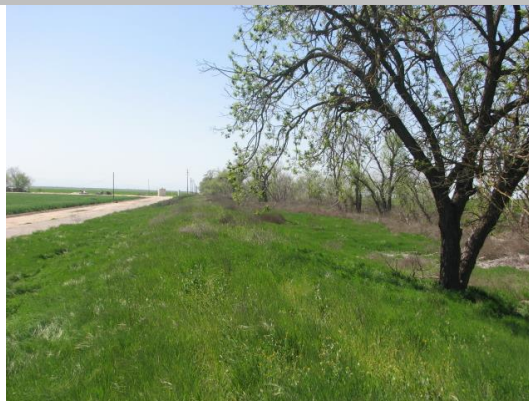
Photo 1 of 1 : SP_2019_NA0011_145_10_20190307_00007.jpg

LM Start	1.19	Rating **	U	Issue No.	10
LM End	1.19	Issue Type +	Ma	Location *	WS
Category	Earthen Levee			GPS Latitude/Longitude	
				Start	End
Item	Trim / Thin Trees			36.995566 °	36.995566 °
				-120.352038 °	-120.352038 °
DWR ID	DWR_NA0011_04_f_2017_10				
Comment Code					
T4 : Trim trees over roadway to at least 12 feet above ground level.					
Inspector Comment

Looking upstream at tree on waterward slope. (Spring 2018)

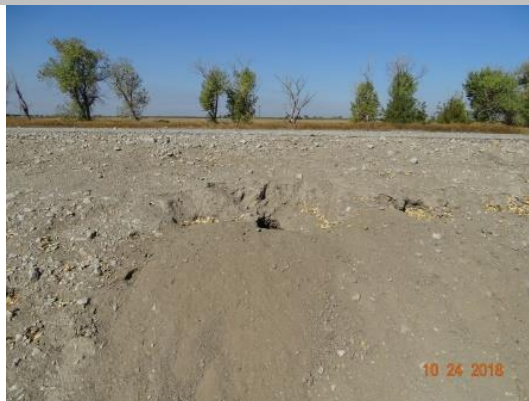
Photo 1 of 2 : SP_2019_NA0011_145_11_20190307_00008.jpg

LM Start	1.50	Rating **	U	Issue No.	11
LM End	2.28	Issue Type +	Ma	Location *	LS
Category	Earthen Levee			GPS Latitude/Longitude	
				Start	End
Item	Animal Control			36.995590 °	37.003740 °
				-120.346406 °	-120.336877 °
DWR ID	DWR_NA0011_04_f_2016_11				
Comment Code					
A1 : Exterminate rodents and backfill and compact or grout burrows.					
Inspector Comment					
Exterminate the rodents and backfill and compact the burrows or grout the burrows in this area.

Large rodent holes along this section. (Fall 2018)

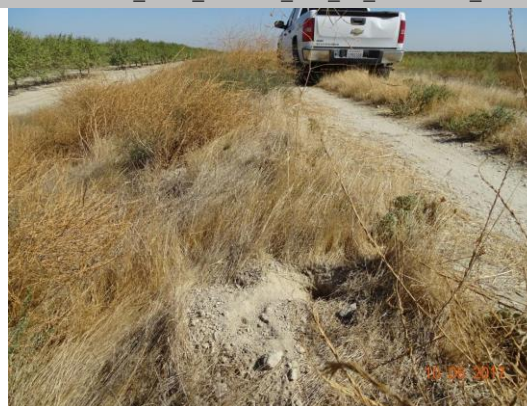
Photo 1 of 1 : SP_2019_NA0011_146_14_20190307_00007.jpg

LM Start	0.00	Rating **	M	Issue No.	14
LM End	4.05	Issue Type +	Ma	Location *	LS
Category	Earthen Levee			GPS Latitude/Longitude	
				Start	End
Item	Animal Control			36.978520 °	36.968168 °
				-120.368567 °	-120.301035 °
DWR ID	DWR_NA0011_05_f_2016_14				
Comment Code					
A1 : Exterminate rodents and backfill and compact or grout burrows.					
Inspector Comment					
Exterminate the rodents along the landside slope and toe throughout the area to levee mile 4.05. Bait stations are needed in infested areas.

Rodent activity on landside slope.

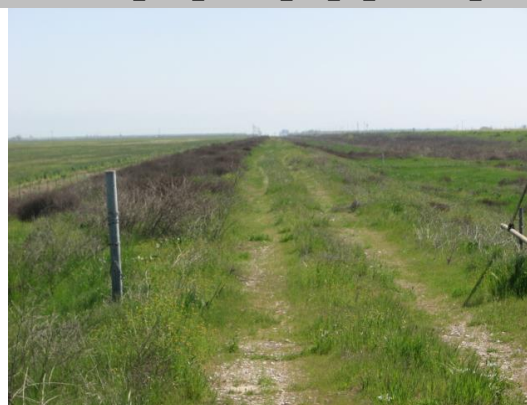
Photo 1 of 1 : SP_2019_NA0011_146_13_20190307_00006.jpg

LM Start	0.00	Rating **	M	Issue No.	13
LM End	4.05	Issue Type +	Ma	Location *	CR
Category	Earthen Levee			GPS Latitude/Longitude	
				Start	End
Item	Crown Surface / Depressions / Rutting			36.978548 °	36.968165 °
				-120.368454 °	-120.301151 °
DWR ID	DWR_NA0011_05_s_2012_13				
Comment Code					
C1 : Add appropriate material and re-grade the levee to bring the crown above the design elevation.					
Inspector Comment					
Regrade the crown for proper drainage. And add appropriate gravel or road base.

Looking downstream at levee crown from 0.00. (Spring 2018)

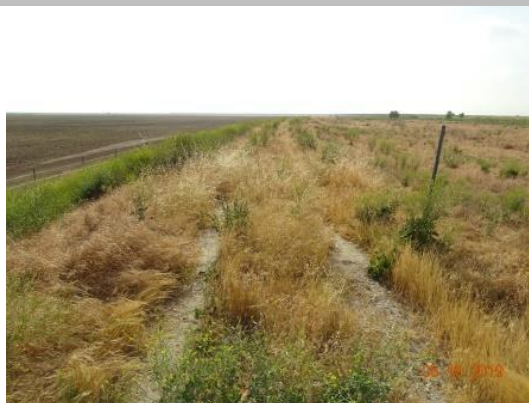
Photo 1 of 1 : SP_2019_NA0011_146_42_20190514_00032.jpg

LM Start	0.04	Rating **	U	Issue No.	42
LM End	4.06	Issue Type +	Ma	Location *	CR
Category	Earthen Levee			GPS Latitude/Longitude	
				Start	End
Item	Vegetation			36.978511 °	36.968173 °
				-120.367758 °	-120.300901 °
DWR ID	DWR_NA0011_05_s_2019_42				
Comment Code					
V9 : Keep the crown roadway free of vegetation.					
Inspector Comment

View of levee crown looking downstream. (Spring 2019)

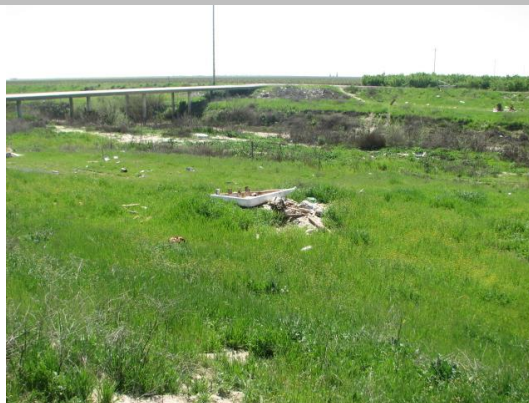
Photo 1 of 1 : SP_2019_NA0011_146_19_20190307_00011.jpg

LM Start	2.50	Rating **	M	Issue No.	19
LM End	2.50	Issue Type +	Ma	Location *	WS
Category	Rivers, Channels & Designated Floodways			GPS Latitude/Longitude	
				Start	End
Item	Encroachments			36.967990 °	36.967990 °
				-120.329131 °	-120.329131 °
DWR ID	DWR_NA0011_05_s_2012_19				
Comment Code					
Inspector Comment					
Trash in channel.

Looking west at garbage in channel. (Spring 2018)

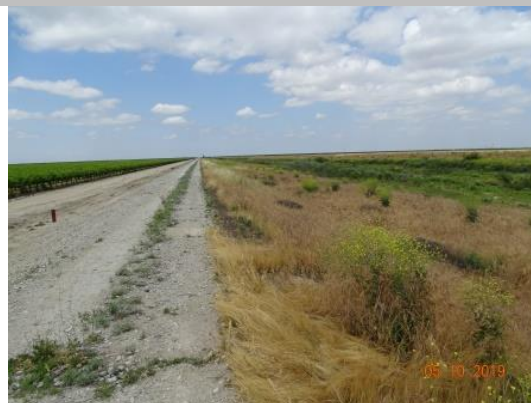
Photo 1 of 1 : SP_2019_NA0011_147_80_20190514_00060.jpg

LM Start	2.46	Rating **	U	Issue No.	80
LM End	3.48	Issue Type +	Ma	Location *	WS
Category	Earthen Levee			GPS Latitude/Longitude	
				Start	End
Item	Vegetation			36.967233 °	36.967369 °
				-120.328568 °	-120.310239 °
DWR ID	DWR_NA0011_06_s_2019_80				
Comment Code					
V1 : Control annual grass and weeds on the levee slopes and easements.					
Inspector Comment

View of vegetation on waterside slope looking downstream. (Spring 2019)

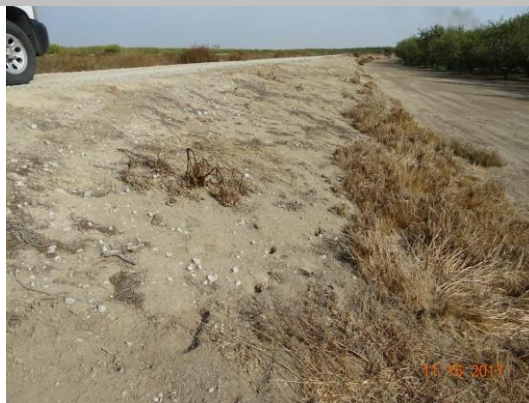
Photo 1 of 1 : SP_2019_NA0011_147_47_20190307_00023.jpg

LM Start	7.71	Rating **	M	Issue No.	47
LM End	8.52	Issue Type +	Ma	Location *	LS
Category	Earthen Levee			GPS Latitude/Longitude	
				Start	End
Item	Animal Control			36.969600 °	36.971509 °
				-120.234229 °	-120.220438 °
DWR ID	DWR_NA0011_06_f_2017_47				
Comment Code					
A3 : No rodents visible, but rodent burrows visible; need to backfill and compact or grout burrows.					
Inspector Comment

Bait traps should be maintained and rodent holes should be backfilled.

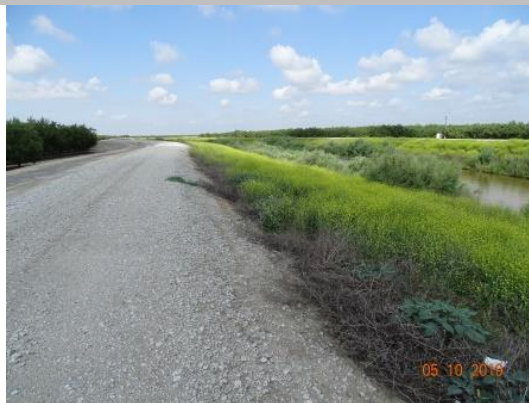
Photo 1 of 1 : SP_2019_NA0011_147_16_20190514_00063.jpg

LM Start	7.95	Rating **	U	Issue No.	16
LM End	9.01	Issue Type +	Ma	Location *	WS
Category	Earthen Levee			GPS Latitude/Longitude	
				Start	End
Item	Vegetation			36.971498 °	36.972571 °
				-120.230503 °	-120.211912 °
DWR ID	DWR_NA0011_06_s_2019_16				
Comment Code					
V1 : Control annual grass and weeds on the levee slopes and easements.					
Inspector Comment

View along the waterside slope looking downstream. (Spring 2019)

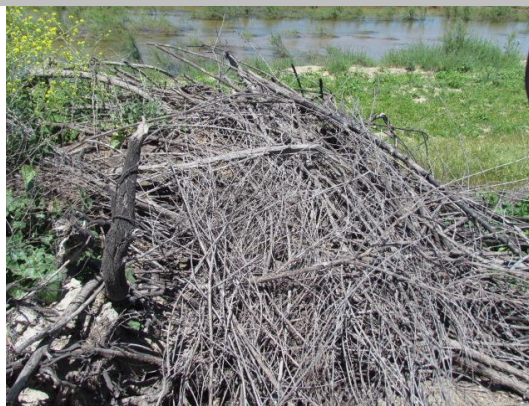
Photo 1 of 1 : SP_2019_NA0011_147_32_20190307_00016.jpg

LM Start	7.96	Rating **	M	Issue No.	32
LM End	7.96	Issue Type +	Ma	Location *	WS
Category	Earthen Levee			GPS Latitude/Longitude	
				Start	End
Item	Encroachments			36.971543 °	36.971543 °
				-120.230285 °	-120.230285 °
DWR ID	DWR_NA0011_06_s_2017_32				
Comment Code					
PR : Prunings					
Inspector Comment					
Remove the brush pile from the levee slope. This pile is providing habitat for rodents.

Fresno River waterside levee mile 7.96.

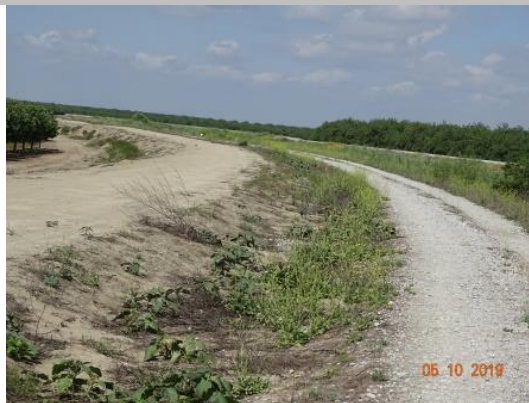
Photo 1 of 1 : SP_2019_NA0011_147_45_20190514_00065.jpg

LM Start	8.01	Rating **	M	Issue No.	45
LM End	8.39	Issue Type +	Ma	Location *	LS
Category	Earthen Levee			GPS Latitude/Longitude	
				Start	End
Item	Vegetation			36.971629 °	36.972212 °
				-120.229491 °	-120.222607 °
DWR ID	DWR_NA0011_06_s_2019_45				
Comment Code					
V1 : Control annual grass and weeds on the levee slopes and easements.					
Inspector Comment

View of the landside slope looking downstream. (Spring 2019)

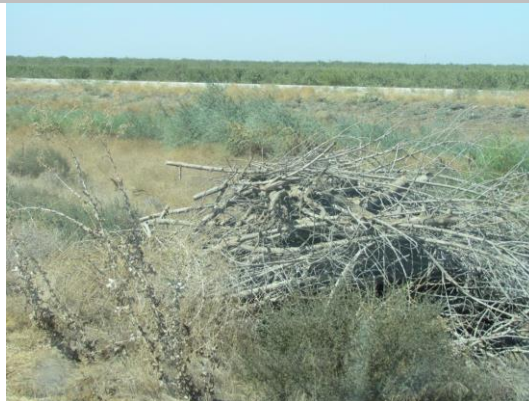
Photo 2 of 2 : SP_2019_NA0011_147_36_20190307_00019.jpg

LM Start	8.03	Rating **	M	Issue No.	36
LM End	8.03	Issue Type +	Ma	Location *	WS
Category	Earthen Levee			GPS Latitude/Longitude	
				Start	End
Item	Encroachments			36.971582 °	36.971582 °
				-120.229180 °	-120.229180 °
DWR ID	DWR_NA0011_06_f_2015_36				
Comment Code					
TR : Tree or limb					
Inspector Comment					
The dead tree has been removed from blocking the roadway but still need to be removed from the levee section.

LM Start	8.03	Rating **	M	Issue No.	36 (cont)
LM End	8.03	Issue Type +	Ma	Location *	WS

Fresno River levee mile 8.03 waterside slope and shoulder.

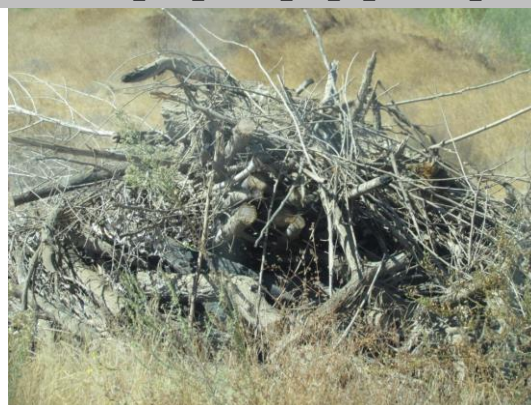
Photo 1 of 1 : SP_2019_NA0011_147_31_20190307_00015.jpg

LM Start	8.09	Rating **	U	Issue No.	31
LM End	8.09	Issue Type +	Ma	Location *	WS
Category	Earthen Levee			GPS Latitude/Longitude	
				Start	End
Item	Encroachments			36.971692 °	36.971692 °
				-120.227957 °	-120.227957 °
DWR ID	DWR_NA0011_06_f_2015_31				
Comment Code					
TR : Tree or limb					
Inspector Comment					
Remove the dead tree off the slope and shoulder, this has been reported in the last two inspections.

Fresno River levee mile 8.09.
