**Flood Control Project Maintenance  
Levee Inspections**

**Maintenance Issue Types Only, Levee Inspection Report By Mile - Spring 2020**

**Madera County FCWCA**

Waterway	Bank	Unit Miles	Inspection Start/End	Inspector
Unit No. 01 Ash Slough	Right	2.37	04/14/2020 04/14/2020	Corey Fujitani

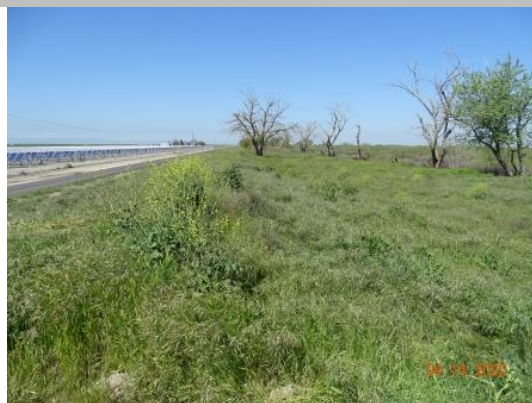
Photo 1 of 1 : SP\_2020\_NA0011\_145\_28\_20200420\_00031.jpg

LM Start	0.00	Rating **	U	Issue No.	28
LM End	1.50	Issue Type +	Ma	Location *	WS
Category	Earthen Levee			GPS Latitude/Longitude	
				Start	End
Item	Vegetation			36.995382 °	36.995604 °
				-120.373470 °	-120.346425 °
DWR ID	DWR_NA0011_04_s_2020_28				
Comment Code					
V1 : Control annual grass and weeds on the levee slopes and easements.					
Inspector Comment

View of the waterside slope looking downstream. (Spring 2020)

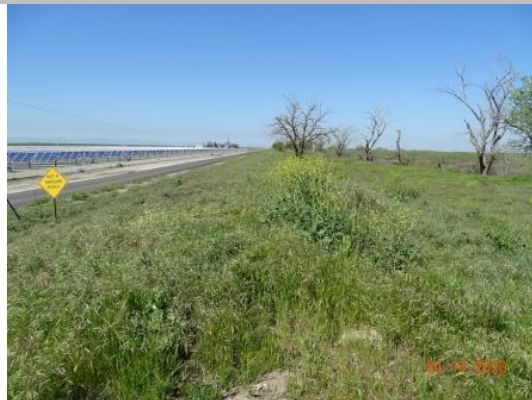
Photo 1 of 1 : SP\_2020\_NA0011\_145\_34\_20200420\_00033.jpg

LM Start	0.93	Rating **	U	Issue No.	34
LM End	1.50	Issue Type +	Ma	Location *	CR
Category	Earthen Levee			GPS Latitude/Longitude	
				Start	End
Item	Vegetation			36.995582 °	36.995604 °
				-120.356689 °	-120.346425 °
DWR ID	DWR_NA0011_04_s_2020_34				
Comment Code					
V9 : Keep the crown roadway free of vegetation.					
Inspector Comment

Looking upstream along the levee crown. (Spring 2020)

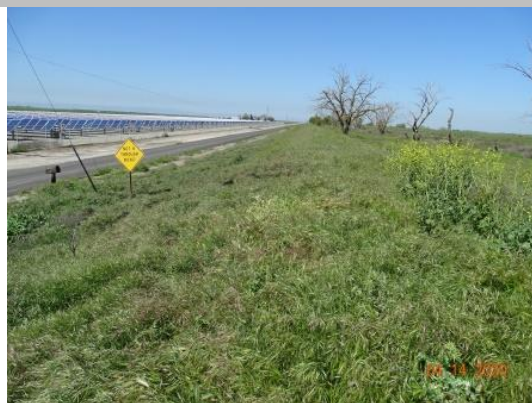
Photo 1 of 1 : SP\_2020\_NA0011\_145\_4\_20200420\_00034.jpg

LM Start	0.93	Rating **	U	Issue No.	4
LM End	1.50	Issue Type +	Ma	Location *	LS
Category	Earthen Levee			GPS Latitude/Longitude	
				Start	End
Item	Vegetation			36.995583 °	36.995604 °
				-120.356688 °	-120.346425 °
DWR ID	DWR_NA0011_04_s_2020_4				
Comment Code					
V1 : Control annual grass and weeds on the levee slopes and easements.					
Inspector Comment

Looking upstream at LM 1.50 along the landside slope. (Spring 2020)

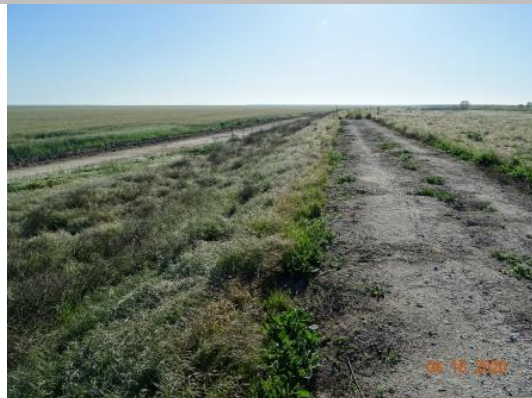
Photo 1 of 1 : SP\_2020\_NA0011\_146\_21\_20200504\_00049.jpg

LM Start	0.01	Rating **	U	Issue No.	21
LM End	4.05	Issue Type +	Ma	Location *	LS
Category	Earthen Levee			GPS Latitude/Longitude	
				Start	End
Item	Vegetation			36.978540 °	36.968171 °
				-120.368318 °	-120.300987 °
DWR ID	DWR_NA0011_05_s_2020_21				
Comment Code					
V1 : Control annual grass and weeds on the levee slopes and easements.					
Inspector Comment

View of the landside slope at LM 0.00. (Spring 2020)

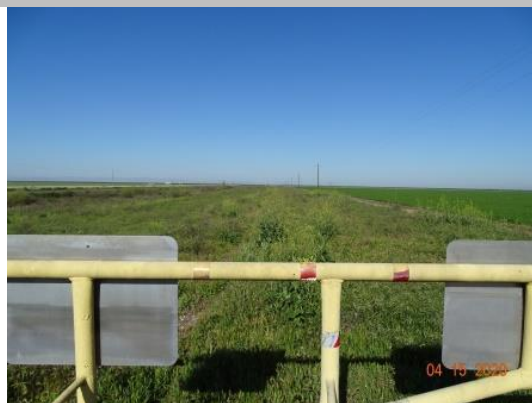
Photo 1 of 1 : SP\_2020\_NA0011\_146\_31\_20200504\_00052.jpg

LM Start	0.04	Rating **	U	Issue No.	31
LM End	4.05	Issue Type +	Ma	Location *	CR
Category	Earthen Levee			GPS Latitude/Longitude	
				Start	End
Item	Vegetation			36.978507 °	36.968172 °
				-120.367803 °	-120.300987 °
DWR ID	DWR_NA0011_05_s_2020_31				
Comment Code					
V9 : Keep the crown roadway free of vegetation.					
Inspector Comment

Looking downstream at the levee crown at LM 4.05. ( Spring 2020)

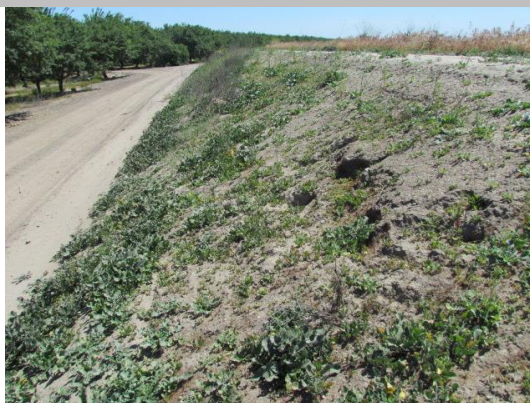
Photo 1 of 1 : SP\_2020\_NA0011\_146\_28\_20200225\_00020.jpg

LM Start	6.75	Rating **	M	Issue No.	28
LM End	6.95	Issue Type +	Ma	Location *	LS
Category	Earthen Levee			GPS Latitude/Longitude	
				Start	End
Item	Animal Control			36.969200 °	36.969507 °
				-120.252462 °	-120.248893 °
DWR ID	DWR_NA0011_05_f_2016_28				
Comment Code					
A1 : Exterminate rodents and backfill and compact or grout burrows.					
Inspector Comment					
Exterminate the rodents in the area listed and place bait stations along the shoulder and/or slope.

Fresno River landside levee slope levee mile 6.75-6.95.

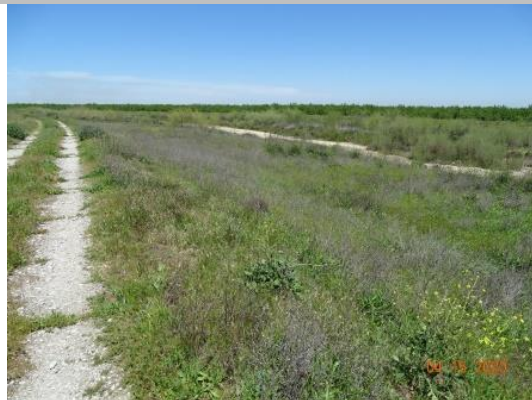
Photo 1 of 1 : SP\_2020\_NA0011\_147\_73\_20200504\_00054.jpg

LM Start	0.00	Rating **	U	Issue No.	73
LM End	0.93	Issue Type +	Ma	Location *	WS
Category	Earthen Levee			GPS Latitude/Longitude	
				Start	End
Item	Vegetation			36.976941 °	36.969700 °
				-120.367494 °	-120.354557 °
DWR ID	DWR_NA0011_06_s_2020_73				
Comment Code					
V1 : Control annual grass and weeds on the levee slopes and easements.					
Inspector Comment

View of the waterside slope looking downstream. (Spring 2020)

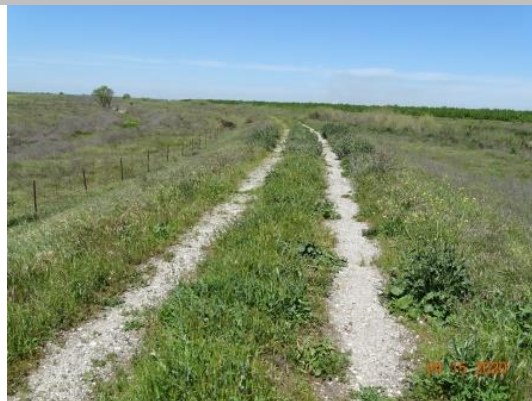
Photo 1 of 1 : SP\_2020\_NA0011\_147\_74\_20200504\_00055.jpg

LM Start	0.00	Rating **	U	Issue No.	74
LM End	0.93	Issue Type +	Ma	Location *	CR
Category	Earthen Levee			GPS Latitude/Longitude	
				Start	End
Item	Vegetation			36.976941 °	36.969700 °
				-120.367494 °	-120.354557 °
DWR ID	DWR_NA0011_06_s_2020_74				
Comment Code					
V9 : Keep the crown roadway free of vegetation.					
Inspector Comment

Looking downstream along the levee crown. (Spring 2020)

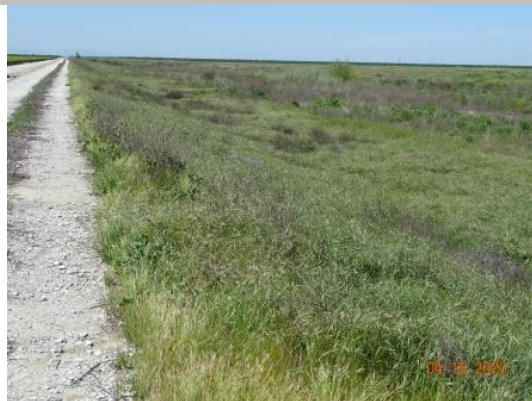
Photo 1 of 1 : SP\_2020\_NA0011\_147\_64\_20200504\_00061.jpg

LM Start	2.46	Rating **	U	Issue No.	64
LM End	3.47	Issue Type +	Ma	Location *	WS
Category	Earthen Levee			GPS Latitude/Longitude	
				Start	End
Item	Vegetation			36.967246 °	36.967380 °
				-120.328536 °	-120.310251 °
DWR ID	DWR_NA0011_06_s_2020_64				
Comment Code					
V1 : Control annual grass and weeds on the levee slopes and easements.					
Inspector Comment

Looking downstream along the waterside slope. (Spring 2020)

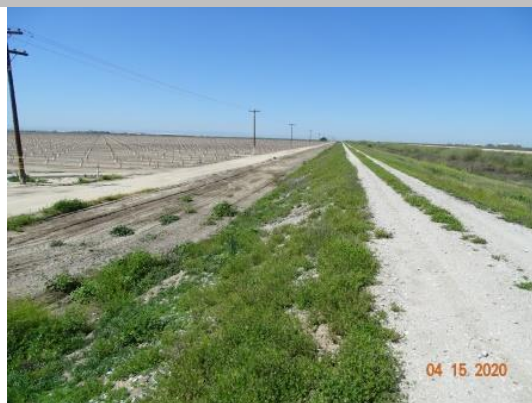
Photo 1 of 1 : SP\_2020\_NA0011\_147\_49\_20200504\_00064.jpg

LM Start	5.48	Rating **	M	Issue No.	49
LM End	5.96	Issue Type +	Ma	Location *	LS
Category	Earthen Levee			GPS Latitude/Longitude	
				Start	End
Item	Vegetation			36.967492 °	36.967480 °
				-120.273970 °	-120.265261 °
DWR ID	DWR_NA0011_06_s_2020_49				
Comment Code					
V1 : Control annual grass and weeds on the levee slopes and easements.					
Inspector Comment

View of the landside slope looking downstream. (Spring 2020)

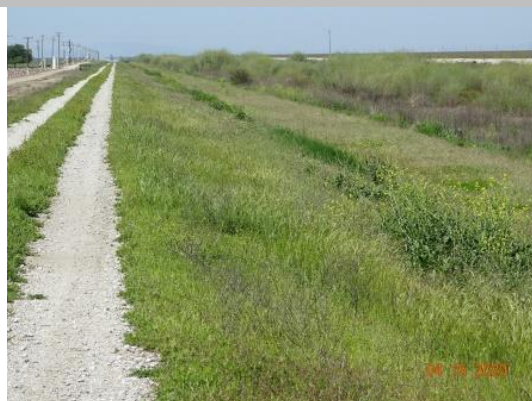
Photo 1 of 1 : SP\_2020\_NA0011\_147\_61\_20200504\_00063.jpg

LM Start	5.48	Rating **	M	Issue No.	61
LM End	5.96	Issue Type +	Ma	Location *	WS
Category	Earthen Levee			GPS Latitude/Longitude	
				Start	End
Item	Vegetation			36.967492 °	36.967480 °
				-120.273970 °	-120.265261 °
DWR ID	DWR_NA0011_06_s_2020_61				
Comment Code					
V1 : Control annual grass and weeds on the levee slopes and easements.					
Inspector Comment

View of waterside slope looking downstream. (Spring 2020)

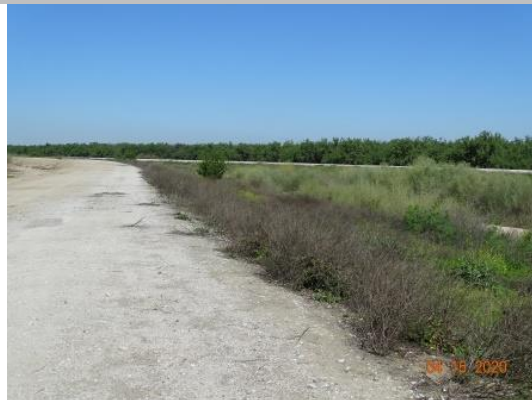
Photo 1 of 1 : SP\_2020\_NA0011\_147\_25\_20200504\_00066.jpg

LM Start	7.95	Rating **	U	Issue No.	25
LM End	8.51	Issue Type +	Ma	Location *	WS
Category	Earthen Levee			GPS Latitude/Longitude	
				Start	End
Item	Vegetation			36.971485 °	36.971546 °
				-120.230566 °	-120.220596 °
DWR ID	DWR_NA0011_06_s_2020_25				
Comment Code					
V1 : Control annual grass and weeds on the levee slopes and easements.					
Inspector Comment

View of the waterside slope looking downstream. (Spring 2020)
