**Flood Control Project Maintenance
Levee Inspections**

Maintenance Issue Types Only, Levee Inspection Report By Mile - Spring 2022

Madera County FCWCA

Waterway	Bank	Unit Miles	Inspection Start/End	Inspector
Unit No. 01 Ash Slough	Right	2.37	04/28/2022 04/28/2022	Corey Fujitani

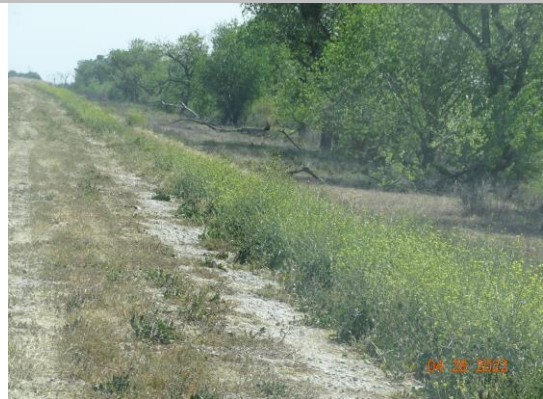
Photo 1 of 1 : SP_2022_NA0011_144_4_20220504_00016.jpg

LM Start	0.19	Rating **	M	Issue No.	4
LM End	1.50	Issue Type +	Ma	Location *	WS
Category	Earthen Levee			GPS Latitude/Longitude	
				Start	End
Item	Vegetation			36.996215 °	36.996604 °
				-120.370376 °	-120.346807 °
DWR ID	DWR_NA0011_03_s_2022_4				
Comment Code					
V1 : Control annual grass and weeds on the levee slopes and easements.					
Inspector Comment

Looking downstream along the waterside slope. (Spring 2022)

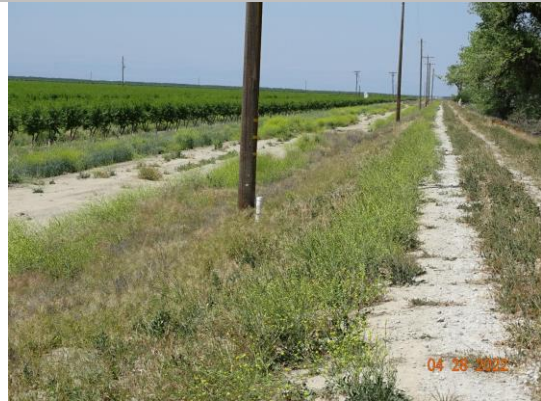
Photo 1 of 1 : SP_2022_NA0011_145_36_20220504_00023.jpg

LM Start	0.05	Rating **	M	Issue No.	36
LM End	0.48	Issue Type +	Ma	Location *	LS
Category	Earthen Levee			GPS Latitude/Longitude	
				Start	End
Item	Vegetation			36.995559 °	36.995578 °
				-120.372600 °	-120.364851 °
DWR ID	DWR_NA0011_04_s_2022_36				
Comment Code					
V1 : Control annual grass and weeds on the levee slopes and easements.					
Inspector Comment

Looking downstream along the landside slope. (Spring 2022)

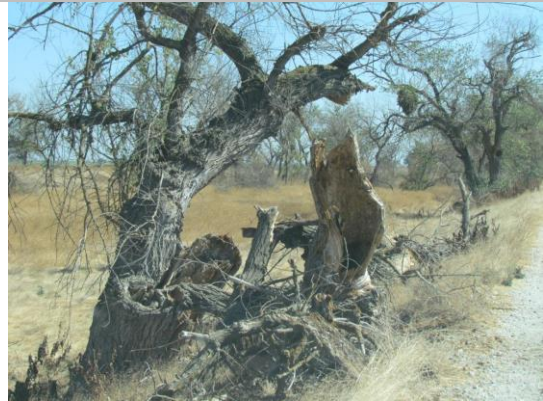
Photo 1 of 1 : SP_2022_NA0011_145_15_20220308_00010.jpg

LM Start	0.14	Rating **	U	Issue No.	15
LM End	0.14	Issue Type +	Ma	Location *	WS
Category	Earthen Levee			GPS Latitude/Longitude	
				Start	End
Item	Encroachments			36.995528 °	36.995528 °
				-120.370922 °	-120.370922 °
DWR ID	DWR_NA0011_04_f_2015_15				
Comment Code					
TR : Tree or limb					
Inspector Comment					
There are many dead trees in the area. Remove the dead trees from the levee section. Many more are subject to fall and possibly block access to the levee crown.

Berenda Slough looking upstream from the levee mile 0.14.

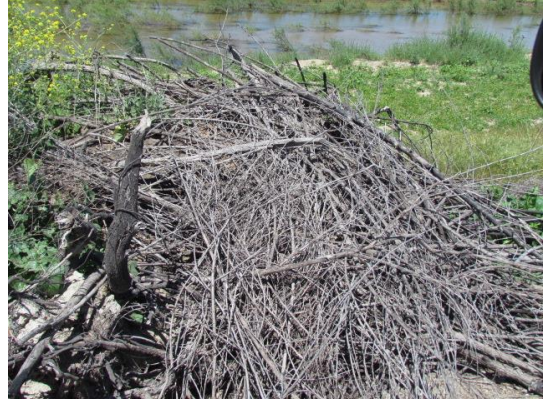
Photo 1 of 1 : SP_2022_NA0011_147_32_20220308_00011.jpg

LM Start	7.96	Rating **	M	Issue No.	32
LM End	7.96	Issue Type +	Ma	Location *	WS
Category	Earthen Levee			GPS Latitude/Longitude	
				Start	End
Item	Encroachments			36.971543 °	36.971543 °
				-120.230285 °	-120.230285 °
DWR ID	DWR_NA0011_06_s_2017_32				
Comment Code					
PR : Prunings					
Inspector Comment					
Remove the brush pile from the levee slope. This pile is providing habitat for rodents.

Fresno River waterside levee mile 7.96.
