**Flood Control Project Maintenance  
Levee Inspections**

**Maintenance Issue Types Only, Levee Inspection Report By Mile - Spring 2024**

**Madera County FCWCA**

Waterway	Bank	Unit Miles	Inspection Start/End	Inspector
Unit No. 01 Ash Slough	Right	2.37	04/25/2024 04/25/2024	Corey Fujitani

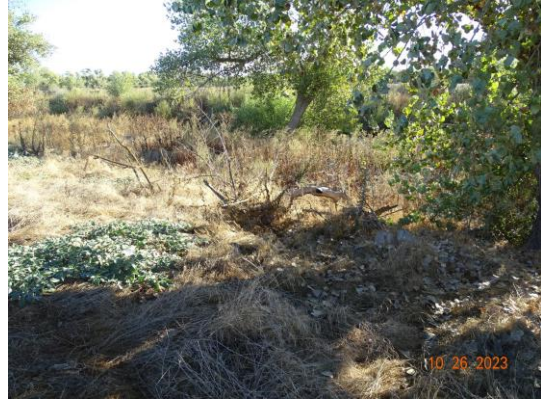
Photo 1 of 1 : SP\_2024\_NA0011\_142\_21\_20240212\_00011.jpg

LM Start	0.75	Rating **	M	Issue No.	21
LM End	0.75	Issue Type +	Ma	Location *	WS
Category	Earthen Levee			GPS Latitude/Longitude	
				Start	End
Item	Trim / Thin Trees			37.052796°	37.052796°
				-120.417641°	-120.417640°
DWR ID	DWR_NA0011_01_f_2023_21				
Comment Code					
T2 : Tree or limb.					
Inspector Comment					
Remove tree limbs from waterside slope.

View of tree limbs on the waterside slope. (Fall 2023)

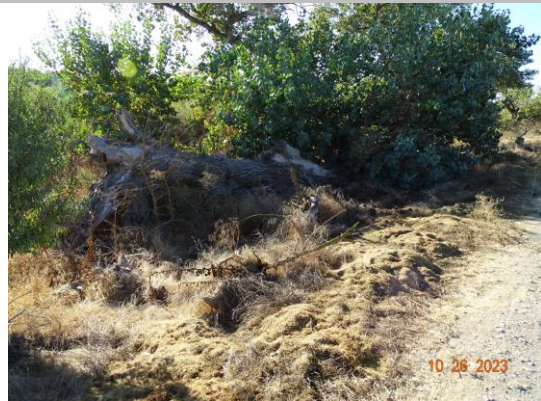
Photo 1 of 1 : SP\_2024\_NA0011\_142\_25\_20240212\_00014.jpg

LM Start	0.79	Rating **	U	Issue No.	25
LM End	0.79	Issue Type +	Ma	Location *	WS
Category	Earthen Levee			GPS Latitude/Longitude	
				Start	End
Item	Trim / Thin Trees			37.053329°	37.053329°
				-120.417448°	-120.417448°
DWR ID	DWR_NA0011_01_f_2018_25				
Comment Code					
T2 : Tree or limb.					
Inspector Comment					
There is a fallen tree blocking the waterside slope.

Tree limbs and trunks are on the waterside shoulder and slope. (Fall 2023)

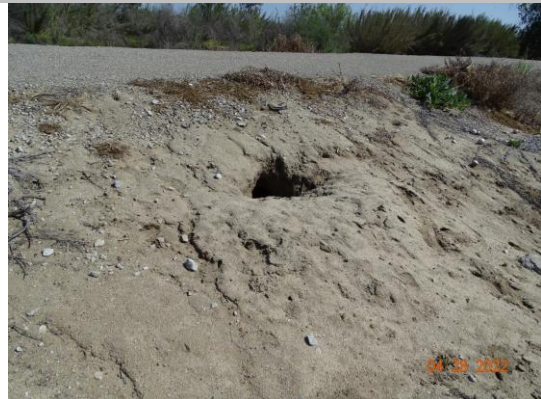
Photo 1 of 1 : SP\_2024\_NA0011\_143\_30\_20240212\_00018.jpg

LM Start	0.01	Rating **	U	Issue No.	30
LM End	0.01	Issue Type +	Ma	Location *	LS
Category	Earthen Levee			GPS Latitude/Longitude	
				Start	End
Item	Animal Control			37.045531°	37.045531°
				-120.427244°	-120.427244°
DWR ID	DWR_NA0011_02_s_2022_30				
Comment Code					
A3 : No rodents visible, but rodent burrows visible; need to backfill and compact or grout burrows.					
Inspector Comment

View of animal burrow on the landside slope. (Spring 2022)

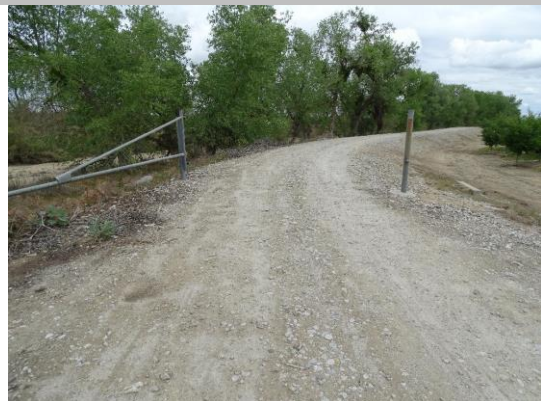
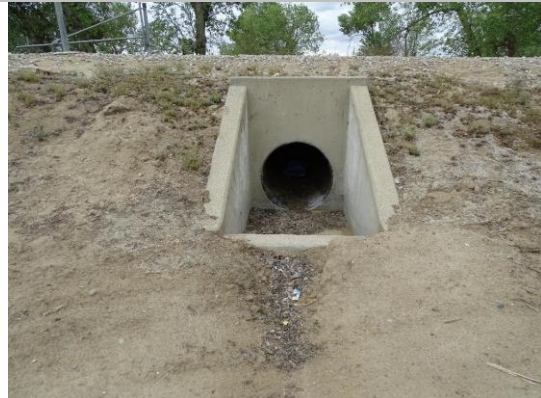
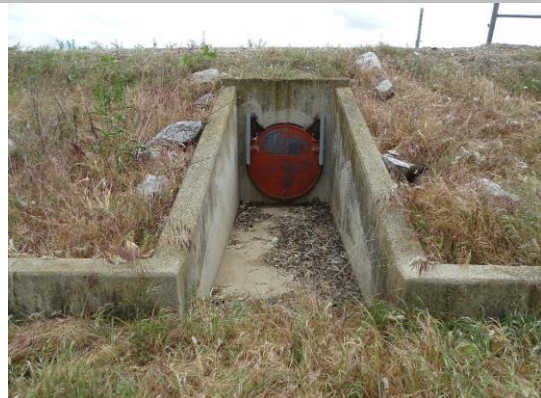
Comment Code						
Inspector Comment						
DS_ID:21515 FS_ID:77411 EP_NO: N/A Repair Type: No Action Needed EVAL Issue: Crossing Status: Found UCIP Comments: 04/19/2022 Record updated from No Action Needed to Non-Urgent. Owner needs to coordinate with CVFPB to authorize crossing. DMP internal video inspection has not found pipe integrity issues. LOF of crossing is less or equal to 4. Recommend next video inspection in 5 years. No issues observed during inspection. (M.Thao - DWR UCIP) FIELD_STRUCT_DESC: 36-inch corrugated metal gravity drainage pipe through the levee, 7.3 feet below the crown. Headwall and wing wall on each end. Flap gate on the waterside (WS) end. [Additional Reference(s): Levee Log, 2005 (HLM 0.99). USACE San Joaquin O&M Manual 605 (Station 52+50), listed as 36-inch pipe]. FS Date: 4/19/2022

Levee crown looking upstream.

LS view: Concrete headwall and pipe inlet on toe.

WS view: Concrete headwall and flap gate on toe.

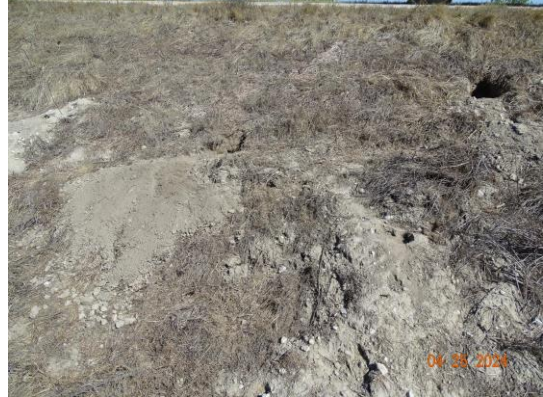
Photo 1 of 1 : SP\_2024\_NA0011\_145\_28\_20240429\_00036.jpg

LM Start	0.13	Rating **	M	Issue No.	28
LM End	0.13	Issue Type +	Ma	Location *	LS
Category	Earthen Levee			GPS Latitude/Longitude	
				Start	End
Item	Animal Control			36.995531°	36.995531°
				-120.371133°	-120.371133°
DWR ID	DWR_NA0011_04_s_2024_28				
Comment Code					
A3 : No rodents visible, but rodent burrows visible; need to backfill and compact or grout burrows.					
Inspector Comment

Multiple rodent burrows observed on the landside slope. (Spring 2024)

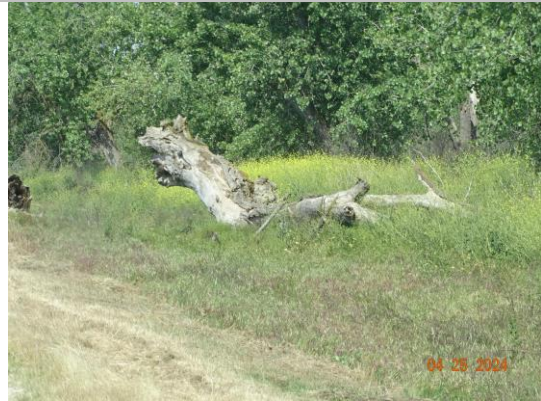
Photo 1 of 1 : SP\_2024\_NA0011\_145\_16\_20240429\_00037.jpg

LM Start	0.47	Rating **	M	Issue No.	16
LM End	0.49	Issue Type +	Ma	Location *	WS
Category	Earthen Levee			GPS Latitude/Longitude	
				Start	End
Item	Trim / Thin Trees			36.995603°	36.995568°
				-120.364978°	-120.364634°
DWR ID	DWR_NA0011_04_s_2014_16				
Comment Code					
T2 : Tree or limb.					
Inspector Comment					
This dead tree on the waterward slope should be removed from the levee section.

View of tree trunk on the waterside slope. (Spring 2024)

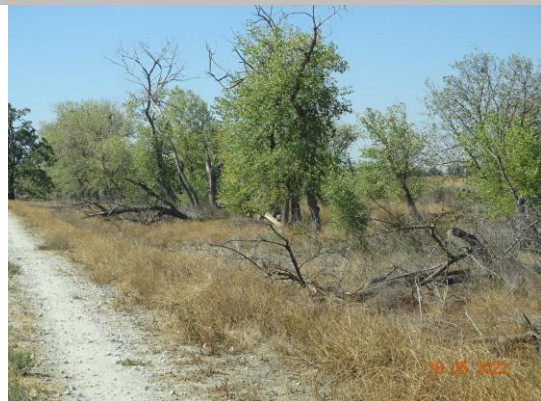
Photo 1 of 1 : SP\_2024\_NA0011\_145\_39\_20240212\_00027.jpg

LM Start	0.54	Rating **	M	Issue No.	39
LM End	0.71	Issue Type +	Ma	Location *	WS
Category	Earthen Levee			GPS Latitude/Longitude	
				Start	End
Item	Trim / Thin Trees			36.995565°	36.995574°
				-120.363779°	-120.360695°
DWR ID	DWR_NA0011_04_f_2022_39				
Comment Code					
T2 : Tree or limb.					
Inspector Comment					
Several fallen trees in this section.

Fallen trees washed up on the waterside slope and berm from high water. (Fall 2022)

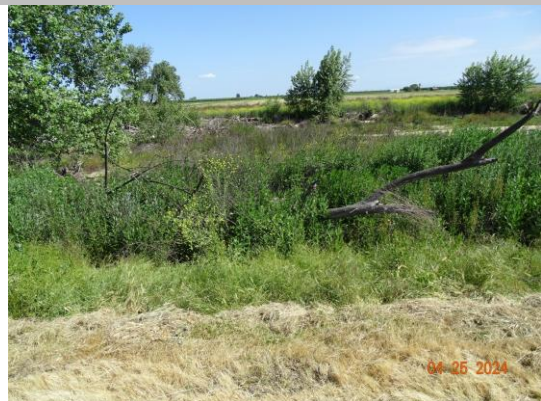
Photo 1 of 1 : SP\_2024\_NA0011\_145\_6\_20240429\_00038.jpg

LM Start	0.78	Rating **	U	Issue No.	6
LM End	0.78	Issue Type +	Ma	Location *	WS
Category	Earthen Levee			GPS Latitude/Longitude	
				Start	End
Item	Trim / Thin Trees			36.995582°	36.995582°
				-120.359451°	-120.359451°
DWR ID	DWR_NA0011_04_s_2019_6				
Comment Code					
T2 : Tree or limb.					
Inspector Comment

View of fallen tree on waterside slope. (Spring 2024)

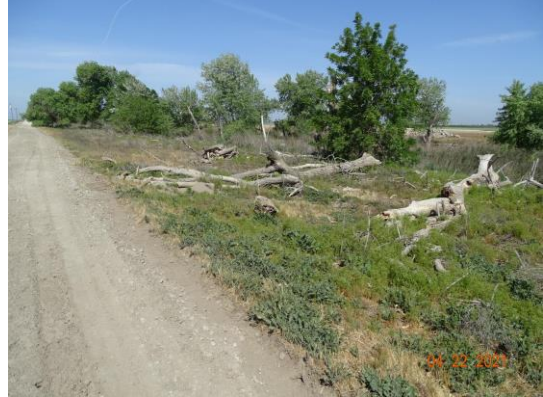
Photo 1 of 1 : SP\_2024\_NA0011\_145\_24\_20240212\_00017.jpg

LM Start	1.07	Rating **	U	Issue No.	24
LM End	1.07	Issue Type +	Ma	Location *	WS
Category	Earthen Levee			GPS Latitude/Longitude	
				Start	End
Item	Trim / Thin Trees			36.995587°	36.995587°
				-120.354128°	-120.354128°
DWR ID	DWR_NA0011_04_s_2021_24				
Comment Code					
T2 : Tree or limb.					
Inspector Comment

View of fallen trees on the waterside slope and berm. (Spring 2021)

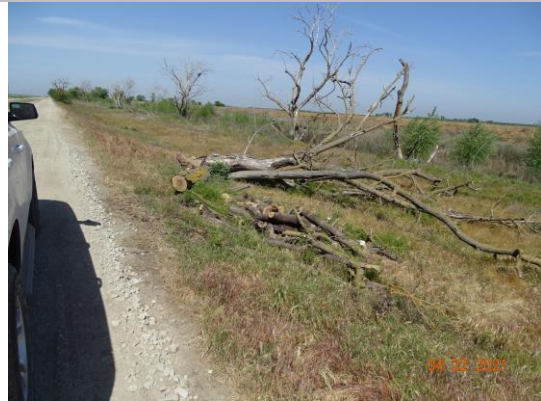
Photo 1 of 1 : SP\_2024\_NA0011\_145\_7\_20240212\_00004.jpg

LM Start	1.46	Rating **	M	Issue No.	7
LM End	1.46	Issue Type +	Ma	Location *	WS
Category	Earthen Levee			GPS Latitude/Longitude	
				Start	End
Item	Trim / Thin Trees			36.995600°	36.995600°
				-120.347175°	-120.347175°
DWR ID	DWR_NA0011_04_s_2021_7				
Comment Code					
T2 : Tree or limb.					
Inspector Comment

View of tree limbs on the waterside slope. (Spring 2021)

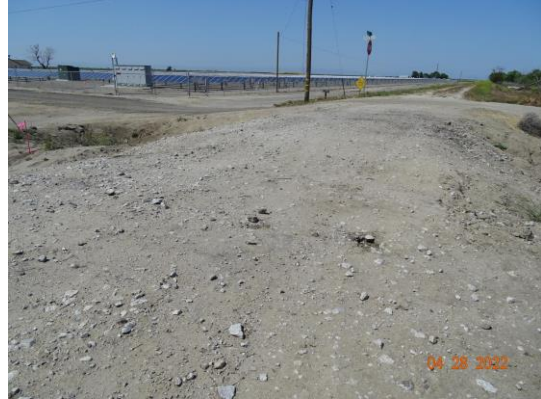
Photo 1 of 1 : SP\_2024\_NA0011\_145\_10\_20240212\_00006.jpg

LM Start	1.50	Rating **	M	Issue No.	10
LM End	1.50	Issue Type +	Ma	Location *	CR
Category	Earthen Levee			GPS Latitude/Longitude	
				Start	End
Item	Crown Surface / Depressions / Rutting			36.995629°	36.995629°
				-120.346319°	-120.346319°
DWR ID	DWR_NA0011_04_s_2022_10				
Comment Code					
C1 : Add appropriate material and re-grade the levee to bring the crown above the design elevation.					
Inspector Comment					
Depression is in line with pipe crossing and could be related to a potential issue with the pipe.

Depression in the levee crown should be brought to level with appropriate material. (Spring 2022)

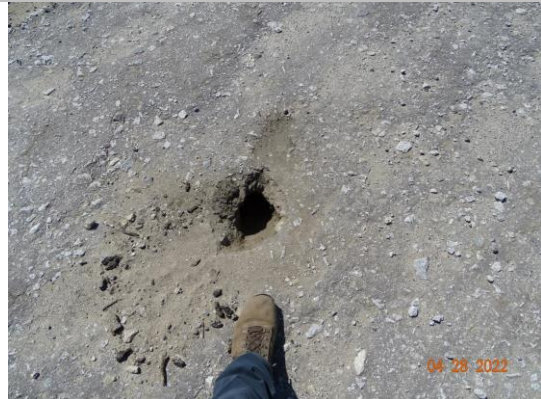
Photo 1 of 1 : SP\_2024\_NA0011\_145\_59\_20240212\_00029.jpg

LM Start	1.63	Rating **	U	Issue No.	59
LM End	1.67	Issue Type +	Ma	Location *	CR
Category	Earthen Levee			GPS Latitude/Longitude	
				Start	End
Item	Animal Control			36.996573°	36.997002°
				-120.344428°	-120.343977°
DWR ID	DWR_NA0011_04_s_2012_59				
Comment Code					
A3 : No rodents visible, but rodent burrows visible; need to backfill and compact or grout burrows.					
Inspector Comment					
Rodent holes should be backfilled and compacted or grouted.

Representative rodent hole in the levee crown along this section. (Spring 2022)

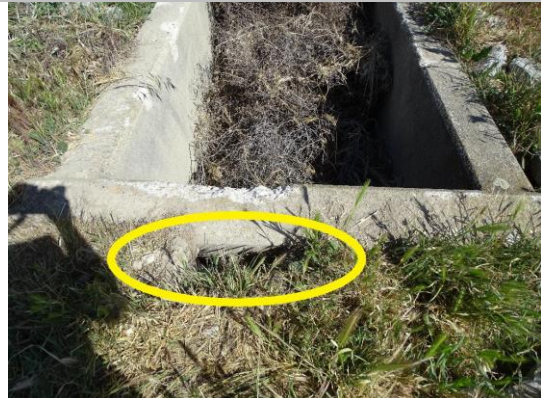
Photo 1 of 3 : UCIP\_SP\_2024\_81023\_112417.jpg

DS\_ID:21520  
FS\_ID:81023  
EP\_NO: N/A  
Repair Type: Urgent  
EVAL Issue: 1, Pipe Integrity  
Crossing Status: Found  
UCIP Comments: 09/19/2023 Record updated from Non-Urgent to Urgent. DMP internal video inspection has found severe pipe defects. Crossing will be monitored until funding becomes available to address the issues. (O. Yakimov - DWR UCIP)  
04/20/2022 Record remains Non-Urgent. Tumbleweeds are blocking the pipe inlet and outlet; recommend removal. Minor rodent activity was observed behind the LS headwall. DMP internal video inspection has not found pipe integrity issues. LOF of crossing is less or equal to 4. Recommend next video inspection in 5 years. (M.Thao - DWR UCIP)  
05/06/2014 Need to contact owner. Dense vegetation limits the inspector's visibility to identify signs of pipe failure (leaks) along the landward slope. Recommend removing vegetation along pipe alignment to conduct proper inspection of structure. (DWR UCIP - O. Magana)

LS view: Rodent activity behind headwall on slope.

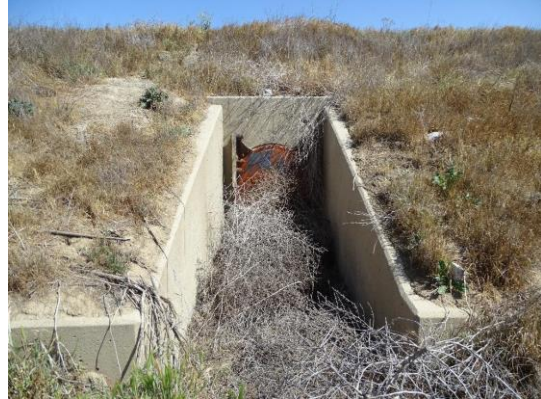
Photo 3 of 3 : UCIP\_SP\_2024\_81023\_112412.jpg

WS view: Concrete headwall and flap gate on toe; tumbleweeds at pipe outlet.

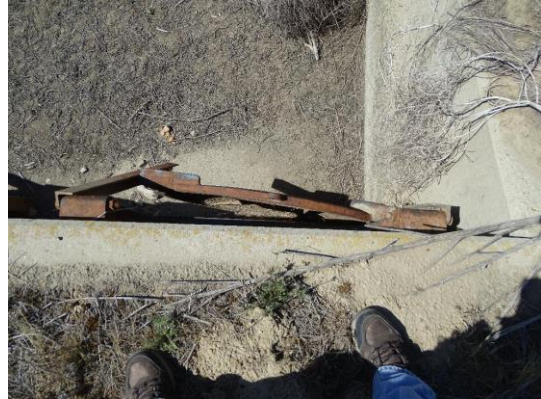
Photo 2 of 2 : UCIP\_SP\_2024\_82670\_112480.jpg

DS\_ID:21623  
 FS\_ID:82670  
 EP\_NO: N/A  
 Repair Type: Non-Urgent  
 EVAL Issue: 11, Maintenance Compliance Issue  
 Crossing Status: Found  
 UCIP Comments: 04/20/2022 Record updated from No Action Needed to Non-Urgent. Flap gate on WS does not close properly and does not appear to be propped open with anything; flap gate hinges appear skewed. Recommend flap gate be repaired. (M. Thao - DWR UCIP)

WS view: View from above; flap gate does not close properly and appears not to be propped open with anything.

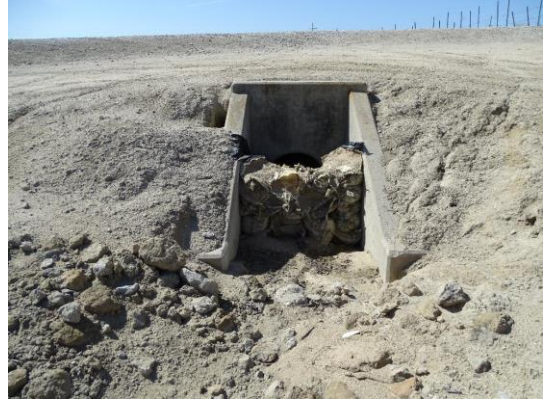
Photo 3 of 3 : UCIP\_SP\_2024\_80588\_112421.jpg

Comment Code						
Inspector Comment						
DS_ID:21529 FS_ID:80588 EP_NO: N/A Repair Type: Non-Urgent EVAL Issue: 11, Maintenance Compliance Issue Crossing Status: Found UCIP Comments: 04/20/2022 Record updated from No Action Needed to Non-Urgent. Pipe inlet on LS is being blocked with sandbags; recommend removal for crossing to function properly. DMP internal video inspection has not found pipe integrity issues. LOF of crossing is less or equal to 4. Recommend next video inspection in 5 years. (M.Thao - DWR UCIP) FIELD_STRUCT_DESC: 30-inch corrugated metal gravity drainage pipe through the levee, 9 feet below the crown. Concrete headwall and wing wall on each end. Flap gate on waterside (WS) end. [Additional Reference(s): DWR Levee Log, 2005 (HLM 4.10). USACE San Joaquin O&M Manual, Unit 606. USACE As-Built Drawing No. 07-04-0085, (Station 214+20), Sheets 85/6.1 and 85/31.1, March 1975]. FS Date: 4/20/2022

LS view: Concrete headwall at toe; stacked sandbags are blocking pipe inlet.

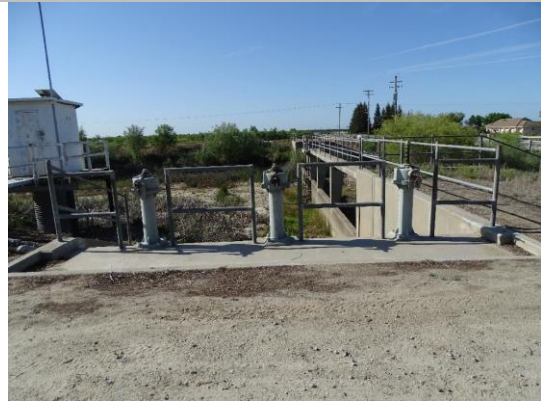
Photo 3 of 3 : UCIP\_SP\_2024\_80624\_112454.jpg

WS view: Looking from crown; slide gate operator on shoulder.

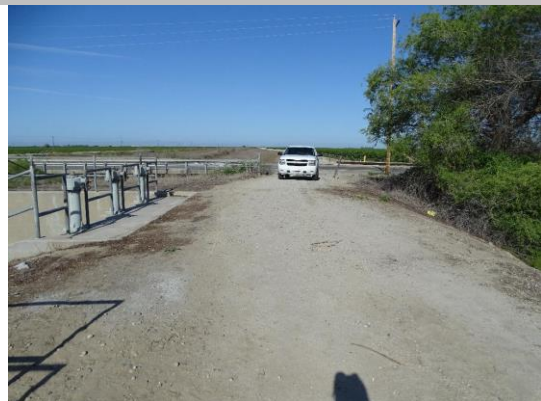
Photo 1 of 3 : UCIP\_SP\_2024\_80625\_112456.jpg

DS\_ID:21525  
FS\_ID:80625  
EP\_NO: N/A  
Repair Type: No Action Needed  
EVAL Issue:  
Crossing Status: Found  
UCIP Comments: 04/20/2022 Record remains No Action Needed. No issues observed during inspection. (M.Thao - DWR UCIP)  
FIELD\_STRUCT\_DESC: [Fresno Diversion Weir] 3 of 3: 60-inch by 48-inch reinforced concrete box gravity drainage culvert through the levee, 13 feet below the crown. Concrete headwall and wing wall on the landside (LS) shoulder. Slide gate on the waterside (WS). [Additional Reference(s): DWR Levee Log, 2005 (HLM 6.64). USACE San Joaquin O&M Manual, Unit 606, (located just upstream from Road 16), listed as diversion dam].  
FS Date: 4/20/2022

Levee crown looking downstream.

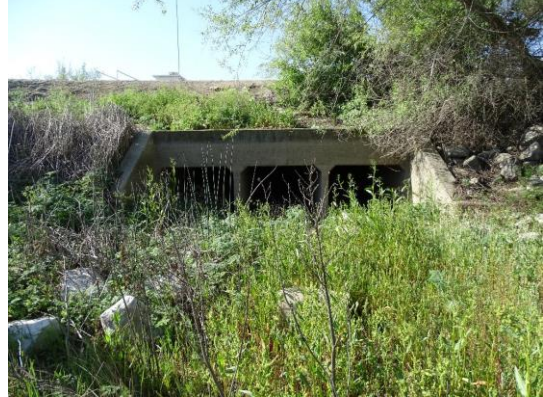
Photo 2 of 3 : UCIP\_SP\_2024\_80625\_112457.jpg

LS view: Looking toward levee; inlet of reinforced concrete box culvert.

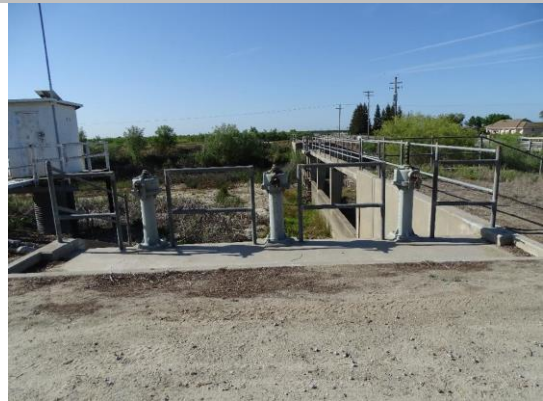
Photo 3 of 3 : UCIP\_SP\_2024\_80625\_112458.jpg

WS view: Looking from crown; slide gate operator on shoulder.

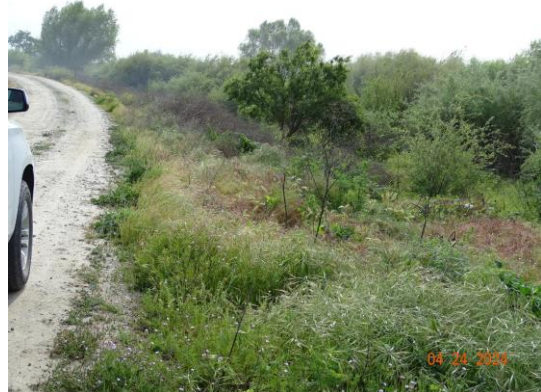
Photo 1 of 1 : SP\_2024\_NA0011\_146\_53\_20240429\_00066.jpg

LM Start	6.59	Rating **	M	Issue No.	53
LM End	7.58	Issue Type +	Ma	Location *	WS
Category	Earthen Levee			GPS Latitude/Longitude	
				Start	End
Item	Vegetation			36.968506°	36.969550°
				-120.255232°	-120.237510°
DWR ID	DWR_NA0011_05_s_2024_53				
Comment Code					
V1 : Control annual grass and weeds on the levee slopes and easements.					
Inspector Comment

View of vegetation on the waterside slope. (Spring 2024)

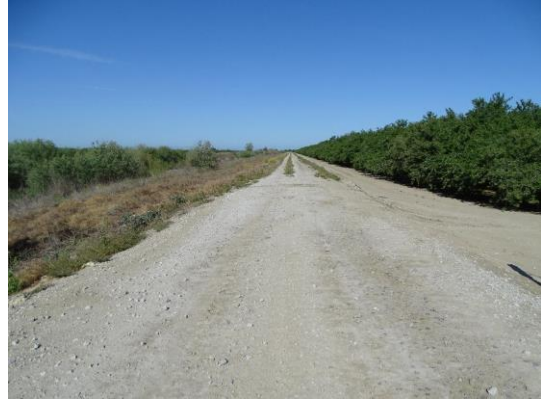
Photo 1 of 3 : UCIP\_SP\_2024\_80579\_112465.jpg

Comment Code						
Inspector Comment						
DS_ID:21526 FS_ID:80579 EP_NO: N/A Repair Type: No Action Needed EVAL Issue: Crossing Status: Found UCIP Comments: 04/20/2022 Record remains No Action Needed. DMP internal video inspection has not found pipe integrity issues. LOF of crossing is less or equal to 4. Recommend next video inspection in 5 years. (M. Thao - DWR UCIP) 05/06/2014 Descriptions modified based on field confirmation. (DWR UCIP - O. Magana) FIELD_STRUCT_DESC: 30-inch corrugated metal gravity drainage pipe through the levee, 9.4 feet below the crown. Concrete headwall and wing wall on each end. Flap gate on the waterside (WS) end. [Additional Reference(s): DWR Levee Log, 2005 (HLM 7.61). USACE San Joaquin O&M Manual, Unit 606. USACE As-Built Drawing No. 07-04-0085, Sheets 85/8A.1 and 85/31.1, (Station 397+16), March 1975]. FS Date: 4/20/2022

Levee crown looking downstream.

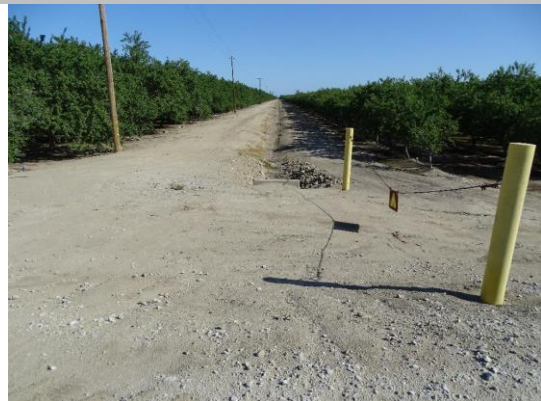
Photo 2 of 3 : UCIP\_SP\_2024\_80579\_112466.jpg

LS view: Looking from crown; concrete headwall approximately 20 feet off toe.

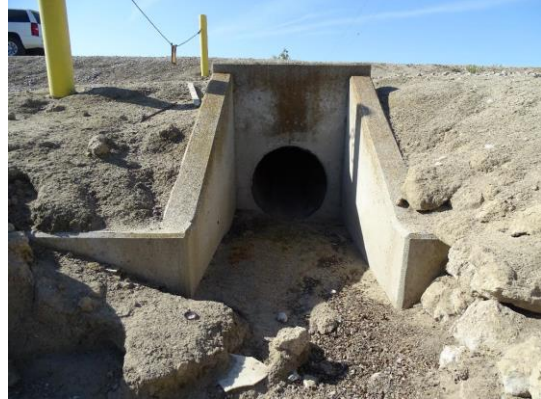
Photo 3 of 3 : UCIP\_SP\_2024\_80579\_112467.jpg

LS view: Concrete headwall and pipe inlet.

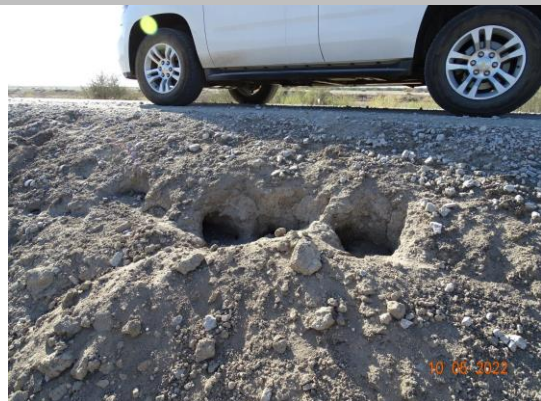
Photo 1 of 1 : SP\_2024\_NA0011\_146\_44\_20240212\_00022.jpg

LM Start	7.55	Rating **	M	Issue No.	44
LM End	7.55	Issue Type +	Ma	Location *	LS
Category	Earthen Levee			GPS Latitude/Longitude	
				Start	End
Item	Animal Control			36.969539°	36.969539°
				-120.238136°	-120.238136°
DWR ID	DWR_NA0011_05_f_2022_44				
Comment Code					
A3 : No rodents visible, but rodent burrows visible; need to backfill and compact or grout burrows.					
Inspector Comment

View of rodent holes on the landside slope. (Fall 2022)

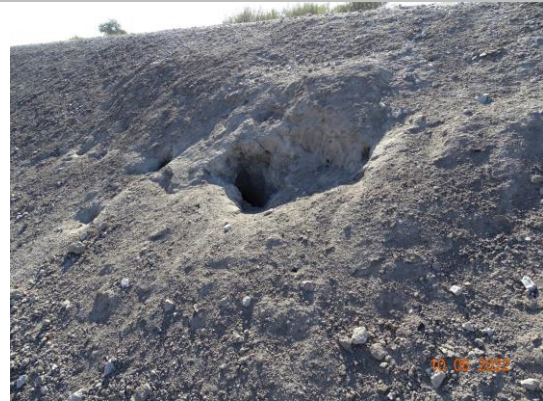
Photo 1 of 1 : SP\_2024\_NA0011\_146\_24\_20240212\_00013.jpg

LM Start	7.62	Rating **	U	Issue No.	24
LM End	7.66	Issue Type +	Ma	Location *	LS
Category	Earthen Levee			GPS Latitude/Longitude	
				Start	End
Item	Animal Control			36.969543°	36.969606°
				-120.236801°	-120.236091°
DWR ID	DWR_NA0011_05_f_2018_24				
Comment Code					
A3 : No rodents visible, but rodent burrows visible; need to backfill and compact or grout burrows.					
Inspector Comment					
Large rodent burrows on the landside slope should be backfilled and compacted.

Representative burrow on the landside slope. (Fall 2022)

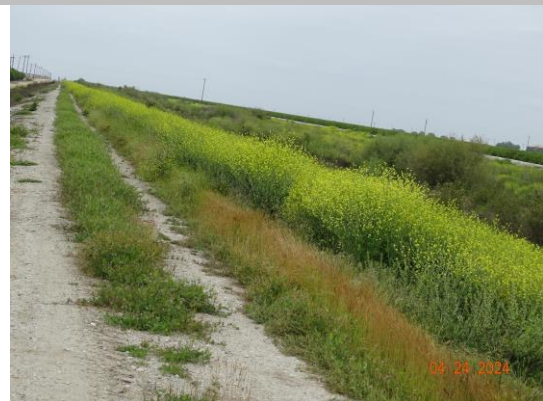
Photo 1 of 1 : SP\_2024\_NA0011\_147\_21\_20240429\_00041.jpg

LM Start	4.41	Rating **	M	Issue No.	21
LM End	5.96	Issue Type +	Ma	Location *	WS
Category	Earthen Levee			GPS Latitude/Longitude	
				Start	End
Item	Vegetation			36.967475°	36.967483°
				-120.293437°	-120.265302°
DWR ID	DWR_NA0011_06_s_2024_21				
Comment Code					
V1 : Control annual grass and weeds on the levee slopes and easements.					
Inspector Comment

View of vegetation growing on the waterside slope. (Spring 2024)

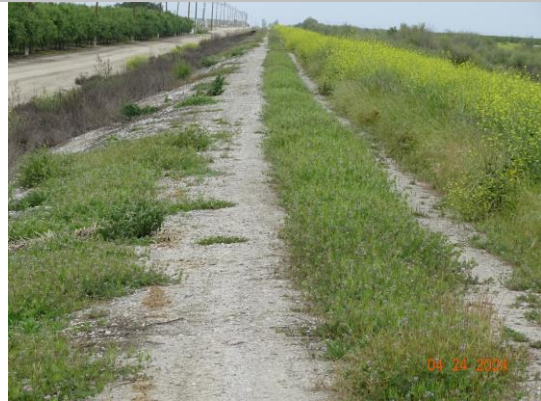
Photo 1 of 1 : SP\_2024\_NA0011\_147\_22\_20240429\_00042.jpg

LM Start	5.44	Rating **	M	Issue No.	22
LM End	5.96	Issue Type +	Ma	Location *	CR
Category	Earthen Levee			GPS Latitude/Longitude	
				Start	End
Item	Vegetation			36.967489°	36.967482°
				-120.274684°	-120.265302°
DWR ID	DWR_NA0011_06_s_2024_22				
Comment Code					
V3 : Keep the crown roadway free of vegetation.					
Inspector Comment

View of vegetation along the levee crown. (Spring 2024)

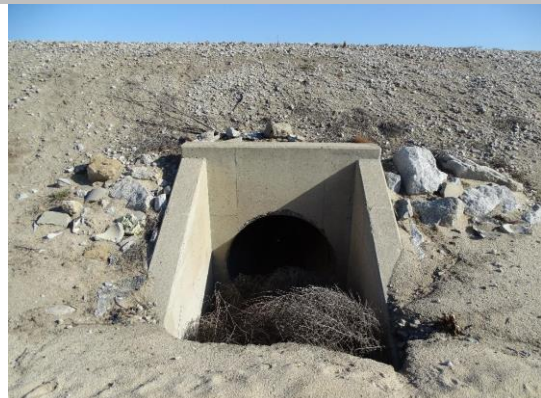
Photo 2 of 3 : UCIP\_SP\_2024\_80596\_112510.jpg

LS view: Concrete headwall and pipe inlet on toe.

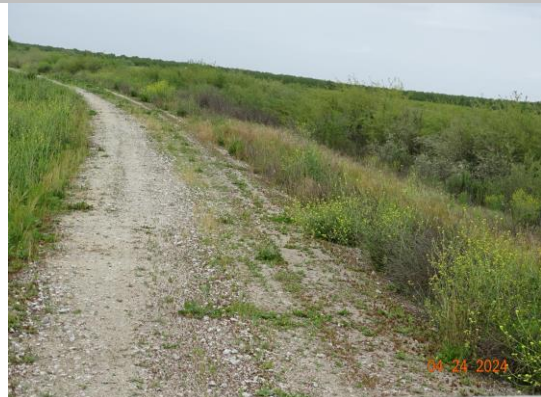
Photo 1 of 1 : SP\_2024\_NA0011\_147\_14\_20240429\_00044.jpg

LM Start	7.53	Rating **	M	Issue No.	14
LM End	8.47	Issue Type +	Ma	Location *	WS
Category	Earthen Levee			GPS Latitude/Longitude	
				Start	End
Item	Vegetation			36.968854°	36.971816°
				-120.237136°	-120.221358°
DWR ID	DWR_NA0011_06_s_2024_14				
Comment Code					
V1 : Control annual grass and weeds on the levee slopes and easements.					
Inspector Comment

View of vegetation growing on the waterside slope and shoulder. (Spring 2024)

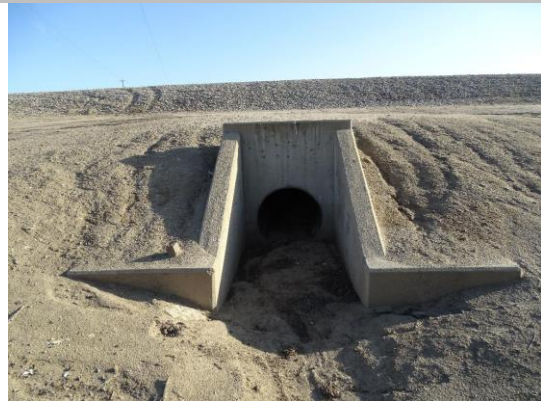
Photo 1 of 2 : UCIP\_SP\_2024\_80595\_113270.jpg

Comment Code					
Inspector Comment					
DS_ID:21534 FS_ID:80595 EP_NO: N/A Repair Type: Non-Urgent EVAL Issue: 5, Pipe Damage Crossing Status: Found UCIP Comments: 04/20/2022 Record remains Non-Urgent. DMP internal video inspection has found pipe integrity issues. LOF of crossing is greater than or equal to 4.1 and less than 5. Crossing will be monitored until funding becomes available for rehabilitation. (M.Thao - DWR UCIP) 05/06/2014 Need to contact owner. Rip rap has been added around concrete headwall on waterward side--need to determine details for rip rap around structure. (DWR UCIP - O. Magana) FIELD_STRUCT_DESC: 30-inch corrugated metal gravity drainage pipe through the levee, 11 feet below the crown. Concrete headwall and wing wall on each end. Flap gate on the waterside (WS) end. [Additional Reference(s): DWR Levee Log, 2005 (8.64). USACE San Joaquin O&M Manual, Unit 606. USACE As-Built Drawing 07-04-0085, Sheets 85/10.2 and 85/31.1, Station 450+10, March 1975]. FS Date: 4/20/2022

LS view: Concrete headwall and pipe inlet approximately 30 feet off toe.

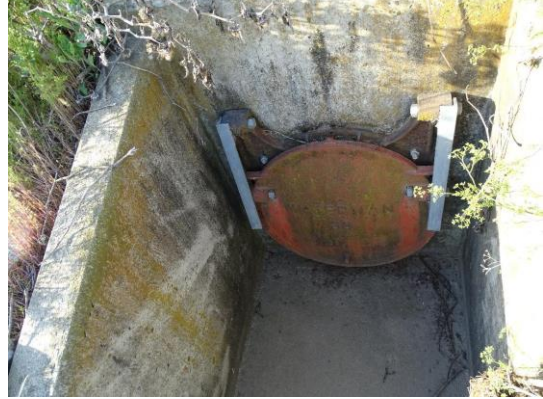
Photo 2 of 2 : UCIP\_SP\_2024\_80595\_113267.jpg

WS view: Concrete headwall and flap gate.
