**Flood Control Project Maintenance
Levee Inspections**

2012 Channel Summary Report

Merced Streams Group

2012 Channel Inspection Results

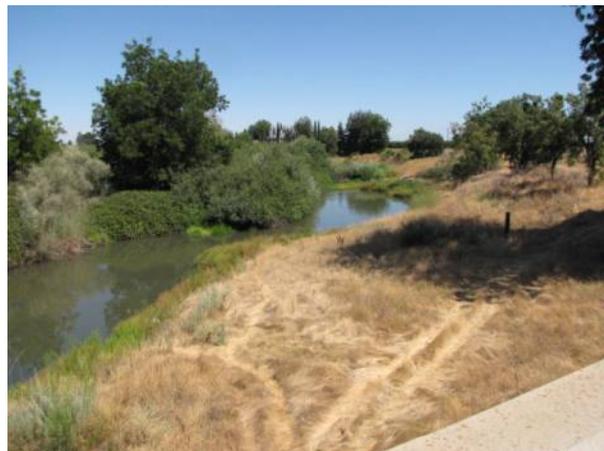
Levee Mile Report Line	11
Start Levee Mile	0.00
End Levee Mile	0.00
Location	
Category	Channels
Item	Vegetation & Obstructions
<p>Bear Creek looking upstream from Arboleda Drive, very wide flood control channel. Brush build up on right bank, flow not impeded. Photo taken 7-30-2012.</p> <p>phillips_c_20120828_167.jpg</p>

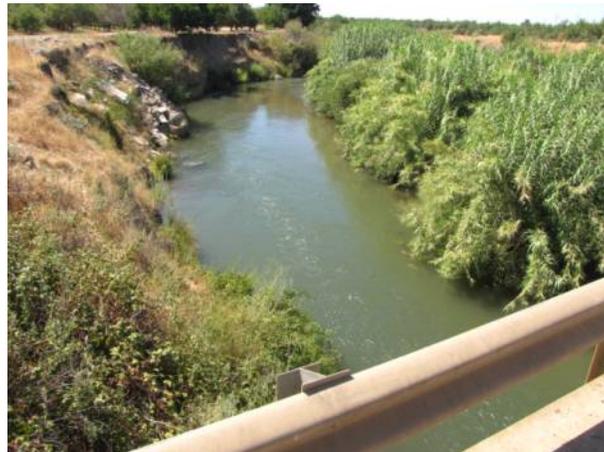
Levee Mile Report Line	26
Start Levee Mile	0.00
End Levee Mile	0.00
Location	
Category	Channels
Item	Vegetation & Obstructions
<p>Bear Creek looking downstream from Kibby Rd crossing. Bambo covers right bank. Photo taken 7-30-2012.</p>	
<p>phillips_c_20120828_170.jpg</p>

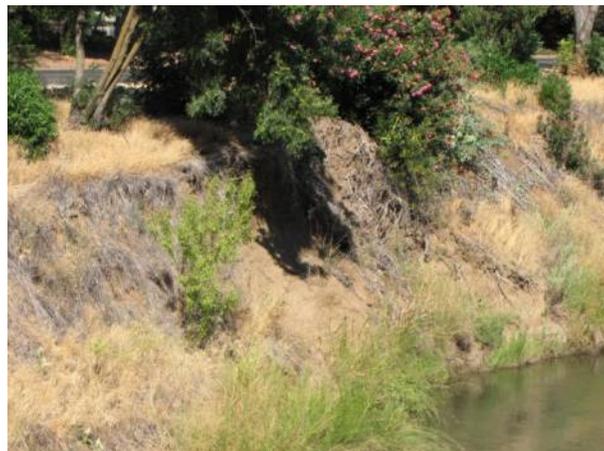
Levee Mile Report Line	33
Start Levee Mile	0.00
End Levee Mile	0.00
Location	
Category	Channels
Item	Erosion / Bank Caving
<p>Erosion upstream from bridge right bank levee slope. This erosion was noted in the inspection 2011 Report. No change. 2012.</p>	
<p>phillips_c_20120830_175.jpg</p>

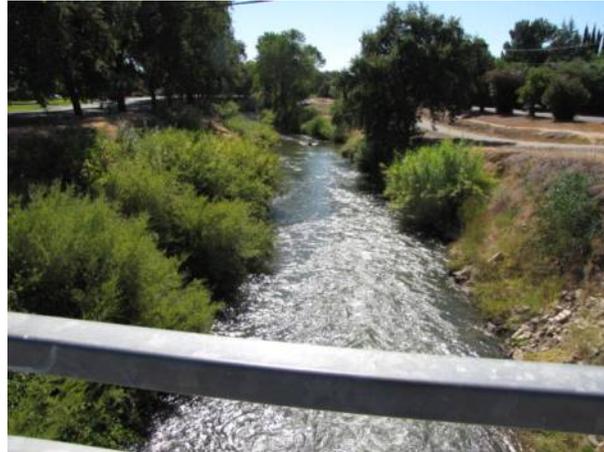
phillips_c_20120830_176.jpg

Bear Creek looking downstream from McKee Rd. Vegetation present on left bank flow not impeded. Photo taken 7-30-2012.

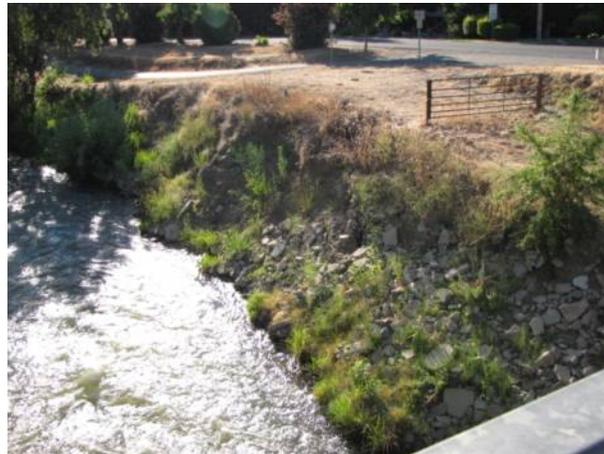
phillips_c_20120611_053.jpg

Levee Mile Report Line	38
Start Levee Mile	0.00
End Levee Mile	0.00
Location	
Category	Channels
Item	Erosion / Bank Caving

Looking downstream from McKee Rd crossing erosion present on the right bank. This photo was taken 7-30-2012. This erosion hasn't change since last year.

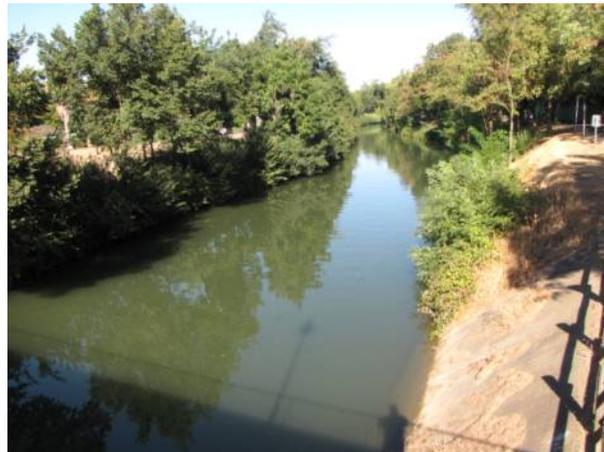
phillips_c_20120830_178.jpg

Bear Creek looking upstream from R St. crossing. Photo taken 7-30-2012.

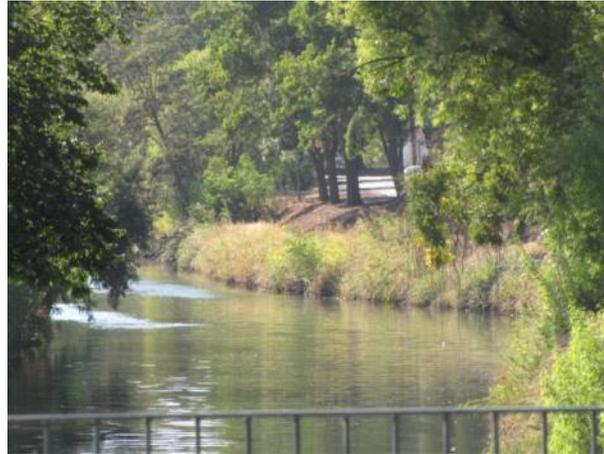
phillips_c_20120830_179.jpg

Bear Creek looking downstream from R St. crossing Vegetation not blocking channel. Photo taken 7-30-2012.

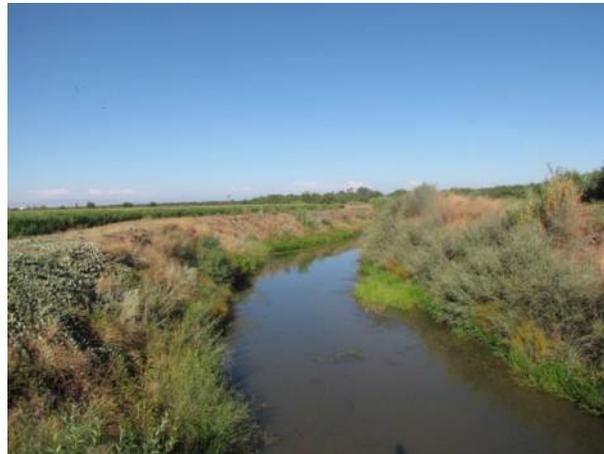
phillips_c_20120830_180.jpg

Bear Creek looking upstream from Franklin Rd crossing. Photo taken 7-30-2012.

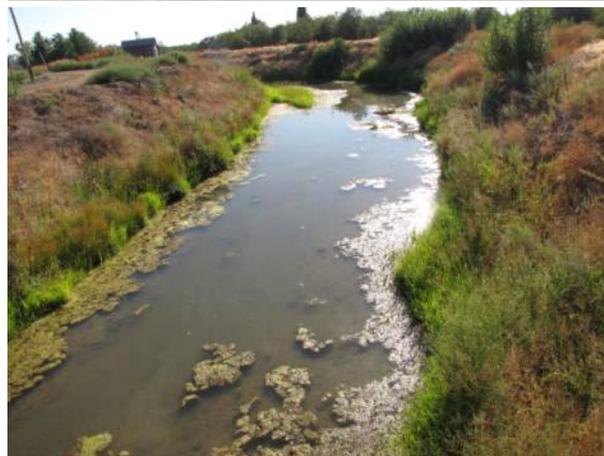
phillips_c_20120830_181.jpg

Bear Creek looking downstream from Franklin Rd crossing. Photo taken 7-30-2012.

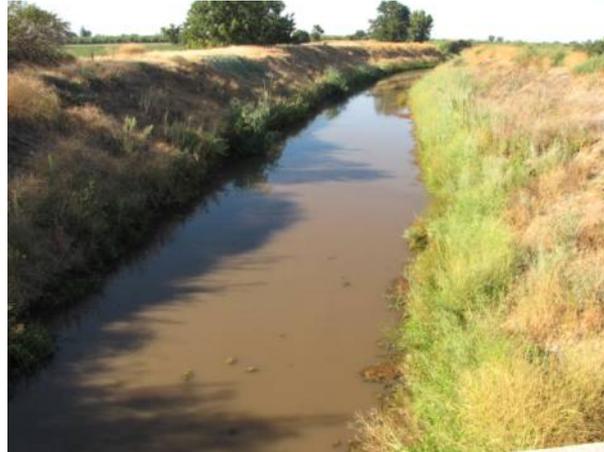
phillips_c_20120830_182.jpg

Bear Creek looking upstream from Hwy 140. Photo taken 7-30-2012.

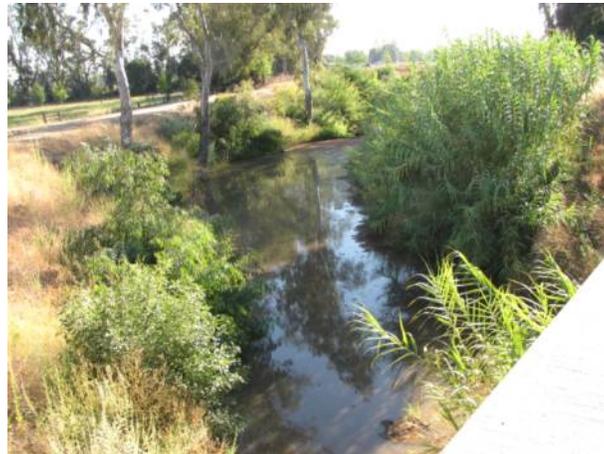
phillips_c_20120830_183.jpg

Bear Creek looking downstream from Hwy 140. Photo taken 7-30-2012. Vegetation on banks and in channel.

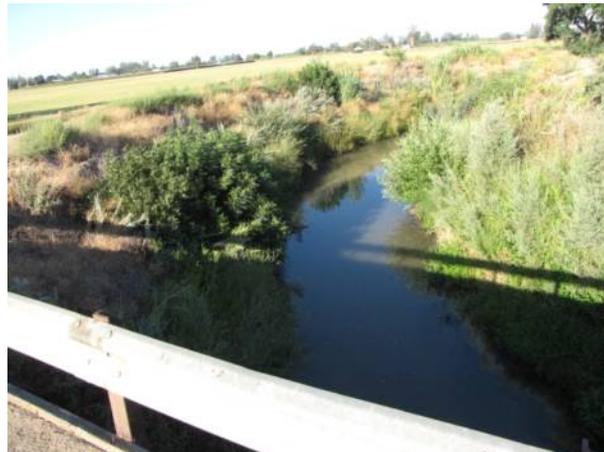
phillips_c_20120830_184.jpg

Bear Creek Looking upstream from Buhach Rd. Vegetation heavy on both banks. Photo taken 7-30-2012.

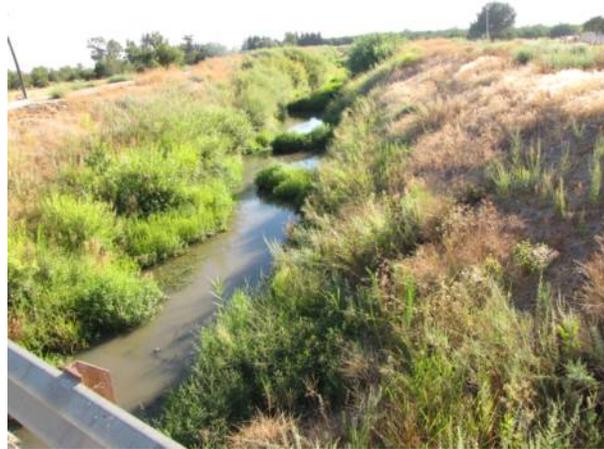
Levee Mile Report Line	76
Start Levee Mile	0.00
End Levee Mile	0.00
Location	
Category	Channels
Item	Vegetation & Obstructions
<p>Bear Creek looking downstream from Buhach Rd. Photo taken 7-30-2012. Vegetation partially blocking creek.</p>	
<p>phillips_c_20120830_185.jpg</p>

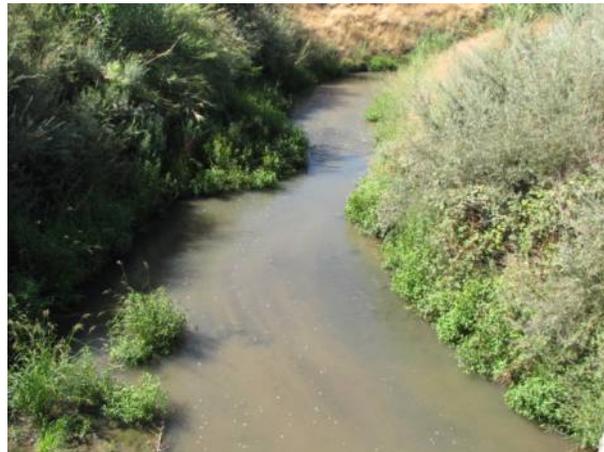
Levee Mile Report Line	86
Start Levee Mile	0.00
End Levee Mile	0.00
Location	
Category	Channels
Item	Vegetation & Obstructions
<p>Bear Creek looking downstream from Dickerson Ferry Rd. Photo taken 7-30-2012. Vegetation on both banks and in channel.</p>	
<p>phillips_c_20120830_187.jpg</p>

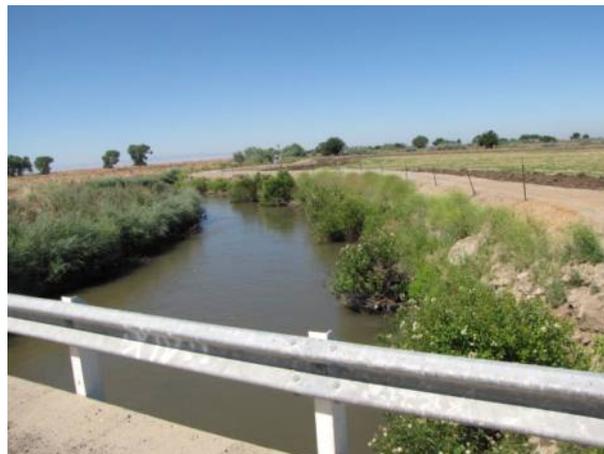
Levee Mile Report Line	96
Start Levee Mile	0.00
End Levee Mile	0.00
Location	
Category	Channels
Item	Vegetation & Obstructions
Bert Crane Rd. Crossing the Bear Creek looking downstream. Photo taken 7-30-2012	
phillips_c_20120611_065.jpg

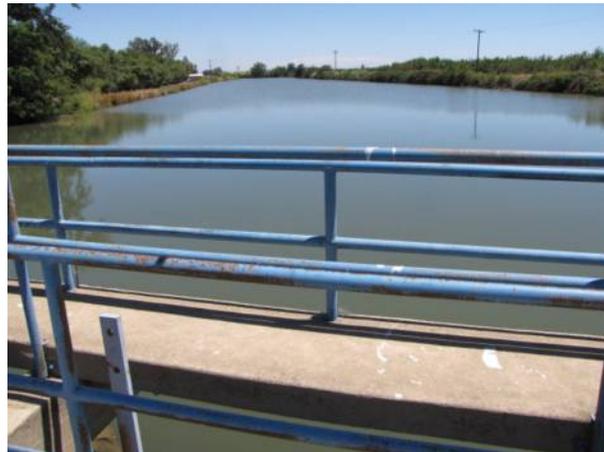
Levee Mile Report Line	11
Start Levee Mile	0.00
End Levee Mile	0.00
Location	
Category	Channels
Item	Vegetation & Obstructions
Black Rascal from structure crossing looking upstream. Photo taken 8-1-2012.	
phillips_c_20120816_130.jpg

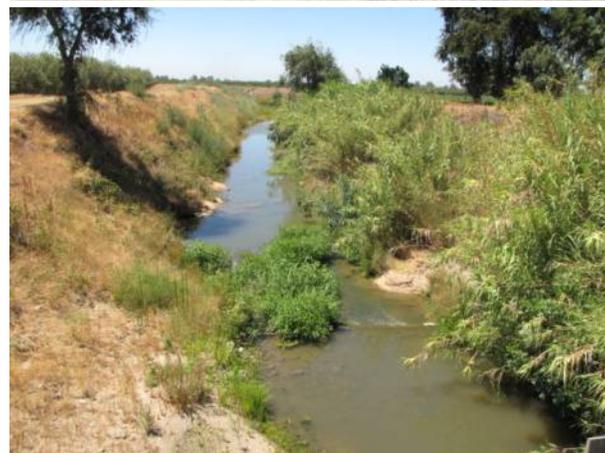
Levee Mile Report Line	26
Start Levee Mile	0.00
End Levee Mile	0.00
Location	
Category	Channels
Item	Vegetation & Obstructions
<p>Black Rascal Creek from Franklin Road crossing. Photo taken 8-1-2012.</p>	
<p>phillips_c_20120817_133.jpg</p>

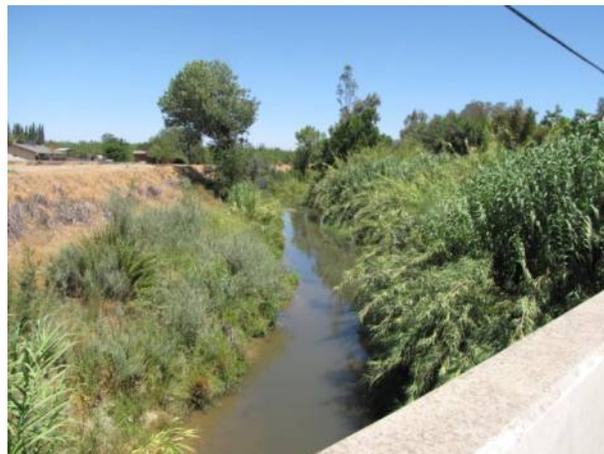
Levee Mile Report Line	41
Start Levee Mile	0.00
End Levee Mile	0.00
Location	
Category	Channels
Item	Vegetation & Obstructions
Black Rascal Creek from Hwy. 140 looking upstream. Photo taken 8-1-2012.	
phillips_c_20120817_136.jpg

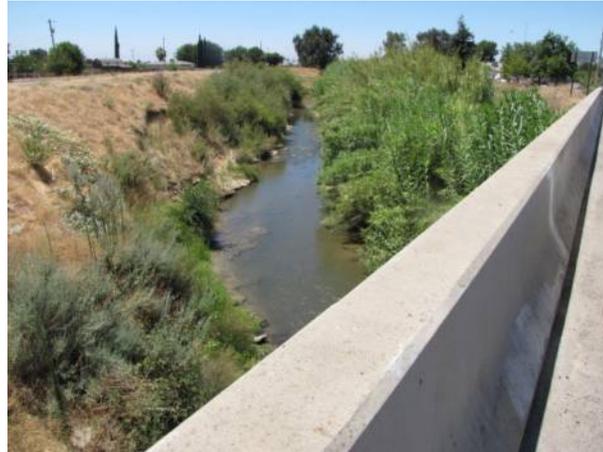
Levee Mile Report Line	46
Start Levee Mile	0.00
End Levee Mile	0.00
Location	
Category	Channels
Item	Vegetation & Obstructions
Black Rascal Creek looking downstream from Hwy 140. Photo taken 8-1-2012.	
phillips_c_20120817_137.jpg

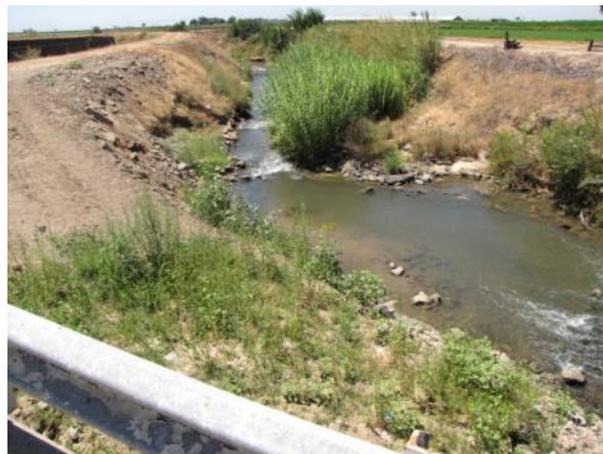
Levee Mile Report Line	55
Start Levee Mile	0.00
End Levee Mile	0.00
Location	
Category	Channels
Item	Vegetation & Obstructions
Black Rascal Creek looking downstream from Quinley Rd. Right on left banks there is a ramp creating a earthen dam. Photo taken 8-1-2012.	
phillips_c_20120817_139.jpg

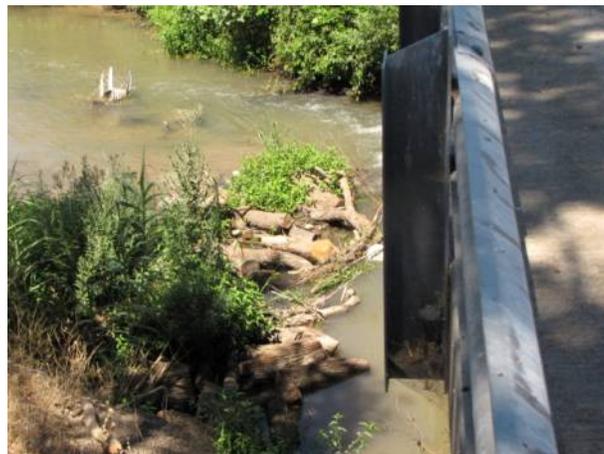
Levee Mile Report Line	70
Start Levee Mile	0.00
End Levee Mile	0.00
Location	
Category	Channels
Item	Encroachments
<p>Black Rascal Creek looking downstream from Oak Ave. bridge crossing fire wood dumped in channel along with material causing the channel to divert. Photo taken 8-1-2012.</p>	
<p>phillips_c_20120830_177.jpg</p>

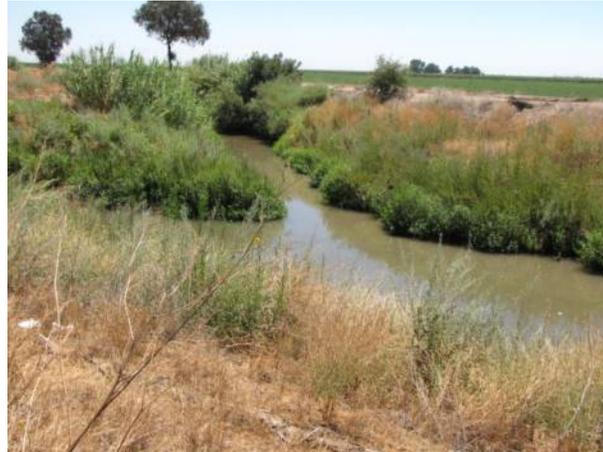
Levee Mile Report Line	71
Start Levee Mile	0.00
End Levee Mile	0.00
Location	
Category	Channels
Item	Vegetation & Obstructions
Looking upstream at the confluence of the Bear Creek merging into the Black Rascal Creek. Photo taken 8-1-2012.	
phillips_c_20120822_142.jpg

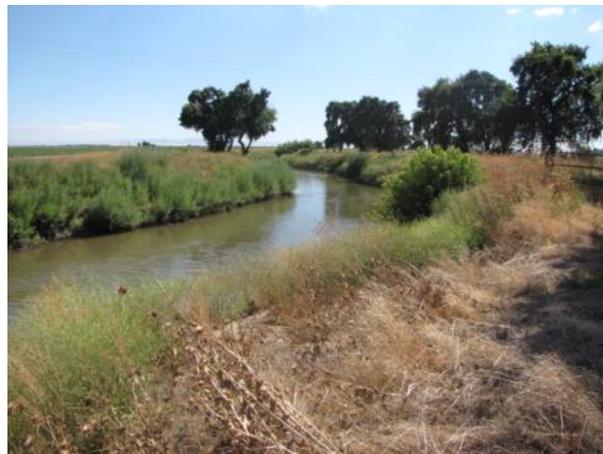
Levee Mile Report Line	76
Start Levee Mile	0.00
End Levee Mile	0.00
Location	
Category	Channels
Item	Vegetation & Obstructions
Looking downstream at Black Rascal Creek down from the confluence. 8-1-2012	
phillips_c_20120611_086.jpg

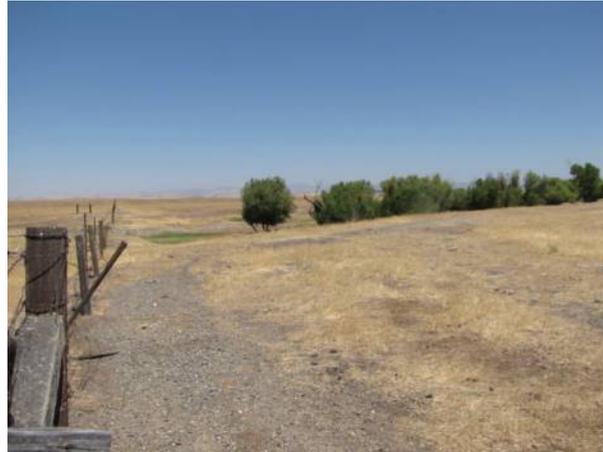
Levee Mile Report Line	1
Start Levee Mile	0.00
End Levee Mile	0.00
Location	
Category	Channels
Item	Vegetation & Obstructions
Mariposa Creek looking upstream from White Rock Road. Photo taken 7-26-2012.	
phillips_c_20120904_189.jpg

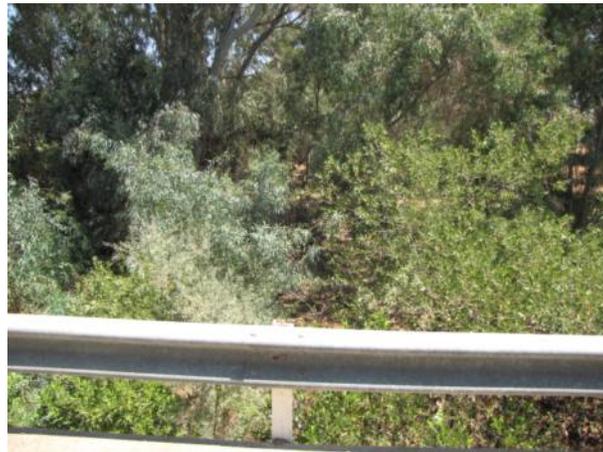
Levee Mile Report Line	11
Start Levee Mile	0.00
End Levee Mile	0.00
Location	
Category	Channels
Item	Vegetation & Obstructions
Mariposa Creek looking upstream from Fresno Road, channel overgrown with vegetation. Photo taken 7-26-2012.	
phillips_c_20120904_191.jpg

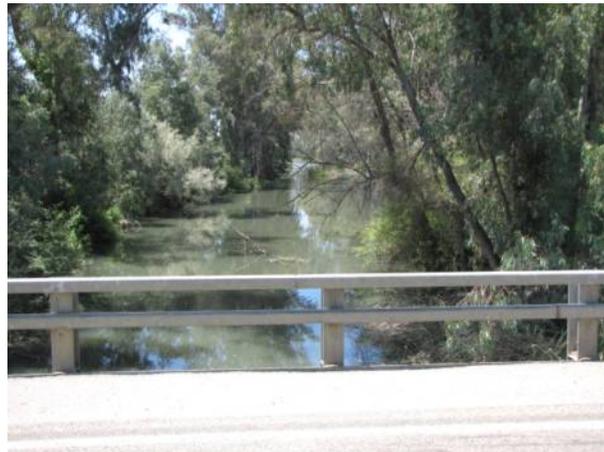
Levee Mile Report Line	26
Start Levee Mile	0.00
End Levee Mile	0.00
Location	
Category	Channels
Item	Vegetation & Obstructions
<p>Mariposa Creek looking downstream from Cunningham Road. Photo taken 7-26-2012.</p>	
<p>phillips_c_20120904_194.jpg</p>

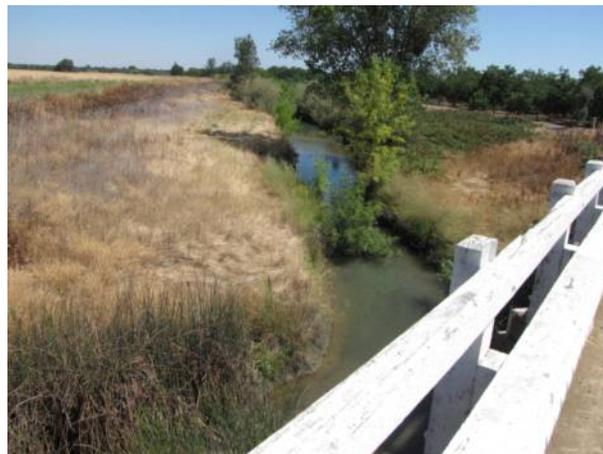
Levee Mile Report Line	41
Start Levee Mile	0.00
End Levee Mile	0.00
Location	
Category	Channels
Item	Vegetation & Obstructions
<p>Mariposa Creek looking upstream from Brucell Rd. crossing. Right off to the left bottom view is the Black Rascal Creek entering Mariposa Creek. Photo taken 7-26-2012.</p> <p>phillips_c_20120904_197.jpg</p>

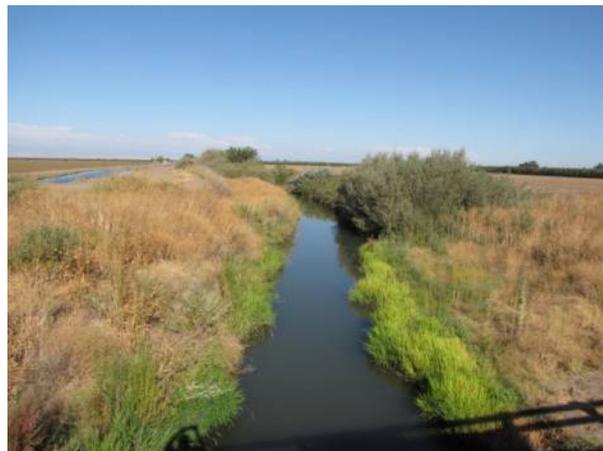
Levee Mile Report Line	51
Start Levee Mile	0.00
End Levee Mile	0.00
Location	
Category	Channels
Item	Vegetation & Obstructions
Mariposa Creek looking upstream from Plainsburg Rd. Photo taken 7-26-2012.	
phillips_c_20120904_200.jpg

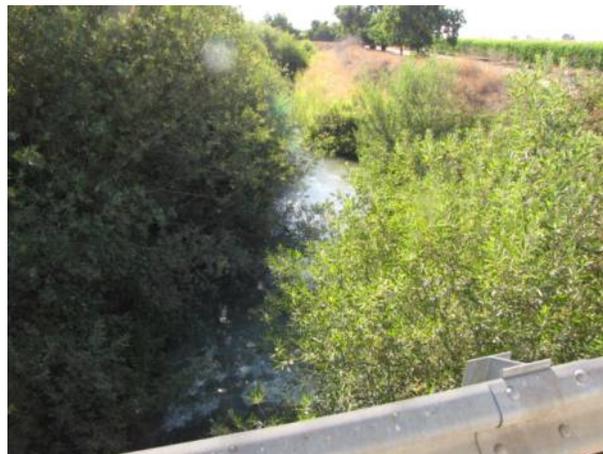
Levee Mile Report Line	66
Start Levee Mile	0.00
End Levee Mile	0.00
Location	
Category	Channels
Item	Vegetation & Obstructions
Mariposa Creek looking downstream from Whealan Rd. Right bank and left bank overgrown channel being choked with growth. Photo taken 7-26-2012.	
phillips_c_20120904_203.jpg

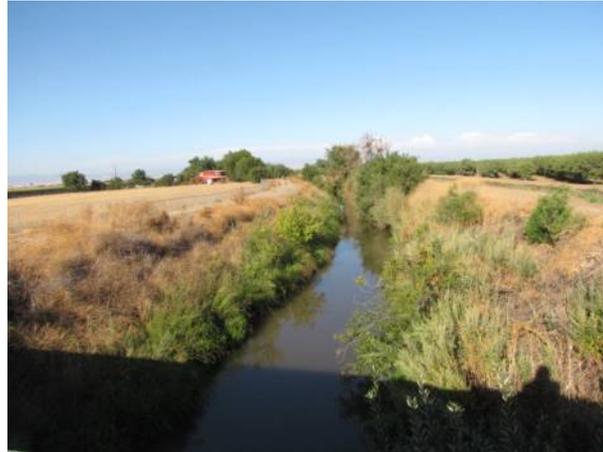
Levee Mile Report Line	71
Start Levee Mile	0.00
End Levee Mile	0.00
Location	
Category	Channels
Item	Vegetation & Obstructions
Mariposa Creek looking downstream from Arobelda Rd. Photo taken 7-26-2012.	
phillips_c_20120904_204.jpg

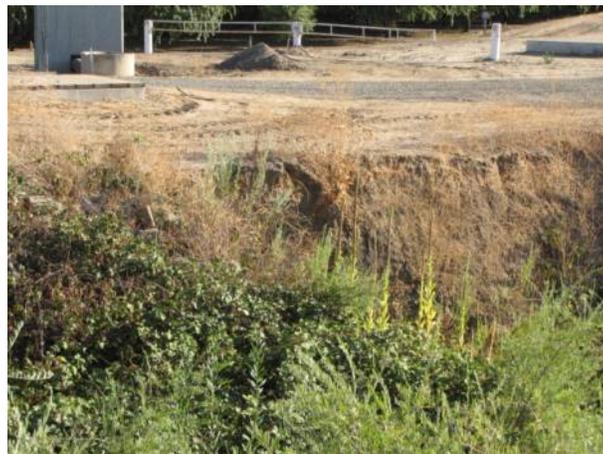
Levee Mile Report Line	78
Start Levee Mile	0.00
End Levee Mile	0.00
Location	
Category	Channels
Item	Erosion / Bank Caving
Mariposa Creek erosion on left bank, this erosion was noted in the last Channel Inspection 2011. This photo was taken 7-26-2012.	
phillips_c_20120904_206.jpg

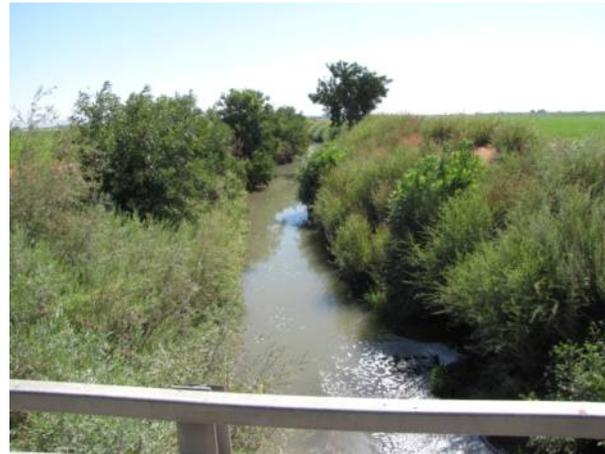
Levee Mile Report Line	81
Start Levee Mile	0.00
End Levee Mile	0.00
Location	
Category	Channels
Item	Vegetation & Obstructions
Mariposa Creek looking upstream from Healy Rd. Channel has wild growth on both banks.	
phillips_c_20120904_207.jpg

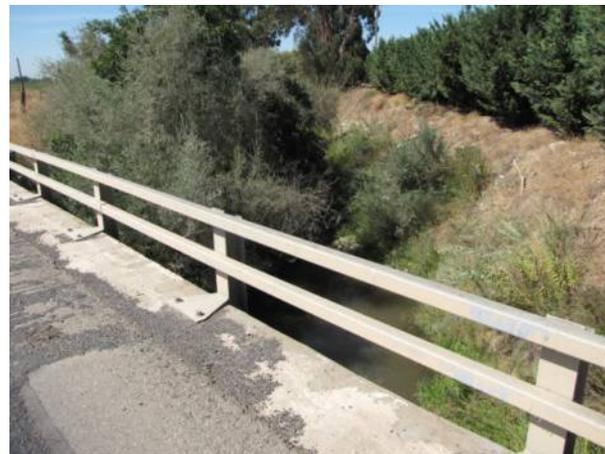
Levee Mile Report Line	86
Start Levee Mile	0.00
End Levee Mile	0.00
Location	
Category	Channels
Item	Vegetation & Obstructions
Mariposa Creek looking downstream from Healy Rd, wild growth in channel and on left bank slowing down the flow. Photo taken 7-26-2012.	
phillips_c_20120904_208.jpg

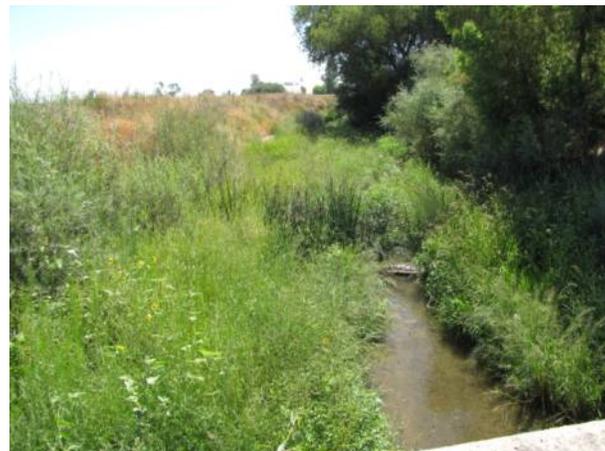
Levee Mile Report Line	91
Start Levee Mile	0.00
End Levee Mile	0.00
Location	
Category	Channels
Item	Vegetation & Obstructions
Mariposa Creek looking upstream from Hwy 59. Photo taken 7-26-2012.	
phillips_c_20120904_209.jpg

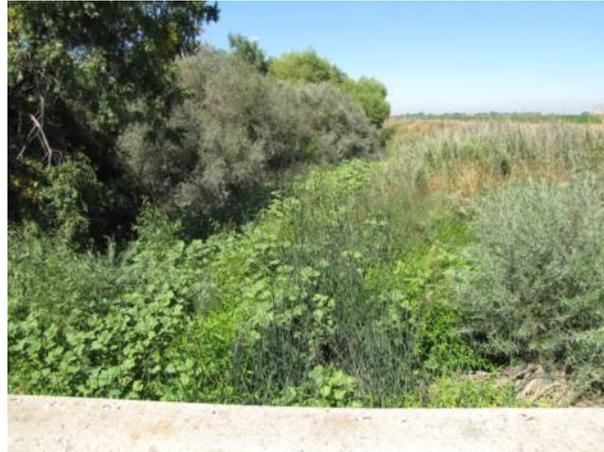
Levee Mile Report Line	96
Start Levee Mile	0.00
End Levee Mile	0.00
Location	
Category	Channels
Item	Vegetation & Obstructions
<p>Mariposa Creek Looking downstream from Hwy 59. Wild growth cover both banks and channel. Photo taken 7-26-2012.</p>	
<p>phillips_c_20120904_210.jpg</p>

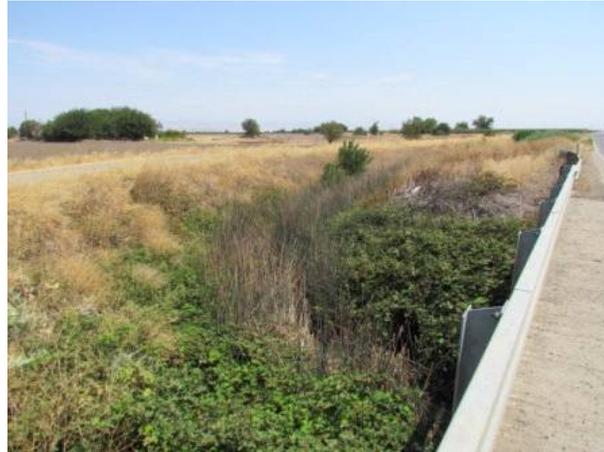
Levee Mile Report Line	1
Start Levee Mile	0.00
End Levee Mile	0.00
Location	
Category	Channels
Item	Vegetation & Obstructions
08/14/2012 Upstream view from Childs Ave. crossing.	
mkhashch_c_20120822_053.JPG

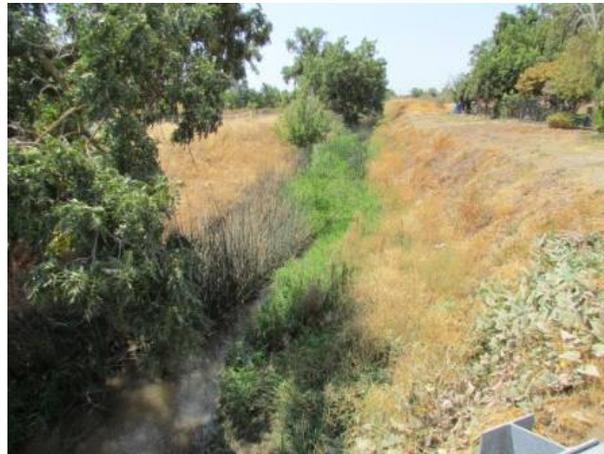
Levee Mile Report Line	6
Start Levee Mile	0.00
End Levee Mile	0.00
Location	
Category	Channels
Item	Vegetation & Obstructions
08/14/2012 Downstream view Childs Ave. crossing.	
mkhashch_c_20120822_054.JPG

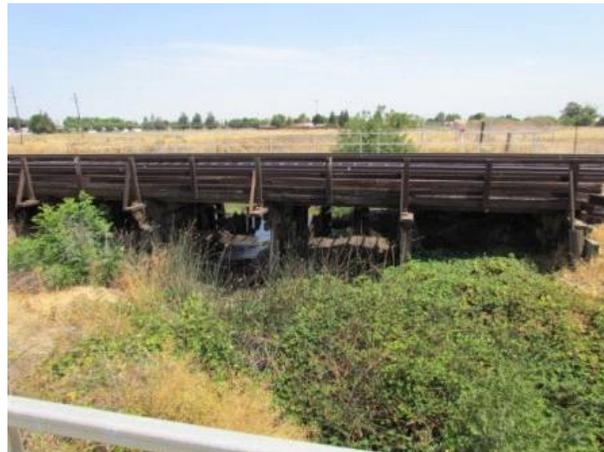
Levee Mile Report Line	11
Start Levee Mile	0.00
End Levee Mile	0.00
Location	
Category	Channels
Item	Vegetation & Obstructions
08/14/2012 Santa Fe Dr. crossing looking upstream.	
mkhashch_c_20120822_055.JPG

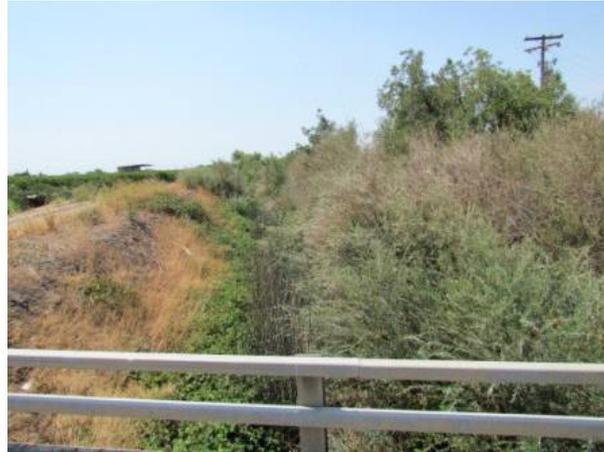
Levee Mile Report Line	16
Start Levee Mile	0.00
End Levee Mile	0.00
Location	
Category	Channels
Item	Vegetation & Obstructions
08/14/2012 Santa Fe Dr. crossing downstream view, note woody vegetation on right side of channel.	
mkhashch_c_20120822_056.JPG

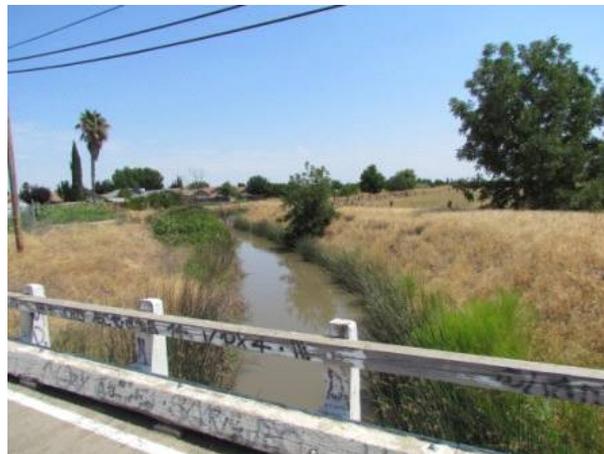
Levee Mile Report Line	21
Start Levee Mile	0.00
End Levee Mile	0.00
Location	
Category	Channels
Item	Vegetation & Obstructions
08/14/2012 Plainsburg Road upstream view.	
mkhashch_c_20120822_057.JPG

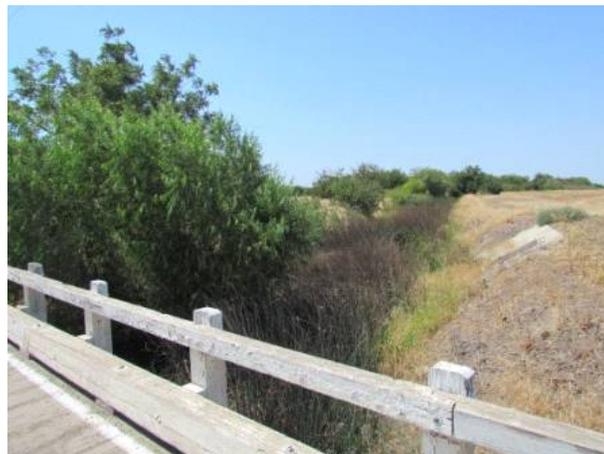
Levee Mile Report Line	26
Start Levee Mile	0.00
End Levee Mile	0.00
Location	
Category	Channels
Item	Vegetation & Obstructions
08/14/2012 Plainsburg Rd crossing, downstream view, Note woody vegetation on left side of channel.	
mkhashch_c_20120822_058.JPG

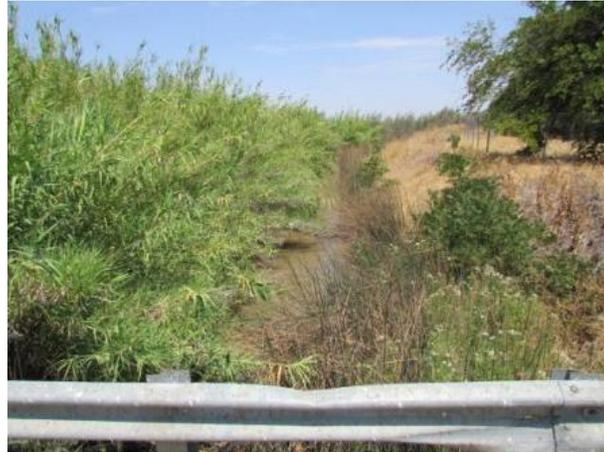
Levee Mile Report Line	31
Start Levee Mile	0.00
End Levee Mile	0.00
Location	
Category	Channels
Item	Vegetation & Obstructions
08/14/2012 Downstream view from Gerard Ave. crossing.	
mkhashch_c_20120822_059.JPG

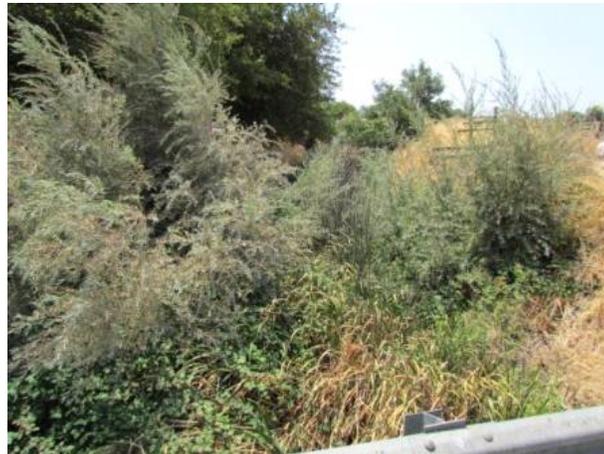
Levee Mile Report Line	36
Start Levee Mile	0.00
End Levee Mile	0.00
Location	
Category	Channels
Item	Vegetation & Obstructions
08/14/2012 Downstream view from Gerard Ave. crossing.	
mkhashch_c_20120822_060.JPG

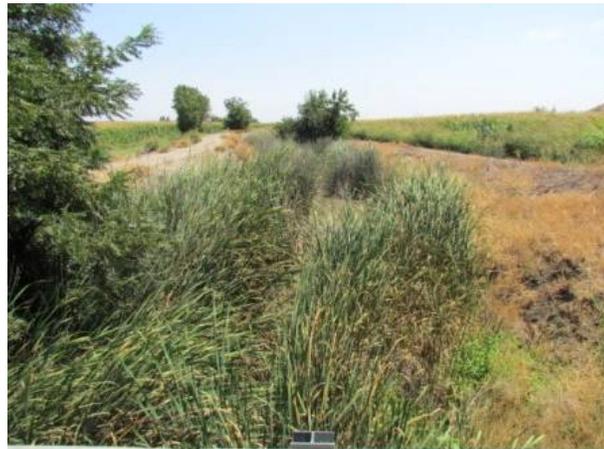
Levee Mile Report Line	41
Start Levee Mile	0.00
End Levee Mile	0.00
Location	
Category	Channels
Item	Vegetation & Obstructions
08/14/2012 Downstream view from Whealan Rd. crossing.	
mkhashch_c_20120822_061.JPG

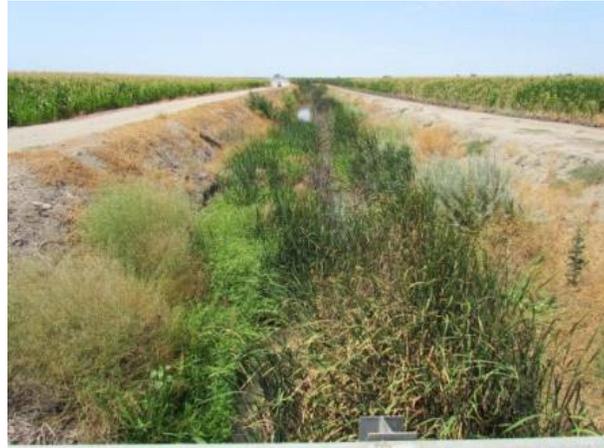
Levee Mile Report Line	46
Start Levee Mile	0.00
End Levee Mile	0.00
Location	
Category	Channels
Item	Vegetation & Obstructions
08/14/2012 Downstream view from Whealan Rd. crossing.	
mkhashch_c_20120822_062.JPG

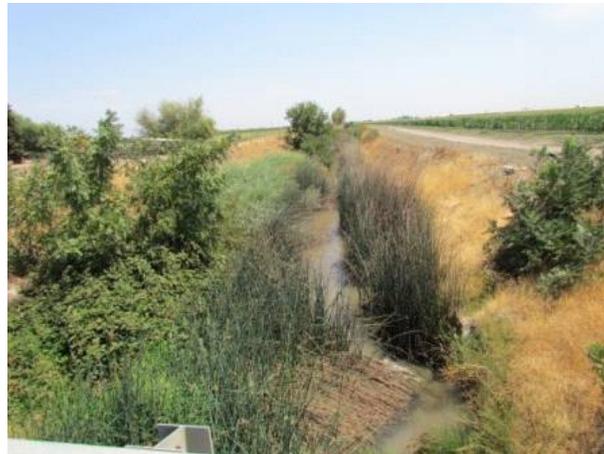
Levee Mile Report Line	51
Start Levee Mile	0.00
End Levee Mile	0.00
Location	
Category	Channels
Item	Vegetation & Obstructions
08/14/2012 Upstream view from Arboleda Dr. crossing.	
mkhashch_c_20120822_063.JPG

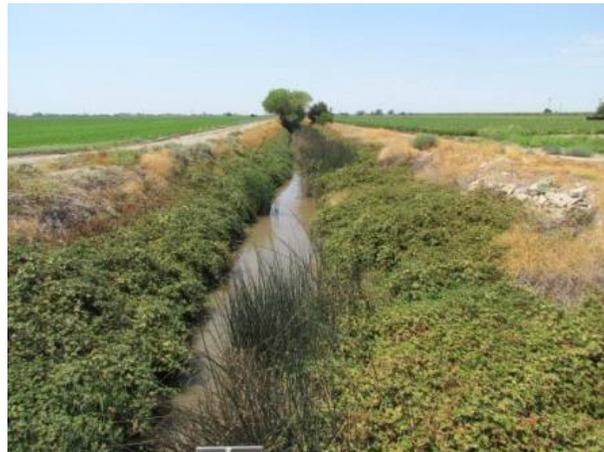
Levee Mile Report Line	56
Start Levee Mile	0.00
End Levee Mile	0.00
Location	
Category	Channels
Item	Vegetation & Obstructions
08/14/2012 Downstream view from Arboleda Dr. crossing	
mkhashch_c_20120822_064.JPG

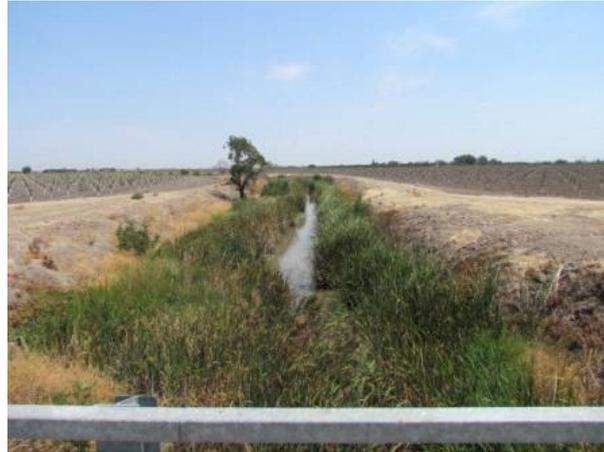
Levee Mile Report Line	61
Start Levee Mile	0.00
End Levee Mile	0.00
Location	
Category	Channels
Item	Vegetation & Obstructions
08/14/2012 Upstream view from Archard Rd. crossing.	
mkhashch_c_20120822_065.JPG

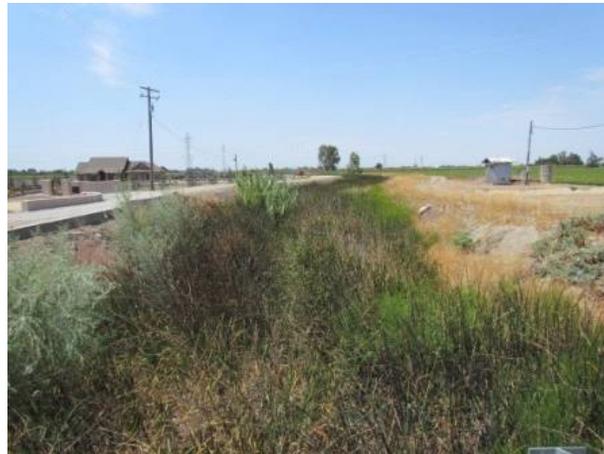
Levee Mile Report Line	66
Start Levee Mile	0.00
End Levee Mile	0.00
Location	
Category	Channels
Item	Vegetation & Obstructions
08/14/2012 Downstream view from Orchard Rd. crossing.	
mkhashch_c_20120822_066.JPG

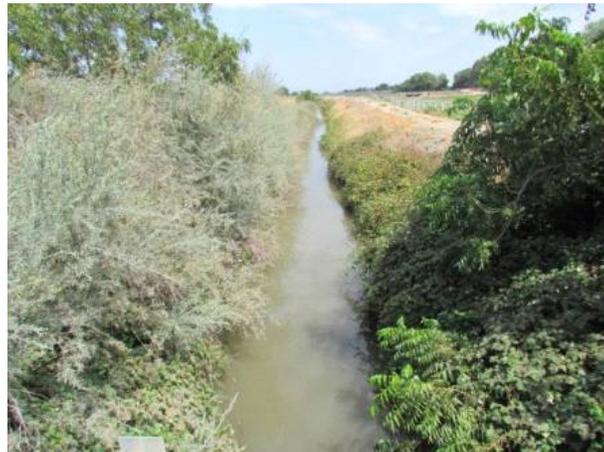
Levee Mile Report Line	71
Start Levee Mile	0.00
End Levee Mile	0.00
Location	
Category	Channels
Item	Vegetation & Obstructions
08/14/2012 Upstream view from Healy Rd. crossing.	
mkhashch_c_20120822_067.JPG

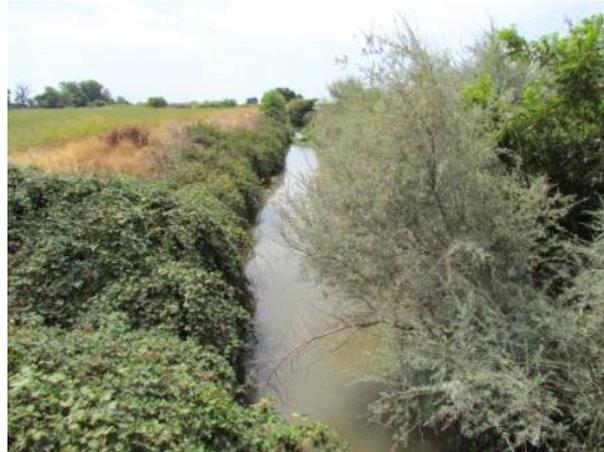
Levee Mile Report Line	76
Start Levee Mile	0.00
End Levee Mile	0.00
Location	
Category	Channels
Item	Vegetation & Obstructions
08/14/2012 Downstream view from Healy Rd. crossing.	
mkhashch_c_20120822_068.JPG

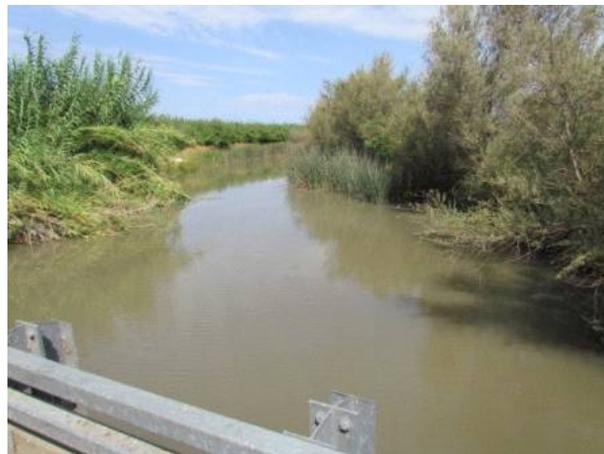
Levee Mile Report Line	81
Start Levee Mile	0.00
End Levee Mile	0.00
Location	
Category	Channels
Item	Vegetation & Obstructions
08/14/2012 Upstream view from Tyler Rd. crossing.	
mkhashch_c_20120822_069.JPG

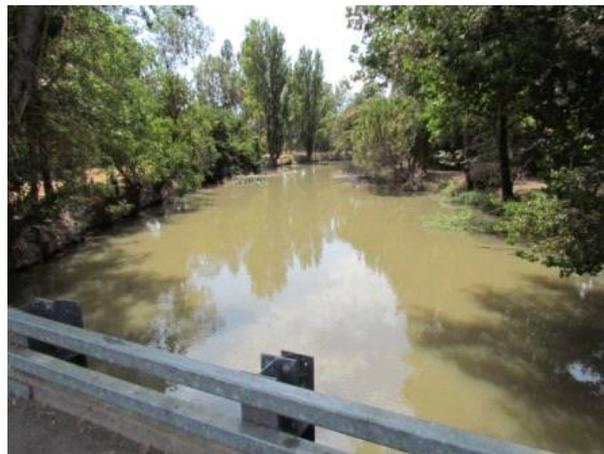
Levee Mile Report Line	86
Start Levee Mile	0.00
End Levee Mile	0.00
Location	
Category	Channels
Item	Vegetation & Obstructions
08/14/2012 Downstream view from Tyler Rd. crossing.	
mkhashch_c_20120822_070.JPG

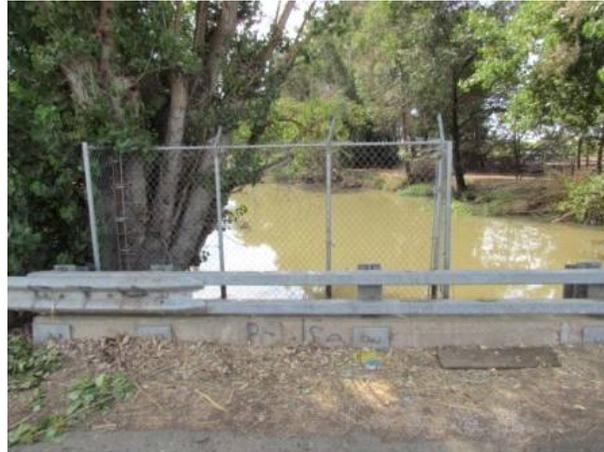
Levee Mile Report Line	90
Start Levee Mile	0.00
End Levee Mile	0.00
Location	
Category	Channels
Item	Encroachments
08/14/2012 View of the chain link fence encroaching into the channel on the left bank.	
mkhashch_c_20120822_071.JPG

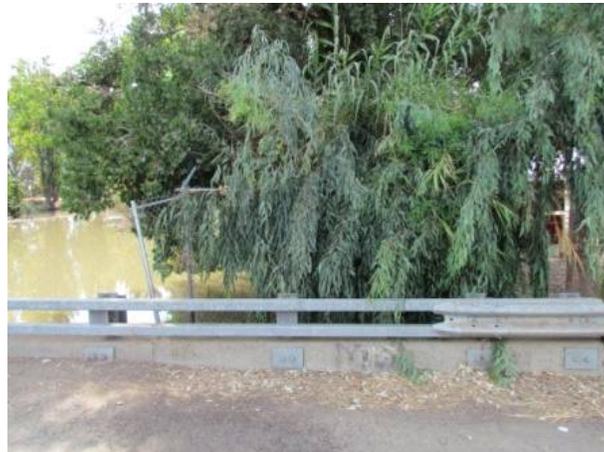
Levee Mile Report Line	90
Start Levee Mile	0.00
End Levee Mile	0.00
Location	
Category	Channels
Item	Encroachments
08/14/2012 View of the chain link fence encroaching into the channel on the right bank.	
mkhashch_c_20120822_072.JPG

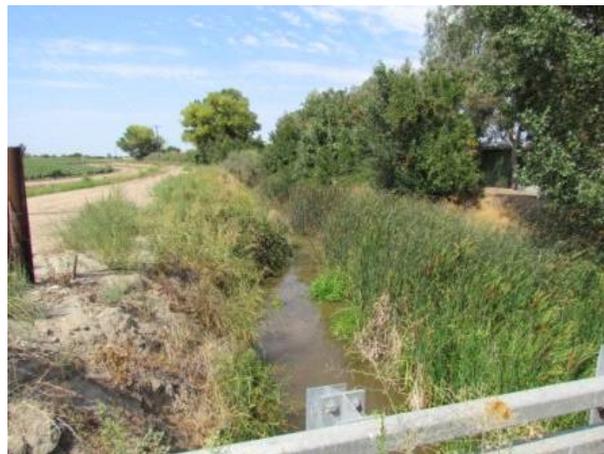
Levee Mile Report Line	91
Start Levee Mile	0.00
End Levee Mile	0.00
Location	
Category	Channels
Item	Vegetation & Obstructions
08/14/2012 Upstream view from Reilly Rd. crossing.	
mkhashch_c_20120822_073.JPG

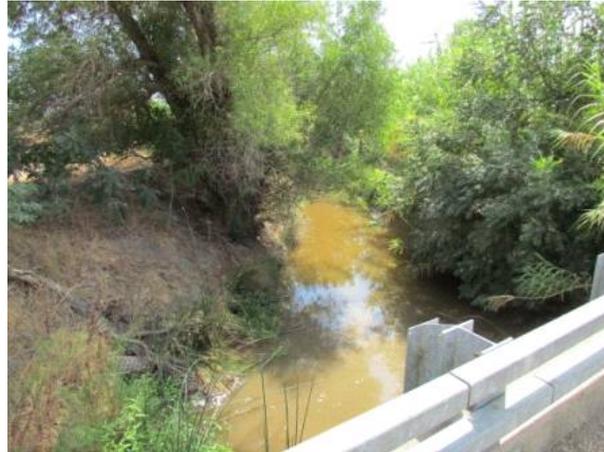
Levee Mile Report Line	96
Start Levee Mile	0.00
End Levee Mile	0.00
Location	
Category	Channels
Item	Vegetation & Obstructions
08/14/2012 Downstream view from Reilly Rd. crossing.	
mkhashch_c_20120822_074.JPG

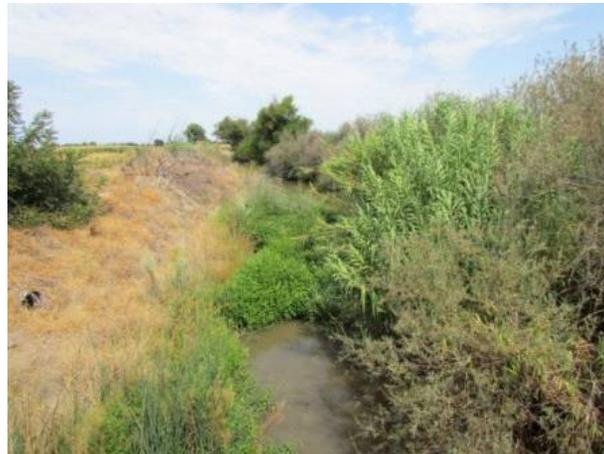
Levee Mile Report Line	101
Start Levee Mile	0.00
End Levee Mile	0.00
Location	
Category	Channels
Item	Vegetation & Obstructions
08/14/2012 Upstream view from Highway 59 crossing.	
mkhashch_c_20120822_075.JPG

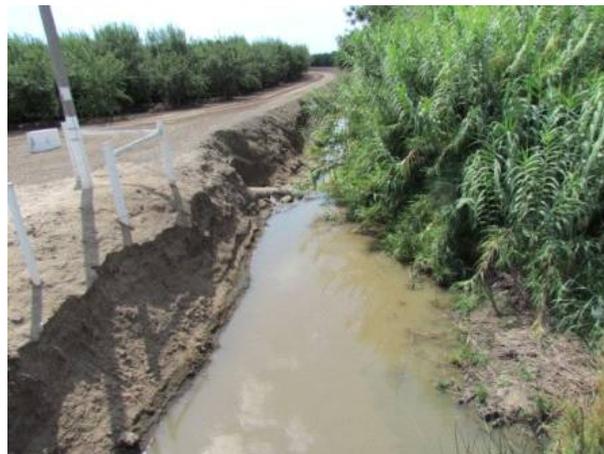
Levee Mile Report Line	106
Start Levee Mile	0.00
End Levee Mile	0.00
Location	
Category	Channels
Item	Vegetation & Obstructions
08/14/2012 Downstream view from Highway 59 crossing.	
mkhashch_c_20120822_076.JPG

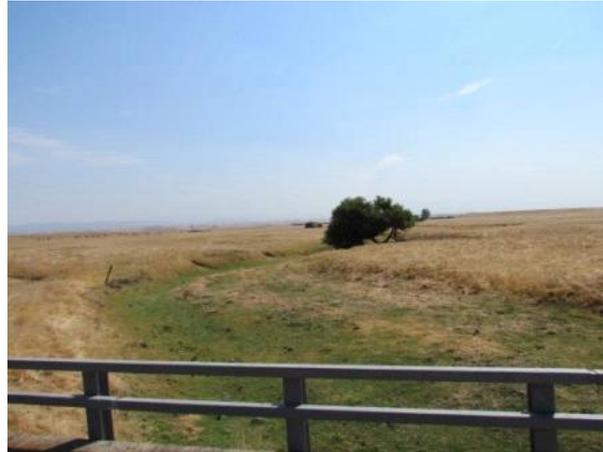
Levee Mile Report Line	1
Start Levee Mile	0.00
End Levee Mile	0.00
Location	
Category	Channels
Item	Vegetation & Obstructions
08/14/2012 Upstream view from Cunningham Road crossing.	
mkhashch_c_20120815_037.JPG

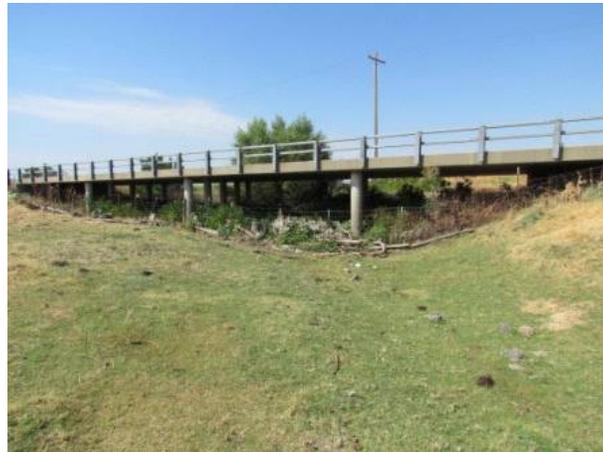
Levee Mile Report Line	5
Start Levee Mile	0.00
End Levee Mile	0.00
Location	
Category	Channels
Item	Encroachments
08/14/2012 Wire fence on upstream side of Cunningham crossing.	
mkhashch_c_20120815_038.JPG

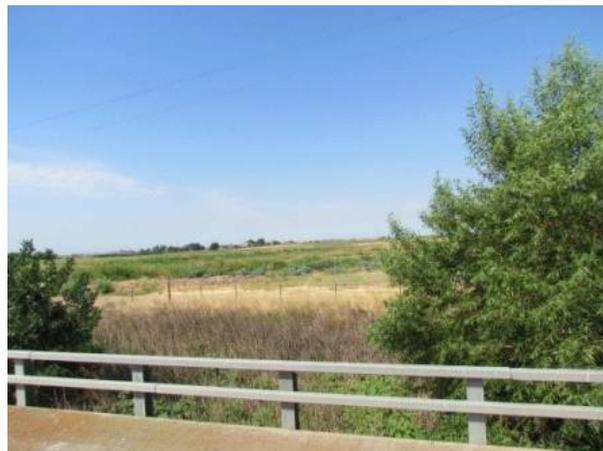
Levee Mile Report Line	6
Start Levee Mile	0.00
End Levee Mile	0.00
Location	
Category	Channels
Item	Vegetation & Obstructions
08/14/2012 Cunningham crossing downstream view.	
mkhashch_c_20120815_039.JPG

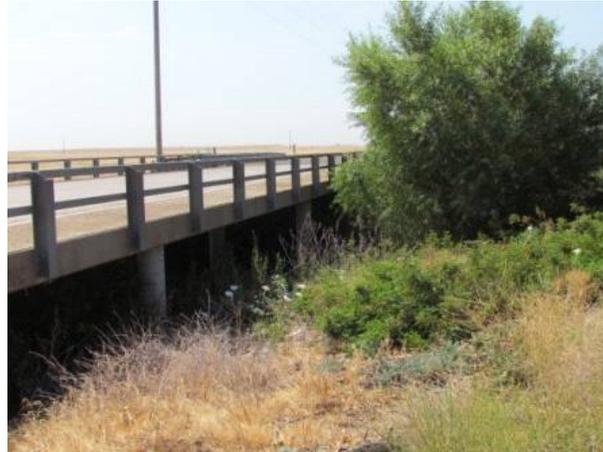
Levee Mile Report Line	10
Start Levee Mile	0.00
End Levee Mile	0.00
Location	
Category	Channels
Item	Encroachments
08/14/2012 Debris accumulated under bridge.	
mkhashch_c_20120815_041.JPG

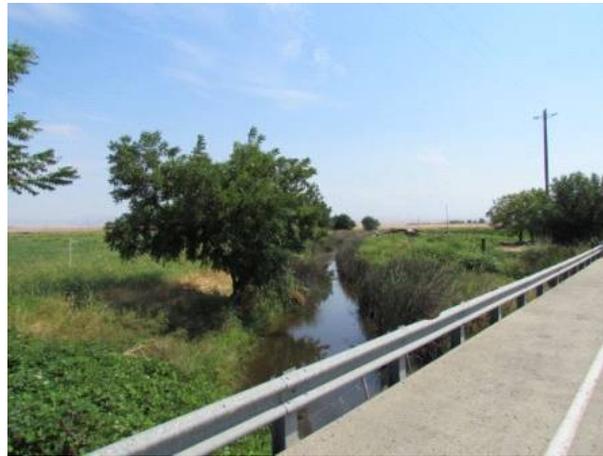
Levee Mile Report Line	11
Start Levee Mile	0.00
End Levee Mile	0.00
Location	
Category	Channels
Item	Vegetation & Obstructions
08/14/2012 Upstream view Childs Ave. crossing.	
mkhashch_c_20120815_040.JPG

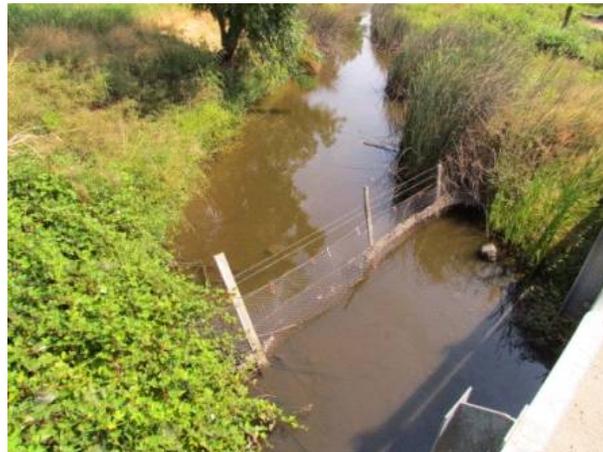
Levee Mile Report Line	15
Start Levee Mile	0.00
End Levee Mile	0.00
Location	
Category	Channels
Item	Encroachments
08/14/2012 Fence crossing channel upstream.	
mkhashch_c_20120815_042.JPG

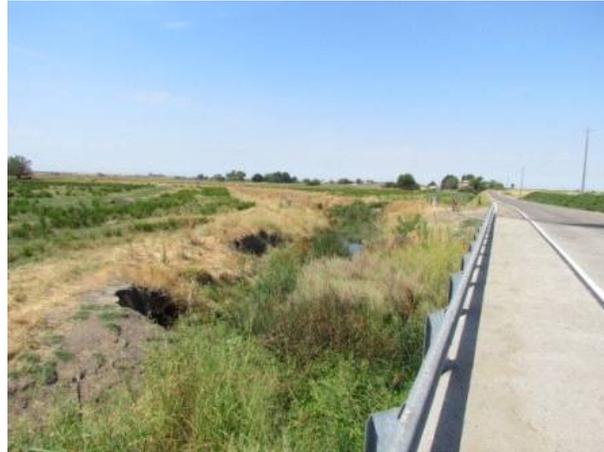
Levee Mile Report Line	16
Start Levee Mile	0.00
End Levee Mile	0.00
Location	
Category	Channels
Item	Vegetation & Obstructions
08/14/2012 View of downstream channel at Childs Ave.	
mkhashch_c_20120815_043.JPG

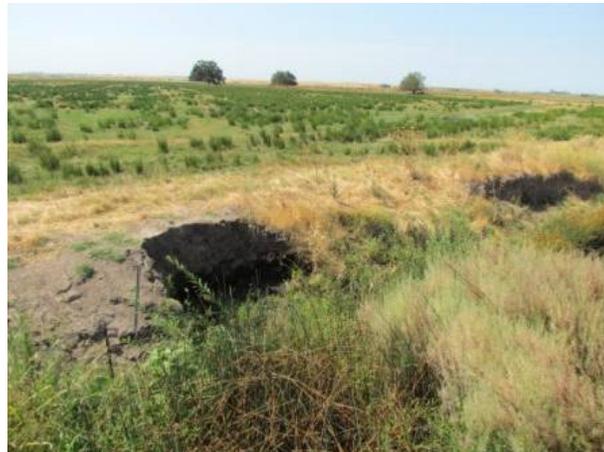
Levee Mile Report Line	18
Start Levee Mile	0.00
End Levee Mile	0.00
Location	
Category	Channels
Item	Erosion / Bank Caving
08/14/2012 View of bank caving.	
mkhashch_c_20120815_044.JPG

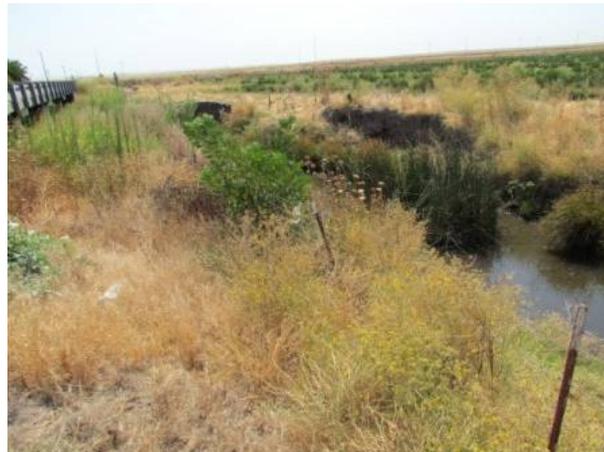
Levee Mile Report Line	20
Start Levee Mile	0.00
End Levee Mile	0.00
Location	
Category	Channels
Item	Encroachments
08/14/2012 Wire fence across channel downstream of Childs Ave. crossing.	
mkhashch_c_20120815_045.JPG
