**Flood Control Project Maintenance
Levee Inspections**

2012 Channel Summary Report

Merced Streams Group

2012 Channel Inspection Results

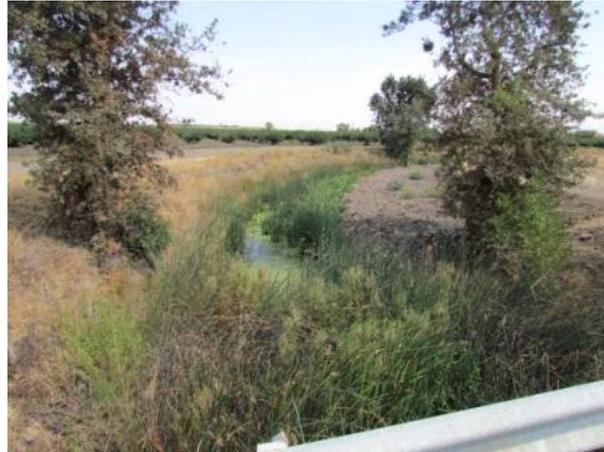
Levee Mile Report Line	21
Start Levee Mile	0.00
End Levee Mile	0.00
Location	
Category	Channels
Item	Vegetation & Obstructions
08/14/2012 Upstream view from Mission Ave. crossing.	
mkhashch_c_20120815_046.JPG

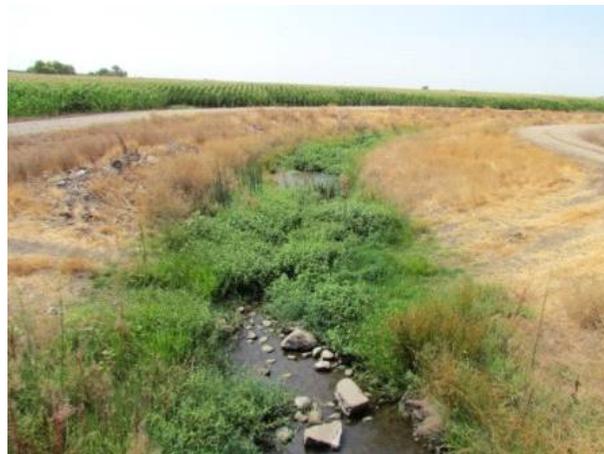
Levee Mile Report Line	26
Start Levee Mile	0.00
End Levee Mile	0.00
Location	
Category	Channels
Item	Vegetation & Obstructions
08/14/2012 Downstream view from Mission Ave. crossing.	
mkhashch_c_20120815_047.JPG

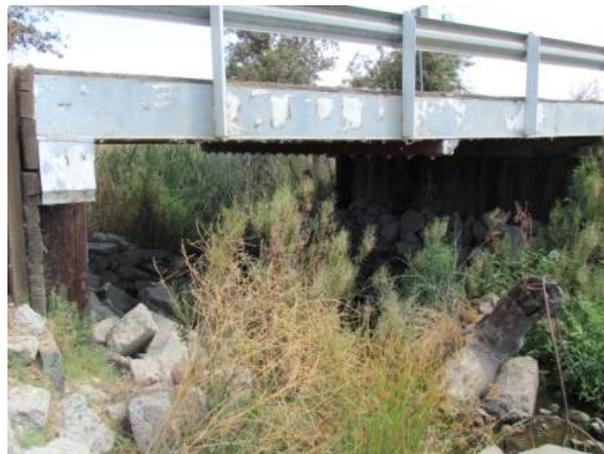
Levee Mile Report Line	29
Start Levee Mile	0.00
End Levee Mile	0.00
Location	
Category	Channels
Item	Revetments
08/14/2012 Mission Ave. crossing rip rap shown in channel.	
mkhashch_c_20120815_048.JPG

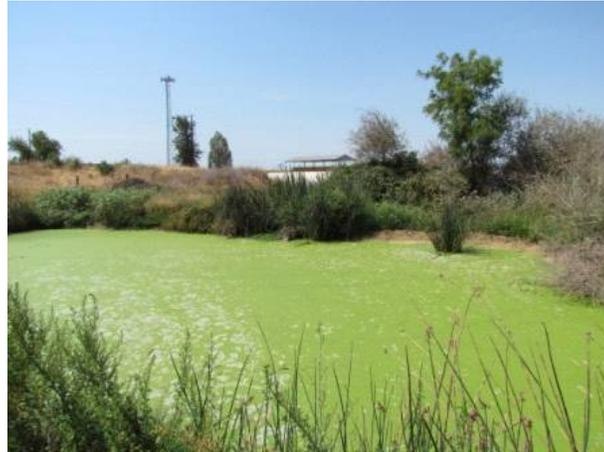
Levee Mile Report Line	31
Start Levee Mile	0.00
End Levee Mile	0.00
Location	
Category	Channels
Item	Vegetation & Obstructions
08/14/2012 Upstream view of Owens Creek at diversion.	
mkhashch_c_20120815_049.JPG

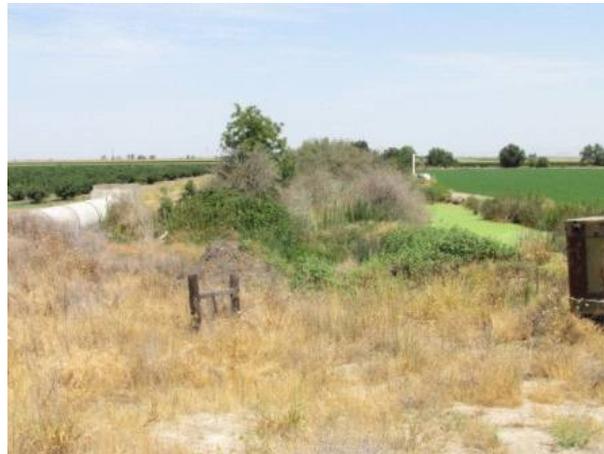
34		Up	Revetments		N	Inspector Comments: No revetments present at this location.	37.273619 ° -120.277469 °		34
35		Up	Encroachments		M	Inspector Comments: Possible excavation at this location, which appears to be impeding flow.	37.273619 ° -120.277469 °	Y	35
36		Down	Vegetation & Obstructions		A	Inspector Comments: Vegetation is noted but not enough to impeded flows.	37.273619 ° -120.277469 °	Y	36
37		Down	Shoaling / Sedimentation		A	Inspector Comments: No shoaling or sedimentation present.	37.273619 ° -120.277469 °		37
38		Down	Erosion / Bank Caving		A	Inspector Comments: No visible erosion or bank caving.	37.273619 ° -120.277469 °		38
39		Down	Revetments		N	Inspector Comments: No revetment observed.	37.273619 ° -120.277469 °		39
40		Down	Encroachments		A	Inspector Comments: No trash, debris or other encroachments noted at this location.	37.273619 ° -120.277469 °		40

Levee Mile Report Line	35
Start Levee Mile	0.00
End Levee Mile	0.00
Location	
Category	Channels
Item	Encroachments
08/14/2012 Photo shows what appears to be material placed in the channel, material is overgrown with vegetation, "Fresh" material can be seen in the center of the photo.	
mkhashch_c_20120815_050.JPG

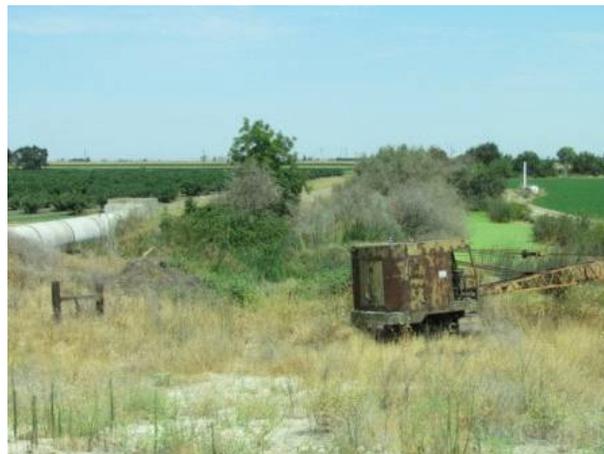
Levee Mile Report Line	35
Start Levee Mile	0.00
End Levee Mile	0.00
Location	
Category	Channels
Item	Encroachments
08/14/2012 View of excavating equipment.	
mkhashch_c_20120815_051.JPG

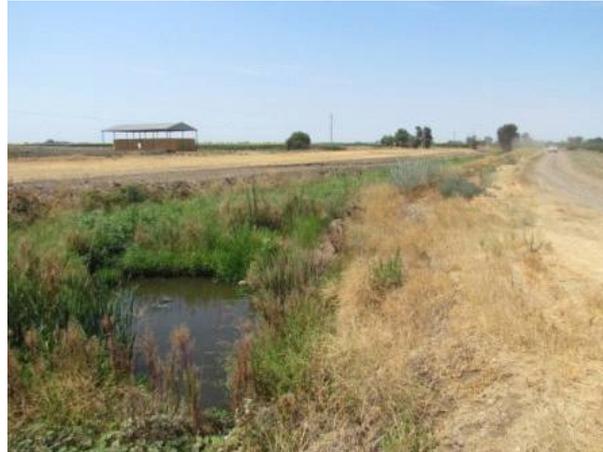
mkhashch_c_20120815_052.JPG

08/14/2012 View of downstream from the diversion.
