**Flood Control Project Maintenance
Levee Inspections**

2014 Channel Summary Report

Merced Streams Group

Levee Inspection Report By Mile - Channel 2014

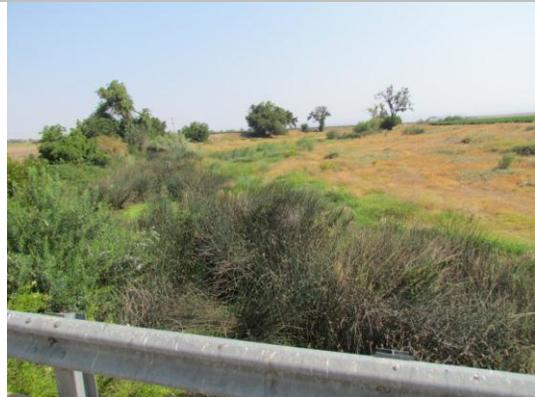
Photo 1 of 1 : CH_2014_NA0013_32_1_20140826_00026.jpg

Check Point / View			
Bonner Rd / Up			
Rating **	A	Issue No.	1
Issue Type +	Ma	Location *	GPS Lat/Long
Category	Rivers, Channels & Designated Flood		37.336900 °
Item	Vegetation & Obstructions		-120.311100 °
DWR ID	DWR_NA0013_32_c_2012_1		
Action/Comments			
Inspector Comments: Minimal, scattered obstructions or vegetation. The flow is not impeded.

Looking upstream from Bonner Road Bridge crossing the Bear Creek.

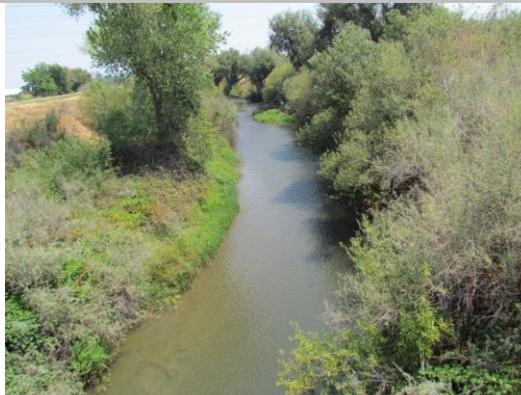
Photo 1 of 1 : CH_2014_NA0013_32_31_20140826_00030.jpg

Check Point / View			
Kibby Rd / Up			
Rating **	M	Issue No.	31
Issue Type +	Ma	Location *	
Category	Rivers, Channels & Designated Flood		GPS Lat/Long
Item	Vegetation & Obstructions		
DWR ID	DWR_NA0013_32_c_2012_31		
Action/Comments			
Inspector Comments: Vegetation present on both banks. Wild trees present on left bank and grasses on the right bank.

Kibby Road bridge crossing the Bear Creek looking upstream. Dense tree growth on the left bank and wild weeds on right bank.

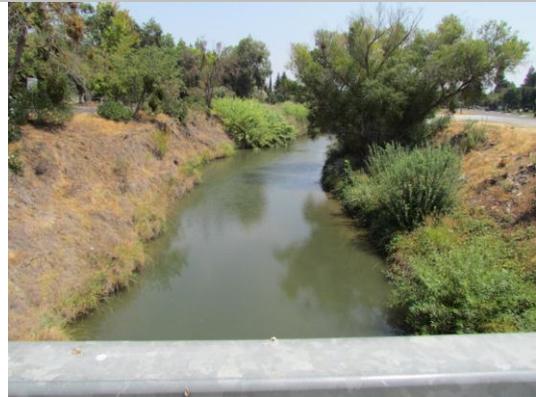
Photo 1 of 1 : CH_2014_NA0013_32_41_20140826_00033.jpg

Check Point / View			
McKee Rd / Up			
Rating **	A	Issue No.	41
Issue Type +	Ma	Location *	GPS Lat/Long
Category	Rivers, Channels & Designated Flood		37.309600 °
Item	Vegetation & Obstructions		
DWR ID	DWR_NA0013_32_c_2012_41		
Action/Comments			
Inspector Comments: There is an existence of vegetation present on both banks flow is not diverted.

McKee Road crossing the Bear Creek looking upstream.

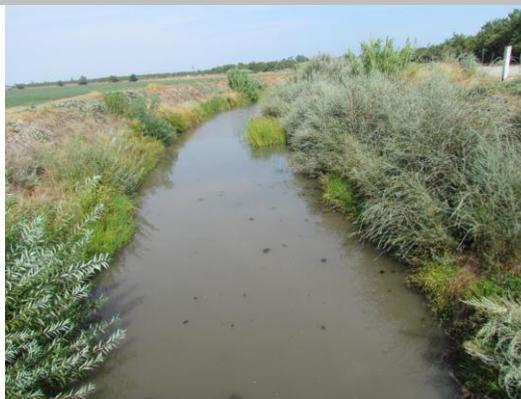
Photo 1 of 1 : CH_2014_NA0013_32_61_20140826_00040.jpg

Check Point / View			
Franklin Rd / Up			
Rating **	A	Issue No. 61	GPS Lat/Long
Issue Type +	Ma	Location *	37.311400 °
Category	Rivers, Channels & Designated Flood		-120.541000 °
Item	Vegetation & Obstructions		
DWR ID	DWR_NA0013_32_c_2012_61		
Action/Comments			
Inspector Comments: Minimal, scattered obstructions or vegetation. The flow is not impeded.

Bear Creek looking upstream from Franklin Road crossing.

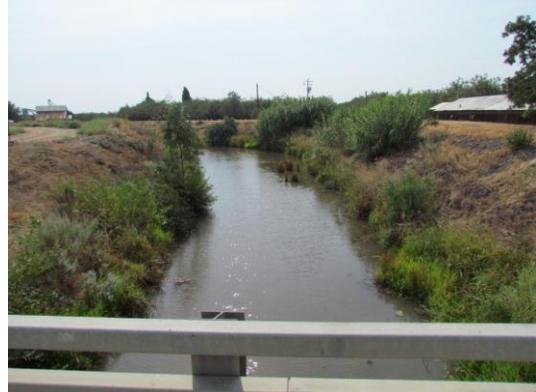
Photo 1 of 1 : CH_2014_NA0013_32_66_20140826_00041.jpg

Check Point / View			
Franklin Rd / Down			
Rating **	A	Issue No.	66
Issue Type +	Ma	Location *	37.311400 °
Category	Rivers, Channels & Designated Flood		-120.541000 °
Item	Vegetation & Obstructions		
DWR ID	DWR_NA0013_32_c_2012_66		
Action/Comments			
Inspector Comments: Minimal, scattered obstructions or vegetation. The flow is not impeded.

Looking downstream from the Franklin Road crossing the Bear Creek.

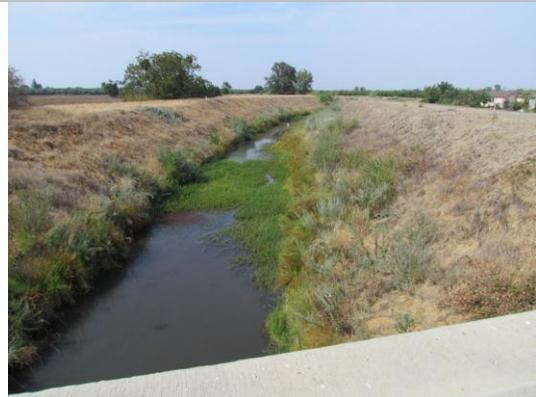
Photo 1 of 1 : CH_2014_NA0013_32_71_20140826_00042.jpg

Check Point / View			
Hwy 140 / Up			
Rating **	A	Issue No.	71
Issue Type +	Ma	Location *	GPS Lat/Long
Category	Rivers, Channels & Designated Flood		37.302500 °
Item	Vegetation & Obstructions		-120.551500 °
DWR ID	DWR_NA0013_32_c_2012_71		
Action/Comments			
Inspector Comments: Minimal, scattered obstructions of vegetation. The flow is not impeded.

Bear Creek looking upstream from Hwy 140 bridge crossing.

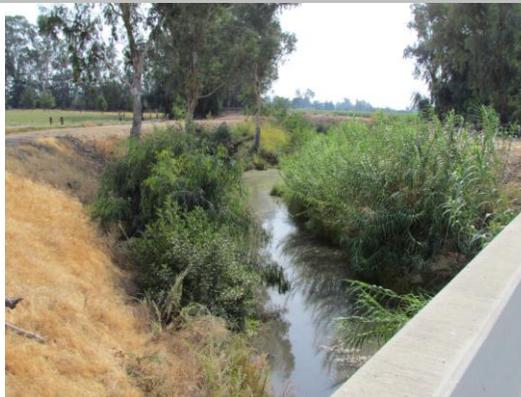
Photo 1 of 1 : CH_2014_NA0013_32_76_20140826_00043.jpg

Check Point / View			
Hwy 140 / Down			
Rating **	M	Issue No. 76	GPS Lat/Long
Issue Type +	Ma	Location *	37.302500 °
Category	Rivers, Channels & Designated Flood		-120.551500 °
Item	Vegetation & Obstructions		
DWR ID	DWR_NA0013_32_c_2012_76		
Action/Comments			
Inspector Comments: Log jams, snags, vegetation growth (such as cat tails, bull rushes, bushes or saplings) or other obstructions block approximately 25% of the FCW.

Bear Creek looking downstream from Hwy 140 bridge crossing young willows and arundo present on both banks.

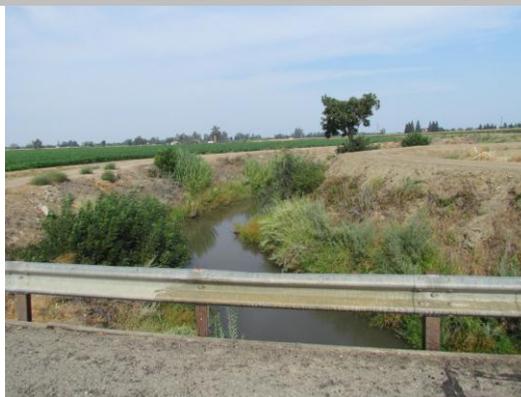
Photo 1 of 1 : CH_2014_NA0013_32_81_20140826_00044.jpg

Check Point / View			
Buhach Rd / Up			
Rating **	A	Issue No. 81	GPS Lat/Long
Issue Type +	Ma	Location *	37.291200 °
Category	Rivers, Channels & Designated Flood		-120.577900 °
Item	Vegetation & Obstructions		
DWR ID	DWR_NA0013_32_c_2012_81		
Action/Comments			
Inspector Comments: Minimal, scattered obstructions or vegetation. The flow is not impeded.

Bear Creek looking upstream from Buhach Road crossing.

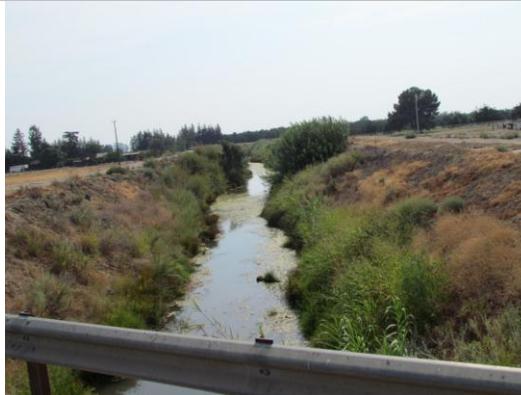
Photo 1 of 1 : CH_2014_NA0013_32_86_20140826_00045.jpg

Check Point / View			
Buhach Rd / Down			
Rating **	M	Issue No. 86	GPS Lat/Long
Issue Type +	Ma	Location *	37.291200 °
Category	Rivers, Channels & Designated Flood		-120.577900 °
Item	Vegetation & Obstructions		
DWR ID	DWR_NA0013_32_c_2012_86		
Action/Comments			
Inspector Comments: Channel partially blocked by grasses and weeds.

Bear Creek looking downstream from Buhach Road crossing.

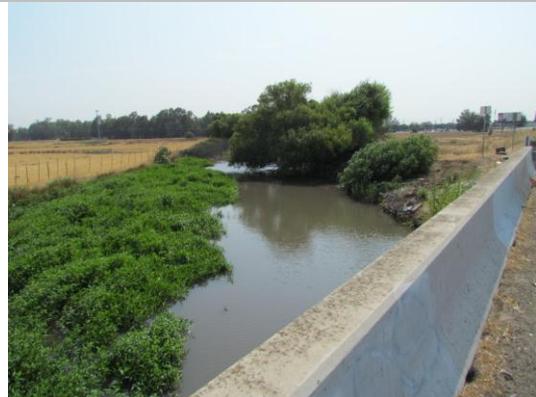
Photo 1 of 1 : CH_2014_NA0013_33_1_20140805_00020.jpg

Check Point / View			
Santa Fe Dr / Up			
Rating **	A	Issue No.	1
Issue Type +	Ma	Location *	GPS Lat/Long
Category	Rivers, Channels & Designated Flood		37.320720 °
Item	Vegetation & Obstructions		-120.508760 °
DWR ID	DWR_NA0013_33_c_2012_1		
Action/Comments			
Inspector Comments: Vegetation present along both banks and in the channel. Vegetation present along left bank at bridge.

Santa Fe Drive crossing the Black Rascal Creek looking upstream, plant growth present in channel.

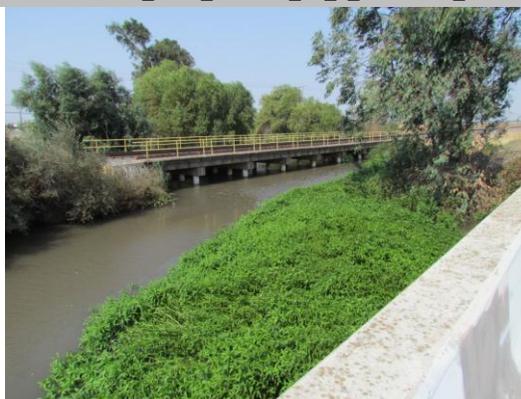
Photo 1 of 1 : CH_2014_NA0013_33_6_20140805_00021.jpg

Check Point / View			
Santa Fe Dr / Down			
Rating **	M	Issue No. 6	GPS Lat/Long
Issue Type +	Ma	Location *	37.320720 °
Category	Rivers, Channels & Designated Flood		-120.508760 °
Item	Vegetation & Obstructions		
DWR ID	DWR_NA0013_33_c_2012_6		
Action/Comments			
Inspector Comments: Vegetation present in channel downstream from bridge crossing.

Santa Fe Drive crossing Black Rascal Creek looking downstream from bridge. More plant growth present in channel on right bank.

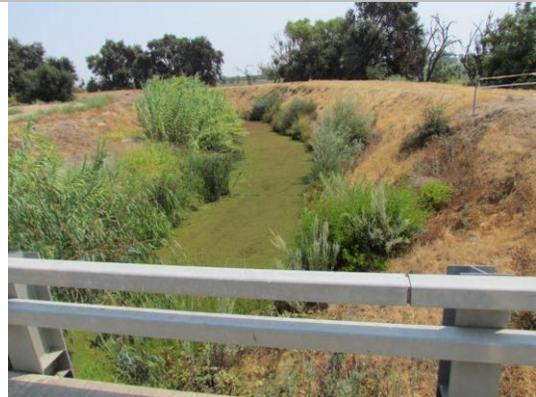
Photo 1 of 1 : CH_2014_NA0013_33_21_20140805_00025.jpg

Check Point / View				
Franklin Rd / Up				
Rating **	M	Issue No.	21	GPS Lat/Long
Issue Type +	Ma	Location *		37.314050 °
Category	Rivers, Channels & Designated Flood			-120.541078 °
Item	Vegetation & Obstructions			
DWR ID	DWR_NA0013_33_c_2012_21			
Action/Comments				
Inspector Comments: Minor vegetation in the channel.

Looking upstream from the Franklin Road crossing the Black Rascal Creek.

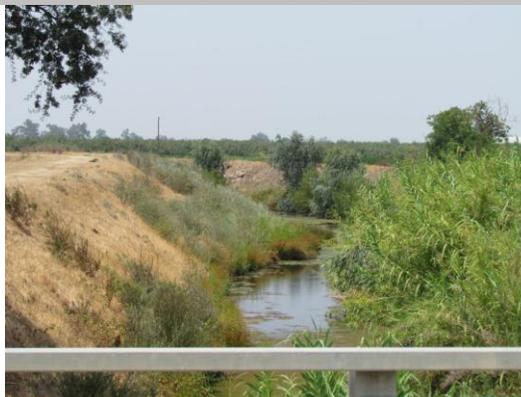
Photo 1 of 1 : CH_2014_NA0013_33_26_20140805_00027.jpg

Check Point / View			
Franklin Rd / Down			
Rating **	M	Issue No. 26	GPS Lat/Long
Issue Type +	Ma	Location *	37.314050 °
Category	Rivers, Channels & Designated Flood		-120.541078 °
Item	Vegetation & Obstructions		
DWR ID	DWR_NA0013_33_c_2012_26		
Action/Comments			
Inspector Comments: Vegetation is present on both banks of the Black Rascal Creek. Bambo growth increased from last inspection.

Looking downstream from the Franklin Road crossing the Black Rascal Creek. Arundo is present on the right bank and under the bridge.

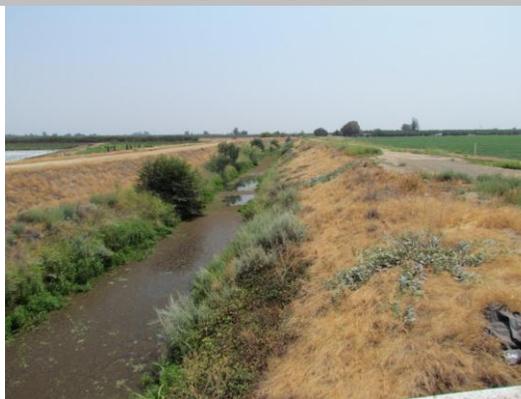
Photo 1 of 1 : CH_2014_NA0013_33_31_20140820_00028.jpg

Check Point / View				
Gurr Rd / Up				
Rating **	A	Issue No.	31	GPS Lat/Long
Issue Type +	Ma	Location *		37.313110 °
Category	Rivers, Channels & Designated Flood			-120.559070 °
Item	Vegetation & Obstructions			
DWR ID	DWR_NA0013_33_c_2012_31			
Action/Comments				
Inspector Comments: Minimal, scattered obstructions of vegetation. The flow is not impeded.

Black Rascal Creek looking upstream from Gurr Road crossing.

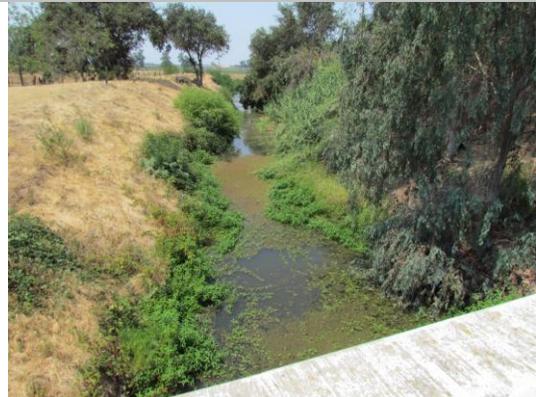
Photo 1 of 1 : CH_2014_NA0013_33_36_20140820_00029.jpg

Check Point / View				
Gurr Rd / Down				
Rating **	M	Issue No.	36	GPS Lat/Long
Issue Type +	Ma	Location *		37.313110 °
Category	Rivers, Channels & Designated Flood			-120.559070 °
Item	Vegetation & Obstructions			
DWR ID	DWR_NA0013_33_c_2012_36			
Action/Comments				
Inspector Comments: Vegetation on both banks and in channel.

Black Rascal Creek looking downstream from Gurr Road crossing.

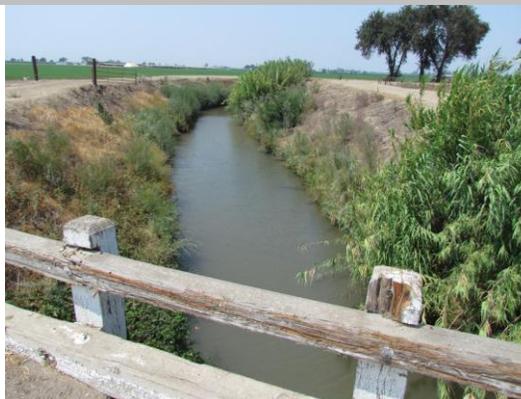
Photo 1 of 1 : CH_2014_NA0013_33_51_20140820_00032.jpg

Check Point / View			
Quinley Rd / Up			
Rating **	A	Issue No. 51	GPS Lat/Long
Issue Type +	Ma	Location *	37.293797 °
Category	Rivers, Channels & Designated Flood		-120.596922 °
Item	Vegetation & Obstructions		
DWR ID	DWR_NA0013_33_c_2012_51		
Action/Comments			
Inspector Comments: Growth in channel on left bank; arundo present. The flow is not impeded.

Black Rascal Creek from Quinley Road crossing .

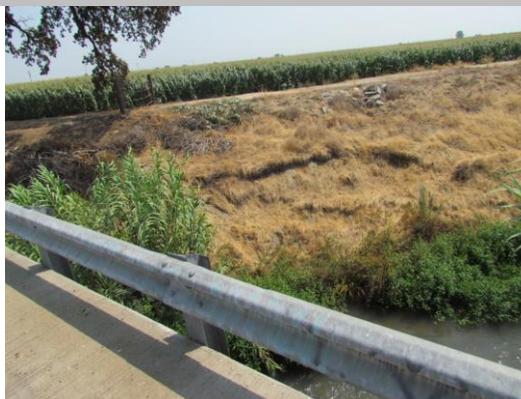
Photo 1 of 1 : CH_2014_NA0013_33_68_20140821_00039.jpg

Rating **	M	Issue No.	68	GPS Lat/Long
Issue Type +	Ob	Location *		37.280330 °
Category	Rivers, Channels & Designated Flood			-120.609400 °
Item	Erosion / Bank Caving			
DWR ID	DWR_NA0013_33_c_2012_68			
Action/Comments				
Inspector Comments: Erosion downstream on the left bank of Black Rascal Creek off Oak Avenue road crossing.

Erosion present on the left bank midway up the slope downstream from the bridge crossing.

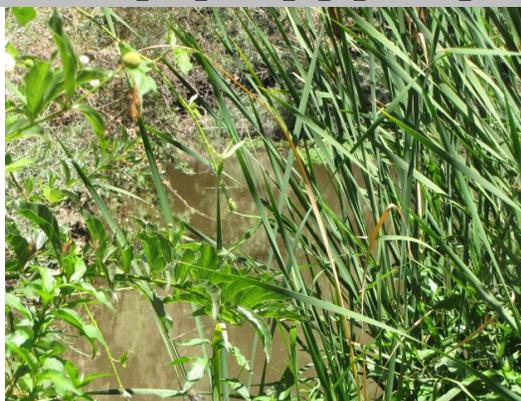
Photo 1 of 1 : CH_2014_NA0013_34_21_20140707_00002.jpg

Check Point / View			
Low Water Crossing / Down			
Rating **	M	Issue No. 21	GPS Lat/Long
Issue Type +	Ma	Location *	37.332490 °
Category	Rivers, Channels & Designated Flood		-120.321150 °
Item	Vegetation & Obstructions		
DWR ID	DWR_NA0013_34_c_2013_21		
Action/Comments			
Inspector Comments: Minimal, scattered vegetation present. The flow is not impeded.

Low Water Crossing looking downstream minimal brush in channel.

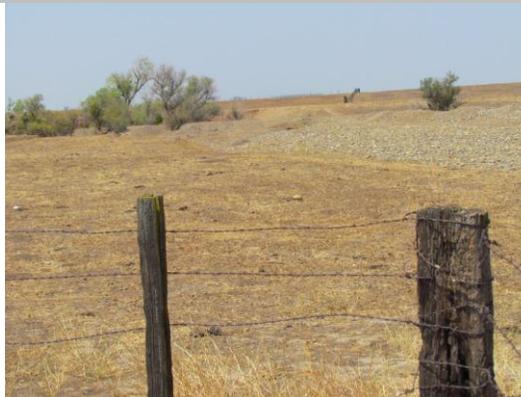
Photo 1 of 1 : CH_2014_NA0013_35_6_20140824_00025.jpg

Check Point / View			
White Rock Rd / Down			
Rating **	A	Issue No. 6	GPS Lat/Long
Issue Type +	Ma	Location *	37.261425 °
Category	Rivers, Channels & Designated Flood		-120.198078 °
Item	Vegetation & Obstructions		
DWR ID	DWR_NA0013_35_c_2012_6		
Action/Comments			
Inspector Comments: No problems with vegetation channel is clear and dry at this location.

Maraposa Creek looking downstream from White Rock Road. No vegetation and no water in channel.

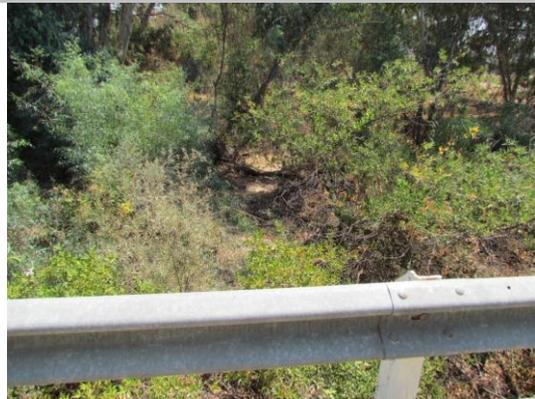
Photo 1 of 1 : CH_2014_NA0013_35_11_20140824_00026.jpg

Check Point / View				
Fresno Rd / Up				
Rating **	U	Issue No.	11	GPS Lat/Long
Issue Type +	Ma	Location *		37.238030 °
Category	Rivers, Channels & Designated Flood			-120.243520 °
Item	Vegetation & Obstructions			
DWR ID	DWR_NA0013_35_c_2012_11			
Action/Comments				
Inspector Comments: Log jams, snags, vegetation growth (such as cat tails, bull rushes, bushes or saplings) or other obstructions block approximately 50% of the capacity.

Mariposa Creek looking upstream from Fresno Road.

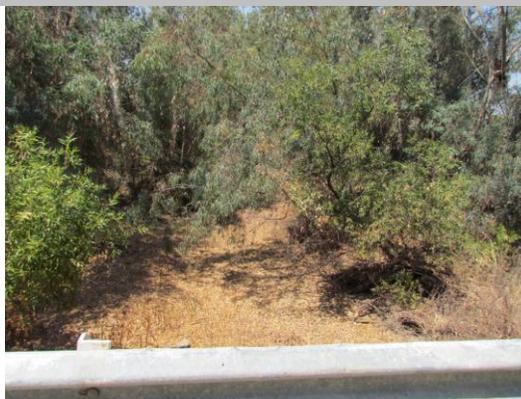
Photo 1 of 1 : CH_2014_NA0013_35_16_20140824_00027.jpg

Check Point / View			
Fresno Rd / Down			
Rating **	U	Issue No. 16	GPS Lat/Long
Issue Type +	Ma	Location *	37.238030 °
Category	Rivers, Channels & Designated Flood		-120.243520 °
Item	Vegetation & Obstructions		
DWR ID	DWR_NA0013_35_c_2012_16		
Action/Comments			
Inspector Comments: Log jams, snags, vegetation growth (such as cat tails, bull rushes, bushes or saplings) or other obstructions block approximately 50% of the capacity.

Mariposa Creek looking downstream from Fresno bridge crossing.

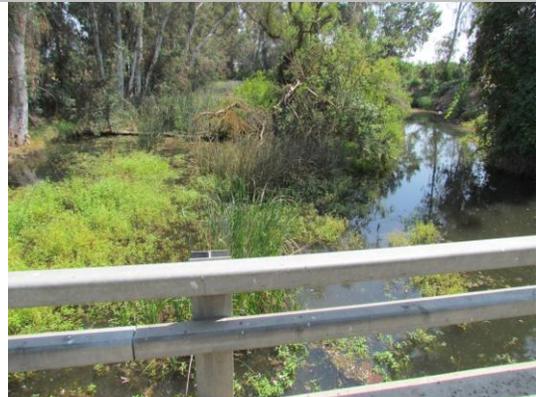
Photo 1 of 1 : CH_2014_NA0013_35_21_20140824_00028.jpg

Check Point / View			
Cunningham Rd / Up			
Rating **	M	Issue No. 21	GPS Lat/Long
Issue Type +	Ma	Location *	37.238920 °
Category	Rivers, Channels & Designated Flood		-120.252550 °
Item	Vegetation & Obstructions		
DWR ID	DWR_NA0013_35_c_2012_21		
Action/Comments			
Inspector Comments: Vegetation present in channel.

Mariposa Creek looking upstream from Cunningham Road.

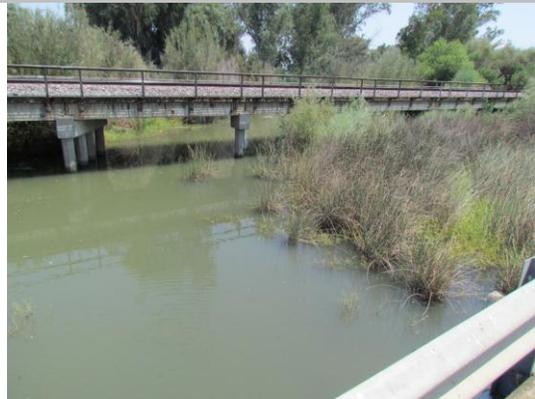
Photo 1 of 1 : CH_2014_NA0013_35_31_20140824_00030.jpg

Check Point / View				
RR Bridge near Santa Fe Dr / Up				
Rating **	A	Issue No.	31	GPS Lat/Long
Issue Type +	Ma	Location *		37.239220 °
Category	Rivers, Channels & Designated Flood			-120.259020 °
Item	Vegetation & Obstructions			
DWR ID	DWR_NA0013_35_c_2012_31			
Action/Comments				
Inspector Comments: Minimal, scattered obstructions or vegetation. The flow is not impeded.

Mariposa Creek Looking upstream from Santa Fe Drive crossing.

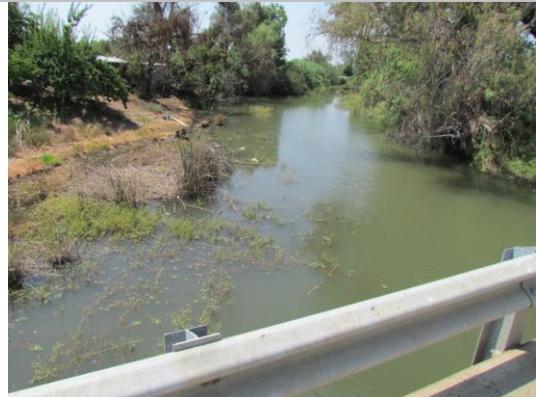
Photo 1 of 1 : CH_2014_NA0013_35_36_20140824_00031.jpg

Check Point / View			
RR Bridge near Santa Fe Dr / Down			
Rating **	A	Issue No. 36	GPS Lat/Long
Issue Type +	Ma	Location *	37.239220 °
Category	Rivers, Channels & Designated Flood		-120.259020 °
Item	Vegetation & Obstructions		
DWR ID	DWR_NA0013_35_c_2012_36		
Action/Comments			
Inspector Comments: Minimal, scattered obstructions or vegetation. The flow is not impeded.

Mariposa Creek looking downstream from Santa Fe Bridge crossing .

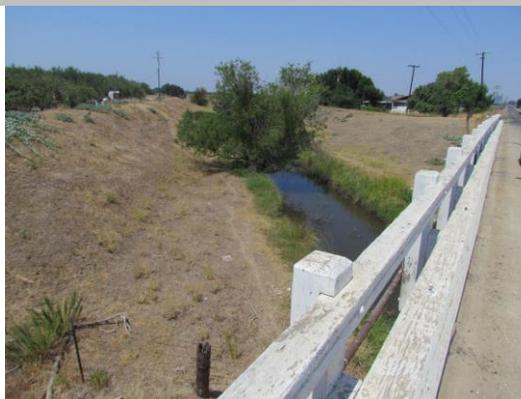
Photo 1 of 1 : CH_2014_NA0013_35_46_20140824_00033.jpg

Check Point / View			
Burchell Rd / Down			
Rating **	A	Issue No.	46
Issue Type +	Ma	Location *	37.257610 °
Category	Rivers, Channels & Designated Flood		-120.288730 °
Item	Vegetation & Obstructions		
DWR ID	DWR_NA0013_35_c_2012_46		
Action/Comments			
Inspector Comments: No vegetation problems. The flow is not impeded.

Mariposa Creek looking downstream from Burchell Road crossing.

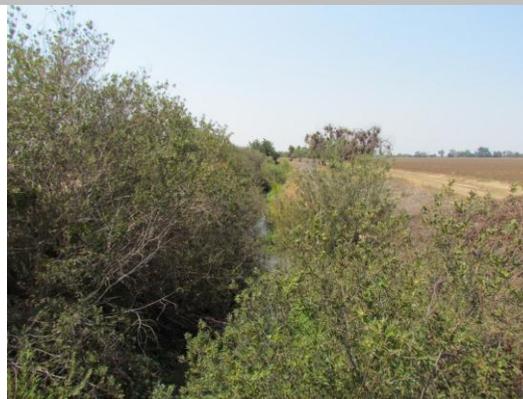
Photo 1 of 1 : CH_2014_NA0013_35_66_20140825_00040.jpg

Check Point / View			
Whealan Rd / Down			
Rating **	M	Issue No. 66	GPS Lat/Long
Issue Type +	Ma	Location *	37.261540 °
Category	Rivers, Channels & Designated Flood		-120.343200 °
Item	Vegetation & Obstructions		
DWR ID	DWR_NA0013_35_c_2012_66		
Action/Comments			
Inspector Comments: Log jams, snags, vegetation growth (such as cat tails, bull rushes, bushes or saplings) or other obstructions block approximately 25% of the FCW. Both banks covered with wild tree growth.

Mariposa Creek looking downstream from Whealan Road Crossing.

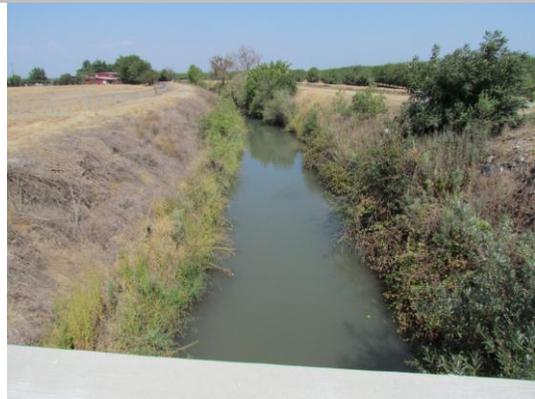
Photo 1 of 1 : CH_2014_NA0013_35_71_20140825_00041.jpg

Check Point / View				
Arboleda Rd / Up				
Rating **	M	Issue No.	71	GPS Lat/Long
Issue Type +	Ma	Location *		37.257036 °
Category	Rivers, Channels & Designated Flood			-120.379219 °
Item	Vegetation & Obstructions			
DWR ID	DWR_NA0013_35_c_2012_71			
Action/Comments				
Inspector Comments: Vegetation collection up on the left bank of channel, flow is not impeded.

Mariposa Creek looking upstream from Arboleda Road crossing.

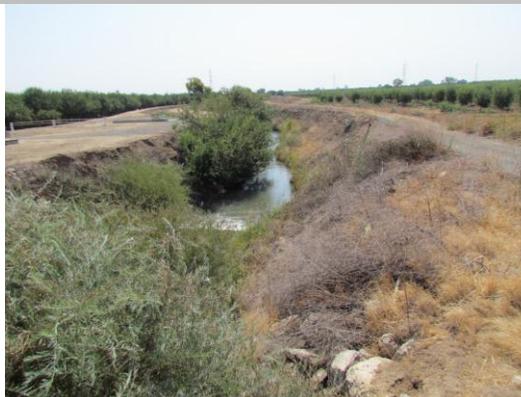
Photo 1 of 1 : CH_2014_NA0013_35_76_20140825_00042.jpg

Check Point / View			
Arboleda Rd / Down			
Rating **	M	Issue No. 76	GPS Lat/Long
Issue Type +	Ma	Location *	37.257036 °
Category	Rivers, Channels & Designated Flood		-120.379219 °
Item	Vegetation & Obstructions		
DWR ID	DWR_NA0013_35_c_2012_76		
Action/Comments			
Inspector Comments: Log jams, snags, vegetation growth (such as cat tails, bull rushes, bushes or saplings) or other obstructions blocking approximately 25% of the capacity.

Mariposa Creek looking downstream from Arboleda Road crossing.

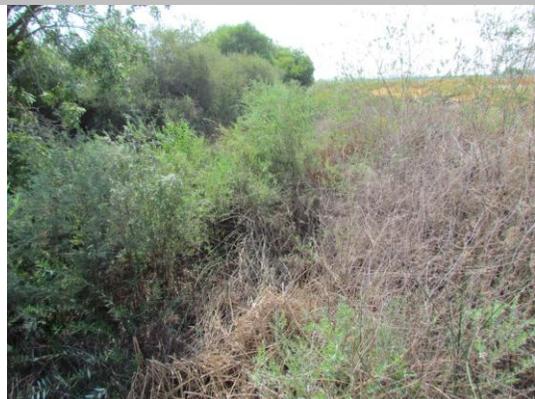
Photo 1 of 1 : CH_2014_NA0013_35_96_20140825_00047.jpg

Check Point / View			
Hwy 59 / Down			
Rating **	U	Issue No. 96	GPS Lat/Long
Issue Type +	Ma	Location *	37.233961 °
Category	Rivers, Channels & Designated Flood		-120.487872 °
Item	Vegetation & Obstructions		
DWR ID	DWR_NA0013_35_c_2012_96		
Action/Comments			
Inspector Comments: Log jams, snags, vegetation growth (such as cat tails, bull rushes, bushes or saplings) or other obstructions block approximately 50% of the capacity.

Mariposa Creek looking downstream from Hwy 59 at overgrown vegetation.

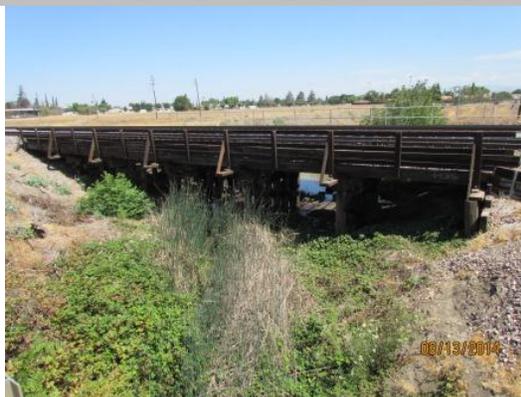
Photo 1 of 1 : CH_2014_NA0013_36_11_20140818_00031.jpg

Check Point / View			
Santa Fe Dr / Up			
Rating **	A	Issue No.	11
Issue Type +	Ma	Location *	GPS Lat/Long
Category	Rivers, Channels & Designated Flood		37.284393 °
Item	Vegetation & Obstructions		-120.315455 °
DWR ID	DWR_NA0013_36_c_2012_11		
Action/Comments			
Inspector Comments: Minor vegetation, but does not appear to be sufficient to impede flows.

View from the Santa Fe Dr. crossing looking upstream.

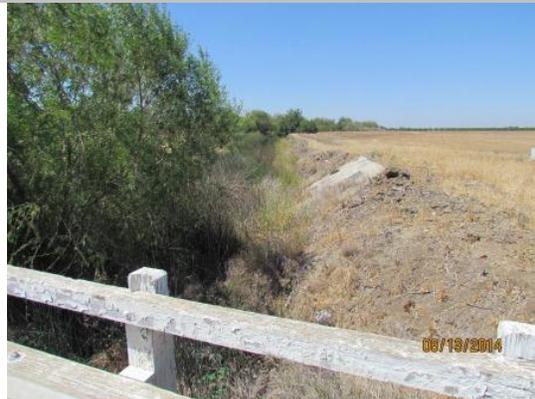
Photo 1 of 1 : CH_2014_NA0013_36_26_20140818_00034.jpg

Check Point / View				
Plainsburg Rd / Down				
Rating **	M	Issue No.	26	GPS Lat/Long
Issue Type +	Ma	Location *		37.282060 °
Category	Rivers, Channels & Designated Flood			-120.324870 °
Item	Vegetation & Obstructions			
DWR ID	DWR_NA0013_36_c_2012_26			
Action/Comments				
Inspector Comments: Trees are beginning to grow in channel. They appear to be a willow and a black walnut; please remove.

Plainsburg Rd crossing, downstream view, Note woody vegetation on left side of channel.

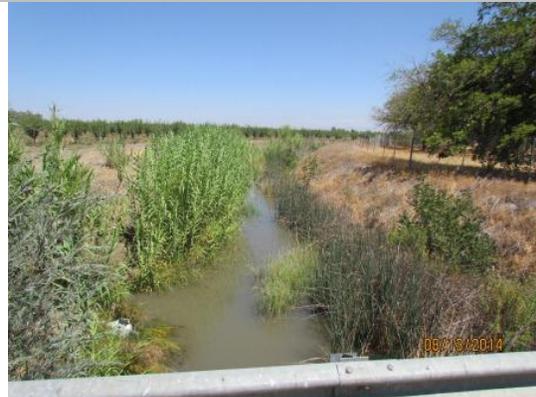
Photo 1 of 1 : CH_2014_NA0013_36_31_20140818_00035.jpg

Check Point / View			
Gerard Ave / Up			
Rating **	A	Issue No. 31	GPS Lat/Long
Issue Type +	Ma	Location *	37.280811 °
Category	Rivers, Channels & Designated Flood		-120.331170 °
Item	Vegetation & Obstructions		
DWR ID	DWR_NA0013_36_c_2012_31		
Action/Comments			
Inspector Comments: Minor vegetation, but does not appear to be enough to impede flow.

Upstream view from Gerard Ave. crossing.

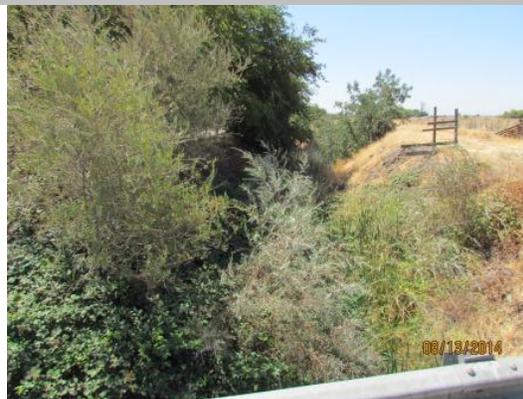
Photo 1 of 1 : CH_2014_NA0013_36_36_20140818_00036.jpg

Check Point / View			
Gerard Ave / Down			
Rating **	M	Issue No. 36	GPS Lat/Long
Issue Type +	Ma	Location *	37.280811 °
Category	Rivers, Channels & Designated Flood		-120.331170 °
Item	Vegetation & Obstructions		
DWR ID	DWR_NA0013_36_c_2012_36		
Action/Comments			
Inspector Comments: Dense blackberry growth near the downstream end of the bridge which may be enough to impede flow.

Downstream view from Gerard Ave. crossing.

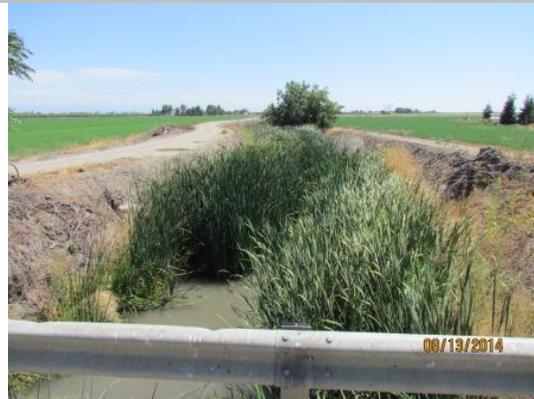
Photo 1 of 1 : CH_2014_NA0013_36_41_20140818_00037.jpg

Check Point / View				
Whealan Rd / Up				
Rating **	A	Issue No.	41	GPS Lat/Long
Issue Type +	Ma	Location *		37.278696 °
Category	Rivers, Channels & Designated Flood			-120.343029 °
Item	Vegetation & Obstructions			
DWR ID	DWR_NA0013_36_c_2012_41			
Action/Comments				
Inspector Comments: Minimally obstructive vegetation present, but does not appear that it will impede flow.

Upstream view from Whealan Rd. crossing.

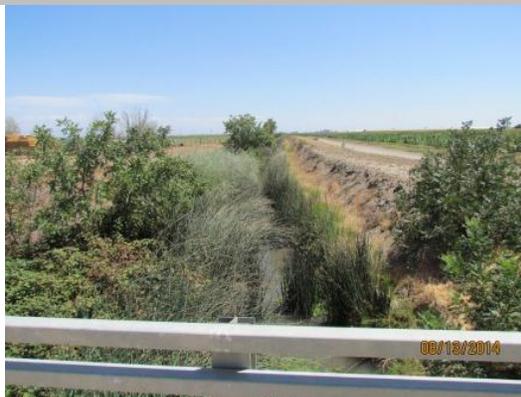
Photo 1 of 1 : CH_2014_NA0013_36_51_20140818_00039.jpg

Check Point / View			
Arboleda Dr / Up			
Rating **	A	Issue No.	51
Issue Type +	Ma	Location *	
Category	Rivers, Channels & Designated Flood		GPS Lat/Long
Item	Vegetation & Obstructions		
DWR ID	DWR_NA0013_36_c_2012_51		
Action/Comments			
Inspector Comments: Minor vegetation present, but does not appear to impede flow.

Upstream view from Arboleda Dr. crossing.

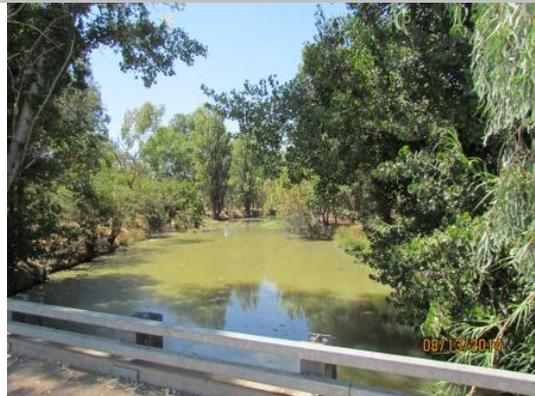
Photo 1 of 1 : CH_2014_NA0013_36_86_20140825_00051.jpg

Check Point / View				
Tyler Rd / Down				
Rating **	A	Issue No.	86	GPS Lat/Long
Issue Type +	Ma	Location *		37.263658 °
Category	Rivers, Channels & Designated Flood			-120.469770 °
Item	Vegetation & Obstructions			
DWR ID	DWR_NA0013_36_c_2012_86			
Action/Comments				
Inspector Comments: Minor vegetation, but does not appear to be enough to impede flow.

Downstream view of Miles Creek from Tyler Rd. crossing.

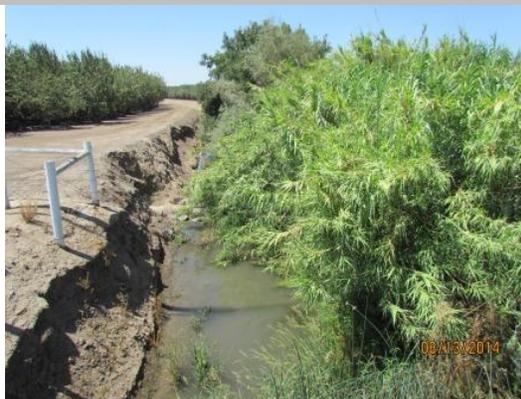
Photo 1 of 1 : CH_2014_NA0013_36_106_20140825_00057.jpg

Check Point / View			
Hwy 59 / Down			
Rating **	M	Issue No. 106	GPS Lat/Long
Issue Type +	Ma	Location *	37.255886 °
Category	Rivers, Channels & Designated Flood		-120.487970 °
Item	Vegetation & Obstructions		
DWR ID	DWR_NA0013_36_c_2012_106		
Action/Comments			
Inspector Comments: It appears that the Black walnut tree has been removed at the bridge. However there is more woody vegetation growing downstream in the channel, this can impede flow, please remove.

Downstream view of Miles Creek from Highway 59 crossing.

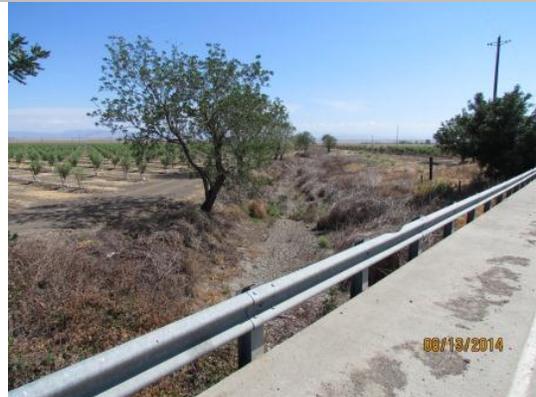
Photo 1 of 1 : CH_2014_NA0013_37_11_20140814_00020.jpg

Check Point / View			
Childs Ave / Up			
Rating **	A	Issue No.	11
Issue Type +	Ma	Location *	37.287303 °
Category	Rivers, Channels & Designated Flood		-120.254863 °
Item	Vegetation & Obstructions		
DWR ID	DWR_NA0013_37_c_2012_11		
Action/Comments			
Inspector Comments: Some vegetation, but does not appear to be enough to impede flows.

Upstream view of Childs Ave. crossing.

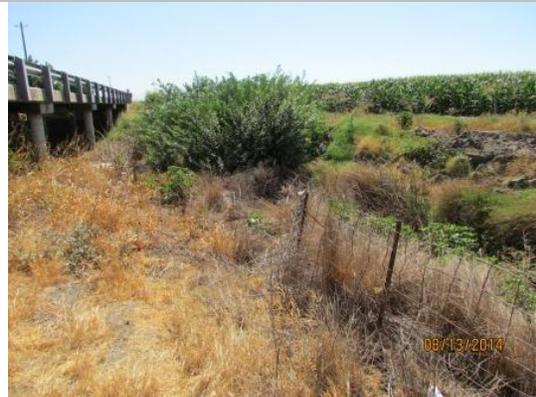
Photo 1 of 1 : CH_2014_NA0013_37_20_20140814_00023.jpg

Check Point / View			
Childs Ave / Down (cont)			
Rating **	M	Issue No.	20
Issue Type +	Ma	Location *	37.287303 °
Category	Rivers, Channels & Designated Flood		-120.254863 °
Item	Encroachments		
DWR ID	DWR_NA0013_37_c_2012_20		
Action/Comments			
Inspector Comments: Wire fence has been placed across the channel, fence is holding debris and needs to be constructed so it will not impede flows during high water events. Note removal of fence may accelerate the erosion at this point. See erosion comment.

View of the wire fence across the channel downstream of Childs Ave. crossing.
