**Flood Control Project Maintenance  
Levee Inspections**

**Fall 2010 Levee Maintenance Deficiency Summary Report**

**Levee Inspection Report By Mile - Fall 2010**

**Merced Streams Group**

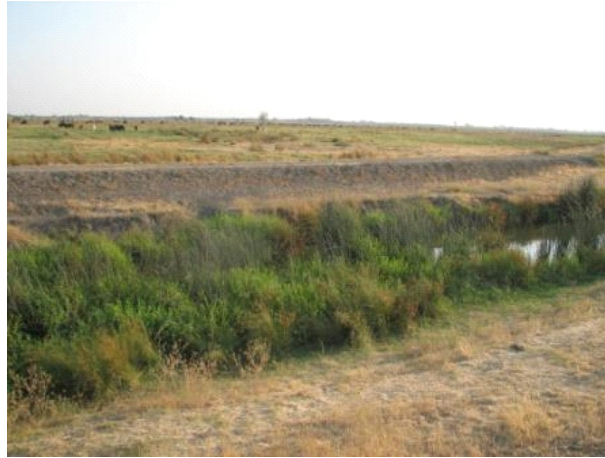
SJR2010\_RM0.21U4LM0.21LBa.jpg

Photo taken in 2007.

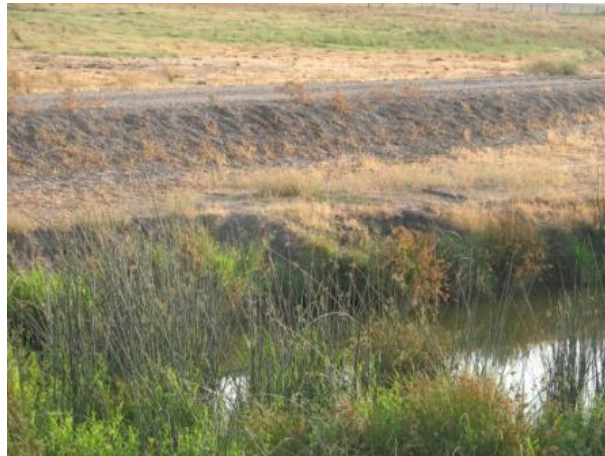
SJR2010\_RM0.21U4LM0.21LBb.jpg

Levee Mile Report Line	4
Start Levee Mile	0.15
End Levee Mile	0.28
Location	Water Side
Category	Supplemental
Item	DWR Erosion Survey

Photo taken in 2007.

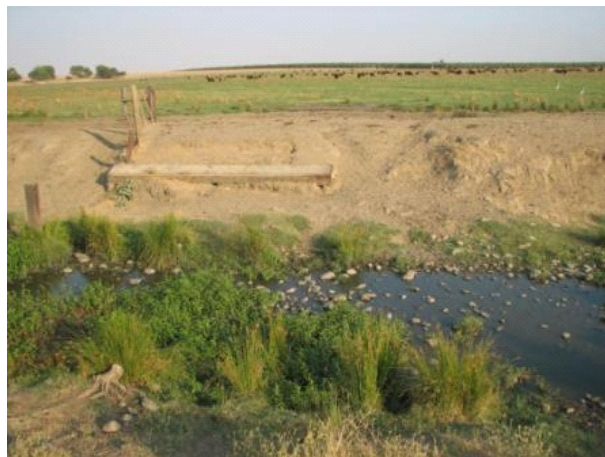
SJR2010\_RM0.42U4LM0.42LBa.jpg

Levee Mile Report Line	10
Start Levee Mile	0.42
End Levee Mile	0.43
Location	Water Side
Category	Supplemental
Item	DWR Erosion Survey

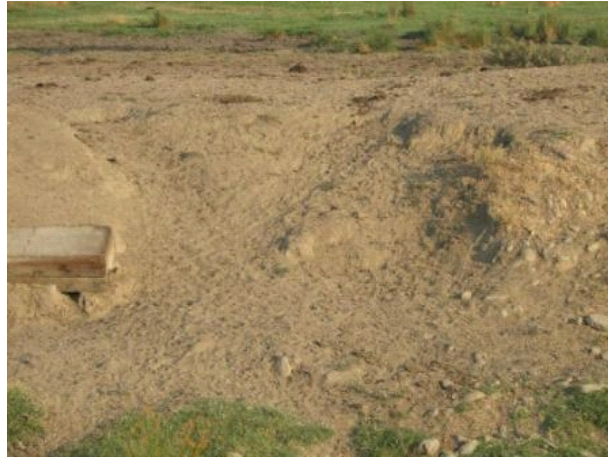
SJ2010\_RM0.42U4LM0.42LBb.jpg

Levee Mile Report Line	10
Start Levee Mile	0.42
End Levee Mile	0.43
Location	Water Side
Category	Supplemental
Item	DWR Erosion Survey

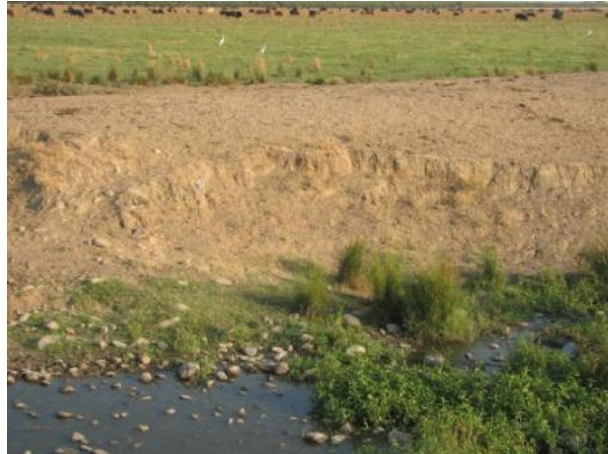
SJ2010\_RM0.42U4LM0.42LBc.jpg

Levee Mile Report Line	10
Start Levee Mile	0.42
End Levee Mile	0.43
Location	Water Side
Category	Supplemental
Item	DWR Erosion Survey

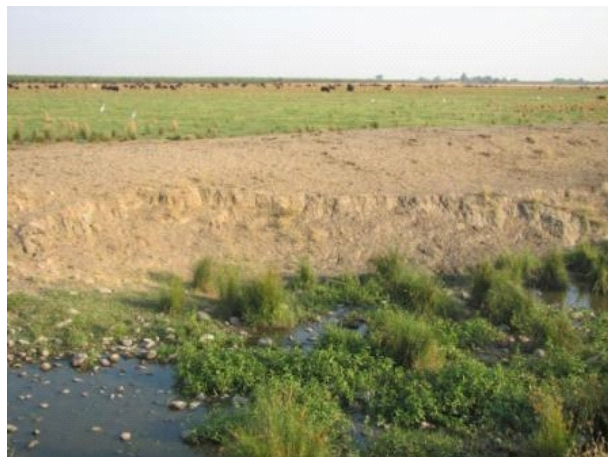
SJ2010\_RM0.42U4LM0.42LBd.jpg

Levee Mile Report Line	10
Start Levee Mile	0.42
End Levee Mile	0.43
Location	Water Side
Category	Supplemental
Item	DWR Erosion Survey
