**Flood Control Project Maintenance
Levee Inspections**

Fall 2016 Levee Maintenance Deficiency Summary Report

Fall 2016 Levee Inspection Results

Merced Streams Group

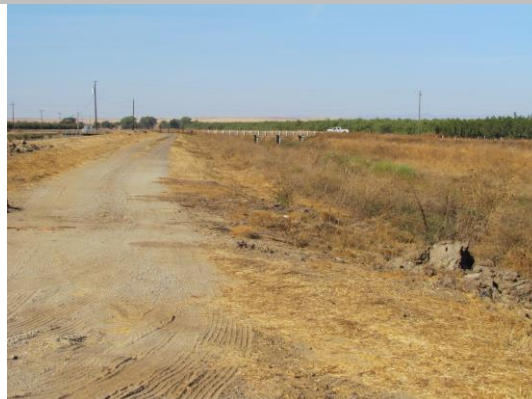
Photo 1 of 1 : FA_2016_NA0013_331_1_20161012_00001.jpg

LM Start	0.00	Rating **	A	Issue No.	1
LM End	1.27	Issue Type +	Ma	Location *	WS
Category	Earthen Levee			GPS Latitude/Longitude	
				Start	End
Item	Vegetation			37.314708 °	37.332582 °
				-120.396403 °	-120.394752 °
DWR ID	DWR_NA0013_01_f_2016_1				
Comment Code					
V1 : Control annual grass and weeds on the levee slopes and easements.					
Inspector Comment					
No unwanted vegetation.

NA0013 Merced Streams Group Unit 1 levee mile 0.00.

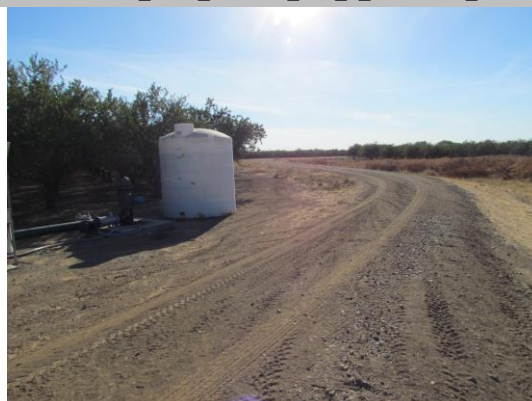
Photo 1 of 1 : FA_2016_NA0013_332_7_20161012_00019.jpg

LM Start	0.01	Rating **	A	Issue No.	7
LM End	1.85	Issue Type +	Ma	Location *	LS
Category	Earthen Levee			GPS Latitude/Longitude	
				Start	End
Item	Vegetation			37.337027 °	37.314620 °
				-120.387473 °	-120.395820 °
DWR ID	DWR_NA0013_02_f_2016_7				
Comment Code					
V1 : Control annual grass and weeds on the levee slopes and easements.					
Inspector Comment					
No unwanted vegetation.

Unit 2 looking downstream landside slope levee mile 0.00.

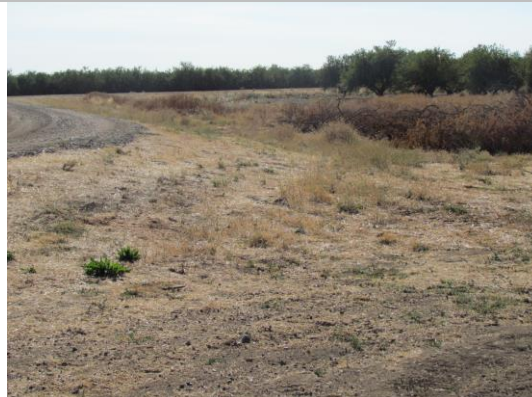
Photo 1 of 1 : FA_2016_NA0013_332_8_20161012_00018.jpg

LM Start	0.01	Rating **	A	Issue No.	8	
LM End	1.85	Issue Type +	Ma	Location *	WS	
Category	Earthen Levee			GPS Latitude/Longitude		
				Start		End
Item	Vegetation			37.337027 °		37.314620 °
				-120.387473 °		-120.395820 °
DWR ID	DWR_NA0013_02_f_2016_8					
Comment Code						
V1 : Control annual grass and weeds on the levee slopes and easements.						
Inspector Comment						
No unwanted vegetation.

Unit 2 levee mile 0.00 waterside slope looking downstream.

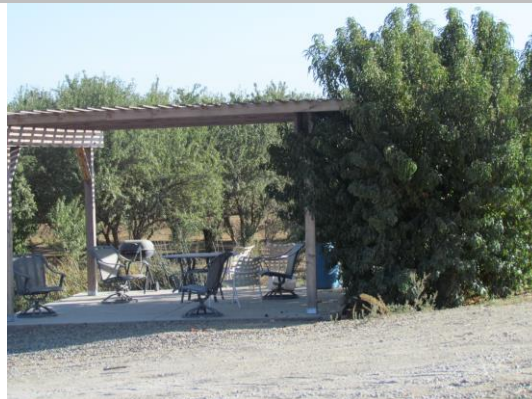
Photo 3 of 3 : FA_2016_NA0013_332_24_20161012_00020.jpg

LM Start	0.88	Rating **	U	Issue No.	24 (cont)
LM End	0.88	Issue Type +	En	Location *	N/A

Unit 2 looking downstream from levee mile 0.88.

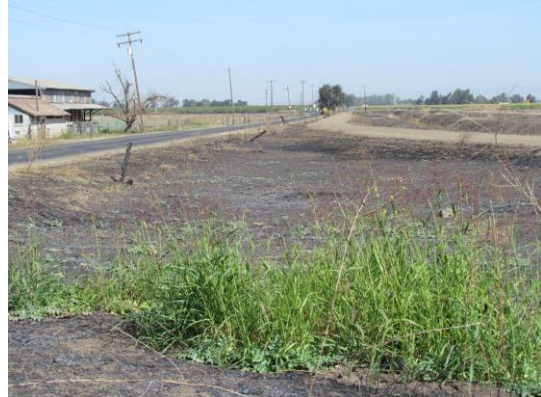
Photo 1 of 1 : FA_2016_NA0013_333_1_20161013_00001.jpg

LM Start	0.01	Rating **	A	Issue No.	1
LM End	0.40	Issue Type +	Ma	Location *	LS
Category	Earthen Levee			GPS Latitude/Longitude	
				Start	End
Item	Vegetation			37.257745 °	37.263288 °
				-120.288458 °	-120.288303 °
DWR ID	DWR_NA0013_03_f_2016_1				
Comment Code					
V1 : Control annual grass and weeds on the levee slopes and easements.					
Inspector Comment					
Levee mile 0.01-0.40 no unwanted vegetation on the landside slope.

Unit 3 Owens Creek Diversion landside levee mile 0.01.

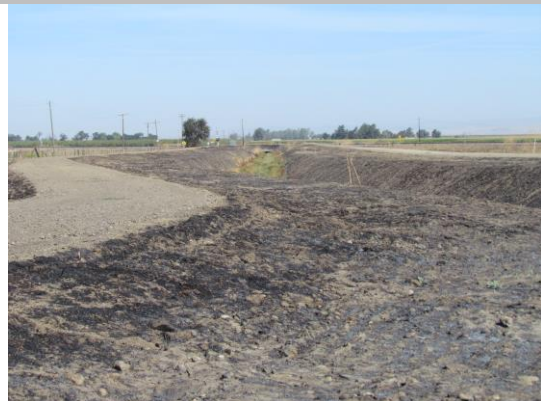
Photo 1 of 1 : FA_2016_NA0013_333_2_20161013_00002.jpg

LM Start	0.01	Rating **	A	Issue No.	2
LM End	1.42	Issue Type +	Ma	Location *	WS
Category	Earthen Levee			GPS Latitude/Longitude	
				Start	End
Item	Vegetation			37.257745 °	37.273657 °
				-120.288458 °	-120.277787 °
DWR ID	DWR_NA0013_03_f_2016_2				
Comment Code					
V1 : Control annual grass and weeds on the levee slopes and easements.					
Inspector Comment					
Levee mile 0.01-1.42 there is no unwanted vegetation along the waterside slope.

Unit 3 waterside levee slope looking upstream from levee mile 0.01-1.42.

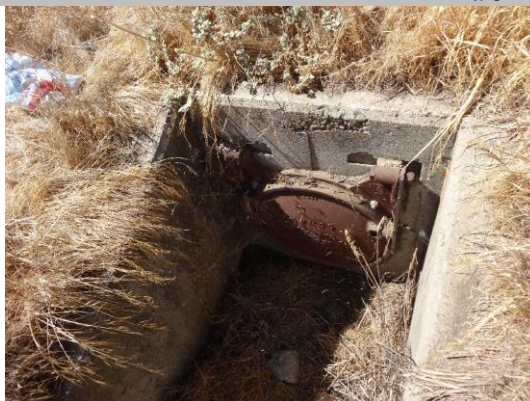
Photo 1 of 2 : UCIP_FA_2016_41815_35533.jpg

LM Start	0.19	Rating **	M	Issue No.	10 (cont)
LM End	0.19	Issue Type +	En	Location *	CR

WS view: U typed concrete headwall, CM pipe, and flap gate.

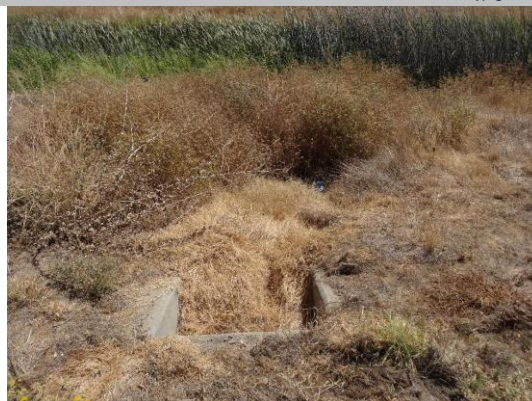
Photo 1 of 2 : UCIP_FA_2016_50152_35544.jpg

Comment Code					
Inspector Comment					
FS_ID:50152 DS_ID:23064 EP_NO: N/A Repair Type: Non-Urgent Crossing Status: Found UCIP Comments: 09/29/2016: WS outlet has been cleared by NA0013. Crossing will be downgraded from Non-Urgent to No Action Needed upon receipt of photo showing cleared LS. (K. Fazel - UCIP)09/2013:- vegetations need to be removed from spillway and outlet at flapgate (blocked). It needs clearing.- more than half of inlet pipe was buried in inlet. It needs cleaning & clearing. (P. Amatya - UCIP) FIELD_STRUCT_DESC: 24-inch corrugated metal drainage pipe through the levee, 5.0 feet below the crown, concrete headwall, flap gate, and concrete grouted cobble spillway on the waterward toe, concrete headwall on the landward toe (O&M Unit No. 607, 1962) FS Date: 9/7/2016

WS view: cobble spillway and channel on waterside.

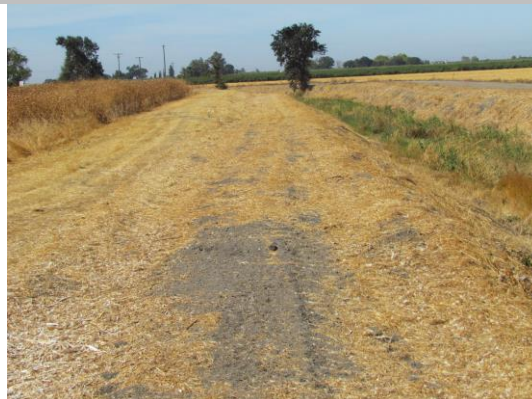
Photo 1 of 1 : FA_2016_NA0013_334_7_20161013_00019.jpg

LM Start	0.01	Rating **	A	Issue No.	7
LM End	1.41	Issue Type +	Ma	Location *	WS
Category	Earthen Levee			GPS Latitude/Longitude	
				Start	End
Item	Vegetation			37.273313 °	37.257423 °
				-120.277797 °	-120.288225 °
DWR ID	DWR_NA0013_04_f_2016_7				
Comment Code					
V1 : Control annual grass and weeds on the levee slopes and easements.					
Inspector Comment					
Levee mile 0.01-1.41 no unwanted vegetation on the waterside slope.

Unit 4 levee mile 0.01 looking downstream of the waterside slope.
