**Flood Control Project Maintenance  
Levee Inspections**

**Fall 2017 Levee Maintenance Deficiency Summary Report**

***San Joaquin River Basin***

**Merced Streams Group**

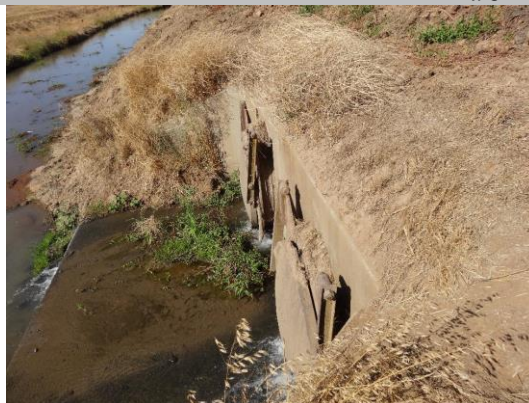
Photo 1 of 3 : UCIP\_FA\_2017\_20983\_35302.jpg

LM Start	0.91	Rating **	A/W	Issue No.	30
LM End	0.91	Issue Type +	Ma	Location *	
Category	Supplemental			GPS Latitude/Longitude	
				Start	End
Item	DWR UCIP LMA Responsibility			37.328267 °	37.328267 °
				-120.396084 °	-120.396084 °
DWR ID					
Comment Code					
Inspector Comment					
FS_ID:20983 DS_ID:23080 EP_NO: N/A Repair Type: No Action Needed Crossing Status: Found UCIP Comments: It was working during field inspection. Dense vegetation in drainage ditch. FIELD_STRUCT_DESC: 2 of 2: 60-inch corrugated metal drainage pipe through the levee, 10.0 feet below the crown. Concrete headwall and flap gate on the waterward berm. 5 feet from the levee toe. Concrete headwall on the landward toe. [Additional Reference(s): DWR Levee Log, 2005. USACE Sacramento O&M Manual 607, 1962 (HLM 0.9186)]. FS Date: 9/17/2013

WS view: two CMPs with flap gate, concrete spillway and channel on waterside.

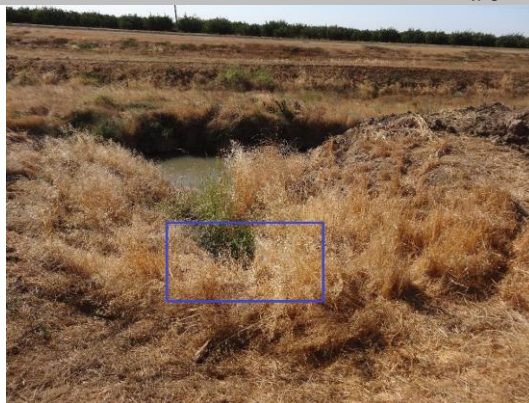
Photo 1 of 3 : UCIP\_FA\_2017\_20984\_35305.jpg

LM Start	1.30	Rating **	A/W	Issue No.	31
LM End	1.30	Issue Type +	Ma	Location *	
Category	Supplemental			GPS Latitude/Longitude	
				Start	End
Item	DWR UCIP LMA Responsibility			37.322499 °	37.322499 °
				-120.396045 °	-120.396045 °
DWR ID					
Comment Code					
Inspector Comment					
FS_ID:20984 DS_ID:23057 EP_NO: N/A Repair Type: No Action Needed Crossing Status: Found UCIP Comments: - working during field inspection. FIELD_STRUCT_DESC: 24-inch corrugated metal drainage pipe through the levee, 10.0 feet below the crown. Concrete headwall, flap gate, and concrete grouted cobble spillway on the waterward toe. Concrete headwall on the landward toe. [Additional Reference(s): DWR Levee Log, 2005. USACE Sacramento O&M Manual 607, 1962 (HLM 1.324)]. FS Date: 9/17/2013

WS view: U type concrete headwall and channel on waterside.

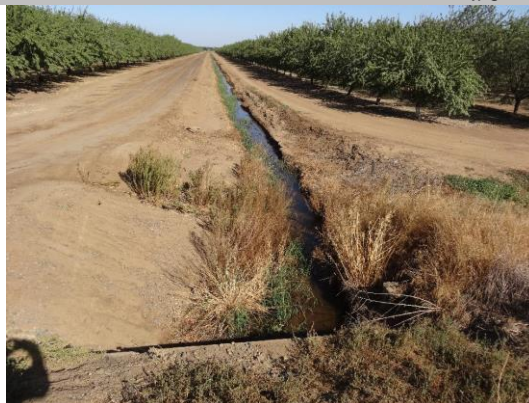
Photo 3 of 3 : UCIP\_FA\_2017\_20984\_35303.jpg

LS view: concrete headwall on levee toe and drainage ditch.

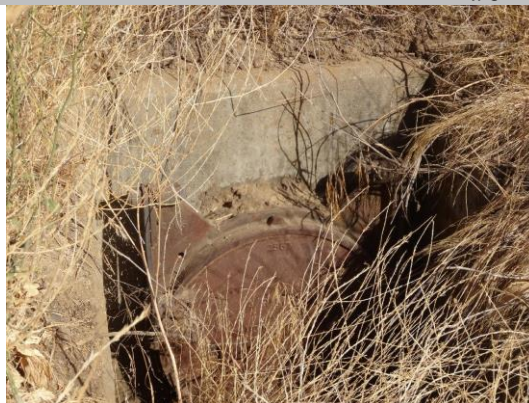
Photo 2 of 3 : UCIP\_FA\_2017\_42993\_35309.jpg

Comment Code						
Inspector Comment						
FS_ID:42993						
DS_ID:23058						
EP_NO: N/A						
Repair Type: Non-Urgent						
Crossing Status: Found						
UCIP Comments: - needs cleaning of debris on spillway on WS.						
Flapgate blocked by debris on WS. - needs cleaning inside CMP on LS						
FIELD_STRUCT_DESC: 24-inch corrugated metal drainage pipe through the levee, 8.0 feet below the crown, concrete headwall, flap gate, and concrete grouted cobble spillway on the waterward toe.						
Concrete headwall on the landward toe. [Additional Reference(s): DWR Levee Log, 2005. USACE Sacramento O&M Manual 607, 1962 (HLM 1.641)].						
FS Date: 9/17/2013

WS view: U typed concrete headwall, CM pipe and flap gate. Vegetation and debris need to be cleared.

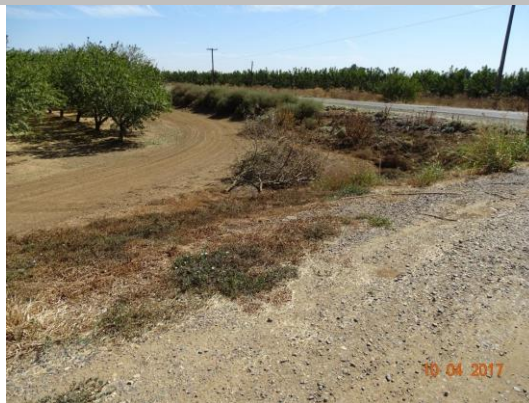
Photo 1 of 1 : FA\_2017\_NA0013\_332\_11\_20171009\_00058.jpg

LM Start	1.62	Rating **	M	Issue No.	11
LM End	1.62	Issue Type +	En	Location *	LS
Category	Earthen Levee			GPS Latitude/Longitude	
				Start	End
Item	Encroachments			37.318010 °	37.318010 °
				-120.395739 °	-120.395739 °
DWR ID	DWR_NA0013_02_f_2017_11				
Comment Code					
TR : Tree or limb					
Inspector Comment					
The walnut tree has been cut down (Issue 9), but the remnants should be removed.

Walnut tree has been cut down. Should be removed to allow access to toe area.

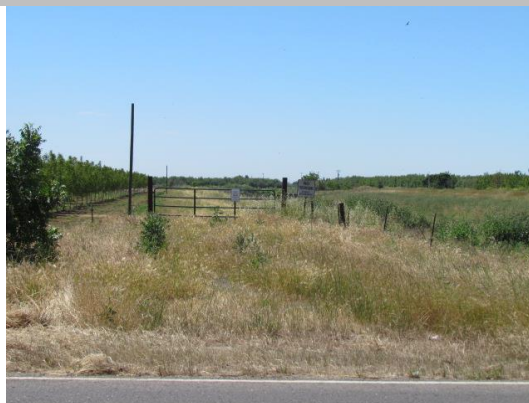
Photo 1 of 2 : FA\_2017\_NA0013\_332\_17\_20171002\_00005.jpg

LM Start	1.62	Rating **	A/W	Issue No.	17
LM End	1.85	Issue Type +	Ma	Location *	CR
Category	Earthen Levee			GPS Latitude/Longitude	
				Start	End
Item	Vegetation			37.317882 °	37.314609 °
				-120.395718 °	-120.395807 °
DWR ID	DWR_NA0013_02_s_2017_17				
Comment Code					
V9 : Keep the crown roadway free of vegetation.					
Inspector Comment					
Crown and slopes have been mowed to allow visibility and access.

Looking downstream from levee mile 1.62 to 1.85 crown roadway completely overgrown with vegetation.

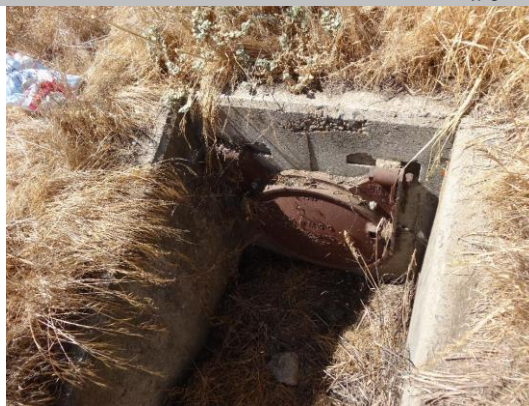
Photo 1 of 3 : UCIP\_FA\_2017\_41815\_35533.jpg

LM Start	0.19	Rating **	M	Issue No.	14	
LM End	0.19	Issue Type +	Ma	Location *		
Category	Supplemental			GPS Latitude/Longitude		
				Start		End
Item	DWR UCIP LMA Responsibility			37.260355 °		37.260355 °
				-120.288517 °		-120.288517 °
DWR ID						
Comment Code						
Inspector Comment						
FS_ID:41815 DS_ID:23060 EP_NO: N/A Repair Type: Non-Urgent Crossing Status: Found UCIP Comments: - more than a half of inet pipe burried on LS. - needs vegetation cleaning on both sides.- inlet needs silt removed and cleaning. FIELD_STRUCT_DESC: 24-inch corrugated metal drainage pipe through the levee, 6.0 feet below the crown. Concrete headwall, flap gate, and concrete grouted cobble spillway on the waterward toe. Concrete headwall on the landward toe. [Additional Reference(s): DWR Levee Log, 2005. USACE Sacramento O&M Manual 607, 1962 (HLM 0.2)]. FS Date: 9/17/2013

WS view: U typed concrete headwall, CM pipe, and flap gate.

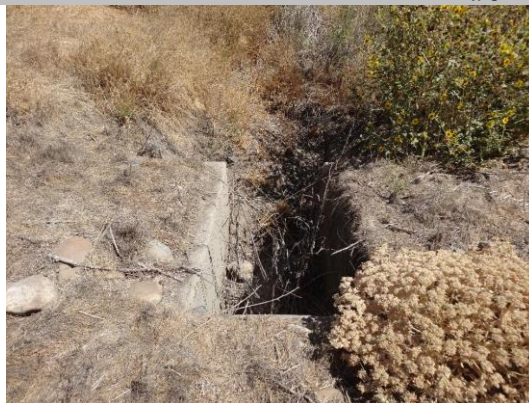
Photo 1 of 3 : UCIP\_FA\_2017\_50144\_35422.jpg

Comment Code						
Inspector Comment						
FS_ID:50144						
DS_ID:23061						
EP_NO: N/A						
Repair Type: No Action Needed						
Crossing Status: Found						
UCIP Comments: 09/01/2016: Crossing has been downgraded from Urgent to No Action Needed. (K. Fazel - UCIP)09/01/2016: Not abandoned. LS and WS cleared. Gate swings free. Photos uploaded. (M. Walejko - NA0013)08/23/2016: Same as last inspection. (K. Fazel - UCIP)09/17/2013:Appears to be abandoned. Flapgate blocked by debris.- debris blocked inlet pipe on LS.- Needs to be cleared on both sides or it needs to be abandoned properly. (P. Amatya - UCIP)						
FIELD_STRUCT_DESC: 24-inch corrugated metal drainage pipe through the levee, 10 feet below the crown. Concrete headwall, flap gate, and concrete grouted cobble spillway on the waterside (WS) toe. Concrete headwall on the landside (LS) toe [Additional Reference(s): DWR Levee Log, 2005. USACE San Joaquin O&M Manual No. 607, 1962 (HLM 0.4)].

WS view: U typed concrete headwall, cobble spillway, and channel on waterside.

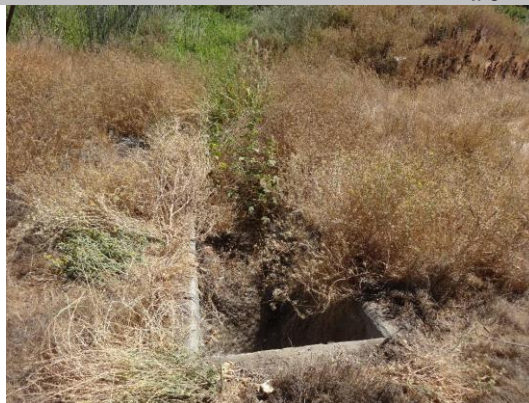
Photo 1 of 3 : UCIP\_FA\_2017\_50149\_35535.jpg

Comment Code						
Inspector Comment						
FS_ID:50149						
DS_ID:23062						
EP_NO: N/A						
Repair Type: No Action Needed						
Crossing Status: Found						
UCIP Comments: 09/29/2016: LS and WS ends have been cleared by Mike Walejko of NA0013. Crossing has been downgraded from Non-Urgent to No Action Needed. (K. Fazel - UCIP)09/2013:- needs clearing and cleaning on inlet and outlet. (P. Amatya - UCIP)						
FIELD_STRUCT_DESC: 24-inch corrugated metal drainage pipe through the levee, 7.5 feet below the crown, concrete headwall, flap gate, and concrete grouted cobble spillway on the waterward toe, concrete headwall on the landward toe (O&M Unit No. 607, 1962)						
FS Date: 9/7/2016

WS view: cobble spillway and channel on waterside. Dense vegetation on levee slope.

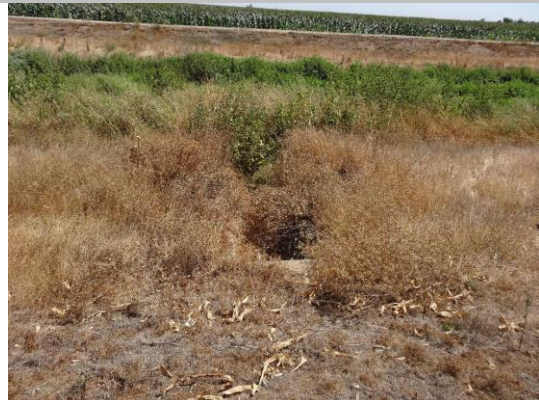
Photo 1 of 3 : UCIP\_FA\_2017\_50151\_35539.jpg

LM Start	0.79	Rating **	A/W	Issue No.	17
LM End	0.79	Issue Type +	Ma	Location *	
Category	Supplemental			GPS Latitude/Longitude	
				Start	End
Item	DWR UCIP LMA Responsibility			37.268420 °	37.268420 °
				-120.286231 °	-120.286231 °
DWR ID					
Comment Code					
Inspector Comment					
FS_ID:50151 DS_ID:23063 EP_NO: N/A Repair Type: No Action Needed Crossing Status: Found UCIP Comments: 09/2016: LS and WS ends have been cleared by NA0013 and crossing has been downgraded to No Action Needed. (K. Fazel - UCIP)09/2013: Needs vegetation clearing on WS. (P. Amatya - UCIP) FIELD_STRUCT_DESC: 24-inch corrugated metal drainage pipe through the levee, 6.5 feet below the crown, concrete headwall, flap gate, and concrete grouted cobble spillway on the waterward toe, concrete headwall on the landward toe (O&M Unit No. 607, 1962) FS Date: 9/7/2016

WS view: overview of spillway/outlet area on waterside.

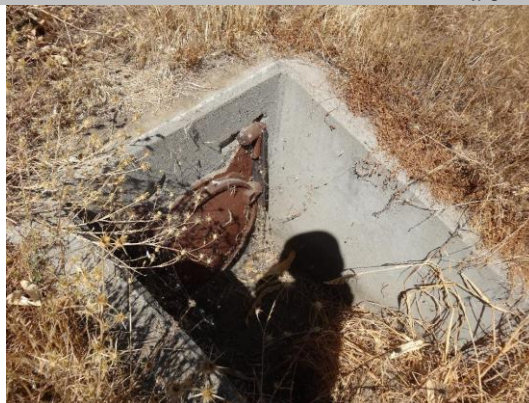
Photo 2 of 3 : UCIP\_FA\_2017\_50151\_35538.jpg

WS view: U typed concrete headwall, CM pipe, and flap gate. Vegetation needs to be cleared.

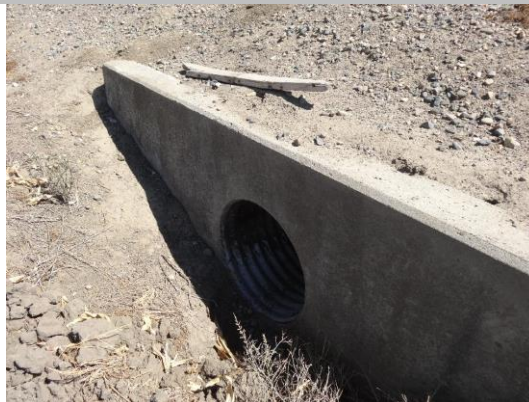
Photo 3 of 3 : UCIP\_FA\_2017\_50151\_35541.jpg

LS view: concrete headwall and CM pipe.

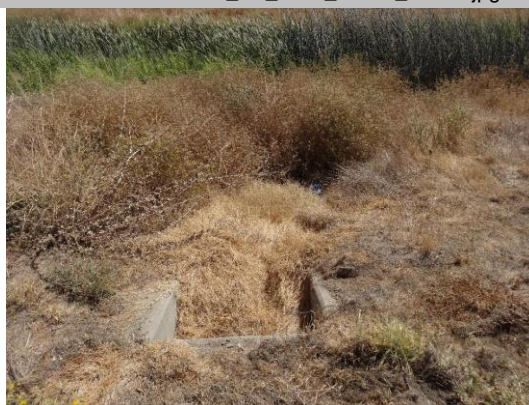
Photo 1 of 3 : UCIP\_FA\_2017\_50152\_35544.jpg

Comment Code						
Inspector Comment						
FS_ID:50152 DS_ID:23064 EP_NO: N/A Repair Type: Non-Urgent Crossing Status: Found UCIP Comments: 09/29/2016: WS outlet has been cleared by NA0013. Crossing will be downgraded from Non-Urgent to No Action Needed upon receipt of photo showing cleared LS. (K. Fazel - UCIP)09/2013:- vegetations need to be removed from spillway and outlet at flapgate (blocked). It needs clearing.- more than half of inlet pipe was buried in inlet. It needs cleaning & clearing. (P. Amatya - UCIP) FIELD_STRUCT_DESC: 24-inch corrugated metal drainage pipe through the levee, 5.0 feet below the crown, concrete headwall, flap gate, and concrete grouted cobble spillway on the waterward toe, concrete headwall on the landward toe (O&M Unit No. 607, 1962) FS Date: 9/7/2016

WS view: cobble spillway and channel on waterside.

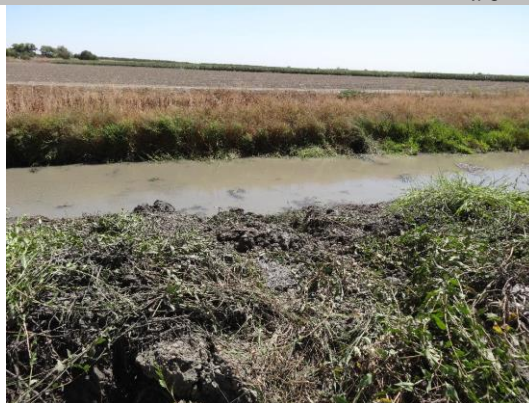
Photo 1 of 3 : UCIP\_FA\_2017\_21063\_35502.jpg

WS view: U typed concrete headwall, CM pipe, and flap gate buried under mud/debris.

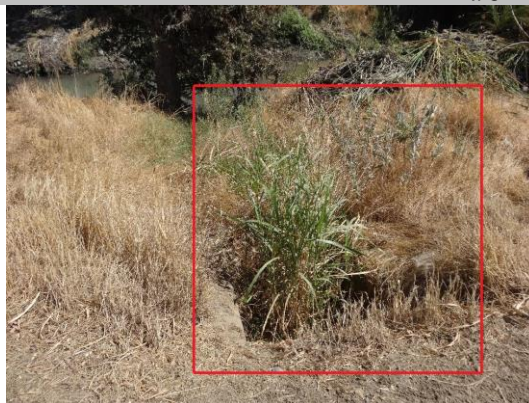
Photo 1 of 3 : UCIP\_FA\_2017\_21064\_35506.jpg

WS view: cobble spillway and channel on waterside. Dense vegetation on levee slope and spillway.

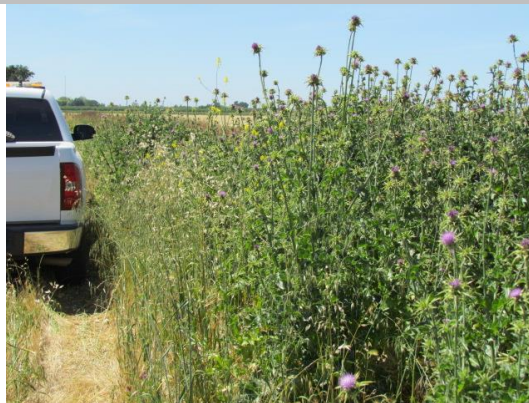
Photo 1 of 2 : FA\_2017\_NA0013\_334\_12\_20171002\_00002.jpg

LM Start	0.03	Rating **	A/W	Issue No.	12
LM End	1.41	Issue Type +	Ma	Location *	WS
Category	Earthen Levee			GPS Latitude/Longitude	
				Start	End
Item	Vegetation			37.273302 °	37.257383 °
				-120.278158 °	-120.288233 °
DWR ID	DWR_NA0013_04_s_2017_12				
Comment Code					
V2 : Remove the wild growth other than native grasses from the levee slopes.					
Inspector Comment					
Tall weeds mowed on crown and slopes.

Owens Creek Unit 4 looking at the waterside levee sloped downstream.

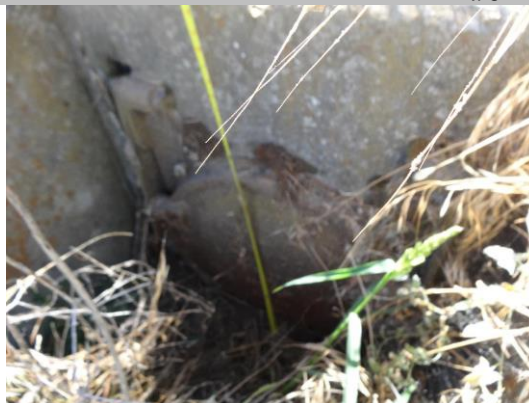
Photo 2 of 3 : UCIP\_FA\_2017\_42991\_35750.jpg

WS view: U typed concrete headwall, CM pipe, and flap gate. Vegetation and silt need to be cleared.

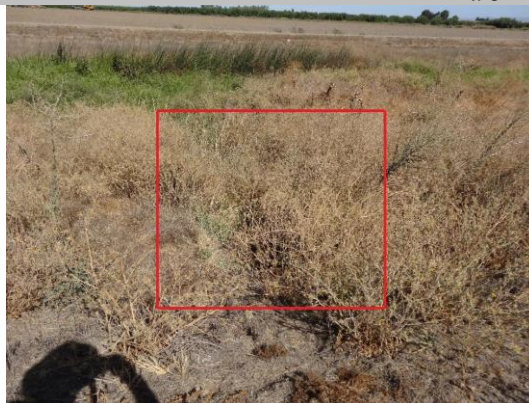
Photo 1 of 3 : UCIP\_FA\_2017\_50154\_35608.jpg

WS view: Dense vegetation on levee slope and spillway.

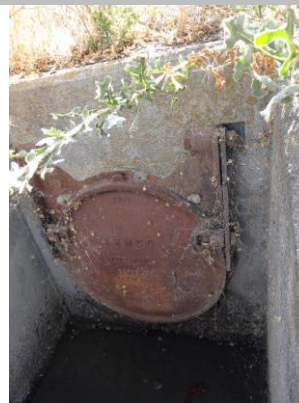
Photo 2 of 3 : UCIP\_FA\_2017\_50148\_35612.jpg

WS view: U typed concrete headwall, CM pipe, and flap gate.

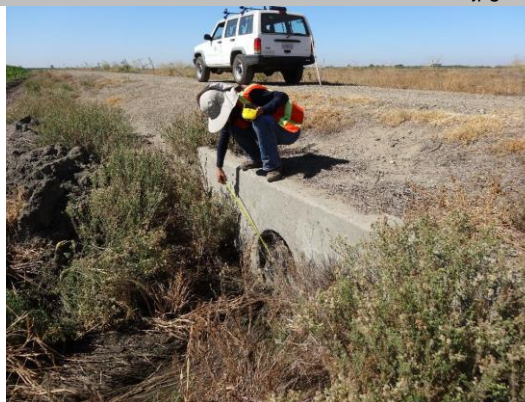
Photo 3 of 3 : UCIP\_FA\_2017\_50148\_35611.jpg

LS view: concrete headwall and CM pipe.

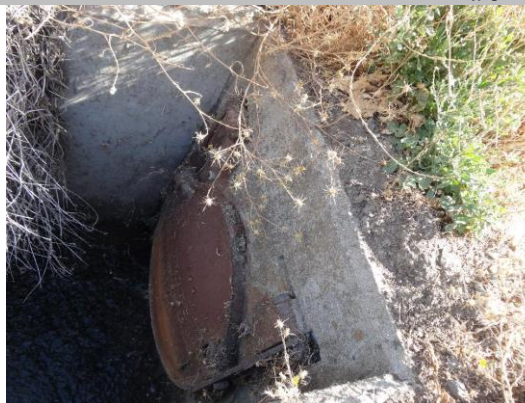
Photo 2 of 3 : UCIP\_FA\_2017\_21126\_35651.jpg

WS view: U typed concrete headwall, CM pipe, and flap gate. Vegetation needs to be cleared on spillway.

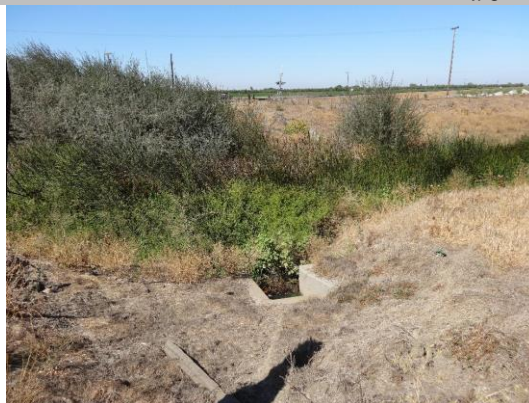
Photo 1 of 3 : UCIP\_FA\_2017\_21127\_35657.jpg

WS view: U typed concrete headwall and channel on waterside.

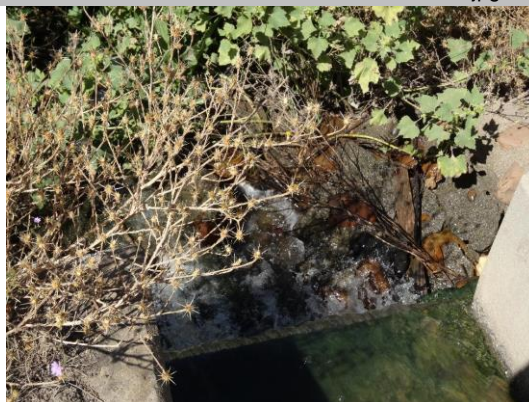
Photo 2 of 3 : UCIP\_FA\_2017\_21127\_35656.jpg

WS view: concrete headwall and concrete spillway on waterside.

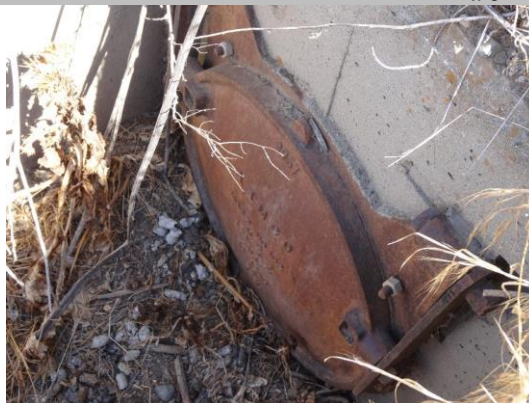
Photo 2 of 3 : UCIP\_FA\_2017\_21210\_35708.jpg

Comment Code						
Inspector Comment						
FS_ID:21210						
DS_ID:23075						
EP_NO: N/A						
Repair Type: Non-Urgent						
Crossing Status: Found						
UCIP Comments: - needs clearing on both inlet and outlet. - needs vegetations clearing on spillway on waterside and inlet on landside.						
FIELD_STRUCT_DESC: 24-inch corrugated metal drainage pipe through the levee, 10.0 feet below the crown. Concrete headwall, flap gate, and concrete grouted cobble spillway on the waterward toe. Concrete headwall on the landward toe. [Additional Reference(s): DWR Levee Log, 2005. USACE Sacramento O&M Manual 607, 1962 (HLM 1.0851)].						
FS Date: 9/17/2013

WS view: U typed concrete headwall, CM pipe, and flap gate. Spillway needs to be cleared.

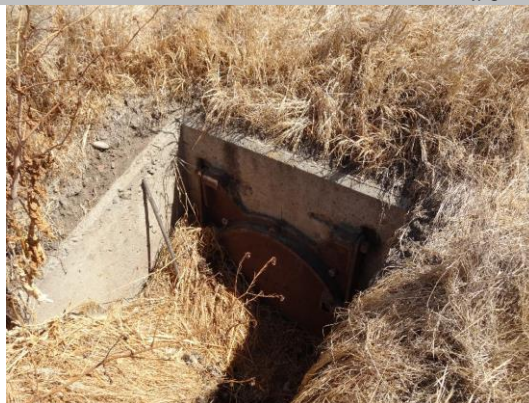
Photo 1 of 3 : UCIP\_FA\_2017\_50153\_35745.jpg

Comment Code					
Inspector Comment					
FS_ID:50153 DS_ID:23076 EP_NO: N/A Repair Type: No Action Needed Crossing Status: Found UCIP Comments: 09/01/2016: Per Mike Walejko, WS outlet has been cleared. See photos. Crossing has been downgraded from Urgent to No Action Needed. (K. Fazel - UCIP)08/23/2016: LS inlet is clear. WS outlet is still buried. Cracks on crown characteristic of entire left bank and not associated with the crossing at this location. (K. Fazel - UCIP)09/17/2013:- significant levee crown and slope cracks along the pipe. Detailed investigation required.- inlet pipe burried on landside. Needs removal of silts. Needs clearing and cleaning.- half of outlet pipe burried. Needs clearing and removal of vegetations and silts. (P. Amatya - UCIP) FIELD_STRUCT_DESC: 24-inch corrugated metal drainage pipe through the levee, 10 feet below the crown. Concrete headwall, flap gate, and concrete grouted cobble spillway on the waterside (WS) toe. Concrete headwall on the landside (LS) toe. [Additional Reference(s): DWR Levee Log, 2005. USACE San Joaquin O&M Manual No. 607, 1962 (HLM 1.24)]. FS Date: 9/1/2016

WS view: U typed concrete headwall, CM pipe, and flap gate. Dirt and vegetations need to be removed and cleared.
