**Flood Control Project Maintenance  
Levee Inspections**

**Fall 2018 Levee Maintenance Deficiency Summary Report**

***San Joaquin River Basin***

<b>NA0013</b>	Overall LMA Rating	Total LMA Miles						
<b>Merced Streams Group</b>	<b>U</b>	<b>6.31</b>						
Rated Item	Maintenance Deficiency				Enforcement		Design & System Obsolescence	
	M Miles	U Miles	M + 4U Miles	Threshold %	M Miles	U Miles	M Miles	U Miles
<i>Earthen Levee</i>								
Vegetation	0.62	1.09	4.98	78.96%				
Trim / Thin Trees	0.02		0.02	0.32%				
Encroachments	0.01		0.01	0.16%	0.23	0.02		
Animal Control	1.08		1.08	17.12%				
Slope Stability	0.01		0.01	0.16%				
Erosion / Bank Caving	0.02		0.02	0.32%				
Crown Surface / Depressions / Rutting	1.22		1.22	19.34%				
<i>Supplemental</i>								
DWR UCIP Field Study					0.02			
DWR UCIP LMA Responsibility								
<i>LMA Totals:</i>	2.98	1.09	7.34	116.38%	0.25	0.02	0.00	0.00
<b>Unit No. 01 Black Rascal Diversion RB</b>	Overall Unit Rating	Total Unit Miles						
<b>NA0013</b>	<b>M</b>	<b>1.61</b>						
Rated Item	Maintenance Deficiency				Enforcement		Design & System Obsolescence

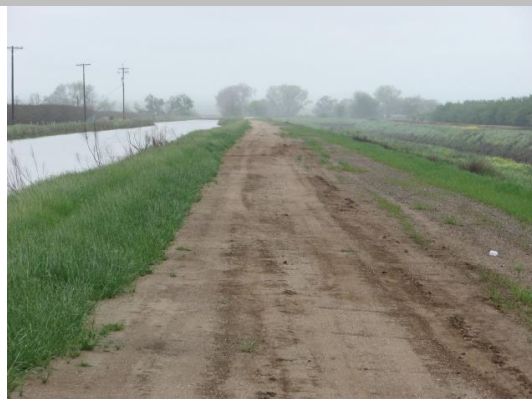
Photo 2 of 2 : FA\_2018\_NA0013\_331\_8\_20180905\_00003.jpg

LM Start	<b>0.27</b>	Rating **	A/W	Issue No.	<b>8 (cont)</b>
LM End	<b>1.62</b>	Issue Type +	Ma	Location *	CR

Looking downstream at typical view of levee crown (Spring 2018)

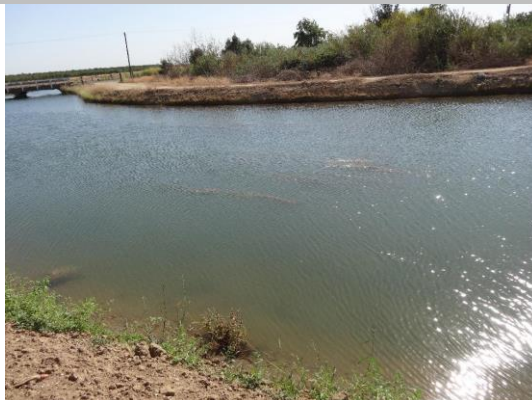
Photo 1 of 3 : UCIP\_FA\_2018\_41672\_35211.jpg

Comment Code						
Inspector Comment						
FS_ID:41672 DS_ID:23079 EP_NO: N/A Repair Type: Non-Urgent Crossing Status: Indicator Found UCIP Comments: 09/17/2013 Verify Pipe is abandoned or still intact.- may be this crossing was abandoned/removed during recent levee reconstruction.- no signs of pipe and appurtenances on waterside.- only a CM pipe riser with slide gate found on landside. (DWR UCIP - P. Amatya) FIELD_STRUCT_DESC: 36-inch corrugated metal irrigation pipe through the levee, 10 feet below the crown. Riser on the landside (LS). Screw gate in a 48-inch pipe well on the waterside (WS) slope. Concrete headwall and cobble spillway at the LS toe. Concrete headwall at the WS toe. [Additional Reference(s): USACE San Joaquin O&M Manual 607, June 1962, (HLM 1.32)]. FS Date: 9/17/2013

WS view: no signs of pipe and appurtenances on levee slope and channel bank.

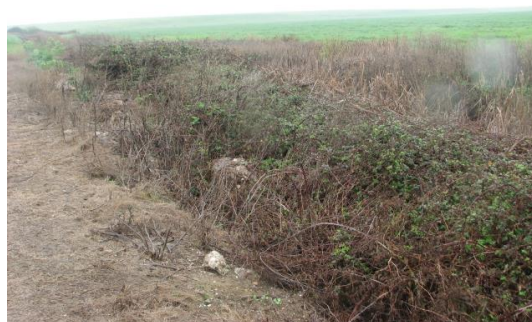
Photo 1 of 2 : FA\_2018\_NA0013\_331\_7\_20180905\_00001.jpg

LM Start	1.57	Rating **	U	Issue No.	7
LM End	1.61	Issue Type +	Ma	Location *	WS
Category	Earthen Levee			GPS Latitude/Longitude	
				Start	End
Item	Vegetation			37.336576 °	37.337098 °
				-120.396540 °	-120.396528 °
DWR ID	DWR_NA0013_01_s_2018_7				
Comment Code					
V2 : Remove the wild growth other than native grasses from the levee slopes.					
Inspector Comment					
Remove wildroses from waterward slope.

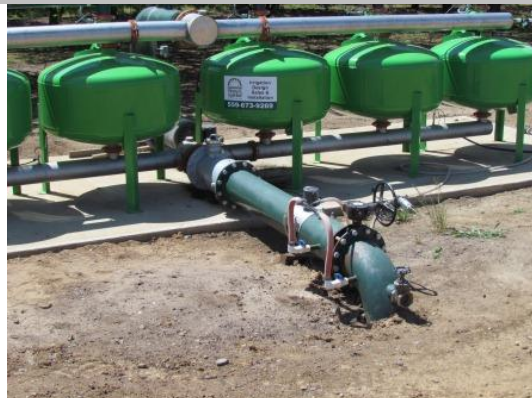
Photo 1 of 3 : FA\_2018\_NA0013\_332\_2\_20180905\_00001.jpg

There is no CVFPB permit on file for this installation. Photo taken 4-23-2014

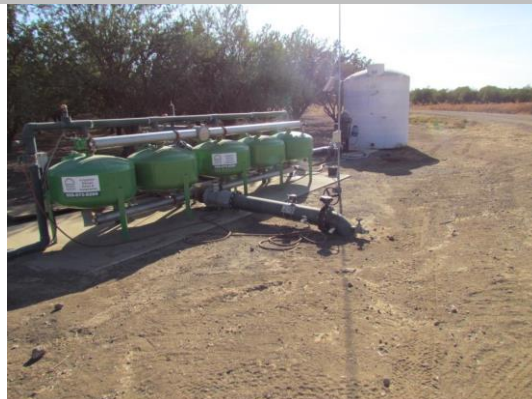
Photo 3 of 3 : FA\_2018\_NA0013\_332\_2\_20180905\_00003.jpg

No Permit for this filtration system and tank on the easement. 2016

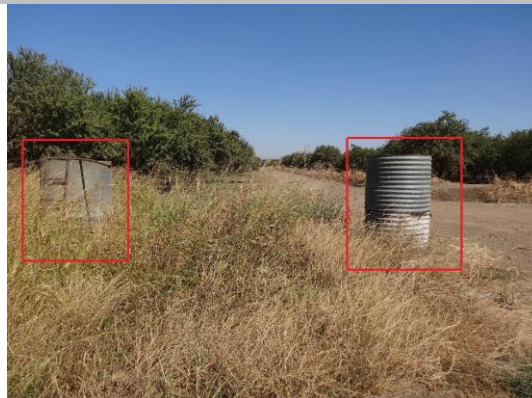
Photo 1 of 3 : UCIP\_FA\_2018\_21263\_35761.jpg

Comment Code						
Inspector Comment						
FS_ID:21263						
DS_ID:23052						
EP_NO: N/A						
Repair Type: Non-Urgent						
Crossing Status: Found						
UCIP Comments: 09/17/2013 - needs more investigations on this crossing. - new water filtration plant on LS with pump and concrete vault.- a concrete standpipe and CM pipe riser on WS. (DWR UCIP - P. Amatya)						
FIELD_STRUCT_DESC: 10-inch steel irrigation pipe through the levee, 5 feet below the crown. Riser on the landside (LS). Screw gate in a 36-inch pipe well on the waterside (WS) slope. [Additional Reference(s): DWR Levee Log, 2005. USACE San Joaquin O&M Manual 607, June 1962, (HLM 0.00)].						
FS Date: 9/17/2013

WS view: concrete standpipe (left) and CMP standpipe (right).

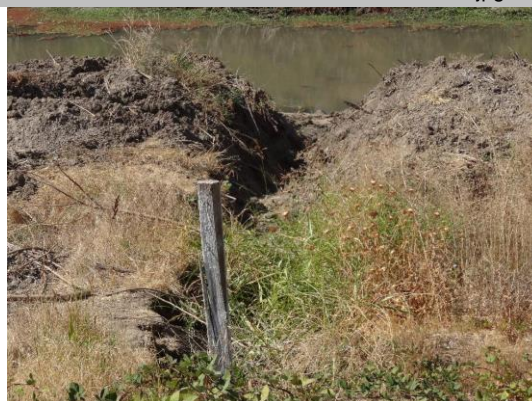
Photo 1 of 3 : UCIP\_FA\_2018\_50156\_35245.jpg

Comment Code					
Inspector Comment					
FS_ID:50156 DS_ID:23053 EP_NO: N/A Repair Type: No Action Needed Crossing Status: Found UCIP Comments: 08/23/2016: LS inlet is clear. WS gate has been cleared of vegetation and functions properly. Crossing has been downgraded from Urgent to No Action Needed. (K. Fazel - UCIP)09/17/2013:- needs vegetation cleaning on both sides.- flap gate was not closed during field survey.- inlet needs cleaning. (P. Amatya - UCIP) FIELD_STRUCT_DESC: 24-inch corrugated metal gravity drainage pipe through the levee, 8 feet below the crown. Concrete headwall, flap gate, and concrete grouted cobble spillway on the waterside (WS) toe. Concrete headwall on the landside (LS) toe. [Additional Reference(s): DWR Levee Log, 2005. USACE San Joaquin O&M Manual 607, June 1962, (HLM 0.29)]. FS Date: 8/23/2016

WS view: cobble spillway and channel on waterside.

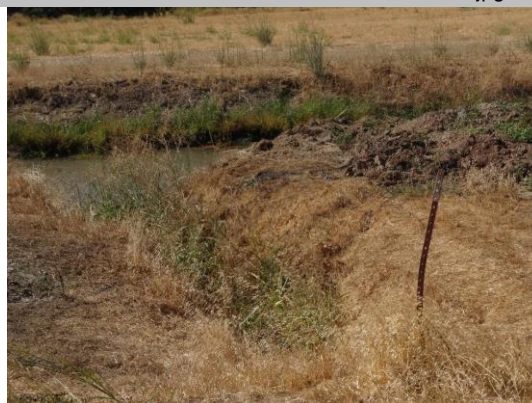
Photo 1 of 3 : UCIP\_FA\_2018\_20946\_35266.jpg

LM Start	0.54	Rating **	M	Issue No.	27	
LM End	0.54	Issue Type +	Ma	Location *		
Category	Supplemental			GPS Latitude/Longitude		
				Start		End
Item	DWR UCIP LMA Responsibility			37.333180 °		37.333180 °
				-120.394069 °		-120.394069 °
DWR ID	23054					
Comment Code						
Inspector Comment						
FS_ID:20946 DS_ID:23054 EP_NO: N/A Repair Type: Non-Urgent Crossing Status: Found UCIP Comments: 09/17/2013 - needs vegetation cleaning on both sides.- flap gate was not properly closed during field survey.- inlet needs cleaning. (DWR UCIP - P. Amatya) FIELD_STRUCT_DESC: 24-inch corrugated metal gravity drainage pipe through the levee, 12 feet below the crown. Concrete headwall, flap gate, and concrete grouted cobble spillway on the waterside (WS) toe. Concrete headwall on the landside (LS) toe. [Additional Reference(s): DWR Levee Log, 2005]. FS Date: 9/17/2013

WS view: cobble spillway and channel on waterside.

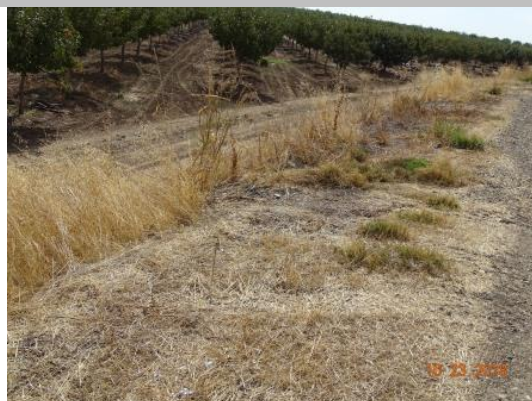
Photo 1 of 1 : FA\_2018\_NA0013\_332\_19\_20181108\_00038.jpg

LM Start	0.64	Rating **	M	Issue No.	19
LM End	0.69	Issue Type +	Ma	Location *	LS
Category	Earthen Levee			GPS Latitude/Longitude	
				Start	End
Item	Vegetation			37.331678 °	37.331128 °
				-120.394287 °	-120.394670 °
DWR ID	DWR_NA0013_02_f_2018_19				
Comment Code					
V1 : Control annual grass and weeds on the levee slopes and easements.					
Inspector Comment					
patches of tall grass partially blocking view of landside slope

View of landside slope looking downstream. (Fall 2018)

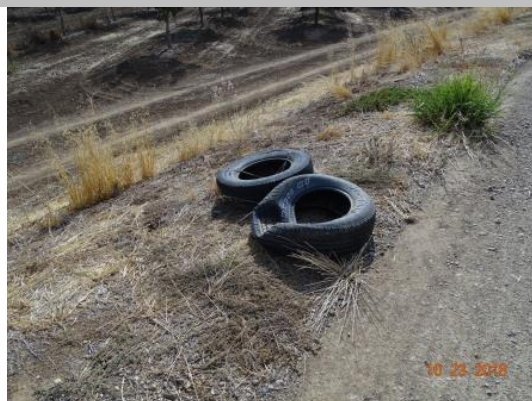
Photo 1 of 1 : FA\_2018\_NA0013\_332\_20\_20181108\_00039.jpg

LM Start	0.70	Rating **	M	Issue No.	20
LM End	0.70	Issue Type +	Ma	Location *	LS
Category	Earthen Levee			GPS Latitude/Longitude	
				Start	End
Item	Encroachments			37.331013 °	37.331013 °
				-120.394765 °	-120.394765 °
DWR ID	DWR_NA0013_02_f_2018_20				
Comment Code					
DE : Debris					
Inspector Comment					
Tires left on landside shoulder

Tires left on landside shoulder. (Fall 2018)

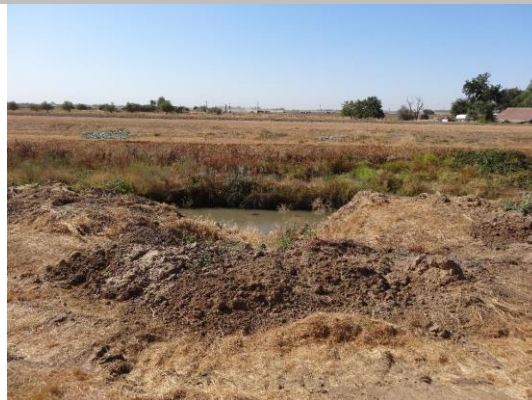
Photo 1 of 3 : UCIP\_FA\_2018\_20992\_35370.jpg

Comment Code						
Inspector Comment						
FS_ID:20992						
DS_ID:23055						
EP_NO: N/A						
Repair Type: Non-Urgent						
Crossing Status: Found						
UCIP Comments: 09/17/2013 - mud and debris from recent channel cleaning needs to be removed from spillway and outlet - pipe filled with debris, it needs cleaning.- half of intet pipe burried. (DWR UCIP - P. Amatya)						
FIELD_STRUCT_DESC: 24-inch corrugated metal gravity drainage pipe through the levee, 8 feet below the crown. Concrete headwall, flap gate, and concrete grouted cobble spillway on the waterside (WS) toe. Concrete headwall on the landside (LS) toe. [Additional Reference(s): DWR Levee Log, 2005. USACE San Joaquin O&M Manual 607, June 1962, (HLM 0.73)].						
FS Date: 9/17/2013

WS view: concrete headwall and CM pipe buried under debris and mud.

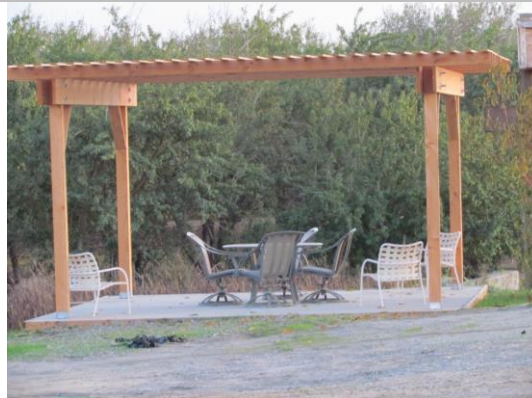
Photo 1 of 4 : FA\_2018\_NA0013\_332\_24\_20180905\_00009.jpg

Unauthorized encroachment placed on the landside shoulder and berm.

LM Start	0.88	Rating **	U	Issue No.	24 (cont)	
LM End	0.88	Issue Type +	En	Location *	LS	
Category	Earthen Levee			GPS Latitude/Longitude		
				Start	End	
Item	Encroachments			37.328567 °	37.328567 °	
				-120.396062 °	-120.396062 °	
DWR ID	DWR_NA0013_02_s_2014_24					
Comment Code						
TR : Tree or limb						
Inspector Comment						
Three fruit trees with irrigation system, stock pile of material (2) piles on the land side toe and rock pad placed on land side toe. Discovered during the fall 2014 inspection a structure has been installed on the landward levee slope and berm. No permit for these encroachments.

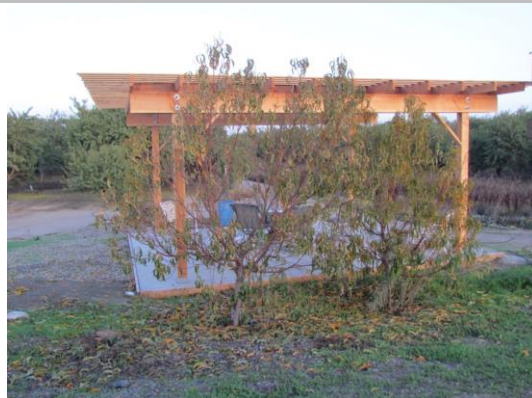
Photo 2 of 4 : FA\_2018\_NA0013\_332\_24\_20180905\_00010.jpg

Another view of unauthorized structure.

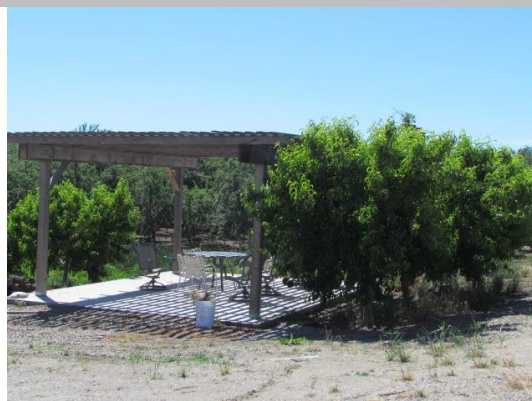
Photo 4 of 4 : FA\_2018\_NA0013\_332\_24\_20180905\_00012.jpg

No change 5-2017.

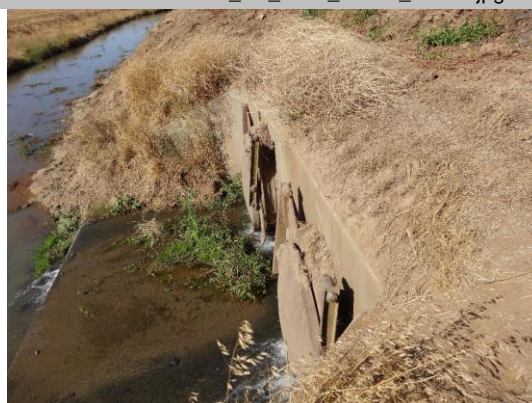
Photo 1 of 3 : UCIP\_FA\_2018\_20965\_35292.jpg

Comment Code					
Inspector Comment					
FS_ID:20965					
DS_ID:23056					
EP_NO: N/A					
Repair Type: No Action Needed					
Crossing Status: Found					
UCIP Comments: 09/17/2013 - working during field inspection. -					
vegetation on drainage ditch/channel (DWR UCIP - P. Amatya)					
FIELD_STRUCT_DESC: 1 of 2: 60-inch corrugated metal gravity					
drainage pipe through the levee, 10 feet below the crown. Concrete					
headwall and flap gate on the waterside (WS) berm, 5 feet from the					
levee toe. Concrete headwall on the landside (LS) toe. [Additional					
Reference(s): DWR Levee Log, 2005. USACE San Joaquin O&M					
Manual 607, June 1962, (HLM 0.91)].					
FS Date: 9/17/2013

WS view: two 60" CMPs, flap gates, and headwall on channel bank.

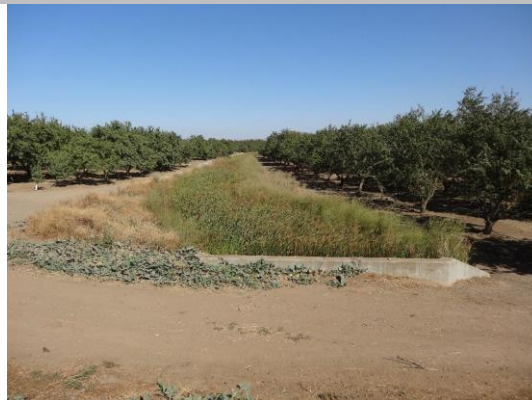
Photo 2 of 3 : UCIP\_FA\_2018\_20965\_35291.jpg

LS view: headwall on levee toe. Green vegetation in drainage channel.

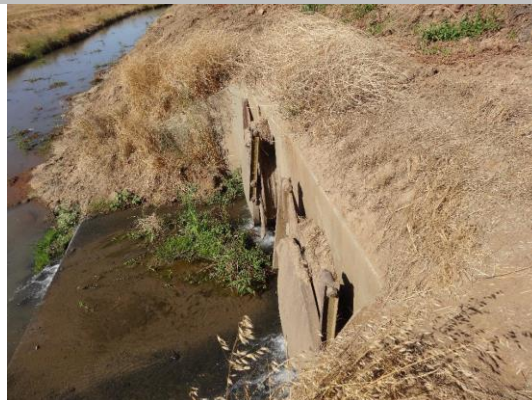
Photo 1 of 3 : UCIP\_FA\_2018\_20983\_35302.jpg

LM Start	0.91	Rating **	A/W	Issue No.	30	
LM End	0.91	Issue Type +	Ma	Location *		
Category	Supplemental			GPS Latitude/Longitude		
				Start		End
Item	DWR UCIP LMA Responsibility			37.328267 °		37.328267 °
				-120.396084 °		-120.396084 °
DWR ID	23080					
Comment Code						
Inspector Comment						
FS_ID:20983 DS_ID:23080 EP_NO: N/A Repair Type: No Action Needed Crossing Status: Found UCIP Comments: 09/17/2013 It was working during field inspection.  Dense vegetation in drainage ditch (DWR UCIP - P. Amatya). FIELD_STRUCT_DESC: 2 of 2: 60-inch corrugated metal gravity drainage pipe through the levee, 10 feet below the crown. Concrete headwall and flap gate on the waterside (WS) berm, 5 feet from the levee toe. Concrete headwall on the landside (LS) toe. [Additional Reference(s): DWR Levee Log, 2005. USACE San Joaquin O&M Manual 607, June 1962, (HLM 0.91)]. FS Date: 9/17/2013

WS view: two CMPs with flap gate, concrete spillway and channel on waterside.

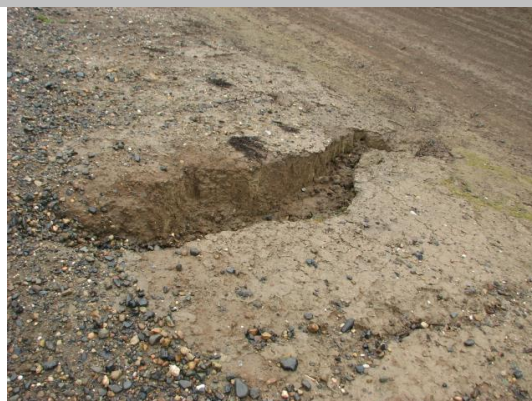
Photo 2 of 3 : FA\_2018\_NA0013\_332\_15\_20180905\_00006.jpg

LM Start	0.97	Rating **	M	Issue No.	15 (cont)	
LM End	0.97	Issue Type +	Ma	Location *	LS	
Category	Earthen Levee			GPS Latitude/Longitude		
				Start	End	
Item	Erosion / Bank Caving			37.327336 °	37.327336 °	
				-120.396085 °	-120.396085 °	
DWR ID	DWR_NA0013_02_f_2017_15					
Comment Code						
E1 : Note and monitor erosion site.						
Inspector Comment						
Large finger erosion on landward slope. Couple smaller erosions starting just downstream of large erosion

Looking downstream at finger erosion on landward slope. (Spring 2018)

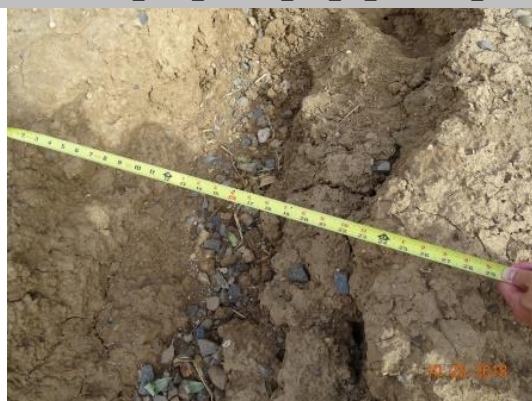
Photo 3 of 3 : FA\_2018\_NA0013\_332\_15\_20181108\_00040.jpg

Measurement across erosion at widest point. (Fall 2018)

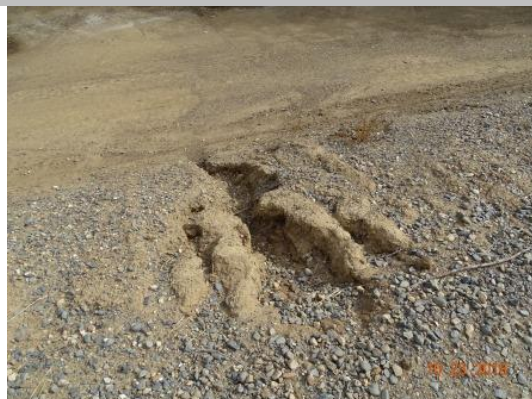
Photo 1 of 2 : FA\_2018\_NA0013\_332\_16\_20181108\_00043.jpg

LM Start	1.10	Rating **	M	Issue No.	16
LM End	1.10	Issue Type +	Ma	Location *	LS
Category	Earthen Levee			GPS Latitude/Longitude	
				Start	End
Item	Erosion / Bank Caving			37.325487 °	37.325487 °
				-120.396052 °	-120.396052 °
DWR ID	DWR_NA0013_02_s_2017_16				
Comment Code					
E1 : Note and monitor erosion site.					
Inspector Comment					
large finger erosion on landside slope

View of large finger erosion in landside slope. (Fall 2018)

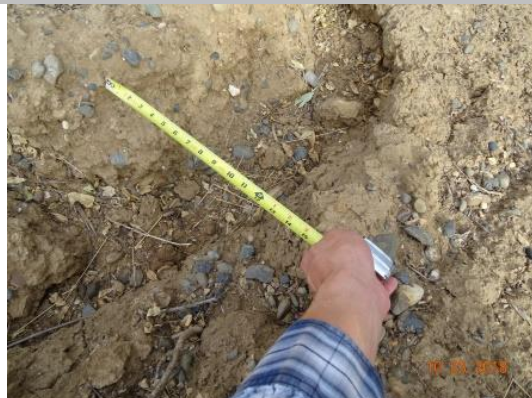
Photo 2 of 2 : FA\_2018\_NA0013\_332\_16\_20181108\_00044.jpg

LM Start	1.10	Rating **	M	Issue No.	16 (cont)
LM End	1.10	Issue Type +	Ma	Location *	LS
Category	Earthen Levee			GPS Latitude/Longitude	
				Start	End
Item	Erosion / Bank Caving			37.325487 °	37.325487 °
				-120.396052 °	-120.396052 °
DWR ID	DWR_NA0013_02_s_2017_16				
Comment Code					
E1 : Note and monitor erosion site.					
Inspector Comment					
large finger erosion on landside slope

Measurement across finger erosion. (Fall 2018)

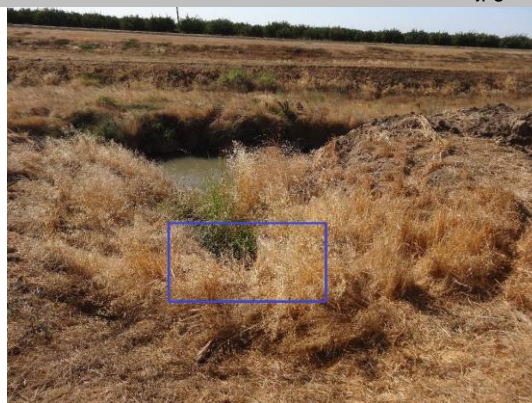
Photo 1 of 3 : UCIP\_FA\_2018\_20984\_35305.jpg

WS view: U type concrete headwall and channel on waterside.

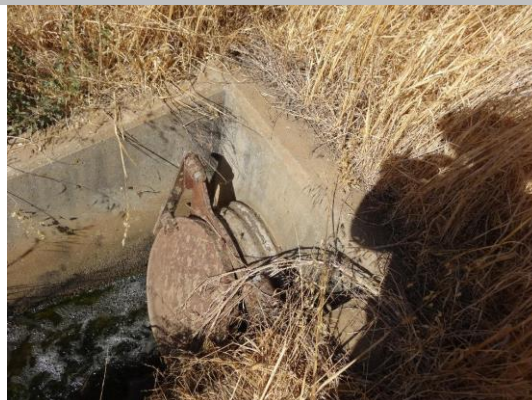
Photo 2 of 3 : UCIP\_FA\_2018\_20984\_35304.jpg

WS view: U typed concrete headwall, CM pipe, and flap gate. It was working during field inspection.

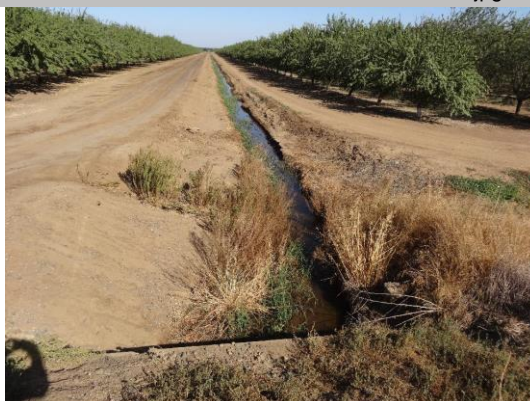
Photo 3 of 3 : UCIP\_FA\_2018\_20984\_35303.jpg

LM Start	1.30	Rating **	A/W	Issue No.	31 (cont)	
LM End	1.30	Issue Type +	Ma	Location *		
Category	Supplemental			GPS Latitude/Longitude		
				Start	End	
Item	DWR UCIP LMA Responsibility			37.322499 °	37.322499 °	
				-120.396045 °	-120.396045 °	
DWR ID	23057					
Comment Code						
Inspector Comment						
FS_ID:20984 DS_ID:23057 EP_NO: N/A Repair Type: No Action Needed Crossing Status: Found UCIP Comments: 09/17/2013 - working during field inspection. (DWR UCIP - P. Amatya) FIELD_STRUCT_DESC: 24-inch corrugated metal gravity drainage pipe through the levee, 10 feet below the crown. Concrete headwall, flap gate, and concrete grouted cobble spillway on the waterside (WS) toe. Concrete headwall on the landside (LS) toe. [Additional Reference(s): DWR Levee Log, 2005. USACE San Joaquin O&M Manual 607, June 1962, (HLM 1.32)]. FS Date: 9/17/2013

LS view: concrete headwall on levee toe and drainage ditch.

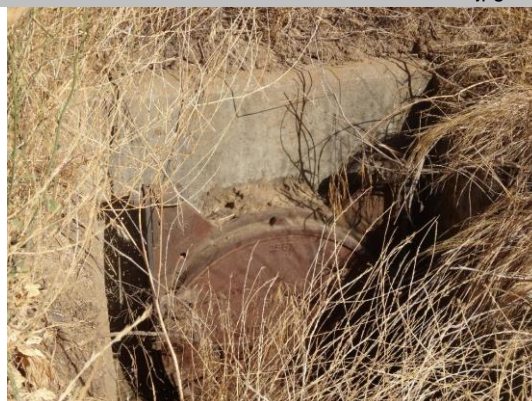
Photo 2 of 3 : UCIP\_FA\_2018\_42993\_35309.jpg

WS view: U typed concrete headwall, CM pipe and flap gate. Vegetation and debris need to be cleared.

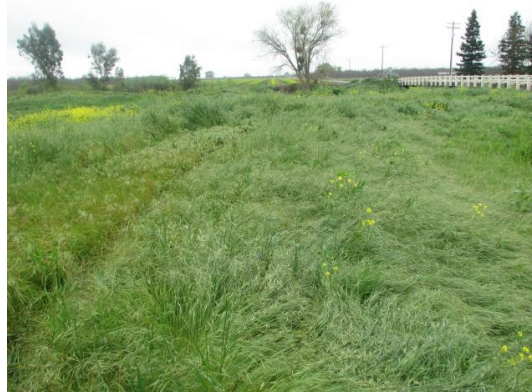
Photo 2 of 2 : FA\_2018\_NA0013\_333\_10\_20180905\_00002.jpg

LM Start	<b>0.03</b>	Rating **	U	Issue No.	<b>10 (cont)</b>
LM End	<b>0.43</b>	Issue Type +	Ma	Location *	LS

Looking downstream at landward slope. (Spring 2018)

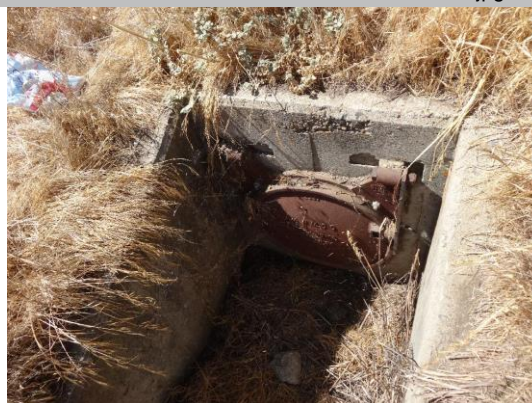
Photo 1 of 3 : UCIP\_FA\_2018\_41815\_35533.jpg

Comment Code						
Inspector Comment						
FS_ID:41815						
DS_ID:23060						
EP_NO: N/A						
Repair Type: Non-Urgent						
Crossing Status: Found						
UCIP Comments: 09/17/2013 - more than a half of inet pipe burried on						
LS. - needs vegetation cleaning on both sides.- inlet needs silt						
removed and cleaning. (DWR UCIP - P. Amaty)						
FIELD_STRUCT_DESC: 24-inch corrugated metal gravity drainage pipe						
through the levee, 6 feet below the crown. Concrete headwall, flap gate,						
and concrete grouted cobble spillway on the waterside (WS) toe.						
Concrete headwall on the landside (LS) toe. [Additional Reference(s):						
DWR Levee Log, 2005. USACE San Joaquin O&M Manual 607, June						
1962, (HLM 0.18)].						
FS Date: 9/17/2013

WS view: U typed concrete headwall, CM pipe, and flap gate.

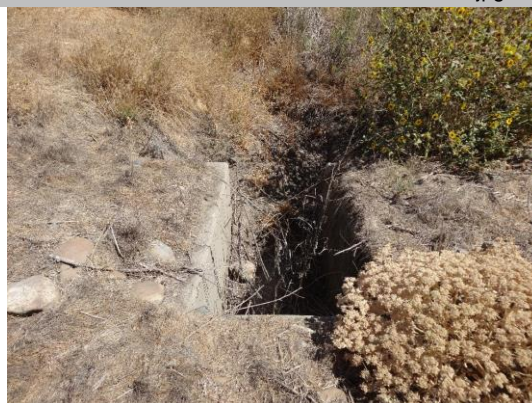
Photo 1 of 3 : UCIP\_FA\_2018\_50144\_35422.jpg

WS view: U typed concrete headwall, cobble spillway, and channel on waterside.

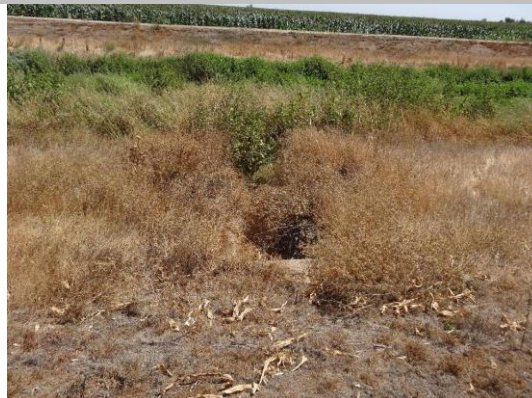
Photo 1 of 3 : UCIP\_FA\_2018\_50151\_35539.jpg

WS view: overview of spillway/outlet area on waterside.

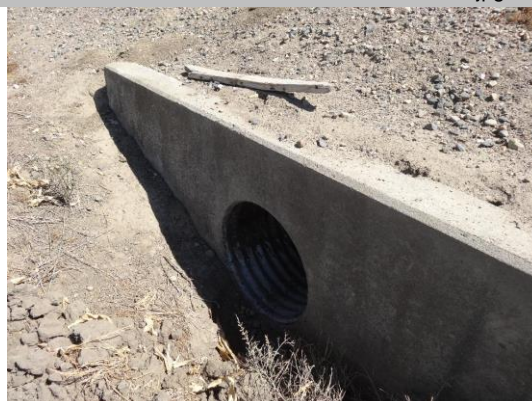
Photo 3 of 3 : UCIP\_FA\_2018\_50151\_35541.jpg

LS view: concrete headwall and CM pipe.

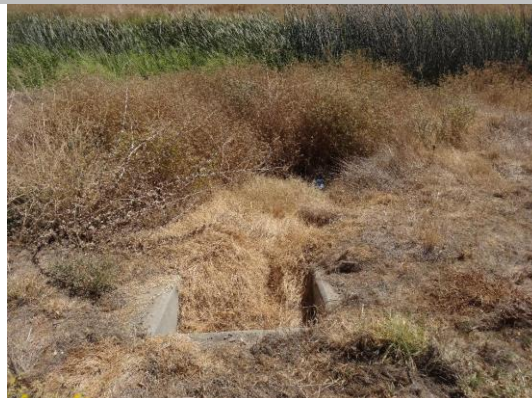
Photo 1 of 3 : UCIP\_FA\_2018\_50152\_35544.jpg

WS view: cobble spillway and channel on waterside.

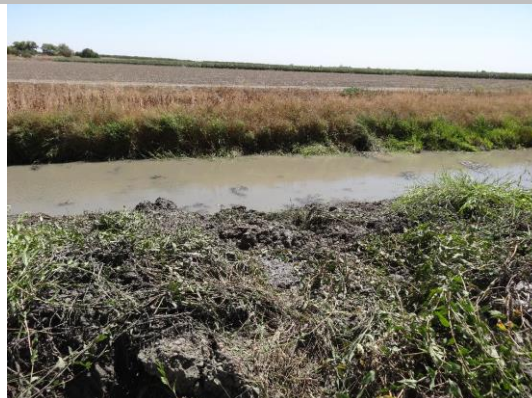
Photo 1 of 3 : UCIP\_FA\_2018\_21063\_35502.jpg

Comment Code						
Inspector Comment						
FS_ID:21063						
DS_ID:23065						
EP_NO: N/A						
Repair Type: Non-Urgent						
Crossing Status: Found						
UCIP Comments: 09/17/2013 - mud and debris from recent channel cleaning needs to be removed from spillway and outlet - inlet pipe needs clearing and cleaning on landside (DWR UCIP - P. Amatya).						
FIELD_STRUCT_DESC: 24-inch corrugated metal gravity drainage pipe through the levee, 6 feet below the crown. Concrete headwall, flap gate, and concrete grouted cobble spillway on the waterside (WS) toe.						
Concrete headwall on the landside (LS) toe. [Additional Reference(s): DWR Levee Log, 2005. USACE San Joaquin O&M Manual 607, June 1962, (HLM 1.17)].						
FS Date: 9/17/2013

WS view: U typed concrete headwall, CM pipe, and flap gate buried under mud/debris.

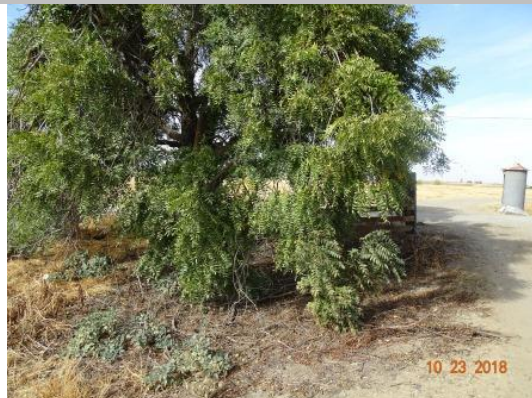
Photo 1 of 1 : FA\_2018\_NA0013\_333\_16\_20181108\_00032.jpg

LM Start	1.25	Rating **	M	Issue No.	16
LM End	1.25	Issue Type +	Ma	Location *	LS
Category	Earthen Levee			GPS Latitude/Longitude	
				Start	End
Item	Trim / Thin Trees			37.272801 °	37.272801 °
				-120.280304 °	-120.280304 °
DWR ID	DWR_NA0013_03_f_2018_16				
Comment Code					
T1 : Trim trees to at least five feet above ground level.					
Inspector Comment

tree on landside slope. (Fall 2018)

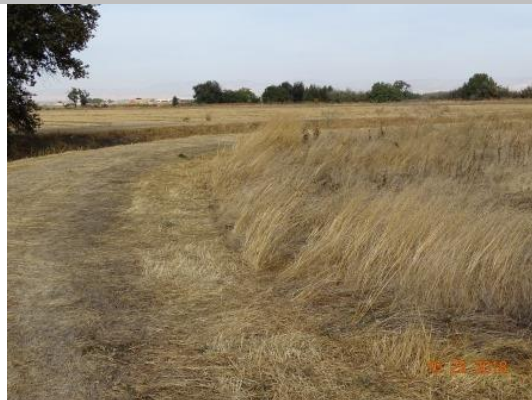
Photo 1 of 1 : FA\_2018\_NA0013\_334\_15\_20181108\_00031.jpg

LM Start	0.00	Rating **	U	Issue No.	15
LM End	0.15	Issue Type +	Ma	Location *	LS
Category	Earthen Levee			GPS Latitude/Longitude	
				Start	End
Item	Vegetation				° 37.272847 °
					° -120.280015 °
DWR ID	DWR_NA0013_04_f_2018_15				
Comment Code					
V1 : Control annual grass and weeds on the levee slopes and easements.					
Inspector Comment

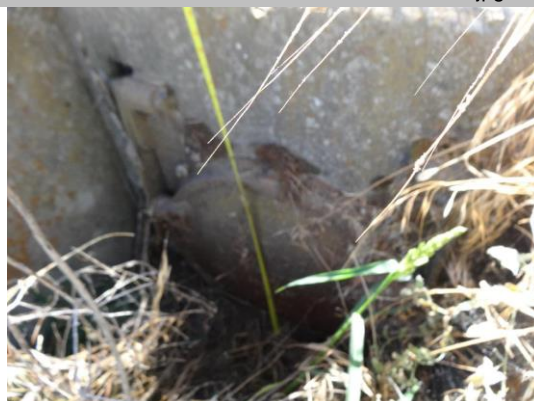
Photo 2 of 3 : UCIP\_FA\_2018\_42991\_35750.jpg

Comment Code						
Inspector Comment						
FS_ID:42991						
DS_ID:23068						
EP_NO: N/A						
Repair Type: Non-Urgent						
Crossing Status: Found						
UCIP Comments: 09/17/2013 - needs vegetation clearing on both sides. Flapgate blocked by debris on WS. - inlet and outlet need silt clearing and cleaning. (DWR UCIP - P. Amatya)						
FIELD_STRUCT_DESC: 24-inch corrugated metal gravity drainage pipe through the levee, 5 feet below the crown. Concrete headwall, flap gate, and concrete grouted cobble spillway on the waterside (WS) toe. Concrete headwall on the landside (LS) toe. [Additional Reference(s): DWR Levee Log, 2005. USACE San Joaquin O&M Manual 607, June 1962, (HLM 0.10)].						
FS Date: 9/17/2013

WS view: U typed concrete headwall, CM pipe, and flap gate. Vegetation and silt need to be cleared.

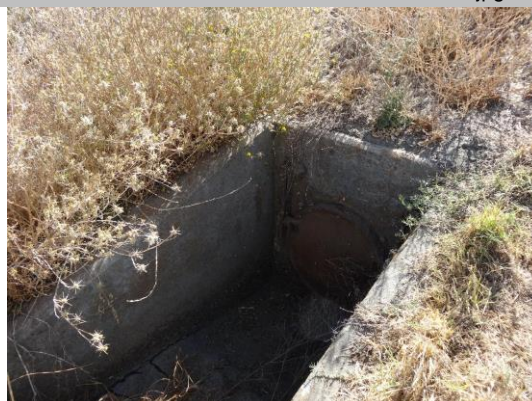
Photo 2 of 3 : UCIP\_FA\_2018\_50154\_35607.jpg

WS view: U typed concrete headwall, CM pipe, and flap gate. Vegetation needs to be cleared on spillway.

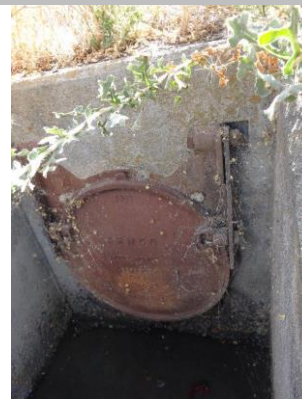
Photo 2 of 3 : UCIP\_FA\_2018\_50148\_35612.jpg

WS view: U typed concrete headwall, CM pipe, and flap gate.

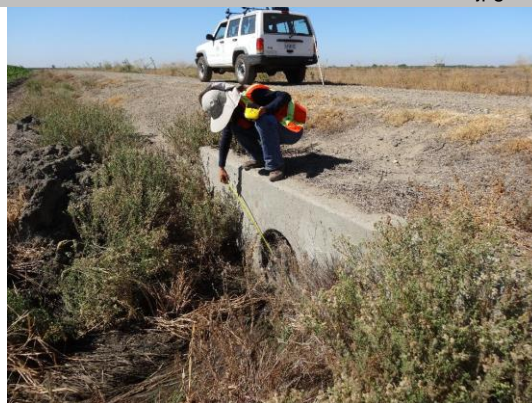
Photo 3 of 3 : UCIP\_FA\_2018\_50148\_35611.jpg

LS view: concrete headwall and CM pipe.

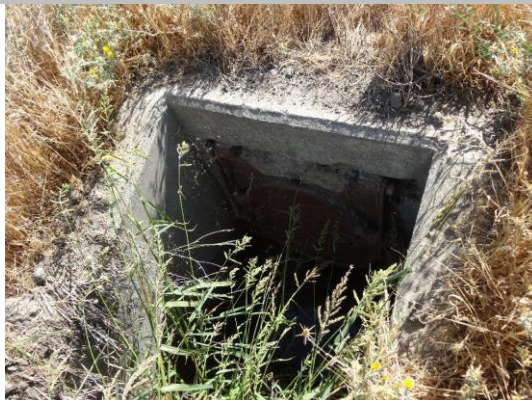
Photo 2 of 3 : UCIP\_FA\_2018\_50155\_35641.jpg

WS view: U typed concrete headwall, CM pipe, and flap gate. Vegetation needs to be cleared.

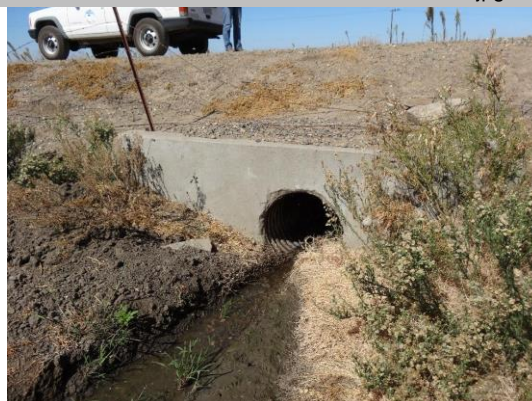
Photo 3 of 3 : UCIP\_FA\_2018\_21126\_35654.jpg

Comment Code						
Inspector Comment						
FS_ID:21126						
DS_ID:23073						
EP_NO: N/A						
Repair Type: Non-Urgent						
Crossing Status: Found						
UCIP Comments: 09/17/2013 - needs vegetation clearing on						
waterside.- concrete spillway on waterside.- the drainage was						
working during field survey. (DWR UCIP - P. Amatya)						
FIELD_STRUCT_DESC: 24-inch corrugated metal gravity drainage pipe						
through the levee, 6 feet below the crown. Concrete headwall, flap gate,						
and concrete grouted cobble spillway on the waterside (WS) toe.						
Concrete headwall on the landside (LS) toe. [Additional Reference(s):						
DWR Levee Log, 2005. USACE San Joaquin O&M Manual 607, June						
1962, (HLM 0.82)].						
FS Date: 9/17/2013

LS view: concrete headwall and CM pipe. Drain pipe was working during field survey.

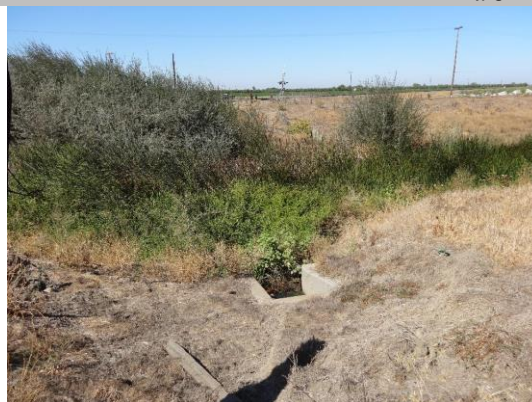
Photo 1 of 3 : UCIP\_FA\_2018\_21127\_35657.jpg

WS view: U typed concrete headwall and channel on waterside.

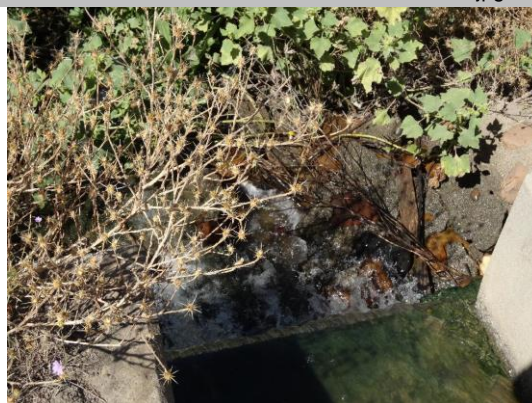
Photo 2 of 3 : UCIP\_FA\_2018\_21127\_35656.jpg

WS view: concrete headwall and concrete spillway on waterside.

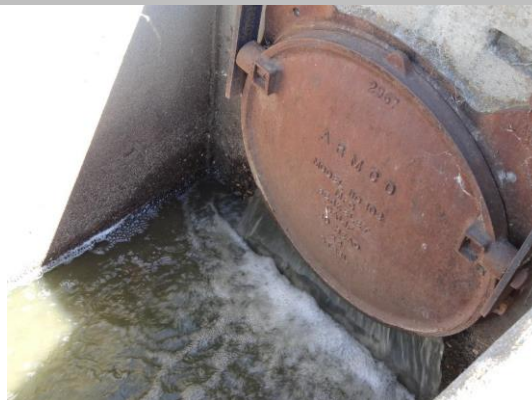
Photo 3 of 3 : UCIP\_FA\_2018\_21127\_35655.jpg

WS view: U typed concrete headwall, CM pipe, and flap gate. Drainage was working during survey.

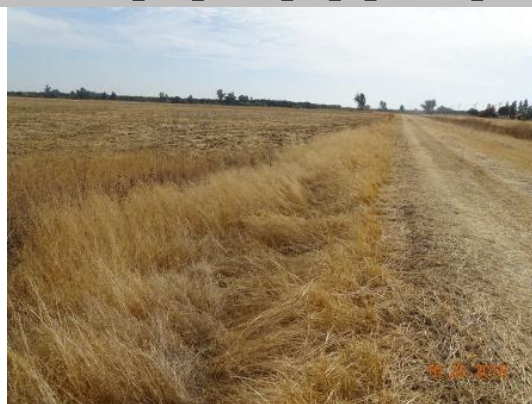
Photo 1 of 2 : FA\_2018\_NA0013\_334\_11\_20181108\_00037.jpg

LM Start	1.08	Rating **	U	Issue No.	11
LM End	1.41	Issue Type +	Ma	Location *	LS
Category	Earthen Levee			GPS Latitude/Longitude	
				Start	End
Item	Vegetation			37.273322°	37.257383°
				-120.277913°	-120.288233°
DWR ID	DWR_NA0013_04_s_2017_11				
Comment Code					
V2 : Remove the wild growth other than native grasses from the levee slopes.					
Inspector Comment					
Mow on crown and slopes.

View of landside slope looking downstream. (Fall 2018)

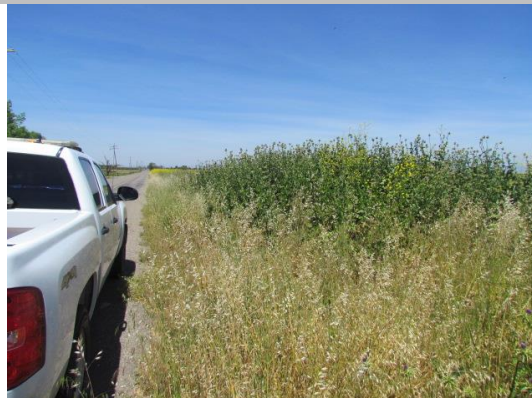
Photo 2 of 2 : FA\_2018\_NA0013\_334\_11\_20180905\_00002.jpg

LM Start	1.08	Rating **	U	Issue No.	11 (cont)	
LM End	1.41	Issue Type +	Ma	Location *	LS	
Category	Earthen Levee			GPS Latitude/Longitude		
				Start		End
Item	Vegetation			37.273322°	37.257383°	
				-120.277913°	-120.288233°	
DWR ID	DWR_NA0013_04_s_2017_11					
Comment Code						
V2 : Remove the wild growth other than native grasses from the levee slopes.						
Inspector Comment						
Mow on crown and slopes.

Owens Creek Unit 4 looking upstream the unsatisfactory wild weed growth has completely block the view of the levee section.

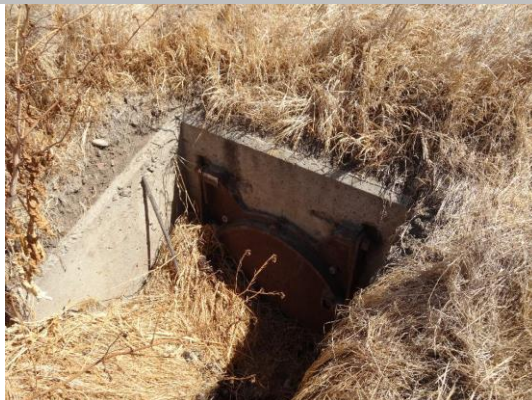
Photo 1 of 3 : UCIP\_FA\_2018\_50153\_35745.jpg

WS view: U typed concrete headwall, CM pipe, and flap gate. Dirt and vegetations need to be removed and cleared.
