**Flood Control Project Maintenance
Levee Inspections**

Fall 2019 Levee Maintenance Deficiency Summary Report

San Joaquin River Basin

**Flood Control Project Maintenance
Levee Inspections****LMA District Cover Sheet****Fall 2019 Levee Inspection Results****Merced Streams Group**

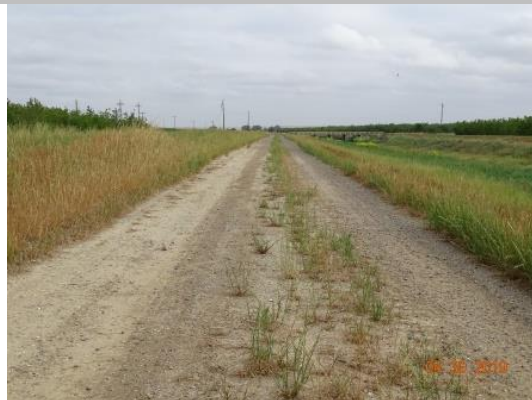
Photo 1 of 1 : FA_2019_NA0013_331_12_20190912_00007.jpg

LM Start	0.04	Rating **	M	Issue No.	12
LM End	0.17	Issue Type +	Ma	Location *	CR
Category	Earthen Levee			GPS Latitude/Longitude	
				Start	End
Item	Vegetation			37.315268 °	37.317130 °
				-120.396387 °	-120.396335 °
DWR ID	DWR_NA0013_01_s_2019_12				
Comment Code					
V9 : Keep the crown roadway free of vegetation.					
Inspector Comment

View of vegetation along levee crown looking upstream. (Spring 2019)

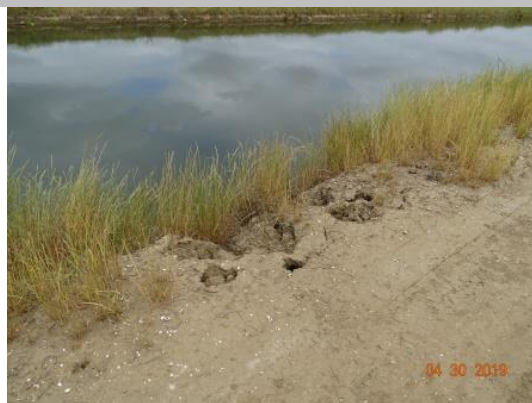
Photo 1 of 1 : FA_2019_NA0013_331_14_20190912_00009.jpg

LM Start	0.75	Rating **	A/W	Issue No.	14
LM End	0.75	Issue Type +	Ma	Location *	LS
Category	Earthen Levee			GPS Latitude/Longitude	
				Start	End
Item	Erosion / Bank Caving			37.325485 °	37.325485 °
				-120.396700 °	-120.396700 °
DWR ID	DWR_NA0013_01_s_2019_14				
Comment Code					
E1 : Note and monitor erosion site.					
Inspector Comment

View of erosion on landside slope. (Spring 2019)

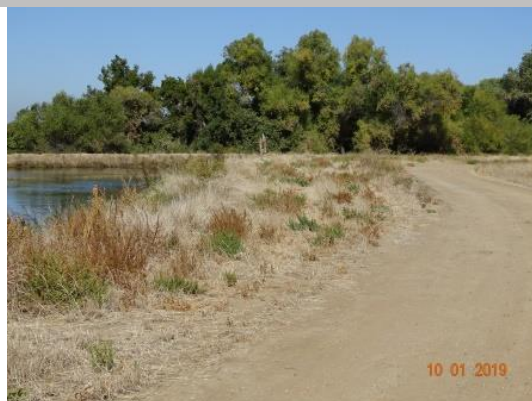
Photo 1 of 1 : FA_2019_NA0013_331_10_20191007_00018.jpg

LM Start	1.26	Rating **	U	Issue No.	10
LM End	1.54	Issue Type +	Ma	Location *	LS
Category	Earthen Levee			GPS Latitude/Longitude	
				Start	End
Item	Vegetation			37.332458 °	37.336083 °
				-120.394762 °	-120.396522 °
DWR ID	DWR_NA0013_01_f_2019_10				
Comment Code					
V1 : Control annual grass and weeds on the levee slopes and easements.					
Inspector Comment

View of landside slope looking upstream. (Fall 2019)

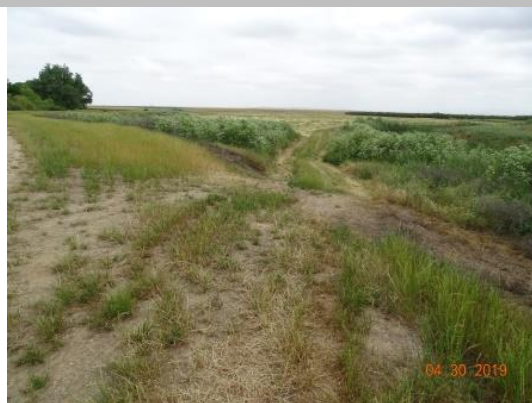
Photo 1 of 1 : FA_2019_NA0013_331_18_20190912_00011.jpg

LM Start	1.27	Rating **	M	Issue No.	18
LM End	1.27	Issue Type +	En	Location *	WS
Category	Earthen Levee			GPS Latitude/Longitude	
				Start	End
Item	Encroachments			37.332554 °	37.332554 °
				-120.394767 °	-120.394767 °
DWR ID	DWR_NA0013_01_s_2019_18				
Comment Code					
RA : Ramp					
Inspector Comment

View of ramp on waterside slope looking Northeast. (Spring 2019)

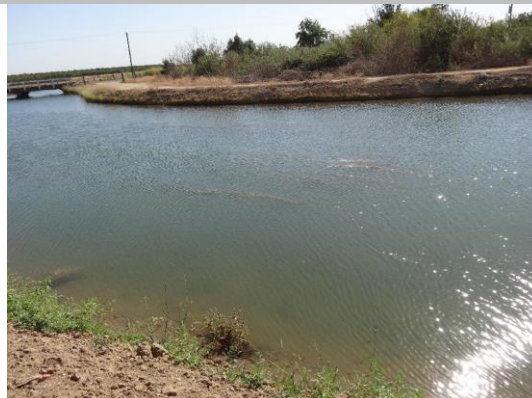
Photo 1 of 3 : UCIP_FA_2019_41672_35211.jpg

Comment Code					
Inspector Comment					
DS_ID:23079 FS_ID:41672 EP_NO: N/A Repair Type: Non-Urgent Crossing Status: Indicator Found UCIP Comments: 09/17/2013 Verify Pipe is abandoned or still intact.- may be this crossing was abandoned/removed during recent levee reconstruction.- no signs of pipe and appurtenances on waterside.- only a CM pipe riser with slide gate found on landside. (DWR UCIP - P. Amatya) FIELD_STRUCT_DESC: 36-inch corrugated metal irrigation pipe through the levee, 10 feet below the crown. Riser on the landside (LS). Screw gate in a 48-inch pipe well on the waterside (WS) slope. Concrete headwall and cobble spillway at the LS toe. Concrete headwall at the WS toe. [Additional Reference(s): USACE San Joaquin O&M Manual 607, June 1962, (HLM 1.32)]. FS Date: 9/17/2013

WS view: no signs of pipe and appurtenances on levee slope and channel bank.

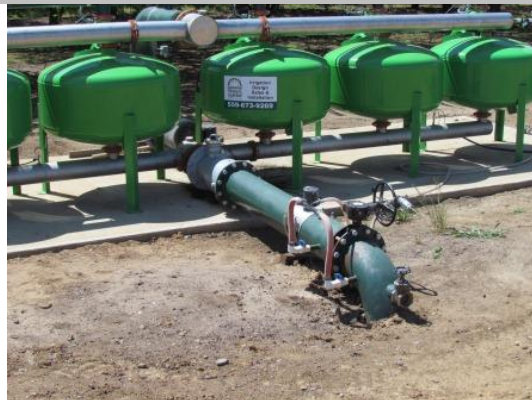
Photo 1 of 3 : FA_2019_NA0013_332_2_20190912_00001.jpg

There is no CVFPB permit on file for this installation. Photo taken 4-23-2014

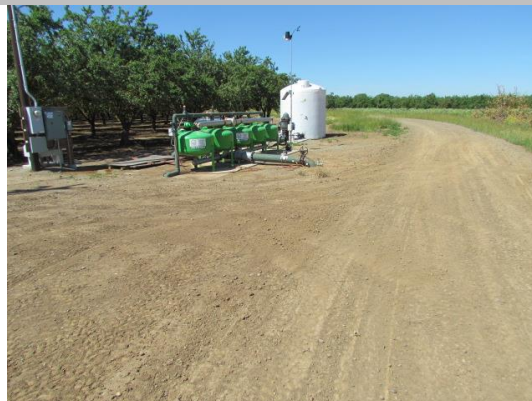
Photo 2 of 3 : FA_2019_NA0013_332_2_20190912_00002.jpg

No Permit for this filtration system and tank on the easement. No change since last inspection.

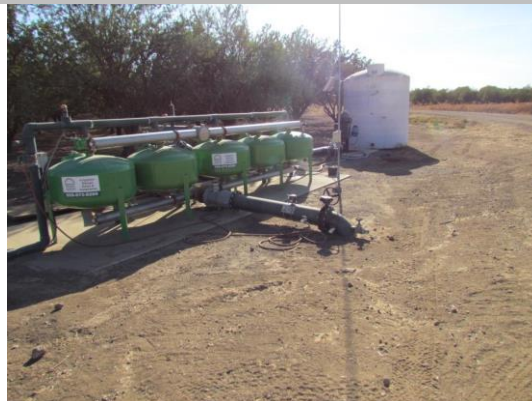
Photo 3 of 3 : FA_2019_NA0013_332_2_20190912_00003.jpg

No Permit for this filtration system and tank on the easement. 2016

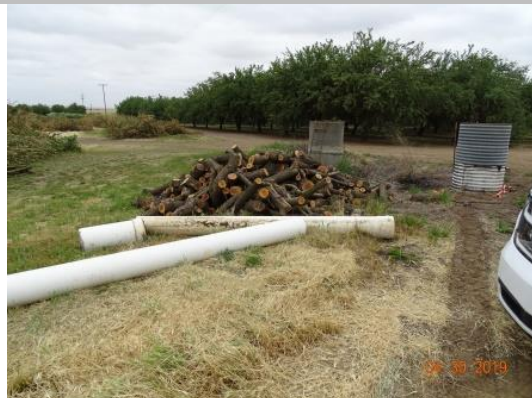
Photo 1 of 1 : FA_2019_NA0013_332_11_20190912_00004.jpg

LM Start	0.01	Rating **	U	Issue No.	11
LM End	0.01	Issue Type +	En	Location *	WS
Category	Earthen Levee			GPS Latitude/Longitude	
				Start	End
Item	Encroachments			37.337010 °	37.337010 °
				-120.387448 °	-120.387448 °
DWR ID	DWR_NA0013_02_s_2019_11				
Comment Code					
FW : Firewood					
Inspector Comment					
Landowner left wood and pipes on waterside slope.

View of wood pile and pipes on waterside slope. (Spring 2019)

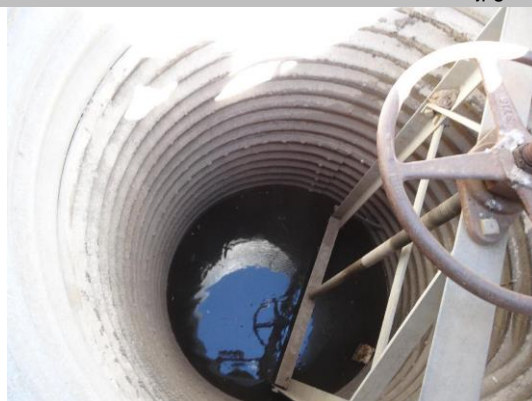
Photo 2 of 3 : UCIP_FA_2019_21263_35760.jpg

Comment Code						
Inspector Comment						
DS_ID:23052 FS_ID:21263 EP_NO: N/A Repair Type: Non-Urgent Crossing Status: Found UCIP Comments: 09/17/2013 - needs more investigations on this crossing. - new water filtration plant on LS with pump and concrete vault.- a concrete standpipe and CM pipe riser on WS. (DWR UCIP - P. Amatya) FIELD_STRUCT_DESC: 10-inch steel irrigation pipe through the levee, 5 feet below the crown. Riser on the landside (LS). Screw gate in a 36-inch pipe well on the waterside (WS) slope. [Additional Reference(s): DWR Levee Log, 2005. USACE San Joaquin O&M Manual 607, June 1962, (HLM 0.00)]. FS Date: 9/17/2013

WS view: inside view of CMP standpipe with slide gate.

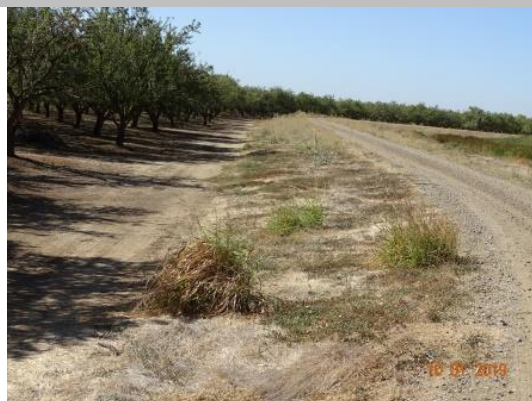
Photo 1 of 1 : FA_2019_NA0013_332_10_20191007_00042.jpg

LM Start	0.05	Rating **	M	Issue No.	10
LM End	0.14	Issue Type +	Ma	Location *	LS
Category	Earthen Levee			GPS Latitude/Longitude	
				Start	End
Item	Vegetation			37.336745 °	37.335900 °
				-120.388077 °	-120.389423 °
DWR ID	DWR_NA0013_02_f_2019_10				
Comment Code					
V1 : Control annual grass and weeds on the levee slopes and easements.					
Inspector Comment

View of landside slope looking downstream. (Fall 2019)

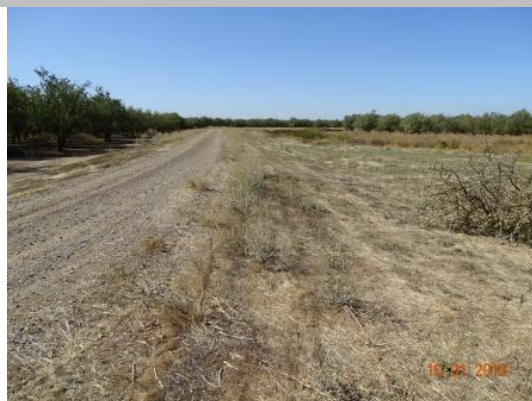
Photo 1 of 1 : FA_2019_NA0013_332_12_20191008_00043.jpg

LM Start	0.07	Rating **	M	Issue No.	12
LM End	0.48	Issue Type +	Ma	Location *	WS
Category	Earthen Levee			GPS Latitude/Longitude	
				Start	End
Item	Vegetation			37.336463 °	37.333587 °
				-120.388432 °	-120.393118 °
DWR ID	DWR_NA0013_02_f_2019_12				
Comment Code					
V1 : Control annual grass and weeds on the levee slopes and easements.					
Inspector Comment

View of waterside slope looking downstream. (Fall 2019)

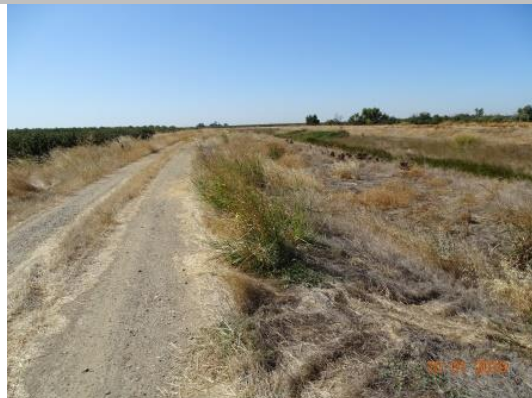
Photo 1 of 1 : FA_2019_NA0013_332_14_20191008_00045.jpg

LM Start	0.65	Rating **	U	Issue No.	14
LM End	1.10	Issue Type +	Ma	Location *	WS
Category	Earthen Levee			GPS Latitude/Longitude	
				Start	End
Item	Vegetation			37.331603°	37.325383°
				-120.394248°	-120.396020°
DWR ID	DWR_NA0013_02_f_2019_14				
Comment Code					
V1 : Control annual grass and weeds on the levee slopes and easements.					
Inspector Comment

View of waterside slope looking downstream. (Fall 2019)

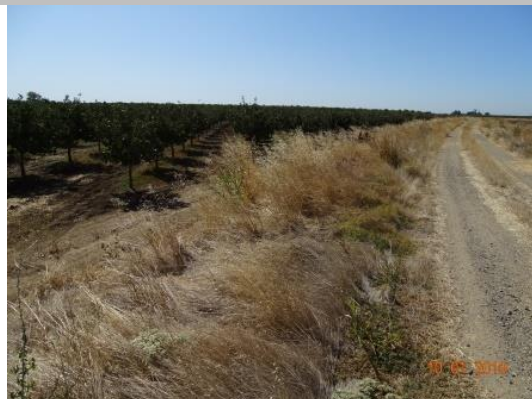
Photo 1 of 1 : FA_2019_NA0013_332_13_20191008_00046.jpg

LM Start	0.65	Rating **	U	Issue No.	13
LM End	0.93	Issue Type +	Ma	Location *	LS
Category	Earthen Levee			GPS Latitude/Longitude	
				Start	End
Item	Vegetation			37.331605 °	37.327978 °
				-120.394265 °	-120.396042 °
DWR ID	DWR_NA0013_02_f_2019_13				
Comment Code					
V1 : Control annual grass and weeds on the levee slopes and easements.					
Inspector Comment

View of landside slope looking downstream. (Fall 2019)

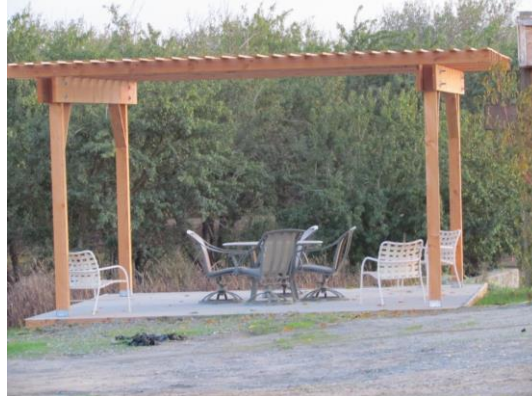
Photo 1 of 4 : FA_2019_NA0013_332_24_20190912_00011.jpg

LM Start	0.88	Rating **	U	Issue No.	24
LM End	0.88	Issue Type +	En	Location *	LS
Category	Earthen Levee			GPS Latitude/Longitude	
				Start	End
Item	Encroachments			37.328567 °	37.328567 °
				-120.396062 °	-120.396062 °
DWR ID	DWR_NA0013_02_s_2014_24				
Comment Code					
TR : Tree or limb					
Inspector Comment					
Three fruit trees with irrigation system, two stock piles of material, and a rock pad are placed on landside toe. Discovered during the fall 2014 inspection was a structure had been installed on the landward levee slope and berm. There are no permits for these encroachments.

Unauthorized encroachment placed on the landside shoulder and berm.

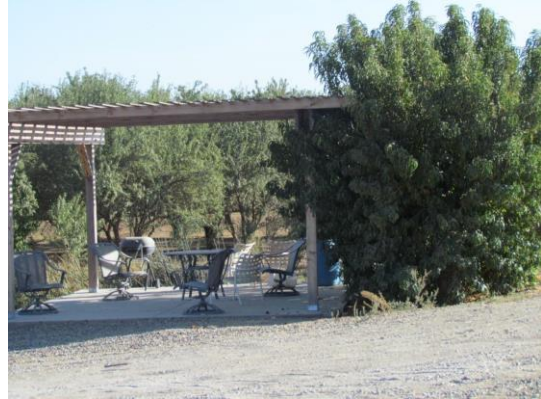
Photo 3 of 4 : FA_2019_NA0013_332_24_20190912_00013.jpg

Unit 2 looking downstream from levee mile 0.88.

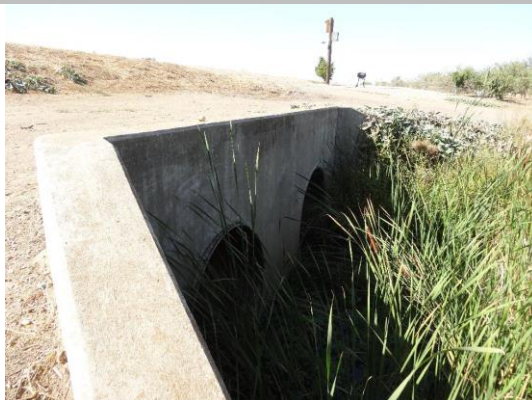
Photo 2 of 3 : UCIP_FA_2019_20983_35301.jpg

LS view: U typed concrete headwall, two CMPs in drainage ditch. Dense vegetation in drainage ditch.

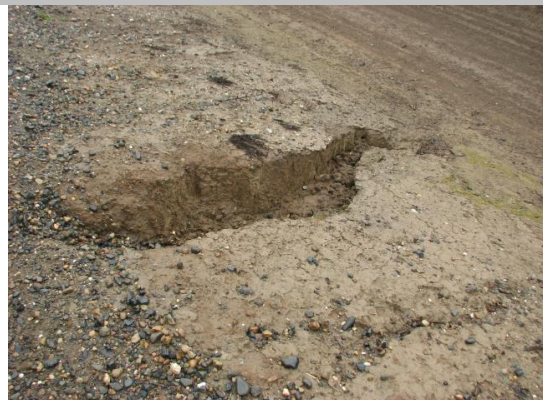
Photo 2 of 3 : FA_2019_NA0013_332_15_20190912_00006.jpg

Looking downstream at finger erosion on landward slope. (Spring 2018)

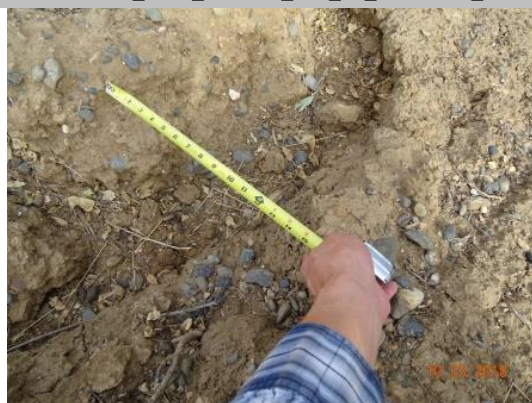
Photo 2 of 2 : FA_2019_NA0013_332_16_20190912_00009.jpg

Measurement across finger erosion. (Fall 2018)

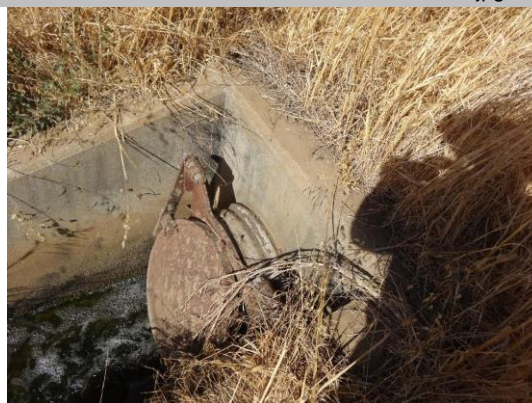
Photo 2 of 3 : UCIP_FA_2019_20984_35304.jpg

WS view: U typed concrete headwall, CM pipe, and flap gate. It was working during field inspection.

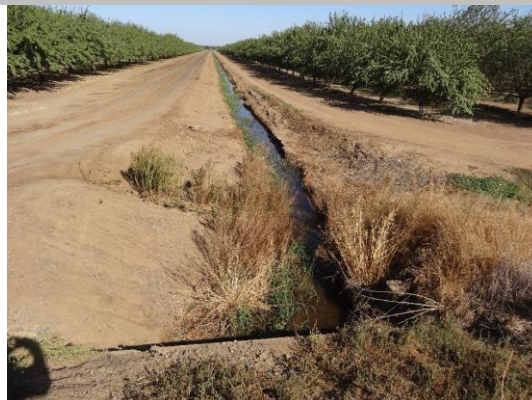
Photo 3 of 3 : UCIP_FA_2019_20984_35303.jpg

LS view: concrete headwall on levee toe and drainage ditch.

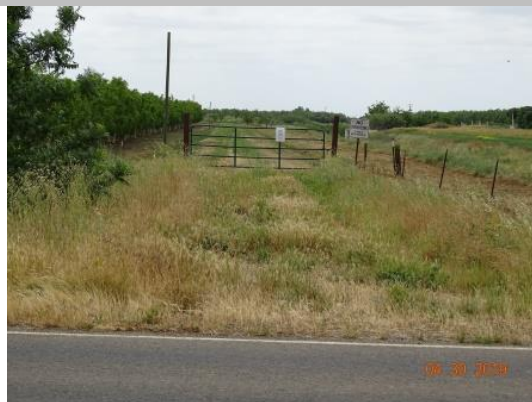
Photo 1 of 1 : FA_2019_NA0013_332_30_20190912_00017.jpg

LM Start	1.62	Rating **	M	Issue No.	30
LM End	1.66	Issue Type +	Ma	Location *	CR
Category	Earthen Levee			GPS Latitude/Longitude	
				Start	End
Item	Vegetation			37.317984 °	37.317361 °
				-120.395758 °	-120.395748 °
DWR ID	DWR_NA0013_02_s_2019_30				
Comment Code					
V9 : Keep the crown roadway free of vegetation.					
Inspector Comment

View along levee crown looking downstream. (Spring 2019)

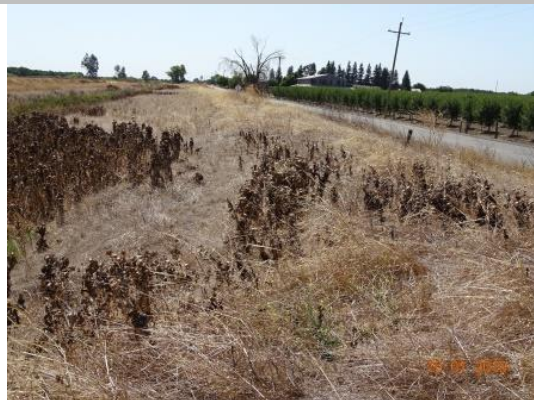
Photo 1 of 1 : FA_2019_NA0013_333_10_20191008_00027.jpg

LM Start	0.00	Rating **	U	Issue No.	10
LM End	0.34	Issue Type +	Ma	Location *	CR
Category	Earthen Levee			GPS Latitude/Longitude	
				Start	End
Item	Vegetation			37.257654 °	37.262447 °
				-120.288501 °	-120.288363 °
DWR ID	DWR_NA0013_03_f_2019_10				
Comment Code					
V9 : Keep the crown roadway free of vegetation.					
Inspector Comment

View of levee crown looking downstream. (Fall 2019)

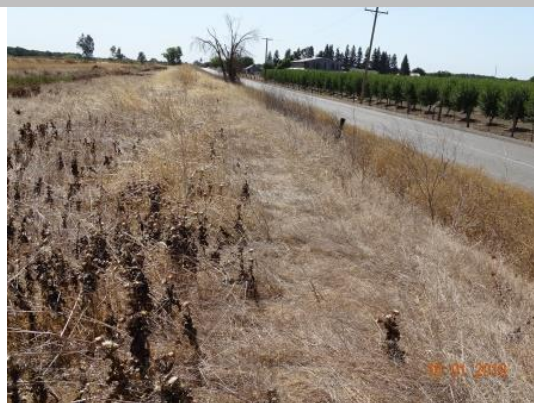
Photo 1 of 2 : FA_2019_NA0013_333_12_20191008_00030.jpg

LM Start	0.00	Rating **	U	Issue No.	12
LM End	1.27	Issue Type +	Ma	Location *	LS
Category	Earthen Levee			GPS Latitude/Longitude	
				Start	End
Item	Vegetation			37.257654 °	37.273110 °
				-120.288501 °	-120.280280 °
DWR ID	DWR_NA0013_03_f_2019_12				
Comment Code					
V1 : Control annual grass and weeds on the levee slopes and easements.					
Inspector Comment

View of landside slope looking downstream at LM 0.34. (Fall 2019)

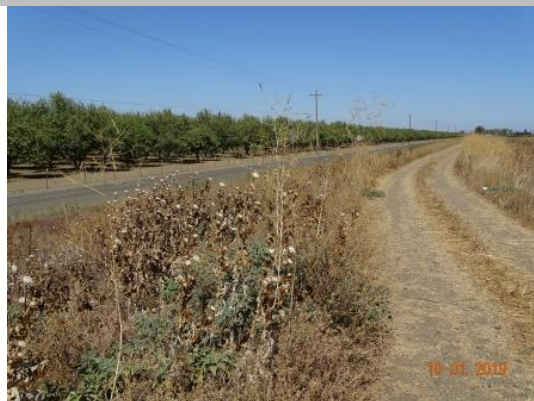
Photo 2 of 2 : FA_2019_NA0013_333_12_20191008_00031.jpg

LM Start	0.00	Rating **	U	Issue No.	12 (cont)
LM End	1.27	Issue Type +	Ma	Location *	LS

View of landside slope looking upstream at LM 0.44. (Fall 2019)

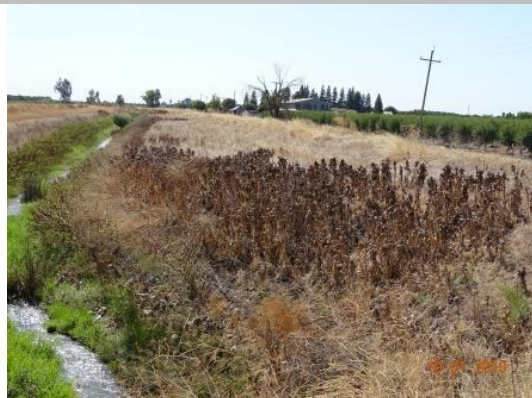
Photo 1 of 2 : FA_2019_NA0013_333_13_20191008_00028.jpg

LM Start	0.00	Rating **	U	Issue No.	13
LM End	1.27	Issue Type +	Ma	Location *	WS
Category	Earthen Levee			GPS Latitude/Longitude	
				Start	End
Item	Vegetation			37.257654 °	37.273113 °
				-120.288501 °	-120.280288 °
DWR ID	DWR_NA0013_03_f_2019_13				
Comment Code					
V1 : Control annual grass and weeds on the levee slopes and easements.					
Inspector Comment

View of waterside slope looking downstream at LM 0.34. (Fall 2019)

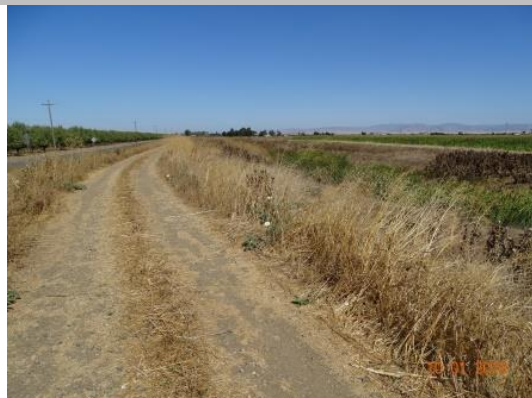
Photo 2 of 2 : FA_2019_NA0013_333_13_20191008_00029.jpg

LM Start	0.00	Rating **	U	Issue No.	13 (cont)
LM End	1.27	Issue Type +	Ma	Location *	WS

View of waterside slope looking upstream at LM 0.44. (Fall 2019)

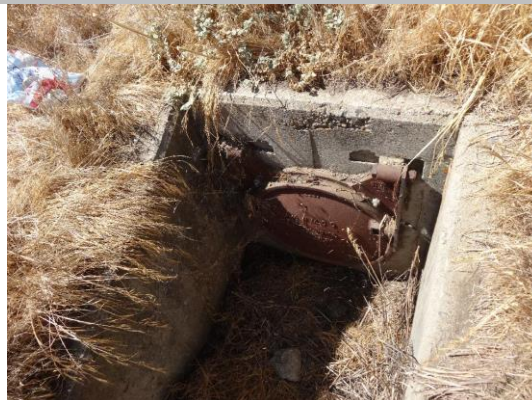
Photo 1 of 3 : UCIP_FA_2019_41815_35533.jpg

Comment Code						
Inspector Comment						
DS_ID:23060						
FS_ID:41815						
EP_NO: N/A						
Repair Type: Non-Urgent						
Crossing Status: Found						
UCIP Comments: 09/17/2013 - more than a half of inet pipe burried on						
LS. - needs vegetation cleaning on both sides.- inlet needs silt						
removed and cleaning. (DWR UCIP - P. Amatya)						
FIELD_STRUCT_DESC: 24-inch corrugated metal gravity drainage pipe						
through the levee, 6 feet below the crown. Concrete headwall, flap gate,						
and concrete grouted cobble spillway on the waterside (WS) toe.						
Concrete headwall on the landside (LS) toe. [Additional Reference(s):						
DWR Levee Log, 2005. USACE San Joaquin O&M Manual 607, June						
1962, (HLM 0.18)].						
FS Date: 9/17/2013

WS view: U typed concrete headwall, CM pipe, and flap gate.

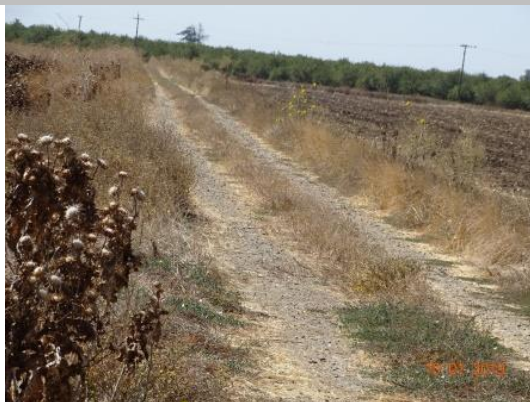
Photo 1 of 1 : FA_2019_NA0013_333_18_20191008_00032.jpg

LM Start	0.44	Rating **	M	Issue No.	18
LM End	1.27	Issue Type +	Ma	Location *	CR
Category	Earthen Levee			GPS Latitude/Longitude	
				Start	End
Item	Vegetation			37.263977 °	37.273125 °
				-120.288480 °	-120.280300 °
DWR ID	DWR_NA0013_03_f_2019_18				
Comment Code					
V9 : Keep the crown roadway free of vegetation.					
Inspector Comment

View of levee crown looking upstream. (Fall 2019)

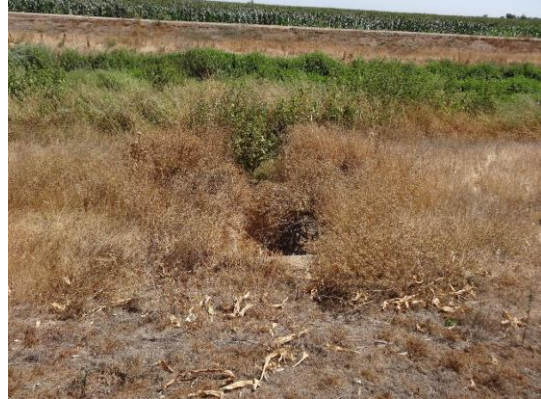
Photo 1 of 3 : UCIP_FA_2019_50151_35539.jpg

Comment Code						
Inspector Comment						
DS_ID:23063 FS_ID:50151 EP_NO: N/A Repair Type: No Action Needed Crossing Status: Found UCIP Comments: 09/2016: LS and WS ends have been cleared by NA0013 and crossing has been downgraded to No Action Needed. (K. Fazel - UCIP)09/2013: Needs vegetation clearing on WS. (P. Amatya - UCIP) FIELD_STRUCT_DESC: 24-inch corrugated metal gravity drainage pipe through the levee, 6.5 feet below the crown. Concrete headwall, flap gate, and concrete grouted cobble spillway on the waterside (WS) toe. Concrete headwall on the landside (LS) toe. [Additional Reference(s): DWR Levee Log, 2005. USACE San Joaquin O&M Manual 607, June 1962, (HLM 0.80), referenced as 10 feet below the crown]. FS Date: 9/7/2016

WS view: overview of spillway/outlet area on waterside.

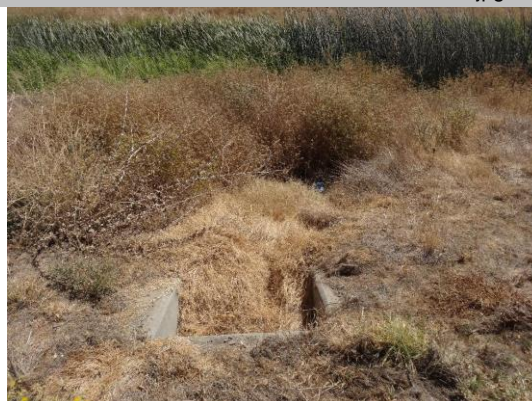
Photo 1 of 3 : UCIP_FA_2019_50152_35544.jpg

Comment Code						
Inspector Comment						
DS_ID:23064 FS_ID:50152 EP_NO: N/A Repair Type: Non-Urgent Crossing Status: Found UCIP Comments: 09/29/2016: WS outlet has been cleared by NA0013. Crossing will be downgraded from Non-Urgent to No Action Needed upon receipt of photo showing cleared LS. (K. Fazel - UCIP)09/2013:- vegetations need to be removed from spillway and outlet at flapgate (blocked). It needs clearing.- more than half of intet pipe was burried in inlet. It needs cleaning & clearing. (P. Amatya - UCIP) FIELD_STRUCT_DESC: 24-inch corrugated metal gravity drainage pipe through the levee, 5 feet below the crown. Concrete headwall, flap gate, and concrete grouted cobble spillway on the waterside (WS) toe. Concrete headwall on the landside (LS) toe. [Additional Reference(s): DWR Levee Log, 2005. USACE San Joaquin O&M Manual 607, June 1962, (HLM 1.04), O&M Manual reads "HLM 0.04" by mistake]. FS Date: 9/7/2016

WS view: cobble spillway and channel on waterside.

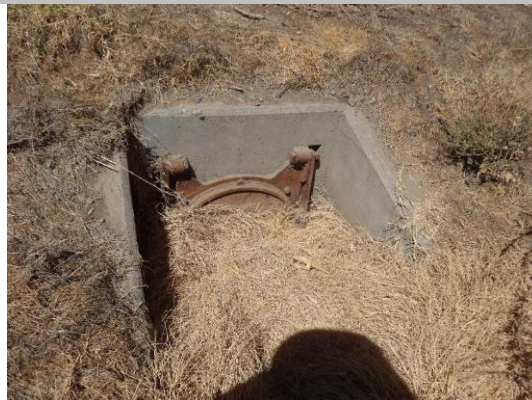
Photo 2 of 3 : UCIP_FA_2019_50152_35543.jpg

Comment Code						
Inspector Comment						
DS_ID:23064 FS_ID:50152 EP_NO: N/A Repair Type: Non-Urgent Crossing Status: Found UCIP Comments: 09/29/2016: WS outlet has been cleared by NA0013. Crossing will be downgraded from Non-Urgent to No Action Needed upon receipt of photo showing cleared LS. (K. Fazel - UCIP)09/2013:- vegetations need to be removed from spillway and outlet at flapgate (blocked). It needs clearing.- more than half of inlet pipe was buried in inlet. It needs cleaning & clearing. (P. Amatya - UCIP) FIELD_STRUCT_DESC: 24-inch corrugated metal gravity drainage pipe through the levee, 5 feet below the crown. Concrete headwall, flap gate, and concrete grouted cobble spillway on the waterside (WS) toe. Concrete headwall on the landside (LS) toe. [Additional Reference(s): DWR Levee Log, 2005. USACE San Joaquin O&M Manual 607, June 1962, (HLM 1.04), O&M Manual reads "HLM 0.04" by mistake]. FS Date: 9/7/2016

WS view: U typed concrete headwall, CM pipe, and flap gate. Vegetation needs to be cleared.

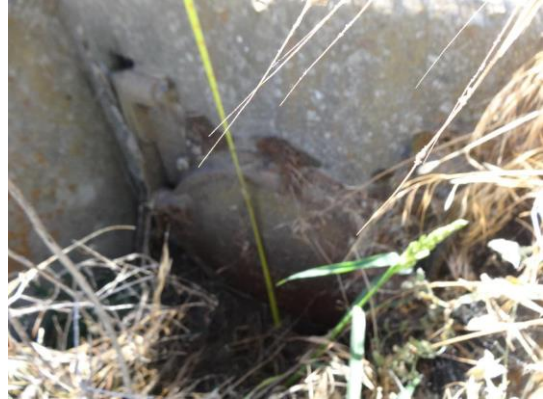
Photo 2 of 3 : UCIP_FA_2019_42991_35750.jpg

Comment Code						
Inspector Comment						
DS_ID:23068						
FS_ID:42991						
EP_NO: N/A						
Repair Type: Non-Urgent						
Crossing Status: Found						
UCIP Comments: 09/17/2013 - needs vegetation clearing on both sides. Flapgate blocked by debris on WS. - inlet and outlet need silt clearing and cleaning. (DWR UCIP - P. Amatya)						
FIELD_STRUCT_DESC: 24-inch corrugated metal gravity drainage pipe through the levee, 5 feet below the crown. Concrete headwall, flap gate, and concrete grouted cobble spillway on the waterside (WS) toe.						
Concrete headwall on the landside (LS) toe. [Additional Reference(s): DWR Levee Log, 2005. USACE San Joaquin O&M Manual 607, June 1962, (HLM 0.10)].						
FS Date: 9/17/2013

WS view: U typed concrete headwall, CM pipe, and flap gate. Vegetation and silt need to be cleared.

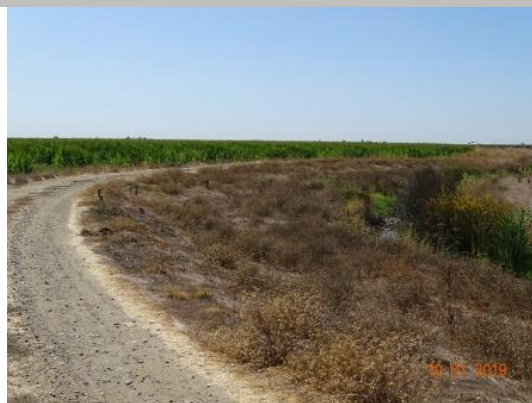
Photo 1 of 1 : FA_2019_NA0013_334_15_20191008_00033.jpg

LM Start	0.15	Rating **	U	Issue No.	15
LM End	1.02	Issue Type +	Ma	Location *	WS
Category	Earthen Levee			GPS Latitude/Longitude	
				Start	End
Item	Vegetation			37.272823 °	37.263038 °
				-120.279993 °	-120.287805 °
DWR ID	DWR_NA0013_04_f_2019_15				
Comment Code					
V1 : Control annual grass and weeds on the levee slopes and easements.					
Inspector Comment

Looking downstream along waterside slope. (Fall 2019)

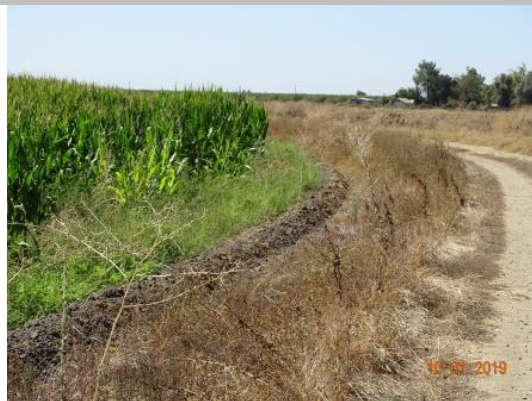
Photo 1 of 1 : FA_2019_NA0013_334_16_20191008_00034.jpg

LM Start	0.15	Rating **	U	Issue No.	16
LM End	0.81	Issue Type +	Ma	Location *	LS
Category	Earthen Levee			GPS Latitude/Longitude	
				Start	End
Item	Vegetation			37.272808 °	37.265972 °
				-120.280003 °	-120.287727 °
DWR ID	DWR_NA0013_04_f_2019_16				
Comment Code					
V1 : Control annual grass and weeds on the levee slopes and easements.					
Inspector Comment

Looking downstream along landside slope. (Fall 2019)

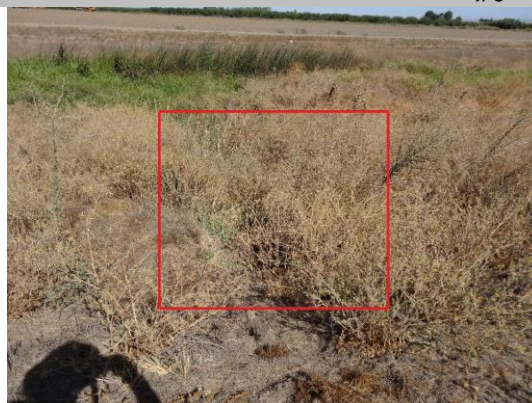
Photo 1 of 3 : UCIP_FA_2019_50154_35608.jpg

WS view: Dense vegetation on levee slope and spillway.

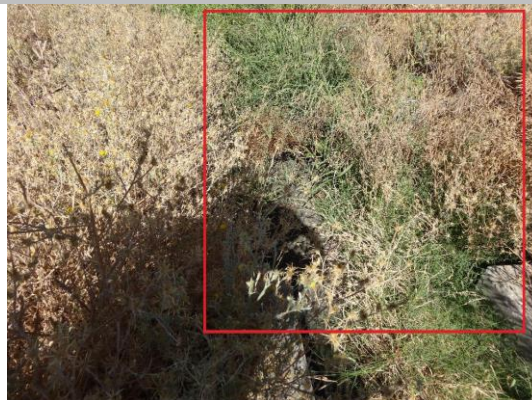
Photo 1 of 3 : UCIP_FA_2019_50148_35613.jpg

WS view: Dense vegetation on levee slope and spillway.

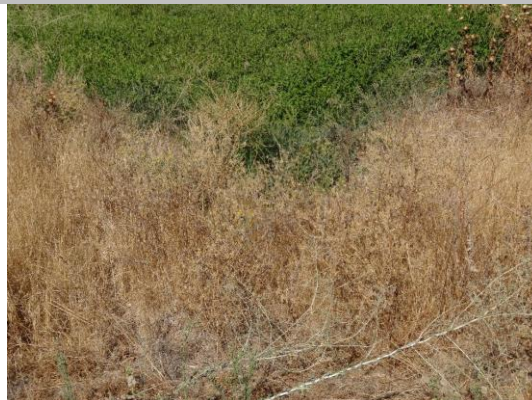
Photo 1 of 3 : UCIP_FA_2019_50155_35642.jpg

WS view: Dense vegetation on levee slope and spillway.

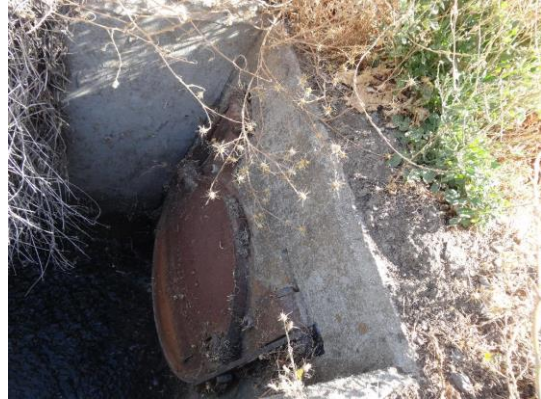
Photo 2 of 3 : UCIP_FA_2019_21126_35651.jpg

WS view: U typed concrete headwall, CM pipe, and flap gate. Vegetation needs to be cleared on spillway.

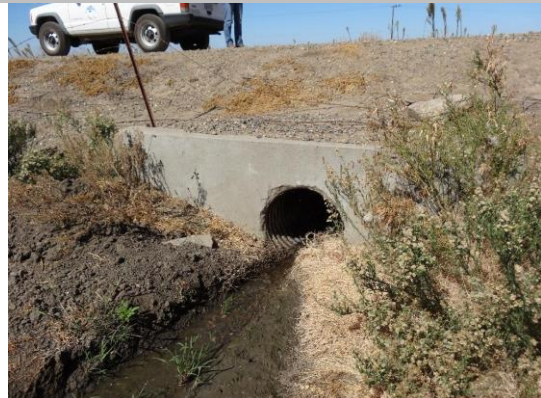
Photo 3 of 3 : UCIP_FA_2019_21126_35654.jpg

LS view: concrete headwall and CM pipe. Drain pipe was working during field survey.

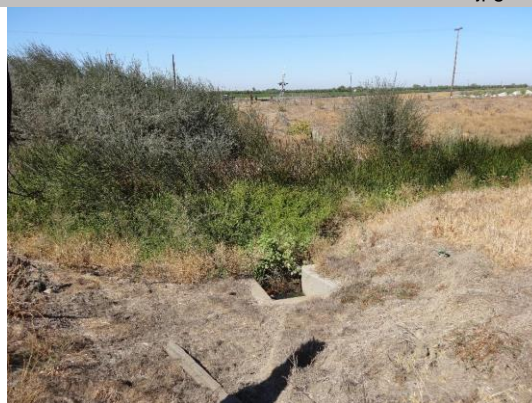
Photo 1 of 3 : UCIP_FA_2019_21127_35657.jpg

Comment Code						
Inspector Comment						
DS_ID:23074						
FS_ID:21127						
EP_NO: N/A						
Repair Type: No Action Needed						
Crossing Status: Found						
UCIP Comments: 09/17/2013 - concrete spillway on waterside.- drainage was working during field survey (DWR UCIP - P. Amatya).						
FIELD_STRUCT_DESC: 24-inch corrugated metal gravity drainage pipe through the levee, 8 feet below the crown. Concrete headwall, flap gate, and concrete grouted cobble spillway on the waterside (WS) toe.						
Concrete headwall on the landside (LS) toe. [Additional Reference(s): DWR Levee Log, 2005. USACE San Joaquin O&M Manual 607, June 1962, (HLM 1.02)].						
FS Date: 9/17/2013

WS view: U typed concrete headwall and channel on waterside.

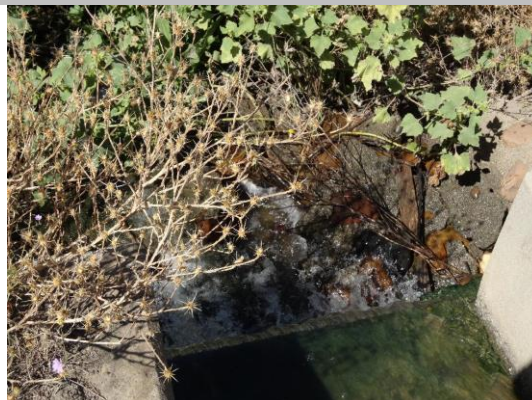
Photo 2 of 3 : UCIP_FA_2019_21127_35656.jpg

WS view: concrete headwall and concrete spillway on waterside.

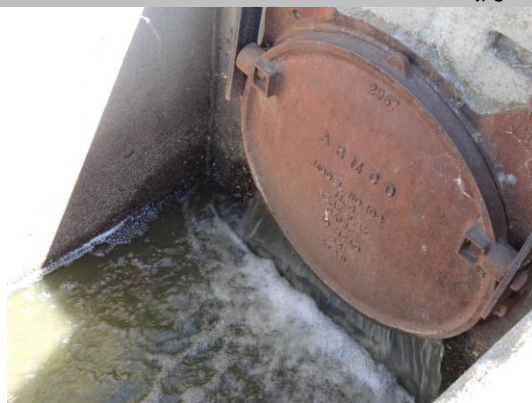
Photo 3 of 3 : UCIP_FA_2019_21127_35655.jpg

LM Start	1.01	Rating **	A/W	Issue No.	32 (cont)	
LM End	1.01	Issue Type +	Ma	Location *		
Category	Supplemental			GPS Latitude/Longitude		
				Start	End	
Item	DRAFT DWR UCIP LMA Responsibility			37.263139°	37.263139°	
				-120.287799°	-120.287799°	
DWR ID	23074					
Comment Code						
Inspector Comment						
DS_ID:23074 FS_ID:21127 EP_NO: N/A Repair Type: No Action Needed Crossing Status: Found UCIP Comments: 09/17/2013 - concrete spillway on waterside.- drainage was working during field survey (DWR UCIP - P. Amatya). FIELD_STRUCT_DESC: 24-inch corrugated metal gravity drainage pipe through the levee, 8 feet below the crown. Concrete headwall, flap gate, and concrete grouted cobble spillway on the waterside (WS) toe. Concrete headwall on the landside (LS) toe. [Additional Reference(s): DWR Levee Log, 2005. USACE San Joaquin O&M Manual 607, June 1962, (HLM 1.02)]. FS Date: 9/17/2013

WS view: U typed concrete headwall, CM pipe, and flap gate. Drainage was working during survey.

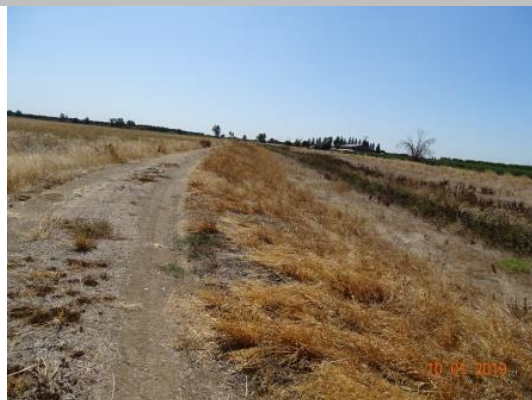
Photo 1 of 1 : FA_2019_NA0013_334_11_20191008_00035.jpg

LM Start	1.07	Rating **	U	Issue No.	11
LM End	1.29	Issue Type +	Ma	Location *	WS
Category	Earthen Levee			GPS Latitude/Longitude	
				Start	End
Item	Vegetation			37.262302°	37.259153°
				-120.288180°	-120.288157°
DWR ID	DWR_NA0013_04_f_2019_11				
Comment Code					
V1 : Control annual grass and weeds on the levee slopes and easements.					
Inspector Comment

View of waterside slope looking downstream. (Fall 2019)

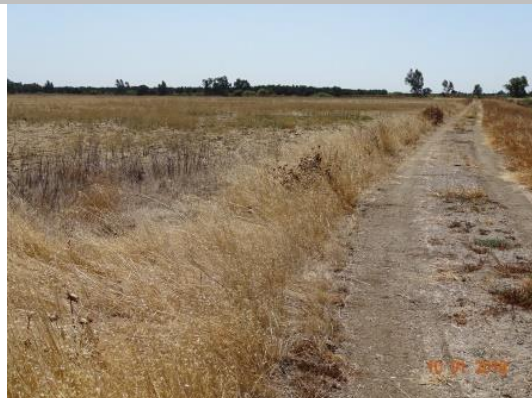
Photo 1 of 1 : FA_2019_NA0013_334_12_20191008_00036.jpg

LM Start	1.07	Rating **	U	Issue No.	12
LM End	1.36	Issue Type +	Ma	Location *	LS
Category	Earthen Levee			GPS Latitude/Longitude	
				Start	End
Item	Vegetation			37.262297 °	37.258048 °
				-120.288167 °	-120.287970 °
DWR ID	DWR_NA0013_04_f_2019_12				
Comment Code					
V1 : Control annual grass and weeds on the levee slopes and easements.					
Inspector Comment

View of landside slope looking downstream. (Fall 2019)

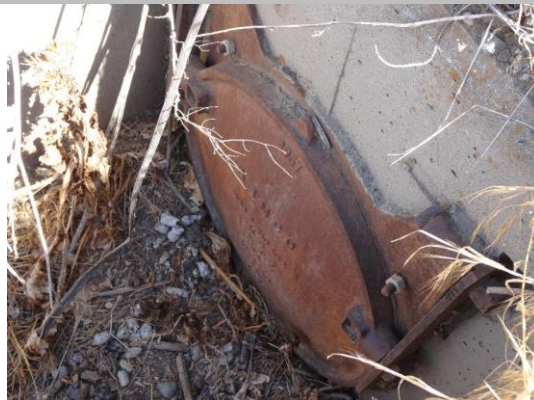
Photo 2 of 3 : UCIP_FA_2019_52888_35708.jpg

WS view: U typed concrete headwall, CM pipe, and flap gate. Spillway needs to be cleared.

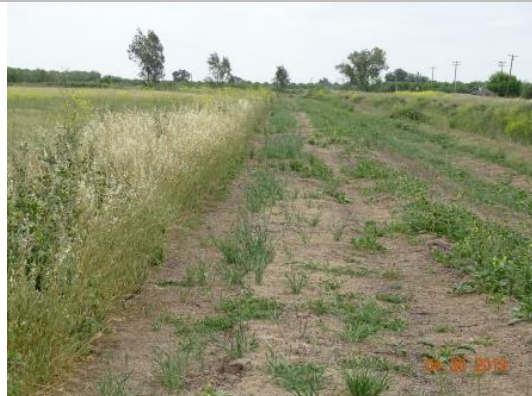
Photo 1 of 1 : FA_2019_NA0013_334_14_20190912_00002.jpg

LM Start	1.08	Rating **	M	Issue No.	14
LM End	1.25	Issue Type +	Ma	Location *	CR
Category	Earthen Levee			GPS Latitude/Longitude	
				Start	End
Item	Vegetation			37.262196°	37.259628°
				-120.288137°	-120.288132°
DWR ID	DWR_NA0013_04_s_2019_14				
Comment Code					
V9 : Keep the crown roadway free of vegetation.					
Inspector Comment

View of vegetation along levee crown. (Spring 2019)
